FOREVER HOME INSPECTION - OKLAHOMA

RESIDENTIAL REAL ESTATE INSPECTION REPORT

1234 Main St. Beggs OK 74421

06/12/2021 9:00AM

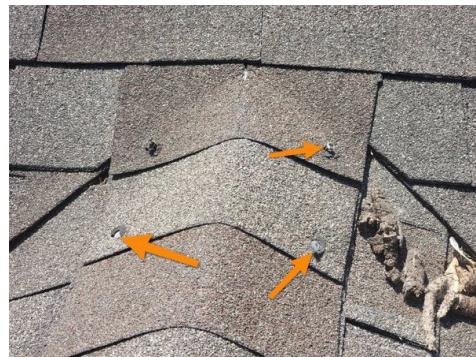
North

Exposed nail heads were present on the shingles in the referenced area(s). Sealing any exposed nail heads is recommended to be conducted by a qualified roofing professional to prevent the possibility of leaks.

Defect - Medium Concern

Contact a qualified roofing professional.

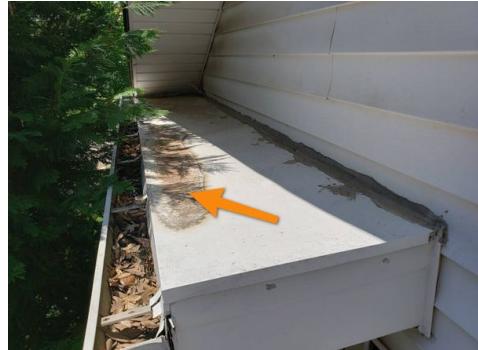
East

The referenced surfaces appeared to have been holding water at one time. This may be due to improper pitch and can lead to water penetration. Recommend further evaluation and repair be a qualified roofing contractor.

Contact a qualified roofing professional.

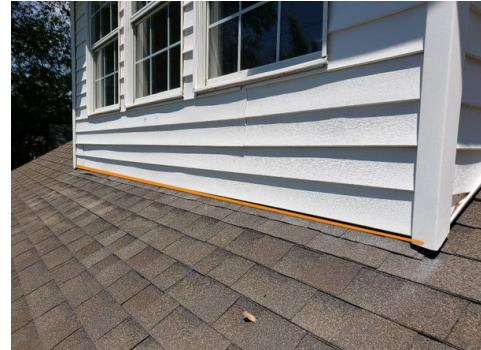
South

APRON FLASHING- MISSING

The apron flashing was found to be missing. Recommend evaluation and repair be performed by a qualified roofing contractor.

Contact a qualified roofing professional.

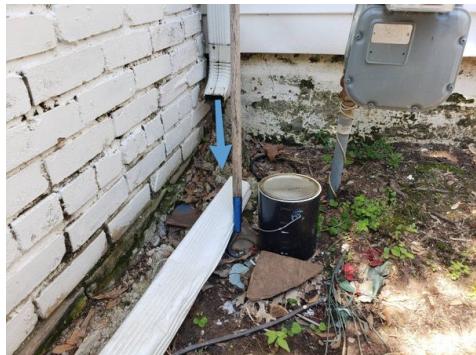
Southeast

DOWNSPOUTS TERMINATING NEAR FOUNDATION

There were downspouts present that were discharging next to the foundation of the home. It is recommended they divert away from the foundation to prevent gradient erosion and/or potential foundation issues over time. Installation of downspout extensions are recommended by a qualified person where needed.

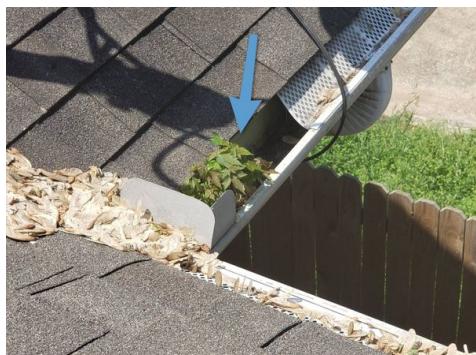
West

A heavy amount of leaves and organic debris was present in the gutters. This can create blockages in the downspouts, allowing water to overflow the gutters. Cleaning/removal of any debris in the guttering is recommended by a qualified person as soon as possible.

Contact a qualified professional.

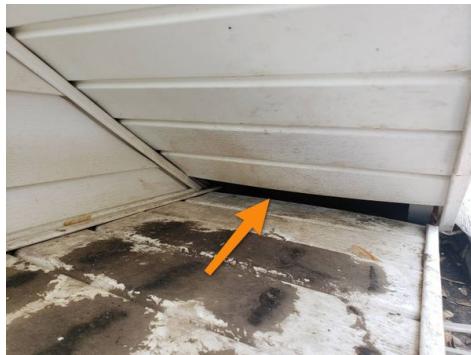
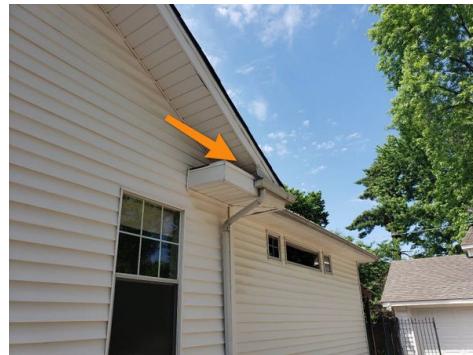
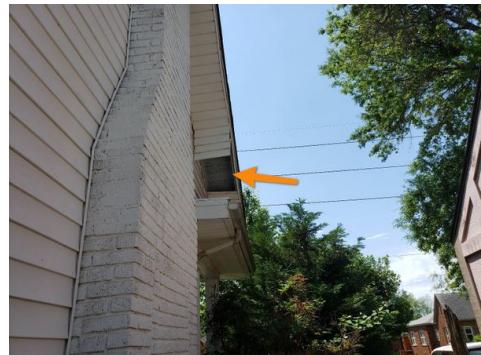
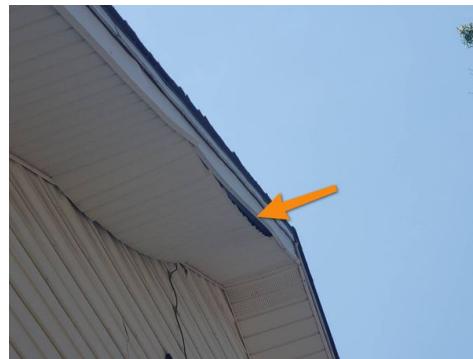
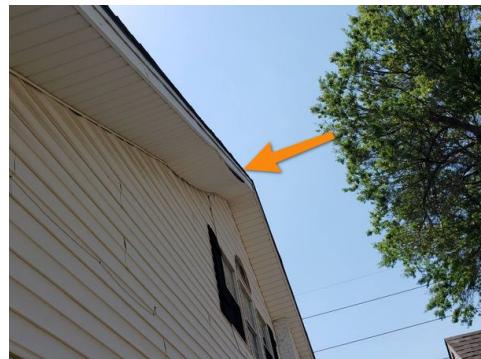
Soffits was found damaged in the represented areas. It is recommended a qualified contractor repair/replace as necessary.

Contact a qualified siding specialist.

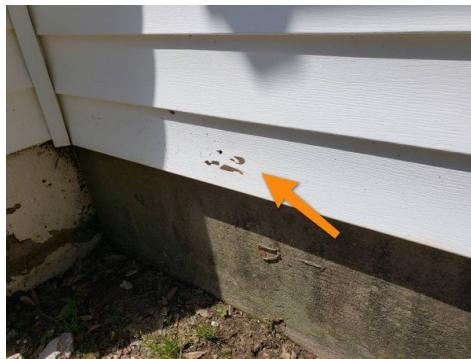
East

VINYL SIDING DAMAGE

There was some degree of damage present to areas of the vinyl siding (holes, cracks, etc.). Repairs or replacement of damaged sections is recommended to be conducted as needed by qualified siding contractor.

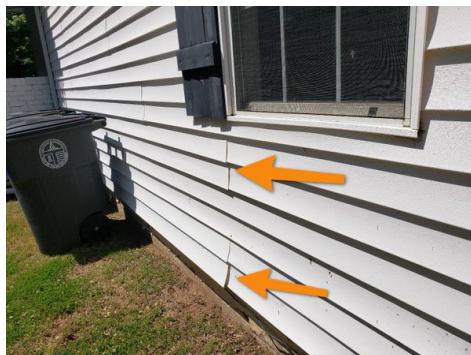
East

The vinyl siding was not lapped properly in areas creating a gap between the pieces. This can allow for rainwater infiltration behind the siding. Repairs are recommended as needed by a qualified siding contractor to prevent water infiltration.

Contact a qualified siding specialist.

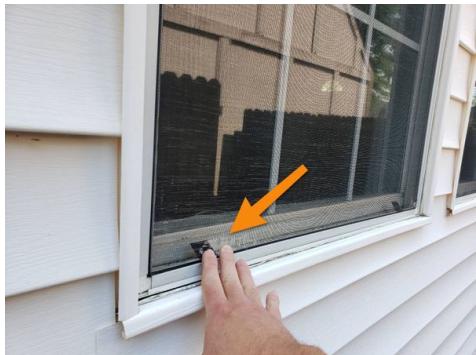
West

SCREENS-MISSING/DAMAGED

Multiple windows were observed with damaged and/or missing screens. Replacement of screens are recommended as needed.

Contact a qualified professional.

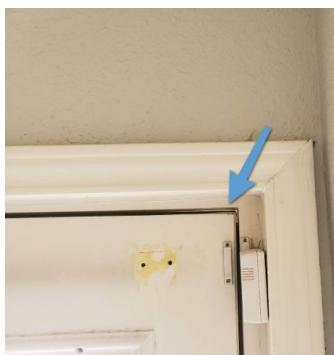
Kitchen

Light was visible around the door(s) while closed. Adjustments or modifications are recommended to be conducted as needed to eliminate any visible light for energy efficiency by a qualified person. This may require the addition of weatherstripping and/or re-setting of the door.

Contact a qualified handyman.

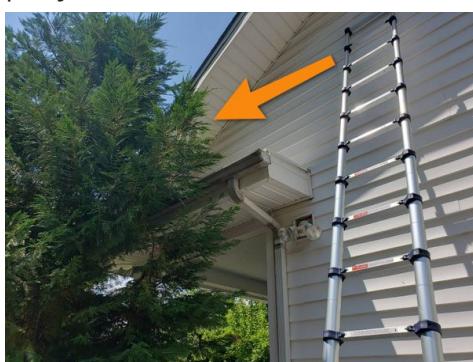
East

Tree were contacting the roof surface. These limbs can abrade the shingles causing damage, as well as holding moisture against the roof surface. Recommend a qualified tree contractor evaluate further for repair.

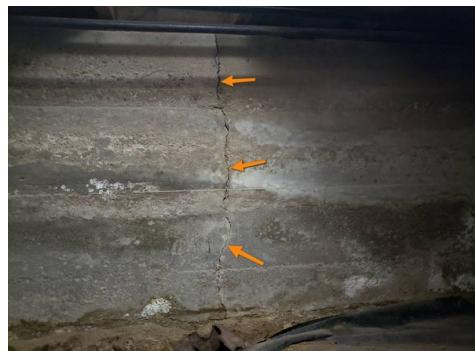
Crawlspace East

STRUCTURE - CRACKING PRESENT

Cracks were present in the foundation at the referenced areas.

Evaluation and repairs are recommended as needed by a structural contractor.

Contact a qualified structural engineer.

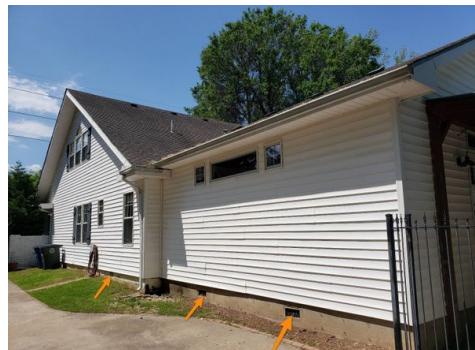
East

There were closed or blocked off ventilation openings present in the crawl space. At least one sq. ft of ventilation is recommended for every 150 sq. ft of crawl space area, this can be reduced to one sq. ft for every 1500 sq. ft with a continuous vapor barrier installed. Opening or removing blockages of the ventilation openings is recommended to be conducted by a qualified person.

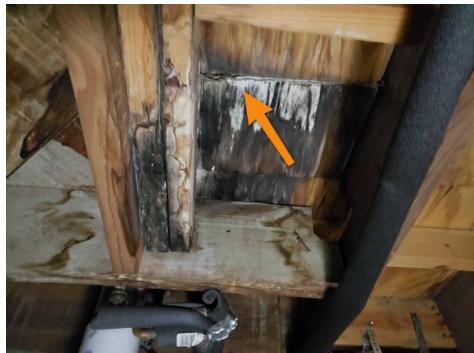
Crawlspace East

ACTIVE LEAK

There was an active leak from an unknown source at the time of inspection. Presumed from 1st Floor Bathroom. Recommend evaluation and repair by a qualified plumbing contractor.

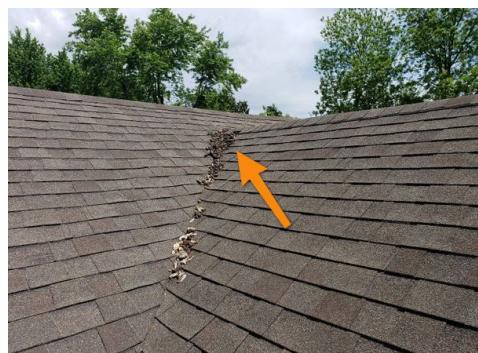
South

Presumed raccoon feces was present on the roof. Recommend evaluation by qualified pest control professional.

Contact a qualified pest control specialist.

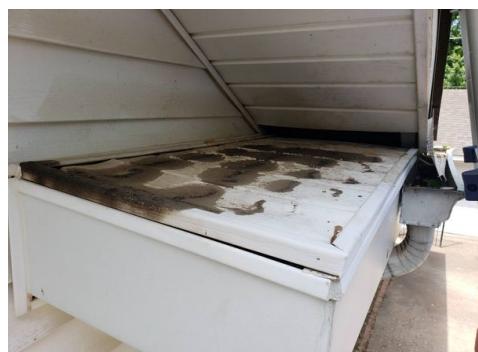
Possible Entrance

There were indications of a Raccoon residing within a wall of the structure. Indications include heat signature within wall, audible vocalizations and movement, and hair/ tracks present near opening. Recommend evaluation and correction by a qualified pest control professional.

Contact a qualified pest control specialist.

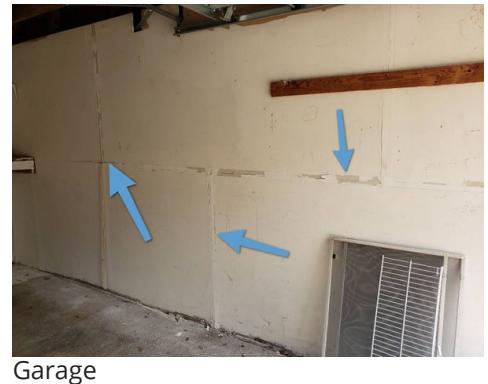
Garage

DRYWALL JOINT CRACKING

Crack(s) were present at drywall joints on the ceiling and/or walls In the garage. This can be caused by expansion and contraction of building materials, or standard settlement. If a concern have a drywall contractor to evaluate for repair.

Contact a qualified drywall contractor.

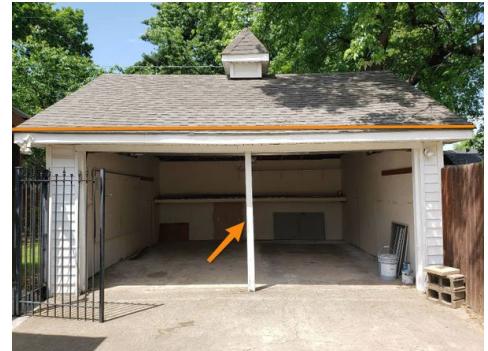
Garage

The framing above the garage door opening appeared to be sagging. Presumed previous owners propped up with post. Recommend further evaluation by Structural Engineer.

Contact a qualified structural engineer.

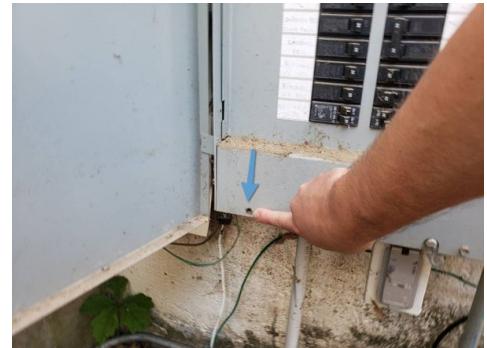
West, Sub Panel

MISSING SCREW LOCATIONS

There were screw hole location(s) that secure the panel cover to the panelboard that were missing. Repairs are recommended as needed to allow for proper securing of the panel cover by a qualified person.

Contact a qualified electrical contractor.

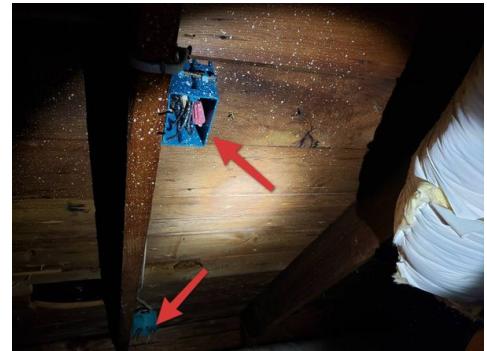
Attic

ELECTRICAL BOX - MISSING COVER

There were electrical box(es) present without a cover. This is a potential electrocution hazard, and can be a fire hazard when the box is located near combustibles, due to the possibility of arcing. The installation of UL listed cover(s) is recommended to be conducted by a licensed electrician on any and all electrical boxes in the home missing covers.

Contact a qualified electrical contractor.

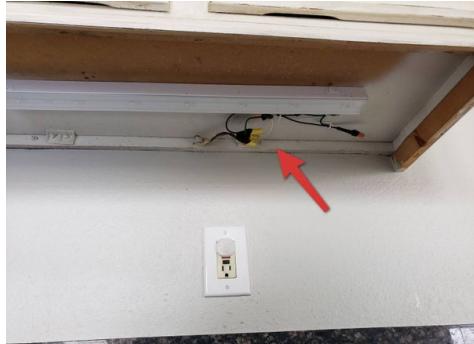
Kitchen

There were wiring connection(s) present that were made outside of an electrical box. This can be a potential fire or electrocution hazard. Any wiring connections made outside of an electrical box in the home are recommended to be made in a proper box by a licensed electrician.

Contact a qualified electrical contractor.

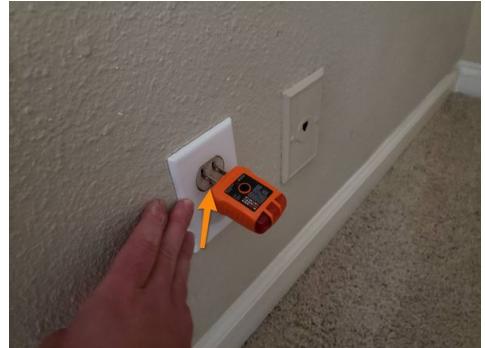
2nd Floor West Bedroom Closet

A foreign object was present in a receptacle slot. Repairs are recommended as needed by a licensed electrician for proper operation of the receptacle.

Contact a qualified electrical contractor.

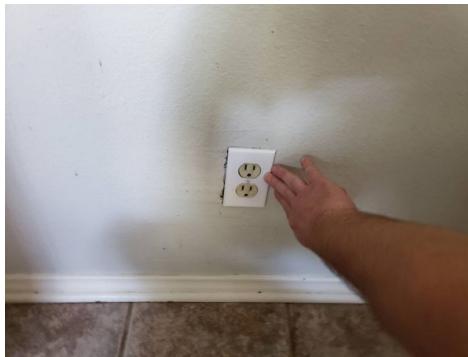
Kitchen

RECEPTACLE LOOSE IN WALL

There were receptacle(s) present that were loose in the wall. Proper securement of any loose receptacles is recommended to be conducted by a licensed electrician to prevent loose wire connections.

Contact a qualified electrical contractor.

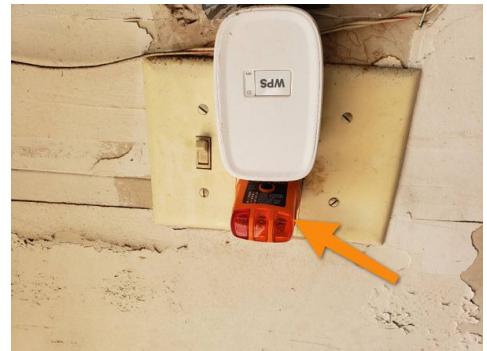
Garage

There were receptacle(s) present in the referenced areas that were not functional at the time of inspection. Evaluation for repairs or replacement as needed for proper operation is recommended to be performed by a licensed electrician.

Contact a qualified electrical contractor.

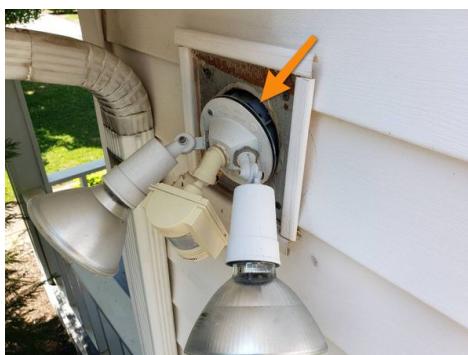
Southeast

There were exterior light(s) present that were not secured properly. Repairs are recommended to be performed as needed to properly secure the fixture(s) by a licensed electrician or other qualified person.

Contact a qualified electrical contractor.

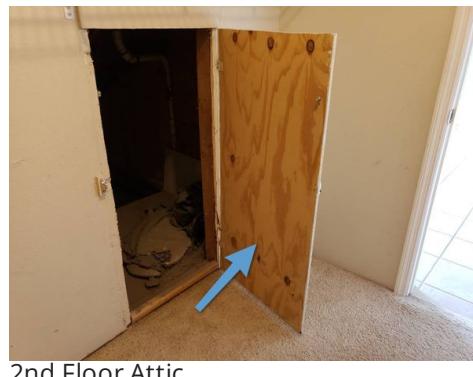
2nd Floor Attic

The scuttle panel was not insulated and/or weatherstripped around the opening. This can affect energy efficiency. I recommend placing weatherstripping around the attic opening, and adhering a batt of R-30 insulation or foamboard to the backside of the cover for energy savings.

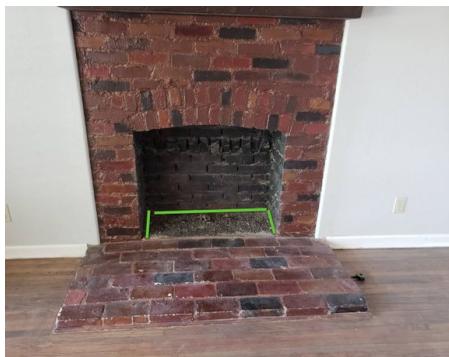
Living Room

Fireplace(s): Shallow Depth Firebox

A shallow depth fireplace was present. These were common in older homes, when homes actually relied on fireplaces for the homes main heating source. These shallow depth fireplaces allowed for a hotter, more efficient fire. Today's fireplaces have a deeper firebox that produces a longer lasting fire. Modifications may have to be made for these fireplaces to convert to a gas log style. <https://www.curbed.com/2016/3/24/11300930/rumford-fireplace-design-historic-home>

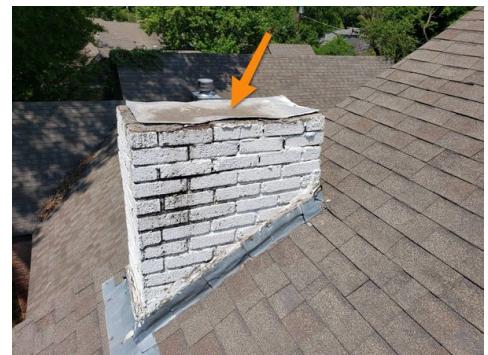
South

The fireplace was not in use and should not be attempted to be used until evaluation and repairs have been conducted as deemed necessary by a qualified chimney sweep.

Contact a qualified chimney contractor.

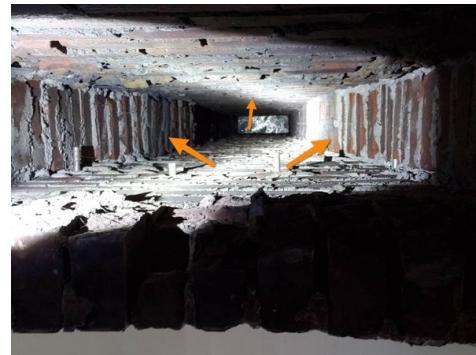
Living Room

The chimney was unlined at visible portions. Though common in older homes, an unlined chimney can affect proper drafting, efficiency, damage masonry, and increase the likelihood of a house fire. An evaluation of the chimney with the installation of a liner made as needed is recommended by a qualified chimney sweep. More information can be found at this link:<https://american-chimney.com/problems-due-unlined-chimney/>

Contact a qualified chimney contractor.

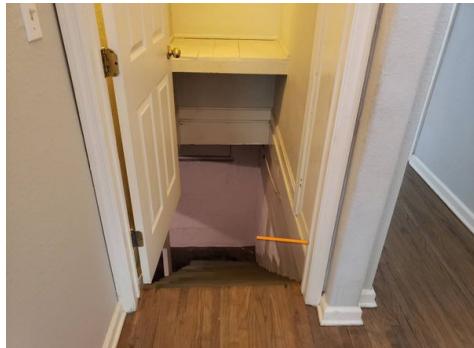
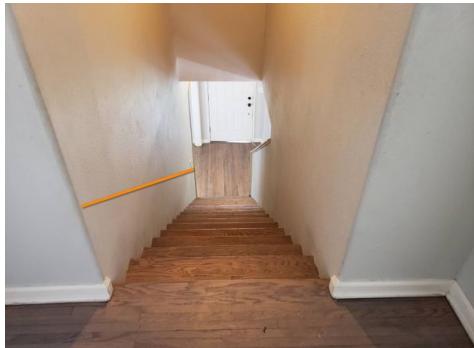
CONTINUOUS HANDRAIL MISSING

A continuous handrail was not present. Current safety standards require that handrails are continuous for the full length of the flight of stairs, measured from a point directly above the top riser to a point directly above the lowest riser of the flight, and can only be interrupted by a newel post. Safety upgrades are recommended to be performed here by a qualified contractor for safety.

Contact a qualified professional.

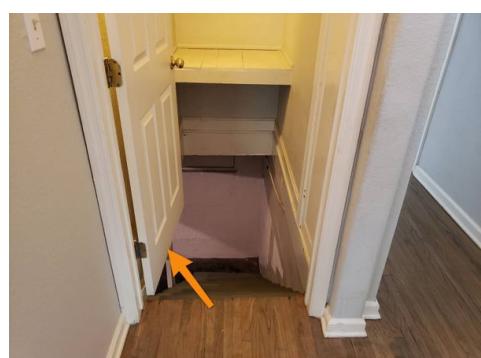
Basement

A door was present that swung open over the stairs. For the door to open in this orientation a 36 inch deep landing would have to be in place at the top of the stairs. A door that opens into the home (not over the stairs) is recommended to be installed by a qualified person for safety.

Contact a qualified professional.

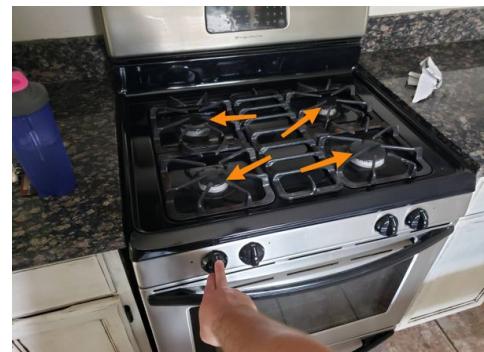
Kitchen

RANGE - BURNERS WOULD NOT IGNITE

The gas burners did not ignite for the range. Repairs are recommended as needed for proper operation by an appliance repair company or other qualified person.

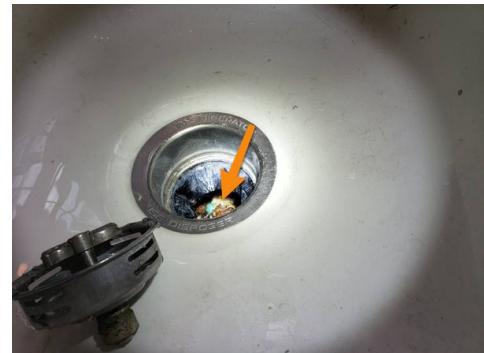
Kitchen

The garbage disposal unit made an irregular noise when operated. Repairs are recommended to be conducted as needed by a qualified person for proper operation.

Contact a qualified plumbing contractor.

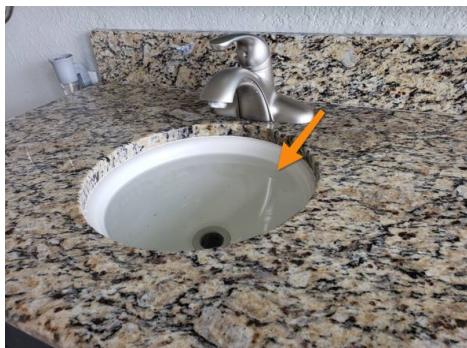
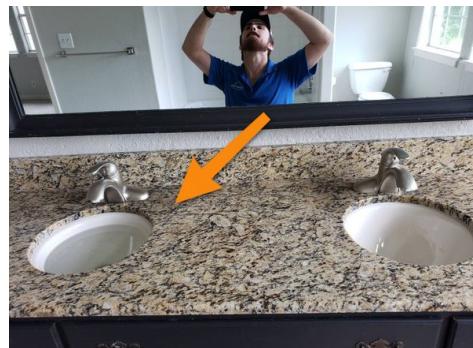
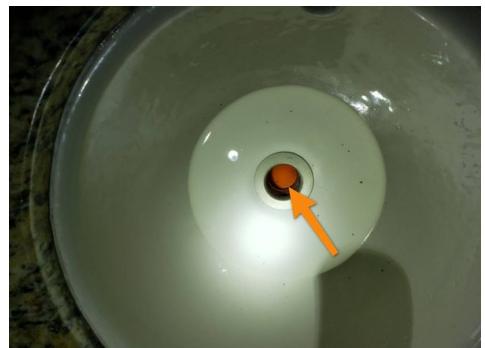
2nd Floor Bathroom

- Defect - Medium Concern

Contact a qualified plumbing contractor.

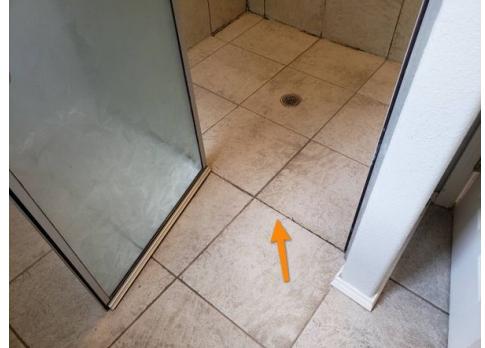
1st Floor Bathroom

- Defect - Medium Concern

Contact a qualified professional.

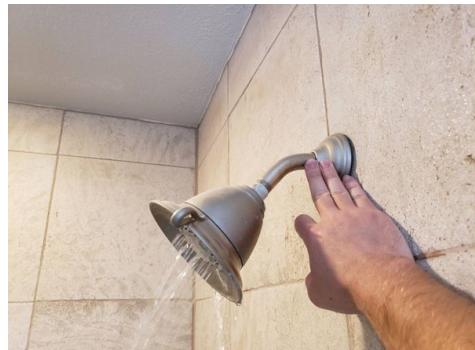
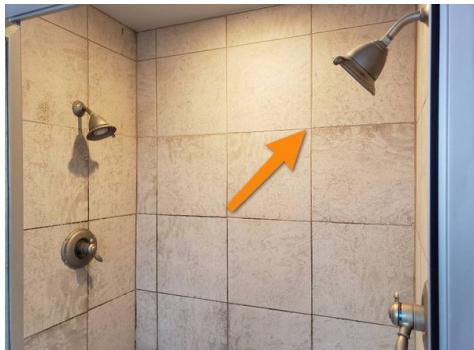
1st Floor Bathroom

SHOWER WATER PIPE LOOSE

Contact a qualified plumbing contractor.
