# HOOSIER HOME INSPECTION, LLC (317) 627-2691

### CONFIDENTIAL HOME INSPECTION REPORT

1234 Main St. Indianapolis IN 46222

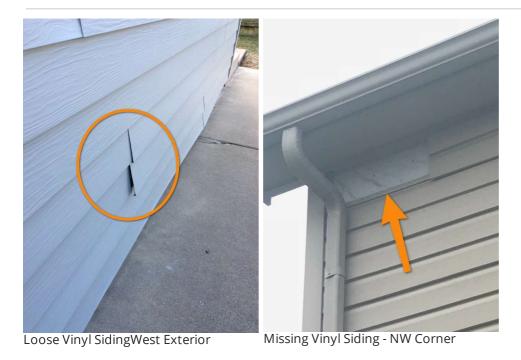
4.1.1 Siding

#### LOOSE/SEPARATED/MISSING

One or more areas of loose/separated/missing siding were observed at the time of the inspection. Recommend qualified contractor evaluate/repair as necessary.

Contact a qualified professional.
