FOREVER HOME INSPECTION - OKLAHOMA

RESIDENTIAL REAL ESTATE INSPECTION REPORT

1234 Main St. Tulsa OK 74108

06/12/2021 9:00AM

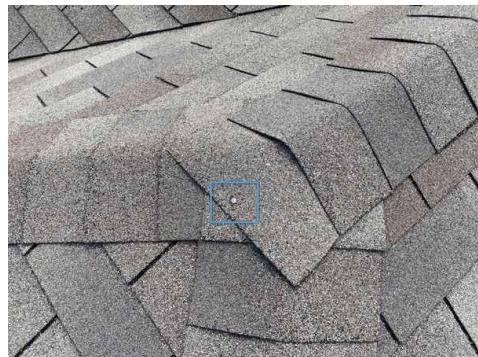
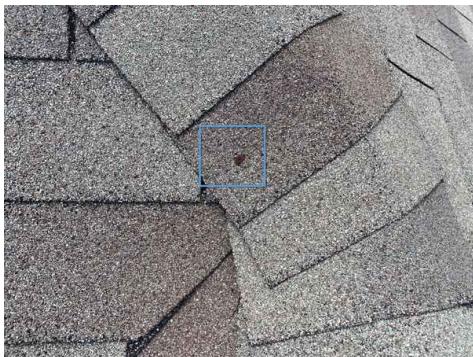
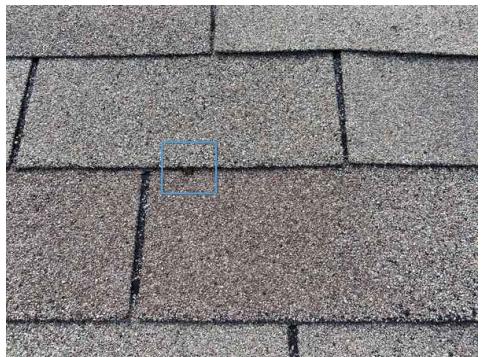
2.1.2 Roof Covering

Exposed nail heads were present on the shingles in the referenced area(s). Sealing any exposed nail heads is recommended to be conducted by a qualified roofing professional to prevent the possibility of leaks.

Contact a qualified roofing professional.

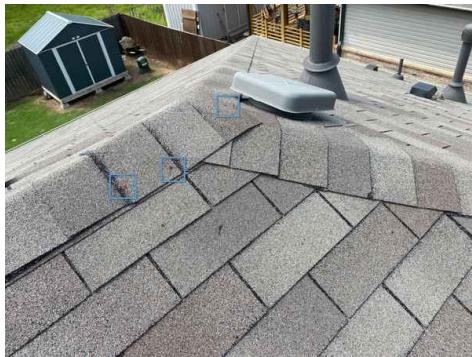
SHINGLES-EXPOSED NAIL HEADS

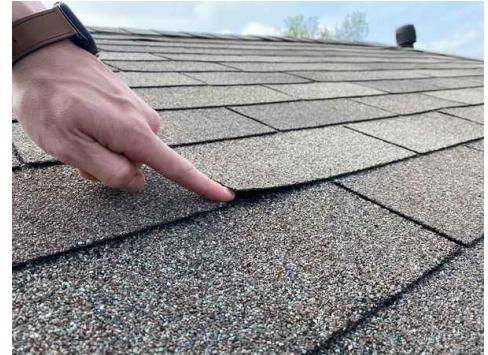
2.1.3 Roof Covering

Loss of adhesion was present on the shingles in the referenced area(s). loss of adhesion can allow wind to lift the shingle, bending it backwards, resulting in damage. Further evaluation of the shingles with repairs to properly seal the affected shingles is recommended to be conducted by a qualified roofing contractor.

Contact a qualified roofing professional.

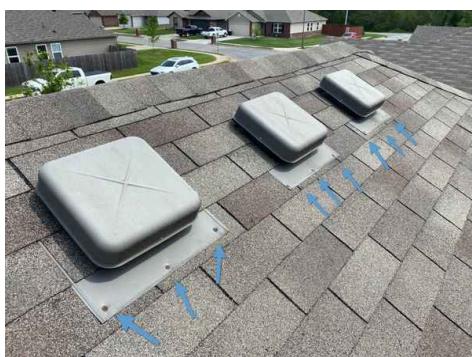
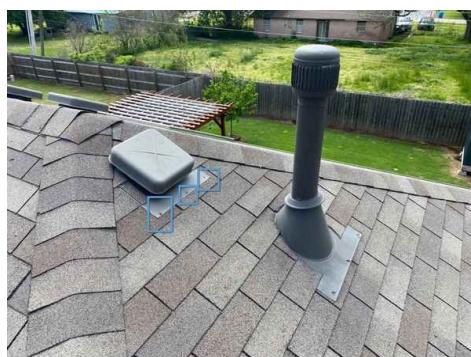
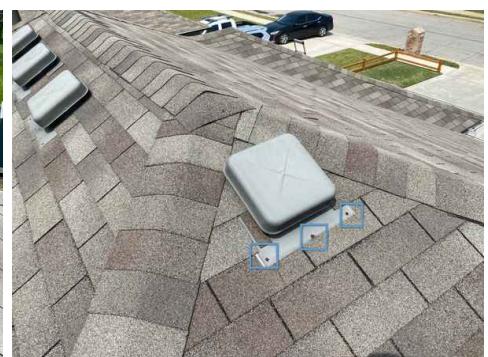
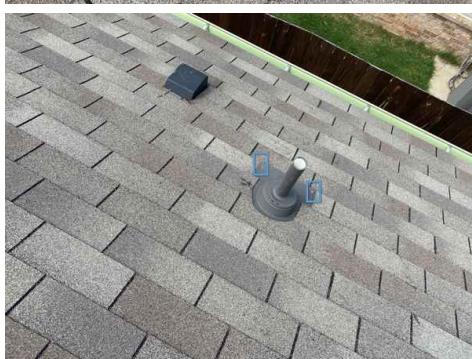
2.3.1 Roof Vents / Protrusions

BOOT-EXPOSED NAIL HEADS

Exposed nail heads were present on the rain boot(s). Proper sealing of any exposed nail heads is recommended by a qualified person to prevent the possibility of leaks.

Contact a qualified professional.

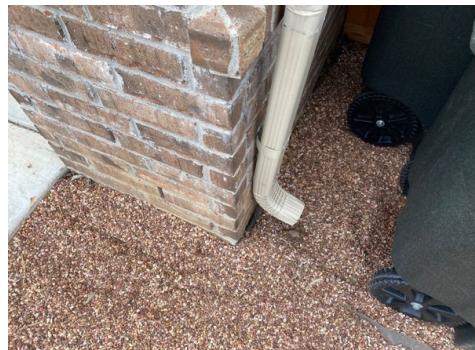
2.5.1 Roof Gutters / Downspouts

DOWNSPOUTS TERMINATING NEAR FOUNDATION**ALL DOWNSPOUTS**

There were downspouts present that were discharging next to the foundation of the home. It is recommended they divert away from the foundation to prevent gradient erosion and/or potential foundation issues over time. Installation of downspout extensions are recommended by a qualified person where needed.

Contact a qualified professional.

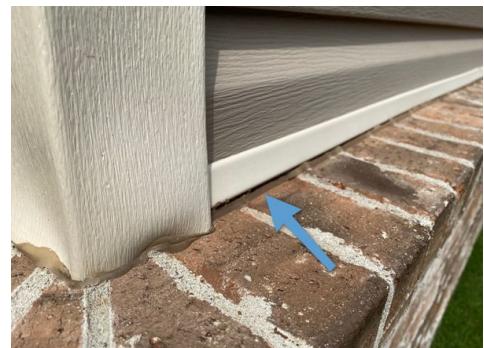
Southwest

MISSING/FAILED SEALANT

There were area(s) in need of sealant to prevent moisture and/or insect infiltration. The application of exterior grade sealant at any gaps into the wall cavity is recommended by a qualified person.

Contact a qualified professional.

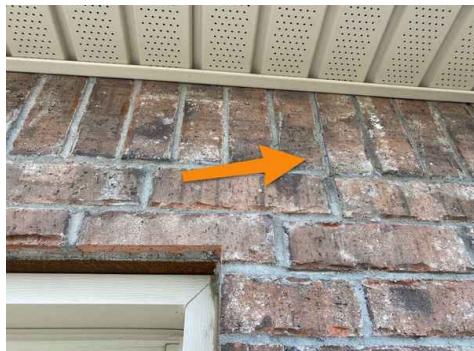
3.1.2 Exterior Walls & Siding Materials

CRACKING PRESENT

Mortar joint cracks were present in the referenced area(s). Further evaluation is recommended by a qualified masonry contractor with sealing or repairs made as deemed necessary.

Contact a qualified masonry professional.

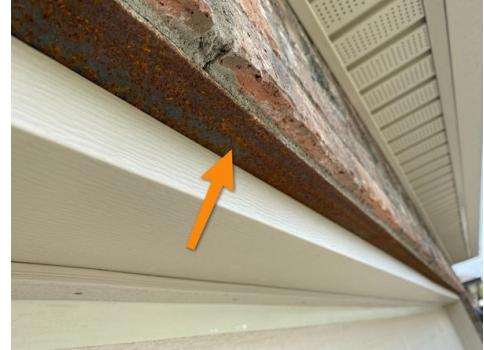
Garage

RUST ON STEEL LINTEL

Surface rust was present on the steel lintel over the garage door, steel lintels support the weight of the brick overhead of the openings, and rust may compromise the integrity of the lintels over time. Current standards require for steel lintels to be painted with a shop coat primer for protection. Sanding and painting the lintels as needed is recommended by a qualified person.

Contact a qualified professional.

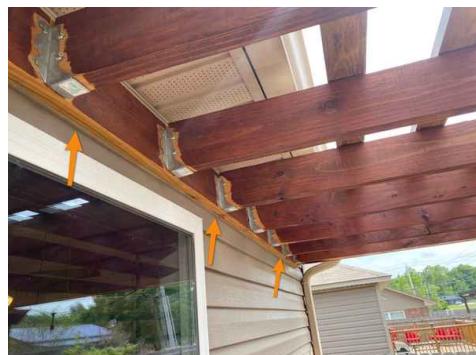
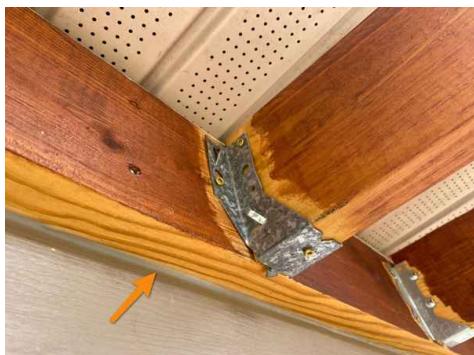
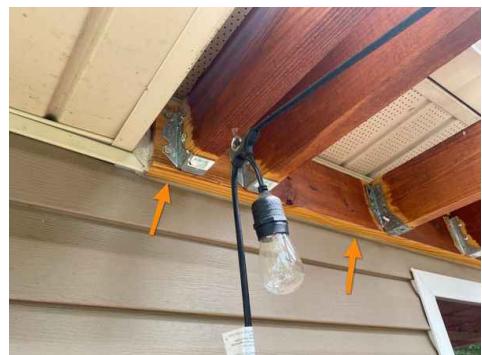
3.1.4 Exterior Walls & Siding Materials

The back deck pergola/roof was observed to be secured to the side of the structure over the vinyl siding. While no damage or warping of the vinyl was observed at the time of inspection, vinyl siding will expand and contract with temperature change which can result in warping or buckling of the surrounding vinyl over time. Evaluation of this areas is recommended by a qualified contractor with repairs made as needed to prevent warping or damage to the vinyl siding as needed.

Contact a qualified professional.

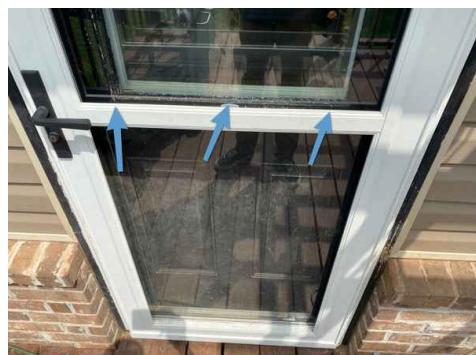
3.3.1 Exterior Doors

DOOR - PAINT/FINISH DAMAGE

The paint or finish on the exterior doors was damaged. Repainting/finishing the door is recommended by a qualified person as needed for water and UV protection.

Contact a qualified professional.

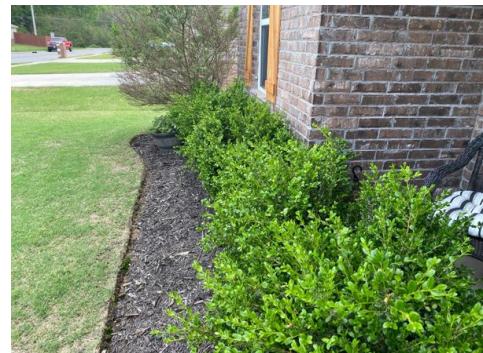
East

There was vegetation in contact or close contact with the home. Pruning or removal is recommended to be conducted by a qualified person to eliminate pathways of wood-destroying insects, and to avoid damage due to moisture retention, or abrasion.

Contact a qualified professional.

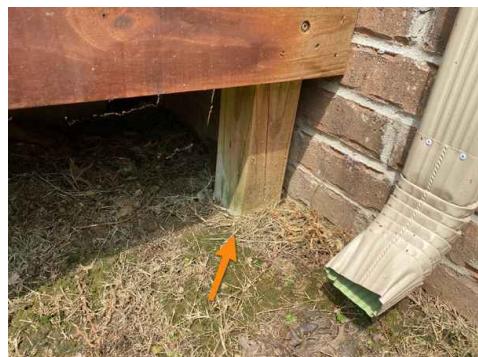
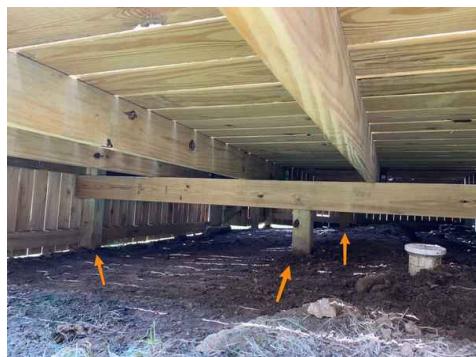
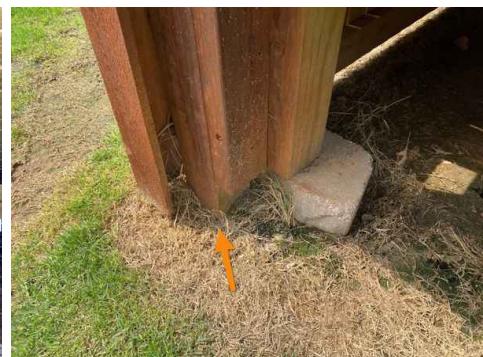
4.4.1 Decks

Wood to soil contact was present on areas of the deck(s). This can encourage decay of the framing members and be susceptible to wood destroying insect activity. Evaluation for repair or corrections to remove any soil around the deck supports and ensure they are properly based on or in concrete is recommended by a qualified professional.

Contact a qualified professional.

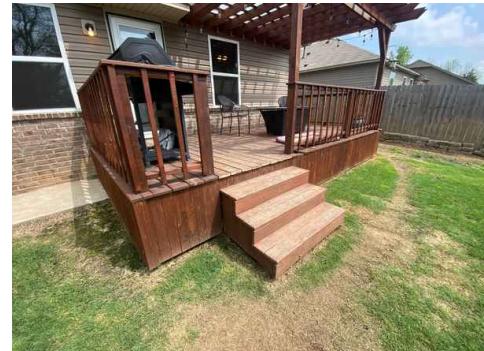
4.4.3 Decks

STAIRS - HANDRAIL NOT PRESENT

A handrail was not present for the stairs. Stairs four or more risers in height are recommended to have a handrail installed on at least one side for safety. The installation of a proper handrail is recommended to be conducted by a qualified person for safety.

Contact a qualified professional.

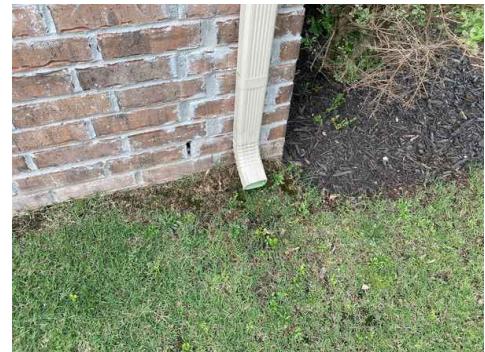
PERIMETER OF SLAB NOT VISIBLE - CLADDING TERMINATED AT GRADE

The perimeter of the slab was not visible due to wall cladding terminating at grade. The condition of the perimeter of the slab is excluded from this inspection.

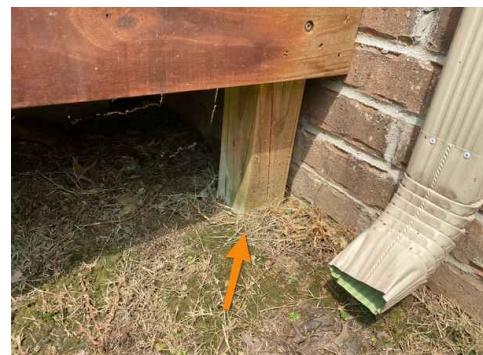
CONDUCIVE CONDITIONS

Conducive conditions to wood destroying organisms/termites were present in the referenced areas. I recommend verifying that the deck support is based in concrete and removing soil away from the wooden support to prevent wood rot or wood destroying insects.

Contact a qualified professional.

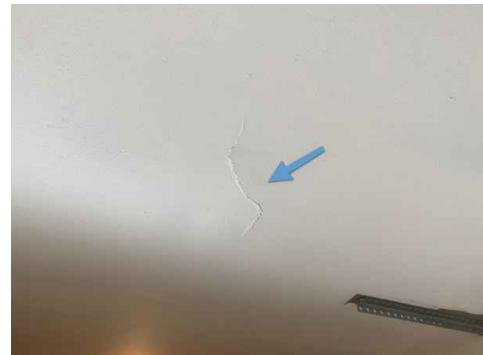
7.2.1 Walls, Floors, Ceiling, Doors

DAMAGED DRYWALL

Damaged drywall was present in the garage. Repairs to any damaged drywall is recommended by a qualified drywall contractor as needed.

Contact a qualified drywall contractor.

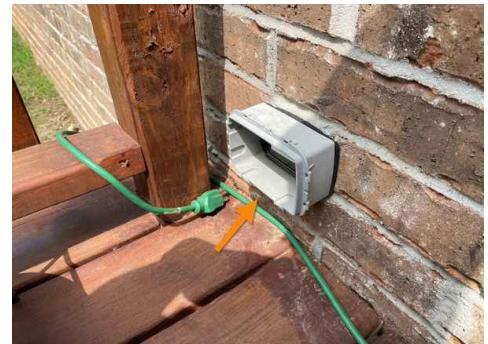
West

MISSING WEATHERPROOF COVER(S)

There were exterior receptacle(s) that had damaged/missing weatherproof covers. Replacement of any damaged or missing covers is recommended to be conducted by a licensed electrician or other qualified person as needed.

Contact a qualified electrical contractor.

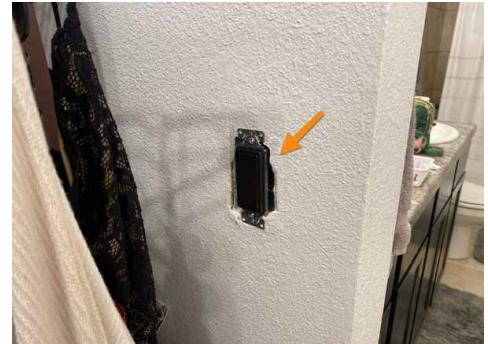
Master closet

MISSING COVER PLATE(S)

A switch was present with a missing cover plate(s). This is a safety hazard, as someone could be shocked by touching live wires. The installation of new plates is recommended to be conducted by a qualified person on any and all plates that are missing throughout the home.

Contact a qualified electrical contractor.

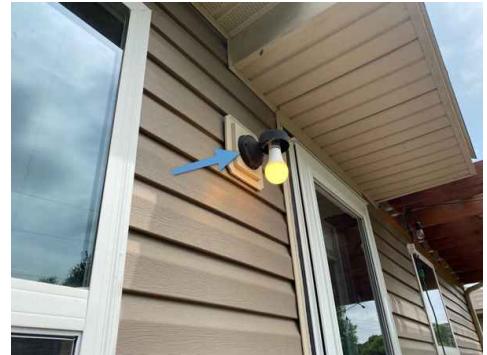
EXTERIOR LIGHT FIXTURE - GLOBE MISSING

Exterior light(s) were present that were missing a globe. This can potentially allow for water to reach electrical components causing damage. The installation of globes is recommended by a qualified person.

Contact a qualified professional.

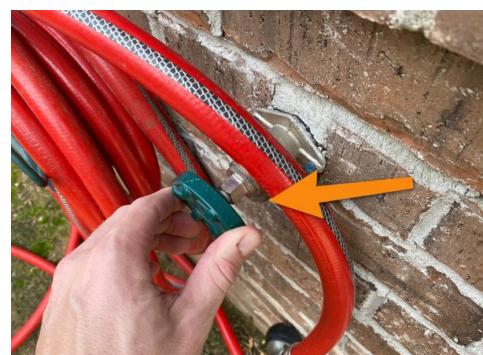
North

**HOSE BIB - DAMAGED**

The hose bib was observed to be damaged at the time of inspection. The water was shut off to the exterior hose bibs so functionality was not inspected, but the hose bib when turned in the full closed position would continue to turn. This can indicate stripped threads on the valve/seal assembly. Repairs or replacement is recommended by a licensed plumber as needed for proper operation.

Contact a qualified plumbing contractor.

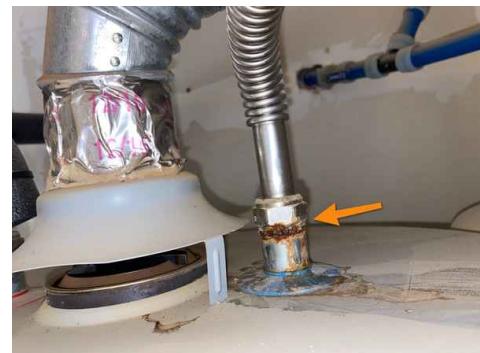
Garage

RUST / CORROSION ON WATER PIPES

Corrosion and/or rust was present on the water pipes in the area of the water heater. This can indicate that a past or present leak at the connection. Evaluation, and repairs are recommended to be conducted as needed by a licensed plumber.

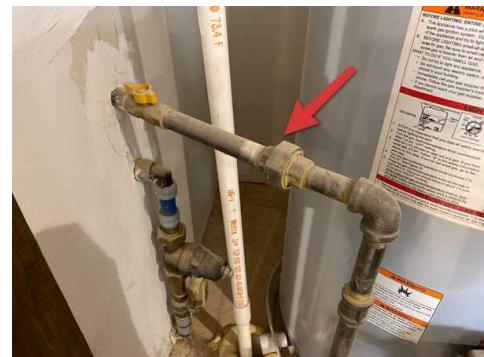
11.3.1 Gas Pipes

GAS LEAK PRESENT

A gas leak was found at the gas pipe near the water heating unit. Evaluation and repairs to the leak is recommended by a licensed plumber for safety.

Safety Hazard - High Concern

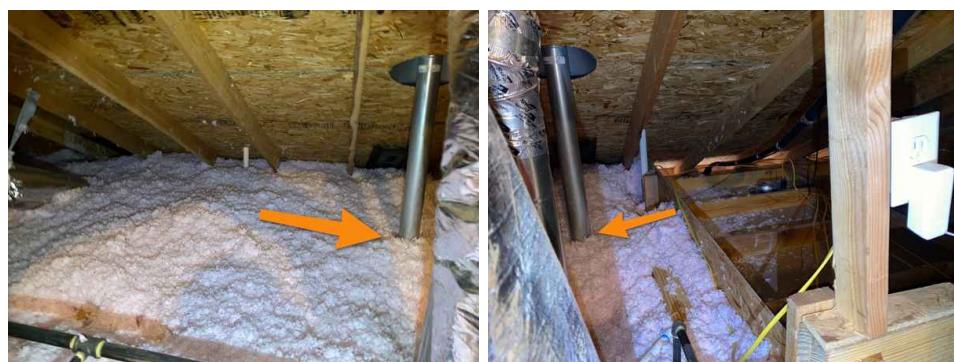
11.4.1 Venting

INADEQUATE CLEARANCE TO INSULATION

The water heater vent pipe was in contact with insulation. Although insulation is not considered "combustible" it does trap and transfer heat to nearby combustibles. The minimum water heater Type-B vent pipe clearance from combustible materials or insulation is 1 inch. The installation of an insulation collar extending in height at least two inches above the insulation level is recommended to be installed by a qualified contractor.

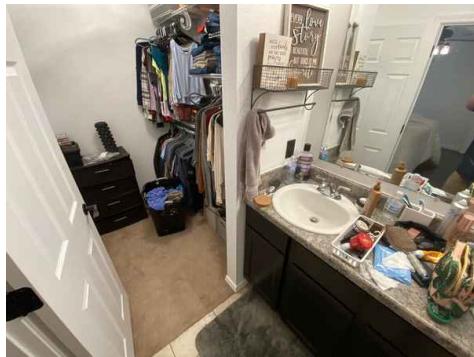
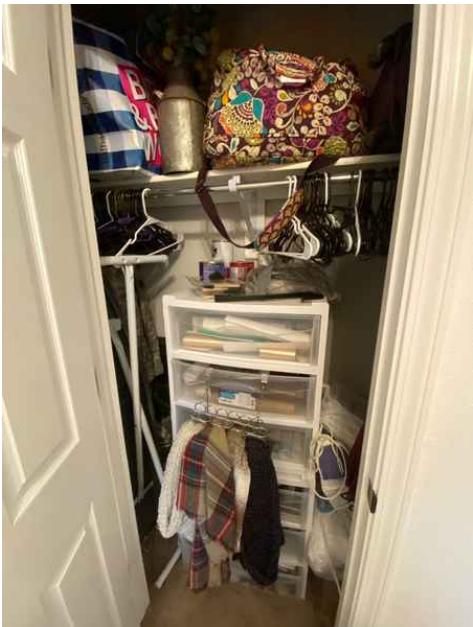
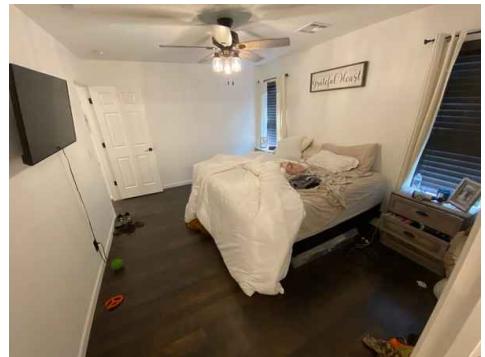
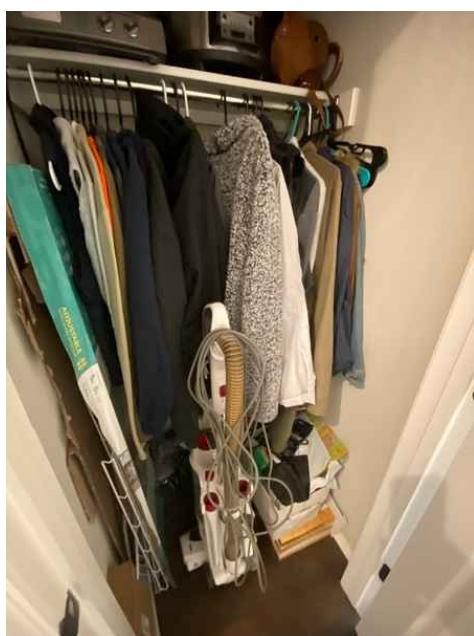
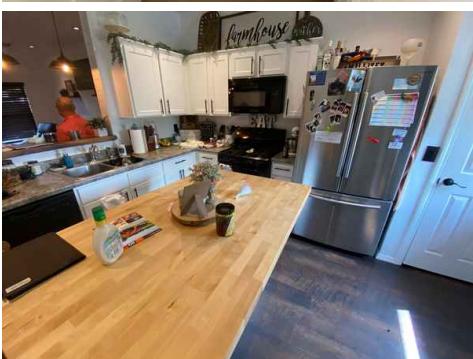
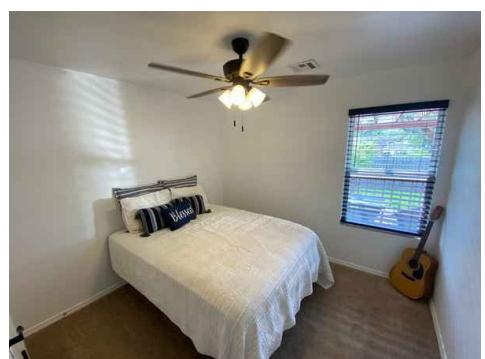
HIGH VOLUME OF PERSONAL BELONGINGS PRESENT

There was a high volume of personal belongings present in the home at the time of inspection which can obstruct the inspector's ability to perform a full visual inspection. These personal belongings were not moved or altered in any way. These belongings did block the visual accessibility of multiple areas and components throughout the home such as walls, flooring, receptacles, plumbing, etc.. This inspection is limited to visual portions only, as furniture is not moved, rugs are not lifted, and cabinet and closet storage is not rearranged for the sake of visual accessibility. It is highly recommended that you evaluate these areas for defects during the final walkthrough or at some point after personal belongings have been removed, as reportable conditions could be present in these areas.

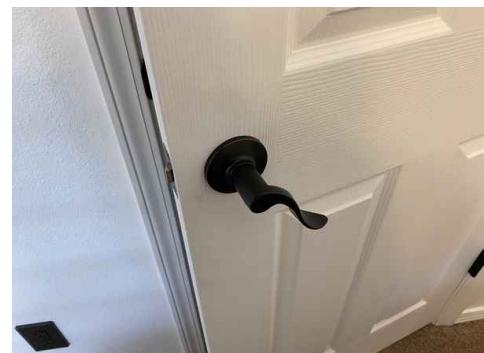
The handle hardware was sticking when the referenced doors were tested. Repairs or replacement of the hardware as needed is recommended by a qualified person for proper operation.

Contact a qualified handyman.

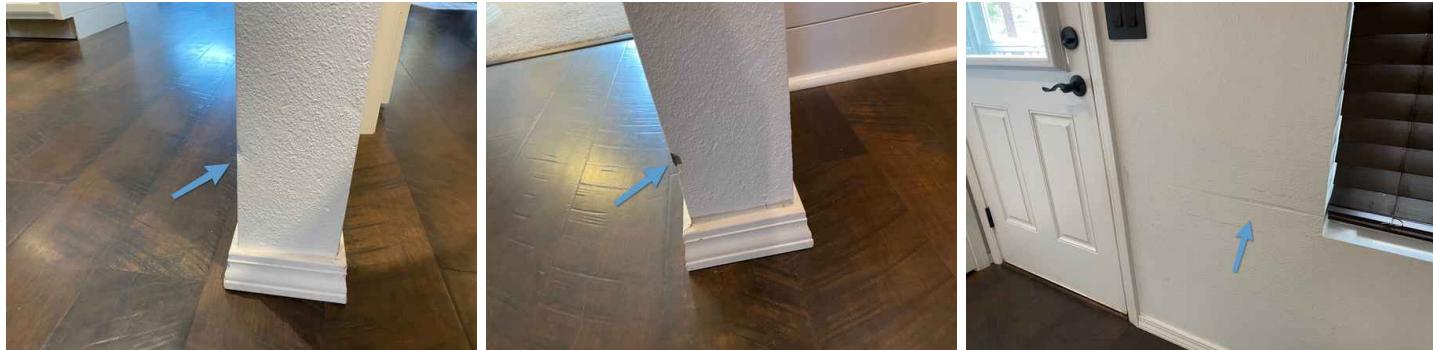
14.2.1 Interior Walls & Ceiling

WALLS - DRYWALL DAMAGE

Contact a qualified drywall contractor.

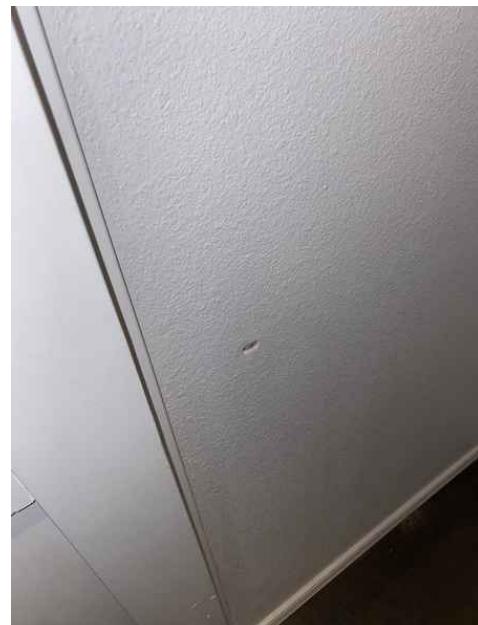
WALLS - DAMAGE FROM DOORKNOB

Wall covering damage was present from a doorknob at the referenced area(s). Repairs are recommended to the wall covering as needed by a drywall contractor or other qualified person.

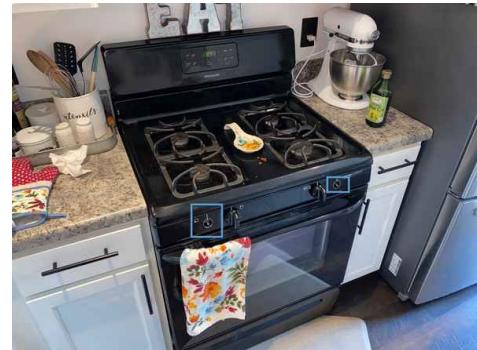
**RANGE - CONTROL KNOBS
DAMAGED/MISSING**

The control knobs for the range burners were removed, missing and/or damaged. Repairs or replacement of the knobs is recommended by a qualified appliance repair professional as needed for proper operation.

Contact a qualified appliance repair professional.

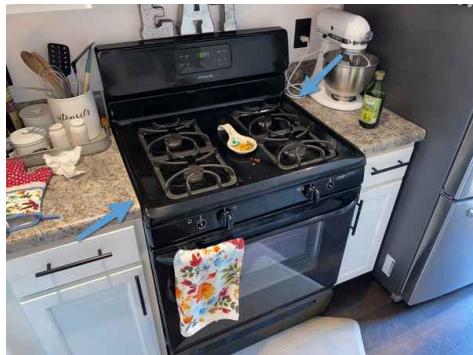
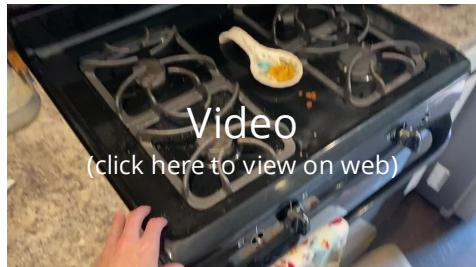
The range was observed to move or rock side to side. This is likely due to the base or feet not being properly adjusted at the floor. Evaluating of the range with repairs or corrections made by a qualified person is recommended to ensure it is stable at the floor.

Contact a qualified professional.

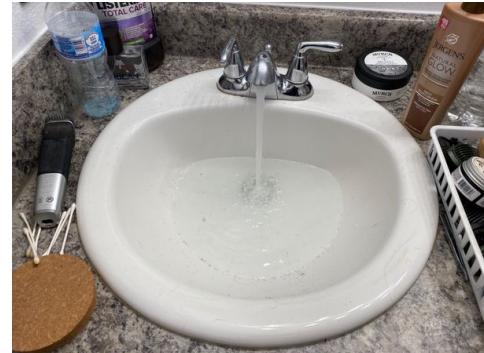
Master left

The referenced sink(s) were observed with slow or hindered drainage. Further evaluation for repairs are recommended to be performed as needed by a licensed plumber to achieve proper drainage.

Contact a qualified plumbing contractor.

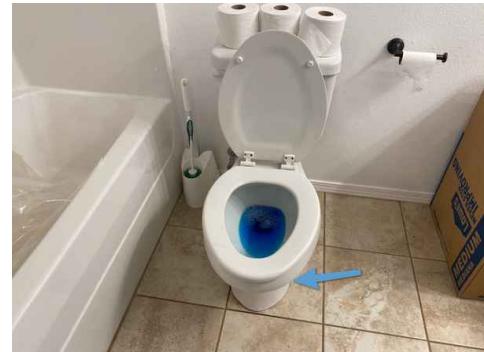
South Bathroom

TOILET LOOSE AT FLOOR

Contact a qualified plumbing contractor.

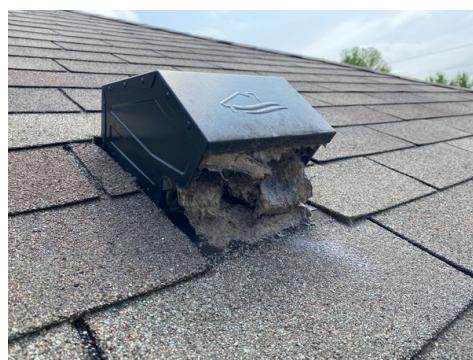
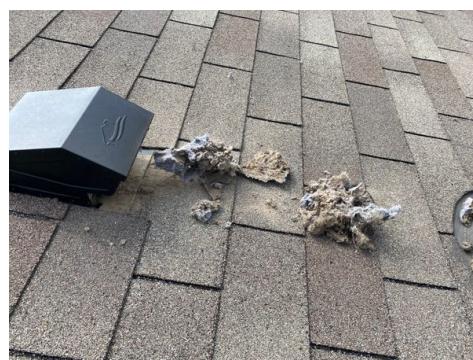
17.3.1 Dryer's Hook-Ups & Ventilation

Defect - Medium Concern
