Inspection Report

Address: 1234 E. Main St, Louisville, KY 40206

**Inspector: Allan Davis Ky 2233 In 008000002
P.O. Box 277
Greenville, In. 47124
502-648-9294
12/1/2015**

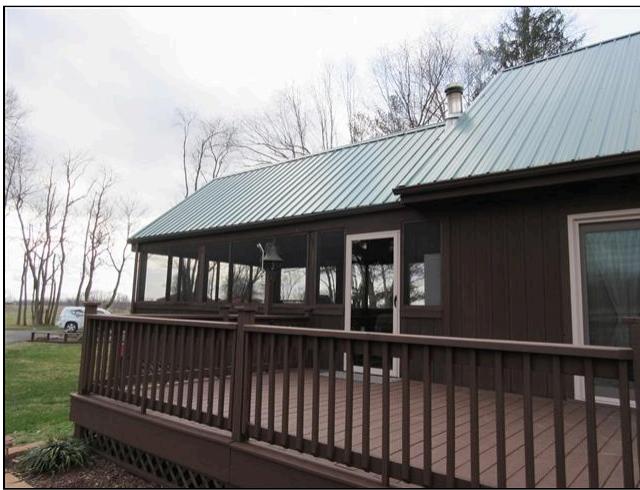
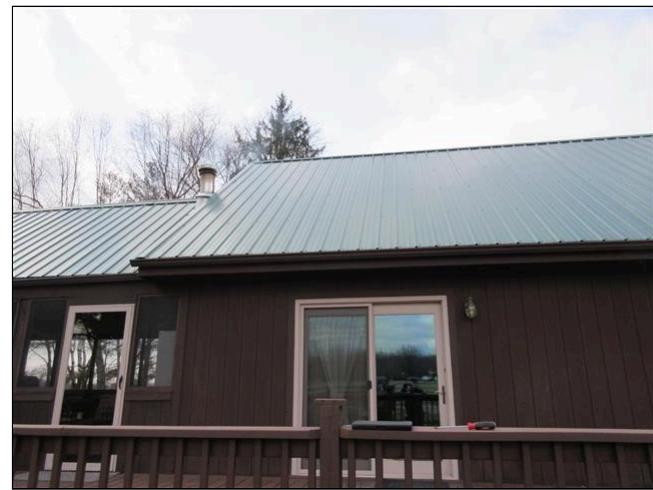
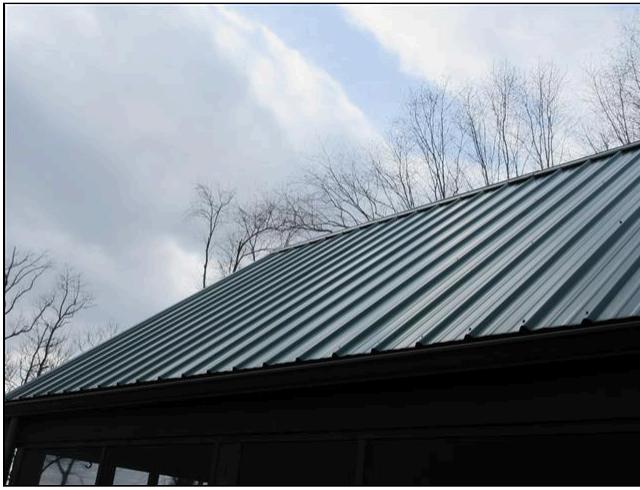
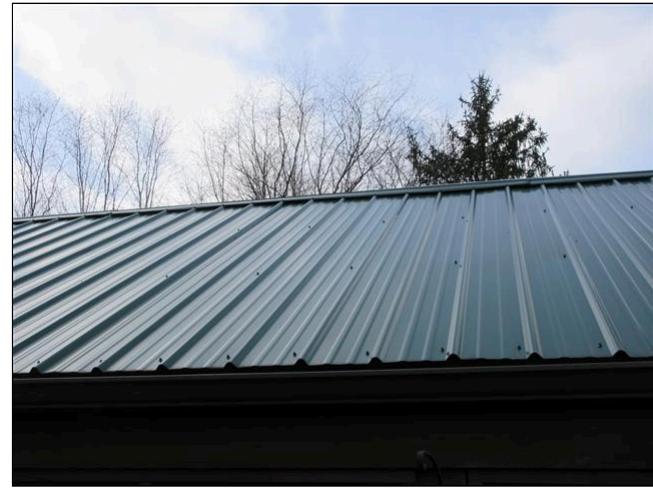
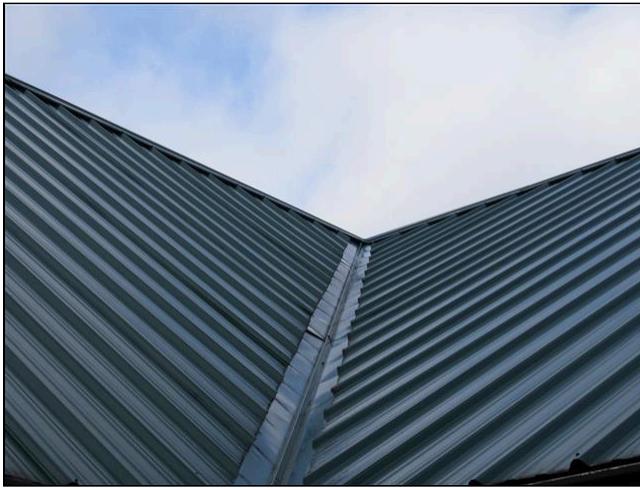
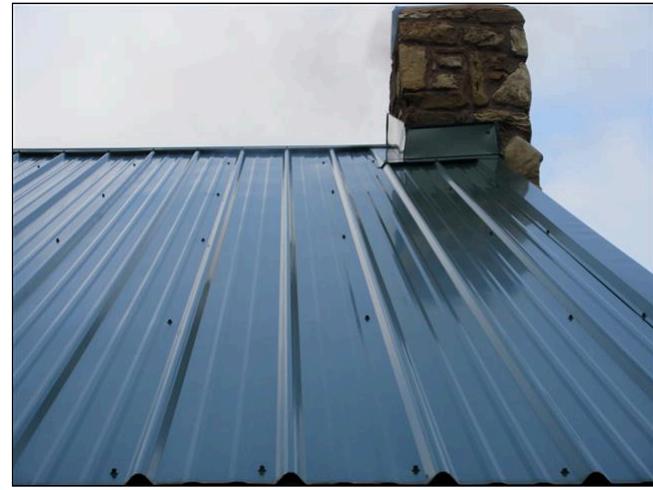
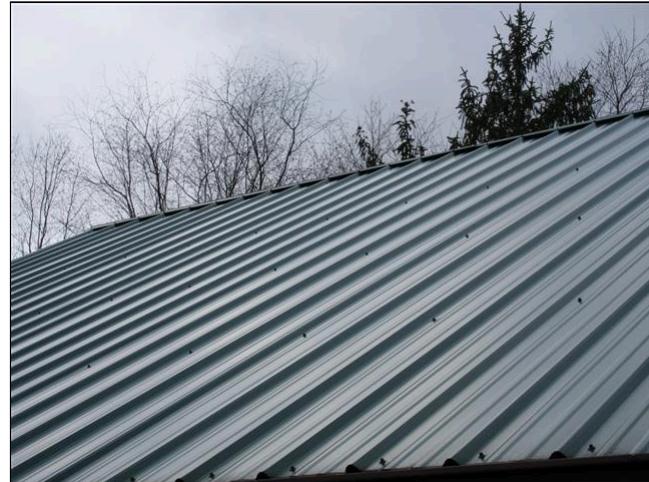
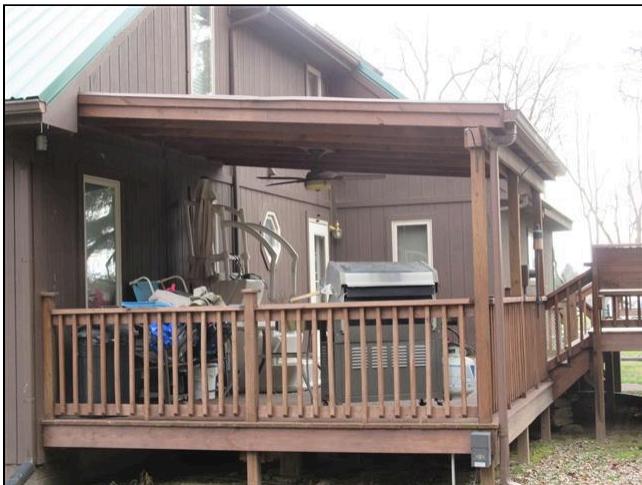
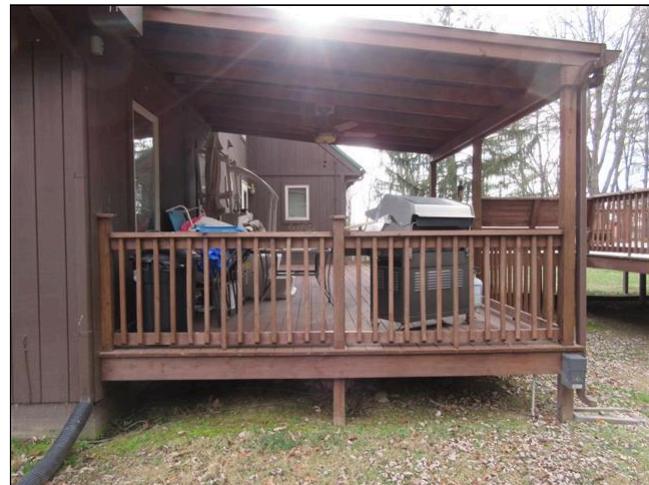
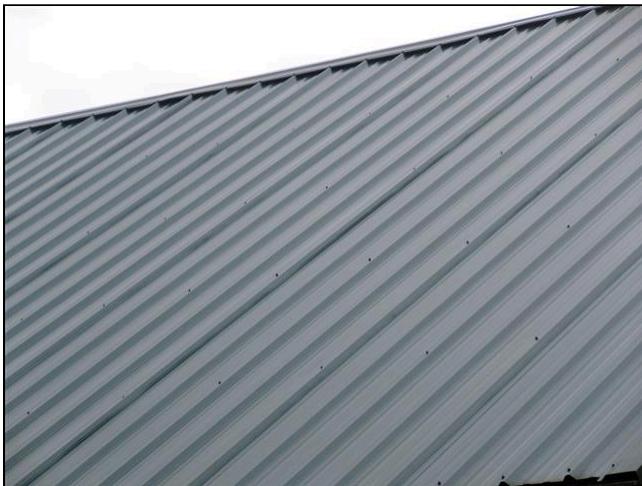
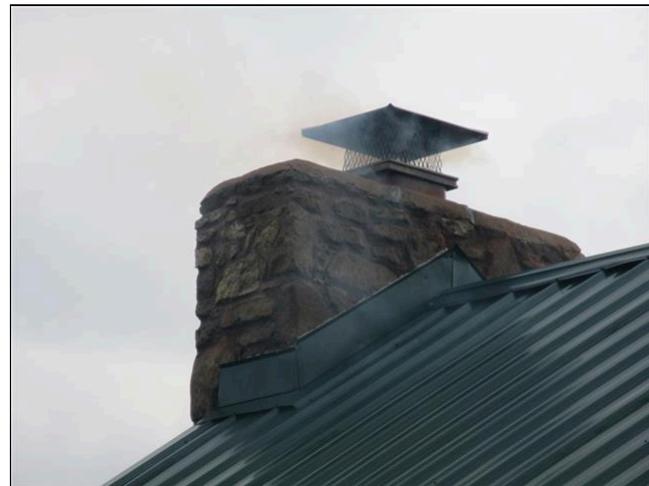
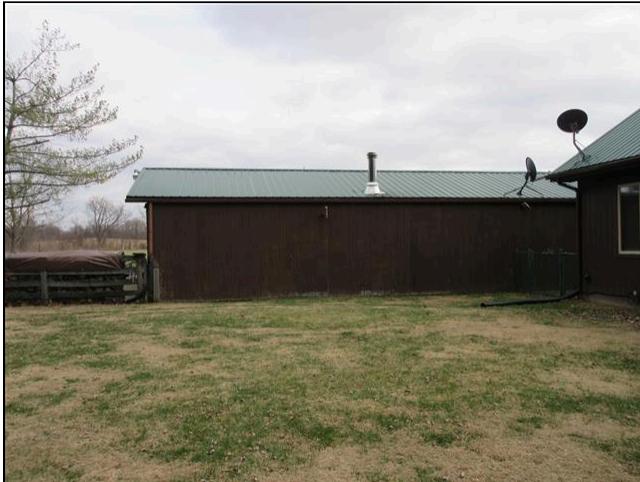
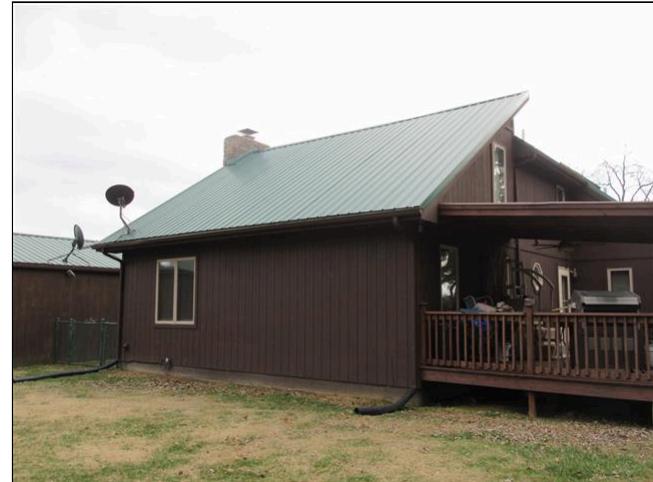
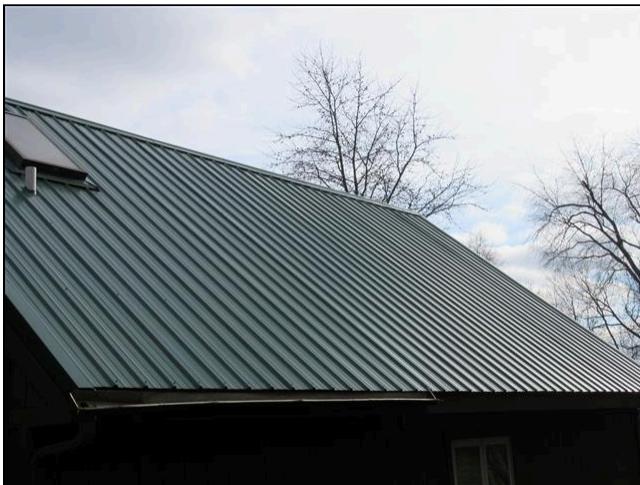
1.0 The roof was viewed from the ground with binoculars due to not being safe to walk. I attempt to mount and walk every roof. However, client is advised that whenever a roof is too steep or too tall, it is viewed from the ground with binoculars for safety reasons. Anytime a roof cannot be mounted, there is a limited view of the roof.

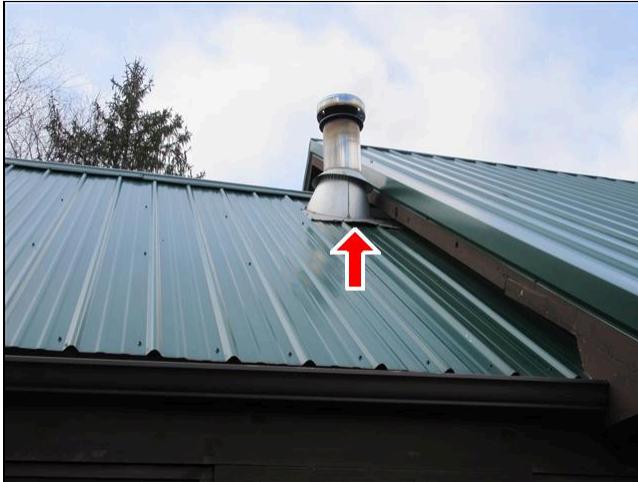
1.1 Roof penetrations can be a source of moisture intrusion. I recommend monitoring the roof penetrations and the interior of the house for evidence of moisture intrusion and contacting a qualified roofer as needed.

1.1 Item 1(Picture) Monitor for leakage

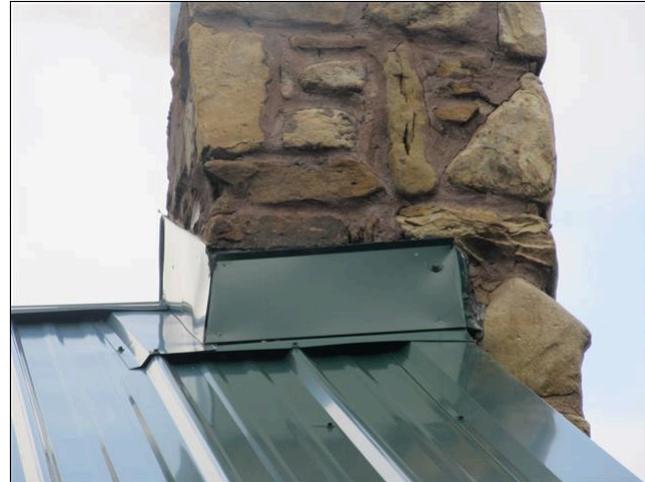
1.1 Item 2(Picture) Monitor around chimneys for moisture - I did not observe any visible evidence of ceiling stains

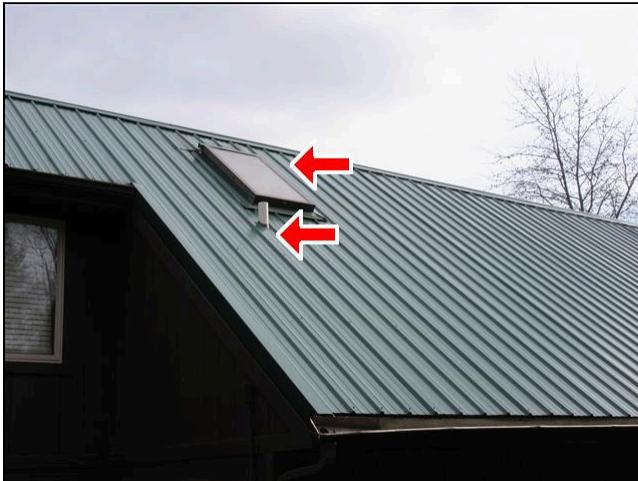
1.1 Item 3(Picture) Roof areas to monitor

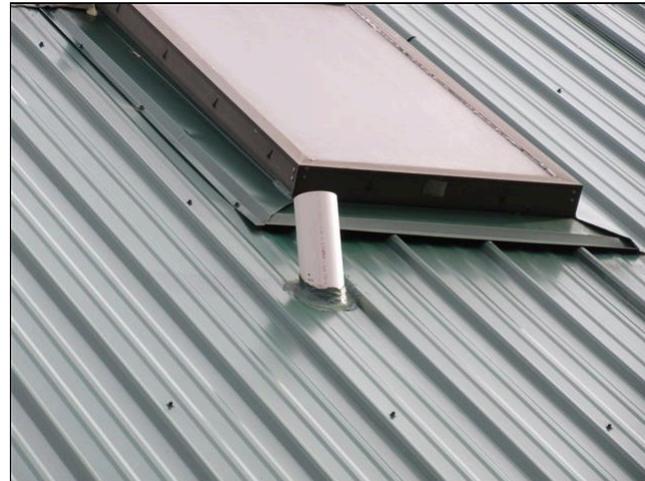
1.1 Item 4(Picture) Skylight are often a source of leakage. I can not see the top edge of the skylight to see how it was installed

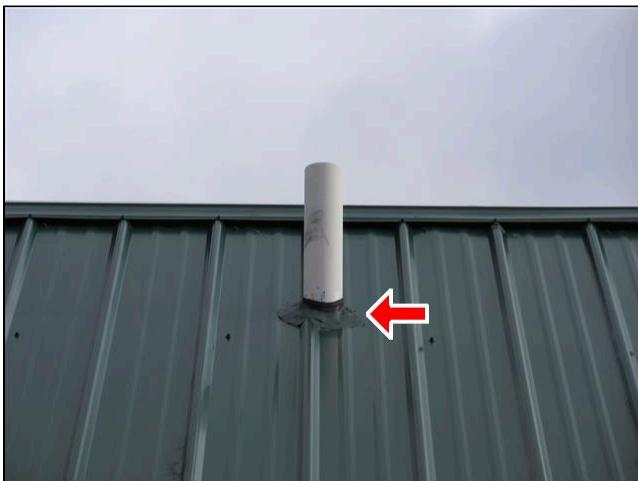
1.1 Item 5(Picture) Sealant can break down due to Sun and weather. Monitor for cracks and deterioration

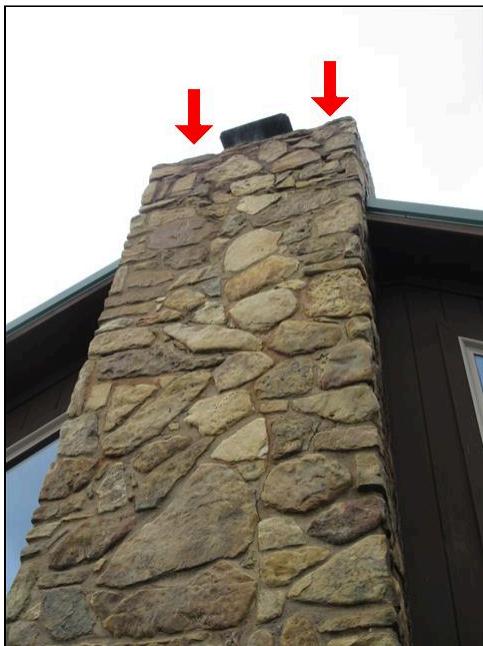
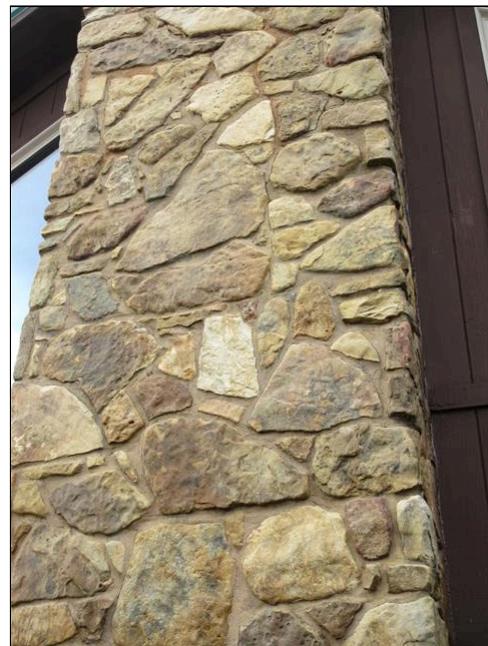
**1.2 (1)** I am not able to view the crown area of the chimney due to not being able to safely get above to inspect. I am unable to view the crown and it was not inspected.

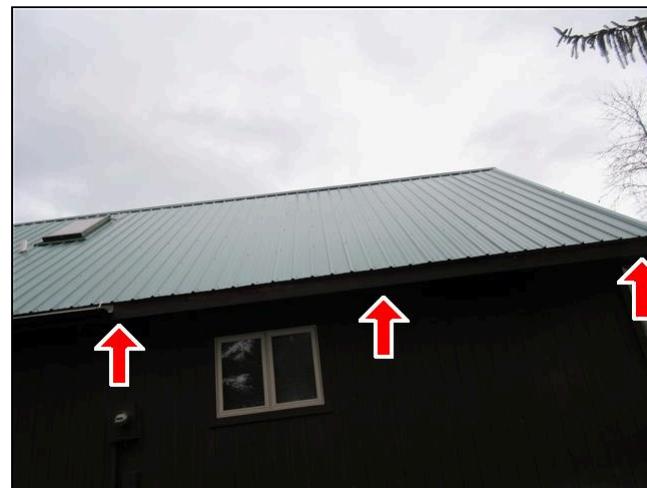
1.3 (1) The gutter is missing from the rear left side of the house. I recommend that a qualified person add a gutter as needed to prevent improper drainage along the foundation.

1.3 Item 1(Picture) Missing gutter

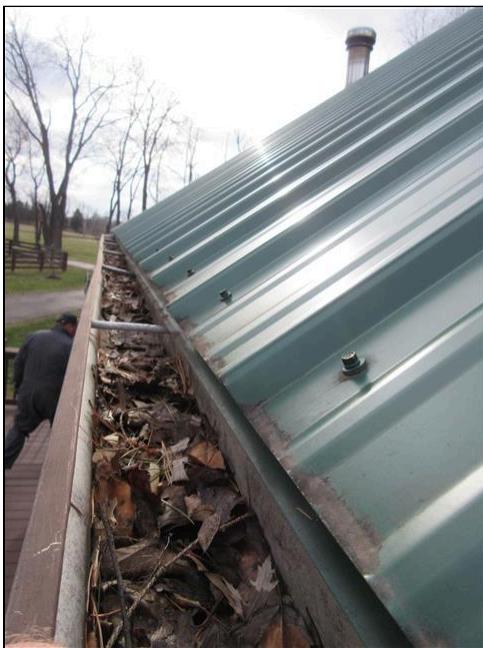
1.3 Item 2(Picture)

1.3 (2) The gutters are full of debris in areas and needs to be cleaned. The debris in gutters can also conceal rust, deterioration or leaks that are not visible until cleaned, and I am unable to determine if such conditions exist. I recommend that the gutters are cleared of debris as needed for proper drainage.

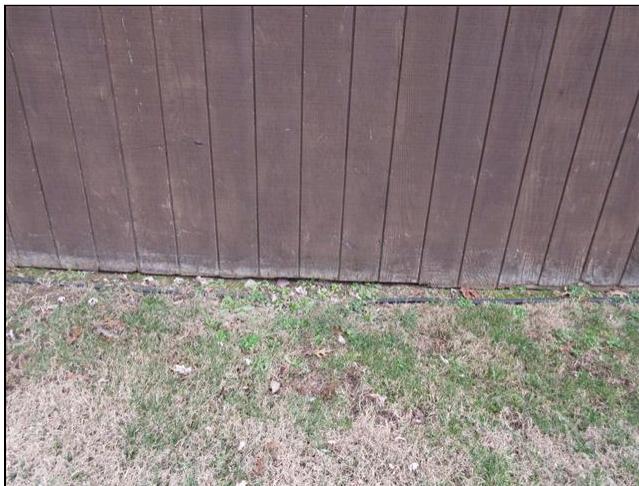
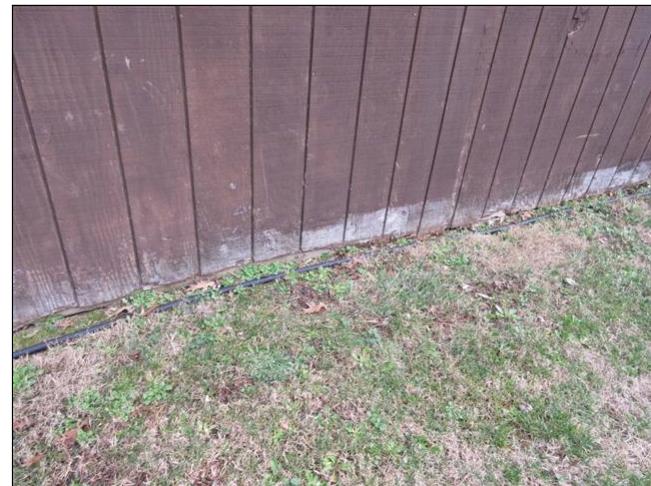
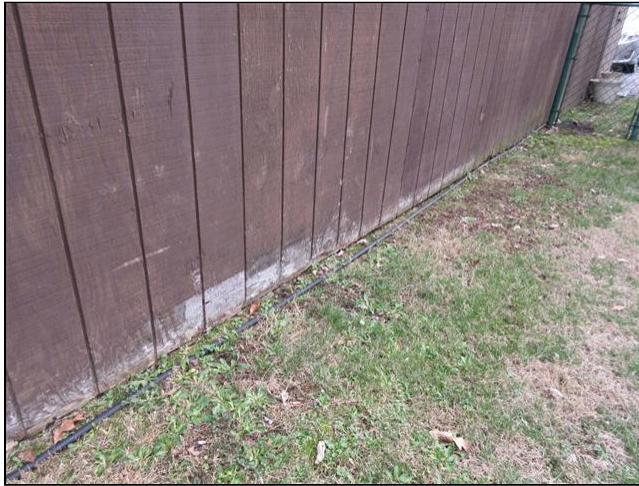
- 2.0 (2) The wood siding on the left side of the garage there is some minor damage to the siding that appears to be either from a weed eater or a mower rubbing along side the wood. This is for your information. I recommend sealing with stains and repairing if needed to slow deterioration.

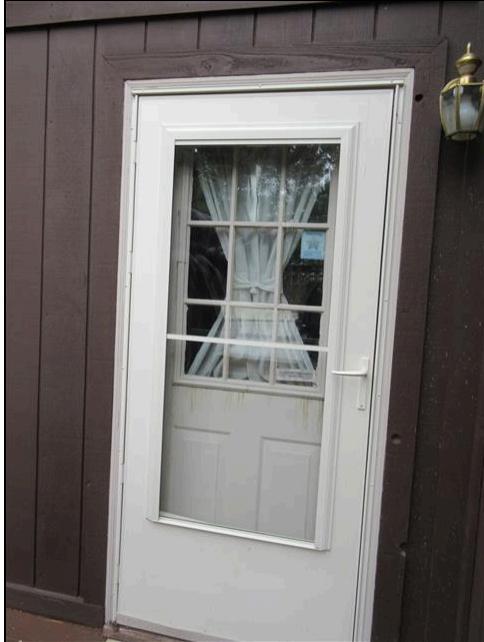
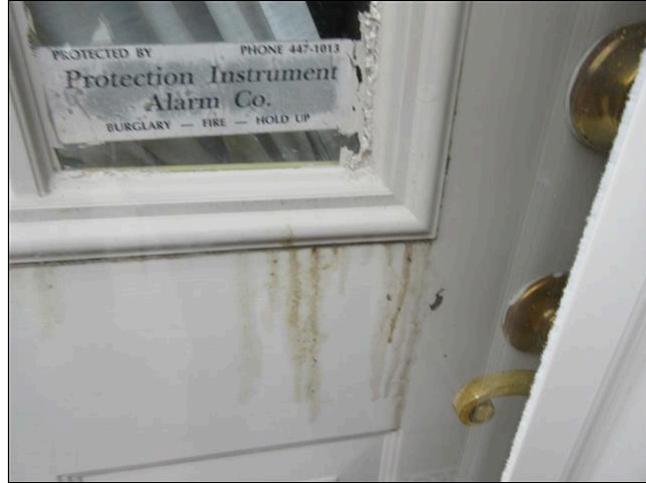
2.1 For your information the rear door of the house has a storm door protecting it. I observed what appeared to be glue which had drained out from under the glass trim. I recommend monitoring the rear door during the summer months, a storm door can trap heat much like a green house. Excessive heat can destroy a door in short period of time. I recommend monitoring and if the door heats up excessively replace the glass with screens during the Summer months.

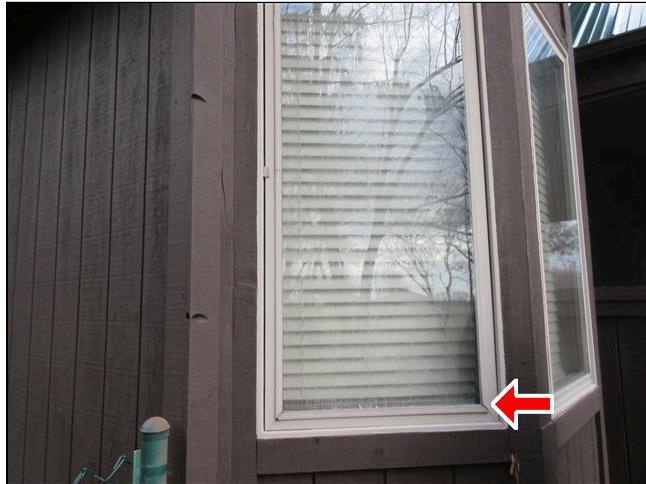
- 1) Left window on left side bay window has a failed thermal pane seal as well as some deterioration around the window at the wood.
- 2) The Octagon window on the rear of the house has significant deterioration at the frame.

2.2 Item 1(Picture) Left side of house

In summary the windows especially the original windows are worn and at or past the end of their life expectancy. I recommend that a qualified contractor evaluate ALL of the windows and repair or replace as needed.

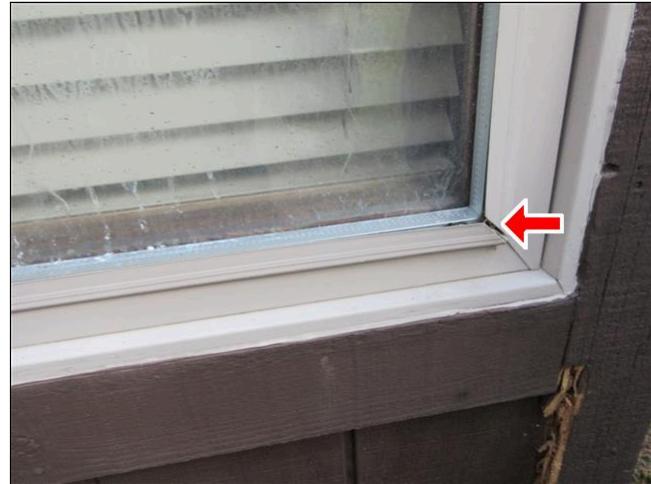
2.2 Item 2(Picture) Left side of bay window on left side house has moisture that is entering around the frame and a failed thermal pane seal

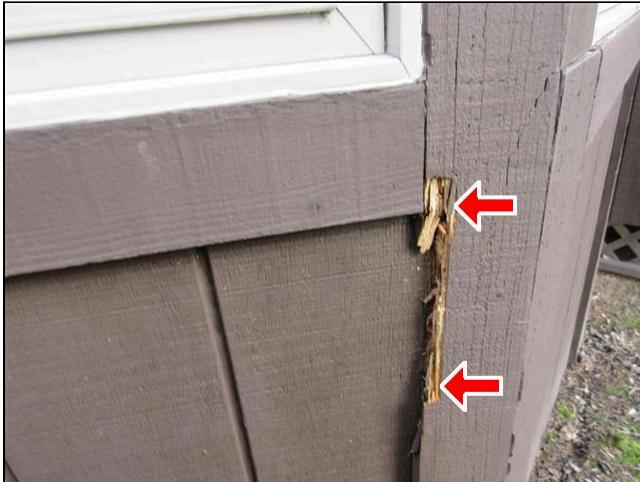
2.2 Item 3(Picture) Deterioration in wood under left side bay window

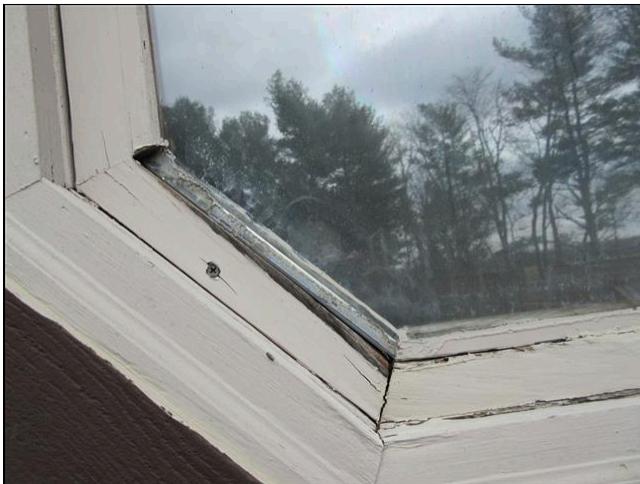
2.2 Item 5(Picture) Close up of the deterioration

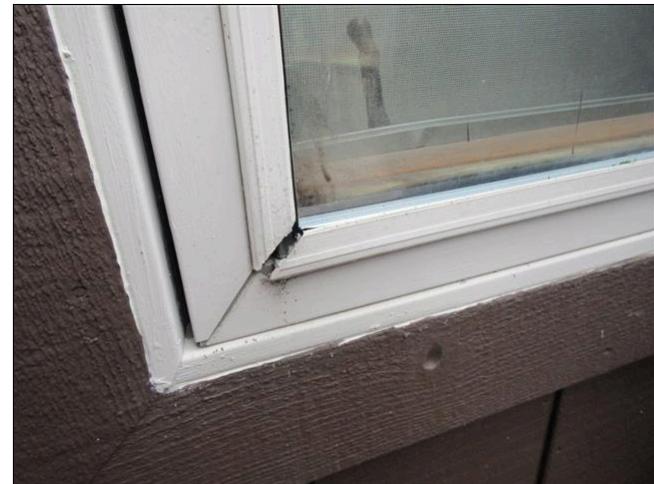
2.2 Item 6(Picture) Window on left side of the house with trim opened up allowing moisture into the window and also a failed thermal pane sill

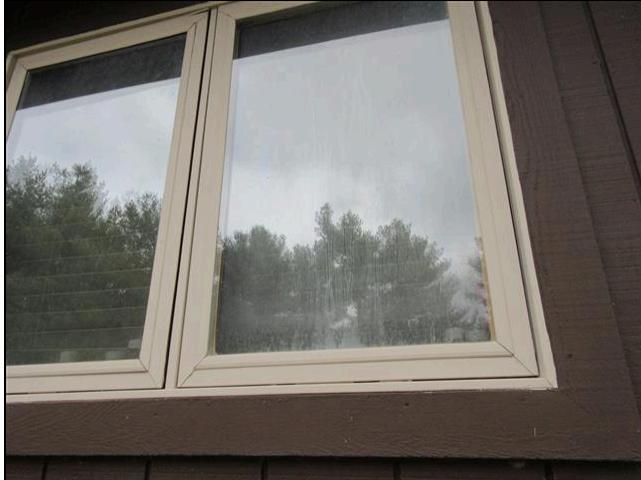
2.2 Item 7(Picture) 2 windows on the rear of the house with failed thermal pane seals

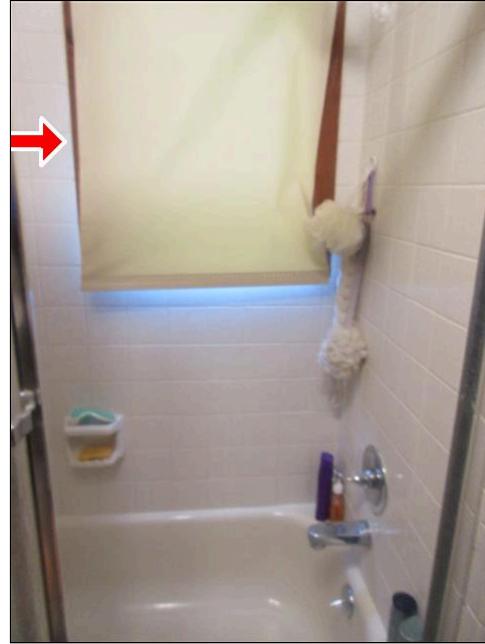
2.2 Item 8(Picture) First floor hall bath window in shower area has a deteriorated frame

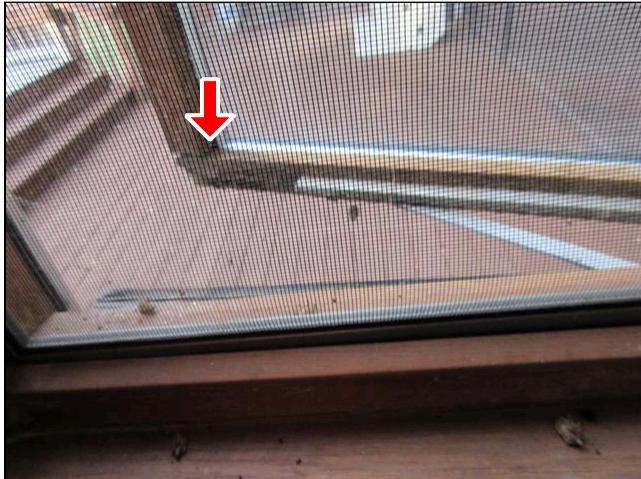
2.2 Item 9(Picture) Bathroom window deteriorated frame

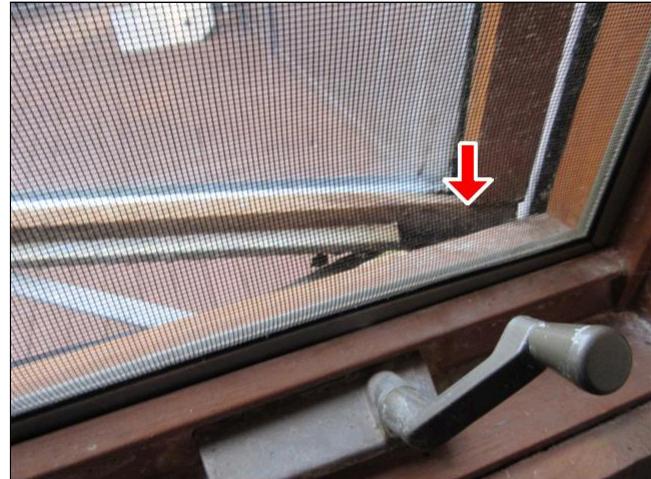
2.2 Item 10(Picture) Bathroom window deteriorated frame

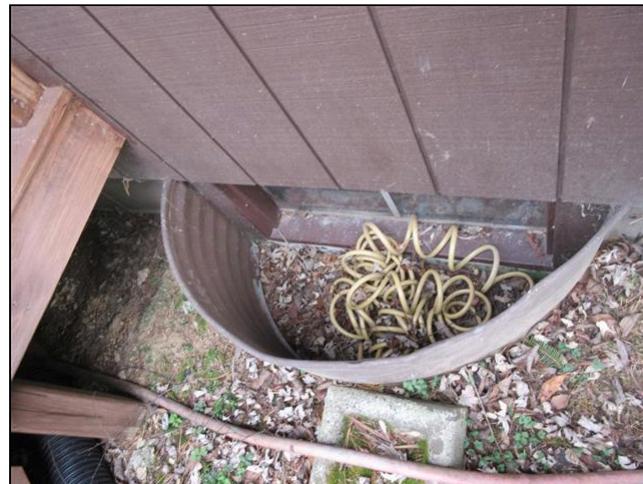
2.2 Item 11(Picture)

2.2 (2) Window wells are present.

Window wells can be a source of moisture intrusion. I recommend monitoring inside the window well areas of the basement for moisture intrusion. If moisture intrusion is a problem around these areas, I recommend adding covers as a first step in correction.

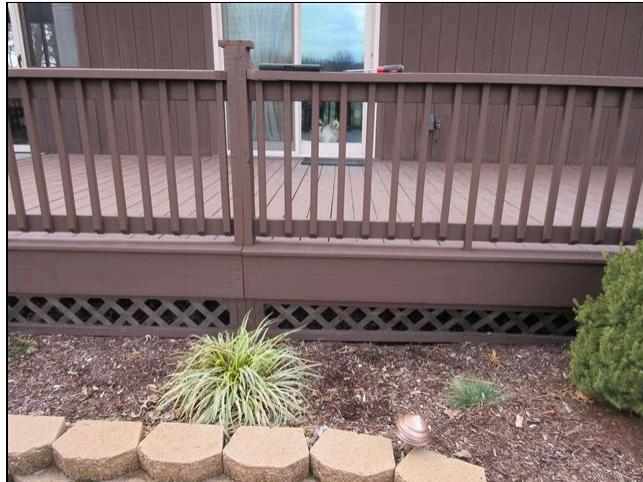
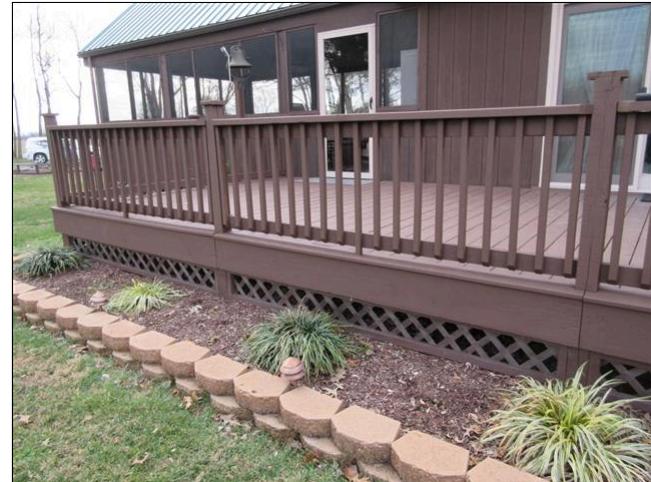
**2.3 (1)** My view under the deck on the left side and across the front of the house was very limited due to sides of the deck being closed off and there being limited access under the deck. I was able to view that added supports had been placed under the hot tub area. The supports were like landscaping timbers and even a tree stump. These added supports did not appear to be secured to the bottom of the floor joist or on a footer. This is for your information. I recommend monitoring for issues a further evaluation and correction if needed.

It is assumed that the supports were added due to the weight of the hot tub.

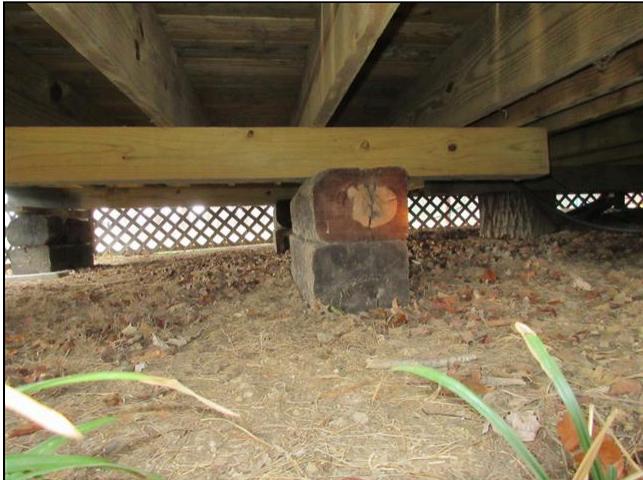
2.3 Item 5(Picture)

- 1) The deck was not bolted or lag screwed to the house, nails were used. Nails can pull out leaving the deck unsupported.
- 2) Joist hangers were NOT used in most locations. Joist hangers that are the proper size and fully nailed (proper type nail) are more secure and will hold more.
- 3) Under the deck I observed boards used to offer additional support. In some cases the supports are not on footers, treated lumber and deteriorating or not offering any support (i.e. stack of wood under steps).
- 4) The upper level of the deck near the pool has not been stained recently, this will allow the wood to deteriorate at a faster rate.

I recommend that a qualified contractor fully evaluate the deck and repair or correct items as needed.

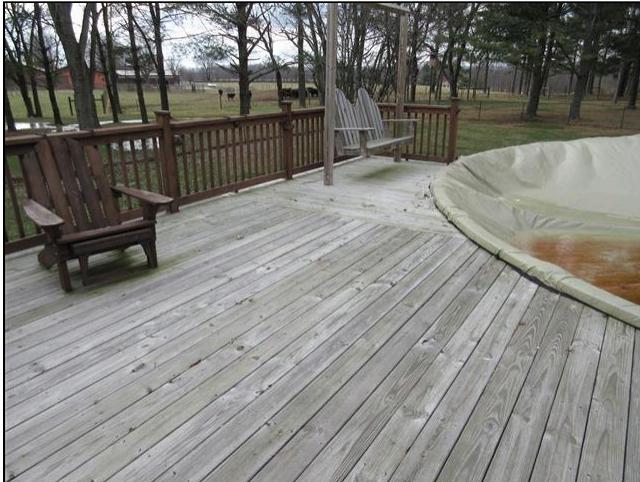
2.3 Item 17(Picture) Deck needs to be cleaned and stain

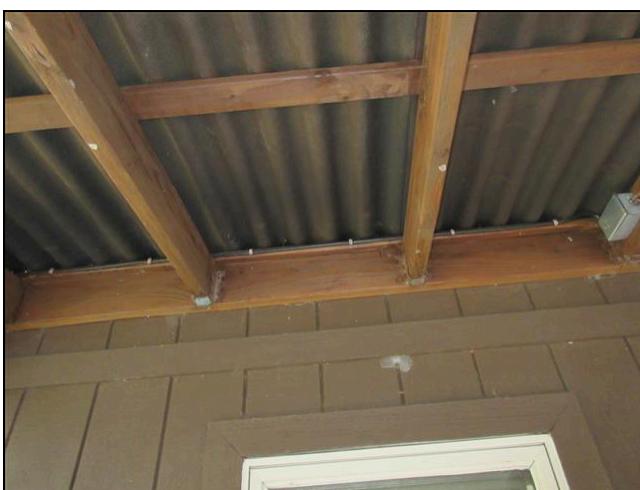
**2.3 (3)** I recommend that the porch rear on the rear of the house is lag screwed to the house. The porch roof is nailed to the house, nails are subject to pulling out

2.3 Item 19(Picture) The porch is secured to the house by nails

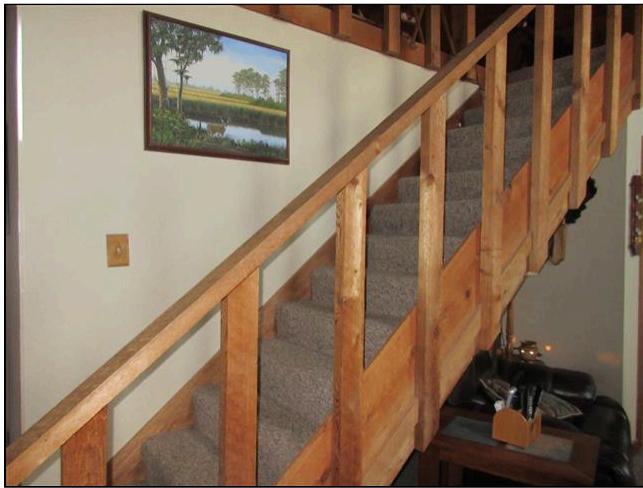
2.3 Item 21(Picture)

2.3 (4) The spindle spacing is wider than the maximum of 4" spacing which is today current standard. A small child or pet could easily fall through the opening at it's current spacing. Correcting the spacing would be a buyer's upgrade and at the buyers expense. This is for your information.

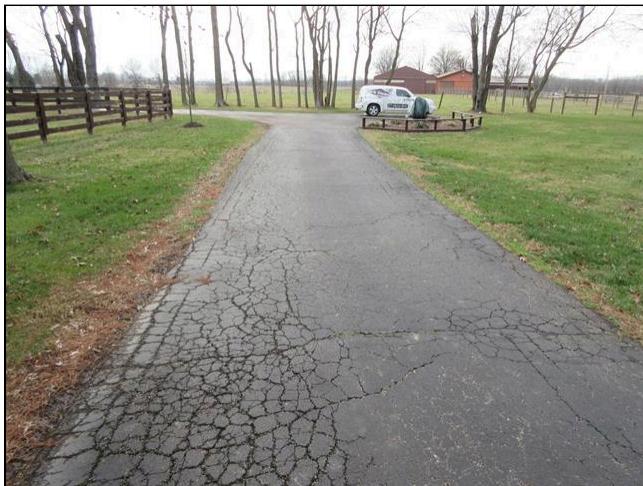
2.4 Item 1(Picture)

2.4 (1) The driveway is asphalt and at the time of the inspection was functional. It does appear that it has been sometime since the driveway has been sealed and or patched. For your information at some point in the future (impossible for me to give a date) the driveway will need maintenance to reduce deterioration and prolong it's life.

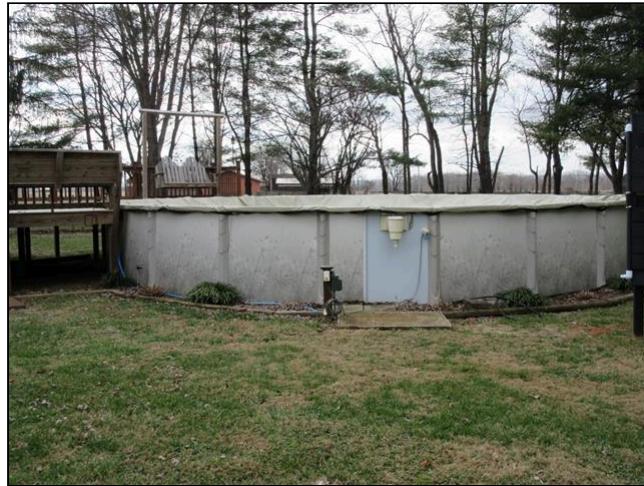
2.6 Item 1(Picture)

2.6 A pool was present. Pools are not part of a home inspection and was not inspected. Recommend that a qualified person inspect and correct as needed the pool.

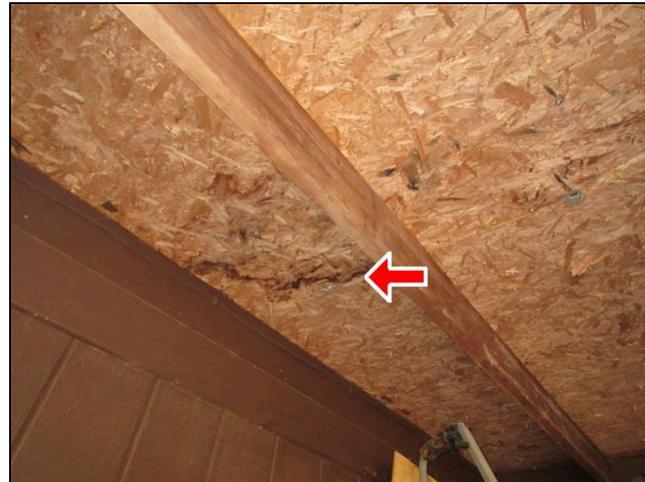
3.0 Item 1(Picture)

3.0 (1) On the right side of the garage under the stall like area I observed a moisture like stain under the roof sheathing. The stain appeared dry at the time of the inspection and when probed was intact. This is for your information.

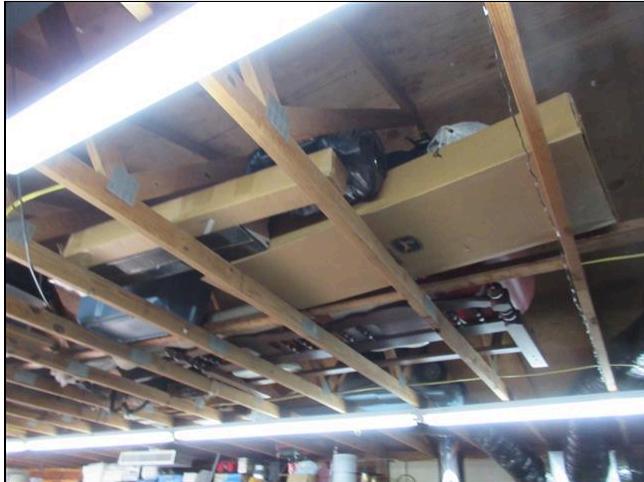
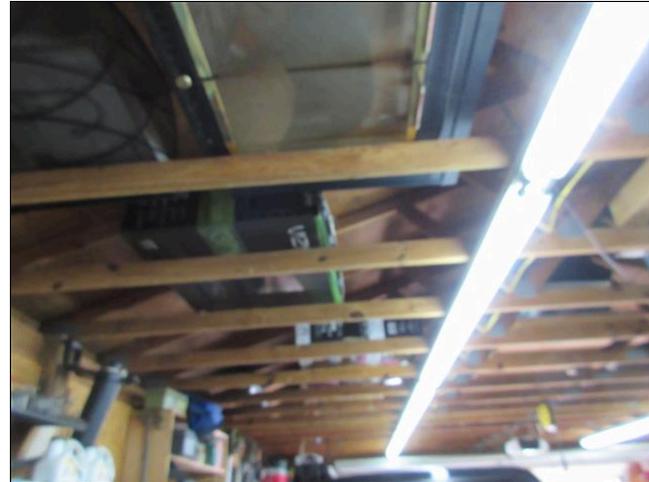
3.0 (2) Inside the garage my view of the ceiling/attic area was extremely limited due to a large amount of stored items

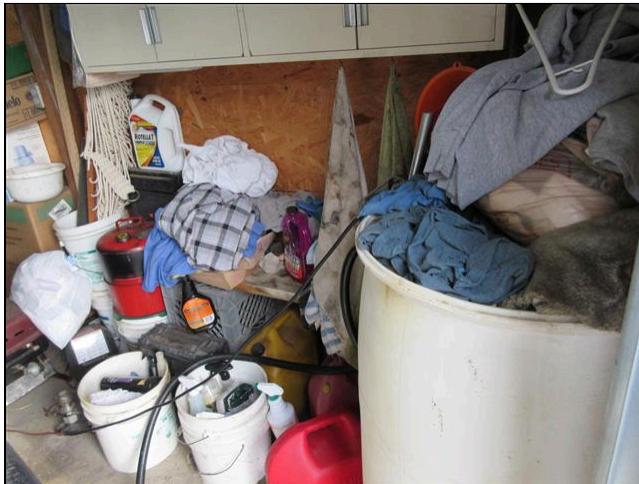
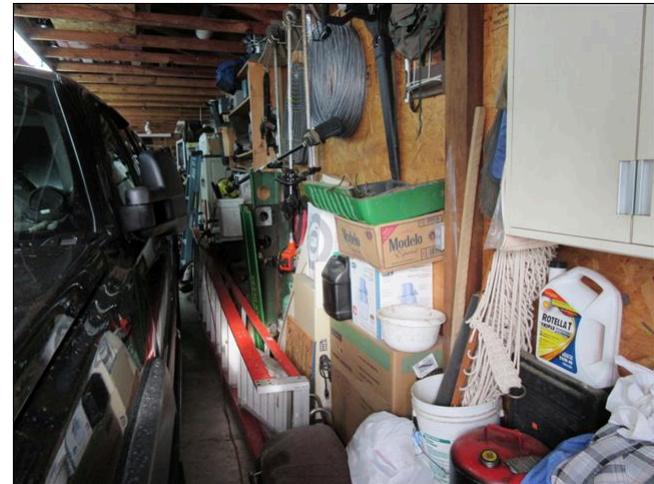
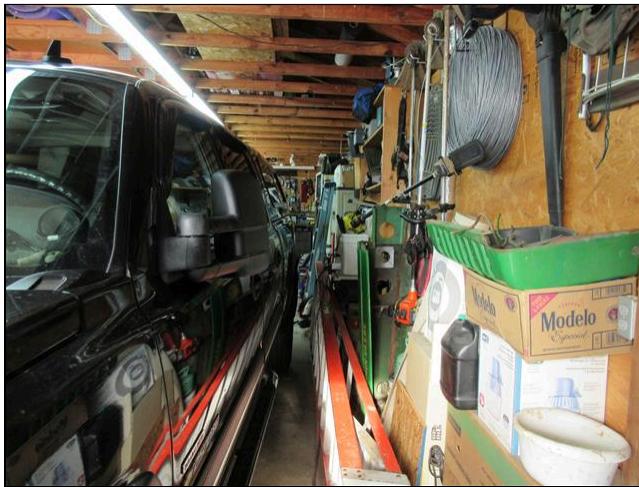
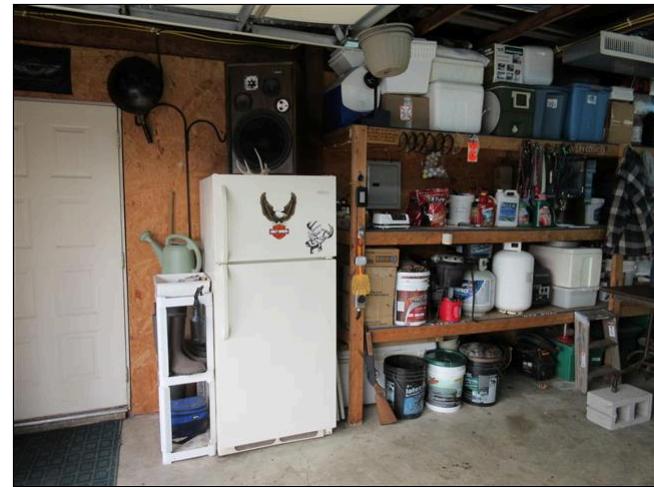
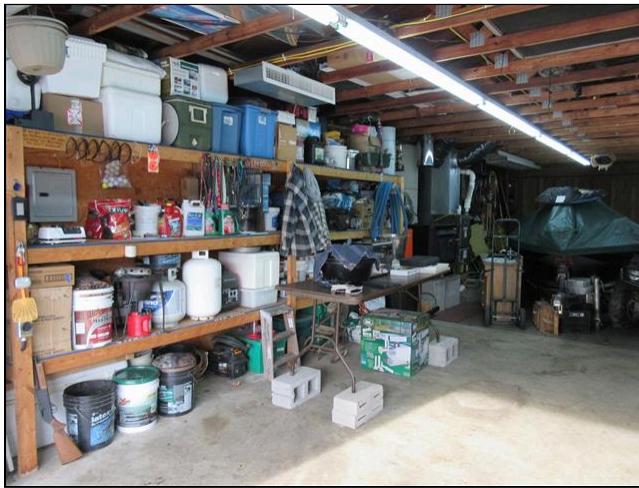
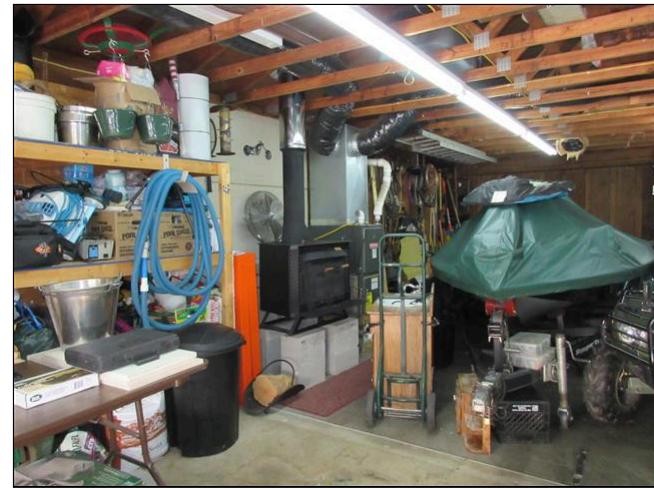
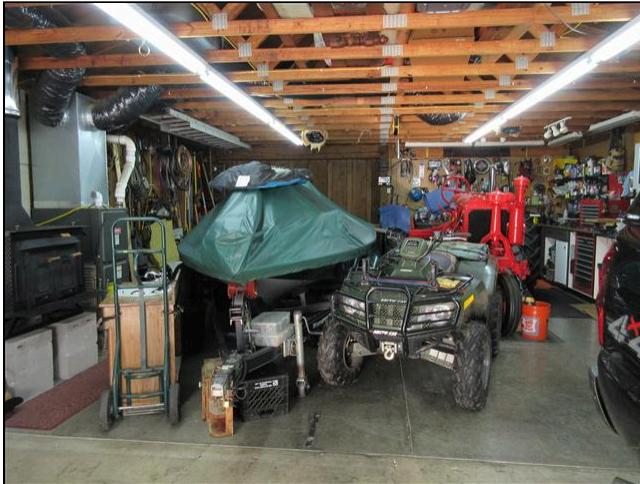
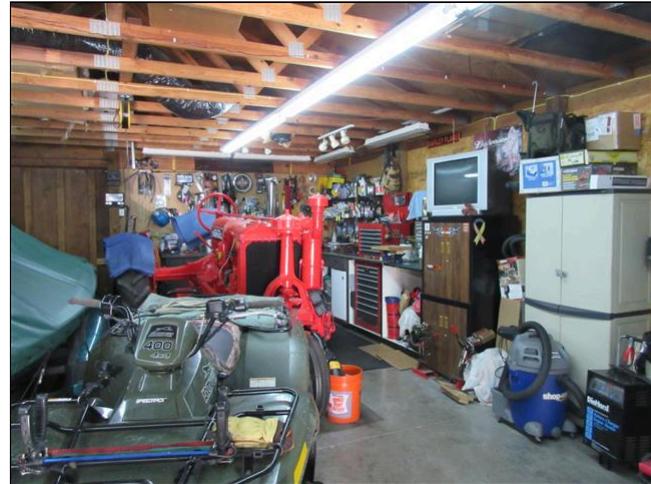
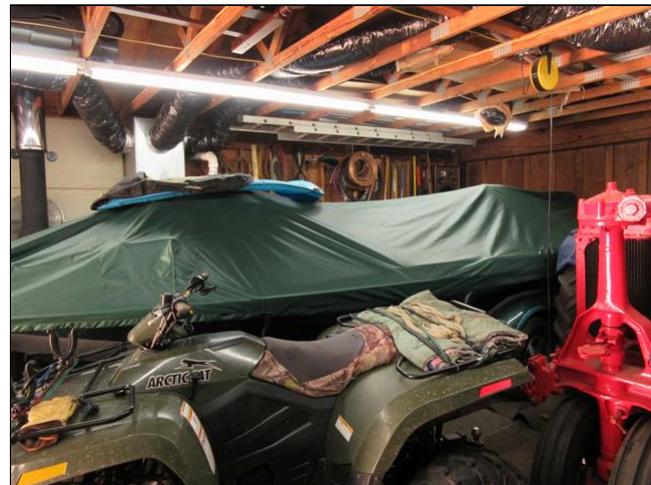
3.1 (1) Large areas of the interior are not fully visible due to the owners belongings. I make every attempt to view the walls and floors, but am limited to the areas that are fully visible.

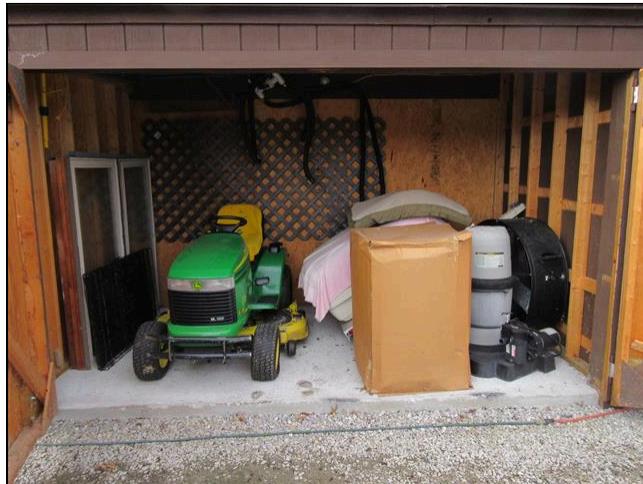
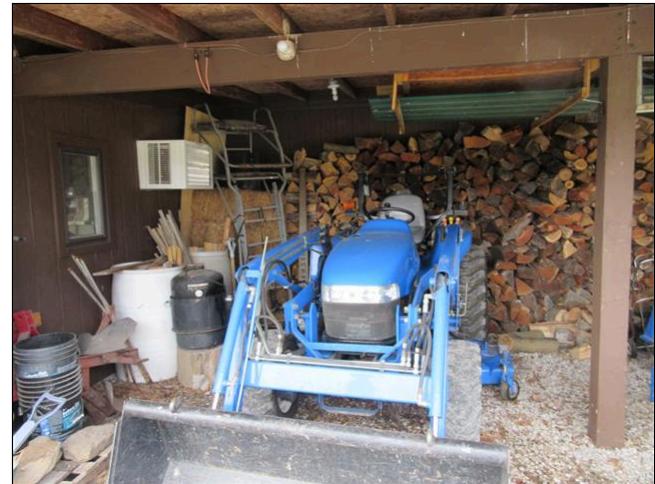
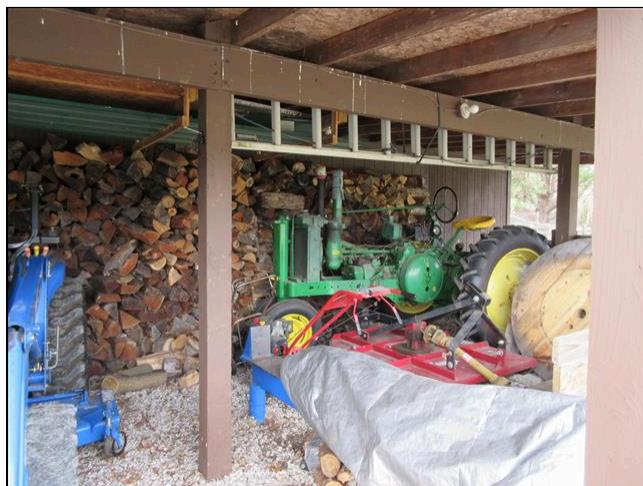
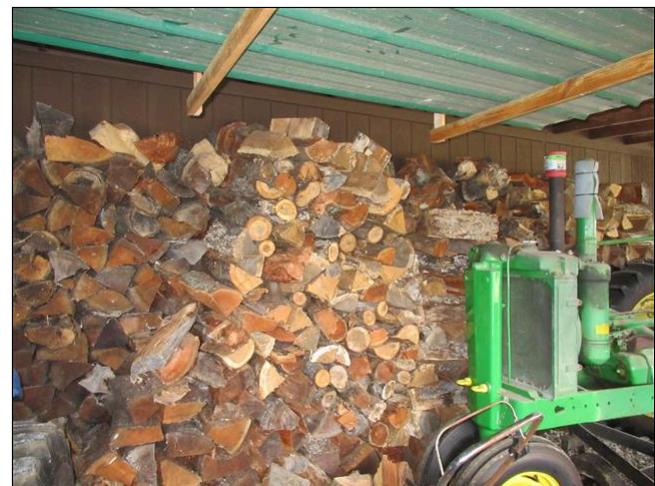
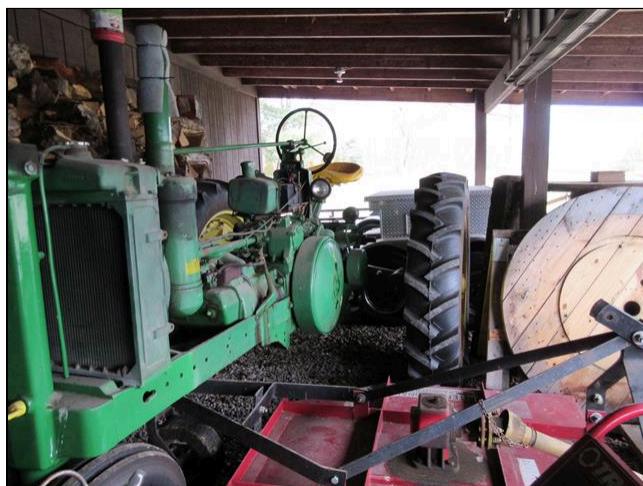
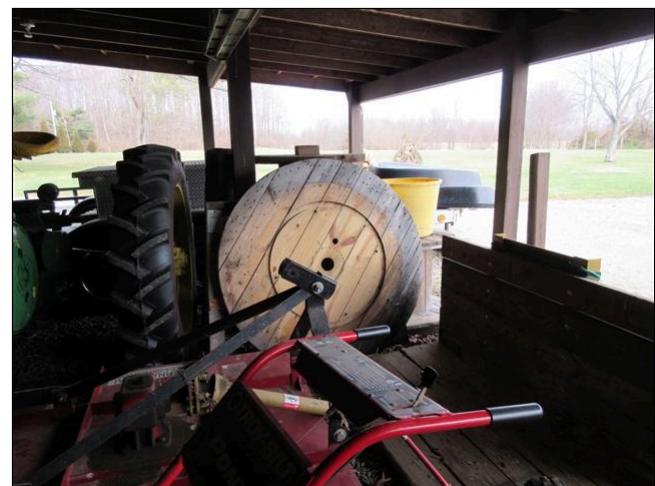
3.1 (2) My view and inspection of the exterior storage areas of the garage was very limited due to a large amount of stored items.

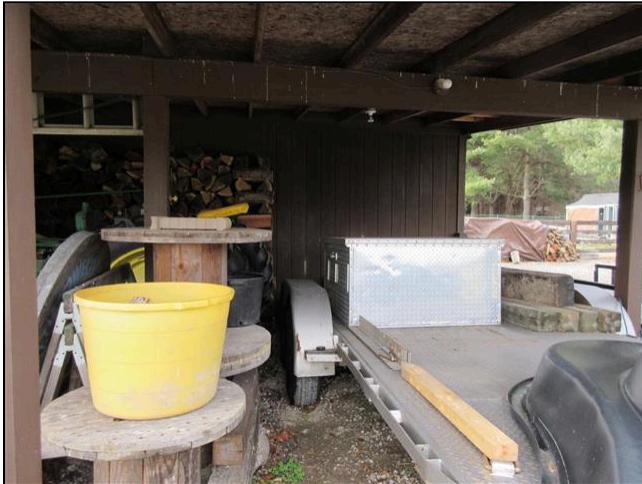
3.1 Item 17(Picture)

**3.1** (3) On the front exterior of the garage there is some deteriorating door trim (brick mold) over the exterior center portion of the overhead door. The deteriorated wood is about 2 foot in length. I could not determine if the deterioration is into the siding as well. I recommend further evaluation and repair or replacement as needed.

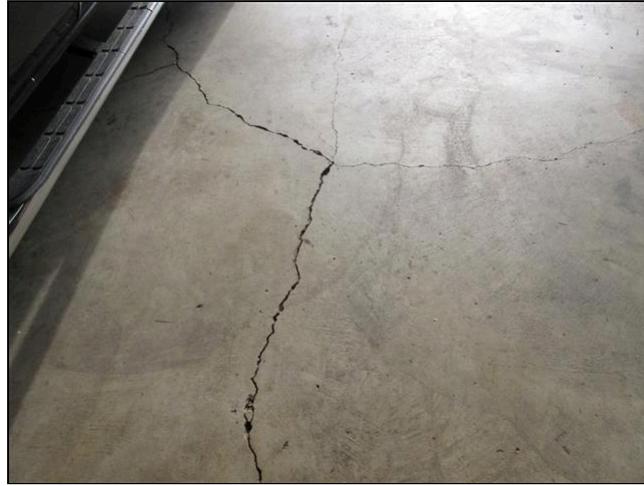
3.2 Item 1(Picture)

3.2 Cracks were noted on the garage floor which appear to be typical of concrete cracks.

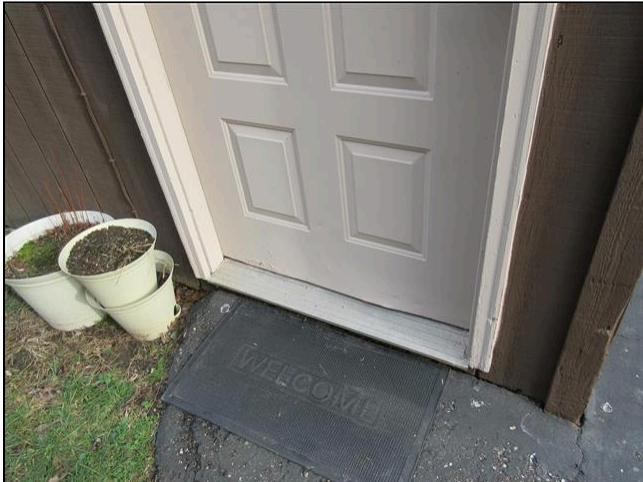
3.3 Item 1(Picture)

**3.3** There is what appears to be minor rust at the main garage storage area at the bottom of the door. I suggest repairing to slow or stop further deterioration at the door.
