Inspection Report

Address: 1234 E. Main St, Louisville, KY 40206

**Inspector: Allan Davis Ky 2233 In 008000002
P.O. Box 277
Greenville, In. 47124
502-648-9294
12/1/2015**

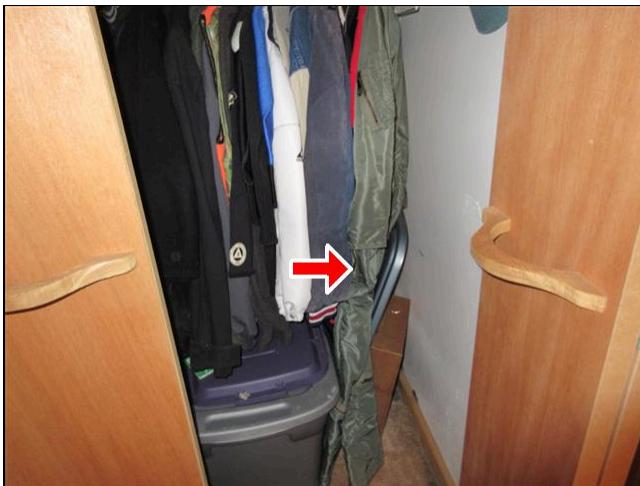
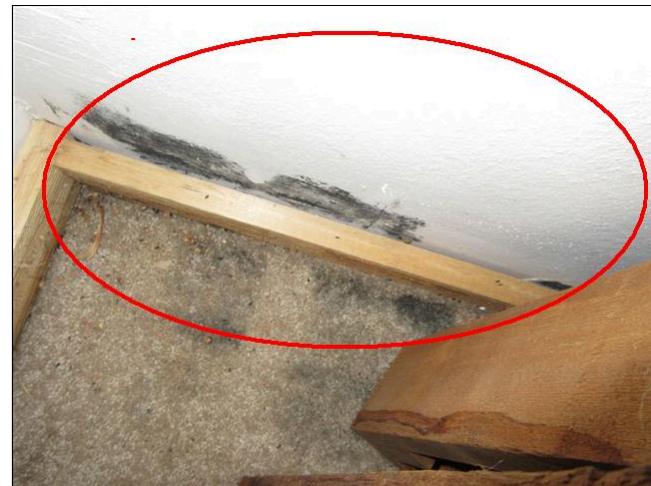
4.1 Item 26(Picture)

4.1 (2) In the finished area of the basement there was a very musty smell present. With carpet on the floor the musty smell could be from a water leak, lack of air circulation or high humidity. In the closet (see pictures) I observed blackish like fungi growth. I recommend further evaluation of the musty smell and the blackish like stains and correction as needed by a qualified person.

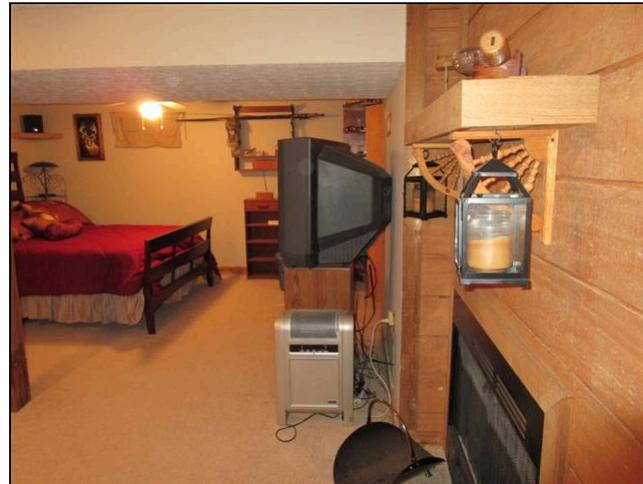
5.0 Item 1(Picture)

5.0 (1) I observed some common shrinkage cracks on the basement walls and floors. I did not observe any signs that the cracks had leaked. The basement was dry at the time of the inspection. Basements can and do leak even if they have been dry for years. It is impossible to predict the likelihood of water penetration or the amount. Recommend consulting with a water proofing professional if water penetration occurs.

Even though the basement was dry there was a musty odor in the finished area of the basement (mentioned earlier in this report along with blackish stains in the closet).

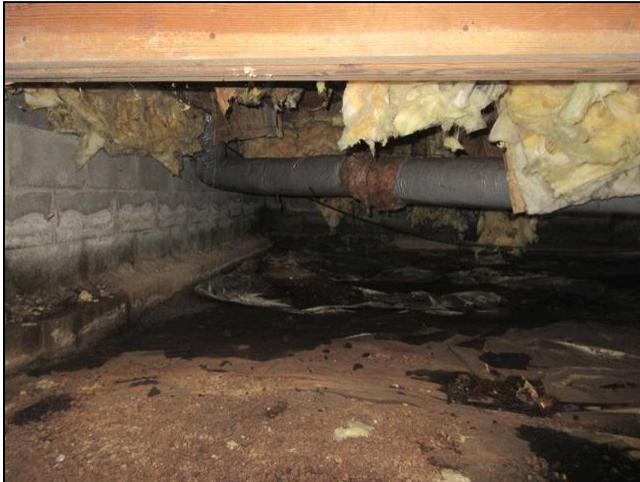
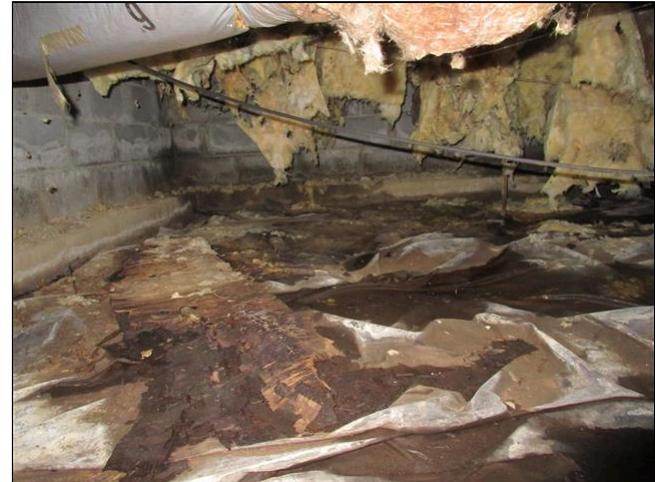
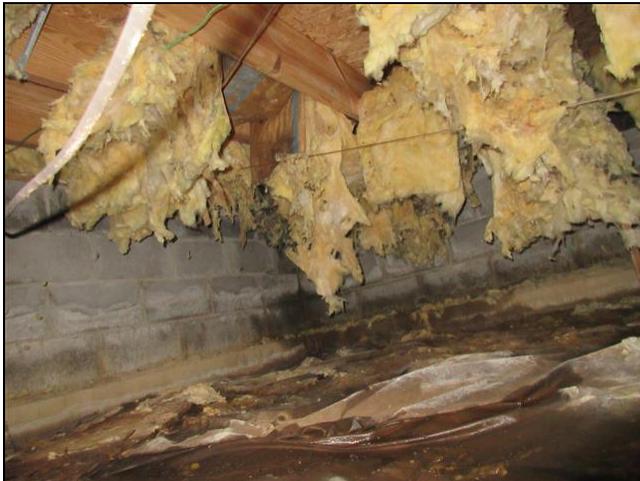
5.0 Item 2(Picture)

**5.0 (2)** The crawl space was mostly dry with the exception of the right side (as looking from the outside of the house) of the crawl space. Moisture was present along the right wall to about 6 feet towards the rest of the house. I recommend that a qualified waterproofer evaluate the crawl space and correct as needed.

Note - due to water draining into the sump crock the entire time I was present I suspect the water table is high around the house.

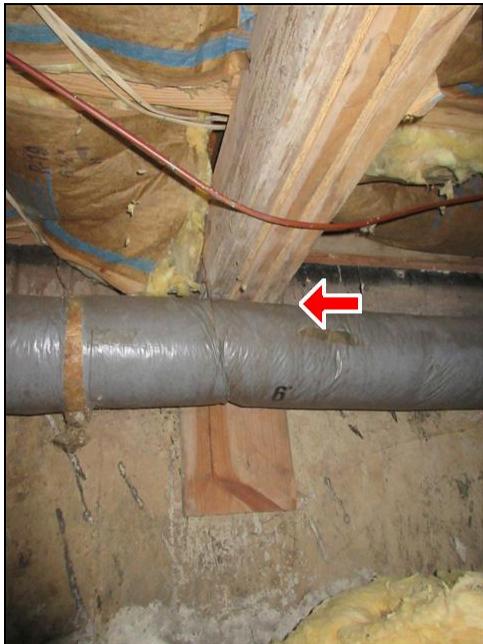
- 1) The beam does NOT sit in a pocket with a minimum of 2 1/2 inches of bearing.
- 2) At the basement side of the crawl space the beam was not in a pocket but resting on a about 1 1/2 inch wide board nailed to the wall.
- 3) At the right side of the crawl space the beam was supported by a metal support column that was deteriorating at the base of it due to significant rust.
- 4) I also observed that 2 of the metal supports along the beam were bending downward at the top plate.

5.2 Item 1(Picture) Inadequate support for the left side of the beam

I recommend that a qualified person to fully evaluate the beam and steel supports and repair, replace or correct as needed for proper support.

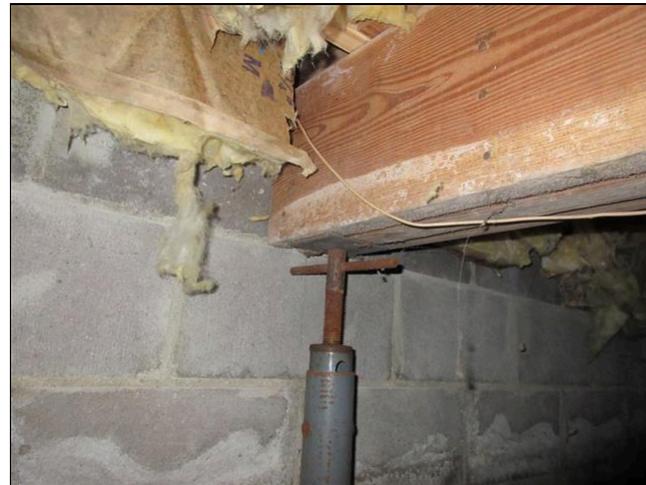
5.2 Item 2(Picture) Right side of crawl space

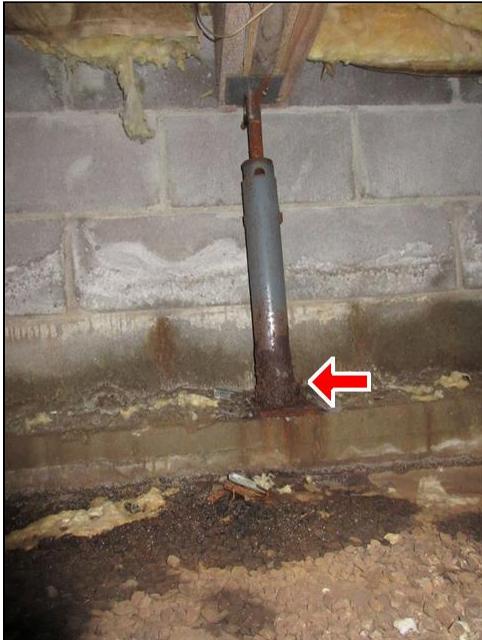
5.2 Item 3(Picture) Significant rust at bottom of right side column

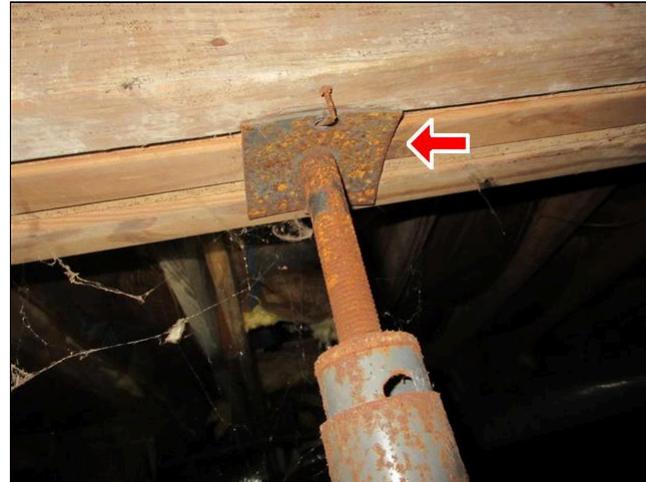
5.2 Item 4(Picture) Bending support column

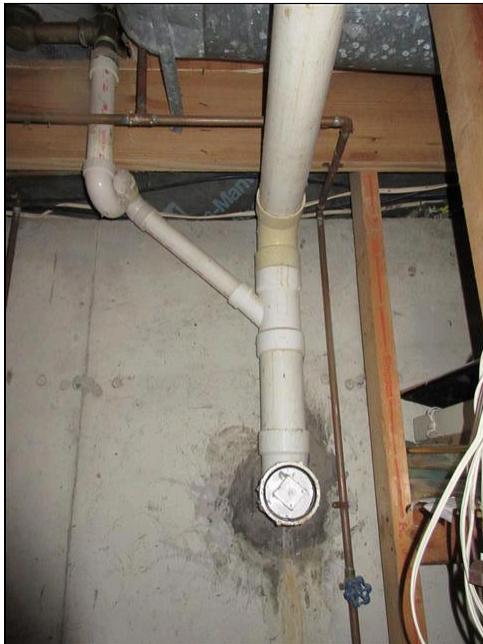
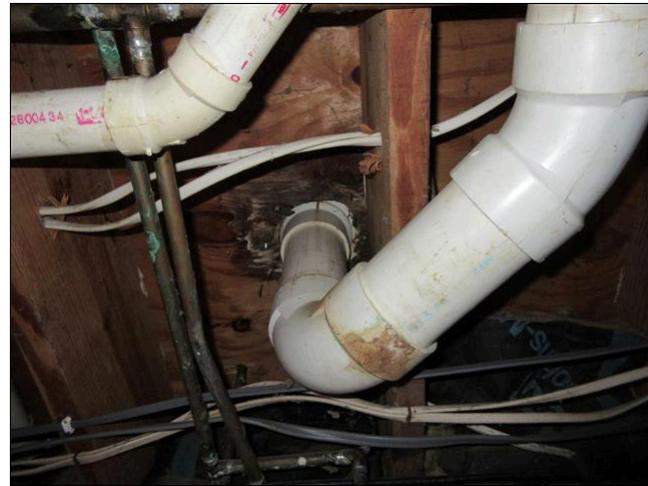
5.3 Item 1(Picture)

5.3 (1) I did observe water stains in the basement under the first flooring. I probed the stained areas and no moisture was present and the wood was mostly intact. No action is needed,I mention this for your information.

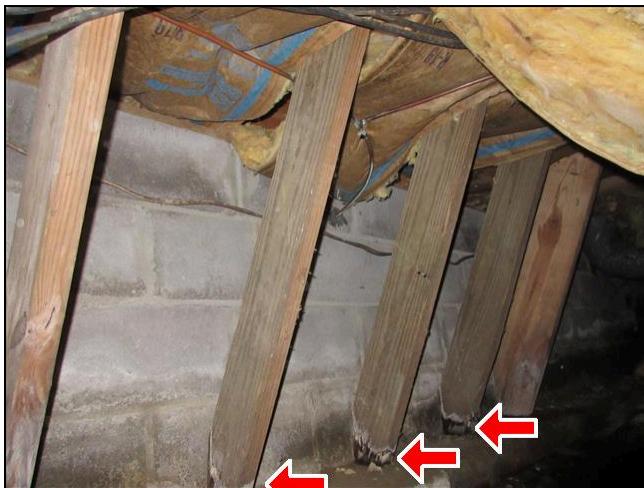
5.3 (2) In the crawl space towards at the front of the house I observed added supports which appear to be under the right (as you are looking at the front of the house) side fireplace. The supports are deteriorated at the foundation due to moisture. I recommend that a qualified person fully evaluate this entire area and repair or replace the supports in this area as needed for proper support.

5.3 Item 5(Picture) Supports appear to be under the right side fireplace

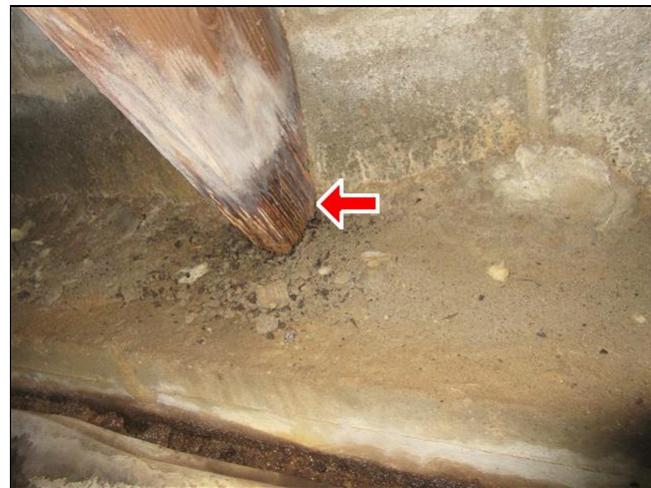
5.3 Item 6(Picture) Deterioration

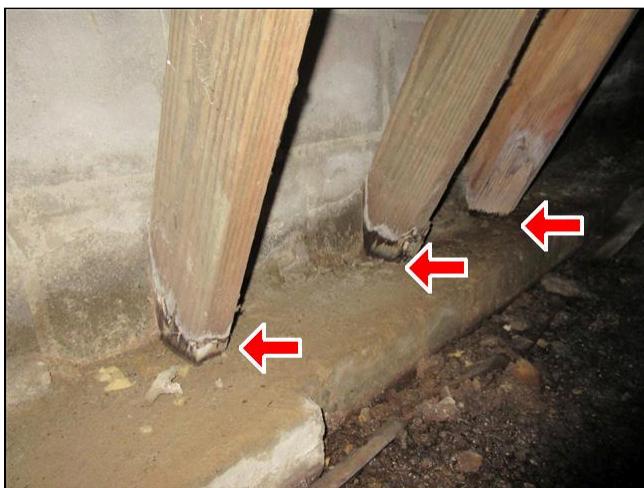
5.3 Item 7(Picture) Deterioration

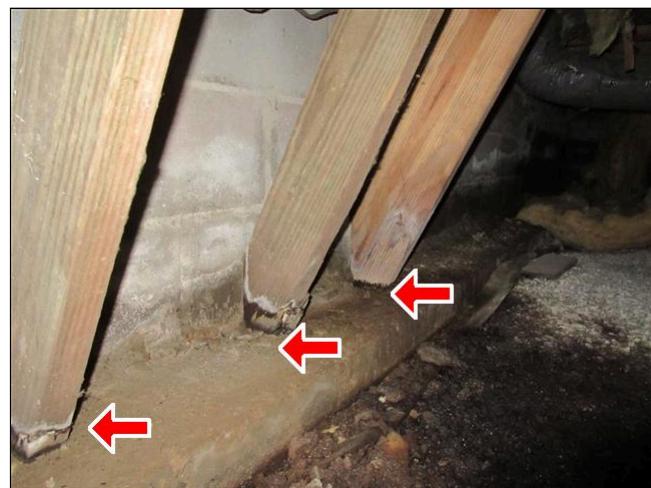
5.3 Item 8(Picture) Deterioration

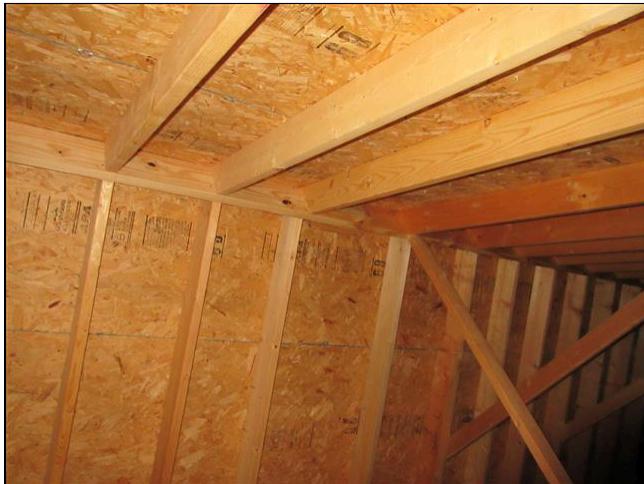
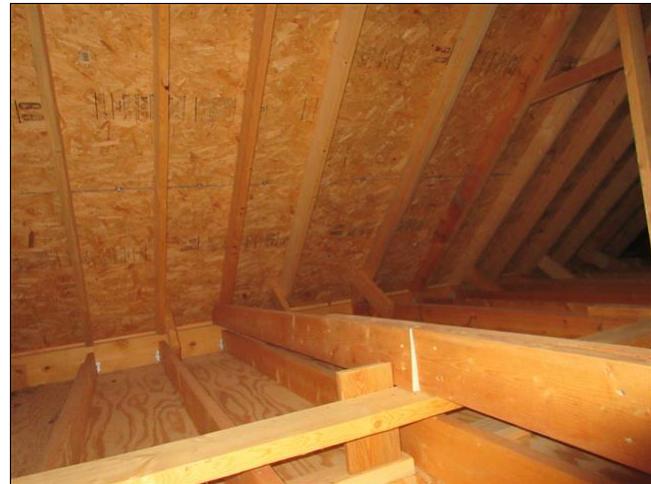
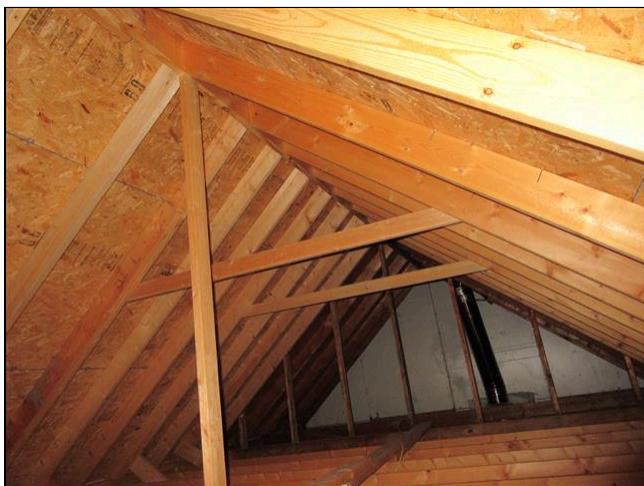
5.5 (1) I was able to view the screened porch attic from the opening. No significant issues was observed from the opening.

5.5 Item 2(Picture) Attic area of screened porch

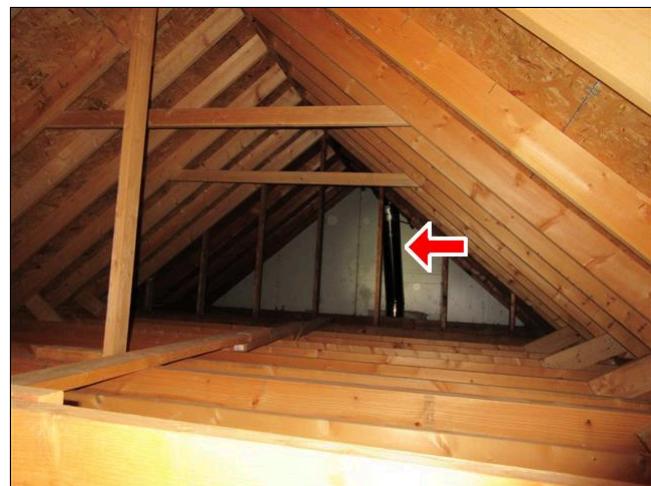
5.5 Item 4(Picture) Attic area of screened porch- I could not see underside of the roof area at the wood burning flue which was at the opposite of the attic

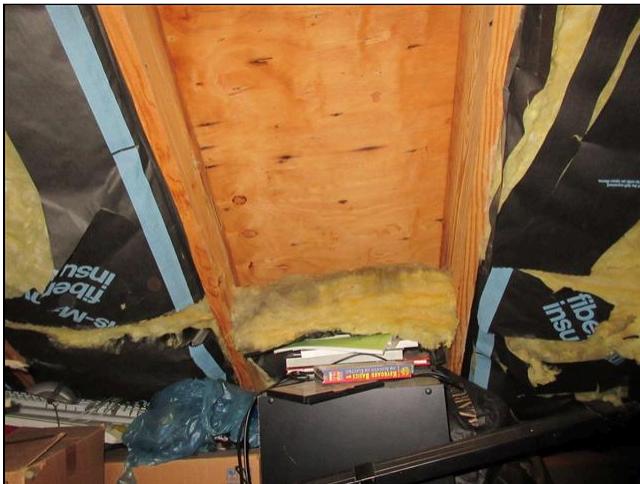
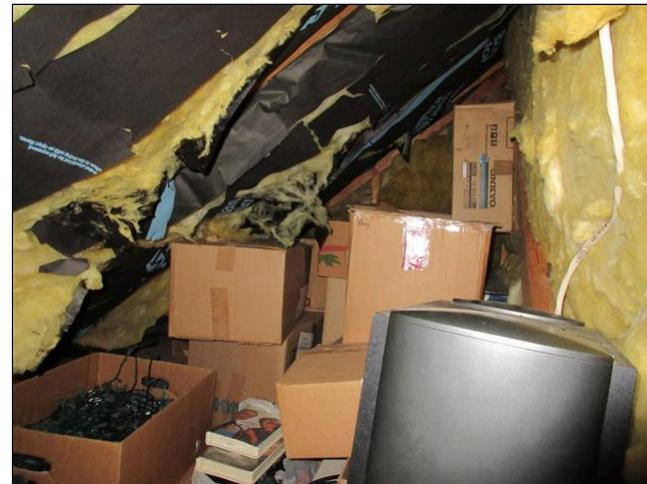
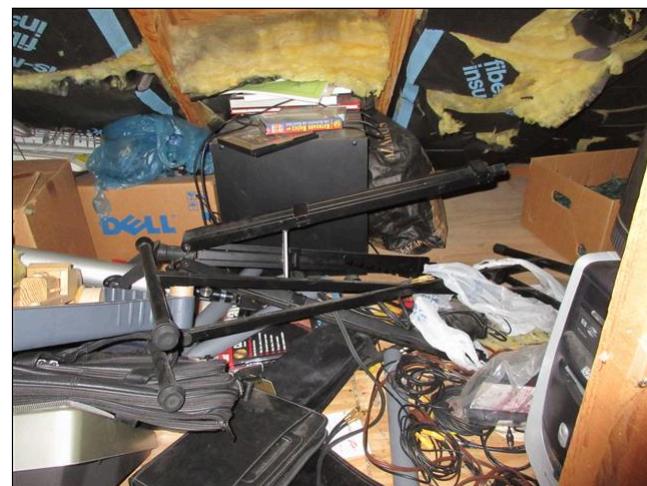
5.5 (2) Due to vaulted ceilings over the house there is only an extremely small area where there is any access to the attic. At the small area that was accessible at the 2nd floor loft the area was so full of storage the view and inspection was almost non- existent due to the owners belongings.

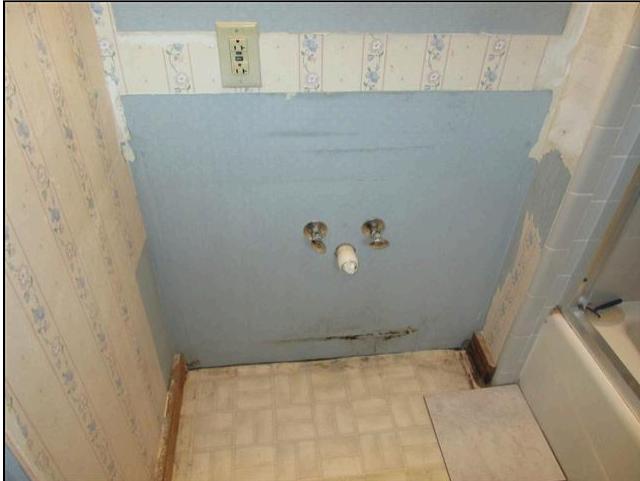
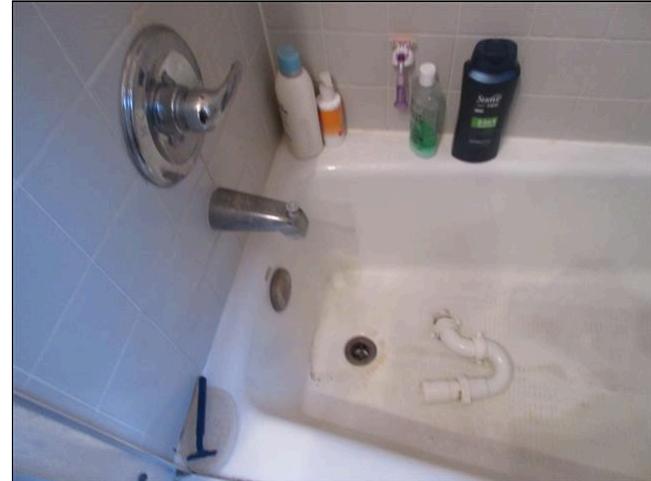
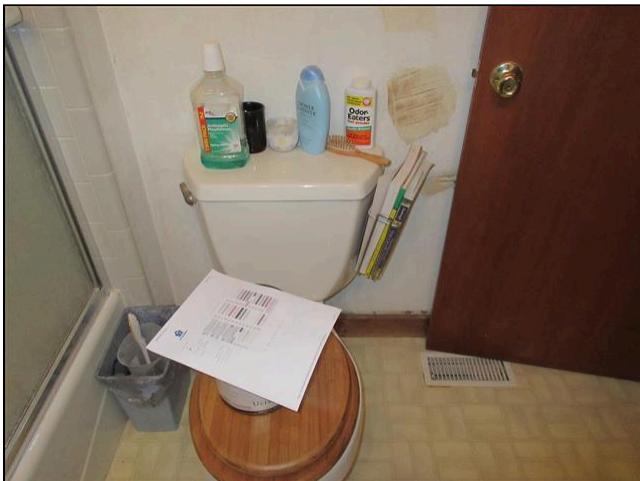
**6.0 (1)** The Master Bathroom sink cabinet and fixture has been removed. The shower/tub and the toilet was functional.

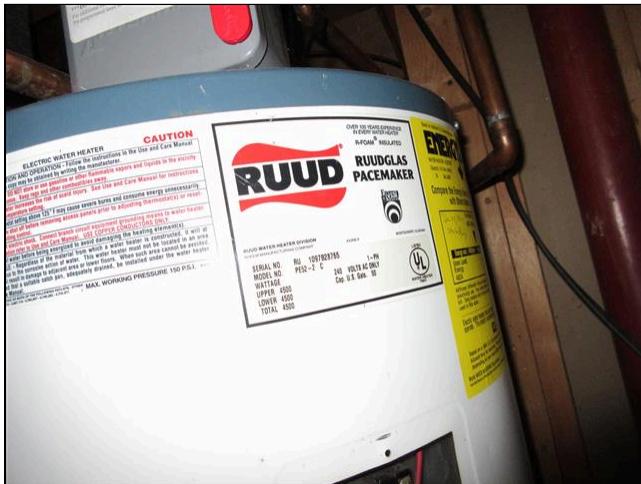
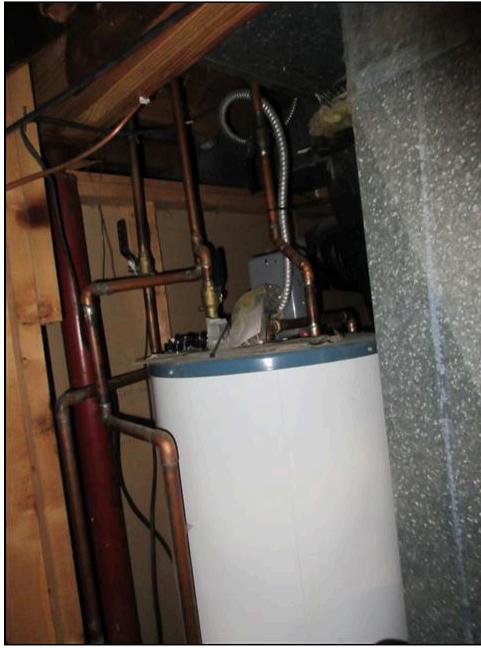
**6.2** The water heater was not fully accessible due to being concealed by a large amount of stored items. I did however observe that someone had removed the covers over the heating elements. I recommend that once the water heater is fully accessible that a qualified person evaluate the water heater and repair or correct as needed. I'm unsure as to why the covers were off the heating elements, but based on the numerous electrical issues I'm concerned about handy man work that may have been performed on the water heater.

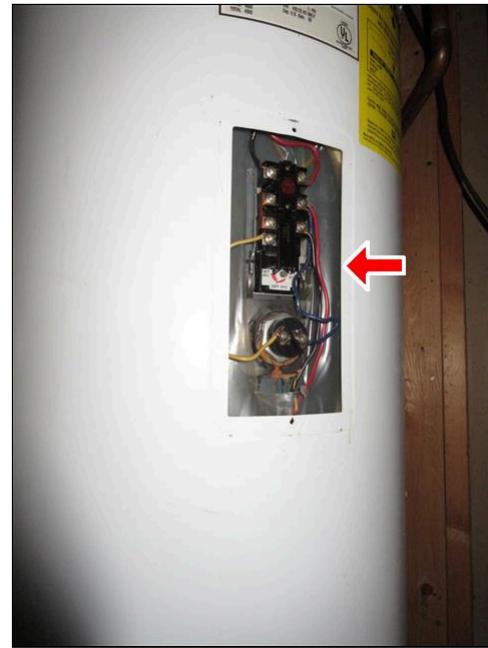
6.2 Item 2(Picture) 1 of 2 cover plates off the water heater elements

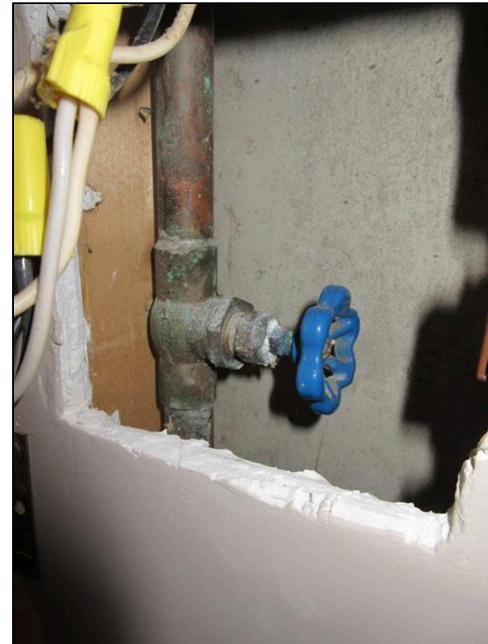
6.3 Item 1(Picture)

6.3 The main shut off is the blue knob located in the basement on the front wall in the basement. This is for your information.

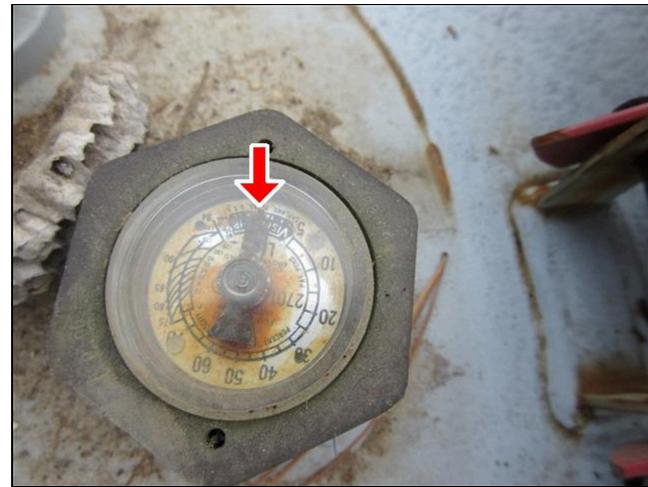
6.5 For your information the propane tank was empty.

6.5 Item 1(Picture) Propane tank was empty.

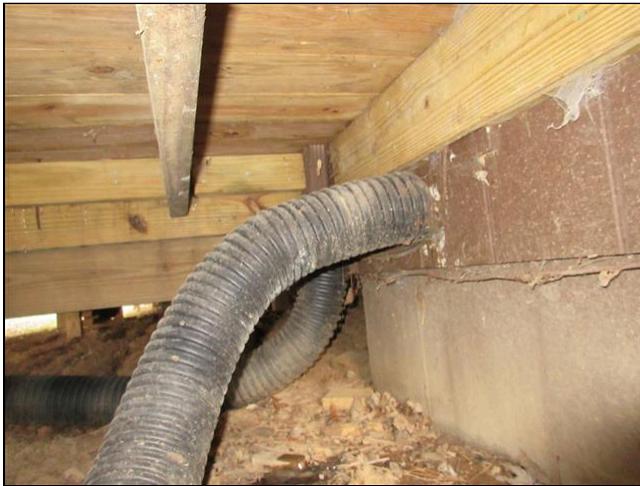
I observed that the basement deep sink is draining into the sump pit and being discharged into the yard. The deep sink should drain into the septic system. I recommend correction as needed.

6.6 Item 1(Picture) Sump pump appears to discharge under the rear deck

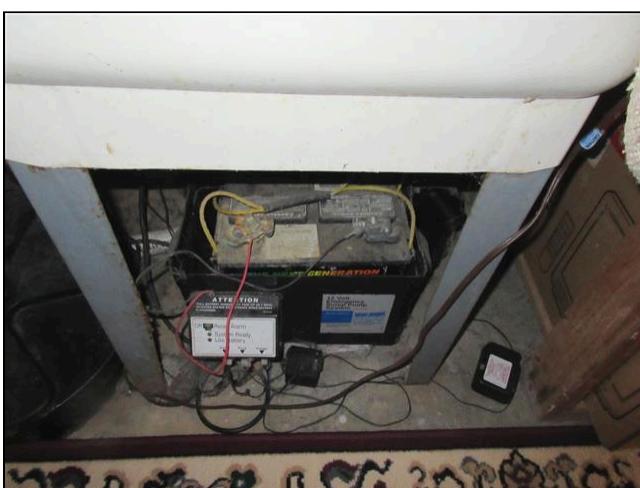
It is very obvious that loosing power would put the basement jeopardy for becoming wet. Battery back ups have a limited amount of run time. I recommend that a water powered back up is added for added protection against water back up.

6.6 Item 3(Picture) Battery back up

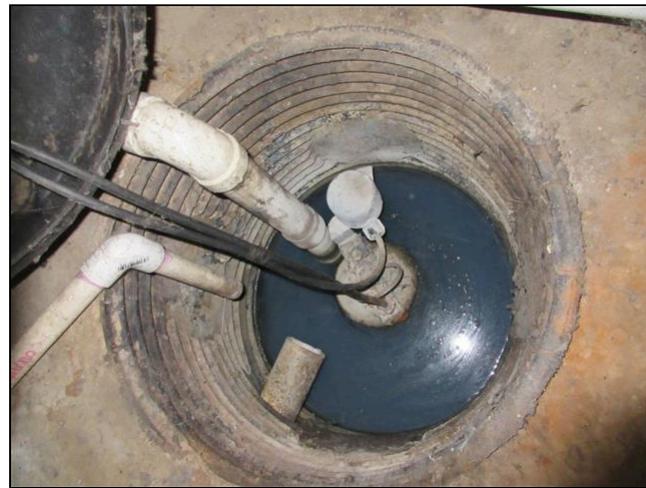
6.7 Item 1(Picture)

6.7 The ejector pit lid was not sealed shut and it should be to keep odors down. The pump was ran and was functional but is obviously older.

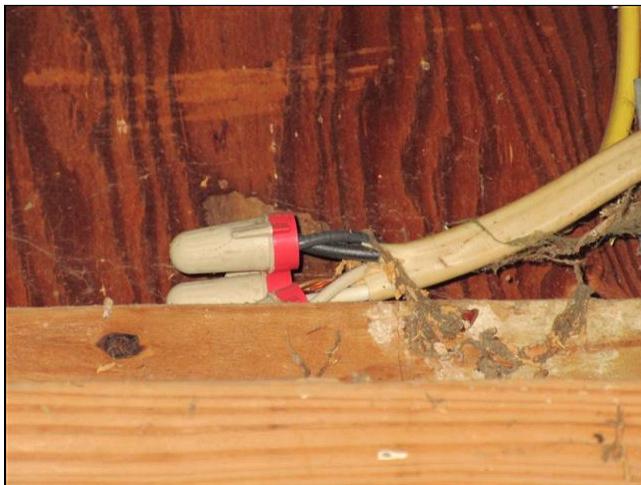
- 2) At the rear main storage area of the garage at the rear wall ceiling area I observed an open electrical splice. Spliced wires should be in junction boxes for safety reasons. I was not able to get up to the wires to more closely examine the splice due to the large amount of stored items below this area. The wires should also be examined to determine if the wires are the same gauge. One wire was sheathed in a cream (could be #12 wire or 14 if the wire is older) color and the other was yellow (#12 wire). Improper size wire ran to a breaker which is too large can result in an electrical incident. Evaluate and repair or replace as needed.

7.3 Item 1(Picture) Spliced wires at the rear wall ceiling are of garage. The wires maybe different size wire (14 and 12).

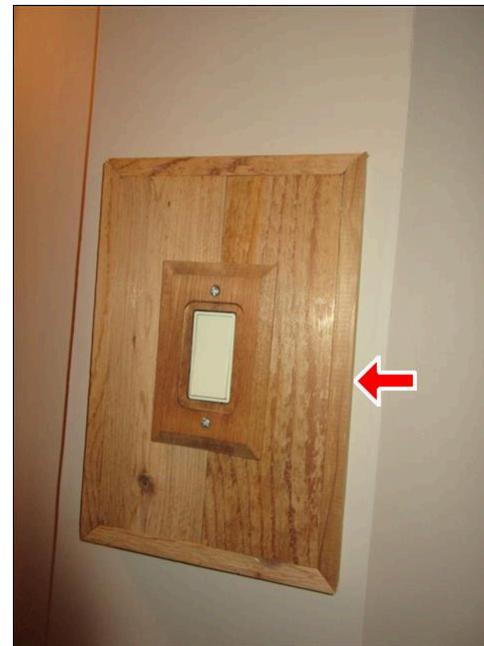
7.3 Item 2(Picture) Water shut off and electrical hazard

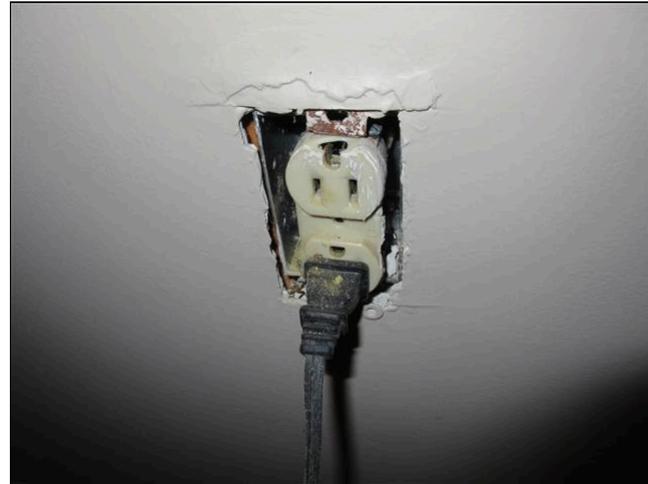
7.3 Item 4(Picture) Missing cover and damaged outlet in the basement finished area

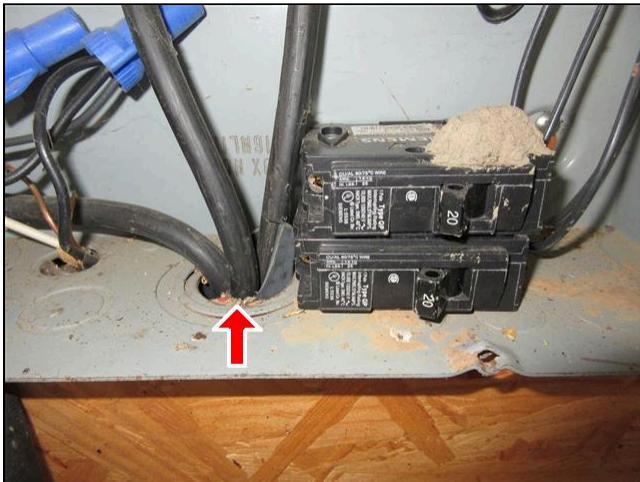
7.6 Item 3(Picture) No Romex connector

A licensed electrician should FULLY evaluate the entire electrical systems of the house and garage repairing or replacing as needed for safety reasons.

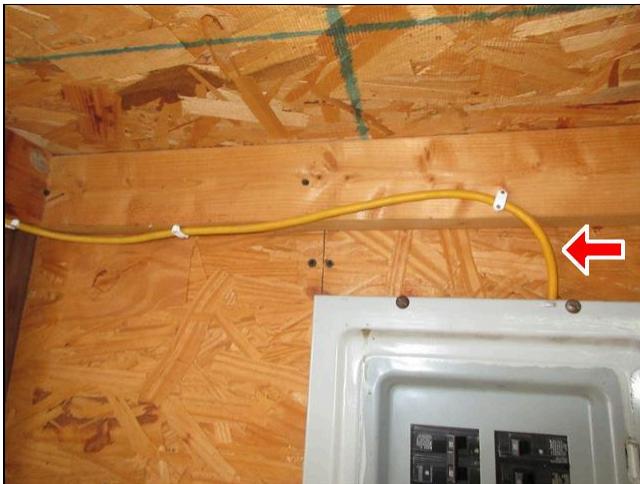
- 3) At the top of the panel there is an extension cord which has been used as wiring (improper) and has the electric panel covered over it which can pinch the wires causing an electrical issue.

7.6 Item 5(Picture) Panel cover installed over a extension cored like wire ran to a wall switch. A cover should not be installed over a wire (pinching) and rome should be used for wiring

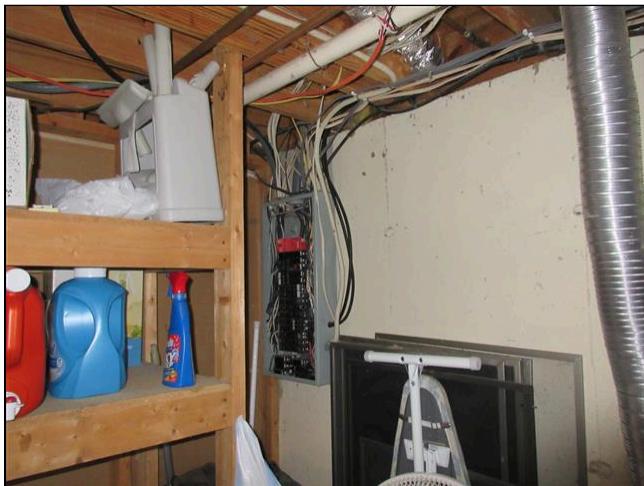
7.6 Item 6(Picture) The panel cover was already off and the panel could not be safely fully accessed

A licensed electrician should FULLY evaluate the entire electrical systems of the house and garage repairing or replacing as needed for safety reasons.

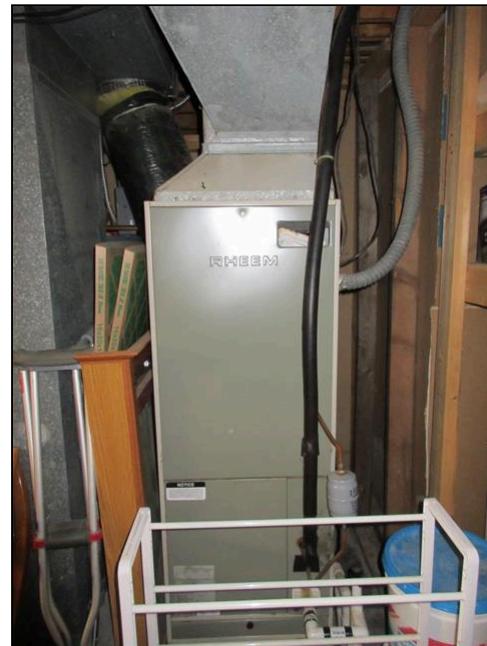
8.0 Item 5(Picture)

The air handler appears to be the same age as the outdoor unit which would put both the air handler and the outdoor unit at the end of the end of their life expectancy.

I recommend that due to the age of the HVAC system that if the system has not been serviced by a qualified contractor in the past 12 months the systems should be evaluated and serviced as needed.

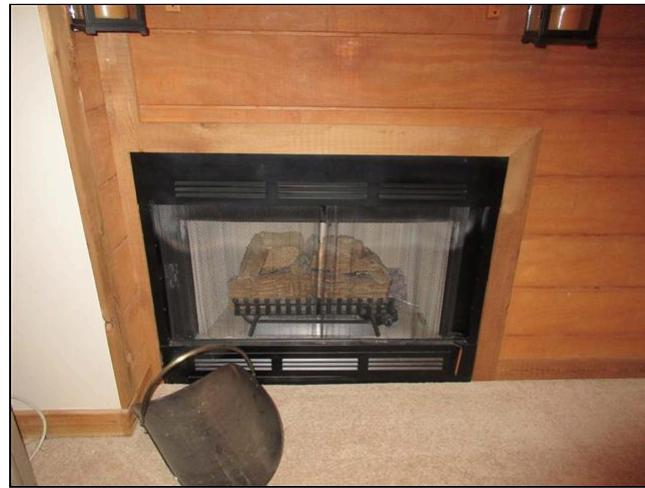
8.7 Item 1(Picture)

8.7 The gas fireplace could not be operated there is no Propane to operate the fireplace. I recommend evaluation of the fireplace once Propane is available.

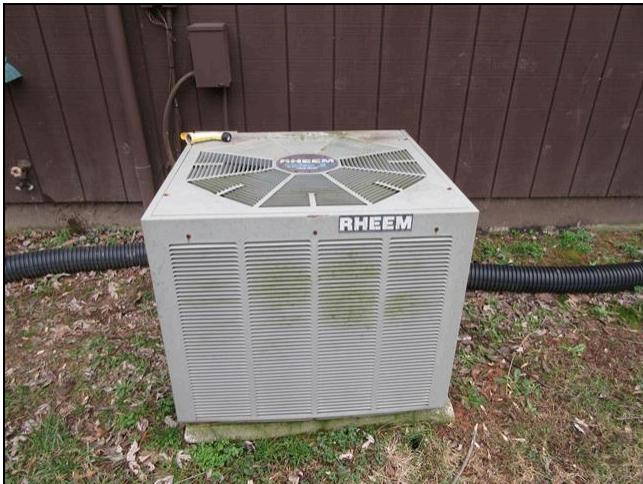
8.10 Item 1(Picture)

**8.10** The condenser outside (AC unit) is very old (23 years old - life expectancy is about 15 years) and may last a few years more, but maybe not. I have seen units fail shortly after a home inspection during the seasonal change from mild to hot weather. I cannot determine how long your AC/Heat Pump will last before a replacement is necessary.

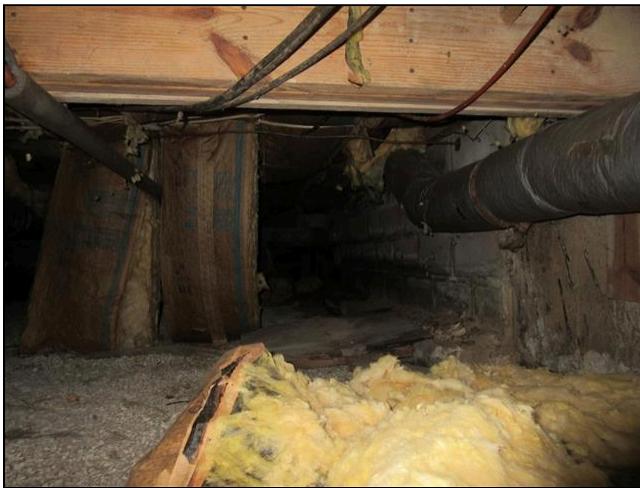
9.1 Item 1(Picture)

**9.1 (2)** The insulation is loose/fallen in the crawlspace. Insulation that has fallen to the ground or has become damp from the ground or from condensation usually needs to be replaced with new insulation. A qualified person should repair or replace as needed.

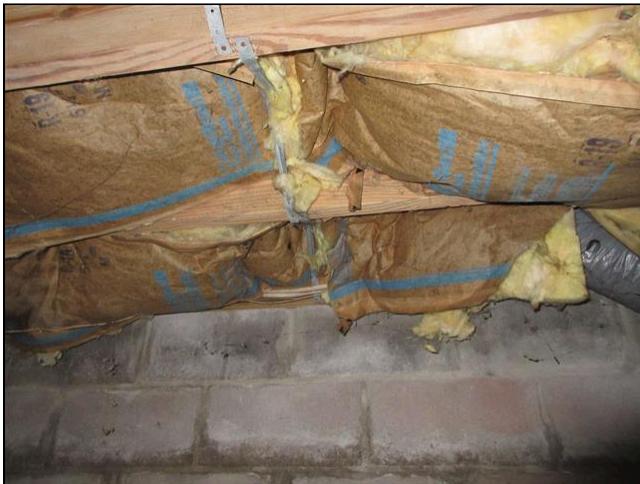
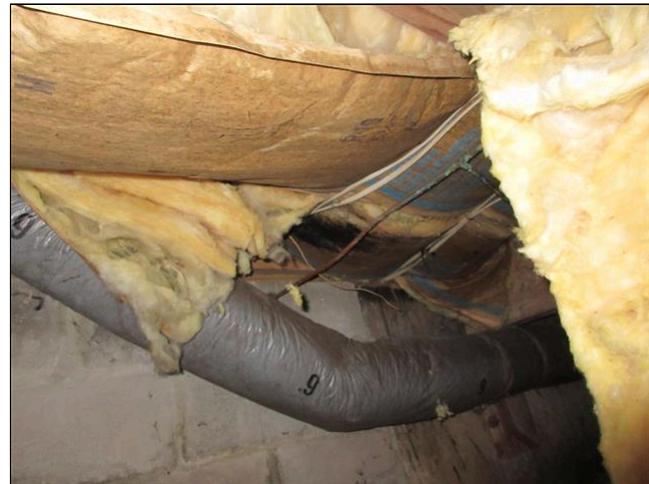
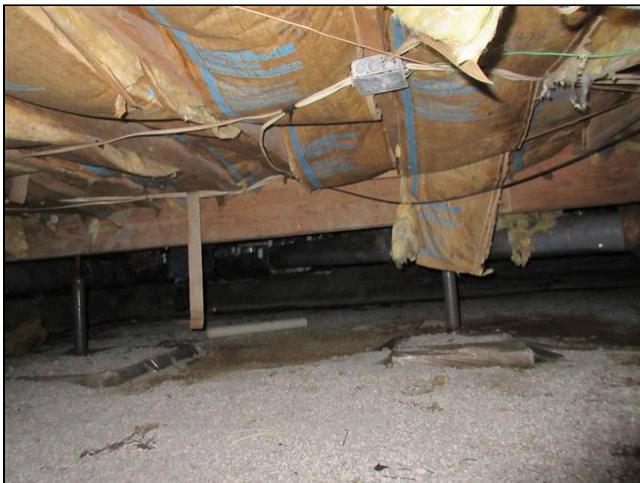
**9.1** (3) The insulation installed wrong side up in the crawlspace. Condensation can cause mold or wood deterioration. A qualified person should repair or replace as needed.

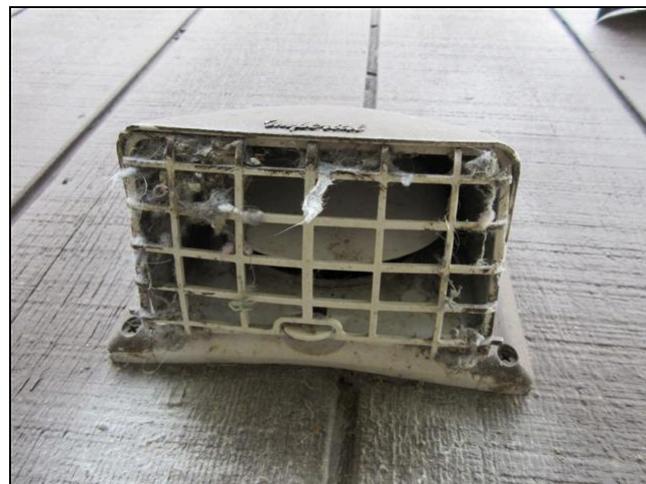
9.4 Item 1(Picture)

**9.4** I observed lint build up at the dryer discharge, I recommend clearing the vent of any excess lint prior to connecting to the vent.

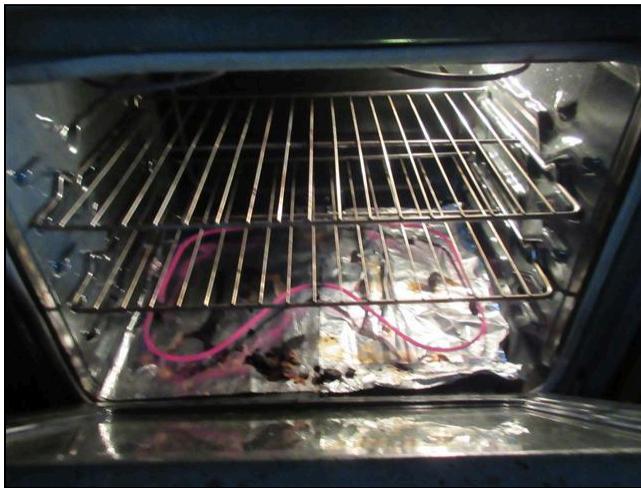
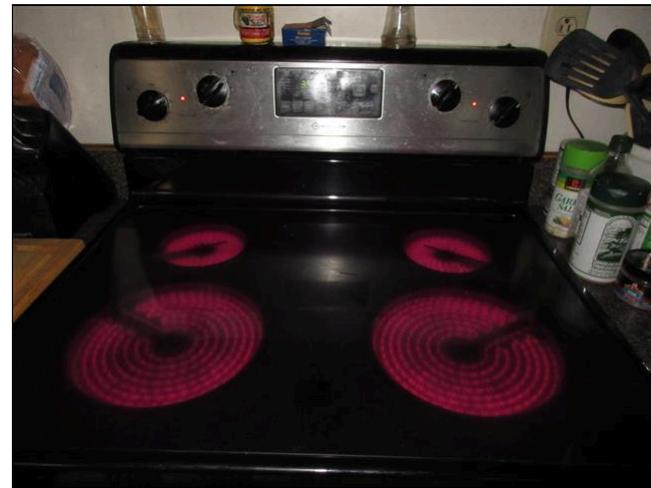
10.1 At the time of the inspection all of the elements/burners were tested and operational.

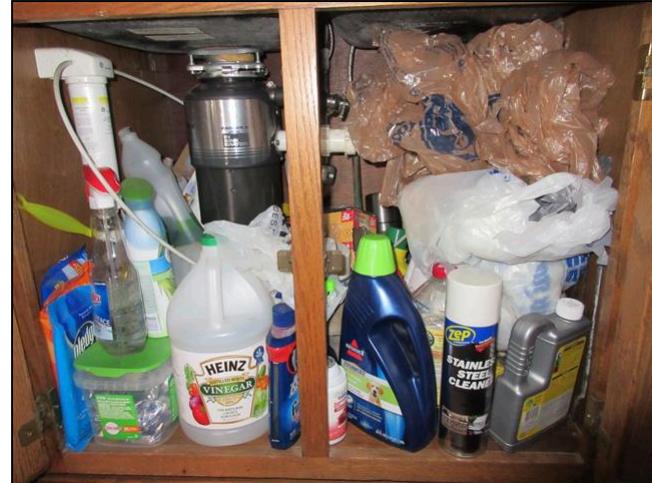
10.4 Item 1(Picture)

10.4 The disposer was functional but my view of the disposer and under the kitchen sink was very limited.

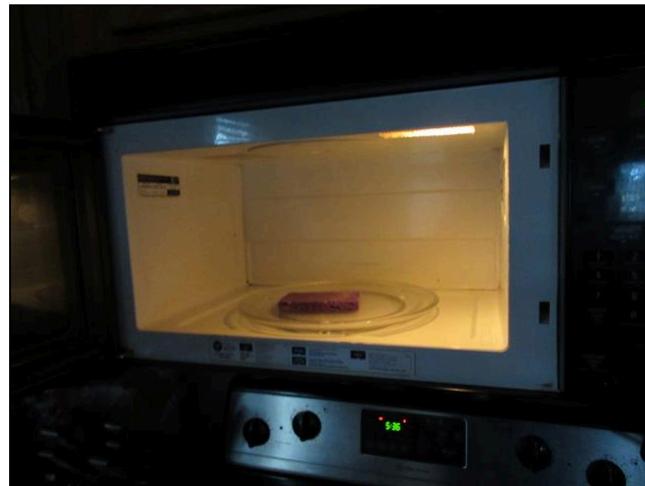
10.5 Item 1(Picture)

10.5 A microwave pad was placed in the microwave and was hot within 30 seconds.

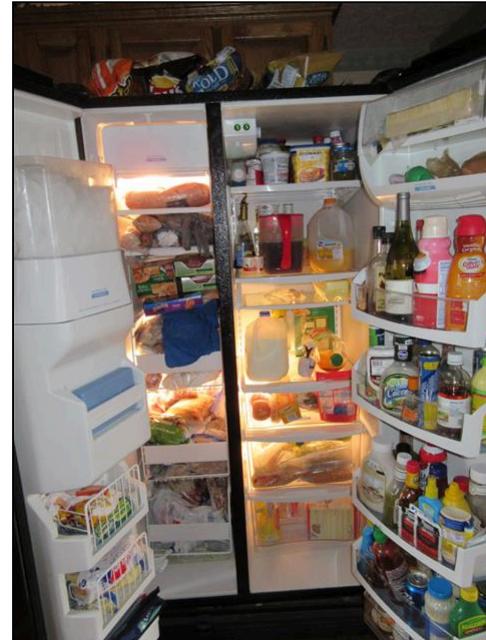
10.6 Item 1(Picture)

10.6 The refrigerator and freezer were both functional.

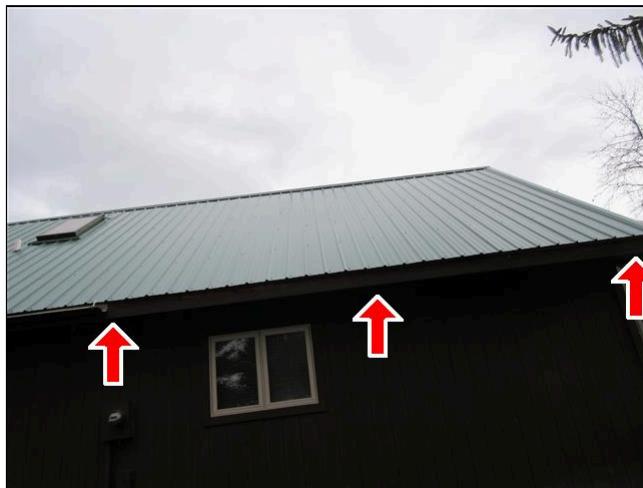
1.3 Item 1(Picture) Missing gutter

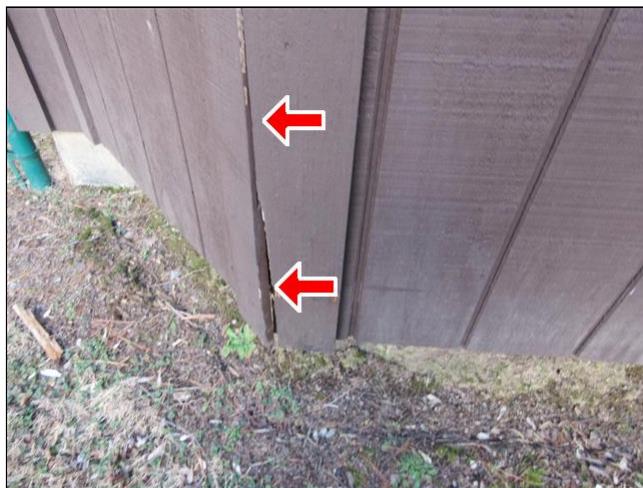
(1) On the left side of the house there was some deterioration (appeared to be minor but I can't see into the wall). below the bay window. I recommend evaluation and repaired of replaced as needed.

2.0 Item 1(Picture) Opening in wood siding on left side of house which can allow moisture entry and deterioration

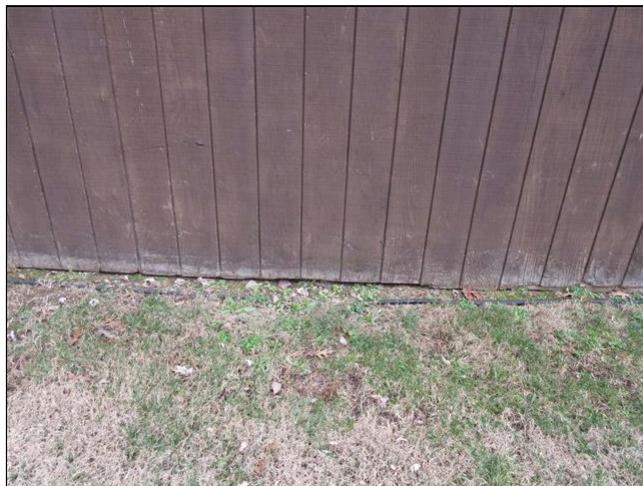
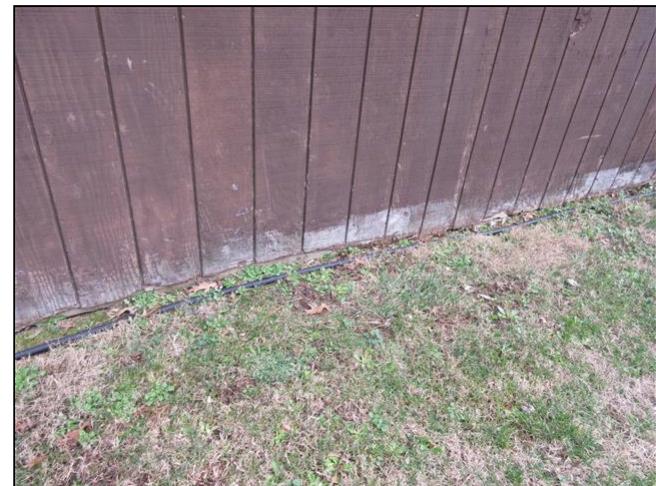
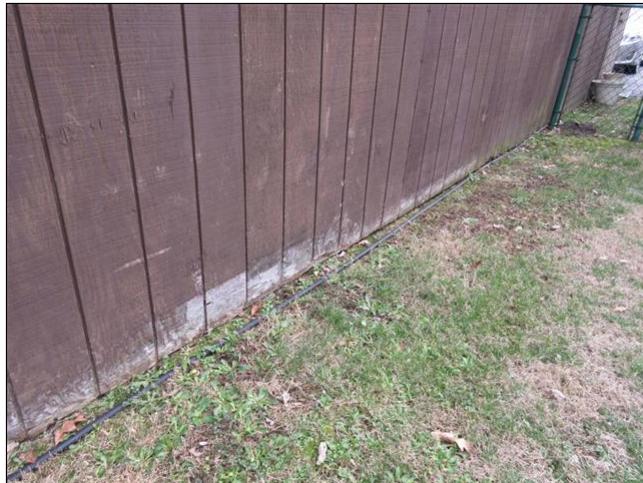
(2) The wood siding on the left side of the garage there is some minor damage to the siding that appears to be either from a weed eater or a mower rubbing along side the wood. This is for your information. I recommend sealing with stains and repairing if needed to slow deterioration.

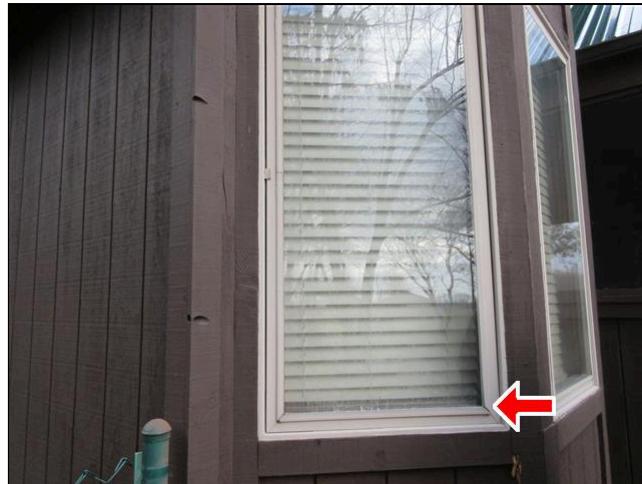
- 1) Left window on left side bay window has a failed thermal pane seal as well as some deterioration around the window at the wood.
- 2) The Octagon window on the rear of the house has significant deterioration at the frame.

2.2 Item 1(Picture) Left side of house

In summary the windows especially the original windows are worn and at or past the end of their life expectancy. I recommend that a qualified contractor evaluate ALL of the windows and repair or replace as needed.

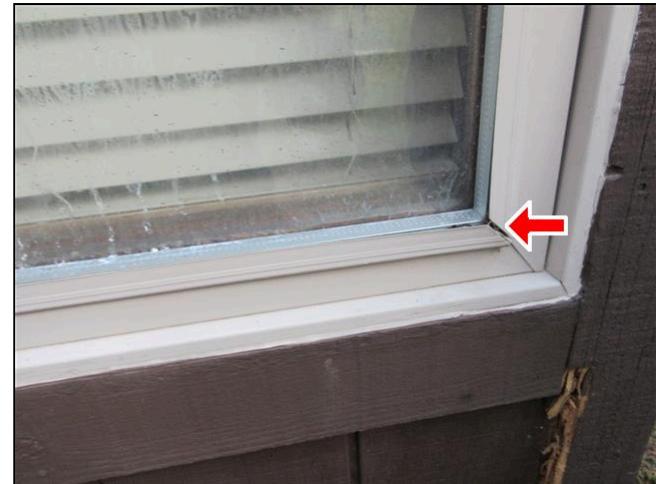
2.2 Item 2(Picture) Left side of bay window on left side house has moisture that is entering around the frame and a failed thermal pane seal

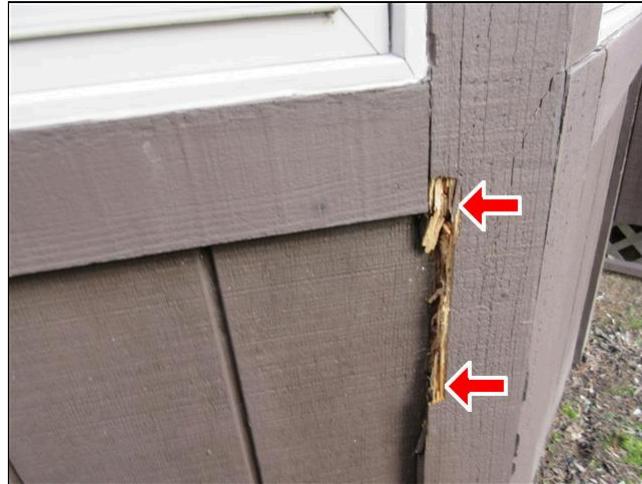
2.2 Item 3(Picture) Deterioration in wood under left side bay window

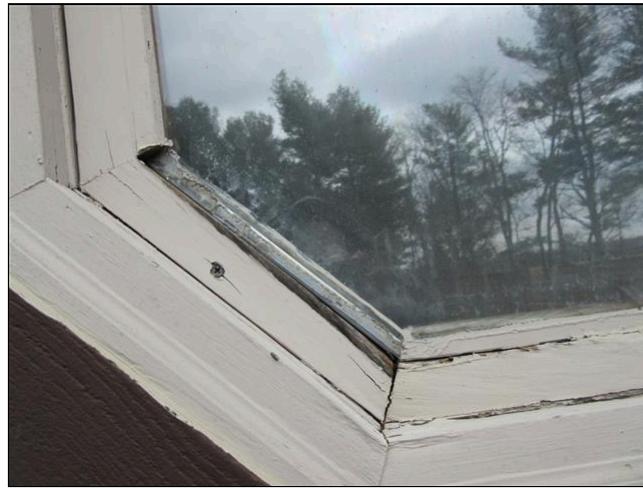
2.2 Item 5(Picture) Close up of the deterioration

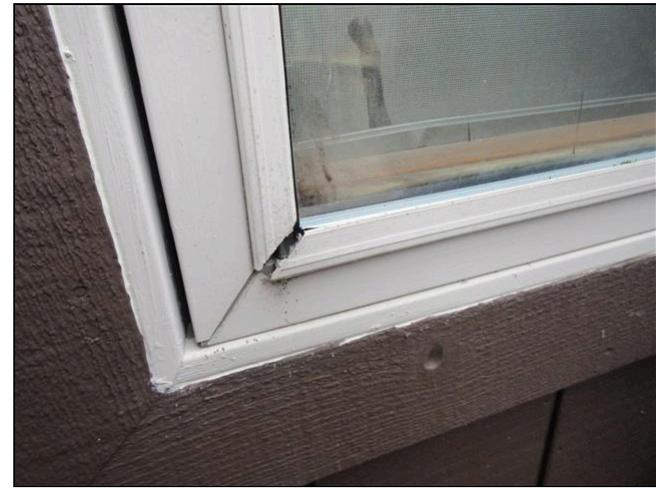
2.2 Item 6(Picture) Window on left side of the house with trim opened up allowing moisture into the window and also a failed thermal pane sill

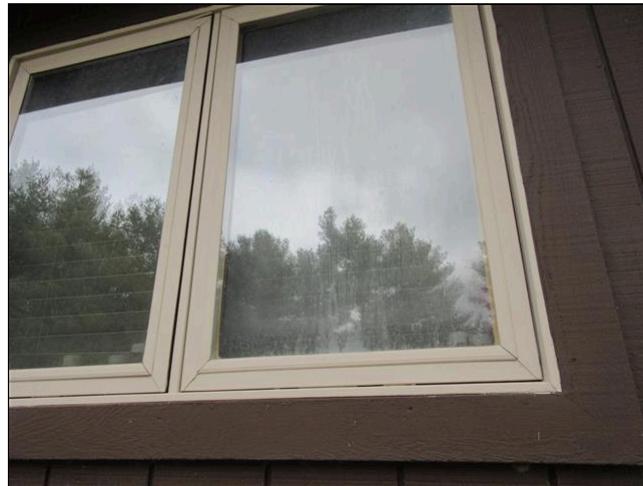
2.2 Item 7(Picture) 2 windows on the rear of the house with failed thermal pane seals
