Inspection Report

Address: 1234 E. Main St, Louisville, KY 40206

**Inspector: Allan Davis Ky 2233 In 008000002
P.O. Box 277
Greenville, In. 47124
502-648-9294
12/1/2015**

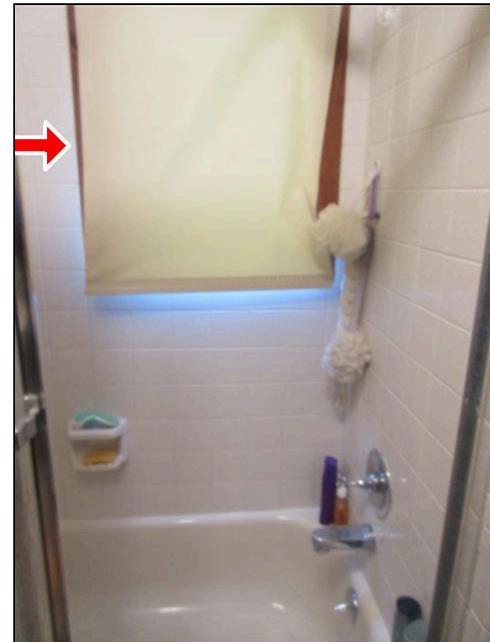
2.2 Item 8(Picture) First floor hall bath window in shower area has a deteriorated frame

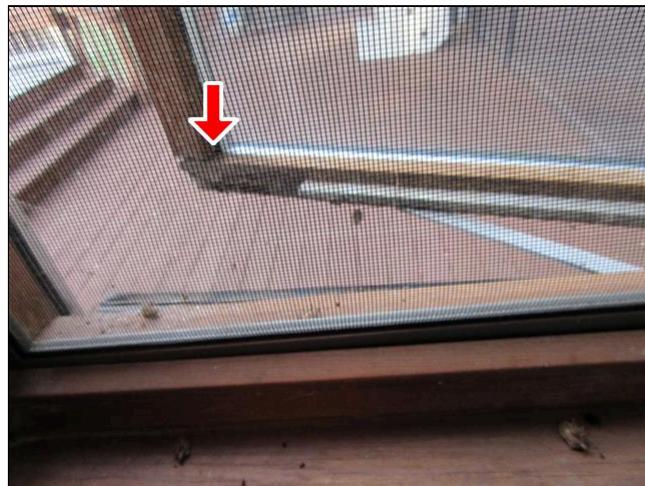
2.2 Item 9(Picture) Bathroom window deteriorated frame

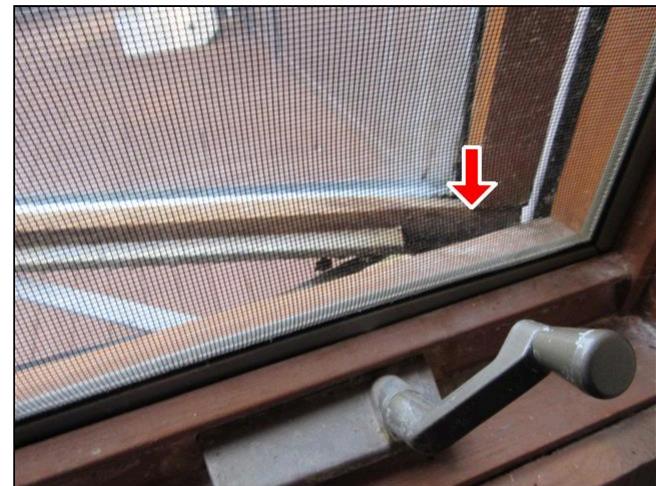
2.2 Item 10(Picture) Bathroom window deteriorated frame

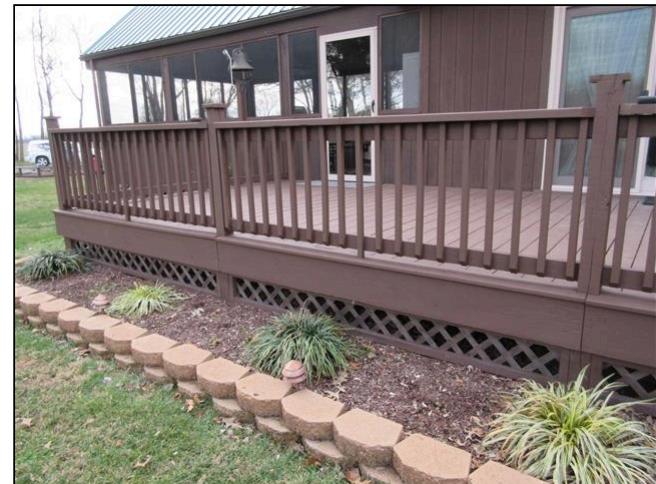
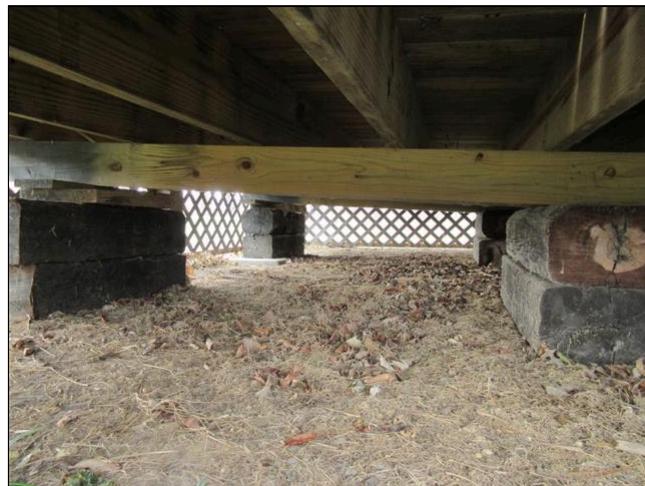
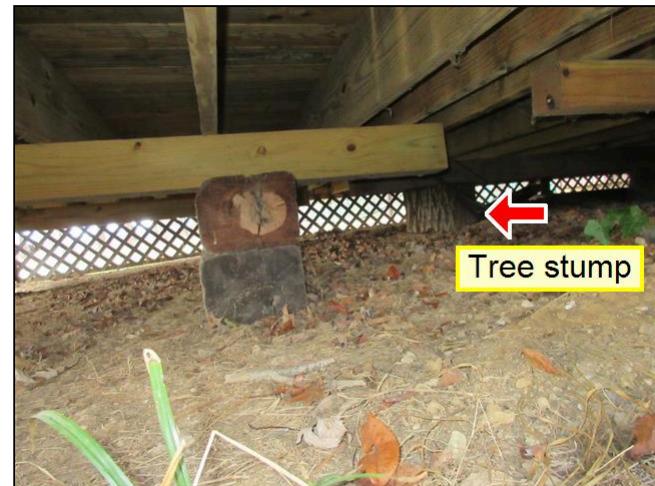
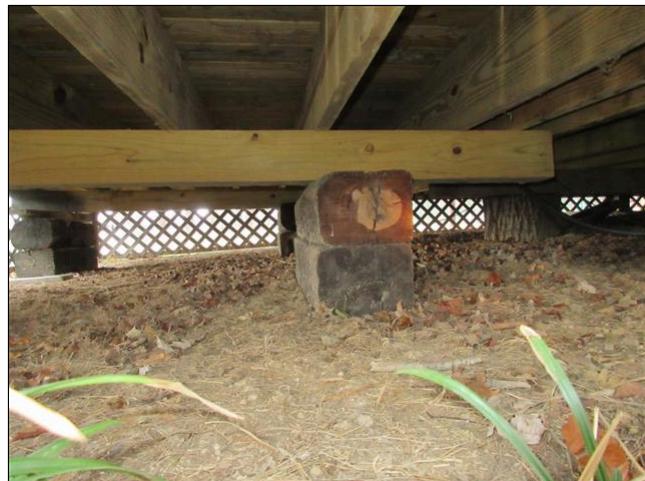
(1) My view under the deck on the left side and across the front of the house was very limited due to sides of the deck being closed off and there being limited access under the deck. I was able to view that added supports had been placed under the hot tub area. The supports were like landscaping timbers and even a tree stump. These added supports did not appear to be secured to the bottom of the floor joist or on a footer. This is for your information. I recommend monitoring for issues a further evaluation and correction if needed.

It is assumed that the supports were added due to the weight of the hot tub.

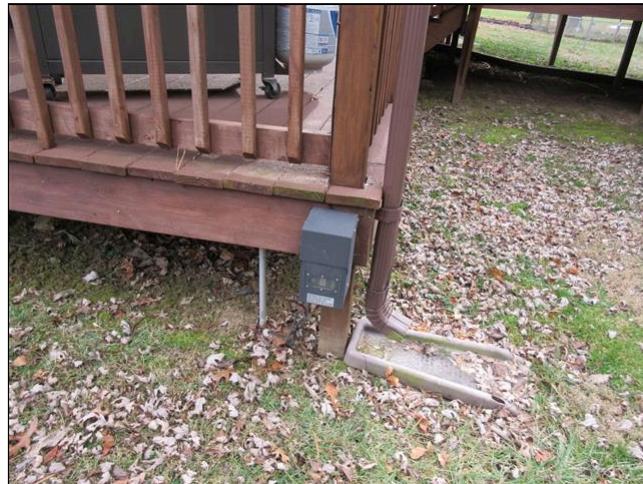
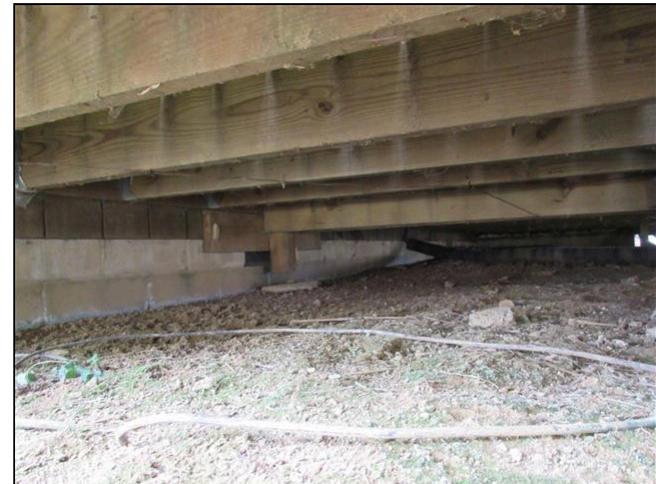
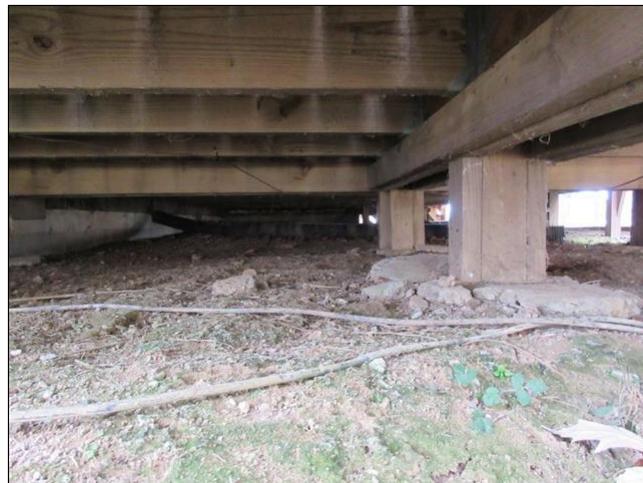
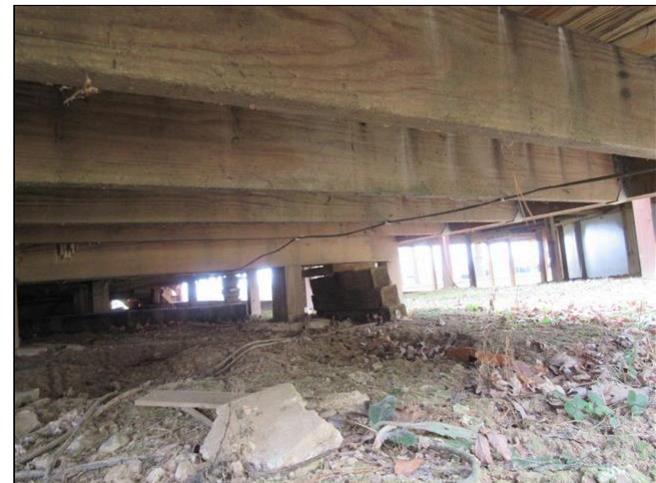
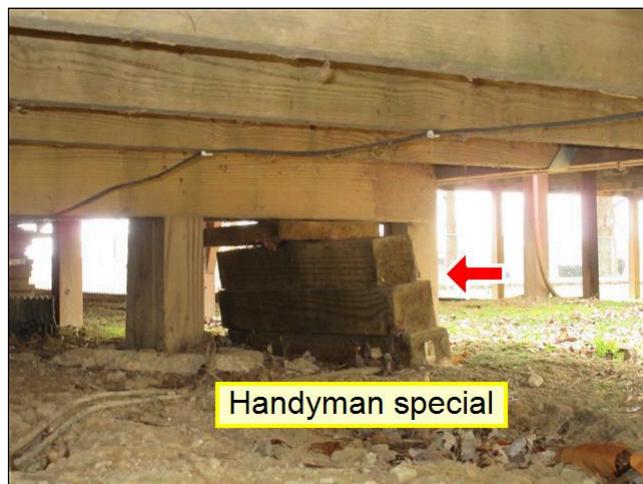
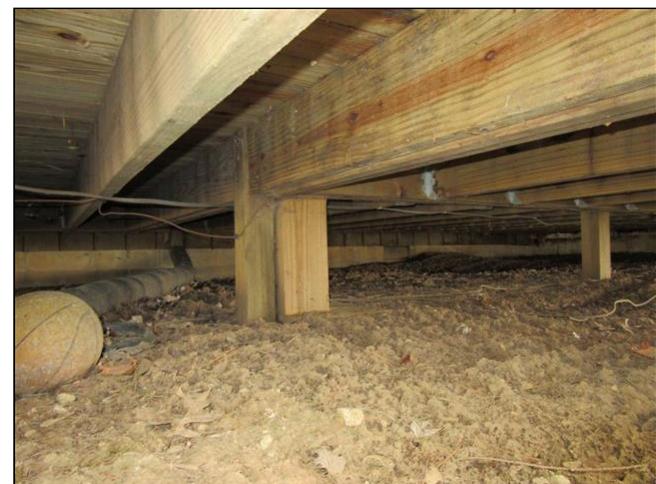
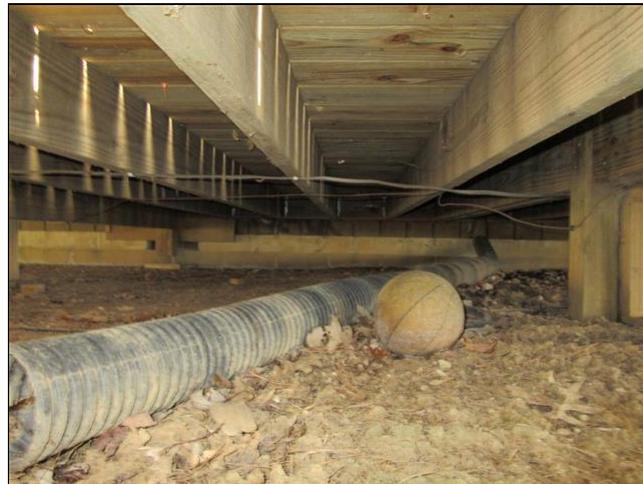
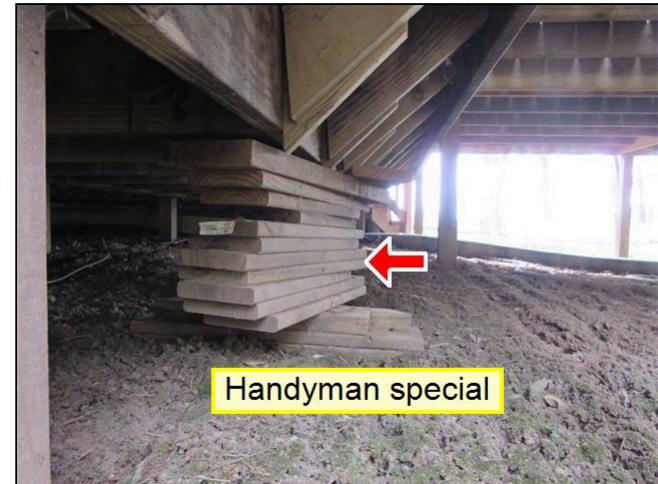
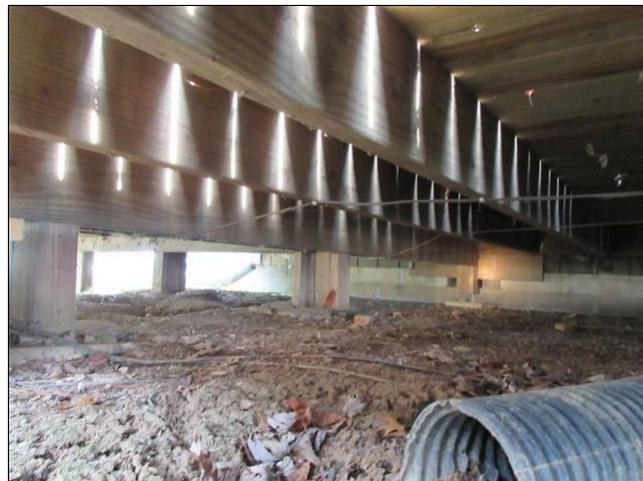
- 1) The deck was not bolted or lag screwed to the house, nails were used. Nails can pull out leaving the deck unsupported.
- 2) Joist hangers were NOT used in most locations. Joist hangers that are the proper size and fully nailed (proper type nail) are more secure and will hold more.
- 3) Under the deck I observed boards used to offer additional support. In some cases the supports are not on footers, treated lumber and deteriorating or not offering any support (i.e. stack of wood under steps).
- 4) The upper level of the deck near the pool has not been stained recently, this will allow the wood to deteriorate at a faster rate.

I recommend that a qualified contractor fully evaluate the deck and repair or correct items as needed.

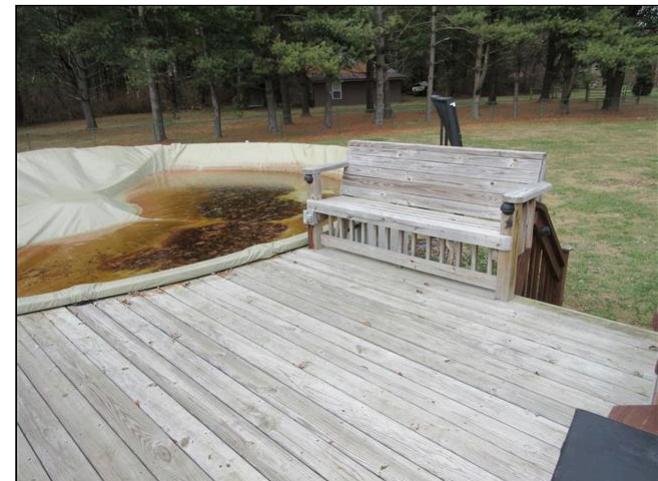
2.3 Item 15(Picture) Deck needs to be cleaned and stain

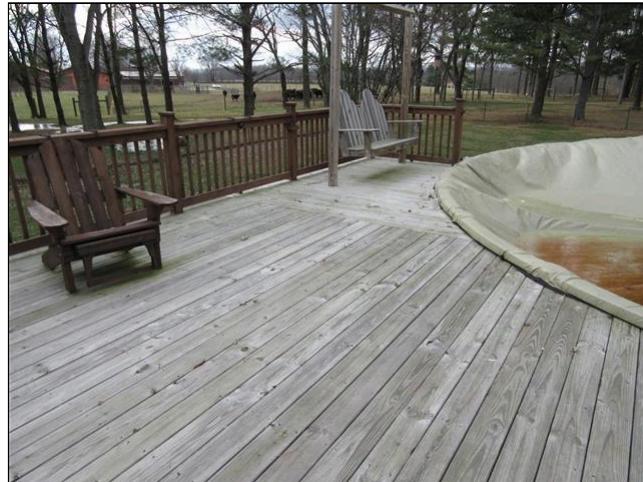
2.3 Item 16(Picture) Deck needs to be cleaned and stained

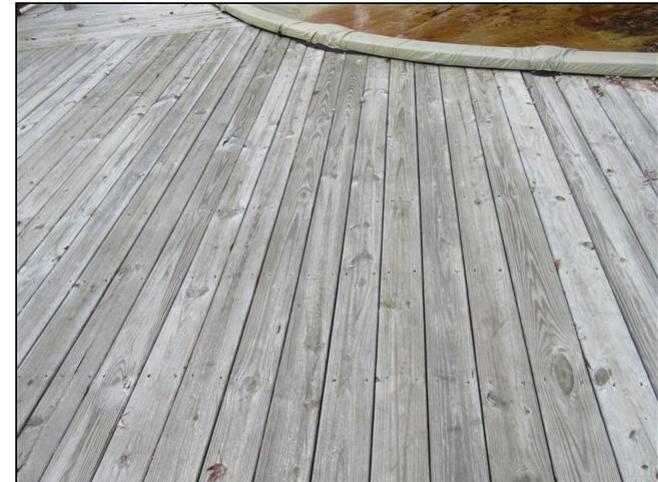
2.3 Item 17(Picture) Deck needs to be cleaned and stain

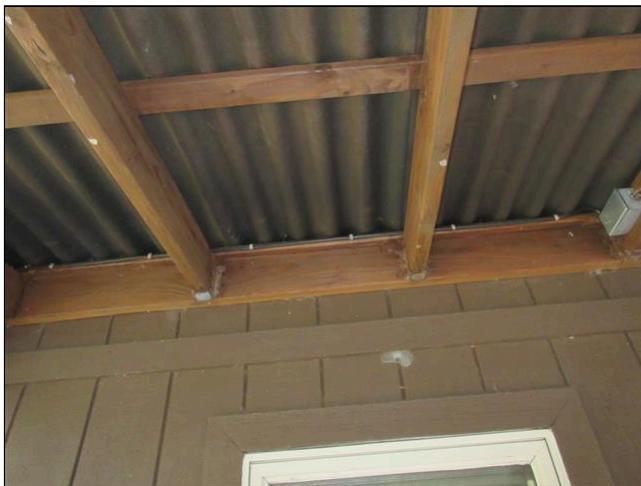
2.3 Item 19(Picture) The porch is secured to the house by nails

(3) I recommend that the porch rear on the rear of the house is lag screwed to the house. The porch roof is nailed to the house, nails are subject to pulling out

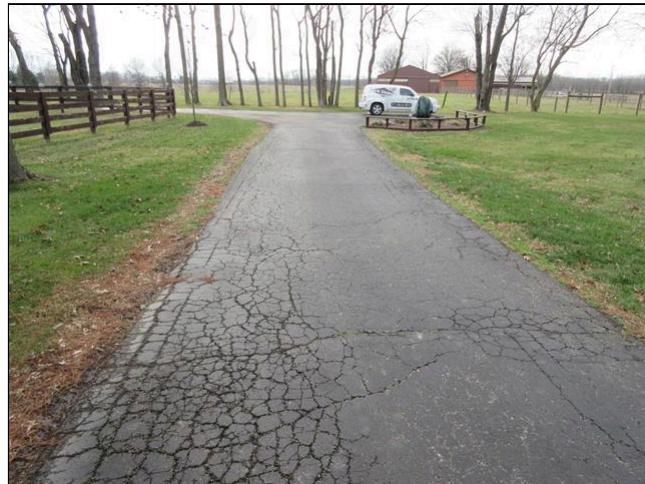
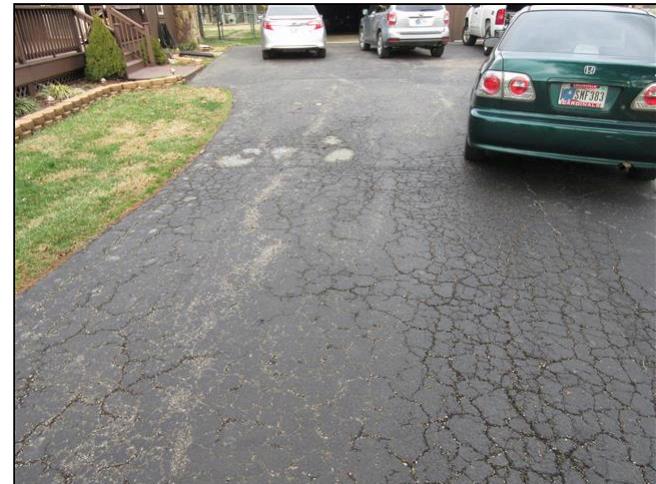
- (1) The driveway is asphalt and at the time of the inspection was functional. It does appear that it has been sometime since the driveway has been sealed and or patched. For your information at some point in the future (impossible for me to give a date) the driveway will need maintenance to reduce deterioration and prolong it's life.

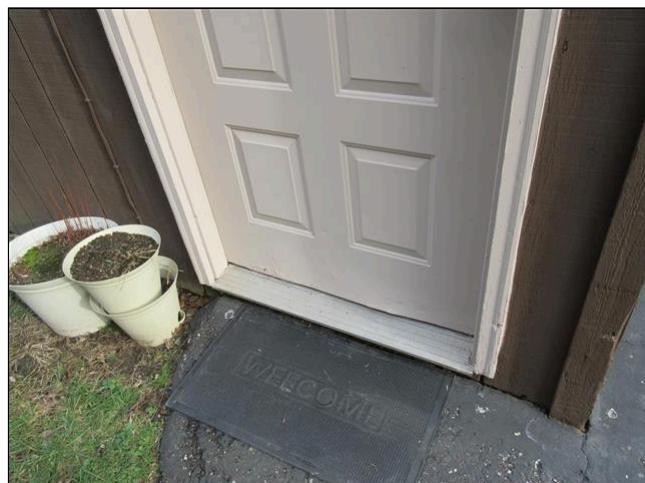
There is what appears to be minor rust at the main garage storage area at the bottom of the door. I suggest repairing to slow or stop further deterioration at the door.

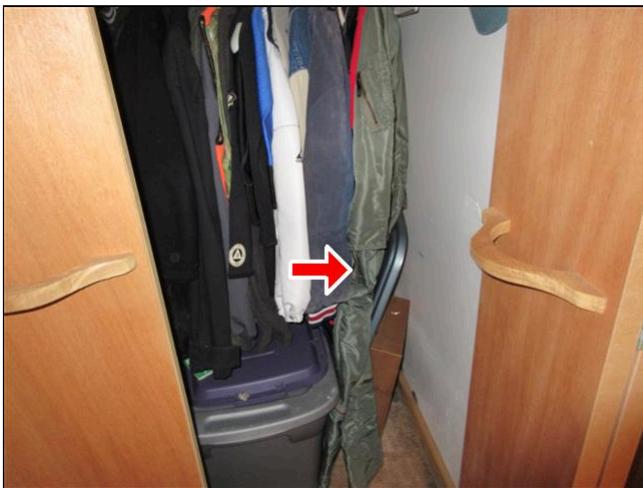
4.1 Item 26(Picture)

- (2) In the finished area of the basement there was a very musty smell present. With carpet on the floor the musty smell could be from a water leak, lack of air circulation or high humidity. In the closet (see pictures) I observed blackish like fungi growth. I recommend further evaluation of the musty smell and the blackish like stains and correction as needed by a qualified person.

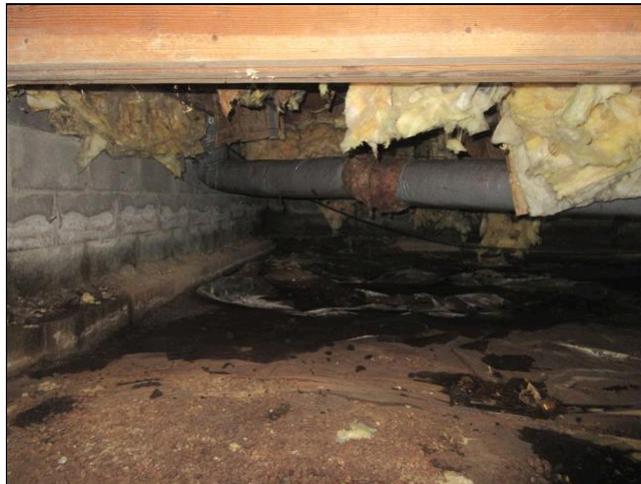
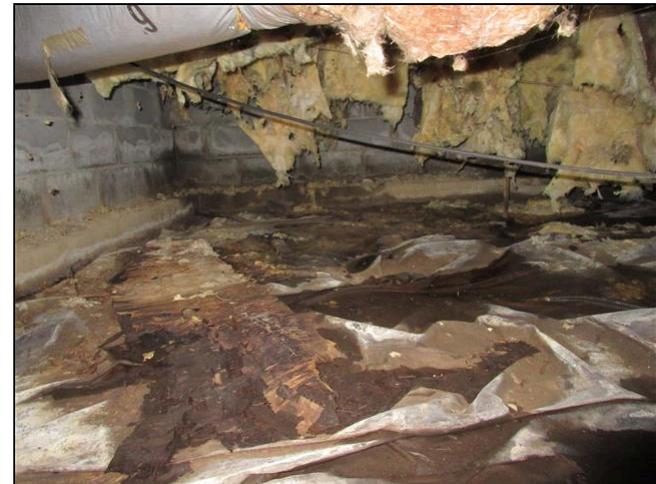
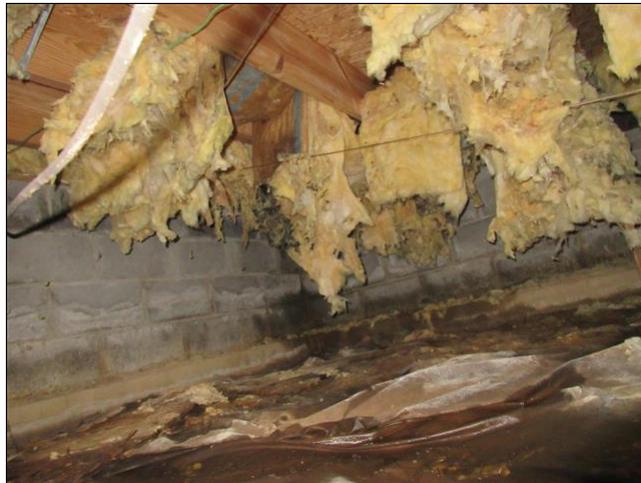
- (2) The crawl space was mostly dry with the exception of the right side (as looking from the outside of the house) of the crawl space. Moisture was present along the right wall to about 6 feet towards the rest of the house. I recommend that a qualified waterproofer evaluate the crawl space and correct as needed.

Note - due to water draining into the sump crock the entire time I was present I suspect the water table is high around the house.

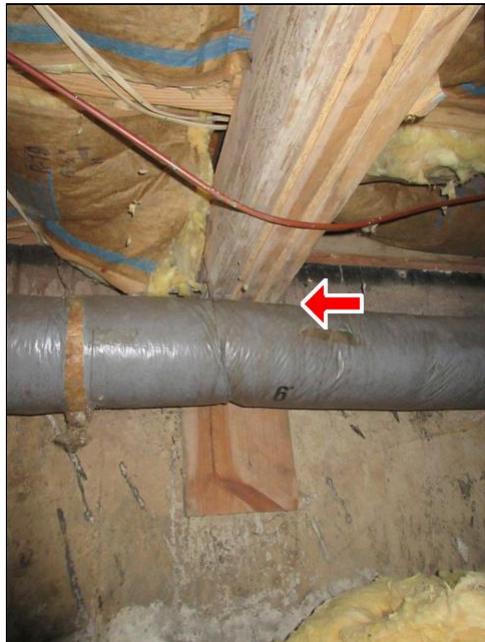
- 1) The beam does NOT sit in a pocket with a minimum of 2 1/2 inches of bearing.
- 2) At the basement side of the crawl space the beam was not in a pocket but resting on a about 1 1/2 inch wide board nailed to the wall.
- 3) At the right side of the crawl space the beam was supported by a metal support column that was deteriorating at the base of it due to significant rust.
- 4) I also observed that 2 of the metal supports along the beam were bending downward at the top plate.

5.2 Item 1(Picture) Inadequate support for the left side of the beam

I recommend that a qualified person to fully evaluate the beam and steel supports and repair, replace or correct as needed for proper support.

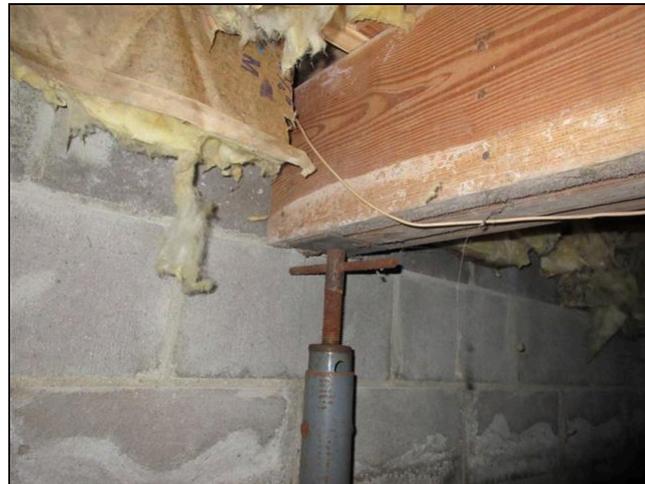
5.2 Item 2(Picture) Right side of crawl space

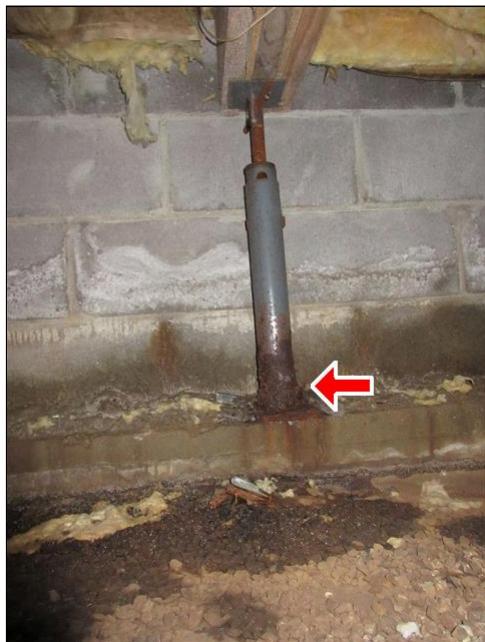
5.2 Item 3(Picture) Significant rust at bottom of right side column

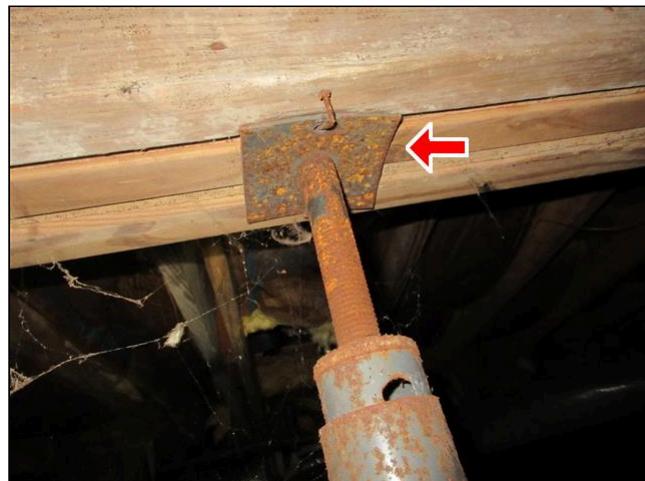
5.2 Item 4(Picture) Bending support column

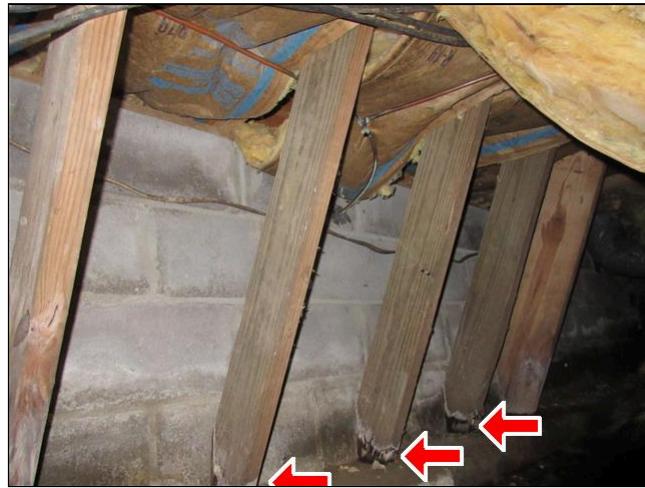
5.3 Item 5(Picture) Supports appear to be under the right side fireplace

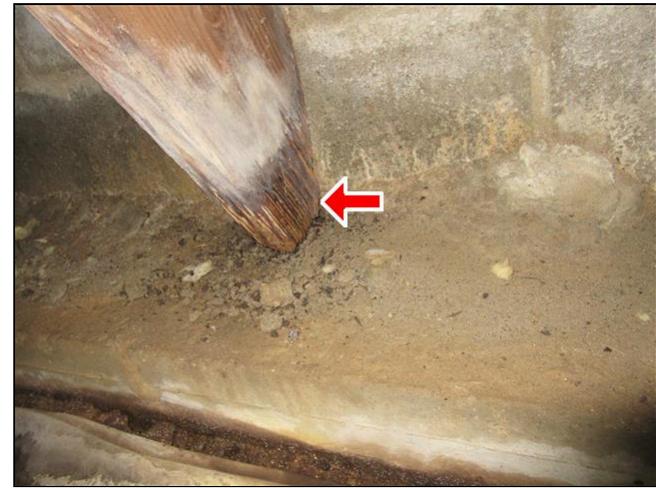
5.3 Item 6(Picture) Deterioration

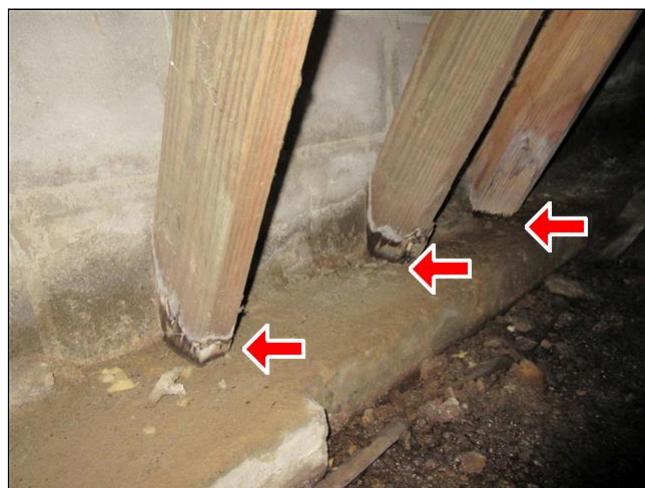
5.3 Item 7(Picture) Deterioration

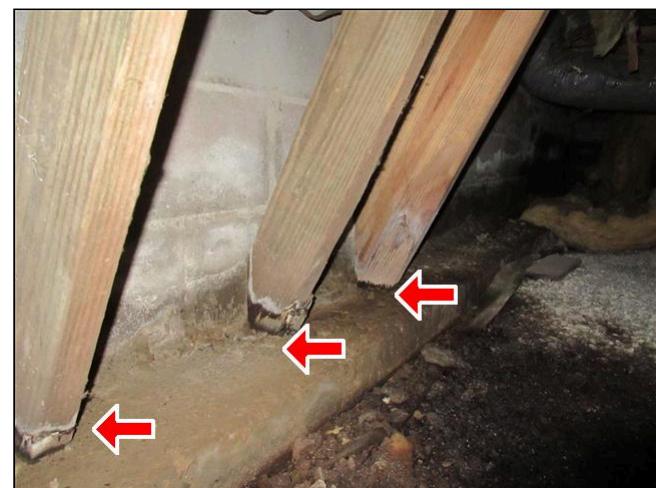
5.3 Item 8(Picture) Deterioration

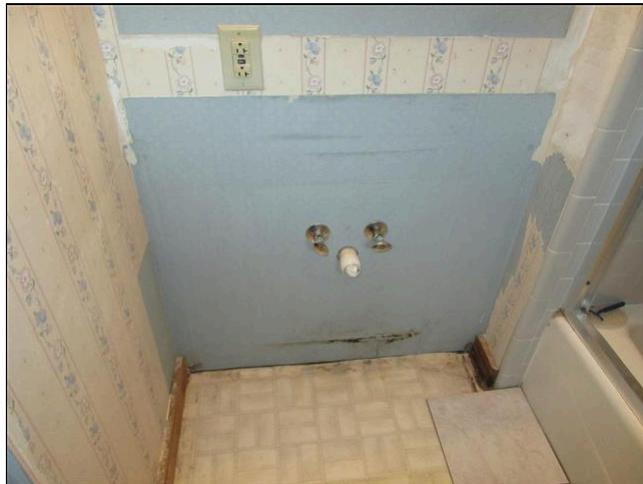
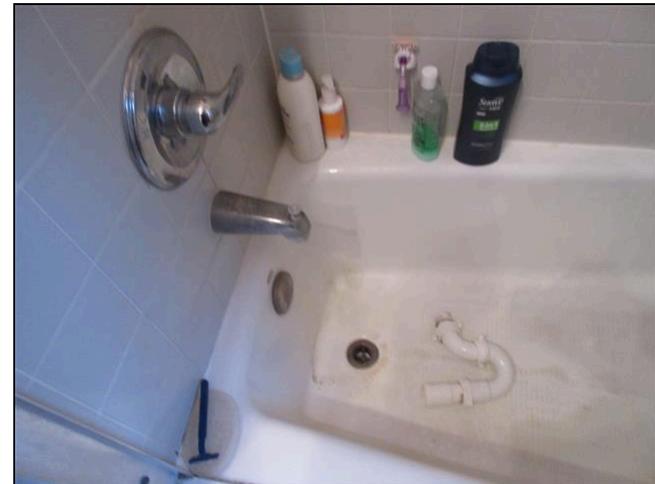
- (1) The Master Bathroom sink cabinet and fixture has been removed. The shower/tub and the toilet was functional.

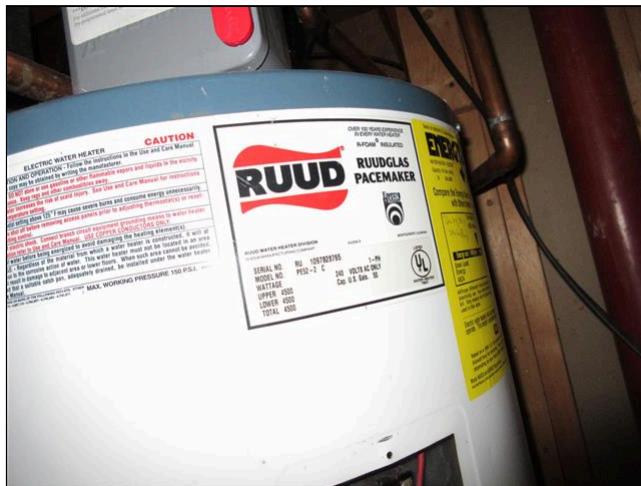
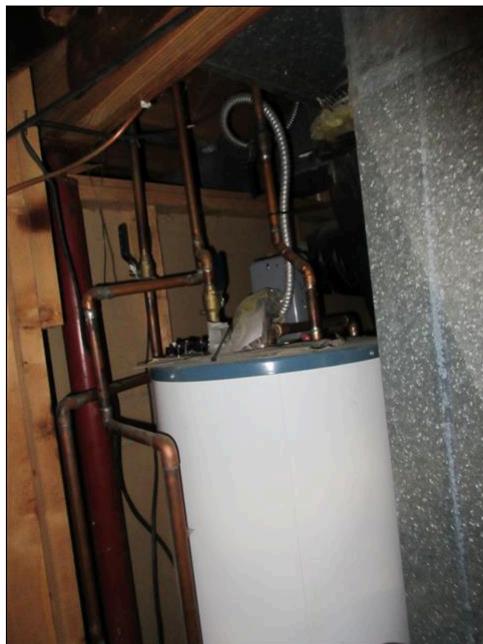
- The water heater was not fully accessible due to being concealed by a large amount of stored items. I did however observe that someone had removed the covers over the heating elements. I recommend that once the water heater is fully accessible that a qualified person evaluate the water heater and repair or correct as needed. I'm unsure as to why the covers were off the heating elements, but based on the numerous electrical issues I'm concerned about handy man work that may have been performed on the water heater.

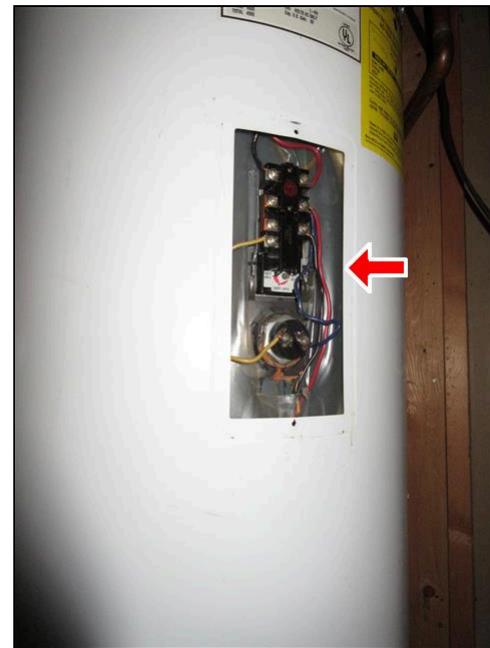
6.2 Item 2(Picture) 1 of 2 cover plates off the water heater elements

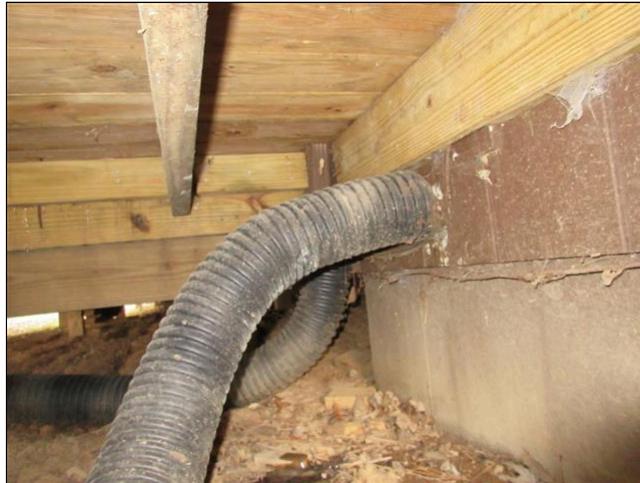
6.6 Item 1(Picture) Sump pump appears to discharge under the rear deck

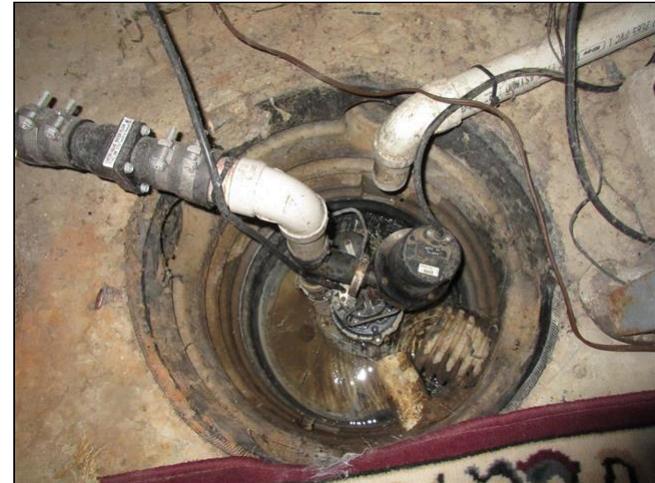
6.6 Item 2(Picture)

I observed that the basement deep sink is draining into the sump pit and being discharged into the yard. The deep sink should drain into the septic system. I recommend correction as needed.

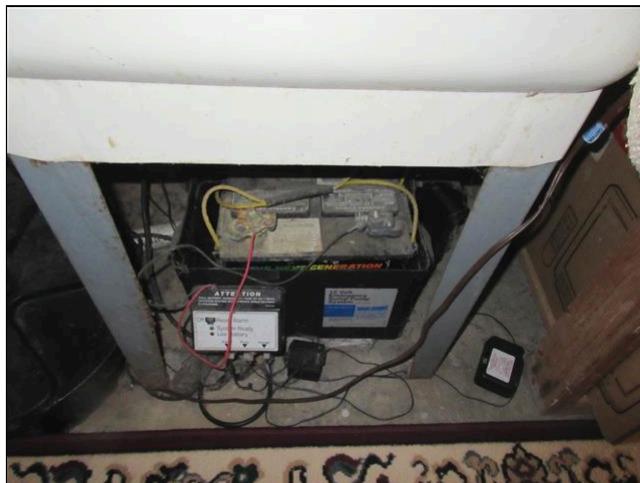
It is very obvious that loosing power would put the basement jeopardy for becoming wet. Battery back ups have a limited amount of run time. I recommend that a water powered back up is added for added protection against water back up.

6.6 Item 3(Picture) Battery back up

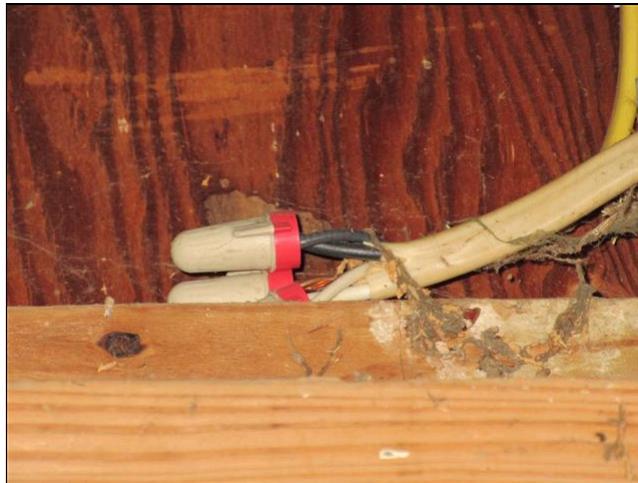
2) At the rear main storage area of the garage at the rear wall ceiling area I observed an open electrical splice. Spliced wires should be in junction boxes for safety reasons. I was not able to get up to the wires to more closely examine the splice due to the large amount of stored items below this area. The wires should also be examined to determine if the wires are the same gauge. One wire was sheathed in a cream (could be #12 wire or 14 if the wire is older) color and the other was yellow (#12 wire). Improper size wire ran to a breaker which is too large can result in an electrical incident. Evaluate and repair or replace as needed.

7.3 Item 1(Picture) Spliced wires at the rear wall ceiling are of garage. The wires maybe different size wire (14 and 12).

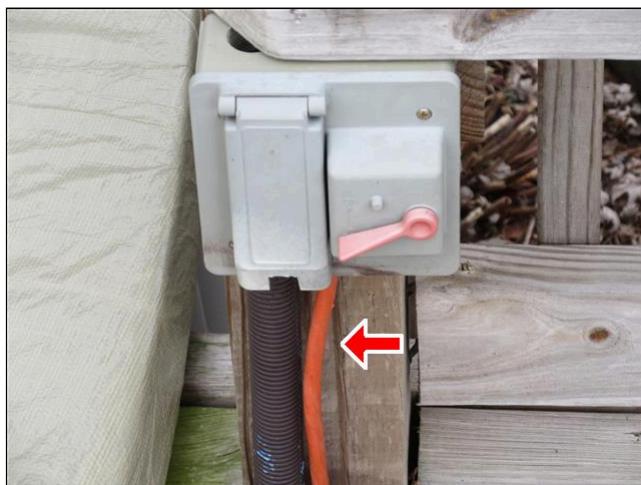
6) At the rear pool area there is an exposed (should be in conduit when above ground) orange which appears to be from an outdoor extension cord. Only Romex should be used to run wiring. I recommend that a licensed electrician to evaluate the orange wire and either repair or replace place as needed.

7.3 Item 5(Picture) Exposed electrical wire at rear pool area also appears to be of extension cord instead of outdoor rated Romex

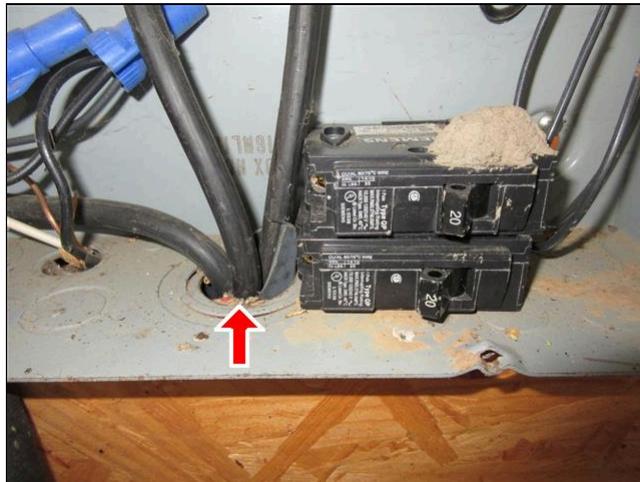
- (1) I observed a number of electrical issues at the garage sub panel :
 - 1) Numerous wires have been brought into the panel without being ran through the Romex connectors to prevent

7.6 Item 3(Picture) No Romex connector

A licensed electrician should FULLY evaluate the entire electrical systems of the house and garage repairing or replacing as needed for safety reasons.

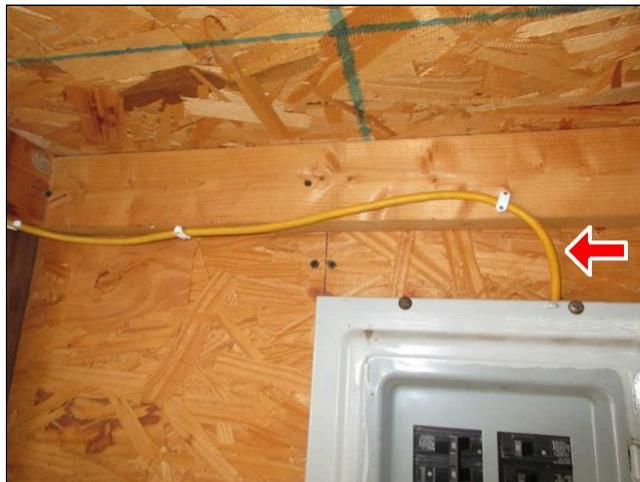
- 5) I observed what appeared to be orange extension cord used as wiring to a wall switch instead of using Romex.
- 6) Inside the panel there are wires spliced together instead of ran to separate circuit breakers. Also where these wires are spliced together the wire size appears to be a both # 12 and #14 which can be an electrical hazard if a 20 amp breaker is used.

7.6 Item 5(Picture) Panel cover installed over a extension cored like wire ran to a wall switch. A cover should not be installed over a wire (pinching) and romex should be used for wiring

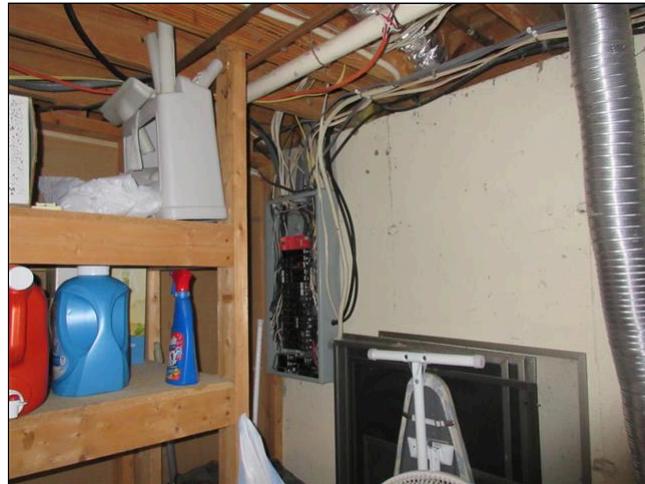
(2) The panel cover was already off at the main electric panel before the inspection. The panel cover was behind a large amount of stored items. I observed the following :

7.6 Item 6(Picture) The panel cover was already off and the panel could not be safely fully accessed

A licensed electrician should FULLY evaluate the entire electrical systems of the house and garage repairing or replacing as needed for safety reasons.

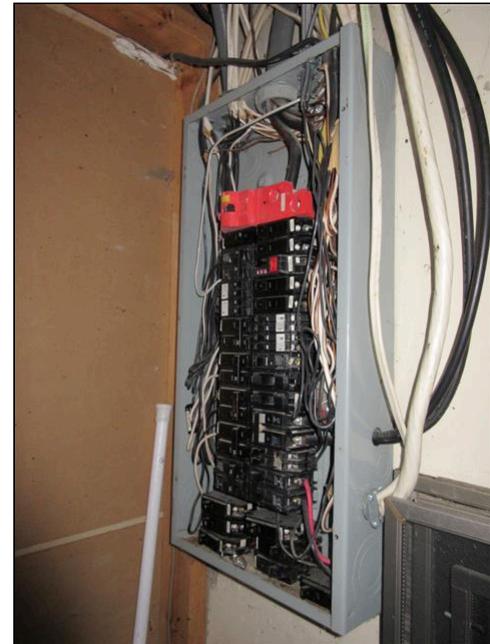
breakers stored inside the panel it is reasonable for me to believe that more "do it yourself" issues will be observed once the main panel is accessible.

7.6 Item 7(Picture) My view into the panel was extremely limited

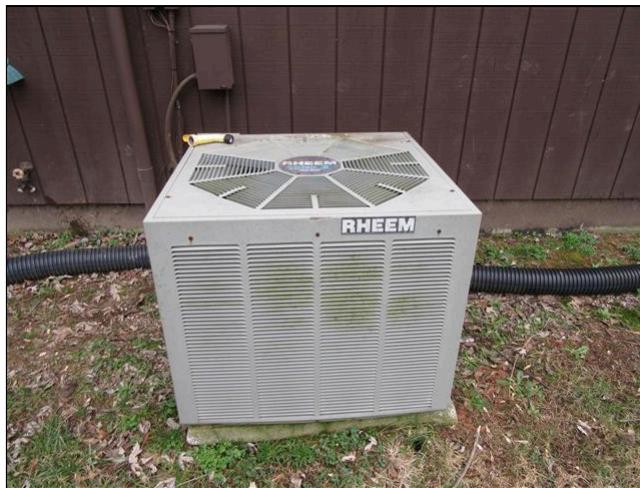
8.10 Item 1(Picture)

The condenser outside (AC unit) is very old (23 years old - life expectancy is about 15 years) and may last a few years more, but maybe not. I have seen units fail shortly after a home inspection during the seasonal change from mild to hot weather. I cannot determine how long your AC/Heat Pump will last before a replacement is necessary.

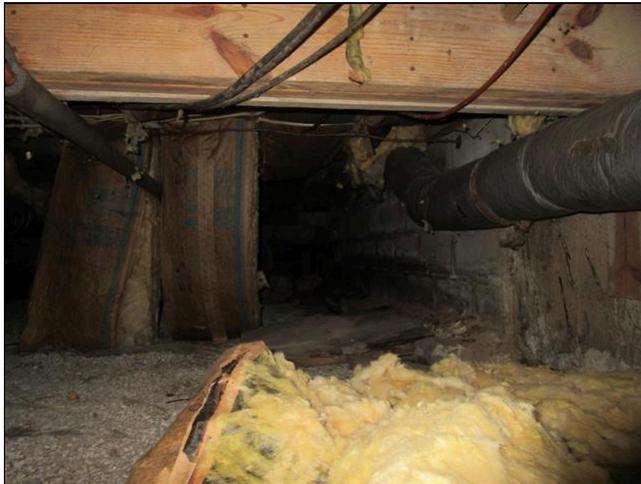
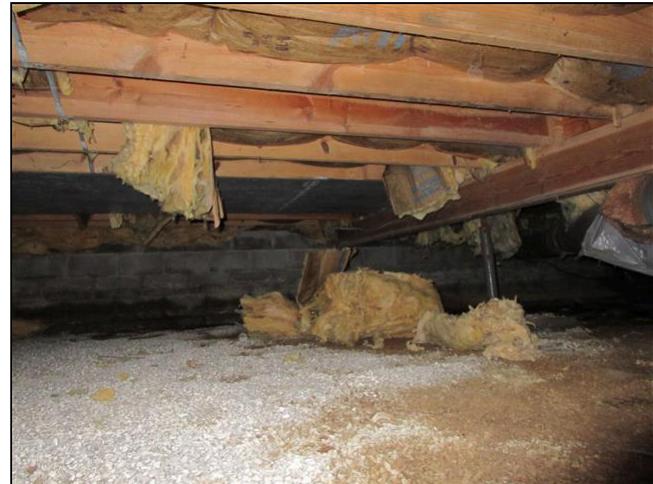
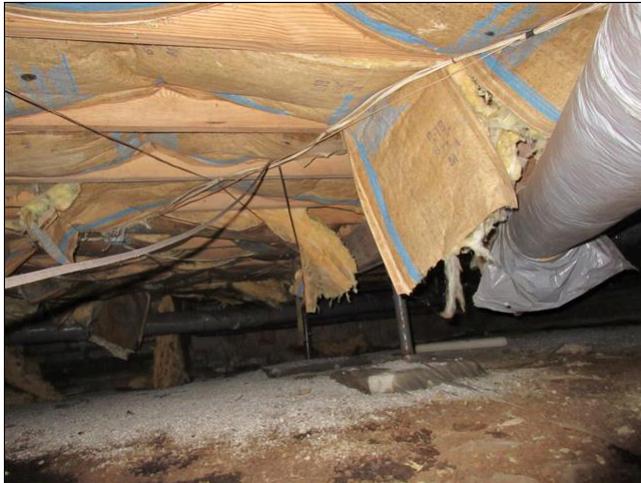
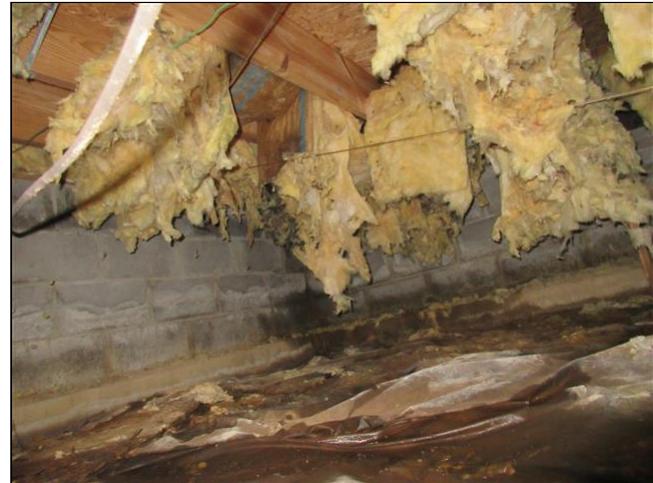
- (2) The insulation is loose/fallen in the crawlspace. Insulation that has fallen to the ground or has become damp from the ground or from condensation usually needs to be replaced with new insulation. A qualified person should repair or replace as needed.

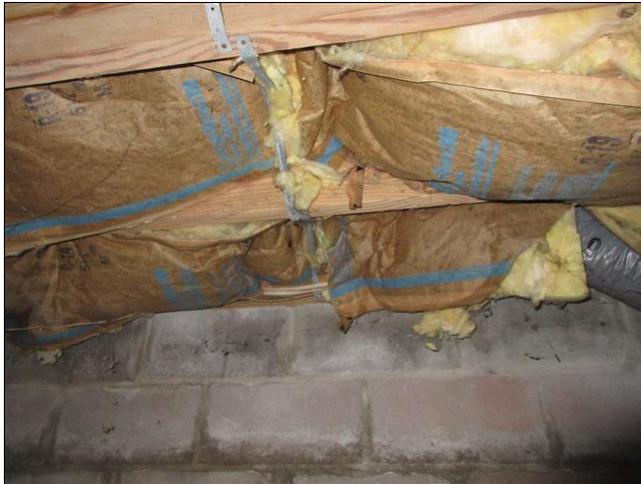
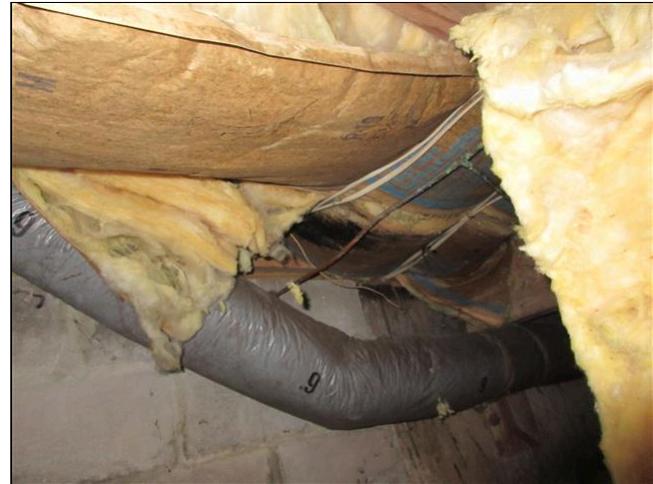
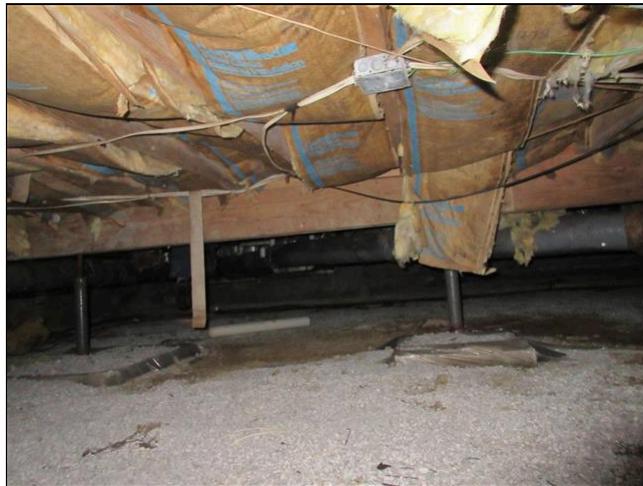
- (3) The insulation installed wrong side up in the crawlspace. Condensation can cause mold or wood deterioration. A qualified person should repair or replace as needed.

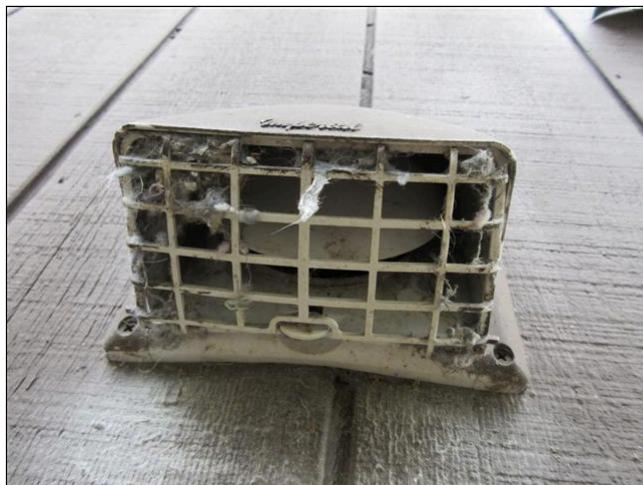
9.4 Item 1(Picture)

I observed lint build up at the dryer discharge, I recommend clearing the vent of any excess lint prior to connecting to the vent.
