Home Inspection Report

Prepared for: Jack & Jill Homeowner

**1234 Your St
Colorado Springs, CO 80901**

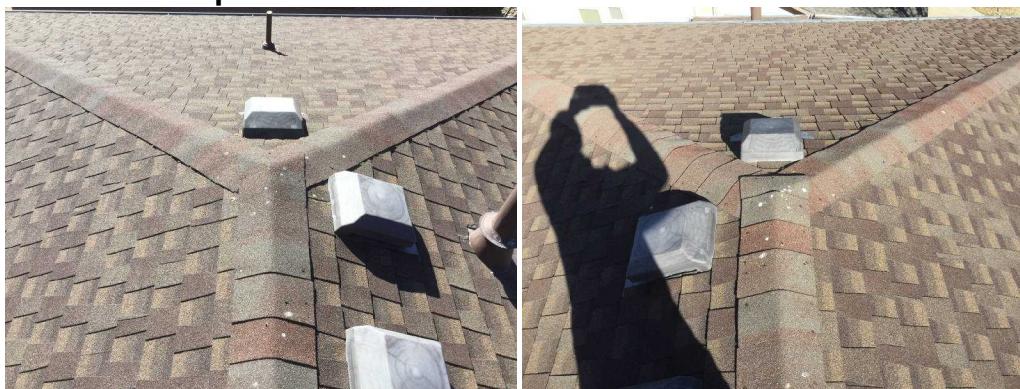
Type of Roofing Material/Shingles: Architectural asphalt shingle - **a. Over all the roof appears to be in good shape (in fact the soft metal on top of both flue pipes at roof level shows almost no signs of hail damage at all) but there are signs of possible minor hail damage on a few of the shingles in the form of granular loss on edges. Recommend a licensed roofer evaluate the roof and if replacement is not necessary then certify the roof.**

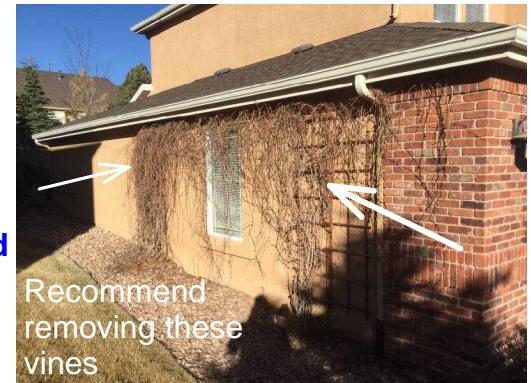
a. Vines growing on siding, though aesthetically pleasing, can do major damage. They can penetrate siding, leading to moisture build up on the sub structure and on structural members. We would highly recommend removing the vines from the side of the home. (Please note that this is a visual inspection, we do not know what the siding looks like behind these vines)

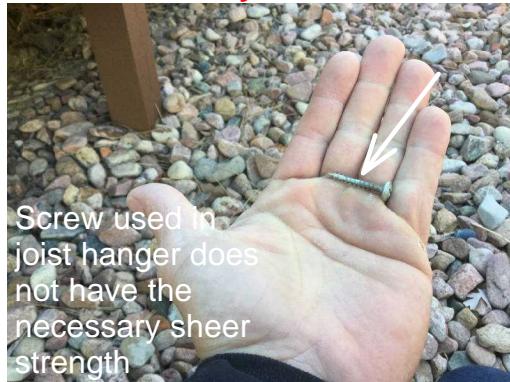
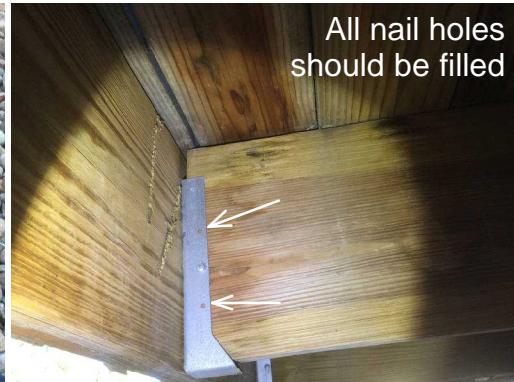
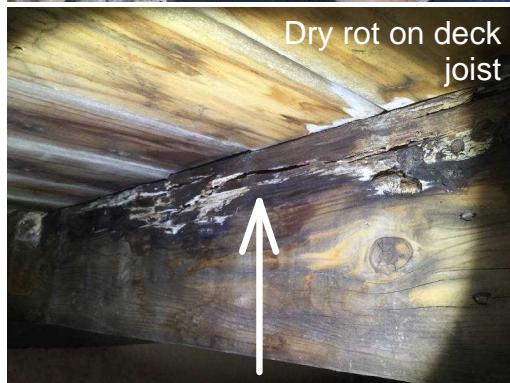
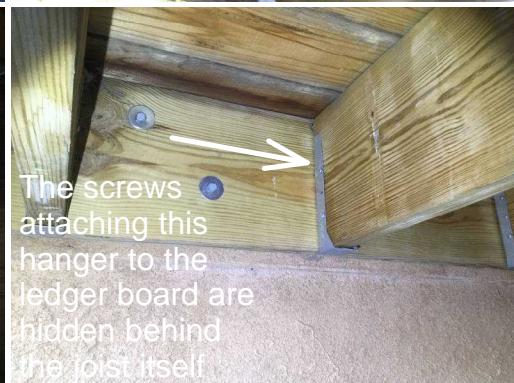
Deck Type: Painted wood - a. We observe the following issues with the wood deck on the back of the home. We recommend a licensed deck contractor evaluate our findings and the deck itself and make all necessary repairs to ensure it is structurally sound and safe:

1. Screws have been used to attach some of the joist hangers to the ledger board and rim joists under the back deck, these are the newer sections of deck. Screws do not have the shear strength to properly support the load on the deck. There are also several nails missing in some of these same hangers. Recommend these screws be removed and hot dip galvanized joist hanger nails be used instead and all nail holes filled. This may require removing some of the joists as some of the hangers do not have exposed nail flanges.

2. There is dry rot developing on a few of the back deck joists in the older section of deck. Recommend a licensed contractor evaluate the entire deck, remove and replace any dry rotted material and make any other repairs they deem necessary.

2. Recommend a licensed contractor evaluate and/or repair items listed below:
a. We observe the following issues with the wood deck on the back of the home. We recommend a licensed deck contractor evaluate our findings and the deck itself and make all necessary repairs to ensure it is structurally sound and safe:

1. Screws have been used to attach some of the joist hangers to the ledger board and rim joists under the back deck, these are the newer sections of deck. Screws do not have the shear strength to properly support the load on the deck. There are also several nails missing in some of these same hangers. Recommend these screws be removed and hot dip galvanized joist hanger nails be used instead and all nail holes filled. This may require removing some of the joists as some of the hangers do not have exposed nail flanges.

2. There is dry rot developing on a few of the back deck joists in the older section of deck. Recommend a licensed contractor evaluate the entire deck, remove and replace any dry rotted material and make any other repairs they deem necessary.

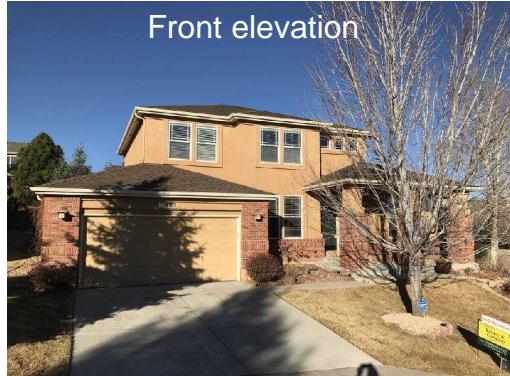
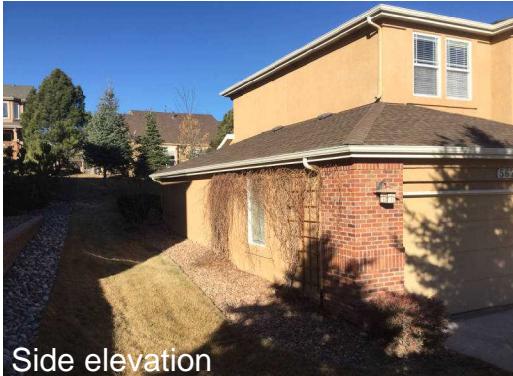
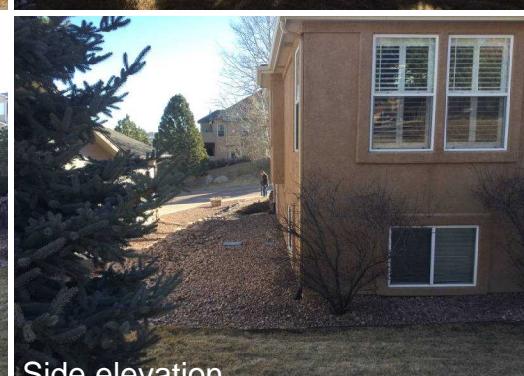
Window Screens: Vinyl mesh - **a. Some of the window screens are damaged and/or missing.**

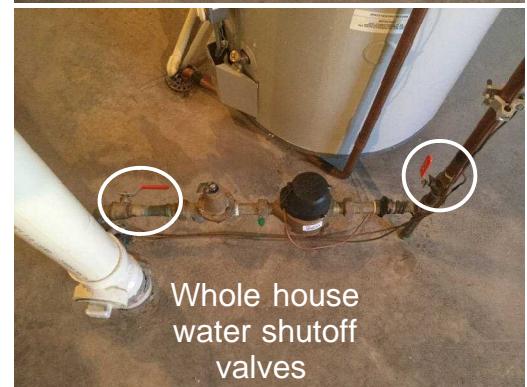
Whole house water shutoff valves

Main Water Shutoff Located In The Basement utility area next to the water heater - See picture. You can use this valve in an emergency situation, for example you come home to find a water leak but can not discover the source.

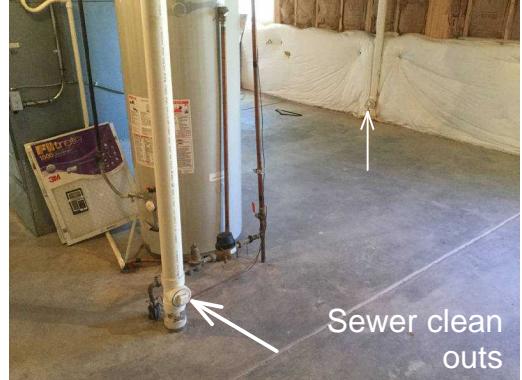
- 7. Functional** Main Sewer Cleanout: Accessible - See picture. This cap can be removed and the cleanout can be used to snake the main sewer line from the house to the street.

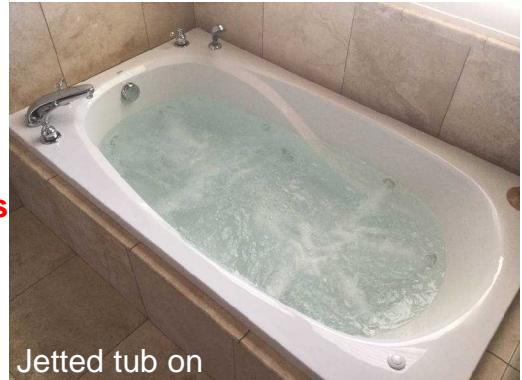
- 13. Action Item** **Tubs/Shower:** All holding and draining water properly, no loose tile or surrounds noted - **a. During the inspection we could not find the GFCI outlet or reset for the master bathroom whirlpool tub. This tub must be GFCI protected for safety and this GFCI outlet or breaker must be accessible. Recommend a licensed electrician evaluate and either provide the necessary protection or make the reset accessible.**

a. During the inspection we could not find the GFCI outlet or reset for the master bathroom whirlpool tub. This tub must be GFCI protected for safety and this GFCI outlet or breaker must be accessible. Recommend a licensed electrician evaluate and either provide the necessary protection or make the reset accessible.

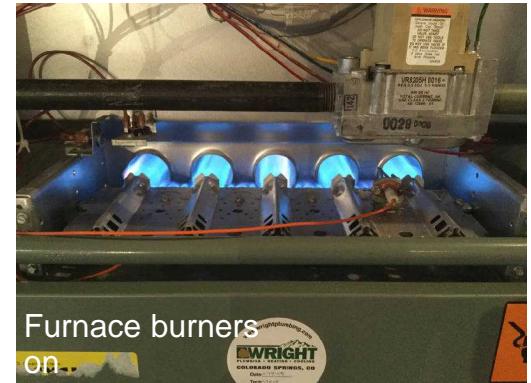
13. Due to most furnace designs the visible portion of the heat exchanger is very small, between 0% to 20%. Home inspections are visual by nature and we do not dismantle any appliances including furnaces. The comments in this report only reflect what we observed during the inspection.

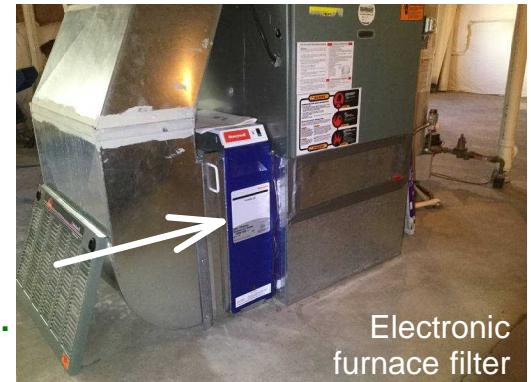
Electronic furnace filter

Furnace Filter Type: Electronic - a. We recommend having your electronic furnace filter cleaned and serviced every year when you have your furnace cleaned and serviced.
b. When your electronic furnace filter is on and working correctly you will hear relatively loud pops and snaps coming regularly from it. This is normal operation.

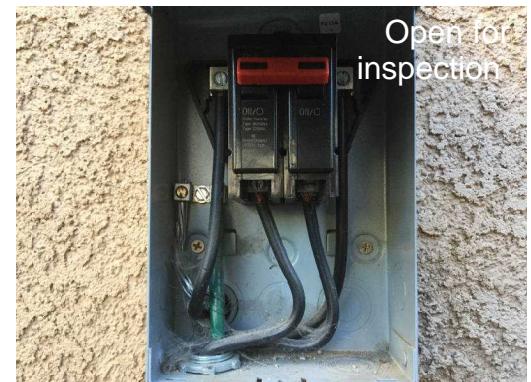
13. Maintenance Interior Service Panel Breaker: 40 Amp - a. The breaker for the AC unit is slightly bigger than the data plate recommends but this installation was approved by regional building so we assume they believed the wire size was still not too large for the unit.

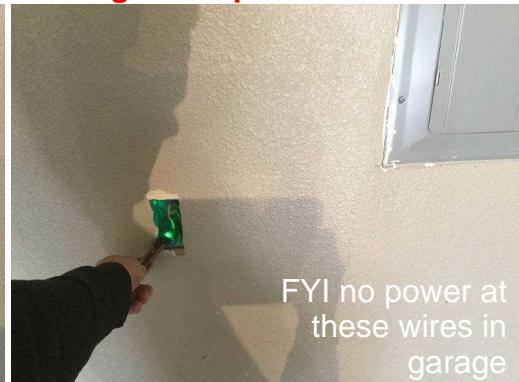
1. Two outlets in the garage are missing cover plates.

b. During the inspection the following outlets, switches and/or junction boxes were found to be missing their cover plates (Recommend installing cover plates for safety):

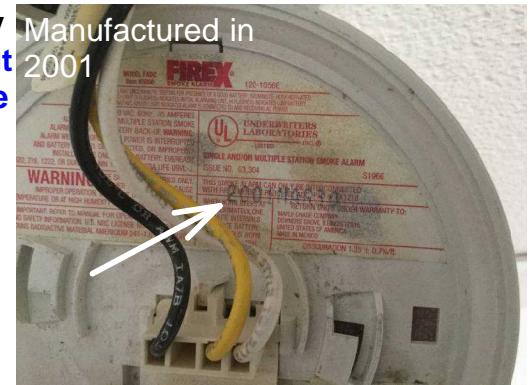
Smoke Detectors: Hard wired with battery backup - a. The smoke alarms throughout the home look older than 10 years old. We recommend replacing all smoke alarms every 8 to 10 years so would recommend replacing these.

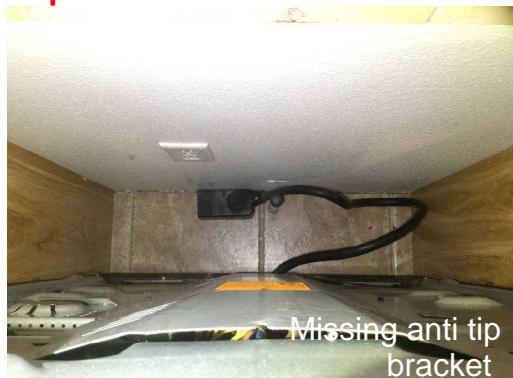
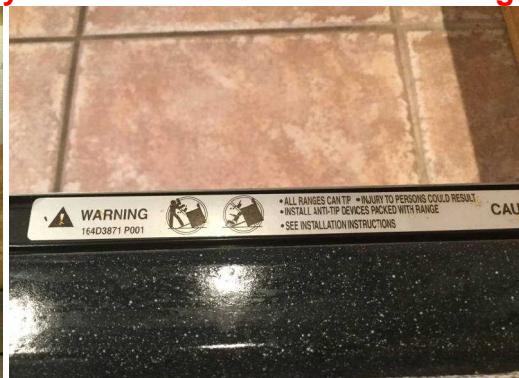
5. Action Item

Stove & Oven Anti-Tip Device: None Installed - **a. There is no anti-tip bracket installed on the stove. These brackets have been a safety requirement since 1991. For safety we would recommend installing one.**

c. There is no anti-tip bracket installed on the stove. These brackets have been a safety requirement since 1991. For safety we would recommend installing one.

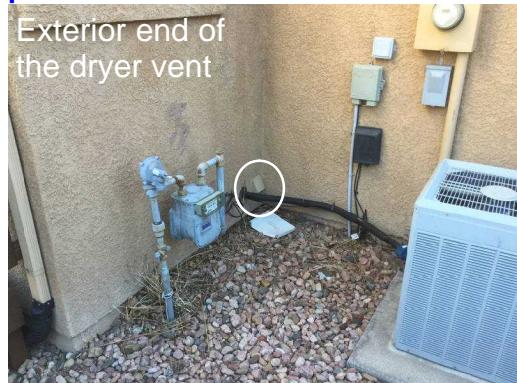
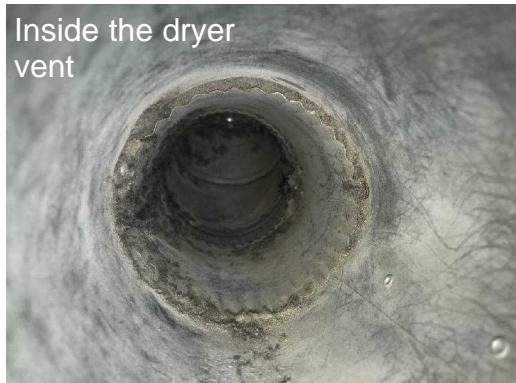
Dryer Vent: Flex line to Rigid metal - **a. Recommend the dryer vent line leading to the exterior of the house be cleaned regularly to avoid lint build up and potential fire hazards.**

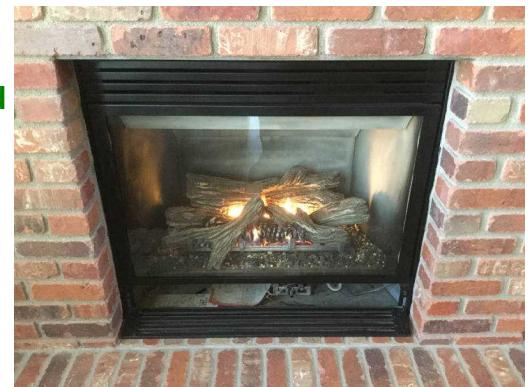
Fireplace Construction: Direct vent prefabricated gas fireplace - a. The fireplace was lit during the inspection and in working condition.

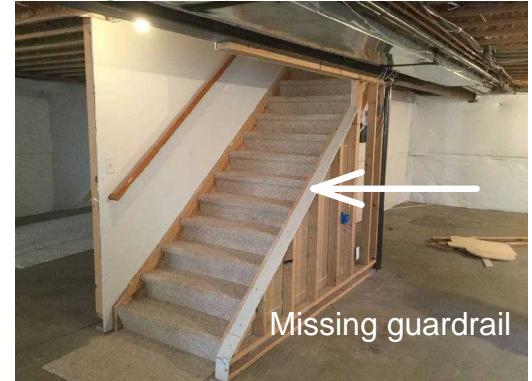
11. Action Item Stairs/Handrails: Manufactured wood frame - a. The stairs leading down to the basement are missing a guardrail. This is a falling hazard so we recommend for safety that a guardrail be installed.

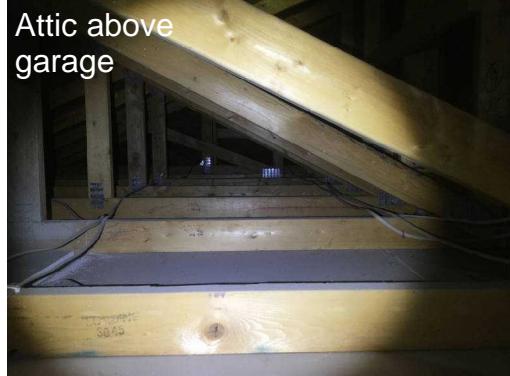
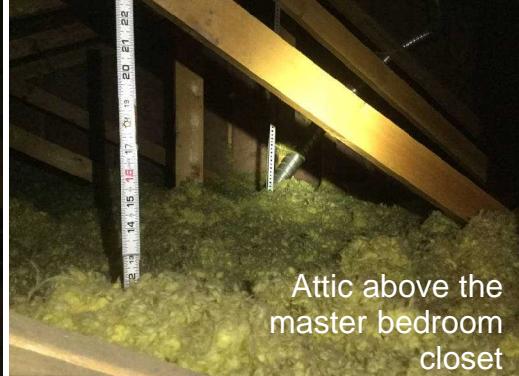
Attic above
garage

Insulation Depth: 0" above the garage, 12" above the living area
