HOME INSPECTION REPORT

1234 Main St.
Colleyville, Texas 76034

Buyer Name
04/07/2020 9:00AM

PROPERTY INSPECTION REPORT

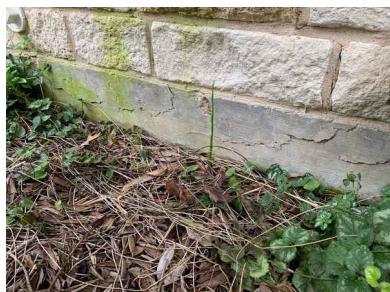
2: Minor cracking/chipping at perimeter slab wall

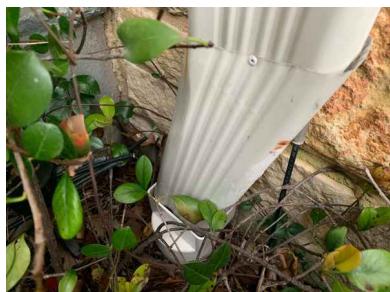
EAST , WEST

**1: Excessive vegetation****⊖ Recommendation**

Vegetation was too close to, touching, or growing on exterior walls and roof. Condition can promote excessive damage and deterby movement of branches, root growth and/or attachment, and moisture retention, and can promote pest infestations. Recommend having vegetation trimmed or removed from affected areas, and regular homeowner monitoring and maintenance thereafter.

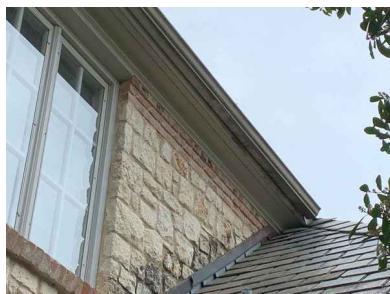
WEST

**3: Gutters: Poor slope observed****⊖ Recommendation**

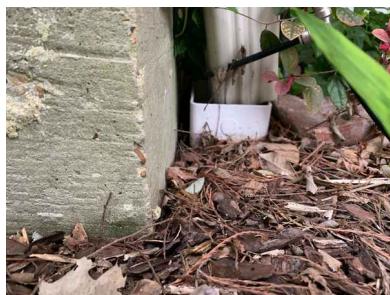
EAST

**4: Gutters: Downspout not connected to the subsurface drain****⊖ Recommendation**

One or more of the downspouts was not properly connected/aligned to the subsurface drain lines. Adjustments/repairs are needed to prevent excess moisture against the foundation.

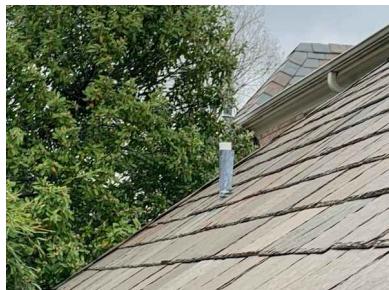
NORTHEAST SOUTHWEST

**2: Tree/Shrub trimming needed****⊖ Recommendation**

Tree and shrub branches need to be trimmed away from the roofing material at all times to help prevent damage to the roofing material. It is the opinion of this Inspector that there are some branches too close to the roofing material at this time and corrective measures are needed.

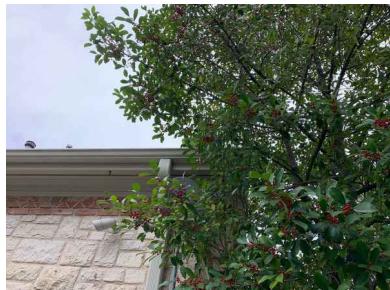
NORTH , NORTHEAST , EAST

**3: Algae growth noted****⊖ Recommendation**

Algae was noted on several sides of the home. This is common on older roofs and is mostly a cosmetic concern that can be treated with an algaecide.

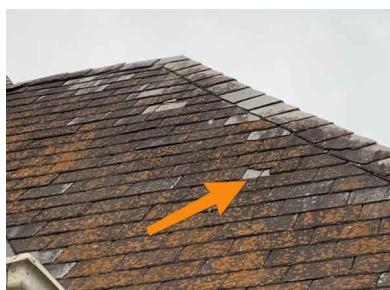
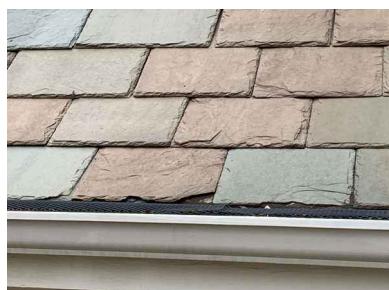
NORTHWEST , SOUTHEAST , EAST

**6: Tile: Damaged****⊖ Recommendation**

One or more of the tiles were observed to be damaged.

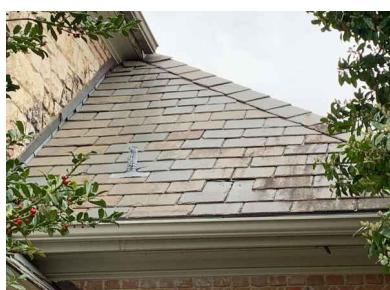
WEST

**7: Tiles: Missing****⊖ Recommendation**

One or more of the tiles were observed to be missing.

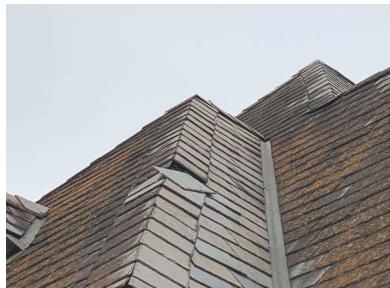
NORTHWEST

I NI NP D**8: TIlE: Ridge Cap Tile Damaged****► Recommendation**

One or more of the ridge cap tiles were observed to be damaged.

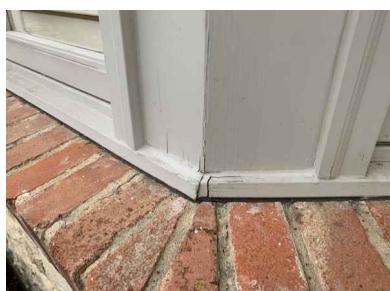
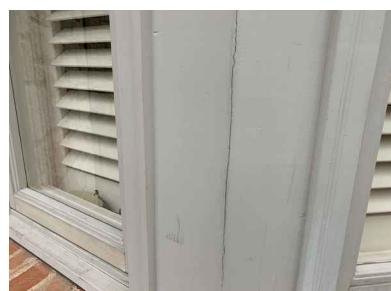
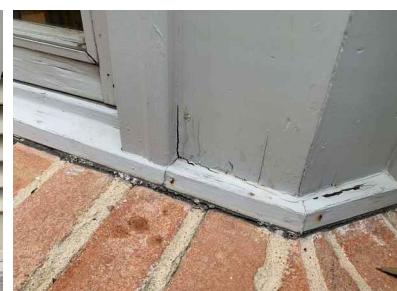
E. Walls (Interior and Exterior)*Comments:**Type(s) of Exterior Cladding:* Stone masonry veneer, Wood type veneer**1: Exterior: Area Veneer Window/Door-Need Sealing****► Recommendation**

Caulking improvements are recommended for the area between the exterior veneer and the window and door frames. It is recommended to use elastomeric caulk.

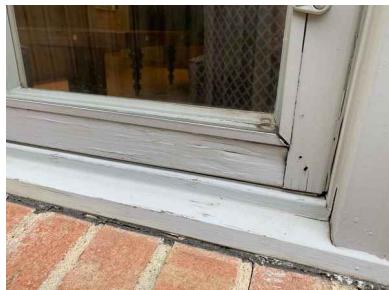
**2: Exterior: Seal between Area Veneer/Garage Trim****⊖ Recommendation**

Caulking improvements are recommended for the area between the exterior veneer and the garage door trim boards. It is recommended to use elastomeric caulk.

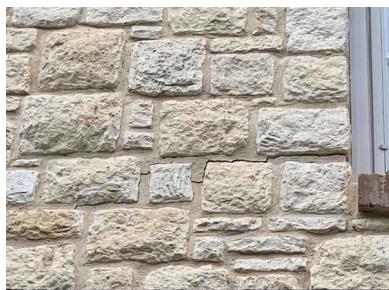
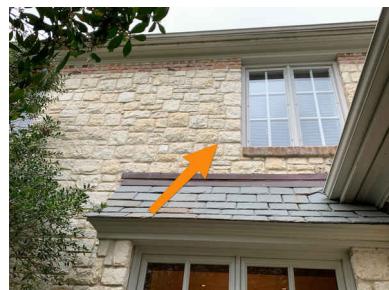
WEST

**3: Exterior: Deflection cracks****⊖ Recommendation**

Deflection cracks were observed in the exterior veneer.

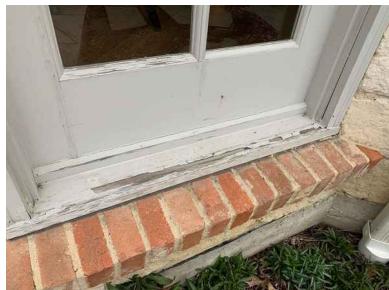
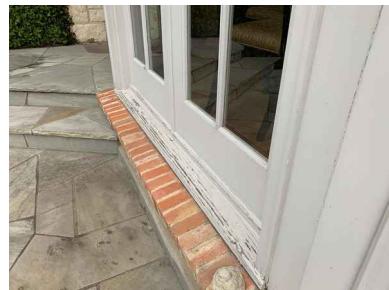
SOUTHEAST , garage

**4: Peeling Paint-No Rot****⊖ Recommendation**

Peeling and/or missing paint was visible. No visible wood rot was seen at the time of the inspection, but the areas should be sealed and painted to prevent further deterioration and wood rot.

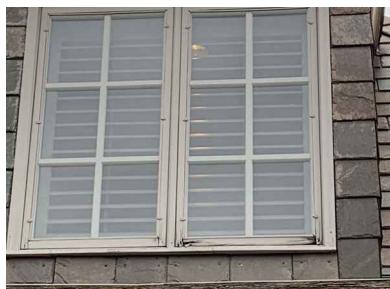
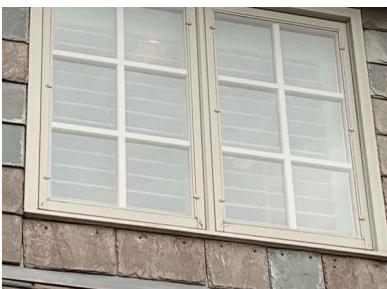
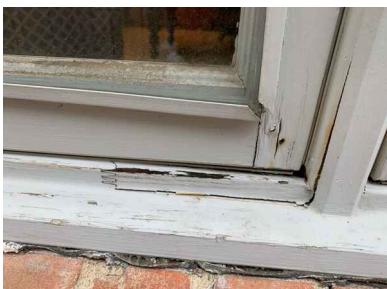
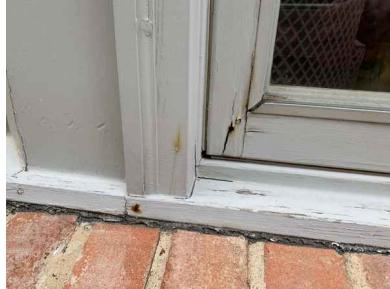
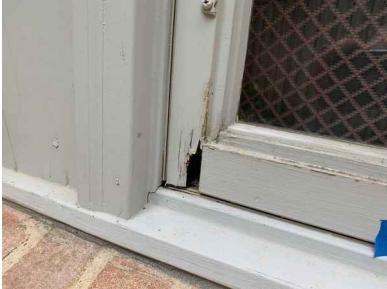
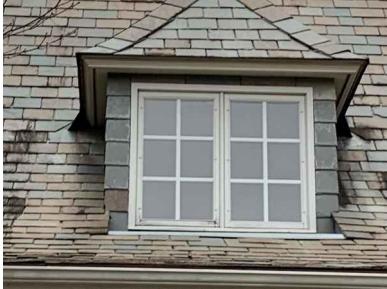
South east upper window , SOUTHWEST EAST ,

**5: Wood rot visible - windows, doors****⊖ Recommendation**

Deterioration and wood rot was visible. Proper repair and replacement of damaged material is needed.

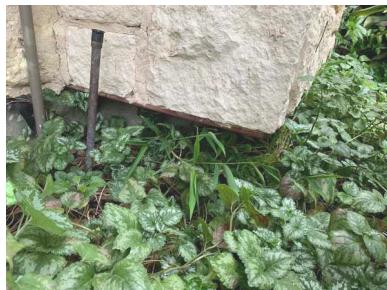
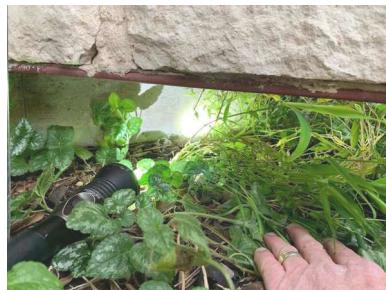
WEST

**6: Exterior Note: Brick extends beyond slab****🔧 Maintenance Item**

Note: The brick veneer extended beyond the perimeter slab wall. This appeared to be a construction related issue by design and more cosmetic in nature. No structural deficiencies were noted as a result at the time of the inspection.

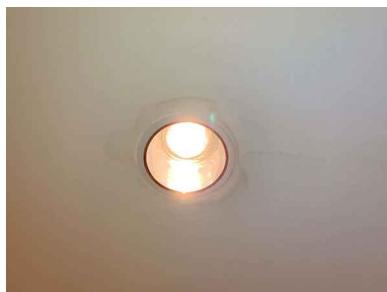
Library

**F. Ceilings and Floors***Comments:***1: Ceiling: Joint Cracks** **Recommendation**

Ceiling joint cracks were observed.

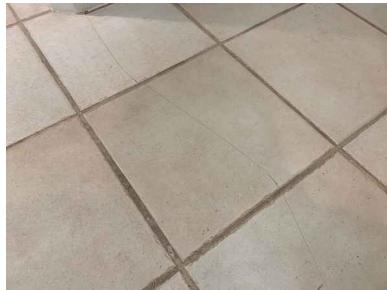
Master bath area

**2: Floors: Tile Cracked / Damaged** **Recommendation**

The floor tile(s) were observed to be cracked and/or damaged.

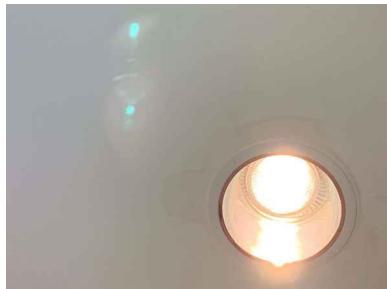
Library

**3: Ceiling: Stains** **Recommendation**

Water stains were observed on the ceiling finish. The cause and remedy should be further evaluated and corrected as necessary.

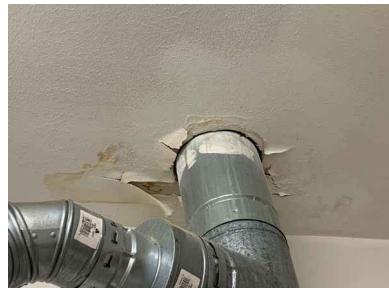
Rear side water heater closet

I NI NP D**4: Ceiling: Water Stain @ Water Heater****⊖ Recommendation**

Water stains were observed on the ceiling at and/or around the water heater flue area. The sealant at the flue roof level storm collar needs to be further investigated and corrected as necessary.

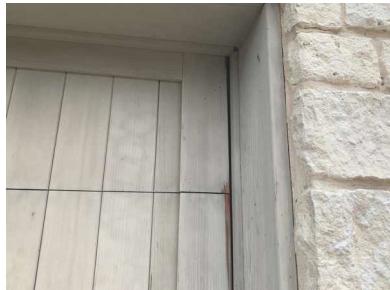
3: Overhead Door: Shifting/Adjustment**⊖ Recommendation**

The overhead garage door did not appear to fit the opening properly. Some shifting/settlement may have occurred in the area.

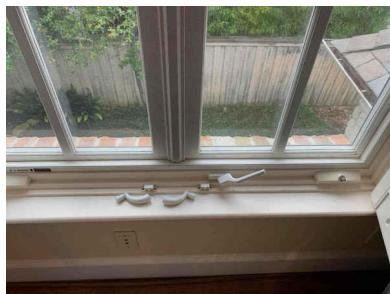
2: Windows: Wouldn't open**⊖ Recommendation**

One or more of the windows would not open. The cause and remedy should be further evaluated and corrected as necessary.

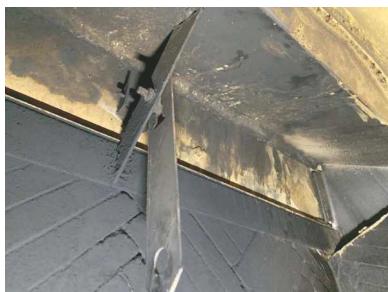
1: Gas Log/Damper Clamp Needed**● Recommendation**

No damper clamp was visible on the damper. When gas logs are installed in a firebox with a manual damper, the damper should be permanently blocked open with a damper clamp to prevent accidental spillage of carbon monoxide into the living space.

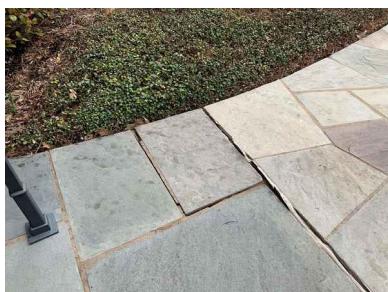
**K. Porches, Balconies, Decks and Carports***Comments:***1: Loose stonework and settlement at front walkway****● Recommendation**

Loose stonework and settlement at front walkway

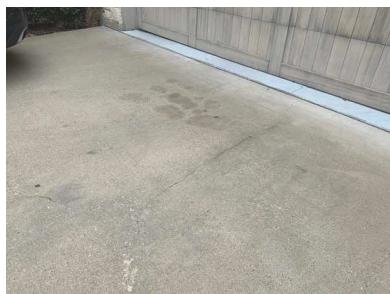
**2: Driveway: minor cracks visible****● Recommendation**

Some typical and slightly larger cracking was observed in the driveway flat work

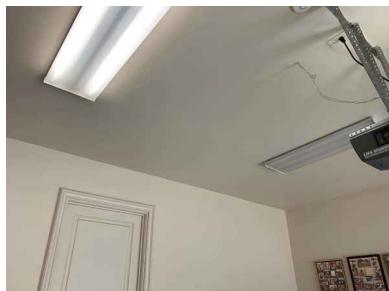
Garage ,master shower

I NI NP D**1: Fixtures: Light inoperative****⊖ Recommendation**

One or more of the light fixtures appeared to be inoperative. This may be due to a bad bulb or some other unknown condition. These fixtures should be further evaluated and corrected as necessary.

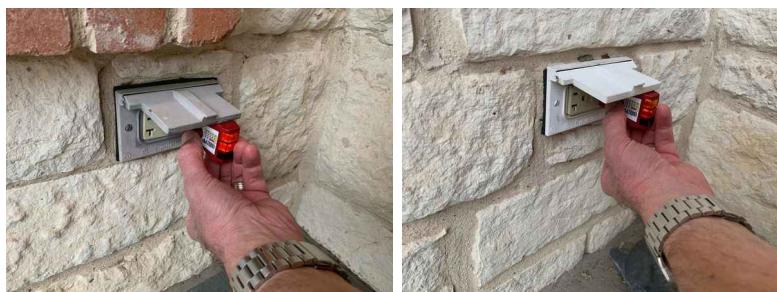
**2: Receptacles: GFCI not functioning properly****⊖ Recommendation**

One of the ground fault circuit interrupter (GFCI) devices did not appear to be functioning properly at the time of this inspection. This appears to be preventing other nearby outlets from functioning that may be on the same circuit. Replacement is recommended by appropriate professional.

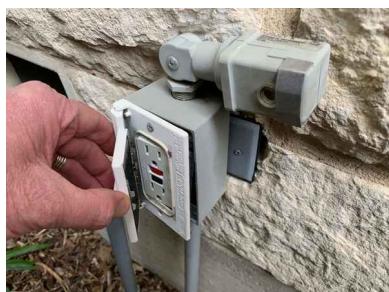
South

**3: Receptacle Note: Weatherproof cover loose/damaged****⊖ Recommendation**

One or more of the exterior receptacle weather proof covers was loose and can allow water to penetrate the box. Proper repairs are needed.

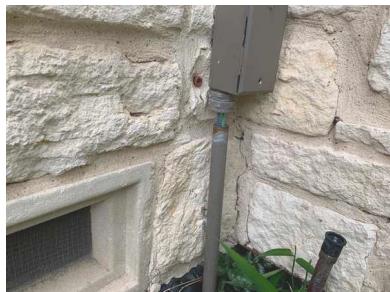
5: Conduit pulled loose**🔧 Maintenance Item**

Conduit had pulled loose at a Westside junction box.

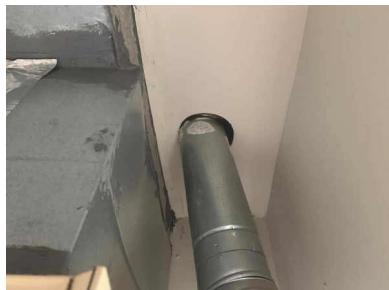
**1: Flue: Poor clearance****► Recommendation**

The heating unit flue (vent pipe) had inadequate clearance from combustible materials. Double walled vent pipes should have at least 1-inch of clearance and single walled vent pipes should have at least 6-inches of clearance from combustible material.

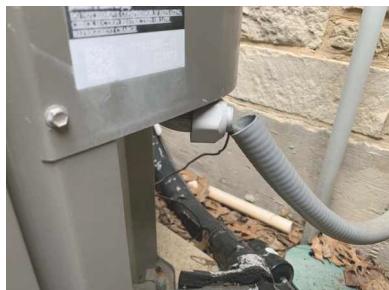
1: Condenser: Wire conduit pulled loose

The electrical wiring for the outside condenser/coils should be protected by conduit. The conduit had pulled loose from the connector

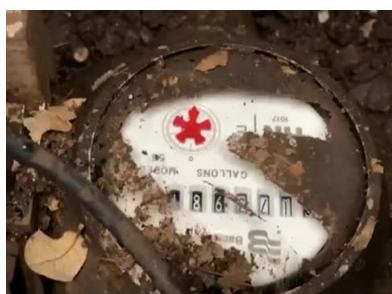
Static Water Pressure Reading: 95 -
95

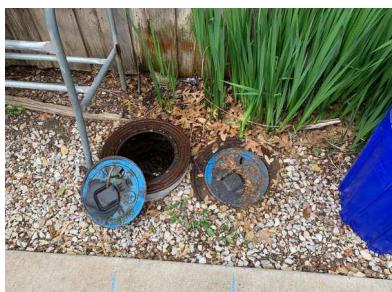
Two water meters were in place for the home. The left (west) meter appeared to service the sprinkler system and the right one serviced the home.

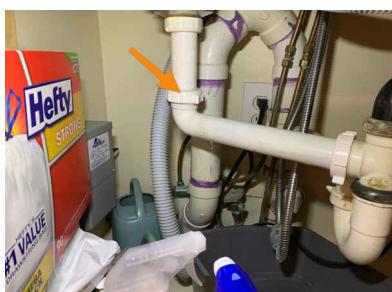
2: Sink: Drain Leaks in Cabinet**⊖ Recommendation****KITCHEN**

The sink drain leaked water into the cabinet when drained under pressure with a volume of water. Repair is needed.

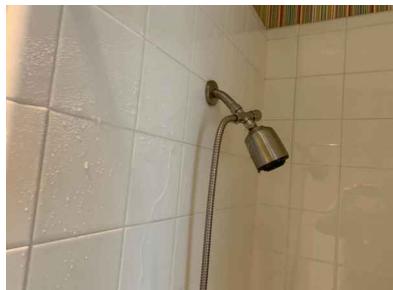
**3: Shower: Leak at neck connection****⊖ Recommendation****Upstairs hall bath**

The shower spout was leaking at the neck connection.

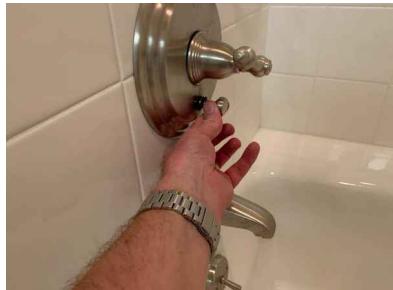
**4: Shower: Diverter not functioning properly****⊖ Recommendation**

The bathtub shower head diverter was not functioning properly. It was frozen in place and I was unable to operate the shower head. The cause and remedy should be further evaluated and corrected as necessary.

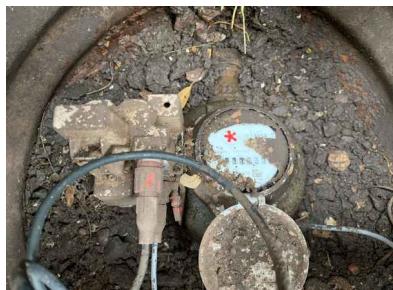
The water meter dial was observed to turn slightly although the interior fixtures were turned off. The cause was not determined. Further evaluation by a licensed plumber is needed as this may indicate a leak in the supply line.

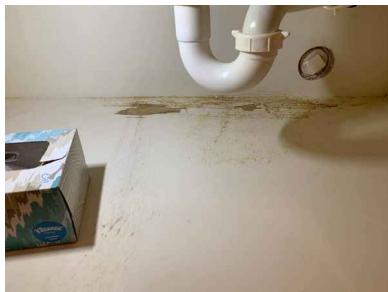
**7: Cabinets: Shelf Under Sink is Damaged****⊖ Recommendation**

The shelf in the cabinet under the sink was damaged.

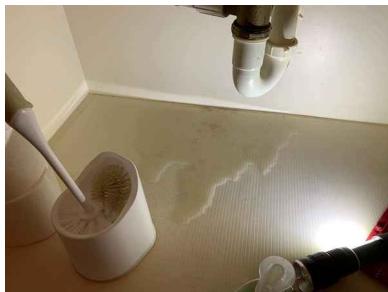
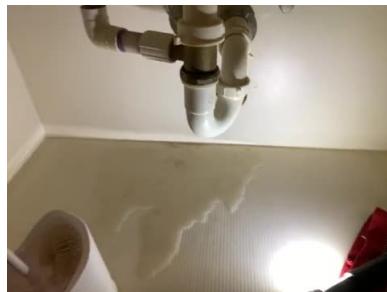
Downstairs half bathroom (off garage)

**8: Faucet: Fixture leaked into cabinet****⊖ Recommendation**

The faucet assembly leaked water into the cabinet when operated. It appeared to be a leak at the hot water supply side. No visible signs of leaking were detected at the drain line. Standing water was present when first opening the cabinet.

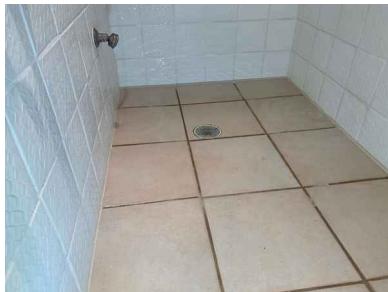
MASTER

**9: Shower: Slow draining****⊖ Recommendation**

The shower drain was observed to drain slowly, suggesting that an obstruction may exist.

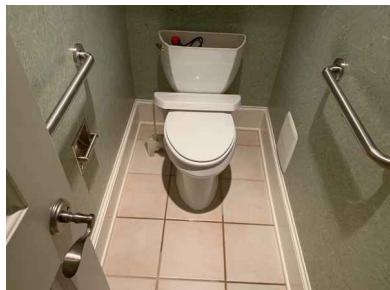
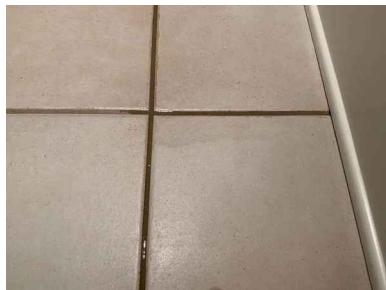
MASTER

11: Commode: Water turned off**⊖ Recommendation**

The water was turned to the commode at the time of this inspection. This condition should be further evaluated and corrected as necessary. Evidence of water was present on the floor. I was unable to test this commode at the time of the inspection.

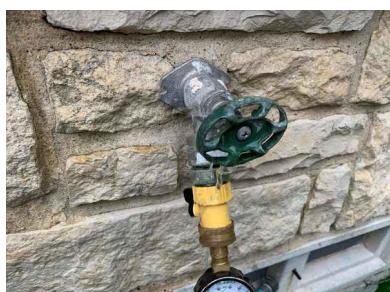
The exterior water hose bibb (faucet) leaked at the handle when operated.

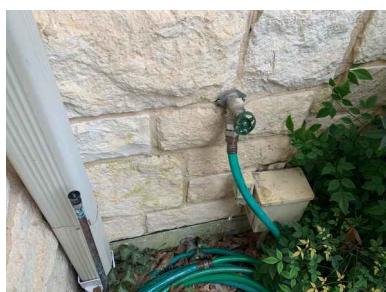
EAST , NORTHEAST

**12: Hose Bib: Leaked when on**

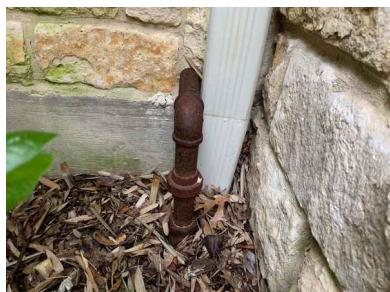
**13: Distribution: Surface rust visible**

Note: Rust was visible on the exterior natural gas piping. This is a natural occurrence based on the nature of the material, but preventative maintenance is recommended by removing surface rust and applying a protective coat of rust inhibiting paint.

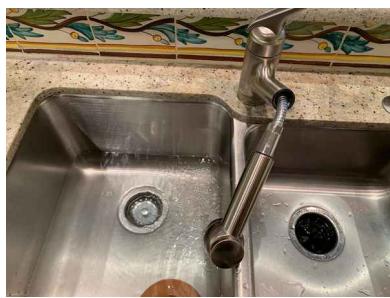
**14: Kitchen: faucet fixture would not turn**

The faucet fixture at the kitchen sink would not rotate from side to side.

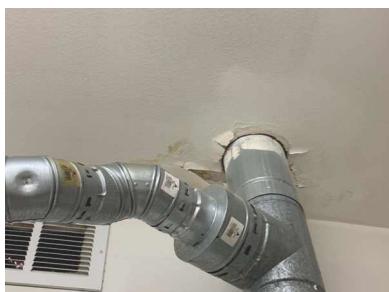
1: Flue: Poor clearance to combustibles

The water heater flue (vent pipe) had inadequate clearance from combustible materials. Double walled vent pipes should have at least 1-inch of clearance and single walled vent pipes should have at least 6-inches of clearance from combustible material.

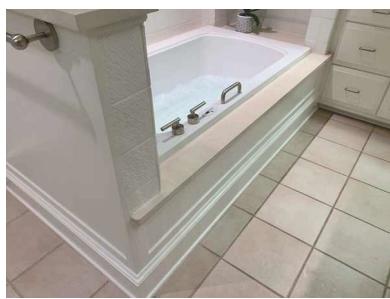
The access to the hydro-massage therapy equipment motor was not readily accessible and inspection of the equipment lines and motor could not be performed. This does not meet current installation standards.

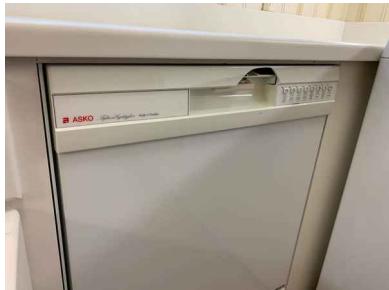
Laundry room unit

**1: Door Damaged****● Recommendation**

Some damage to the dishwasher door or door facing was observed.

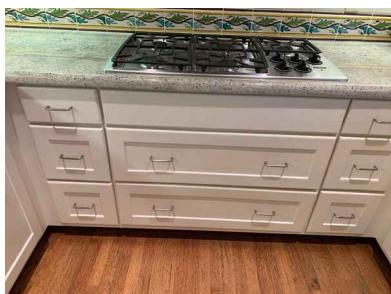
Cooktop

3: Gas Shutoff is Hard to Reach**⊖ Recommendation**

The gas shutoff valve was in a poor location and was hard to reach.

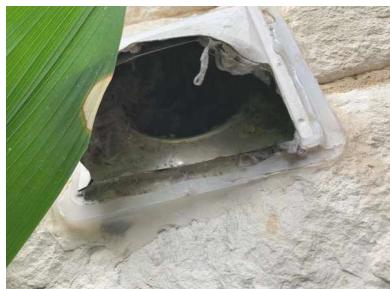
WEST

I NI NP D**1: Damper Clogged Open****⊖ Recommendation**

The damper stuck in the open position. Lint should be cleared from the damper to allow it to close properly when not in use.

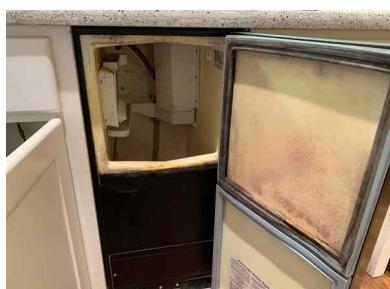
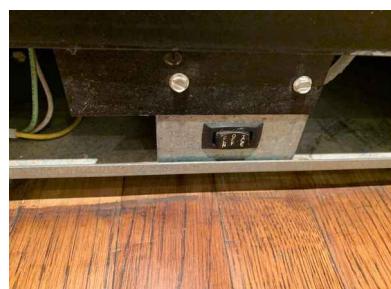
**1: Ice machine turned off/older****⊖ Recommendation**

The ice maker was turned off at the time of the inspection. It appeared functional, but could not be tested.

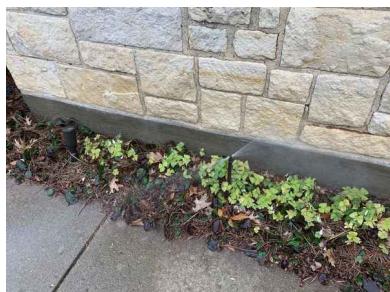
One or more of the sprinkler heads need to be adjusted and/or straightened so to disperse water properly.

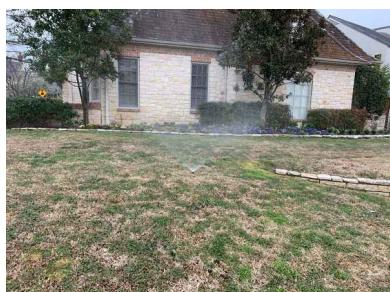
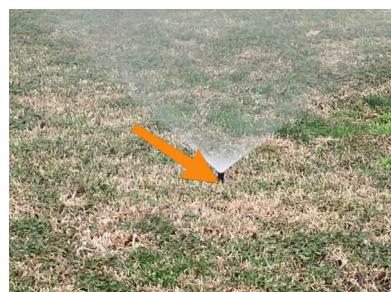
**2: Water Leaks@Base of Head****⊖ Recommendation**

One or more of the sprinkler heads appeared to be leaking at the base of the head. The cause and remedy should be further evaluated and corrected as necessary.

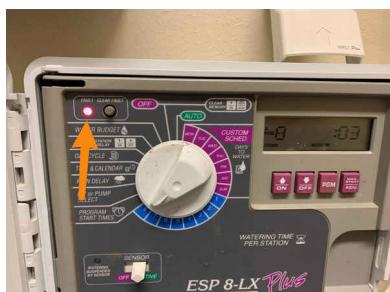
**3: Inoperative Station -Sprinkler****⊖ Recommendation**

A station/zone did not respond when tested in the manual setting. The cause and remedy should be further evaluated and corrected as necessary.

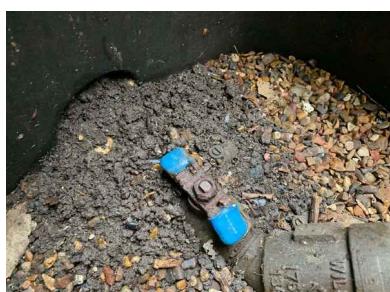
**4: Rusted/Deteriorated shutoff handles****⊖ Recommendation**

The handles to shut off water to the sprinkler system are rusted and no longer operable. Recommend repairs or replacement.
