## YOUR HOME INSPECTION

1234 Main St.  
Garland, Texas 75043

# PROPERTY INSPECTION REPORT

Concerning:1234 Main St. Fort Worth Tx 76137

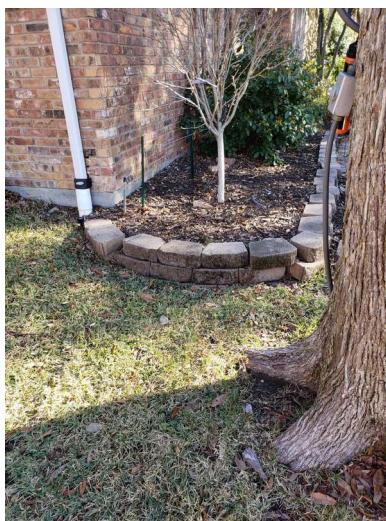
Tree(s) in close proximity of the foundation was observed. Client should consider the installation of a root barrier to reduce the possibility of damage to the foundation from tree roots and moisture removal.

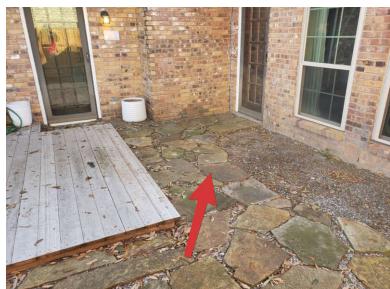
[Here is a helpful article](#) discussing negative grading. There have been previous repairs in what appears to be an attempt to resolve water intrusion into the home. Further evaluation is recommended.

Recommendation: Contact a qualified grading contractor.

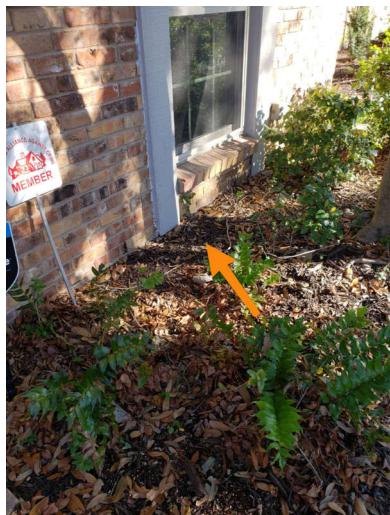
**3: High Soil****⊖ Minor Deficiency and Cosmetic Items**

The soil line is too high on the Exterior Locations of the structure. Under current building standards there should be at least 4-inches of foundation visible below masonry veneer and 6-inches of foundation visible below wood type veneer.

Recommendation: Contact a qualified grading contractor.

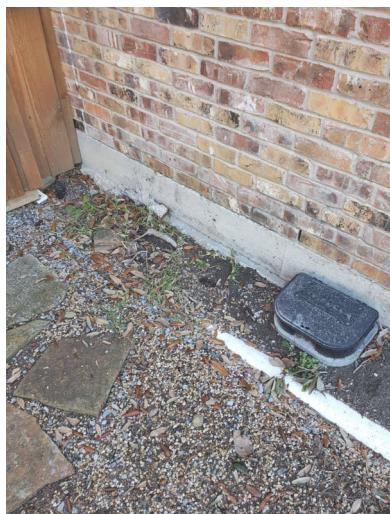
Left Side

**4: Low Soil****⊖ Minor Deficiency and Cosmetic Items**

The soil line is low. Under current building standards there should be 4-inches of foundation visible below masonry veneer and 6-inches of foundation visible below wood type veneer. It is recommended that fill dirt be added around the structure in the noted areas.

Recommendation: Contact a qualified grading contractor.

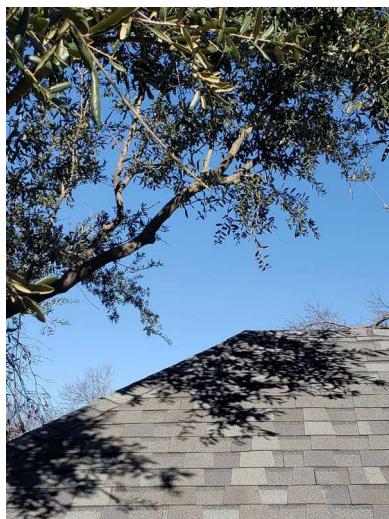
Tree and shrub branches need to be trimmed away from the roofing material at all times to help prevent damage to the roofing material. It is the opinion of this Inspector that there are some branches too close to the roofing material at this time and corrective measures are needed.

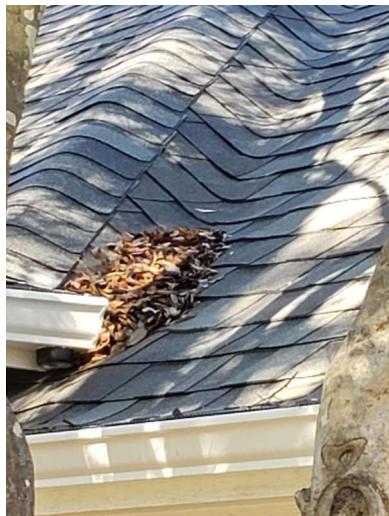
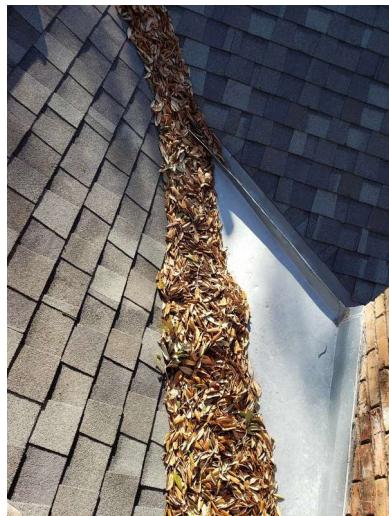
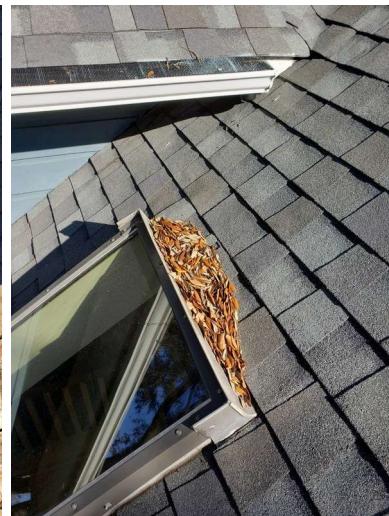
All debris, such as leaf's and branches, should be removed from the roof surface.

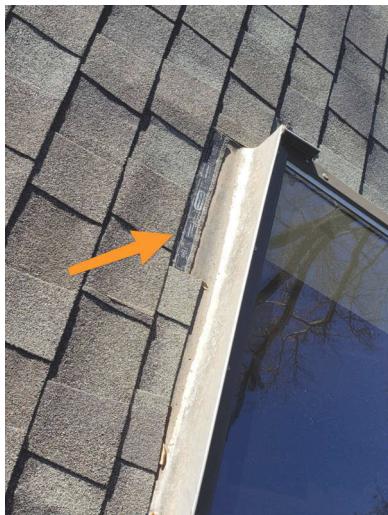
**1: Damaged Coverings****● Minor Deficiency and Cosmetic Items**

Roof coverings exhibited general damage that could affect performance. Recommend a qualified roofer evaluate and repair.

Recommendation: Contact a qualified roofing professional.

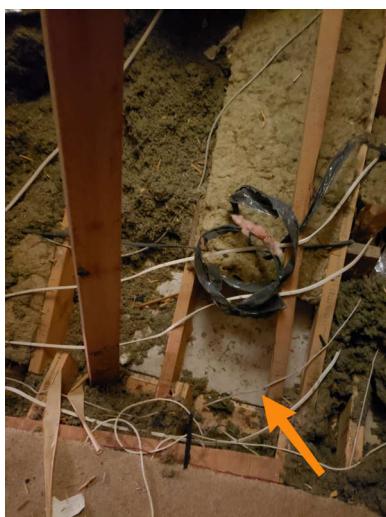
**2: Attic Insulation Missing****⊖ Minor Deficiency and Cosmetic Items**

The attic floor insulation was observed to be missing in some areas.

Recommendation: Contact a qualified insulation contractor.

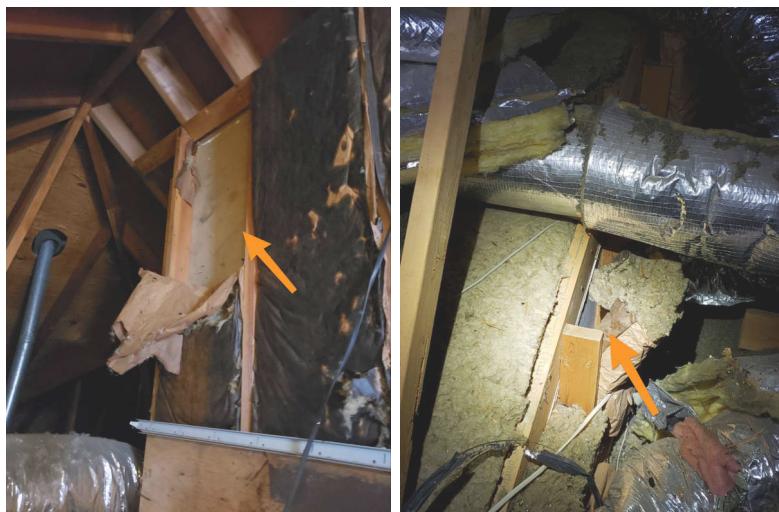
**3: Sidewall Insulation Missing****⊖ Minor Deficiency and Cosmetic Items**

The sidewall insulation was observed to be missing in the attic area. This condition should be further evaluated and corrected as necessary.

Recommendation: Contact a qualified insulation contractor.

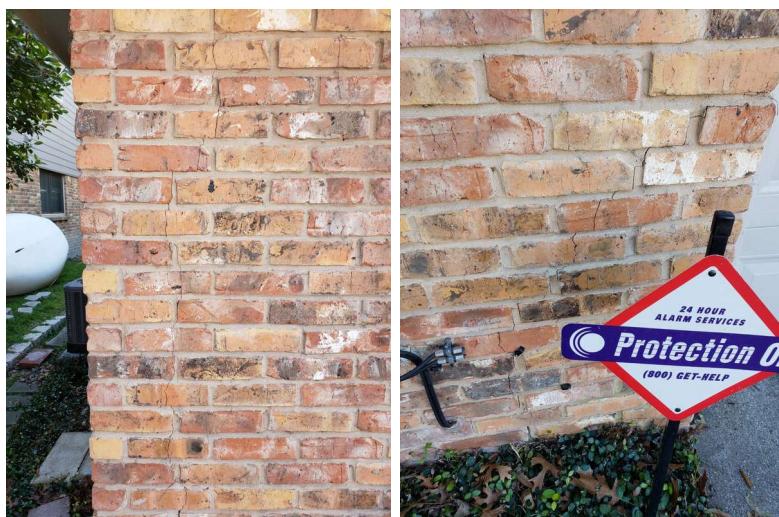
There are a few mortar cracks in the exterior walls that are considered to be cosmetic and average for age. No attempt is made to discover or document an exhaustive list of every crack or anomaly in the exterior. These deficiencies should be repaired to avoid water intrusion.

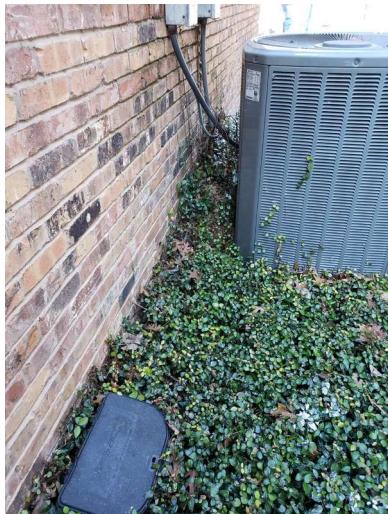
Vines growing on the exterior walls may introduce insects, pests and/or accelerate deterioration of the exterior wall covering by retaining moisture. Over time, vine tendrils may damage wall covering materials. Watering this vegetation will introduce moisture to the soil which may eventually reach the foundation. Moisture in soil supporting the foundation can affect the ability of the foundation to support the weight of the structure above and can cause damage from soil heaving or settling, depending on soil composition and other conditions. The Inspector recommends removal of the vegetation from exterior walls.

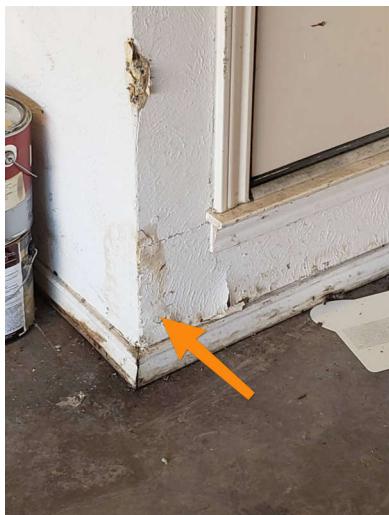
Garage

**3: Old Water Stain****⊖ Minor Deficiency and Cosmetic Items**

Recommendation: Contact a qualified drywall contractor.

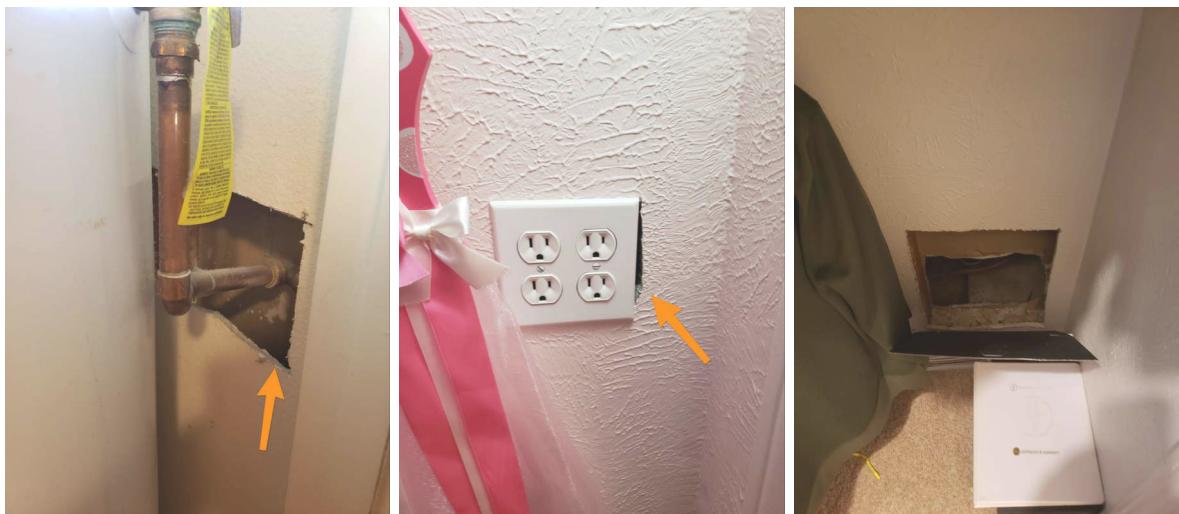
**4: Drywall Damage****⊖ Minor Deficiency and Cosmetic Items**

1st Floor water heater Closet & Stairwell Closet & Master Bedroom Closet  
Drywall wall damage was observed.

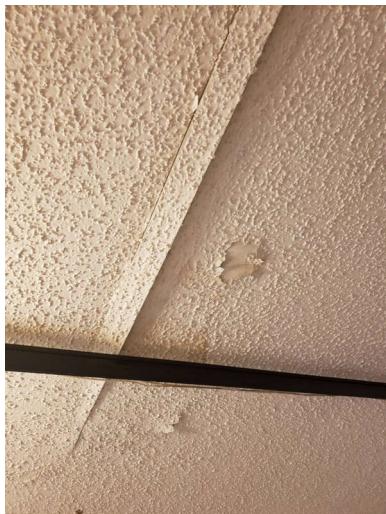
The ceiling texture has some deterioration and/or damage.

Recommendation: Contact a qualified drywall contractor.

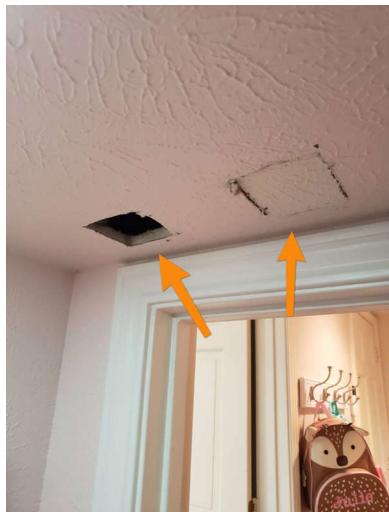
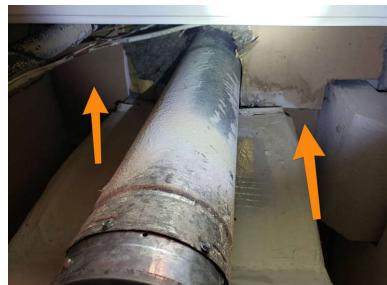
Stairwell Closet &amp; 2nd Floor HVAC Closet

**I NI NP D****2: Damaged Ceiling****● Minor Deficiency and Cosmetic Items**

The ceiling was observed to be damaged.

Recommendation: Contact a qualified drywall contractor.

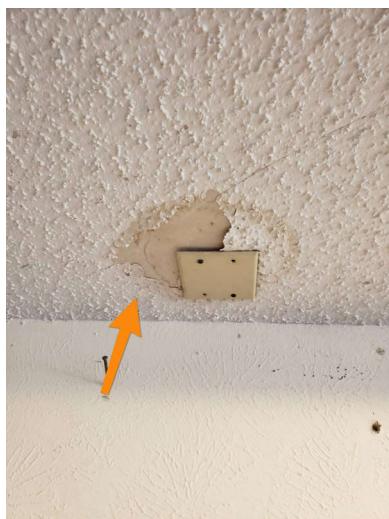
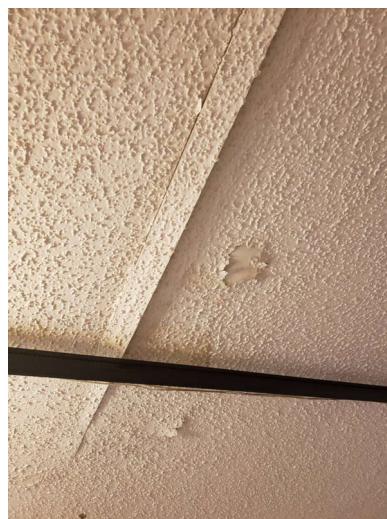
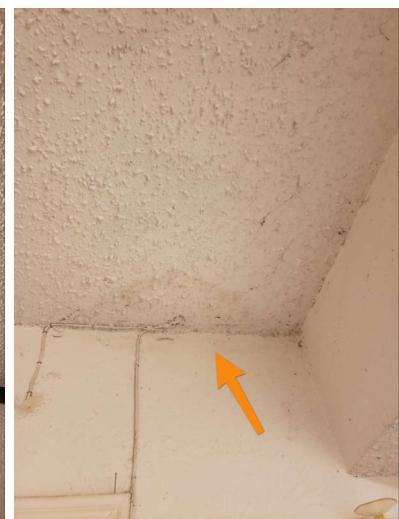
Garage

**3: Water Stain****● Minor Deficiency and Cosmetic Items**

Water stains were observed on the ceiling finish. The cause and remedy should be further evaluated and corrected as necessary.

Recommendation: Contact a handyman or DIY project

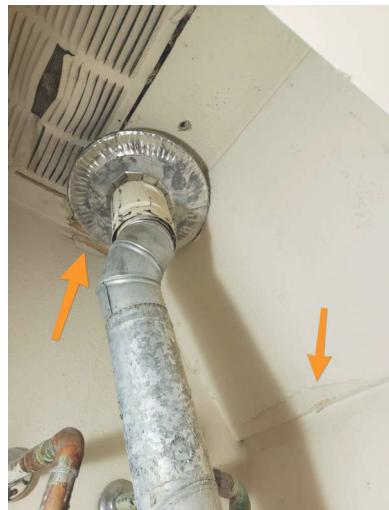
1st Floor Closet

**4: Water Stain at WH Flue****● Minor Deficiency and Cosmetic Items**

Water stains observed on the ceiling at and/or around the water heater flue area. The sealant at the flue roof level storm collar needs to be further investigated and corrected as necessary.

Recommendation: Contact a qualified drywall contractor.

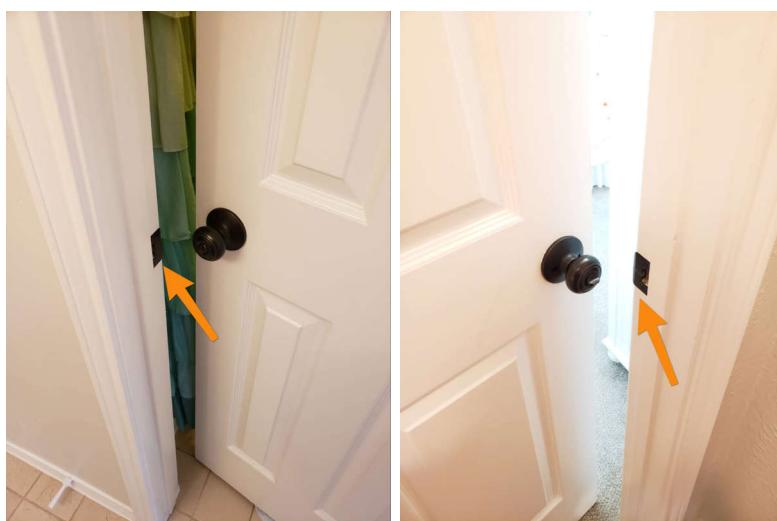
Door(s) not latching properly.

Recommendation: Contact a qualified door repair/installation contractor.

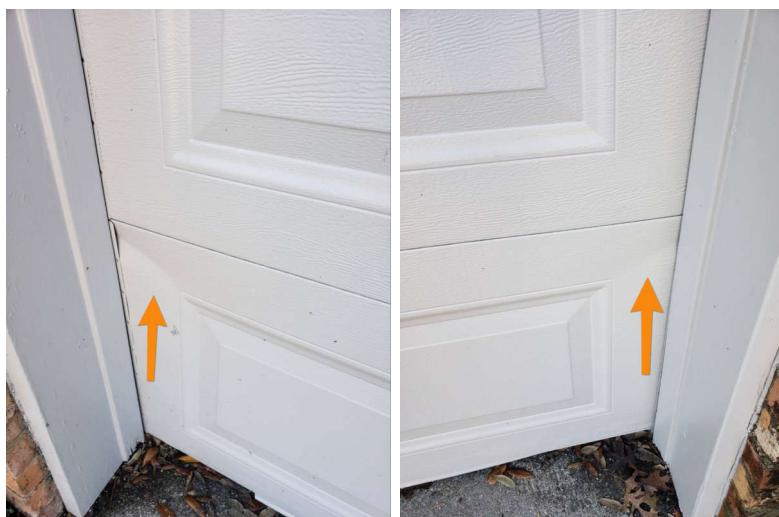
**5: Damaged Garage Door****⊖ Minor Deficiency and Cosmetic Items**

Some damage to the overhead garage door was observed.

Recommendation: Contact a qualified garage door contractor.

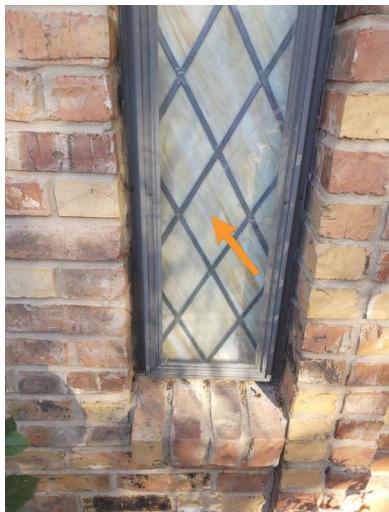
Cracked and/or broken window glass was observed.

Recommendation: Contact a qualified window repair/installation contractor.

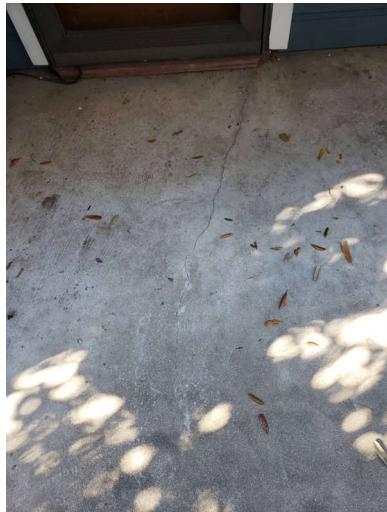
Some deflection and/or cracking of the patio concrete flatwork was observed.

Recommendation: Contact a qualified concrete contractor.

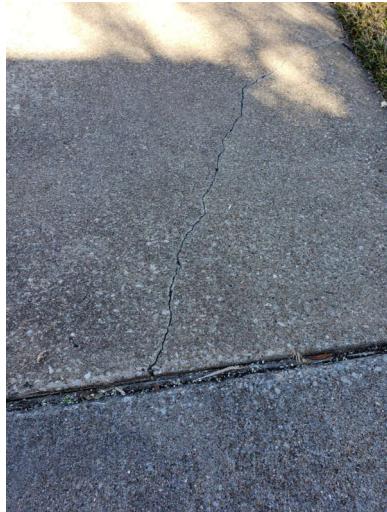
**2: Minor Driveway Cracks****⊖ Minor Deficiency and Cosmetic Items**

Minor cracks and/or deficiencies were observed in the driveway.

Recommendation: Contact a qualified concrete contractor.

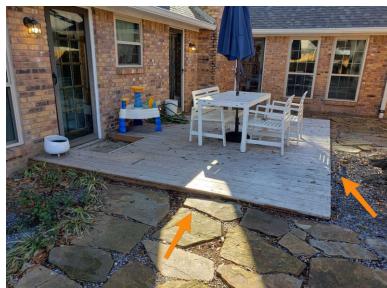
**3: Deck has wood to ground contact****⊖ Minor Deficiency and Cosmetic Items**

The deck has been built with wood to ground contact. This may cause premature wood rot in most cases.

Recommendation: Contact a qualified professional.

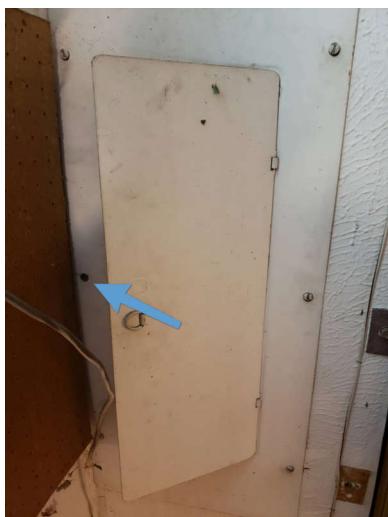
**2: Cover Screw Missing****🔧 Observation and Maintenance Items**

One or more of the cabinet cover plate screws are missing and need to be replaced.

Recommendation: Contact a qualified electrical contractor.

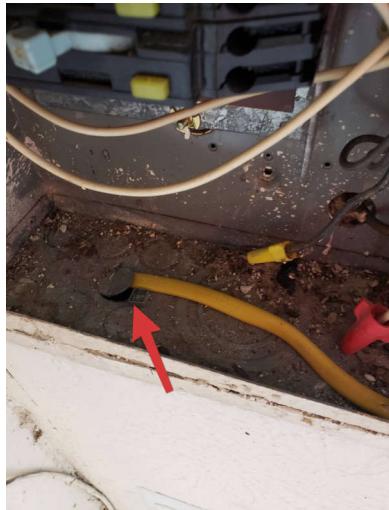
Per TREC standards of practice we are required to report this condition as a deficiency.

Recommendation: Contact a qualified electrical contractor.

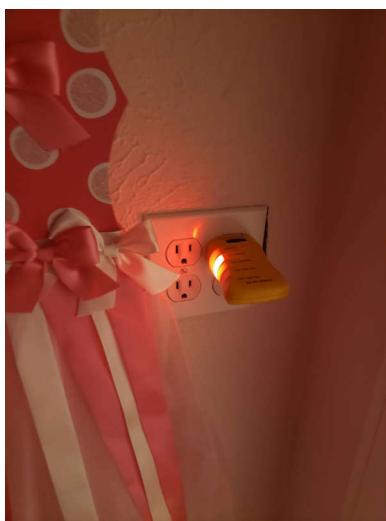
One or more of the receptacles were observed to have an open ground connection.

Recommendation: Contact a qualified electrical contractor.

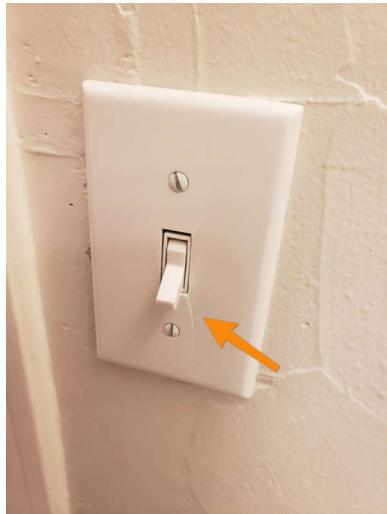
The switch cover plate is missing or damaged.

Recommendation: Contact a qualified electrical contractor.

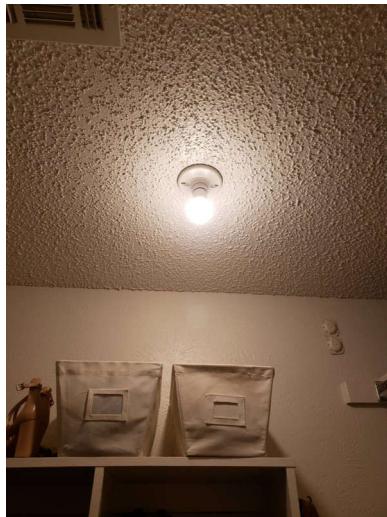
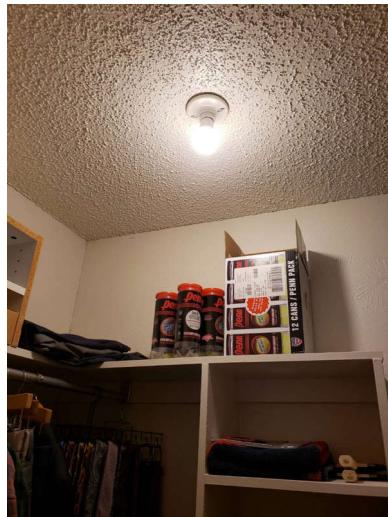
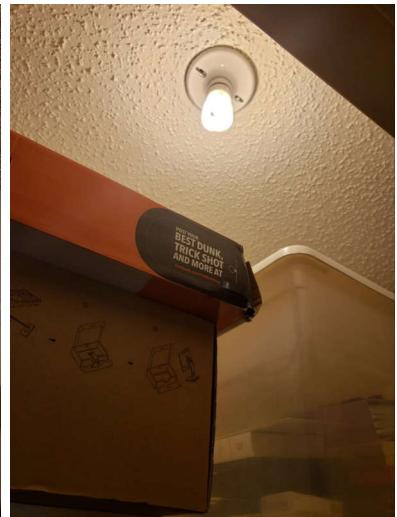
Various Locations

One or more of the closet light fixtures appear to be installed without globes and/or covers. Safety precautions should be taken around these light fixtures. This is an as built condition however we are required by TREC to note this as a deficiency.

Recommendation: Contact a handyman or DIY project

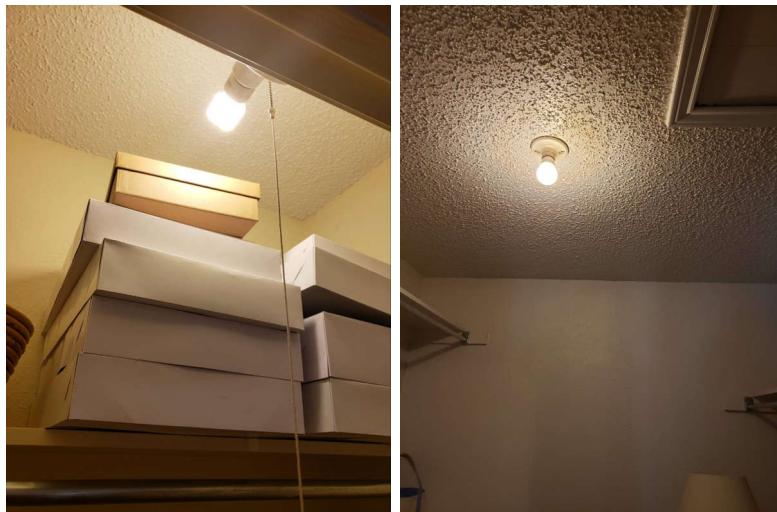
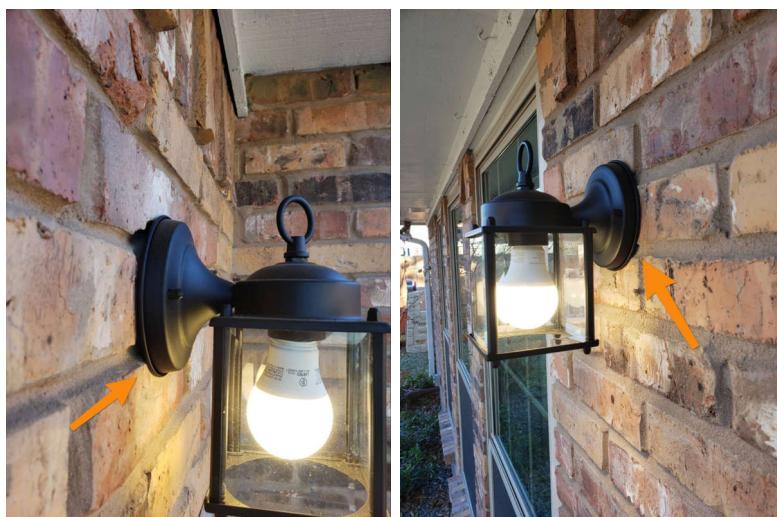
Back

The exterior fixtures should be properly sealed to the wall to avoid water intrusion behind the fixture.

Recommendation: Contact a handyman or DIY project

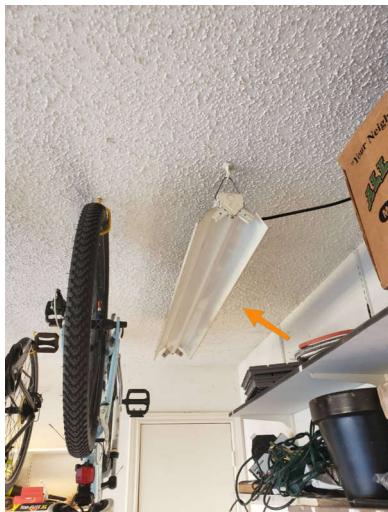
Garage

One or more of the light fixtures appear to be inoperative. This may be due to a bad bulb or some other unknown condition. This condition should be further evaluated and corrected as necessary.

Recommendation: Recommended DIY Project

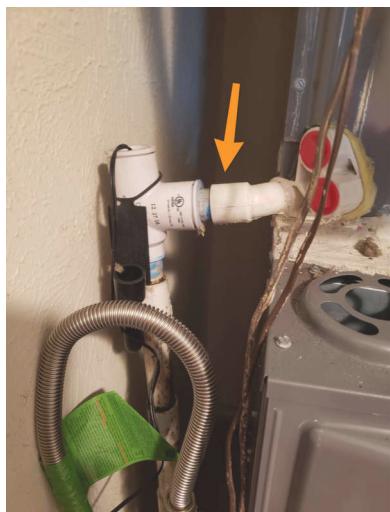
The primary condensate drain line is not equipped with a p-trap. Under current mechanical installation standards, the manufacturer requires a p-trap be installed in the primary condensate drain line within 6-inches of the coil housing.

Recommendation: Contact a qualified professional.

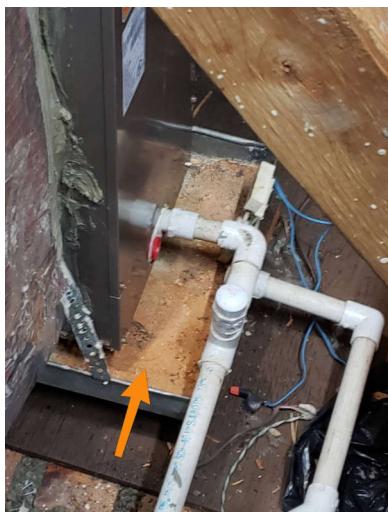
The auxiliary/secondary drain pan under the coil housing has some water staining and/or a rust build-up. This would indicate that the pan has held water in the past and should be closely monitored.

Recommendation: Contact a qualified professional.

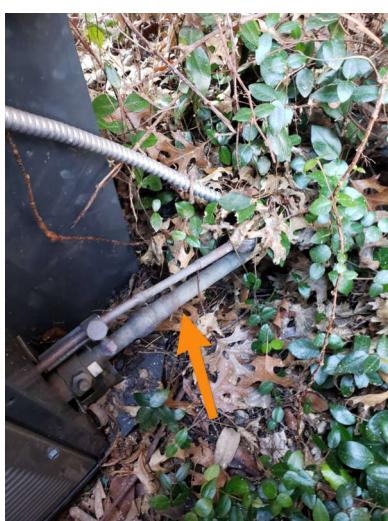
Damaged, deteriorated and/or missing insulation on the refrigerant lines should be repaired or replaced at the outside condenser.

Recommendation: Contact a qualified professional.

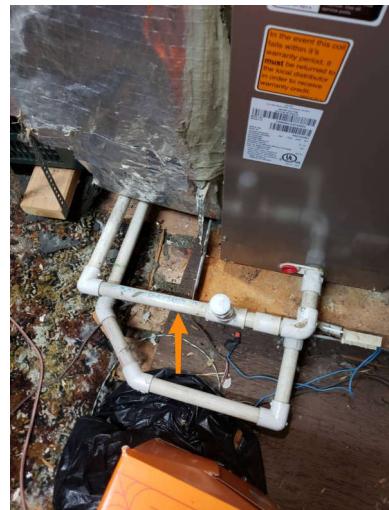
The primary condensate drain line is not equipped with a p-trap. Under current mechanical installation standards, the manufacturer requires a p-trap be installed in the primary condensate drain line within 6-inches of the coil housing.

Recommendation: Contact a qualified professional.

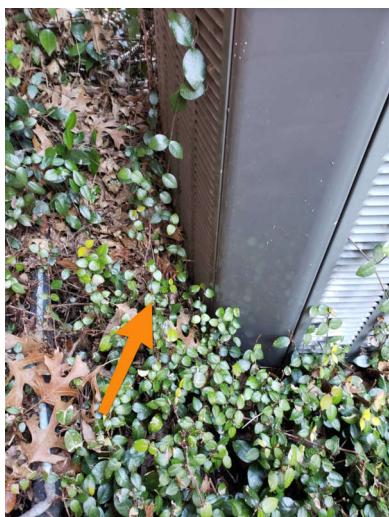
**6: 3" clearance to ground needed****⊖ Minor Deficiency and Cosmetic Items**

Recommendation: Contact a qualified professional.

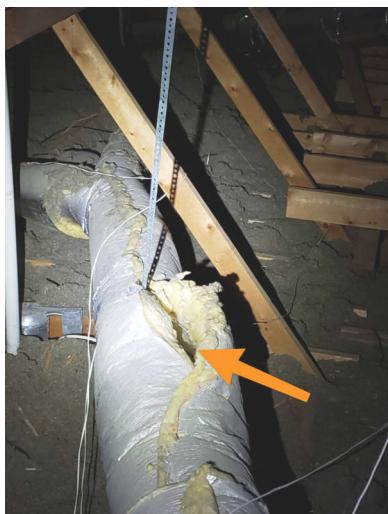
Ductwork insulated covering was observed to be damaged and/or pulling loose.

Recommendation: Contact a qualified professional.

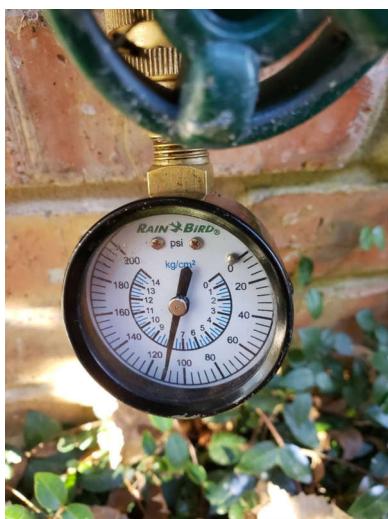
The water pressure was observed to be above 80 psi at the time of this inspection. Under current plumbing standards the maximum water pressure should be 80 psi. This condition should be further evaluated and corrected as necessary.

Recommendation: Contact a qualified plumbing contractor.

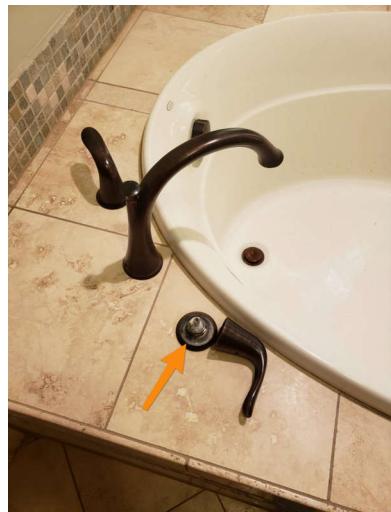
The faucet handle is damaged.

Recommendation: Contact a qualified plumbing contractor.

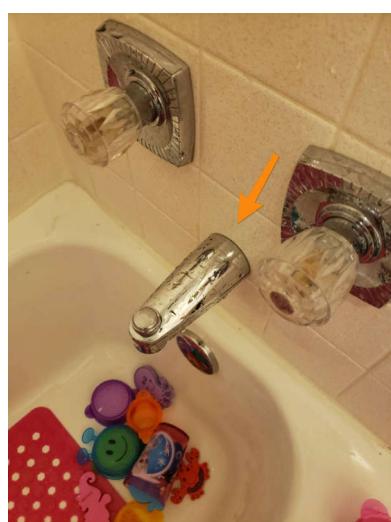
2nd Floor Jack &amp; Jill Bathroom Bathtub

Tub spout should be sealed to avoid water intrusion in the wall.

Recommendation: Contact a handyman or DIY project

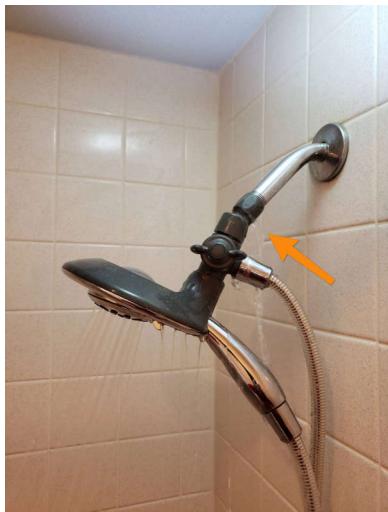
2nd Floor Jack &amp; Jill Bathroom Bathtub

The shower spout is leaking at the neck connection. This condition could result in water intrusion into the wall cavity.

Recommendation: Contact a qualified plumbing contractor.

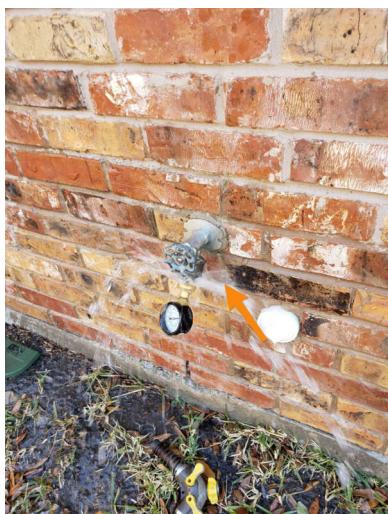
Left Side

The hose bibb vacuum breaker was observed to be damaged

Recommendation: Contact a qualified plumbing contractor.

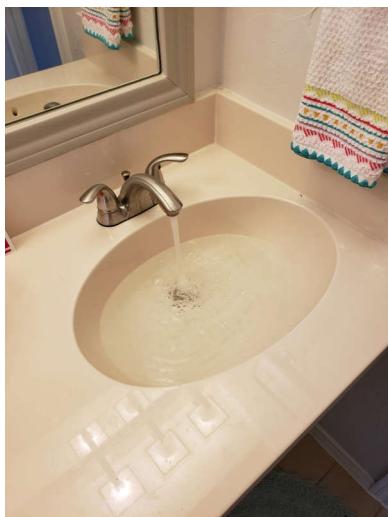
The sink was observed to drain slowly, suggesting that an obstruction may exist.

Recommendation: Contact a qualified plumbing contractor.

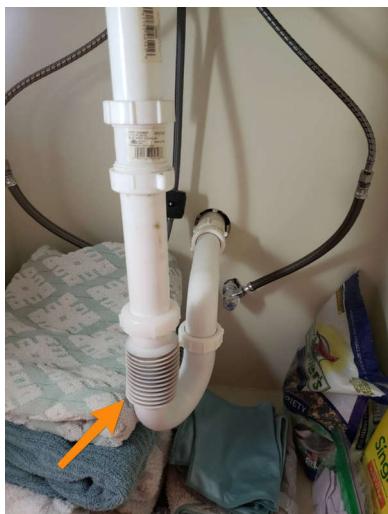
Laundry room

Although available at most home-improvement stores, flexible drain material is not intended for permanent use.

Recommendation: Contact a qualified plumbing contractor.

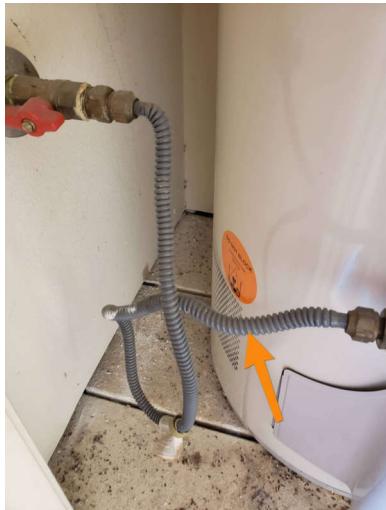
There is a blue/gray gas supply connector in use for the water heater. This is no longer an acceptable material to be used as a gas supply connector and should be replaced with an approved gas supply flex connector. These connectors have been recalled by the Consumer Product Safety Commission.

Recommendation: Contact a qualified plumbing contractor.

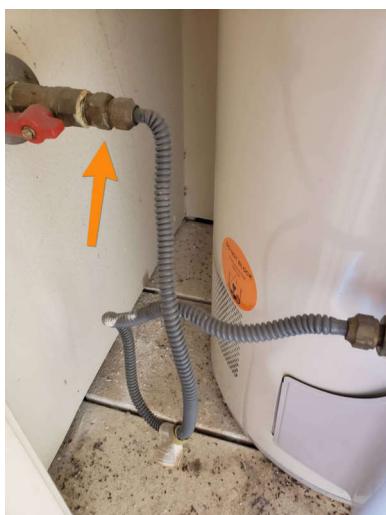
Garage

There is no sediment trap / drip leg present. Per the TREC SOP I am required to note this as a deficiency.

Recommendation: Contact a qualified plumbing contractor.

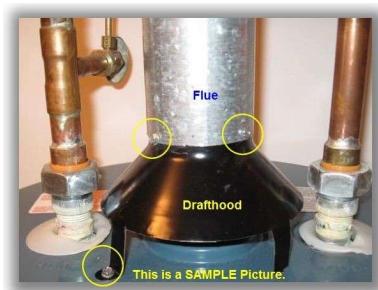
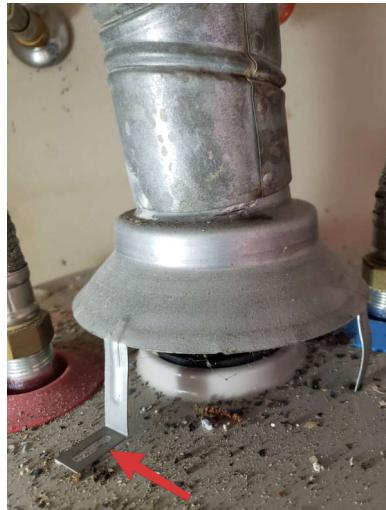
Garage

The draft hood is not properly mounted on the water heater. This configuration will emit Carbon Monoxide into the heater compartment, which is a known safety hazard

Recommendation: Contact a qualified plumbing contractor.

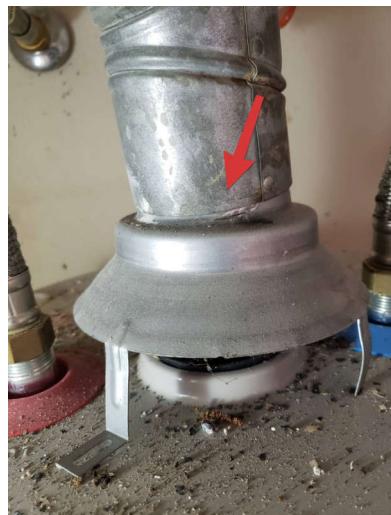
Garage

The water heater flue should be mechanically attached to the draft hood with a minimum of three sheet metal screws. Improperly attached flue can come loose and emit carbon monoxide.

Recommendation: Contact a qualified plumbing contractor.

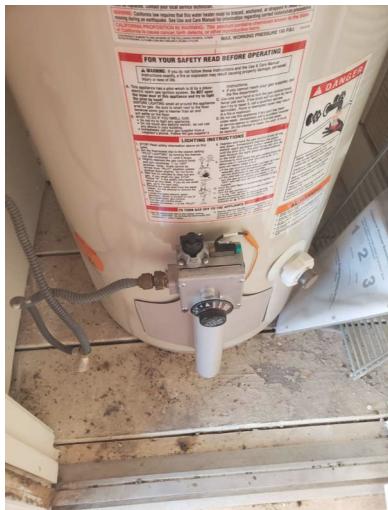
Garage

There is no pan installed under the water heater. This may be an as-built condition but Per TREC standards of practice we are required to report this condition as a deficiency.

Recommendation: Contact a qualified plumbing contractor.

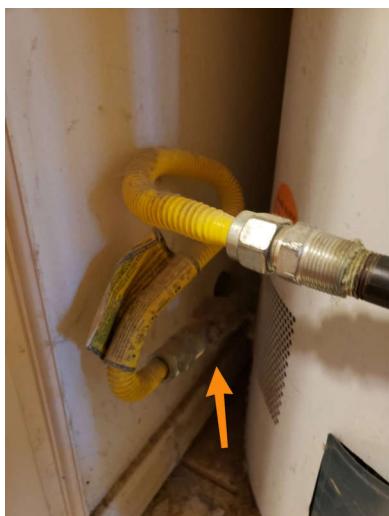
1st Floor Closet

There is no sediment trap / drip leg present. **Per the TREC SOP I am required to note this as a deficiency.**

Recommendation: Contact a qualified plumbing contractor.

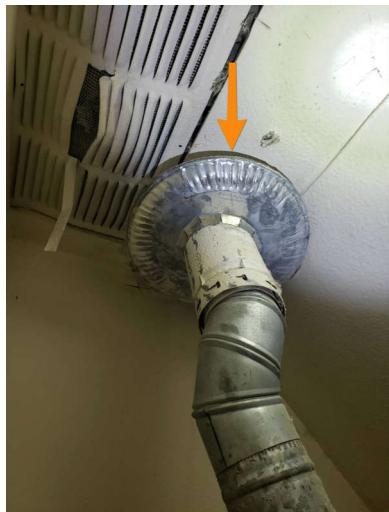
1st Floor Closet

The fire stop collar on the water heater flue is loose or missing. This condition should be corrected for reasons of safety.

Recommendation: Contact a handyman or DIY project

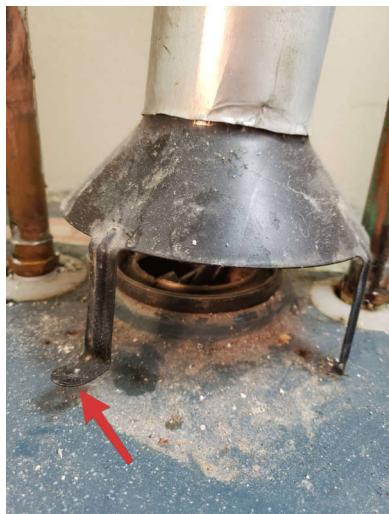
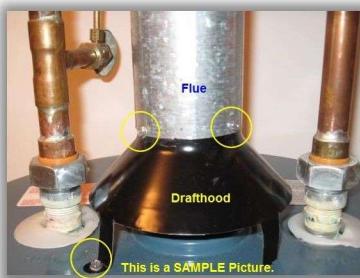
**3: Flue not mounted properly top****▲ Major Deficiency, Essential and Safety Items**

The draft hood is not properly mounted on the water heater. This configuration will emit Carbon Monoxide into the heater compartment, which is a known safety hazard

Recommendation: Contact a qualified plumbing contractor.

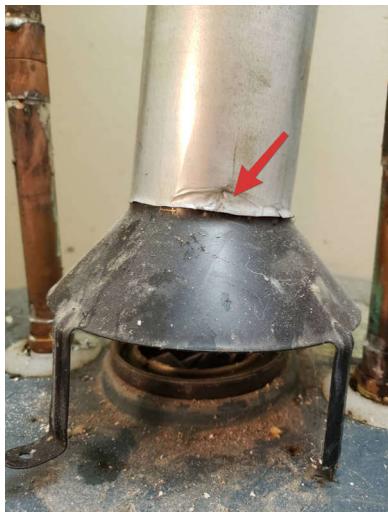
1st Floor Closet

**4: mechanical attach flue****▲ Major Deficiency, Essential and Safety Items**

The water heater flue should be mechanically attached to the draft hood with a minimum of three sheet metal screws. Improperly attached flue can come loose and emit carbon monoxide.

Recommendation: Contact a qualified plumbing contractor.

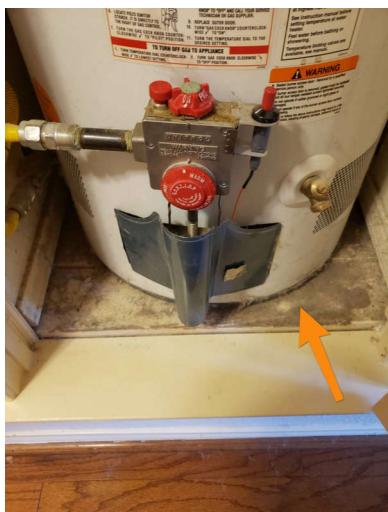
1st Floor Closet

**5: No pan****⊖ Minor Deficiency and Cosmetic Items**

There is no pan installed under the water heater. This may be an as-built condition but Per TREC standards of practice we are required to report this condition as a deficiency.

Recommendation: Contact a qualified plumbing contractor.

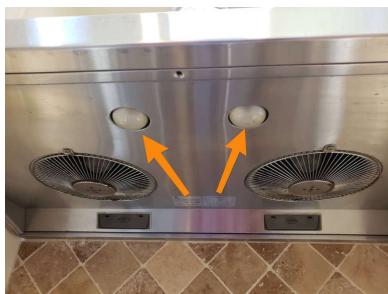
**1: Light inop****⊖ Minor Deficiency and Cosmetic Items**

The light at the range hood is inoperative.

Recommendation: Contact a qualified appliance repair professional.

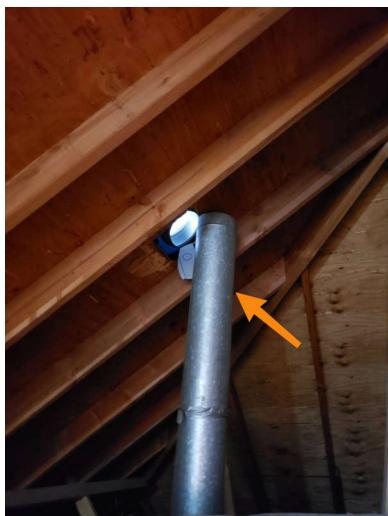
**2: Attic Term****⊖ Minor Deficiency and Cosmetic Items****Attic**

Range hoods shall discharge to the outdoors through a single-wall duct. The duct serving the hood shall have a smooth interior surface, shall be air tight, shall be equipped with a back-draft damper, and shall be independent of all other exhaust systems. Ducts serving range hoods shall not terminate in an attic or crawl space or areas inside the building. Single-wall ducts serving range hoods shall be constructed of galvanized steel, stainless steel or copper.

Recommendation: Contact a handyman or DIY project

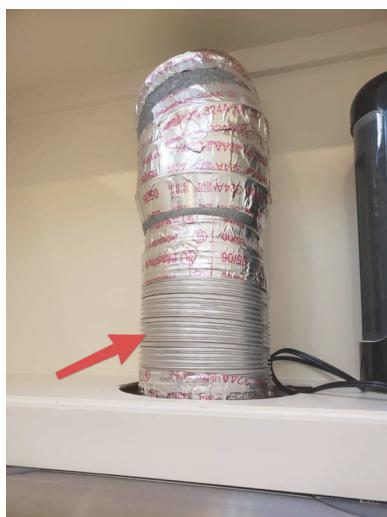
**I NI NP D****3: Flex duct****▲ Major Deficiency, Essential and Safety Items**

"Incorrect type of duct material (flex duct) used to vent range hood. Range hoods shall discharge to the outdoors through a single-wall duct. The duct serving the hood shall have a smooth interior surface, shall be air tight, shall be equipped with a back-draft damper, and shall be independent of all other exhaust systems. Ducts serving range hoods shall not terminate in an attic or crawl space or areas inside the building. Single-wall ducts serving range hoods shall be constructed of galvanized steel, stainless steel or copper.

Recommendation: Contact a qualified appliance repair professional.

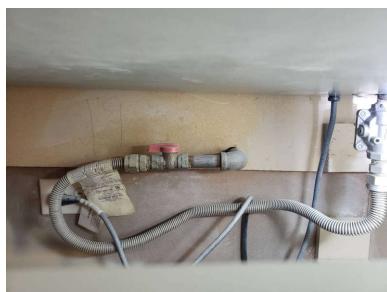
**1: Gas Shutoff Poor Location****▬ Minor Deficiency and Cosmetic Items**

The gas shutoff valve is in a poor location and is hard to reach.

Recommendation: Contact a qualified plumbing contractor.

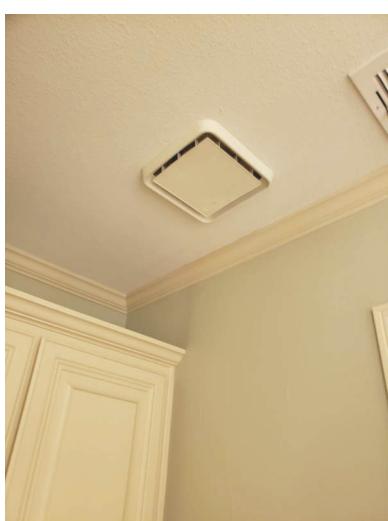
*Comments:***1: Noisy Vent Fan****Minor Deficiency and Cosmetic Items**

The mechanical exhaust vent fan was unusually noisy.

Recommendation: Contact a qualified handyman.

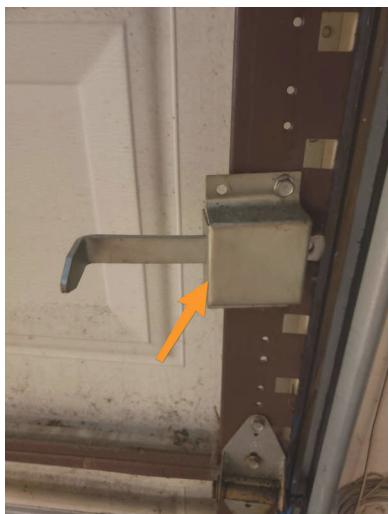
**I    NI    NP    D****1: Latch****⊖ Minor Deficiency and Cosmetic Items**

When an automatic garage door opener is in use, the manual lock should be disabled or removed. Per TREC standards of practice we are required to report this condition as a deficiency.

Recommendation: Recommended DIY Project

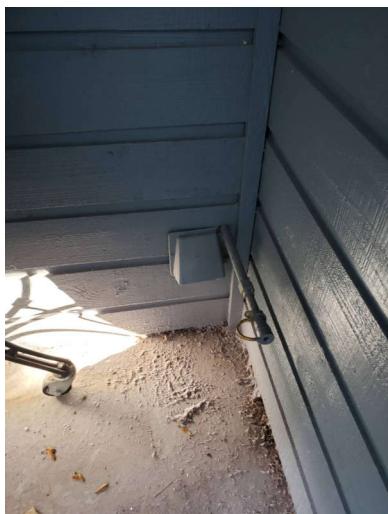
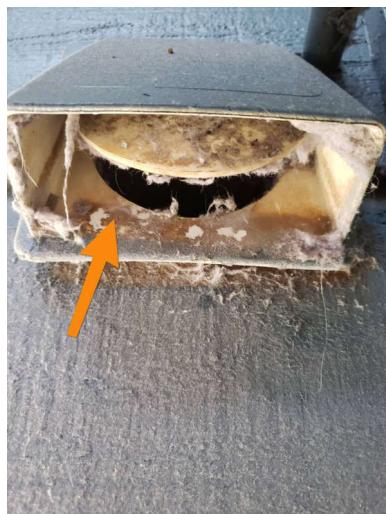
**1: Dryer Vent Clogged****⊖ Minor Deficiency and Cosmetic Items**

The dryer vent termination appears to be clogged and should be cleared.

Recommendation: Contact a qualified professional.

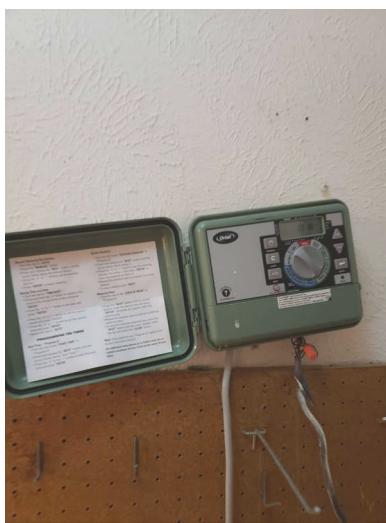
### **1: Control Box damaged**

The control Box for the sprinkler system is damage and unable to operate At time of The inspection. Further evaluation is recommended.

Recommendation: Contact a qualified professional.
