TOPNOTCH BUILDING INSPECTIONS

PRE-PURCHASE RESIDENTIAL

1234 Main St. Preston Victoria 3072

06/08/2020 9:00AM

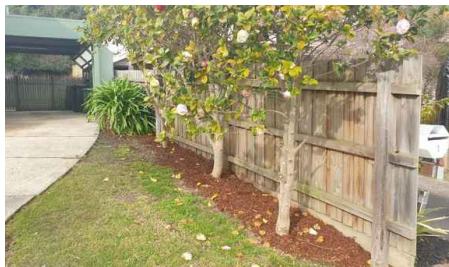
South Boundary Fence is Serviceable.

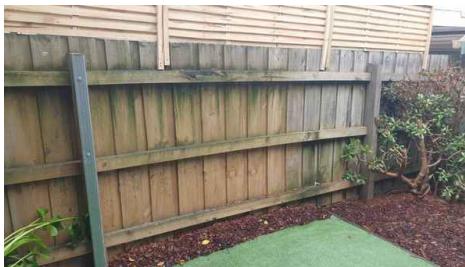
South Boundary Fence is Serviceable.

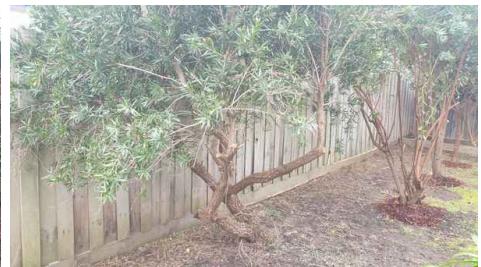
North Boundary Fence Requires Repairs

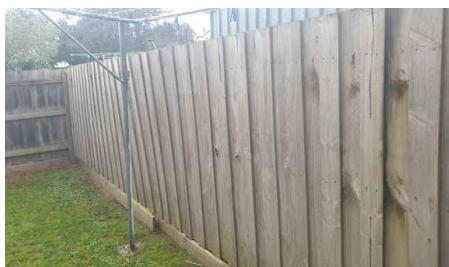
Rear, North Boundary Fence Requires Repairs, Leaning.

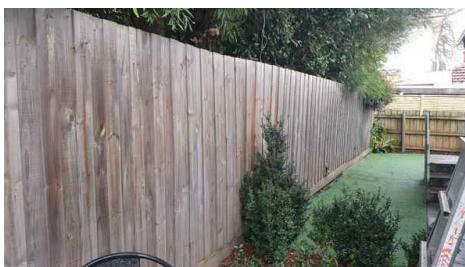
East Boundary Fence Serviceable.

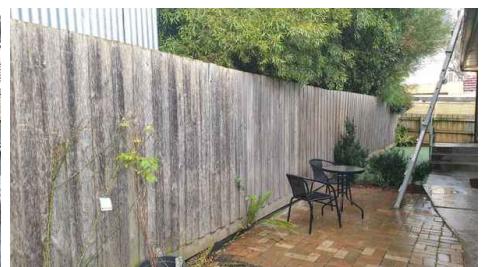
East Boundary Fence Serviceable.

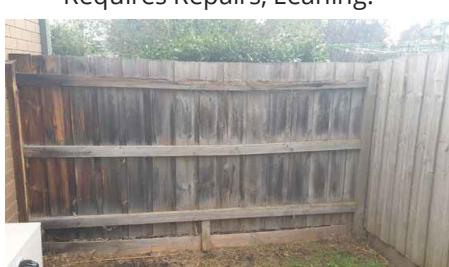
West Paling Fence Requires Replacement.

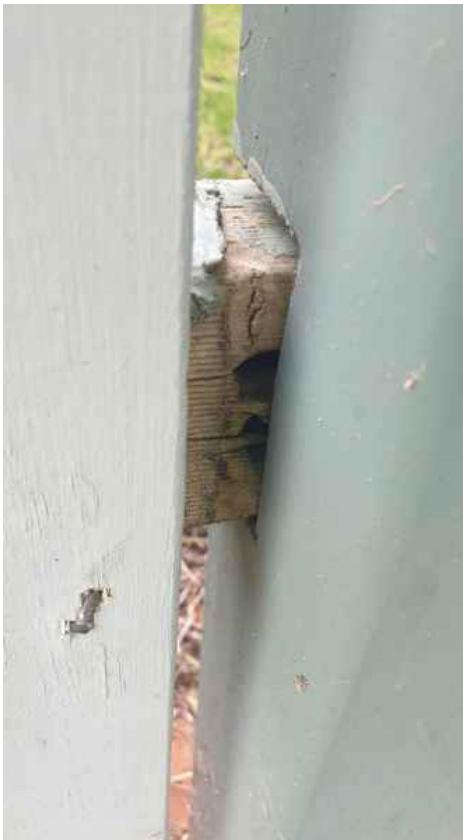
3.2.1 Front Fencing and Gates

PICKET FENCE DEFECT

I observed that the condition of the fence in many areas is poor.

The rails have been poorly installed and they have wood rot in some locations. This picket fence is nearing the end of its life expectancy.

Ageing Picket Fence

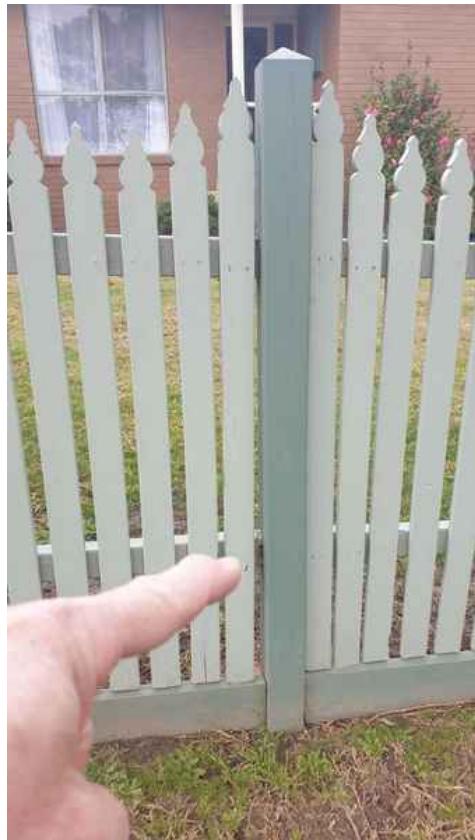
Ageing Picket Fence

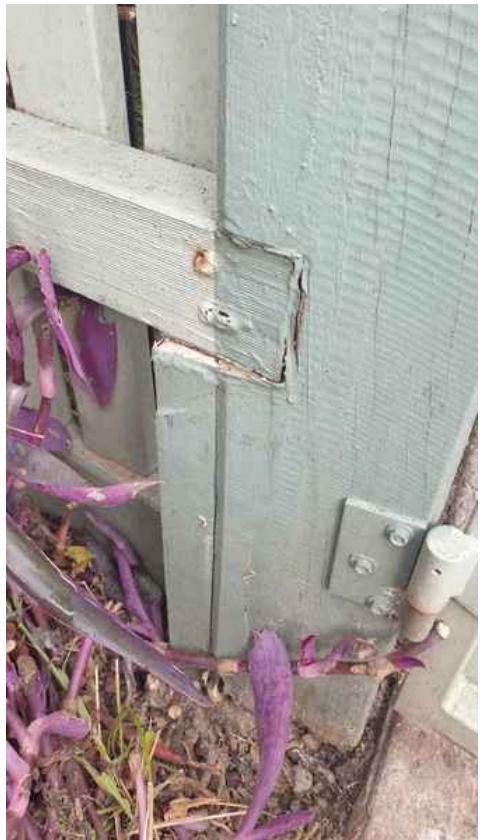
Ageing Picket Fence, Rot

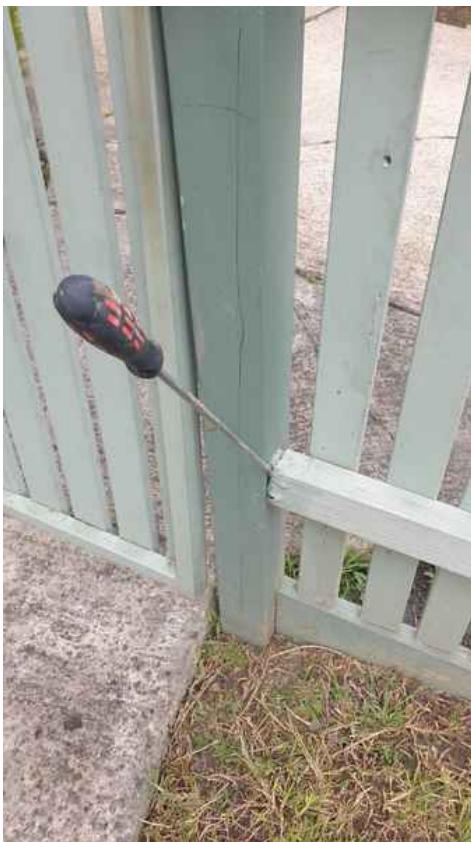
Ageing Picket Fence, poorly installed rail.

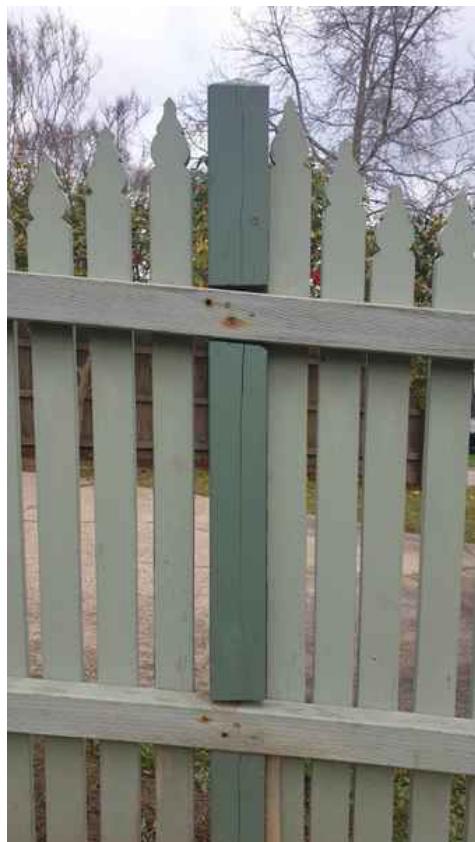
Ageing Picket Fence, poorly installed rail.

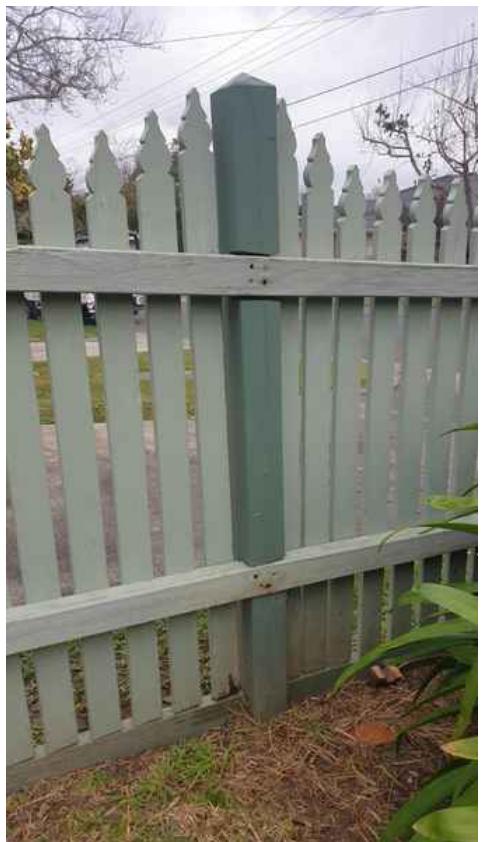
Ageing Picket Fence, poorly installed rail.

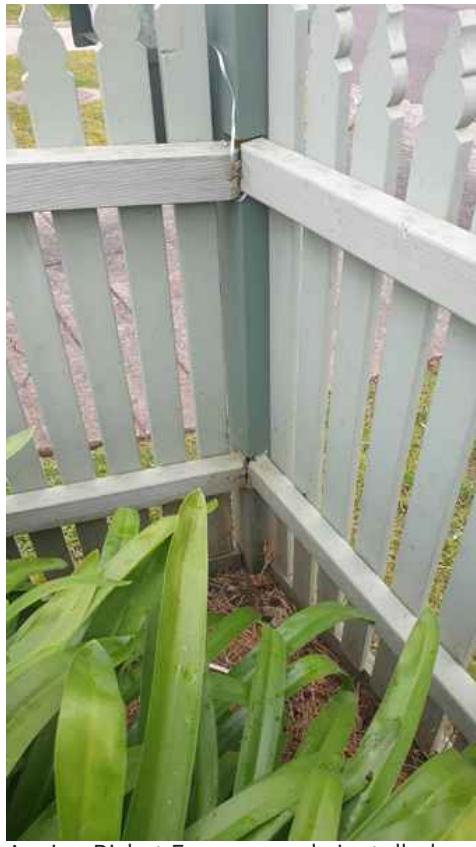
Ageing Picket Fence, poorly installed rail.

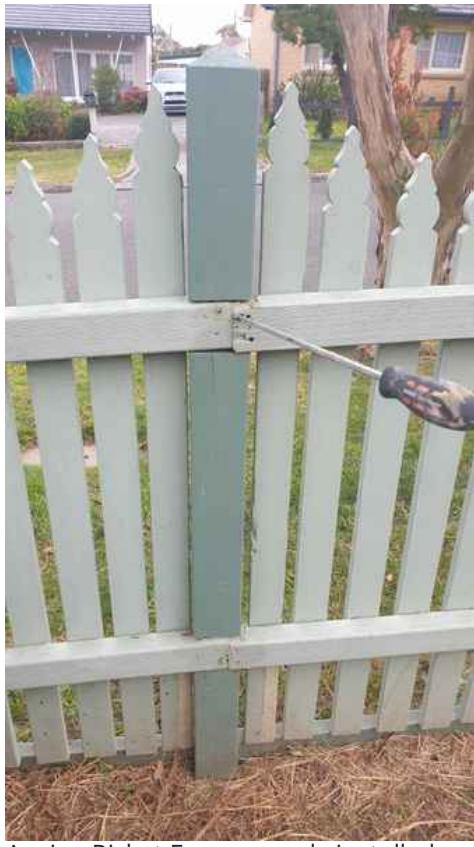
Ageing Picket Fence, poorly installed rail and rot

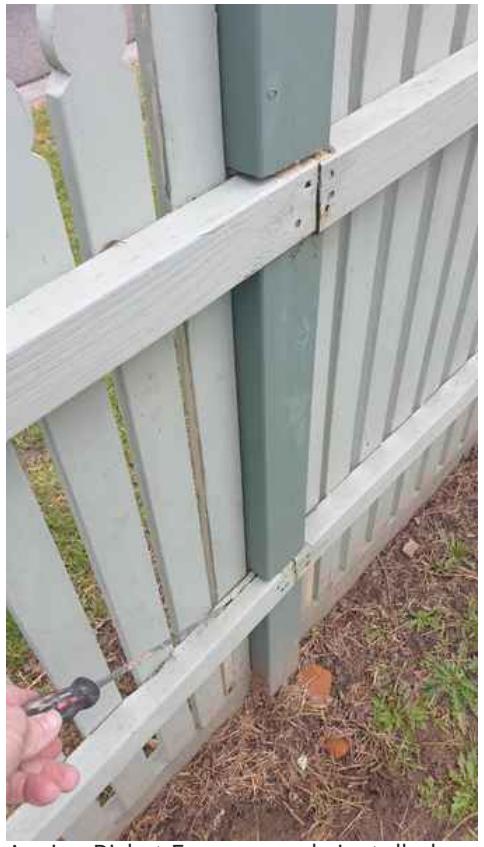
Ageing Picket Fence, poorly installed rail and rot

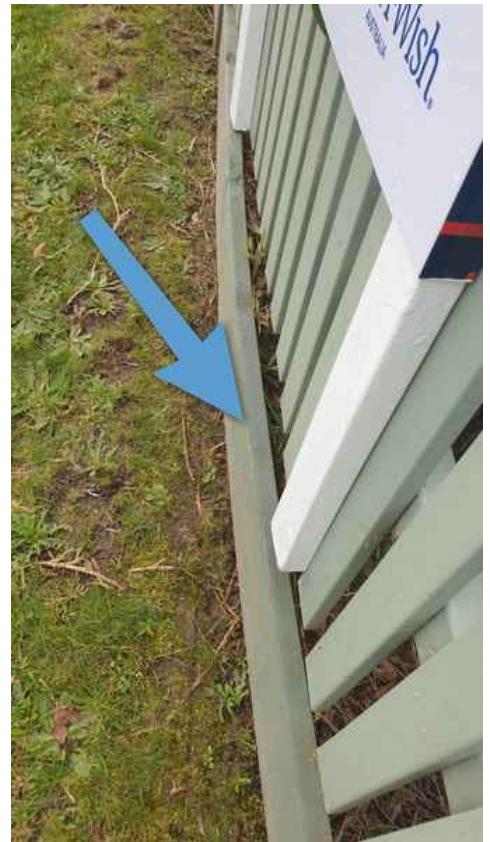
3.2.2 Front Fencing and Gates

Bulging Plinth on Picket Fence

Contact a qualified fencing contractor

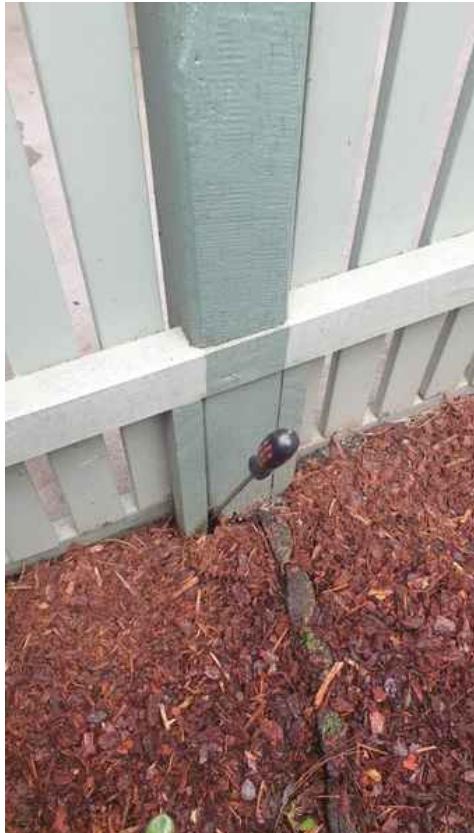
South Picket Fence, Post starting to rot,
Minor at this stage.

Recommend monitoring.

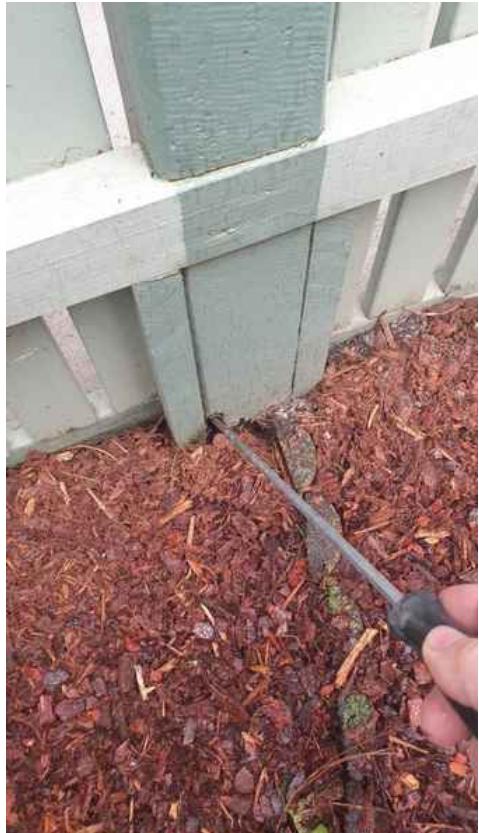
South Picket Fence, Post starting to rot,
Minor at this stage.

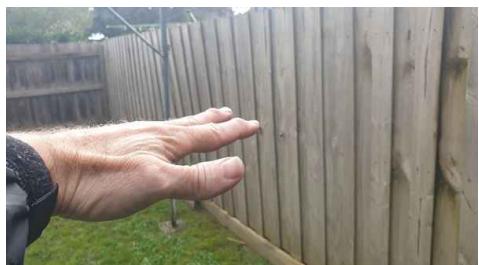
Rear North Boundary Fence Leaning.

Contact a qualified fencing contractor

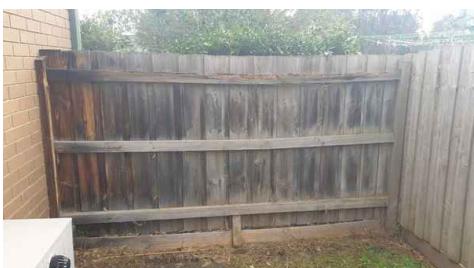
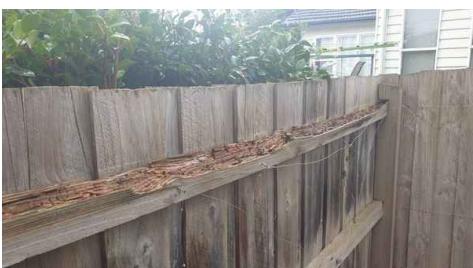
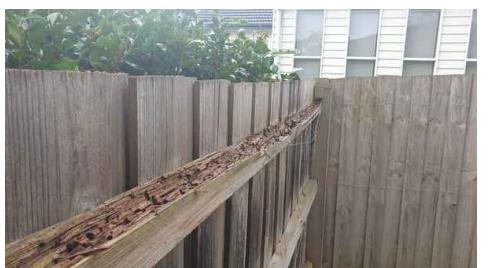
West Paling Fence Requires Replacement

MINOR DEFECT

Recommend to replace the fence with new.

Contact a qualified fencing contractor

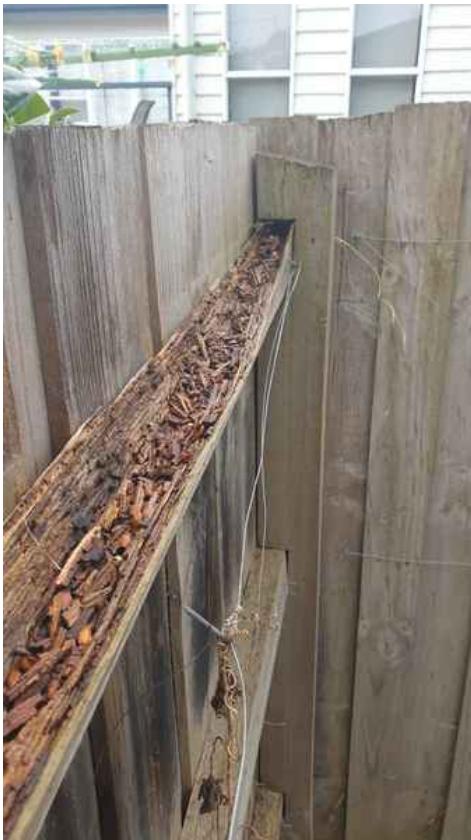
West Paling Fence Requires Replacement

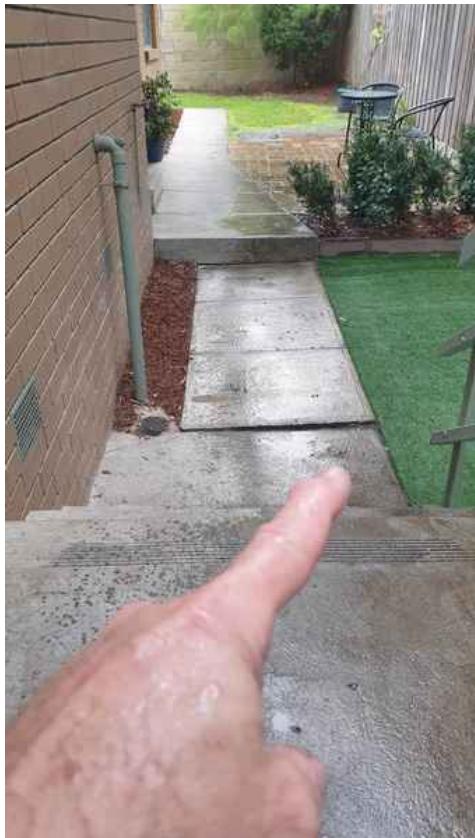
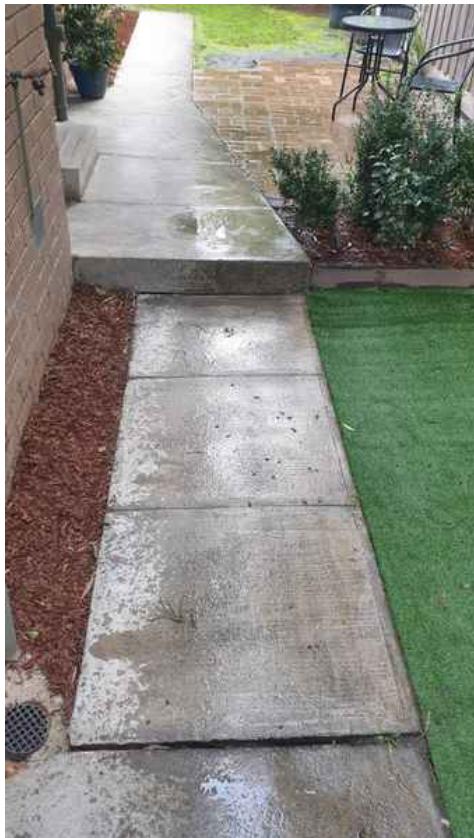
Rear of Dwelling

- MINOR DEFECT

Recommendations: This will need to be assessed during a period of rainfall and if surface water appears to be entering the sub-floor or ponding against the perimeter walls, engage a plumber or landscape gardener to assess and rectify as required.

Contact a qualified professional.

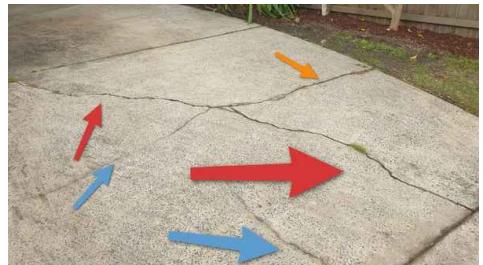
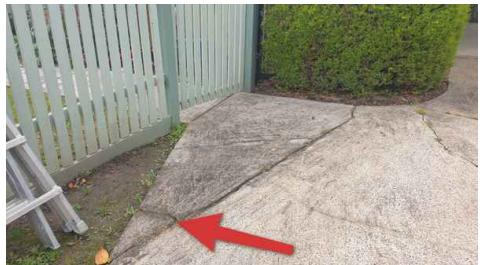
MAJOR CRACKS

The driveway has some major cracks. Large cracks allow water to penetrate beneath the driveway which accelerates the rate of degradation.

MAJOR DEFECT / SAFETY HAZARD

Minor and major Cracking

I recommend engaging a concrete contractor for further advice and rectification works.

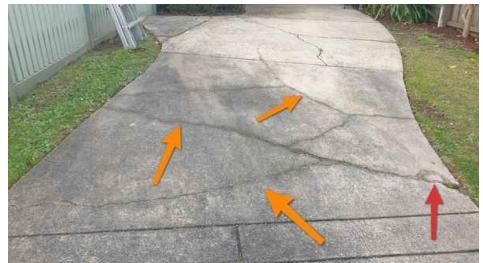
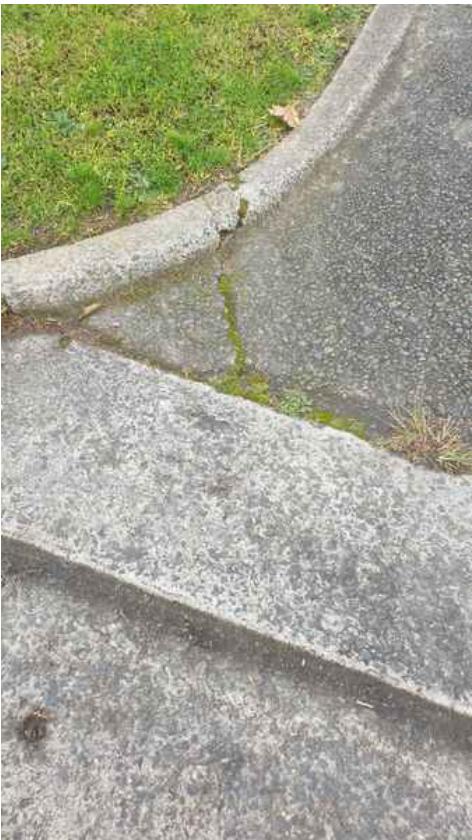
DRIVEWAYS - MINOR

MINOR DEFECT

Minor deterioration (e.g. cracks, holes, settlement, heaving) was found in the driveway, but no trip hazards were found. The client may wish to have repairs made for cosmetic reasons.

Contact a qualified professional.

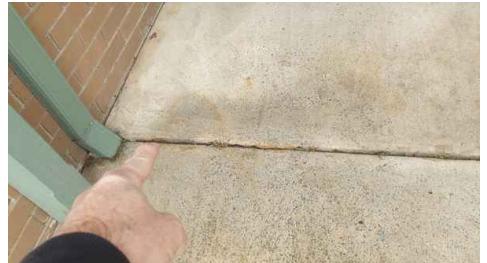
Front of Carport

Sections of the driveway have raised or settled in some areas. This can cause water ponding and degradation of the driveway.

Recommend monitor and if the raised area creates a trip hazard, rectify the affected areas as required.

Contact a qualified driveway contractor.

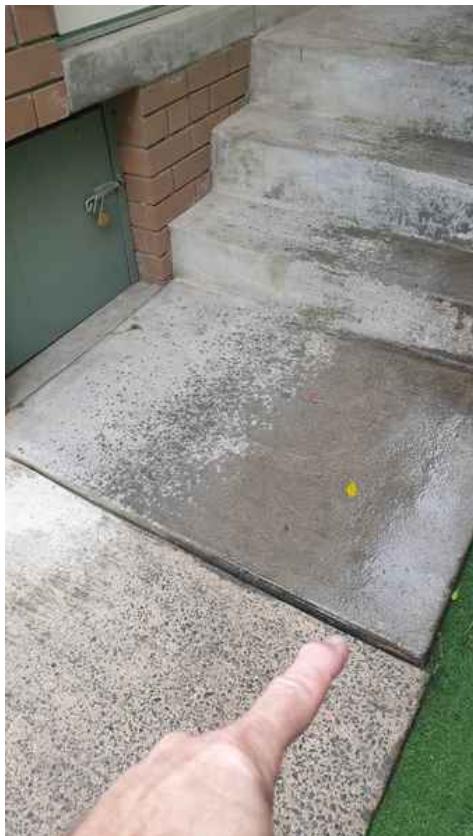
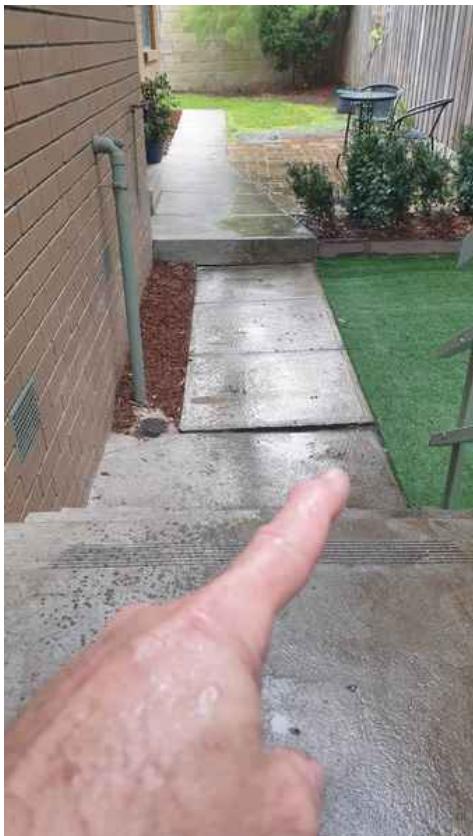
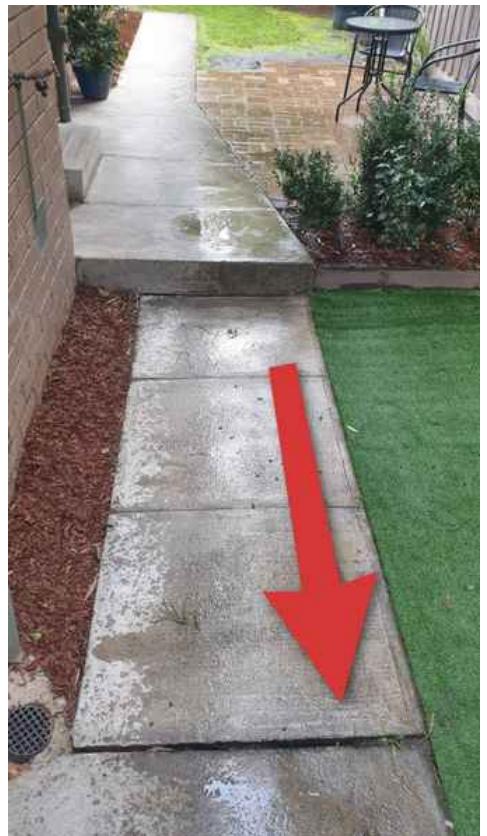
Rear East Path

**PATH TRIP HAZARD**

Trip hazards observed.

Trip hazards are a safety hazard and therefore a defect. In the opinion of the Inspector, this defect has been classified as a Minor Defect.

Recommend to repair and make good to prevent a tripping hazard and possible injury.

Contact a qualified concrete contractor.

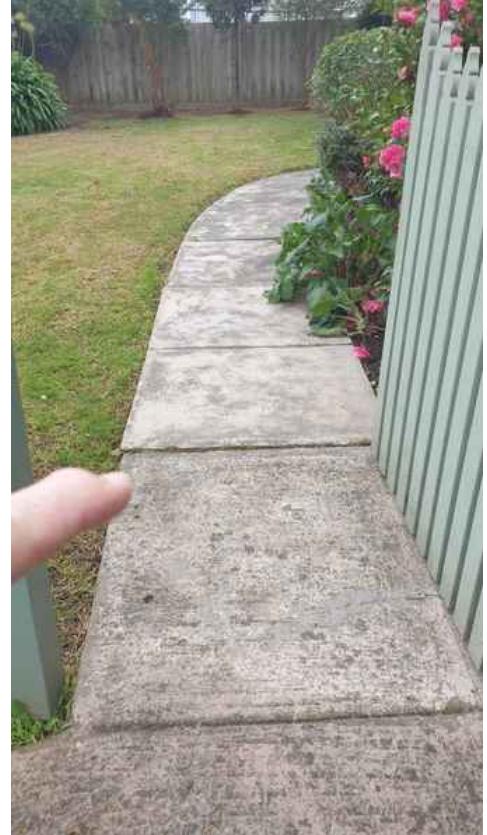
Front Path, Minor Trip Hazard.

Contact a qualified concrete contractor.

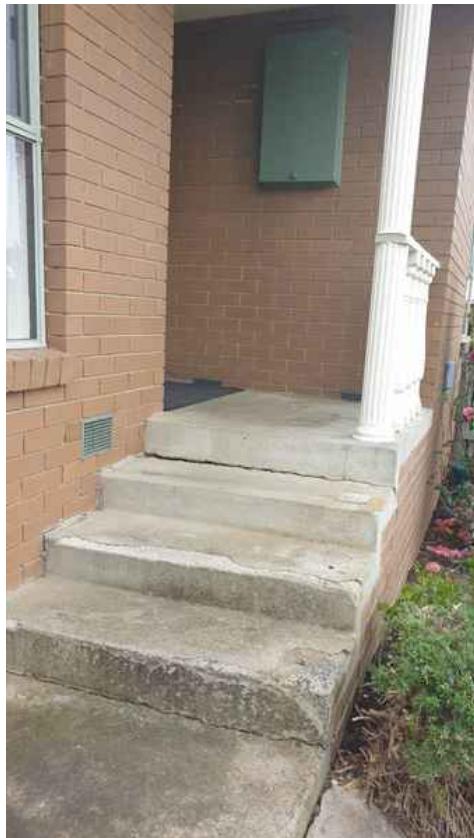
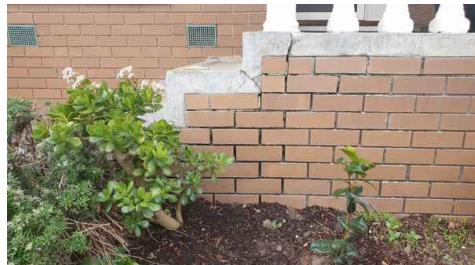
MISSING HANDRAIL AND BALUSTRADE

A handrail and balustrade is missing from the front steps.

The landing height is less than 1 metre from ground level, and although not necessarily a defect, a handrail along a stair is recommended to prevent falls.

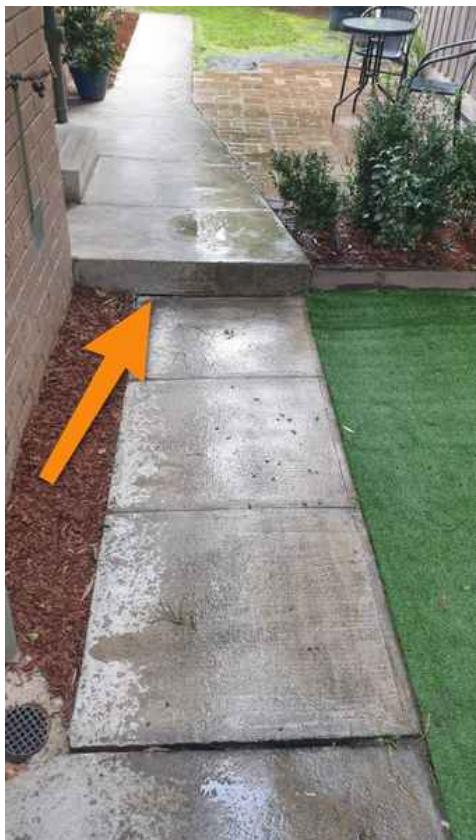
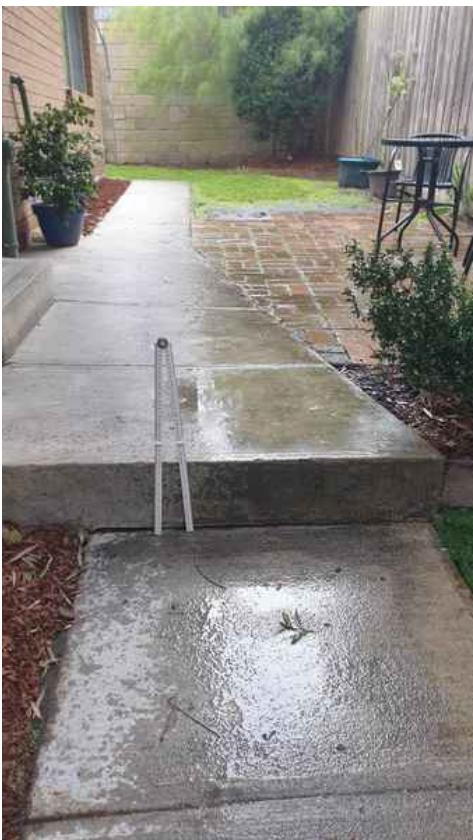
Rear Eastern Path

POSSIBLE TRIP HAZARD (STEP >190MM)

- MINOR DEFECT

A possible trip hazard exists at the step in the path at the rear of the dwelling. A step greater than 190mm is located in the paving and is a potential trip hazard. I recommend installing a ramp in lieu of the step to prevent the tripping hazard..

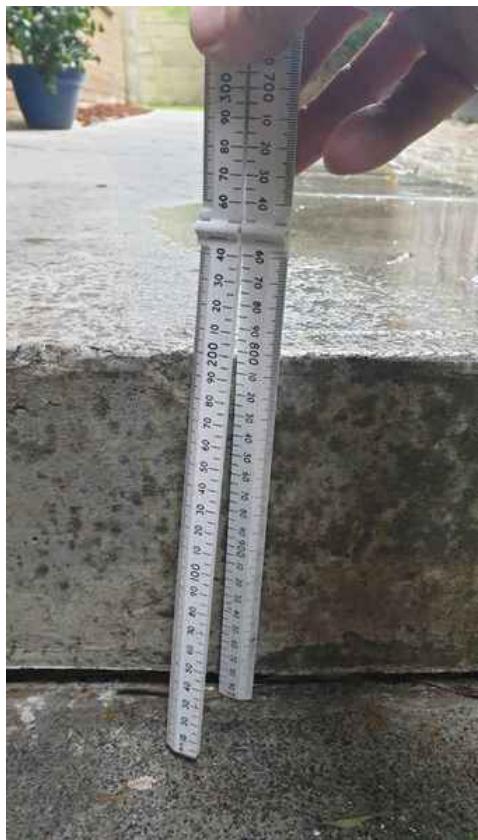
3.8.2 Steps

Rear Eastern Path, Step Greater than 190mm is a trip hazard.

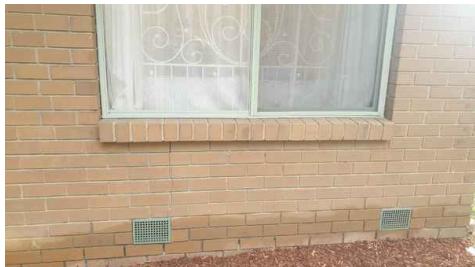
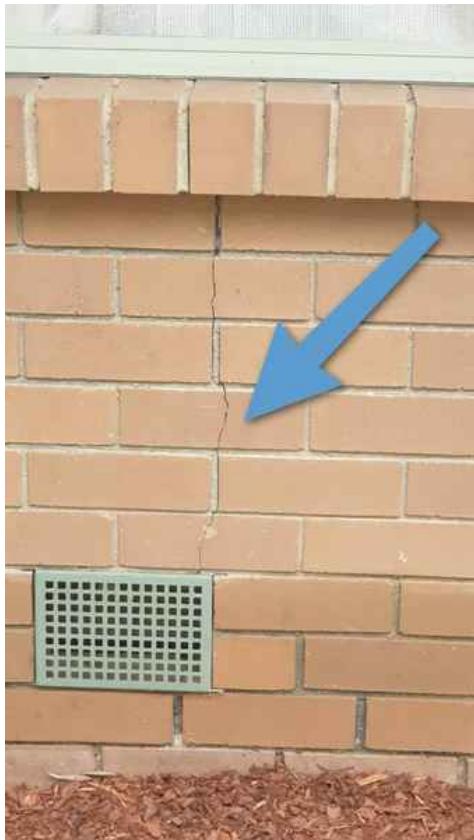
North East Bedroom

MAINTENANCE ITEM / GENERAL ADVICE

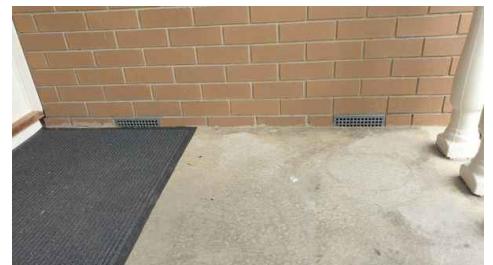
Front Entry Landing

The subfloor vents of the brickwork are fully covered one or more locations which inhibits subfloor ventilation. Covering or partially covering the vents **does not allow the subfloor to ventilate and expel moisture** from within the subfloor structure, furthermore the damp coarse may have been bridged allowing for moisture to draw up the wall. Covering subfloor vents also **invites termites** and other unwanted insect or organisms to enter the subfloor and wall cavity.

Recommendations:- Increase Subfloor Ventilation / Add extra Subfloor Vents to provide adequate ventilation and allow for proper function.

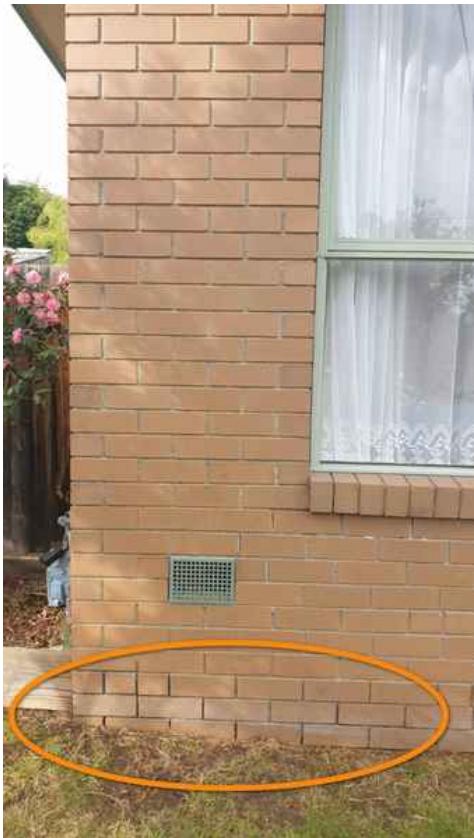
Front North West

MORTAR DETERIORATION AND DAMP (DAMP COURSE)**MINOR DEFECT**

One or more areas of the mortar show signs of deterioration in the damp course area.

A common reason for this to occur is due to a change to the conditions at the base of the wall that put increased pressure on what was always a deficient dpc (e.g mortar dpc with inadequate waterproofer compound mixed into it) which leads to the building developing a dampness problem.

In this case the dampness and mortar deterioration appears to be localised to the damp course area only. I recommend engaging a damp course professional for further advice and repairs.

Contact a qualified professional.

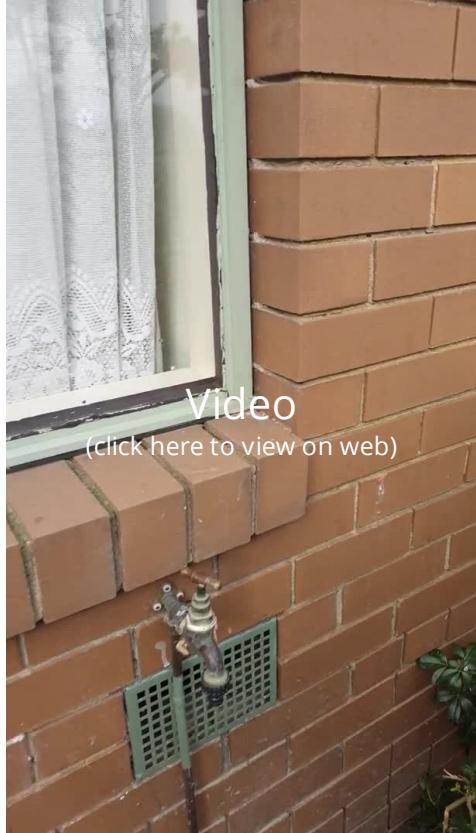
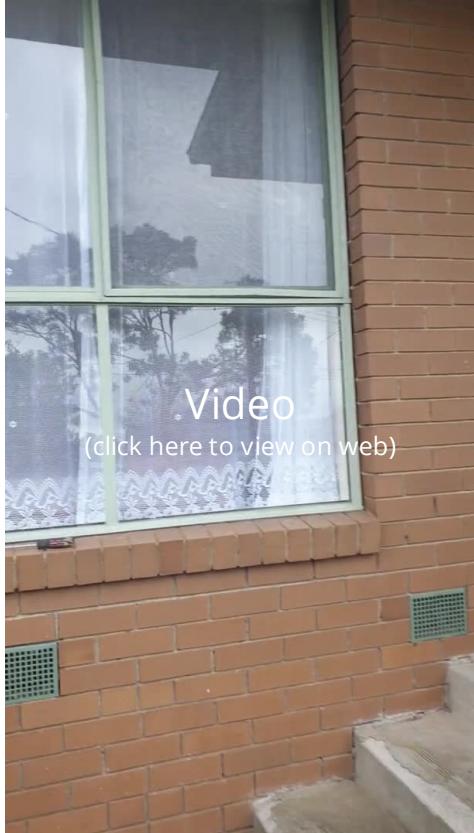
4.3.4 External Cladding **LOOSE SILL BRICKS**

Loose sill bricks were observed in one or more locations.

I recommend engaging a qualified brick layer to repair as required.

Contact a qualified masonry professional.

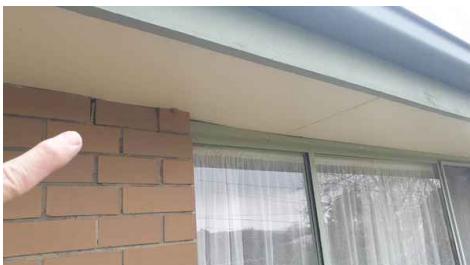
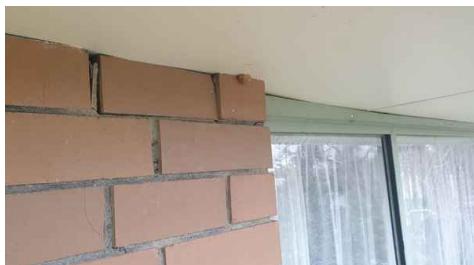
Living Room Window (Front, West)

LOOSE BRICKS (MINOR, COMMON TOP COURSE AT EAVES)

One or more loose bricks were observed at the top of the brickwork under the eaves linings.
This is a common defect.

I recommend engaging a qualified brick layer to repair as required.

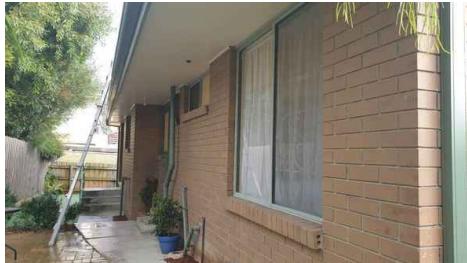
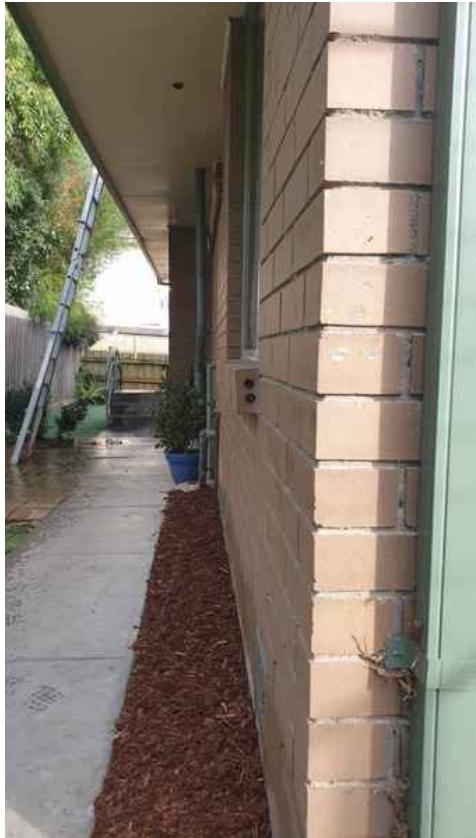
East Bedroom Window Sill

A flat brick sill was observed at the rear bedroom window. This window faces East and is covered by an eaves overhang so is unlikely to cause a major problem.

I recommend to monitor in heavy rains and engage a qualified bricklayer if water is observed entering the brick cavity.

Recommend monitoring.

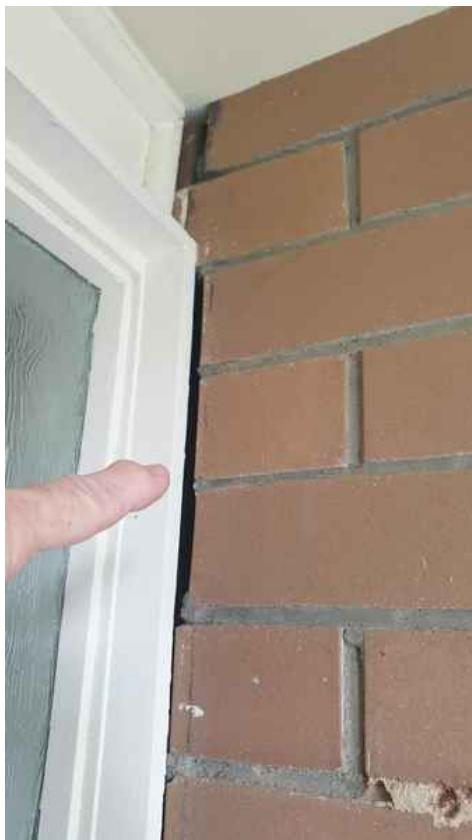
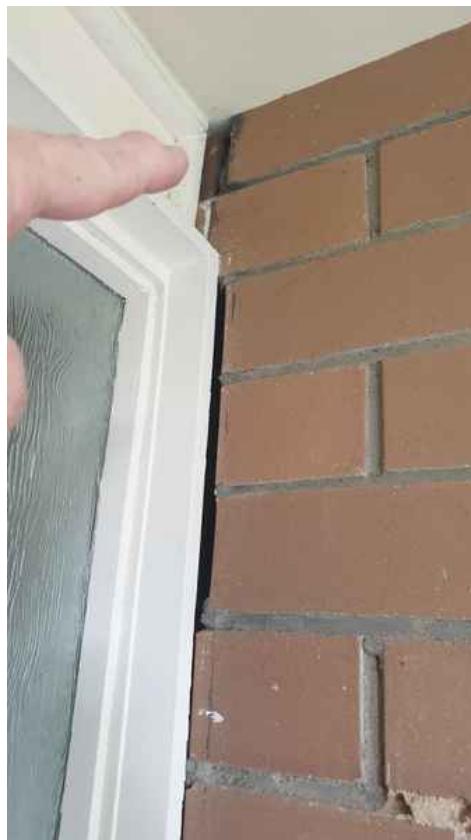
Front Entry Area

Some gaps were observed in the brickwork in one or more locations.

I recommend contacting a qualified bricklayer to rectify.

Contact a qualified masonry professional.

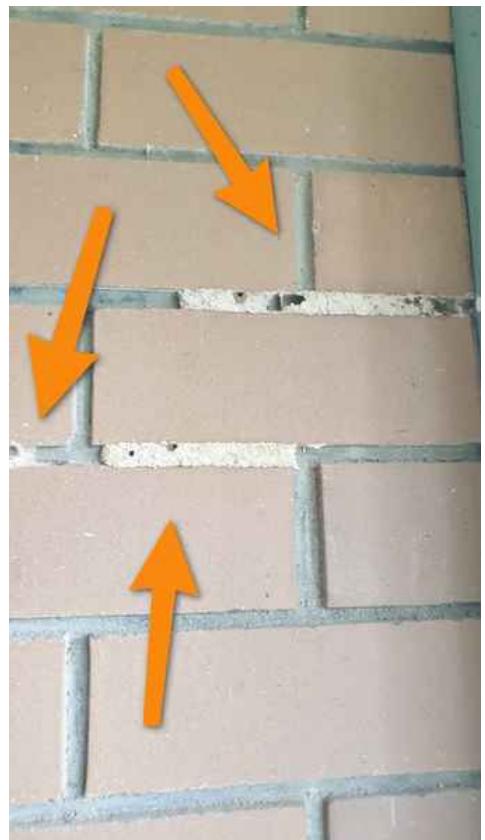
Front Entry Area, Unidentified Nest

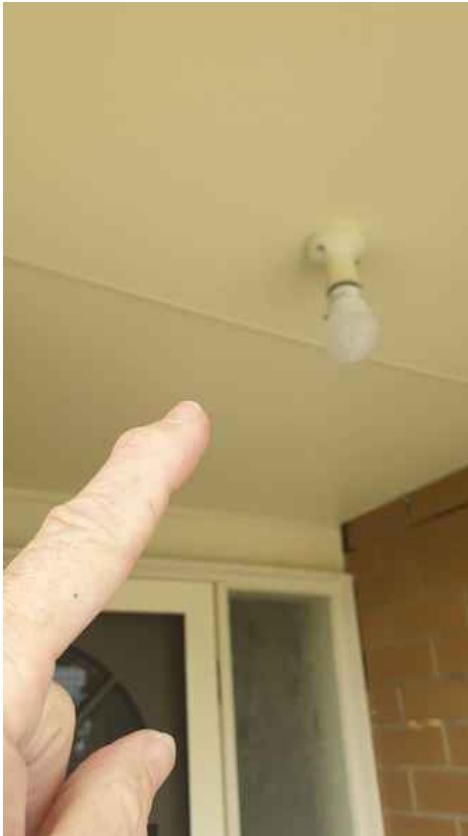
Front Entry

One or more sections of the eaves have moved / settled and are slightly damaged, this is most likely as a result of seasonal movement and the use of unseasoned hardwood framing materials.

This is a common defect in a dwelling of this age, with this construction method of unseasoned hardwood framing.

This is difficult to repair and is presently only a cosmetic defect.

It must be noted however, the eaves linings may be made of an Asbestos containing material and I highly recommend testing the material before any works are undertaken in regards to the eaves linings.

I recommend to monitor and if the damage increases, contact a qualified engineer and carpenter for repairs.

Contact a qualified carpenter.

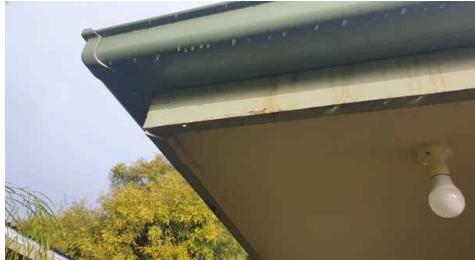
North East

PAINT/FINISH FAILING

The paint or finish is failing. This can lead to deterioration and rot of the material.

Recommend that the areas be properly prepared and painted / finished.

Contact a qualified painting contractor.

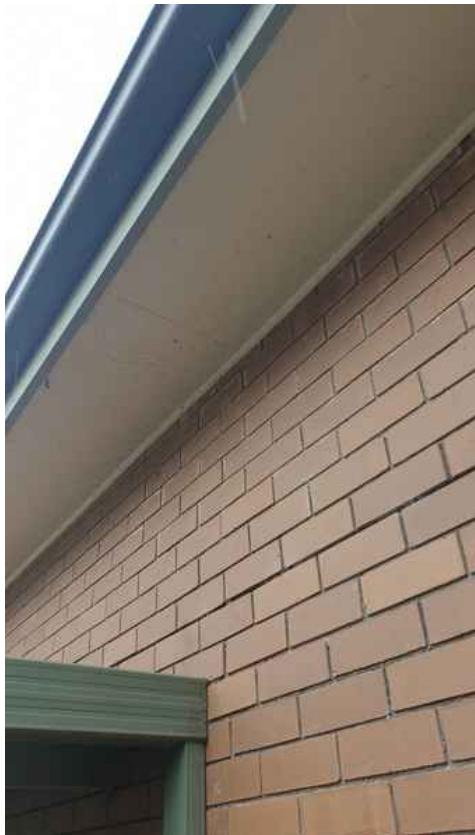
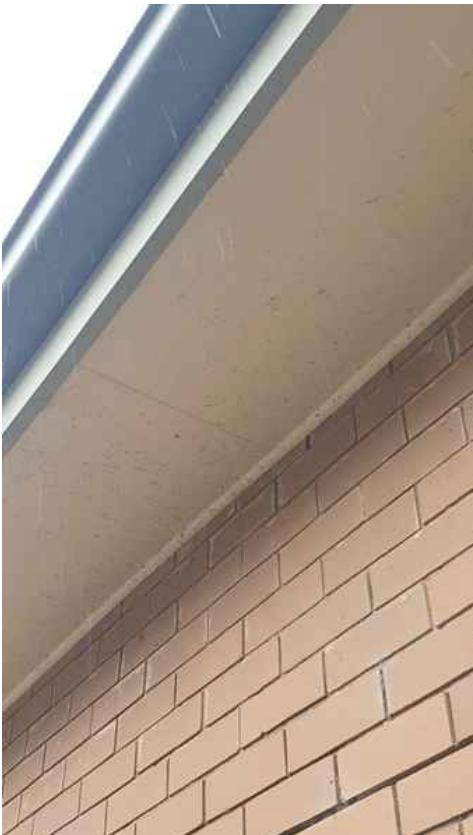
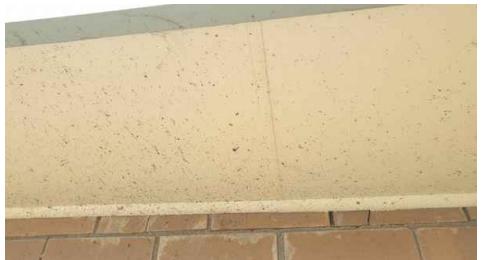
Eaves lining above carport area

EAVES STAINS

A section of the eaves linings above the carport area has splatters / marks or staining of which I was unable to determine the cause!

It appears that some minor brickwork repairs may have been carried out in this area, but that doesn't explain the eaves splatters or marks. They may have occurred as a result of cleaning down the carport roof, however, I can't say with any certainty how or why this has occurred. The marks / splatters or staining appear to be cosmetic.

I recommend to clean down this area, repaint and monitor. If the staining continues contact a qualified person to investigate.

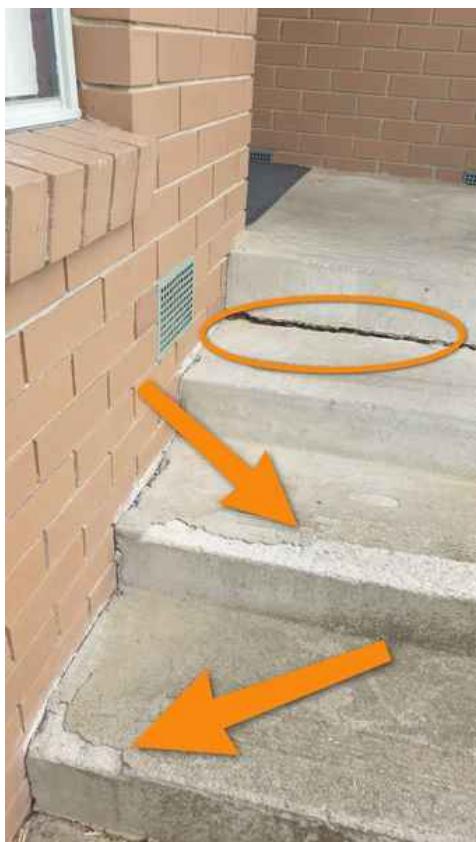
4.7.1 Steps

STAIRS - SPALLING

Spalling and Cracking of Concrete Steps
at Entry Porch

Contact a qualified concrete contractor.

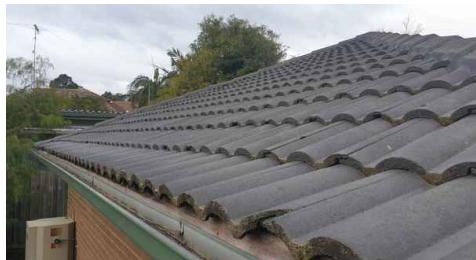
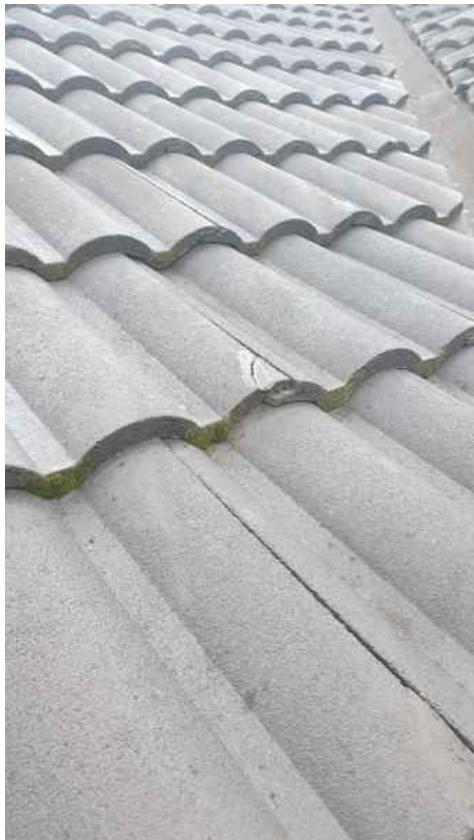
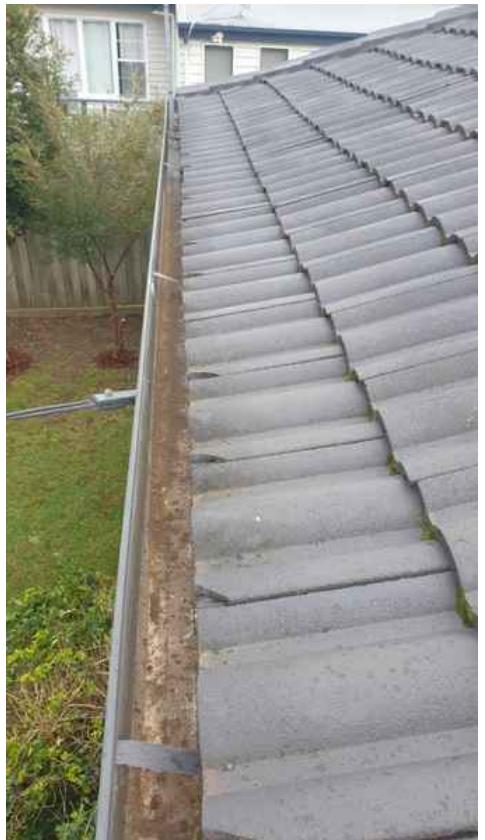
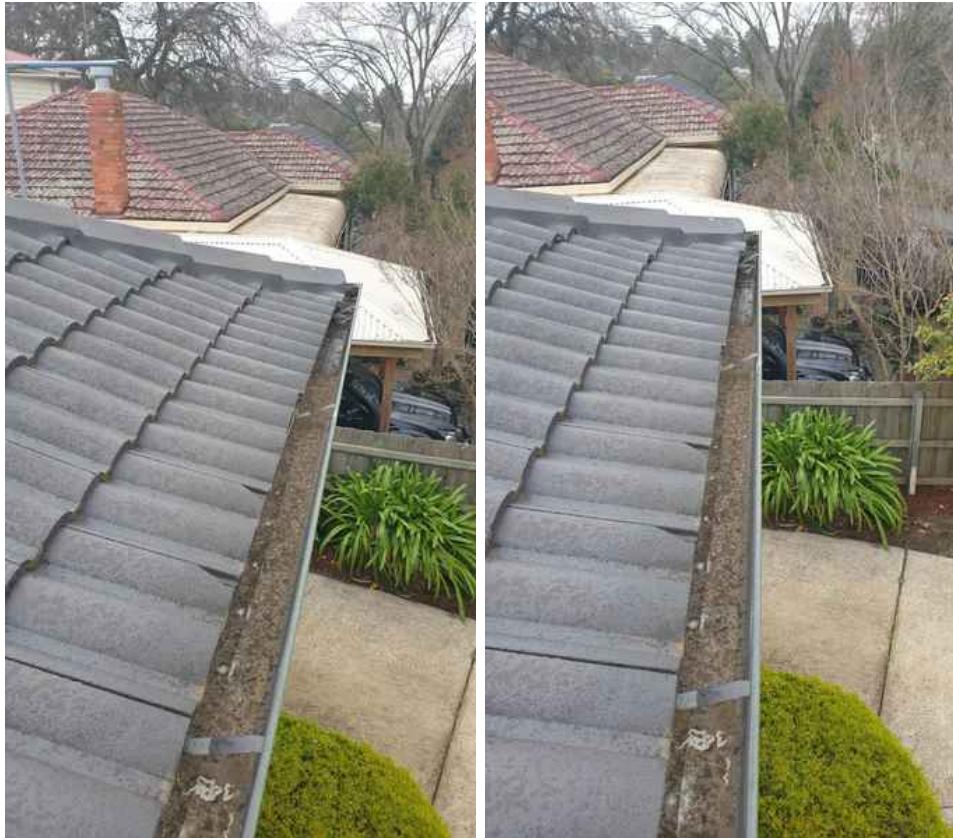
CRACKED / CHIPPED / BROKEN TILES

Some roof tiles were found to be cracked / broken tiles in one or more locations. This is typical of both concrete and terracotta roof tiles, but requires immediate action to be taken by the home owner.

See photographs for locations. Note these photographs are representative photographs and not all broken or defective tiles may be shown. Engage a roof tiler to repair.

Recommend: a qualified roof contractor replace cracked or broken roof tiles to prevent water damage to the roof and ceiling structure. Water leaks can cause rot, decay, mould, health issues and lead to structural failures.

Contact a qualified roofing professional.

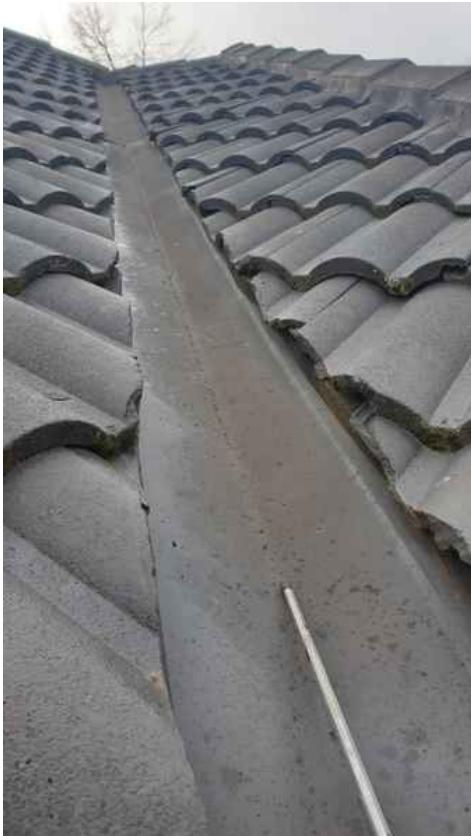
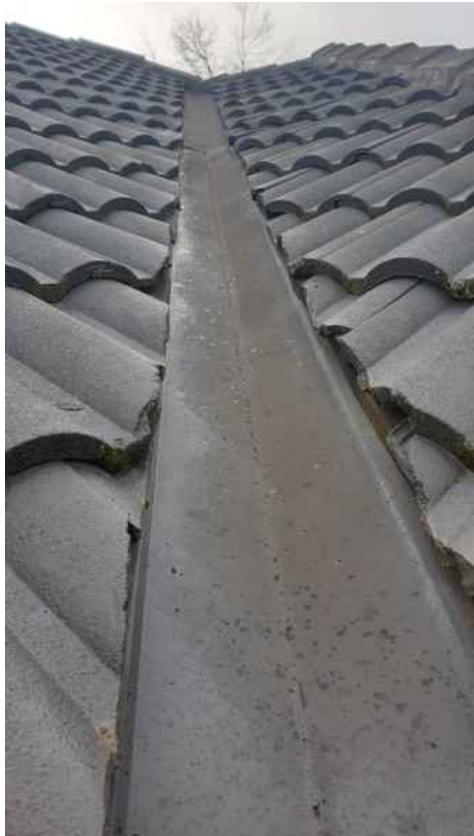
5.2.2 Roof Coverings

METAL ROOF - RUST (MINOR)

Surface Rust
