TOPNOTCH BUILDING INSPECTIONS

PRE-PURCHASE RESIDENTIAL

1234 Main St. Preston Victoria 3072

06/08/2020 9:00AM

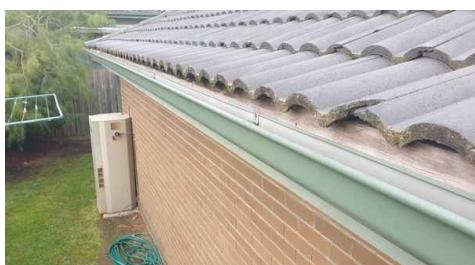
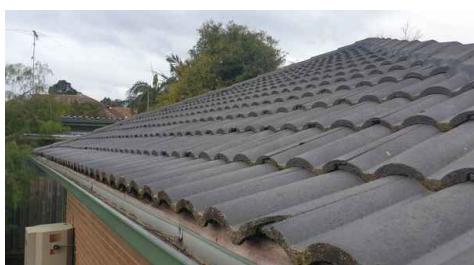
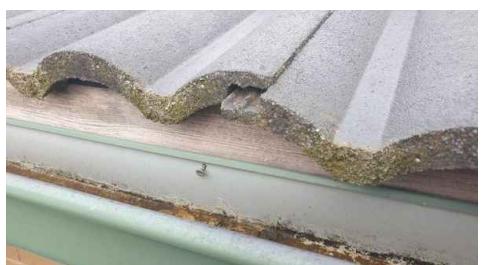
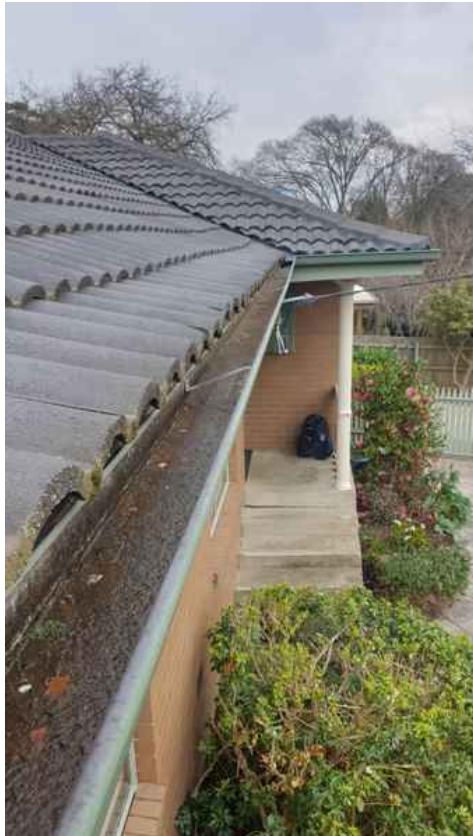
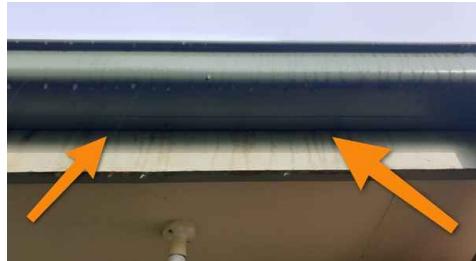
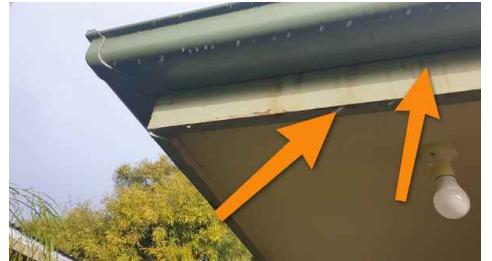
GUTTER LOOSE

The gutter(s) is loose and needs to be re-fastened to fascia and pitched properly.

Water leaking behind fascia

Contact a qualified plumbing contractor.

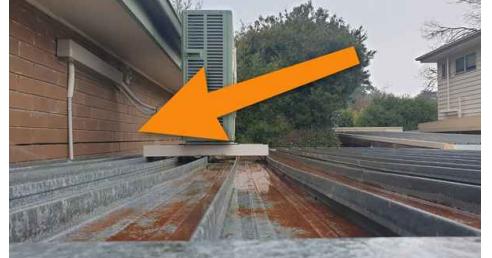
MISSING

Flashings were missing at time of inspection.

Missing flashing

Recommend a qualified roofing contractor evaluate and remedy.

Contact a qualified roofing professional.

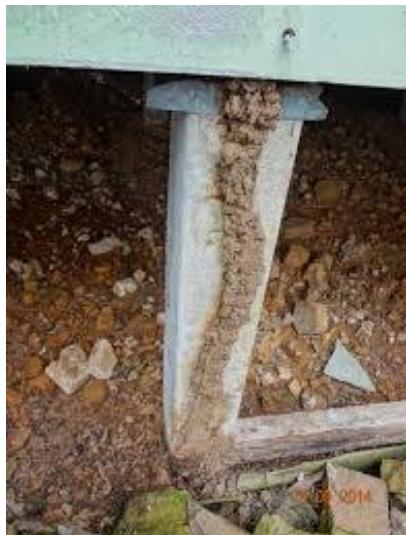
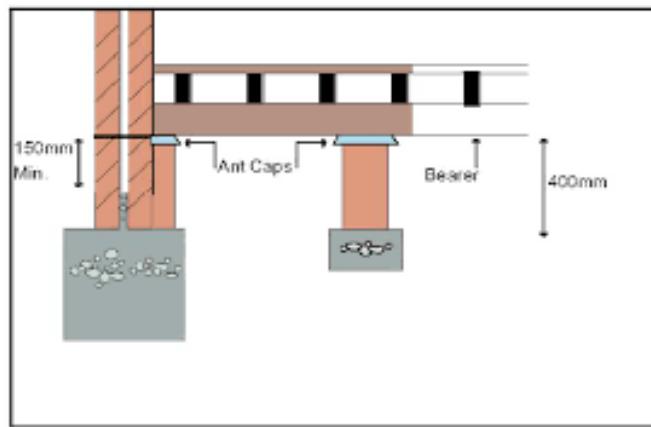
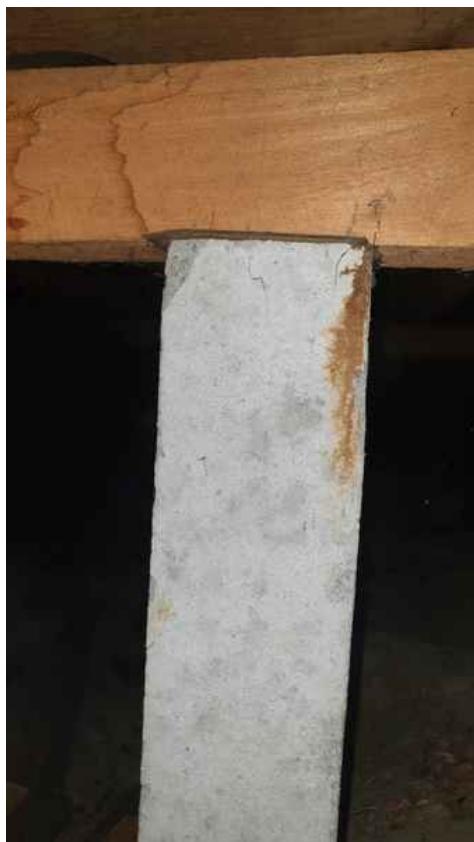
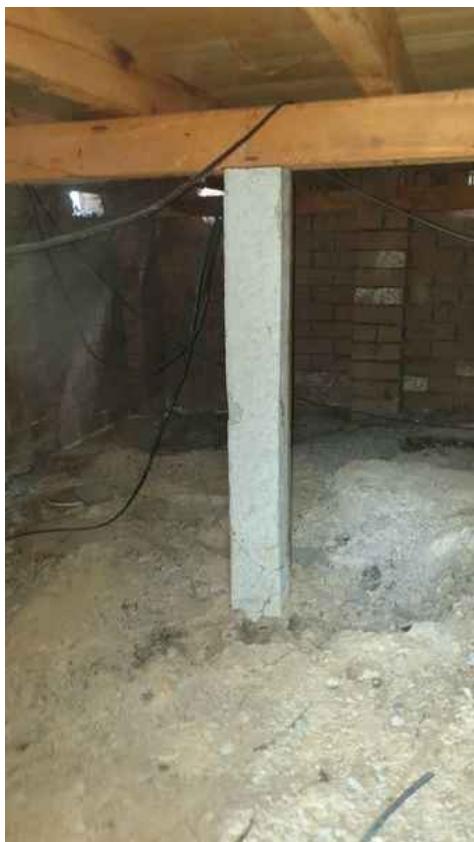
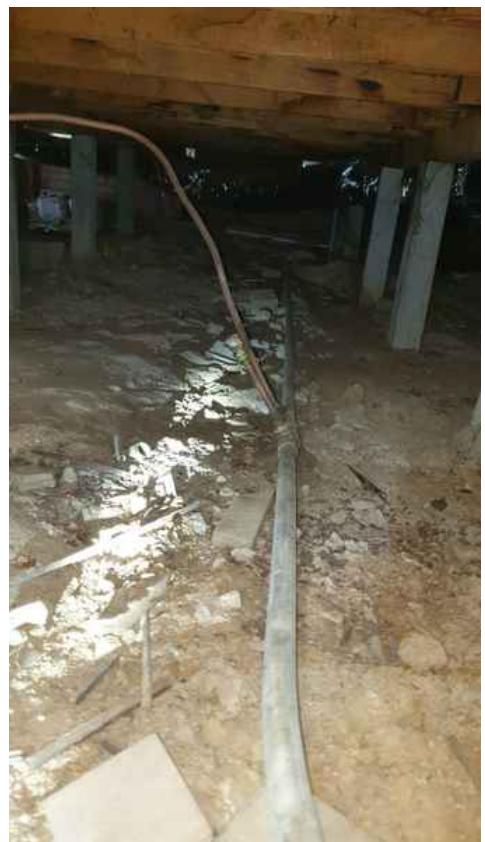
ANT CAPS MISSING

Recommend installing ant caps to all stumps of the dwelling.

Recommendation
Contact a qualified professional.

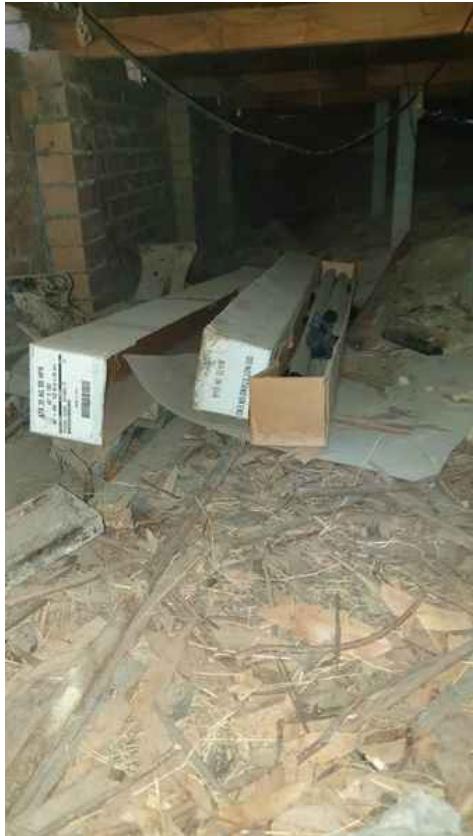
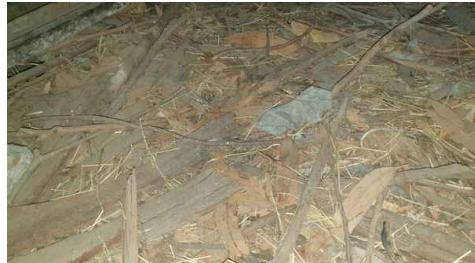
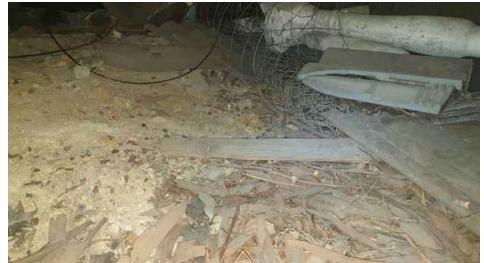
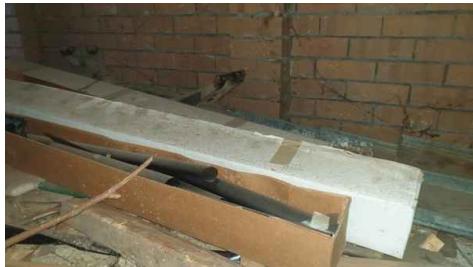
MINOR DEFECT

Large amounts of debris and foreign matter were found at the entrance area of the subfloor.

I recommend removing all foreign matter and debris from the subfloor area.

Contact a handyman or DIY project

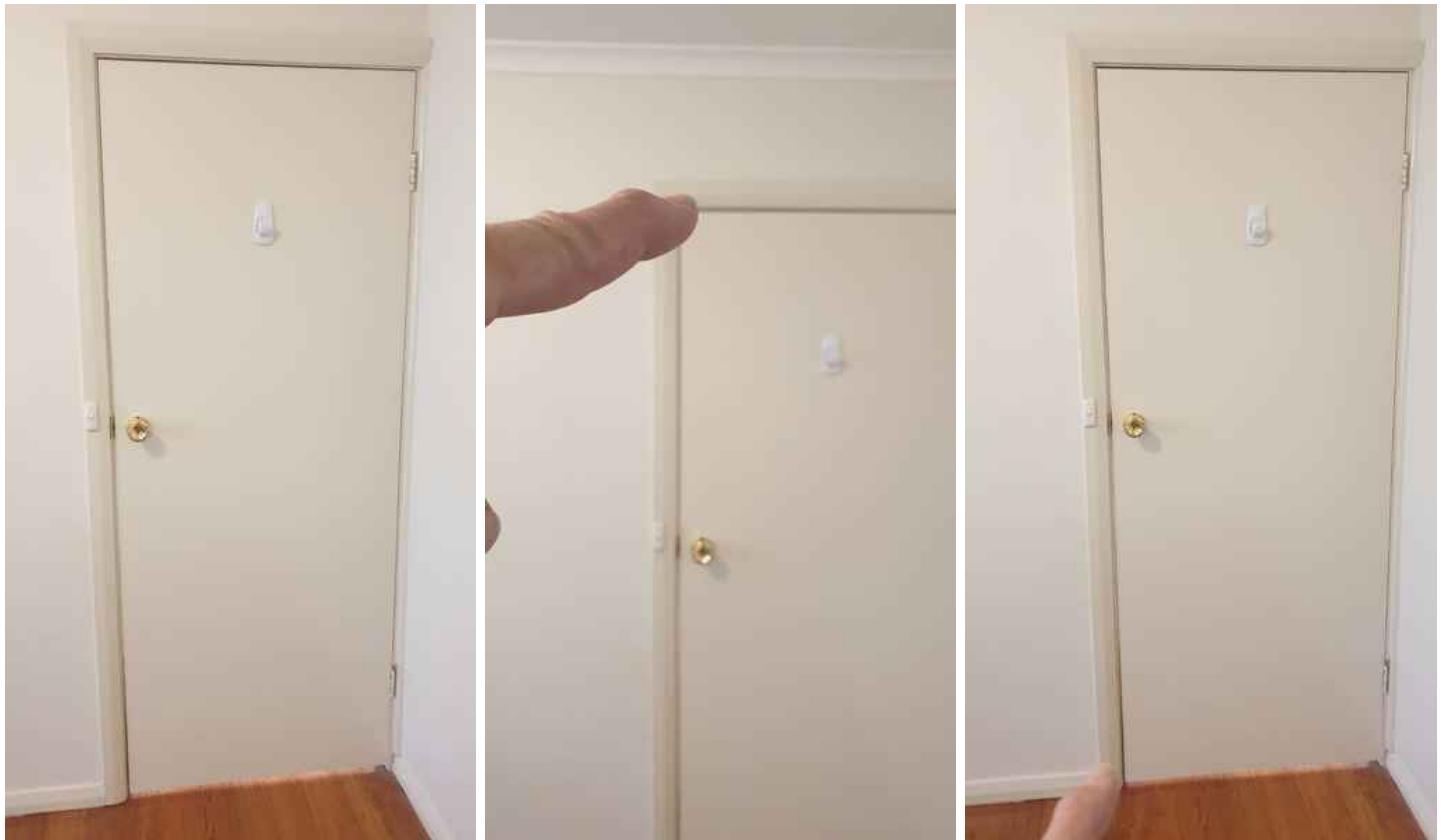
The door margins around the bathroom door are inconsistent, this is likely due to settlement / movement of the sub-floor structure.

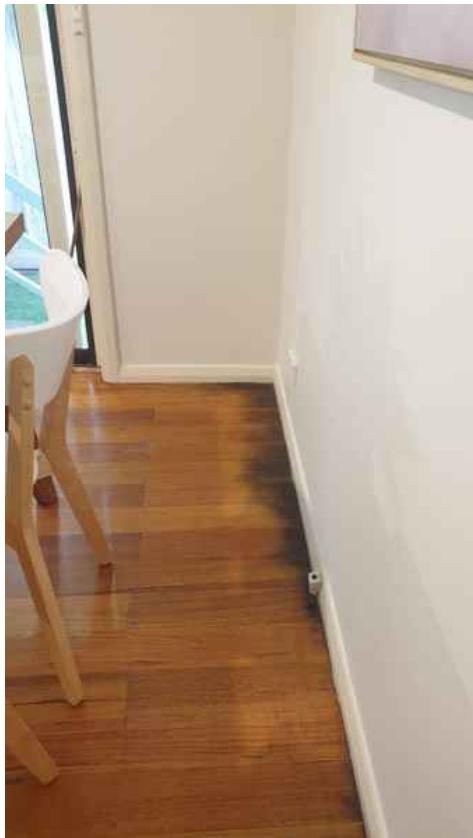
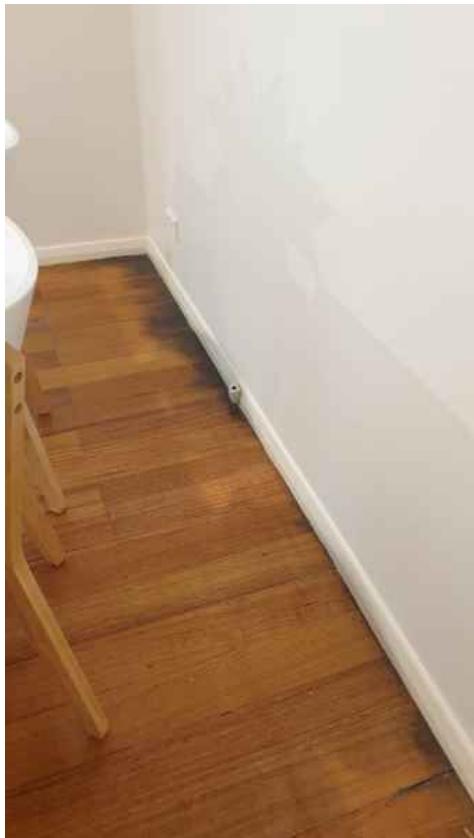
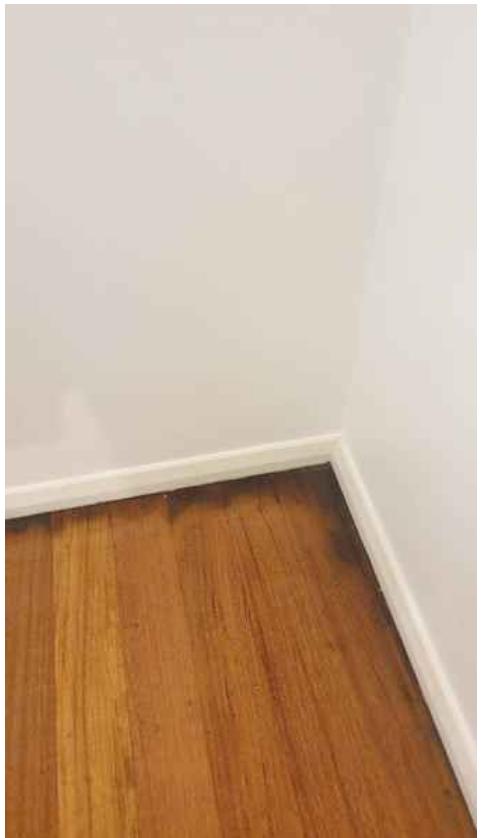
16.5.1 Floors

Meals, Floor Stains

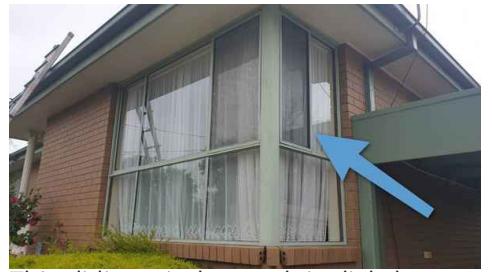
17.2.1 Windows

This sliding window sash is slightly difficult to open. The window is easily removed from the track.

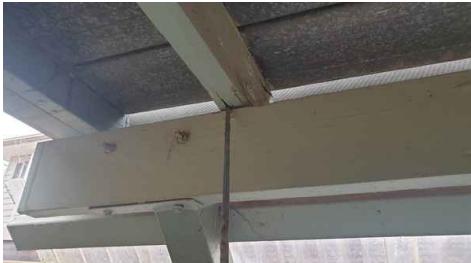
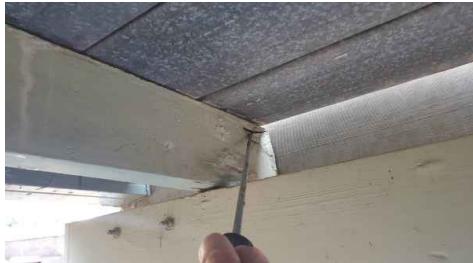
ROT

The carport timber purlin (roof structure) have some rot and decay on their ends.

I recommend engaging a qualified carpenter to laminate a new purlin to the damaged purlins for support and remove rotted ends of purlins.

Contact a qualified carpenter.

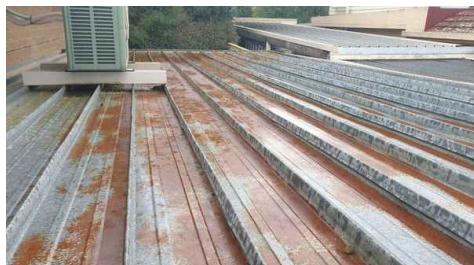
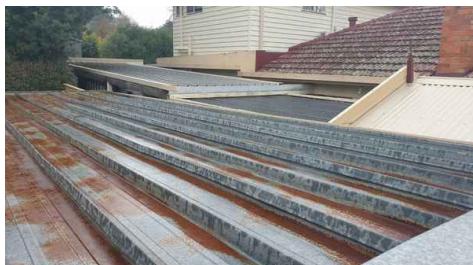
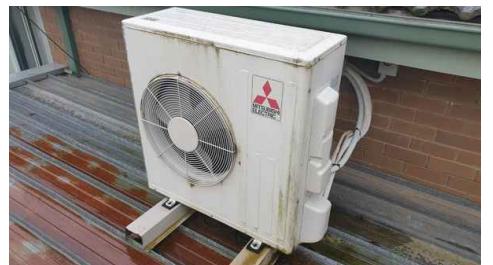
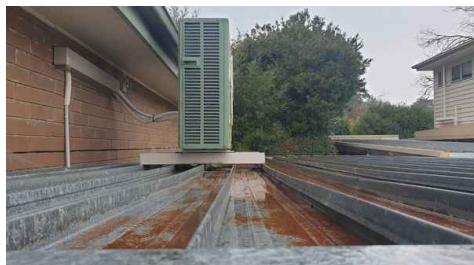
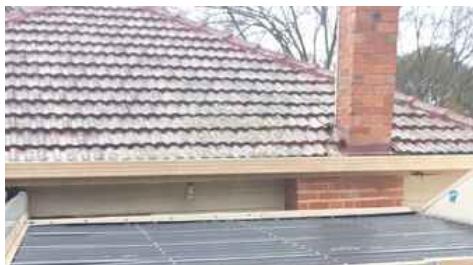
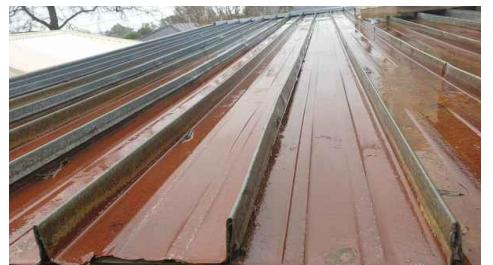
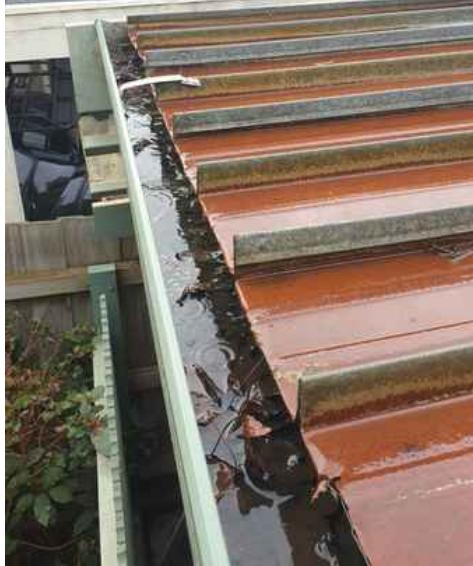
METAL ROOF - RUST (MODERATE)

The metal roof is rusting in some areas and requires repair or replacement.

Recommend: Engage a qualified roofing contractor to repair or replace.

Contact a qualified roofing professional.

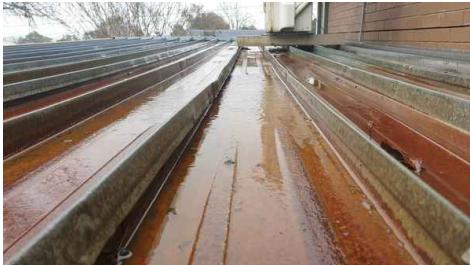
18.3.2 Roof Coverings

PONDING

Observed ponding in one or more areas of the carport roof.

Ponding can lead to accelerated erosion and deterioration.

Recommend a qualified roofing contractor evaluate and repair.

Contact a qualified roofing professional.

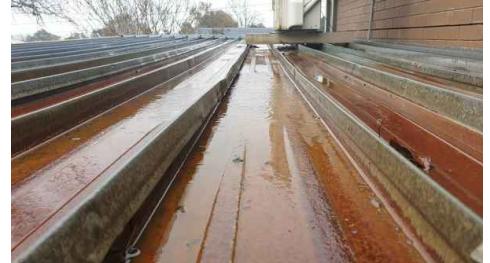
18.4.1 Gutters / Downpipes

GUTTER DEBRIS MAJOR

Recommend cleaning to facilitate water flow and check for adequate fall of guttering.

Contact a qualified roofing professional.

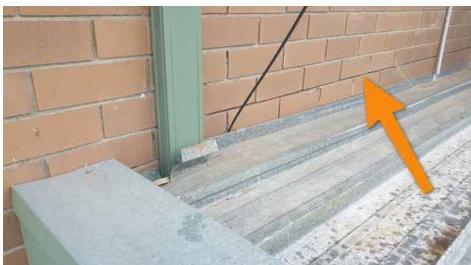
Flashings were missing at time of inspection.

Flashings provide protection against moisture intrusion.

Missing Flashing

Recommend a qualified roofing contractor evaluate and remedy.

Contact a qualified roofing professional.

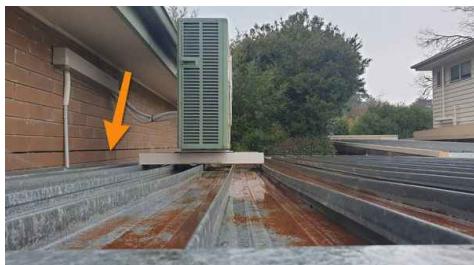
Missing Flashing

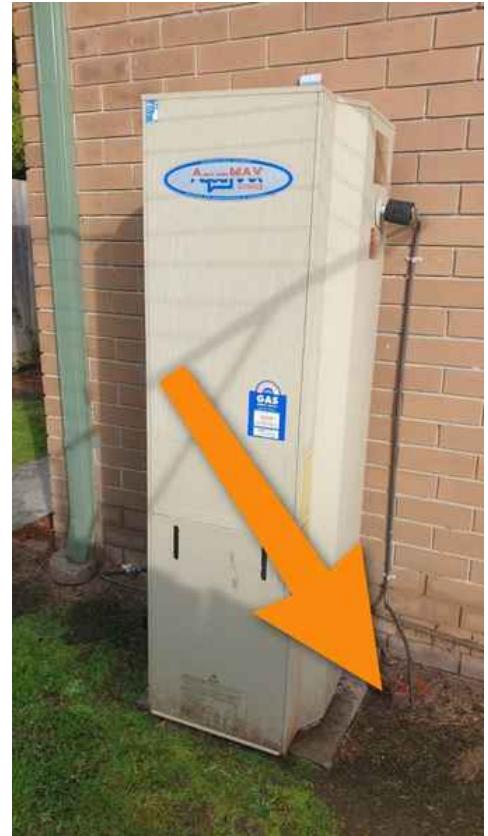
Incorrectly Terminated TPR Valve

Contact a qualified plumbing contractor.

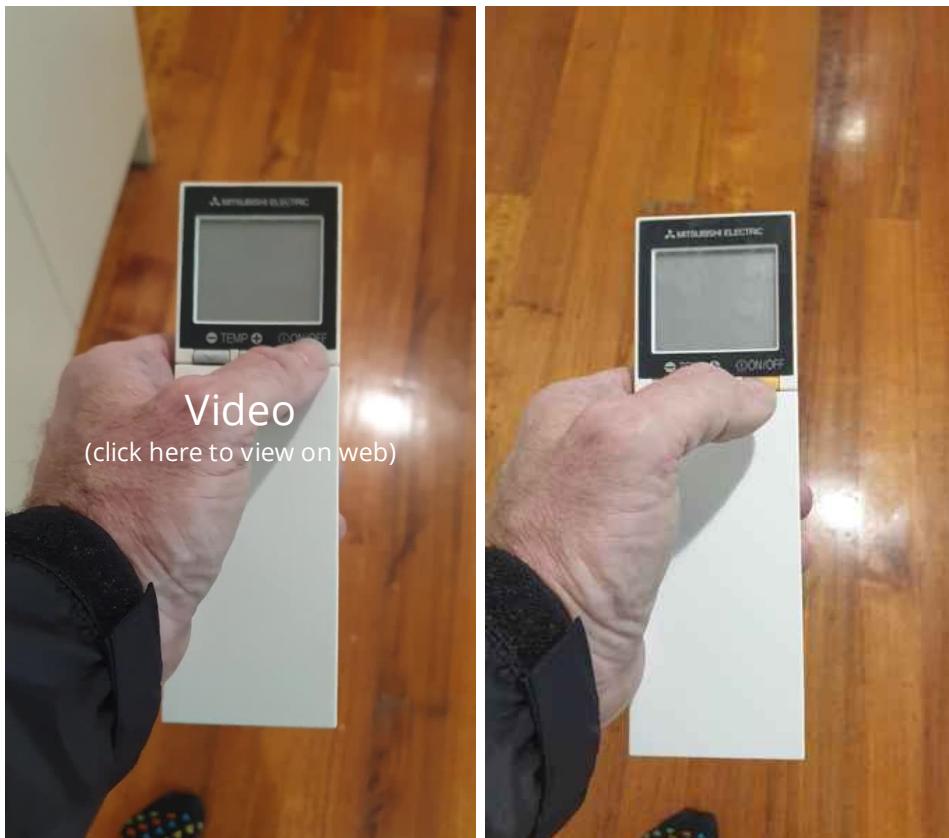
I was unable to operate the Air-Conditioner because the Remote Control was not functioning at the time of the inspection.

This was a limitation to my inspection.
