ROOM-BY-ROOM RESIDENTIAL

1234 Main St. Apex NC 27502

Buyer Name
01/06/2021 9:00AM

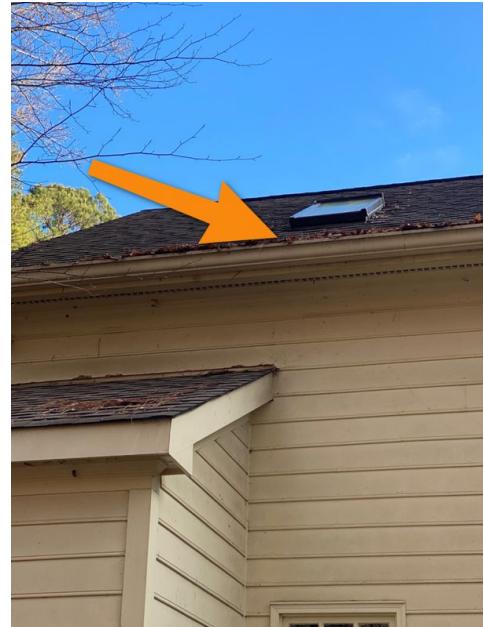
Debris has accumulated in the gutters. Recommend cleaning to facilitate water flow.

Contact a qualified roofing professional.

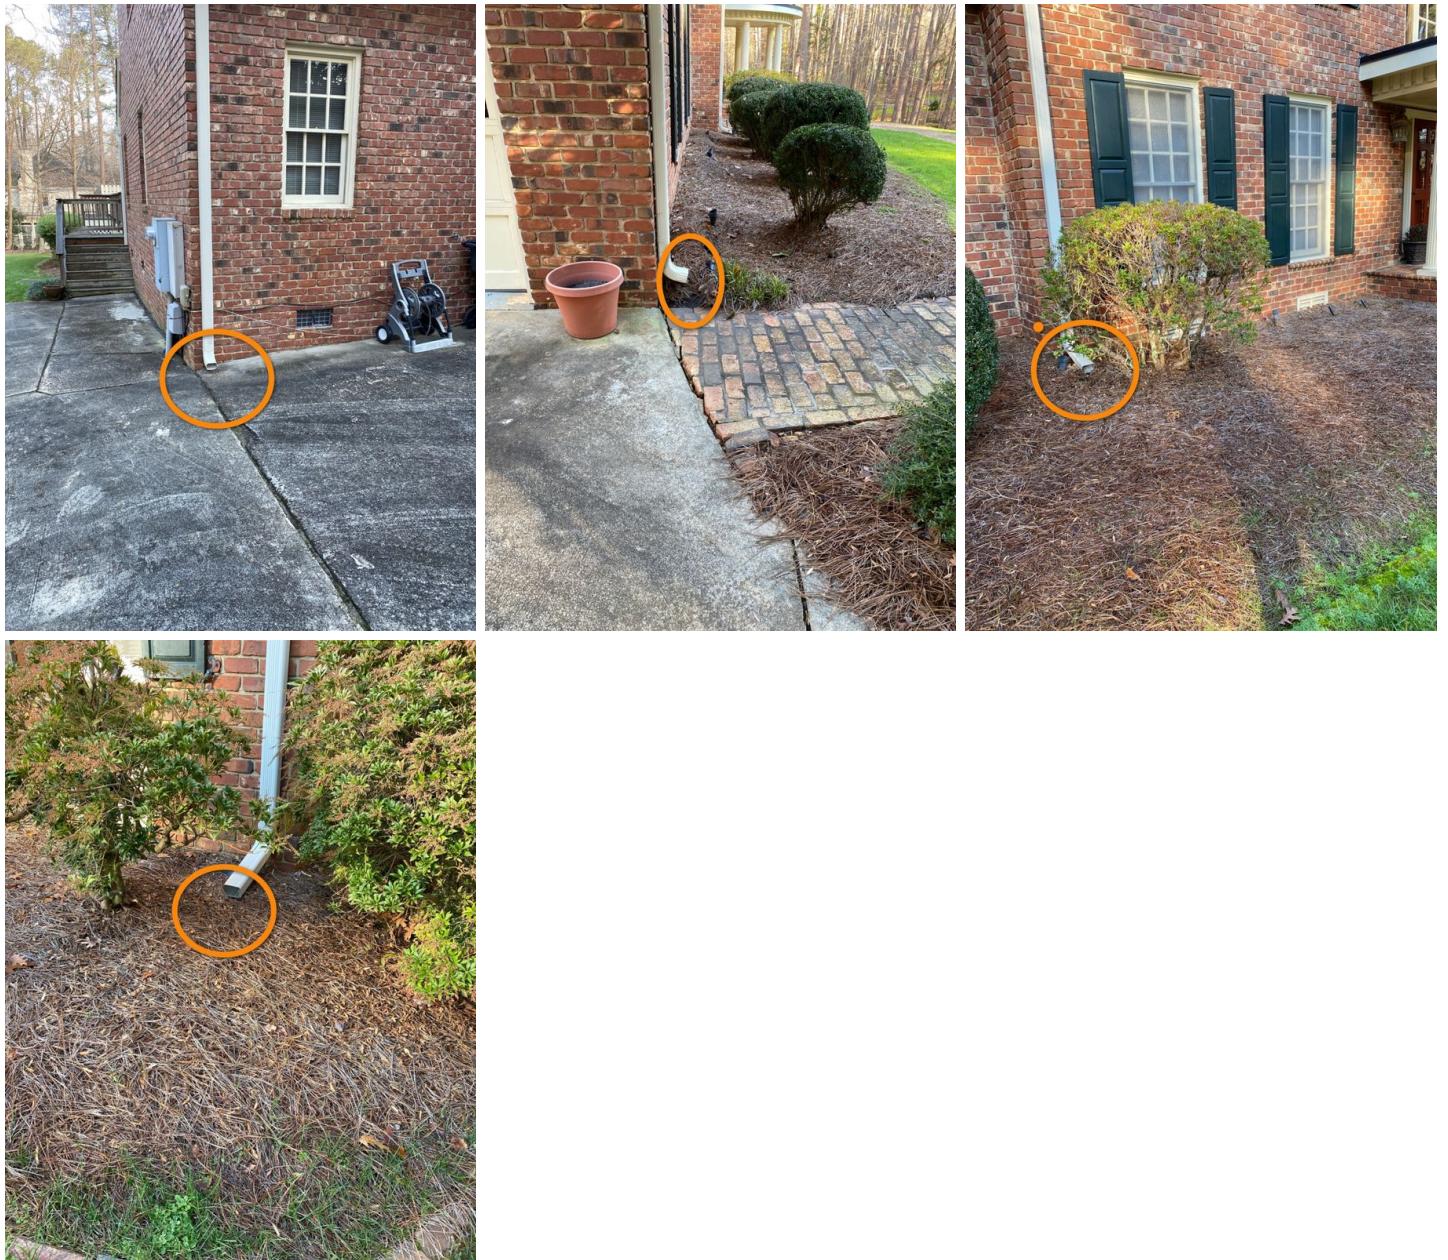
2.2.2 Roof Drainage Systems

MISSING SPLASH GUARDS

At the time of the inspection, it was observed that one or more splash guards were missing. This can lead to water not being directed away from the foundation properly. Recommend a qualified contractor assess and replace as necessary

Contact a qualified professional.

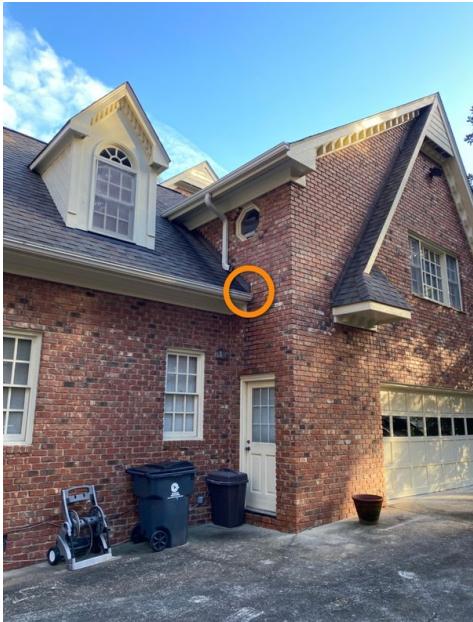
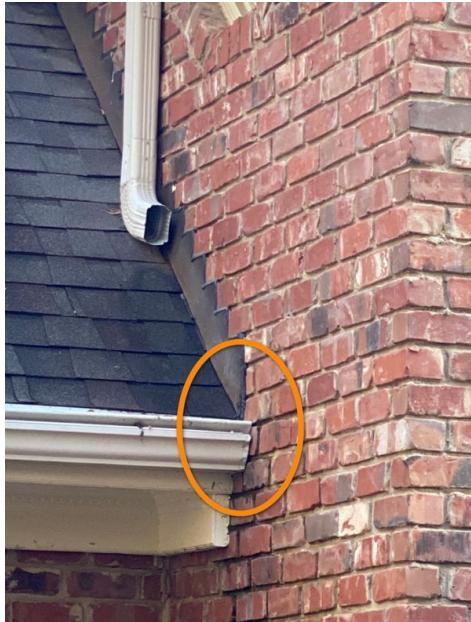
2.3.1 Flashings

KICKOUT FLASHING MISSING

Flashings were missing at time of inspection. Flashings provide protection against moisture intrusion. Recommend a qualified roofing contractor evaluate and remedy.

Contact a qualified roofing professional.

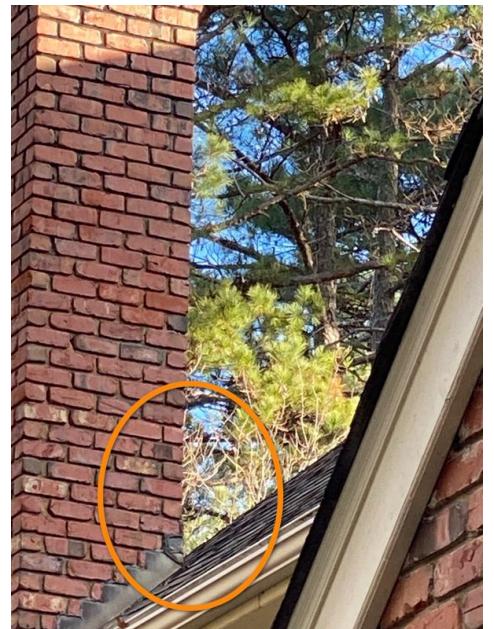
2.4.1 Skylights, Chimneys & Other Roof Penetrations

CHIMNEY CRICKET MISSING

At the time of the inspection, it was observed that the chimney cricket was missing or was not installed. This can lead to moisture penetrating the roof deck by traveling down the brick masonry on the uphill side of the chimney. Recommend a qualified roofing contractor assess and repair as necessary.

Contact a qualified roofing professional.

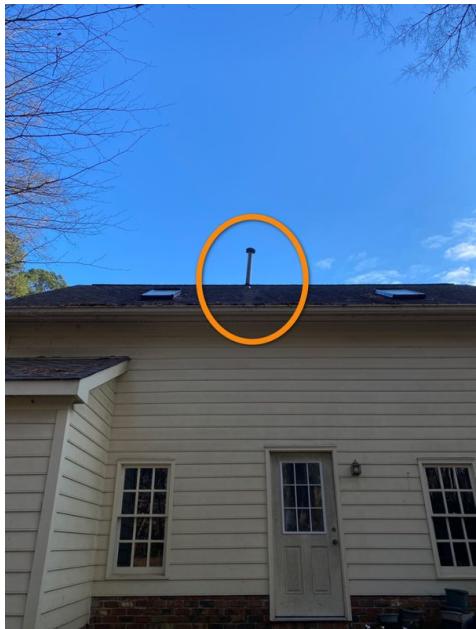
2.4.2 Skylights, Chimneys & Other Roof Penetrations

BENT OR LOOSE FLUE VENT

At the time of the inspection, it was observed that one or more flue vents were not standing vertically. This can lead to improper exhaust ventilation. Recommend a qualified contractor to assess and repair as necessary.

Contact a qualified professional.

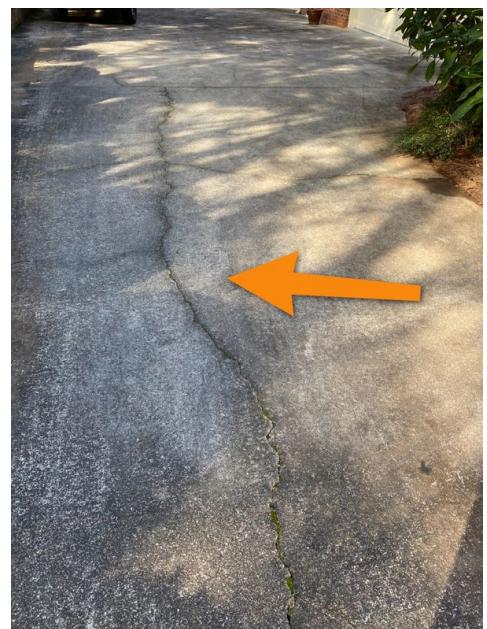
3.4.1 Walkways, Patios & Driveways

DRIVEWAY CRACKING - MINOR

At the time of the inspection, minor cosmetic cracks were observed in the driveway, which may indicate movement in the soil.

Recommend monitoring and/or have a qualified concrete contractor patch/seal.

Contact a qualified concrete contractor.

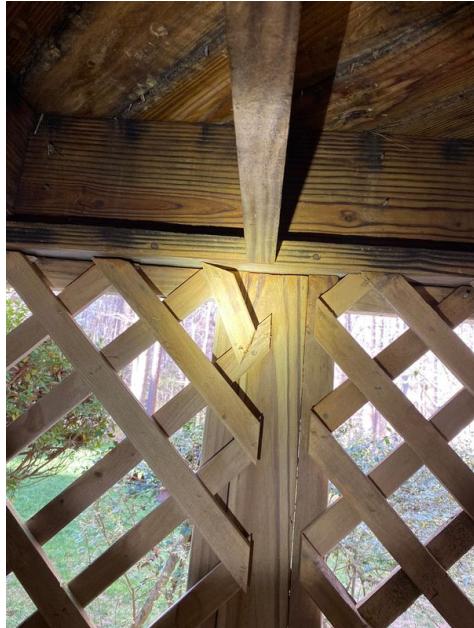
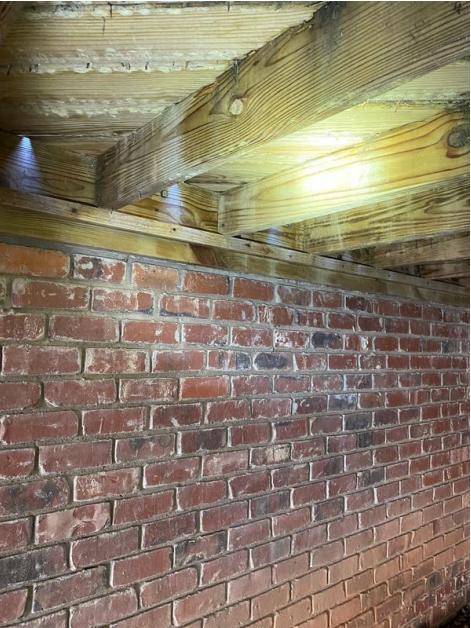
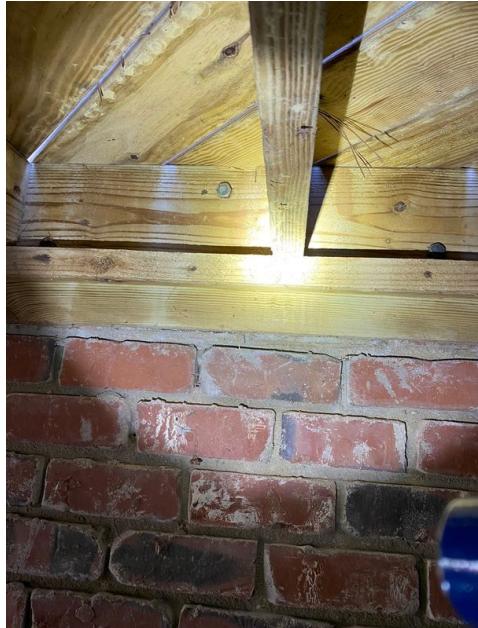
3.5.1 Decks, Balconies, Porches & Steps

IMPROPER NAILING OF THE LEDGER STRIP

Safety Hazard

At the time of the inspection, it was observed that improper nailing practices were used when installing the ledger strip to the ledger board. This can result in insufficient support for the joist beams and deck structure overall. Recommend that a qualified decking contractor assess and repair as necessary.

Contact a qualified professional.

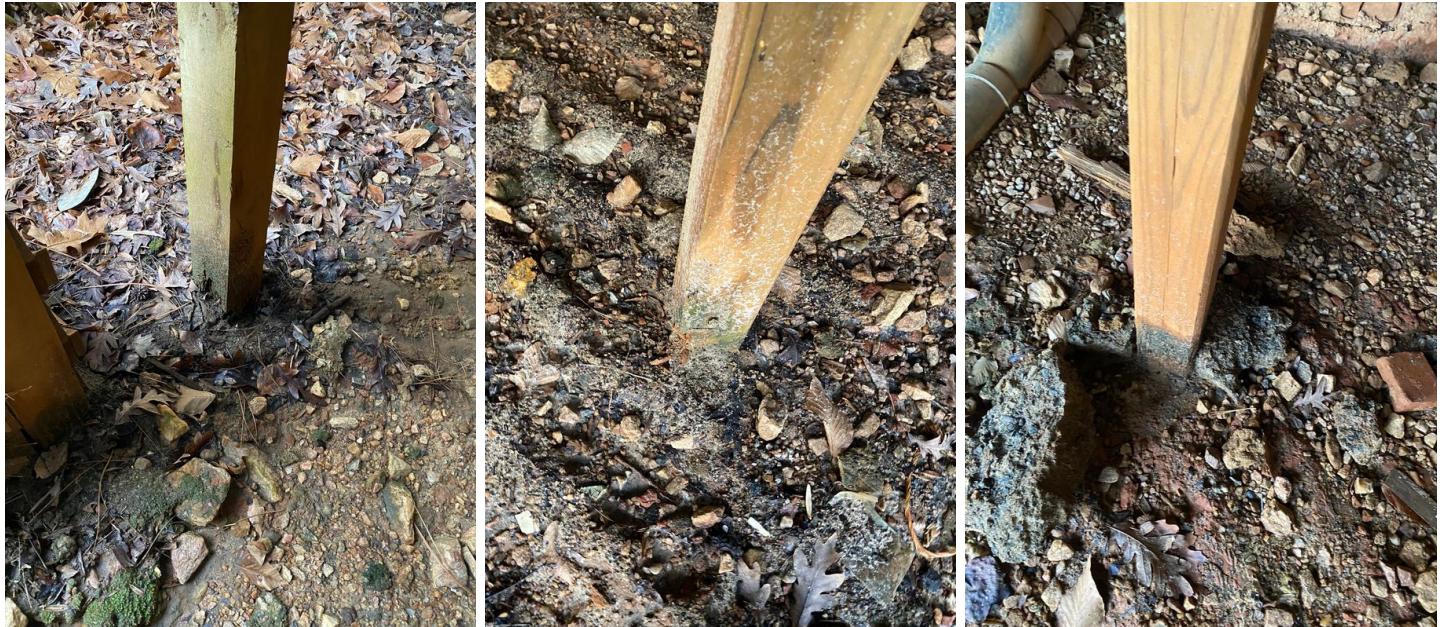
3.5.2 Decks, Balconies, Porches & Steps

DETERIORATING DECK SUPPORT(S)

Safety Hazard

At the time of the inspection, it was observed that one or more deck supports were showing signs of deterioration. This can result in insufficient support for the joist beams and overall structure of the deck. Recommend that a qualified decking contractor assess and repair as necessary.

Contact a qualified professional.

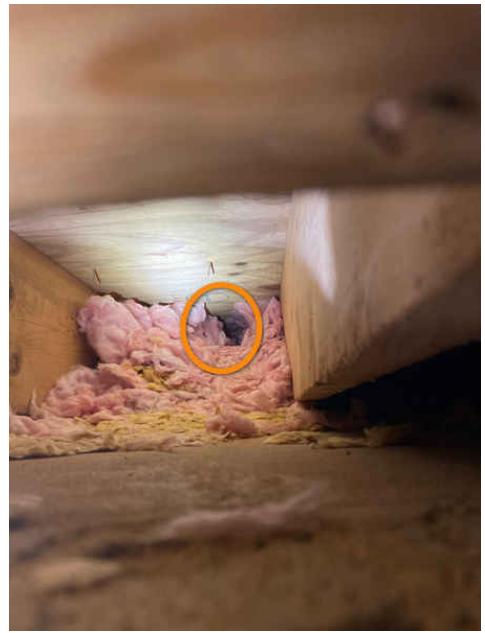
At the time of the inspection, it was observed that animals were present and/or nesting in the crawlspace. Pests can not only cause health related issues but will also destroy components and systems in search of nesting material. Recommend a qualified pest control contractor to assess and remove as necessary.

Squirrel in a Nest

Contact a qualified pest control specialist.

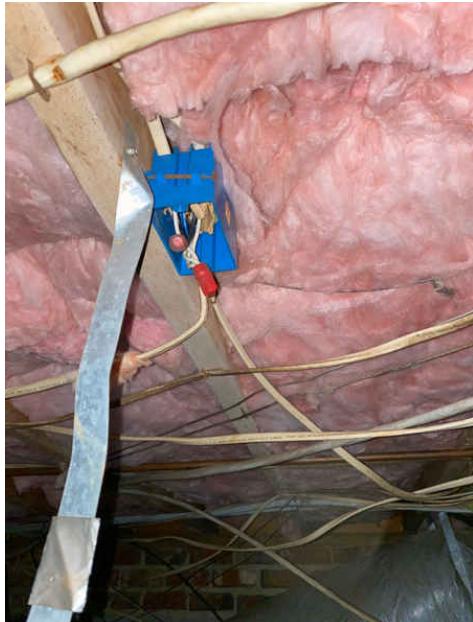
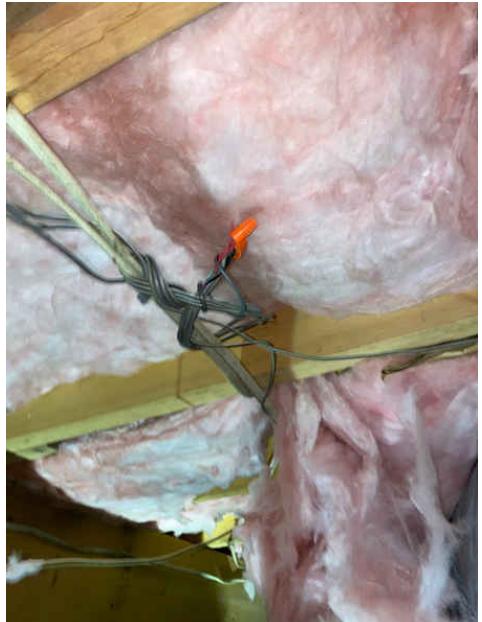
4.1.3 Basements & Crawlspaces

At the time of the inspection, it was observed that there was one or more open junction boxes in the crawlspace. This poses a shocking hazard and can damage the systems these wires serve. Recommend a qualified electrical contractor assess and repair as necessary.

Missing Plate Cover

Missing Junction Box

Contact a qualified professional.

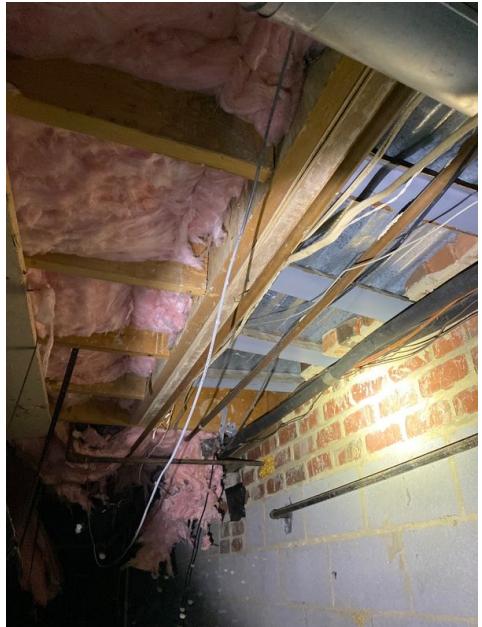
4.3.1 Floor Structure

Safety Hazard

JOISTS NEED REPAIR

At the time of the inspection, it was observed that some sort of repair was made to part of the floor structure. It appeared that floor joist(s) were cut and modified to accommodate the repair. If done incorrectly, the repair may cause damage to the structural integrity of the floor system it supports. Recommend a qualified structural engineer evaluate and advise on how to correct.

Contact a qualified structural engineer.

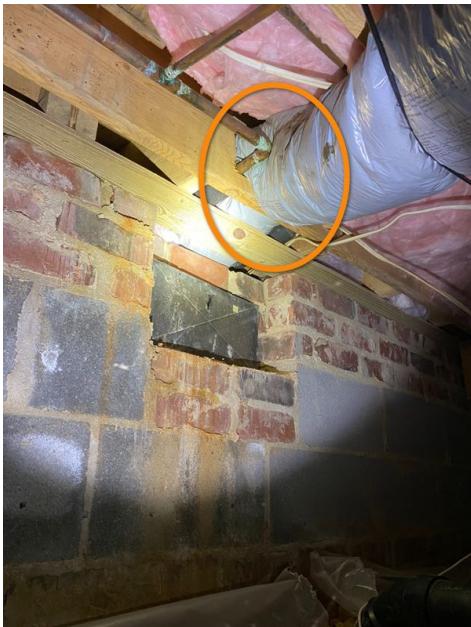
4.3.2 Floor Structure

Safety Hazard

At the time of the inspection, it was observed that one or more joists had been over notched to allow the passage of components of other systems. This can damage the structural integrity of the floor joist(s). Recommend a professional engineer to assess and advise how to correct.

Contact a qualified professional.

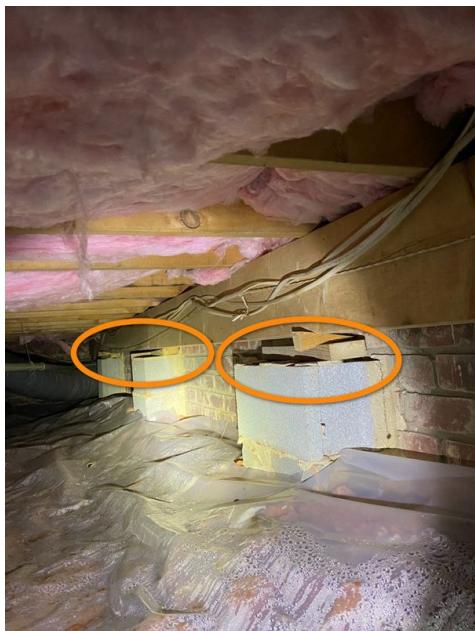
4.3.4 Floor Structure

IMPROPER BUILDING PRACTICES

At the time of the inspection, it was observed that improper building practices may have been used. This beam is not properly supported on the masonry blocks. Recommend a qualified contractor assess and repair as necessary.

Contact a qualified professional.

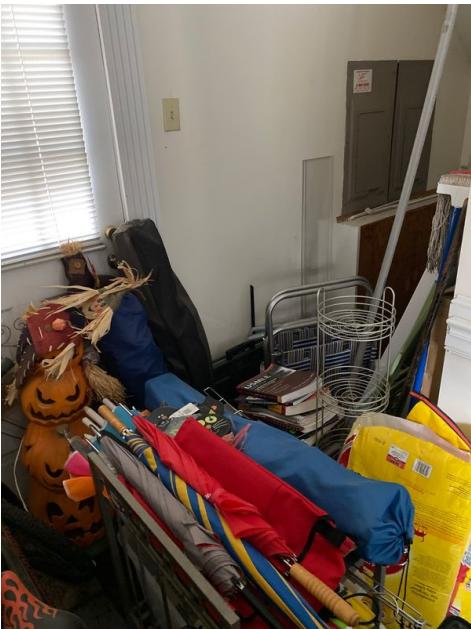
DISTRIBUTION PANEL NOT ACCESSIBLE

At the time of the inspection, access to the distribution panel(s) was obstructed by personal belongings. Recommend a qualified electrical contractor evaluate and repair as necessary.

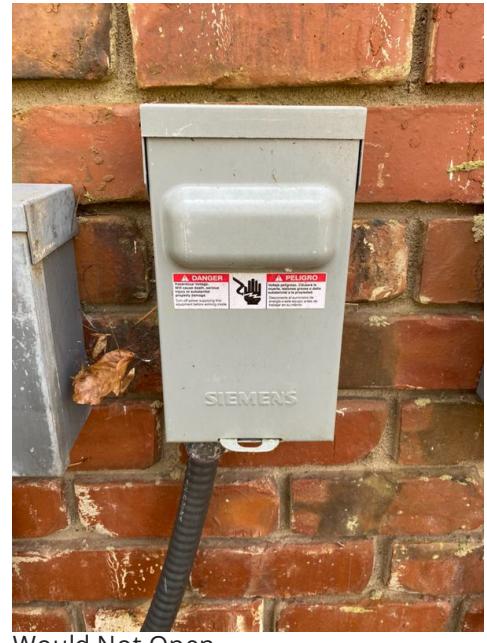
At the time of the inspection, the inspector was unable to open the power shut off panel for one or more units. This poses a safety hazard to anyone working on the unit as the unit could potentially receive power and turn on if the main power shut off can't be accessed.

Contact a qualified professional.

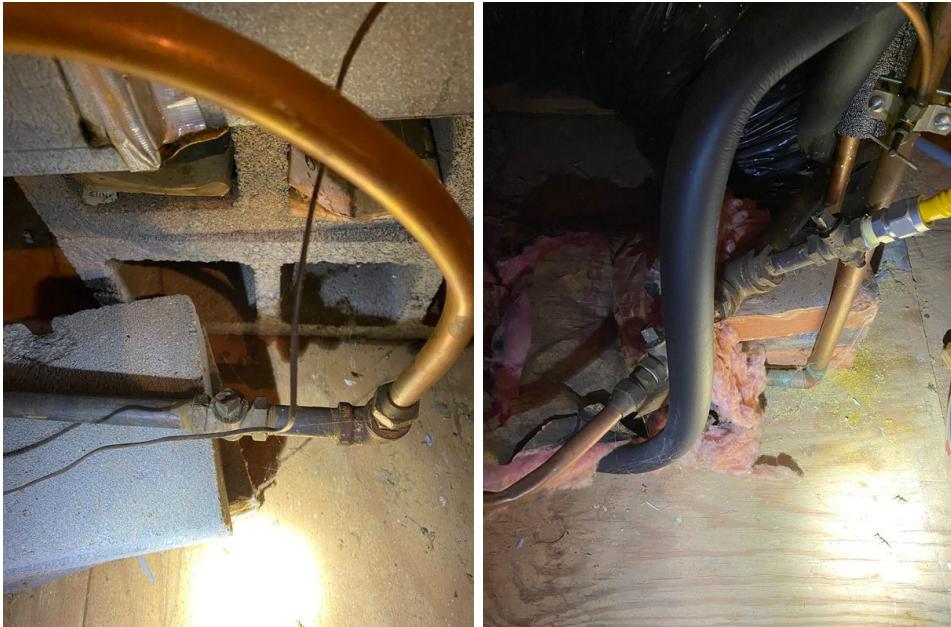
6.2.1 Heating Equipment

GAS SUPPLY DRIP LEG MISSING

At the time of the inspection, it was observed that the gas line supplying the furnace(s) was missing the drip leg. The drip leg allows particulates in the gas supply to drop out before being sent through the burner system. Recommend a qualified contractor assess and repair as necessary.

Contact a qualified professional.

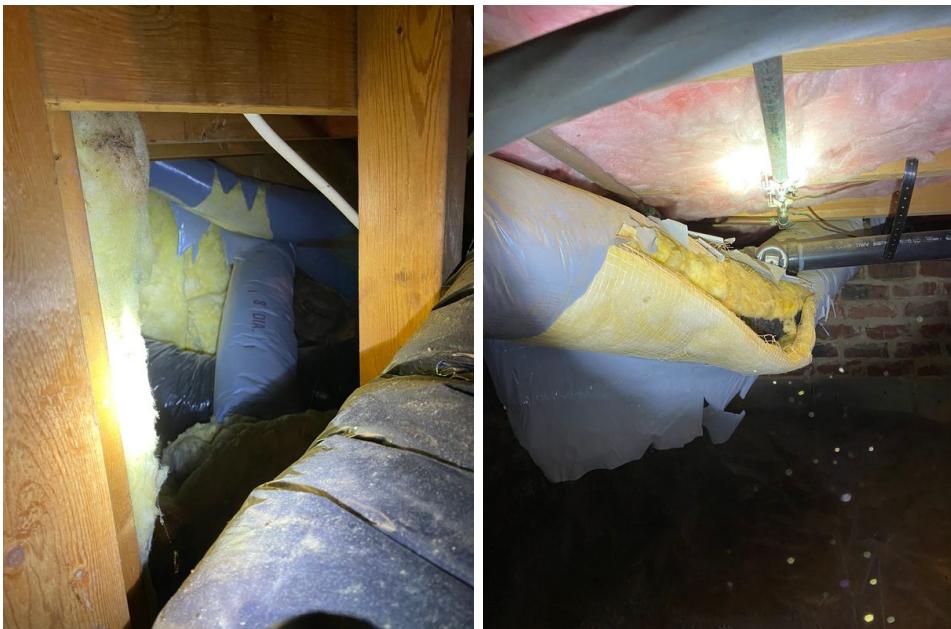
6.3.1 Distribution System

DUCT DAMAGED

At the time of the inspection, it was observed that one or more air supply duct was damaged. Recommend a qualified HVAC contractor to assess and repair as necessary.

Contact a qualified HVAC professional.

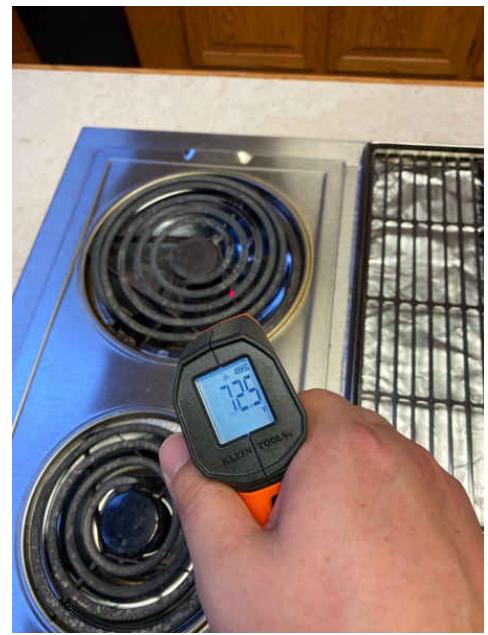
BURNER NOT LIGHTING

One or more heating elements did not heat up when turned on.
Recommend qualified professional evaluate & repair.

Burner Not Turning On

Contact a qualified professional.

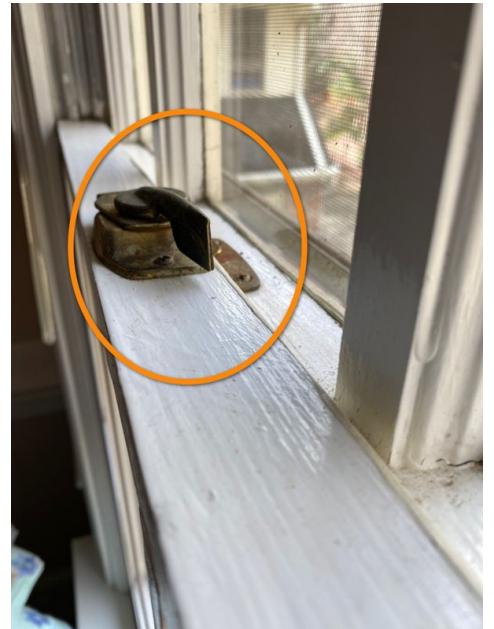
At the time of the inspection, it was observed that one or more windows could not latch properly. This can lead to excessive drafting and loss of heat. Recommend a qualified window contractor assess and repair as necessary.

Contact a qualified professional.

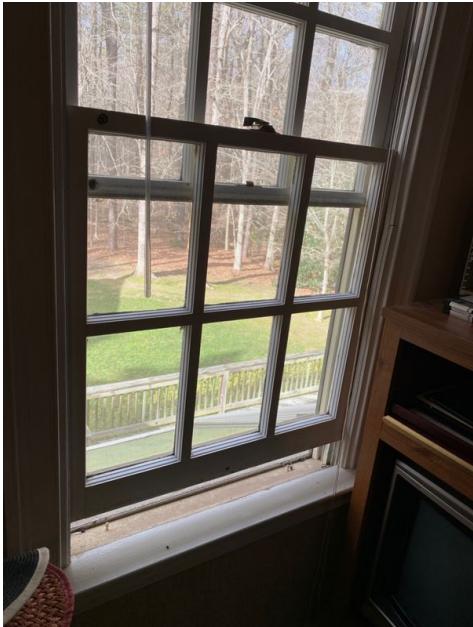
8.3.2 Windows

WINDOW DOESN'T OPEN

At the time of the inspection, it was observed that one or more windows would not open properly. This poses a safety hazard as windows are a point of egress in the event of a fire. Recommend a qualified window contractor to assess and repair as necessary.

Safety Hazard

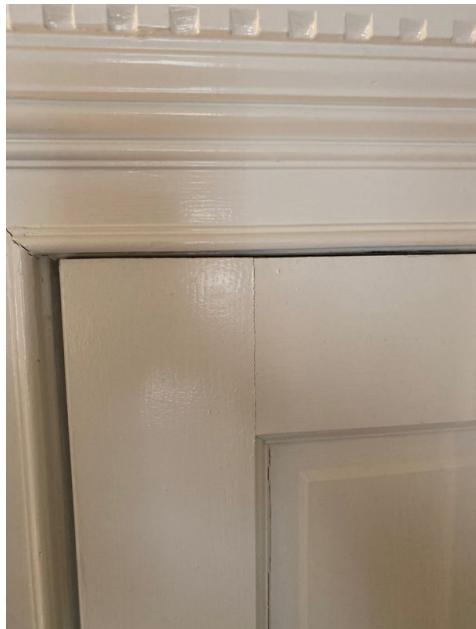
At the time of the inspection, it was observed that the door to this room would stick when operating. Recommend a qualified carpenter to assess and repair as necessary.

Contact a qualified handyman.

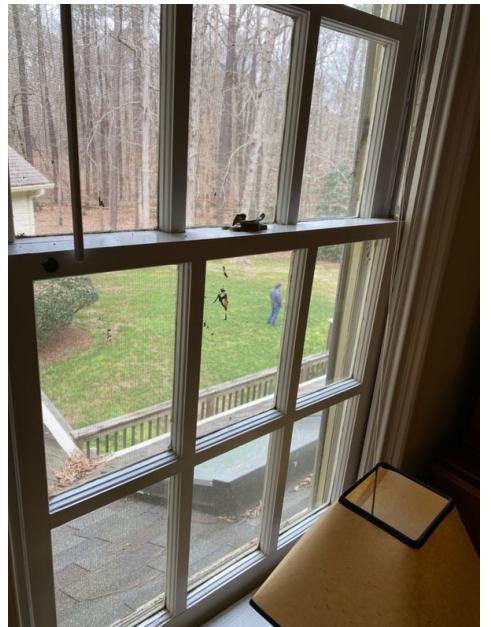
10.3.1 Windows

WINDOW DOESN'T OPEN

At the time of the inspection, it was observed that one or more windows would not open properly. This poses a safety hazard as windows are a point of egress in the event of a fire. Recommend a qualified window contractor to assess and repair as necessary.

Contact a qualified professional.

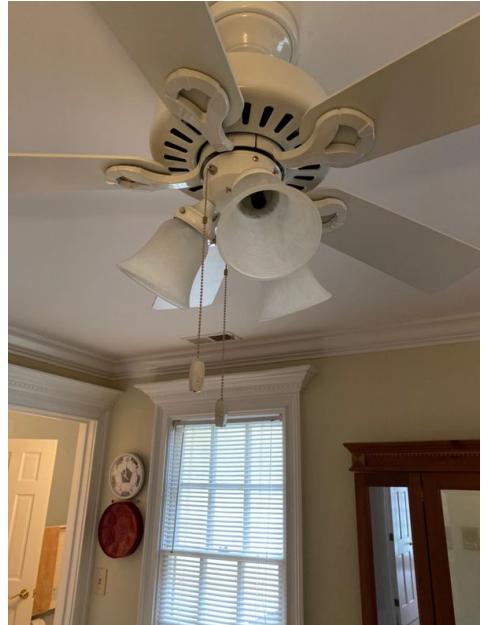
10.7.1 Lighting Fixtures, Switches & Receptacles

LIGHT INOPERABLE

At the time of the inspection, it was observed that one or more lights are not operating. Recommend a qualified handyman to assess and repair as necessary.

Contact a qualified handyman.

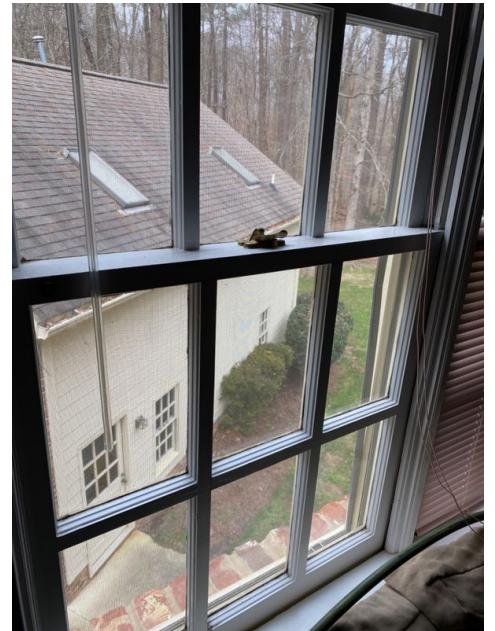
At the time of the inspection, it was observed that one or more windows would not open properly. This poses a safety hazard as windows are a point of egress in the event of a fire. Recommend a qualified window contractor to assess and repair as necessary.

Contact a qualified professional.

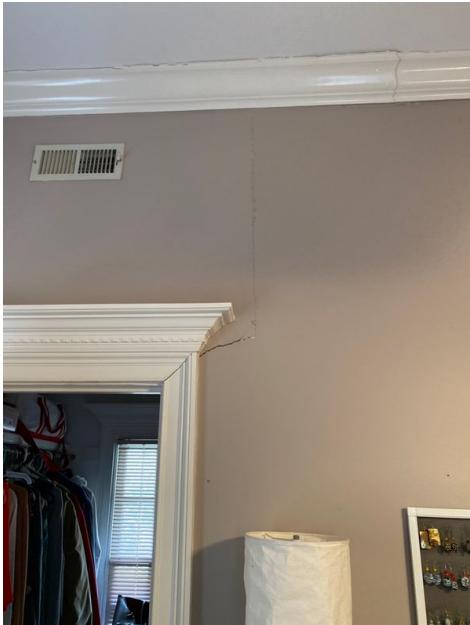
11.5.1 Walls

MINOR CORNER CRACKS

Minor cracks at the corners of doors and windows in walls. Appeared to be the result of long-term settling. Some settling is not unusual in a home of this age and these cracks are not a structural concern.

Contact a qualified professional.

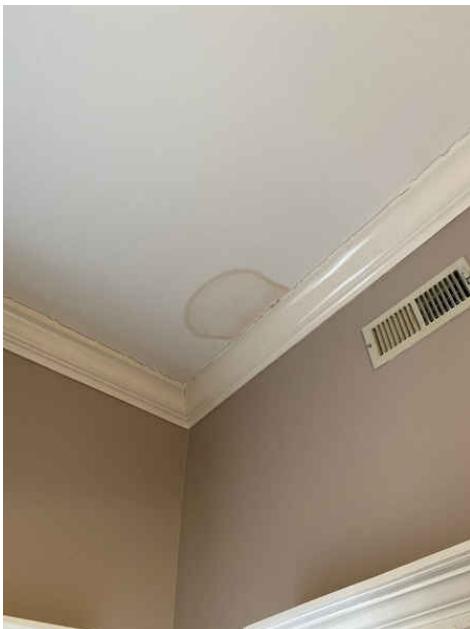
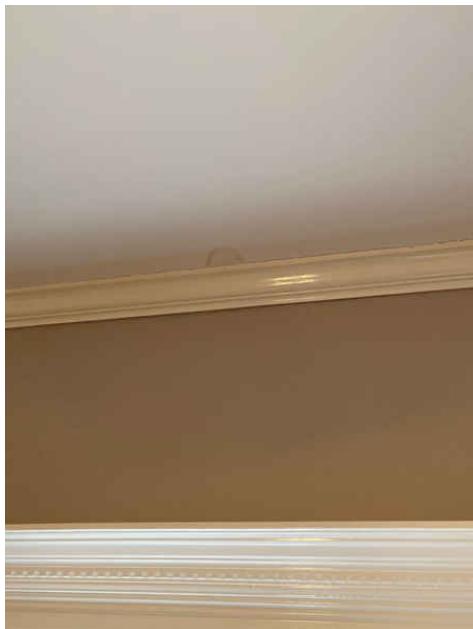
11.6.1 Ceilings

STAIN(S) ON CEILING

At the time of the inspection, stains were observed on the ceiling. This is an indication of a leak in the ceiling structure. Recommend a qualified contractor to assess, determine the source, and repair as necessary.

Moisture Staining

Contact a qualified professional.

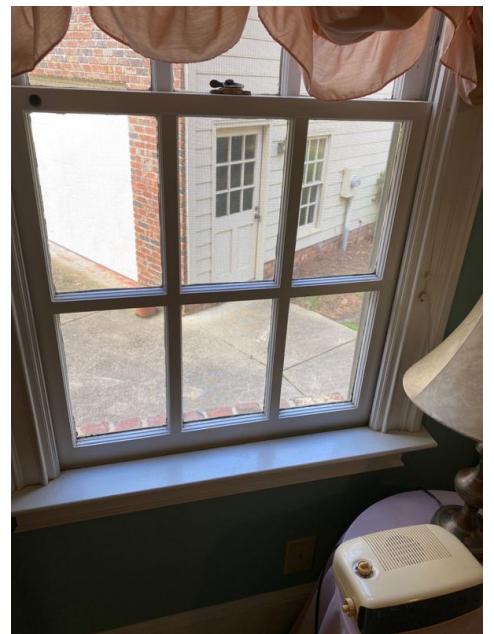
At the time of the inspection, it was observed that one or more windows would not open properly. This poses a safety hazard as windows are a point of egress in the event of a fire. Recommend a qualified window contractor to assess and repair as necessary.

Safety Hazard

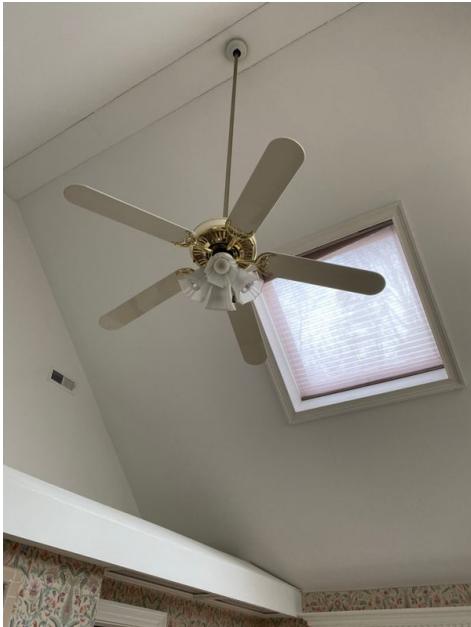
13.5.1 Lighting Fixtures, Switches & Receptacles

FIXTURE NOT OPERABLE

Contact a qualified professional.

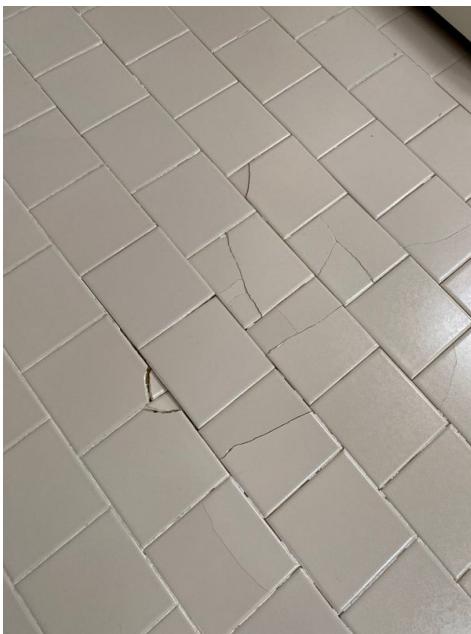
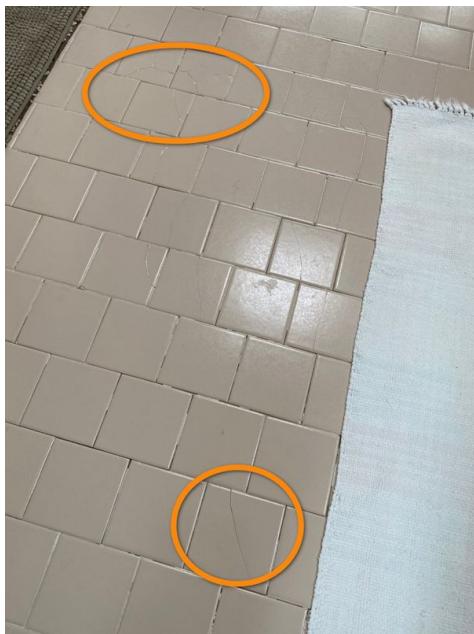
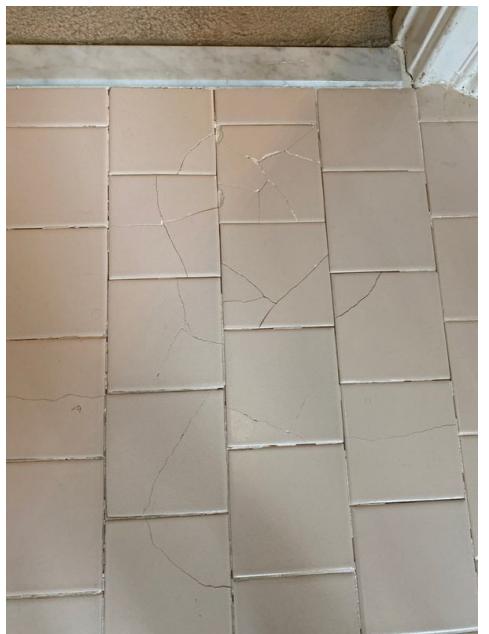
13.6.1 Floors

TILES DAMAGED/MISSING

Contact a qualified professional.

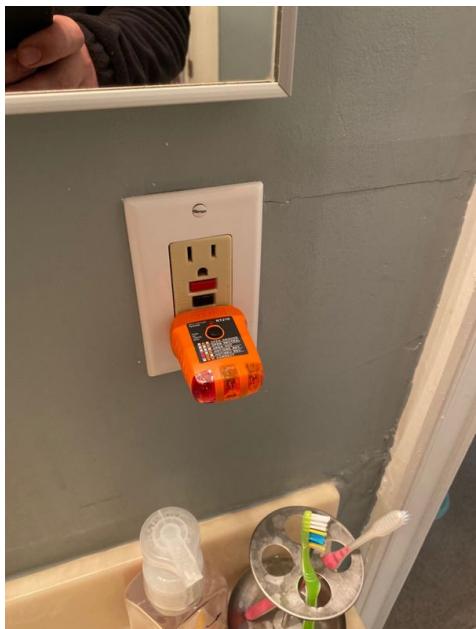
At the time of the inspection, it was observed that one or more GFCI outlets would not operate as intended. In this case the outlet would not reset and indicates a electrical issue on this branch. Recommend a qualified electrician to assess and repair as necessary.

Contact a qualified professional.
