## RESIDENTIAL HOME INSPECTION REPORT

1234 Main St. Charleston SC 29414

04/23/2020 9:00AM

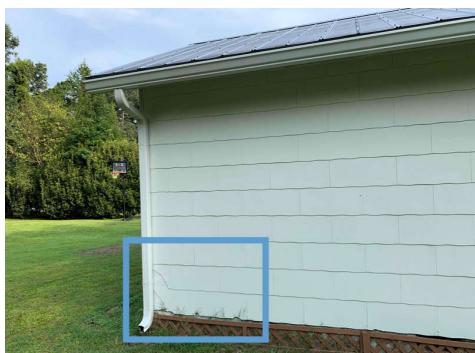
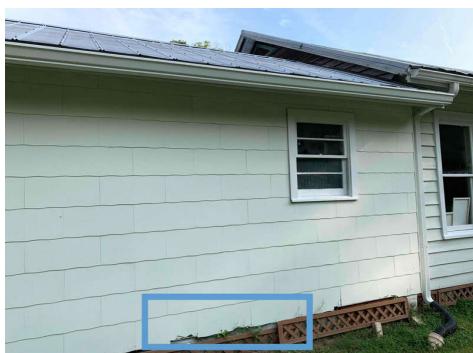
Left side of home

### **SIDING: MINOR DAMAGE**

Minor damage was visible on the ACM (asbestos containing material) siding. Recommend a qualified professional repair or replace.

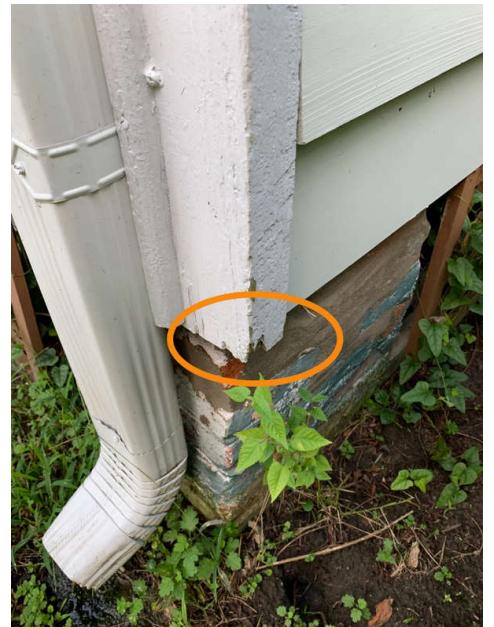
Front left corner of home

**WOOD TRIM: ROT**

Wood rot on trim around the home in one or more locations (locations noted on picture). Recommend a qualified professional repair or replace the damaged materials to prevent further damage.

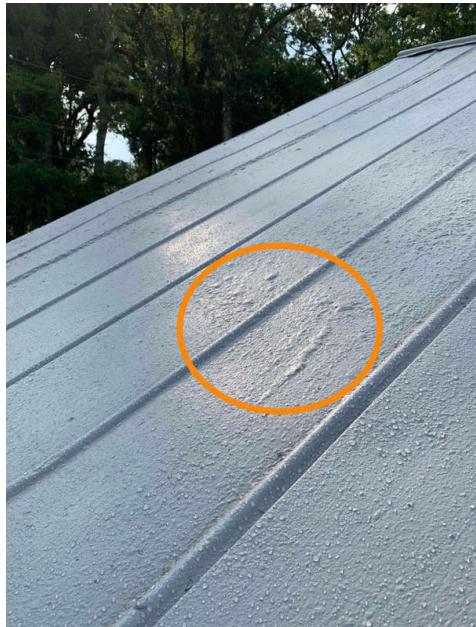
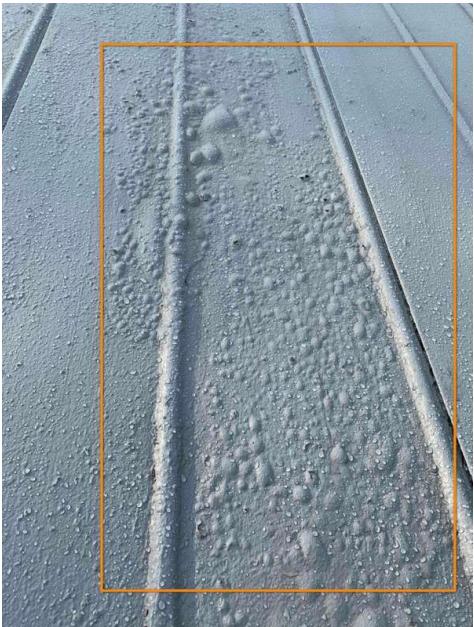
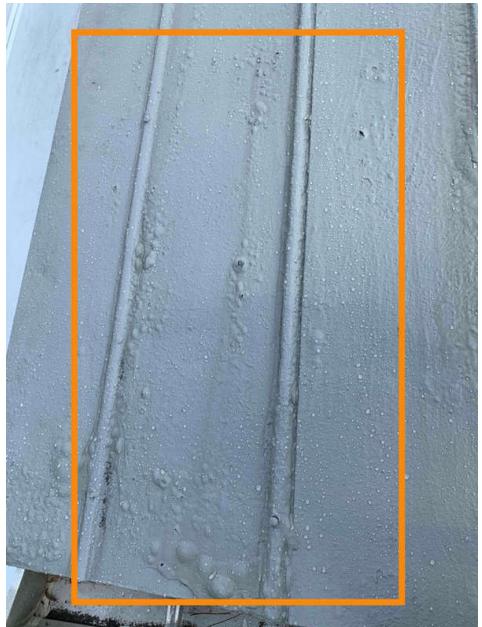
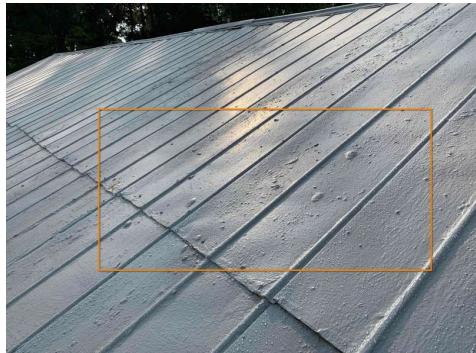
Moderate Deficiency

Observed blistering of the recently coated metal roof in one or more areas. Some of these blisters have broken through which could result in moisture damage. Recommend a qualified roofing professional evaluate and repair.

Contact a qualified roofing professional.

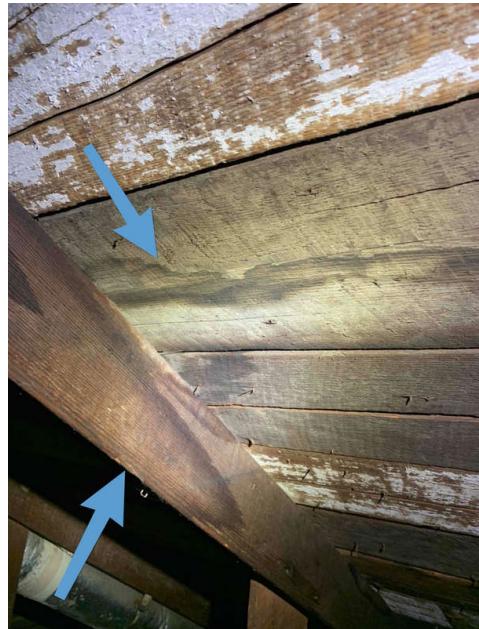
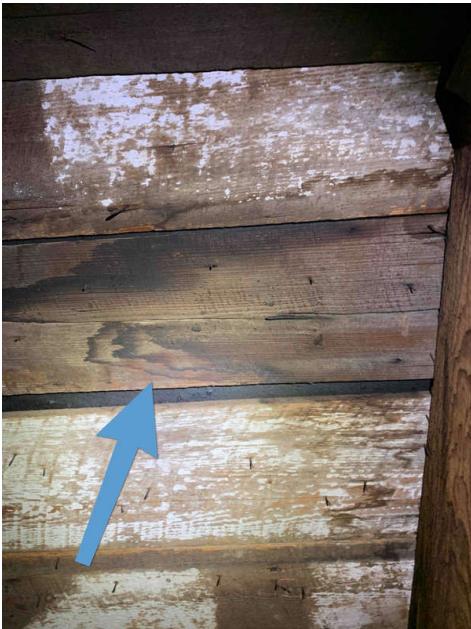
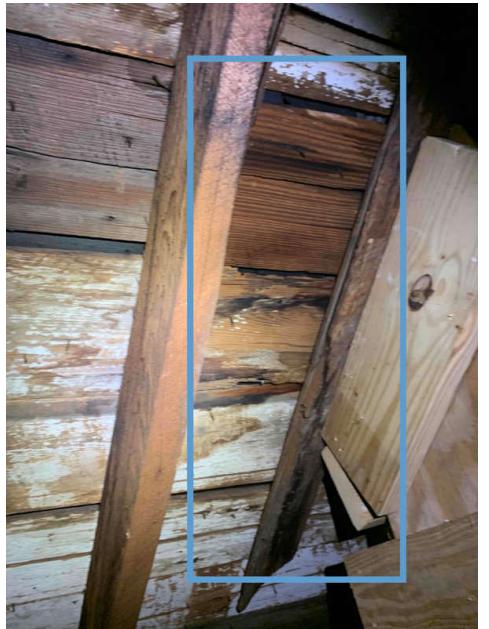
**ROOF SHEATHING: MOISTURE STAINS PRESENT**

Several moisture stains present on the roof sheathing. Moisture meter reading were well within normal range indicating a previous issue. (approx. 5-8%)

Recommend monitoring for future issues.

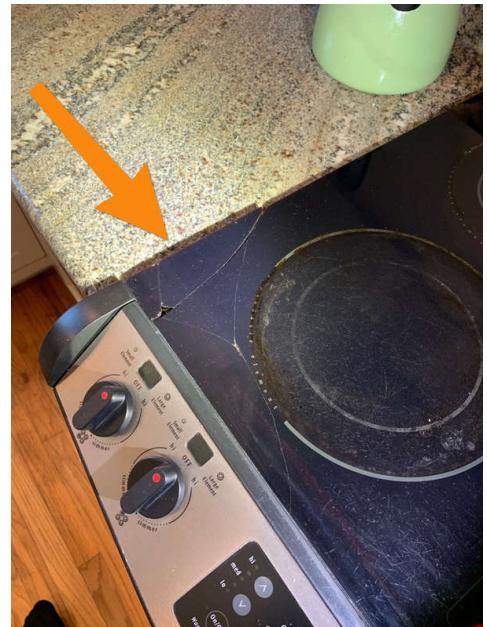
**RANGE: CRACKED GLASSTOP**

Moderate Deficiency

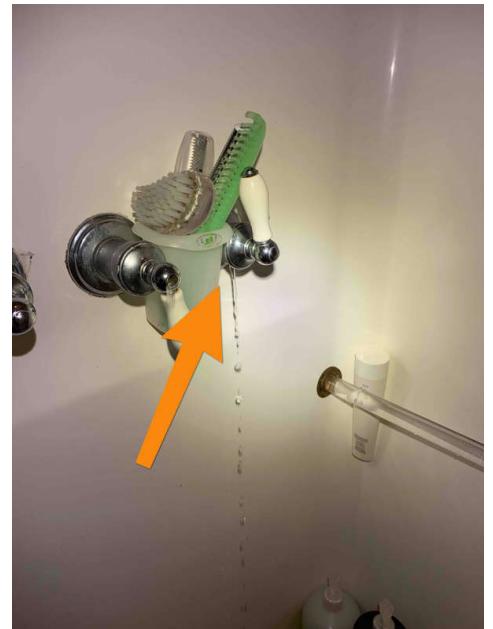
Guest Bathroom

Moderate Deficiency

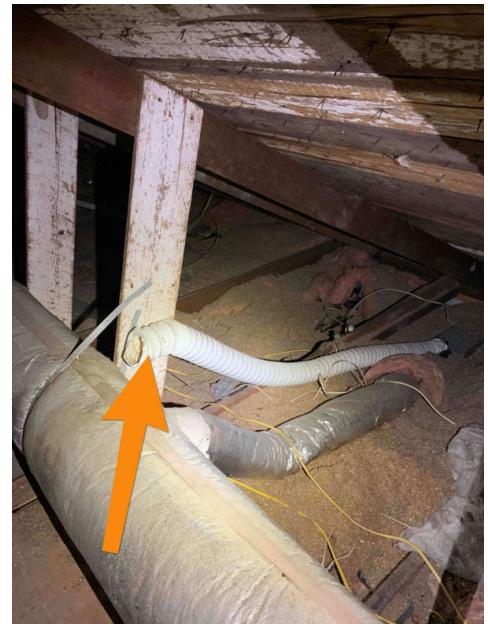
**BATHROOM VENTS INTO ATTIC**

Moderate Deficiency

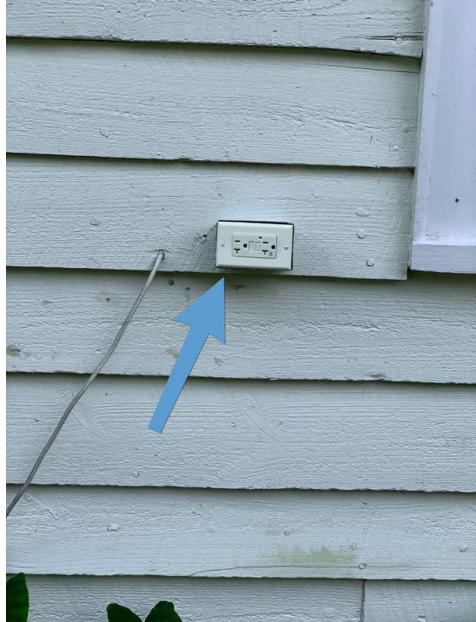
Right side of home

**MISSING OUTDOOR WATERPROOF COVER**

Contact a qualified professional.

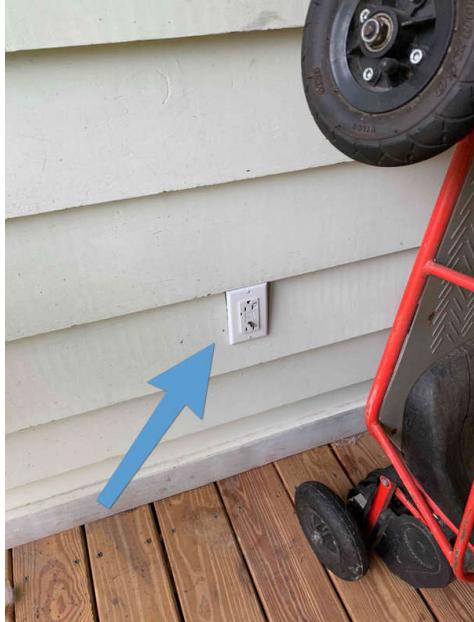
Back deck

Exterior Wet/ Damp location rated receptacle cover is missing. Recommend a qualified professional install.

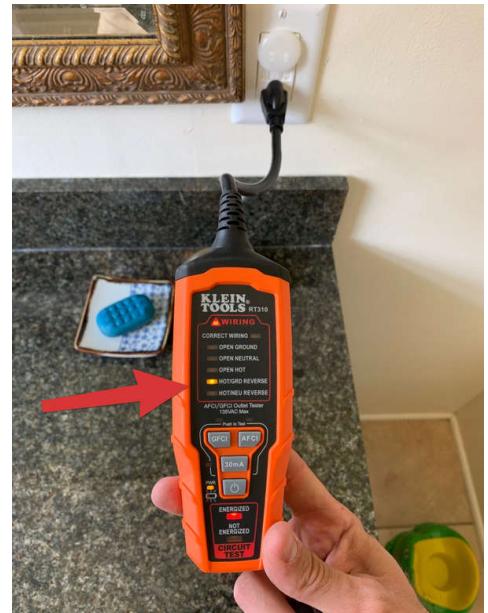
Master Bathroom

Significant Deficiency/ Safety Hazard

The GFCI receptacle in the master bathroom is showing to have the Hot and Ground reversed. Many times this is a false reading and the actual culprit is a loose neutral somewhere on the circuit.

Recommend a licensed electrician evaluate and repair to make sure the circuit is wired properly and this particular receptacle has GFCI protection.

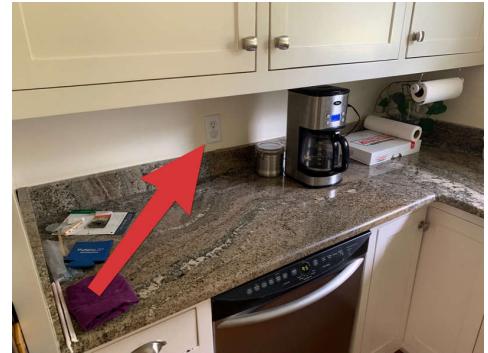
Significant Deficiency/ Safety Hazard

GFCI (Ground Fault Circuit Interrupter) protection was not present in all locations where the receptacle could come in contact with water or other liquid which is a potential safety hazard.

Recommend licensed electrician upgrade by installing ground fault receptacles or breakers for locations specified:

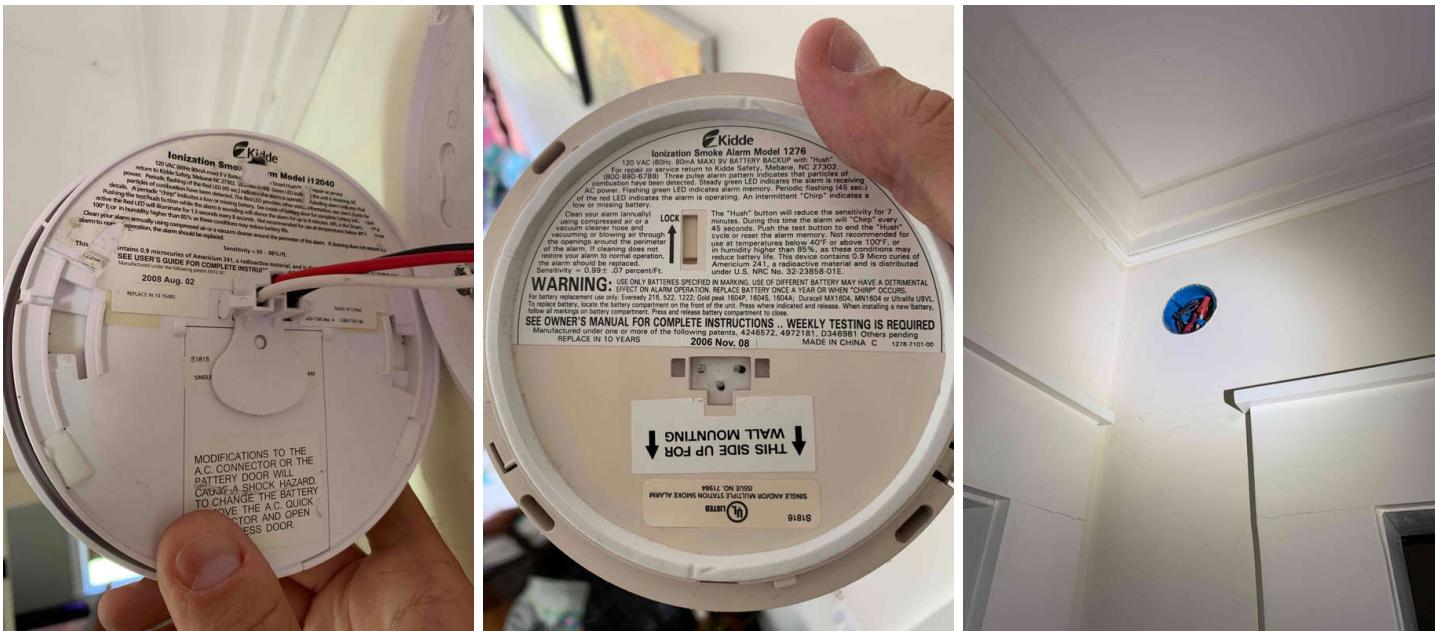
## SMOKE DETECTORS: OVER 10 YEARS OLD

Contact a handyman or DIY project

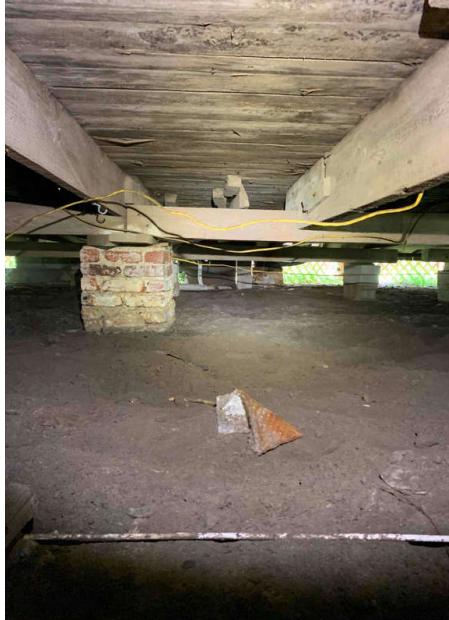
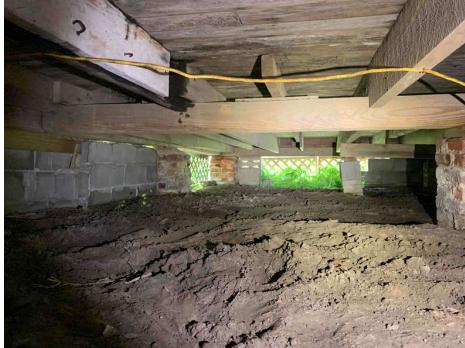
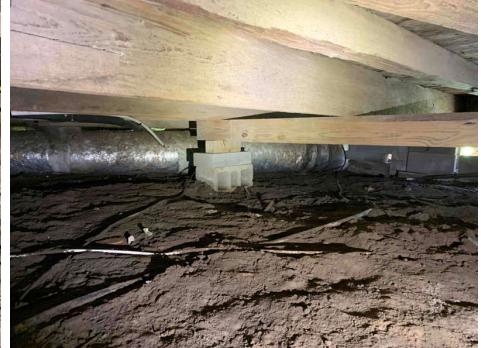
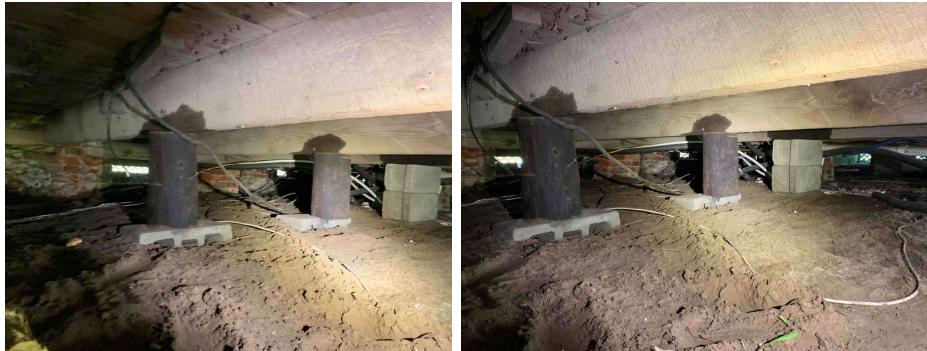
! Significant Deficiency/ Safety Hazard

Multiple piers/supports under the home are leaning which has resulting in an obvious slope to the interior floor. The brick piers are original to the home when it was moved and although it is likely they reached their maximum settlement it is still recommended that a qualified foundation contractor evaluate the piers and discuss options for adding additional supports or repairs to ensure there is no future movement.

Contact a foundation contractor.

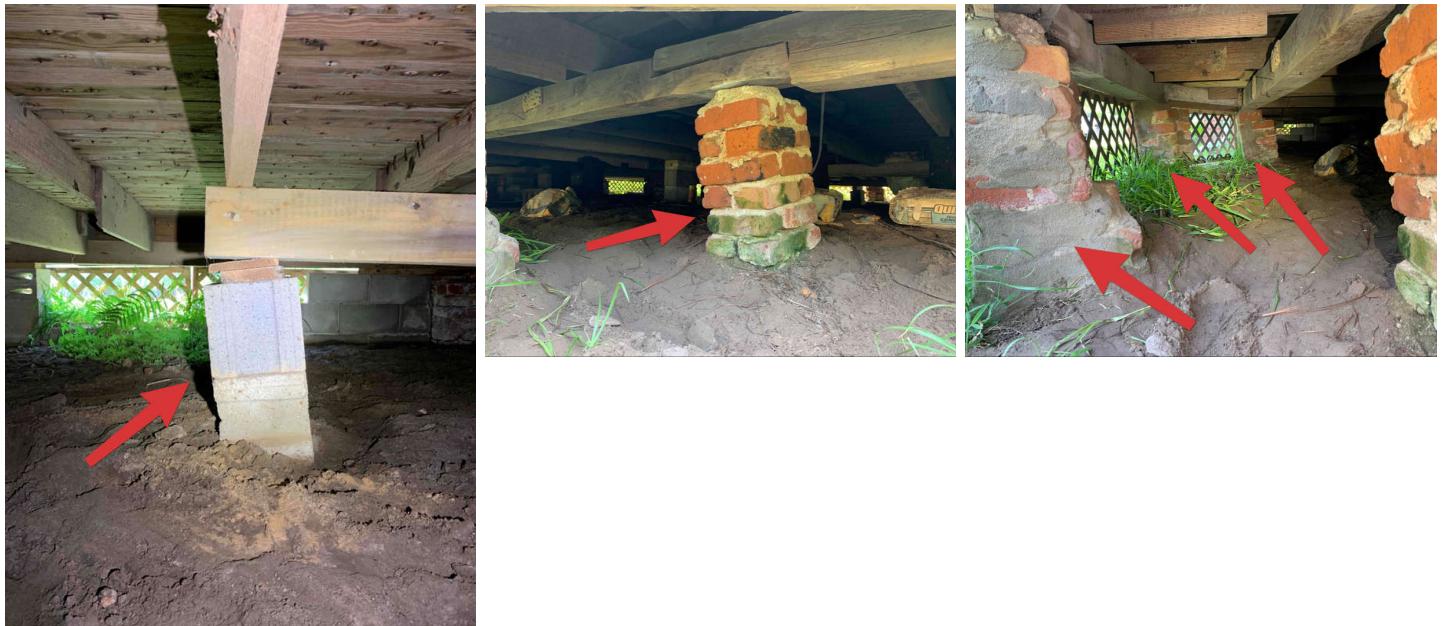
### 12.1.1 Foundation

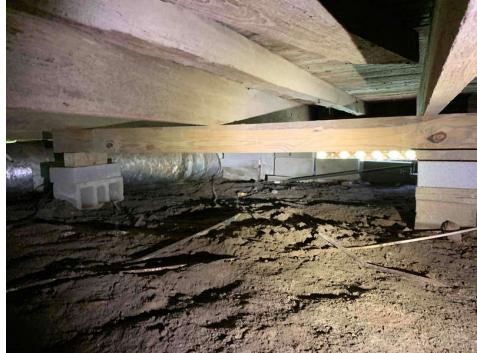
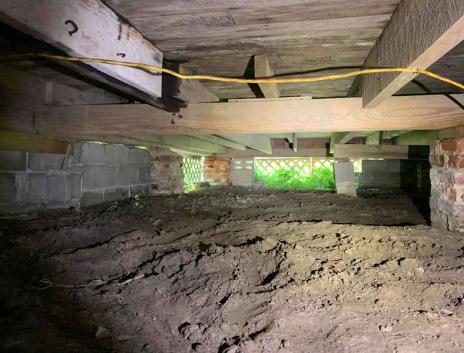
**NO VAPOR BARRIER**

Contact a qualified insulation contractor.

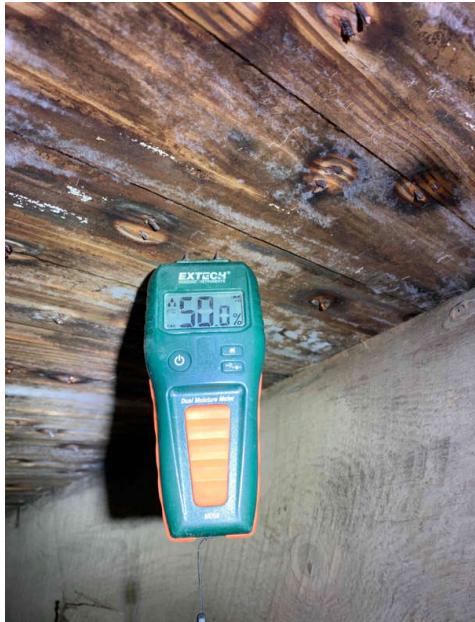
Front Guest Bathroom

**SUBFLOOR: HIGH MOISTURE/ ACTIVE MOISTURE INTRUSION**

Contact a qualified professional.

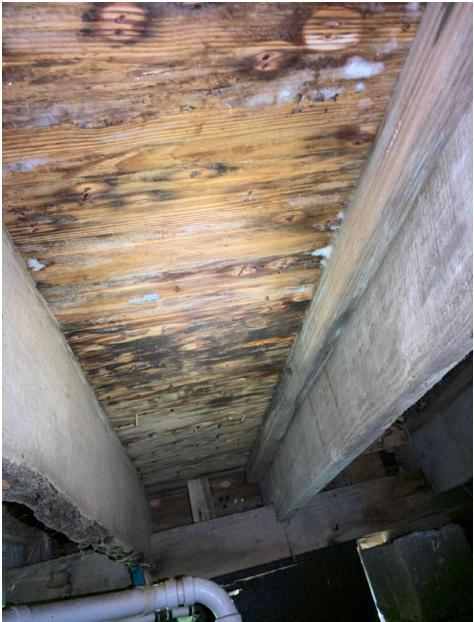
Front Guest Bathroom

Significant Deficiency/ Safety Hazard

High moisture readings beneath the front bathroom possibly due to long term air leakage since there is no specific signs of leaking and around the main duct floor penetration. Recommend a qualified professional evaluate and repair and/or provide long term repair solutions to prevent further damage to the subfloor and joists.

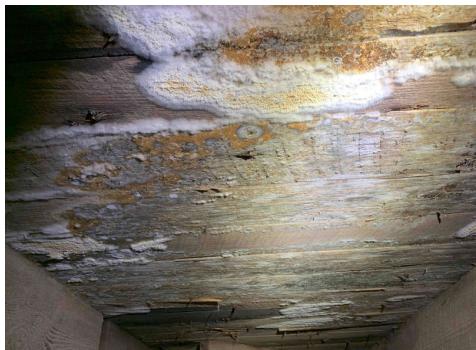
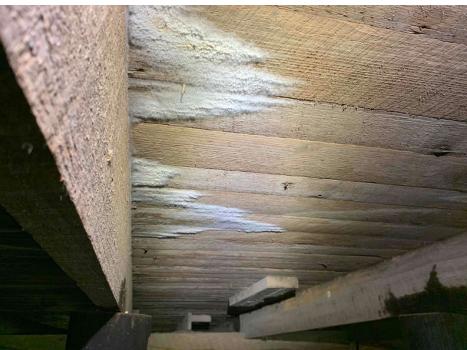
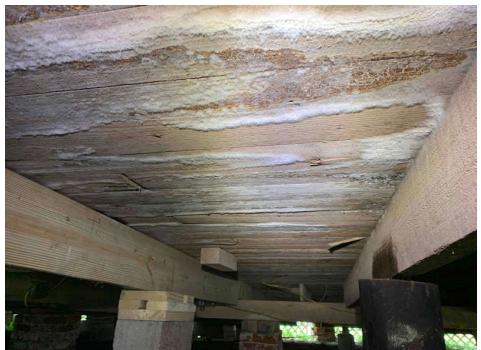
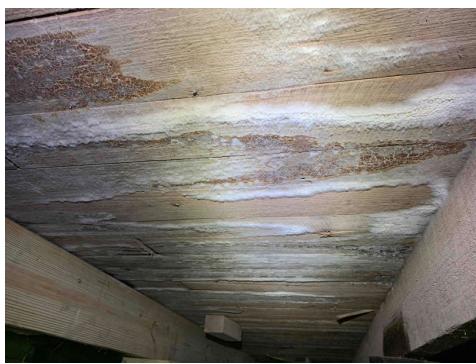
**SUBFLOOR: MICROBIAL GROWTH PRESENT**

Moderate Deficiency

Contact a qualified professional.
