Inspection Report: Report ID# 12022015SI

**Property Address: 1234 Inspection St
Wenatchee WA 98801**

NCW Home Inspections, LLC: Don Hester WA ST#647 WSDA#80050

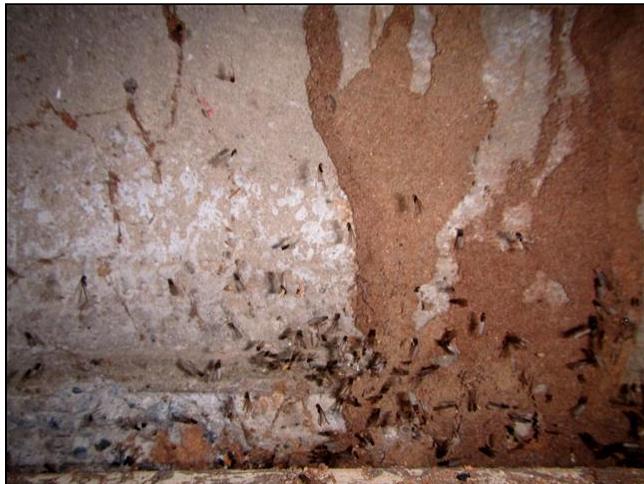
2.3 Photo 1 -- Mud tubes and swarmers

I recommend all damaged/infected wood to be removed and replaced by a qualified contractor.

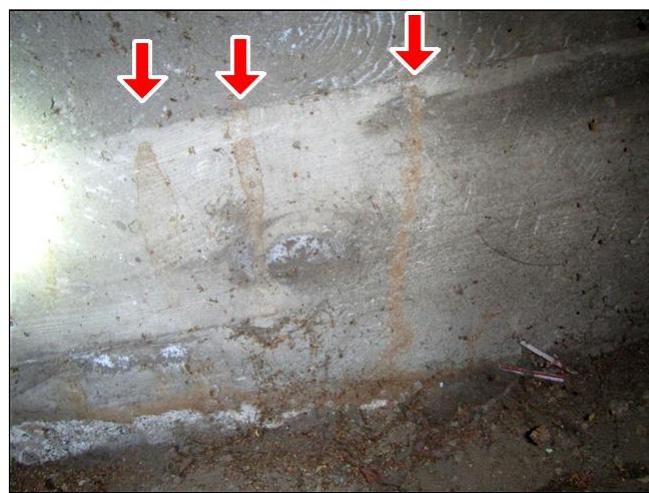
2.3 Photo 4 -- Old mud tube stains west crawl

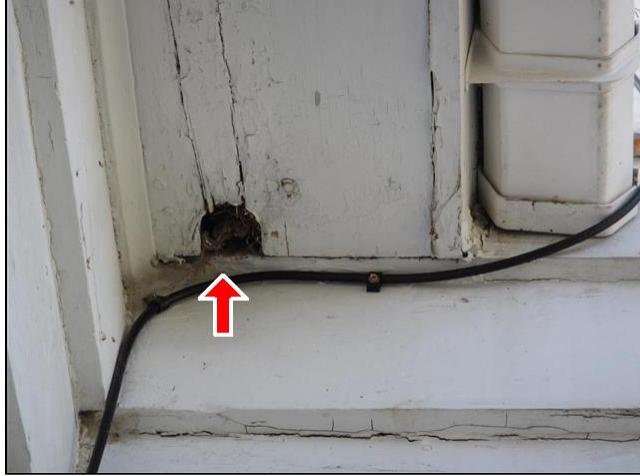
3.0 Photo 1

Maint- There are areas where the soffit materials has gaps. Gaps can allow rodents/birds/insects to enter this area. I recommend installing some type of screening or sealing of these area to prevent entry.

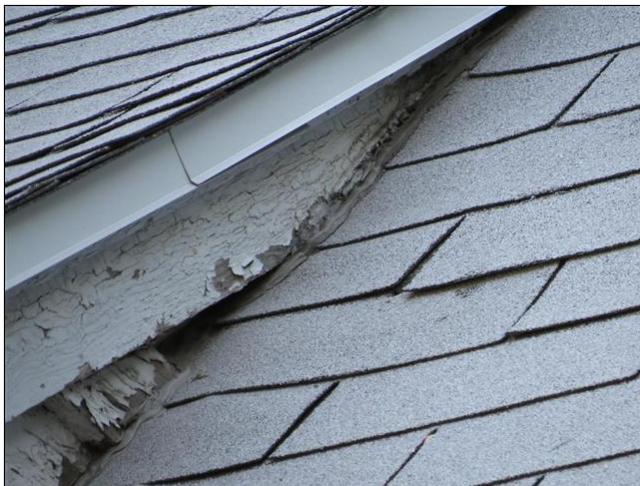
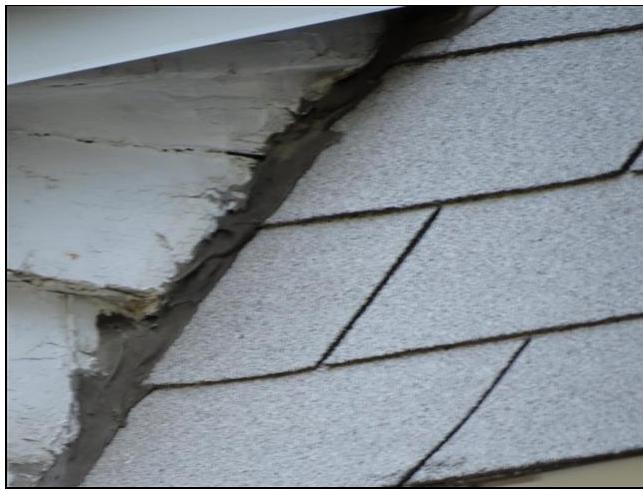
(2) Repair Replace/Maint/Monitor- The wall-roof intersection was not installed by normal building standards. Standards practice is to have the sidewall siding/cladding/trim have a clearance of up to 2" from the roof surface to allow water to shed properly. I advise the client monitor maintain these areas and repair if any deterioration is observed. I recommend trimming the siding to achieve these clearances. I recommend a qualified contractor evaluate and repair as necessary.

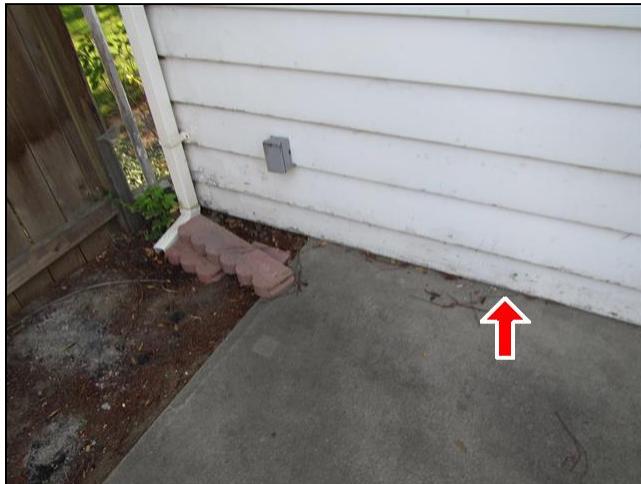
3.2 Photo 4

(4) **Maint/Monitor/Comment-** The siding/trim in front of the patio is in contact with the concrete surface. The siding/trim should have a 1" of clearance from the concrete to allow water/moisture to drain. I recommend monitoring and trim the siding in this area to allow for these clearances if any swelling or deterioration is observed.

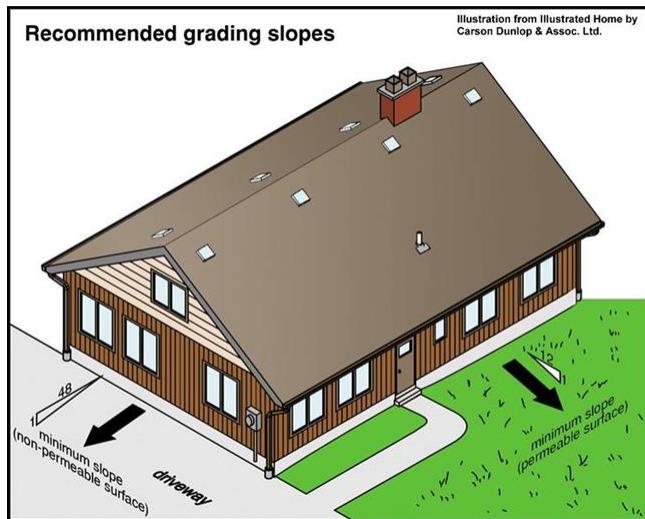
3.6 Photo 1

Maint. Poor/Negative grade at the east side of home. Flat or negative grade can cause or contribute to water intrusion and/or deterioration of foundations and or basements/crawlspaces. Recommended grading is 6 inches within the first 10 feet if possible or a slope of 5 percent and the water should be directed to drains or swales to ensure drainage away from the structure. I recommend correcting landscape to direct water away from home.

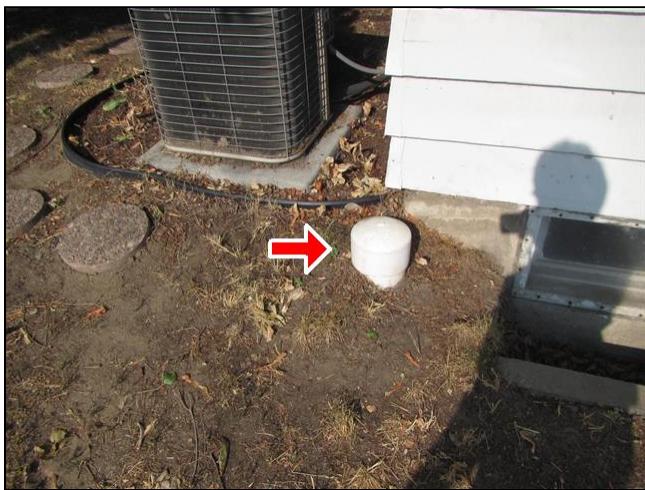
3.9 Photo 2

(3) **Comment-** Unknown accesses (may be to shut offs). I recommend having the owner provide you with information on these accesses.

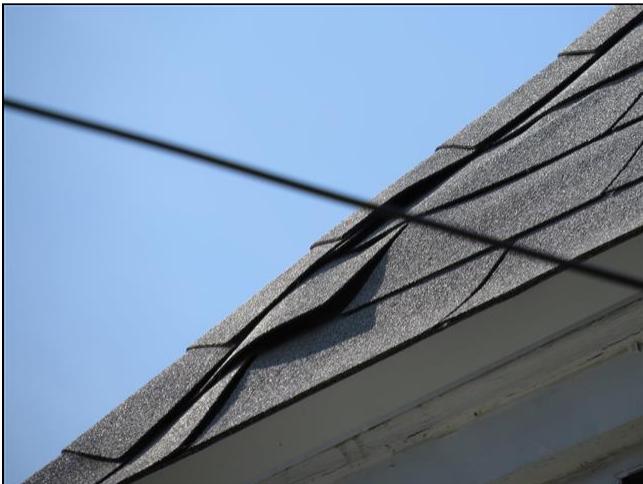
4.0 Photo 1

- (1) **Repair Replace-** Shingles lifted/not laying flat. This can allow water and debris to collect under the shingles and potential damage to the shingle in a wind event.. I recommend a qualified roofing contractor evaluate and repair as necessary.

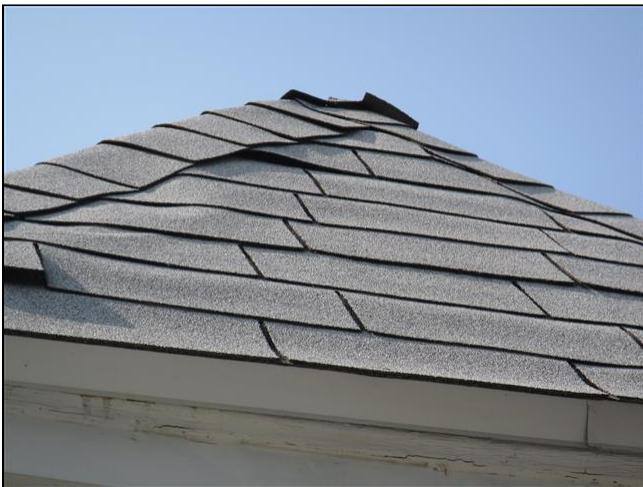
(2) **Repair Replace-** Several roof shingles are missing/damaged. This can lead to leak of the roof. I recommend that a qualified roofing contractor evaluate and repair as necessary.

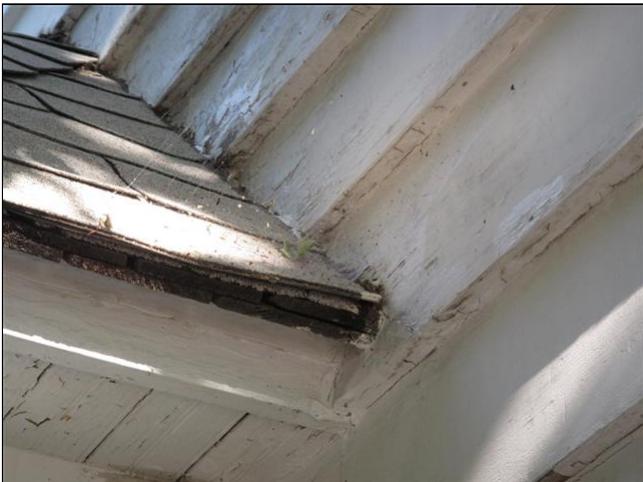
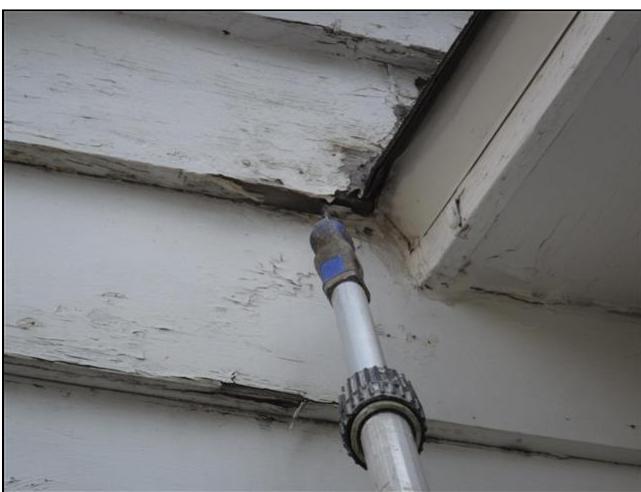
(1) **Repair Replace/Monitor-** Missing kick out flashing. This directs the water from the sidewall into the gutter system or away from the wall. This is a very common installation issue. This flashing is a required flashing where water may go behind siding and trim. This can lead to moisture intrusion of the wall structure below this area. These areas will need to be well maintained due to the lack of this flashing (caulking and painting). I recommend when the roof covering is replaced that these flashings are installed. At a minimum the client will need to monitor these areas and maintain as necessary (Caulking and painting). If deterioration is observed I recommend a contractor evaluate, repair and install as necessary.

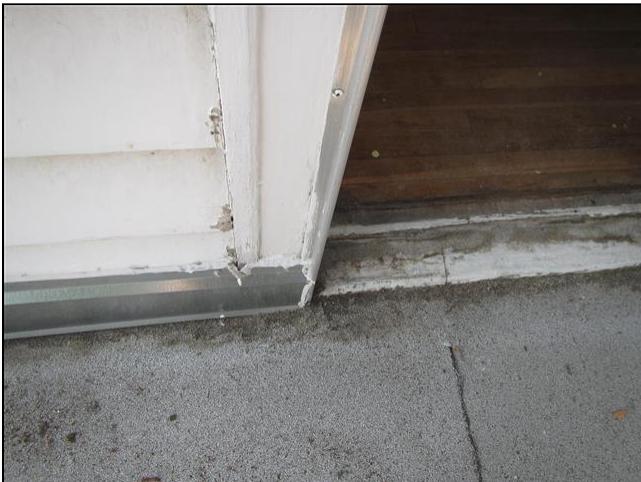
4.1 Photo 4

(3) **Monitor/Comment-** The flashing from the roof to the upper bedroom door and wall will be very susceptible to moisture intrusion. The client should monitor this area for any moisture issues and perform any maintenance as required to prevent moisture intrusion.

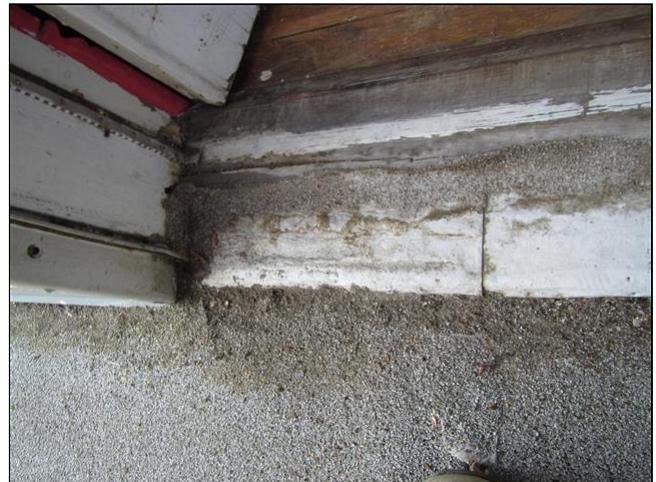
4.1 Photo 5

(2) **Repair Replace-** Sidewall and headwall flashing where not properly installed when roof was replaced. Even when a roof over has been performed the flashing should be re-installed correctly. I recommend that a qualified roofing contractor evaluate, repair and replace as necessary.

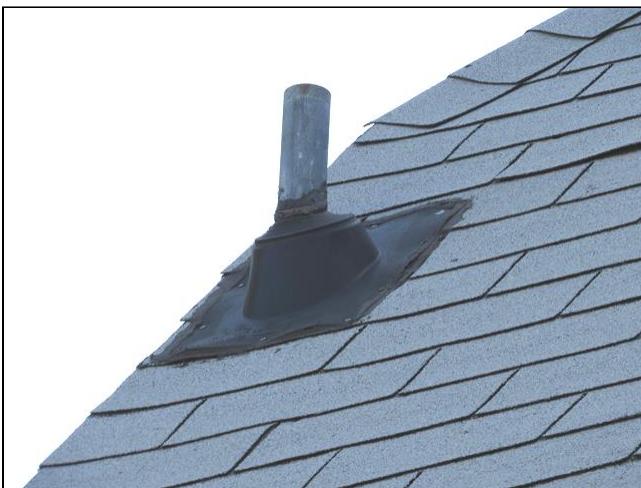
4.2 Photo 1

Repair Replace- Plumbing vent boots where not properly installed. This can lead to leakage. The boot should be replaced and properly installed. I recommend a qualified roofing contractor evaluate, repair and replace as necessary.

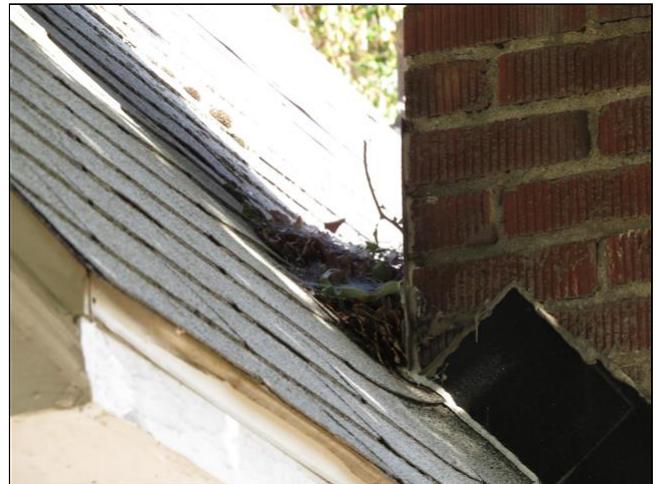
(3) **Repair Replace**- The flashing around the chimney was not performed in normal roofing practices and is very prone to leaking. Light was visible in the attic at this location. I recommend a qualified roofing contractor evaluate and repair as necessary.

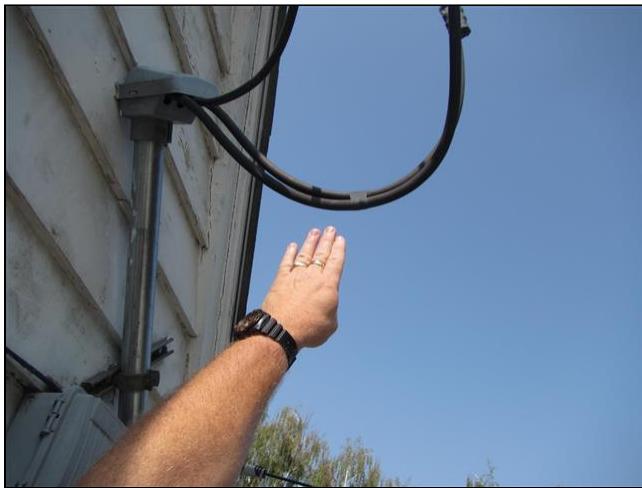
6.0 Photo 2

(2) **Repair Replace-** The service drop wires were in contact with trees or vegetation. The limbs should be pruned to prevent straining or abrading the service conductors. I recommend a qualified arborist/tree trimming contractor trim trees as necessary. I recommend contacting the power company to disconnect the service prior to work performed.

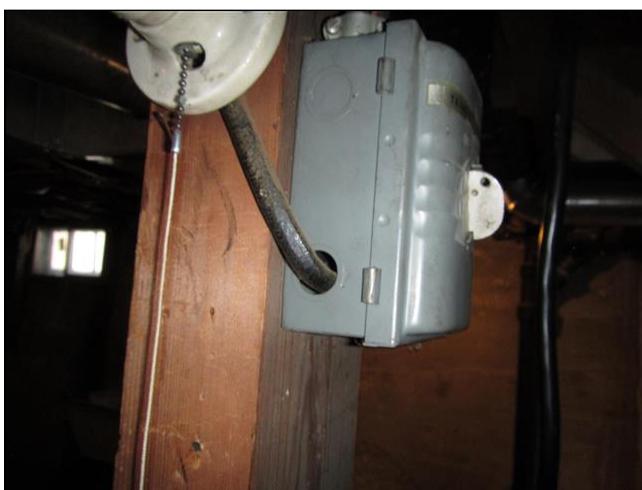
6.1 Photo 3 -- missing restraints

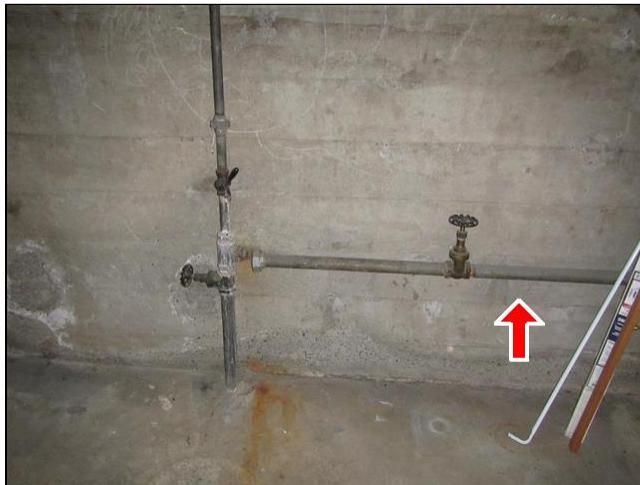
6.2 Photo 3 -- pipe should be bonded also

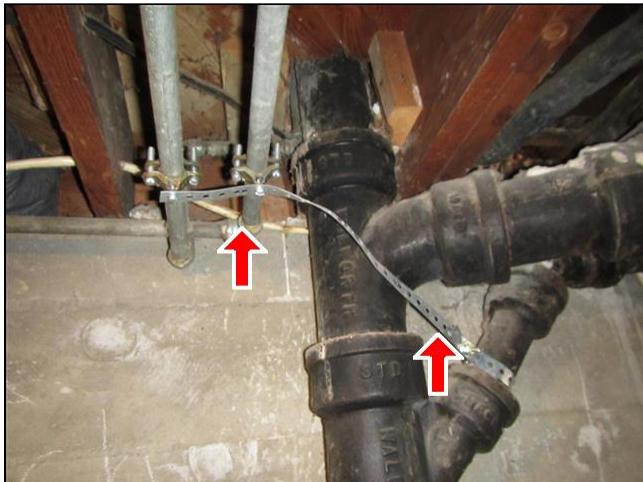
6.2 Photo 4

(3) **Repair Replace-** Improper bonding jumper. Bonding jumpers should be of an approved conductor (typically copper wire) or other listed jumpers. This is to ensure proper bonding of systems that could be energized. I recommend a qualified electrician evaluate repair and replace as necessary.

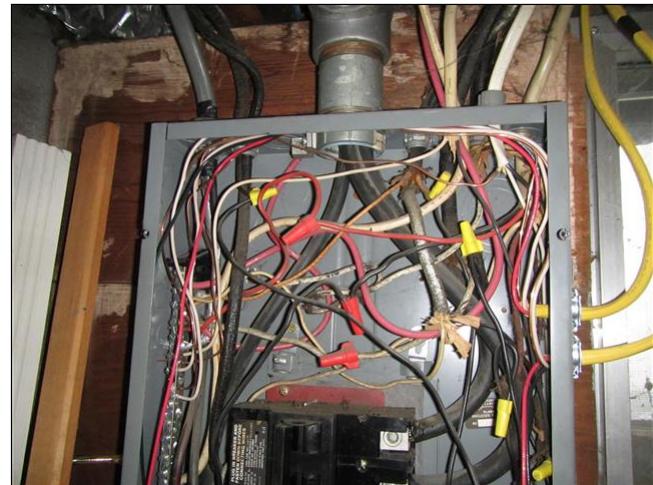
6.3 Photo 2

- (2) **Comment-** All white or grey wires being used as hot (ungrounded) conductors should be marked (re-identified) as such with black or other appropriate color. I recommend that when any work is performed by a qualified electrician that this is performed.

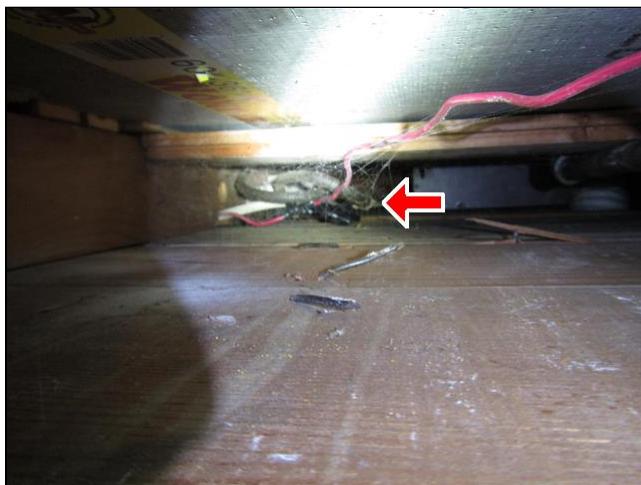
6.4 Photo 1

Areas observed- Wall behind main bathroom tub

I recommend a qualified electrician should evaluate and make repairs as necessary.

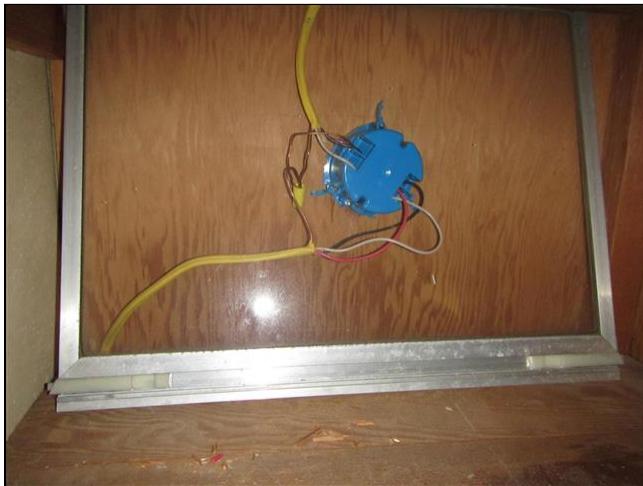
6.4 Photo 2 -- upstairs hall storage

(3) **Repair Replace**- Wire cable sheathing stripped to far back leaving conductors exposed outside of box and not protected from damage at clamp. Standard practice is to have the cable sheathing should extend a minimum of about 1/4 in. inside the box. I recommend a qualified electrician evaluate an repair as necessary.

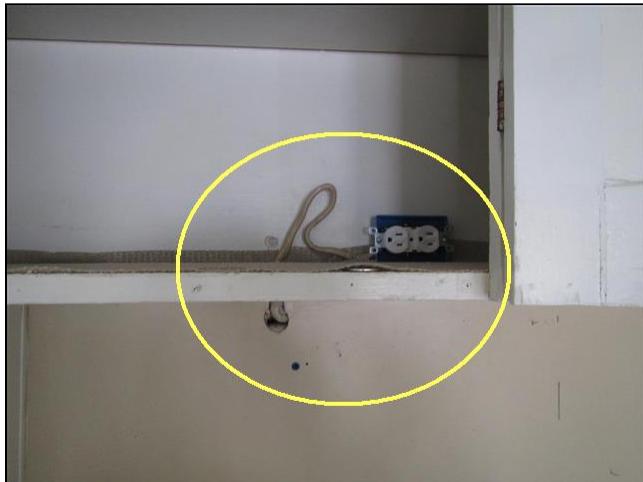
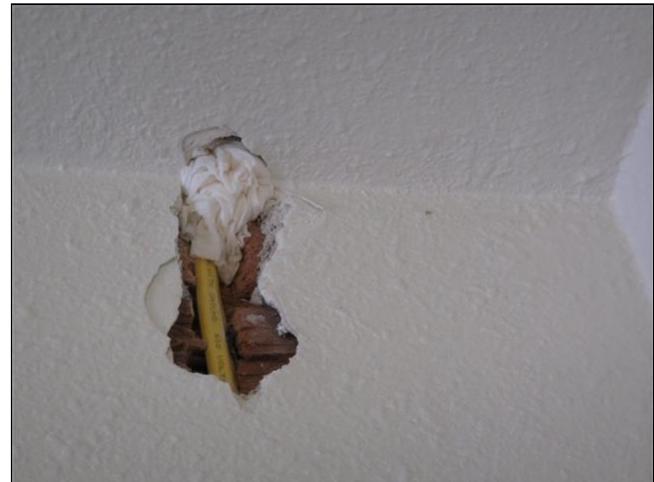
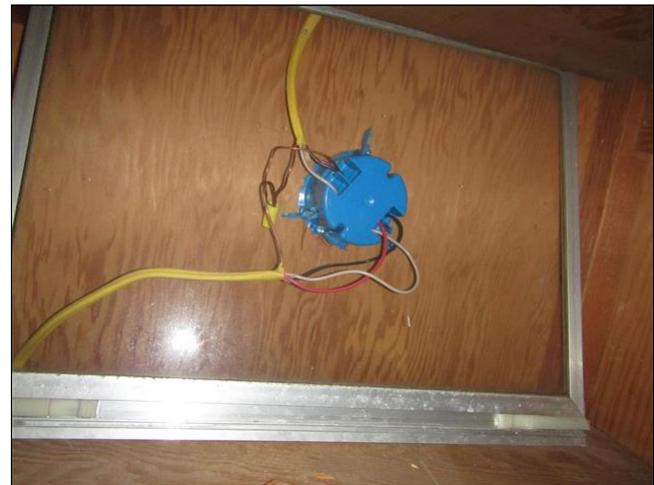
(4) **Repair Replace**- Potential mechanical damage of exposed wiring. Where wiring is run on the surface of walls, baseboards or other interior finishes it should be protected from mechanical damage with a rigid covering (conduit, framing etc...). Alternatively, flexible metal or rigid metal cables can be used. Several junction boxes are missing proper wire restraints. I recommend a qualified electrician evaluate wiring and repair as necessary.

Areas Observed- basement, kitchen above range area and in cabinet, main bathroom south wall, hall storage cabinet upstair

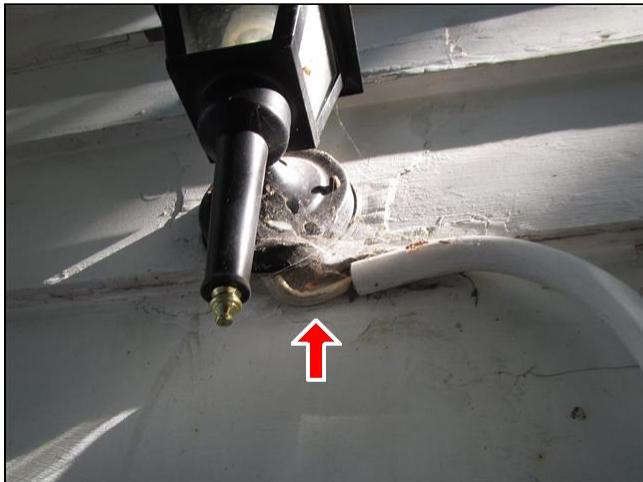
6.4 Photo 7

(5) **Repair Replace/Comment-** Use of NM wiring (Romex) on the exterior of home. Standard practices is that NM wiring should not be used on the exterior of the home (damp or wet locations). Some jurisdictions may allow the use under patio covers and porches. Ideally the use of UF wire or other approved conductors should be used which is designed for wet locations. The wiring should be properly protected from mechanical damage. I recommend that a qualified electrician evaluate, repair and replace as necessary.

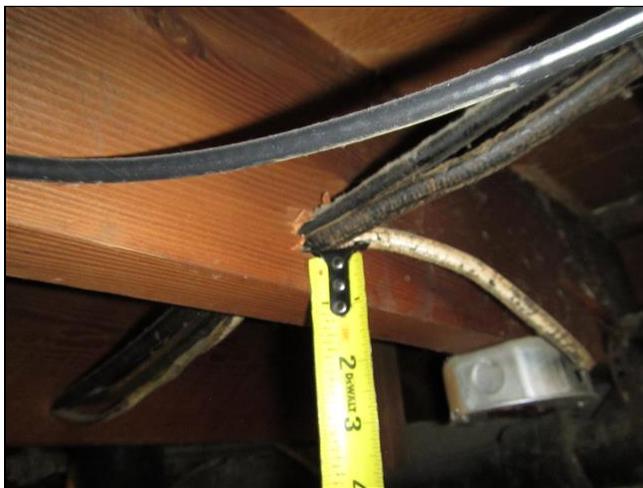
6.4 Photo 8

(7) **Repair Replace-** Missing nail plates for electrical wires. This is risk for damage to the wire, shock and or fire. Nail plates should be installed over electrical cables (and plumbing) if hole in framing is less than 1-1/4 in. from face of framing member. I recommend a qualified contractor or electrician install proper nail plate protection as necessary

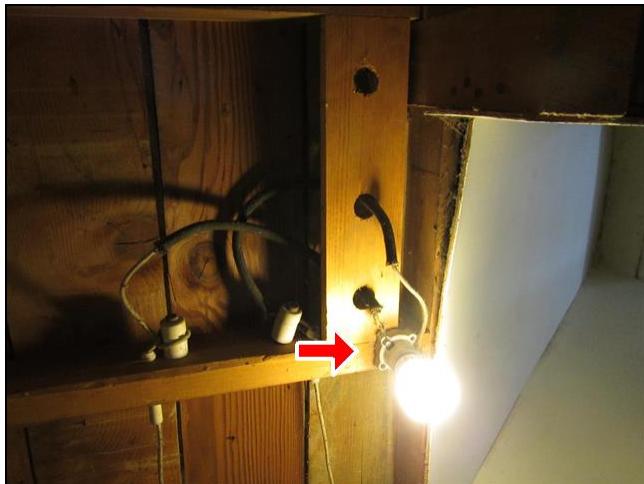
6.5 Photo 2

(3) **Repair Replace-** Old light fixture on porcelain base (on knob and tube system). These old fixture have exposed electrical connections which could lead to accidental contact with live wires. I recommend a qualified electrician evaluate repair and replace as necessary.

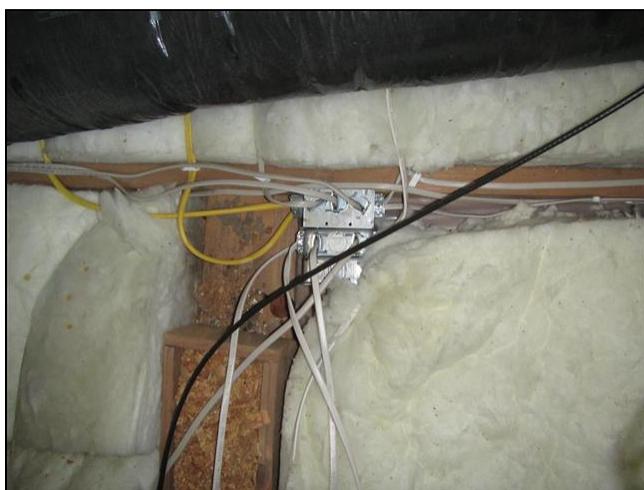
6.5 Photo 3

(5) **Repair Replace-** Wires may exceed junction box capacity. This is a safety issue. I recommend a qualified electrician evaluate and repair as necessary.

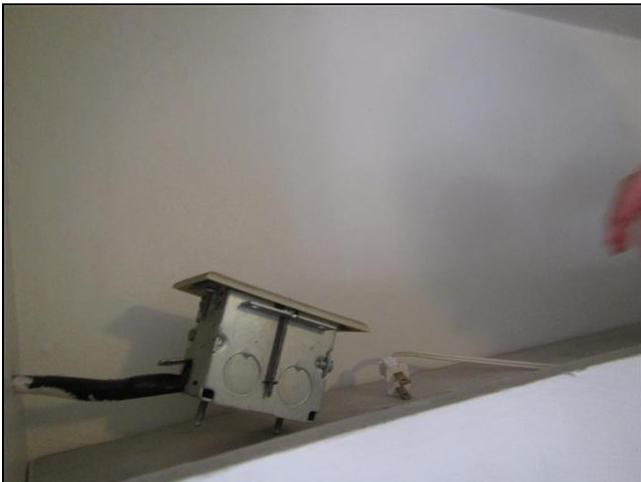
6.5 Photo 4

(6) **Repair Replace-** Junction box not properly secured on shelf above kitchen sink. This can lead to loose connection and/or wire damage. I recommend a qualified electrician repair as necessary.

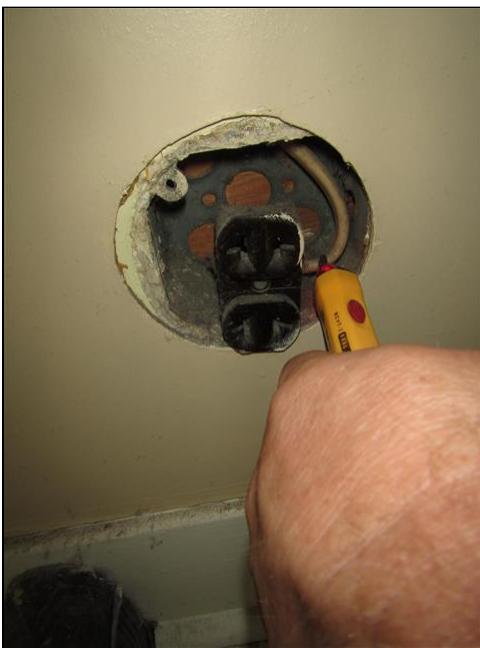
6.5 Photo 5 -- In kitchen

(7) **Maint.**- Several loose receptacles where found. Loose receptacles can cause fatigue of the wires over time. I recommend a qualified person or electrician tighten or replace the receptacles as necessary. Further evaluation of any receptacles that was obstructed by belongings and storage should be performed.

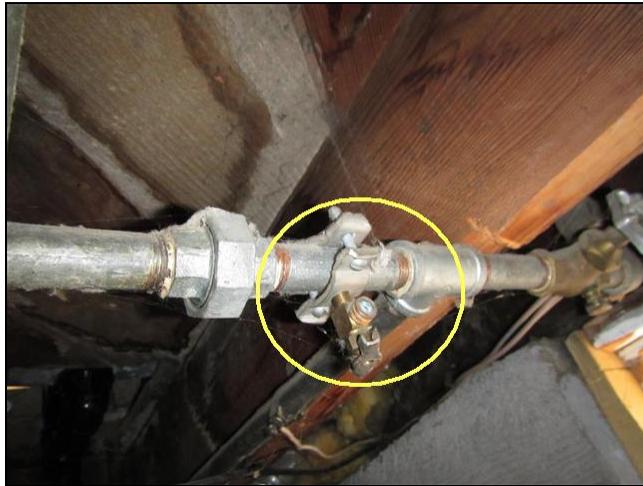
7.0 Photo 1

(4) Repair Replace/Comment- Some, most, or all of the water supply pipes in this structure are made of galvanized steel. Based on the age of this structure, these pipes may be nearing or may have exceeded their estimated useful life of 40 to 60 years. Internal corrosion and rust can reduce the inside diameter of these pipes over time, resulting in reduced flow and eventually, leaks. The inspector performed a "functional flow test" during the inspection where multiple fixtures were run simultaneously, and found the flow to be adequate. For example, the shower flow didn't decrease substantially when the toilet was flushed. Despite this, and because of their apparent age, these pipes may need replacing at any time.

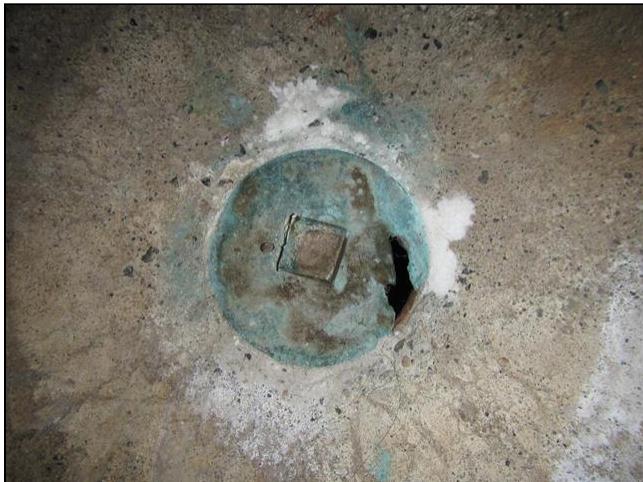
7.1 Photo 1

(1) Repair Replace- Cleanout cap damaged in basement west wall area. This can allow sewer gases into the home and debris into the waste lines. I recommend installing a proper cap on the clean out.

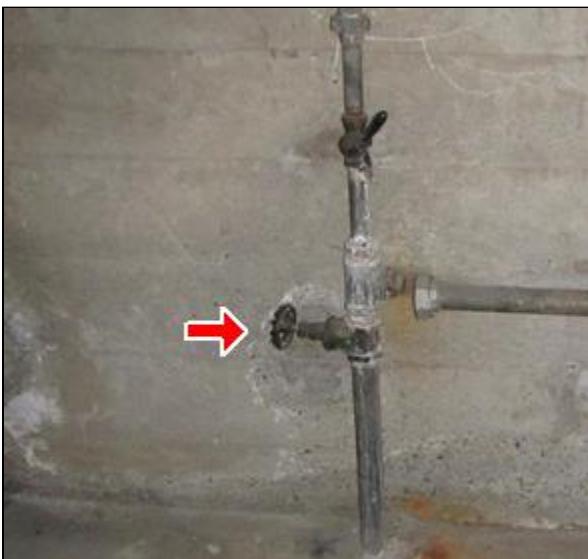
7.3 Photo 1

- (1) **Comment-** The main water shut off is located in basement.

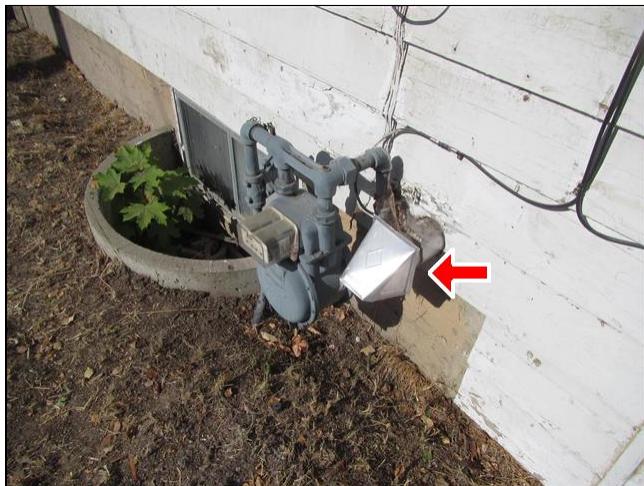
7.6 Photo 1

(2) **Repair Replace-** Improper clearances to gas meter and/or regulator vent. Standard practices is that gas meter regulator vent clearance distance should be three feet in any direction to clothes dryer intake or exhaust vent opening. I recommend a qualified plumber evaluate and move the vent to a proper location or moving the dryer vent to an appropriate location.

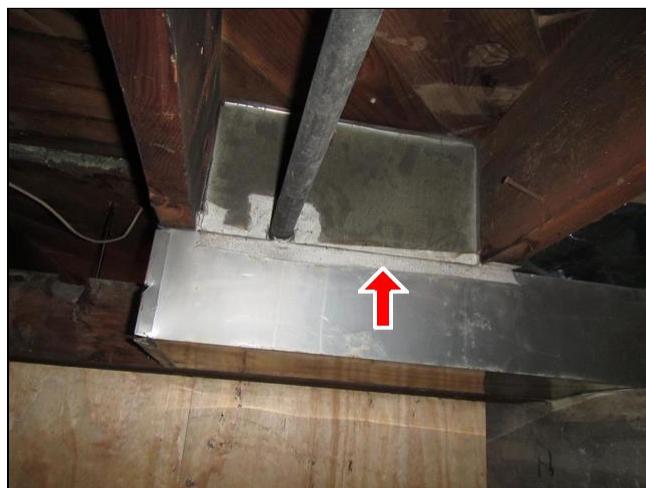
8.3 Photo 1

(4) **Comment**- Ducts attached with (duct tape) non-approved tape for ducts. Instead of using duct tape, it is recommended sealing ducts with mastics, gooey sealants that are painted on and allowed to harden or foil tapes that have metal foil backing and an acrylic adhesive approved fasteners such as nylon ties. (Mastics and tapes should be UL 181 approved.) I recommend replacing this tape with an approved duct tape, mastic and/or fastener.

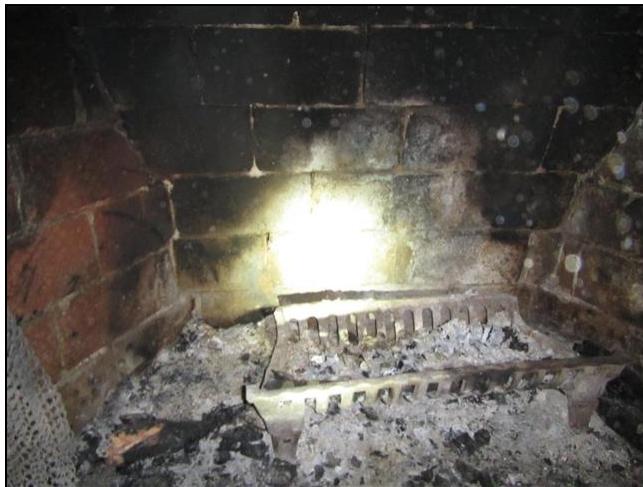
8.6 Photo 1

(1) **Repair Replace-** Fireplace fireproof bricks lining the fireplace are cracked and/or the mortar is failing.

(2) **Maint./Comment-** The fireplace is in need of cleaning. It is advised that proper cleaning of the chimney to remove creosote deposits, and regular inspection of the installation. Creosote is an inevitable by-product of burning wood. Periodically clean out the deposits formed on the chimney walls to ensure good performance of the stove and reduce any safety hazards created by the creosote deposits. Cleaning chimneys at least once a year is recommended. A more specific rule to follow is to clean the chimney whenever there is a 1/4 inch or more creosote buildup on the chimney walls.

These are specialized devices so recommend contracting with a chimney sweep to repair/further evaluate the wood burning device and associated chimney and components. The National Fire Protection Association has stated that an in-depth Level 2 chimney inspection should be part of every sale or transfer of property with a wood burning device. Such an inspection may reveal defects that are not apparent to the home inspector who is a generalist.

I recommend a qualified chimney sweep clean and inspect the woodstove/fireplace and chimney.

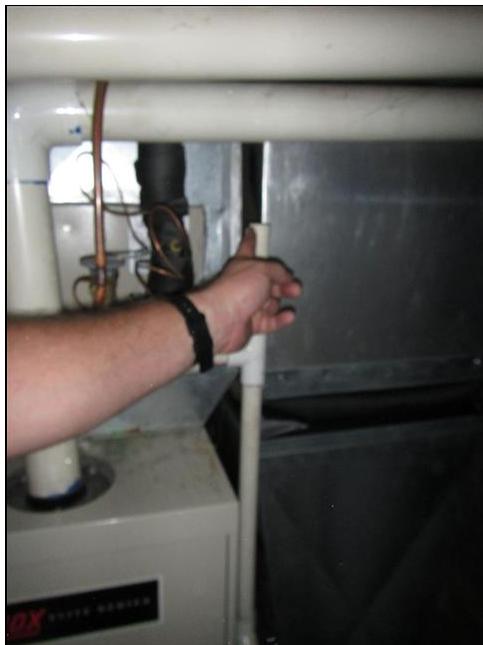
8.7 Photo 1

(1) **Maint-** Condensate line missing a cap. The primary purpose of a condensate trap is to prevent air from moving in or out of the coil box or air handler during operation. Most manufactures require a condensate trap installed as the line leaves the the furnace unit. Manufactures often recommend a drop from the pan at a minimum of 2 inches and then a minimum of a 2-inch trap seal. I recommend installing a cap as necessary.

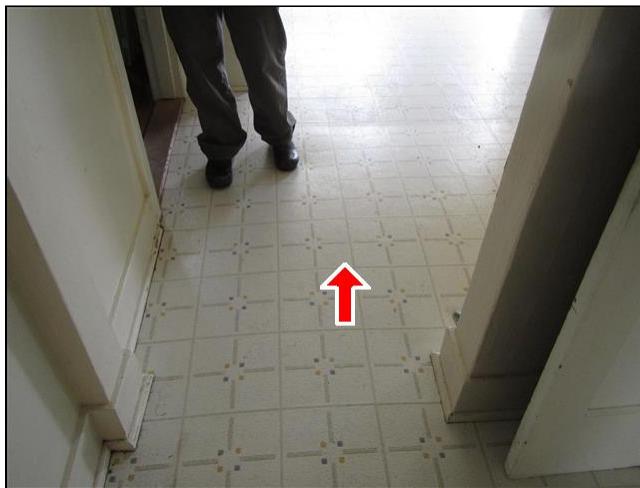
9.0 Photo 1 - floor lifting

Repair Replace/Comment- The vinyl flooring is lifting from air from the register and was not properly adhered. The client may want to repair this to prevent further lifting. I recommend a qualified person or contractor evaluate and repair as necessary.

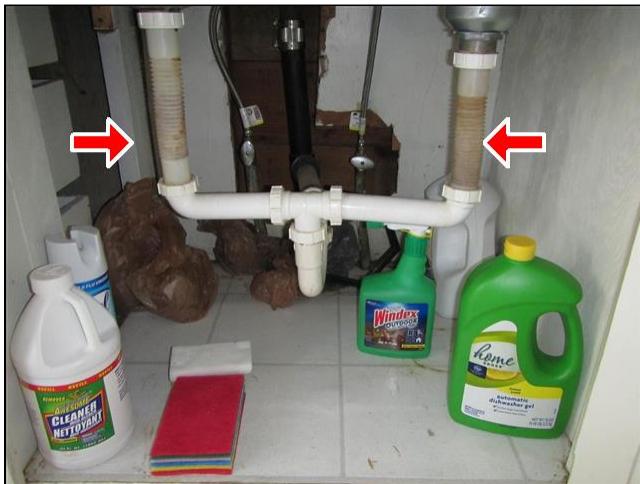
9.4 Photo 1

Comment- The use of a flexible tailpiece on the sink may not a good practice and may not be an approved method. I recommend when any other plumbing work is performed that this be evaluated and repaired as necessary.

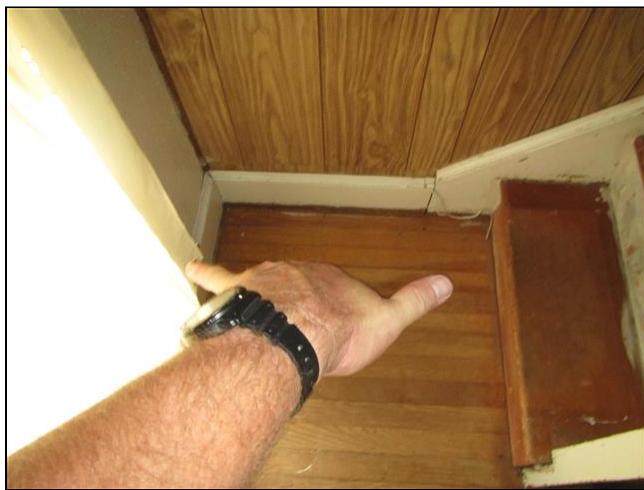
14.3 Photo 1

Repair Replace- Windows in stair landing not safety glass. Standard practices state that any windows that are within a 60 inch width by 60 inch height area, from the first stair tread, should be made using tempered safety glass. The stairway landings that include a window that lacks a guard railing and/or safety glass is a safety concern for someone who falls down the stairs should they fall into and break the window glass, or worse, fall right through the window. I recommend a qualified contractor evaluate, repair and replace as necessary.

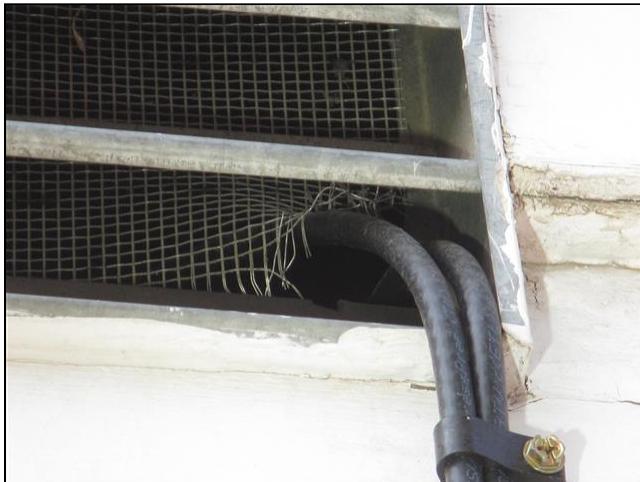
16.2 Photo 1

Repair Replace- The gable vent screen is damaged. This can allow entry by birds, rodents and pests. I recommend repairing the screen and evaluating for any issue from possible entry by pests.

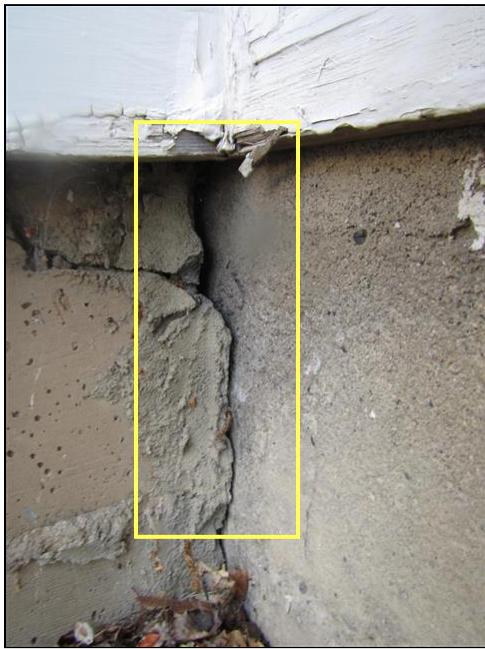
17.1 Photo 1

(2) **Maint-** A penetration/gap on the foundation wall of the crawlspace that could allow pest entry. The penetrations should be properly sealed to prevent rodent and pest entry. I recommend sealing as necessary.

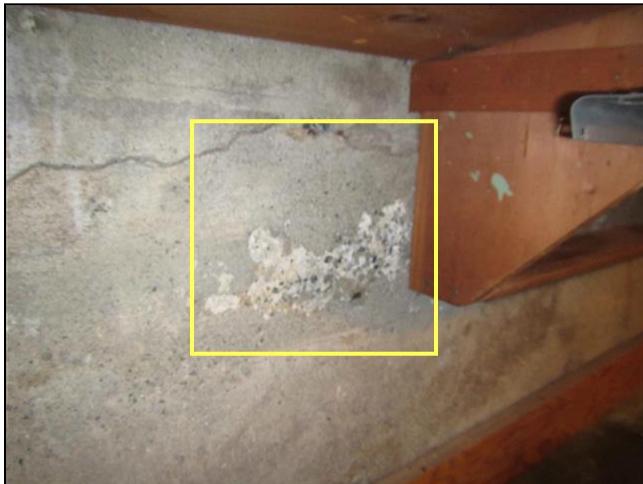
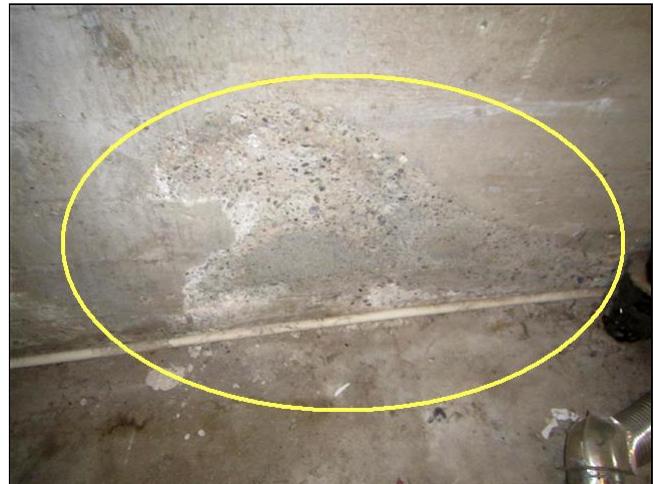
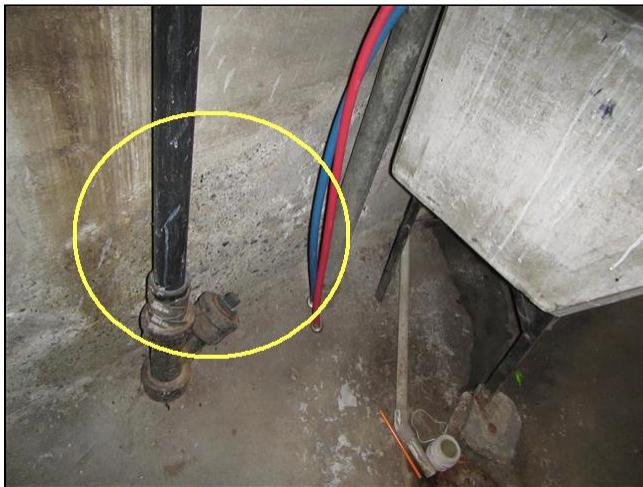
(3) **Monitor/Comment-** Spalling on concrete surface Spalling on concrete surface of foundation. This can be caused by several things from poor mixture of concrete, poor condition during a pour and other conditions. This also can be caused by moisture working through the concrete. If spalling is severe enough it could effect the structural integrity of the concrete. Efflorescence (white powdery material on concrete) and spalling can often be prevented in concrete by stopping moisture migration. This can be accomplished with a capillary break or liquid applied elastomeric waterproofing. At a minimum the client should monitor for any additional deterioration. If the the condition worsens I recommend a qualified contractor evaluate and repair as necessary.

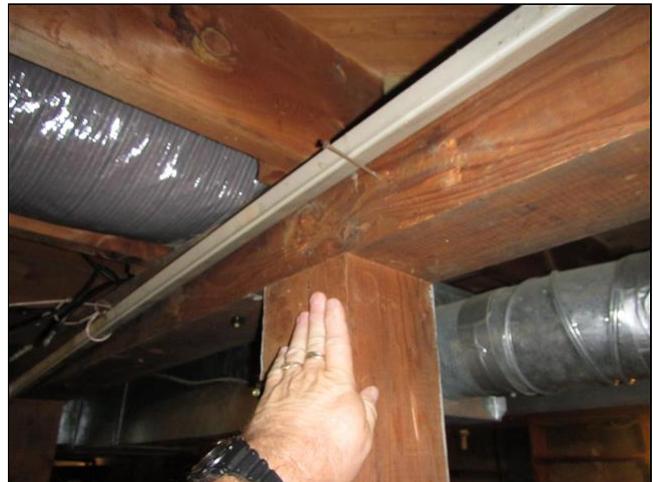
(1) **Repair/Replace-**There is no positive connections between the support posts to the beams above. Installing metal ties, bracing with lumber and/or plywood gussets as per standard building practices is recommended. I recommend a qualified person or contractor should evaluate and make repairs as necessary.

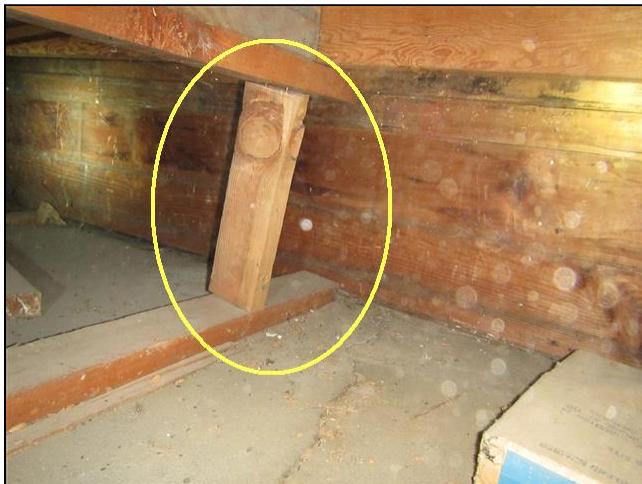
17.5 Photo 3

(2) Repair Replace- Cripple wall under bedroom is out of plumb. I recommend a qualified person or contractor evaluate and repair as necessary.
