CAP CITY PROPERTY INSPECTIONS LLC

HOME INSPECTION REPORT COPY

1234 Main St. Grove City OH 43123

12/17/2019 9:00AM

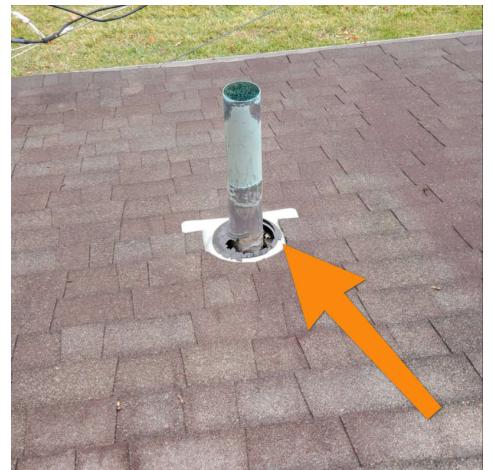
2.2.1 Roof Flashing & Vents

DAMAGED VENT BOOT ON ROOF

The rubber boot at a roof plumbing vent pipe was damaged and may allow moisture intrusion of the roof assembly.

Contact a qualified roofing professional.

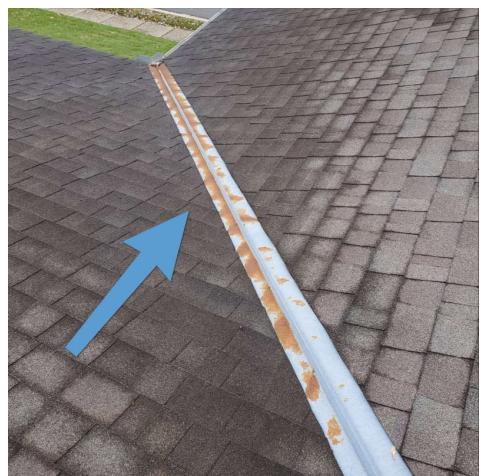
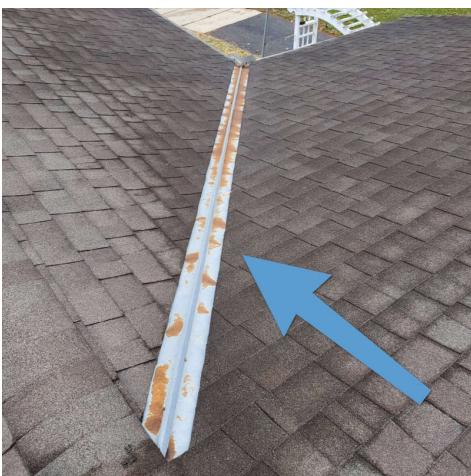
2.2.2 Roof Flashing & Vents

ROOF VALLEY FLASHING CORROSION

Valley flashing exhibited corrosion at the time of the inspection.

Contact a qualified professional.

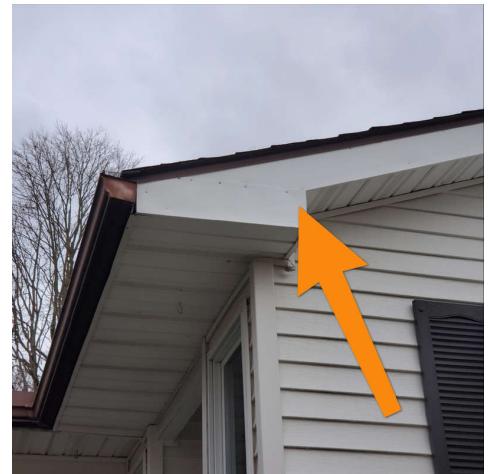
2.5.1 Walls, Trim and Foundation

POOR INSTALLATION - INCORRECT OVERLAP

Trim on the exterior had areas that were poorly installed at the time of the inspection. They were incorrectly overlapped and may allow water to penetrate behind parts of the trim.

Contact a qualified siding specialist.

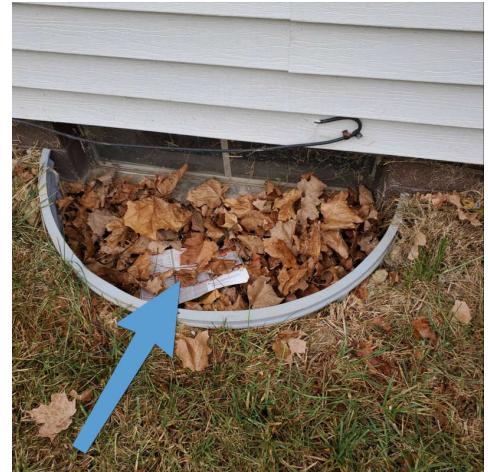
2.6.1 Doors and Windows

DEBRIS SHOULD BE REMOVED FROM WINDOW WELLS

Debris in window wells should be removed to help prevent any possible water or pest infestation.

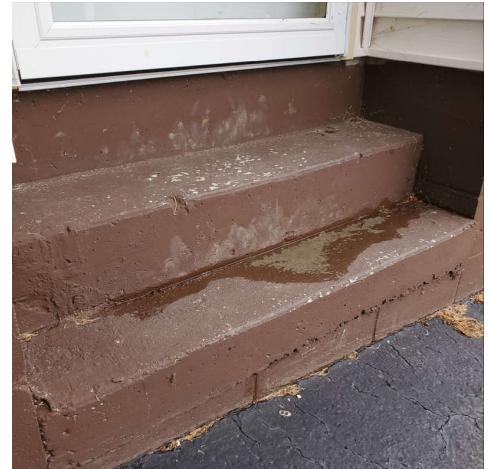
2.7.1 Deck, Porches and Patios

STAIRS STEEP

FRONT OF THE HOME

An exterior stairway was steep and may present a trip/fall hazard.

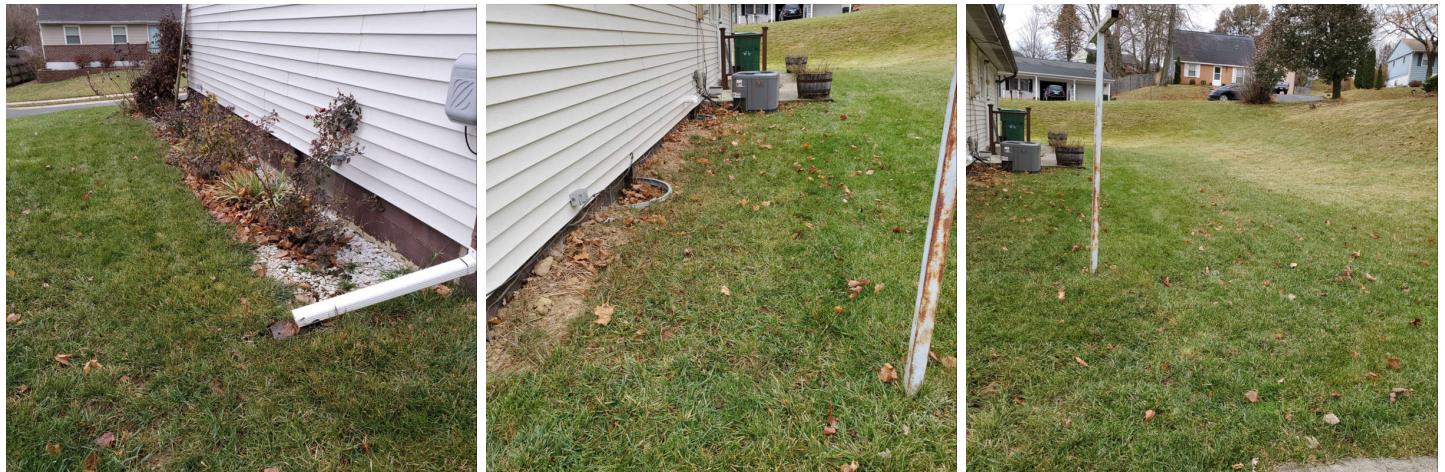
2.8.1 Walkways, Driveways and Grounds

NEUTRAL OR NEGATIVE GRADING AROUND THE HOME.

The home had areas of neutral or negative drainage that will route runoff from precipitation toward the foundation. Excessively high moisture levels in soil supporting the foundation can effect its ability to support the weight of the structure above. The ground should slope away from the home a minimum of 1 inch per foot for a distance of at least six feet from the foundation. The Inspector recommends that these area be re-grading to improve drainage near the foundation.

Contact a qualified grading contractor.

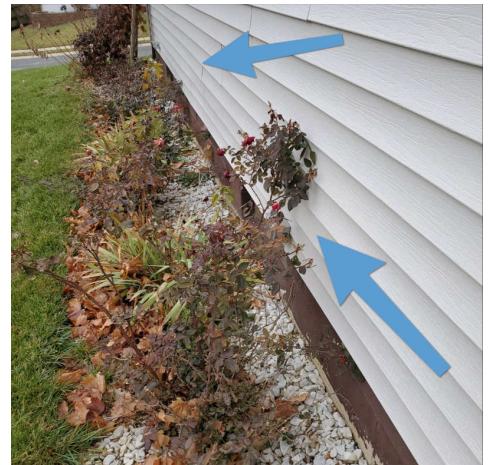
2.8.2 Walkways, Driveways and Grounds

OVERGROWN VEGETATION

Vegetation was overgrown and needed cut back at the time of inspection.

Contact a qualified professional.

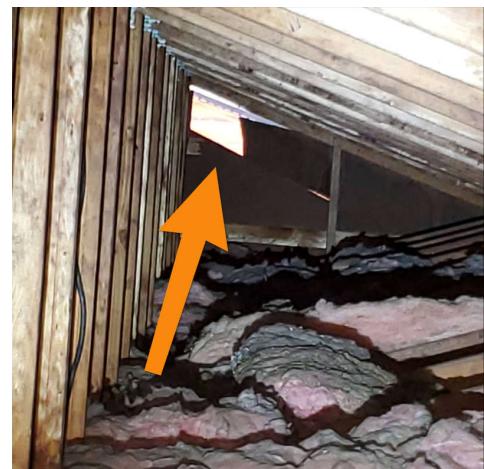
DAMAGE TO SHEATHING

There was damage to the home's sheathing visible from the attic.

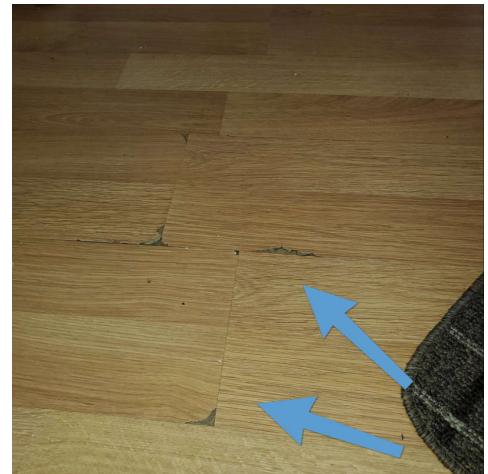
3.2.1 Ceilings, Walls & Floors

**MOISTURE DAMAGE TO LAMINATE FLOOR**

At the time of the inspection, laminate floors had areas of visible moisture damage.

Contact a qualified professional.

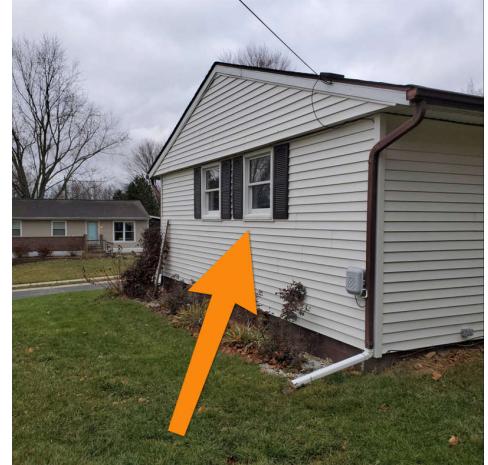
**A WINDOW HAD A FAILED SEAL AND MOISTURE INSIDE.**

Condensation visible in the double-pane glazing of a window indicated a loss of thermal integrity. Signs of thermal seal failure can be intermittent and not visible at the time of inspection. The Inspector recommends that you have each window in the home evaluated by a qualified contractor to determine the cost and exactly how many windows need to be repaired or replaced.

Contact a qualified professional.

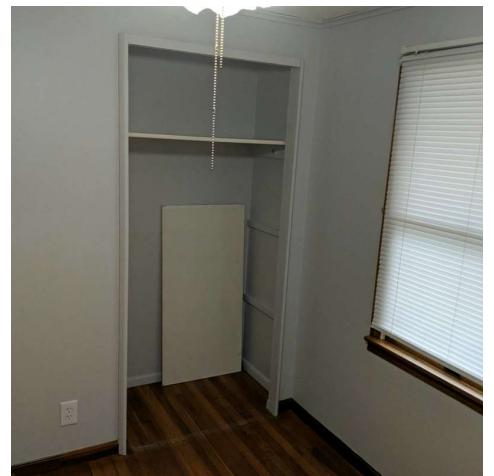
3.4.2 Doors & Windows

CLOSET DOOR MISSING

A closet door was missing at the time of inspection.

Contact a qualified door repair/installation contractor.

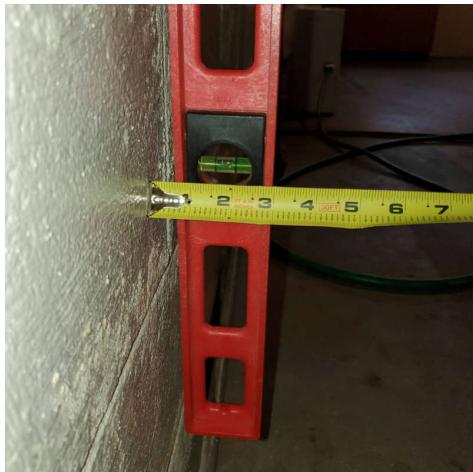
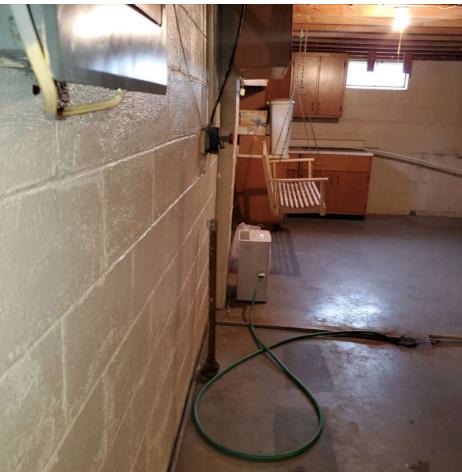
3.6.1 Foundation

FOUNDATION BOWING AT FROST LINE.

Larger than typical foundation bowing and cracking was observed. This is usually the result of expansive soil or frost pressure. Lot drainage and foundation improvements should be addressed to keep water away from the building. A foundation contractor should evaluate the wall to determine if repairs are necessary. The rate of movement cannot be predicted during a one-time inspection. These cracks may need sealing on the exterior to prevent moisture penetration.

Contact a foundation contractor.

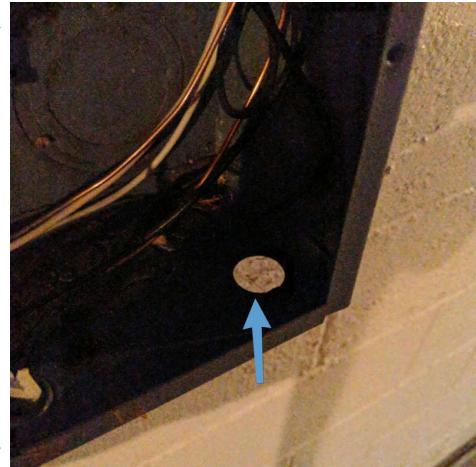
4.2.1 Service Equipment

MISSING KNOCKOUT IN SERVICE PANEL

Missing knockout in the main service panel could allow rodents to enter the panel.

any exposed panel openings
(that would allow access to the
inside of the panel) should be
fitted with secure covers

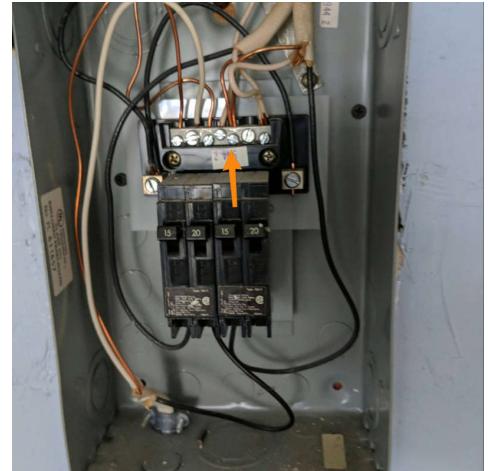
4.3.2 Service Equipment garage

MULTIPLE NEUTRALS UNDER ONE LUG "DOUBLE TAP"

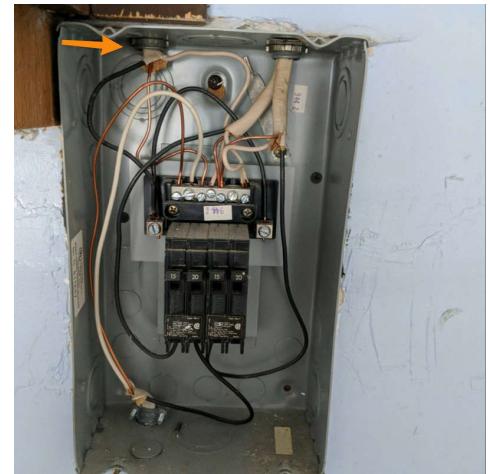
4.3.3 Service Equipment garage

120 VOLT SERVICE TO SUB PANEL

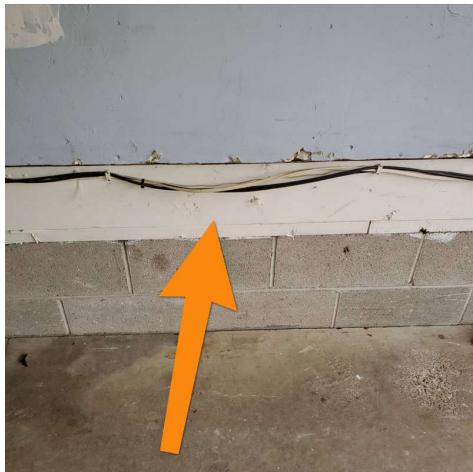
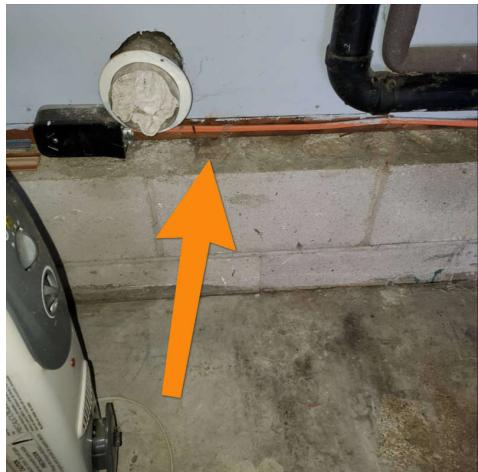
4.5.1 Visible Branch Wiring

ELECTRICAL WIRES EXPOSED TO DAMAGE

These electrical wire were exposed to accidental damage and should be properly protected.

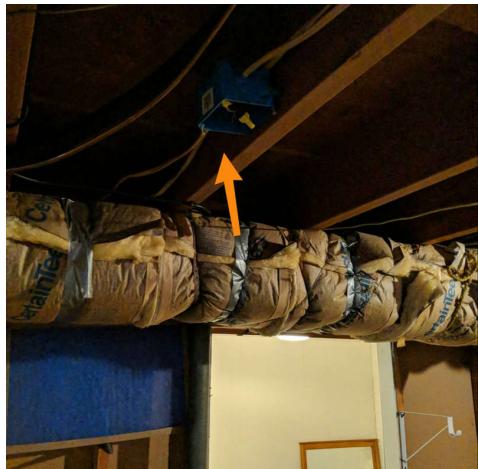
4.5.3 Visible Branch Wiring

MISSING JUNCTION BOX COVER

A junction box installed was missing a cover and energized electrical components were exposed to touch. This condition is an electrical shock/electrocution hazard.

Contact a qualified electrical contractor.

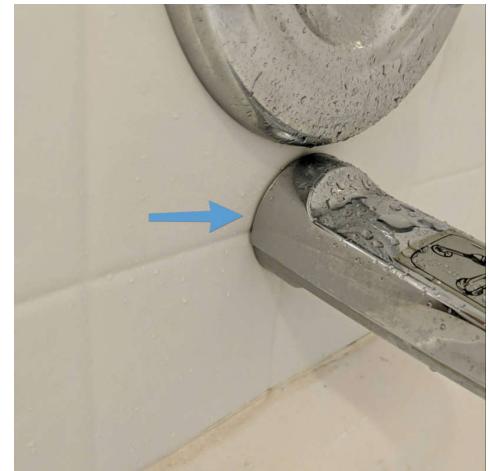
BATHROOM

The spout on the bathtub needed sealant at the time of inspection.

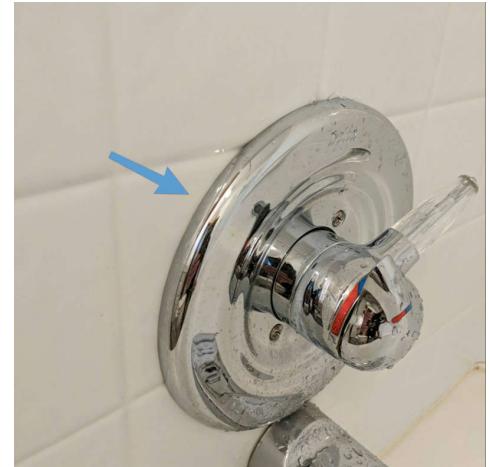
8.3.2 Fixtures

The handle on the bathtub faucet needed sealant at the time of inspection.

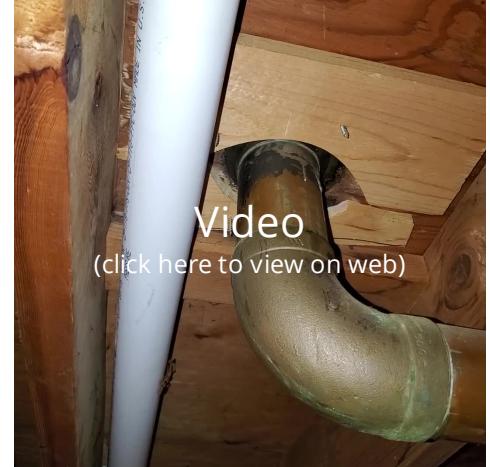
8.3.3 Fixtures

TOILET LEAKED INTO FLOOR BELOW

The toilet leaked into the floor below when it was operated. We could not determine the condition of underlying materials.
