TOPNOTCH BUILDING INSPECTIONS

PRE-PURCHASE RESIDENTIAL

1234 Main St. Preston Victoria 3072

25/10/2021 9:00AM

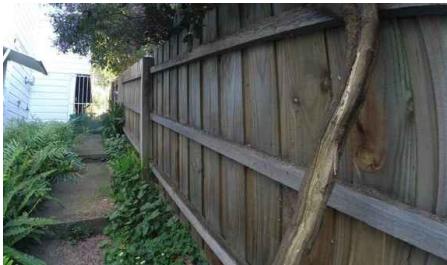
South Fence - Serviceable

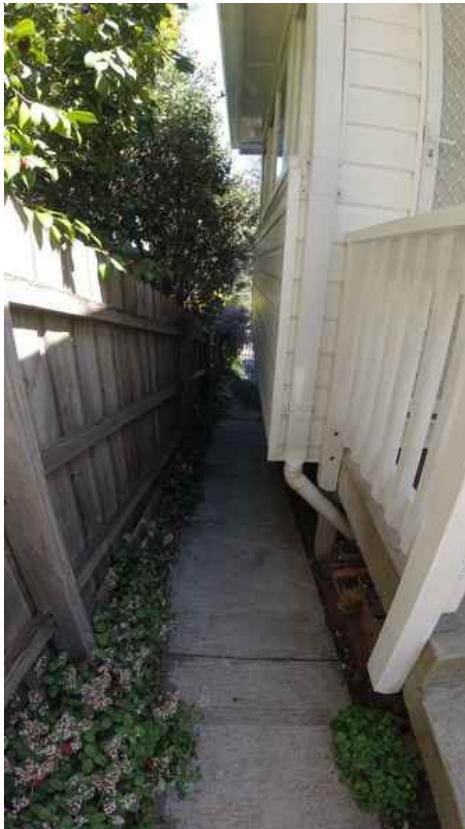
South Fence - Serviceable

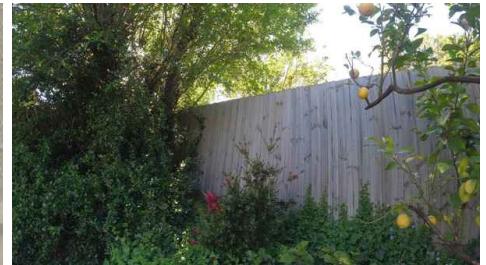
East Fence - Serviceable

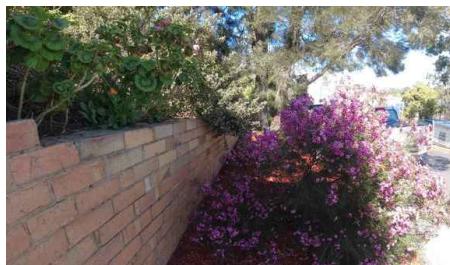
Front Fence - Retaining Wall

The front brick fence has "horizontal and stepped cracking" of the brickwork in one or more locations. Horizontal cracking are just that, horizontal cracking and stepped cracking or cracks are cracks that zig zag and follow the course of the brickwork and they are usually the result of cracking or movement in the footing structure.

It is quite common for a brick fence to crack in this manner and even more so because the wall is also acting as a retaining wall. In this case, the cause of the cracking is most likely due to the influence of the large tree which is located adjacent to the wall, and when combined with the soil loads behind the wall, cracking often occurs.

I have observed this (these) crack(s) and classified them as generally having a crack width limit of <5mm with a Damage Category of 2, Slight.

I recommend to monitor the cracking of the brickwork and should the cracks increase in size or frequency, contact a qualified engineer for further advice.

Recommend monitoring.

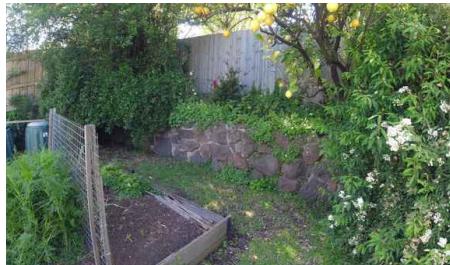
Rear Stone Retaining Wall

The retaining wall or some sections of the retaining wall are cracking and leaning. This is an indication of ground pressure behind the wall.

I recommend to monitor and if the leaning increases, engage an engineer to further evaluate.

Recommend monitoring.

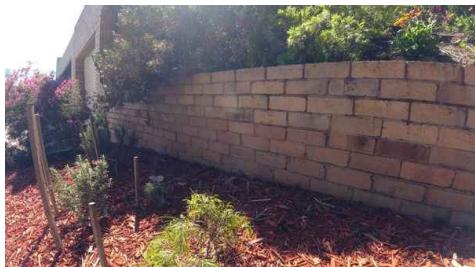
Horizontal and Stepped Cracking

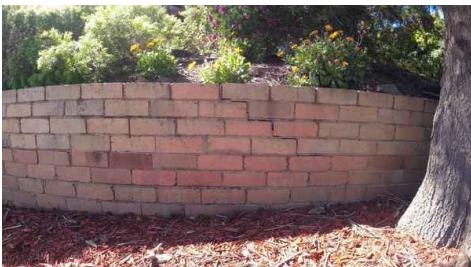
Stepped Cracking

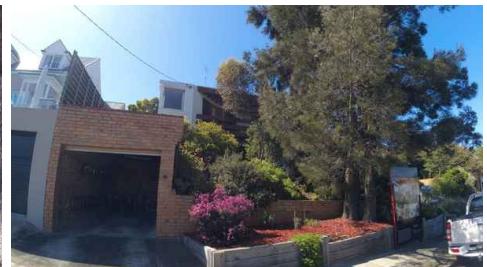
Note Large Tree

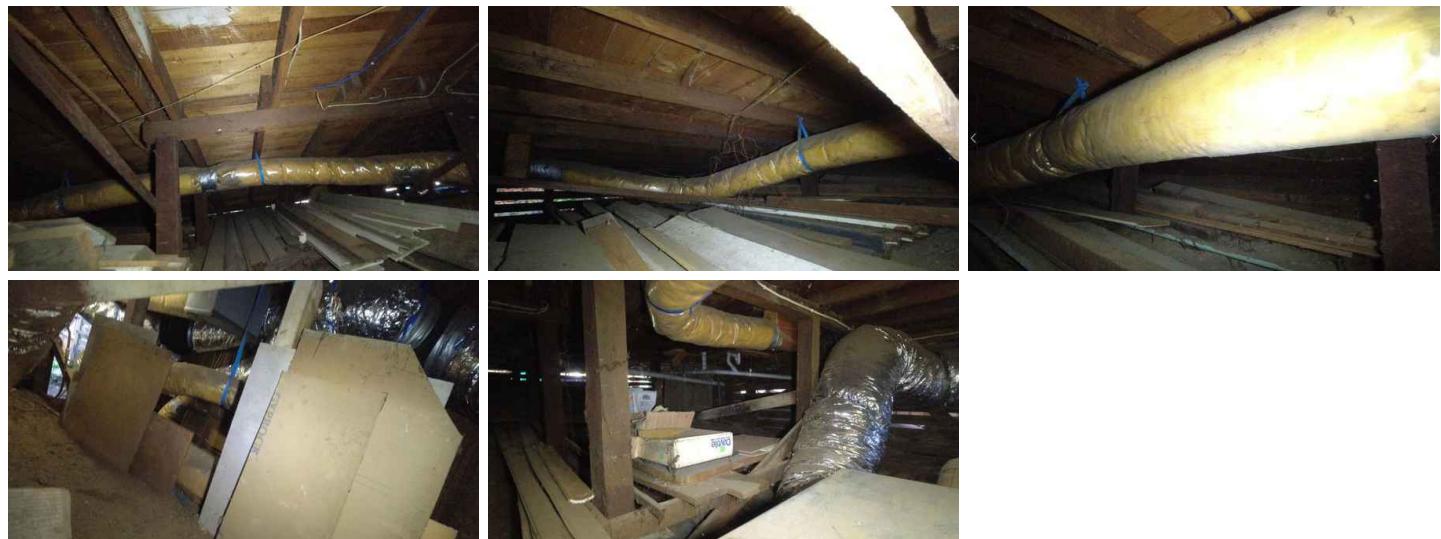
Building materials and or debris / foreign matter were found areas of the subfloor.

I recommend removing all building materials, debris and foreign matter from the subfloor area.

Contact a handyman or DIY project

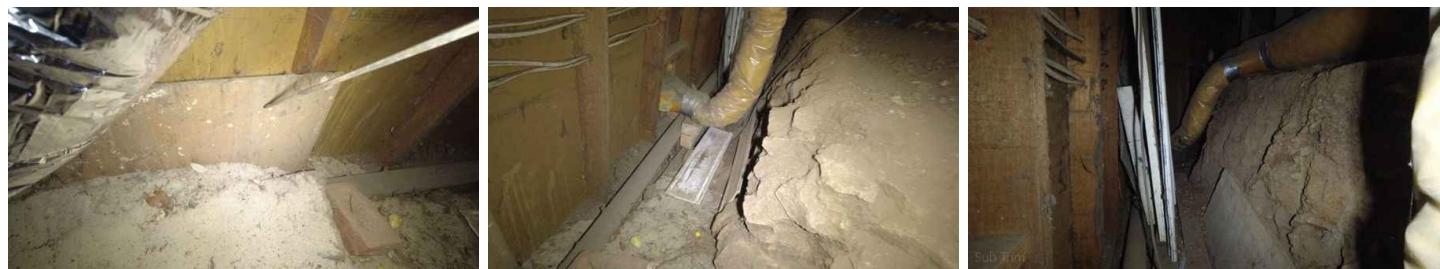
4.3.2 Floor Structure

SOIL / GARDEN HIGH ON FOUNDATION (SLAB)

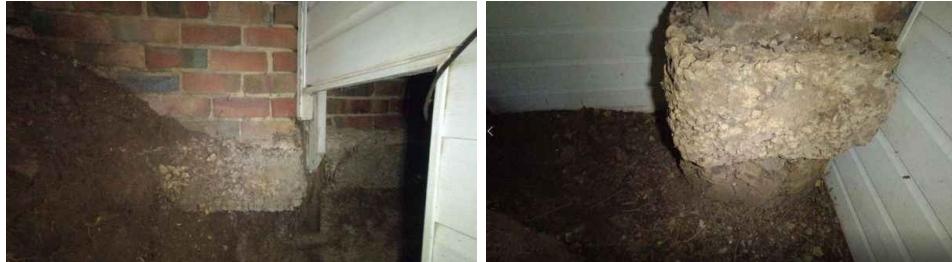
4.3.1 Floor Structure

Soils or other ground finishes were observed to be in contact with; or in close contact with the subfloor structure members.

These condition may cause the subfloor members to prematurely fail due to wood rot, pest/insect attacks, mould etc.

I highly recommend ensuring all structural subfloor members are sufficiently clear of any soils, stones, rocks or organic matter.

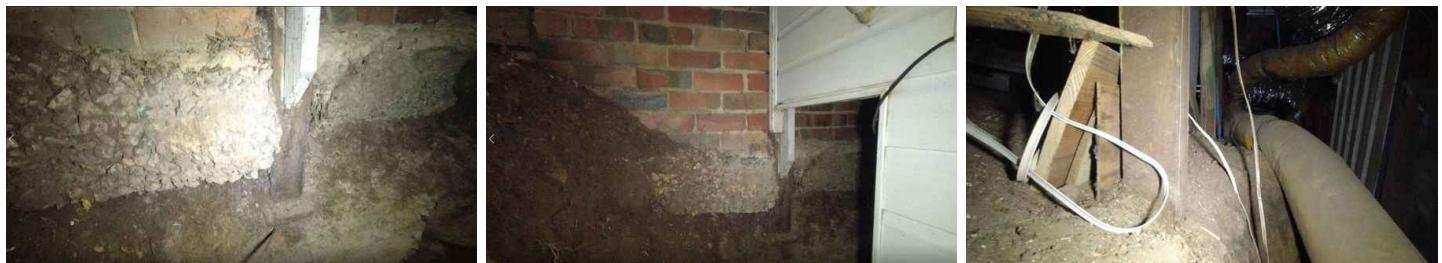
4.3.4 Floor Structure

The soil adjacent some stumps has been removed beyond the angle of repose. Although fortunately this has not created a major problem to date, undermining supporting members such as stumps can lead to structural failures.

I strongly recommend replacing the timber stumps that are in this zone of influence with new concrete stumps that are installed below the angle of repose of the batter created during the excavation.

Contact a qualified professional.

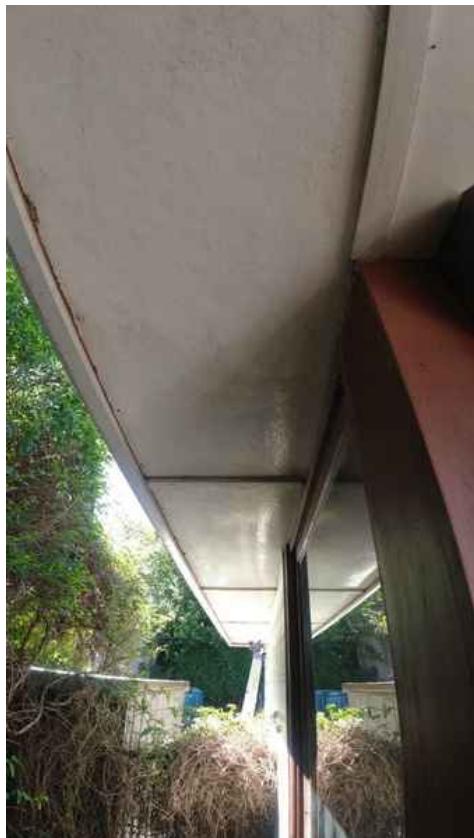
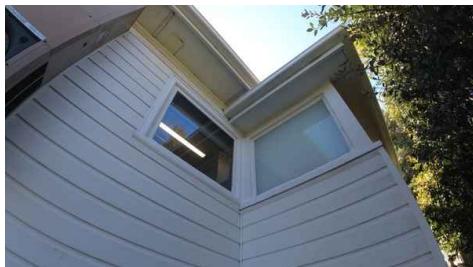
MINOR DEFECT**SUSPECTED ASBESTOS CONTAINING EAVES MATERIALS**

Although identifying asbestos containing materials is beyond the scope of a pre-purchase building inspection; and positively identifying asbestos containing materials must be undertaken by a NATA accredited testing facility; there are tell tale signs that help identify asbestos containing materials and in my professional opinion, I am certain that the eaves linings are made from asbestos containing materials. That said, the as installed linings are considered to be safe unless they are cut, drilled, sanded, broken or removed.

Contact a qualified professional.

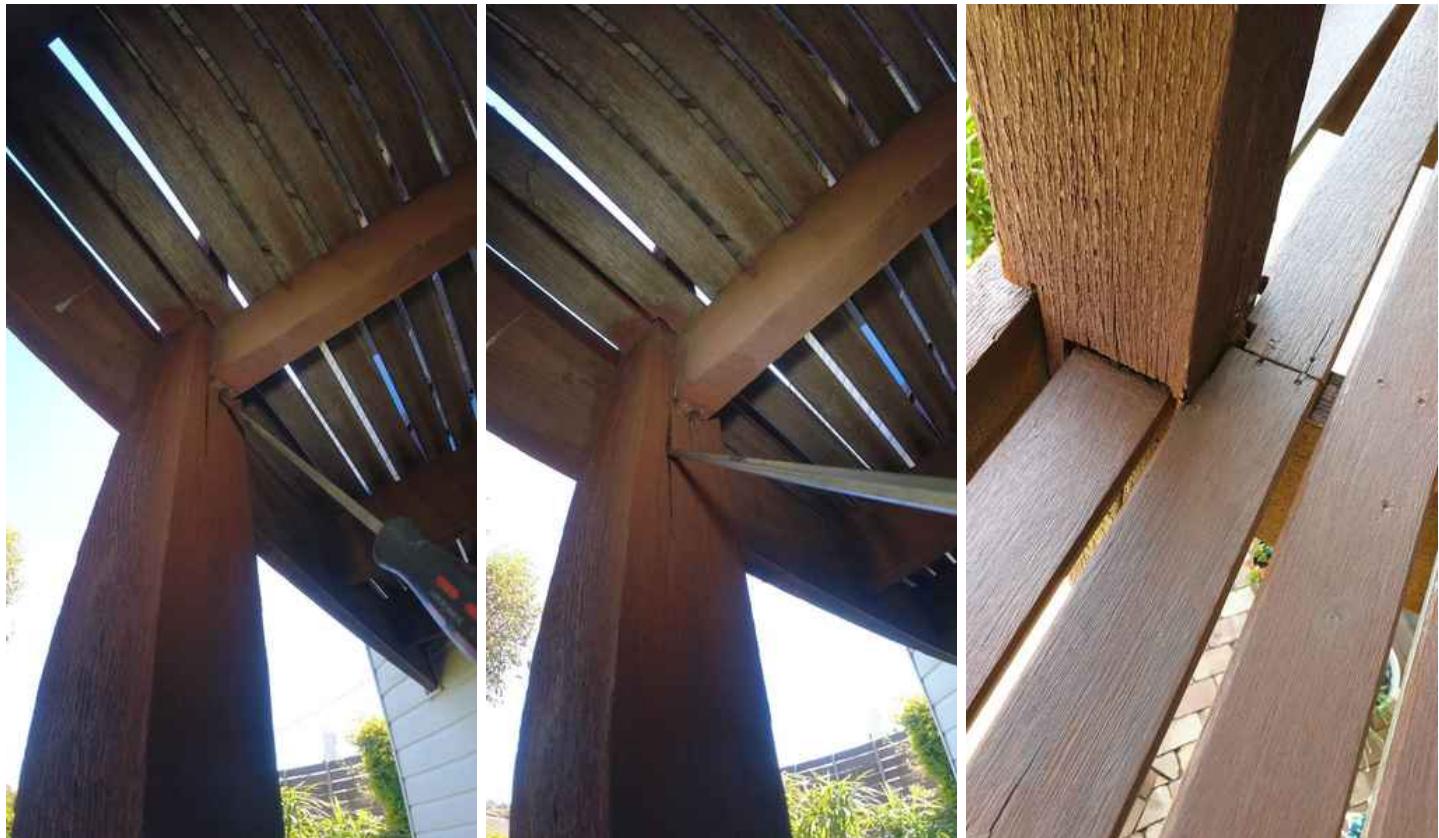
STRUCTURAL POST - WOOD ROT

MAJOR DEFECT / SAFETY HAZARD

The structural posts of the balcony have wood rot at the junction of the post - ledger and joists in one or more locations. This is a safety hazard that must be rectified as a matter of priority to prevent further deterioration of the deck and a structural failure.

I recommend contacting a licenced engineer for advice and a work method to make safe and repair.

Furthermore, I recommend not using the balcony until it is made structurally sound.

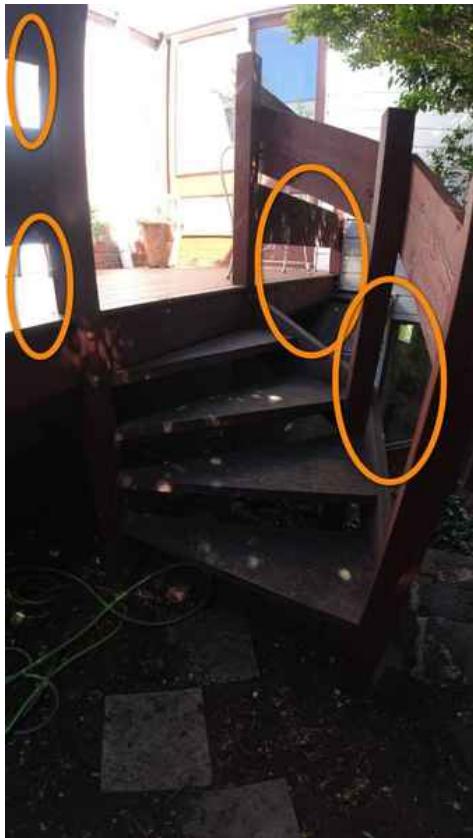
5.10.1 Steps

RAILING UNSAFE

Contact a qualified deck contractor.

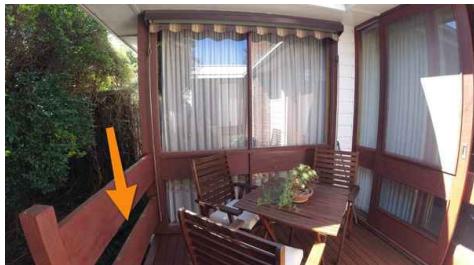
MAJOR DEFECT / SAFETY HAZARD

There are unsafe openings in the balustrade of the stair and decking area. The spacing on the rails should not exceed 125mm. An opening greater than 125mm is a serious safety hazard especially for children as their head or other body part can become trapped.

I recommend reducing the openings of the balustrade / rails of the staircase and decking area.

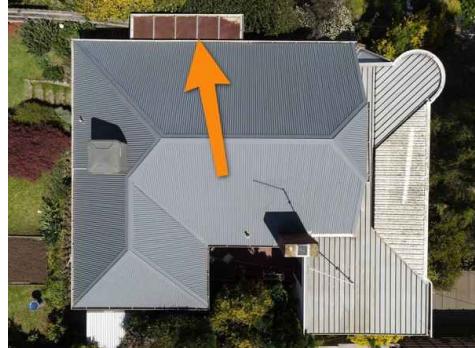
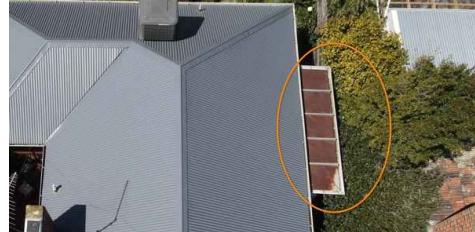
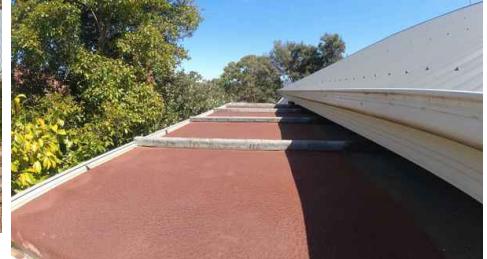
METAL ROOF - RUST (MODERATE)

The metal roof is rusting in some areas and requires repair or replacement.

I recommend to engage a qualified roofing contractor to repair or replace.

Contact a qualified roofing professional.

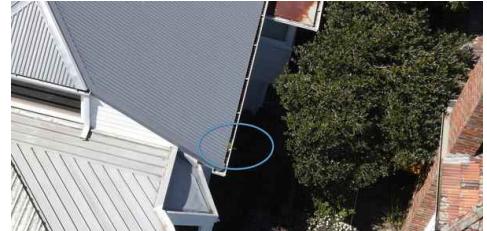
6.3.1 Gutters / Downpipes

Note: Leaf litter and debris may cause premature rusting of the eaves gutter system.

I recommend removing all debris from the eaves gutters and check for adequate falls to downpipes.

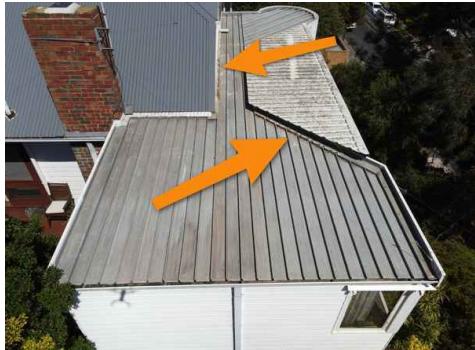
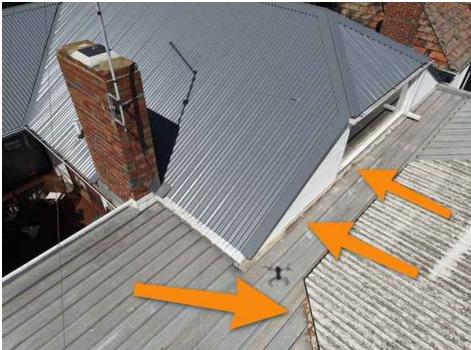
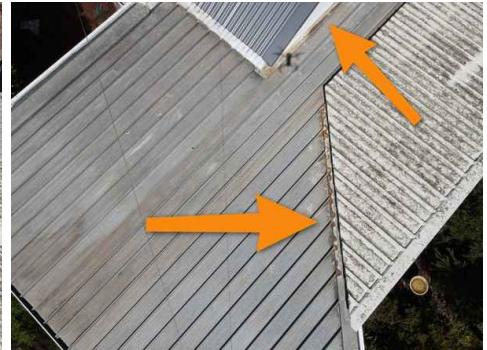
MINOR DEFECT

Contact a qualified roofing professional.

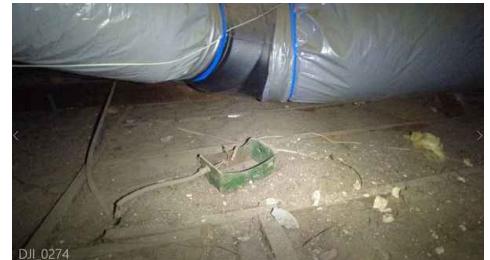
7.2.2 Electrical

UNCLIPPED ELECTRICAL WIRING

Contact a qualified electrical contractor.

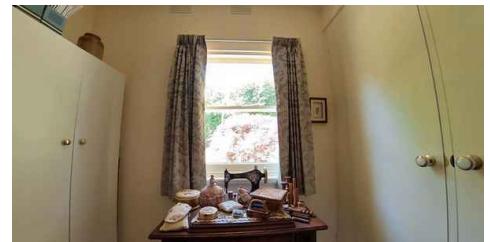
The double hung window is painted shut and inoperable.
I recommend windows be restored to functional use.

Contact a qualified window repair/installation contractor.

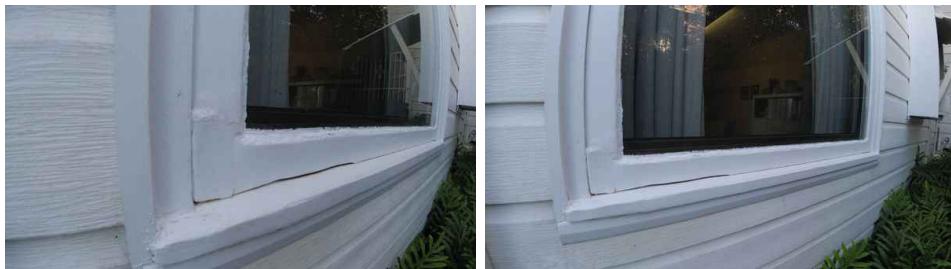
MINOR DEFECT

WOOD ROT AND PAINTED SHUT

The window in this bedroom is not operational has wood rot damage to the frame and sash, and has been painted shut.

I recommend further investigation of the window frame and if it is cost effective repair and install a new window sash. If not, replace the entire window frame and sash with new.

Contact a qualified window repair/installation contractor.

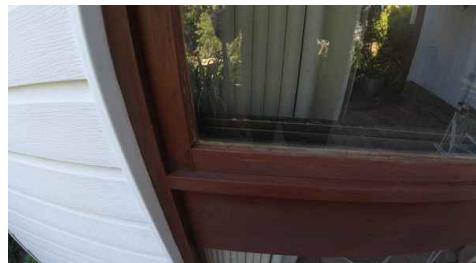
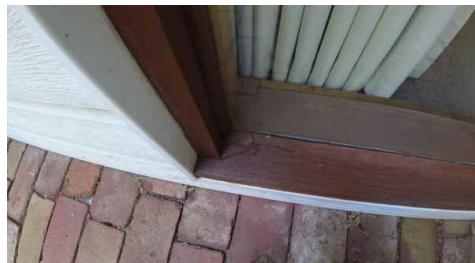
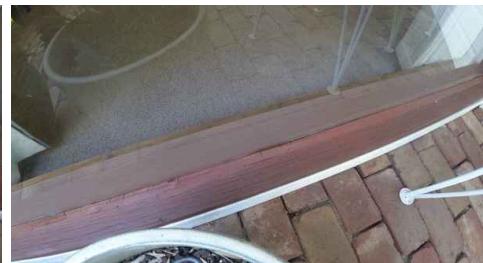
The glazing bead of this window is not installed or damaged.

I recommend to install a new glazing bead and paint as required to prevent damage from moisture ingress.

Contact a qualified window repair/installation contractor.

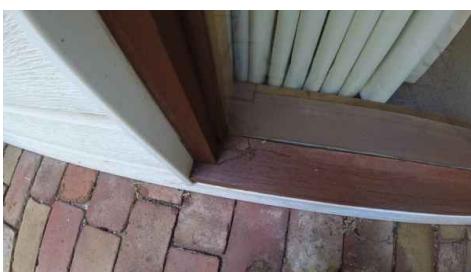
12.2.3 Windows

WOOD ROT - FRAME

Contact a qualified window repair/installation contractor.

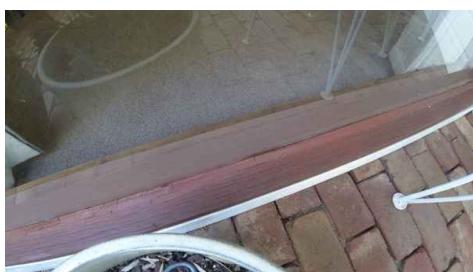
Sill

The window frame in this bedroom has wood rot damage in one or more locations. I recommend to repair, paint and monitor to prevent further damage.

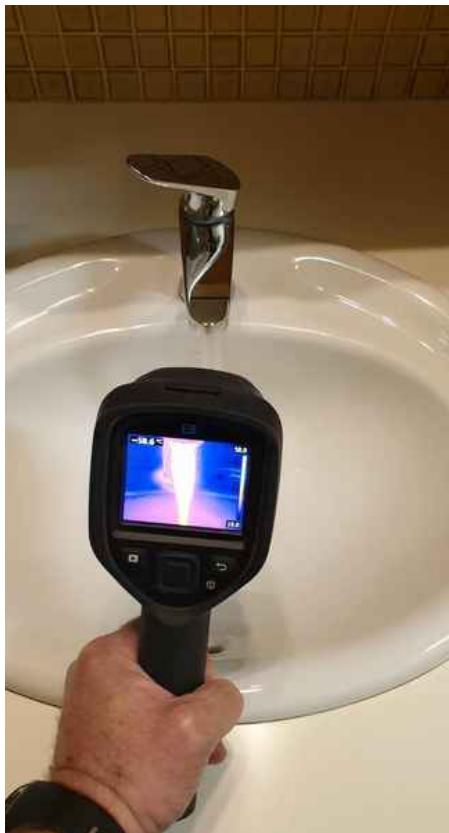
The current regulations state that the maximum temperature for delivery to bathrooms is **50 degrees**. All bathroom areas must adhere to this limit. The temperature is this number because numbers higher than this can cause injury and scalding within seconds. The recommended bathing temperature is 37-38 degrees. This should be regarded as the maximum for young children.

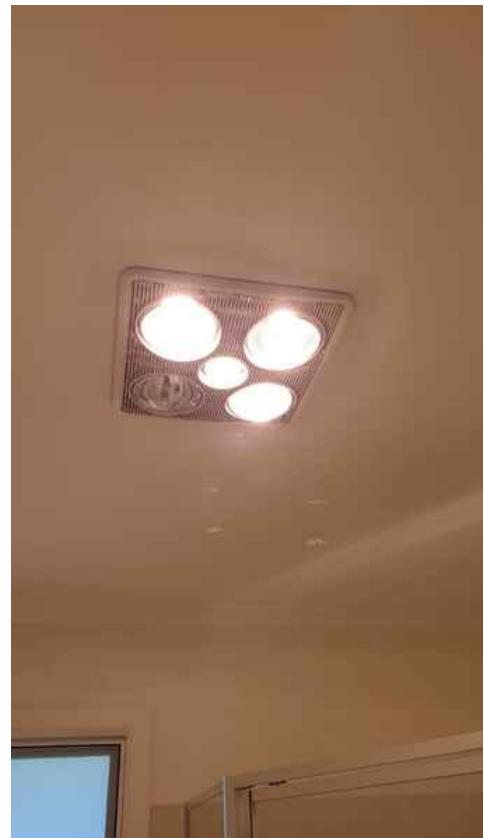
The lamps may only require replacing with new lamps or the fixture may not be operating as intended.

I recommend replacing the heat lamps as required and if that does not solve the problem contact a licenced electrician to rectify or replace as required.

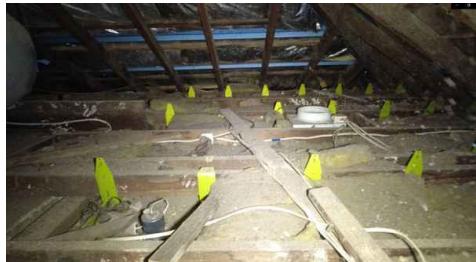
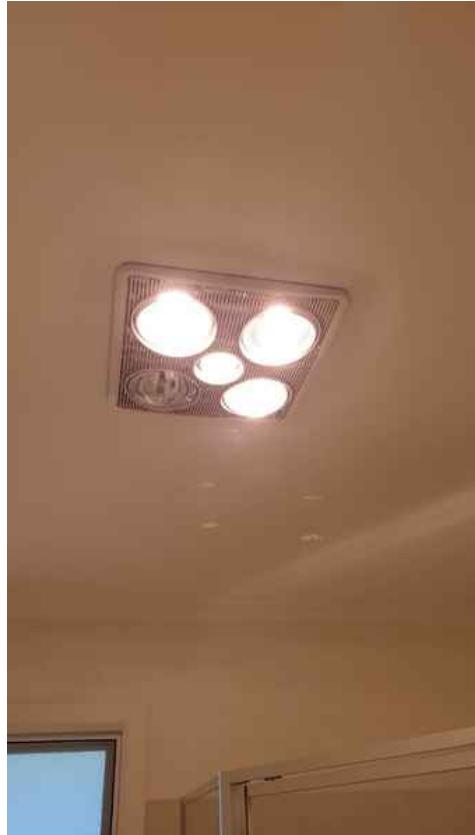
15.22.1 Lighting Fixtures, Switches & Power Outlets

EXHAUST FAN VENTED INTO ROOF SPACE

Although perhaps not a defect at the time of construction, today it is good building practice and in fact now it is a requirement that all exhaust fans within a dwelling are vented to atmosphere.

I recommend venting the exhaust fan to atmosphere to help prevent condensation within the roof space.

Contact a qualified plumbing contractor.

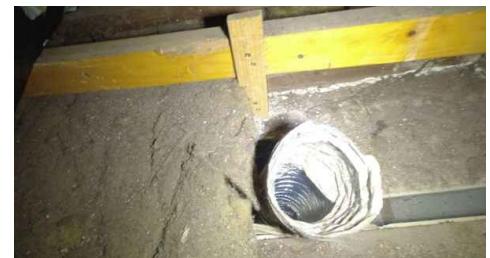
The kitchen range hood is currently vented to the roof space. Previously, a tiled roof was considered to be ventilated and therefore it was adequate to vent exhaust fans into this space. Currently, this has changed and new kitchens are required to be vented directly to atmosphere. Although not a defect when constructed / renovated years ago, it is good building practice and desirable to vent to atmosphere to avoid a build up of moist air in the roof space.

Contact a qualified professional.

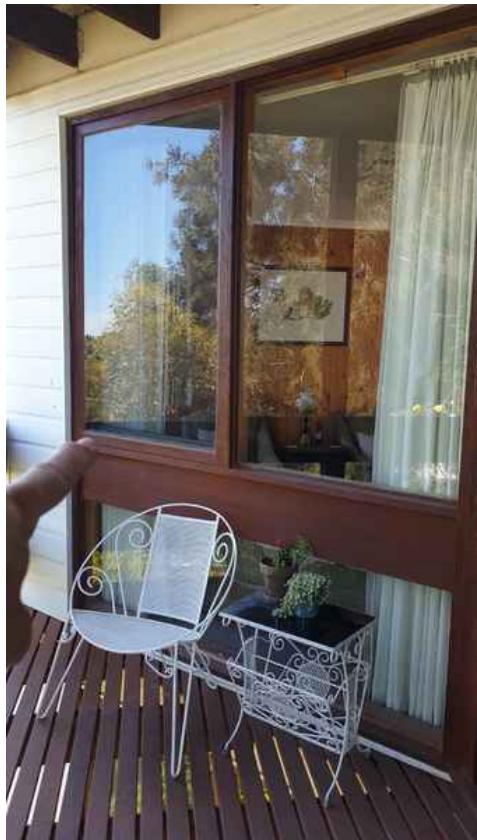
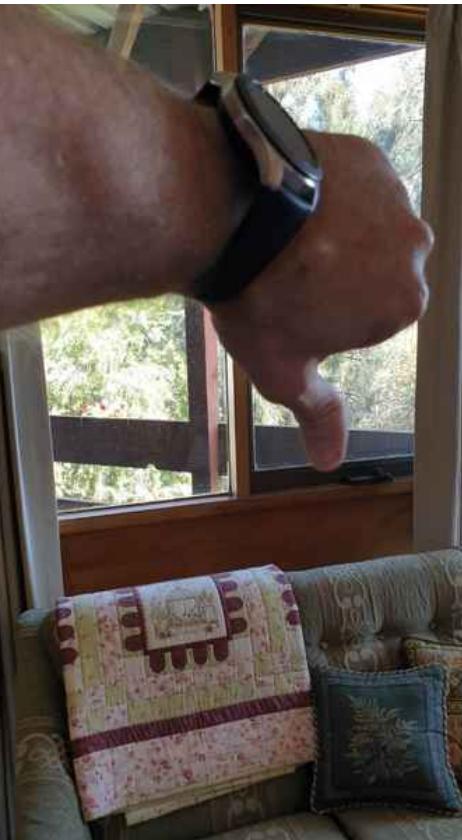
20.2.2 Windows

SASH - NOT FUNCTIONAL

The window sash in this bedroom does not open and does not function as intended.
I recommend to undertake maintenance, repair or replace and paint to make functional.

Contact a qualified window repair/installation contractor.

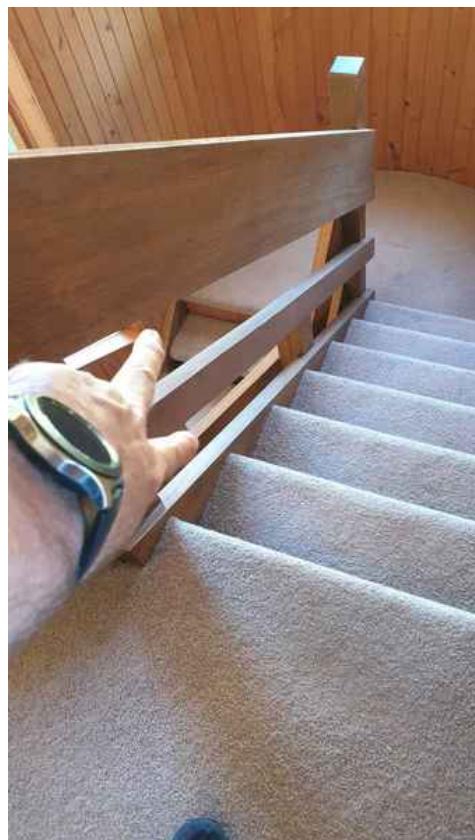
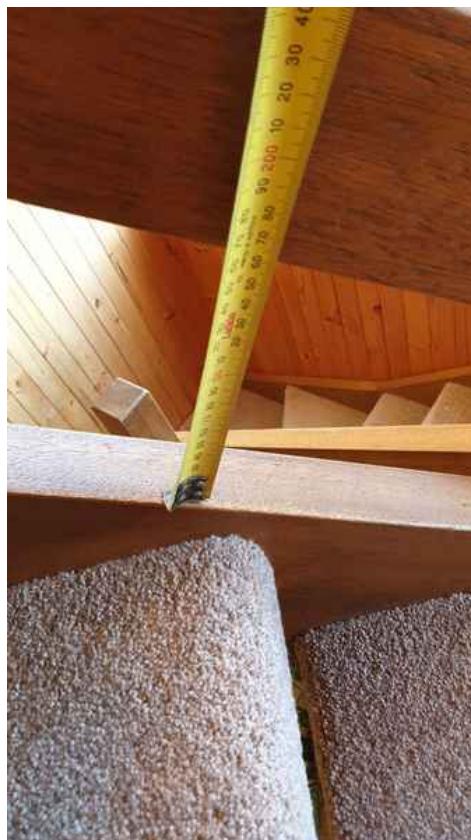
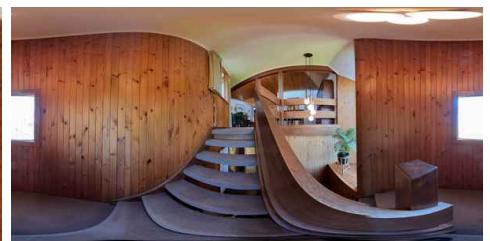
- MINOR DEFECT

Recommend a qualified handyman or original installer repair and bring up to code.

Contact a qualified professional.

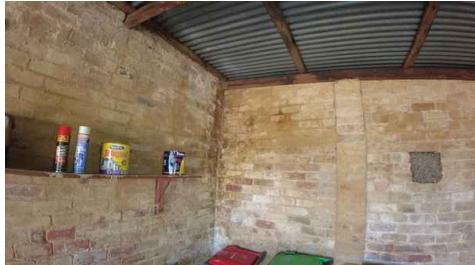
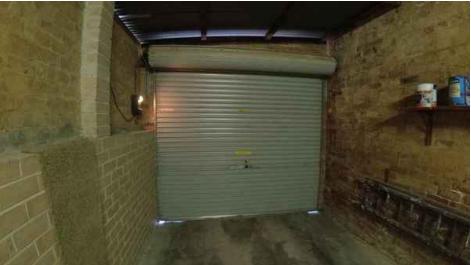
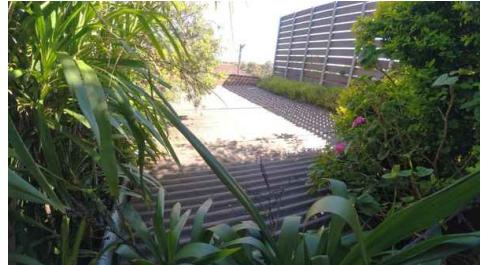
MINOR DEFECT

When inspecting the garage, I observed evidence of dampness - moisture ingress in through the wall structure in one or more locations.

Although this may be a long term issue, it is a failure of the waterproofing (if any) and in time will further degrade the structure. As can be seen in the photographs, evidence of moisture ingress and salt attack is occurring.

I recommend contacting a licenced engineer or waterproofing specialist to help with a methodology to mitigate the water - moisture ingress.

Contact a qualified professional.

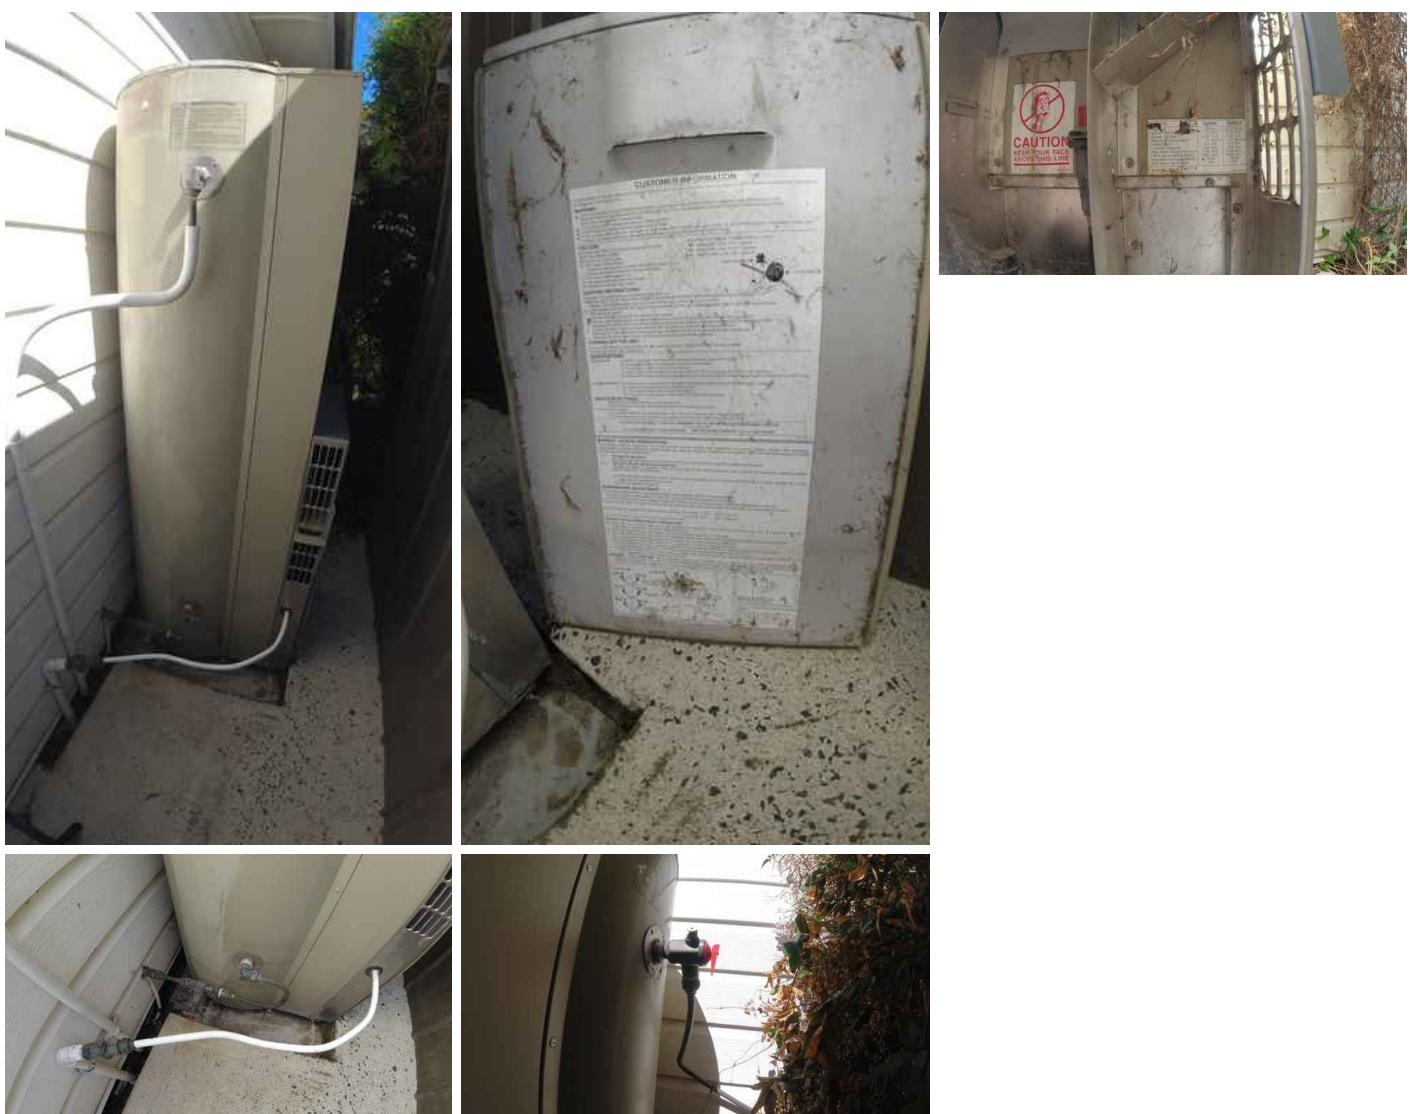
Hot Water System: HOT WATER SERVICE: CONDITION & PHOTOS

Serviceable
