FOREVER HOME INSPECTION - OKLAHOMA

## RESIDENTIAL REAL ESTATE INSPECTION REPORT

1234 Main St. Beggs OK 74421

06/12/2021 9:00AM

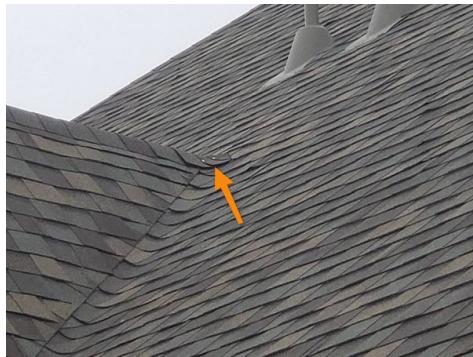
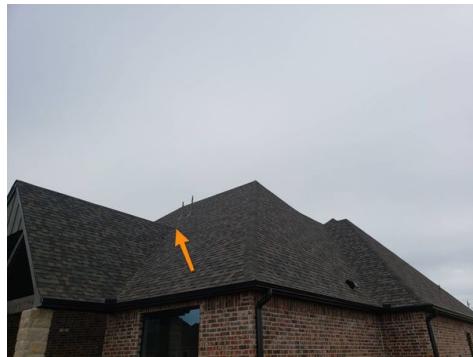
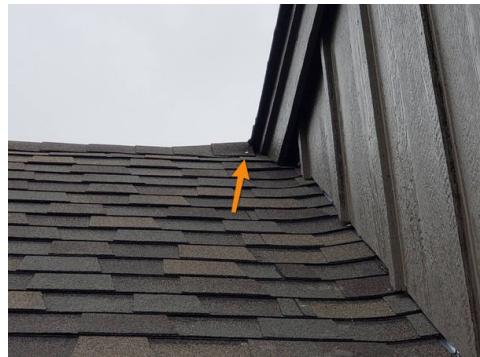
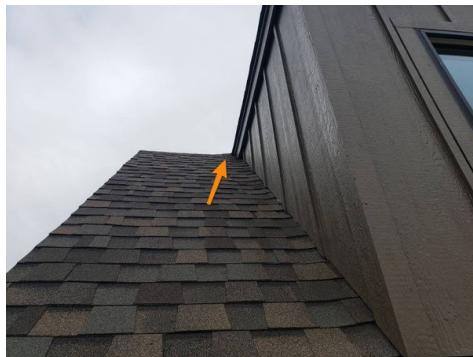
## 2.1.1 Roof Covering

Exposed nail heads were present on the shingles in the referenced area(s). Sealing any exposed nail heads is recommended to be conducted by a qualified roofing professional to prevent the possibility of leaks.

Defect - Medium Concern

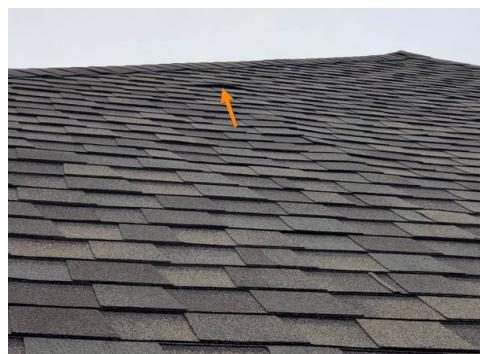
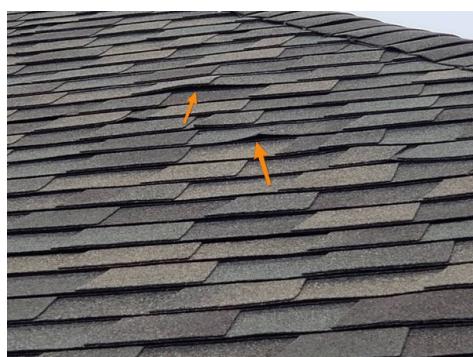
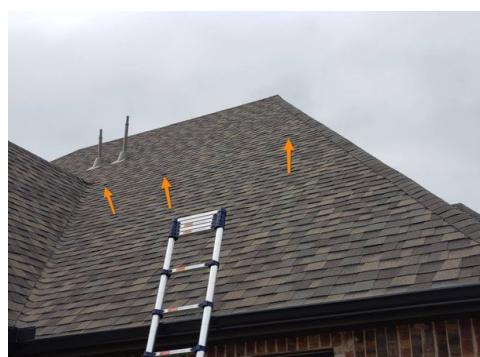
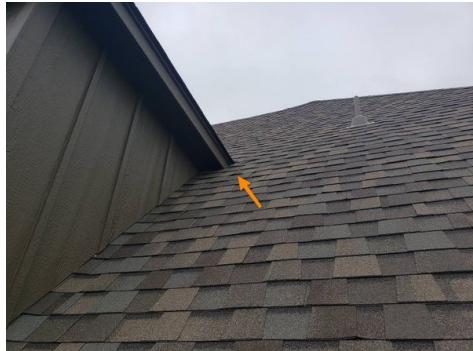
## 2.1.2 Roof Covering

**SHINGLES-IMPROPER INSTALLATION OF FASTENERS**
- Defect - Medium Concern

Fasteners were present that were, underdriven, angled, and/or overdriven. This can allow for roof leaks or for loosening of the shingles. Improper installation will also void the shingle warranty. Evaluation of the shingles is recommended by a roofing contractor with repairs or replacement made as necessary.

Contact a qualified roofing professional.

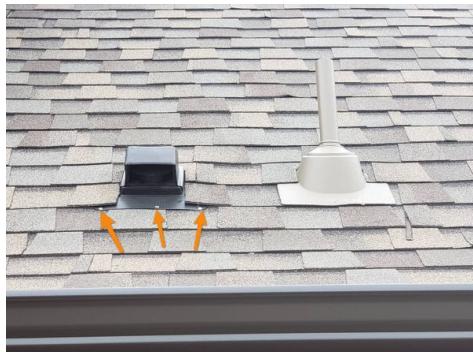
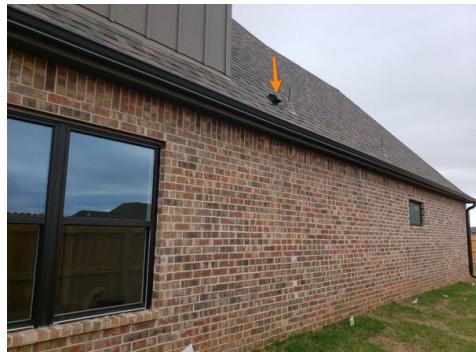
EAST

## 2.3.1 Roof Vents / Protrusions

Exposed nail heads were present on the rain boot(s). Proper sealing of any exposed nail heads is recommended by a qualified person to prevent the possibility of leaks.

Defect - Medium Concern

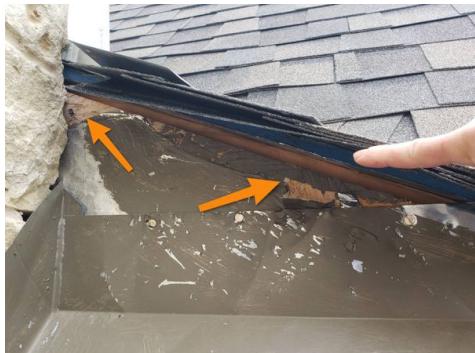
## 2.4.1 Roof Flashings

**FLASHING-INADEQUATE**

Flashings were present that were installed in an improper manner, and/or the flashings were inadequate. This can allow for rainwater infiltration into areas that were intended to be protected by these flashings. An evaluation of the roof flashings with repairs made to prevent rainwater infiltration to underlying wood or into the roof structure is recommended to be conducted by a qualified roofing contractor.

Defect - Medium Concern

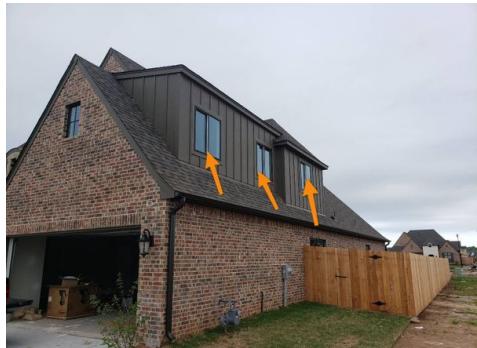
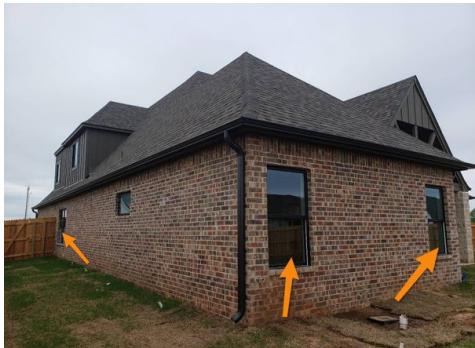
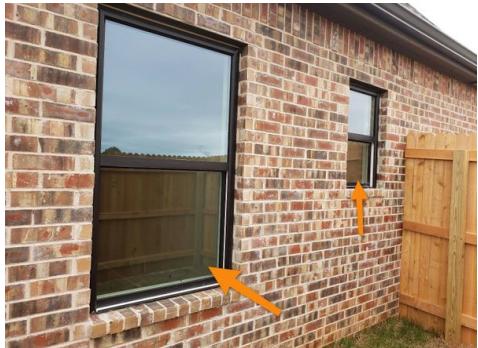
#### **SCREENS-MISSING/DAMAGED**

Multiple windows were observed with damaged and/or missing screens. Replacement of screens are recommended as needed.

Contact a qualified professional.

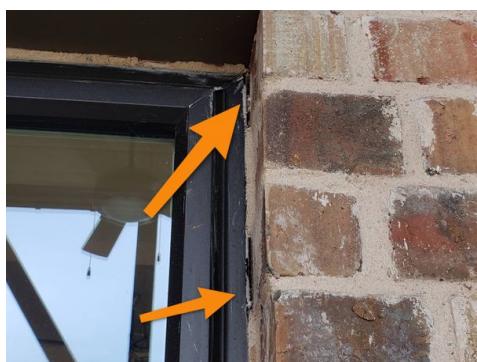
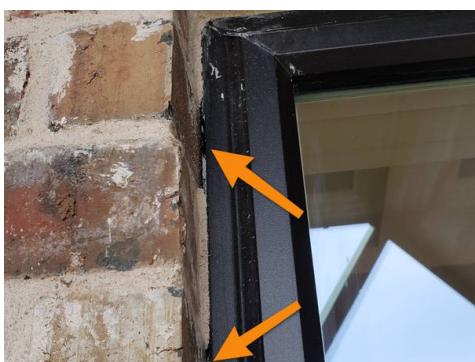
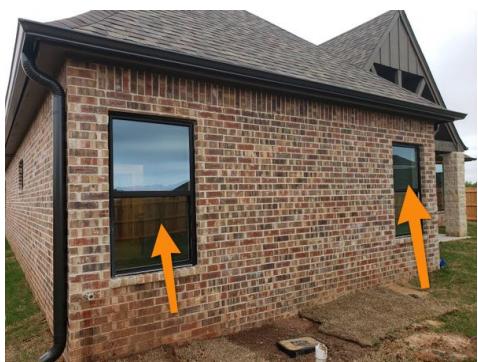
### 3.2.2 Exterior Windows

Some gaps were present in the sealant around the windows. Any gaps are recommended to be sealed as needed to prevent moisture and/or insect infiltration by a qualified person.

Contact a qualified window repair/installation contractor.

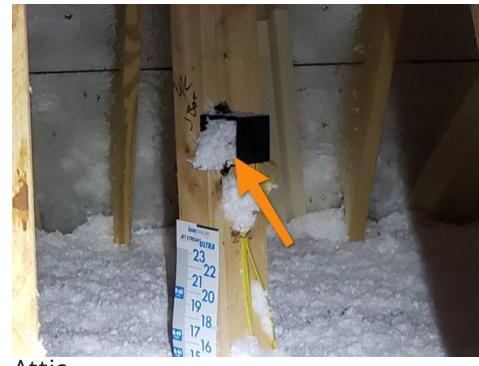
Attic

A junction box was found to be open at the time of inspection. This can expose live wires to insulation. Recommend evaluation and repair by qualified electrical contractor.

- Defect - Medium Concern

Contact a qualified electrical contractor.

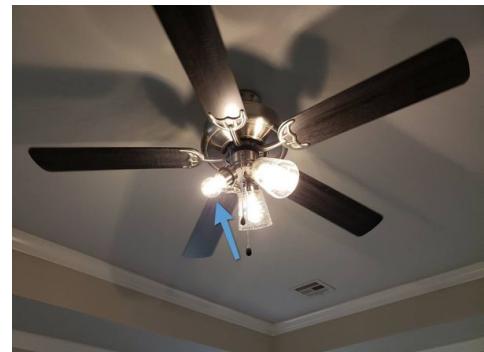
Master Bedroom

## 8.8.1 Ceiling Fans &amp; Lighting

**MISSING GLOBE**

A light globe was missing on the ceiling fan. Replacement of the globe is recommended by a qualified person to prevent accidental breakage of the bulbs.

Contact a qualified professional.

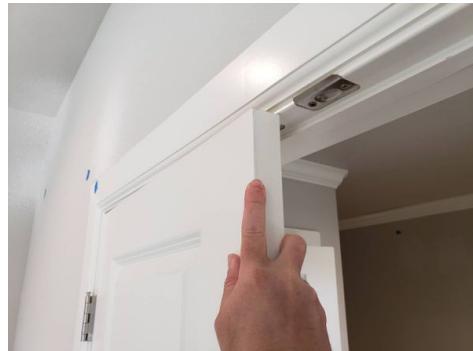
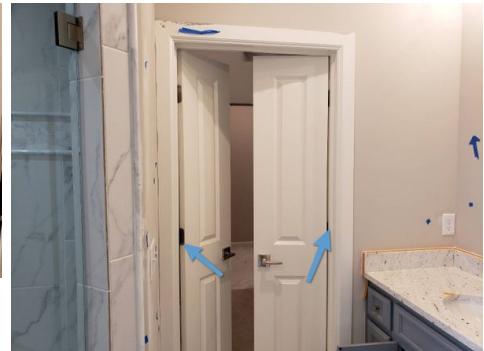
The interior door was binding / rubbing on the jamb. Adjustments or modifications as needed is recommended to be conducted by a qualified person for proper operation.

Contact a qualified door repair/installation contractor.

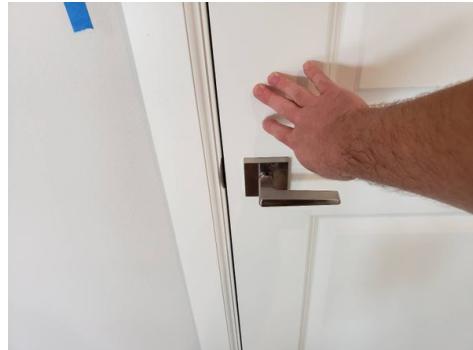
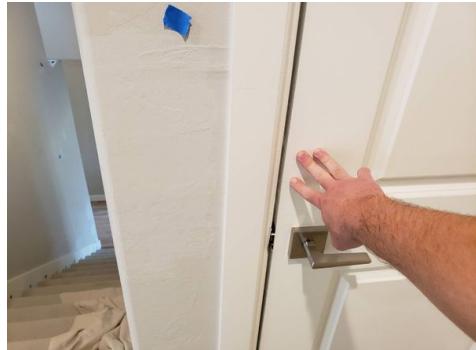
2nd Floor Attic Access

## 14.1.2 Interior Windows &amp; Interior Doors

The door was not latching properly. Adjustments or modifications as needed for proper operation is recommended to be conducted by a qualified person.

Contact a qualified door repair/installation contractor.
