PROPERTY INSPECTION REPORT

By: Travis L. Hooper 20776 / SEI Inspections 5/25/2016

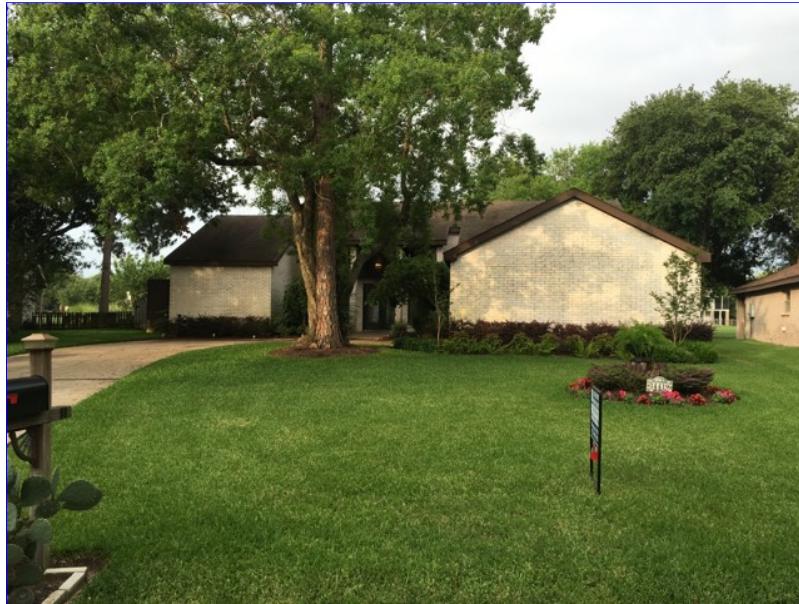
Front of home.

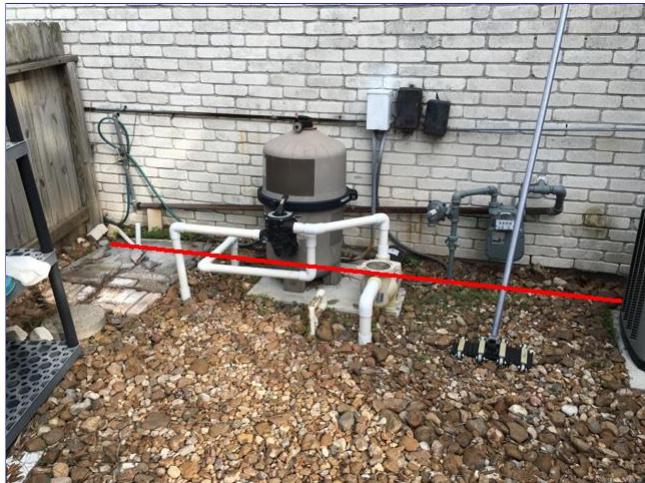
A. Item 1(Picture) Minimum of 4 inches of slab exposure needed at left side of home.

It is recommended that a professional landscaper re-establish the slab exposure in the areas listed in this section.

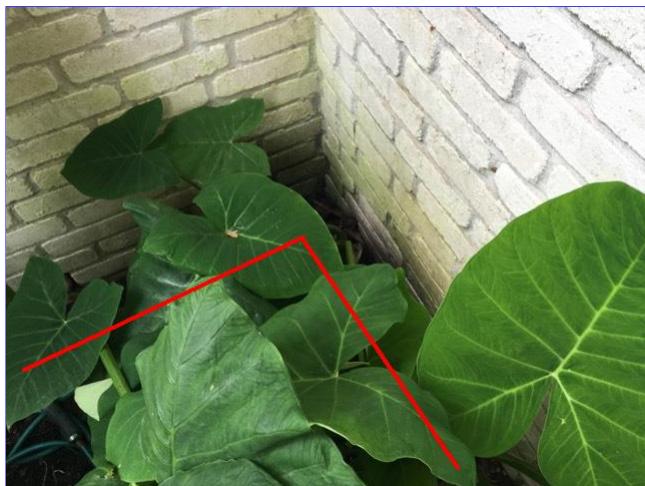
A. Item 2(Picture) Minimum of 4 inches of slab exposure needed at the front of home to the left front entry door.

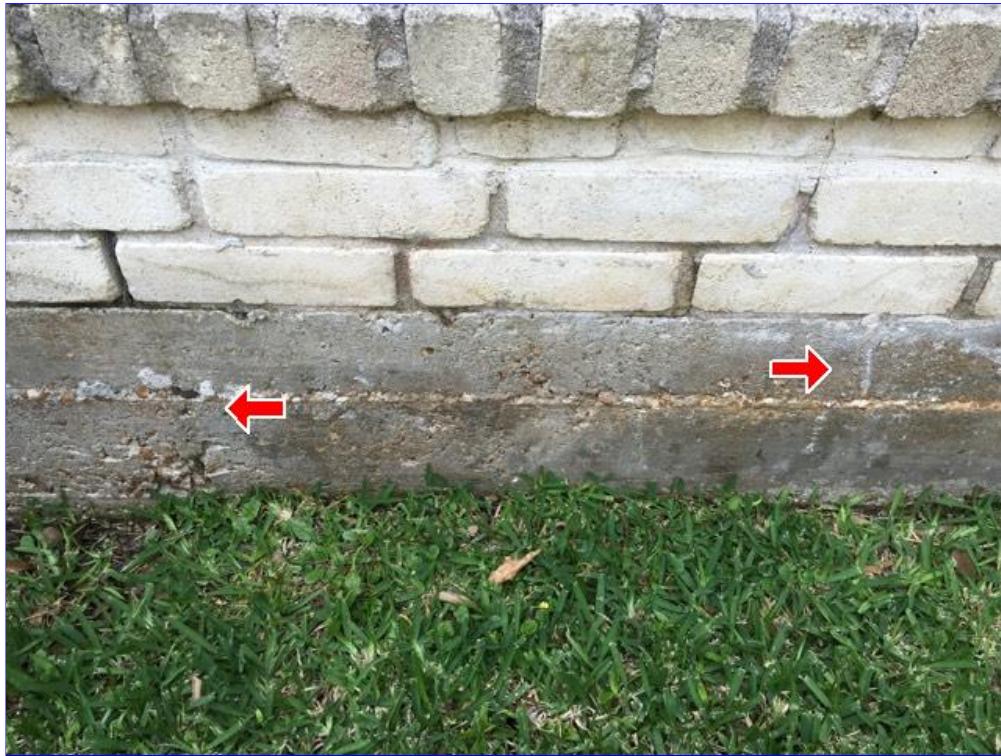
A. Item 3(Picture) Hairline cracks in foundation on right side of home.

With cracks in foundation, cracks in the kitchen tile, cracks in the ceiling near the kitchen and the sloping floor at the front right bedroom, it is recommended that a structural engineer inspect the foundation further to determine if it is failing on the right side.

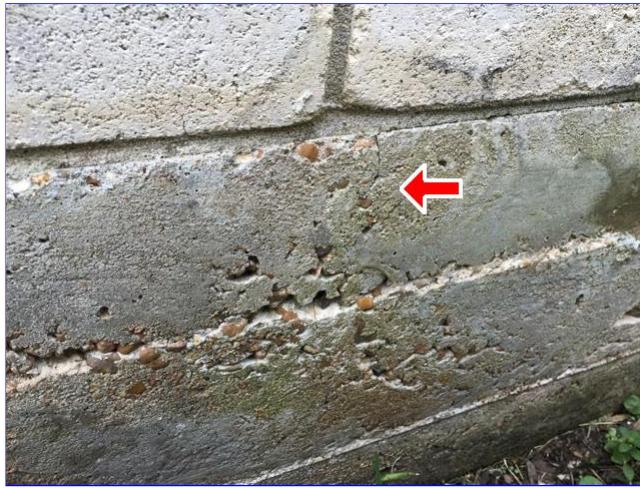
A. Item 4(Picture) Crack in foundation right side of home behind exterior A/C unit.

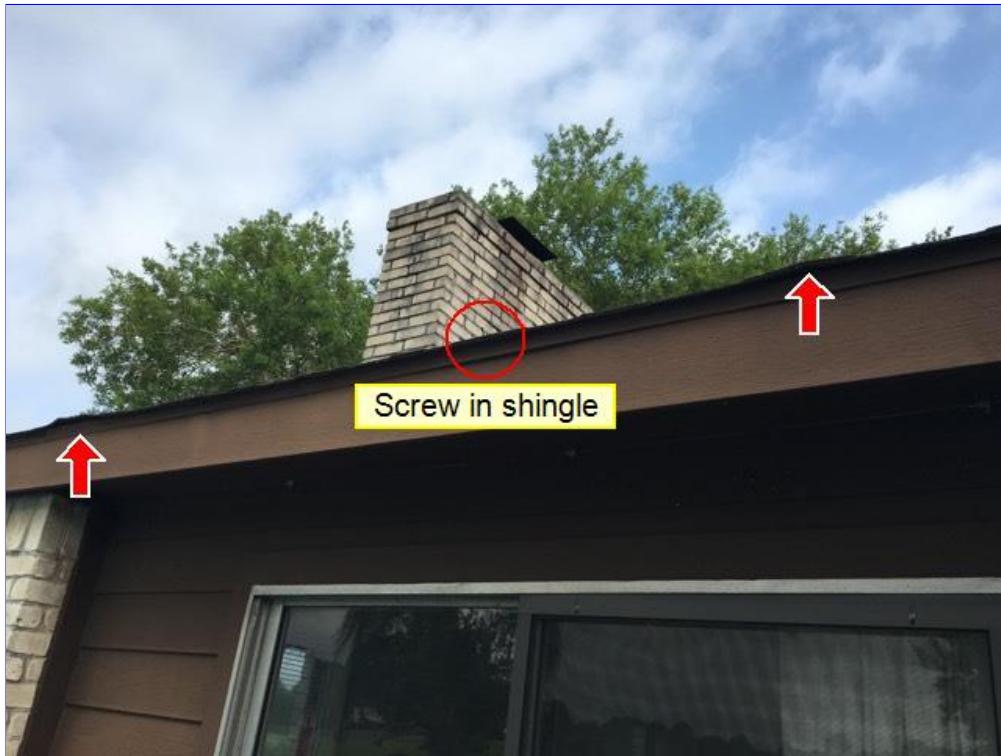
C. Item 1(Picture) Lifted shingles at rear of home. In addition screw in shingle at rear of home.

With wide spread damaged and delamination and since this home still has wood shingles and the max number of shingle layers being two, it is recommended that the roof and decking be replaced.

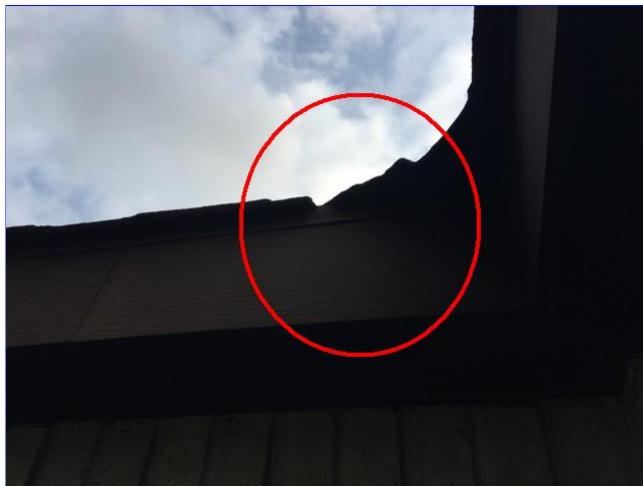
C. Item 2(Picture) Shingles in damaged at rear of home.

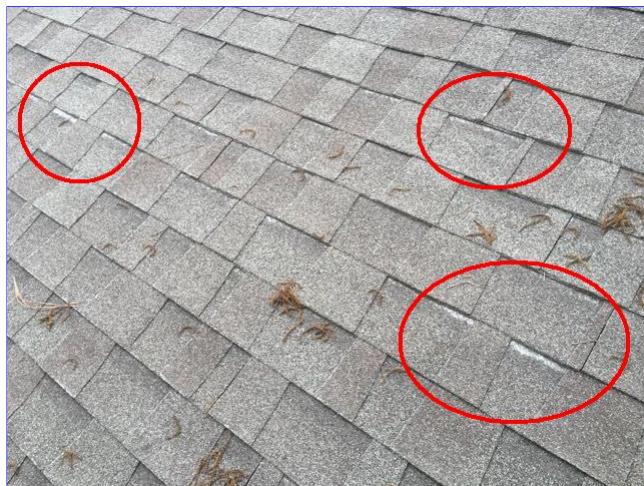
C. Item 4(Picture) Shingles delaminating at left slope above garage.

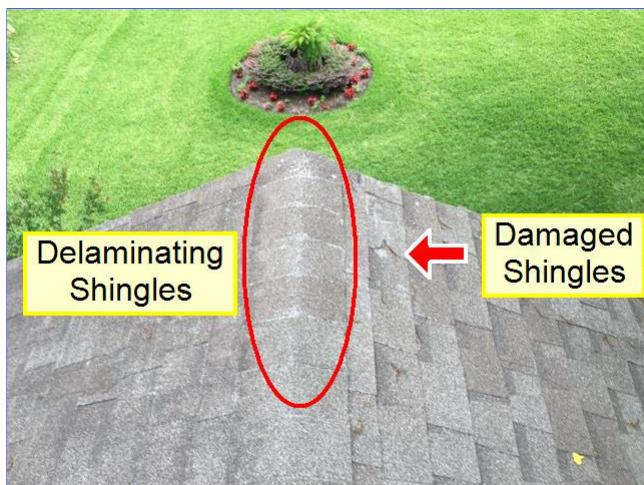
C. Item 5(Picture) Damaged and delaminating shingles at right gable of home.

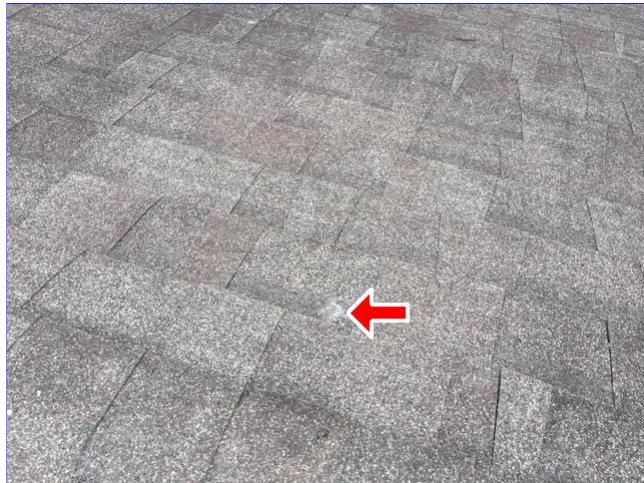
C. Item 6(Picture) Impact damage at right slope of home.

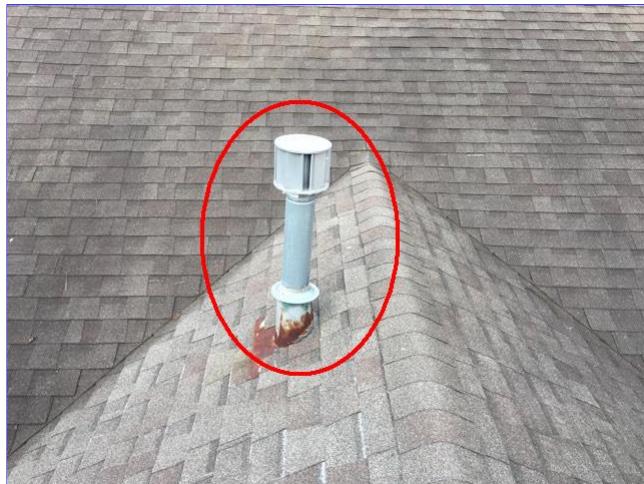
C. Item 7(Picture) Exhaust vent needs to be sanded and painted at front slope of home.

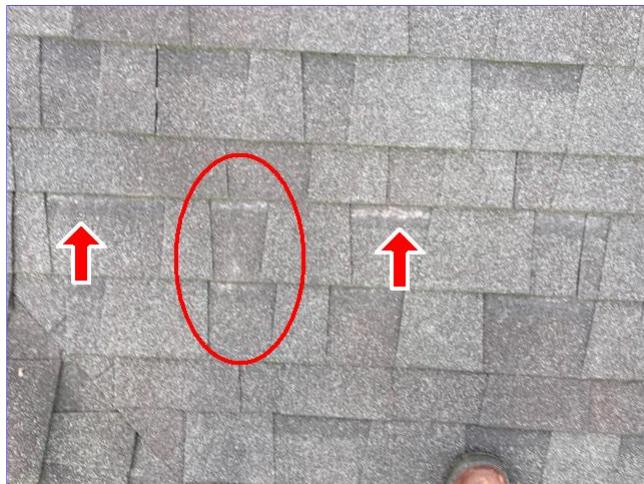
C. Item 8(Picture) Shingles delaminating at the front slope of the home right side.

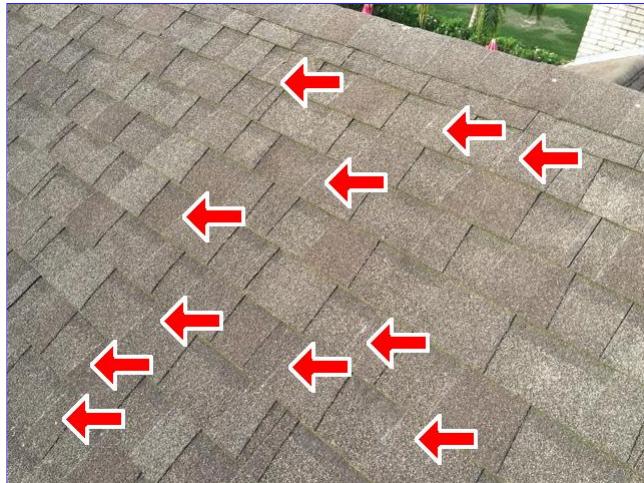
C. Item 9(Picture) Edges of shingles delaminating at front slope of home.

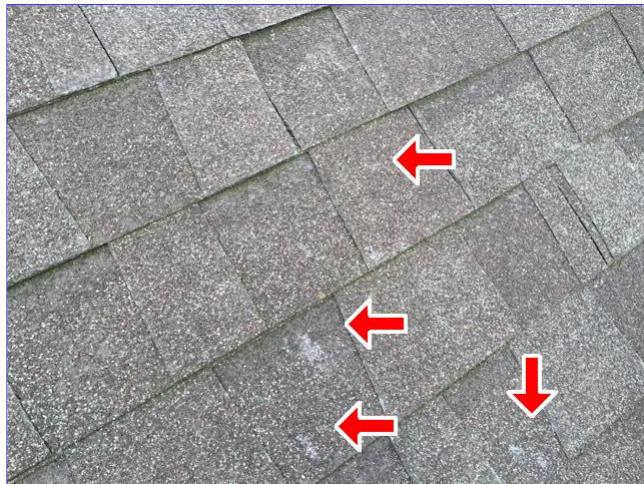
C. Item 10(Picture) Impact damage at front slope of home.

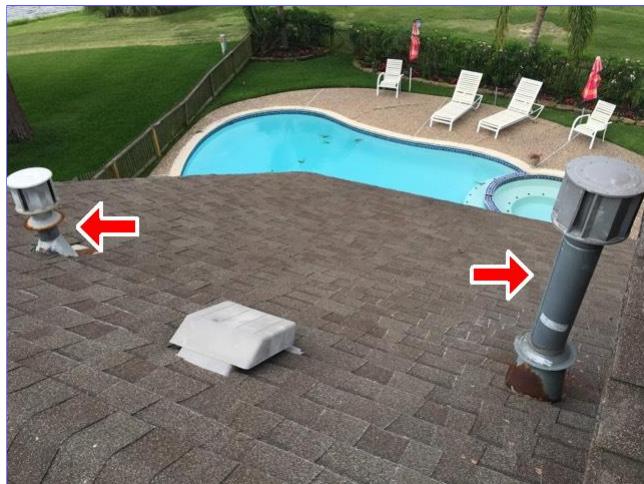
C. Item 11(Picture) Exhaust vents at rear slope of home need to be painted.

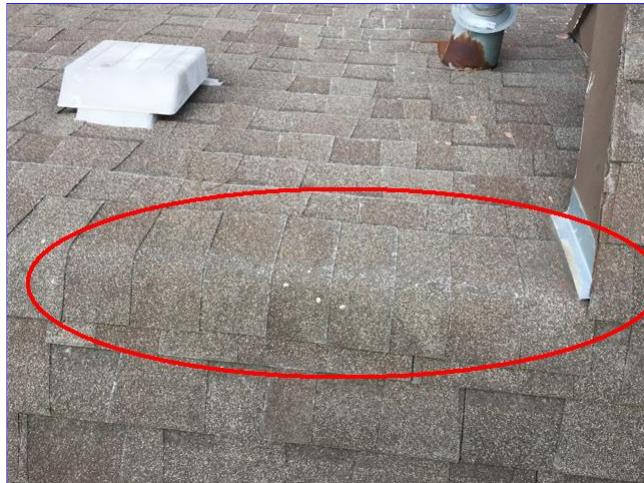
C. Item 12(Picture) Ridge shingles delaminating at middle ridge at home

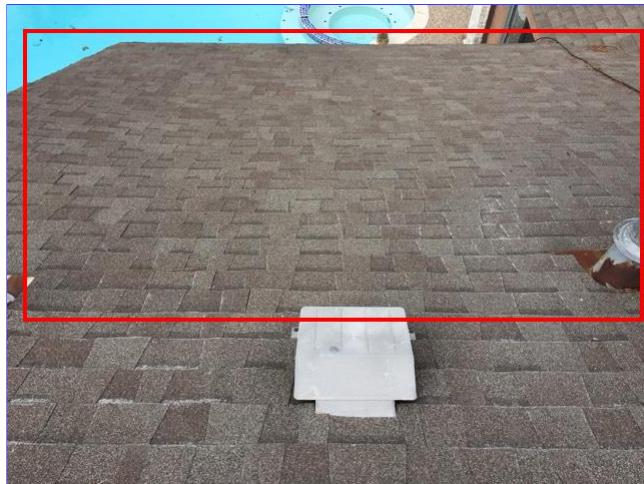
C. Item 13(Picture) Rear slope of home shingles delaminating.

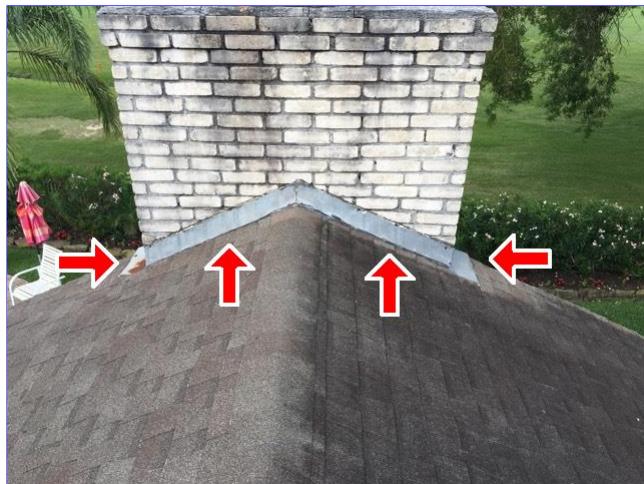
C. Item 14(Picture) Flashing needs to be painted at rear of home.

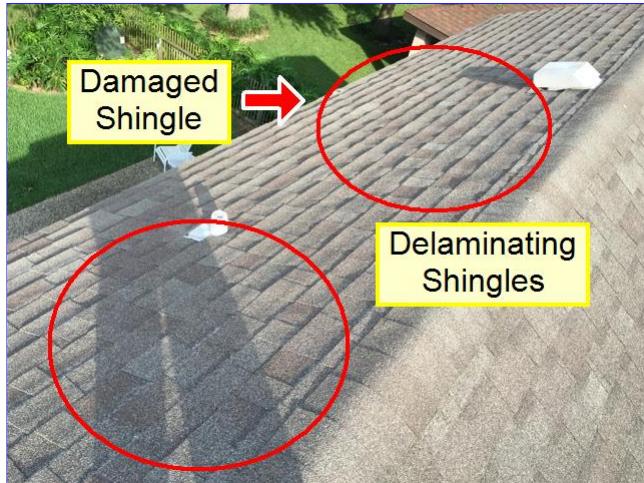
C. Item 15(Picture) Second floor rear slope of home.
Shingles are delaminating. Plus damaged shingle first row.

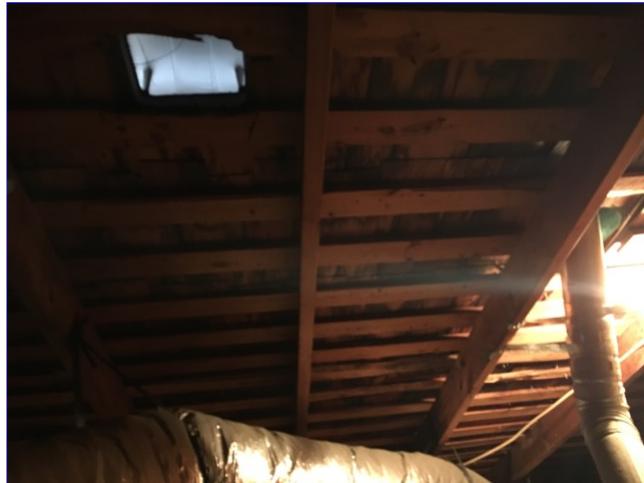
C. Item 16(Picture) NOTE: Original wood shingles still installed underneath architectural shingles on exterior of home.

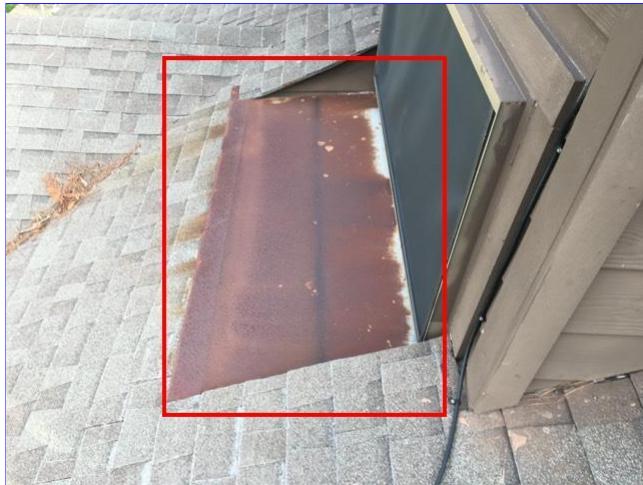
C. Item 17(Picture) Roofing pan needs to be sanded, primed and painted. Nails also need to be sealed at rear of home.

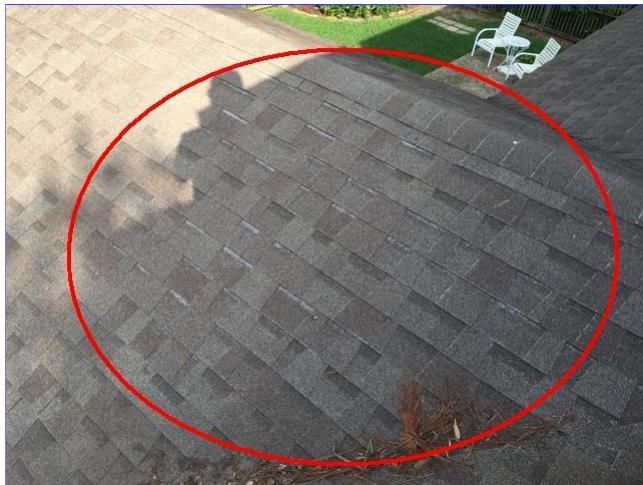
C. Item 18(Picture) Shingles delaminating at rear left slope of home.

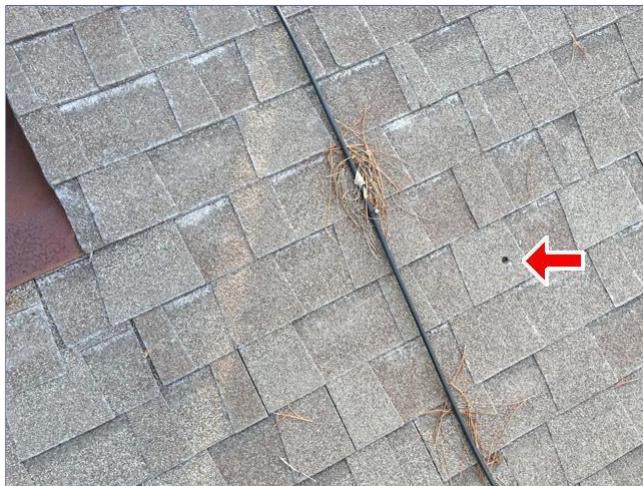
C. Item 19(Picture) Hole goes straight through shingle and decking.

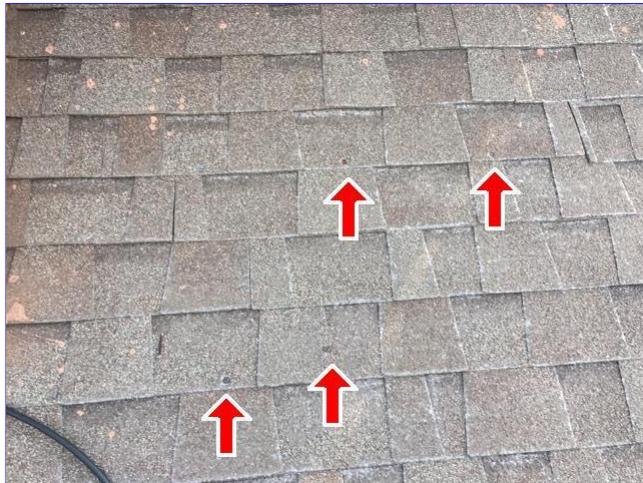
C. Item 20(Picture) Nails hammered through shingles at rear slope of home.

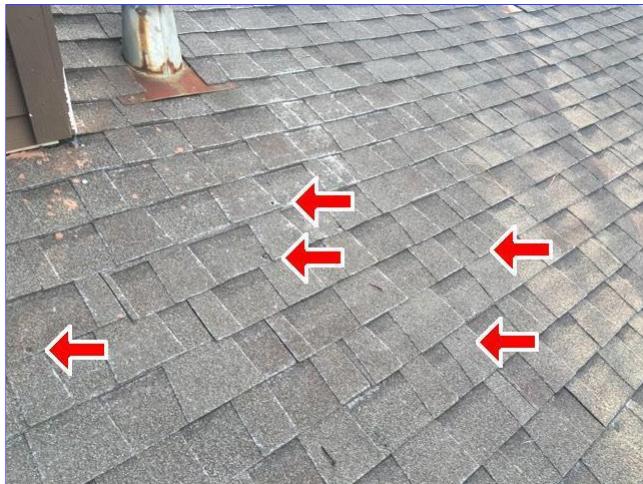
C. Item 21(Picture) Multiple nails hammered through shingles and rear left slope of home.

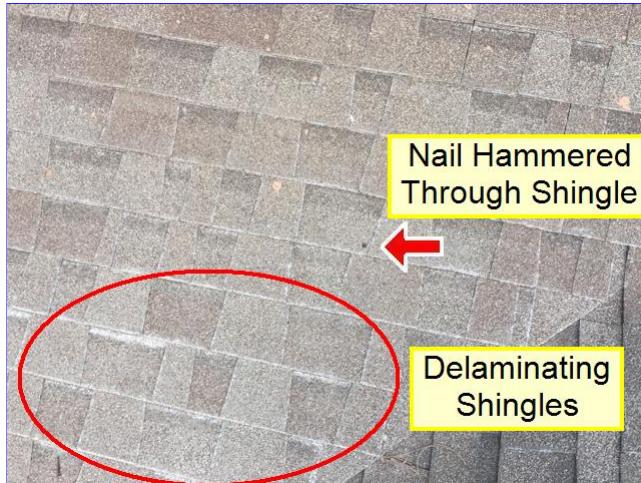
C. Item 22(Picture) Nails hammered through shingles and shingles delaminating at rear slope of home.

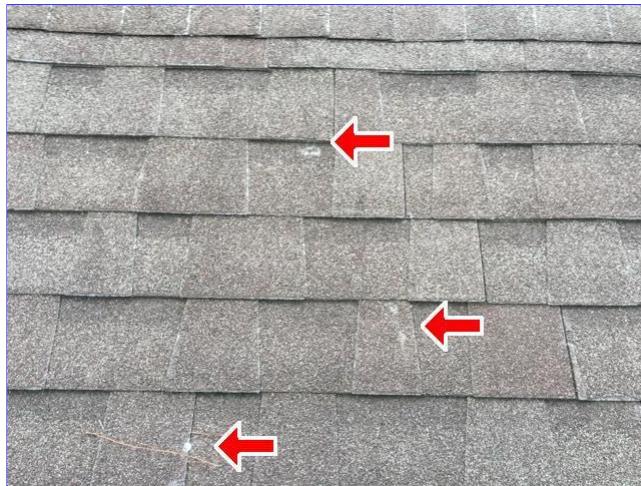
C. Item 23(Picture) Impact damage at rear right slope at home.

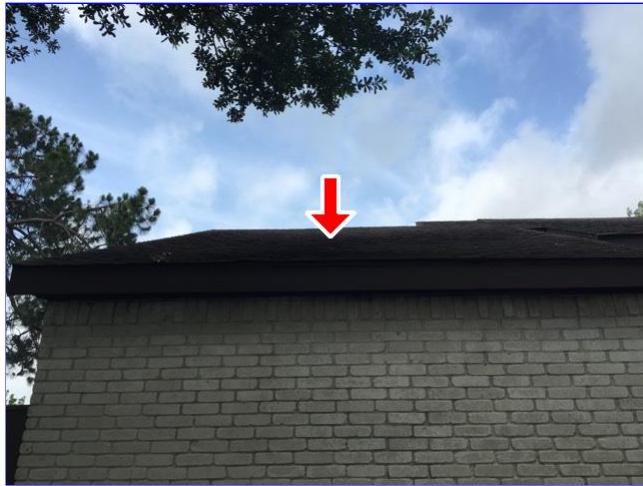
D. Item 1(Picture) Roof deflecting, beginning to sag at the front left slope of home.

It is recommended that a professional carpenter repair the ceiling joist in the garage and add additional support where the roof is sagging.

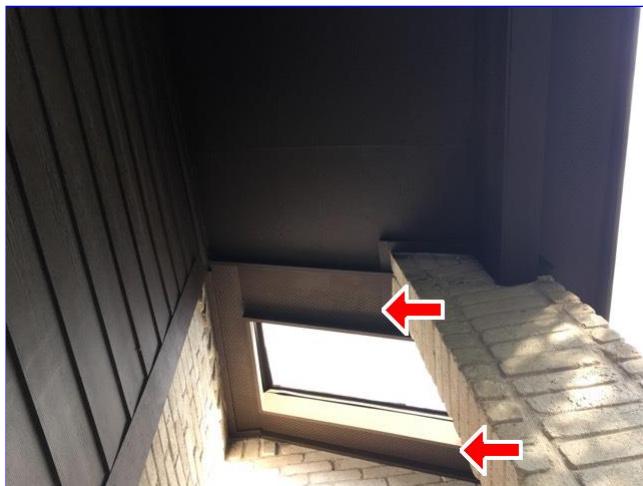
D. Item 2(Picture) Perforated soffit board should not be installed at rakes of a home.

Where perforated soffit vent was used on the rakes, it's recommended holes be filled in or the soffit be replaced by non perforated soffit material.

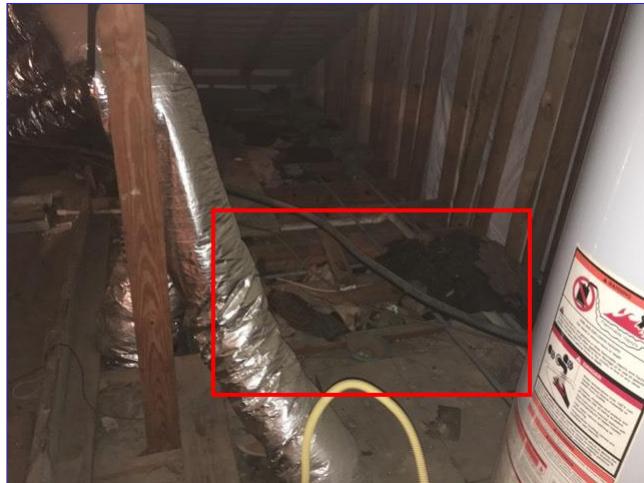
D. Item 3(Picture) Missing insulation above the master bath.

It is recommended that any missing insulation be replaced in the home.

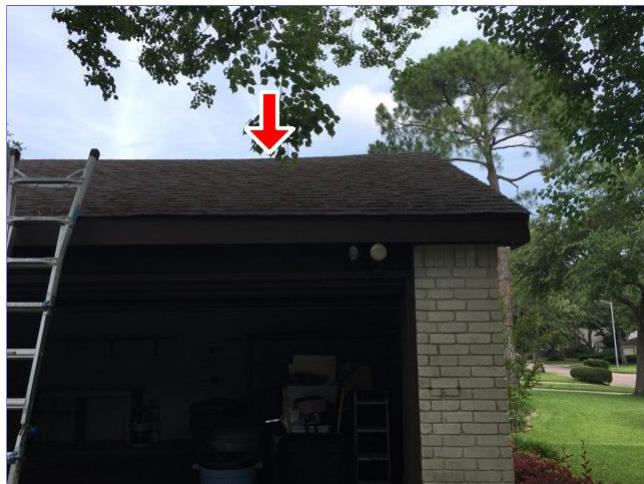
D. Item 5(Picture) Roofline appears to be sagging on right side of garage

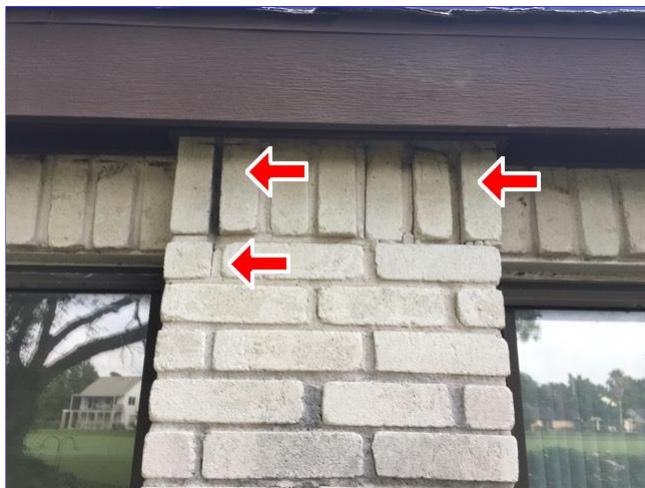
E. Item 1(Picture) Cracks at mortar between the bricks at rear of home.

It is recommended that a professional mason point up all cracks, drilled hole and bee holes in the the bricks mortar.

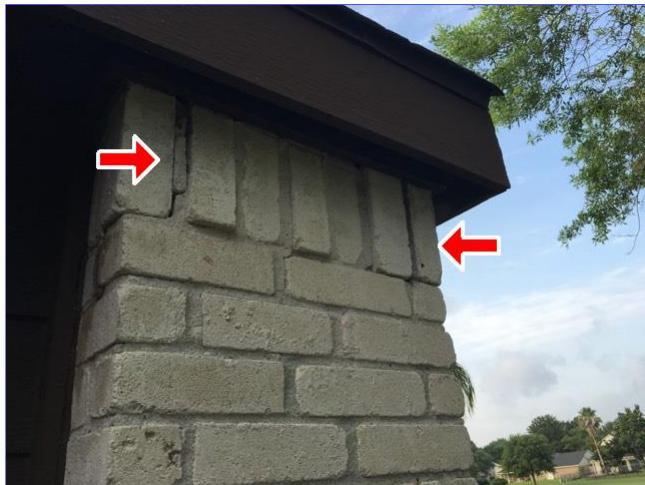
E. Item 2(Picture) Cracks in mortar between brick at rear middle of home.

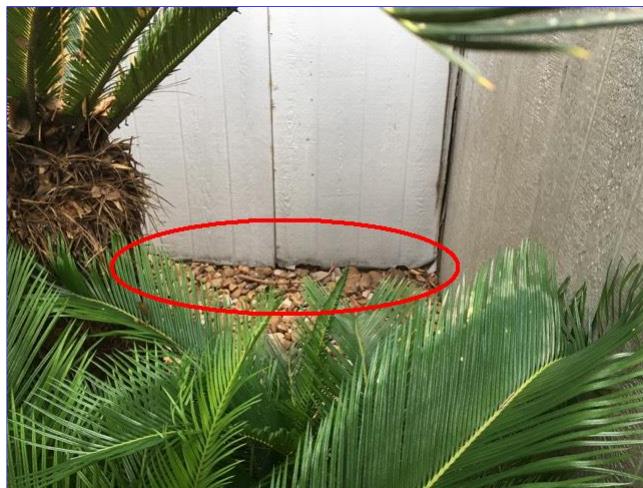
E. Item 4(Picture) Rot noted around partition walls on left side of home.

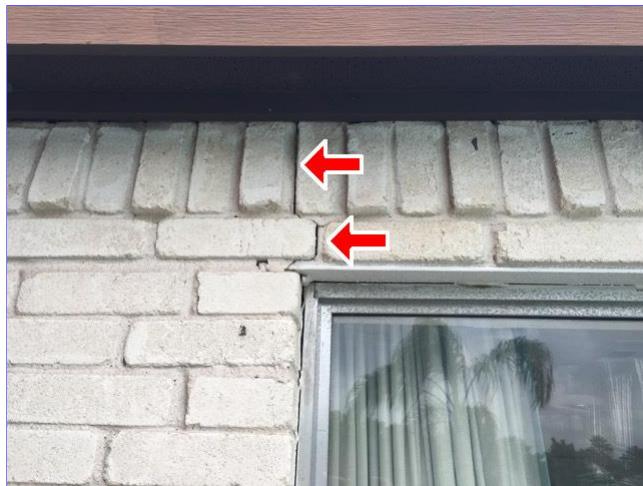
E. Item 5(Picture) Cracks in brick at rear of home.

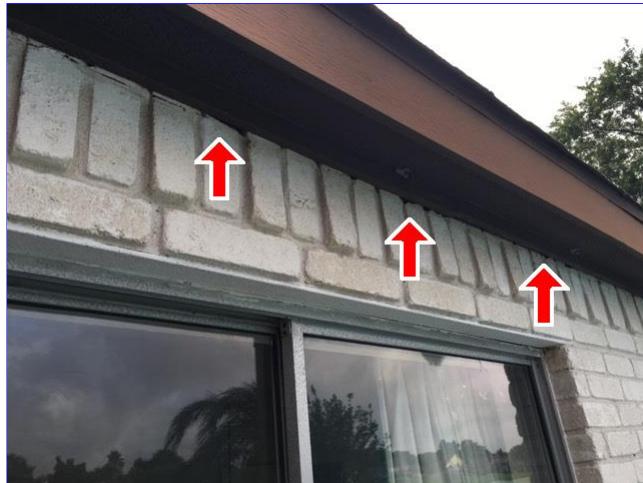
E. Item 6(Picture) Gaps in brick at rear of home need to be pointed up. Above master bed sliding glass door.

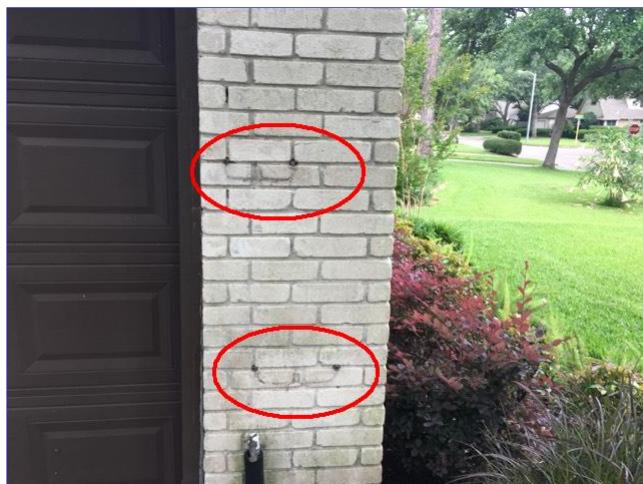
E. Item 8(Picture) Holes drilled into brick in multiple areas around the of home.

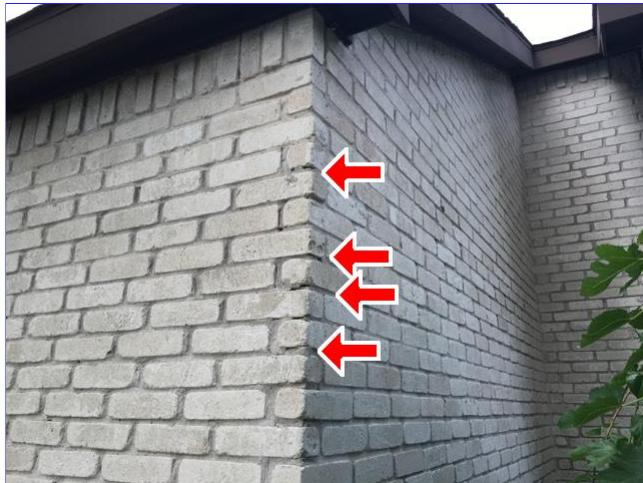
E. Item 9(Picture) Bee holes in brick at front of home.

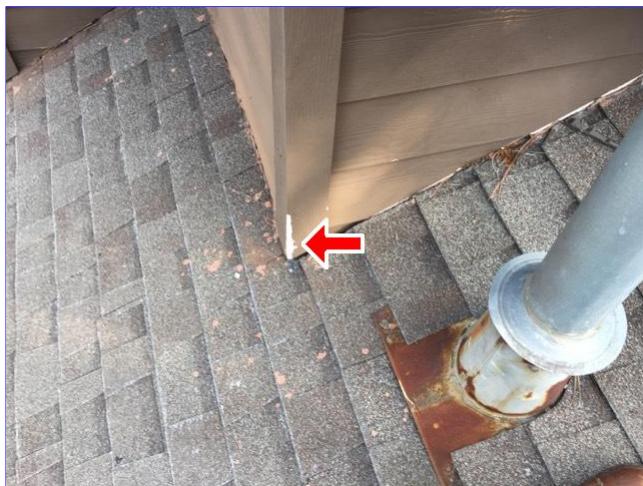
E. Item 10(Picture) Damaged siding at rear left slope of home.

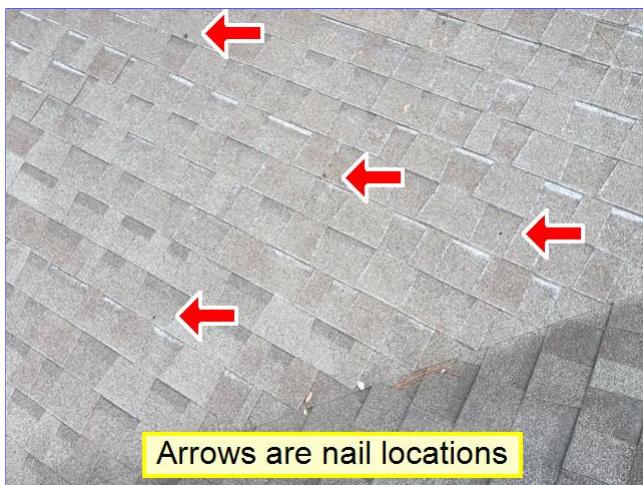
E. Item 11(Picture) Nails hammered through shingles and shingles delaminating had rear slope of home.

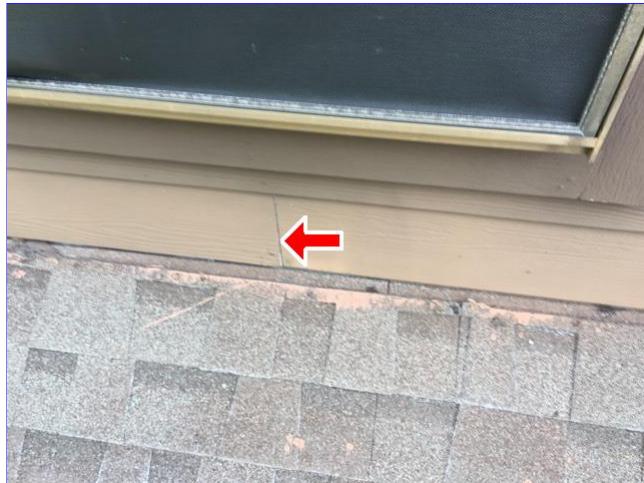
E. Item 12(Picture) Butt joint needs to be caulked at rear slope of home.

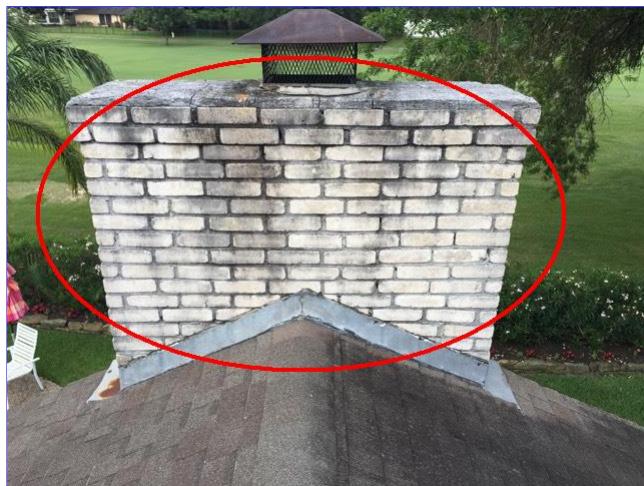
E. Item 13(Picture) Chimney brick has cracks and bee holes in it.

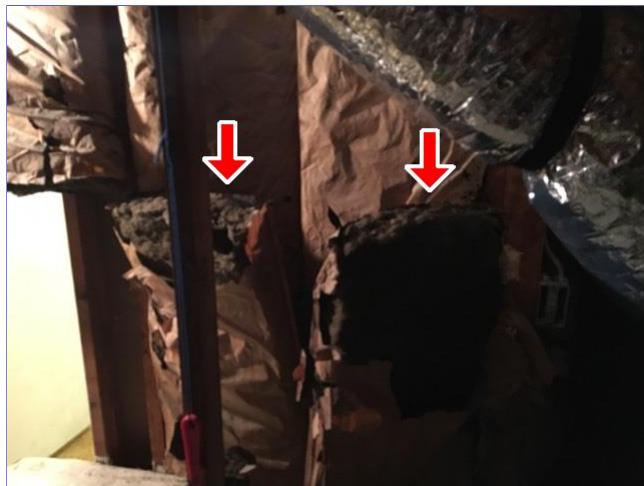
E. Item 14(Picture) Hot wall insulation coming away from wall at left attic.

It is also recommended that any hot walls with falling or missing insulation be re-installed.

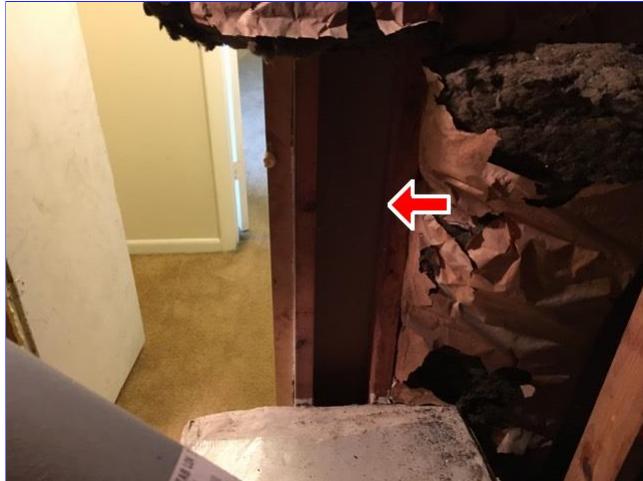
E. Item 15(Picture) Insulation missing at hot wall at left attic.

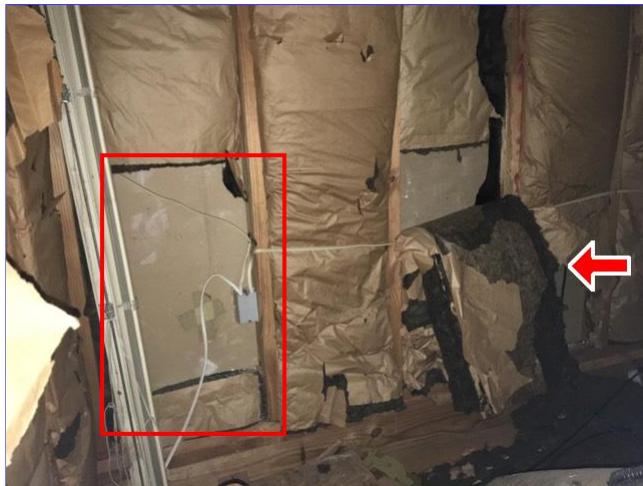
E. Item 16(Picture) Hot walls missing insulation at upstairs right bedroom attic area.

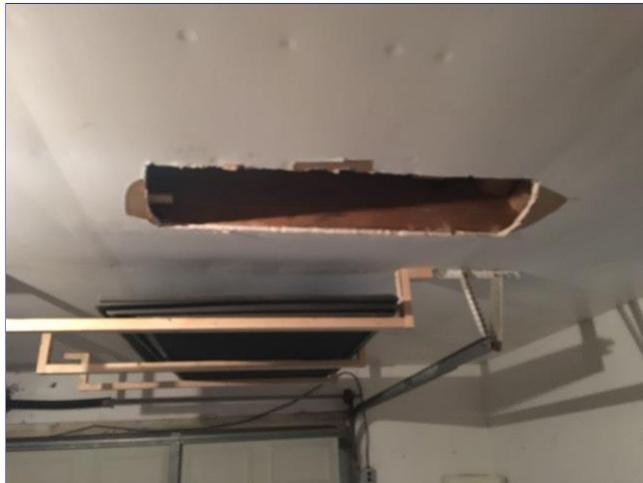
F. Item 1(Picture) Hole in ceiling of garage.

It is recommended that the hole in the garage ceiling be repaired by a professional sheetrocker.

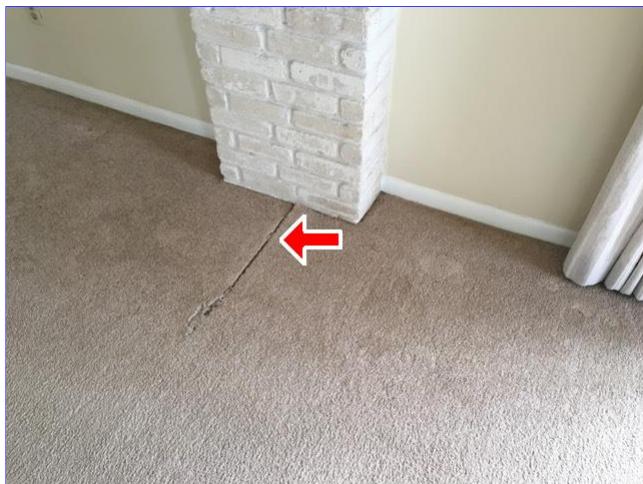
F. Item 2(Picture) Torn carpet a trip hazard in family room.

It is also recommended that the cut carpet be repaired to prevent tripping.

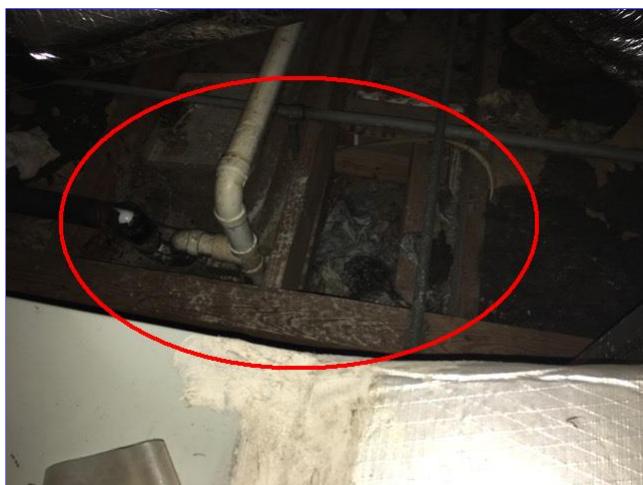
F. Item 3(Picture) Insulation missing above right hall bath. First floor.

All missing insulation should be replaced.

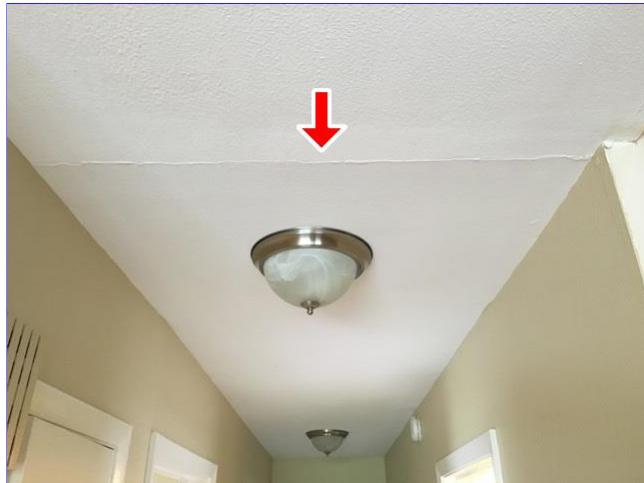
F. Item 4(Picture) Crack in ceiling of hallway on right side of home.

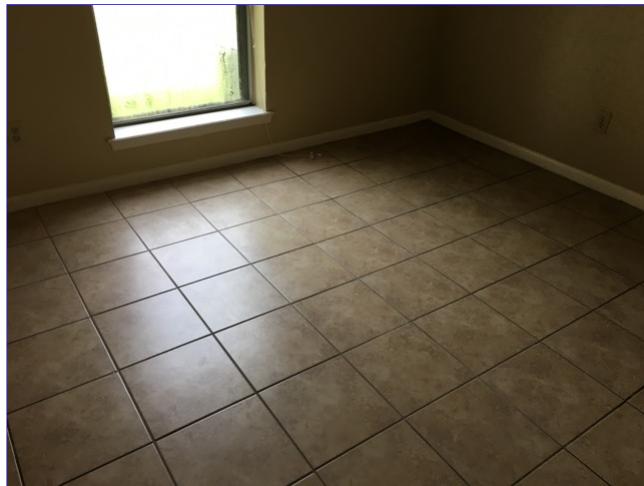
F. Item 5(Picture) Floor sloping to the right at front right bedroom of home.

With cracks in foundation, cracks in the kitchen tile, cracks in the ceiling near the kitchen and the sloping floor at the front right bedroom, it is recommended that a structural engineer inspect the foundation further to determine if it is failing on the right side.

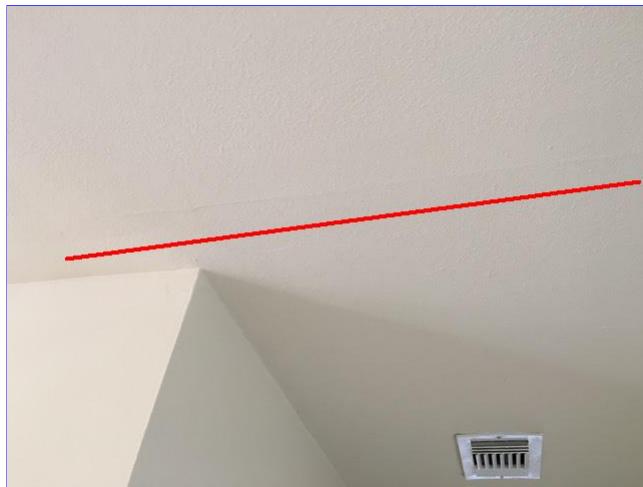
F. Item 7(Picture) Cracking in ceiling at foyer area.

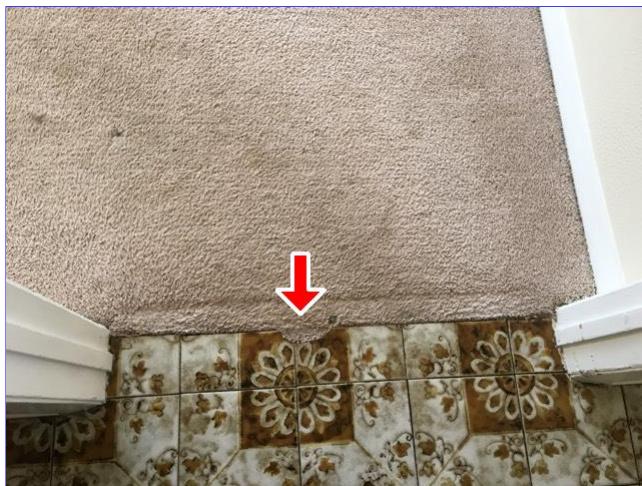
F. Item 9(Picture) Crack at tile between dining room and hallway.

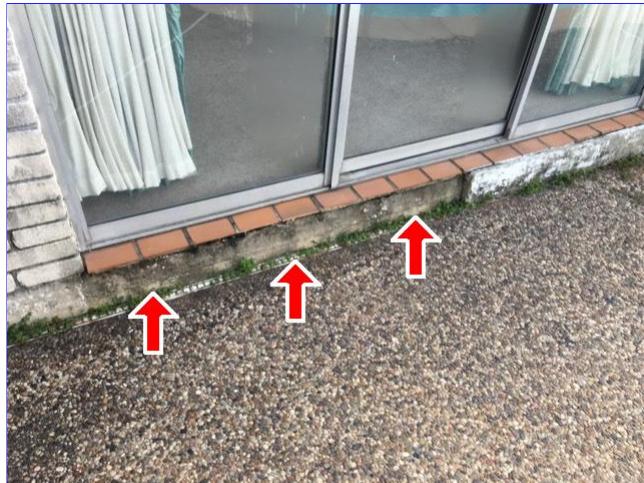
G. Item 1(Picture) Underpinning at rear sliding glass door broken.

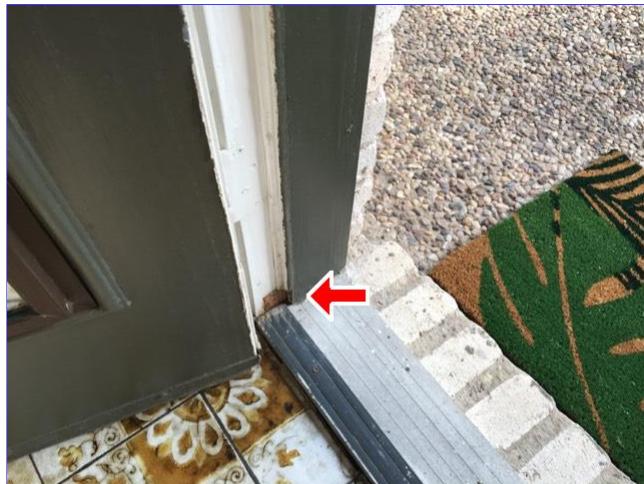
G. Item 2(Picture) Weather stripping missing at bottom right corner of entry french doors.

Any missing weather stripping should be replaced by a professional handy man.

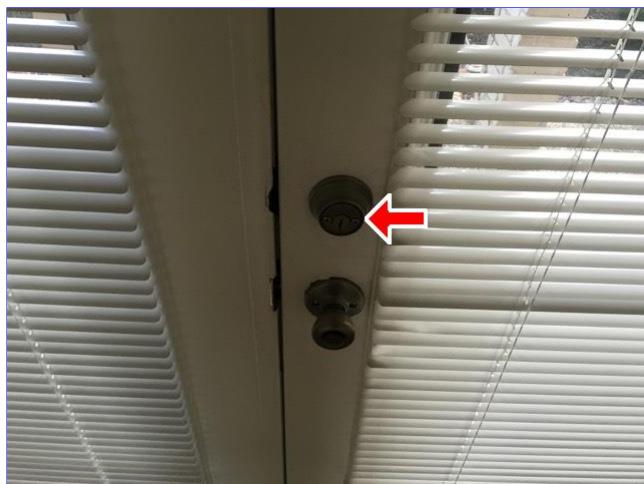
G. Item 3(Picture) NOTE: Double deadbolt at front entry door.

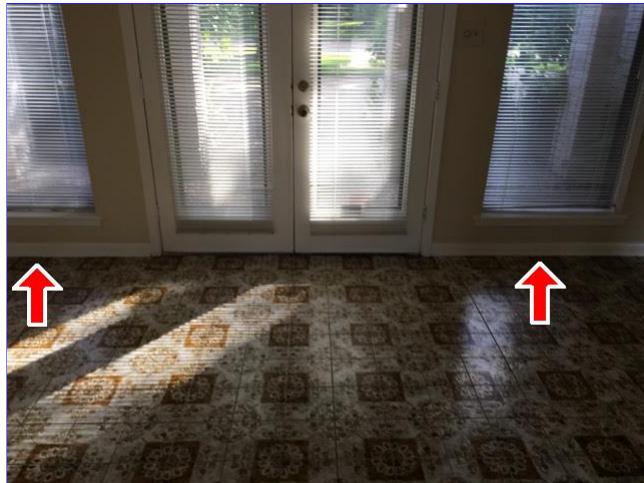
G. Item 4(Picture) Doorstops missing throughout house.

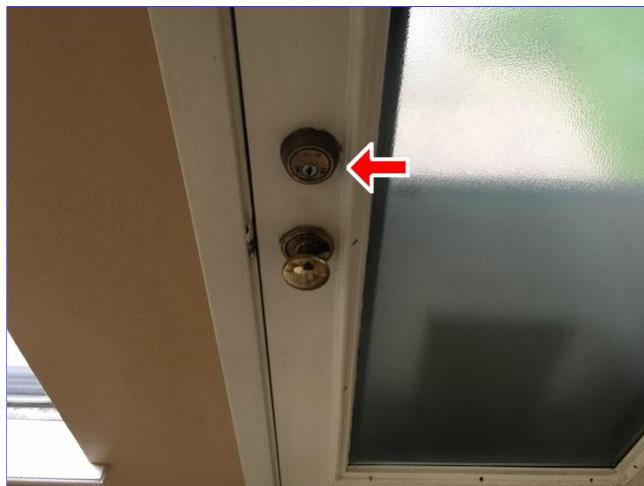
G. Item 5(Picture) NOTE: Double deadbolt at rear exterior door.

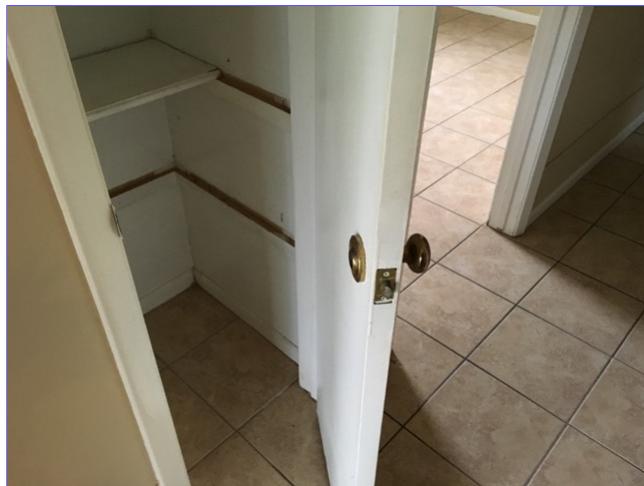
G. Item 6(Picture) Door knob missing handle at the pantry area closet.

The missing door knob and door stops should be replaced by a professional handy man.

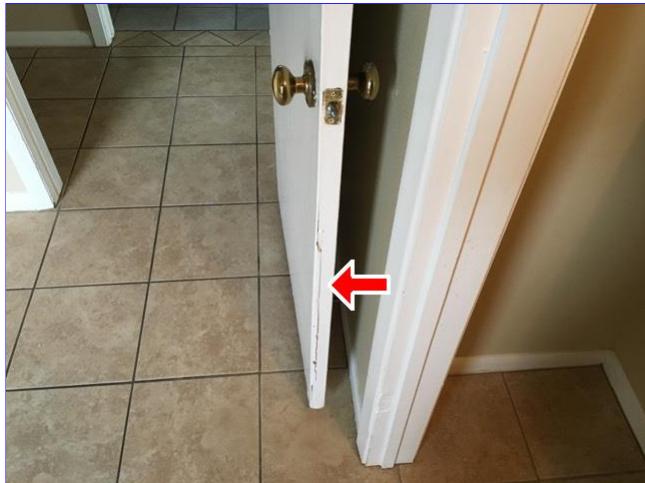
G. Item 7(Picture) Door damaged at front right bedroom of home.

It is recommended that all damaged doors be repaired or replaced by a professional trim carpenter.

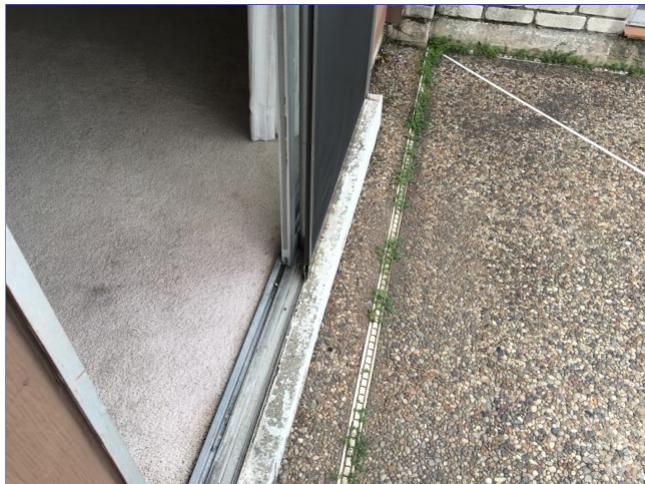
G. Item 8(Picture) Screen for sliding glass door off tracks

The sliding screen that is off tracks be re-installed and the missing screen door replaced.

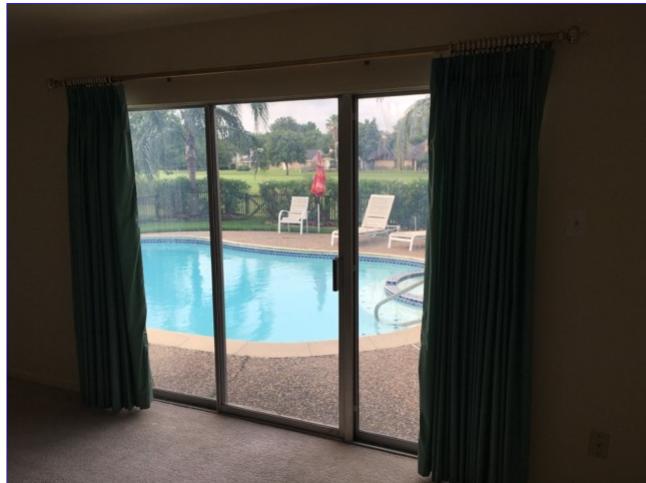
G. Item 9(Picture) Screen missing for sliding glass door at master bedroom.

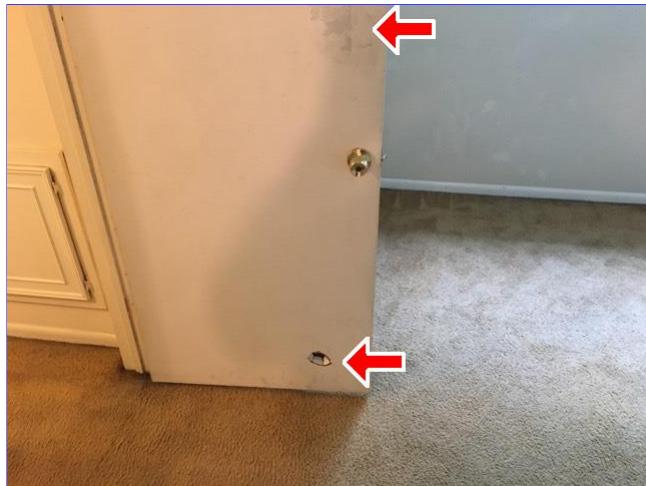
G. Item 10(Picture) Door damaged at upstairs right bedroom.

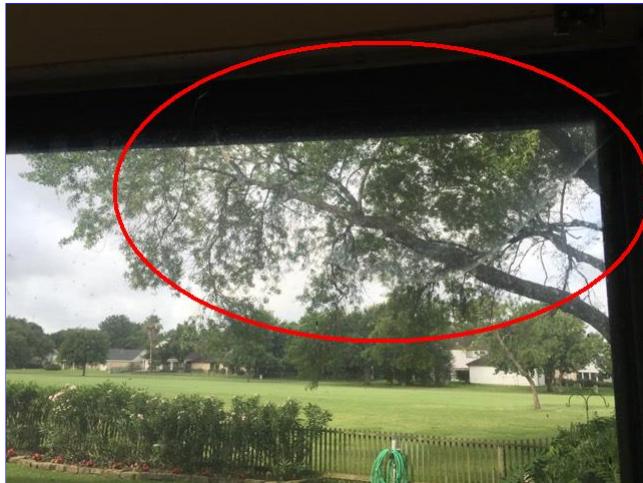
H. Item 1(Picture) Window pane cracked at breakfast area window of home.

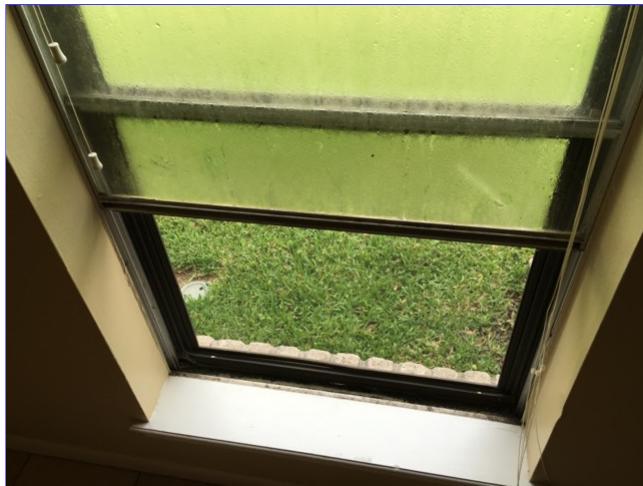
H. Item 2(Picture) Storm window at front right bedroom stuck in the open position.

It is recommended that a professional window glazer replace the damaged window pane and adjust all malfunctioning windows so they open smoothly.
