PROPERTY INSPECTION REPORT

By: Travis L. Hooper 20776 / SEI Inspections 5/25/2016

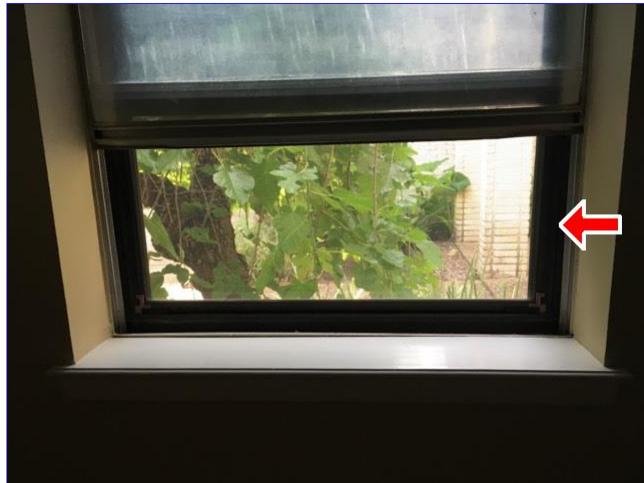
H. Item 3(Picture) Storm window does not open at utility room.

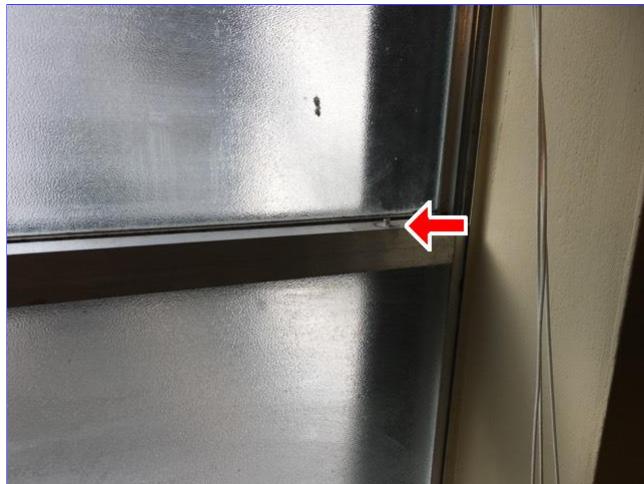
H. Item 4(Picture) Window latch missing at right hall bath. In addition storm window does not open.

It is recommended that a professional window glazer replace the damaged window pane and adjust all malfunctioning windows so they open smoothly.

In addition, the missing window latch should be replaced by a professional window glazer.

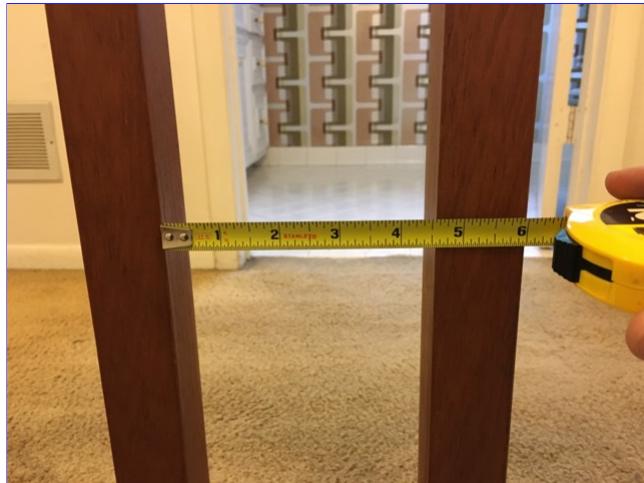
I. Item 1(Picture) Stair parts wider than 4 inches apart.

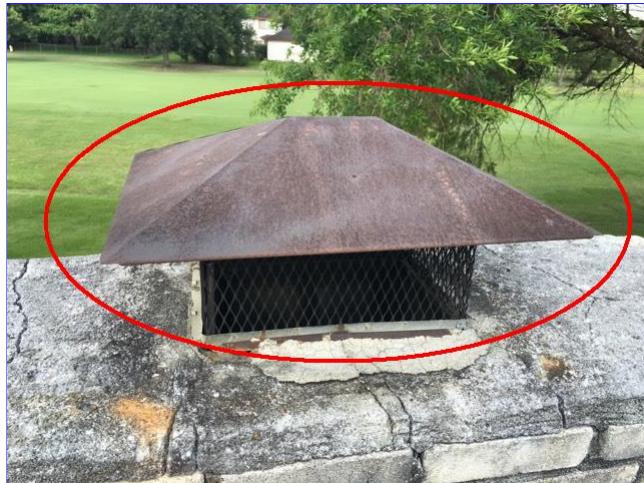
J. Item 1(Picture) Spark arrestor for chimney needs to be painted at rear of home.

It is recommended that a professional painter sand, prime and paint the spark arrestor to prevent it's corrosion.

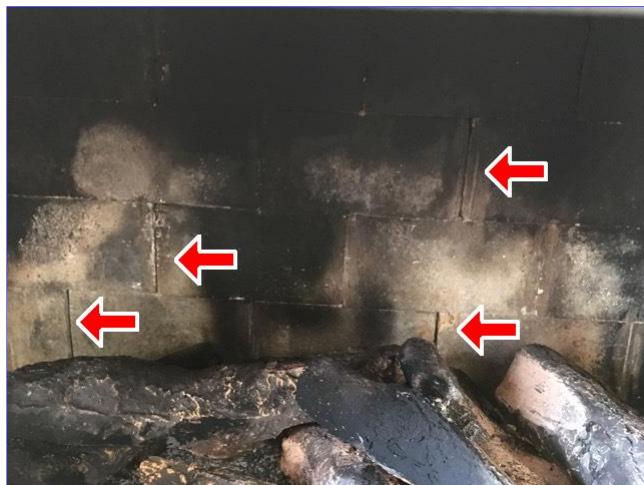
J. Item 3(Picture) Firebricks in fireplace need to be pointed up again. Missing mortar between the fire bricks.

It is recommended that a professional chimney sweep make all necessary repairs to the fireplace in order for it to operate safely.

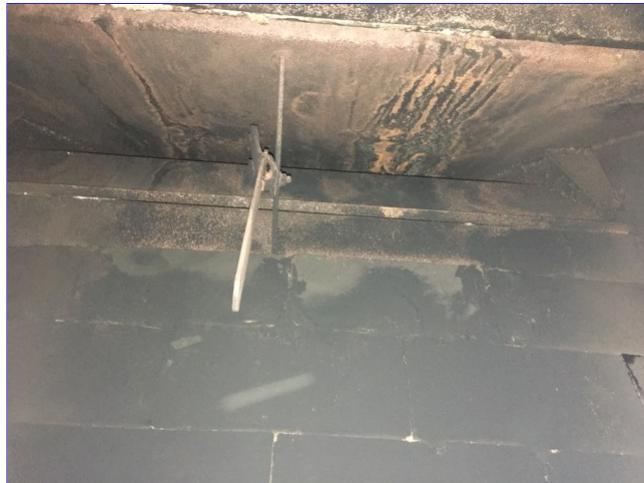
J. Item 4(Picture) Damper difficult to open at fireplace.
Could not open.

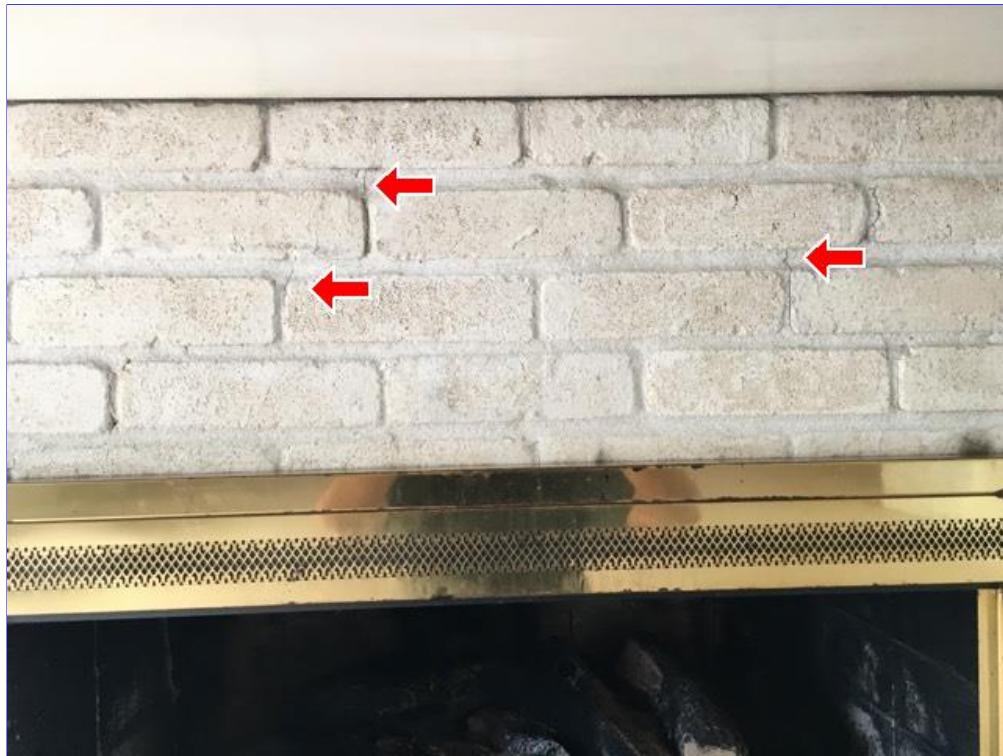
J. Item 5(Picture) Cracks in brick below mantle of fireplace.

It is recommended that all cracked brick be pointed up by a professional mason.

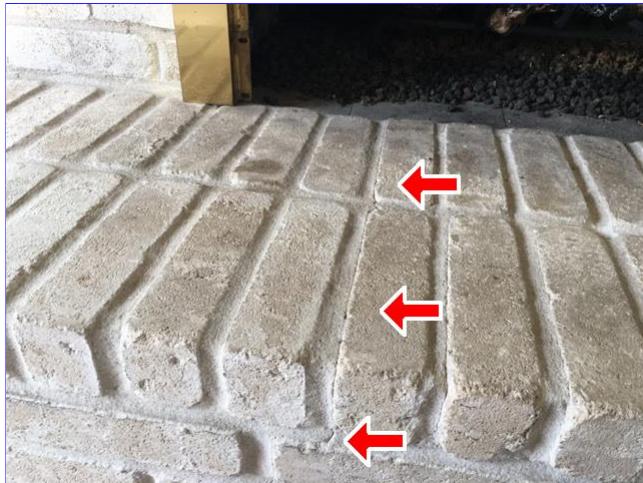
J. Item 6(Picture) Cracks in brick of hearth of fireplace.

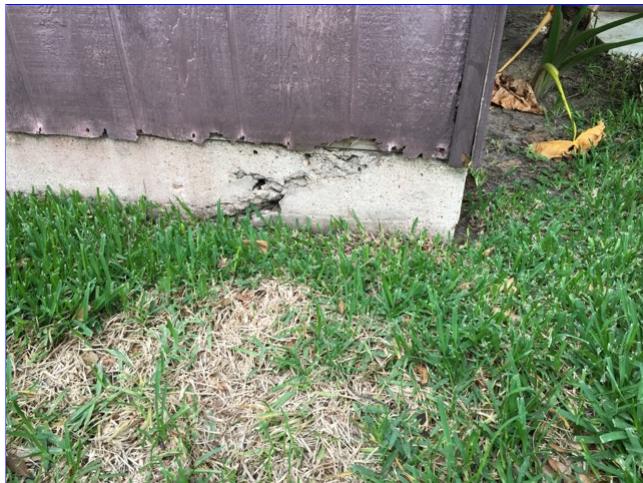
This stem wall is not part of the foundation and is currently not failing. But it should be monitored for failure in the future.

L. Item 1(Picture) Cold joint poor at stem wall surrounding master bath window on left side of home.

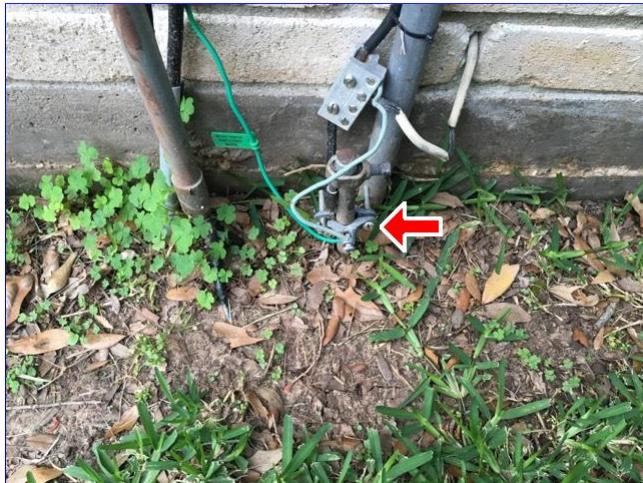
A. Item 1(Picture) Ground rod clamp loose at right side of home near electric service panel box.

It is recommended that a licensed electrician inspect the items listed in this section and make any necessary repairs or replacements.

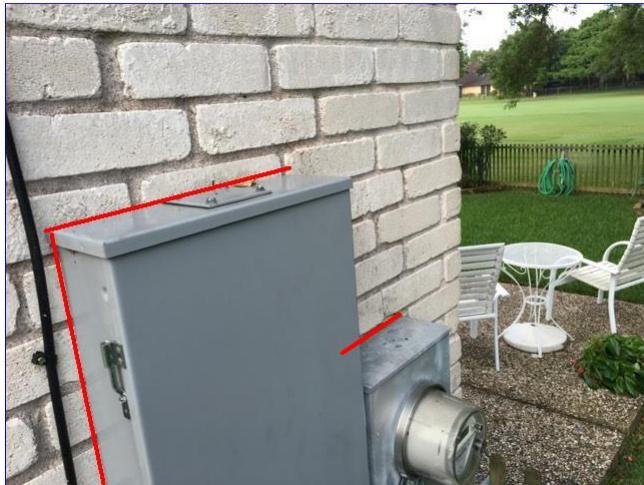
A. Item 3(Picture) Electric service panel box and meter can box should be sealed to the brick. On the right side of the home.

To prevent water intrusion behind the electric service panel box and meter box, it is recommended that a professional painter seal the boxes to the brick wall.

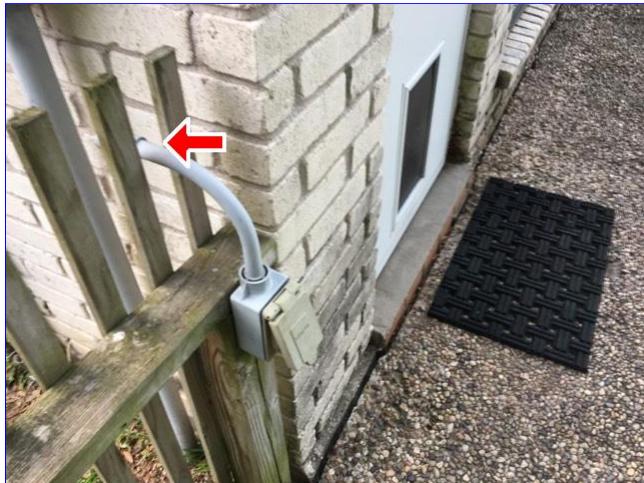
B. Item 1(Picture) Exterior switch at rear right of home not wired to anything

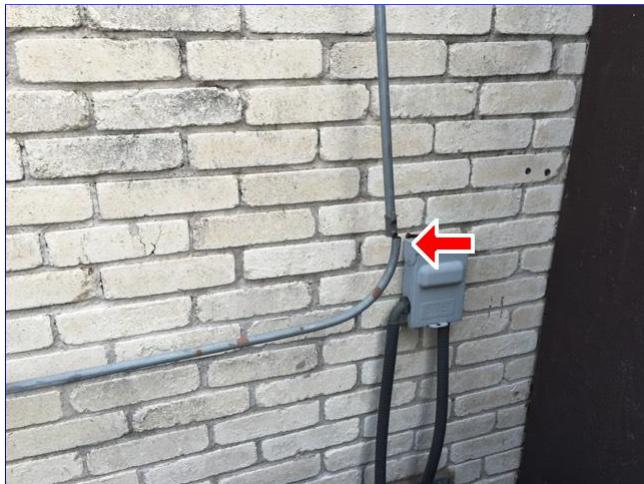
B. Item 2(Picture) Electrical conduit at left side of home needs to be secured to wall. In addition conduit piping needs to be reconnected at coupling.

It is recommended that a licensed electrician inspect the items listed in this section and make any necessary repairs or replacements.

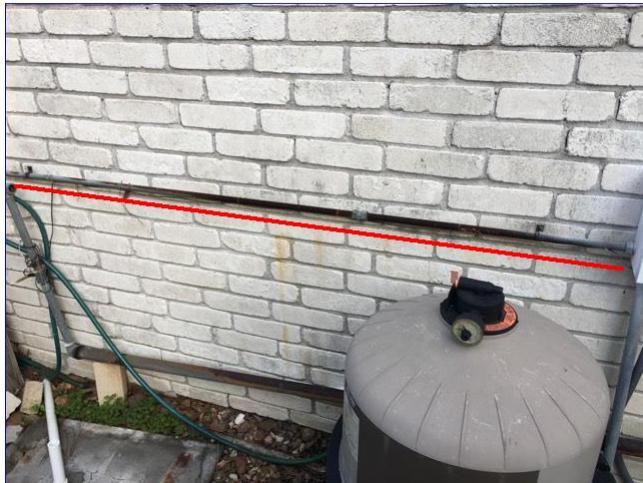
B. Item 3(Picture) Large amount of rust noted at conduit line for pool system. Should be sanded and painted to preserve it

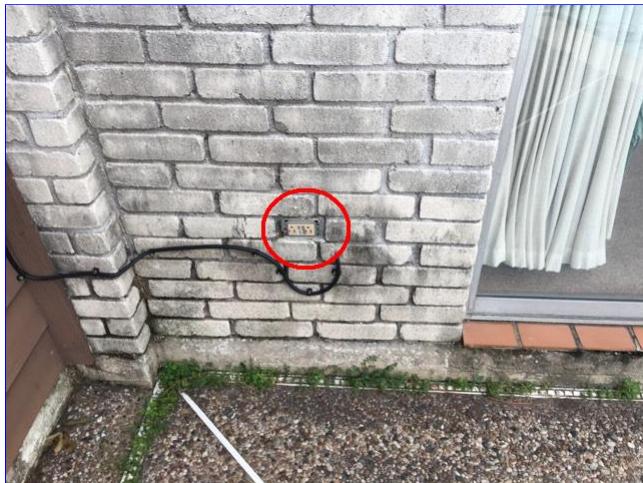
B. Item 4(Picture) Exterior cover plate missing for electrical outlet receptacle at rear of home near pool.

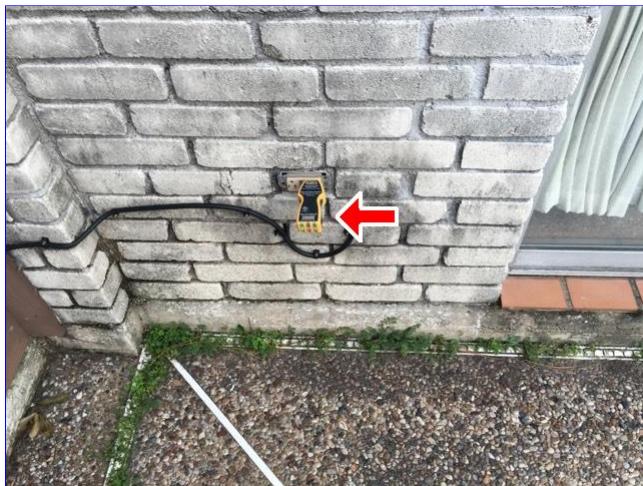
B. Item 5(Picture) GFCI not working at rear electrical outlet receptacle at rear of home.

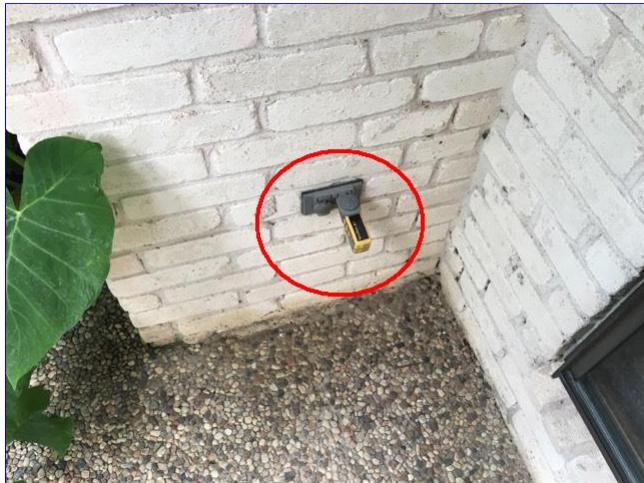
B. Item 6(Picture) Electrical outlet receptacle to the left of front entry door not secured to wall. In addition, GFCI not working.

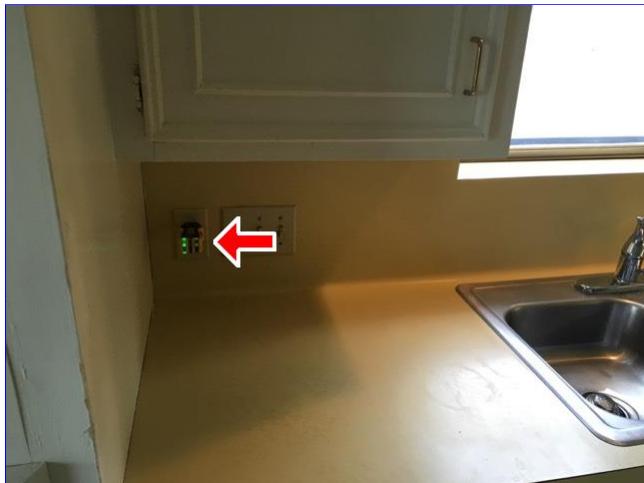
B. Item 7(Picture) Electrical outlet receptacles not wired for GFCI in kitchen. In addition, electrical outlet receptacle has an open ground wire.

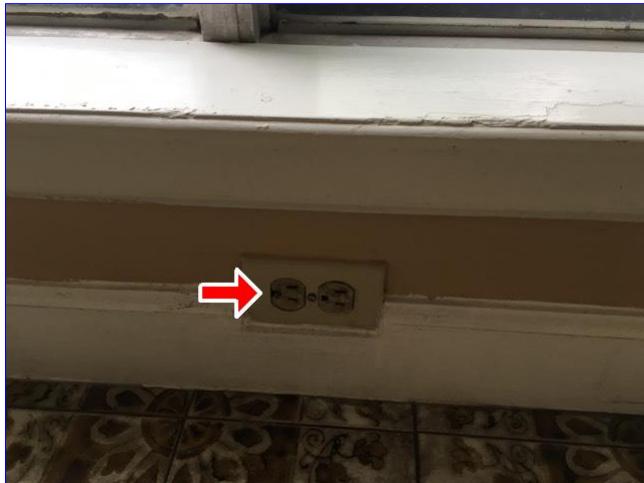
B. Item 8(Picture) Electrical outlet receptacle at breakfast area of kitchen has ground plug broken off in it. In addition, electrical outlet receptacle is loose

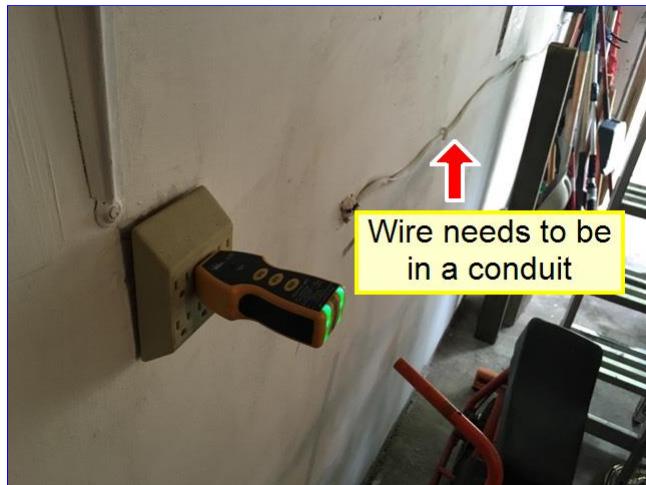
B. Item 10(Picture) Electrical outlet receptacles in the garage not wired for GFCI. In addition wiring along right wall needs to be in a conduit.

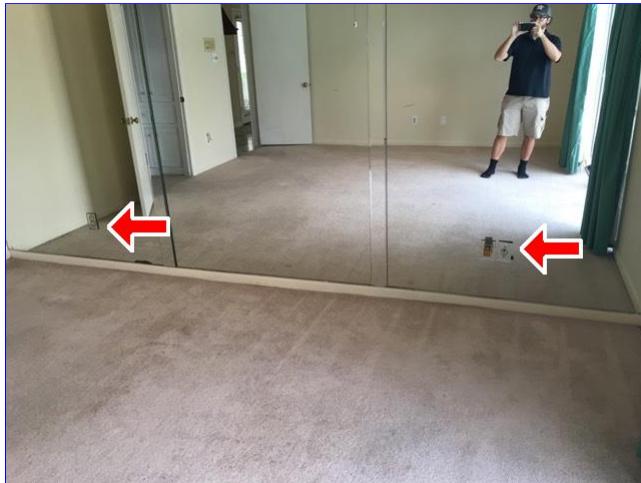
B. Item 16(Picture) Both electrical outlet receptacles on left wall of master bedroom not functioning.

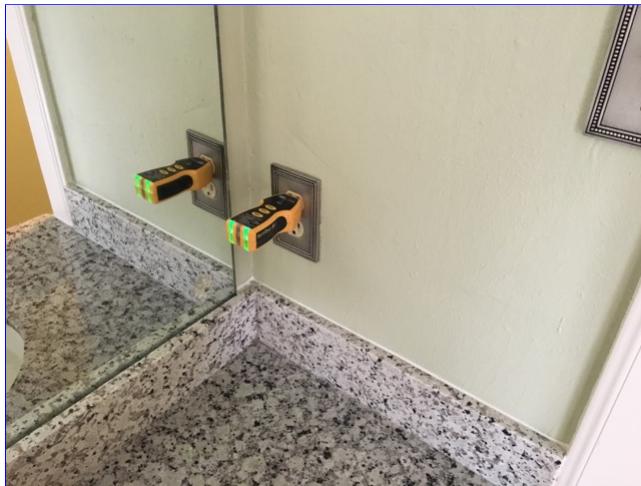
B. Item 17(Picture) Electrical outlet receptacles in master bath not wired for GFCI.

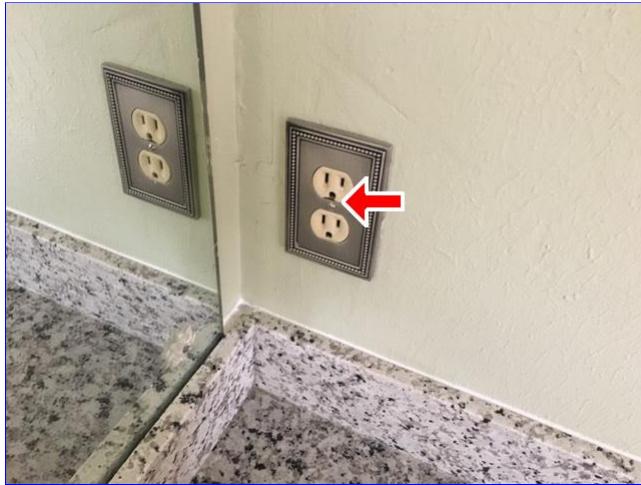
B. Item 18(Picture) Electrical outlet receptacle and right vanity of master bath damaged.

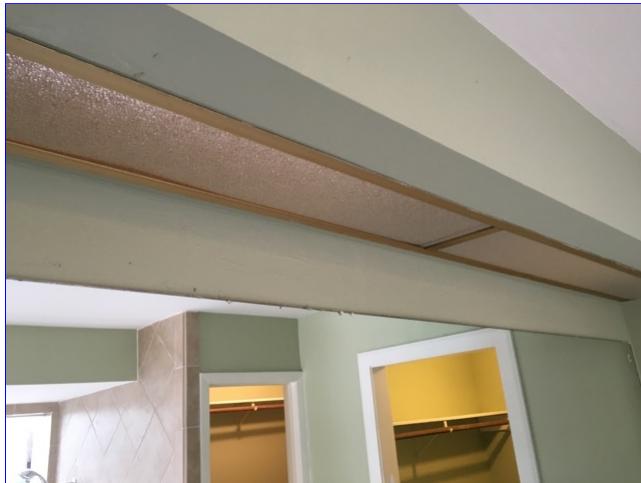
B. Item 19(Picture) Appears fluorescent light ballasts are burnt out at master bath.

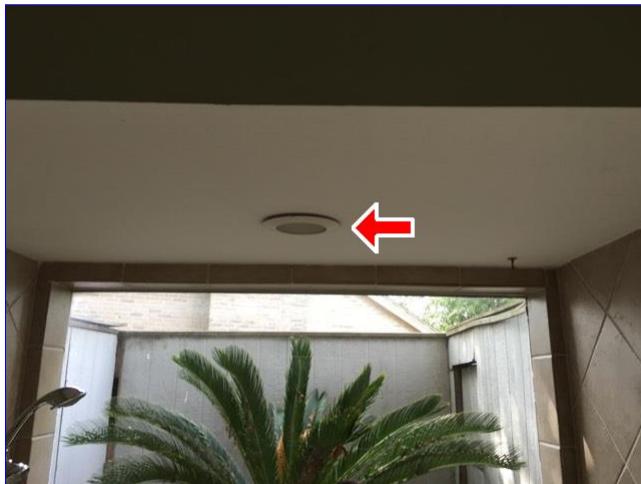
B. Item 20(Picture) Appears recess bulb at master shower area burnt out.

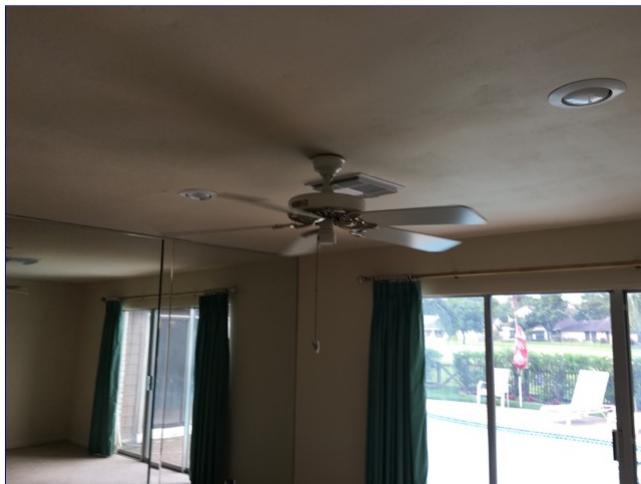
B. Item 21(Picture) NOTE: Ceiling fan in master bed hard wired. Not controlled by switch but by pull chain.

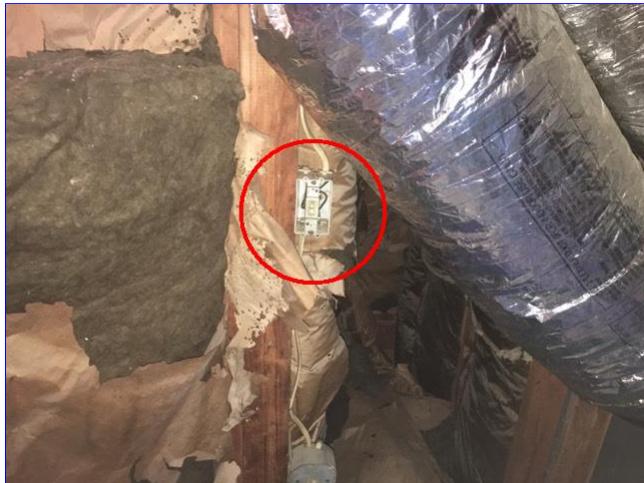
B. Item 22(Picture) Cover plate missing for HVAC cut off switch in attic. Left side attic.

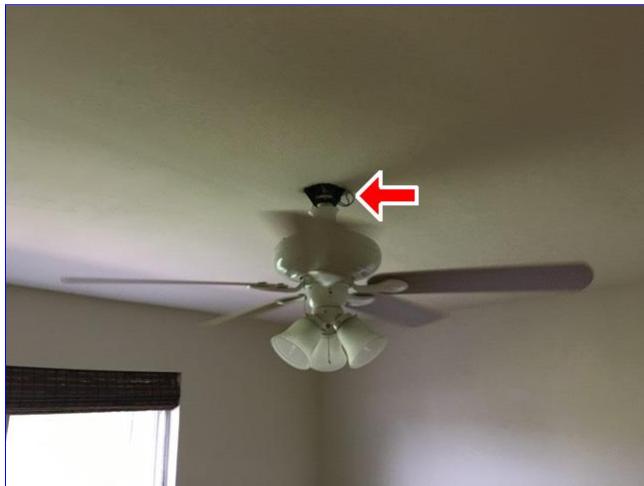
B. Item 23(Picture) Escutcheon missing for ceiling fan in upstairs right bedroom.

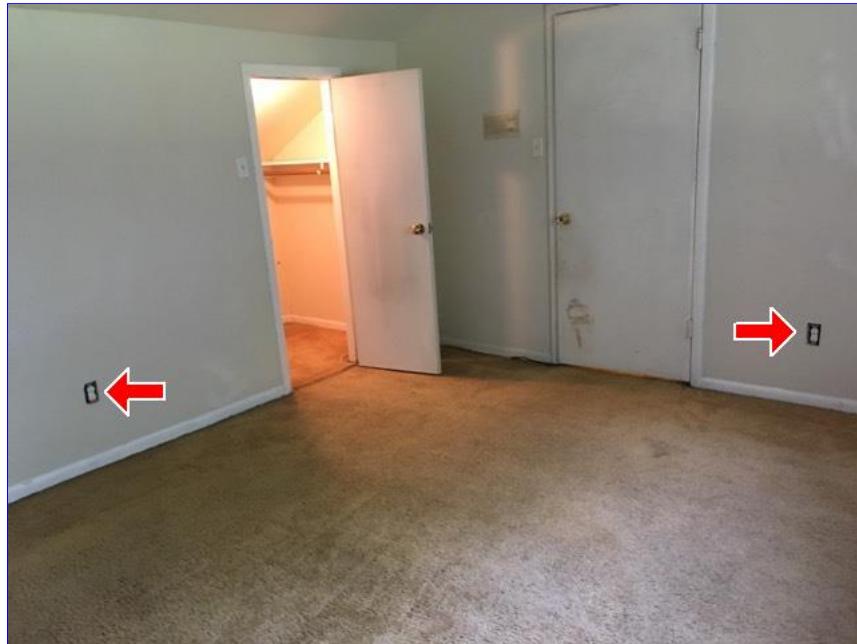
B. Item 24(Picture) Two cover plates missing for electrical outlet receptacles in upstairs right bedroom.

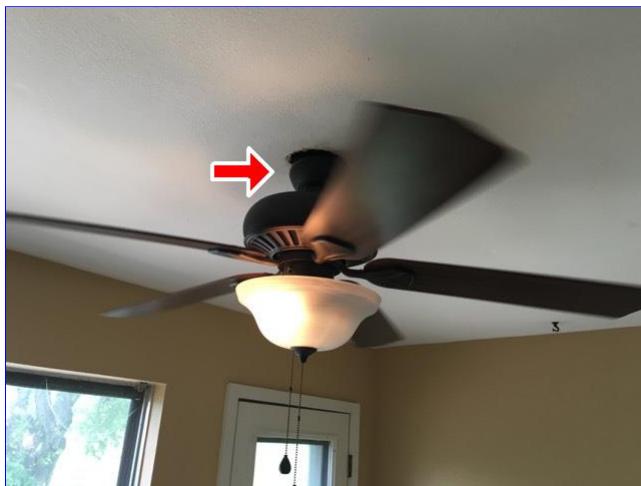
B. Item 27(Picture) Ceiling fan escusion needs to be secured to ceiling in breakfast area of kitchen.

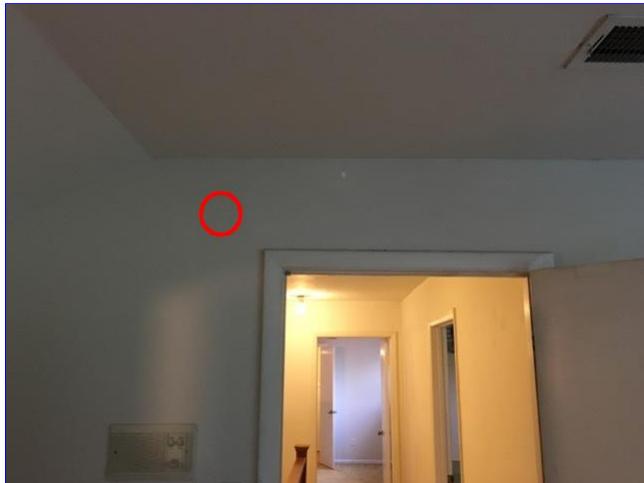
B. Item 28(Picture) Smoke detectors missing at all four bedrooms.

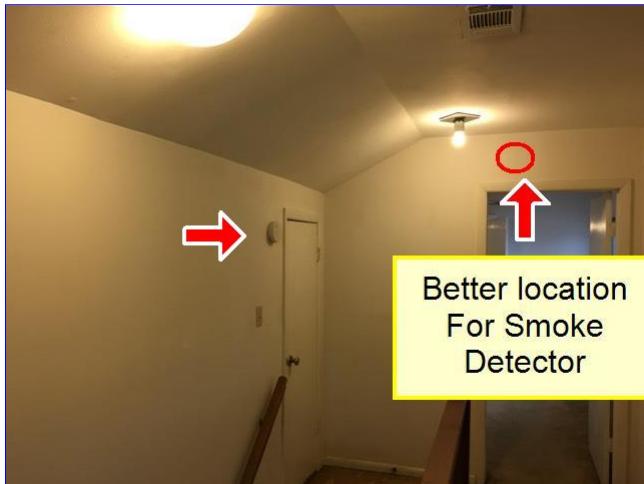
B. Item 29(Picture) Smoke detector in upstairs hallway installed in wrong location. Needs to be within 12 inches of the highest point of the ceiling.

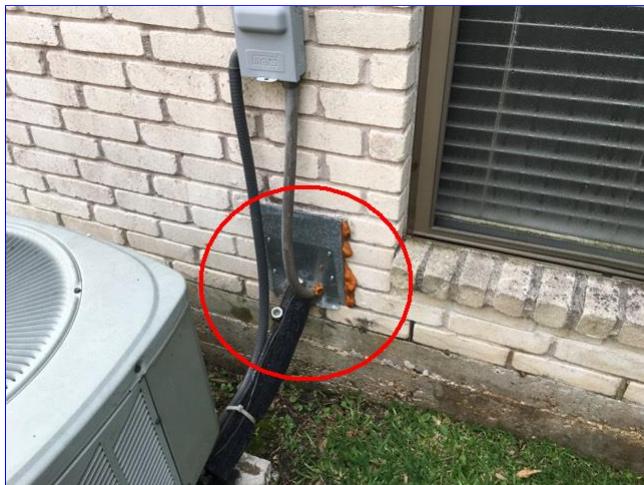
B. Item 1(Picture) Copper box for A/C compressor needs to be painted on right side of home.

It is recommended that a professional painter or handy man paint the copper boxes to prevent deterioration and corrosion.

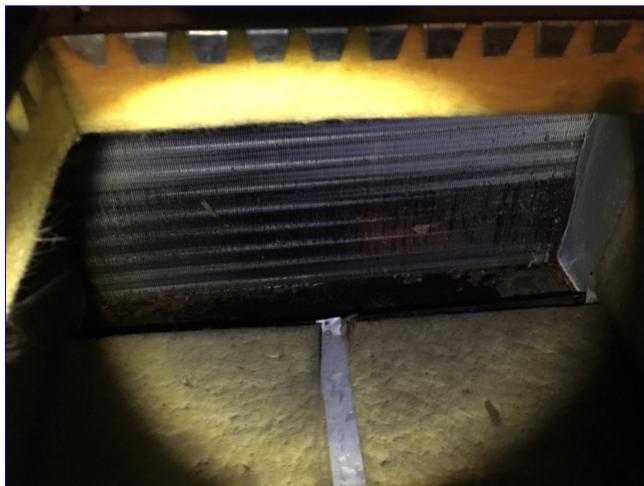
B. Item 3(Picture) Coils need to be cleaned at evaporator coils left HVAC system.

It is recommended that a licensed HVAC technician inspect the items listed in this section and make any necessary repairs. It is also recommended that a licensed HVAC technician clean the evaporator coils of both units in home.

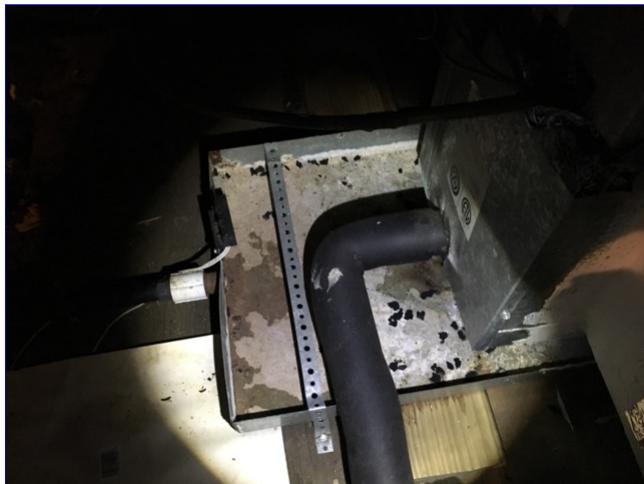
B. Item 5(Picture) Primary drain clogged. Leaking into secondary drain pan.

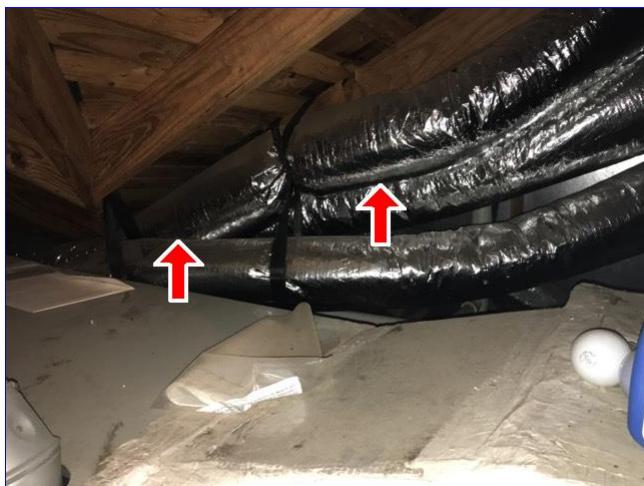
C. Item 1(Picture) Ducts touching each other at right HVAC unit.

It is recommended that all touching duct be separated by an inch of air space to prevent condensation from accumulating between the ducts or install one inch of fiberglass insulation between the touching ducts.

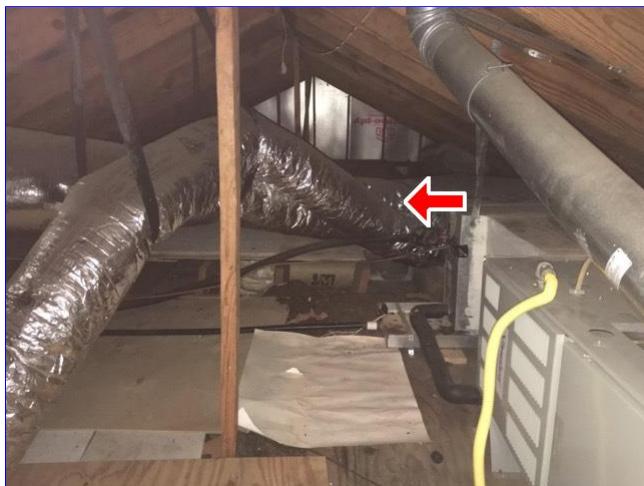
C. Item 2(Picture) Ducts touching each other at right HVAC unit.

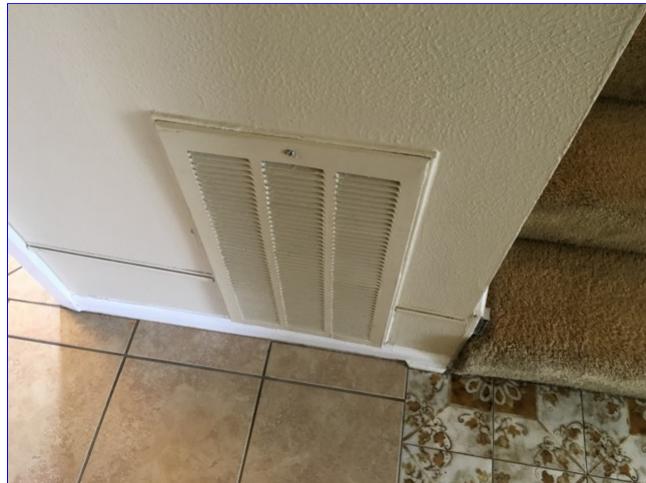
C. Item 3(Picture) Only a 6 degree difference between the return air and supply ducts in living room. Ducts possibly crimped.

It is recommended that a licensed HVAC Technician inspect the cooling supply issues with the duct work of the home and make any necessary repairs to achieve even cooling throughout the home.

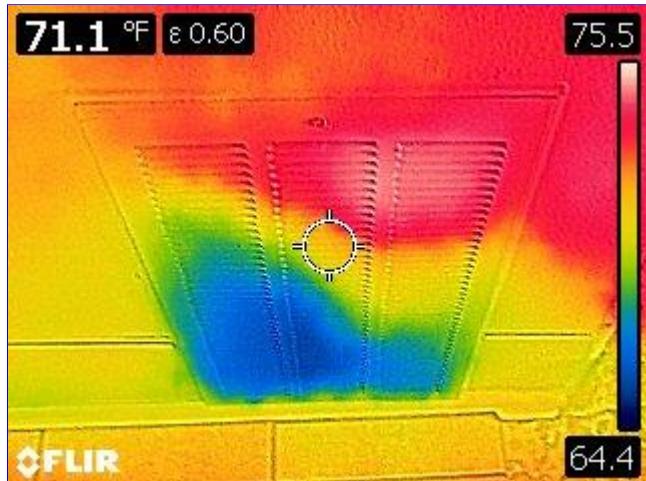
C. Item 4(Picture) Only a 6 degree difference between the return air and supply ducts in living room. Ducts possibly crimped.

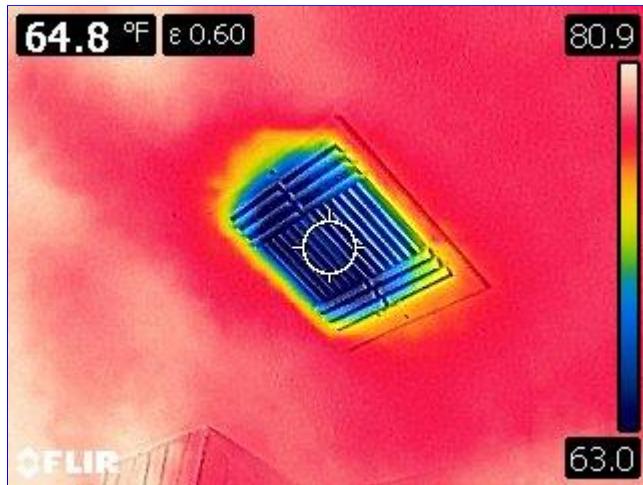
C. Item 5(Picture) Only a 6 degree difference between the return air and supply ducts in living room. Ducts possibly crimped.

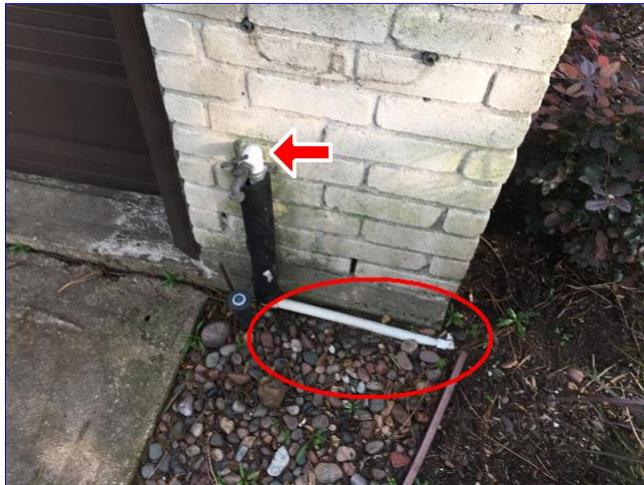
A. Item 1(Picture) Hose bib's entire supply line needs to be insulated at front of home. Also missing vacuum breakers at all exterior hose bibs (Vacuum breakers are a grandfathered item)

It is recommended that the exposed exterior plumbing be insulated.

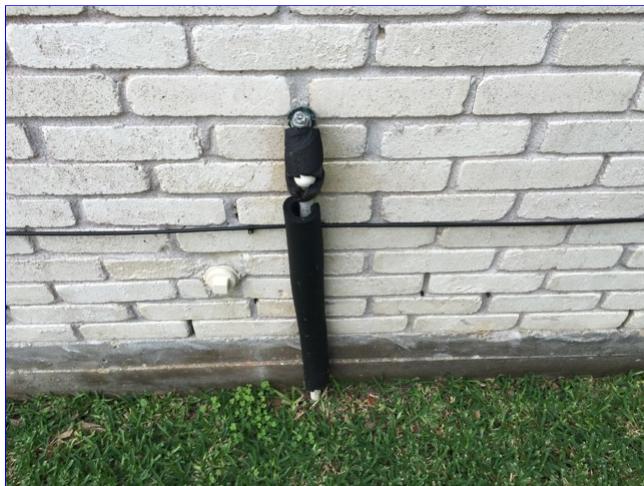
A. Item 2(Picture) NOTE: Hose bib on right side of home connected to a PVC line that goes underground to the rear of the back yard.

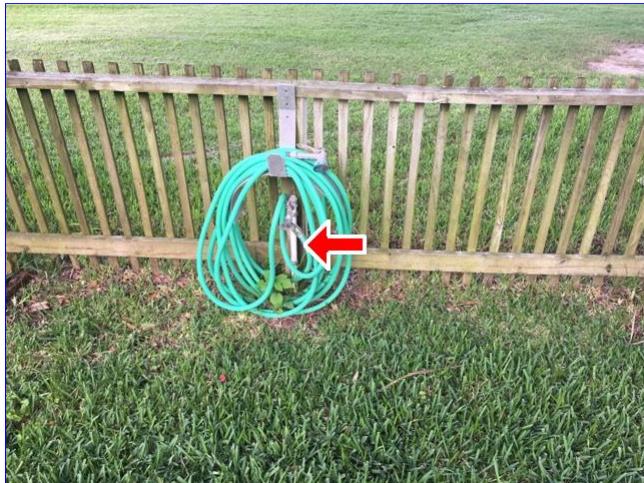
A. Item 3(Picture) Right side hose bib stubs out at rear of backyard. Piping should be insulated.

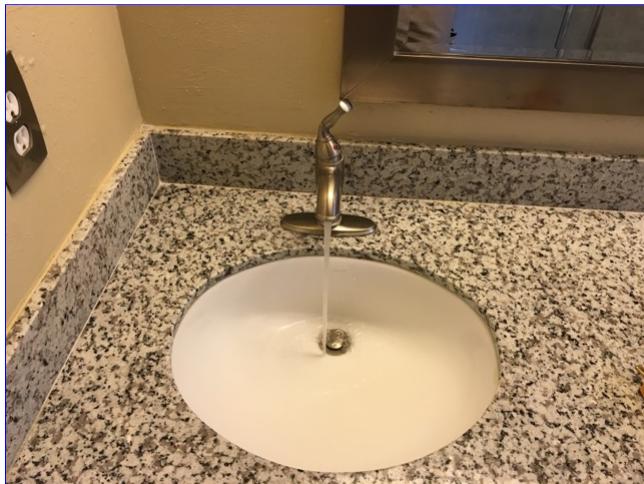
A. Item 4(Picture) Hot and cold reversed at right hall bath faucet.

It is recommended that a licensed plumber inspect the other items listed in this section and make any necessary repairs or replacements.

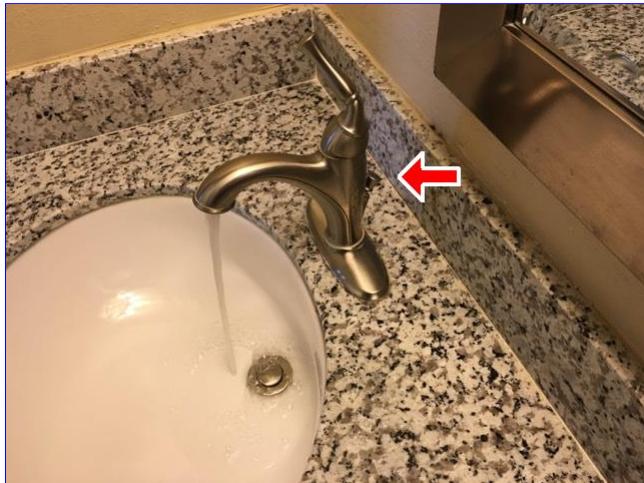
B. Item 1(Picture) Pull handle for stopper at right hall bath sink not working.

It is recommended that a licensed plumber inspect the other plumbing items in this section and make any necessary repairs or replacements.

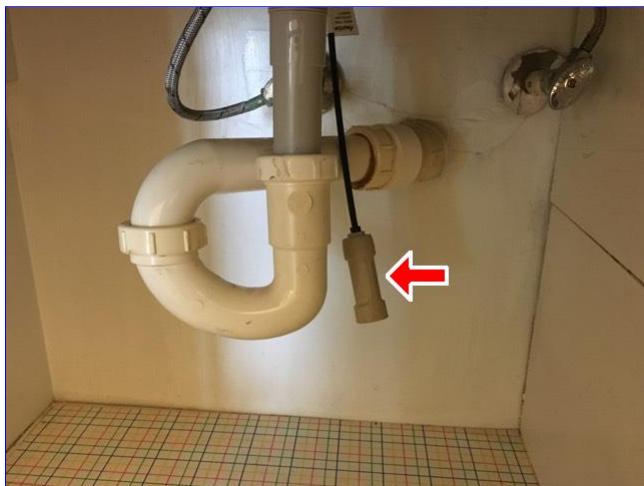
B. Item 2(Picture) Pull handle for stopper not connected at right hall bath.

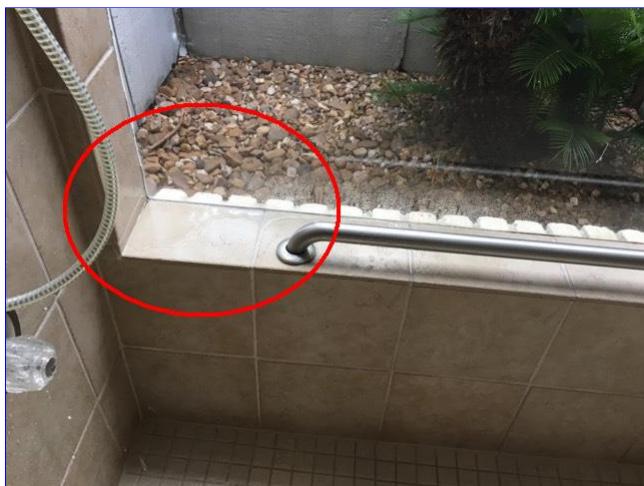
B. Item 3(Picture) Window ledge at master bath not sloped. Holds water when shower is run.

It is recommended that a professional tile installer reset the lower window sill tile so that it slopes away from window and towards the shower drain and reset upper window tile so it does not sag.

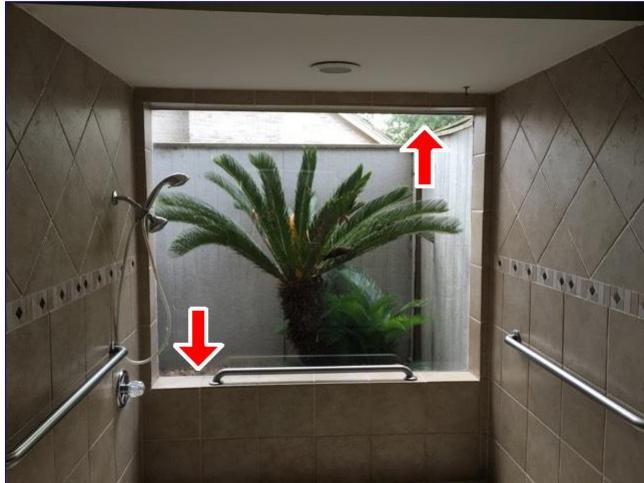
B. Item 4(Picture) Cracks in grout at window sill tile. In addition, appears that upper tiles at window sill are sagging on the right side.

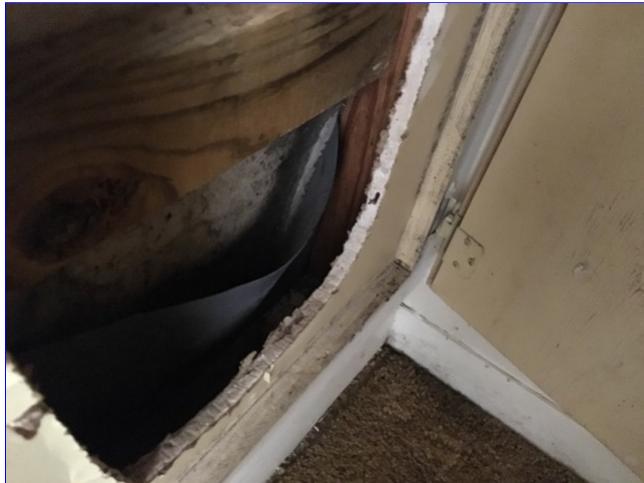
B. Item 5(Picture) Appears to be a water leak behind right hall bath shower.

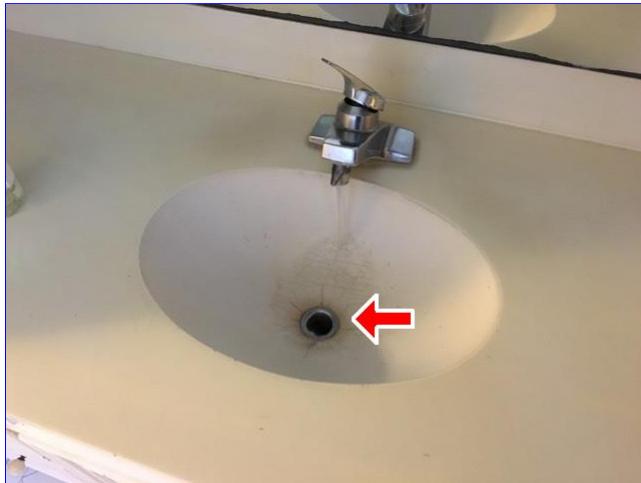
B. Item 6(Picture) Stopper missing in upstairs hall bath.

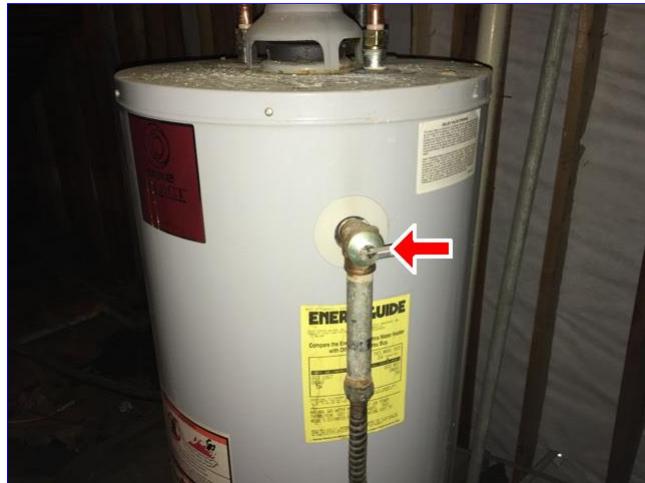
C. Item 1(Picture) T/P valve for water heater leaking.

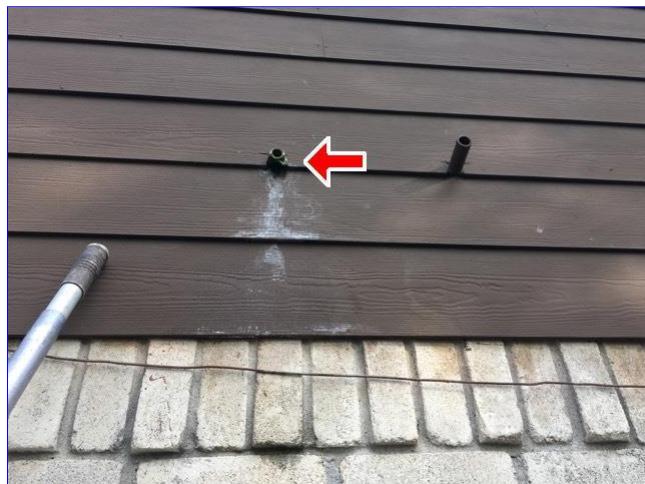
C. Item 2(Picture) T/P valve for water heater leaking.

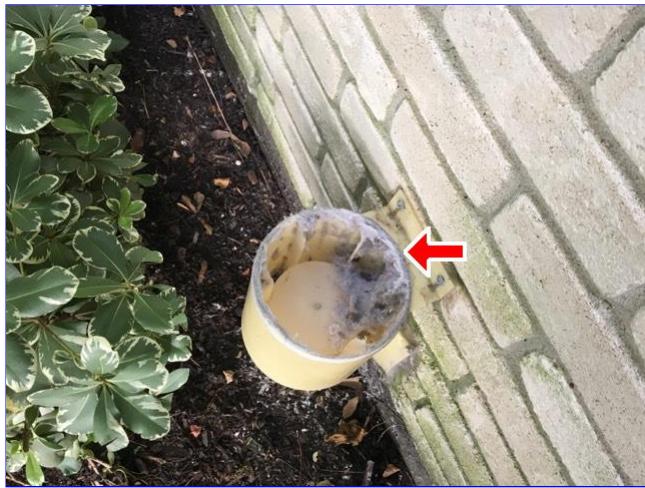
H. Item 1(Picture) Dryer exhaust vent needs to be cleaned out.

To prevent the potential for fire, it is recommended that all lint be cleaned from dryer vent.

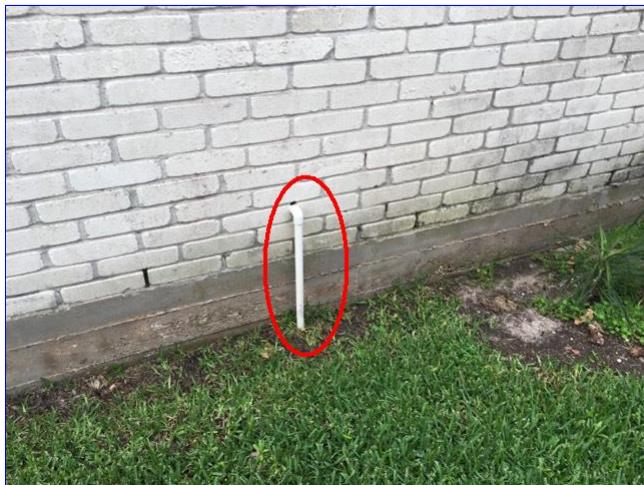
A. Item 1(Picture) Conduit for irrigation system needs to be painted.

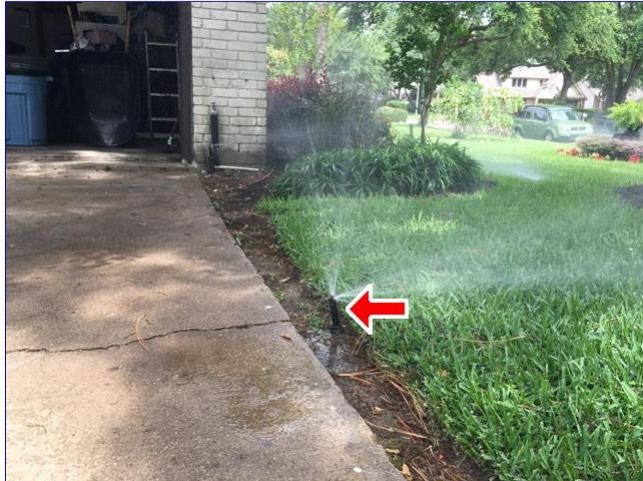
A. Item 3(Picture) Zone two sprinkler head damaged and needs to be replaced.

It is recommended that a licensed irrigation installer replace the damaged sprinkler head, reset the zone 3 sprinkler head and secure the backflow prevention device to the wall.

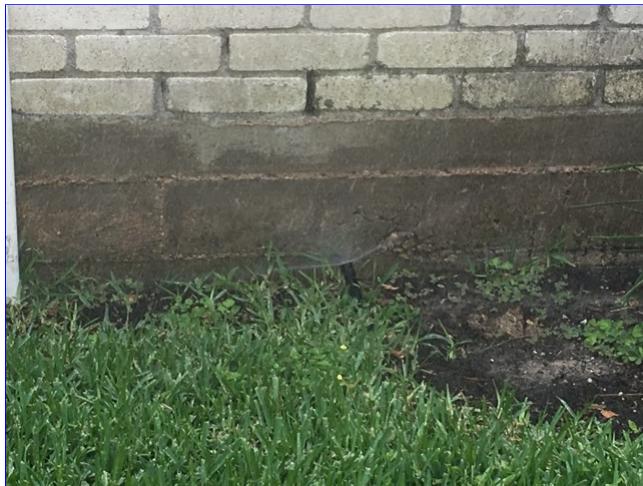
A. Item 4(Picture) Zone three sprinkler head needs to be reset perpendicular to the ground.

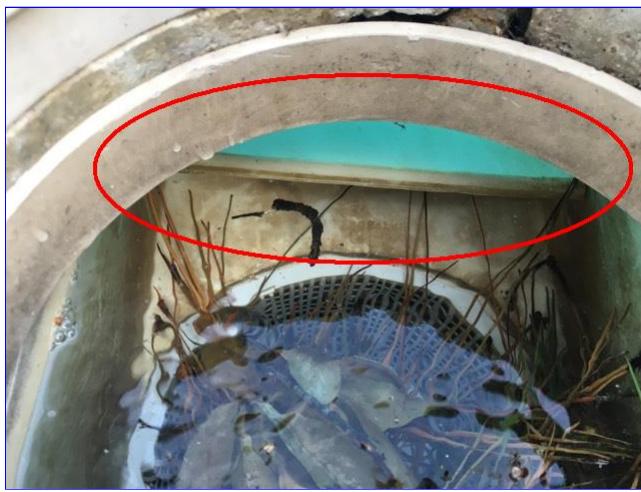
B. Item 2(Picture) Weir wedged between walls of strainer. Also basket needs to be cleaned out

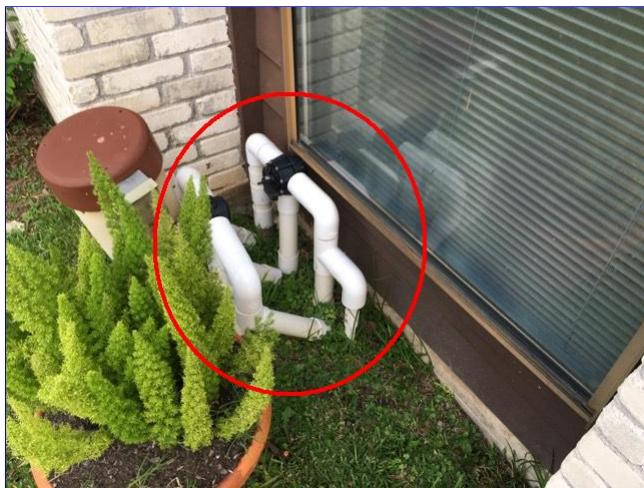
B. Item 4(Picture) It is recommended that PVC pipe being be painted at rear of home

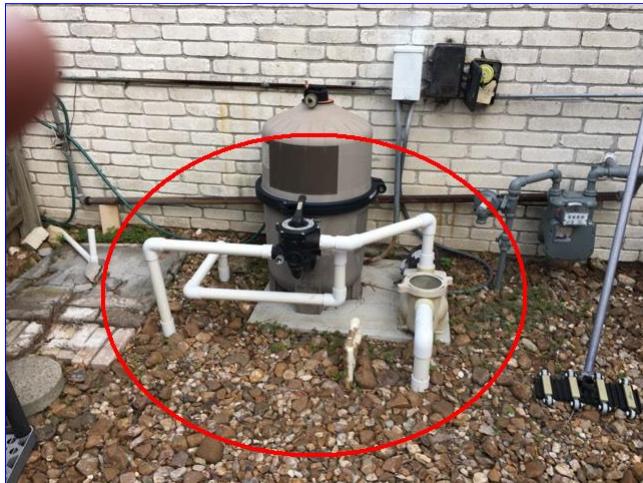
B. Item 6(Picture) It is recommended that PVC piping be painted at left side of home.

It is recommended that a professional painter or handy man paint all PVC exposed to the sun. This will help prevent its deterioration.

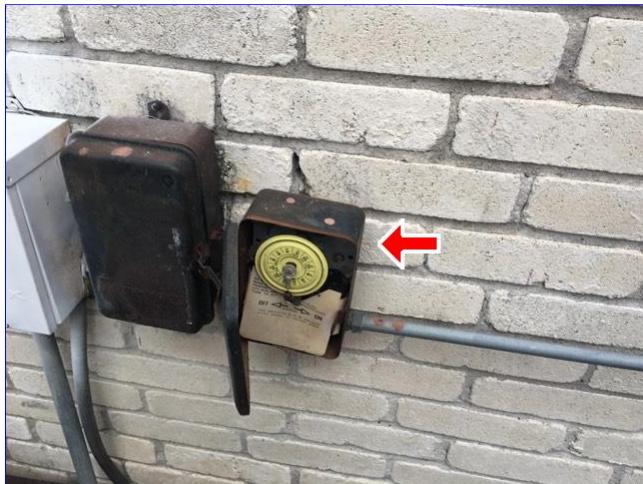
B. Item 7(Picture) Timer box needs to be secured to the wall

It is recommended that a licensed electrician inspect the electrical items listed in this section and make any necessary repairs or replacements.

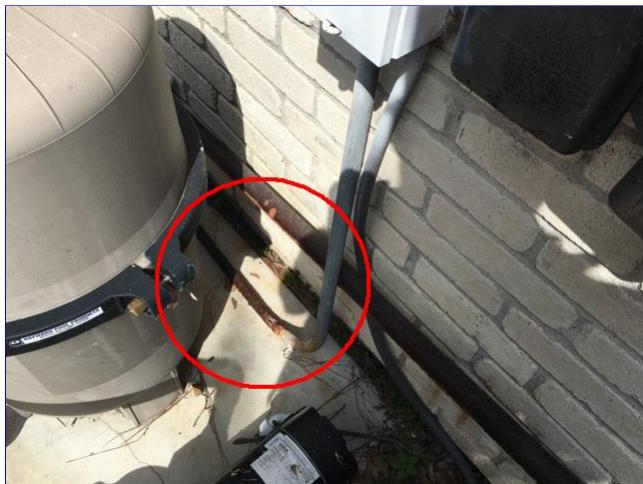
B. Item 8(Picture) Conduit for pool timer rusted through. Needs to be replaced.

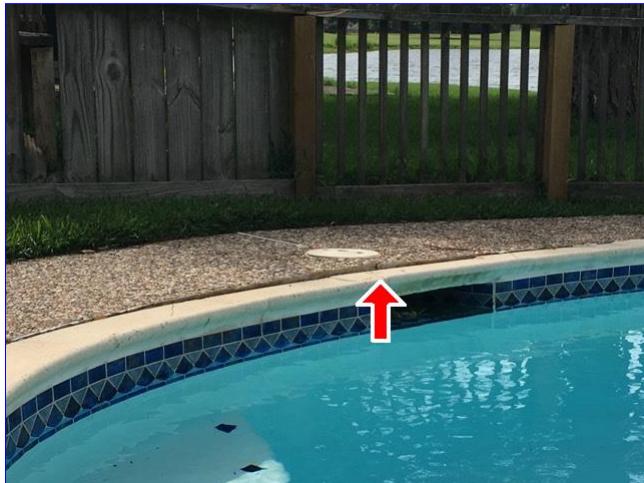
B. Item 9(Picture) Ground heaving around the strainer basket of swimming pool.

It is recommended that a licensed pool technician inspect the other items listed in this section and make any necessary repairs or replacements.
