ON POINT HOME INSPECTIONS LLC

## INSPECTION REPORT

1234 Main St. Tucson Az 85704

09/30/2020 9:00AM

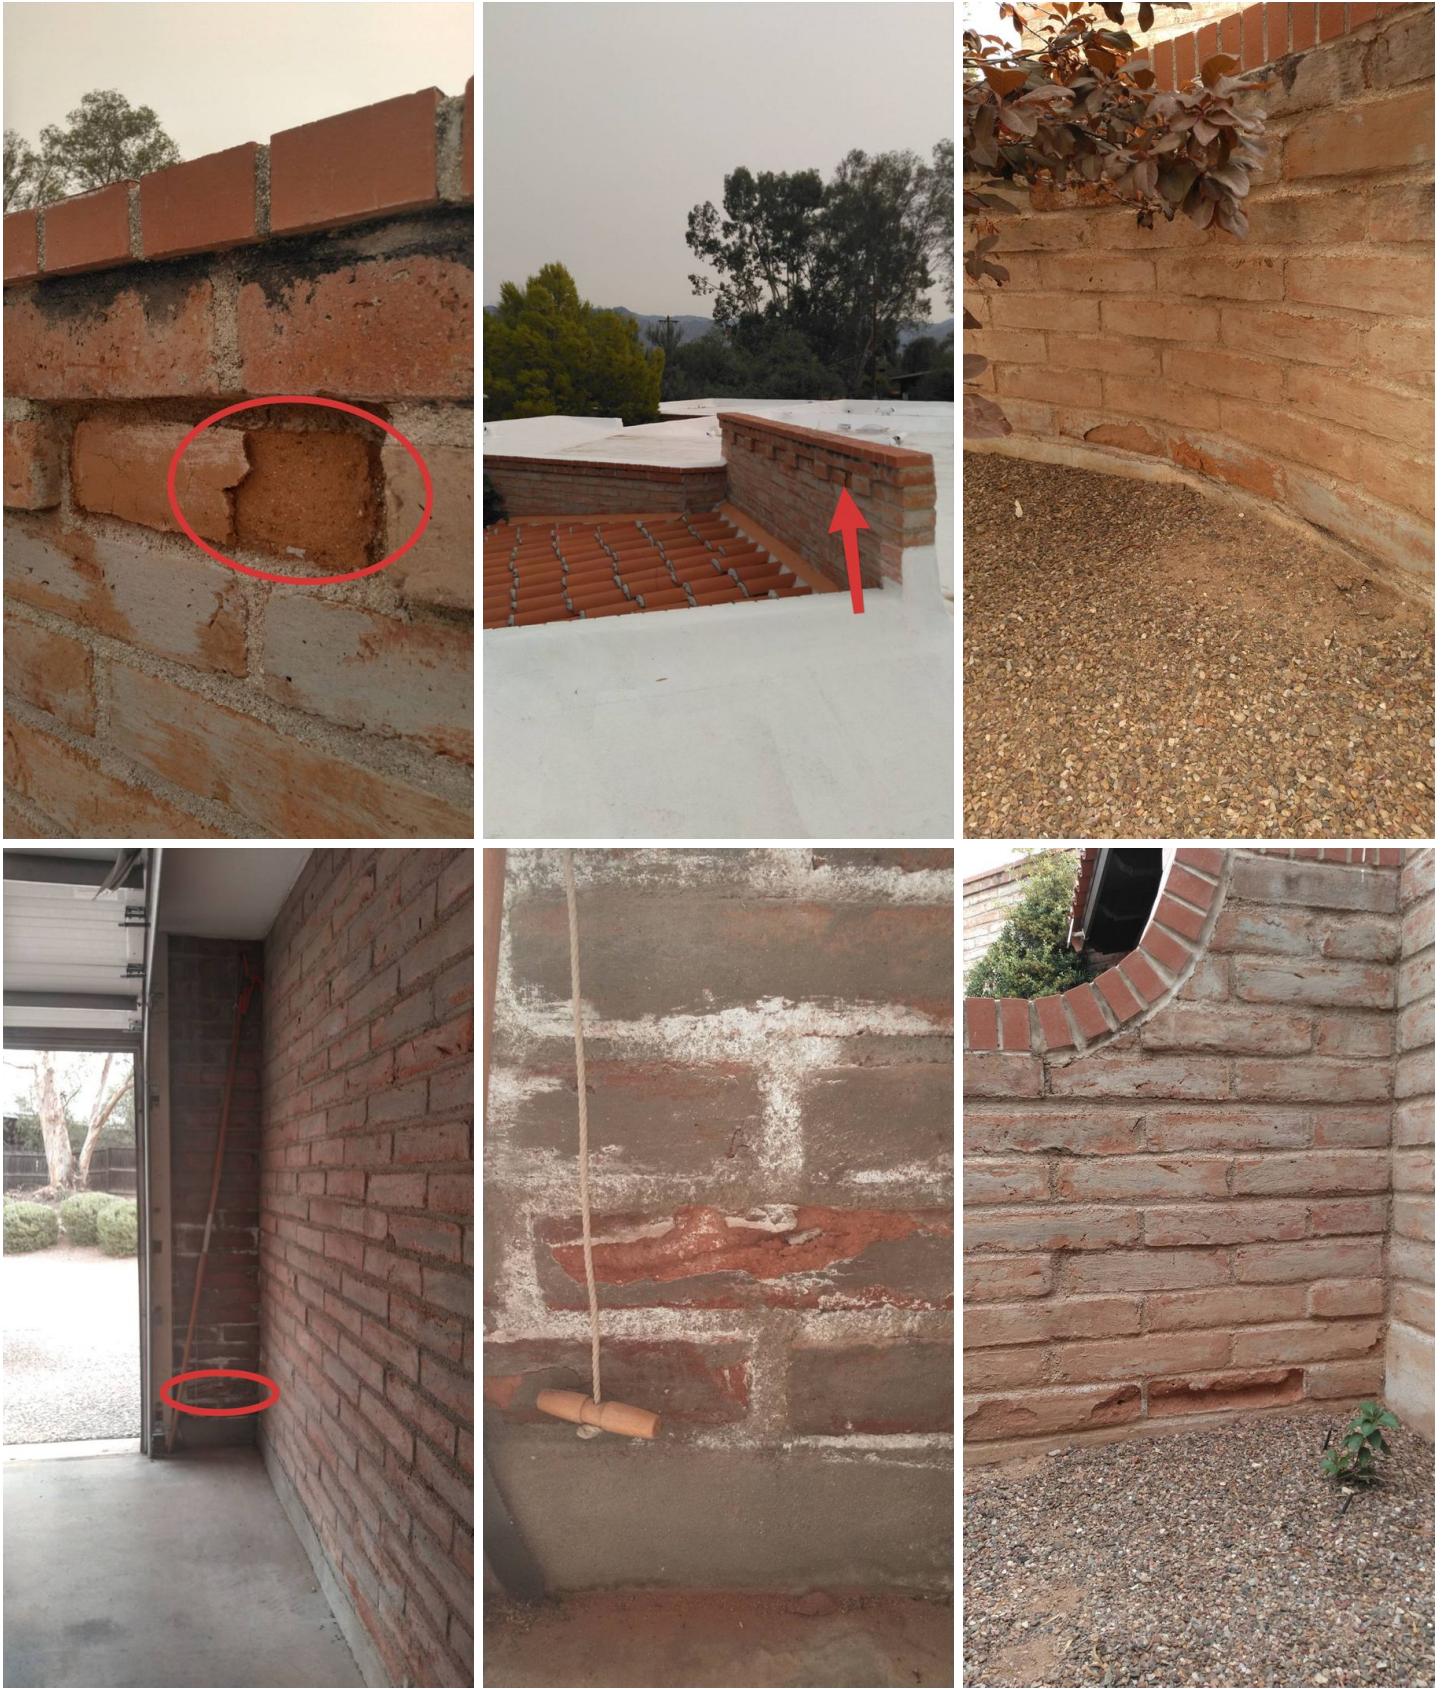
#### ENTRYWAY, GARAGE

### MASONRY SPALLING

At the time of inspection I observed masonry Spalling. Spalling is generally caused by heavy moisture exposure over a number of years that eventually breaks down the outer surface adobe and begins to deteriorate the masonry material. I recommend having a qualified professional evaluate and patch, repair or seal **as needed to prevent further damage**.

Contact a qualified professional.

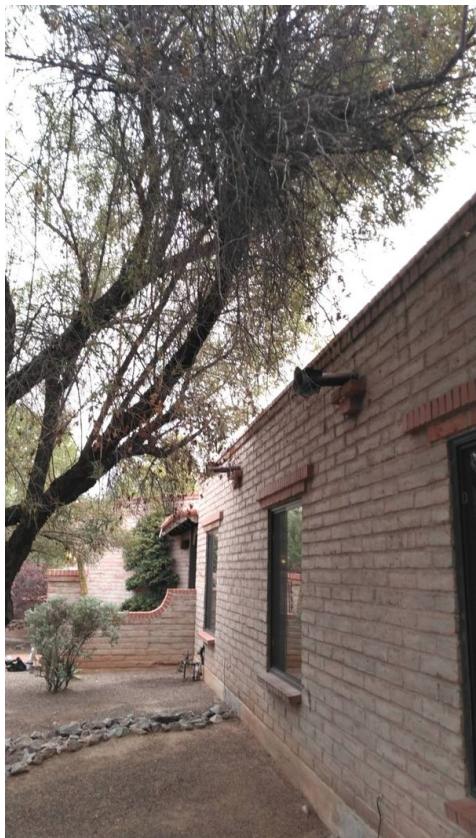
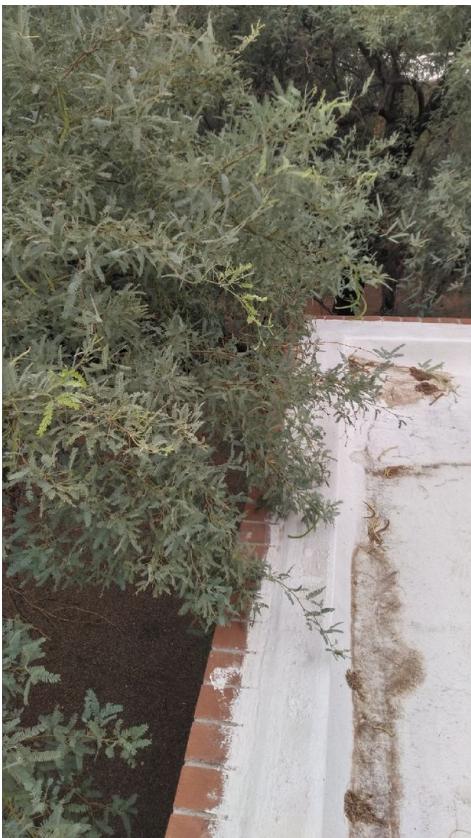
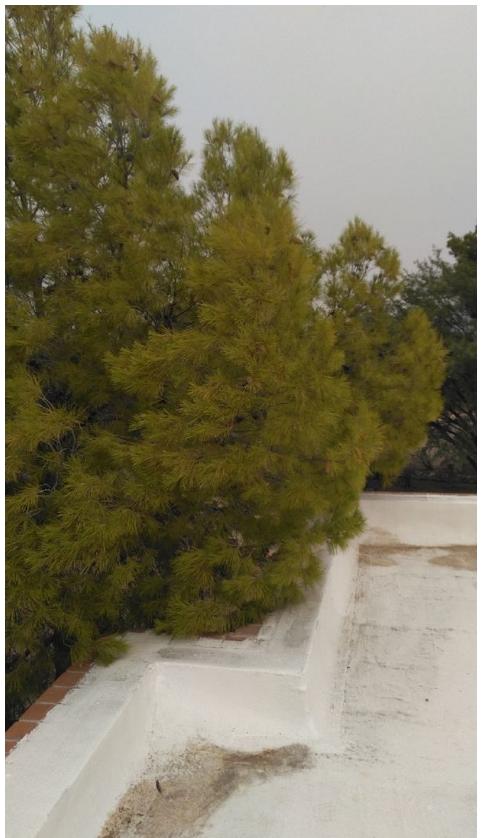
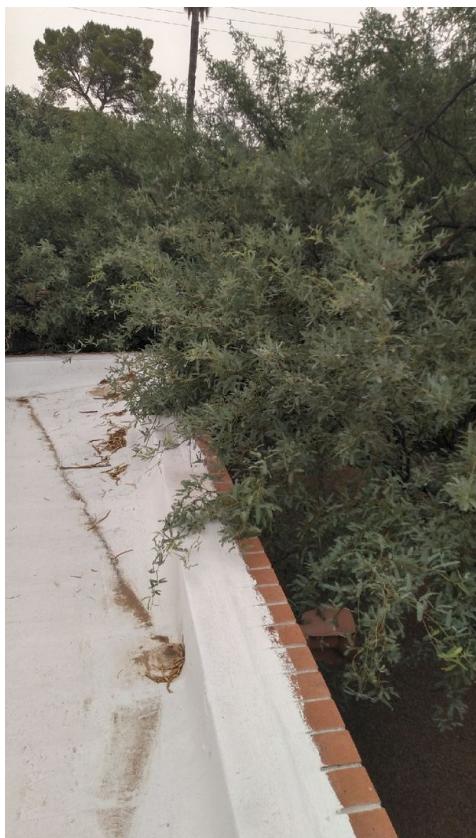
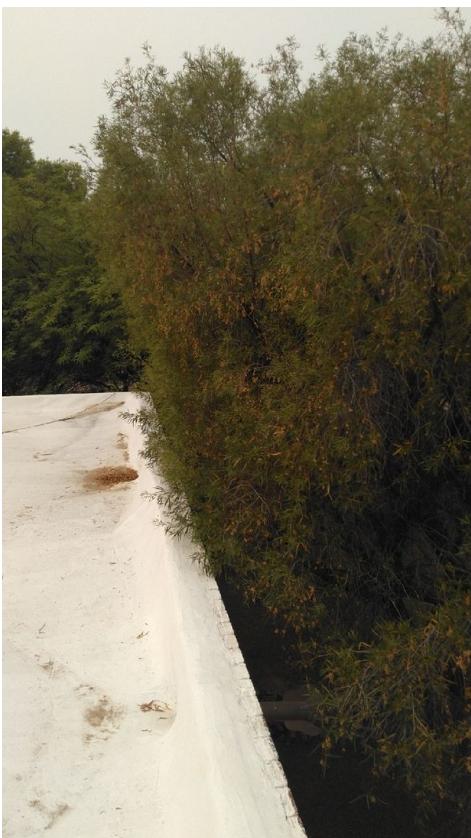
### VEGETATION AGAINST THE HOUSE

At the time of Inspection I observed vegetation against the house. This can allow rodents or pests to nest. Vegetation can also cause damage to the foundation, siding, roof, ETC if not maintained. I recommend having a landscape professional trim, maintain or remove the vegetation as needed to prevent damage.

Contact a qualified landscaping contractor

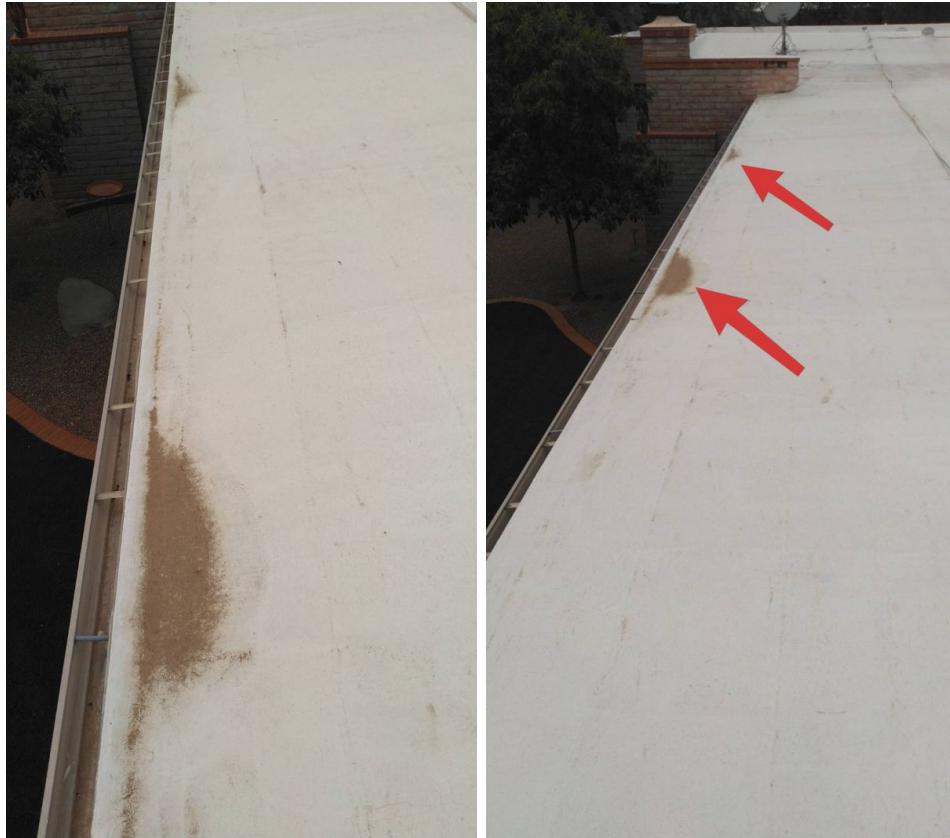
##### BACK PORCH DRIP EDGE

#### MOISTURE PONDING

I observed ponding in areas of the roof. Ponding can lead to accelerated erosion and deterioration of the roof covering materials. I recommend having a roofing professional evaluate and repair as needed.

Contact a qualified roofing professional.

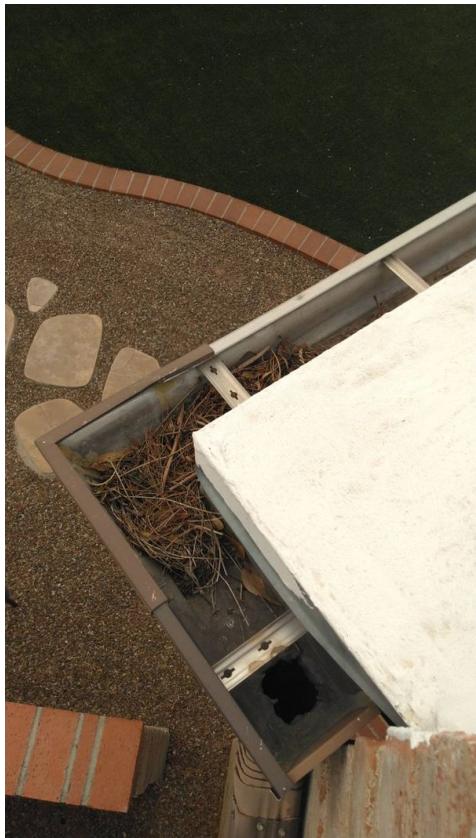
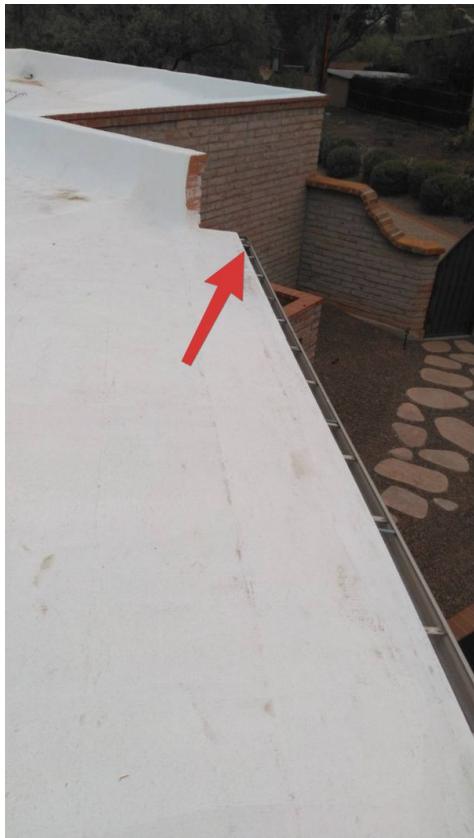
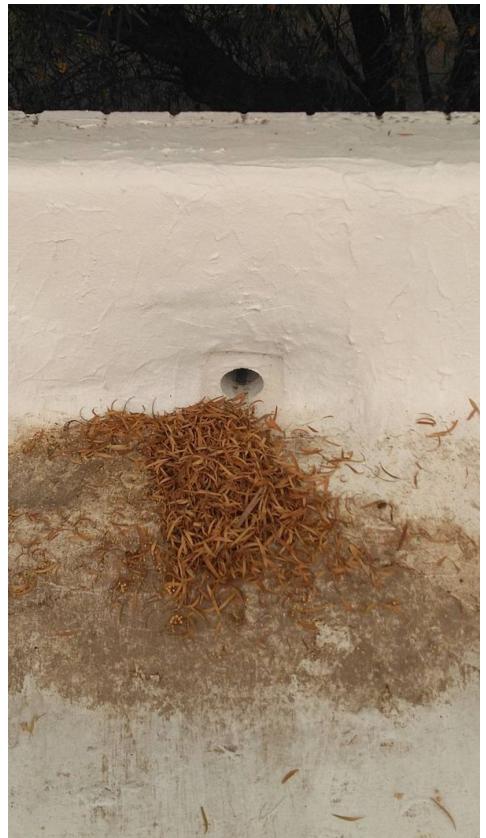
#### **ACCUMULATION OF DEBRIS IN THE GUTTERS AND SCUPPERS**

Tree leaves and debris has accumulated around the roof drains. I recommend cleaning the roof drains and maintaining as needed to facilitate water flow.

Contact a qualified roofing professional.

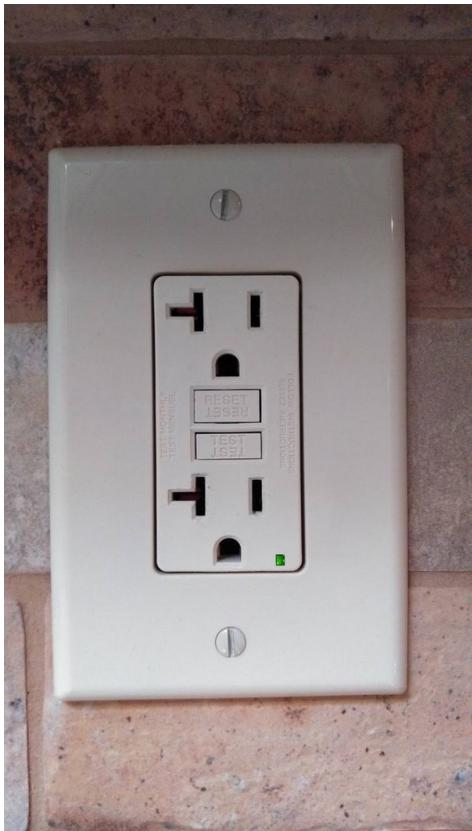
Present, No GFCI protection in the bathrooms

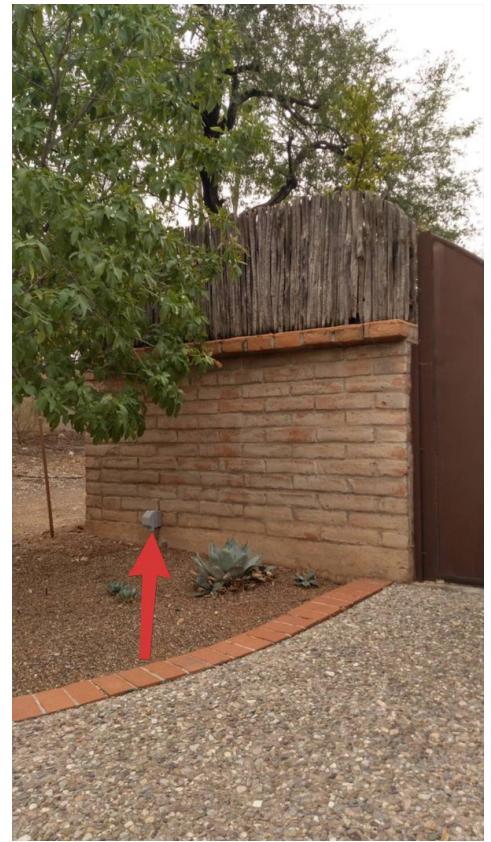
NORTH (OUTSIDE OF COURTYARD)

**INOPERABLE RECEPTACLE(S)**

At the time of inspection an exterior receptacle had no power when tested. I recommend having an electrical professional repair as needed for proper operation.

Contact a qualified professional.

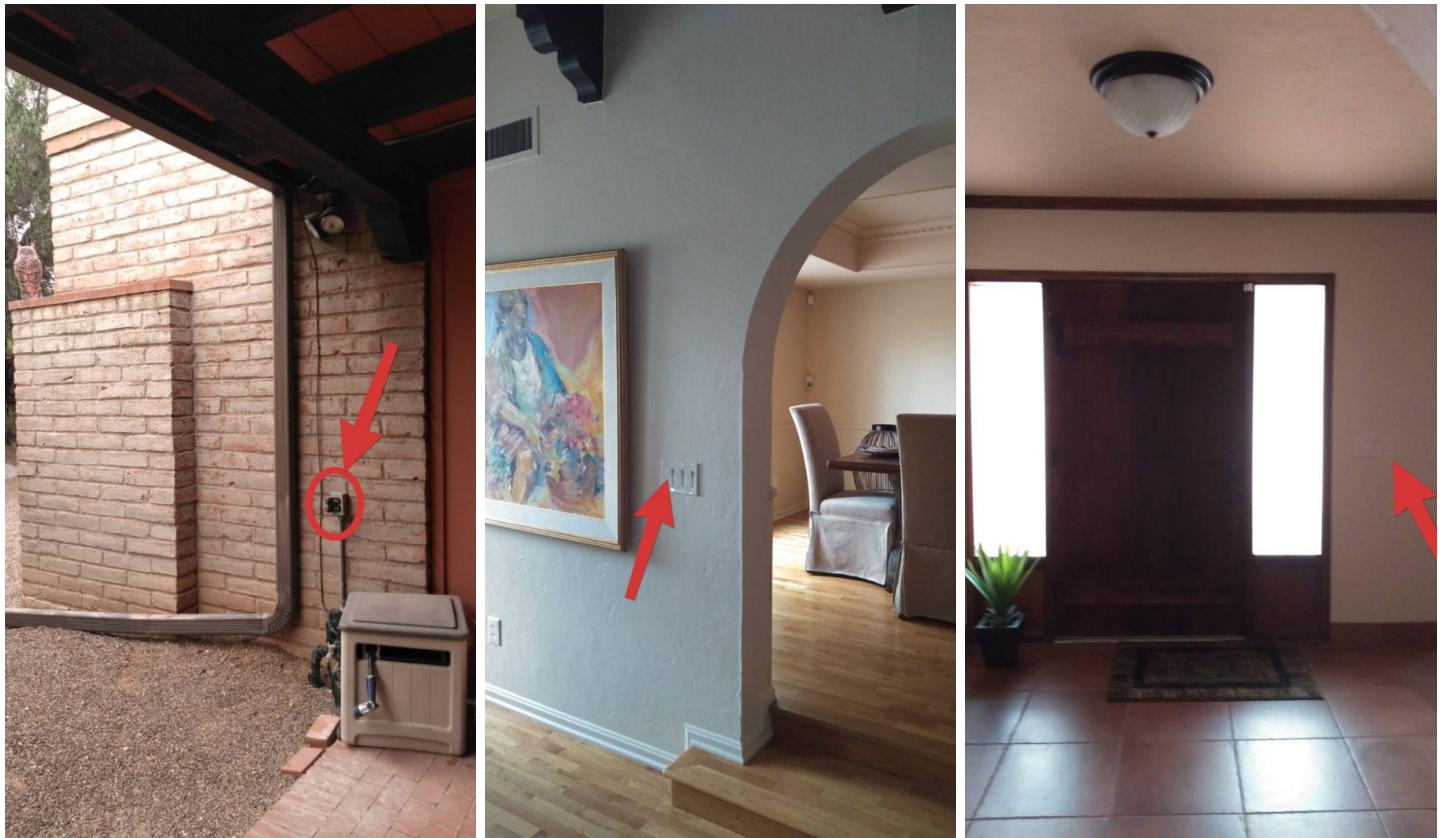
### UNKNOWN SWITCHES IN THE HOME

Contact a qualified professional.

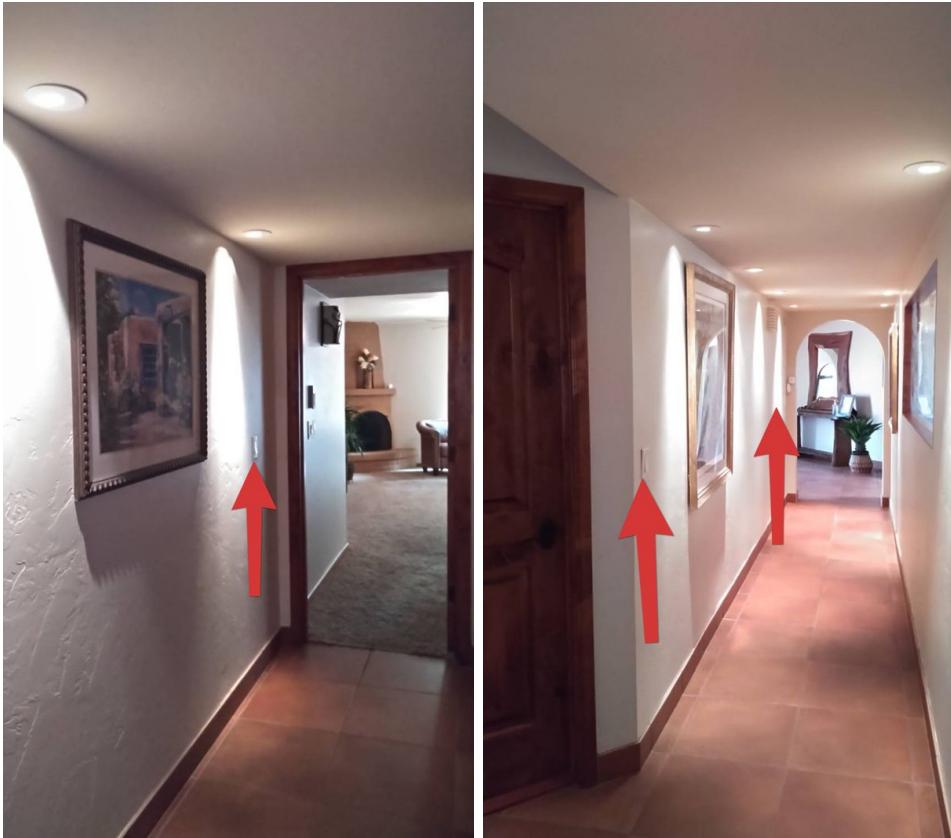
The hallway lighting had multiple switch locations. The switches did not function properly (lights on and off) at each switch. The 2 switches at the bedroom ends would turn the hallway lights off but did not turn the lights on. The dimmer switch at the entryway would turn the lights on and off. I recommend having an electrical professional evaluate and repair as needed for proper operation from the switches at all ends of the hallway.

Contact a qualified professional.

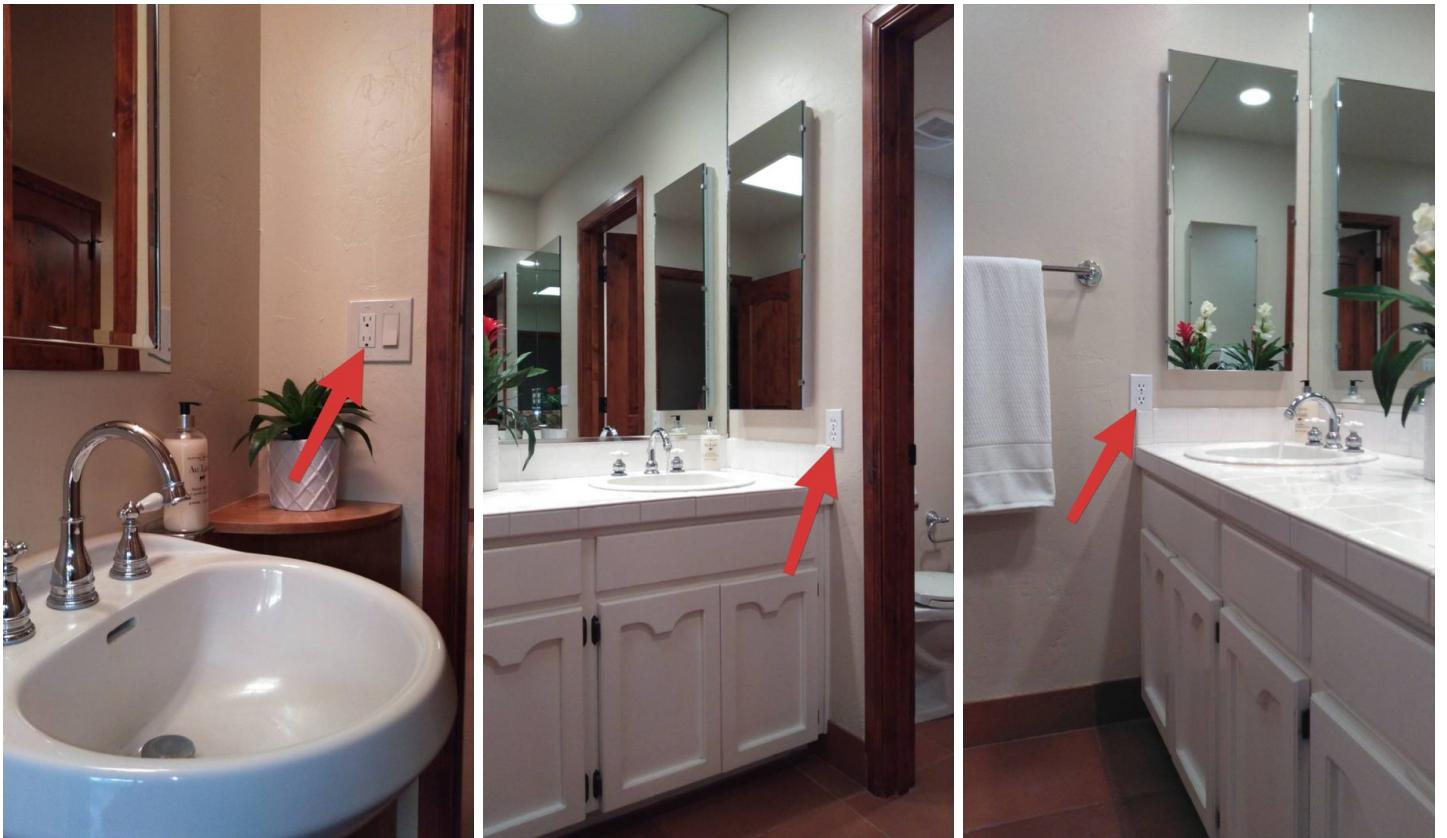
No GFCI protection present in the bathrooms at the time of inspection. Although the age of the house may not have required GFCI protection in the bathroom when it was built, it is recommended that it be upgraded as a safety device near wet locations. I recommend having an electrical professional evaluate and install as needed.

Contact a qualified electrical contractor.

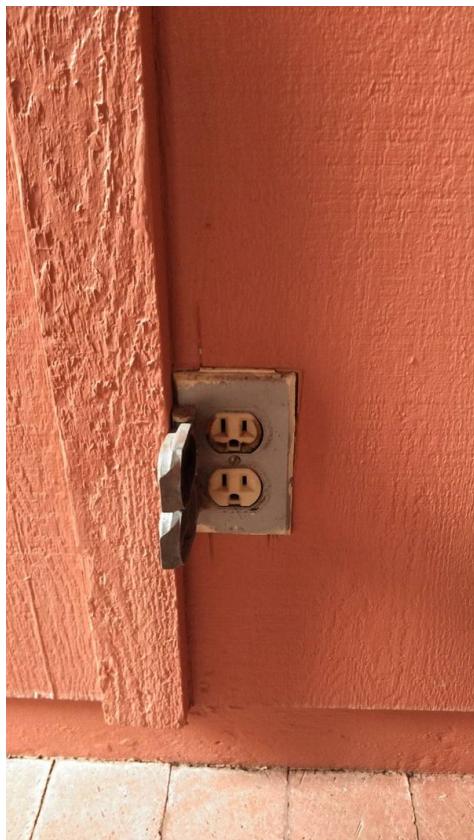
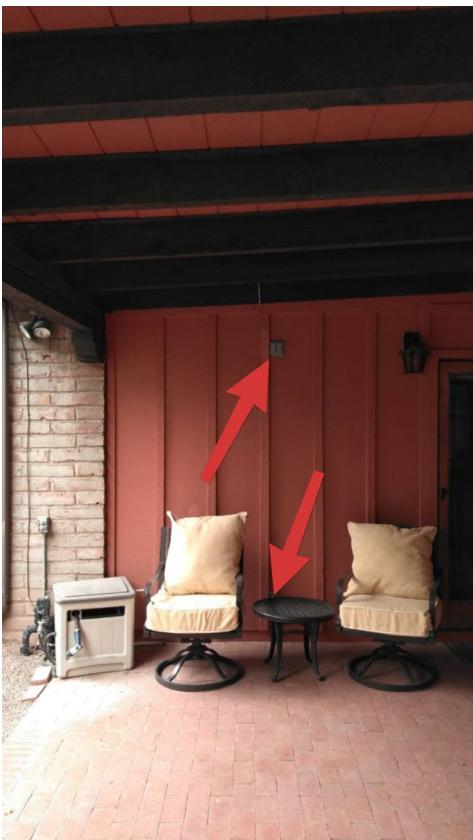
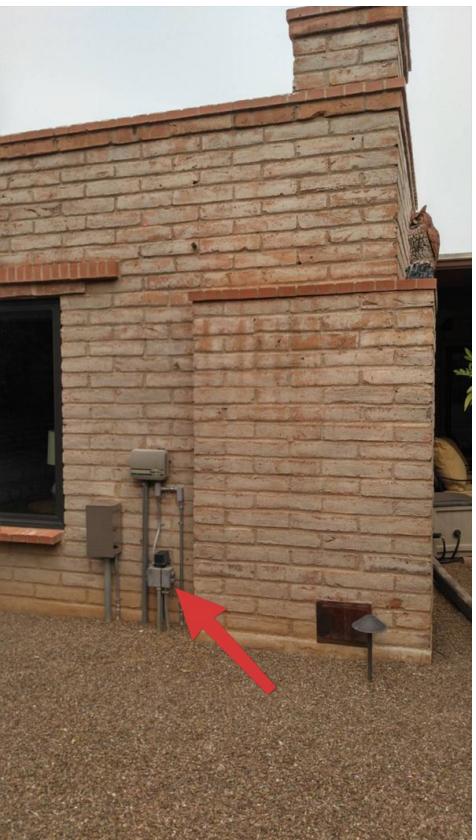
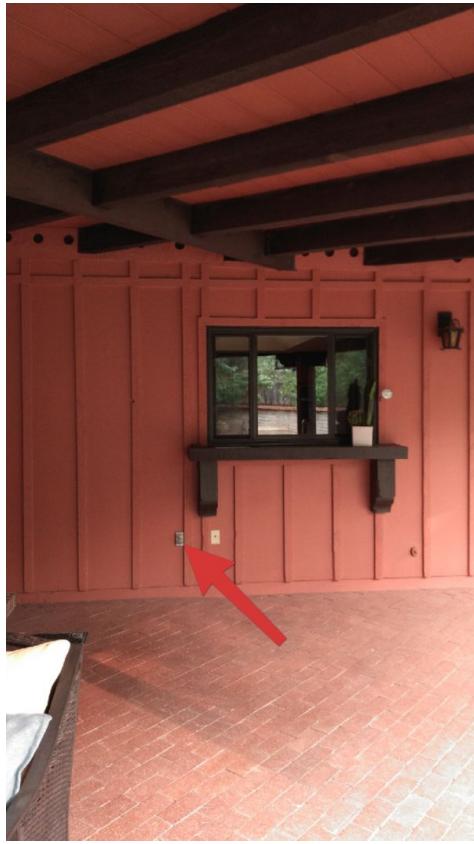
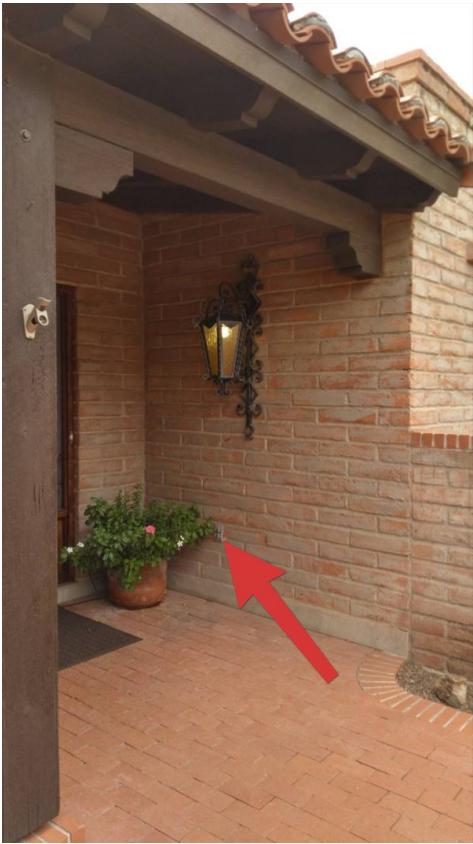
**NO GFCI PROTECTION AT EXTERIOR RECEPTACLES**

At the time of inspection I observed exterior receptacles that were not GFCI protected. I recommend having electrical professional upgrade the receptacles with GFCI protection as an exterior safety device.

Contact a qualified electrical contractor.

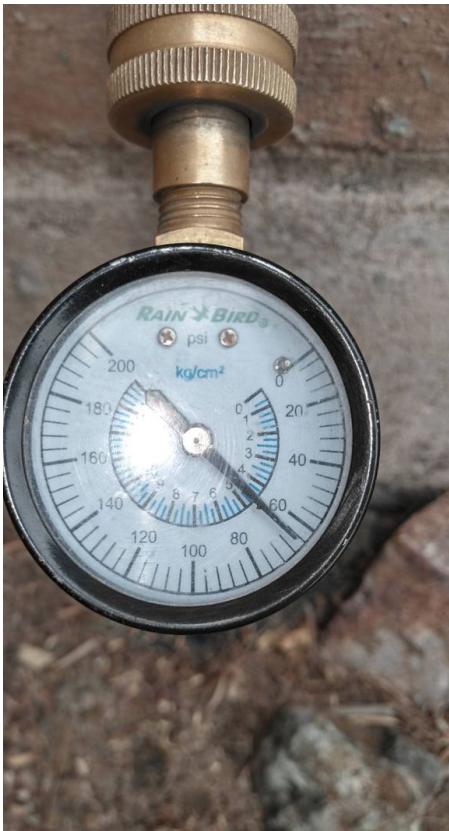
65 Psi

Recommended pressure is generally between 40 PSI and 80 PSI, anything below 40 PSI will have low flow from fixtures in the house and anything above 80 PSI can show accelerated deterioration of the seals in fixtures and faucets due to higher pressure.

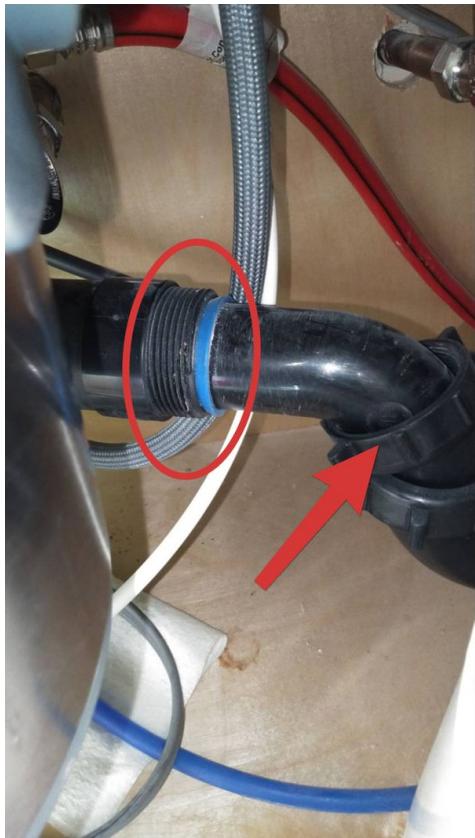
#### DRAIN PIPE - LOOSE

At the time of inspection I observed a loose drain pipe fitting. This can result in leaking and/or damage to the cabinet, wall, floor, ETC if not corrected. I recommend having a plumbing professional evaluate and repair as needed to prevent leaking.

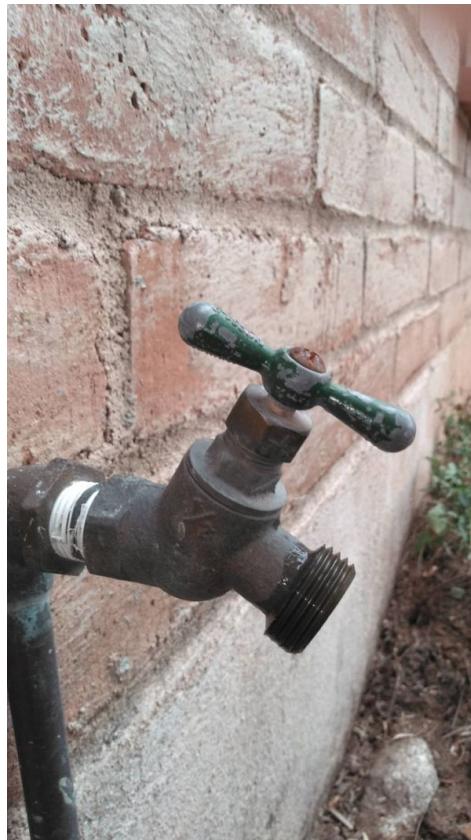
At the time of inspection there was no anti-siphon device on the exterior hose bib(s). I recommend having an anti-siphon device installed to prevent the possibility of contamination.

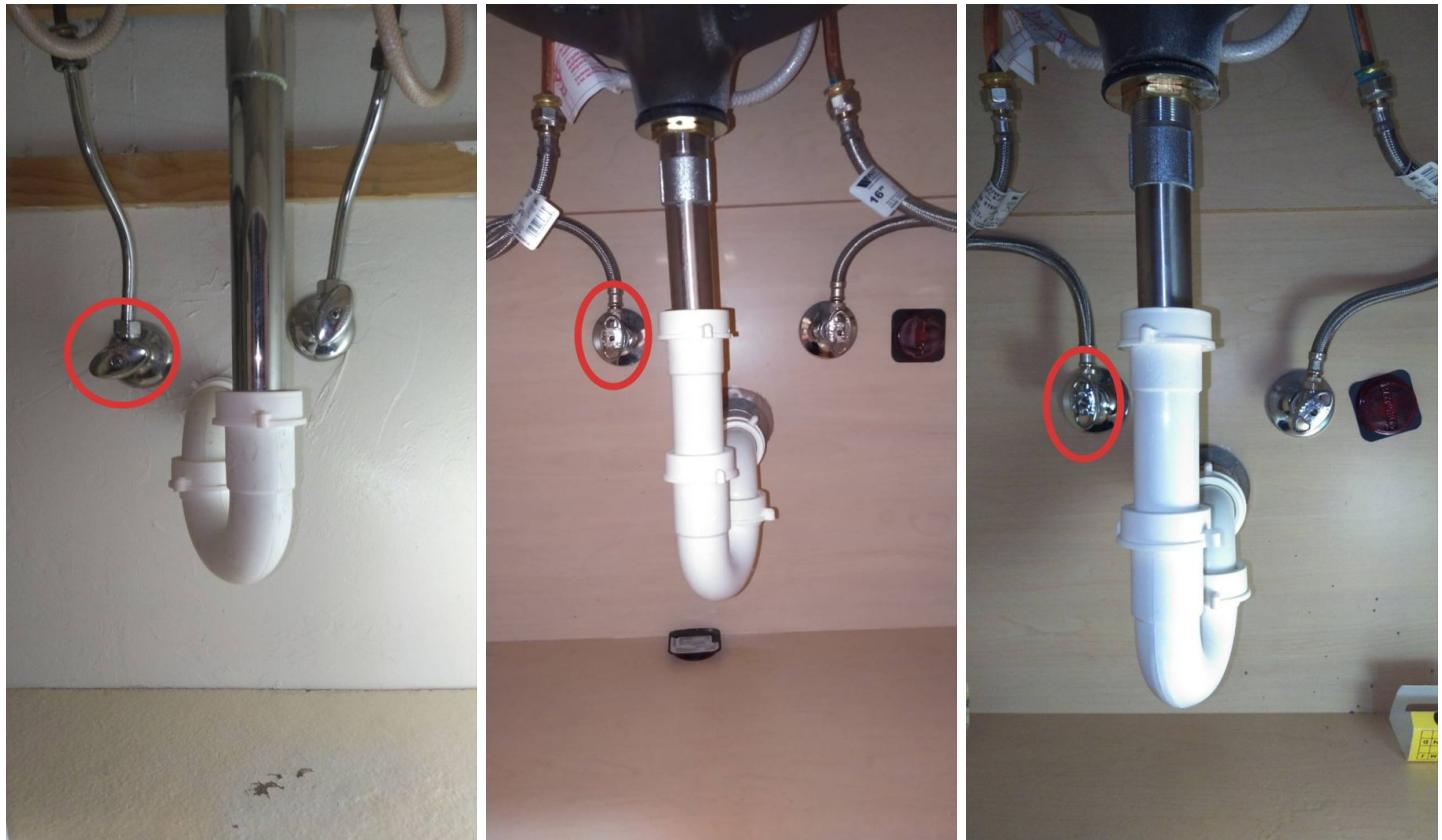
Water shut-off valves in the home were stuck or seized at the time of inspection. This means the valves will not turn with reasonable force to shut the water off in the event of a leak or repairs. I recommend having a plumbing professional repair or replace as needed for proper operation.

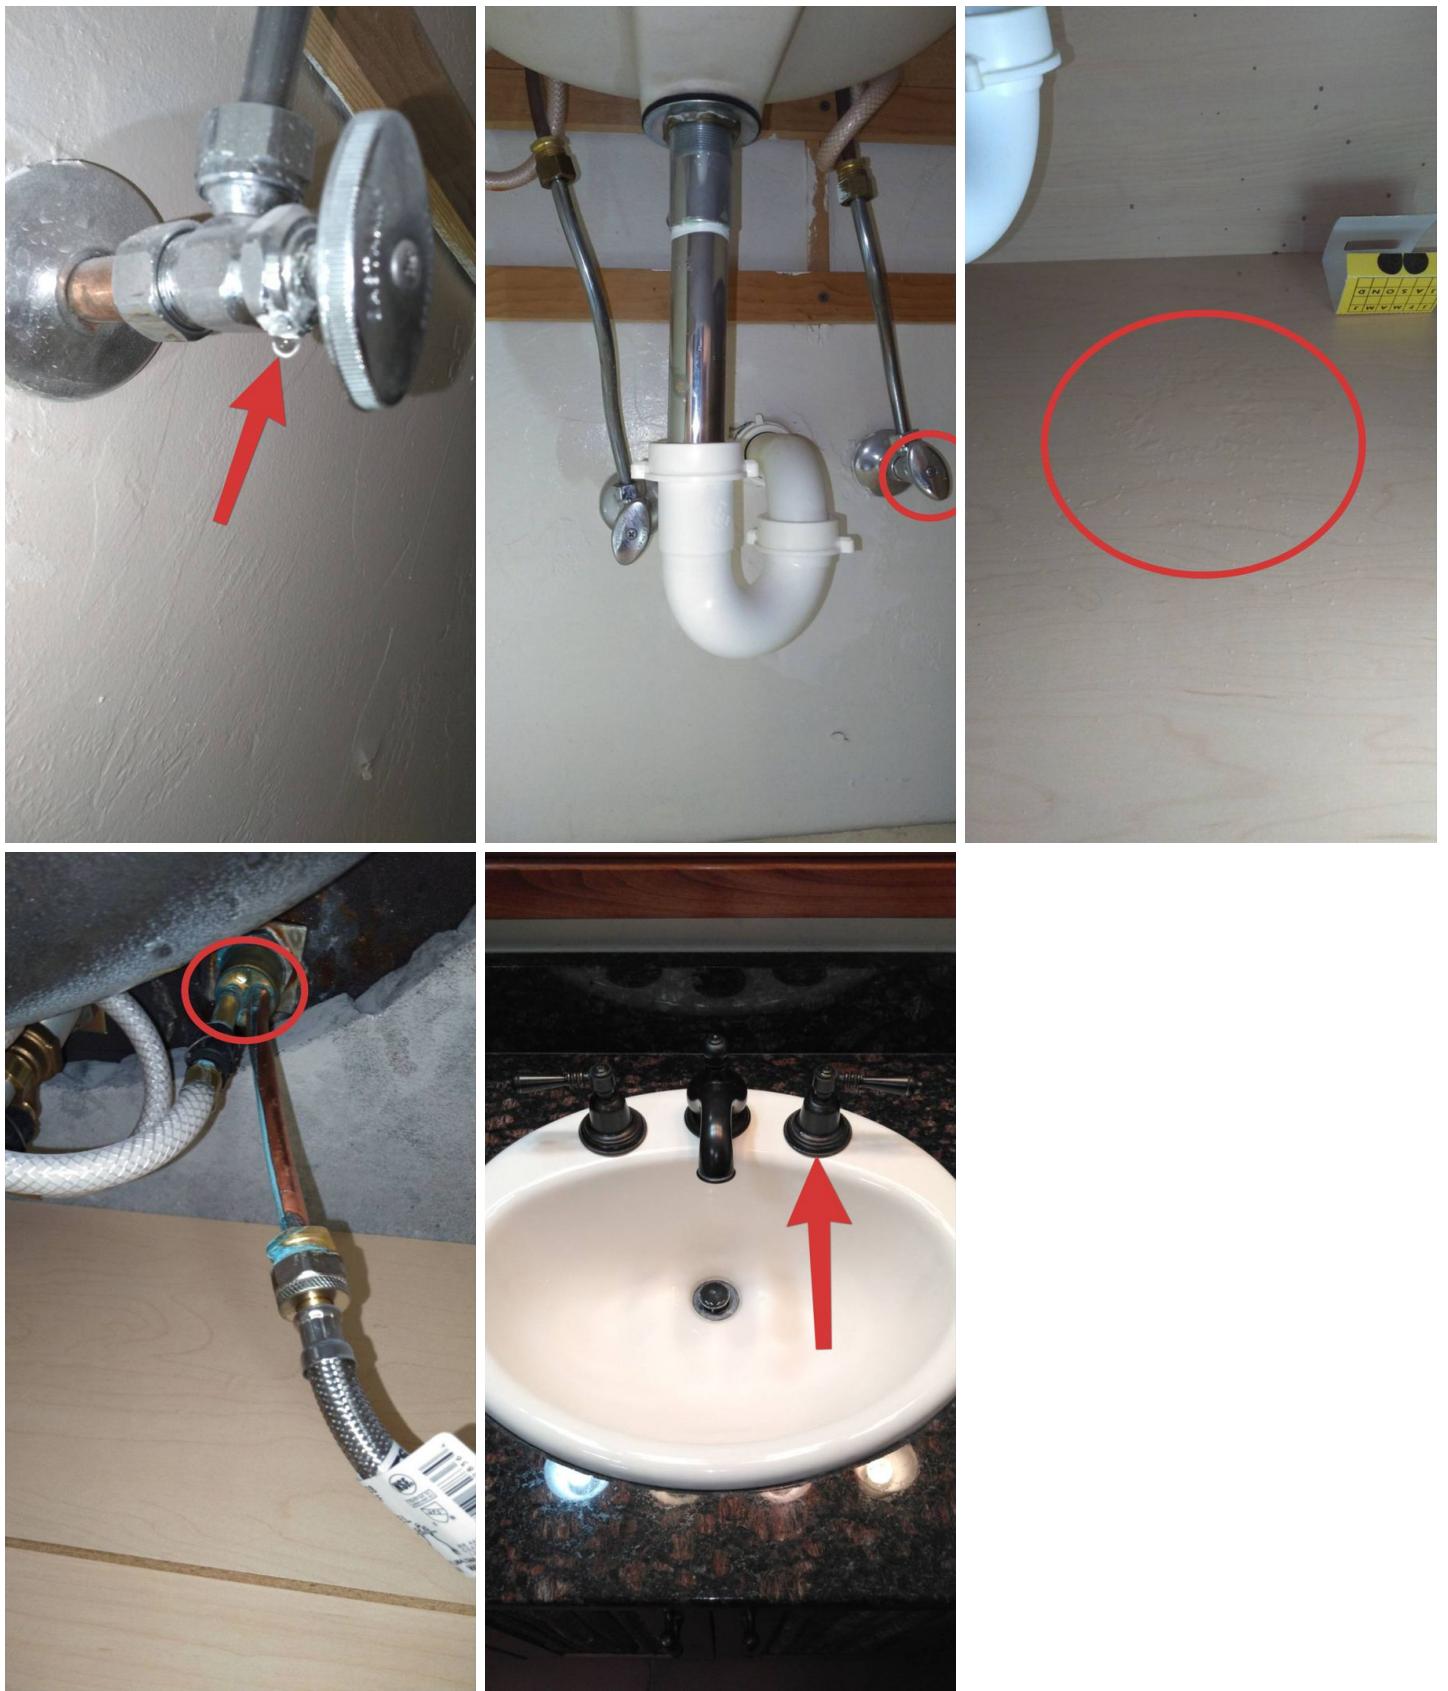
#### **LEAKING / DRIPPING FAUCET VALVES**

At the time of inspection I observed water shut-off valves that were leaking or dripping. I recommend having a plumbing professional evaluate and repair or replace as needed.

Contact a qualified plumbing contractor.

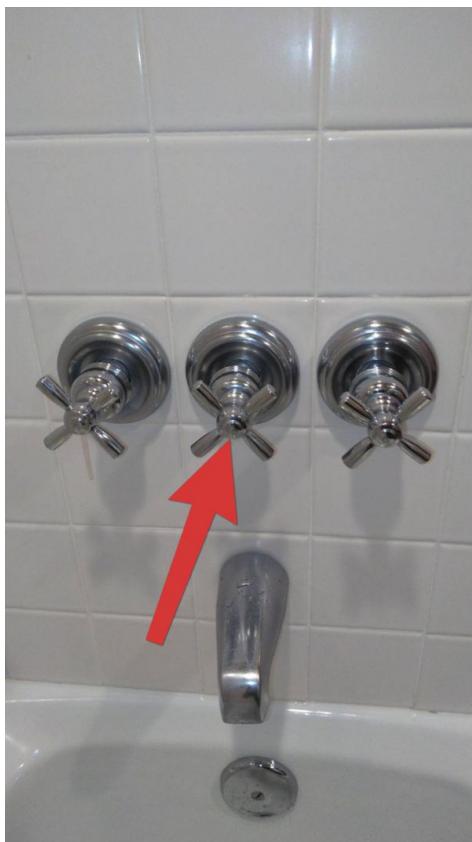
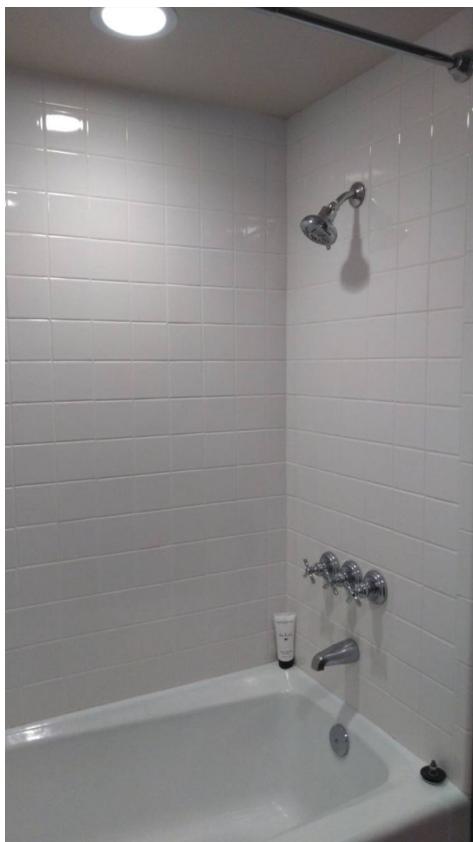
**STUCK SHOWER VALVE**

At the time of inspection the shower valve was stuck in the off position. I recommend having a plumbing professional evaluate and repair or replace as needed for proper operation.

Contact a qualified professional.

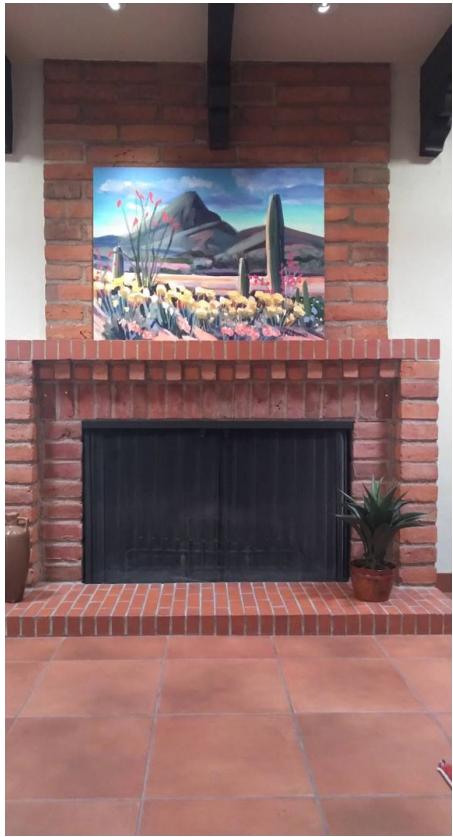
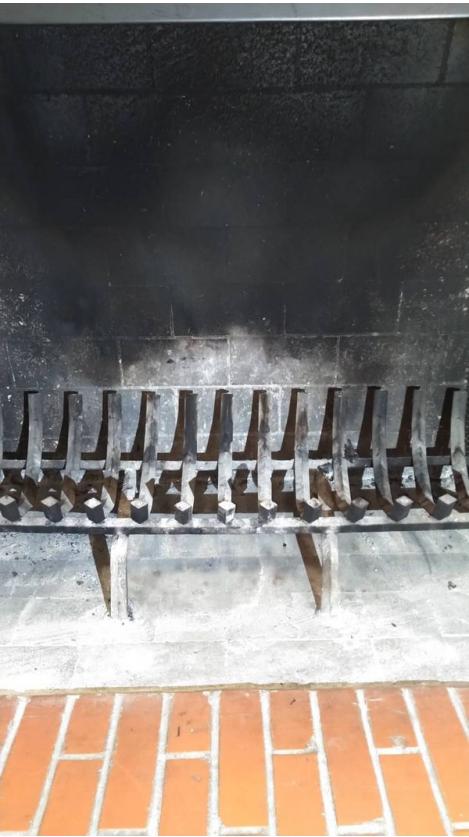
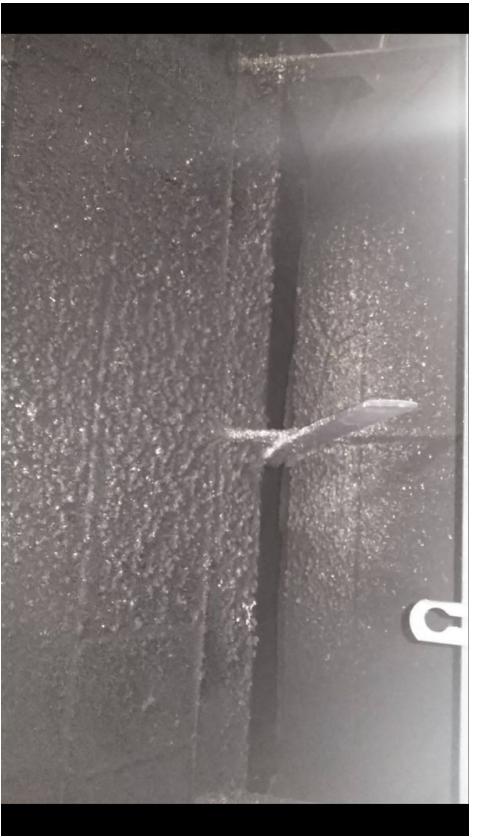
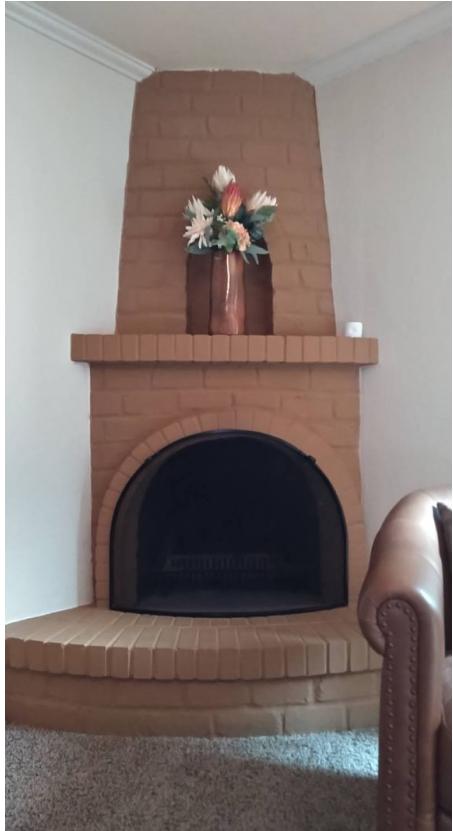
6.10.1 Fireplace

At the time of inspection I observed excessive soot build up in the chimneys. I recommend having a qualified chimney sweep service and clean as needed prior to use.

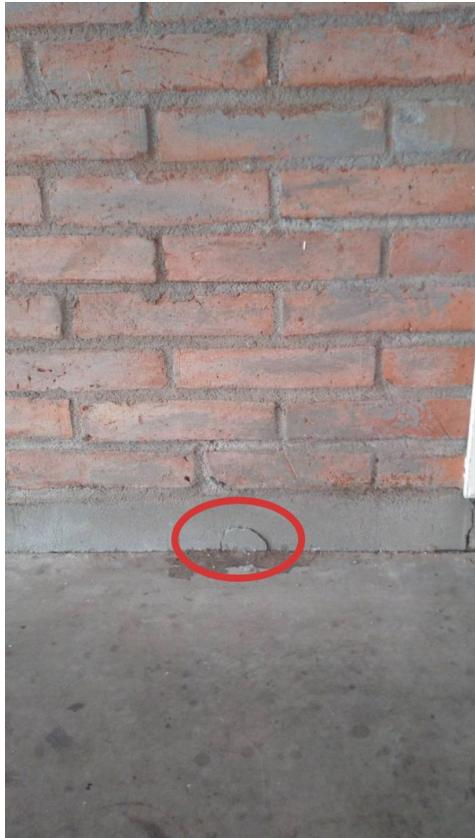
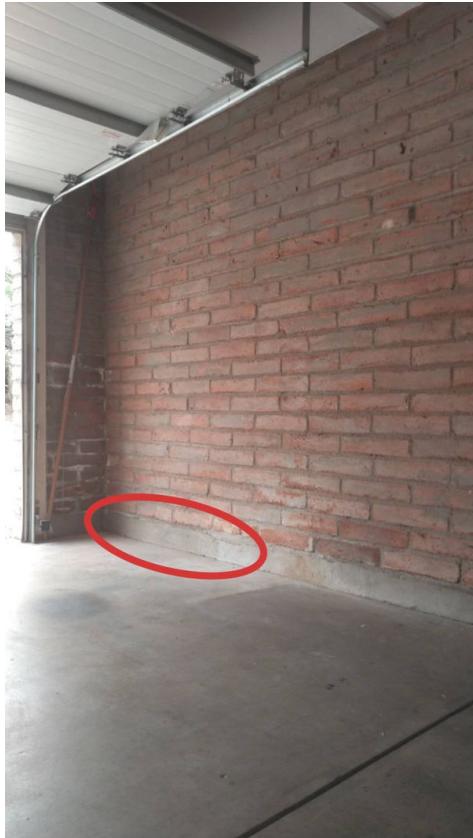
**7.1.1 Foundation****LOOSE PARGING MATERIAL**

At the time of inspection observed loose parging material on the foundation. This is generally the result of minor foundation movement or excessive moisture at the foundation. I recommend having a masonry professional repair as needed.
