ON POINT HOME INSPECTIONS LLC

## INSPECTION REPORT

1234 Main St. Tucson Az 85704

09/30/2020 9:00AM

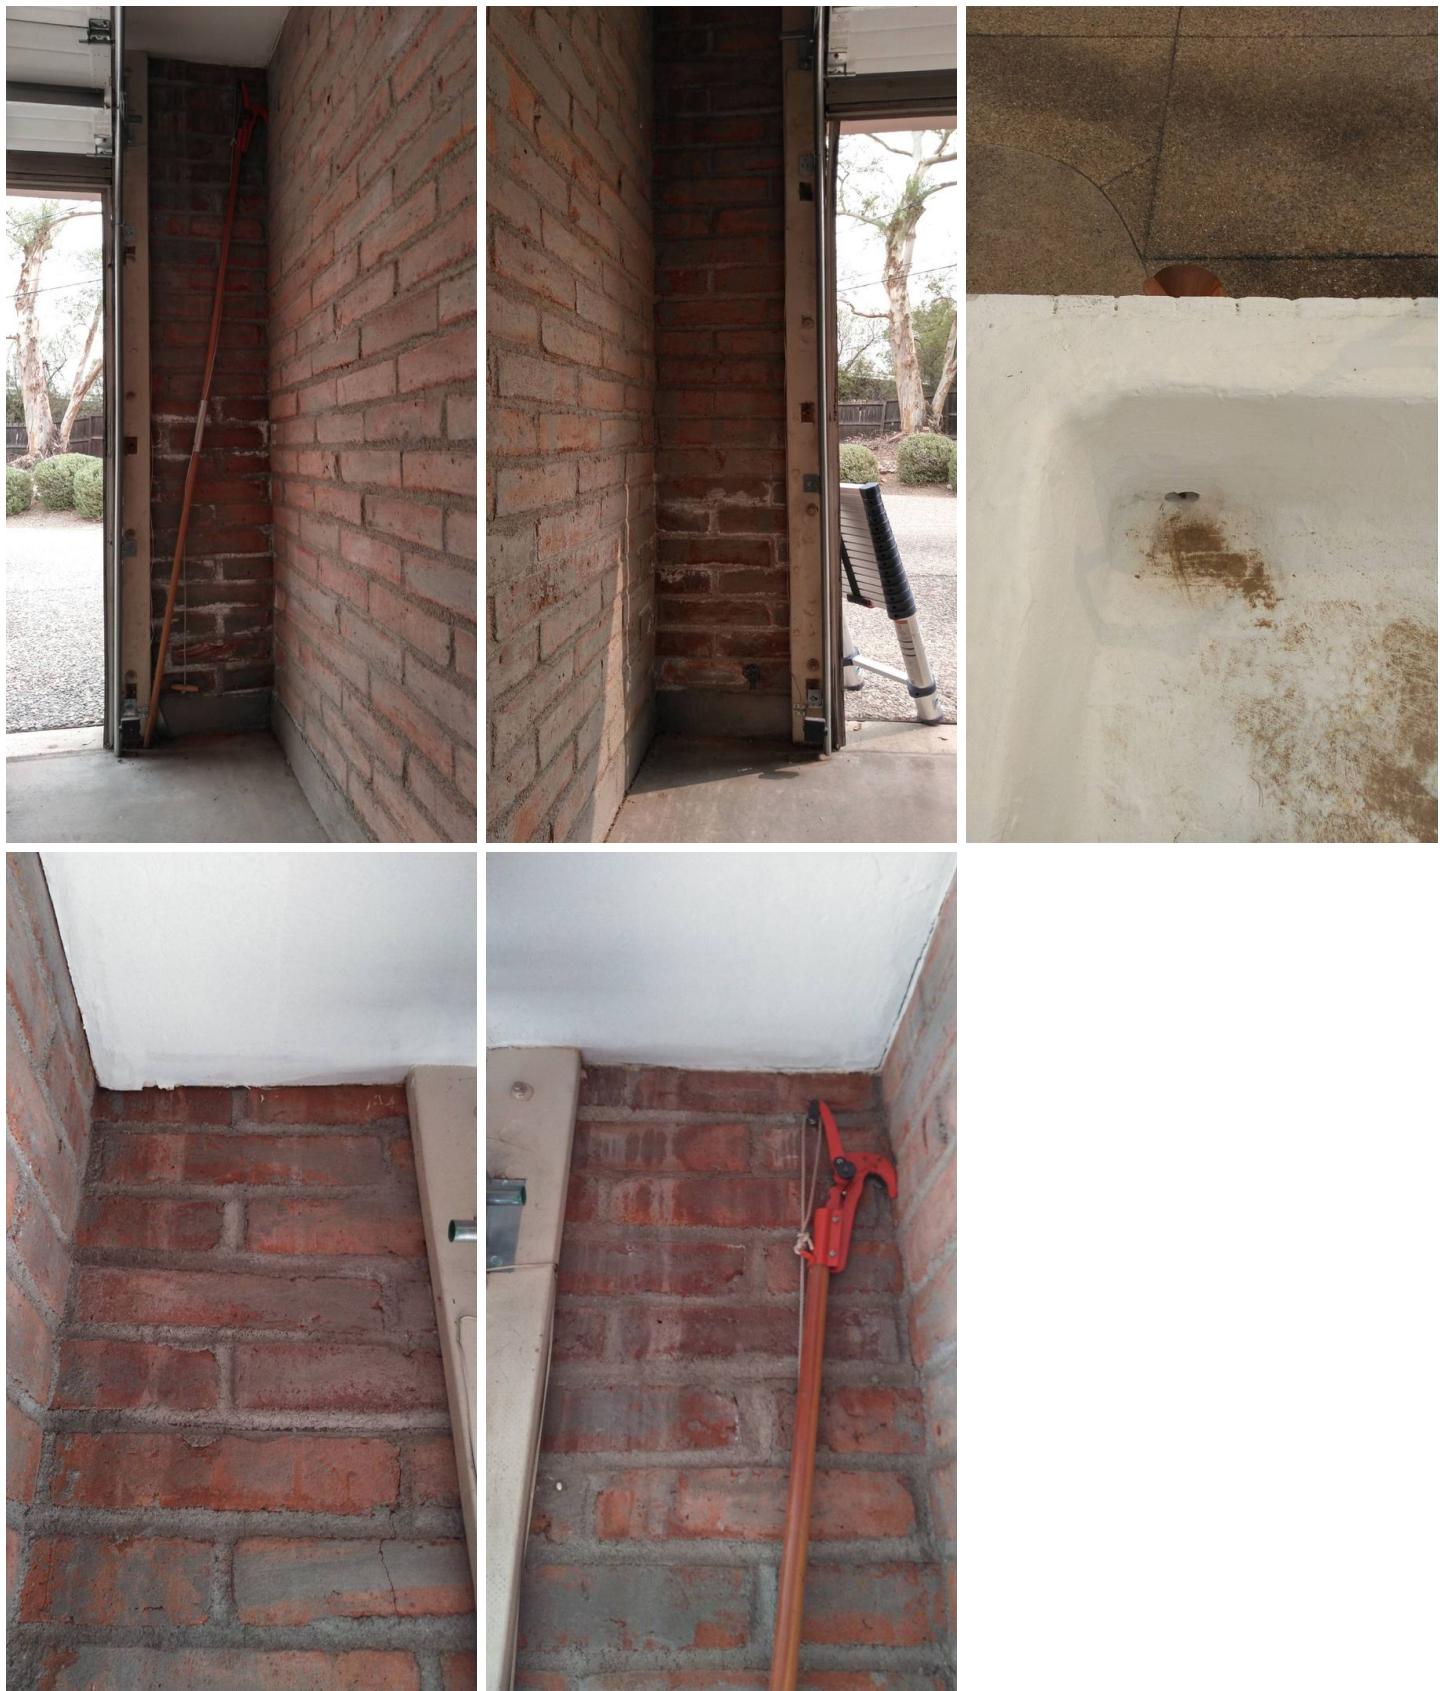
### EFFLORESCENCE OBSERVED

At the time of inspection I observed efflorescence (minerals left behind when water dries) on the walls. This indicates excessive moisture from a past or active leak. The area was not wet at the time of Inspection and no leaks were observed. The roof area above near the scupper beds had visible, previous repairs. I recommend monitoring or having a roofing professional evaluate and repair as needed.

Contact a qualified professional.

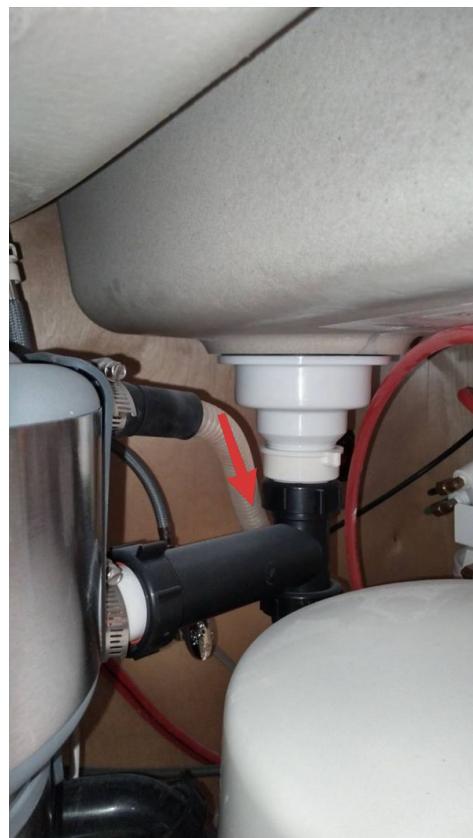
The dishwasher drain hose may be connected to the drain plumbing using a high loop in one of two ways:

- Connect to the under sink dishwasher drain connection (25c).
- Connect to a disposer dishwasher drain connection (25d).

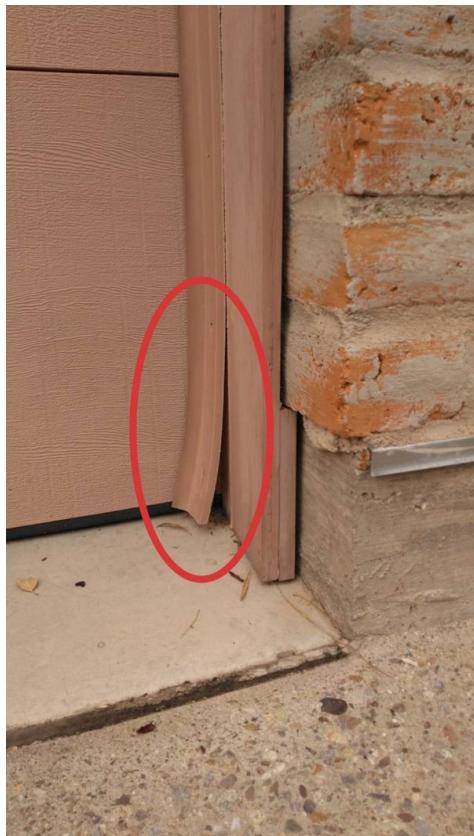
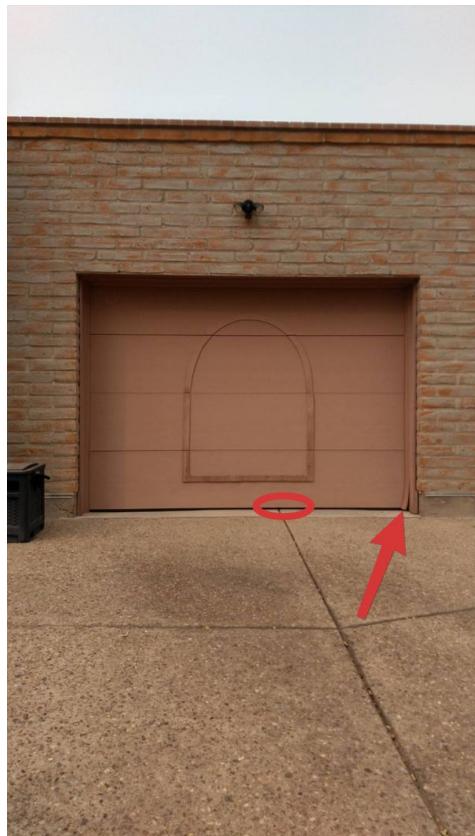
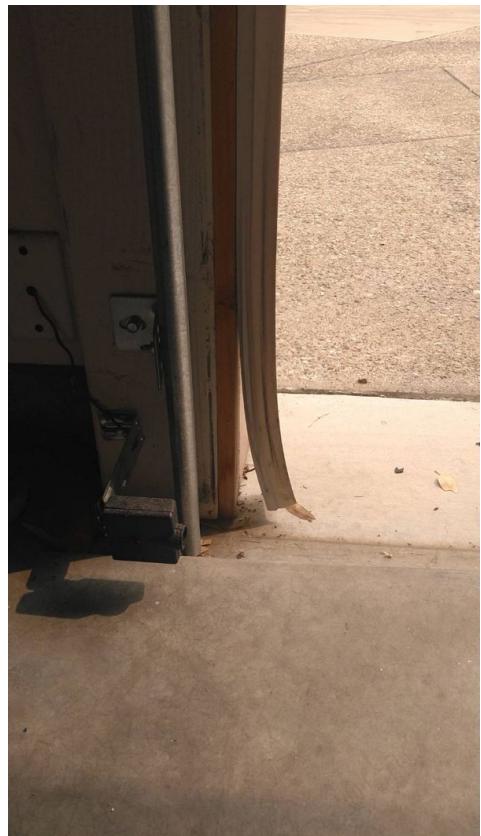
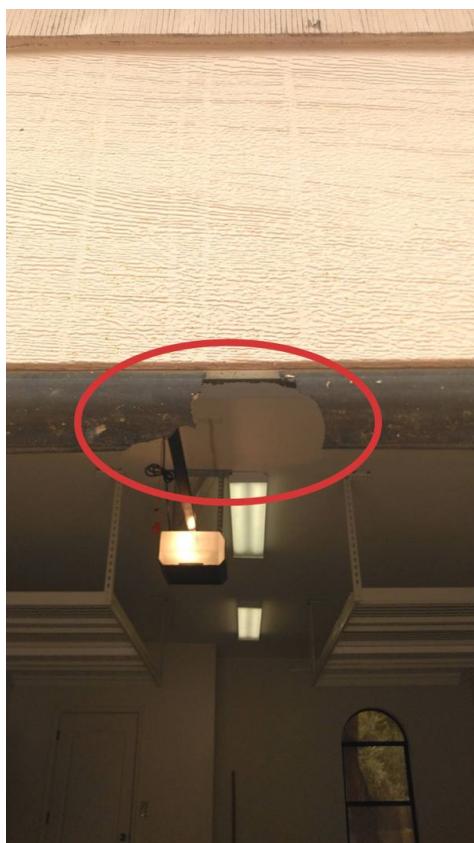
**TRIM/WEATHER STRIPPING LOOSE OR DAMAGED**

At the time of inspection I observed loose / damaged garage door trim and weather stripping. I recommend having a qualified professional repair or replace as needed to prevent pests from entering the garage.

Contact a qualified professional.
