YOUR HOME INSPECTION

(Name of Client)

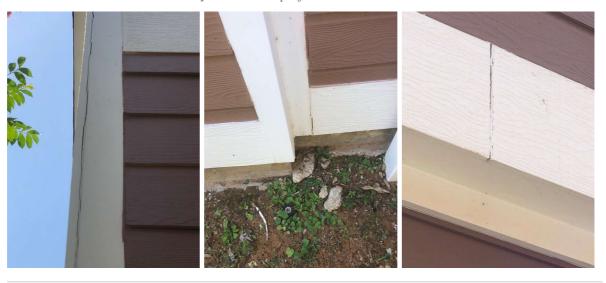
It is recommended to use elastomeric caulking.

Recommendation: Contact a handyman or DIY project

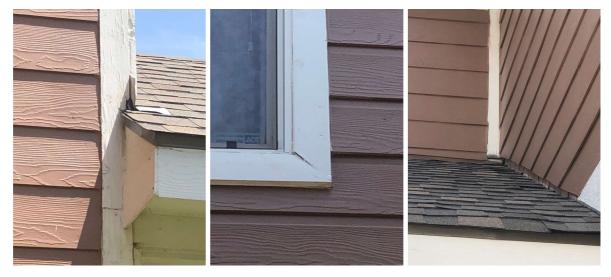
2: Trim Damaged

The wood veneer trim has some deterioration or damage.

Recommendation: Contact a handyman or DIY project
