FOREVER HOME INSPECTION - OKLAHOMA

RESIDENTIAL REAL ESTATE INSPECTION REPORT

1234 Main St. Tulsa OK 74112

06/12/2021 9:00AM

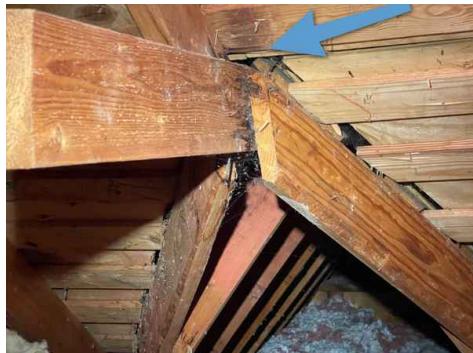
South Attic

INDICATIONS OF PAST/PRESENT LEAKING PRESENT

There were indications of leak(s) on the rafters and/or decking in the attic. The conditions can only be reported as they existed and can not confirm if this is from a past or present leak. Evaluation is recommended to be conducted by a qualified roofing contractor with repairs made as needed, if needed.

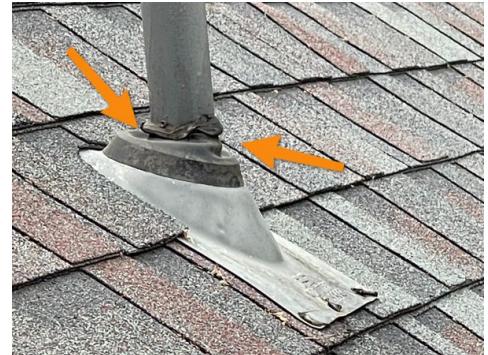
North

There were vent boot(s) that were cracked and/or damaged, this can allow rain water to infiltrate the attic area. Repairs or replacement of the boot(s) is recommended to be conducted as needed by a roofing contractor.

Contact a qualified roofing professional.

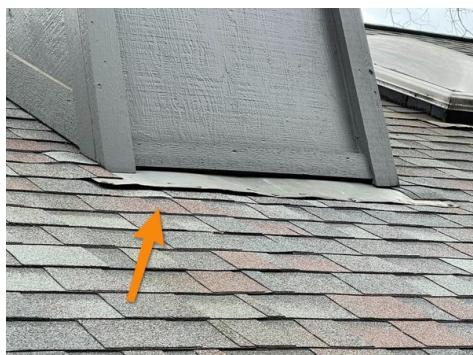
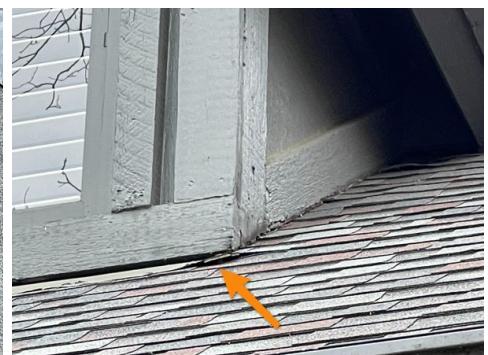
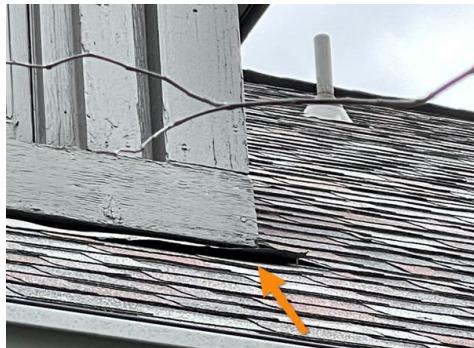
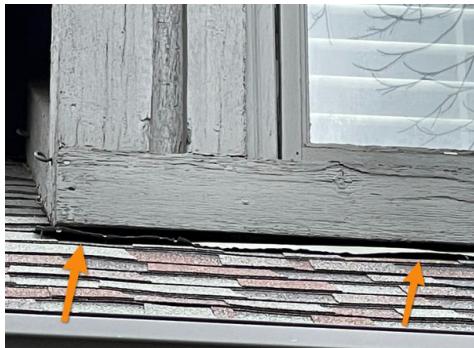
**FLASHING-LOOSE/SEPARATED**

The flashing was observed to be loose, lifted, and/or separated from the roof surface, which can allow for rainwater infiltration under the flashing. Further evaluation for repairs to the lifted flashing(s) is recommended by a qualified roofing contractor.

Contact a qualified roofing professional.

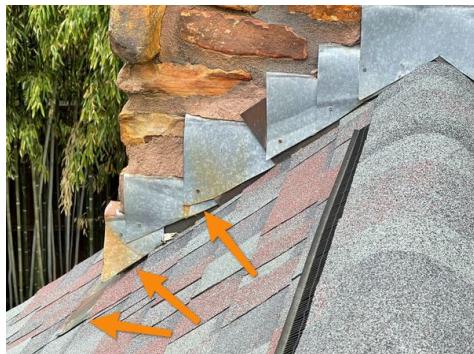
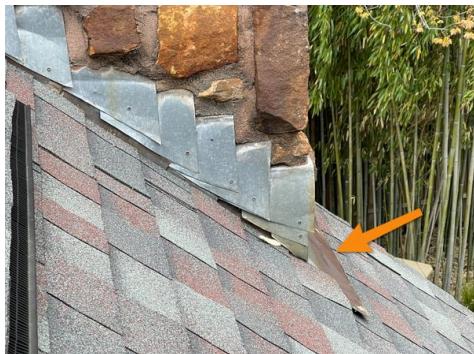
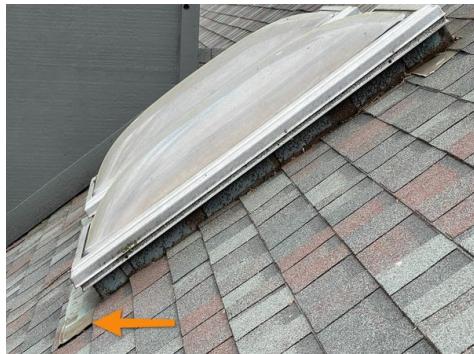
FLASHING-RUST/CORROSION PRESENT

The flashing was observed with rust/corrosion, which can lead to potential leaks and/or premature failure of the material. Further evaluation for repair/replacement is recommended by a qualified professional.

Defect - Medium Concern

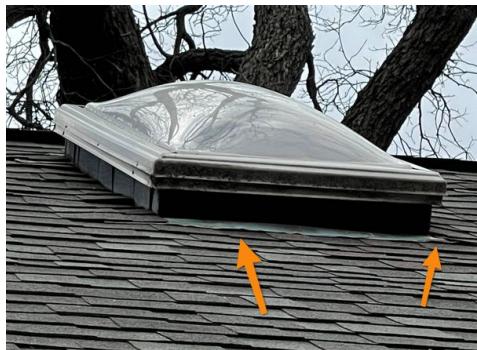
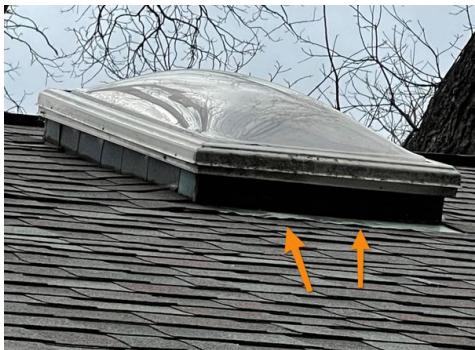
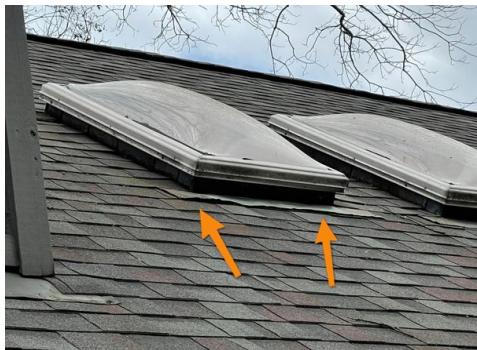
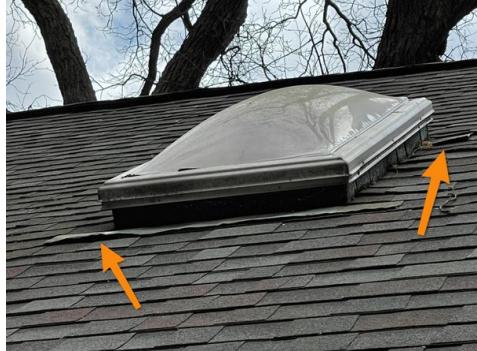
Flashing at the skylights were found lifted or separated from the roofing material, and can possibly lead to moisture infiltration interior. Evaluation and repairs are recommended to be performed by a qualified roofing contractor.

Defect - Medium Concern

Contact a qualified roofing professional.

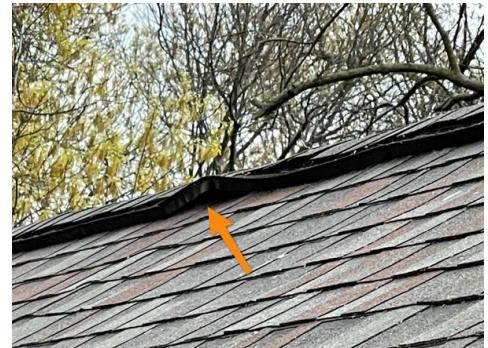
North

An area of the ridge vent was found separated from the roof, possibly allowing for moisture and/or pest penetration. Evaluation and repair is recommended to be performed by a qualified professional.

Contact a qualified professional.

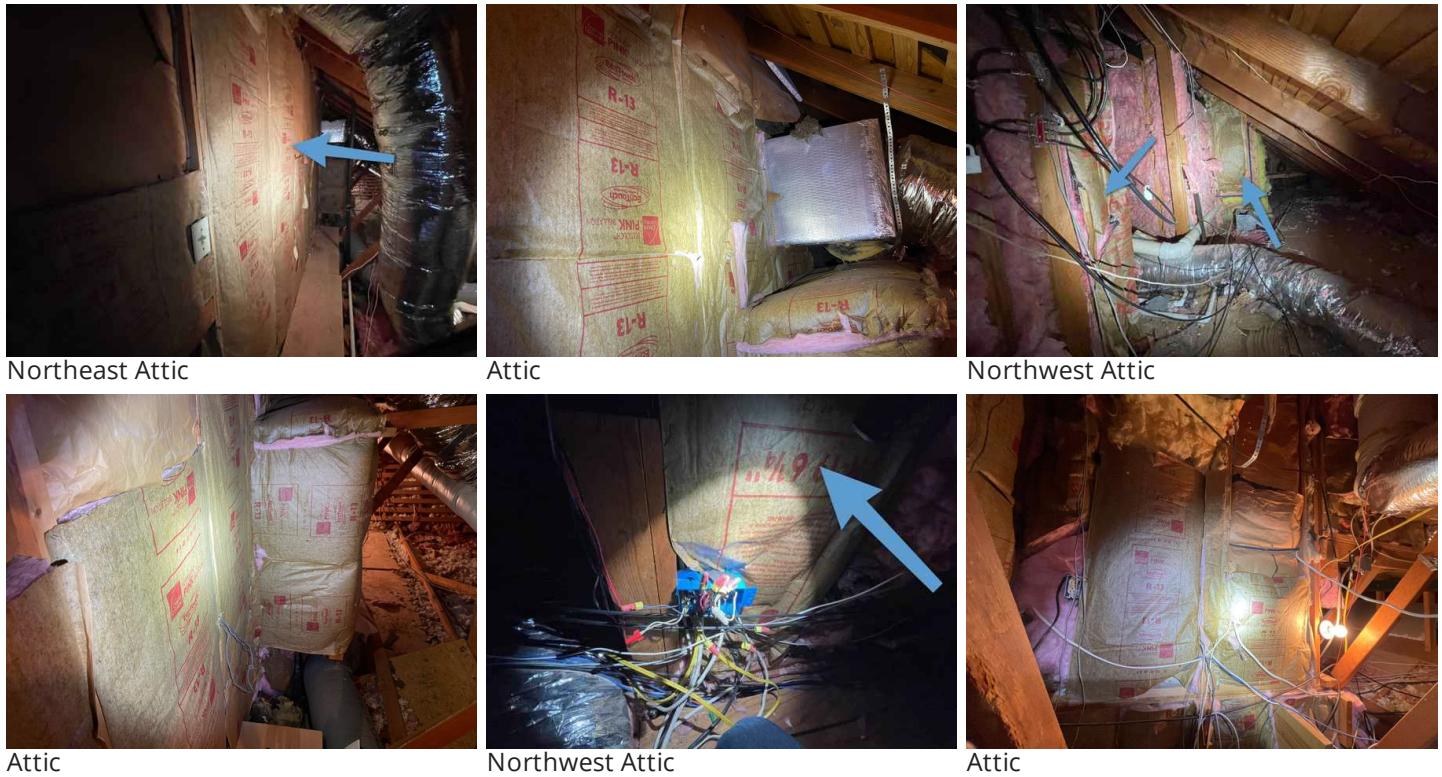
The orientation of the batt insulation in the attic was incorrect. The vapor barrier (kraft paper) face should face the conditioned side of the home. This can potentially allow condensation to form between the drywall and insulation. An evaluation is recommended to be conducted by an insulation company regarding the orientation, with repairs made as needed.

Contact a qualified insulation contractor.

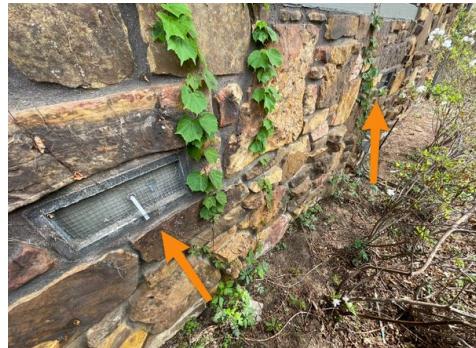
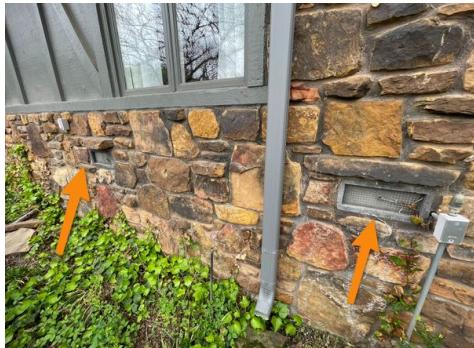
There were closed or blocked off ventilation openings present in the crawl space. At least one sq. ft of ventilation is recommended for every 150 sq. ft of crawl space area, this can be reduced to one sq. ft for every 1500 sq. ft with a continuous vapor barrier installed. Opening or removing blockages of the ventilation openings is recommended to be conducted by a qualified person.

Contact a handyman or DIY project

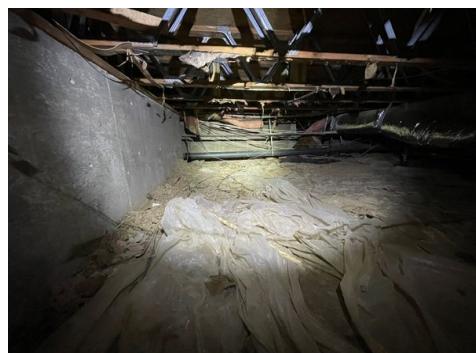
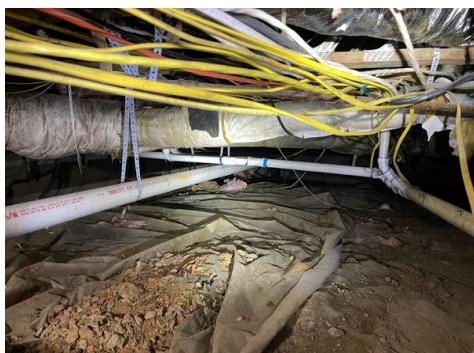
The vapor barrier in the crawl space lacked full coverage. It was placed in several areas and has since been displaced or damaged. Other areas are free of any vapor barrier. Current standards require that vapor barriers cover the entirety of the soil in crawl spaces. Evaluation and modifications to achieve full coverage of the vapor barrier is recommended to be conducted by a qualified contractor.

Defect - Medium Concern

Contact a qualified professional.

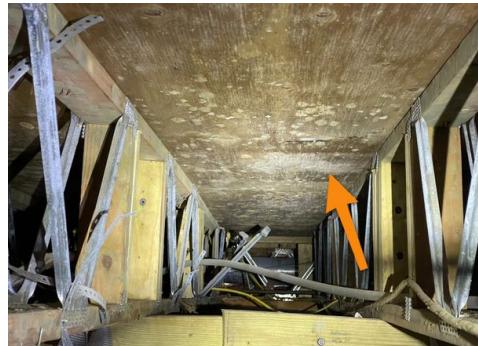
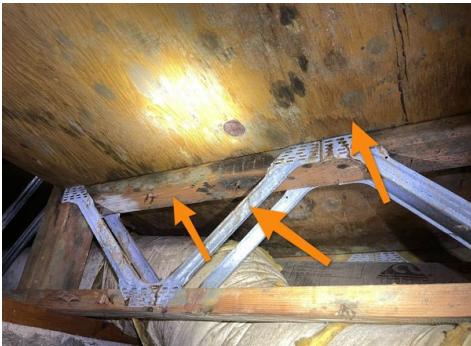
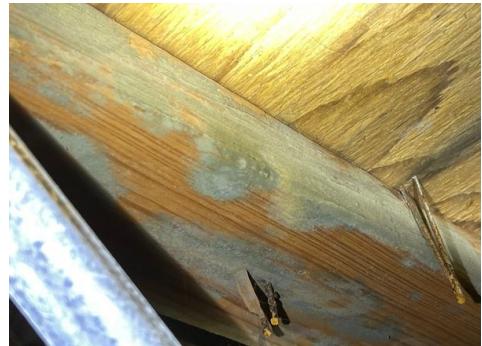
Areas of the subfloor and joists were found with suspected microbial growth. Evaluation by a qualified remediation specialist and results from a lab test is recommended before treatment and control.

Contact a qualified mold remediation contractor

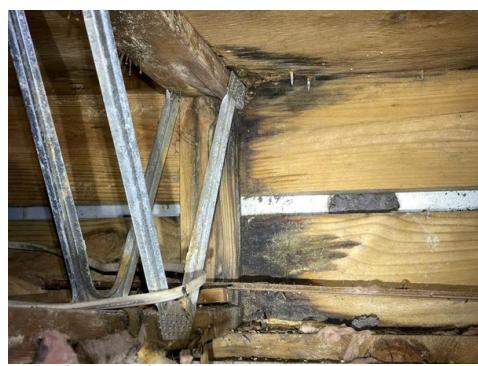
North Crawlspace

Moisture damage and positive indications of moisture was present in the inner wall, sill plate, and joists of the north crawlspace area. A leaking exterior spigot found outside the area is suspect to the moisture and should be repaired by a qualified plumber, and the crawlspace should be properly ventilated for any excess humidity removal.

Contact a qualified professional.

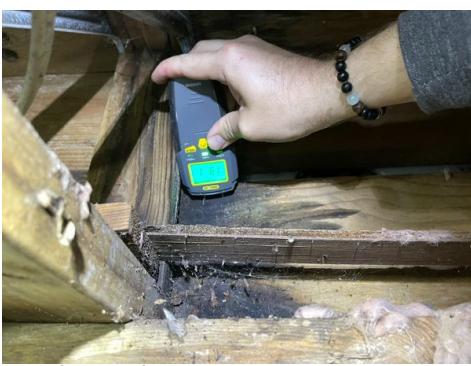
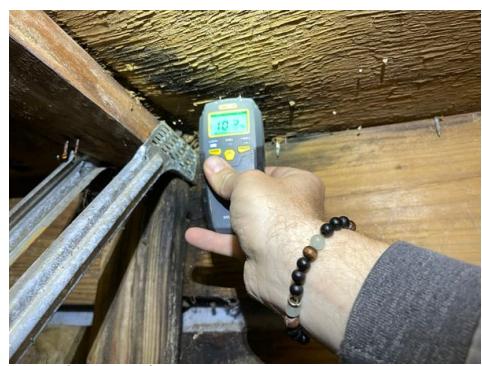
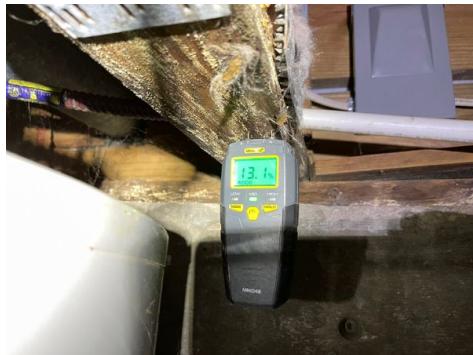
MOISTURE DAMAGE

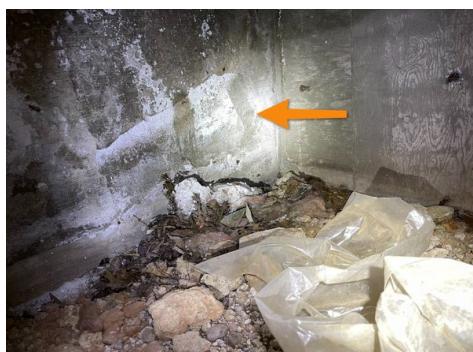
East Crawlspace

EVIDENCE OF MOISTURE

Mineral deposits on the poured concrete foundation (efflorescence) was found in several areas of the crawlspace, indicating past or present moisture seepage in the foundation walls. Proper management of water removal from the edge of the foundation and ventilation of the crawlspace is recommended.

Defect - Medium Concern

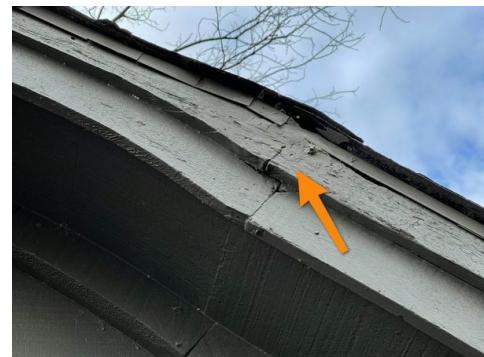
2nd Floor East

DAMAGED FASCIA PRESENT

Fascia was found damaged in the represented areas. It is recommended a qualified contractor repair/replace as necessary.

Contact a qualified siding specialist.

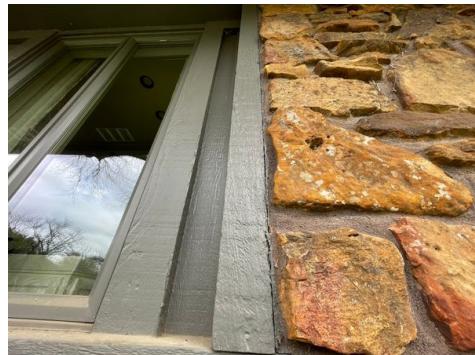
Southeast

There were area(s) in need of sealant to prevent moisture and/or insect infiltration. The application of exterior grade sealant at any gaps into the wall cavity is recommended by a qualified person.

Contact a qualified professional.

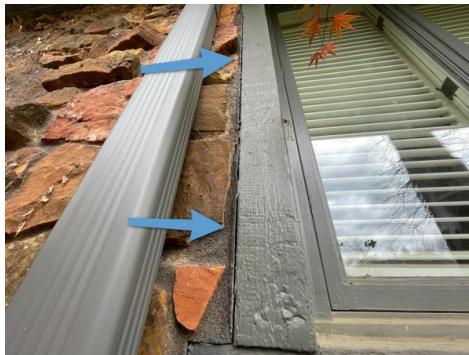
South

MISSING/FAILED SEALANT

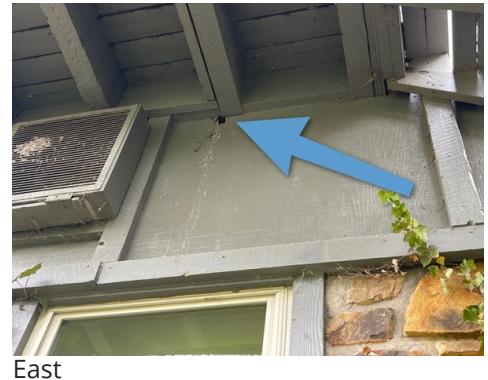
There were gaps present in the cladding at the referenced area(s). This can allow for moisture, insect, and/or rodent entry into the structure. Repairs are recommended to be conducted to properly flash, seal, or fill the gaps by a qualified contractor.

Contact a qualified professional.

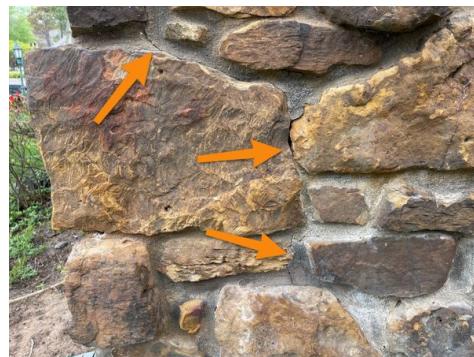
Southeast

CRACKING PRESENT

Cracking was present in the referenced area(s). Further evaluation is recommended by a qualified masonry contractor with sealing or repairs made as deemed necessary.

Contact a qualified masonry professional.

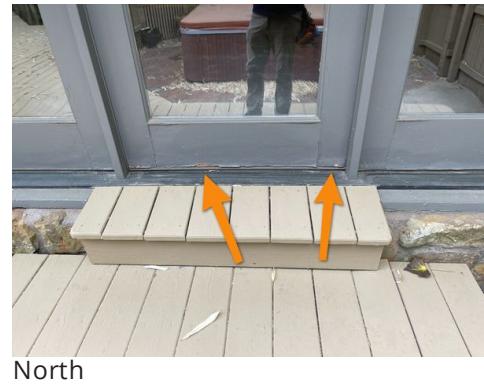
North

GENERAL DAMAGE PRESENT TO DOOR(S)

The door(s) had general damage present. Repairs or replacement of the door(s) as desired is recommended by a qualified person.

Contact a qualified professional.

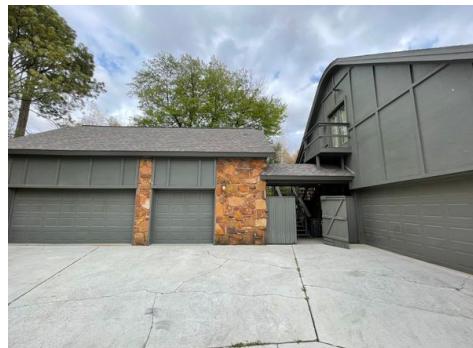
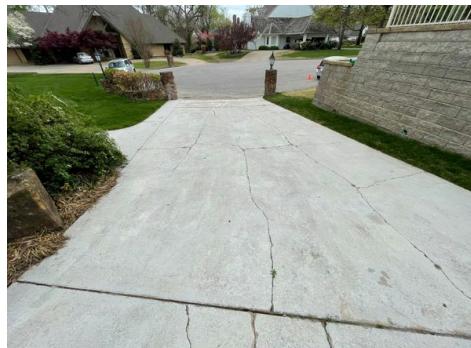
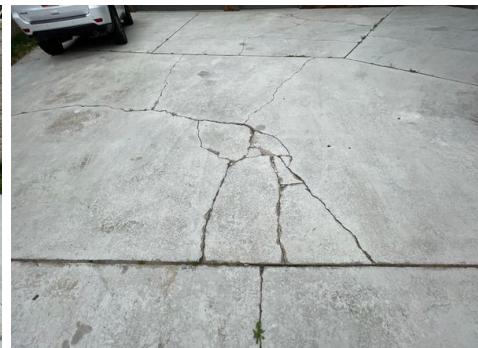
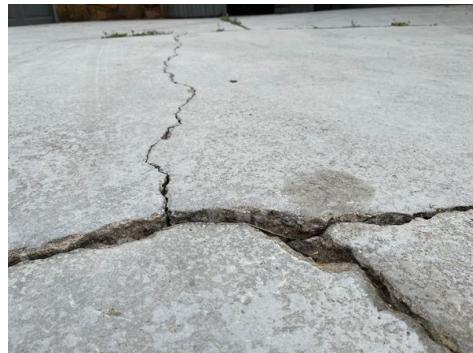
DRIVEWAY CRACKING/DAMAGE

Cracking and/or damage present to the driveway surface. Repairs are recommend by a qualified driveway/concrete contractor as needed.

Defect - Medium Concern

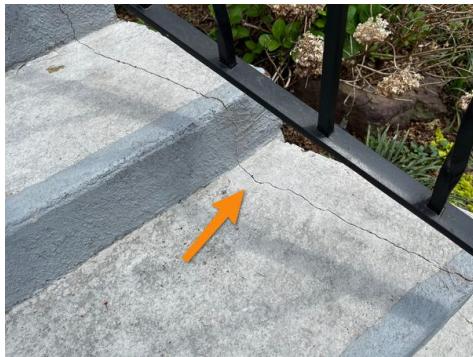
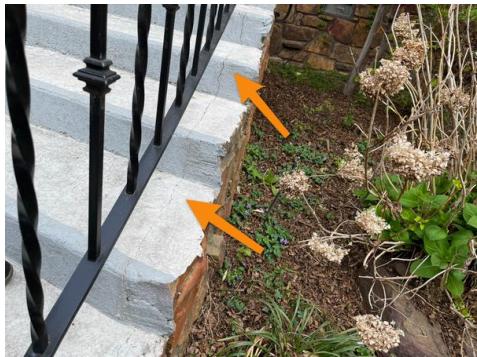
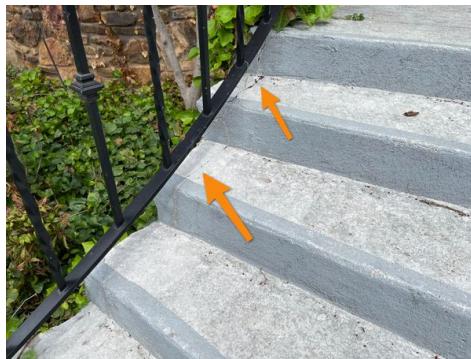
WALKWAY-CRACKING/DAMAGED

Cracking and/or damage present to the walkway surface. Repairs are recommend by a qualified concrete contractor as needed.

Defect - Medium Concern

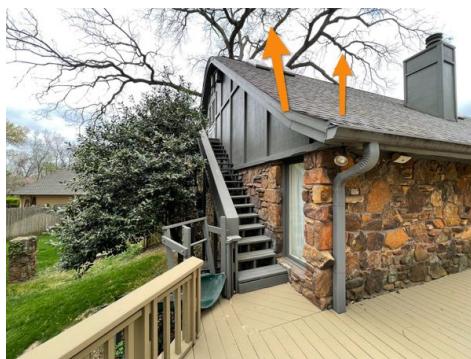
East

Tree limbs were observed to be covering portions of the roof surface or overhanging the roof. Tree limbs within 10 feet of the roof should be trimmed away to provide air and sunlight to the roof, allowing the roof surface to adequately dry after rainfall events. Leaves/debris from overhanging trees can also clog downspouts and gutters allowing them to overflow. Trimming or removal of the offending branches/limbs as needed is recommended to be conducted by a tree trimming company.

Contact a qualified tree service company.

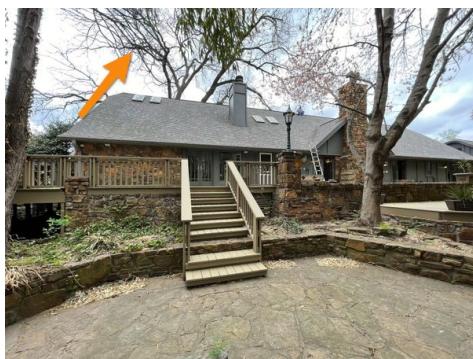
East

Defect - Medium Concern

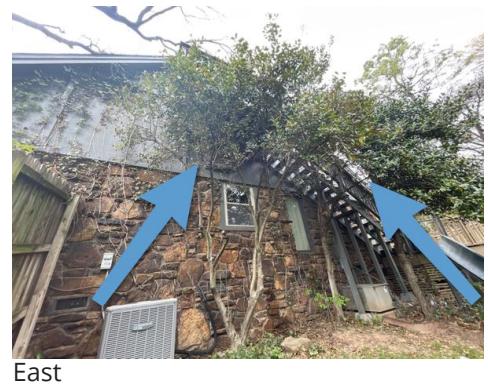
East

There was vegetation in contact or close contact with the home. Pruning or removal is recommended to be conducted by a qualified person to eliminate pathways of wood-destroying insects, and to avoid damage due to moisture retention, or abrasion.

Contact a qualified professional.

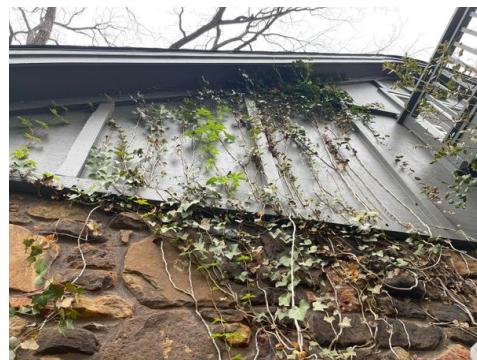
Southeast

Ivy was growing on the structure. This is recommended to be removed as this Ivy can hold moisture against the structure as well as acting as a pathway for wood destroying insects.

Contact a qualified landscaping contractor

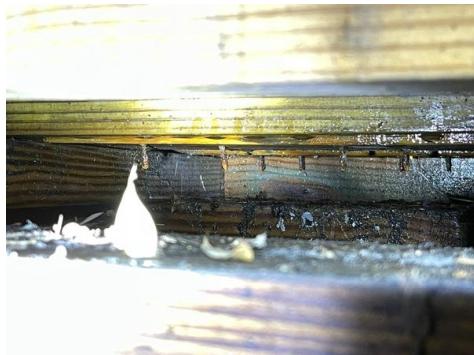
South Deck

MOISTURE DAMAGE-CONDENSATION PRESENT UNDER DECK

Active moisture was present under the deck close to the kitchen area, dripping from the floorboards and pooling on the vapor barrier underneath. This is a possible symptom of the leaking exterior spigot in the area. Repair of the spigot by a qualified plumber and remediation of the excessive moisture under the deck is recommended.

Contact a qualified professional.

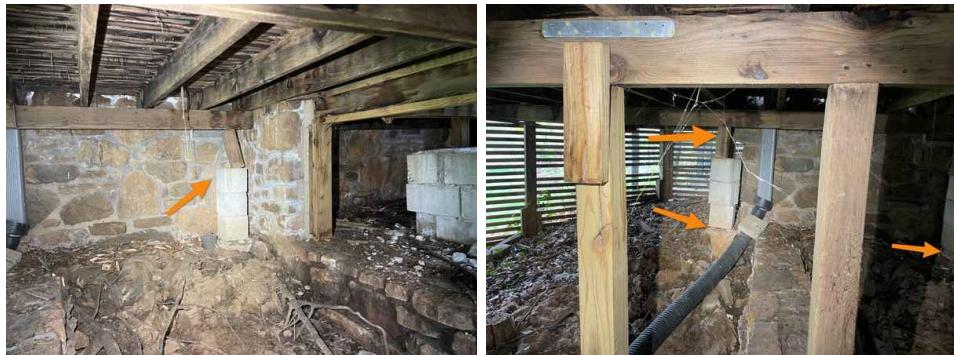
The brick piers that support the front deck have settled and shifted, and unconventional repairs have been undertaken to "re-support" the deck due to the settlement. An evaluation of this area is recommended by a qualified deck contractor with repairs made as needed.

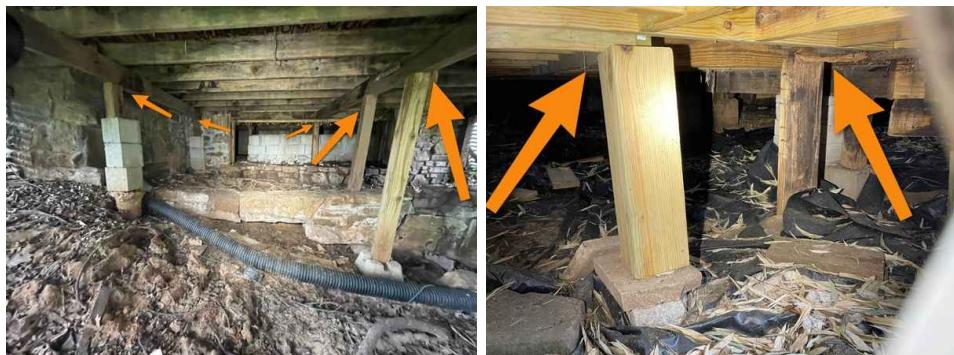
East Deck

SUPPORT POST- POSITIVE CONNECTION MISSING BETWEEN SUPPORT POSTS AND BEAMS
- Defect - Medium Concern

A proper connection was missing between support post(s) and the beam(s). Repairs are recommended here as needed by a deck contractor to provide a proper connection.

Contact a qualified professional.

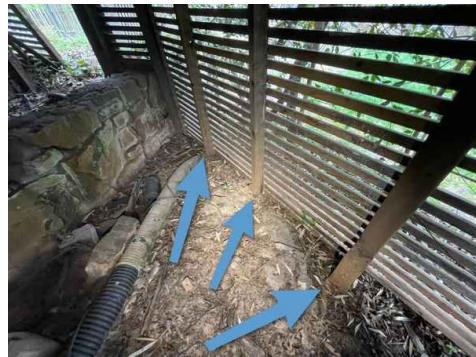
East Deck

Wood to soil contact was present on areas of the deck(s). This can encourage decay of the framing members and be susceptible to wood destroying insect activity. Evaluation and repair by a qualified deck contractor is recommended.

Contact a qualified deck contractor.

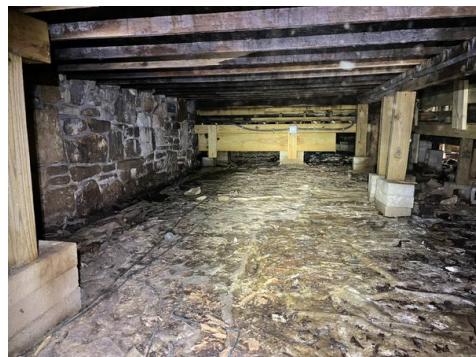
South Deck

A vapor barrier was present underneath the deck. Unlike a crawlspace where a vapor barrier is recommended to keep moisture from evaporating from the ground into the space, moisture under a deck should seep into the ground and drain away while being ventilated out. Without adequate deck ventilation, moisture pooling on the vapor barrier can evaporate back into the underside of the deck materials, causing damage. Removal of the moisture barrier and allowing adequate ventilation under the deck is recommended to be performed by a qualified professional.

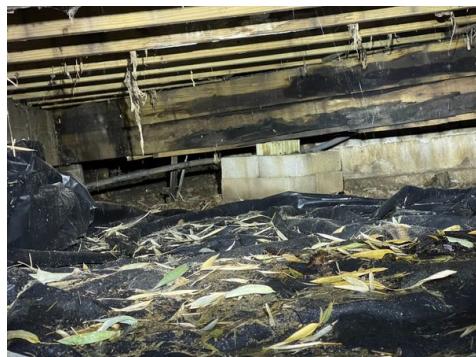
STRUCTURE-DIAGONAL BRACING MISSING

Defect - Medium Concern

The East deck stairs swayed or shifted to some degree while walking on it, and diagonal bracing was not present. Evaluation and repairs as needed to stabilize the deck, including the installation of diagonal bracing is recommended by a qualified contractor.

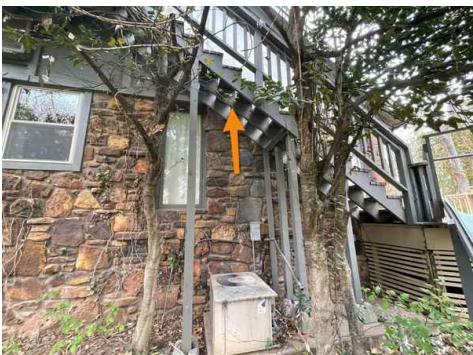
BALUSTERS-LOOSE/MISSING

There were loose and/or missing balusters/pickets present on the guardrailing. Repair is recommended by a qualified person.

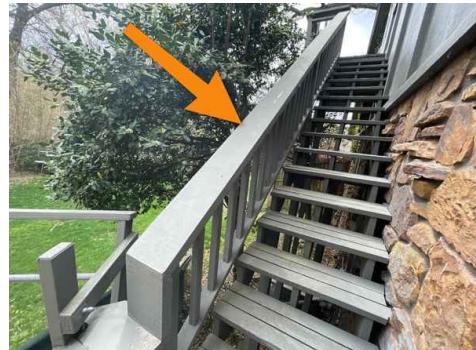
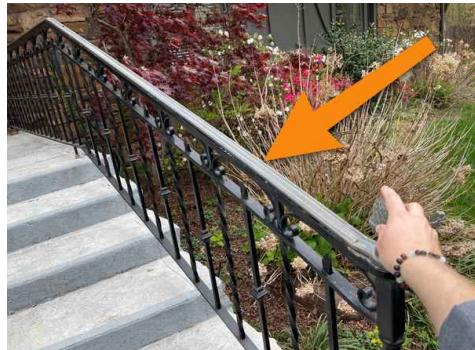
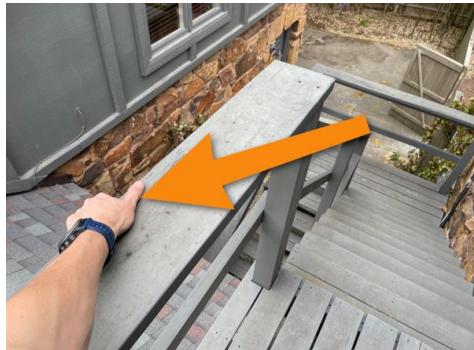
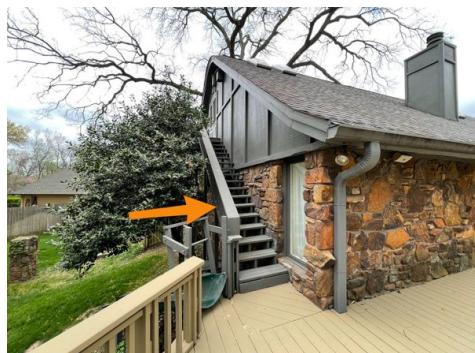
RAILING- LOOSE/DAMAGED

The stair railings were loose and/or damaged. Recommend a qualified contractor repair or replace.

Contact a qualified professional.

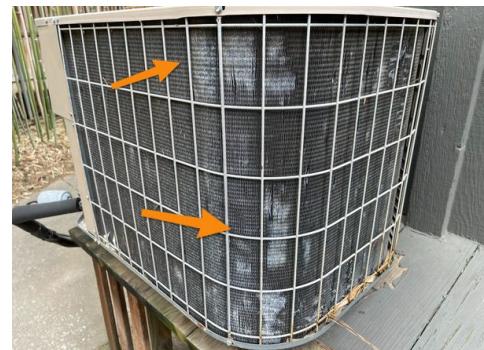
Detached Structure

COOLING FIN DAMAGE

Cooling fin damage was present on the exterior unit of the detached structure. Evaluation and repairs are recommended as needed by an HVAC contractor.

Contact a qualified HVAC professional.

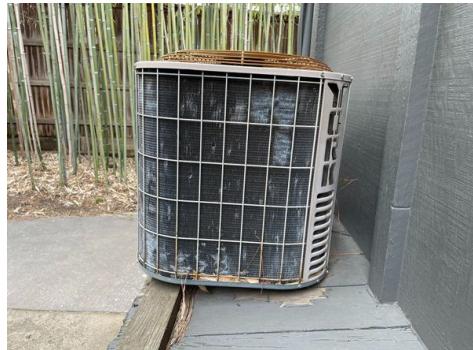
Detached Structure

The detached structure's exterior unit was not level. This can put strain on the fan motor, prevent proper lubrication of the compressor, and affect system performance. Properly leveling the unit and/or pad is recommended to be conducted by an HVAC contractor or other qualified person.

When installing the unit on a support pad, such as a concrete slab, consider the following:

- The pad should be at least 1" larger than the unit on all sides.
- The pad must be separate from any structure.
- The pad must be level.
- The pad should be high enough above grade to allow for drainage.
- The pad location must comply with National, State, and Local codes.

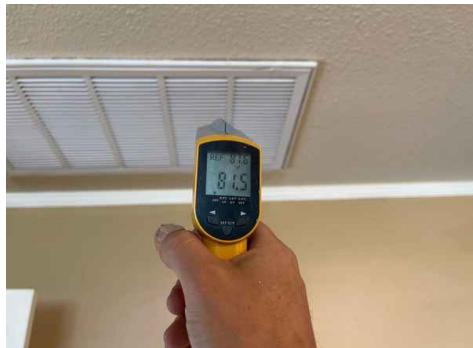
Upstairs Game Room

The Upstairs West HVAC system produced higher than typical supply air temperature in cooling mode at the time of inspection. Evaluation and repairs as needed for proper operation is recommended to be conducted by an HVAC contractor.

Contact a qualified HVAC professional.

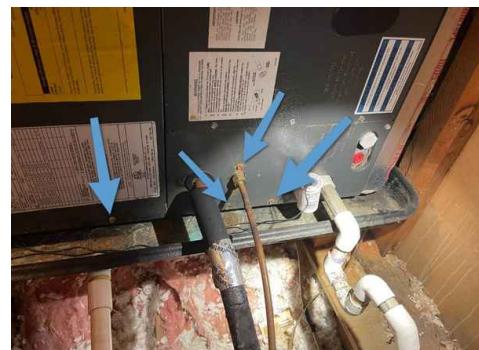
RUST/CORROSION PRESENT

Rust and/or corrosion was present at the unit. An evaluation of the unit with repairs made as needed is recommended by a HVAC contractor.

Contact a qualified heating and cooling contractor

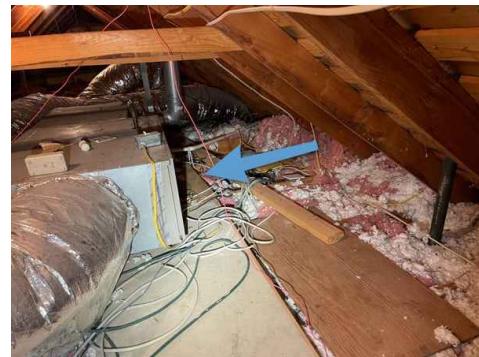
West Attic

ATTIC WALKWAY AND/OR PLATFORM MISSING

An attic walkway and/or platform was missing for the air handler / furnace. A 24 inch wide passageway should be present leading to the unit, with a 30" X 30" platform in front of the unit for servicing / maintenance. The installation of a proper walkway and platform is recommended to be conducted by a qualified person.

Contact a qualified general contractor.

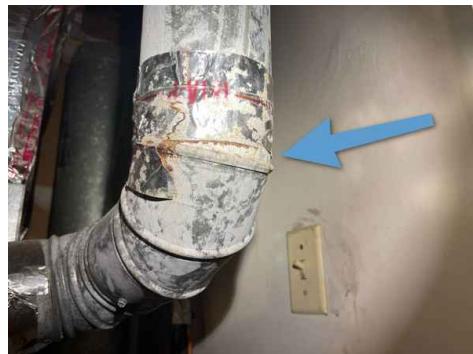
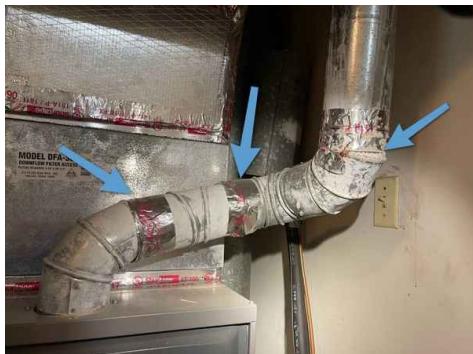
The flue vent connections for the furnace were taped and corroded. Tape should not be used on single or double wall vents as the connections are UL listed to be locked in without the use of tape. Evaluation to determine why tape was used is recommended by a licensed plumber or other qualified person.

Contact a qualified HVAC professional.

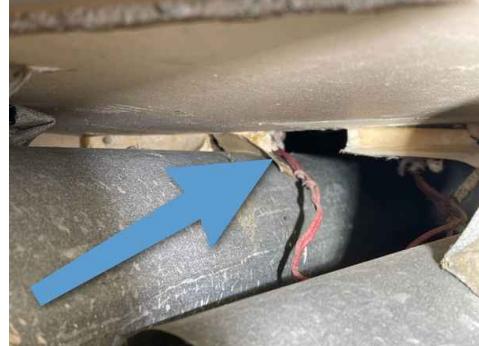
Garage

INADEQUATE CLEARANCE TO COMBUSTIBLES

The water furnace vent pipe lacked adequate clearance from combustible materials. Repairs to achieve the proper clearance is recommended by a licensed plumber or other qualified person.

Contact a qualified HVAC professional.

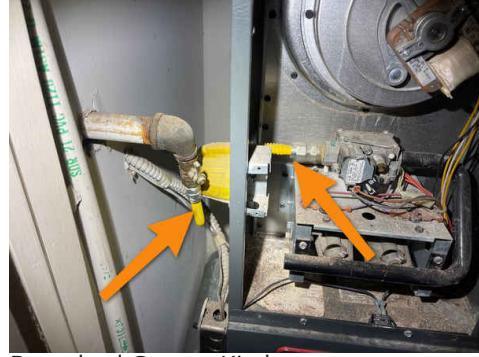
Detached Garage Kitchen

A flexible gas appliance connector entered the metal furnace enclosure. This is prohibited as vibration from the unit could cause mechanical damage to the semi-rigid, thin walled line where it enters through the sharp edges of the knockout at the furnace enclosure. Further evaluation for repair is recommended to be performed by a qualified HVAC contractor.

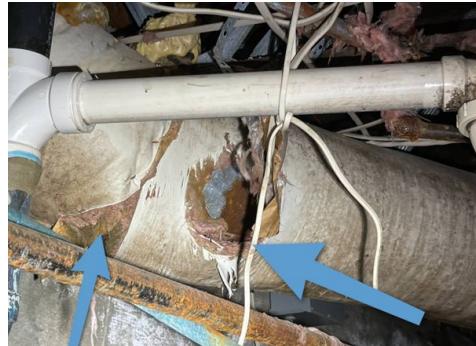
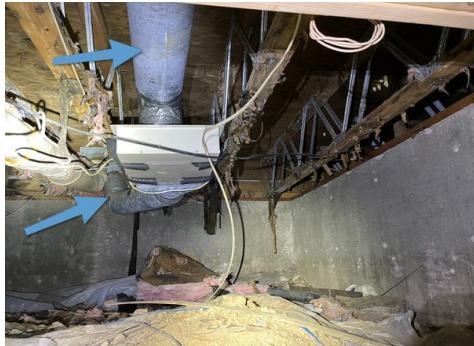
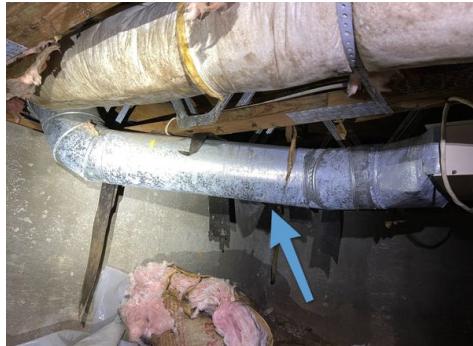
MISSING/DAMAGED DUCTWORK INSULATION

Areas of the ductwork had missing or damaged insulation present. Evaluation and repairs or replacement of any damaged portions of ductwork is recommended to be performed by an HVAC contractor.

Contact a qualified HVAC professional.

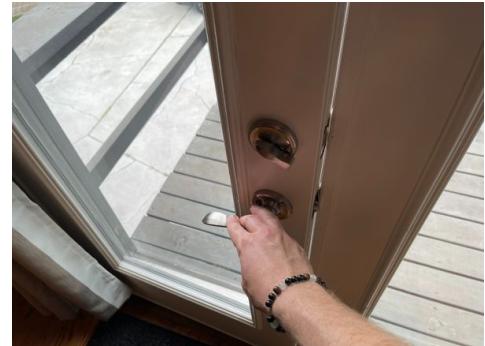
2nd Floor West Exterior

The interior door was binding / rubbing on the jamb. Adjustments or modifications as needed is recommended to be conducted by a qualified person for proper operation.

Contact a qualified professional.

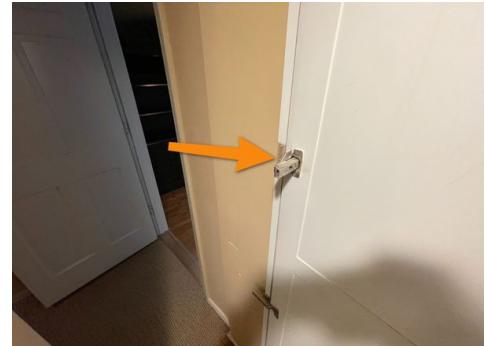
2nd Floor Secret Door

DOORS - HANDLE HARDWARE LOOSE

The door handle hardware was loose. Proper installation of hardware is recommended by a qualified person.

Contact a qualified professional.

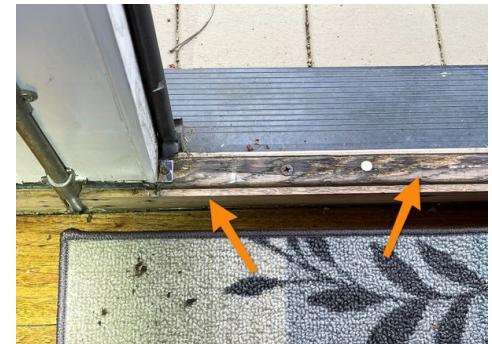
Master Bedroom

DOORS - JAMB DAMAGED

The door jamb was damaged. Repairs or replacement as needed is recommended by a qualified person.

Contact a qualified professional.

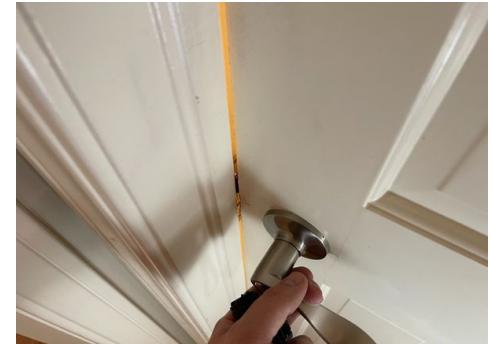
South Bathroom

The door was not latching properly. Adjustments or modifications as needed for proper operation is recommended to be conducted by a qualified person.

Contact a qualified handyman.

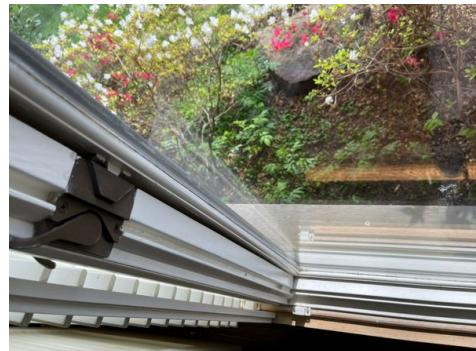
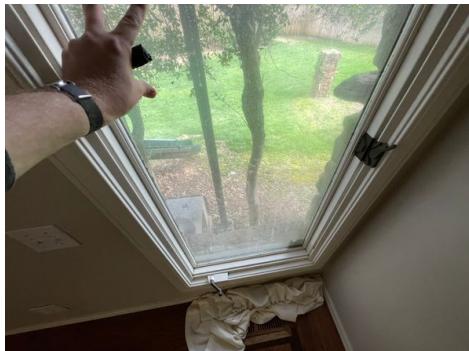
The window(s) in the referenced area(s) were difficult to operate (raise and lower). Repairs or replacement of the window(s) is recommended to be performed by a qualified person as needed for proper operation.

When a property lacks means of egress it present a safety hazard to the occupants as it limits escape from a property during an emergency.

Contact a qualified window repair/installation contractor.

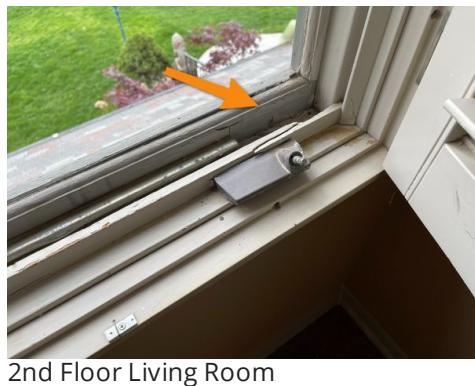
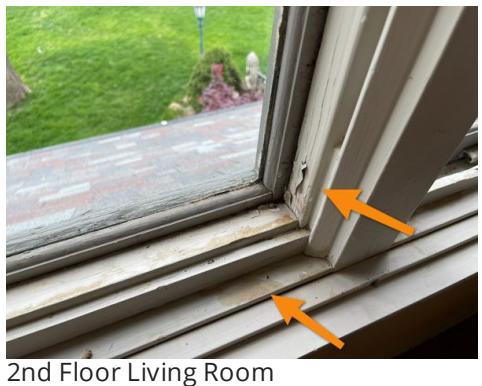
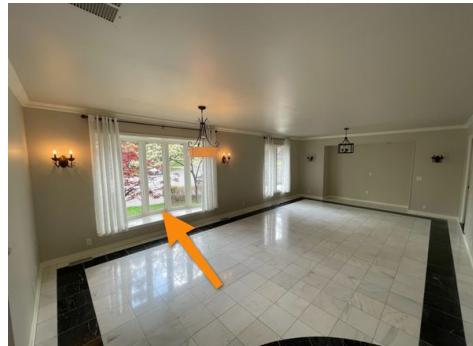
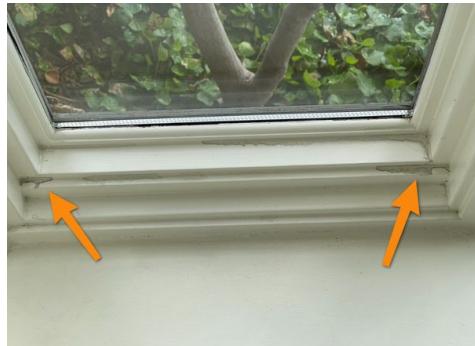
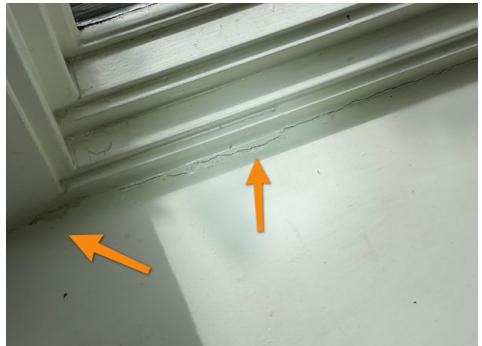
WINDOWS - DAMAGED

There were window(s) present with damage to the wood sash, jambs, and/or moulding. Moisture intrusion was also found at window stools. Repairs to any damaged components is recommended to be conducted by a qualified person.

Contact a qualified professional.

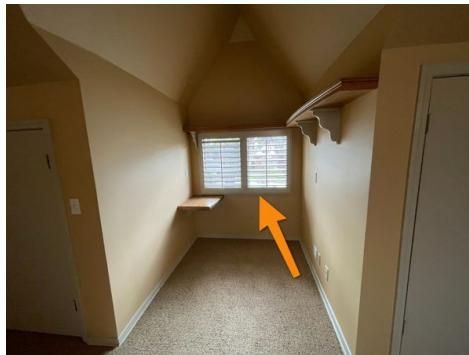
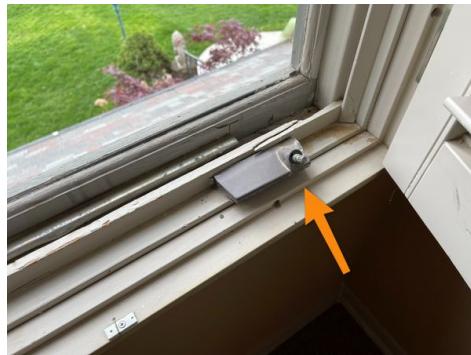
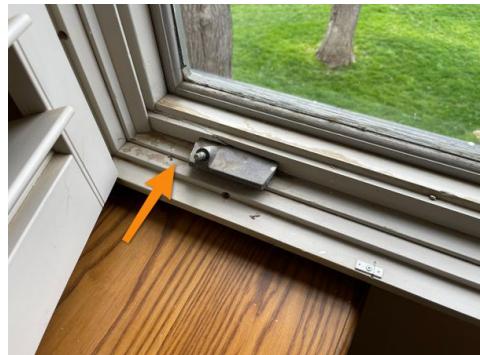
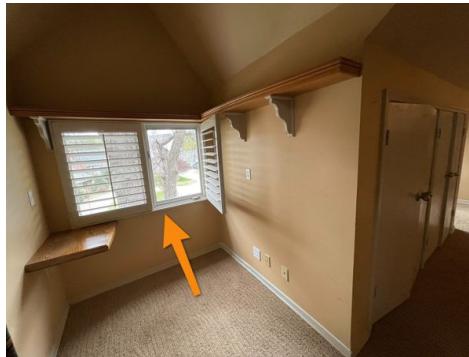
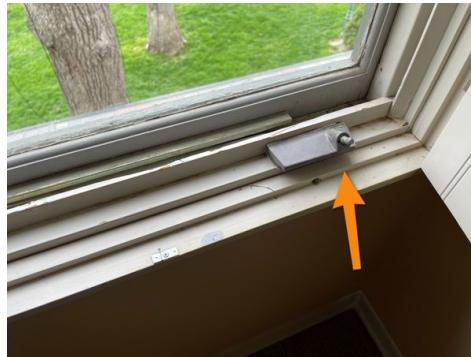
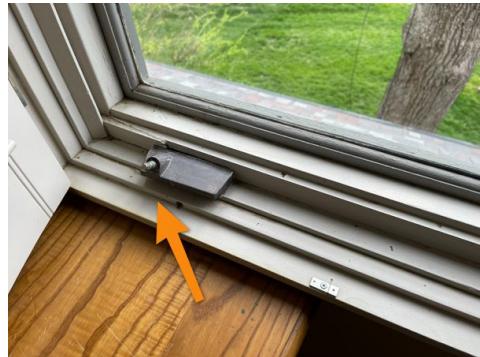
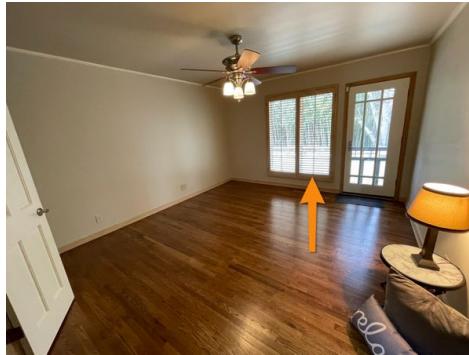
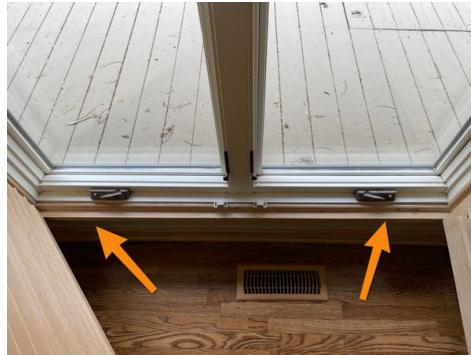
WINDOWS - MISSING CRANK(S)

Contact a qualified professional.

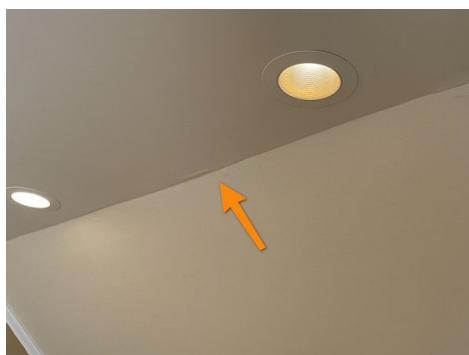
2nd Floor West Bedroom

Crack(s) were present on the ceiling(s) in areas. All homes settle and cracks can be superficial if not associated with binding doors, un-level floors, and/or other signs of serious settlement or construction deficiencies. These cracks are recommended to be repaired by a drywall contractor as desired.

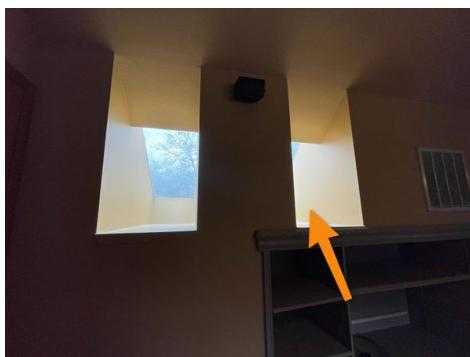
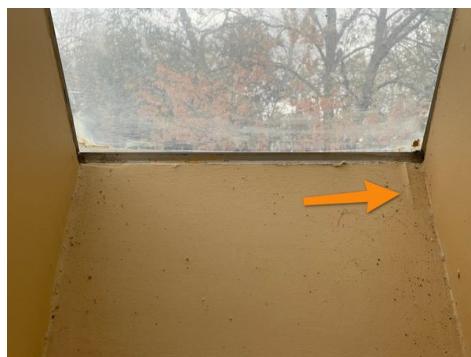
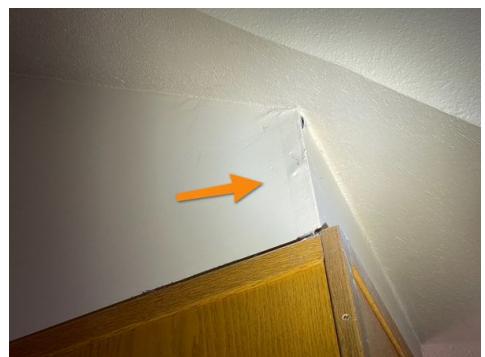
WALLS - CRACKING PRESENT

Cracking was present on the wall in the referenced area(s). Some cracks in homes may be present due to standard settlement of the structure and/or expansion and contraction. Further evaluation for repairs are recommended by a qualified drywall contractor as needed.

Contact a qualified drywall contractor.

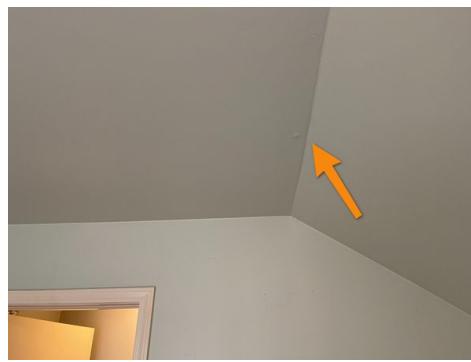
There were "nail pops" present on the referenced areas of the ceiling and/or walls. This is where a nail that supports the ceiling drywall, protrudes through the paper face of the drywall, typically from expansion and contraction or standard settlement. Repairs are recommended as desired by a drywall contractor or other qualified person.

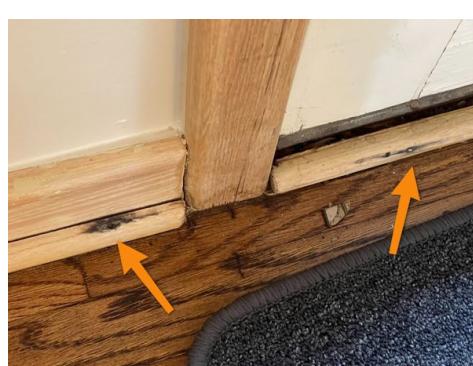
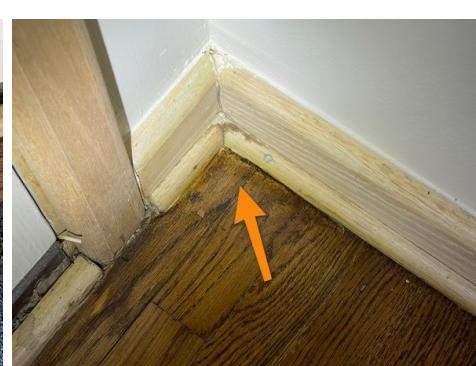
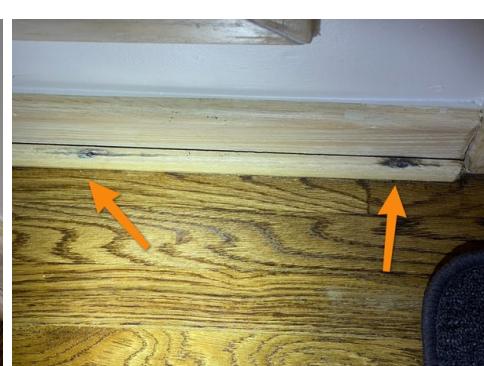
EVIDENCE OF PAST MOISTURE

Evidence of past moisture was present in the referenced area(s). A qualified contractor is recommended to evaluate further, any damage present should be repaired at this time.

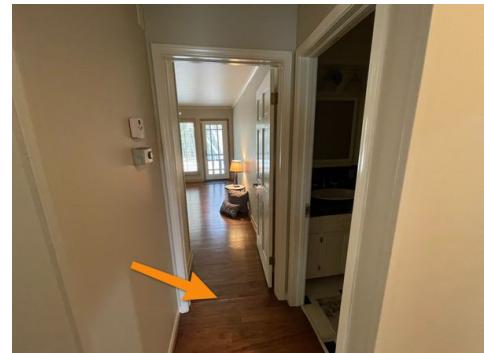
South Bedroom/ Bathroom

SLOPING FLOORS

The interior floors were sloped or uneven in some areas. Individual perception and sensitivity to floor sloping varies greatly. If a concern, I recommend further evaluation by a qualified contractor.

Contact a qualified professional.

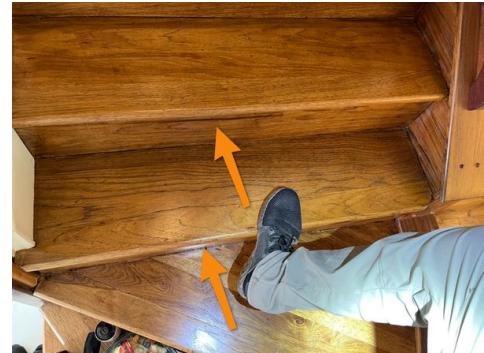
Living Room

LOOSE TREAD(S) PRESENT

Loose stair tread(s) were present on the stairs. Proper securement of any loose treads is recommended by a qualified person.

Contact a qualified professional.

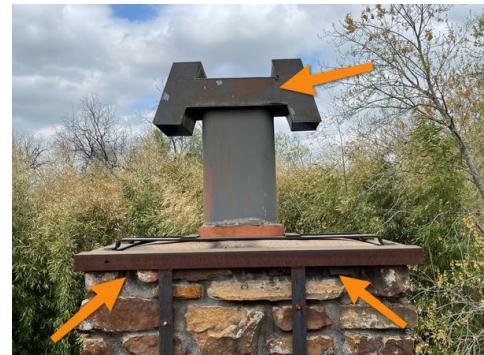
North

CHIMNEY CAP**RUSTED/DETERIORATED**

The chimney cap was rusted. This rust will eventually lead to deterioration, which in turn will allow for leaks through the cap. Refinishing of this cap as needed is recommended to be conducted by a qualified person to properly protect the cap from the elements.

Contact a qualified professional.

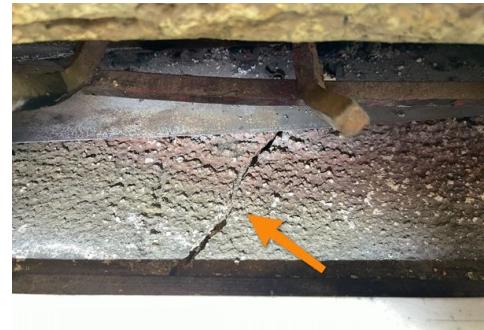
Master Bedroom

CRACKING ON FIREBOX FLOOR

Cracking noted on the masonry of the firebox floor. Repairs are recommended by a chimney sweep.

Contact a qualified fireplace contractor.

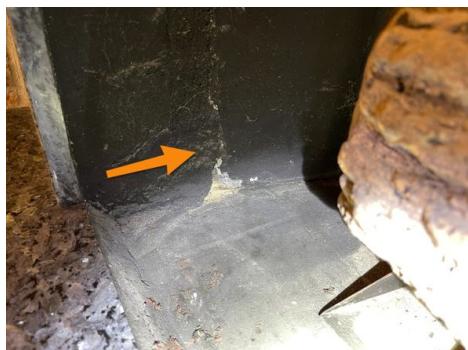
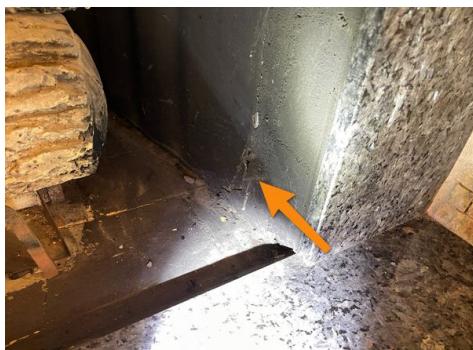
MASONRY DAMAGE/CRACKS IN FIREBOX

The firebox contained some degree of damage, cracking, or gaps to the masonry or refractory panels. Any damage and/or cracks or gaps wider than the thickness of a credit card should be repaired for fire safety. An evaluation of the firebox with repairs made as needed is recommended to be conducted by a chimney sweep or qualified mason.

Contact a qualified chimney sweep.
