FOREVER HOME INSPECTION - OKLAHOMA

RESIDENTIAL REAL ESTATE INSPECTION REPORT

1234 Main St. Tulsa OK 74112

06/12/2021 9:00AM

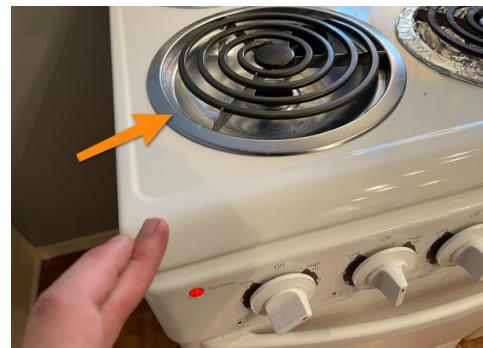
Detached Structure

There were element(s) that were not functional at the time of inspection. Repairs or replacement as needed is recommended by a qualified appliance repair professional.

Contact a qualified appliance repair professional.

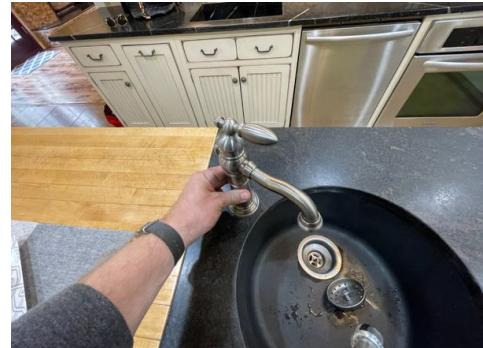
Kitchen

- Defect - Medium Concern
FAUCET LOOSE AT COUNTERTOP

The faucet assembly was loose at the base. Proper securement of the assembly is recommended by a qualified person to prevent loose connections or potential leaks.

Contact a qualified professional.

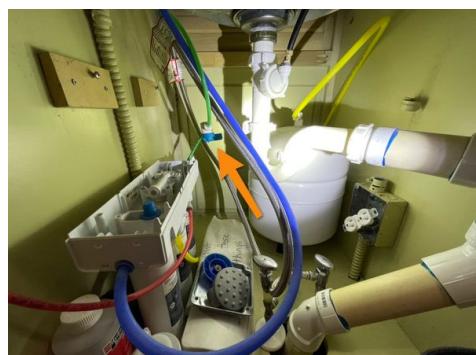
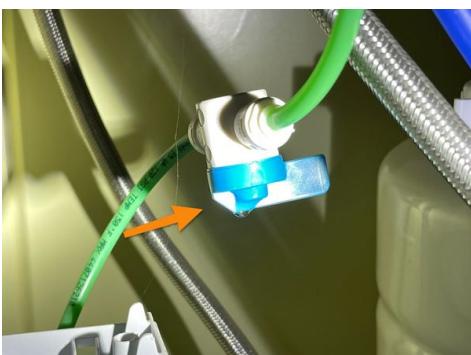
- Defect - Medium Concern
LEAK PRESENT

A leak was present under the kitchen sink. Repairs are recommended to be conducted as needed by a licensed plumber to rectify the leak.

Contact a qualified plumbing contractor.

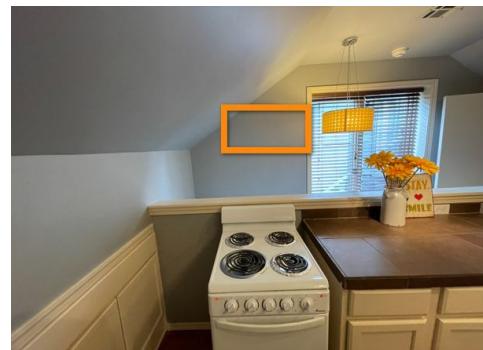
Detached Structure

- Defect - Medium Concern
KITCHEN EXHAUST FAN NOT PRESENT

A kitchen exhaust fan was not present. Installation is recommended as desired by a licensed electrician.

Contact a qualified professional.

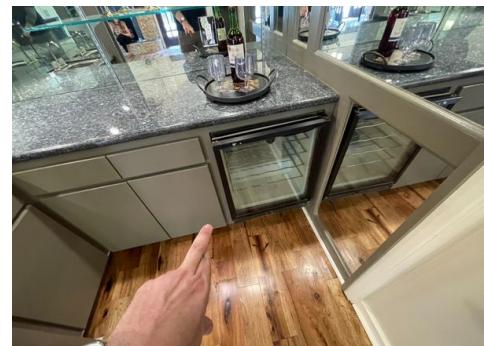
Living Room

Although beyond the scope of this inspection, the wine fridge was found not in working order.

Contact a qualified professional.

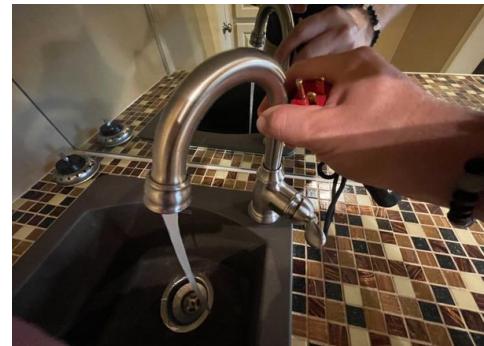
2nd Floor Game Room Bar Kitchen

FAUCET LOOSE AT COUNTERTOP

The faucet assembly was loose at the base. Proper securement of the assembly is recommended by a qualified person to prevent loose connections or potential leaks.

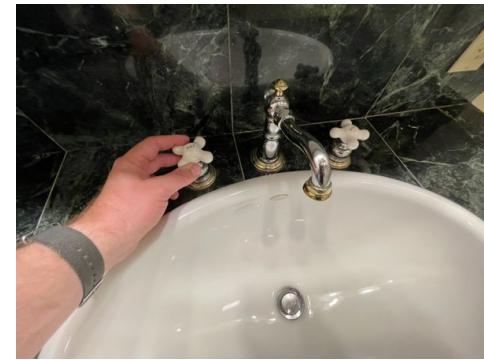
South Bathroom

FAUCET HANDLE LOOSE AT COUNTERTOP

The hot faucet handle was loose at the base. Proper securement of the assembly is recommended by a qualified person to prevent loose connections or potential leaks.

Contact a qualified professional.

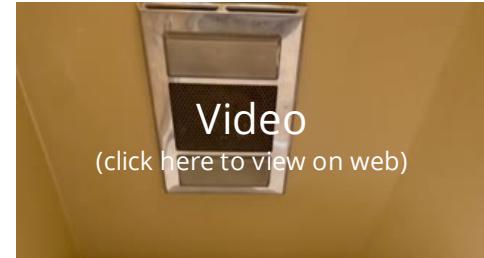
2ND FLOOR GAME ROOM BATHROOM

An irregular noise was produced from the exhaust fan. This may be an indicator that the fan is nearing end of its useful life or an object could be impeding the fan. Evaluation, and repairs or replacement as needed is recommended to be conducted by a licensed electrician.

Recommendation
Contact a qualified electrical contractor.

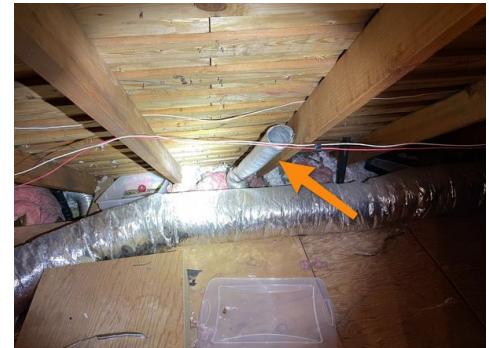
Northwest Bathroom

The referenced bathroom ventilation fan(s) did not visibly terminate to the exterior of the home. Bathroom fans are recommended to terminate to outside air to carry humidity out of the bathroom(s) to the exterior of the home. Repairs to properly terminate the fan(s) is recommended to be conducted by a qualified contractor.

Contact a qualified professional.

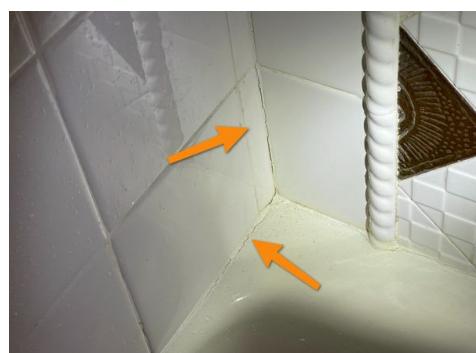
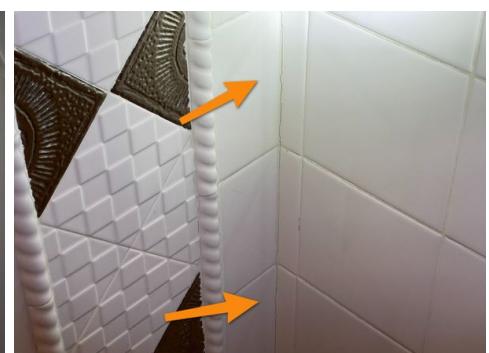
**CRACKED GROUT / SEALANT**

Areas of cracked grout or sealant was present around tiles on the shower walls in the 2nd Floor Game Room Bathroom and the Northwest Bathroom. All missing areas should be repaired or sealed as needed to prevent water infiltration and subsequent damage to the walls / framing of the home. Repairs are recommended by a qualified person.

Contact a qualified handyman.

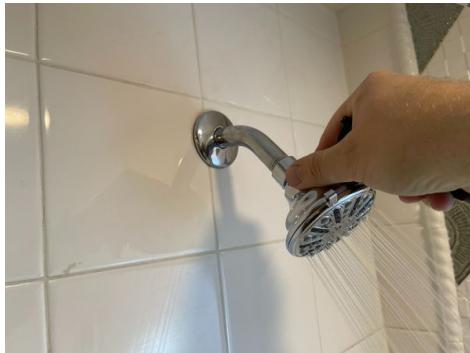
SHOWER WATER PIPE LOOSE

The shower water supply pipe was loose at the wall in the 2nd Floor Game Room Bathroom and the South Bathroom. Proper securement of the water pipe is recommended to be conducted by a licensed plumber.

Contact a qualified plumbing contractor.

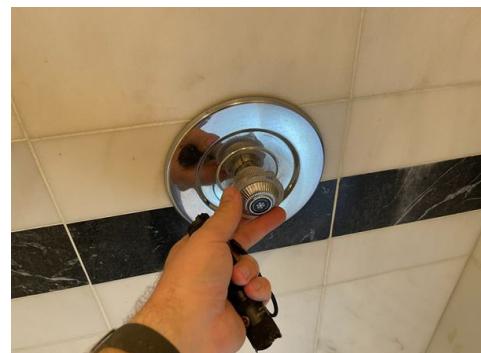
South Bathroom

**SHOWER WATER VALVE LOOSE AT WALL**

The shower water valve was loose at the shower wall. Proper securement is recommended by a licensed plumber or other qualified person.

Contact a qualified plumbing contractor.

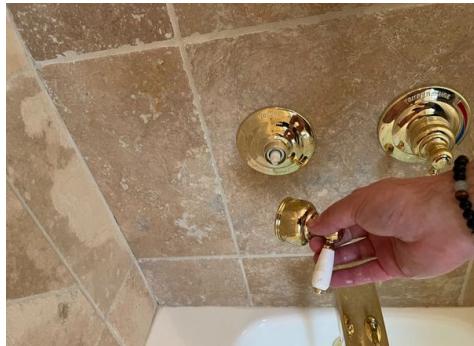
FAUCET VALVE HANDLE LOOSE

The faucet valve handle was loose in the bathtub in the Northwest Bathroom and Master Bathroom. Proper securement is recommended by a qualified person.

Contact a qualified plumbing contractor.

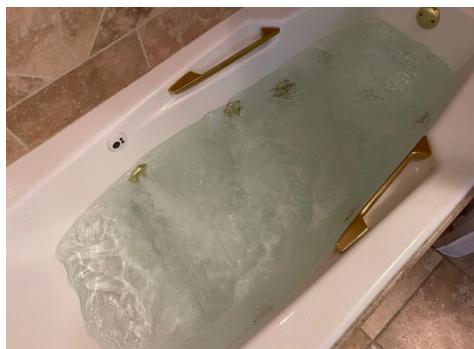
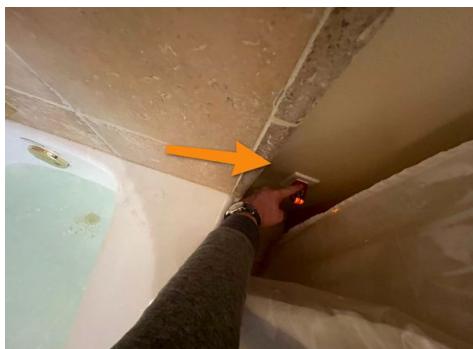
GFCI PROTECTION NOT FOUND - JETTED TUB

GFCI protection was not found for the jetted tub in the Northwest Bathroom and Master Bathroom. I recommend consulting with the sellers as to the location of GFCI protection (if present at all), or to have a licensed electrician to evaluate. I also recommend not using this tub until it is confirmed that it is GFCI protected.

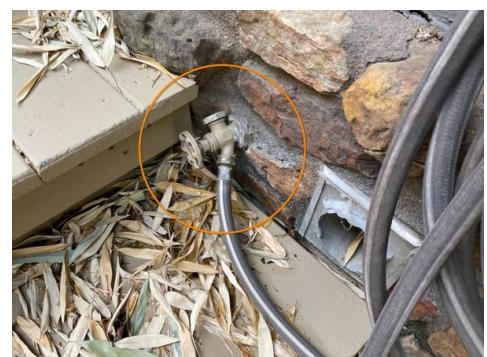
Northwest

EXTERIOR SPIGOT - LEAKING WHEN OFF

The spigot had a drip leak while in the off position. Repairs are recommended as needed by a licensed plumber or other qualified person.

Contact a qualified plumbing contractor.

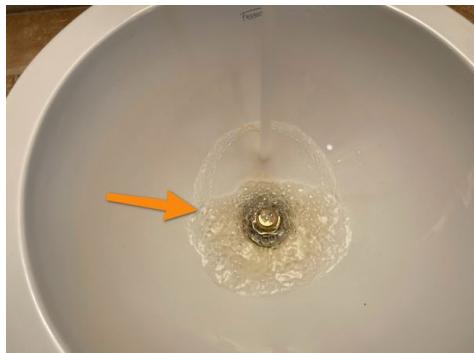
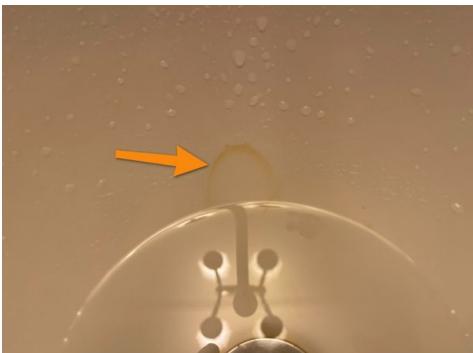
Northwest Bathroom

Defect - Medium Concern
DISCOLORATION OF WATER

The water supply was discolored at the time of inspection. This may be associated with rust or sediment in the water heater or other deficiencies. An evaluation is recommended by a licensed plumber to determine why the water supply was discolored.

Contact a qualified plumbing contractor.

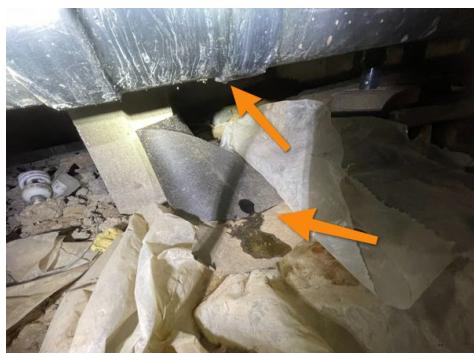
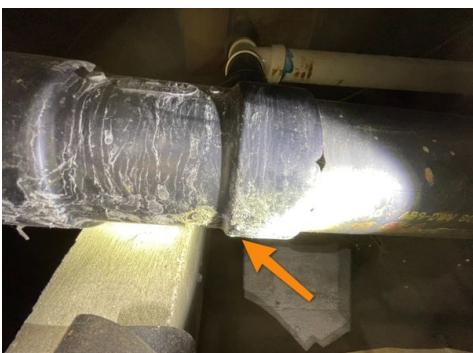
Crawlspace

Defect - Medium Concern
LEAKING PIPE(S) PRESENT

There was leaking present from the drain/waste pipes in the referenced area(s). Repairs are recommended to be performed by a licensed plumber to correct any leaks.

Contact a qualified plumbing contractor.

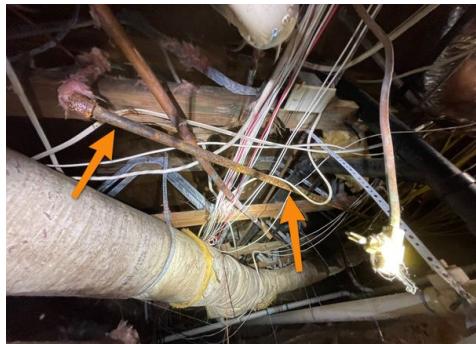
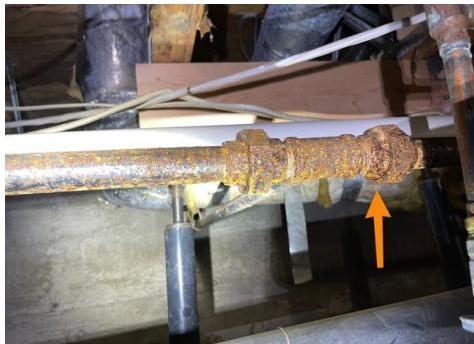
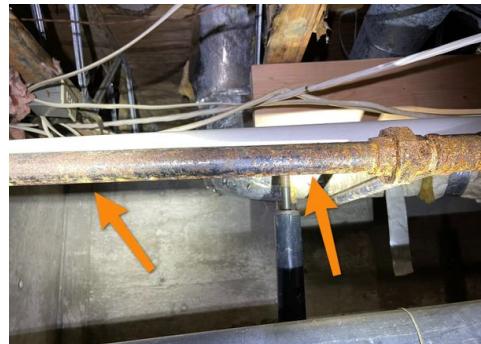
Defect - Medium Concern
GAS PIPES - HEAVY RUST PRESENT

Heavy rust was present on portions of the gas pipes. Evaluation of the pipes in this area with repairs or replacement made as needed is recommended by a qualified person.

Contact a qualified professional.

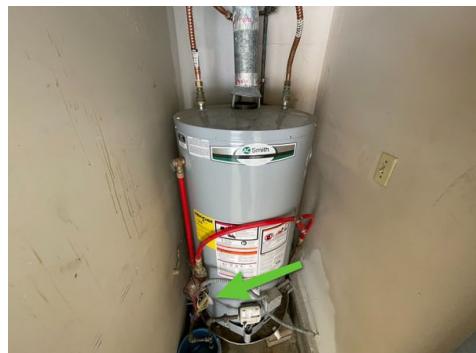
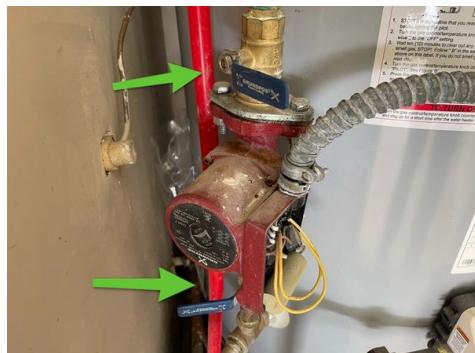
Several valves at the garage water heater were found closed. Assessing the reason for these closed valves is recommended before operating.

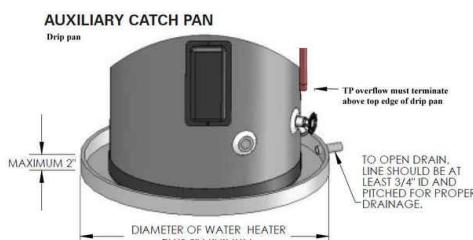
Northwest Crawlspace

DRAIN PAN MISSING

A water heater drain pan was not present. Drain pans also called "Smitty pans" are recommended when the water heater is installed in an area where leaks from the unit could cause damage to framing components and/or interior areas. The installation of a drain pan is recommended to be conducted by a qualified person.

Contact a qualified plumbing contractor.

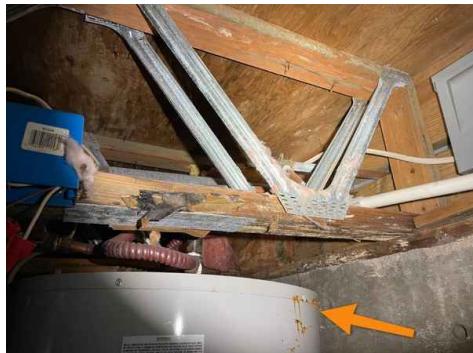
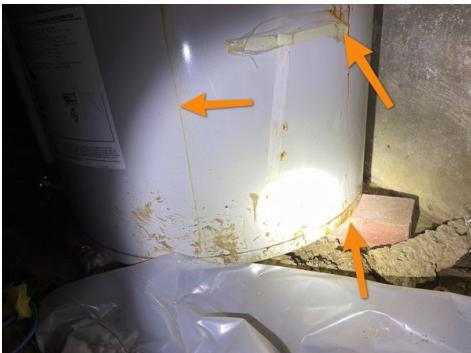
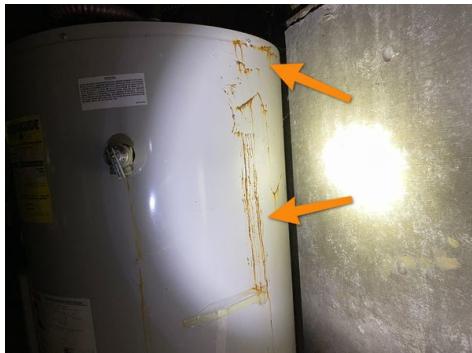
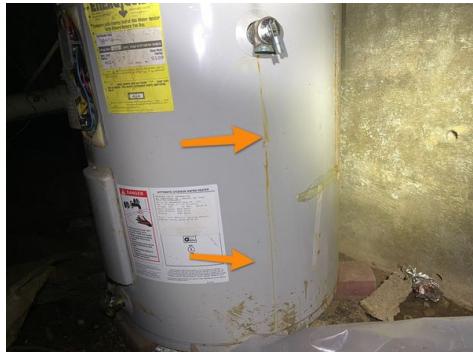
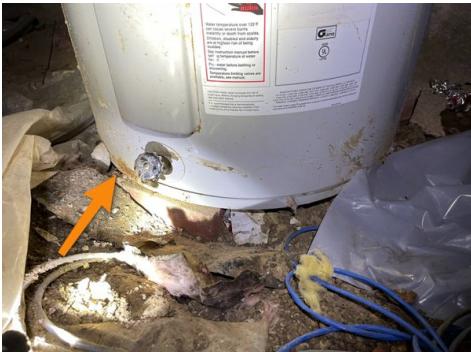
ENCLOSURE RUSTED

The water heater enclosure was rusted in areas. This is a sign of past or present leaking and/or condensation in the area. An evaluation of the unit with repairs or replacement made as needed is recommended to be conducted by a licensed plumber.

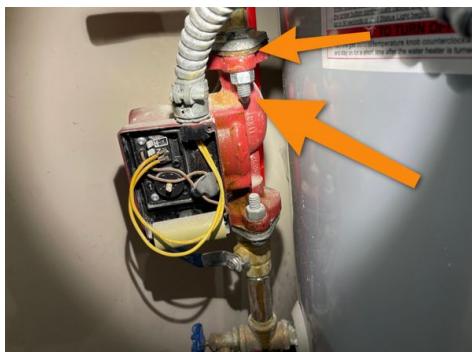
Garage Closet

LEAK PRESENT

A leak was present from the water pipes exiting the bottom of the unit. Repairs are recommended as needed to rectify the leaking by a licensed plumber.

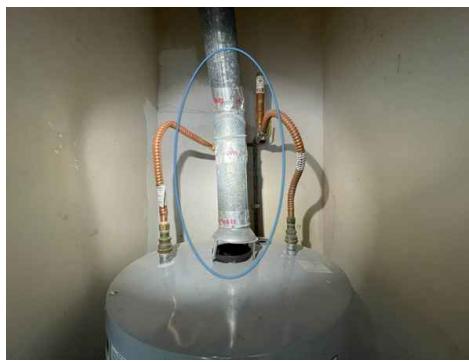
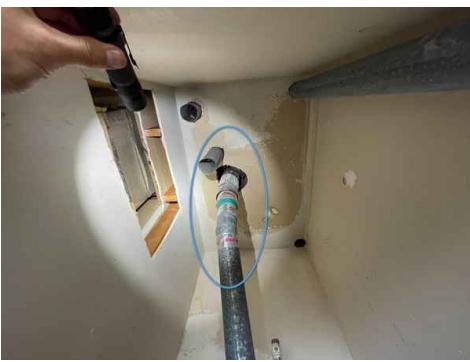
The flue vent connections for the water heater were taped. Tape should not be used on single or double wall vents as the connections are UL listed to be locked in without the use of tape. Evaluation to determine why tape was used is recommended by a licensed plumber or other qualified person.

Contact a qualified plumbing contractor.

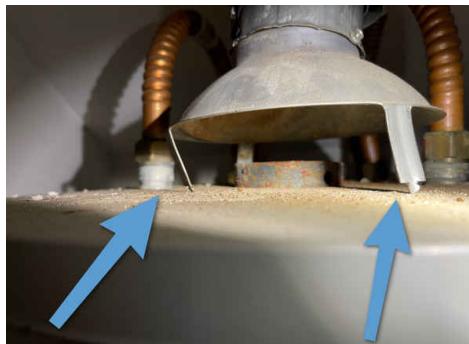
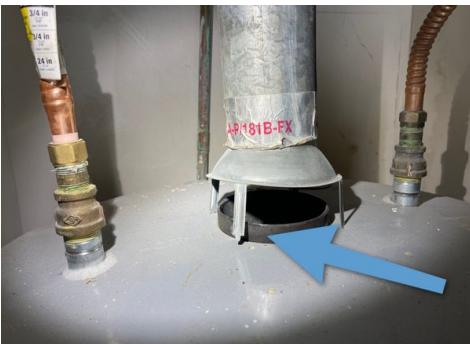
The vent hood was not properly attached to the top of the unit. Repairs are recommended as needed by a licensed plumber.

Contact a qualified plumbing contractor.

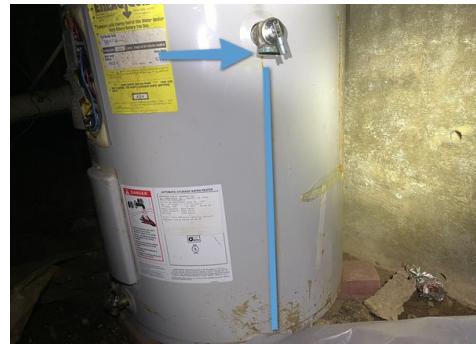
DISCHARGE PIPE ON TPR VALVE

TPR DISCHARGE PIPE MISSING

A TPR valve discharge pipe was not present. A copper, CPVC, or Pex pipe with a 3/4 inch I.D. should be connected to the TPR valve and terminate no more than 6 inches from the floor. The installation of this pipe is recommended to be conducted by a licensed plumber or other qualified person.

Contact a qualified plumbing contractor.

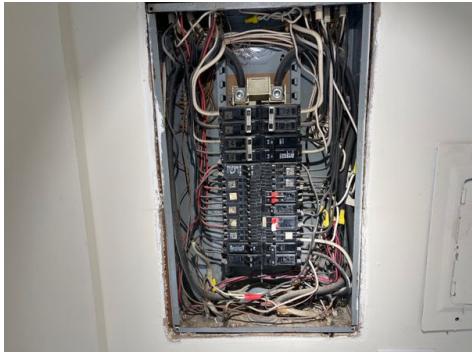
Garage

Service Equipment / Electrical Panel: Manufacture Label - Not Present / Not Visible

The electrical panel label was missing. Electrical panel labels contain important information regarding amperage, voltages, permitted breakers, ground lug quantities, schematics, etc. The proper installation, or condition, of any components that depend on information contained on this label are excluded from this inspection.

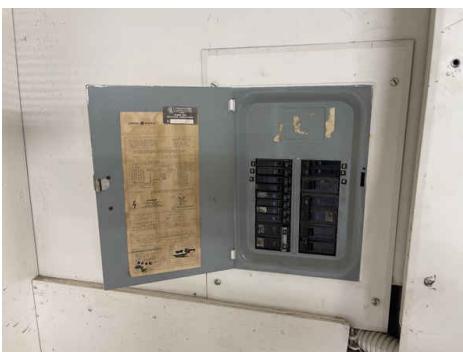
Detached Garage

The electrical panel label was missing. Electrical panel labels contain important information regarding amperage, voltages, permitted breakers, ground lug quantities, schematics, etc. The proper installation, or condition, of any components that depend on information contained on this label are excluded from this inspection.

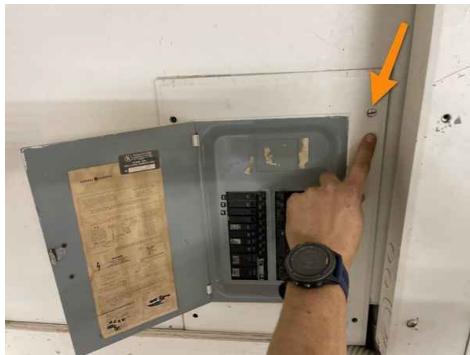
Detached Garage

The electrical subpanel cover (detached garage) was not removed due to being unable to remove one of the screws. The condition of this area is excluded from this inspection.

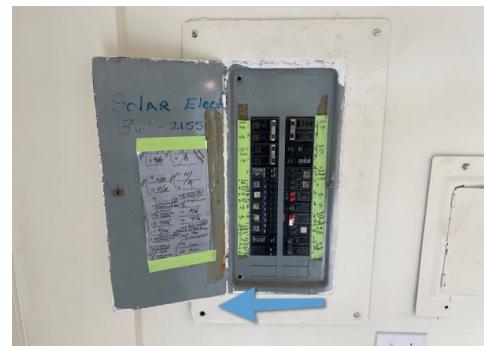
Garage

PANEL COVER SCREWS MISSING

There were one or more panel cover screw(s) missing. All panel cover screw locations are required to be utilized to adequately secure the cover to the panel. Replacement of any missing screws with approved panel cover screws is recommended to be conducted by a qualified person.

Contact a qualified professional.

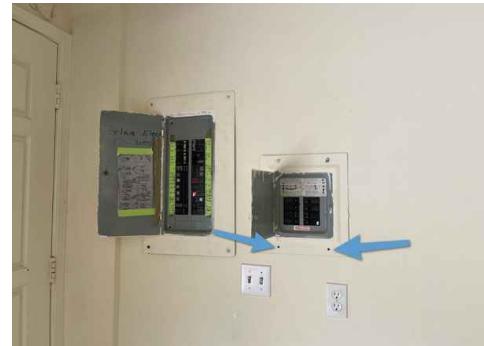
PANEL COVER SCREWS**MISSING**

There were one or more panel cover screw(s) missing. All panel cover screw locations are required to be utilized to adequately secure the cover to the panel. Replacement of any missing screws with approved panel cover screws is recommended to be conducted by a qualified person.

Contact a qualified professional.

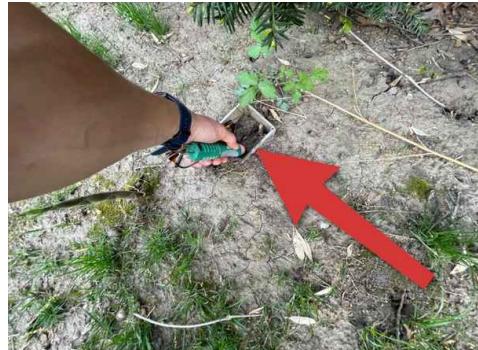
Northeast Grounds

ELECTRICAL BOX - MISSING COVER

There were electrical box(es) present without a cover. This is a potential electrocution hazard, and can be a fire hazard when the box is located near combustibles, due to the possibility of arcing. The installation of UL listed cover(s) is recommended to be conducted by a licensed electrician on any and all electrical boxes in the home missing covers.

Safety Hazard - High Concern

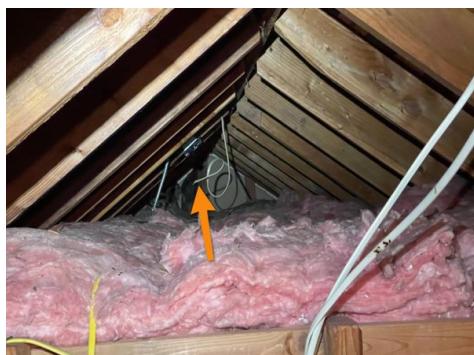
Northeast Attic

There were exposed wiring terminations/exposed wire ends present at the referenced area(s). Any exposed wire termination (live or not) in the home is recommended to either be removed, or terminated into a junction box by a licensed electrician.

Defect - Medium Concern

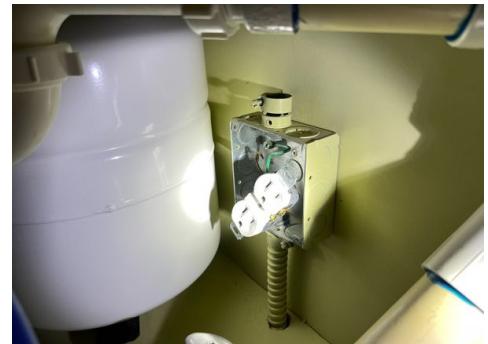
Kitchen

Receptacle(s) tested as having an open neutral. Repairs are recommended to be conducted as needed by a licensed electrician.

Contact a qualified electrical contractor.

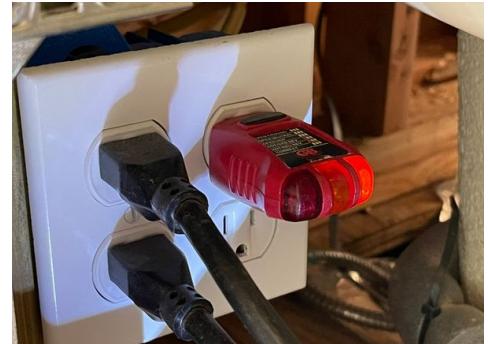
Master Bathroom

The referenced receptacle showed signs of overheating or arcing. Evaluation and replacement of the receptacle is recommended to be conducted by a licensed electrician.

Contact a qualified electrical contractor.

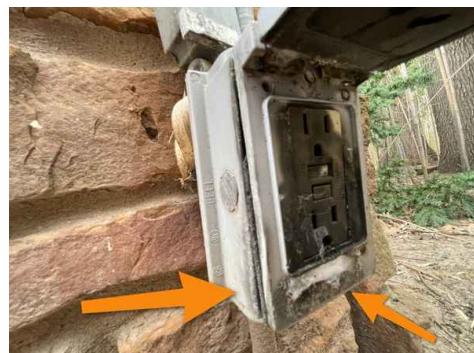
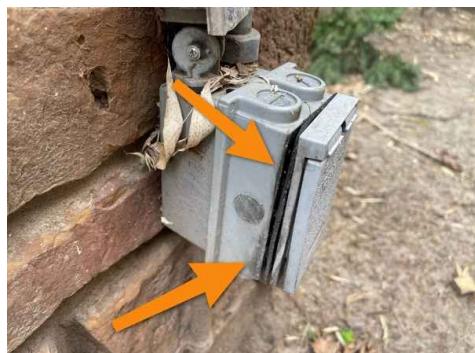
East Yard

RECEPTACLE LOOSE IN WALL/FLOOR

There were receptacle(s) present that were loose in the wall or floor. Proper securement of any loose receptacles is recommended to be conducted by a licensed electrician to prevent loose wire connections.

Contact a qualified electrical contractor.

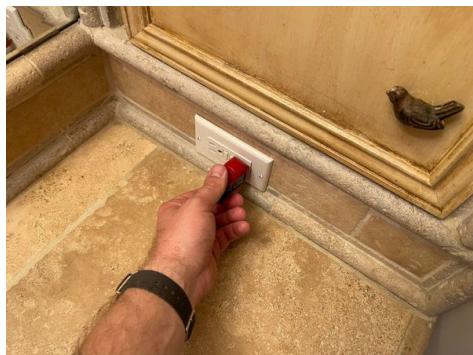
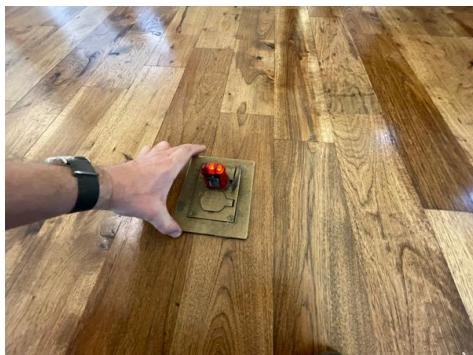
The GFCI receptacle did not trip when tested, Repairs or replacement of the receptacle(s) as needed for proper operation is recommended to be conducted by a licensed electrician.

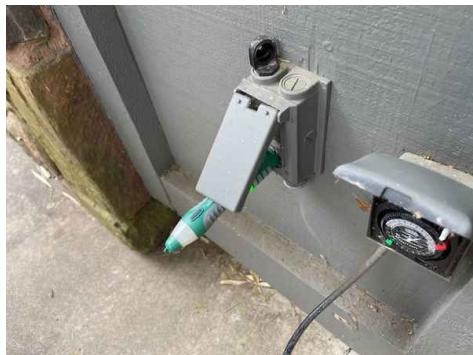
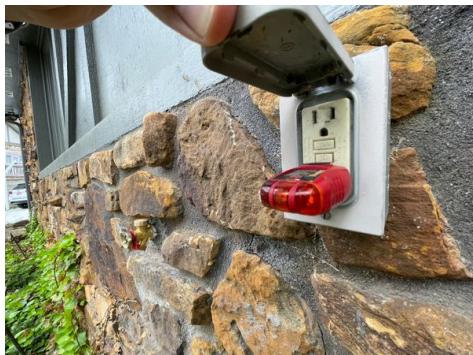
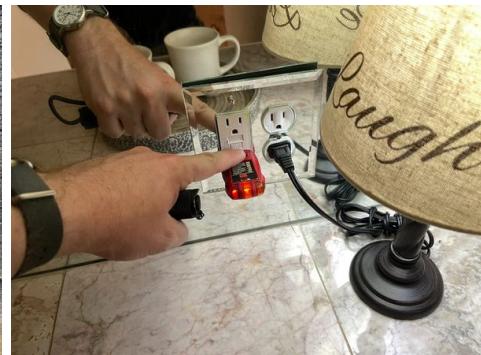
Receptacles were present that were within 6 feet of a sink's edge in the 2nd Floor kitchen and Living Room bar kitchen, and were not GFCI protected. The installation of GFCI protection is recommended here by a licensed electrician for safety.

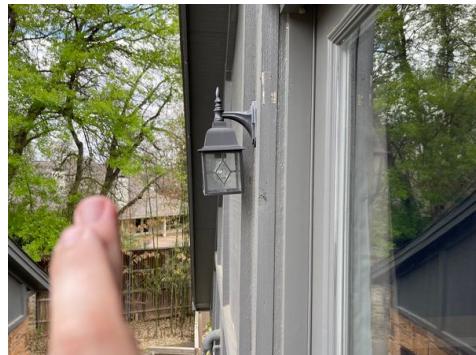
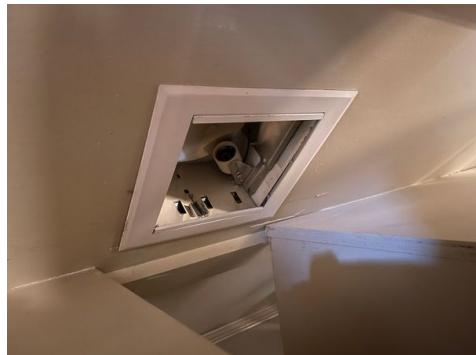
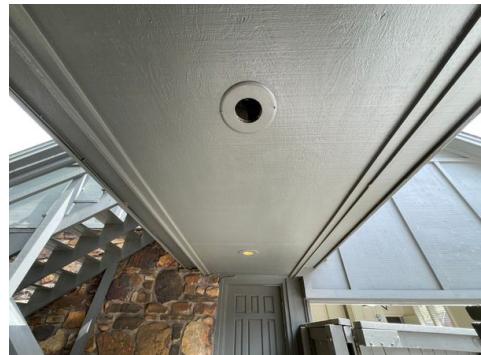
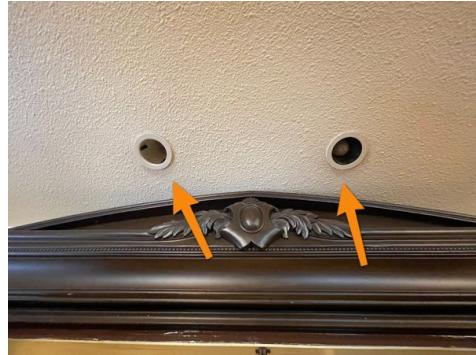
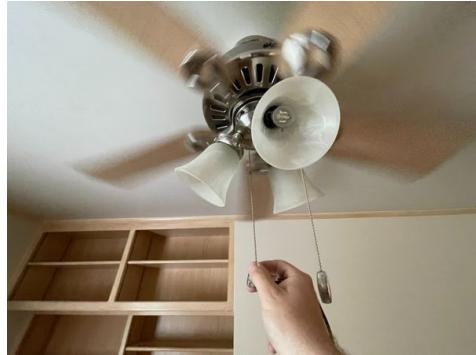
Unsure of what the referenced switches and several others operated at the time of inspection. Repairs or replacement is recommended by a licensed electrician.

Contact a qualified electrical contractor.

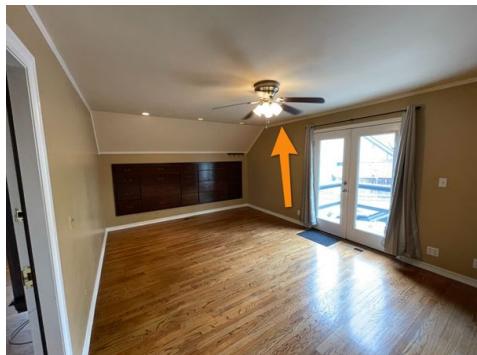
2nd Floor West Bedroom

LIGHT SWITCH MISSING CAP

A light switch was found missing the plastic cap. Replacement of the cap is recommended.

Recommended DIY Project

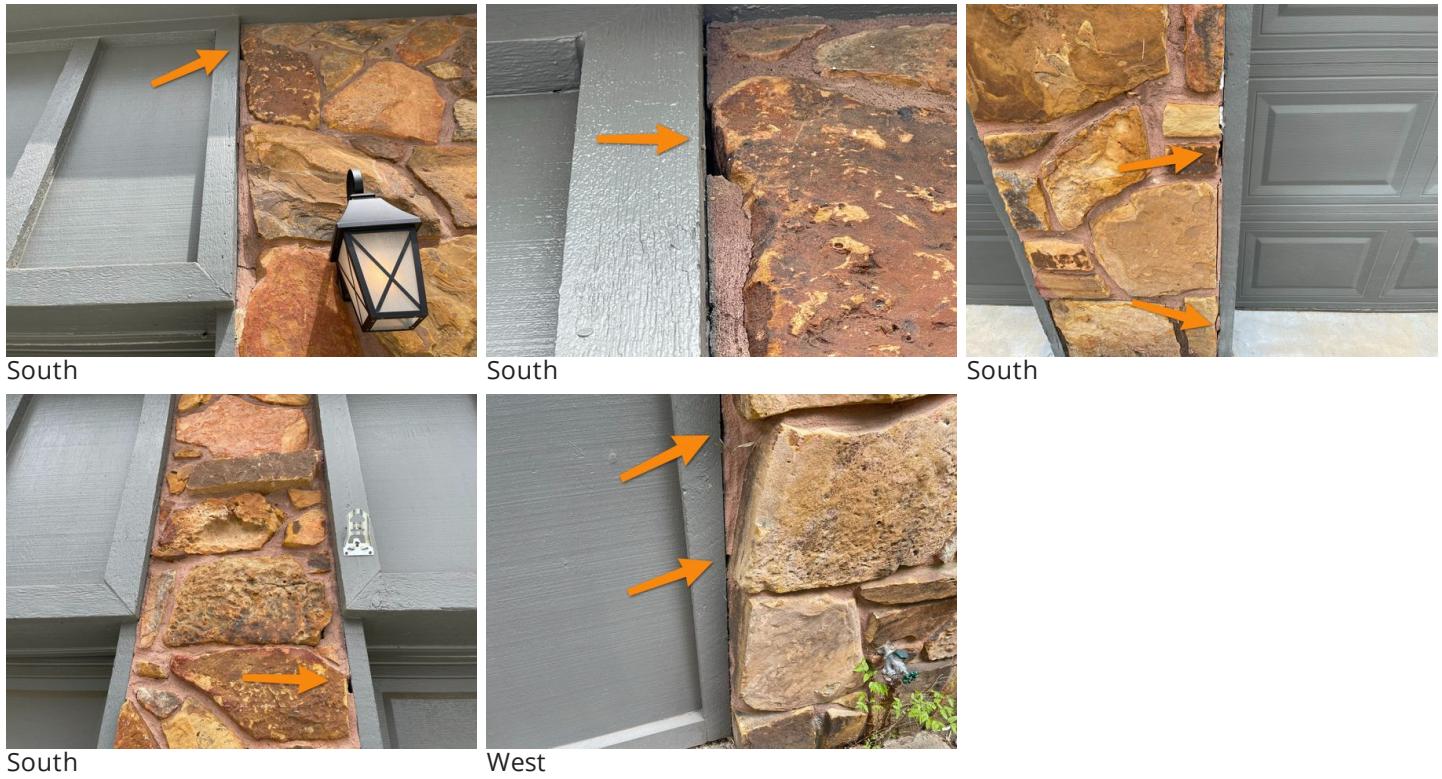
19.8.2 Walls / Cladding

DAMAGE TO WOOD TRIM

Contact a qualified professional.

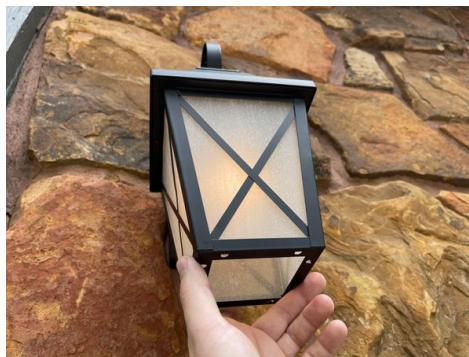
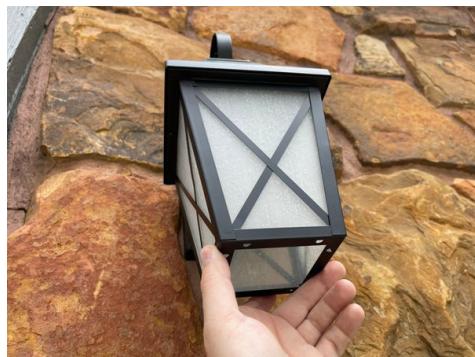
South

The exterior light was not secured properly to the wall and a slight twist would break the circuit. Repairs are recommended as needed by a licensed electrician or other qualified person.

Defect - Medium Concern

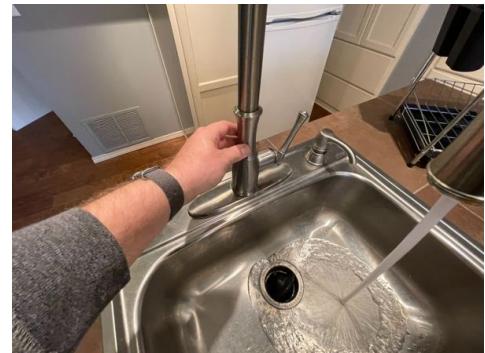
Detached Structure

FAUCET AND VALVES LOOSE

The faucet assembly was loose at the base in the detached structure kitchen. Proper securement of the assembly is recommended by a qualified person, typically this is associated with loose plastic nuts under the sink.

Defect - Medium Concern

Contact a qualified handyman.

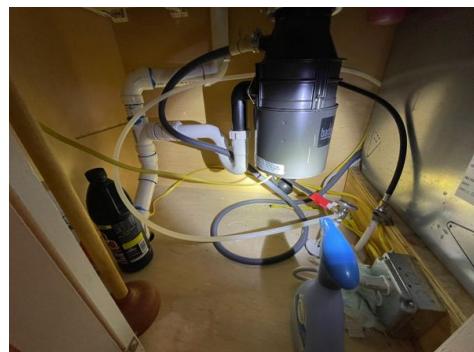
Detached Structure

The disposal in the detached structure kitchen was emitting an irregular noise and vibration at the time of inspection. Evaluation and repairs are recommended to be performed by a qualified professional.

Defect - Medium Concern

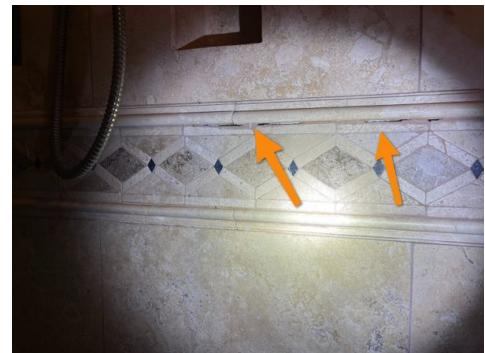
Detached Structure

MISSING GROUT

Grout was missing in areas of the detached structure bathroom. Evaluation and repairs should be performed by a qualified tile contractor.

Defect - Medium Concern

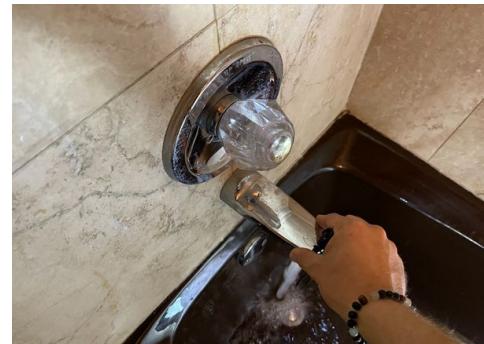
Detached Structure

LOOSE FAUCET / VALVES

Defect - Medium Concern

The faucet and/or water valves were loose at the wall. Securement of the faucet and/or valves is recommended by a qualified person as needed.

Contact a qualified plumbing contractor.

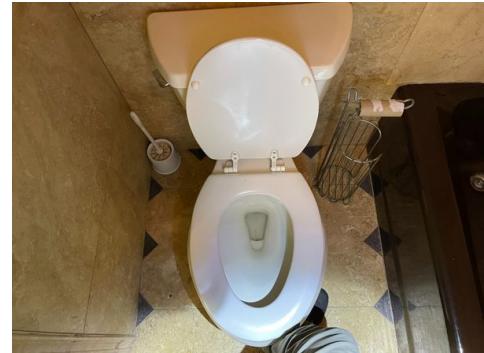
Detached Structure

TOILET LOOSE AT FLOOR

The toilet was loose at the floor anchor bolts. This can hinder a proper connection between the wax ring and toilet flange, which could allow for leaking. Evaluation of the toilet and wax ring, and resecuring as needed to ensure no leaking will occur is recommended by a licensed plumber.

Contact a qualified plumbing contractor.

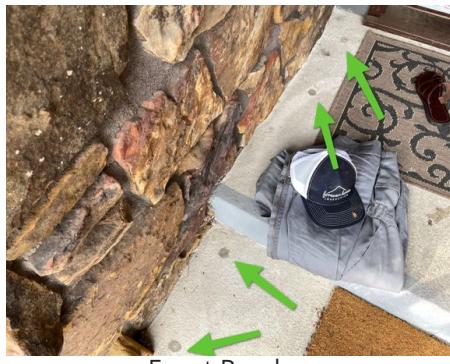
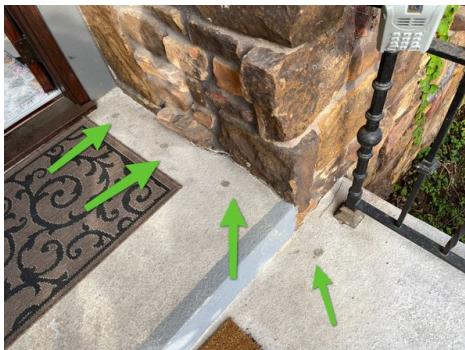
Front Porch

A previous treatment was present in the referenced areas.

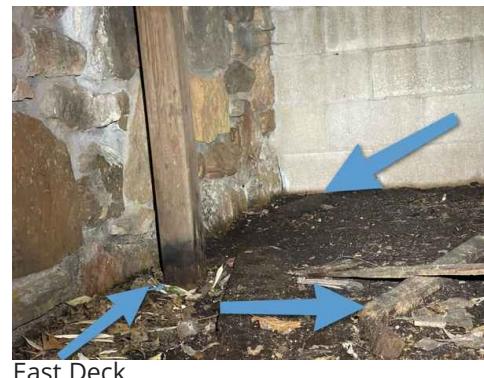
East Deck

Wood to ground contact, Excessive Moisture, Debris (wood or other cellulose material) around structure

Conducive conditions to wood destroying organisms/termites were present in the referenced areas.

Contact a qualified professional.

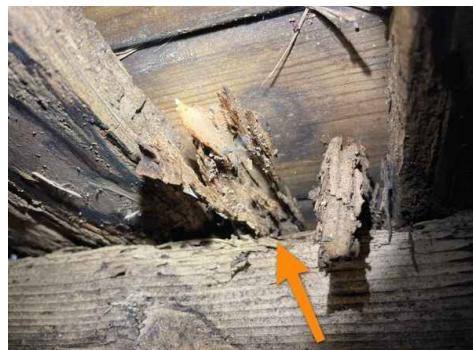
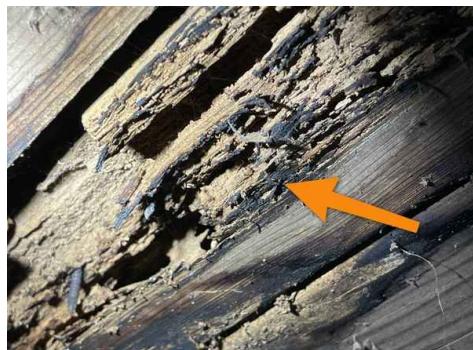
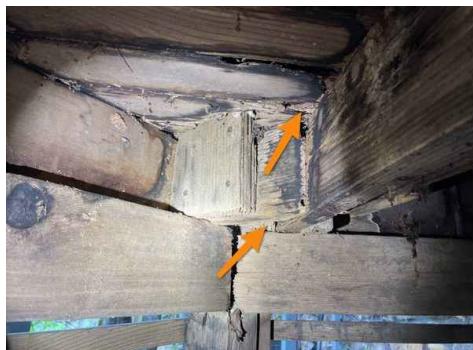
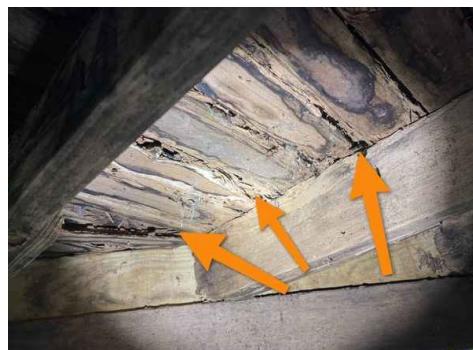
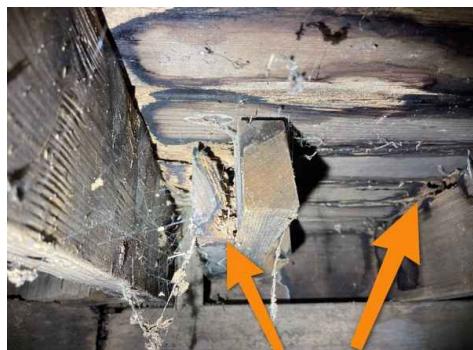
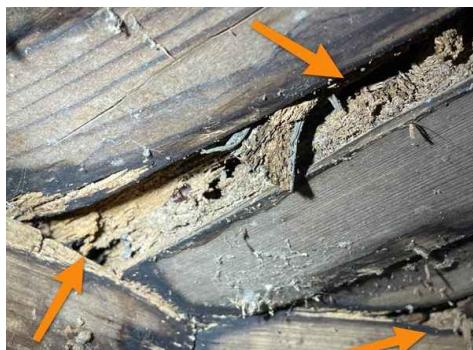
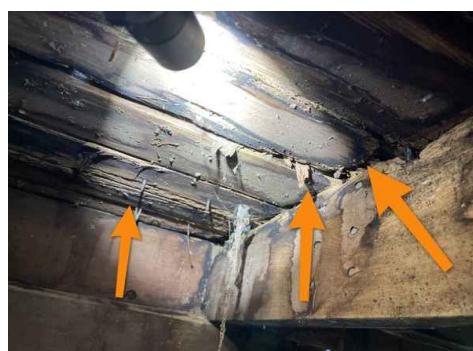
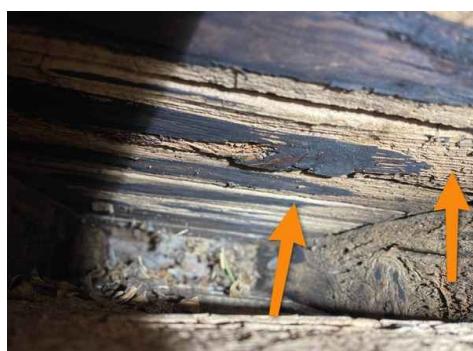
East Deck

VISIBLE EVIDENCE OF TERMITE DAMAGE

Visible evidence of termite damage was found in the referenced areas.

Defect - Medium Concern

Contact a qualified pest control specialist.

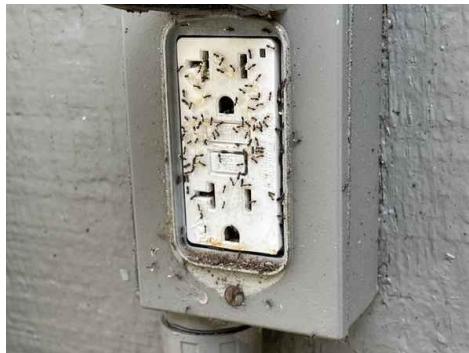
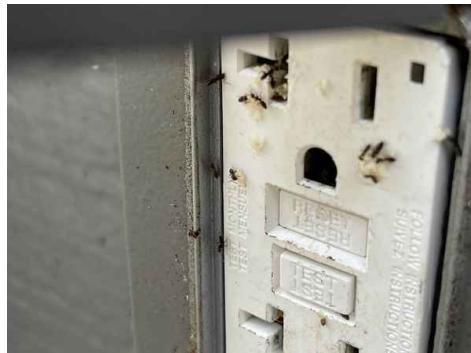
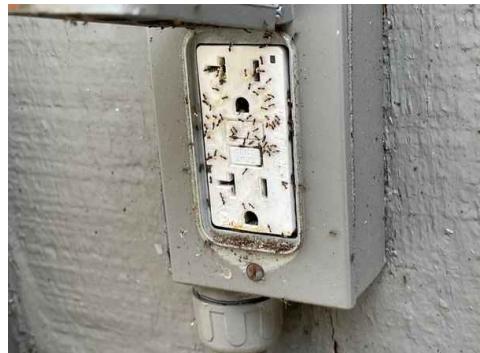
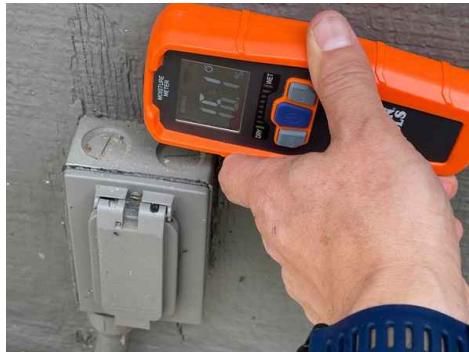
North

Carpenter ants were present at the referenced area. An evaluation of the activity/damage and possible treatment is recommended to be performed by a pest control company.

Defect - Medium Concern

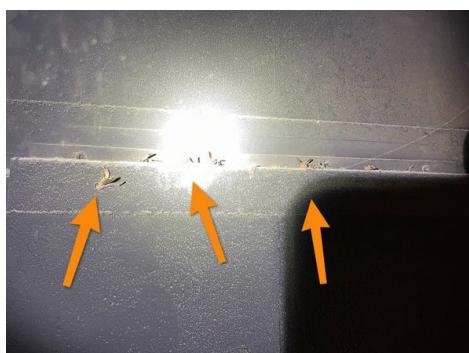
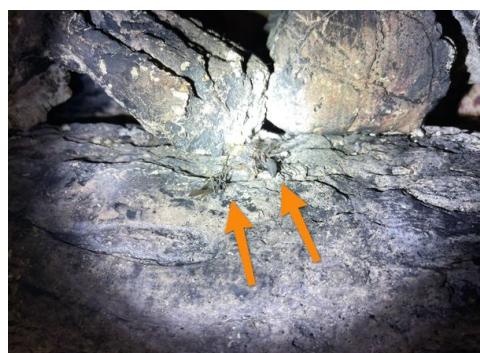
Master Bedroom

Multiple wasps fell out of the fireplace flue when the damper was opened. Removal of the wasps and any nests is recommended by a pest control company or other qualified person.

Defect - Medium Concern

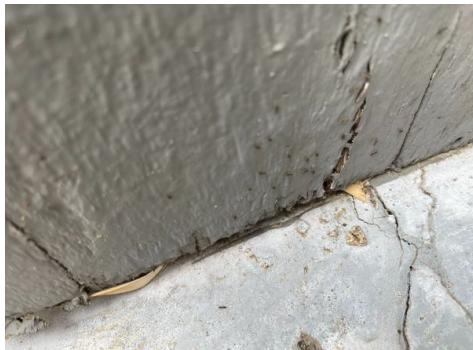
Southwest

An ant nest was present at the trimboard of the west detached garage. Proper pest treatment by a qualified professional is recommended.

Contact a qualified pest control specialist.
