## RESIDENTIAL HOME INSPECTION

1234 Main St. Cambridge MD 21613

01/11/2021 9:00AM

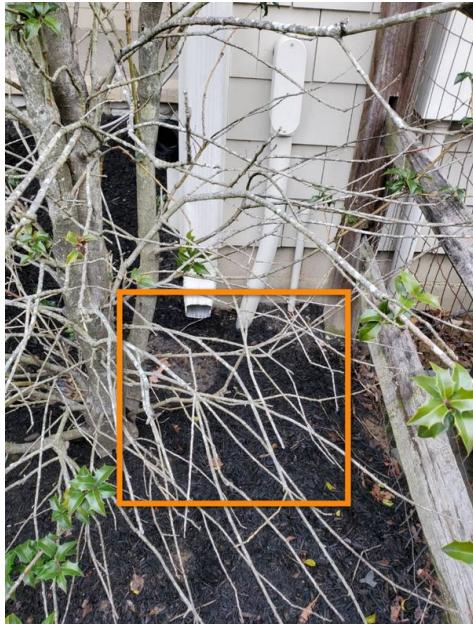
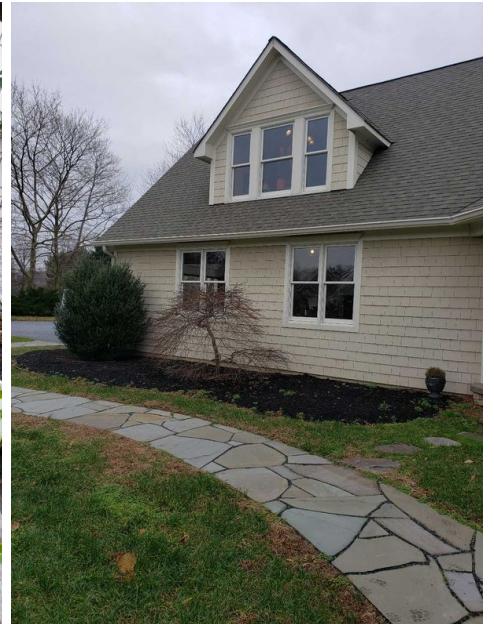
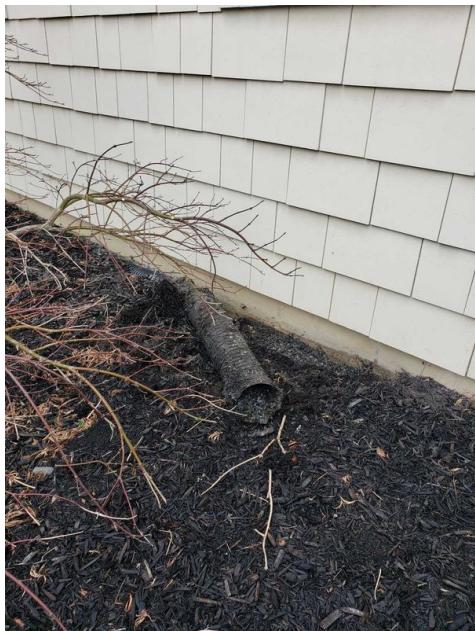
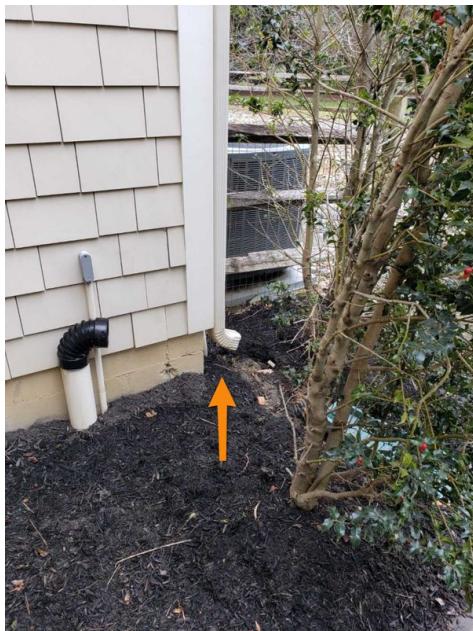
Moisture Intrusion - Downspout

Recommend extending the downspout six feet away from the house.

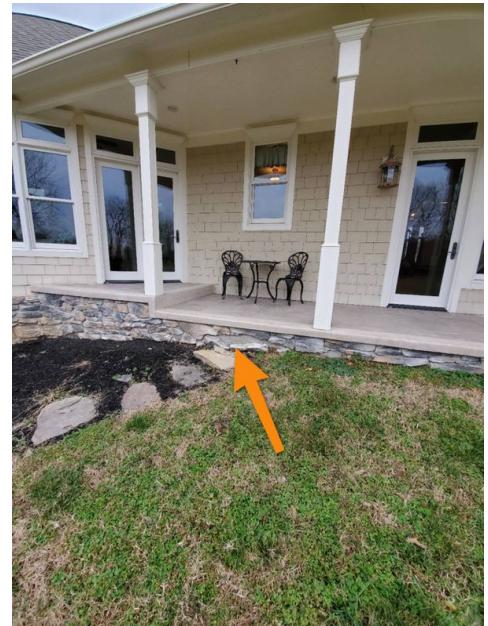
#### DAMAGED MASONRY EXTERIOR

The masonry exterior was damaged in this area.

Recommend evaluation and correction by qualified mason.

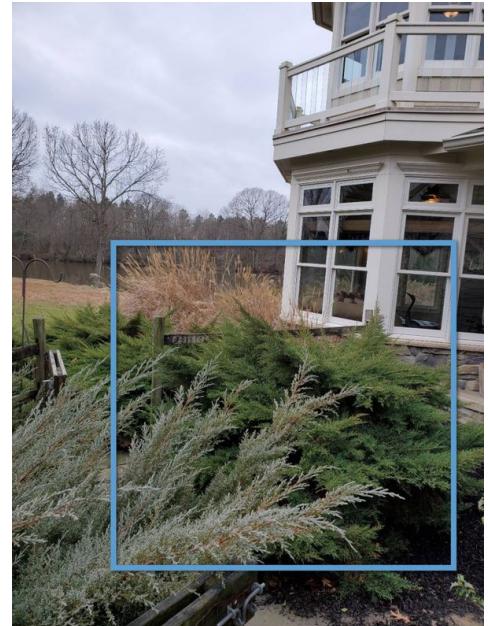
### 3.3.1 Vegetation, Surface Drainage, Retaining Walls & Grading

Vegetation was in contact with the house. This will lead to damage, and water intrusion. Recommend trimming back vegetation 12 inches from house exterior.

Contact a qualified professional.

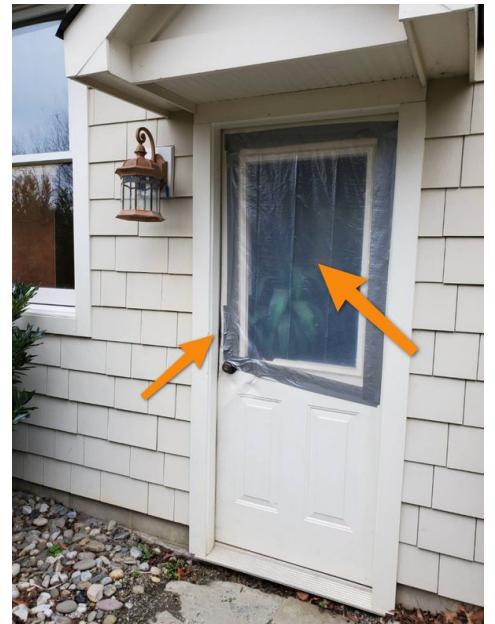
### 3.10.1 Exterior Doors

#### DAMAGED DOOR

This door was damaged.

Recommend correction.

Recommendation  
Contact a qualified carpenter.

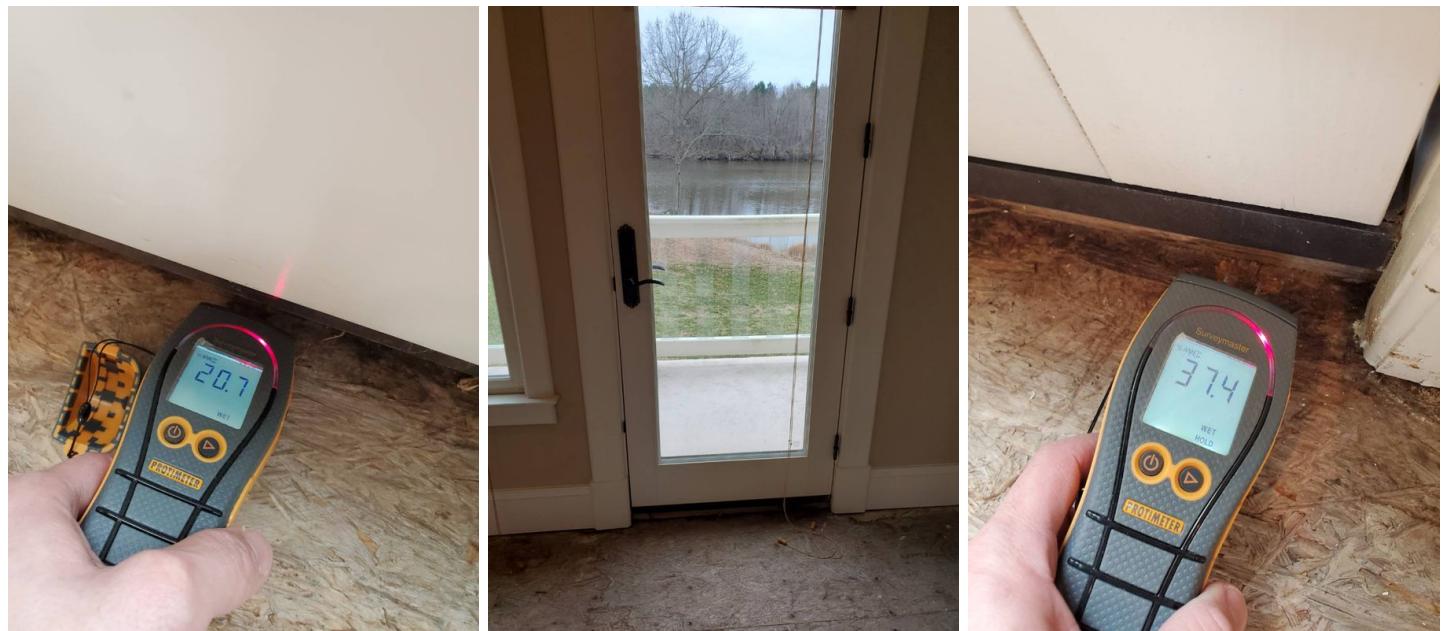
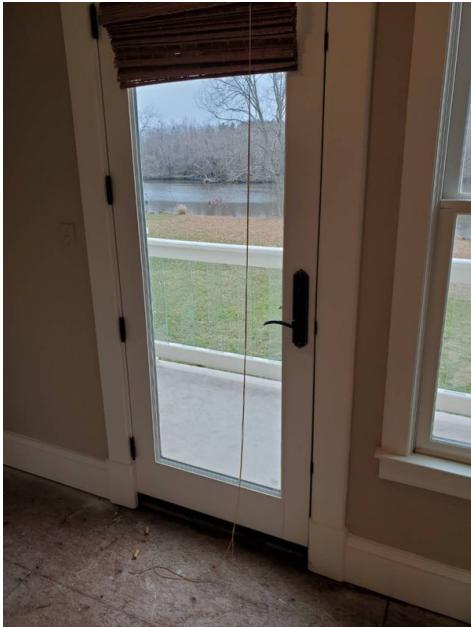
## 3.10.2 Exterior Doors

**MOISTURE INTRUSION**

Moisture intrusion was found in this area.

This will lead to wood rot.

Recommend evaluation and correction.

Contact a qualified professional.

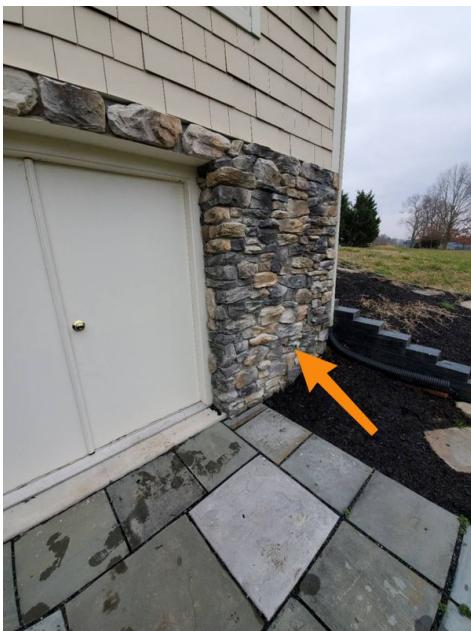
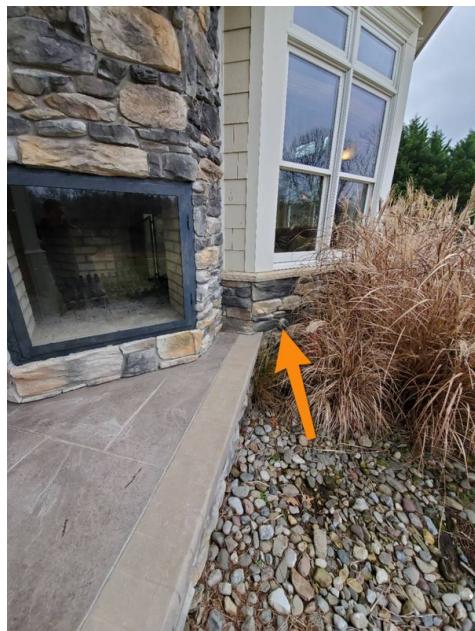
## 3.12.1 Plumbing

**UNSECURED PLUMBING**

Recommend evaluation and correction.

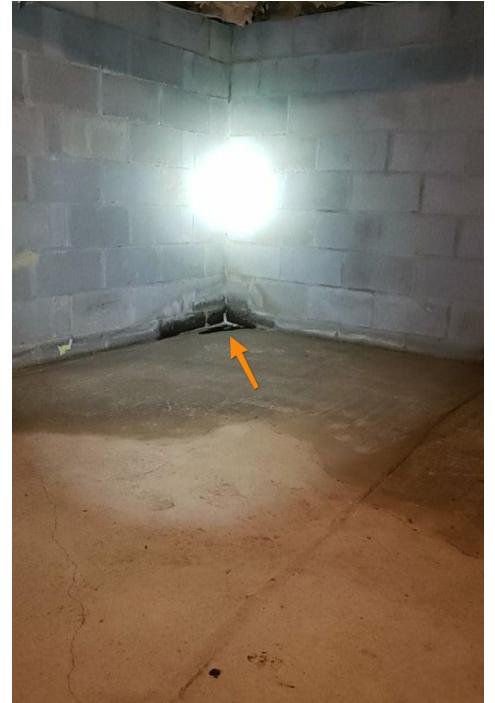
#### 4.1.2 Crawlspace

### ACTIVE WATER PENETRATION OBSERVED

I observed indications of active water penetration into the crawlspace.

Correction and further evaluation is recommended.

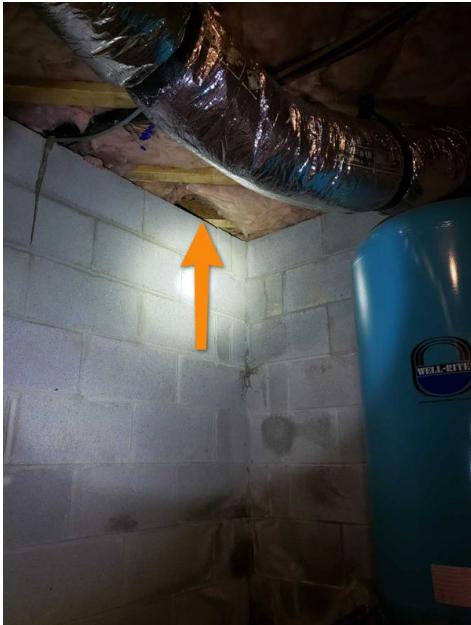
#### 4.1.3 Crawlspace

### ACTIVE WATER PENETRATION OBSERVED

I observed indications of active water penetration into the crawlspace at the perimeter band board framing.

This may be the result of improper flashing behind the siding.

Correction and further evaluation is recommended.

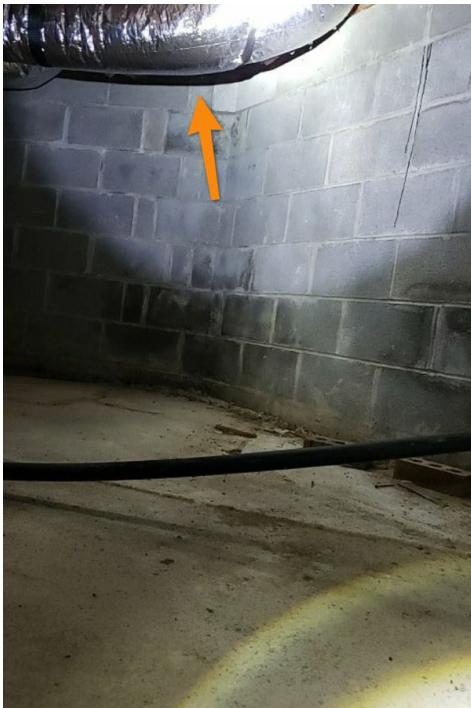
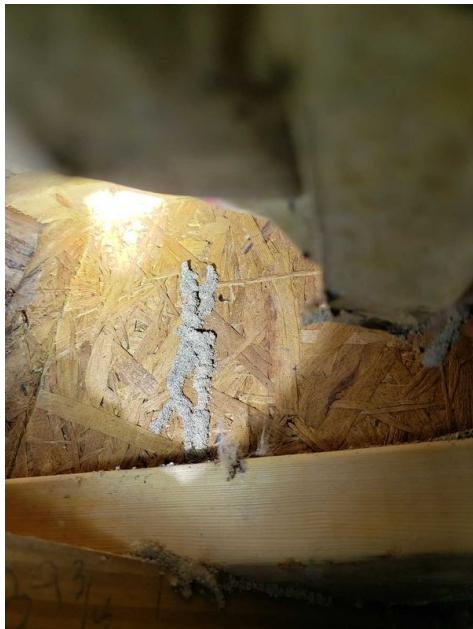
## 4.1.4 Crawl space

**WOOD DESTROYING INSECT EVIDENCE**

Recommend further evaluation and correction.

Contact a qualified pest control specialist.

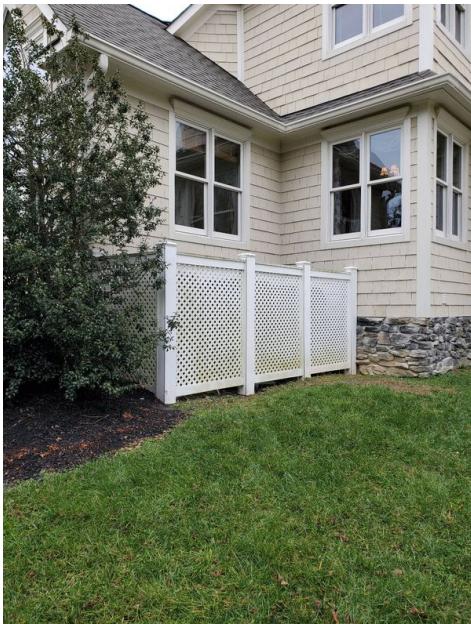
I was unable to access areas containing HVAC equipment. This is an inspection restriction.

Equipment in thus location blocked by fencing without access gate.

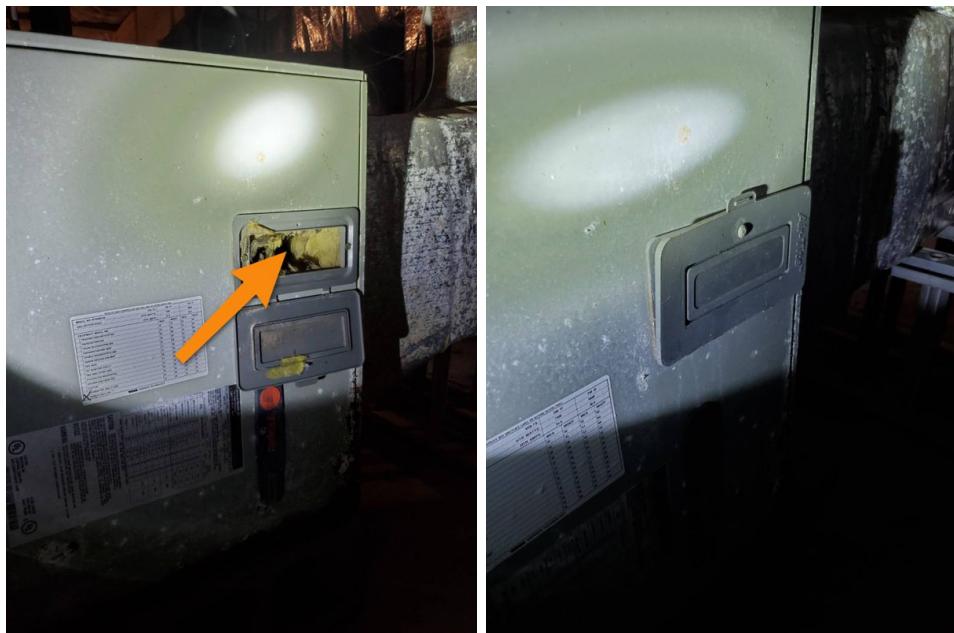
### 7.1.1 System Information

#### AIR LEAKING HVAC SYSTEM AT PASS THROUGH

Air was escaping the HVAC system at this pass through. Recommend correction.

Contact a qualified HVAC professional.

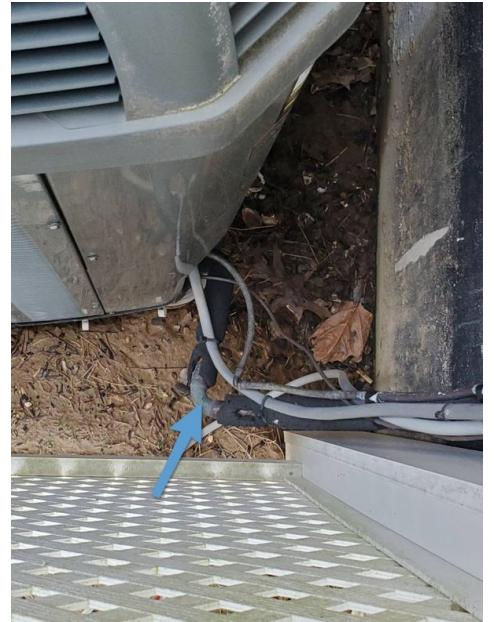
### 7.1.2 System Information

#### REFRIGERANT LINE INSULATION MISSING OR DAMAGED

I observed missing or damaged foam insulation at the cooling system's refrigerant line, which can cause energy loss and condensation.

Contact a qualified HVAC professional.

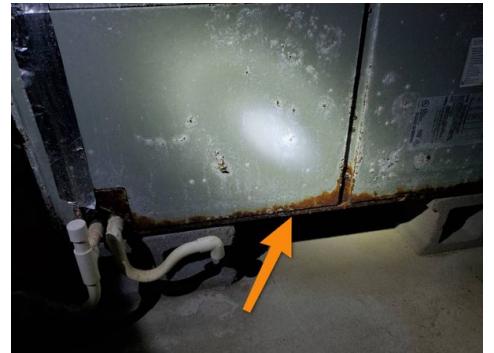
#### 7.1.3 System Information

### RUSTING ON HVAC EQUIPMENT

Rusting was observed on or in the HVAC equipment. Recommend evaluation by qualified HVAC professional.

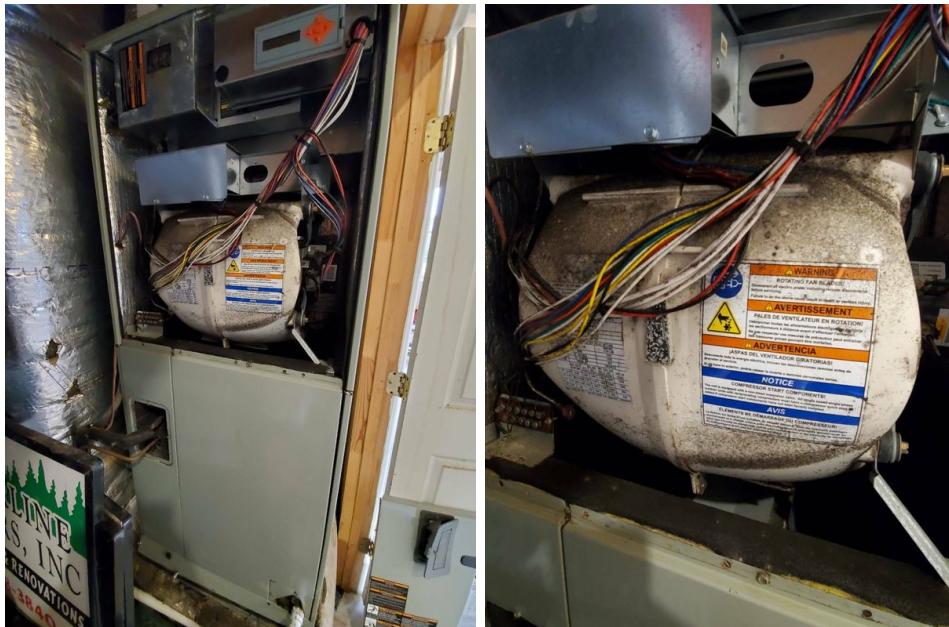
Delayed maintenance was observed at the HVAC equipment. Recommend annual service.

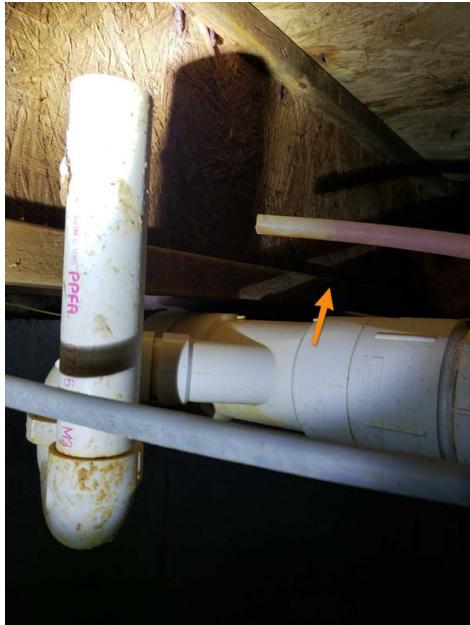
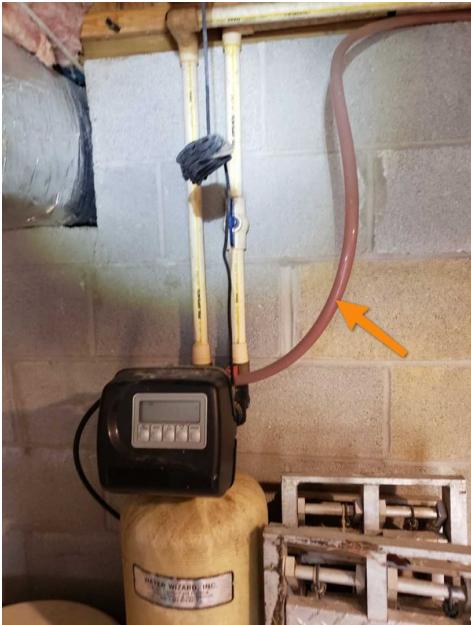
Pipe was disconnected and draining into the crawlspace. Recommend correction.

Contact a qualified plumbing contractor.

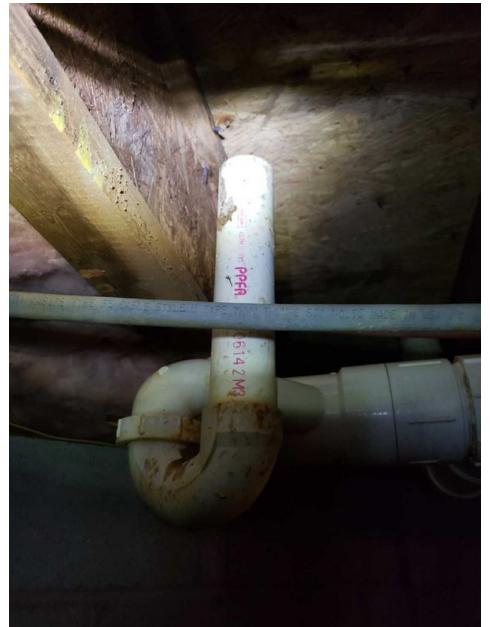
#### 11.4.2 Drain, Waste, & Vent Systems

### UNCAPPED PIPING

Recommend capping these pipes.

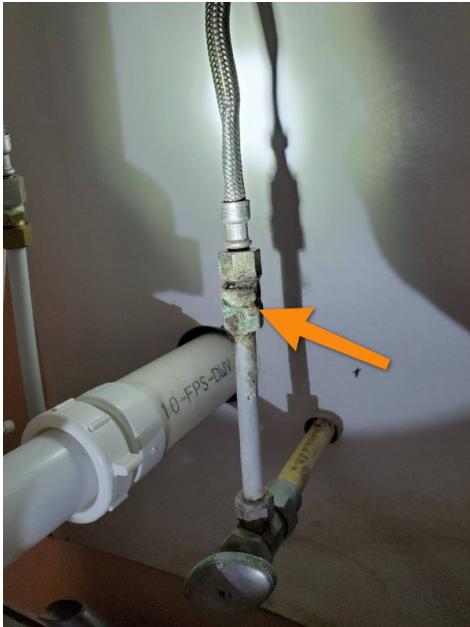
#### 11.5.1 Water Supply & Distribution Systems

### CORROSION

Plumbing showed signs if corrosion in this location.

Recommend evaluation and correction.

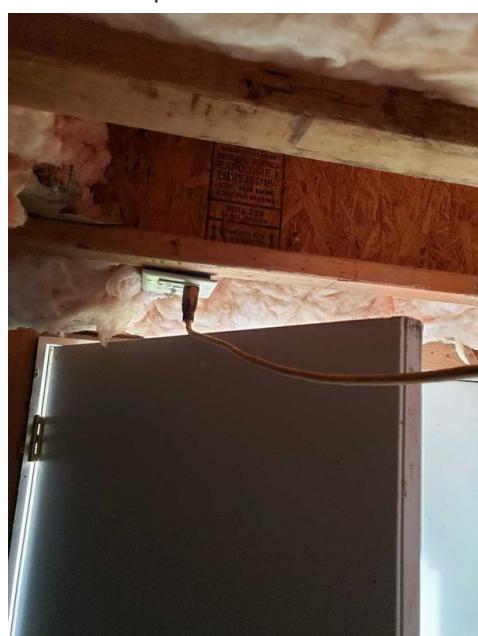
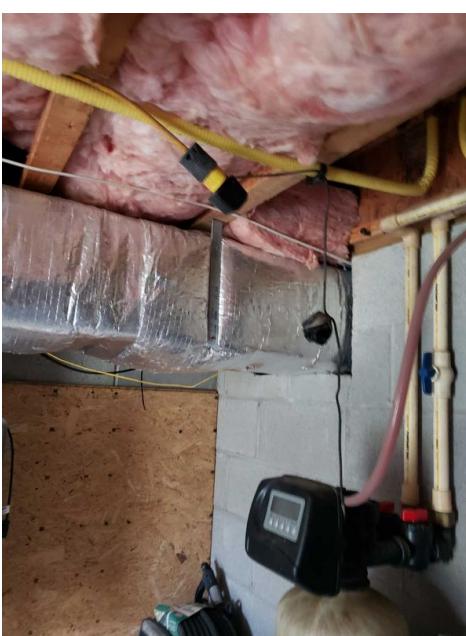
An permanent wiring should be added in this area to replace the extension cord.

Recommend correction.

Contact a qualified electrical contractor.

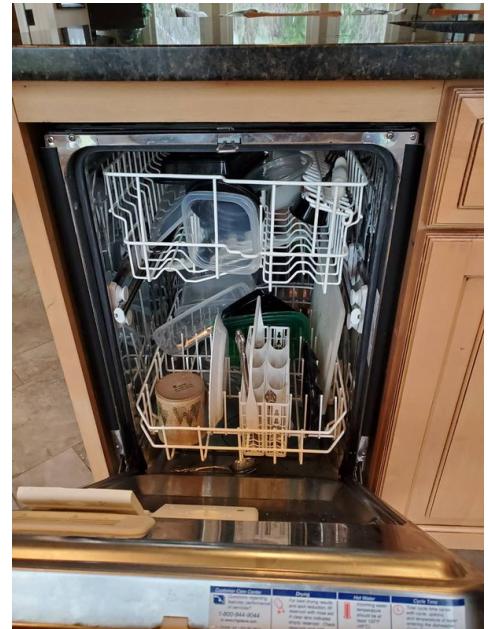
#### **DISHWASHER WAS NOT OPERATED**

I did not operate the dishwasher. Dishwasher was full of occupants dishes.

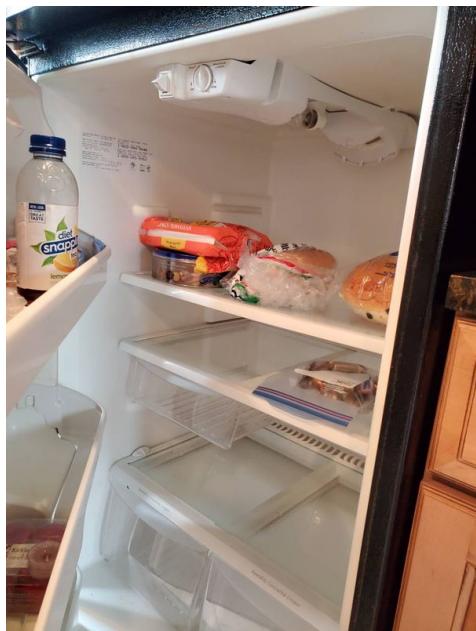
#### **UNPLUGGED**

I observed that the refrigerator was unplugged. Inspection restriction.

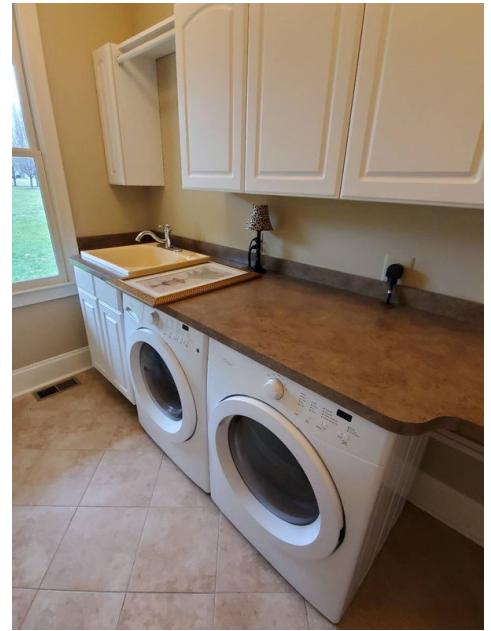
1ST FLOOR LAUNDRY ROOM

The plumbing was inaccessible in this location. The inspection was limited.

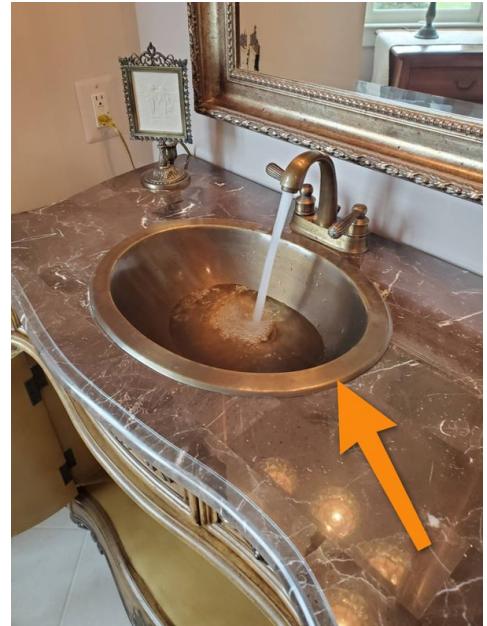
#### **SINK TOP LOOSE**

The sink was loose and not secured to the cabinet.

Recommend correction

Contact a handyman or DIY project

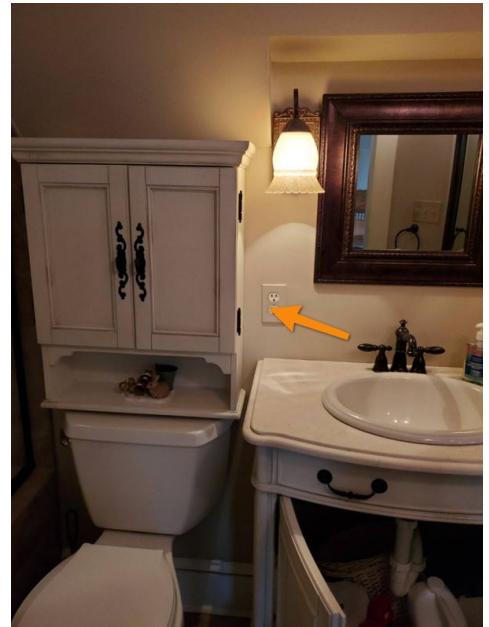
## 17.5.1 GFCI &amp; Electric in Bathroom

**GFCI MISSING**

Recommend qualified electrician install GFCI outlet at this location.

Contact a qualified electrical contractor.

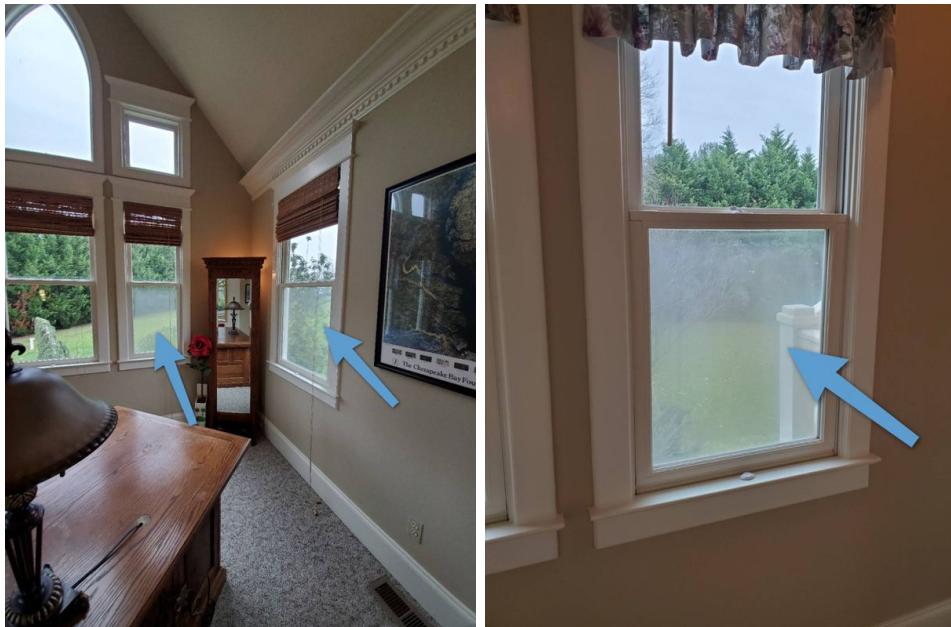
Seal inside window was damaged. Moisture was between the window panes.

Contact a qualified window repair/installation contractor.

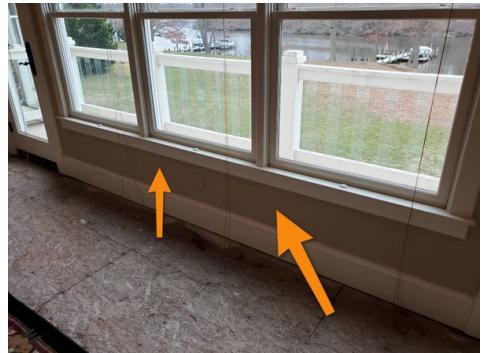
## 18.2.2 Windows

**WATER STAIN AT WINDOW**

Water staining was observed in this area.

This will lead to wood rot.

Recommend locating source of moisture and repairing area as necessary.

Contact a qualified professional.

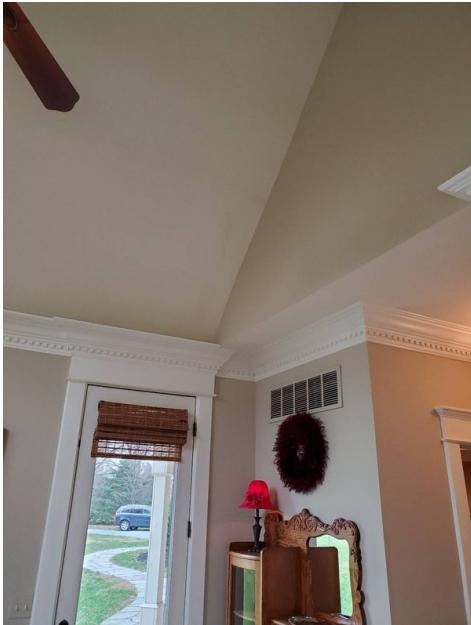
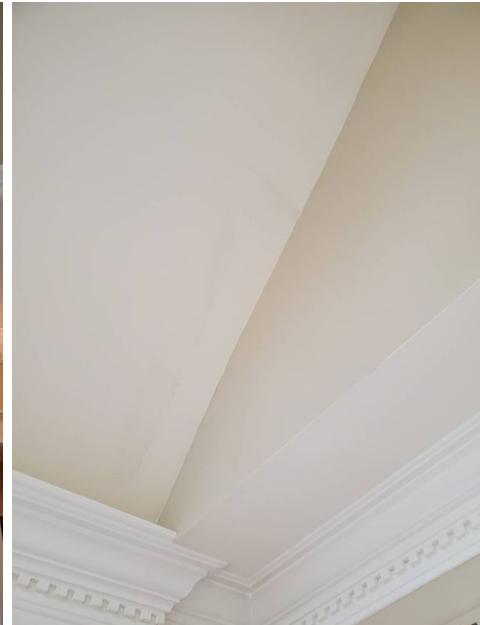
## 18.3.1 Floors, Walls, Ceilings

**WATER STAIN/ACTIVE**

Water staining was found in this area.

The source of leakage should be identified and corrected.

Contact a qualified carpenter.

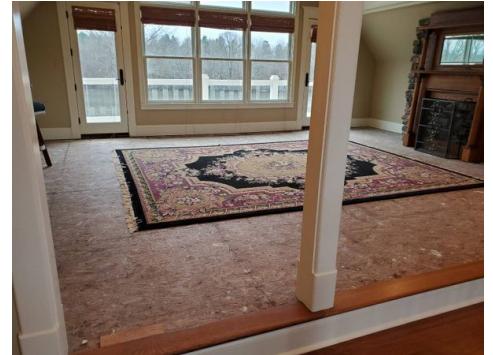
## 18.3.2 Floors, Walls, Ceilings

**FLOORING WAS MISSING**

Flooring was missing in this location.

Recommend adding a floor covering in this location.

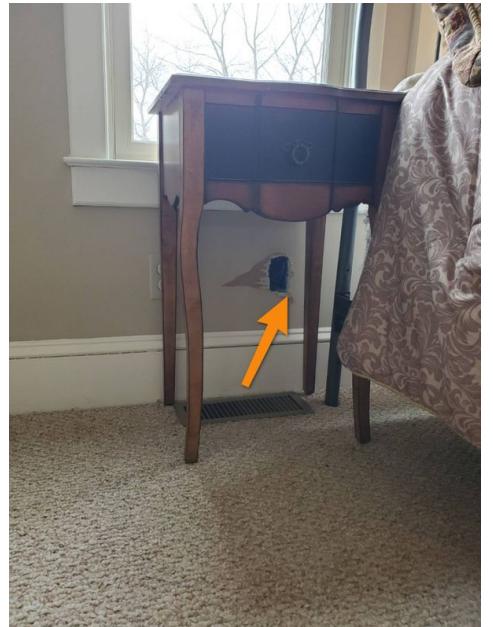
## 18.6.1 Switches, Fixtures &amp; Receptacles

**COVER PLATE MISSING**

I observed a receptacle with a cover plate that was not in place.  
Recommend replacing cover plate.

Contact a qualified electrical contractor.

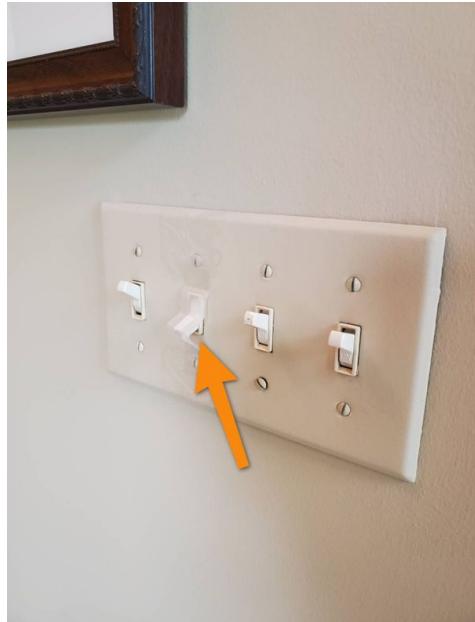
## 18.6.2 Switches, Fixtures &amp; Receptacles

**LIGHT SWITCH TAPE**

The light switch in the location was covered with tape. Unable to determine purpose. Recommend evaluation and correction.

Contact a qualified electrical contractor.

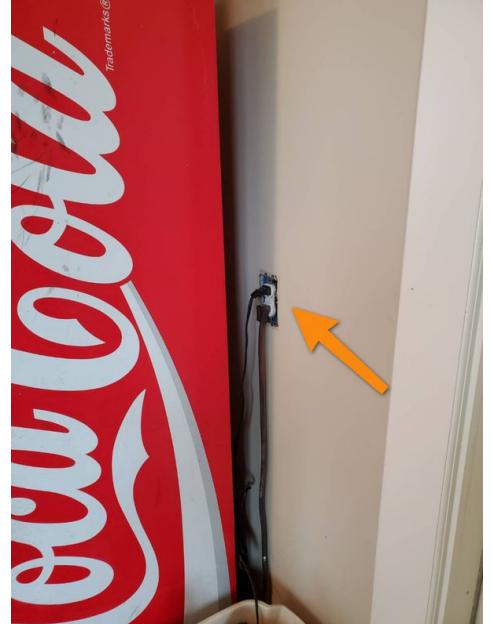
#### MISSING OUTLET COVER

Outlet cover was missing in this location.

Recommend replacing outlet cover.

Contact a handyman or DIY project
