## RESIDENTIAL REAL ESTATE INSPECTION REPORT

1234 Main St. Owasso OK 74055

06/12/2021 9:00AM

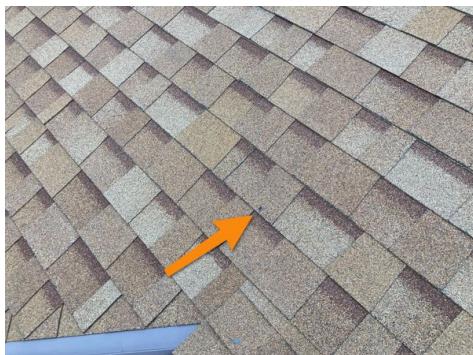
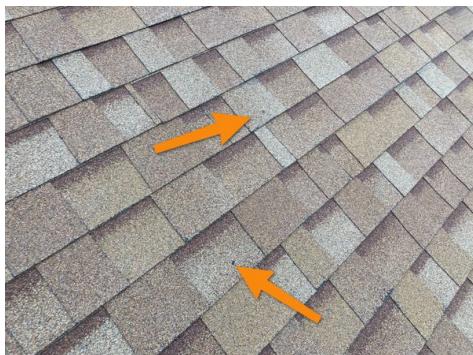
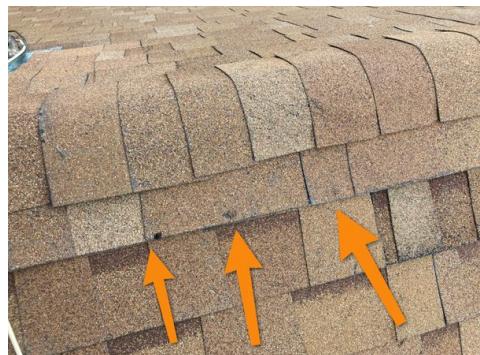
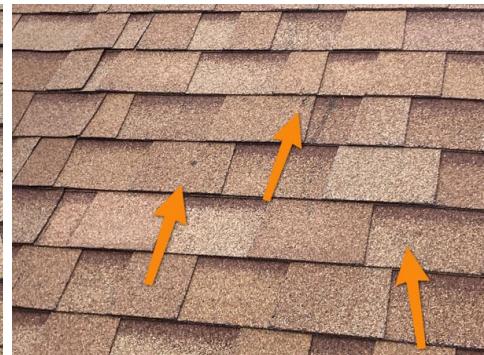
#### SHINGLES-GENERAL DAMAGED

There were damaged shingle(s) present on the roof surface from apparent impact damage, likely hail. Evaluation of the shingles is recommended by a qualified roofing contractor with repairs made to any damaged shingles as deemed necessary.

Defect - Medium Concern

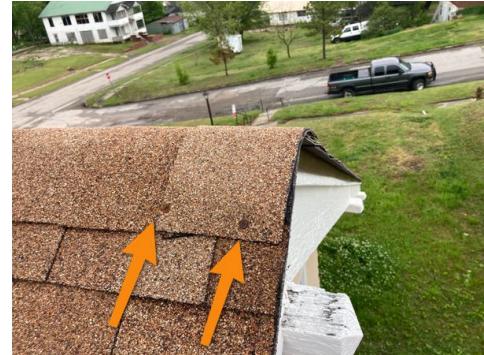
## 2.1.2 Roof Covering

**SHINGLES-EXPOSED NAIL HEADS**

Defect - Medium Concern

Exposed nail heads were present on the shingles in the referenced area(s). Sealing any exposed nail heads is recommended to be conducted by a qualified roofing professional to prevent the possibility of leaks.

Contact a qualified roofing professional.

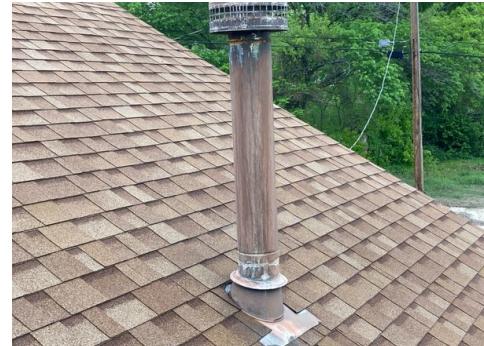
## 2.3.1 Roof Vents / Protrusions

**VENT-RUST/CORROSION PRESENT**

Defect - Medium Concern

The metal vent was observed with rust/corrosion, which can lead to potential leaks and/or premature deterioration of the vent material. Further evaluation for repair/replacement is recommended by a qualified roofing professional.

Contact a qualified professional.

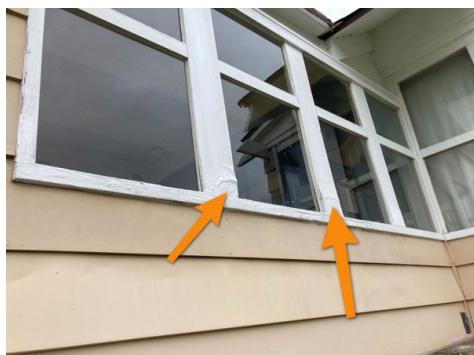
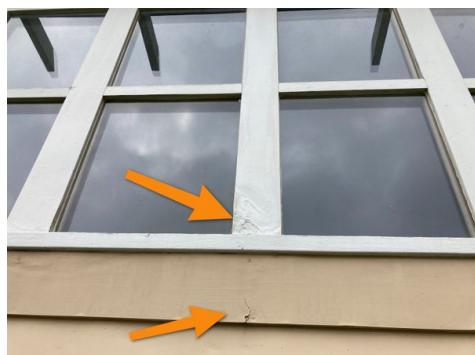
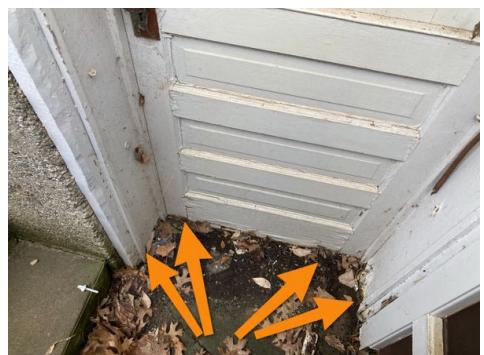
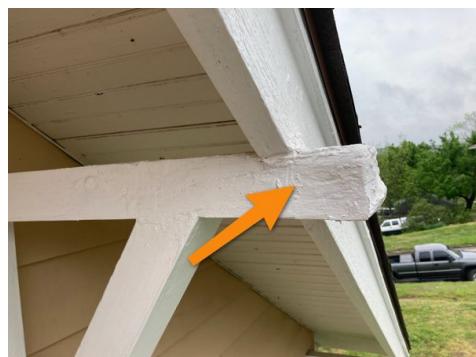
Defect - Medium Concern

###### DAMAGE TO WOOD TRIM

There was damage present to wood trim at the referenced area(s) of the home. Repairs or replacement of the trim is recommended to be conducted by a qualified contractor as needed.

Contact a qualified professional.

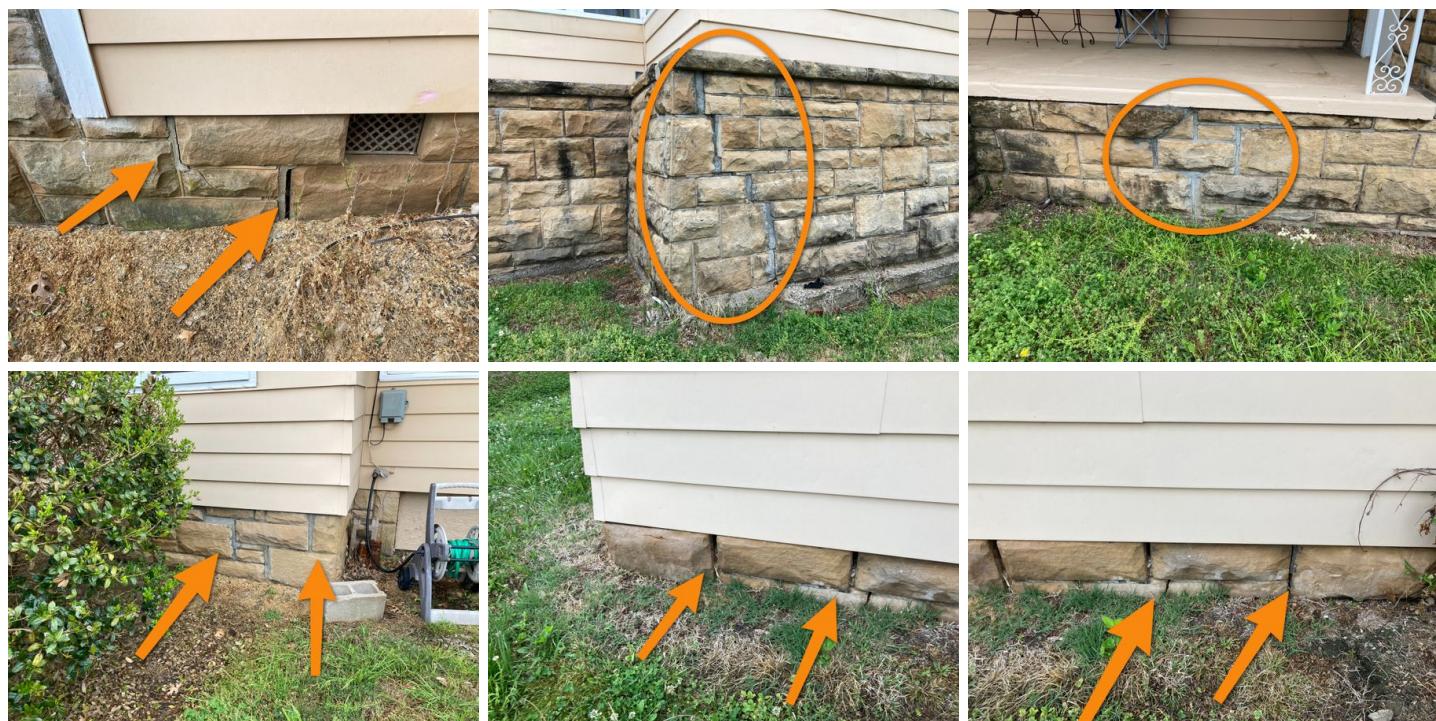
##### 3.1.2 Exterior Walls & Siding Materials

###### CRACKING PRESENT

Defect - Medium Concern

Cracking was present in the referenced area(s). Some previously repaired. Further evaluation is recommended by a qualified masonry contractor with sealing or repairs made as deemed necessary.

Contact a qualified masonry professional.

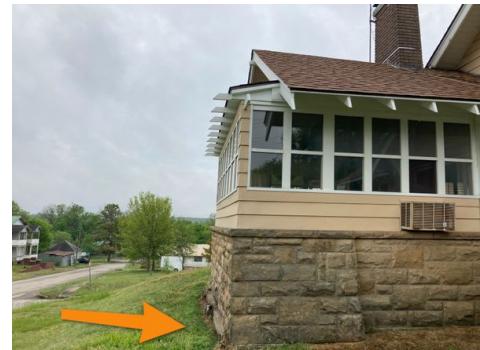
Low area(s) were present along the foundation wall. Low areas can hinder water drainage away from the foundation, resulting in overly saturated soil along/below the foundation. Further evaluation with corrections to achieve a proper slope away from the foundation is recommended by a qualified landscaping professional.

Contact a qualified landscaping contractor

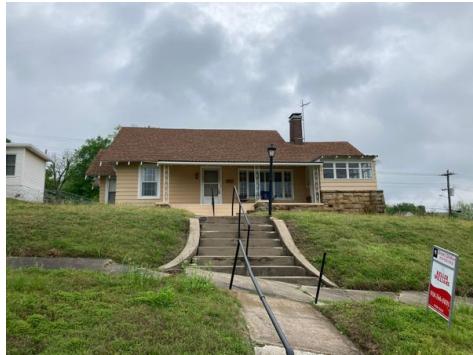
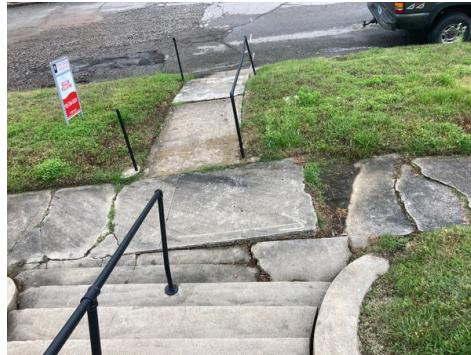
### 4.2.1 Driveway & Walkway

Area(s) of displacement and heavy cracking were present on the walkway. These area(s) are a potential trip hazard. Repairs are recommended by a concrete contractor or other qualified person as needed for safety.

Contact a qualified concrete contractor.

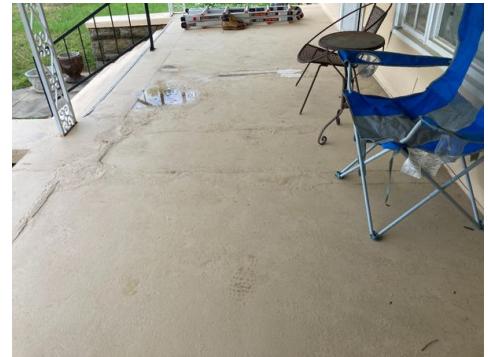
## 4.4.1 Raised Porches

Defect - Medium Concern

**IMPROPER SLOPING TOWARDS HOME**

The porch, or portions of it, sloped towards the structure. Evaluation and repairs are recommended to be conducted by a foundation contractor or other qualified contractor as needed.

Contact a qualified concrete contractor.

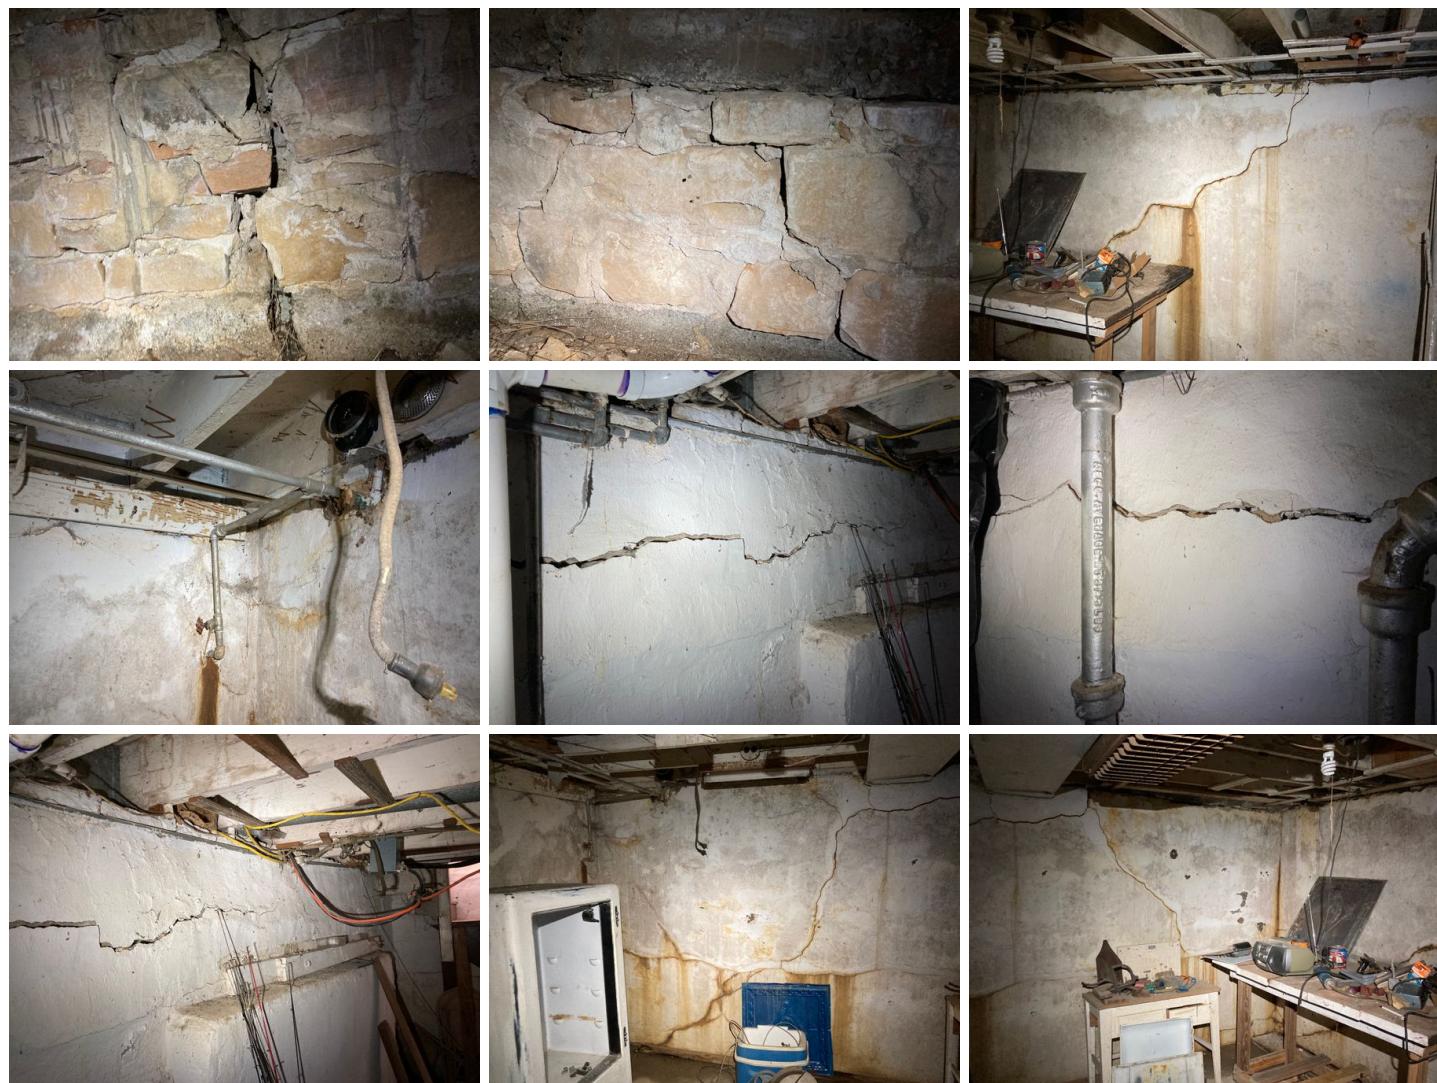
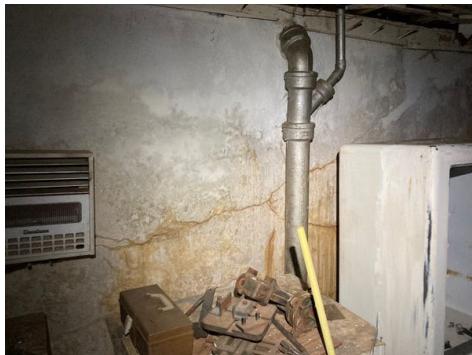
## 5.1.1 Foundation &amp; Structure

**STRUCTURE - MAJOR CRACKING PRESENT**

Major cracks were present in the foundation at the referenced areas.

Defect - Medium Concern

Evaluation and repairs are recommended as needed by a structural contractor.

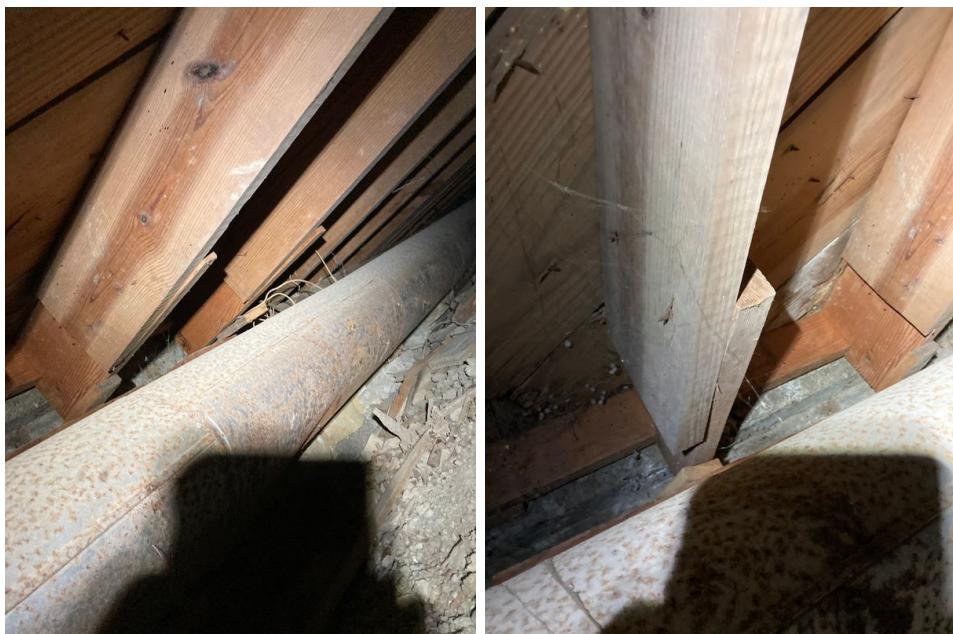
## 5.1.2 Foundation &amp; Structure

**FRAMING MEMBER - IMPROPER REPAIRS**

Safety Hazard - High Concern

Improper repair methods were used to repair termite damaged floor joists. The boards were cut and nailed to short sections of board to make up the gap. Recommend a qualified contractor evaluate and advise on repairs.

Contact a qualified carpenter.

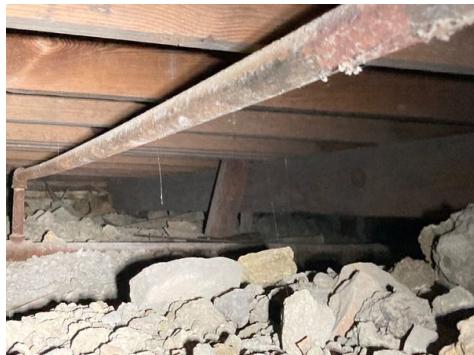
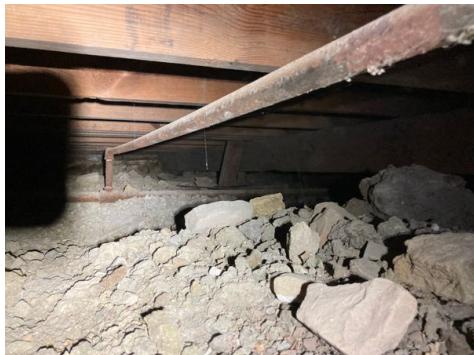
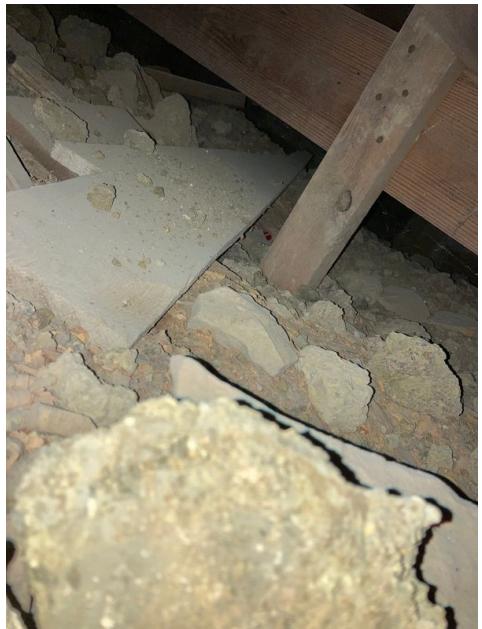
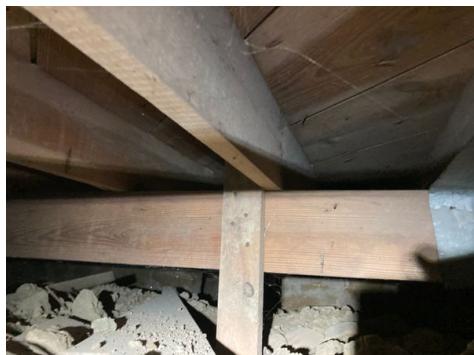
## 5.1.3 Foundation &amp; Structure

**BEAM - WOOD SUPPORTS**

Safety Hazard - High Concern

Wooden supports were observed to be nailed to the side of the main support beam. This is improper practice as it does not adequately support the load of the beam. Recommend a qualified structural contractor evaluate and advise on repairs.

Contact a qualified structural engineer.

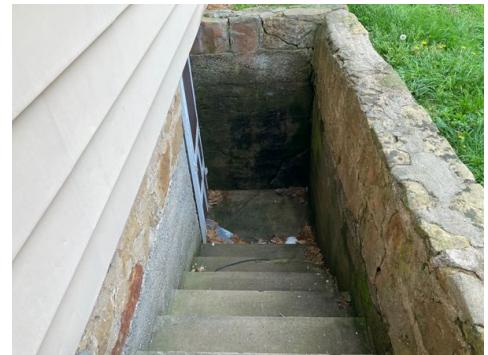
Defect - Medium Concern

A drain was not present at the base of the basement stairs. This may allow rainwater to collect in this area, possibly infiltrating the basement area. Evaluation and the installation of a drain as needed is recommended by a qualified contractor.

Contact a qualified professional.

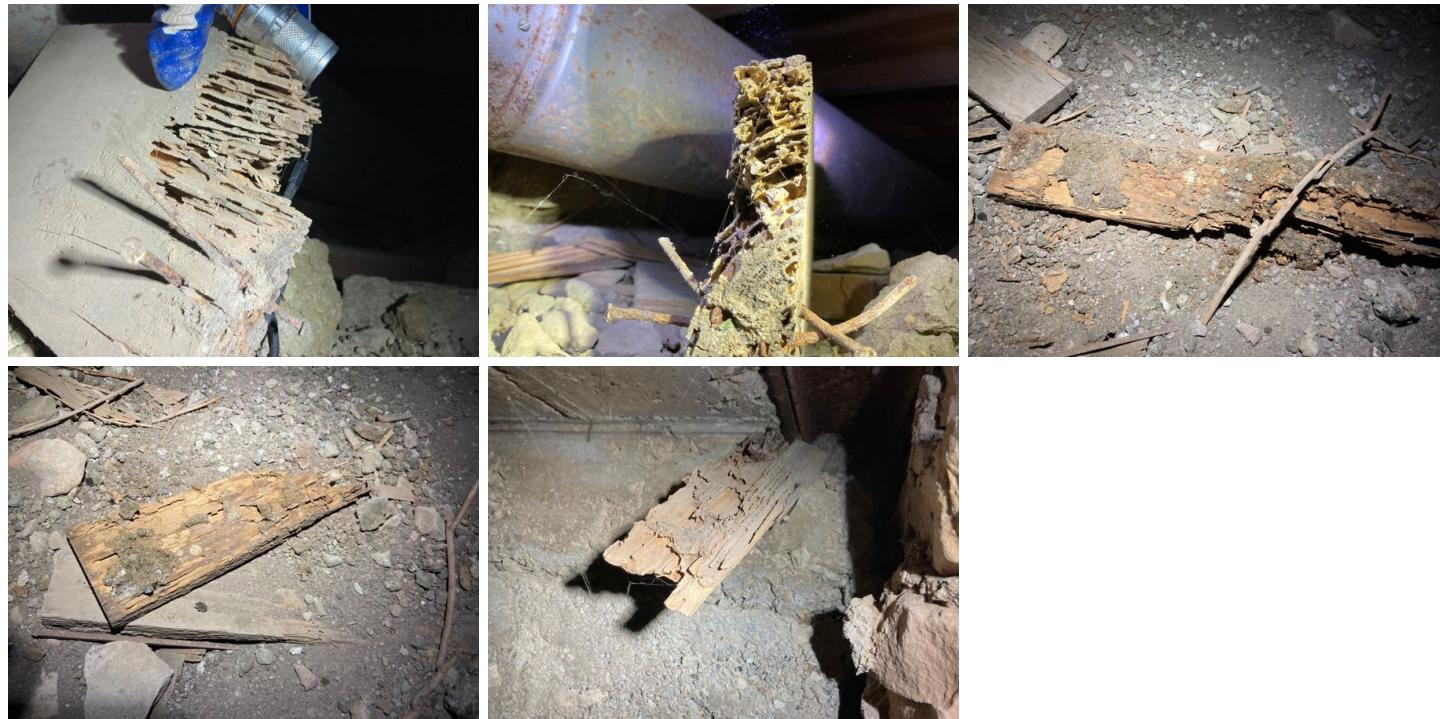
#### TERMITE DAMAGE

Defect - Medium Concern

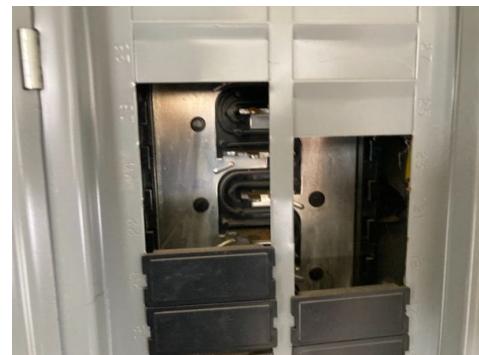
Defect - Medium Concern

Open knockout(s) were present in the electrical panel. Knockout caps should be installed to keep mice out of the panel box, and to avoid potential electrocution hazard. The installation of knockout caps is recommended to be conducted by a licensed electrician or other qualified person.

Contact a qualified electrical contractor.

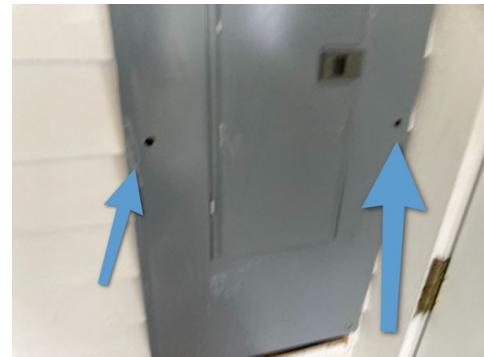
### 7.3.2 Service Equipment / Electrical Panel

#### PANEL COVER SCREWS MISSING

There were one or more panel cover screw(s) missing. All panel cover screw locations are required to be utilized to adequately secure the cover to the panel. Replacement of any missing screws with approved panel cover screws is recommended to be conducted by a qualified person.

Contact a qualified professional.

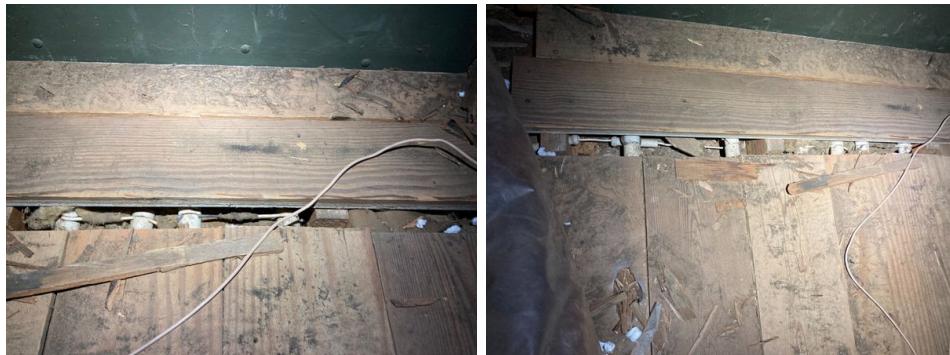
## 7.5.3 Branch Wiring

**KNOB AND TUBE IN CONTACT WITH INSULATION**
! Safety Hazard - High Concern

Knob and Tube wiring was present that was covered by insulation. This is a potential fire hazard as it can allow the conductors to overheat. The "knobs" purpose for this wiring is to give it adequate clearance from insulation and surfaces - preventing overheating. Evaluation of the wiring and repairs or replacement as needed is recommended by a licensed electrician.

Contact a qualified electrical contractor.

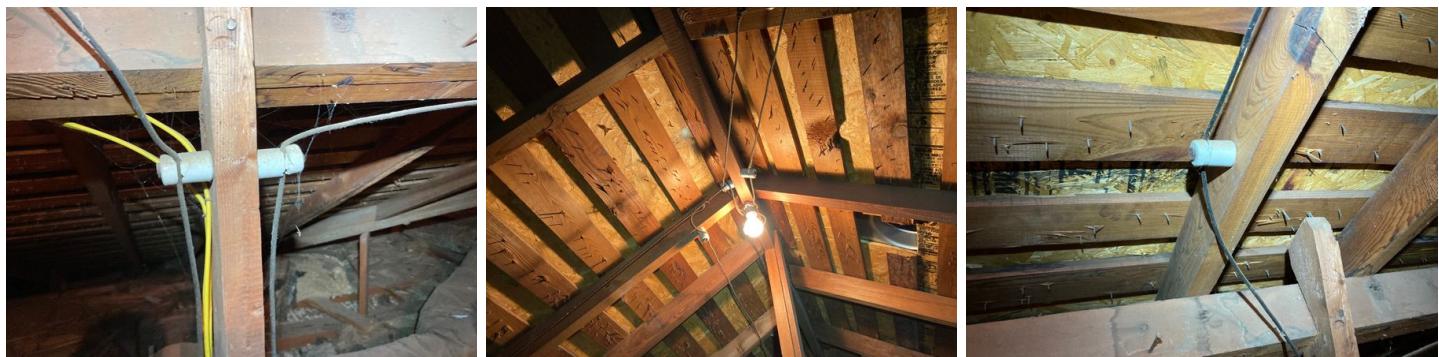
## 7.5.4 Branch Wiring

**KNOB AND TUBE INFORMATION**

This property had "knob and tube" wiring. Over time, the wire's insulation becomes brittle and deteriorates, resulting in exposed conductors and a risk of shock and/or fire. This wiring can be a potential fire hazard by covering it with insulation (a common practice), and incorrectly tapping new wiring into it. It is not within the scope of this inspection to determine what percentage of this property's wiring is of the knob and tube type or to determine what percentage of the knob and tube wiring is energized vs. abandoned. A full evaluation of the knob and tube wiring is recommended to be conducted by a licensed electrician, with repairs and/or replacement made as deemed necessary for safety. I also recommend consulting with your Insurance company as some insurance companies may deny coverage due to knob and tube wiring.

Contact a qualified electrical contractor.

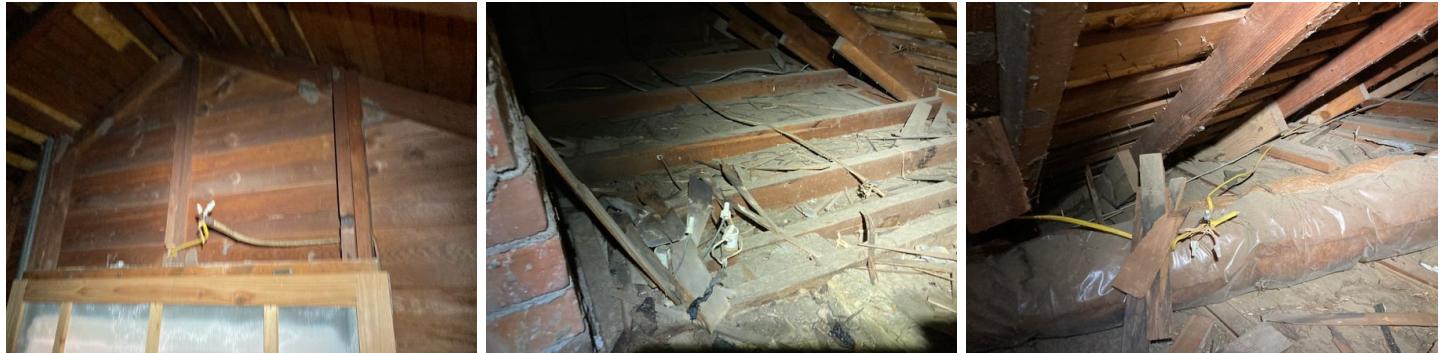
#### 7.5.6 Branch Wiring

### **WIRING - CONNECTIONS MADE OUTSIDE OF ELECTRICAL BOX**

Safety Hazard - High Concern

There were wiring connection(s) present that were made outside of an electrical box. This can be a potential fire or electrocution hazard. Any wiring connections made outside of an electrical box in the home are recommended to be made in a proper box by a licensed electrician.

Contact a qualified electrical contractor.

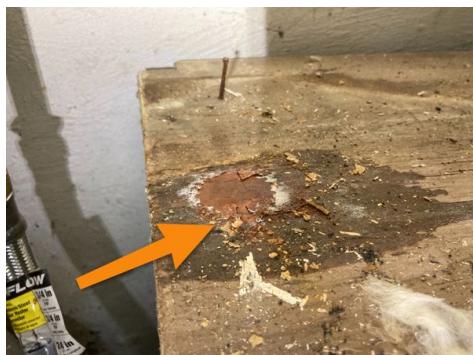
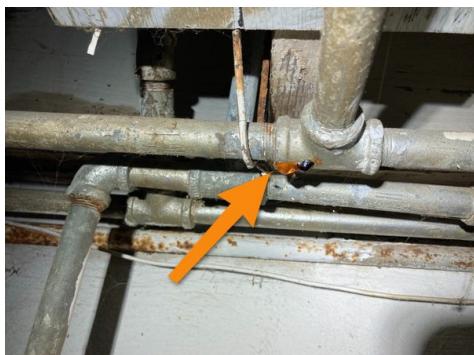
### **GALVANIZED DISTRIBUTION PIPES**

Contact a qualified plumbing contractor.

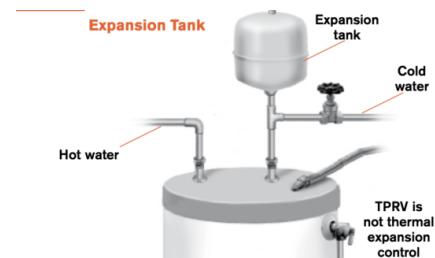
### 10.3.1 Temperature Pressure Relief Valve (TPRV)

#### TPR DISCHARGE PIPE MISSING

Contact a qualified plumbing contractor.

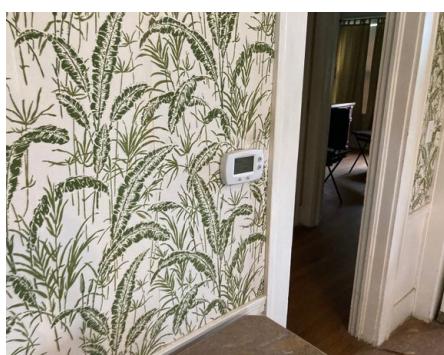
Dining Room

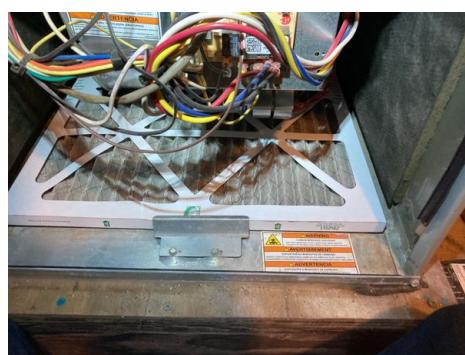
In Air Handler

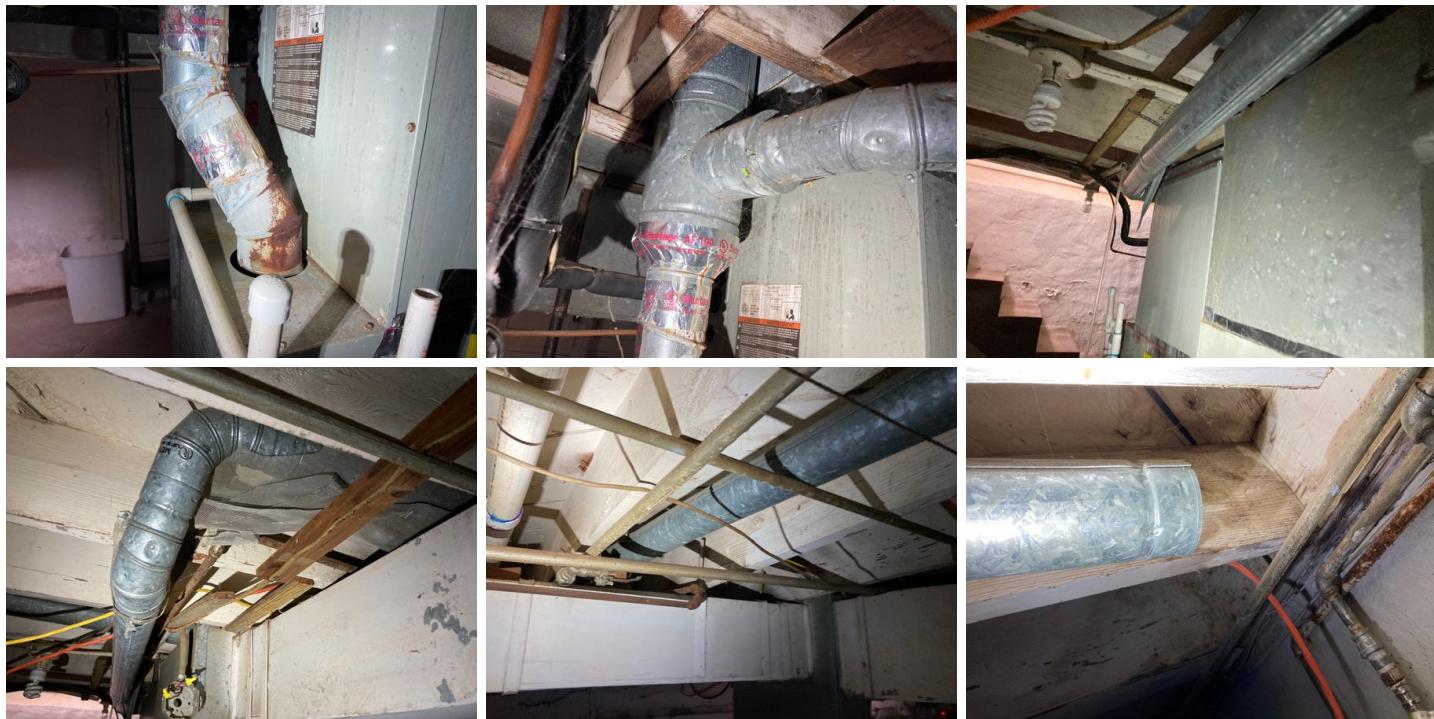
A flue was present above the electric water heater. This is not an inherent defect, but left over from a previous gas water heater. The flue connects to the flue for the furnace. Due to the reduction from two appliances to one, this causes the main vent for the furnace to be oversized. This has resulted in higher levels of condensation within the vent and is causing rust on the vent.

Contact a qualified HVAC professional.

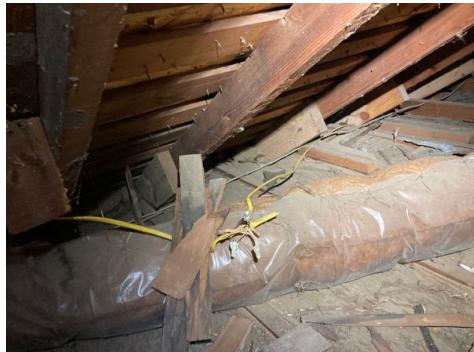
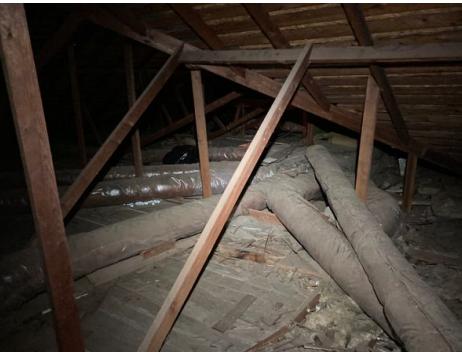
## 12.3.1 Ductwork

**AGED DUCTWORK**

Contact a qualified heating and cooling contractor

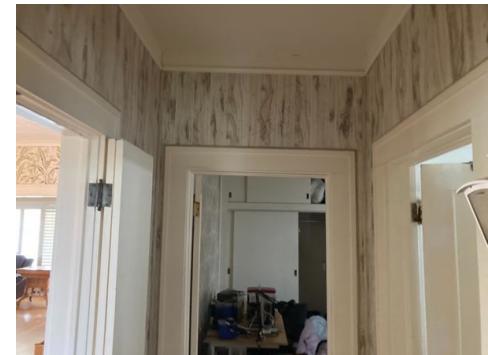
There were door openings that were out of square, this is typically indicative of settlement, or could be from a poor installation. Repairs are recommended to put the door back into "square". Also, look for other comments made in this report in regards to the foundation or settlement.

Contact a foundation contractor.
