PEACH Inspections

THE HOME INSPECTION REPORT

07041802B - [REDACTED]

[REDACTED] 2601 Grant Court Jeffersonville, PA 19403

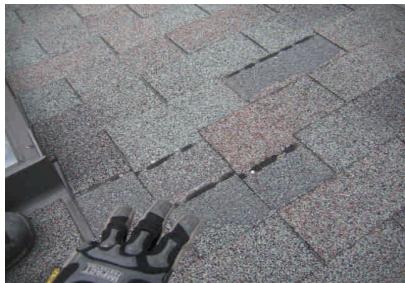
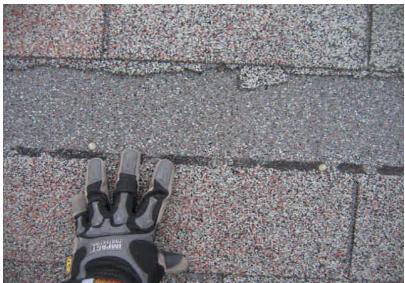
There are about 10 cracked and missing shingles. Prone to leaking. Located at the rear left area of the house roof. Correction and further evaluation by a professional roofer is recommended.

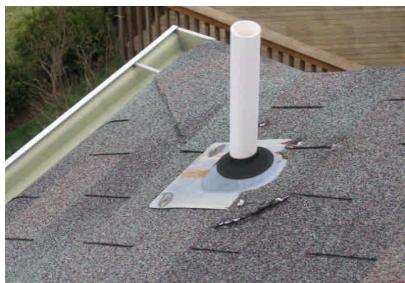
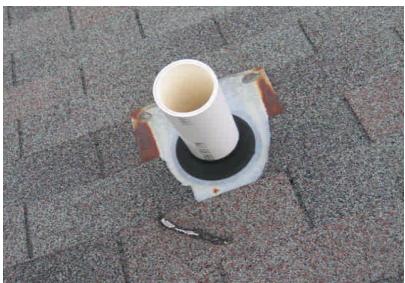
Flashings

The flashing around the vent stacks coming through the roof appear to be in good condition. Good.

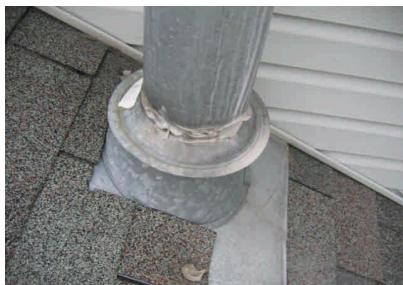
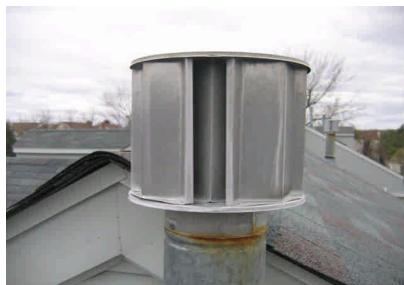
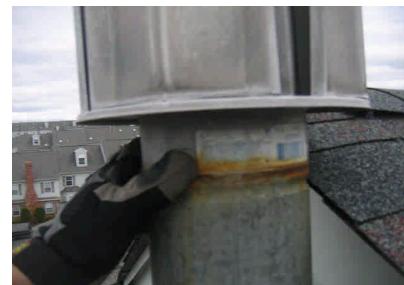
Gas-Venting Chimney Pipe

There is a chimney that is a pre-fabricated Type B gas chimney pipe, designed to carry away the exhaust of the gas-fired appliance(s) connected to it.

Rust on the pipe visible. Does not appear to be a major problem. I believe the rust is caused by the dissimilar metals of the cap and pipe reacting with each other where they connect together.

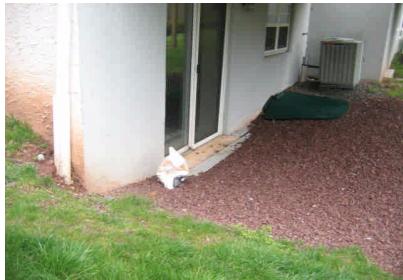
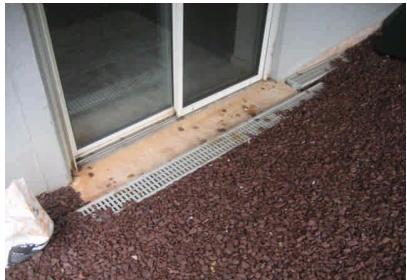
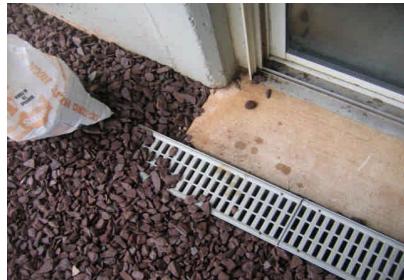
There is a low spot in the ground surface near the near the basement slider. A low lying area could allow water to collect near the house foundation during a heavy rain storm. There's a drainage system installed here. Ask seller for more info.

The general grading around the house foundation perimeter appears functional. Good. Ideally the grading should slope about 6 inches over the first 10 feet away from the house foundation. Monitoring during a rainstorm is recommended.

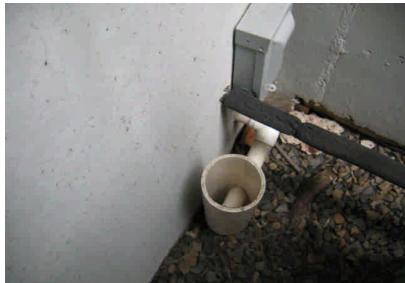
Sump Pump Pipe

There is a drainage system which includes a sump pump. Its discharge pipe is visible.

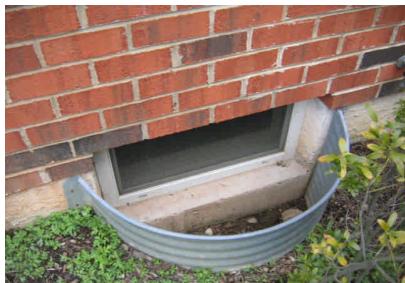
Window Well

There's no window well cover. Consider installing one.

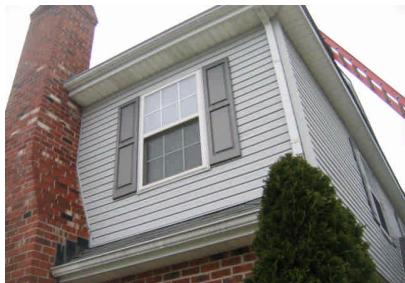
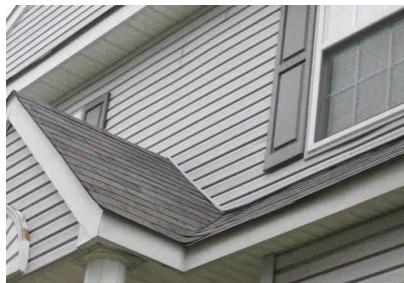
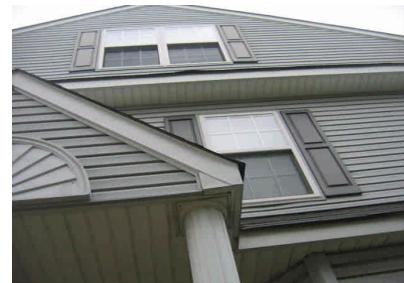
Vinyl

We moved around the house exterior several times, inspecting the vinyl siding on the exterior of the house. Checked for loose panels, missing panels, warped panels, cracked or damaged panels. The vinyl siding appears to be in functional condition. With no major material defects. Good.

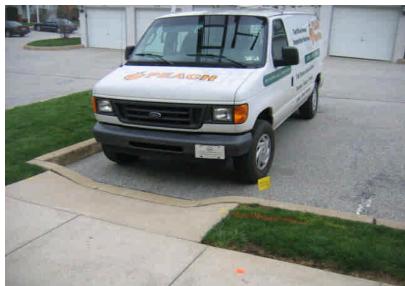
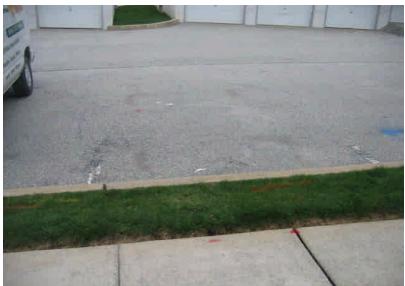
Driveway or Parking

The parking appears functional.

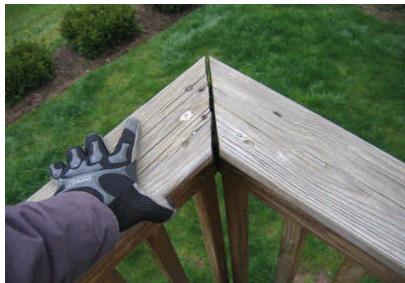
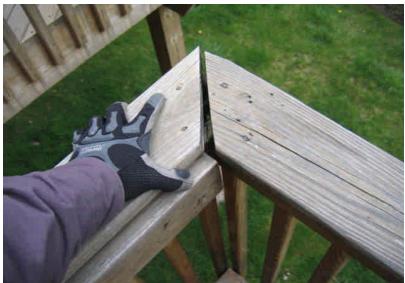
Separations at the deck railing corners.

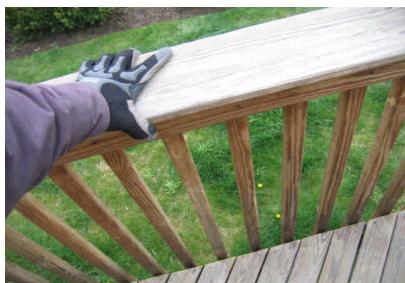
Loose railing on the deck. Rear of the deck. Wobbles back and forth. Supposed to hold 200 lbs. Safety hazard.

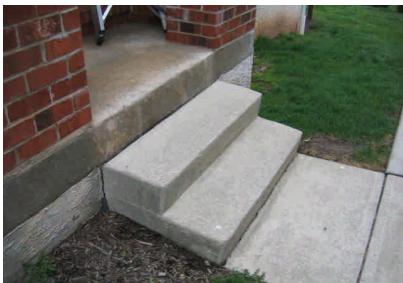
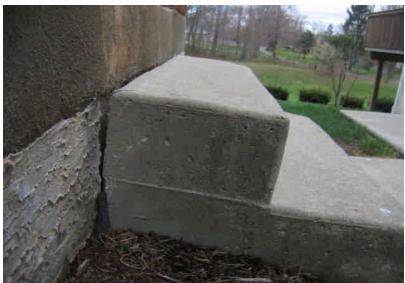
Steps & Handrails

The steps have settled or moved significantly. The steps are now out of level, which appears to be a trip hazard, particularly for children or the elderly. Evaluation and repair is recommended.

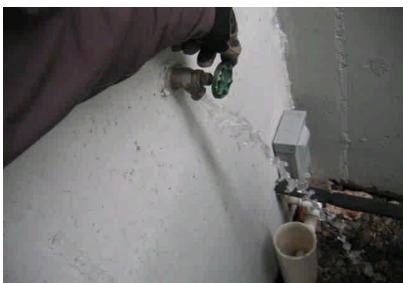
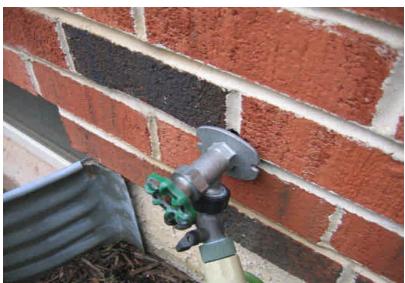
Exterior Water Faucets

The water faucet is frost-free. The faucet is designed so that it should not freeze and burst in the cold winter time. Good.

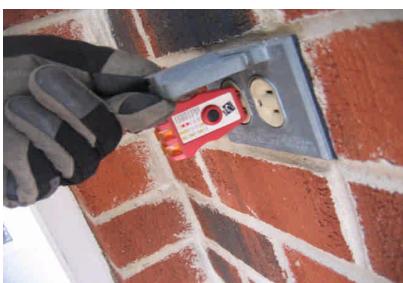
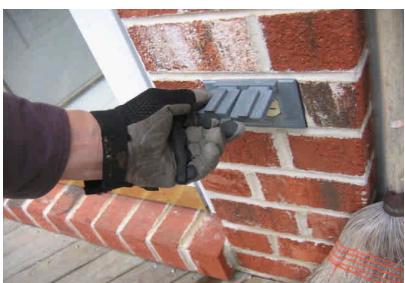
Receptacles & GFCIs

The exterior receptacles that were tested are functional and include ground-fault protection. Good.

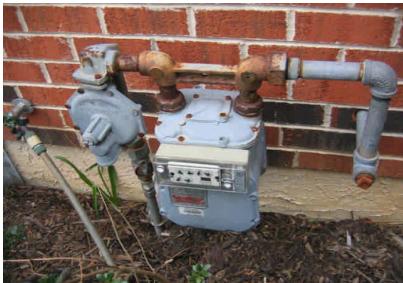
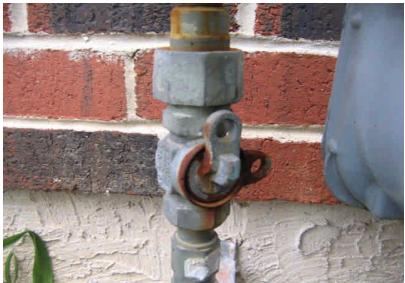
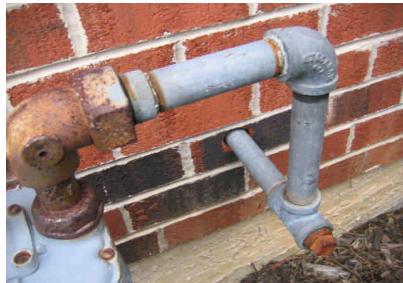
Public Gas Meter

The main gas shut-off valve is located near the gas meter at the side of the house.

The gas meter has some surface rust on it.

Sealant needed around the gas line where it enters the house - minor.

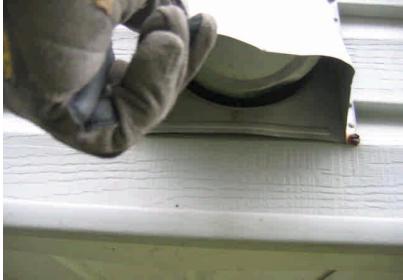
Dryer Vent Hood

The dryer exhaust hood appears functional. No damage to hood or damper. No major lint build-up. We recommend inspecting and cleaning the dryer's exhaust pipe every year.

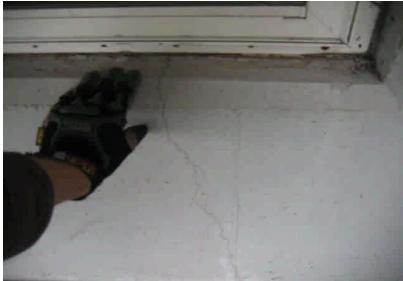
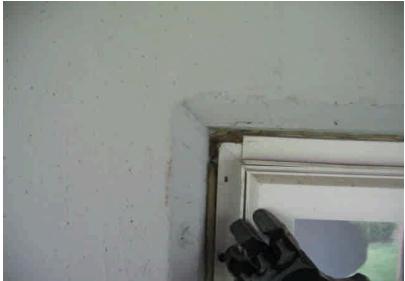
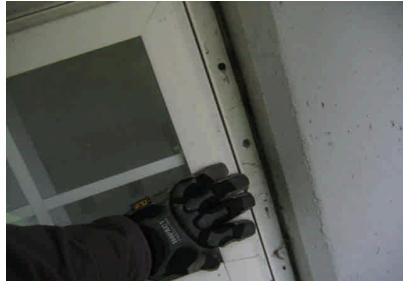
Missing trim and work at the rear basement window.

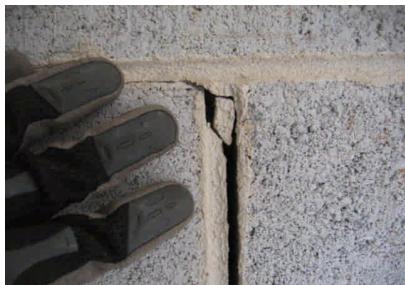
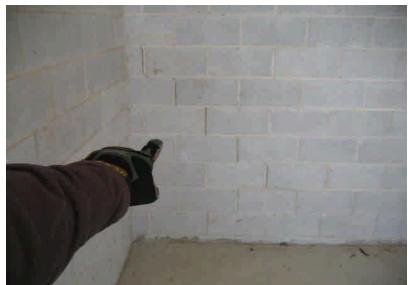
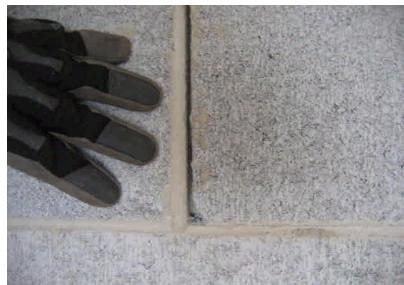
There is a crack in the rear foundation wall that could be evaluated and repaired by a professional.

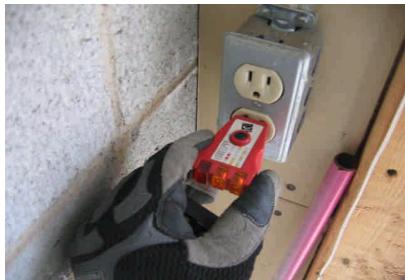
The receptacles in the garage should be upgraded to have GFCI or ground-fault protection, which is required by current standards and is an important safety feature.

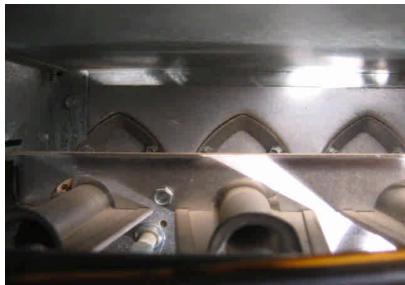
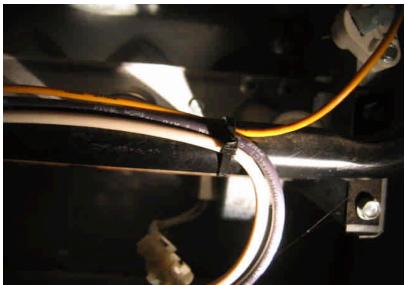
Air filter

The air filter is high-efficiency and dirty. Service needed. A UV filter of some kind. Ask seller for more information.

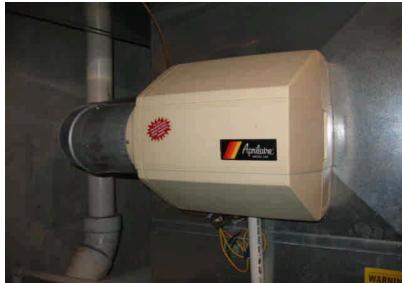
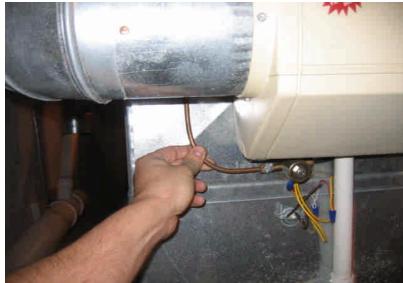
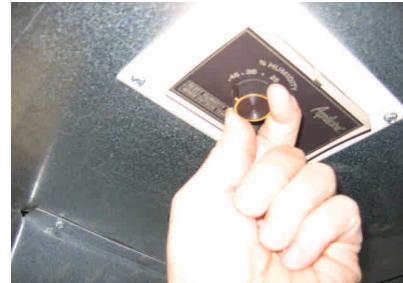
I could not get the humidifier to turn on. ?

The humidifier is missing a damper on the by-pass ductwork.

The humidifier needs service and cleaning by a professional.

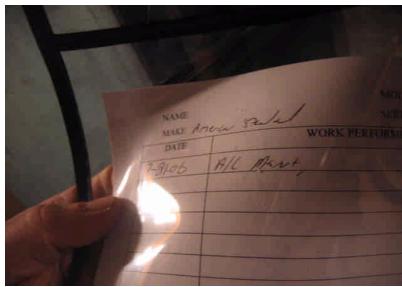
The last time the heating system was service has been recorded. Dated in 7/21/06. The heating system should be serviced every year.

Recommend having the heating system inspected, cleaned, and serviced by an HVAC professional prior to closing.

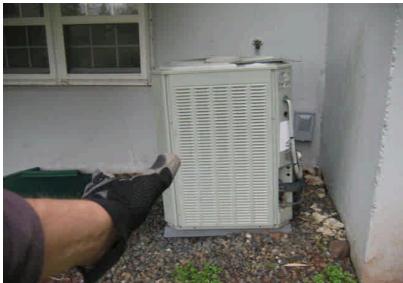
The outdoor condenser unit for the air conditioning system appears off-level. Should be leveled by a HVAC professional. To prevent damaging the unit.

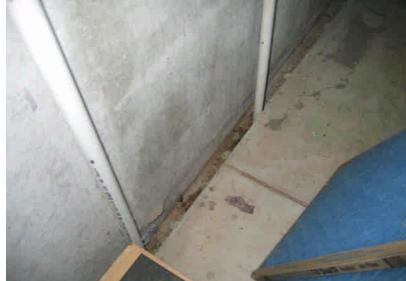
The condensation drains from the unit to a perimeter trench. Appears functional. But close monitoring the trench's drainage performance is recommended. Consider installing a condensate pump to collect the water and pump it outside or into a sump bucket.

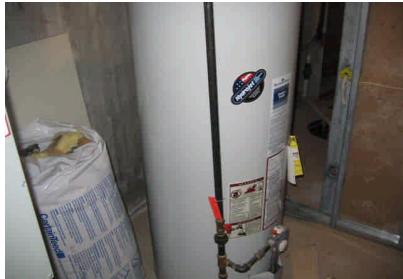
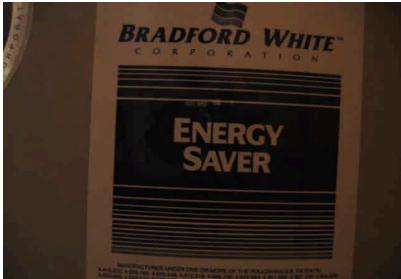
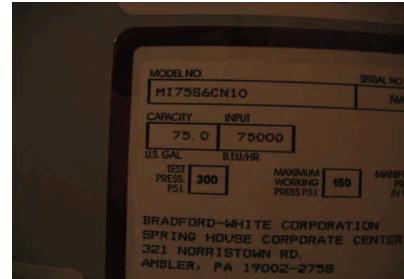
Size

The water heater is 75 gallons in size.

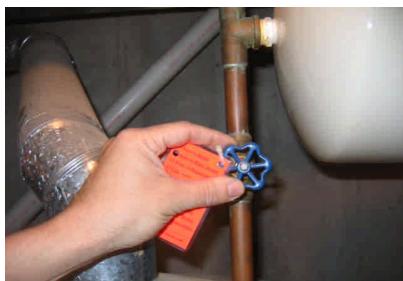
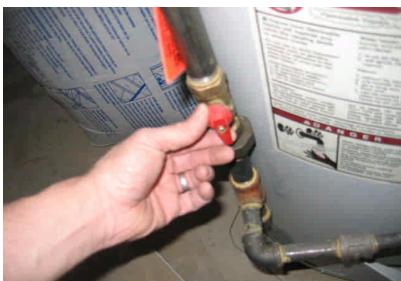
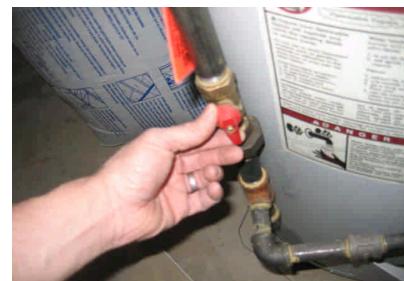
The water shut-off valve to the water heater tank is installed. Not leaking.
This valve turns off the cold water supply to the tank. Good.

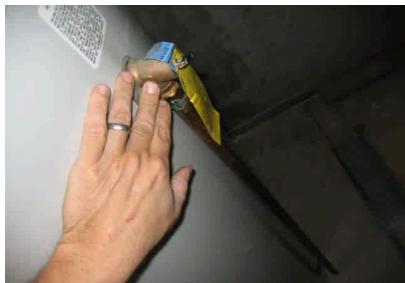
The water heater is equipped with a pressure-temperature relief valve. The pipe is extended to the floor. For safety. Good.

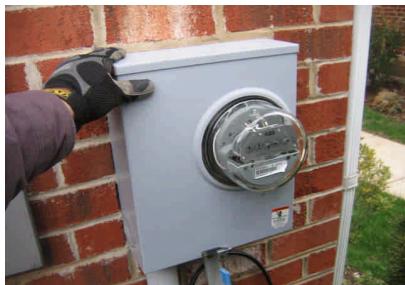
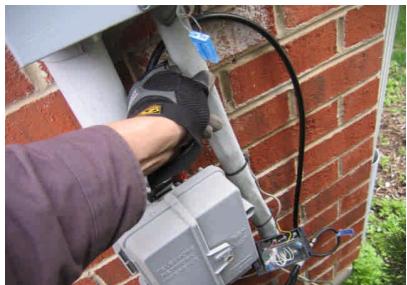
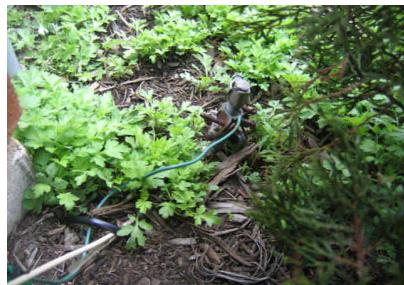
There is one electric meter.

The meter is located at the front of the house.

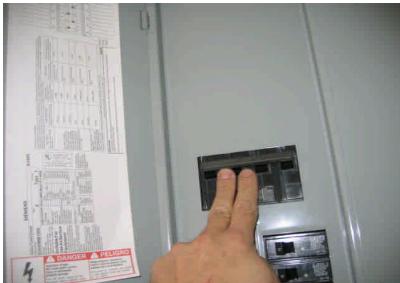
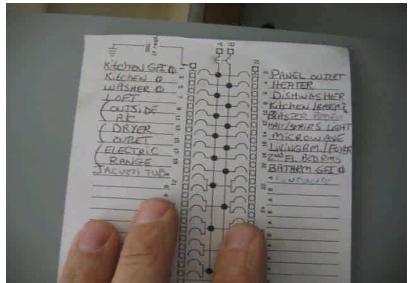
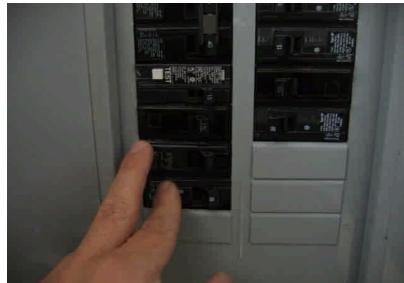
The main panel is located in the basement.

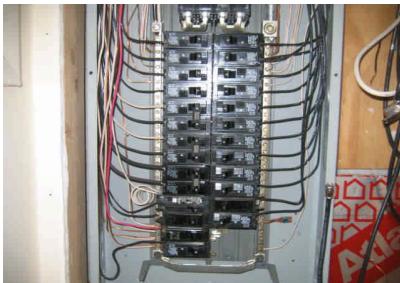
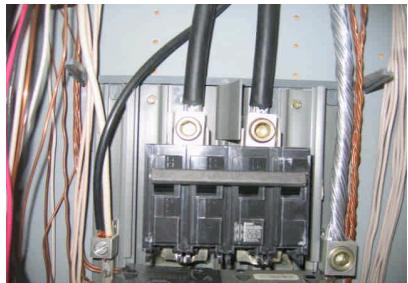
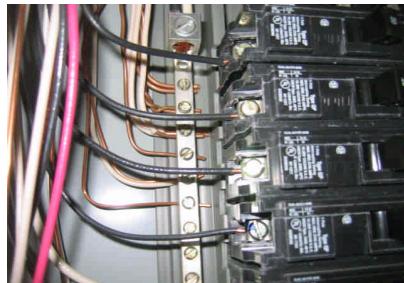
Modern Romex wiring is visible. Good.

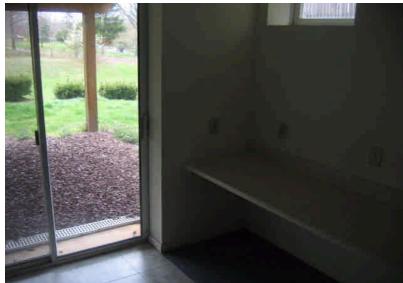
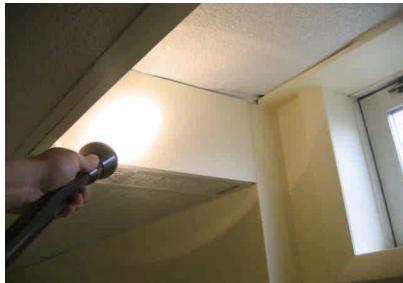
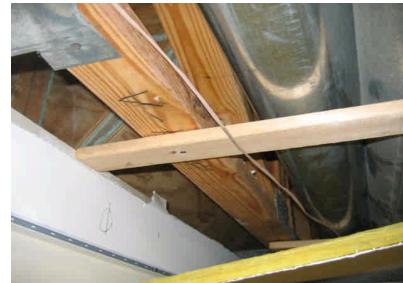
There is insulation at the band or rim joist areas, which is above the foundation wall, at the outer perimeter of the floor system. This insulation restricts the visual inspection of those areas considerably.

The inspection of the basement is restricted by the drop-ceiling tiles. Limited visual access. I will lift and move a random sample of tiles to inspect. However, much of the electrical wires, water and sewer pipes, heating ducts/pipes, and floor structure can not be seen. There may be components above the ceiling tiles that need improving or correcting that the inspector can not see.

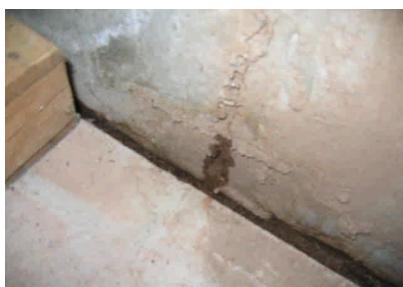
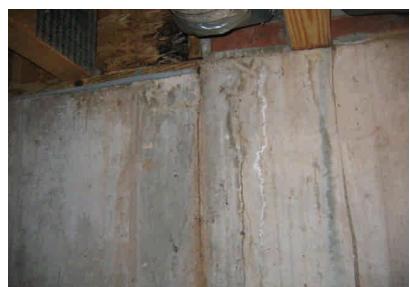
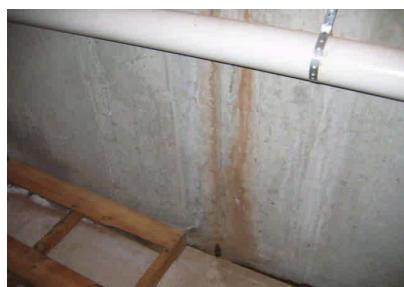
There is active ground water penetration through the foundation crack. Water marks. Located on the front side wall. Near sewer line.

Foundation cracks can be repaired using an epoxy ejection method. Epoxy ejections make a bond between the cracked sections of the foundation that is actually stronger than the concrete itself. Further evaluation and correction to the foundation crack by a professional (one familiar with epoxy injection repairs) is recommended.

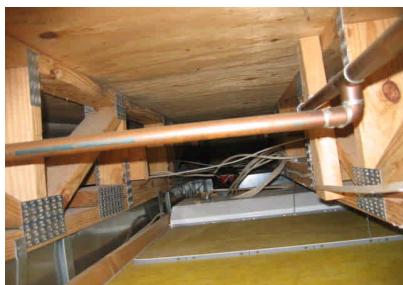
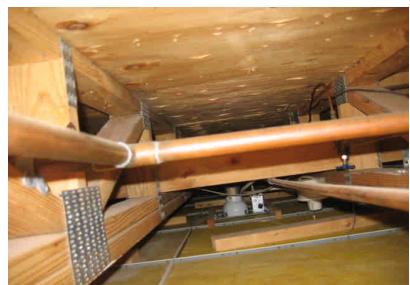
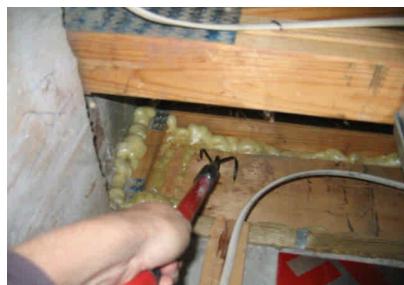
The floor joists are made of engineered joists.

I walked around, probed, checked the floor as best as I could. No material defects apparent. No major structural defects found. Recommend asking the seller if any repairs have been made to the floor structure in the past.

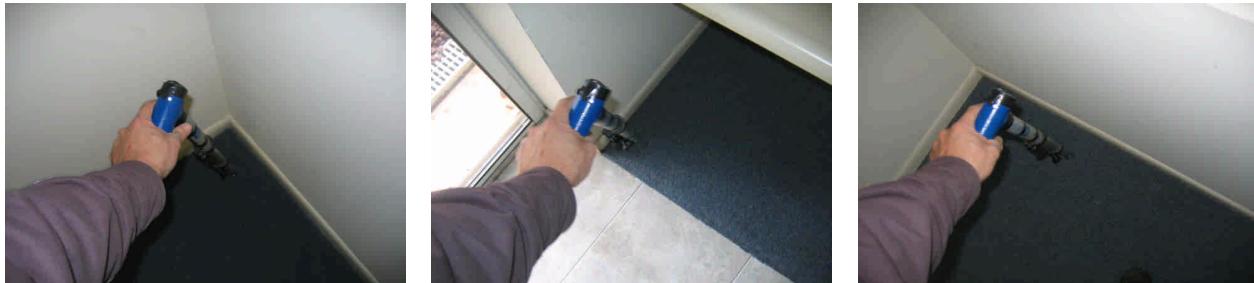
The moisture meter probe was used all around the carpeting, around the basement wall perimeter. No active moisture was detected. Please consult with the seller's disclosure.

There are signs of active, wet water penetration in the basement. Water marks and wood rot. At the wooden components of the wall, above the concrete foundation wall. Front left corner of the unfinished basement. Water coming into this area from outside, where a downspout is located.

Recommend asking the seller about the water leakage, accumulation, or dampness into the structure.

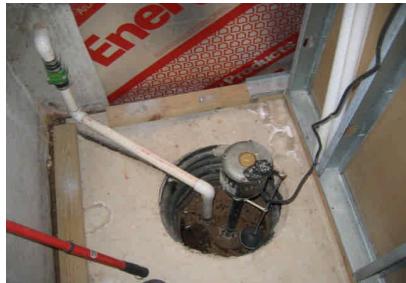
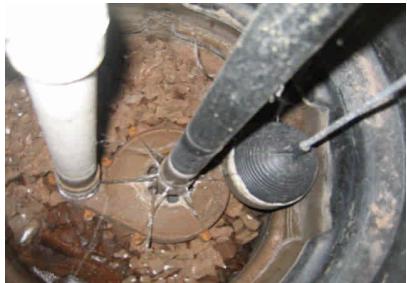
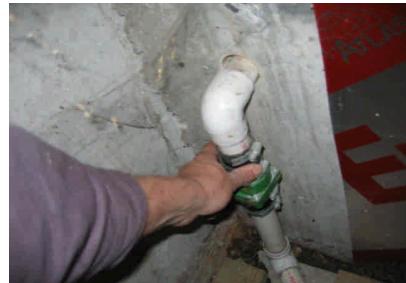
Missing lid at the sump.

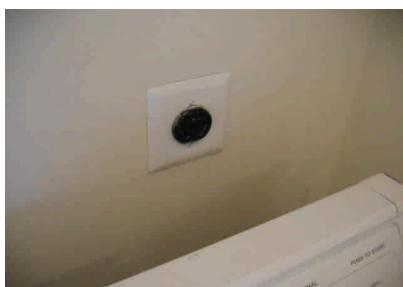
The dryer vents horizontally. The lint trap must be kept clean, because trapped lint can rapidly turn into a fire hazard.

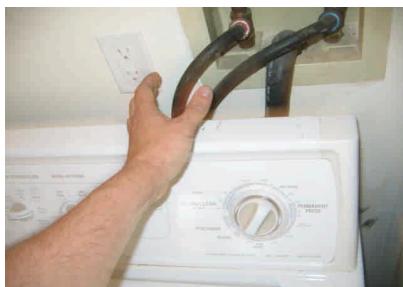
Water Supply Hoses

Rubber hoses should be replaced with more reliable ones - pressure-tested hoses. Such as stainless-steel, braided mesh hoses.

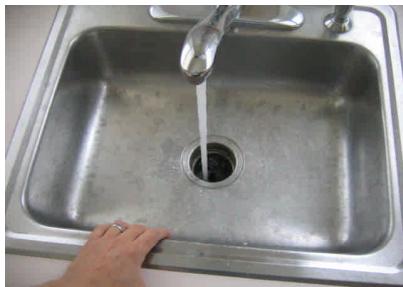
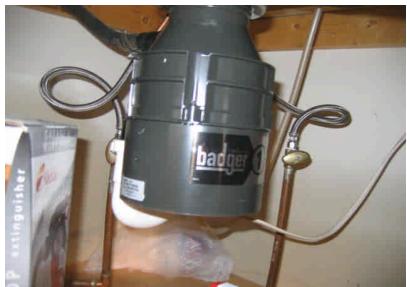
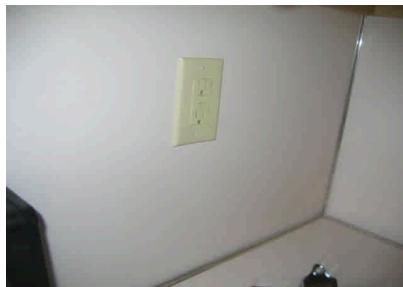
The sink faucet is functional. No active leaks seen.

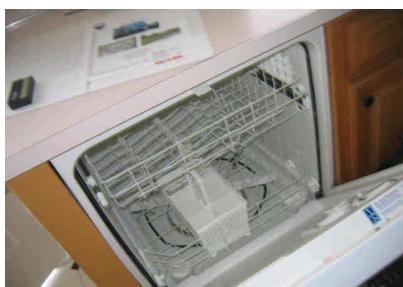
Ran a short cycle with no leaks. (This is no guarantee against future problems.)

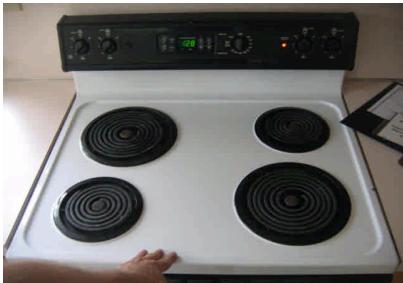
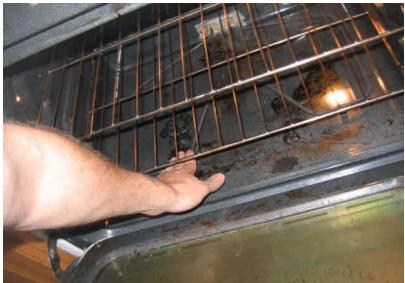
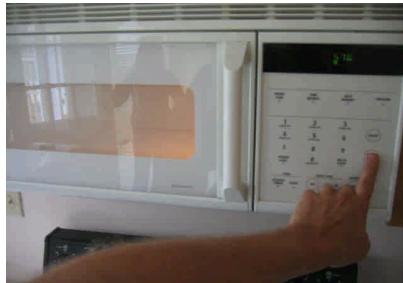
Electric stove elements are functional. Turned on and warmed up. Good.

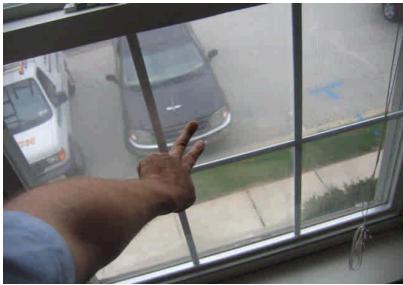
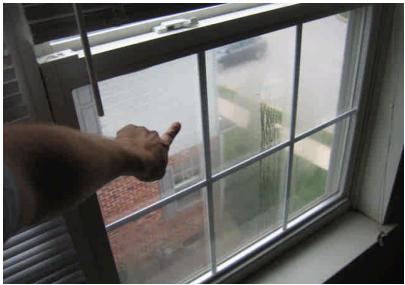
There are fogged windowpanes. Lost seals. Replacement of the insulated windowpanes is needed. Located at the 2nd floor front bedroom. 3rd floor side window.

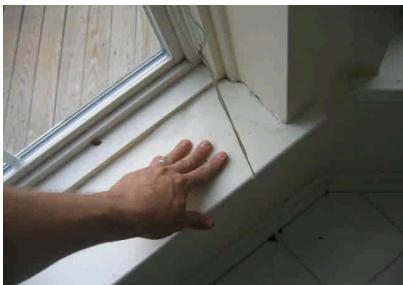
Water Penetration

There are signs of water penetration at the rear bay window of the kitchen. Further evaluation needed.

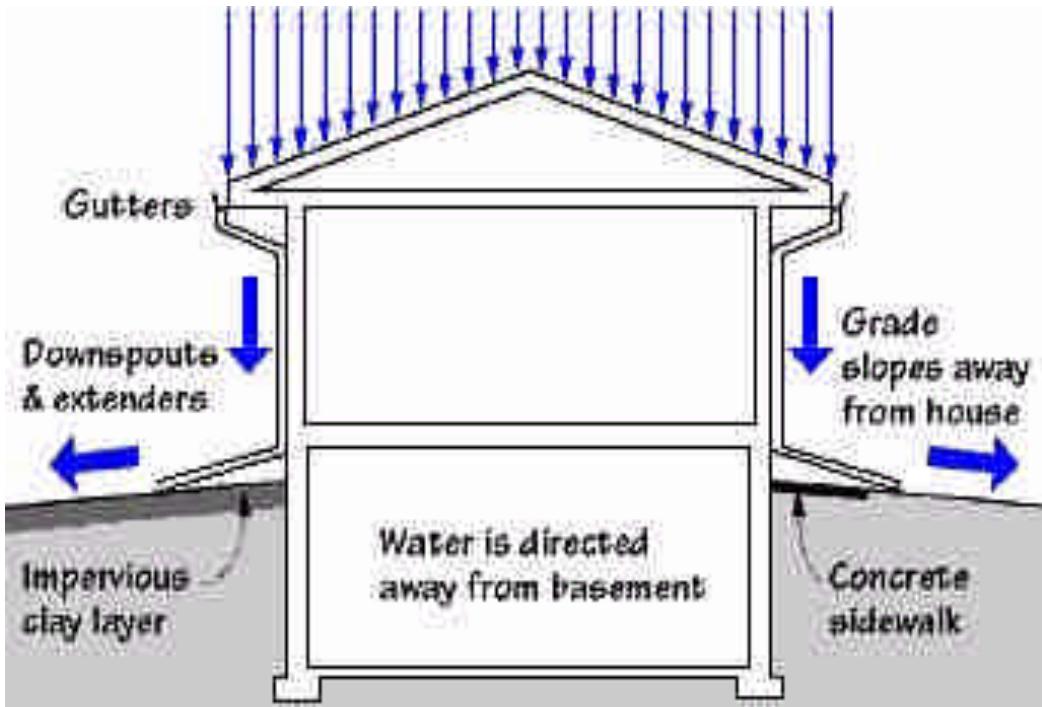
Illustration - 2 Appears functional

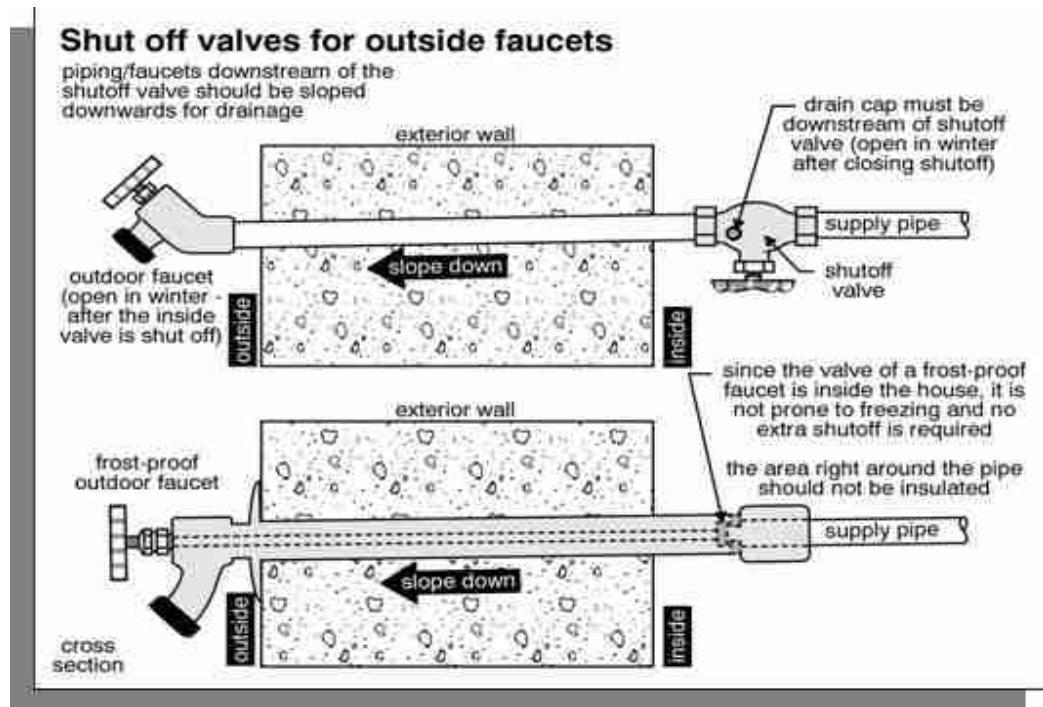
Illustration - 3 Frost-free

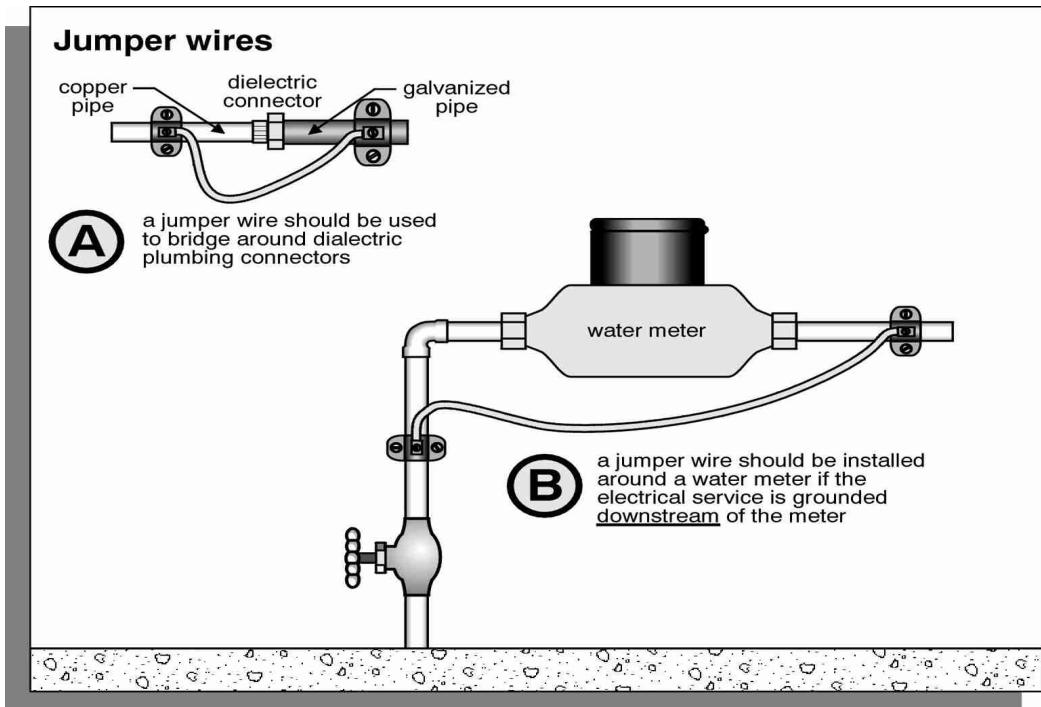
Illustration - 6 Jumper cable installed - Good

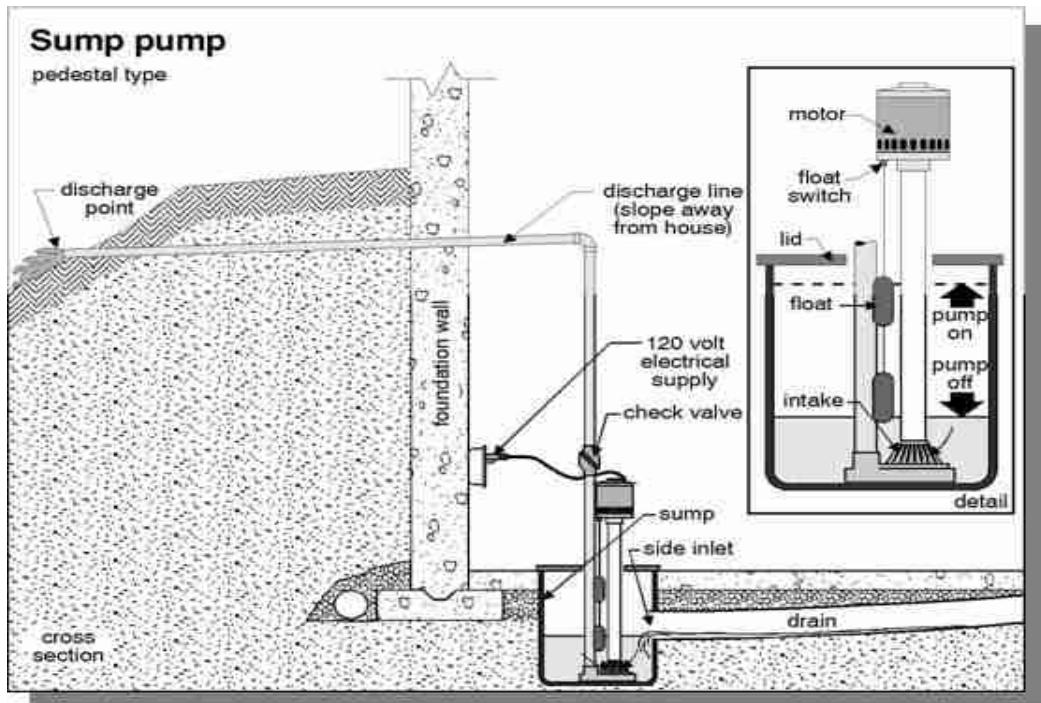
Illustration - 8 A sump pump being used - why
