TOPNOTCH BUILDING INSPECTIONS

PRE-PURCHASE RESIDENTIAL

1234 Main St. Preston Victoria 3072

06/04/2021 9:00AM

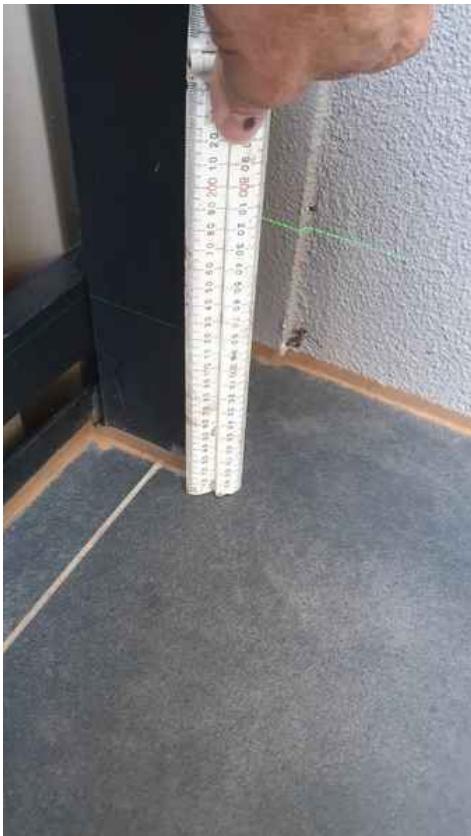
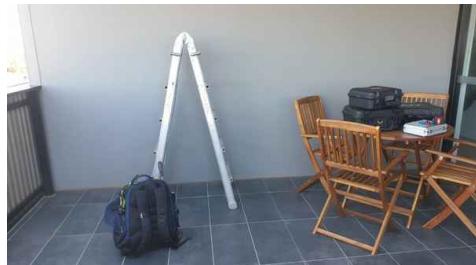
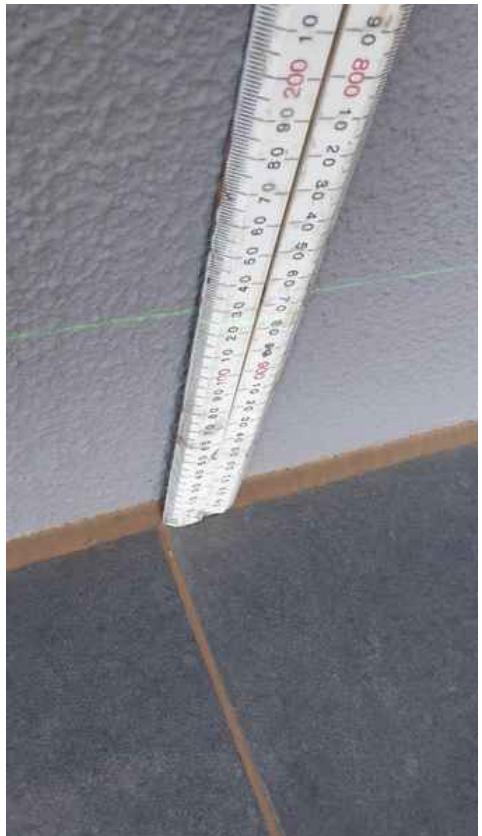
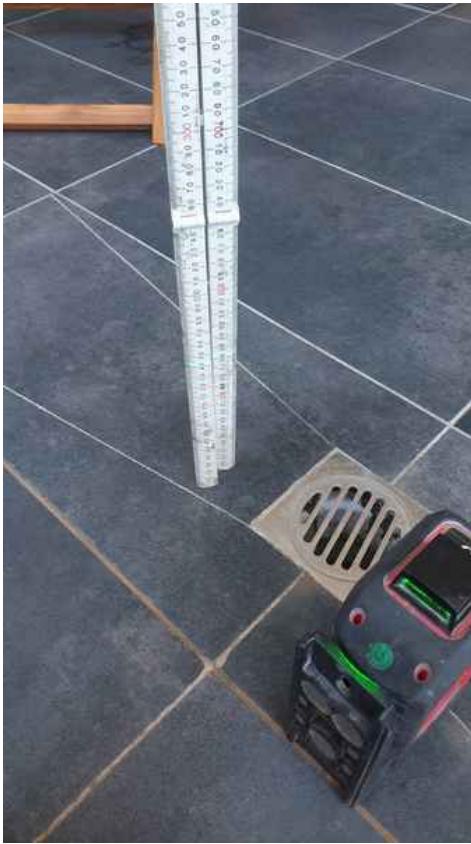
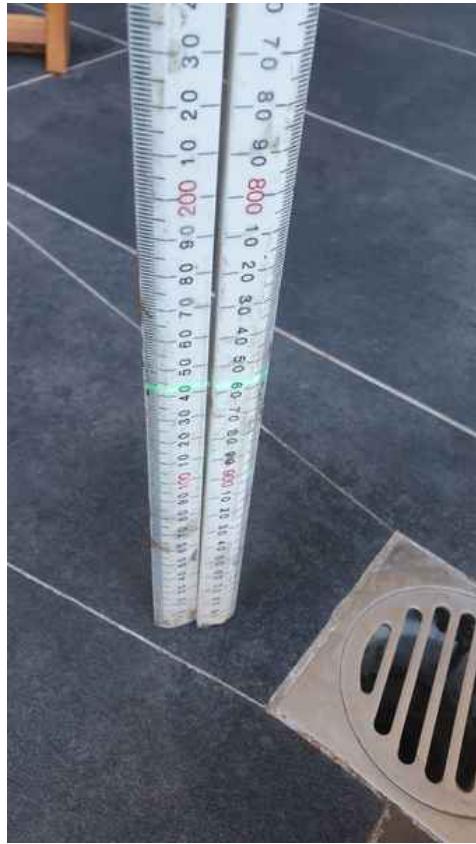
4.6.2 Balconies

DOOR SILL TERMINATION ABOVE BALCONY FLOOR

Recommendation

Contact a qualified professional.

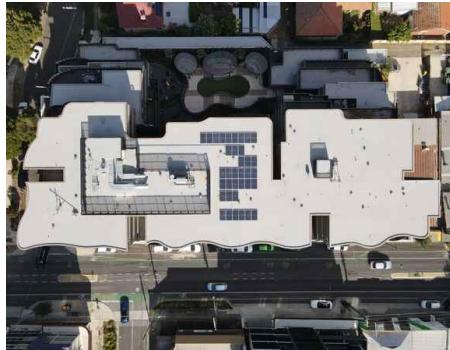
Viewed from the East

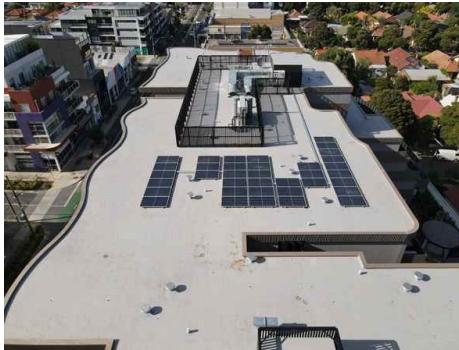
Viewed from the North

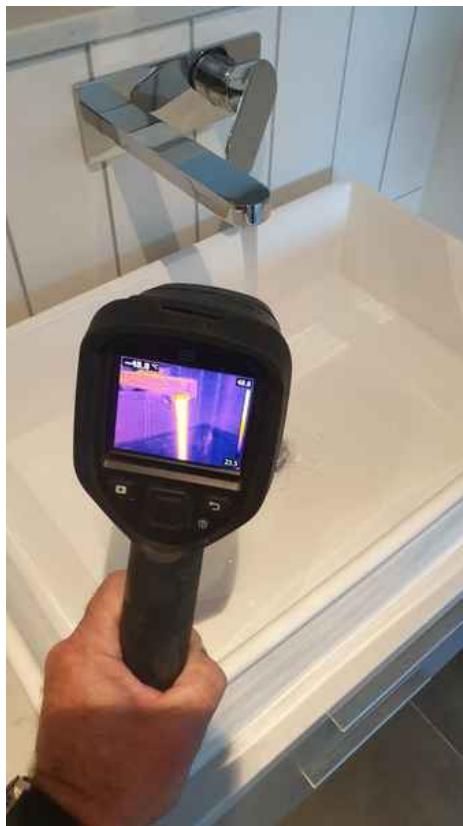
Master Ensuite

**Basin Tap: HOT WATER TEMPERATURE FROM OUTLET**

46-50 Degrees

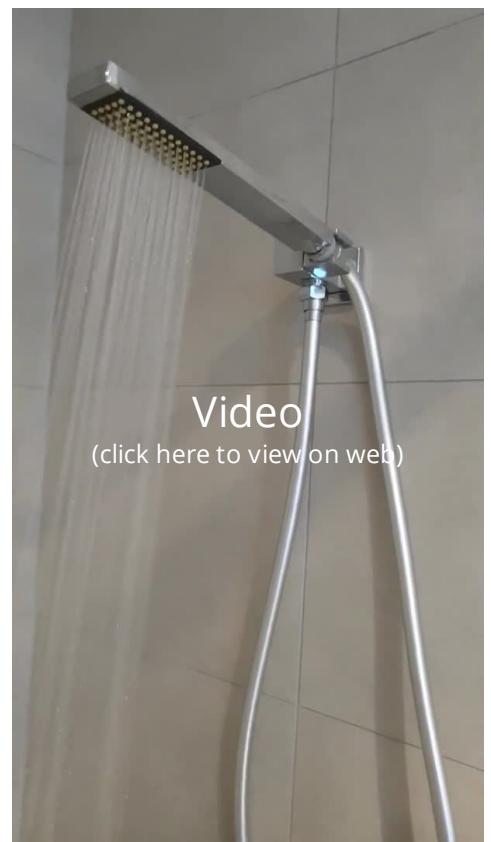
7.14.1 Shower

LEAK FROM SHOWER HOSE

A leak was present from the shower hose outlet (where attached to the hand held shower head) while in use.

Repairs are recommended as needed by a licensed plumber or competent handyman to rectify the leak.

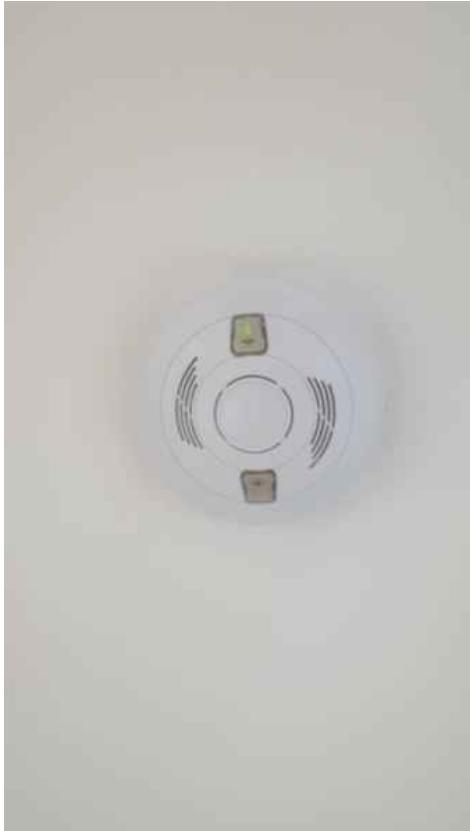
Close up view of smoke detector

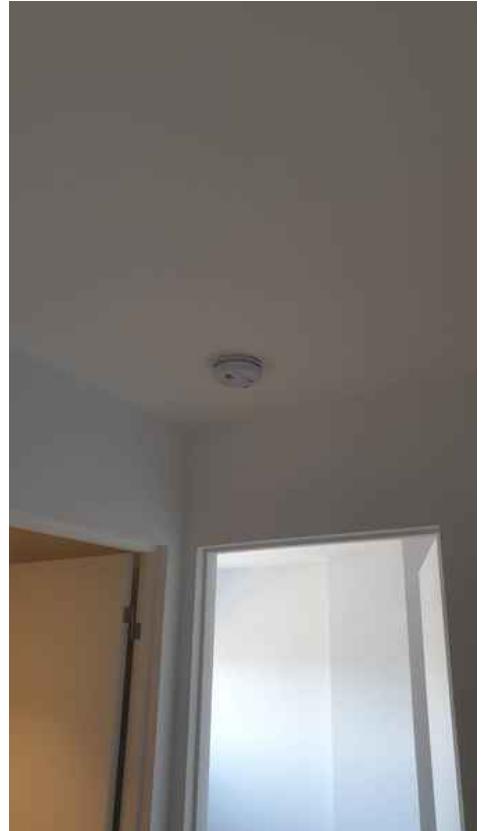
Smoke Detector located in hallway outside of Master Bed

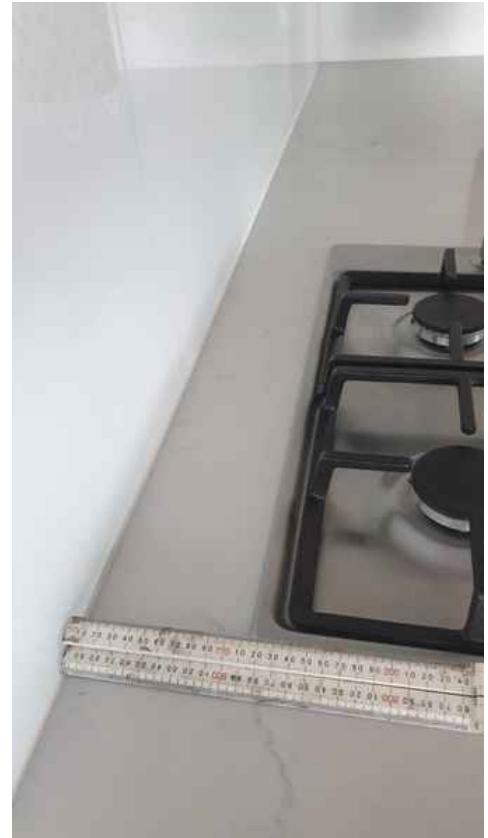
SPLASH-BACK

SUBSTRATE UNKNOWN

The inspector cannot see behind the splash-back to determine the type, adequacy or fixings of the substrate. Glass splash-backs and Stainless Steel Splash-backs behind (or beside) a gas hot plate require a fire rated material to be installed as the substrate material if located within 200mm of the edge of a burner. The substrate cannot be seen and is therefore a limitation on the inspection. If this is a new build or kitchen, the owner or builder should be able to supply a certificate of compliance for this item.

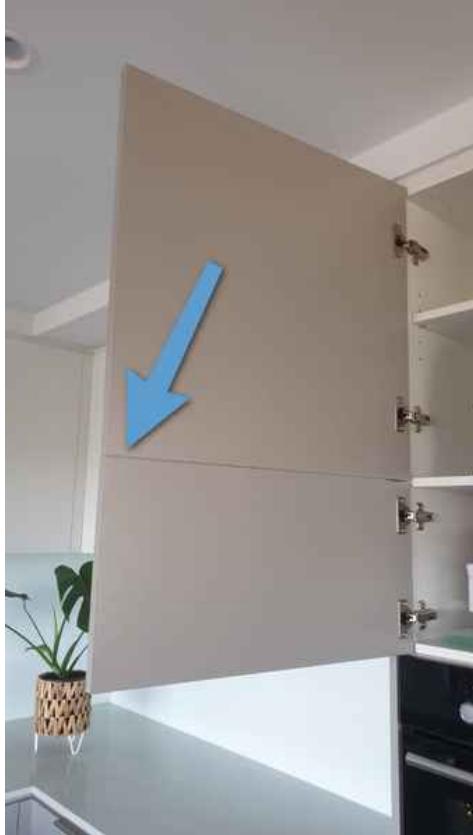
Cabinet doors above oven bind when open, adjust as required

Contact a handyman or DIY project

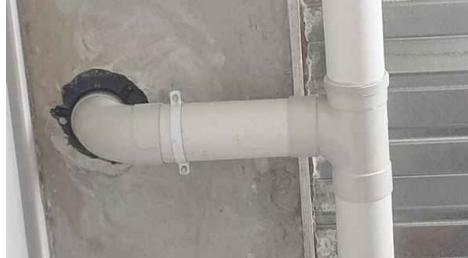
Basement water leak near vehicular exit, currently under investigation by others

Contact a qualified professional.

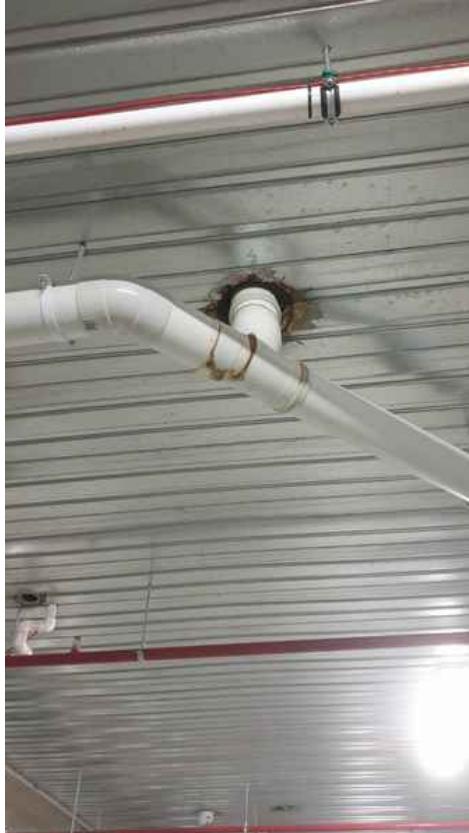
Basement water leak (stormwater) currently under investigation by others. Leaking from courtyard above

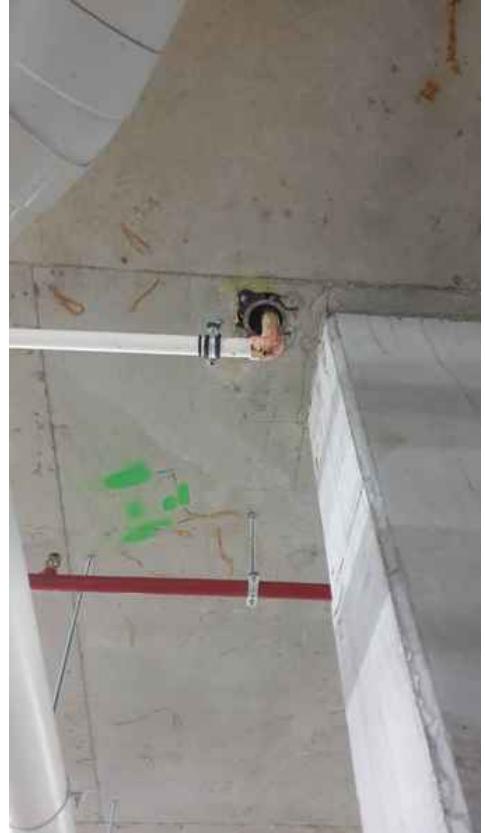
Basement water leak (Irrigation) currently under investigation by others. Leaking from courtyard above

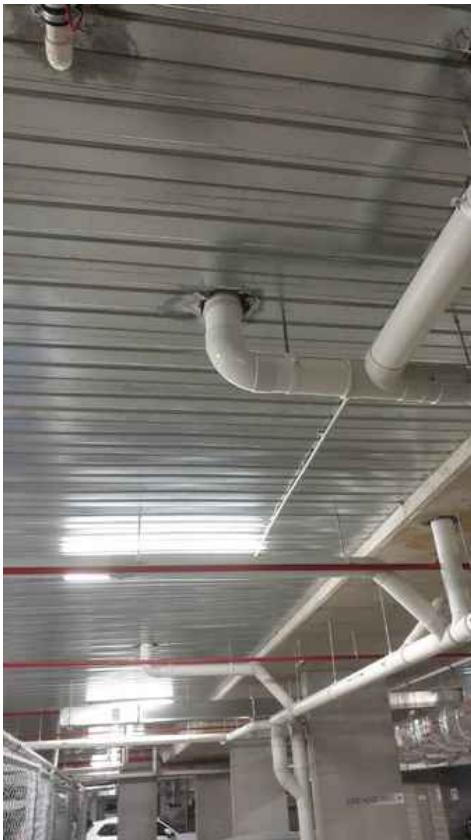
The underside of the concrete ceiling in the basement car park below the outdoor courtyard has active signs of moisture penetration.

An inspection by others was taking place at the time of my inspection. After enquiring with the contractor, it was established that some existing leaks are present in the basement carpark concrete ceiling which are under investigation and repair.

I recommend further investigation through the Body Corp.

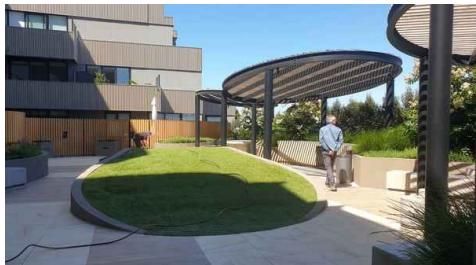
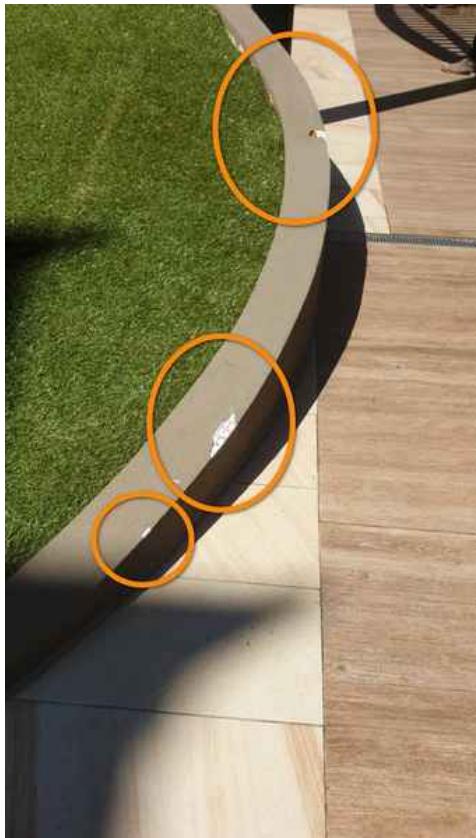
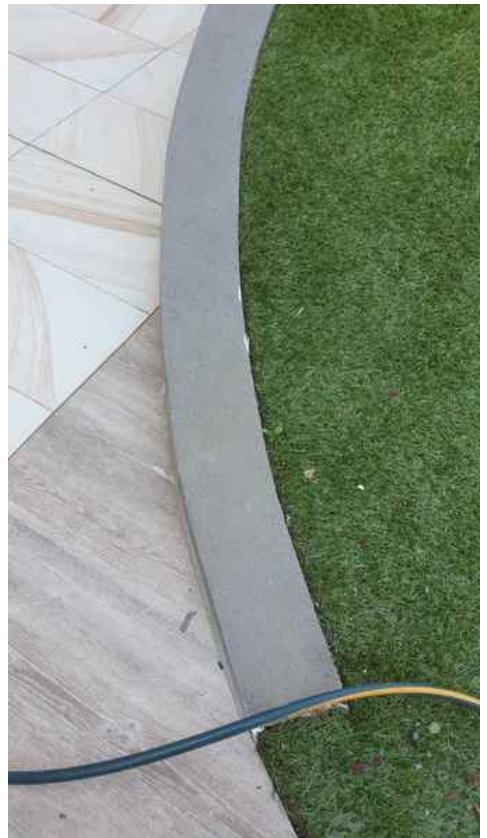
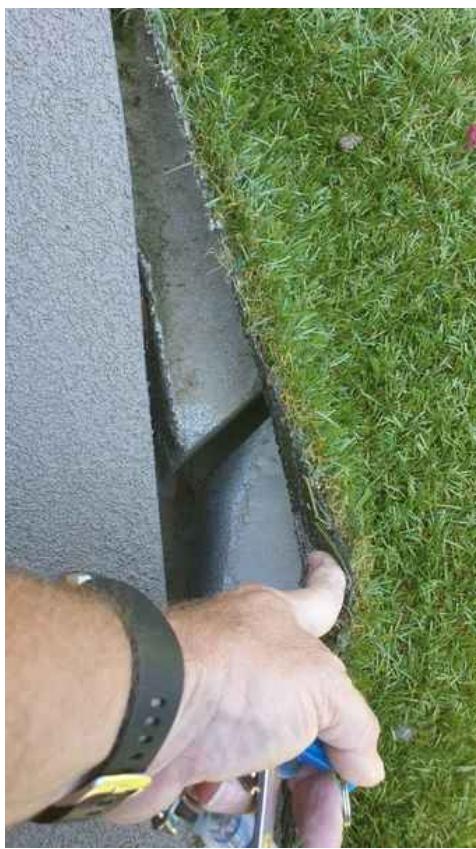
COURTYARD "HILL"

Hill filled with polystyrene and sand!

Contact a qualified professional.

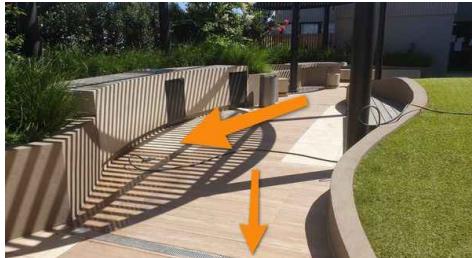
Areas of active leaks

Contact a qualified professional.

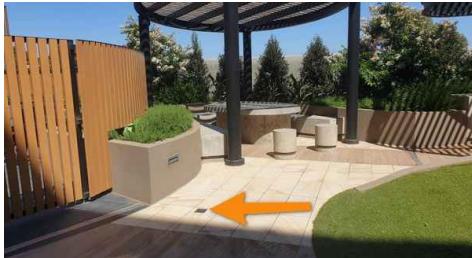
Areas of active leaks
