TOPNOTCH BUILDING INSPECTIONS

## PRACTICLE COMPLETION STAGE INSPECTION

1234 Main St. Preston Victoria 3072

04/04/2021 9:00AM

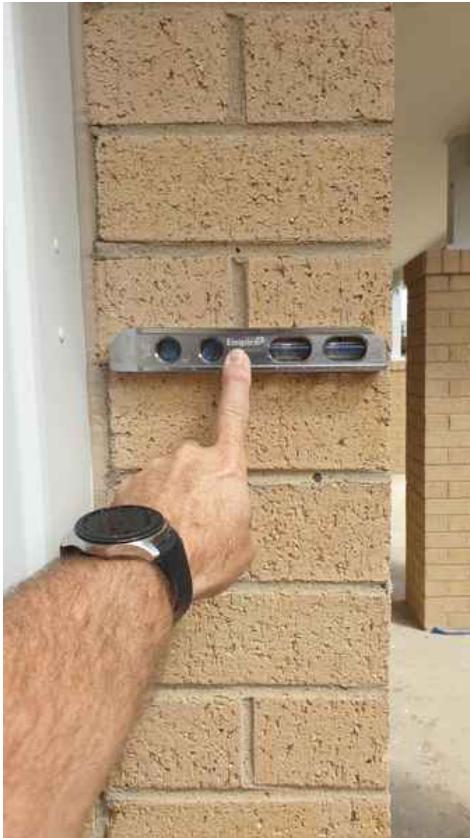
Brickwork not level

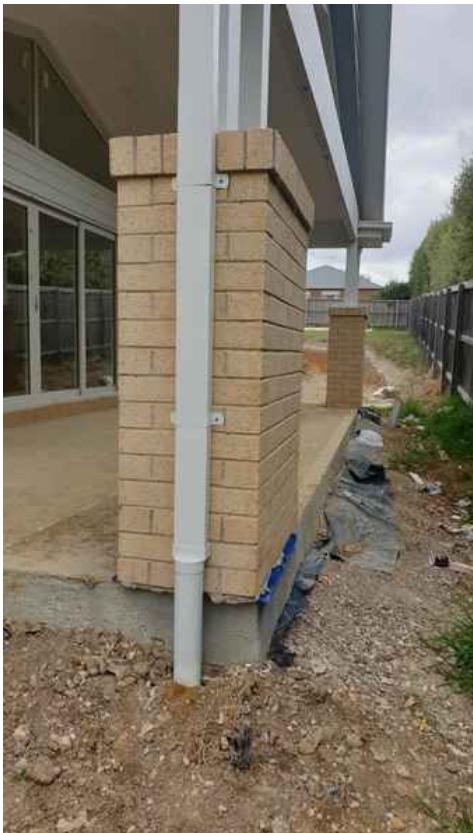
#### 4.3.1 External Cladding

I recommend supporting the brickwork as required by the project engineer.

Recommendation

Contact a qualified professional.

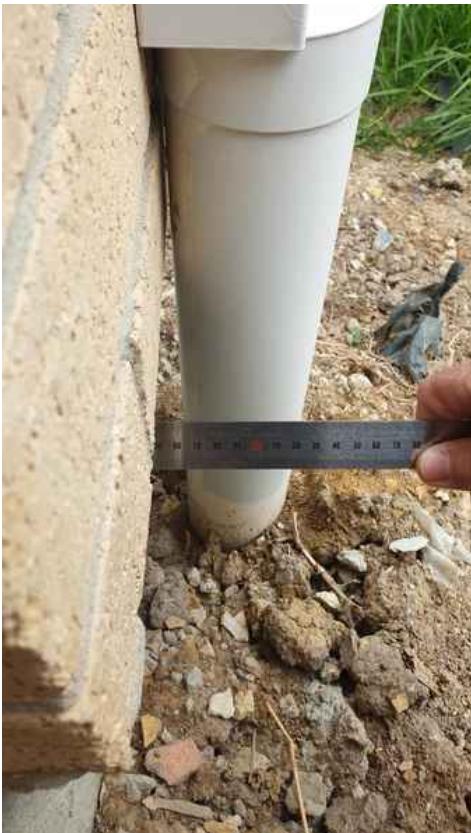
Rear Pergola

### **BRICKWORK OVERHANG**

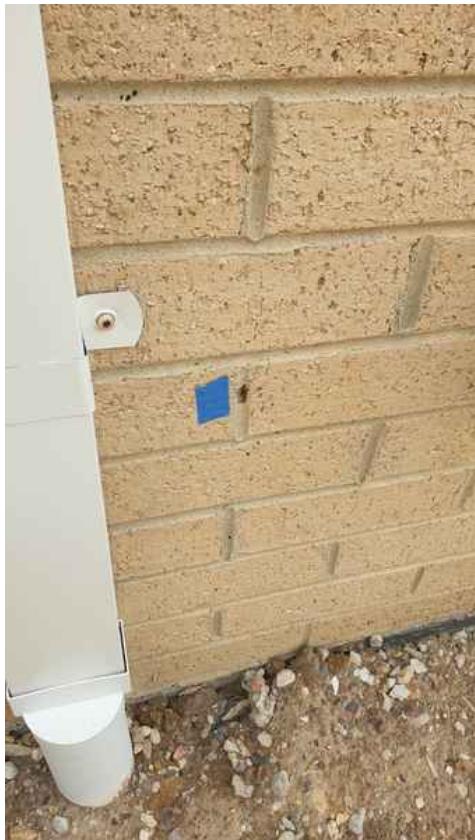
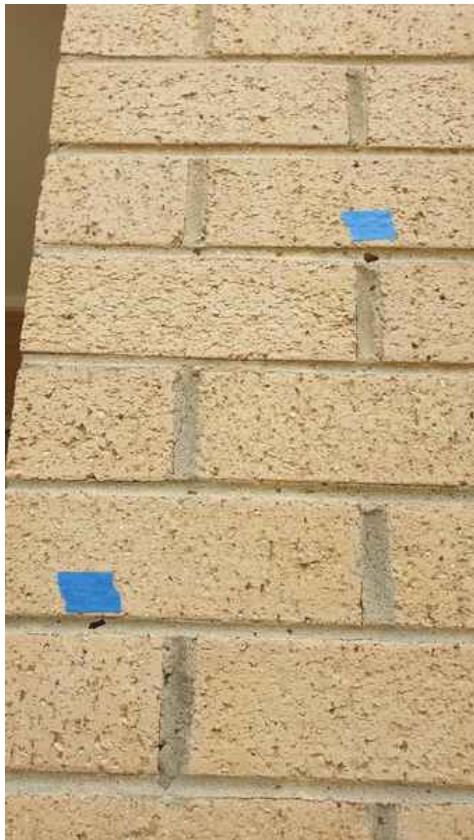
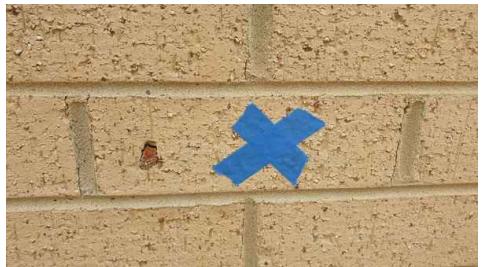
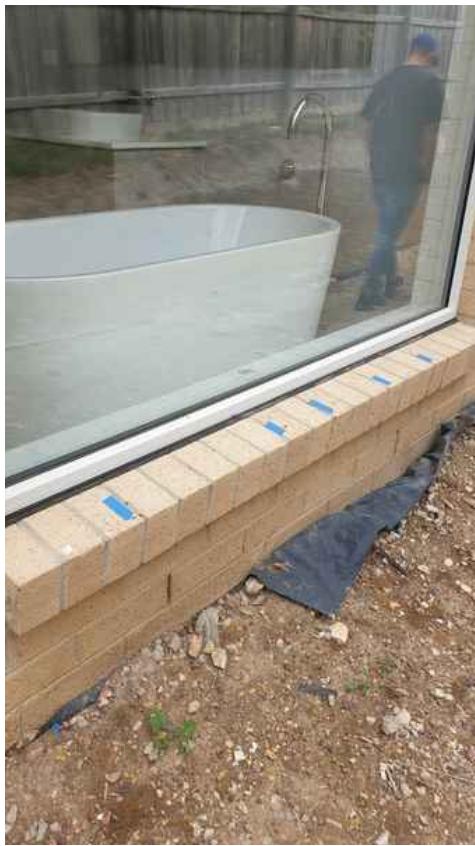
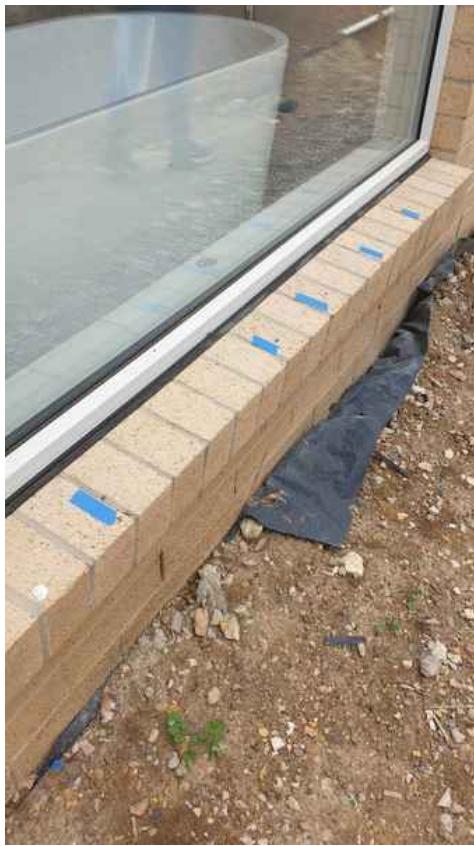
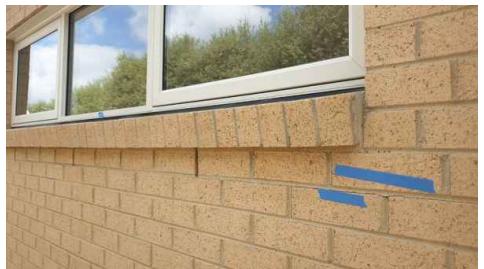
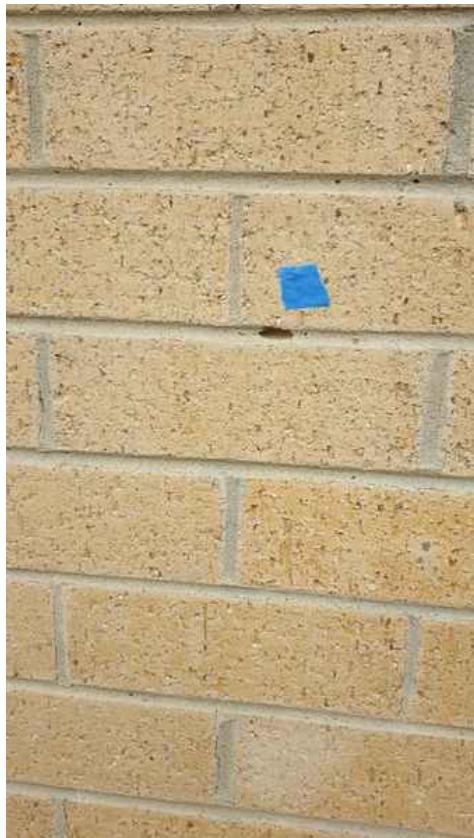
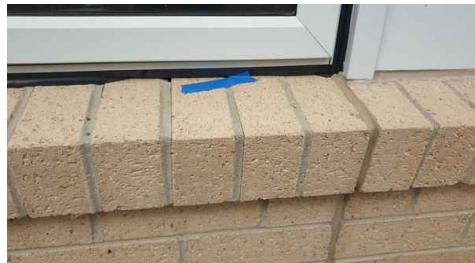
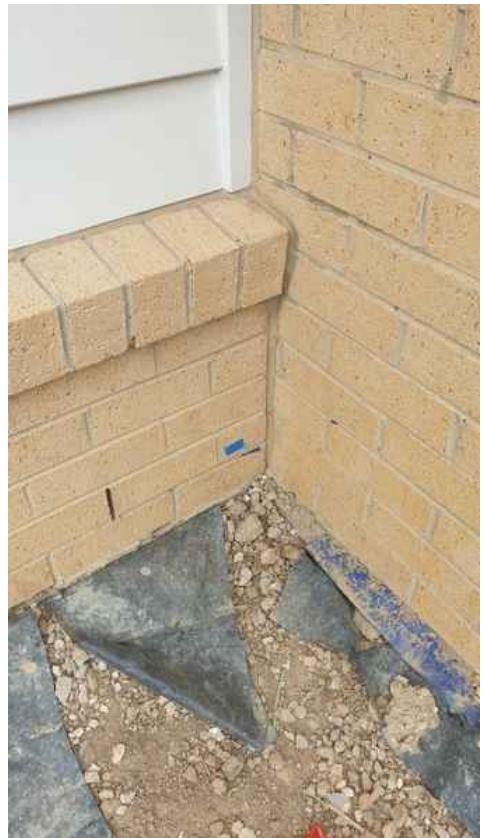
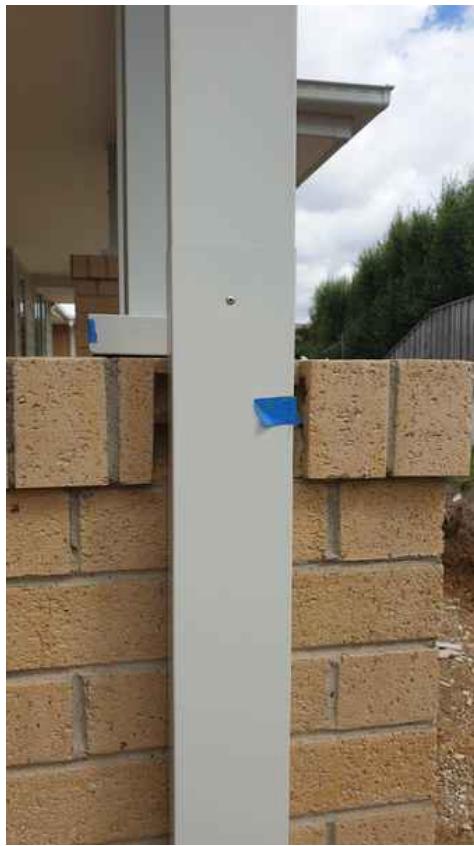
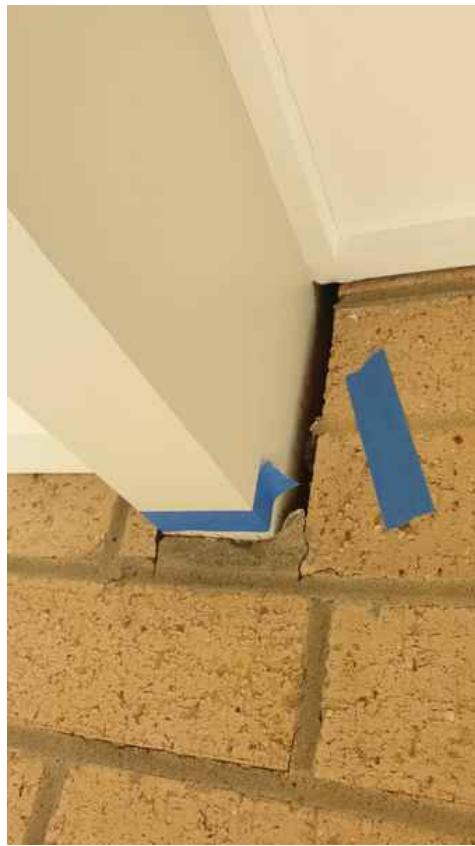
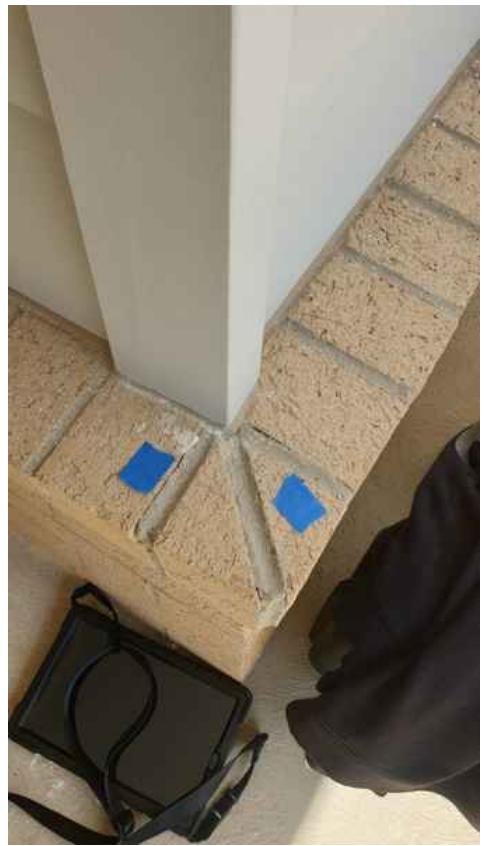
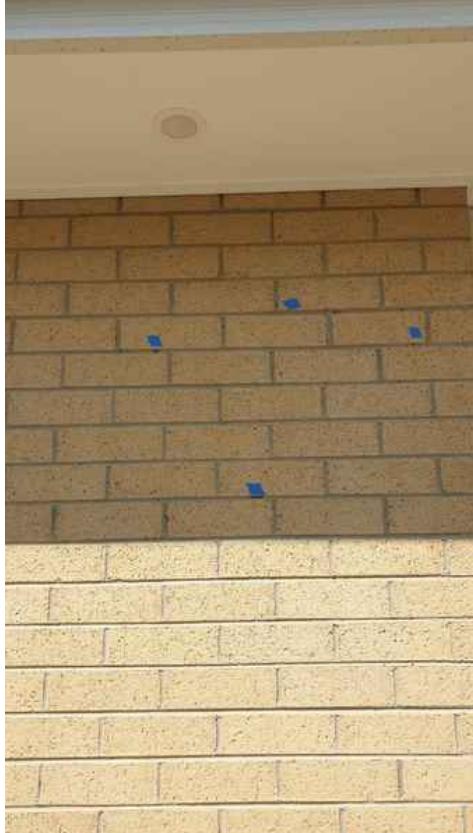
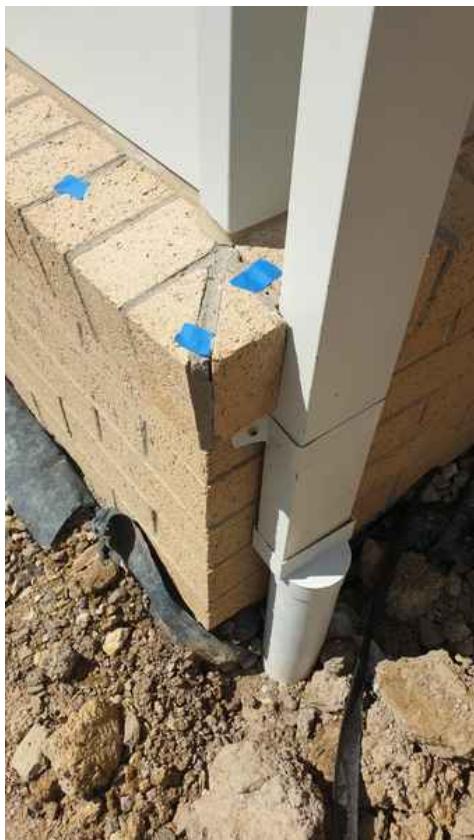
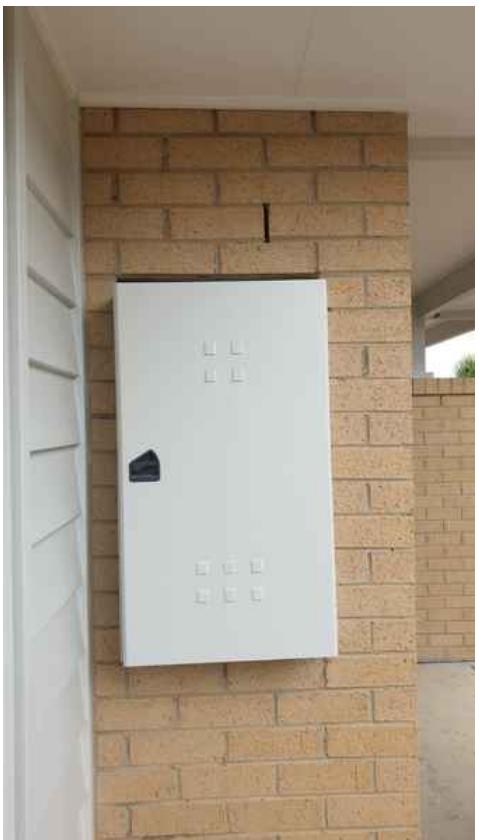
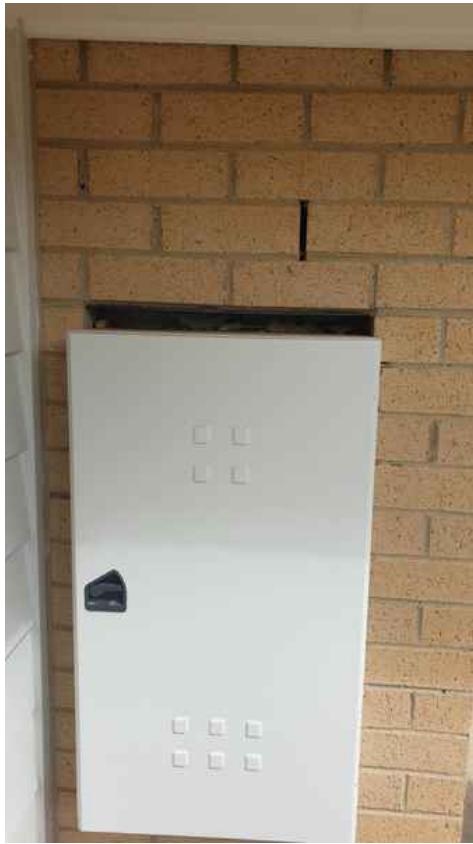
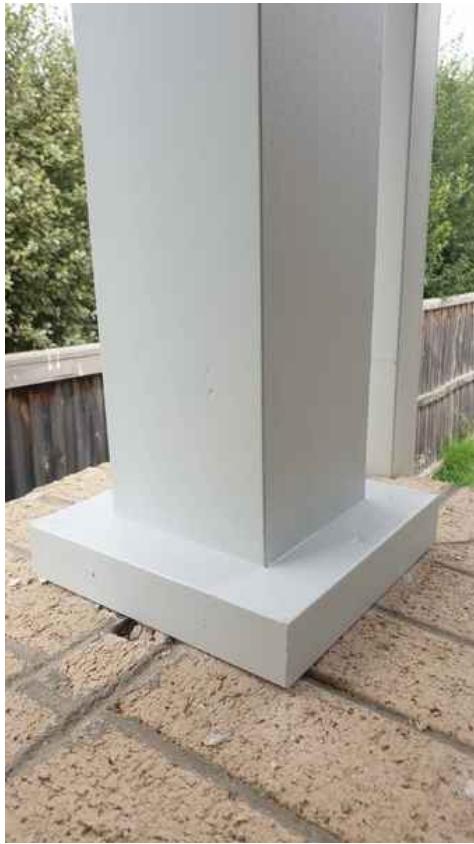
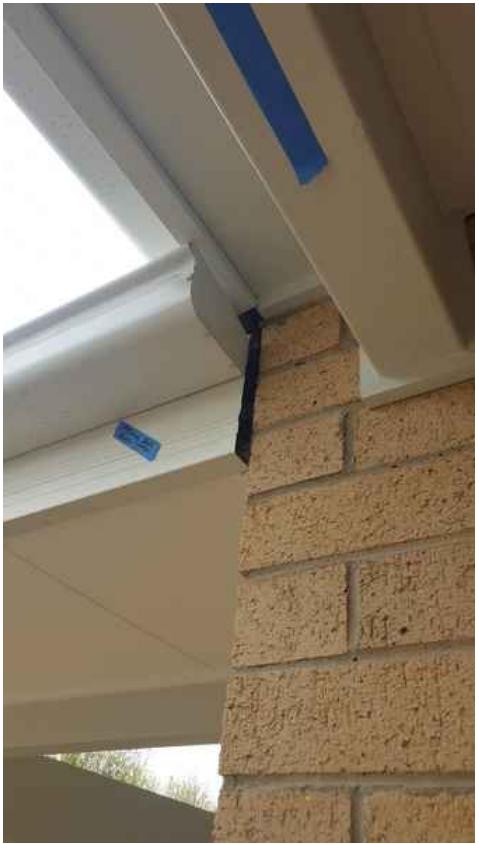
Voids and or holes were observed in the masonry mortar.

*Mortar is defective if it is not in accordance with the requirements of the Building Code of Australia or the contract specifications.*

I recommend repairing all mortar defects with mortar to match existing.

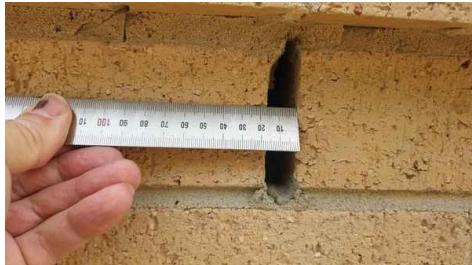
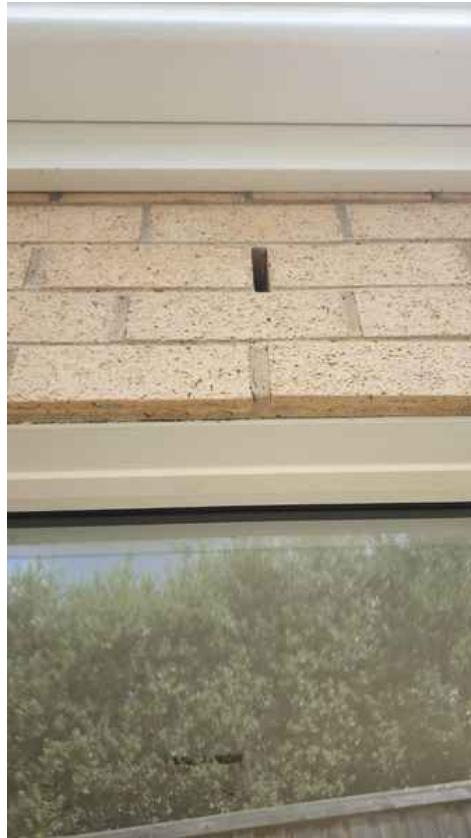
### PERPEND WIDTH

I, J Note: Table 3.04 (K) provides that maximum difference in width of perpends in any wall must not exceed 8 mm.

Recommendation  
Contact your builder.

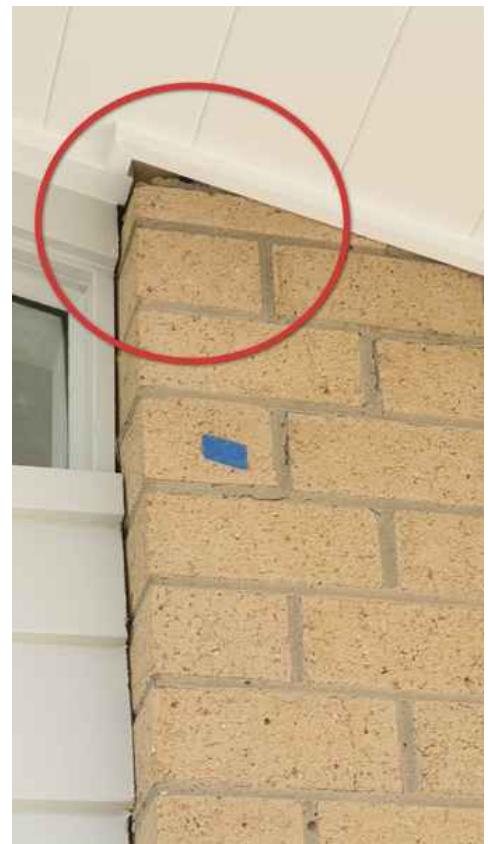
**INCOMPLETE BRICKWORK**

MAJOR DEFECT / SAFETY HAZARD

I recommend completing the external brickwork.

Contact your builder.

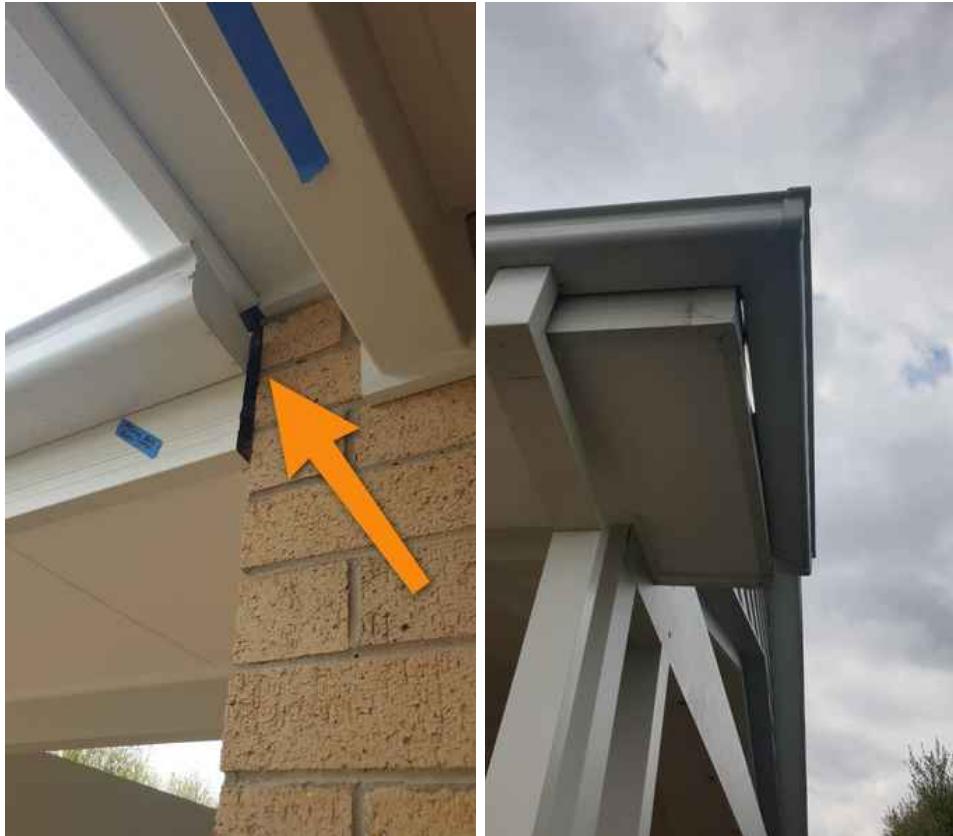
#### 4.4.2 Eaves, Soffits & Fascia

### PAINT/FINISH FAILING

Recommendation

Contact a qualified painting contractor.

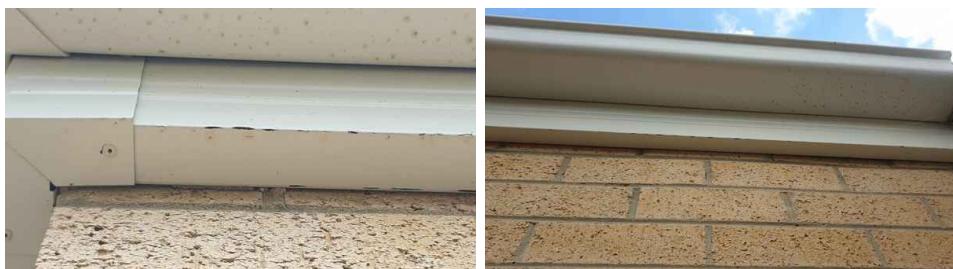
#### 4.4.3 Eaves, Soffits & Fascia

### POORLY INSTALLED

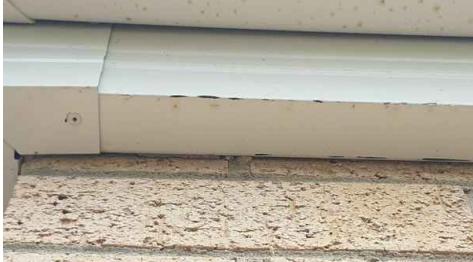
The paint or finish is failing.

Chipping and rust forming

Recommend that the areas be properly prepared and painted / finished.

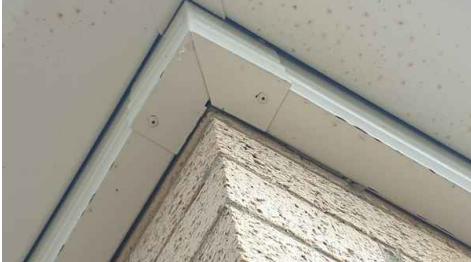
Chipping and rust forming

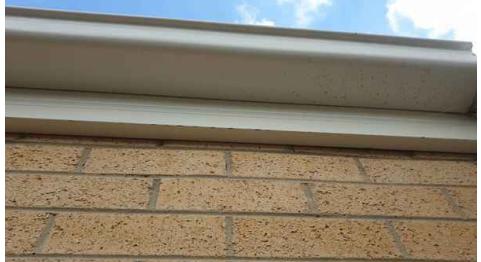
Chipping and rust forming

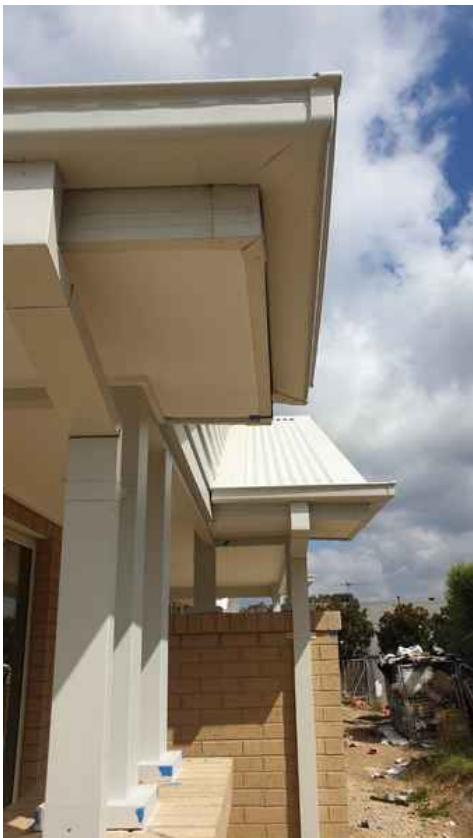
Bowed and not square

I recommend installing the fascia and gutters in a professional and workmanlike manner.

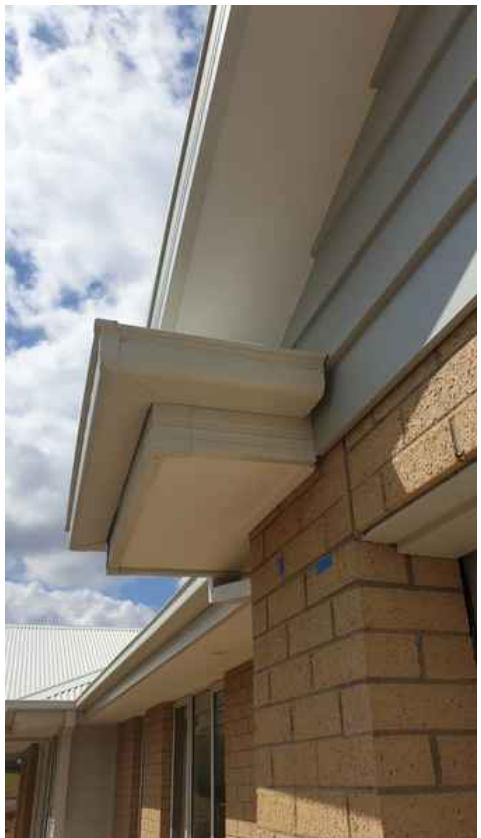
Not Square

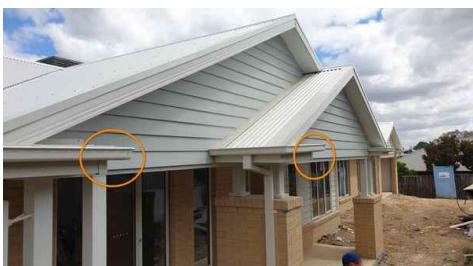
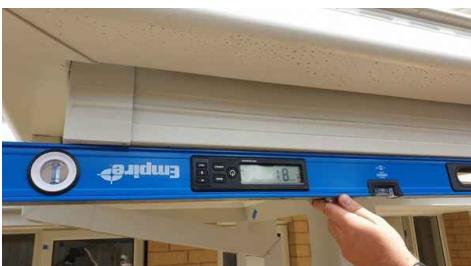
18mm out of level over 1m

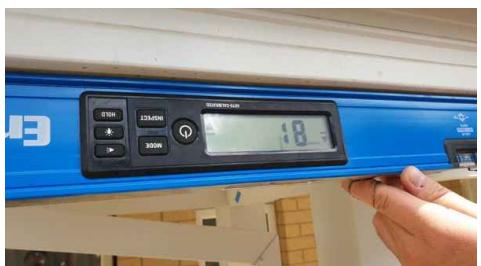
18mm out of level over 1m

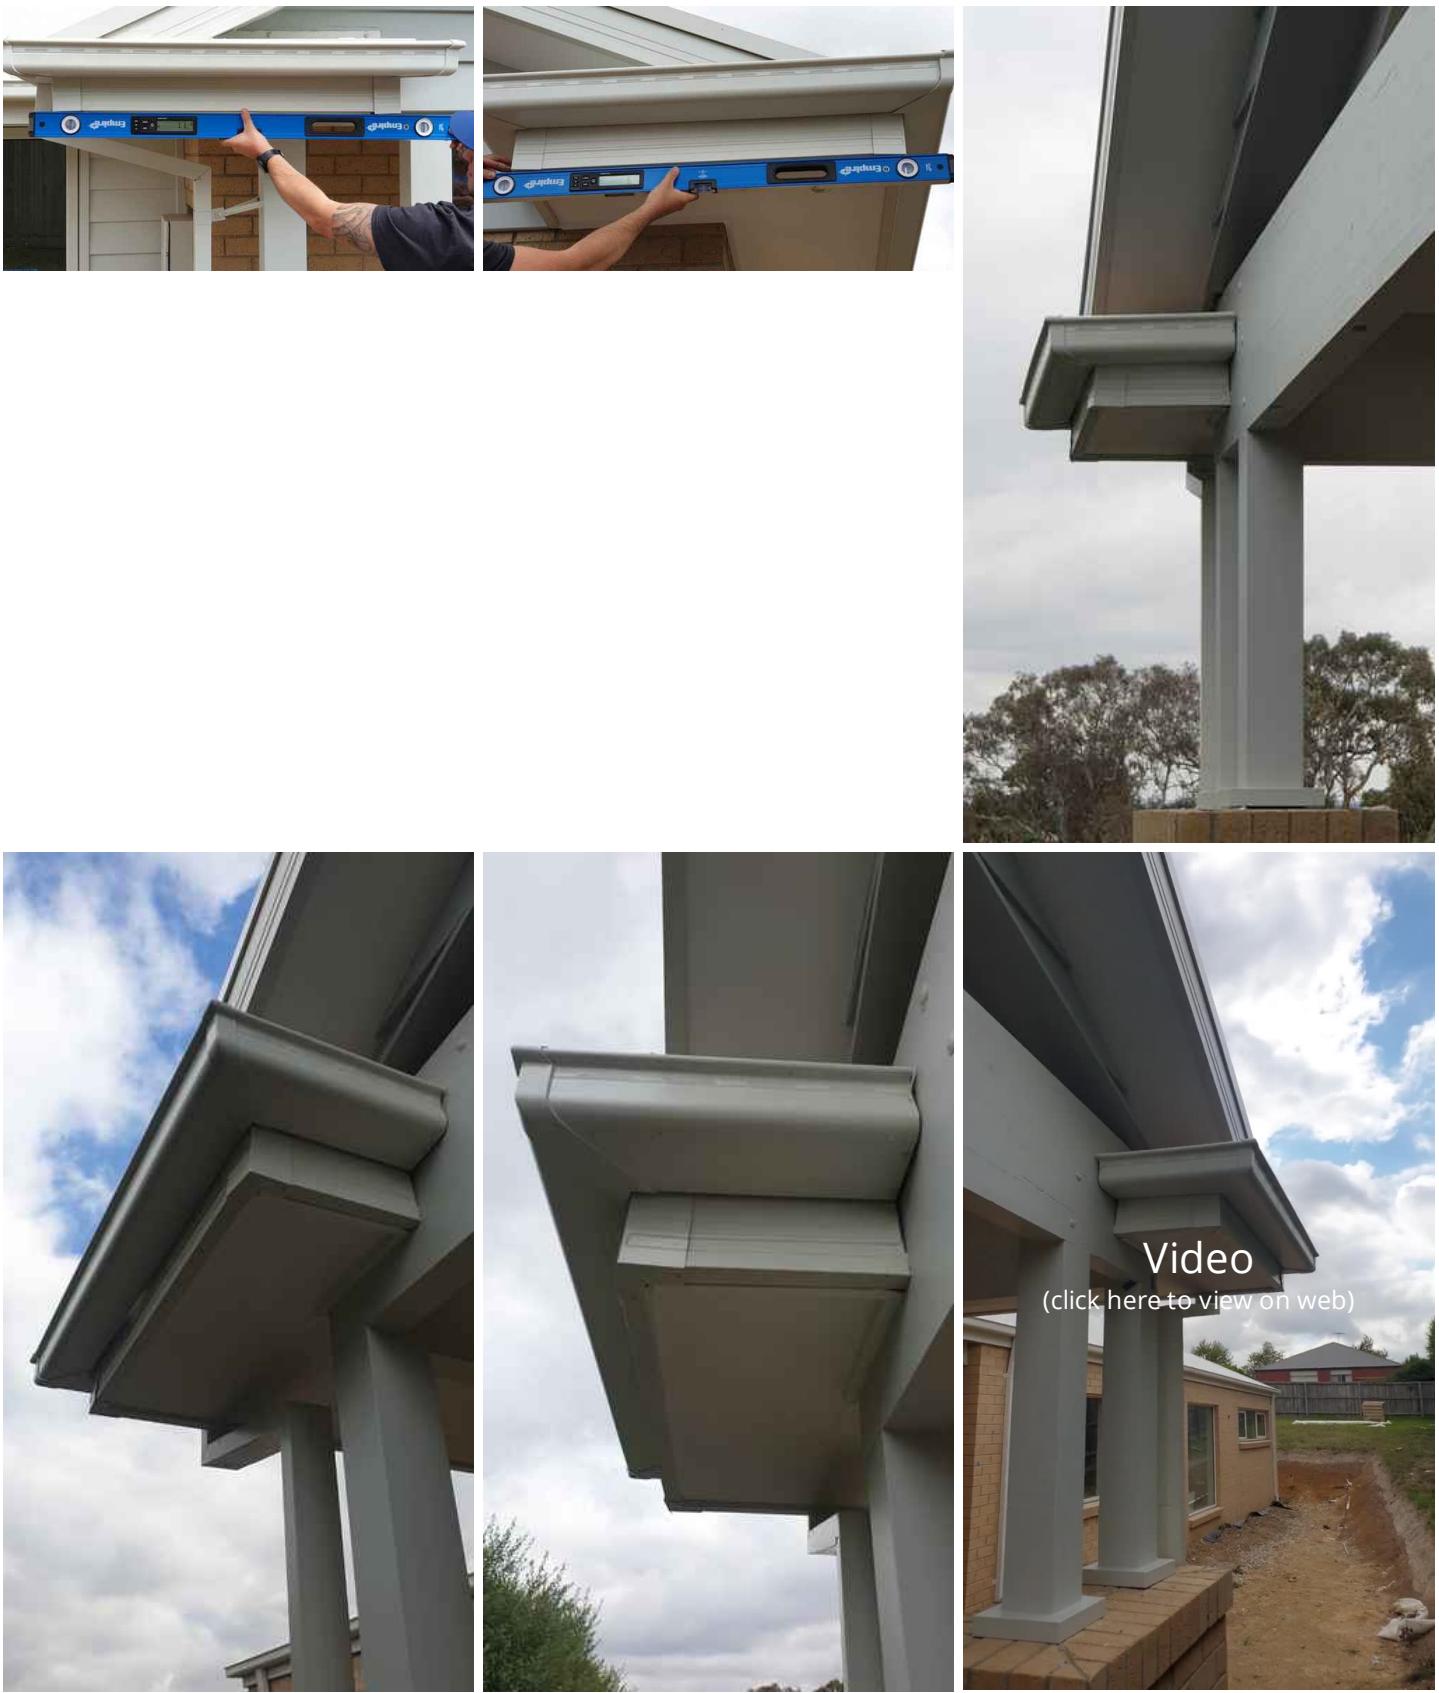
#### **BOLTS**

I recommend cutting the bolts to be more aesthetically pleasing and paint to match.

Contact your builder.

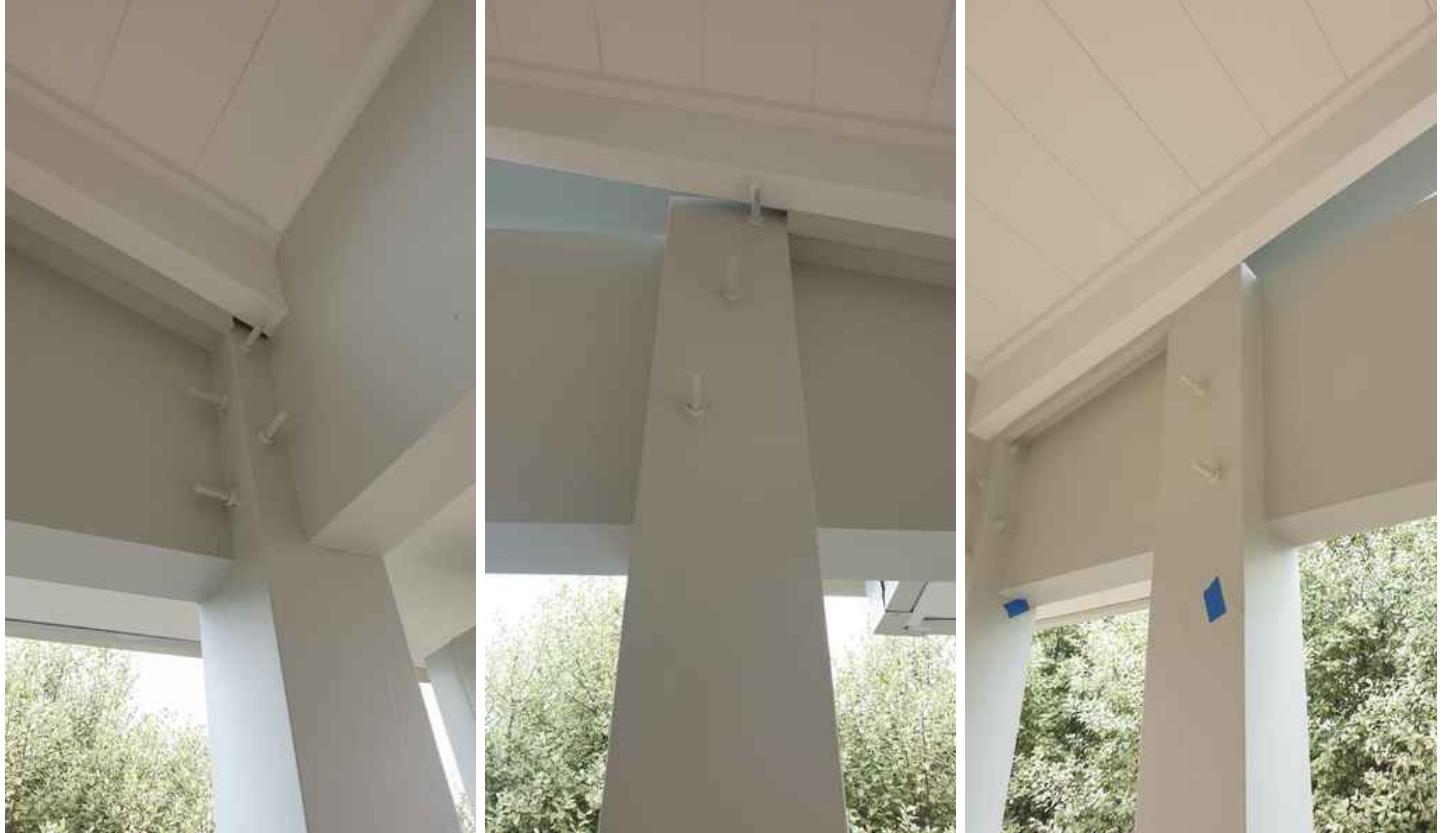
### TIMBER POSTS (ALIGNMENT)

I recommend adjusting the trim in an effort to help conceal that the posts are out of alignment.

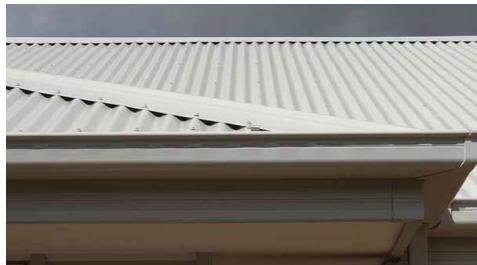
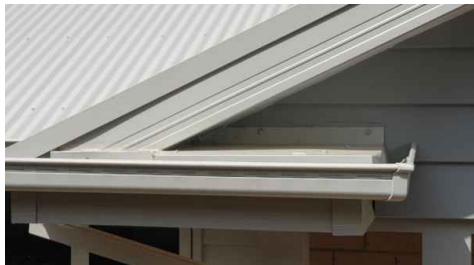
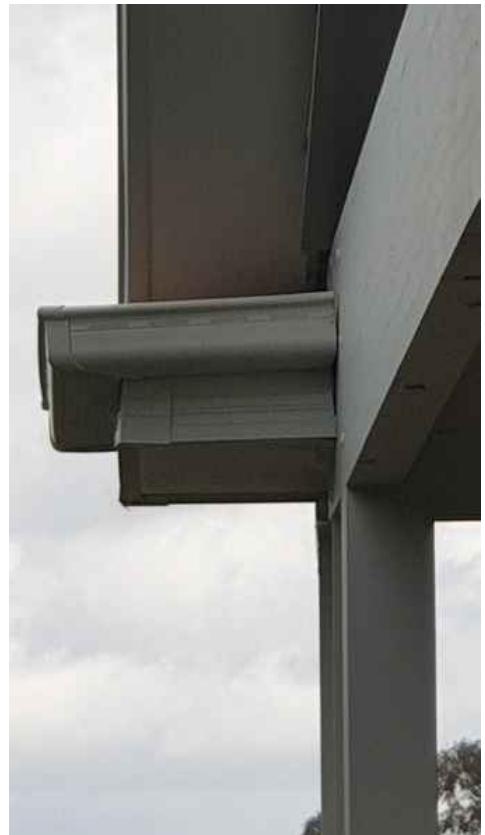
MAJOR DEFECT / SAFETY HAZARD

Recommend: Engage a qualified roof plumber to repair / rectify

Contact a qualified roofing professional.

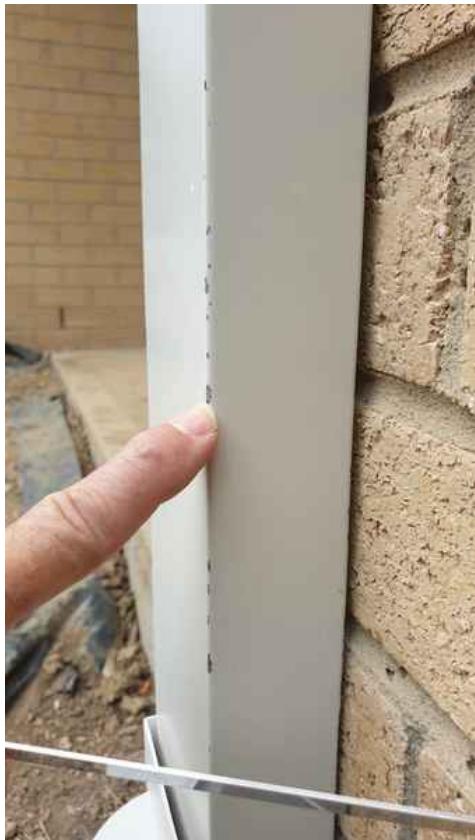
### 6.3.2 Gutters / Downpipes

Some downpipes had chips through the colorbond coating exposing the metal surface beneath. These chips will accelerate the rusting process and may lead to premature failure of the downpipe.

I recommend replacing or repairing the chipped downpipes.

Contact your builder.

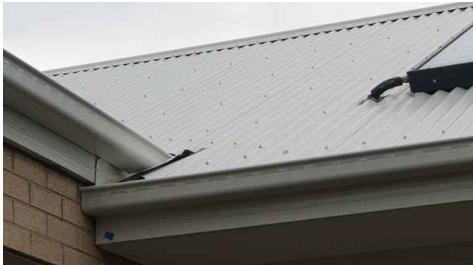
#### 6.4.1 Flashings

#### **LOOSE/SEPARATED**

Flashings observed to be loose or separated, which can lead to water intrusion and/or mold. Recommend a qualified roofing contractor repair.

MAJOR DEFECT / SAFETY HAZARD

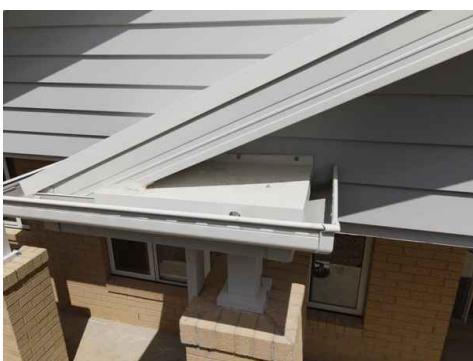
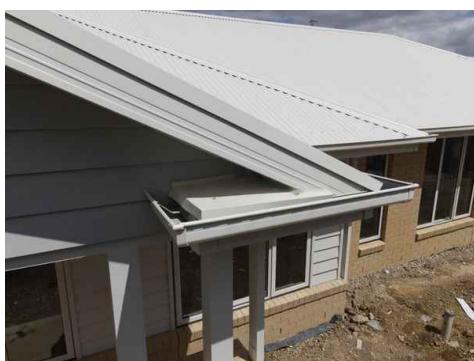
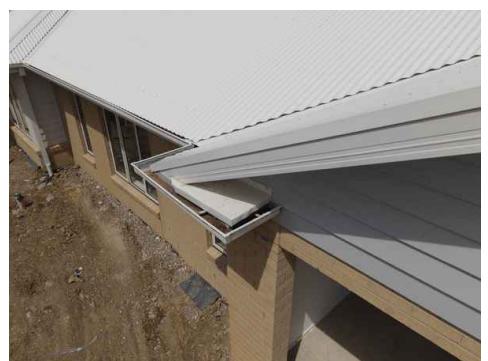
#### 6.4.2 Flashings

### POOR INSTALL AND NON-COMPLIANT

Recommendation

Contact a qualified roofing professional.

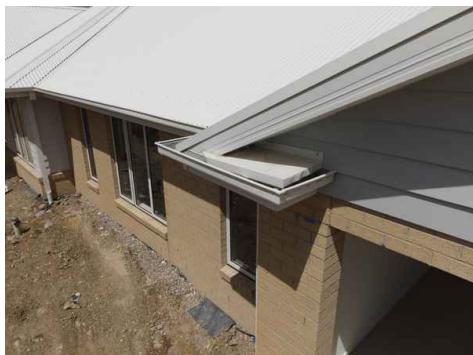
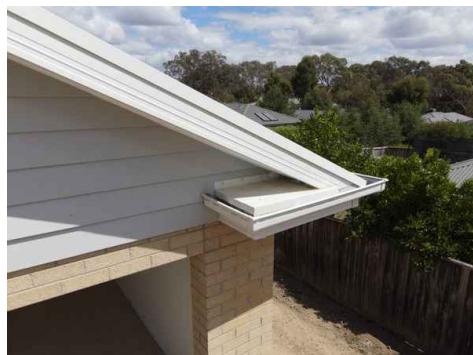
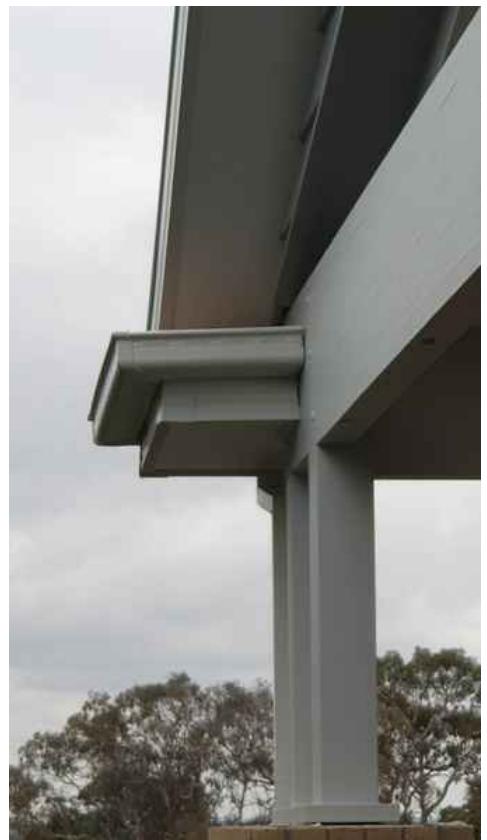
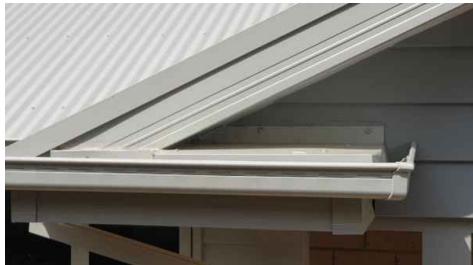
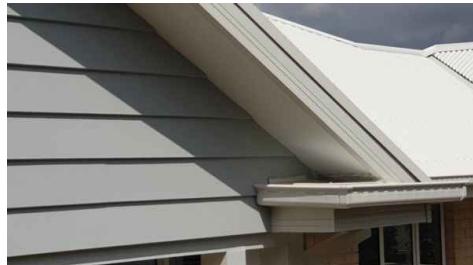
MAJOR DEFECT / SAFETY HAZARD

Recommend: Engage a qualified roof plumber to evaluate and repair.

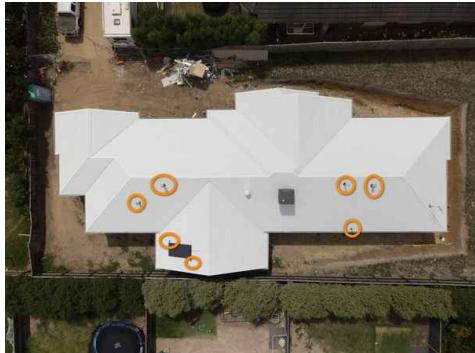
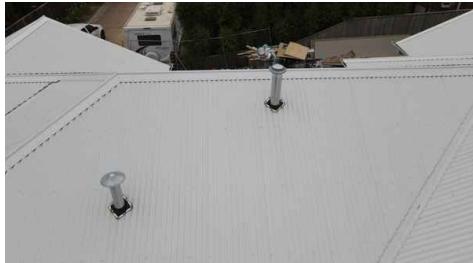
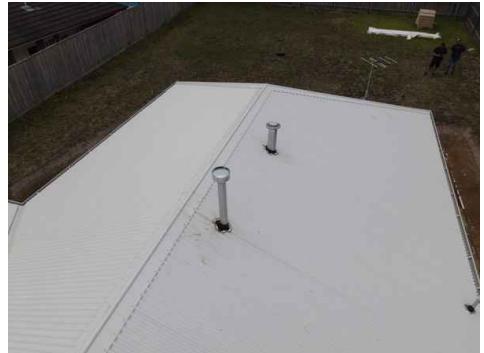
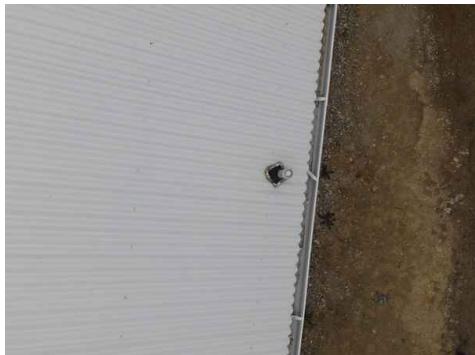
#### 6.5.1 Skylights, Chimneys & Other Roof Penetrations

#### **FIXING OF DEKTITES**

Roof penetrations with Dektites were observed to have been installed without the minimum required amount of mechanical fasteners.

- MINOR DEFECT

I recommend installing the penetration dektites as per the manufacturers recommendations.

Contact your builder.

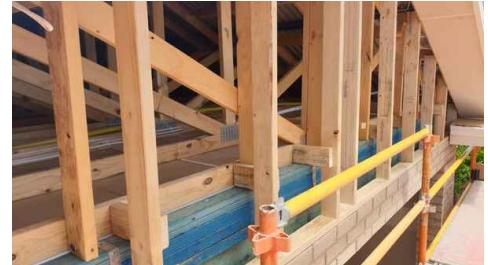
7.1.1 Roof Structure

### BINDERS

At my last inspection, it was noted that the binders required to fix the garage gable end wall had not been installed.  
I recommend the builder install the binders as required by  
**AS1684.2-2010**

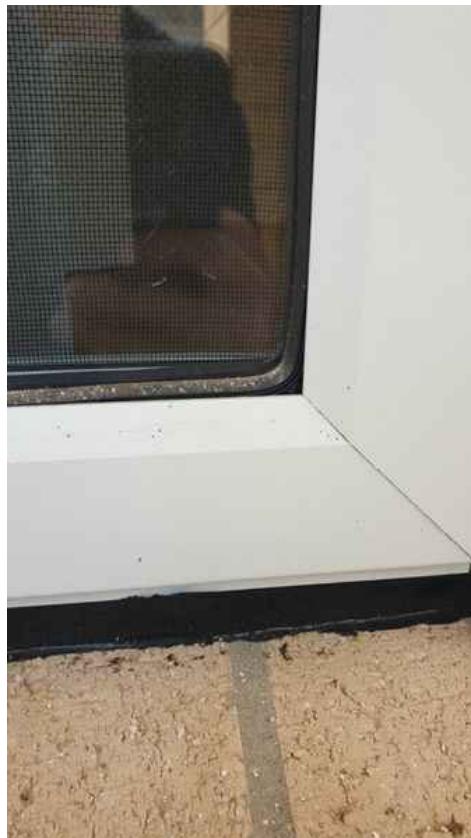
Master Bed window sill, silicone sealed

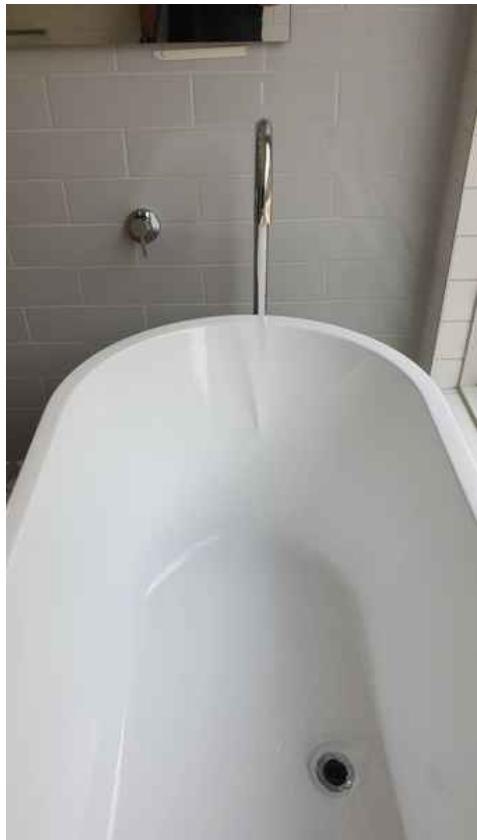
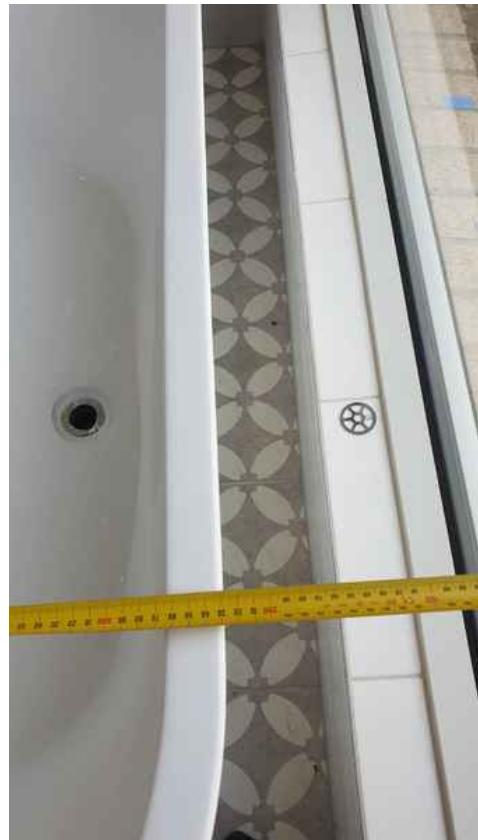
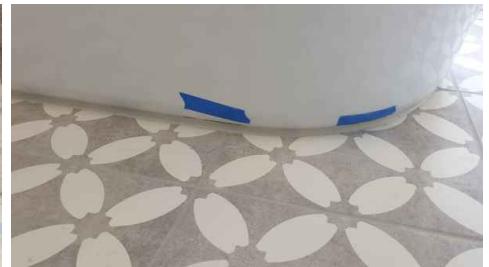
### 20.15.1 Bath

#### NOT CENTRED AS DRAWN

Recommendation

Contact your builder.

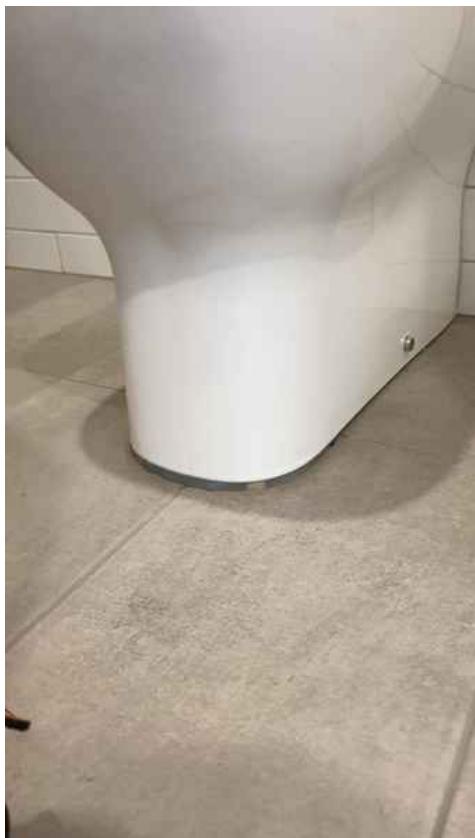
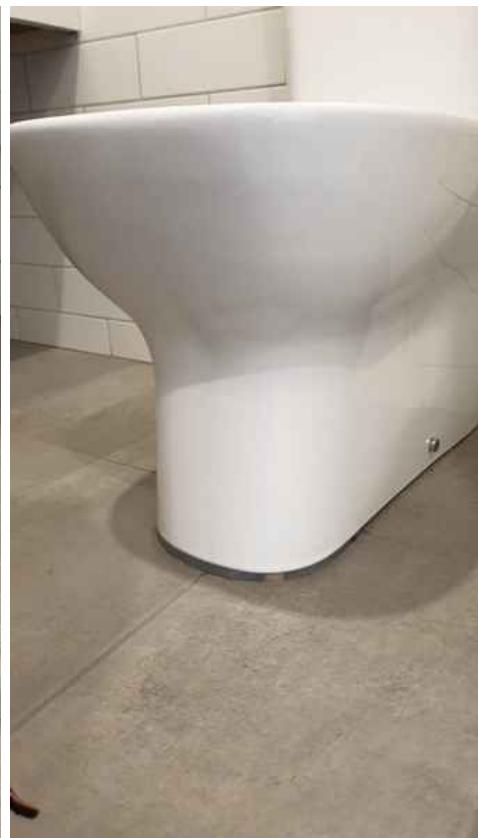
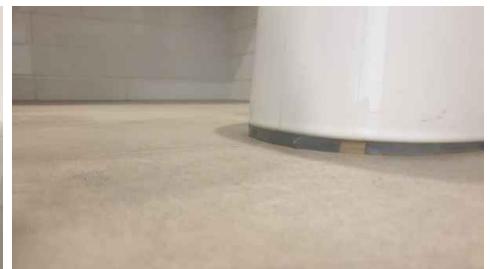
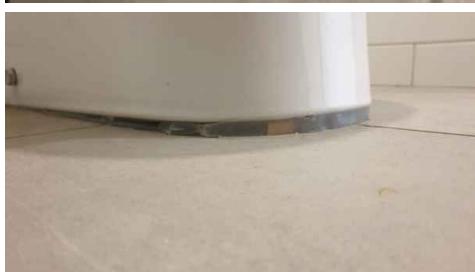
### 21.5.1 Toilet

#### VISIBLE PACKING UNDER PAN

Recommendation

Contact your builder.

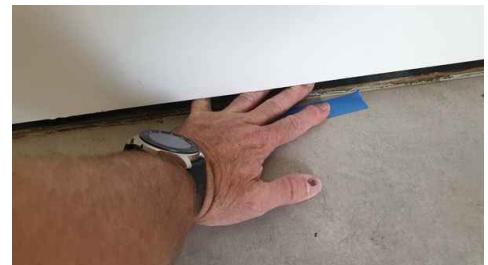
Garage / Laundry Door, No Sill Seal

Contact your builder.

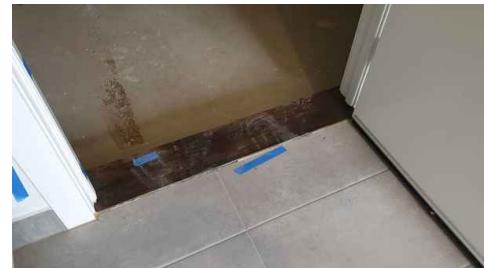
23.6.1 Pedestrian Door

MINOR DEFECT

### WEATHERSTRIP/SEALS MISSING

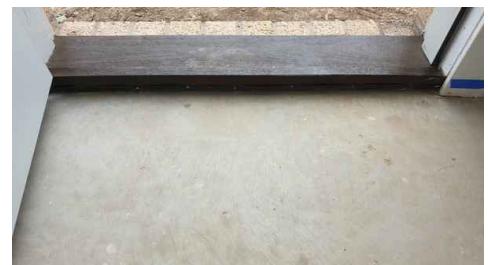
MINOR DEFECT

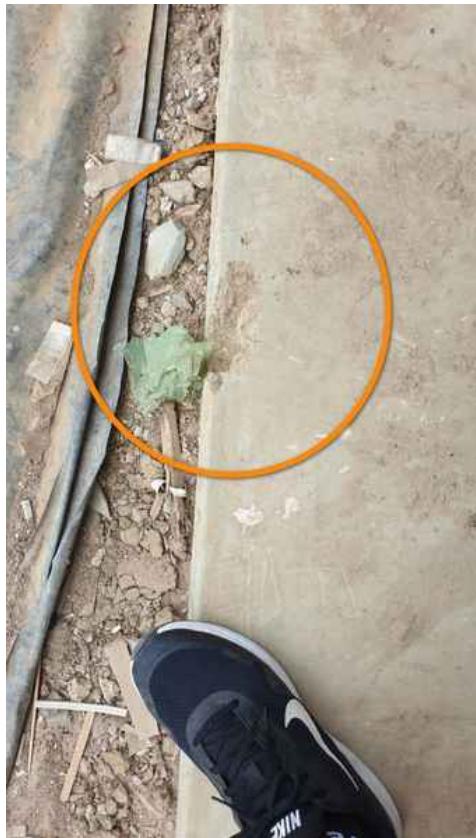
23.11.1 Floor

### CHIP

MINOR DEFECT
