# TOPNOTCH BUILDING INSPECTIONS

## PRE-PURCHASE RESIDENTIAL

1234 Main St. Preston Victoria 3072

08/04/2021 9:00AM

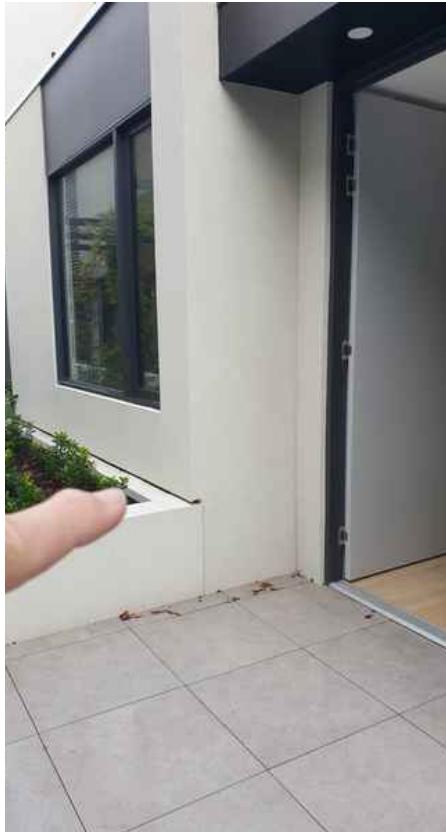
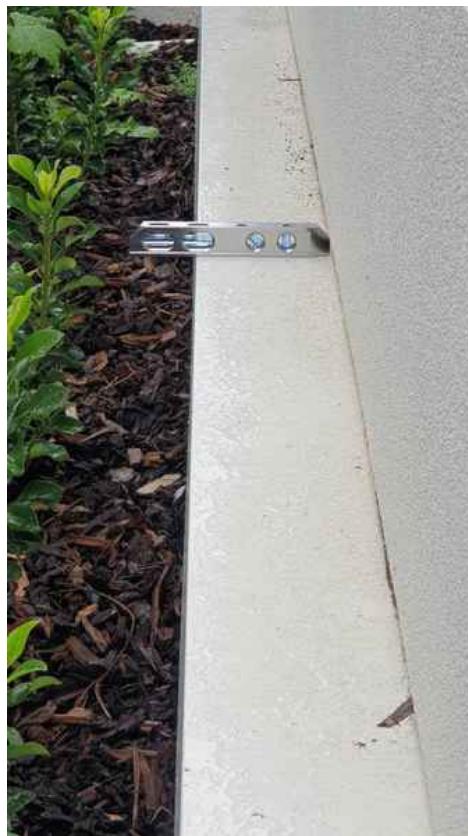
The retaining wall constructed on the front of the dwelling is capped with a flashing that was observed to have negative fall. Water is pooling on this flashing and under the external cladding material. Pooling water will reduce the life expectancy of the flashing and may lead to water ingress into the dwelling.

Pooling Water, negative fall

I recommend altering the flashing to fall away from the dwelling into the garden bed area.

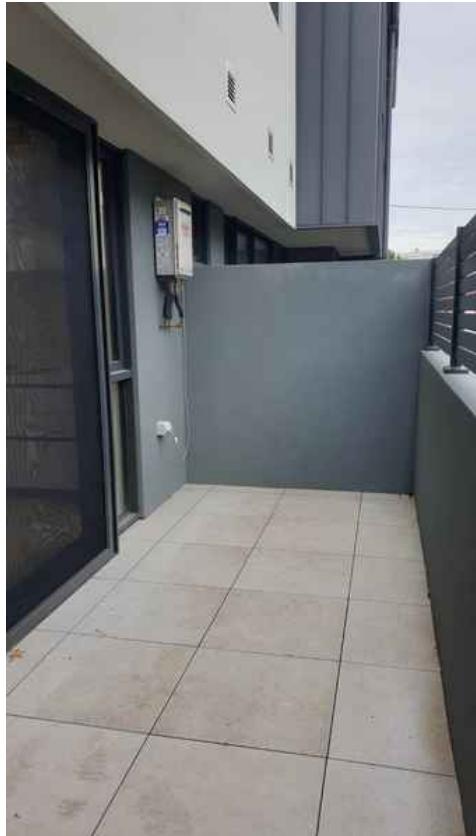
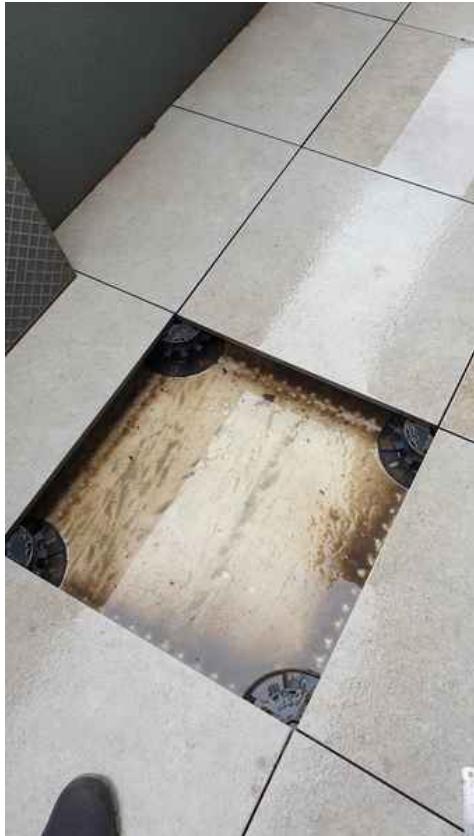
Slime Under Pedestal Tiled Balcony Floor

Contact a qualified professional.

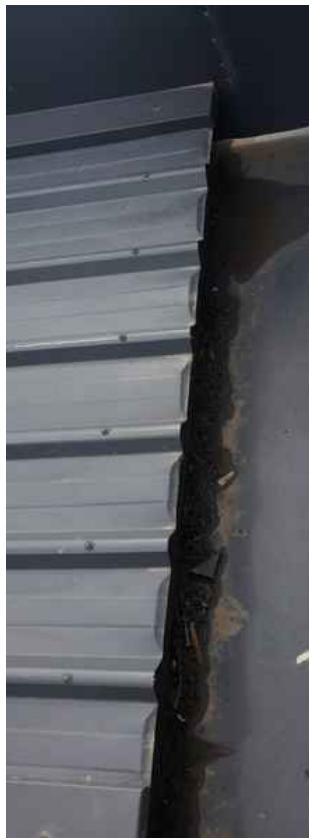
Debris in Gutter

Contact your builder.

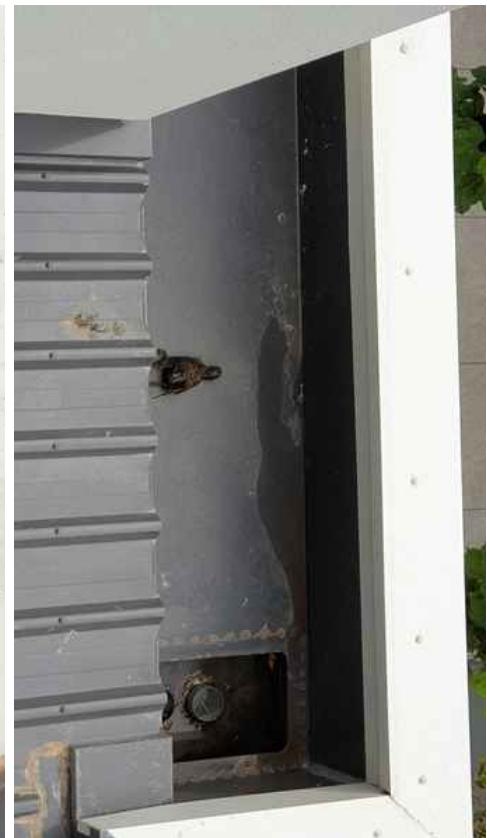
Dead Bird

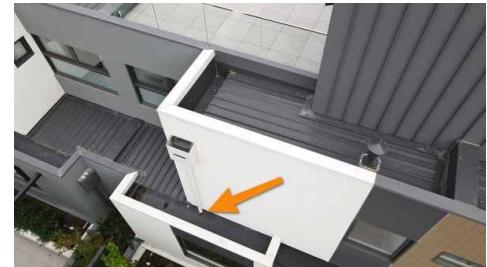
I recommend installing a spreader to the downpipe.

MINOR DEFECT

Recommendation  
Contact your builder.

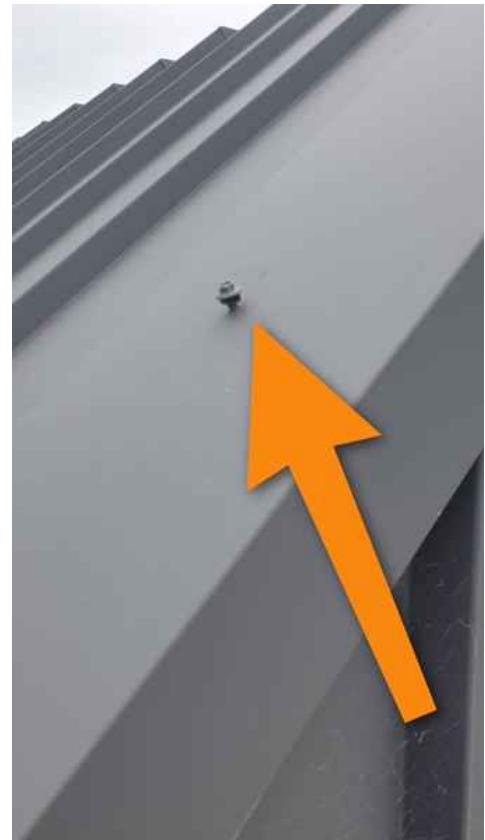
Barge Flashing Staircase Wall on  
Terrace area

Contact your builder.

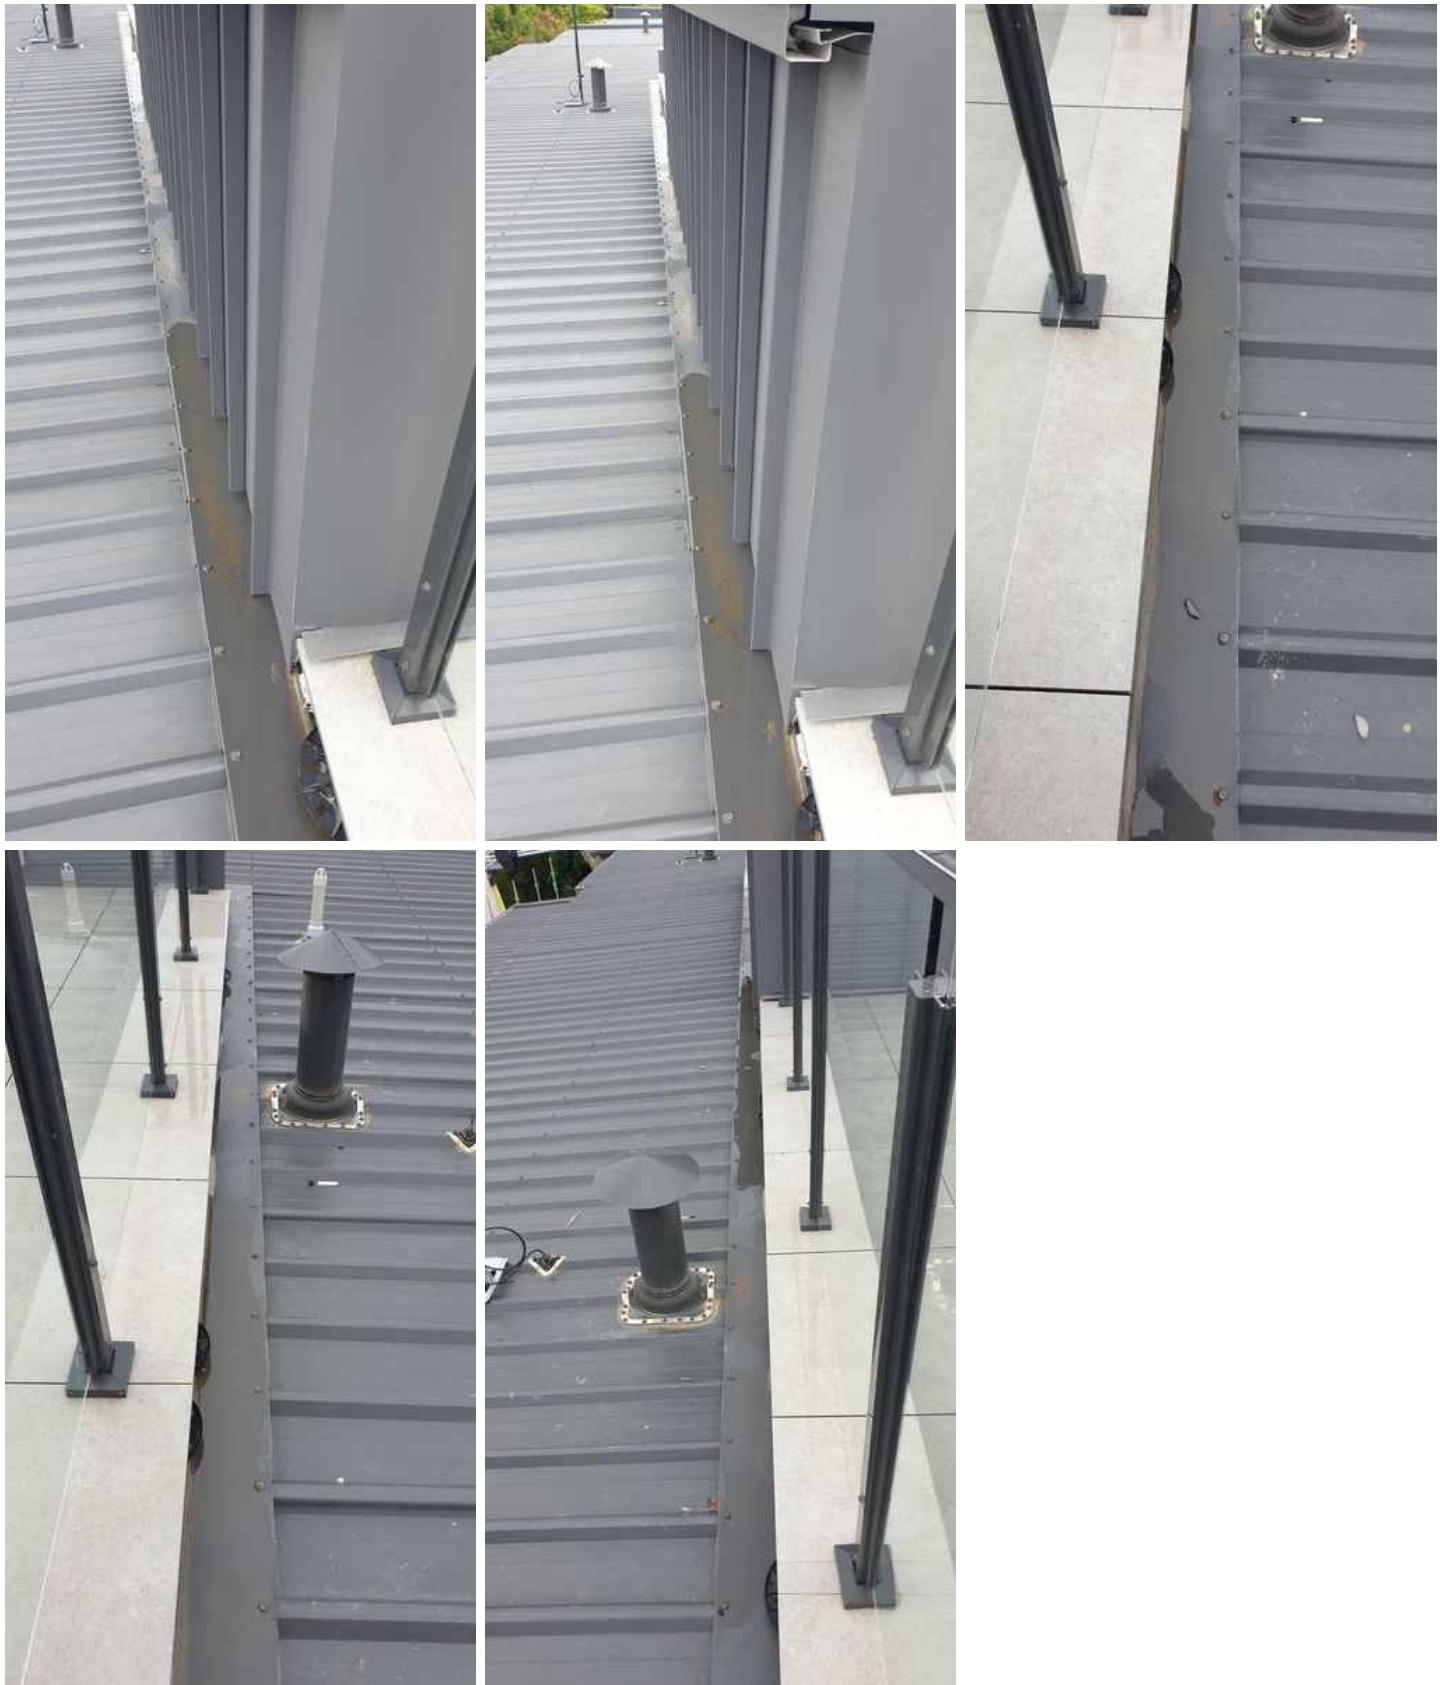
MINOR DEFECT

Pooling water was observed on the apron flashing (profiled to roof sheet) on the roof that abuts the second floor staircase wall.

Australian Standard 3500.3-2018 states "Metal roof drainage systems and support systems shall be designed and installed to achieve complete drainage and drying. Shielded areas capable of causing permanent ponding shall be avoided to prevent the possibility of intense localized corrosion known as crevice corrosion."

I recommend correcting the apron flashing to prevent ponding and premature failure due to ponding and corrosion.

Contact your builder.

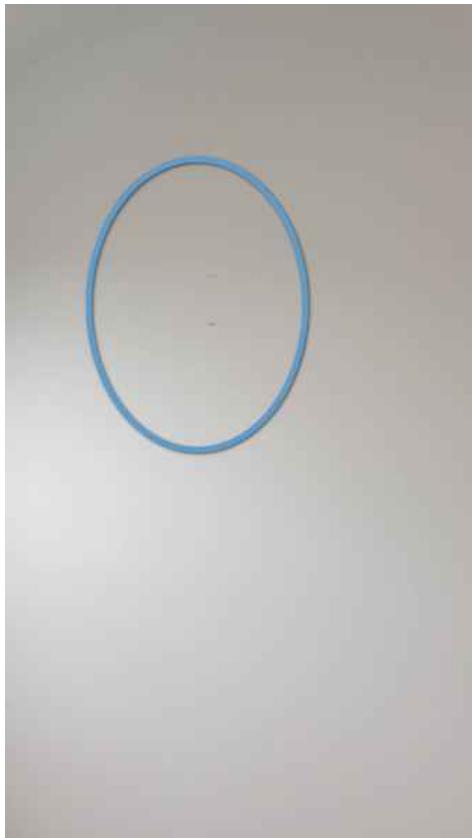
The bedroom wall has nails and pencil marks from previous wall mounted picture frames or paintings.  
I recommend to patch, repair and paint as required.

Contact your builder.

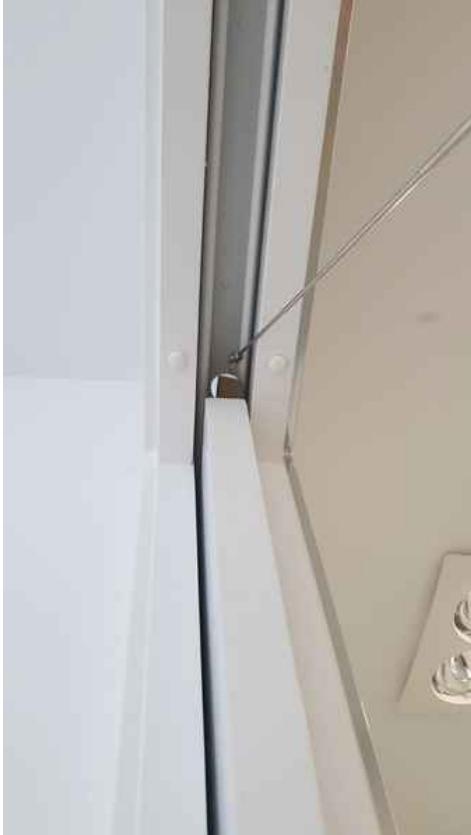
### 9.2.2 Doors

#### **TOP/BOTTOM DOOR EDGES NOT PAINTED**

- MINOR DEFECT

Contact your builder.

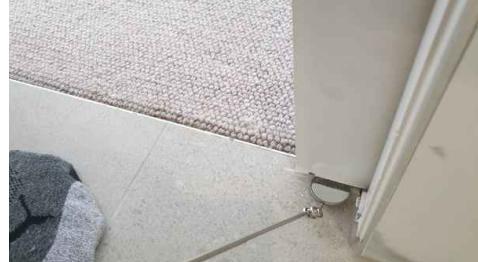
The top or the bottom of the door edges were not painted.  
All door manufacturers require all door edges to be sealed/painted to prevent moisture ingress and bowing of the doors.

I recommend painting/sealing all door edges as required by the manufacturers recommendations / specifications.

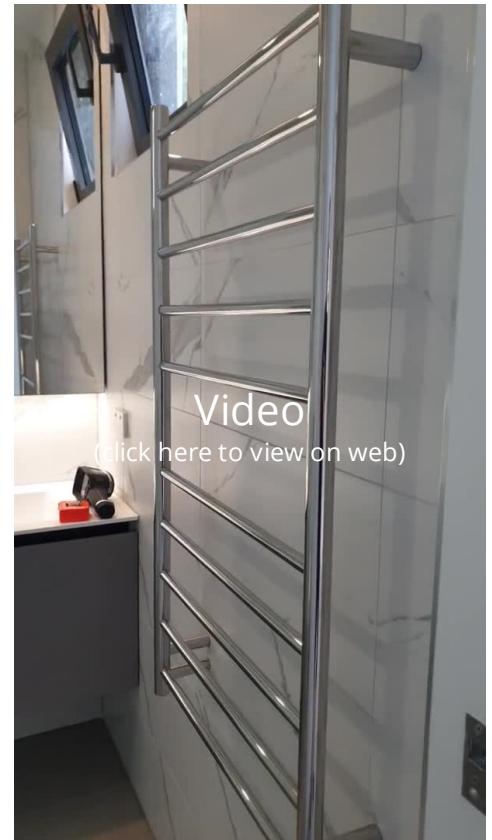
9.17.1 Lighting Fixtures, Switches & Power Outlets  
**HEATED TOWEL RAIL**

MINOR DEFECT

I recommend checking the function of the heated towel rail and rectify as required.

Contact your builder.

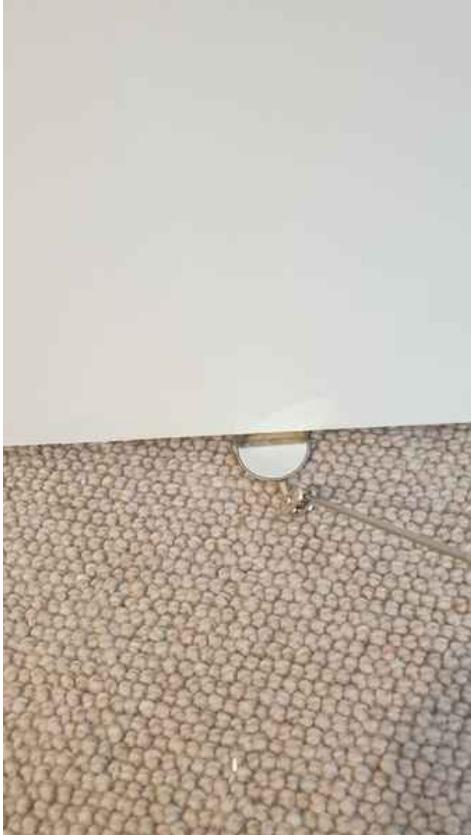
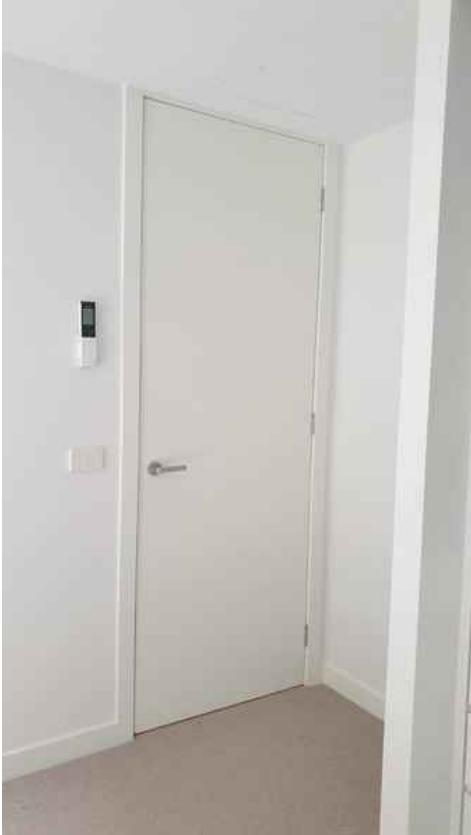
MINOR DEFECT

All door manufacturers require all door edges to be sealed/painted to prevent moisture ingress and bowing of the doors.

I recommend painting/sealing all door edges as required by the manufacturers recommendations / specifications.

Contact your builder.

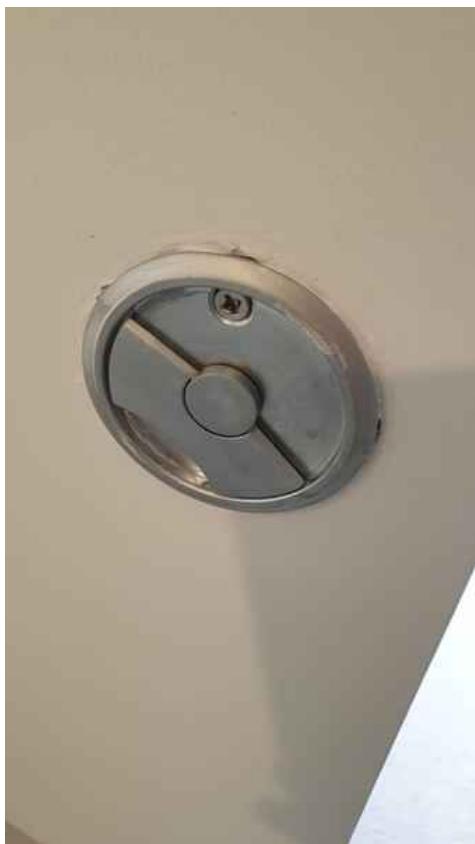
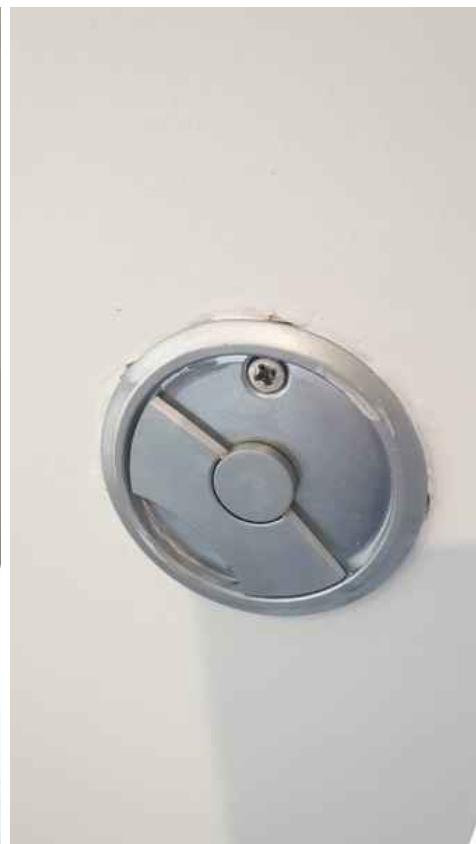
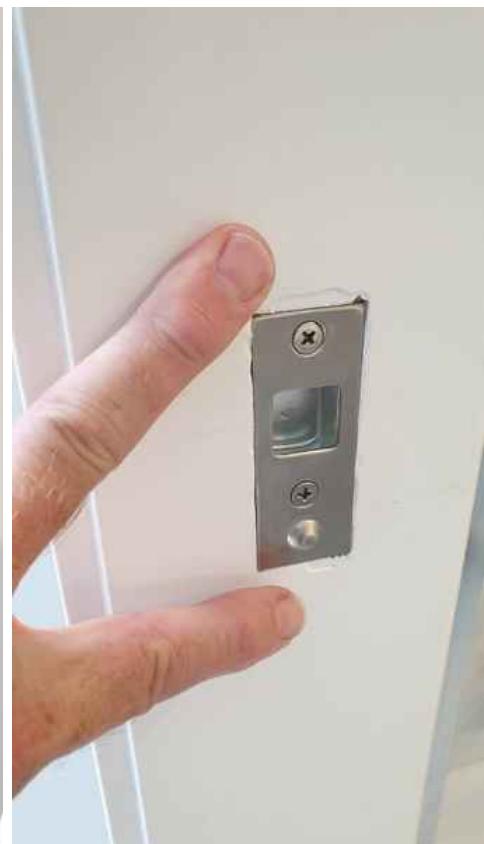
### 11.2.1 Doors

MAINTENANCE ITEM / GENERAL ADVICE

I recommend repairs and painting to make good.

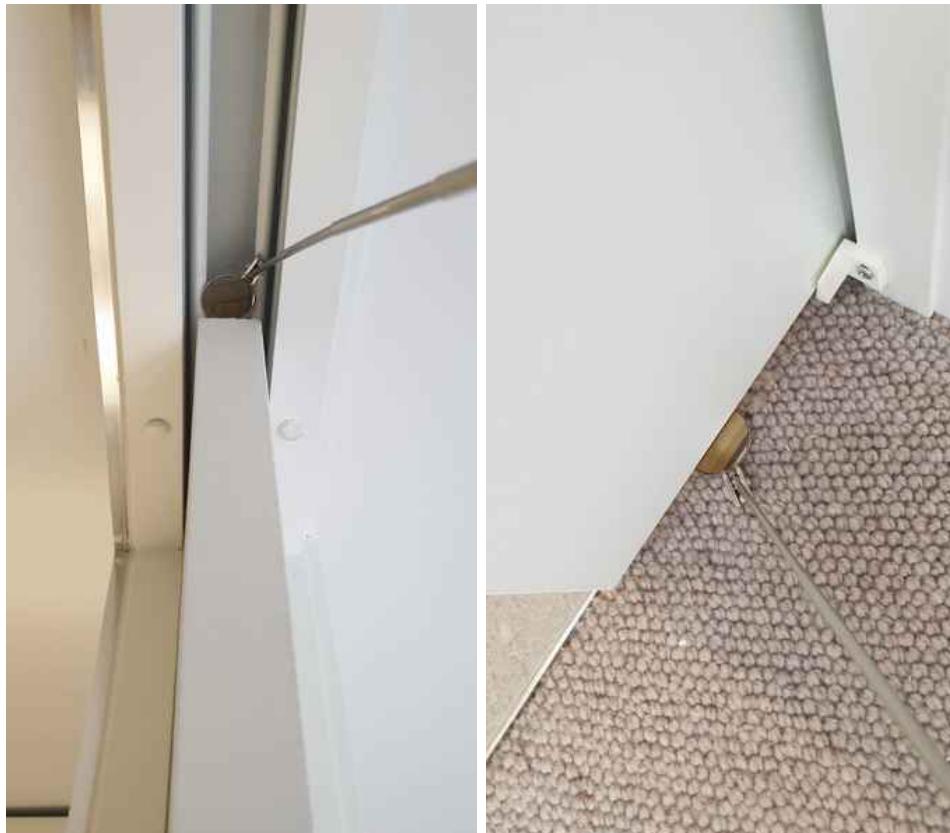
### 11.2.2 Doors

#### TOP/BOTTOM DOOR EDGES NOT PAINTED

MINOR DEFECT

All door manufacturers require all door edges to be sealed/painted to prevent moisture ingress and bowing of the doors.

I recommend painting/sealing all door edges as required by the manufacturers recommendations / specifications.

Contact your builder.

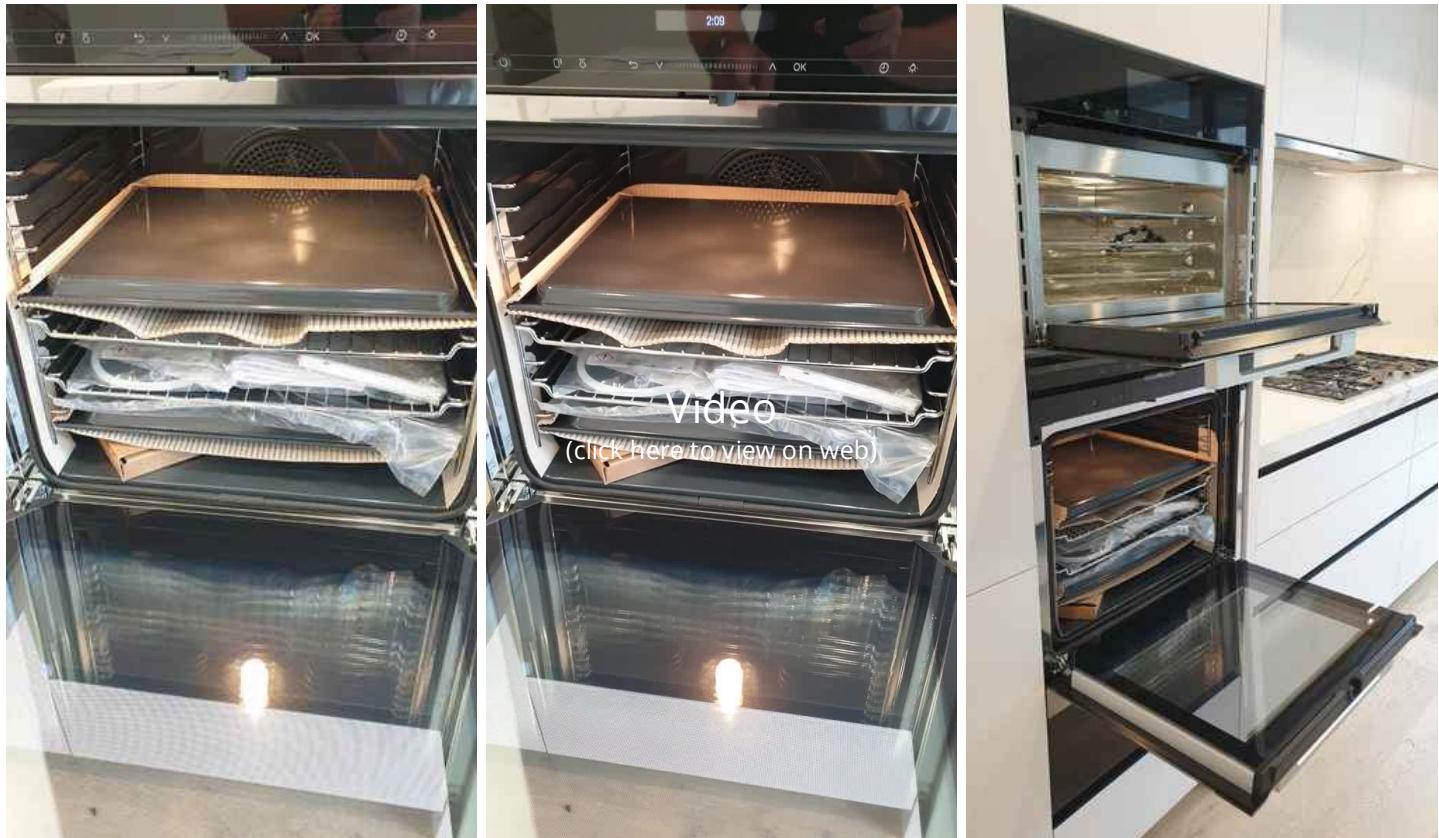
The oven(s) were not operated at the time of the inspection.  
See photo(s) and or Video(s) here in the report.

This was a limitation to my inspection.

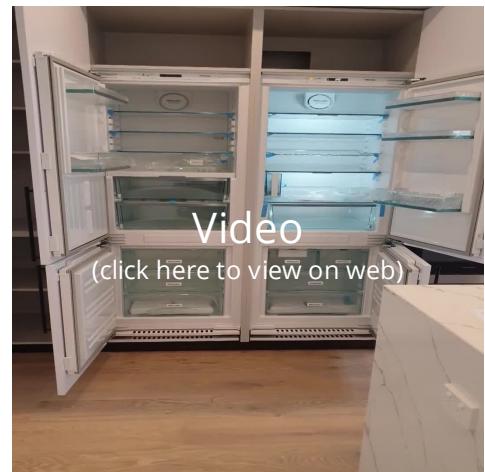
**REFRIGERATOR****REFRIGERATOR OFF**

One of the refrigerators was not working because it had not been connected to the GPO.

I am not aware why the refrigerator was not connected to the power and as such I did not check the refrigerator for function.

This was a limitation to my inspection.

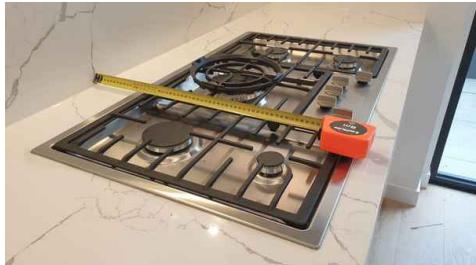
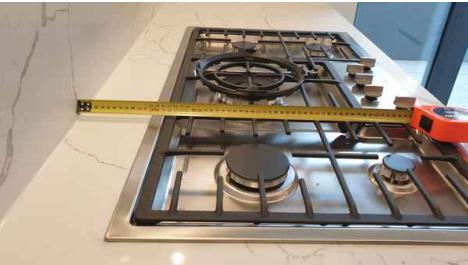
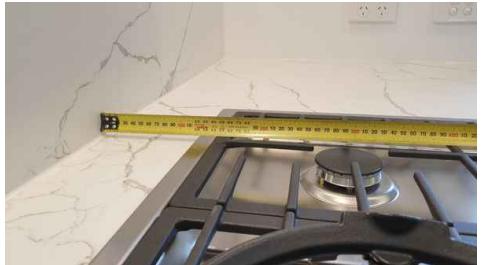
MAJOR DEFECT / SAFETY HAZARD

The gas cook-top does not achieve the minimum clearances to combustible materials and is a Safety Hazard.

A minimum clearance of 200mm is required when measured horizontally from the edge the nearest burner to any vertical combustible surface or conducting material, and the splashback must be a minimum of 150mm in height. Materials such as ceramic tiles less than 5mm thick, non-toughened glass and stainless steel are not fire rated materials and require fire rated substrates behind them to be deemed to comply.

As this is a visual, non-invasive inspection, the inspector can not determine the substrate used in this circumstance and recommends obtaining a certificate of compliance from the current home owner or contacting a licensed gas fitter for further advice and repair / rectifications.

I recommend the builder verify the material used behind the reconstituted stone splashbacks is a suitable fire rated material as per AS/NZS 5601 Appendix C.

Contact your builder.

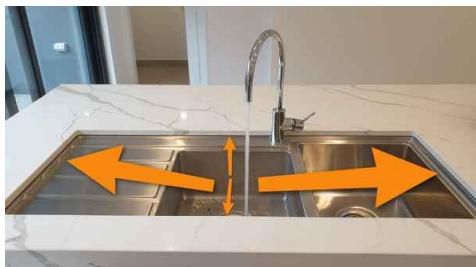
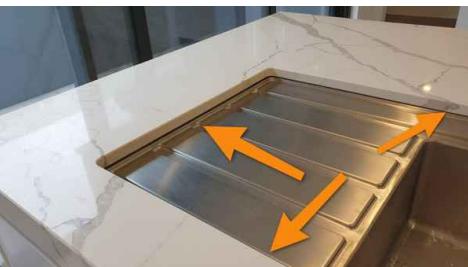
## 12.10.1 SINK

**MISSING SEALANT SINK / BENCHTOP**
- MINOR DEFECT

Sealant has not been installed between the kitchen sink and the benchtop (Island Bench). I recommend installing sealant to the kitchen sink / benchtop area to prevent water damage and ingress into the substrate.

Contact your builder.

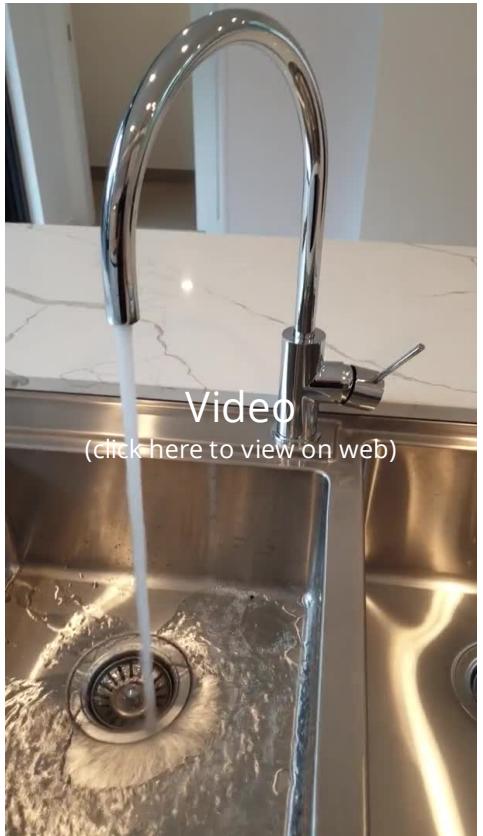
## 12.11.1 SINK MIXER / TAP

**LOOSE MIXER**

The kitchen sink mixer was loose at the time of the inspection.

I recommend tightening the mixer to ensure proper function.

Contact a handyman or DIY project

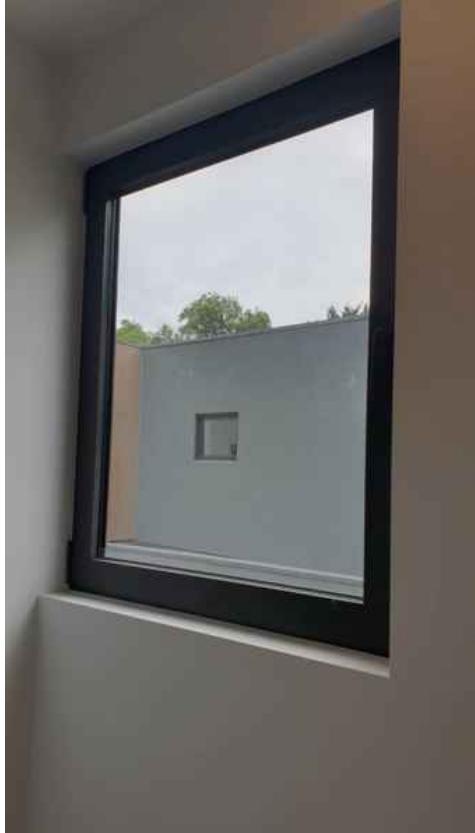
MINOR DEFECT

I recommend checking the function of this window.

Contact a qualified carpenter.

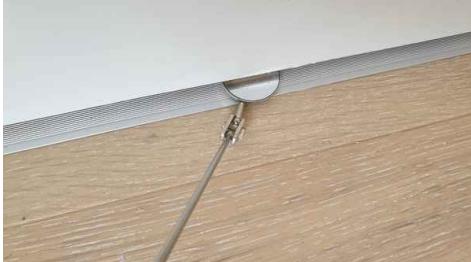
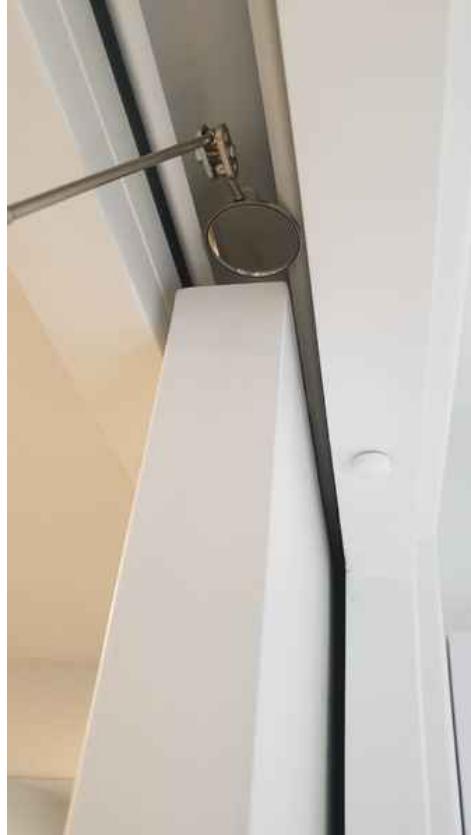
### 17.2.1 Doors

#### **MINOR DAMAGE TO BOTTOM EDGE**

Bottom edge of door has minor surface damage evident and requires repair.

All door manufacturers require all door edges to be sealed/painted to prevent moisture ingress and bowing of the doors.

I recommend painting/sealing all door edges as required by the manufacturers recommendations / specifications.

Contact your builder.

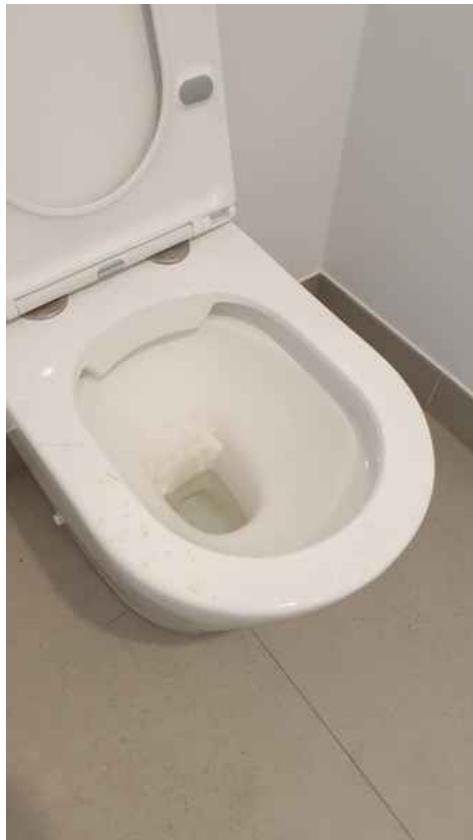
## 17.13.1 Toilet

**REQUIRED TO BE  
CLEANED**

Contact your builder.

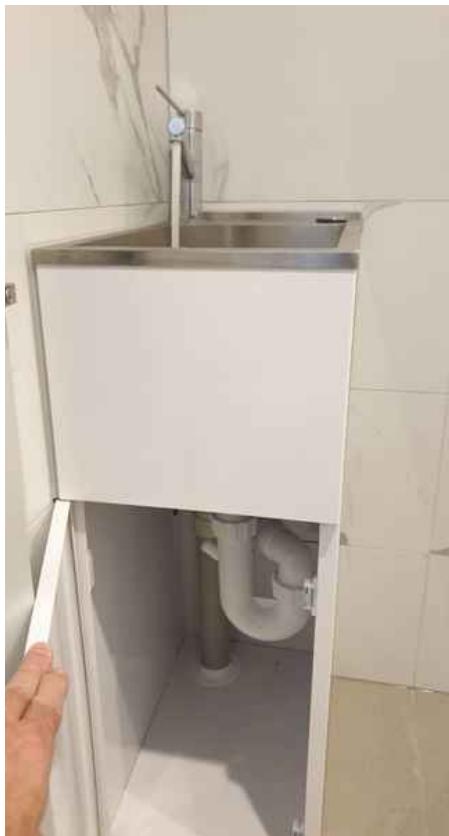
**Laundry Tub: Laundry Taps****In Tub, Mixer**

Laundry taps were operated and checked for function, not defects were found unless noted within the report.

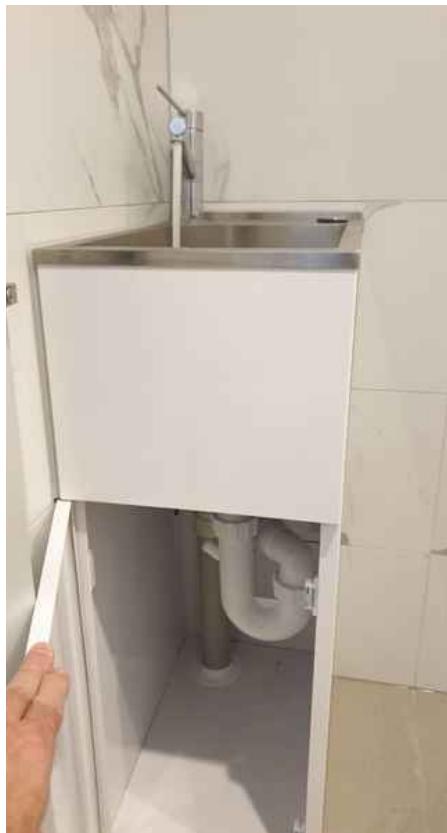
## Under Tub Plumbing: Under Laundry Tub Plumbing

Water is ran in the tub and allowed to drain through the waste outlet. Whilst the water is running the under tub plumbing is checked for active water leaks and evidence of previous water leaks. No Leaks were found at the time of the inspection unless noted in this report.

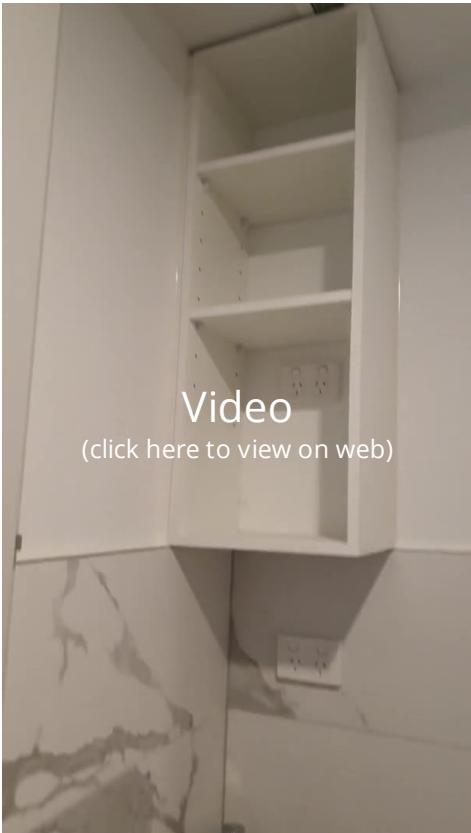
MINOR DEFECT

The exhaust outlet in the laundry ceiling is partially occluded by an overhead cupboard.  
I recommend the builder check and verify the flow rate of the exhaust system to ensure it is a minimum flow rate of 40L/s (Litres per second) as per **NCC2019 Volume 1, Section F Health and amenity, Part F6 Condensation Management, F6.3 Flow rate and discharge of exhaust systems**

Occluded exhaust in laundry

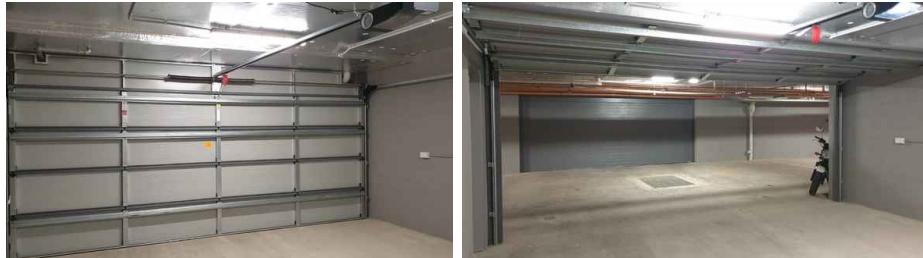
**Vehicle Door: Overhead Garage Door**

Inspection of overhead garage doors typically includes examination for presence, serviceable condition and proper operation of the following components: door condition; mounting brackets; automatic opener; automatic reverse; photo sensor; switch placement; track & rollers; manual disconnect.

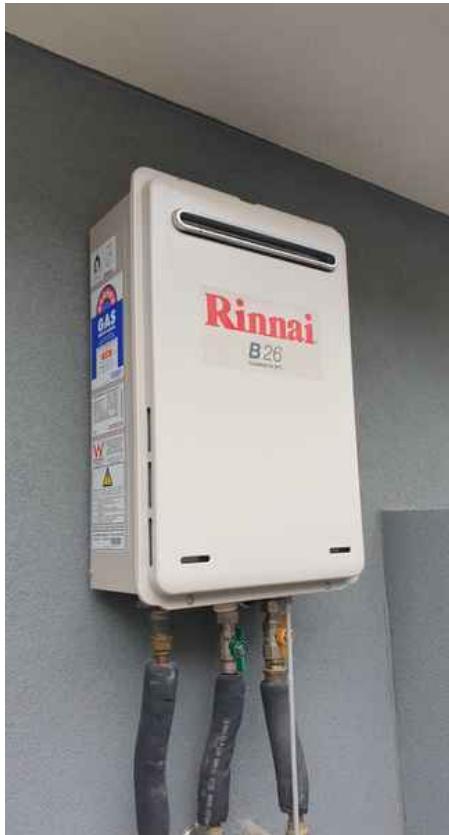
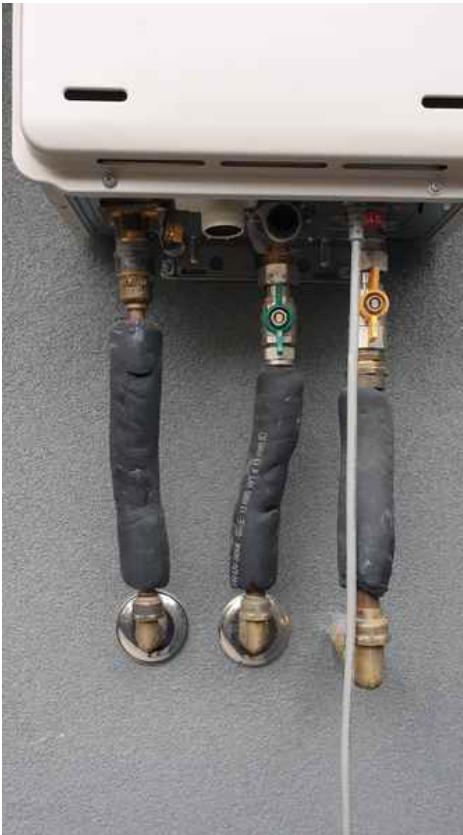
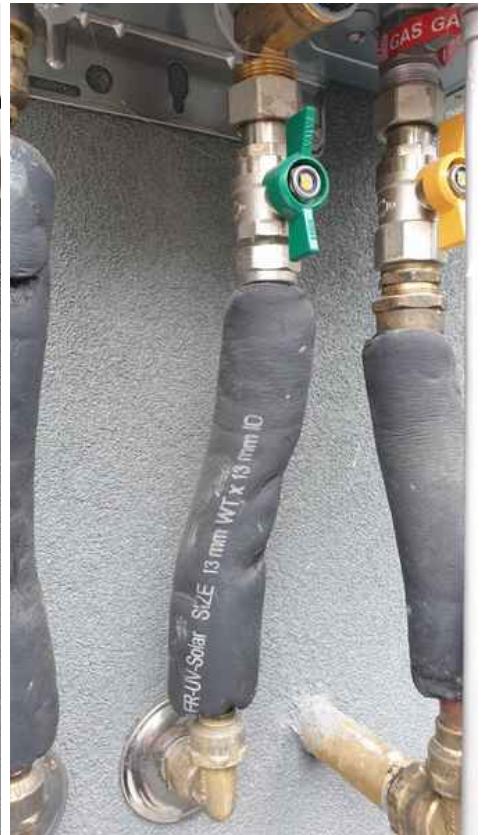
**Hot Water System: HOT WATER SERVICE: CONDITION & PHOTOS**

Serviceable
