ON POINT HOME INSPECTIONS LLC

## RESIDENTIAL REPORT

1234 Main St.  
Wilton, CT 06879

02/24/2020 9:00AM

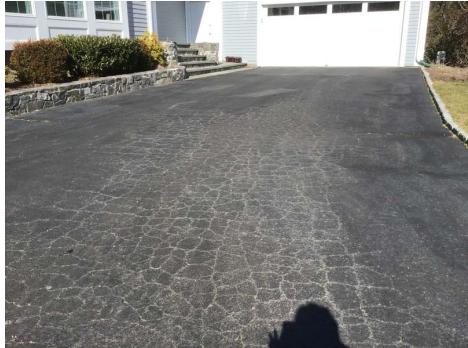
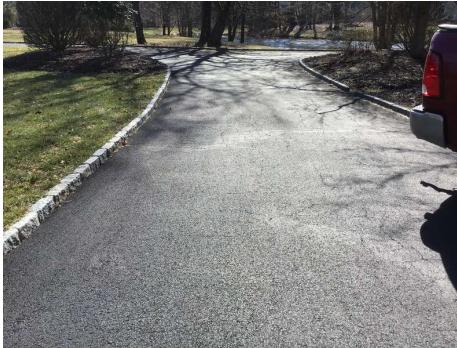
**Driveway: Condition- Deficiencies Observed**

The asphalt driveway had reportable conditions observed at the time of inspection. Underground tree roots, salt, snow melting products, lack of maintenance and age are the biggest contributors to asphalt deterioration. It is recommended regular sealcoating every 2-3 years to preserve the driveway and keep it from cracking and deteriorating.

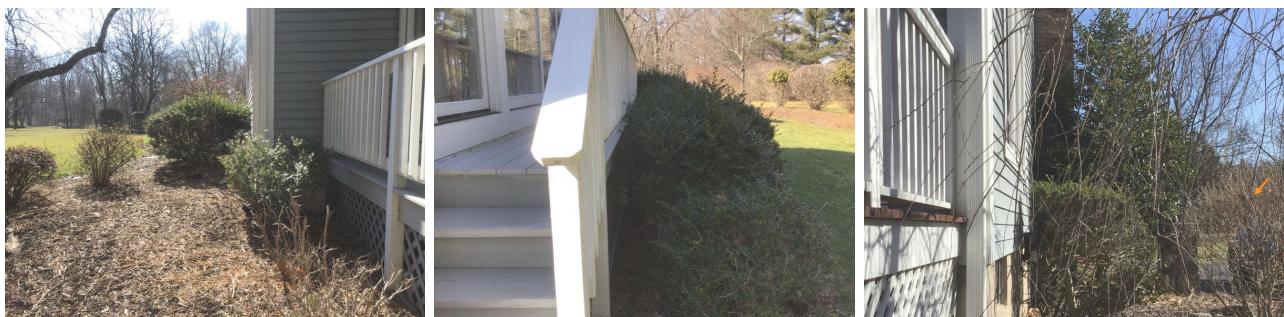
Shrub and tree growth observed making contact with the house. Regular maintenance and pruning should be done on an ongoing basis to prevent contact with the structure. Recommend having a landscape contractor rectify the issue.

Contact a qualified landscaping contractor

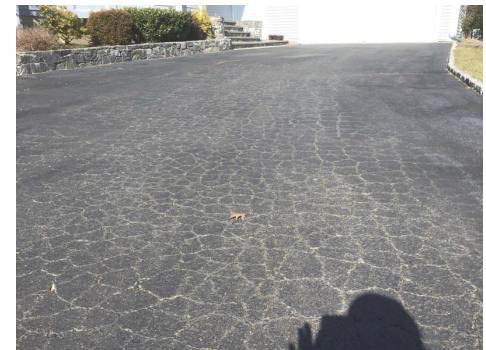
## 2.4.1 Driveway

**DRIVEWAY CRACKING - FATIGUE**

Fatigue cracks observed, which may indicate movement in the soil. Recommend monitor and/or have a asphalt contractor evaluate the deficiency.

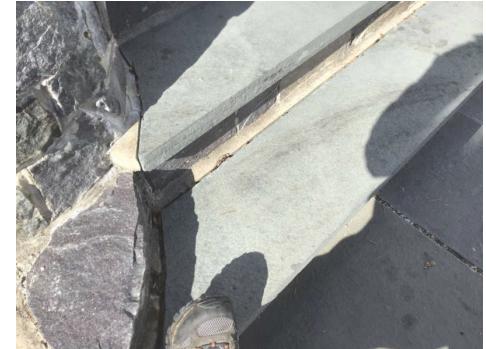
## 2.5.1 Steps

**STAIRS- LOOSE TREAD**

The stair tread(s) are loose. This is a tripping hazard. Recommend having the treads properly affixed.

Contact a qualified professional.

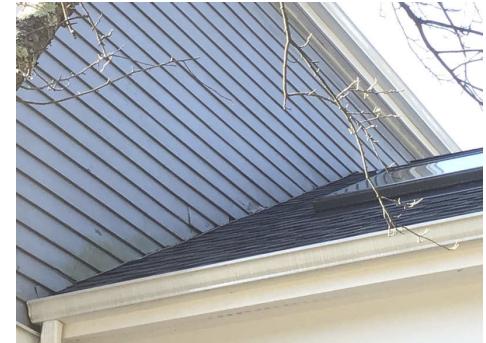
**SIDING DETERIORATION**

An area of the siding appears to be deteriorating. This is most likely caused by inadequate spacing between the roofing material and the siding. It is recommended that a qualified contractor make any and all repairs necessary to rectify the defect.

Contact a qualified professional.

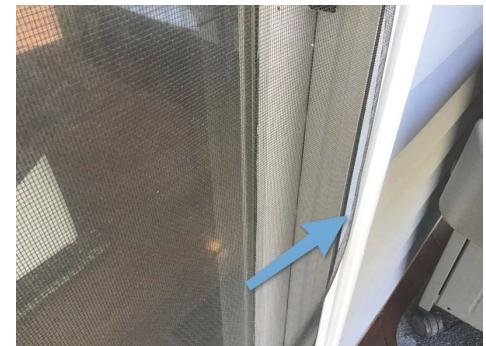
**SCREEN DAMAGED**

Contact a handyman or DIY project

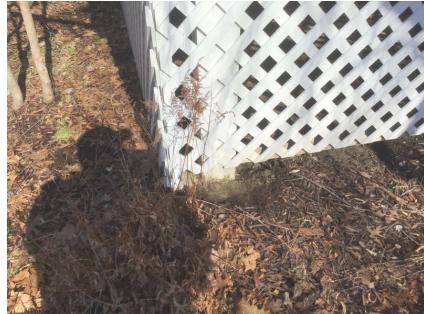
Wood will rot when it is exposed to moisture and in contact with soil or other material which prevents the wood from drying out. The only (partial) exception is ground contact, pressure-treated lumber. However, even such "treated" lumber is usually not fully impregnated with wood preservatives and subject to some wood rot damage.

It is recommended that a separation of six inches or more be maintained between all wood and any soil, gardening material, or firewood.

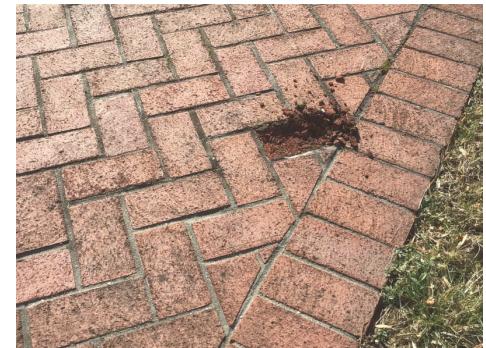
#### 2.9.2 Decks, Balconies, Porches & Steps

#### DAMAGE PAVER

Contact a qualified professional.

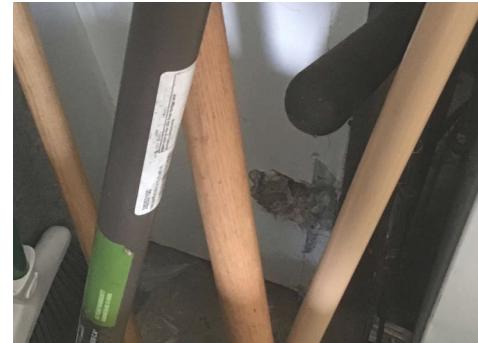
### 3.1.1 Walls & Firewalls

#### DAMAGED DRYWALL

Garage wall had damaged drywall. Recommend repairing.

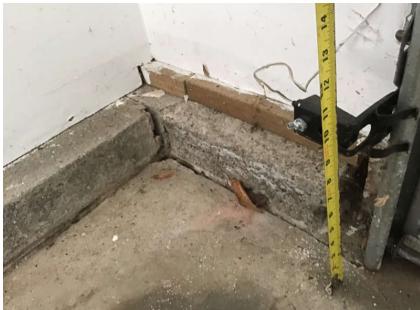
### 3.5.1 Garage Door Opener

#### PHOTO SENSOR NOT INSTALLED AT PROPER HEIGHT

Contact a qualified garage door contractor.

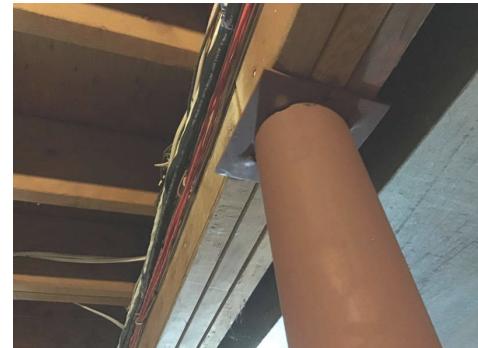
The steel columns were not lagged to the framing overhead. Proper attachment to the framing is recommended by a contractor or other qualified person.

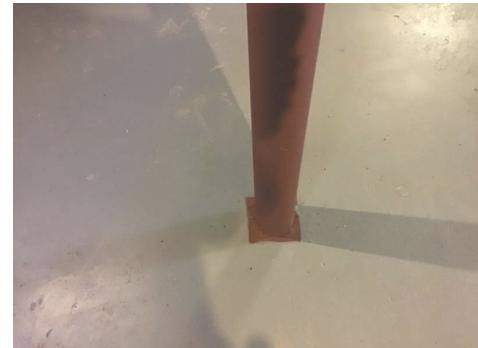
### 4.2.2 Floor Structure/ Framing

#### BOTTOM PLATES OF COLUMNS VISIBLE

The bottom plate of a steel column in the basement was visible. Typically columns are installed on 2 feet by 2 feet by 2 feet footers below the slab, and the slab then poured to the column to secure it in place. No cracks were observed radiating out from the column location at the slab, and the slab may be reinforced below this area. I recommend having a qualified person to evaluate the blueprints for the home (if available), and evaluation by a contractor and/or structural engineer. At a minimum the base plates should be attached to the slab to prevent lateral displacement.

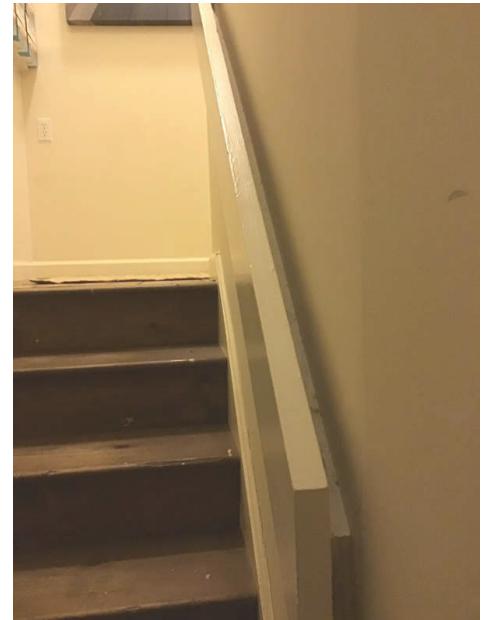
#### 4.4.1 Steps, Stairways & Railings **HANDRAIL NON-CONTINUOUS**

The stairway handrail is non-continuous. This is a safety hazard and it is recommended that a qualified contractor rectify the defect.

Contact a qualified professional.

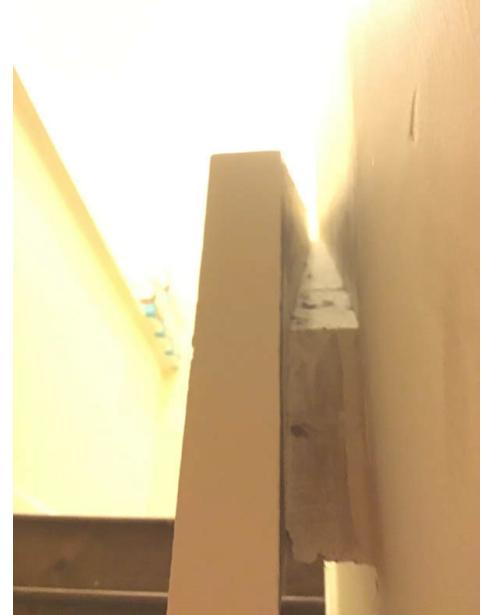
#### 4.4.2 Steps, Stairways & Railings **HANDRAIL, NOT GRASPABLE**

The handrail needs a groove on both sides. The intent of the finger and thumb groove is to provide equivalent grasp ability as might be obtained on a round 2-inch handrail. Recommend having a qualified contractor rectify the defect.

Contact a qualified professional.

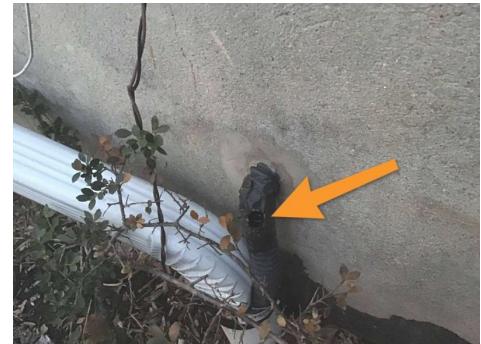
#### 4.7.1 Sump Pump **SUMP DRAIN LINE DAMAGED**

The sump pump drain line was damaged. Recommend a qualified contractor make any and all repairs necessary to rectify the defect.

Contact a qualified professional.

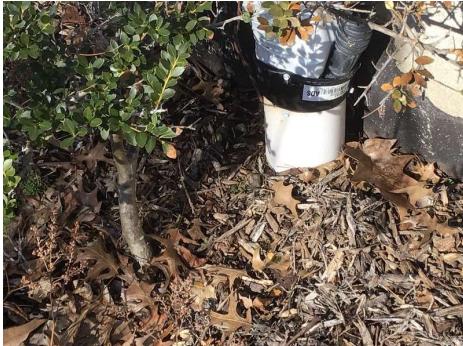
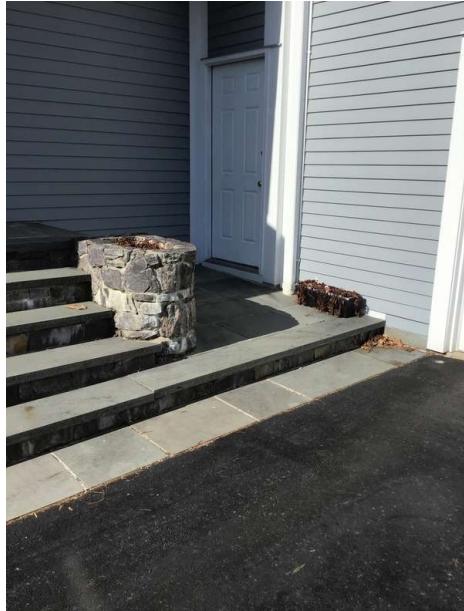
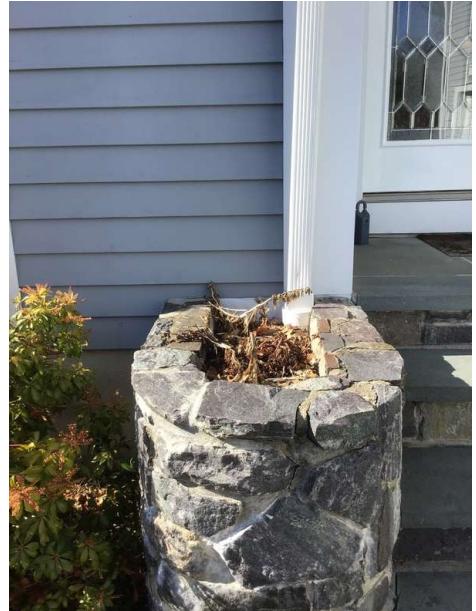
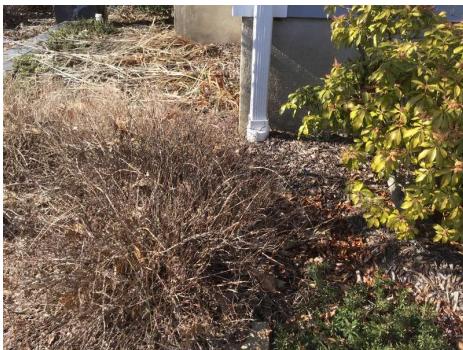
## Roof Drainage Systems: Downspouts- Terminated Below Grade

Some downspouts terminated below grade. Their connection to a drain tube could not be confirmed.

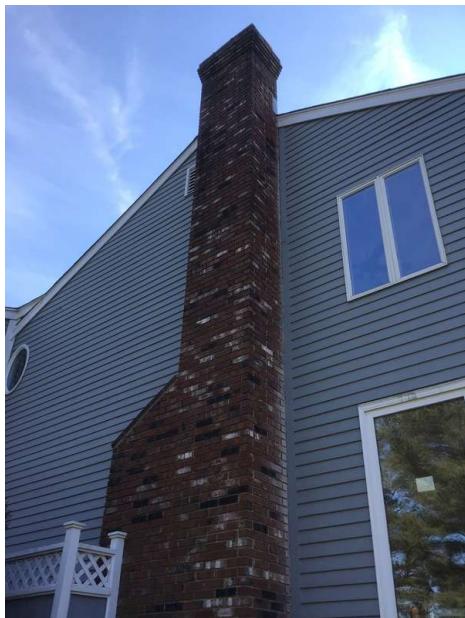
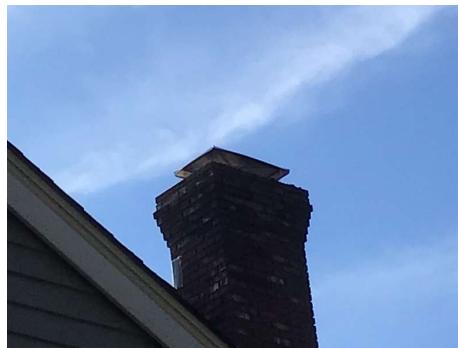
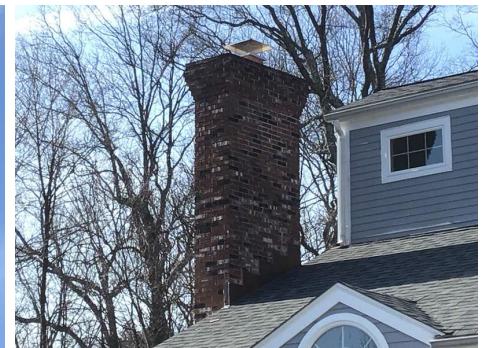
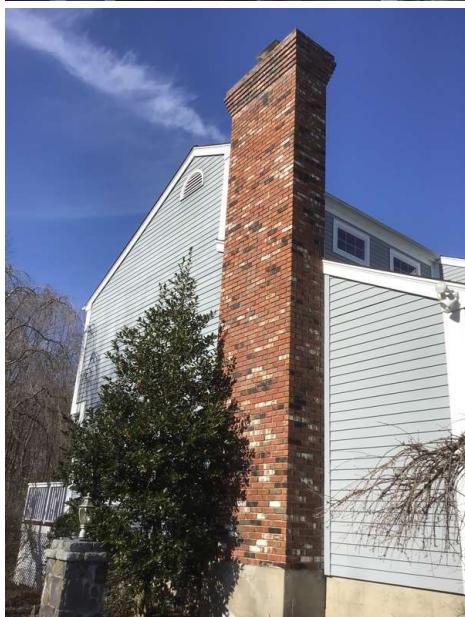
**Skylights, Chimneys & Other Roof Penetrations: Chimney Condition- Satisfactory**

The chimney is in good condition with no major cracking in the mortar joints and flashed correctly to the roof. There is a proper spark arrestor and rain cap on the top of the chimney and no major defects were noted at the time of the inspection.

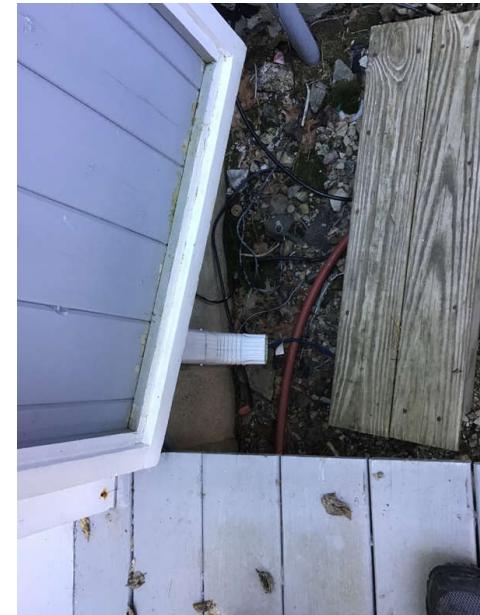
One or more downspouts drain too close to the home's foundation. This can result in excessive moisture in the soil at the foundation, which can lead to foundation/structural movement. Recommend a qualified contractor adjust downspout extensions to drain at least 6 feet from the foundation.

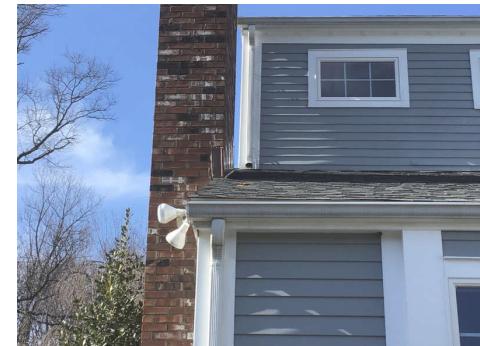
### 5.3.2 Roof Drainage Systems

#### DOWNSPOUT DISCHARGES ON THE ROOF

The downspout is improperly discharging onto the roof because of a missing transition extension.

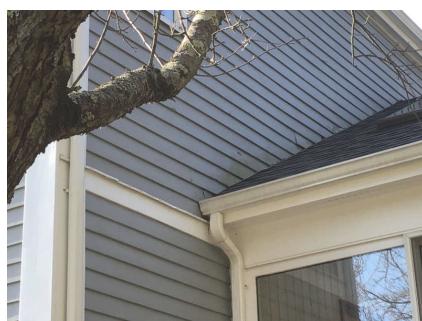
### 5.4.1 Flashings

#### NO KICK-OUT FLASHING

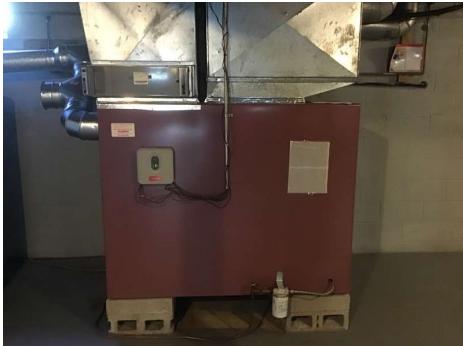
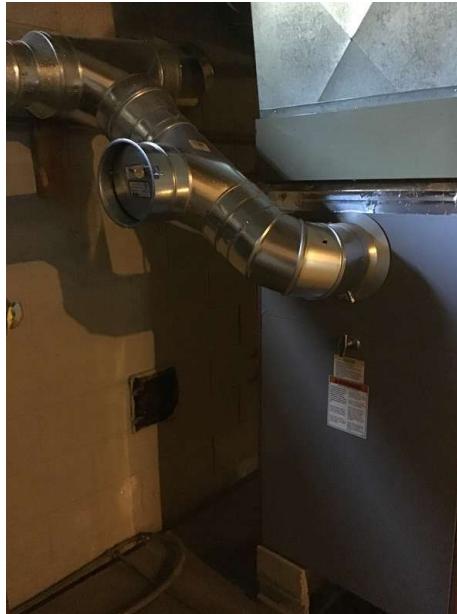
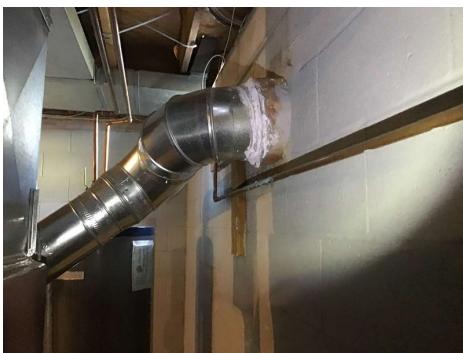
## Furnace Condition- Satisfactory

The furnace was in working condition on the day of the inspection. The system was tested using the thermostat controls and fired properly, as heat was delivered to all areas in the house. The unit appeared to have been serviced properly as evidenced by the service tags. It is recommended to get annual servicing of the unit to keep it at peak operating efficiency.

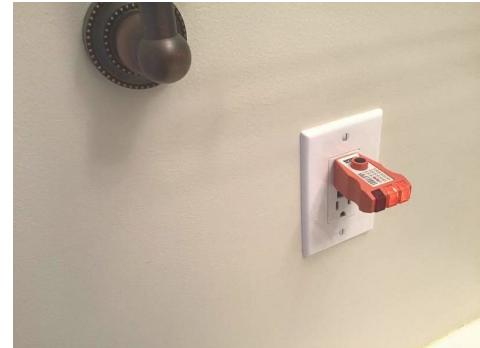
**FYI- This is NOT a safety issue, rather an issue of inconvenience.** The GFCI's in Master Bathroom and Bathroom #1 are on the same circuit and not wired correctly. When the GFCI in bathroom #1 is tripped, it will not reset and also trips the GFCI in the master bathroom. The GFCI in the master bathroom must be reset in order to reset bathroom #1's GFCI. A licensed electrician can rectify this issue.

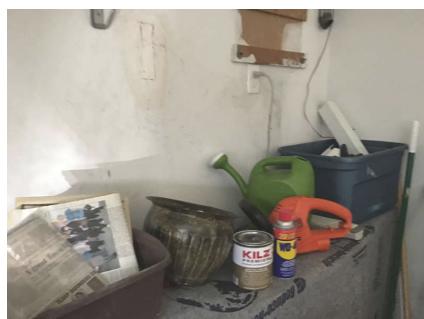
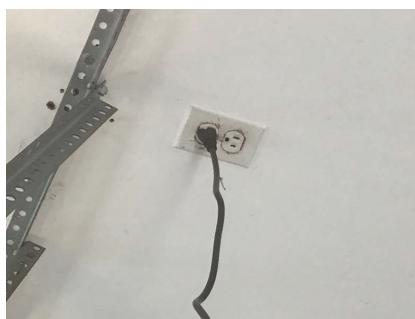
Garage

No GFCI protection present in all locations. Recommend licensed electrician upgrade by installing ground fault receptacles in all locations.

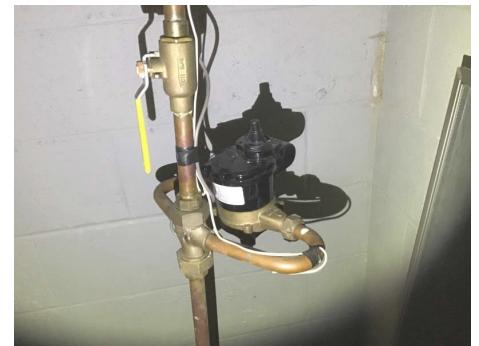
Water Meter- Not Bonded

Water pipe bonding jumper(s) were missing at the referenced area(s). Bonding jumpers should be present at any areas in the piping system that can be removable (pressure regulator, shut off valve(s), etc.) as these removable components can affect continuity, as well as any areas where metallic plumbing has been replaced with non-metallic plumbing. An evaluation of the water pipe bonding is recommended by a licensed electrician with the installation of jumpers made as needed for safety and proper bonding.

Contact a qualified electrical contractor.

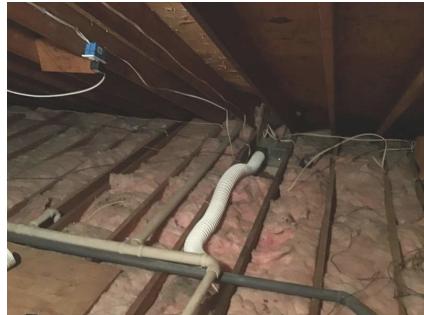
Bathroom fan vents into the attic, which can cause moisture and mold. Recommend having a qualified contractor properly install ductwork to terminate exhaust to the exterior.

Contact a qualified professional.

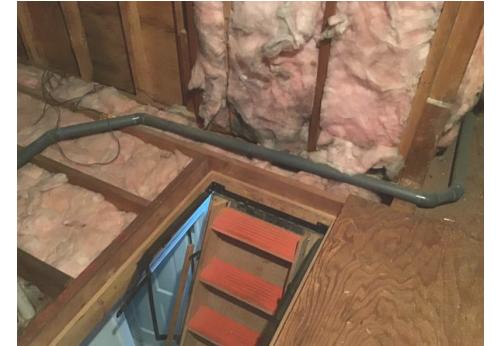
The attic stairs are oriented in such a way that it's difficult to transition from the ladder to the attic space. Recommend having a qualified contractor access the condition/defect and make any and all repairs necessary

Contact a qualified professional.

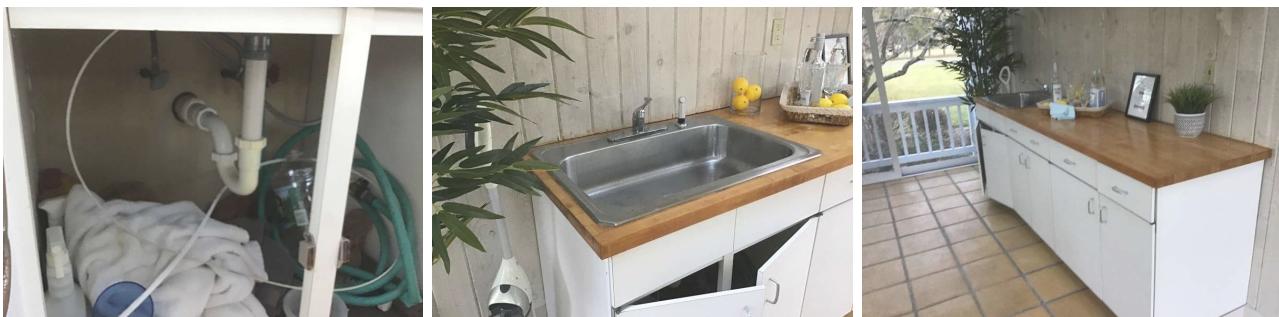
### WET BAR

The wet bar is located in a three season room with the hot tub. The water was turned off at the sink for the winter. The working condition of the sink could not be confirmed, nor could the plumbing for any leaks.

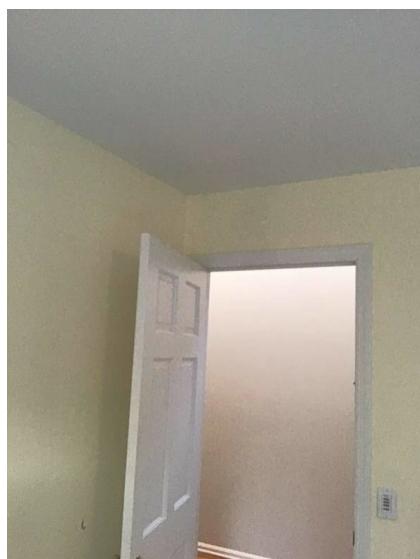
There was no smoke/ CO detector located in the room. This is a major safety hazard. Recommend having a smoke/ CO detector installed prior to moving in.

Contact a qualified professional.

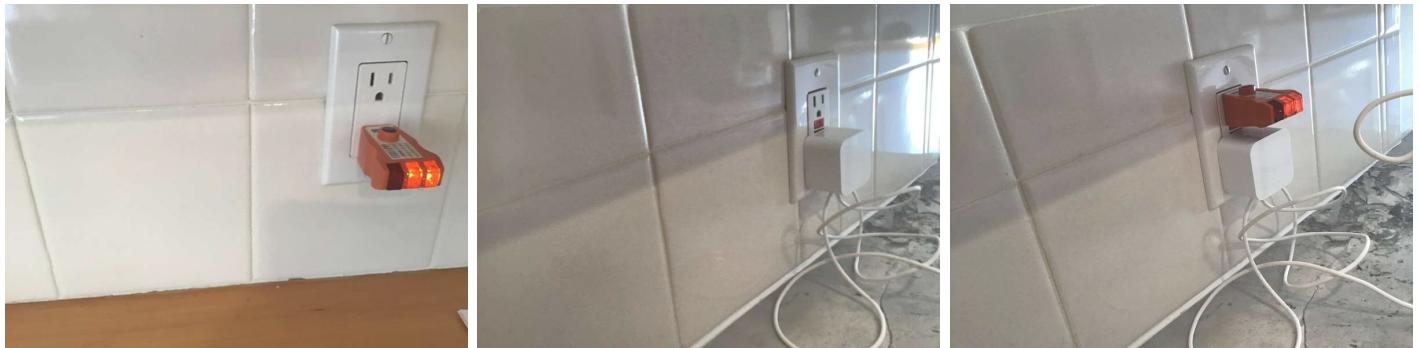
Above Counter

The GFCI was tested and functioned properly on the day of the inspection.

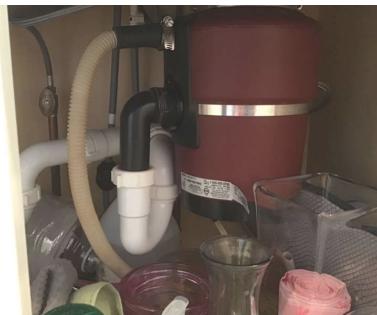
## 12.6.1 Dishwasher

**HIGH LOOP MISSING**

A "high loop" or "air gap" was not present for the dishwasher drain line at visible portions. A high loop or air gap prevents wastewater from siphoning back into the dishwasher during operation. The proper installation of the dishwasher drain line is recommended by a licensed plumber or other qualified person.

Contact a qualified professional.

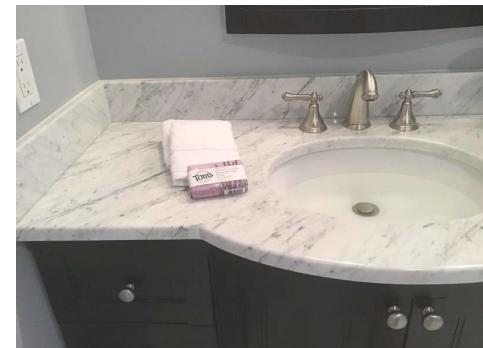
#### 16.2.1 Sink(s)

Slow or hindered drainage was present in the left sink. Repairs are recommended to achieve proper drainage by a licensed plumber or other qualified person.

Contact a qualified professional.
