PROFESSIONAL HOME INSPECTIONS LLC

## RESIDENTIAL PROPERTY INSPECTION

1234 Main St. Fall Branch Tennessee 37656

07/30/2021 9:00AM

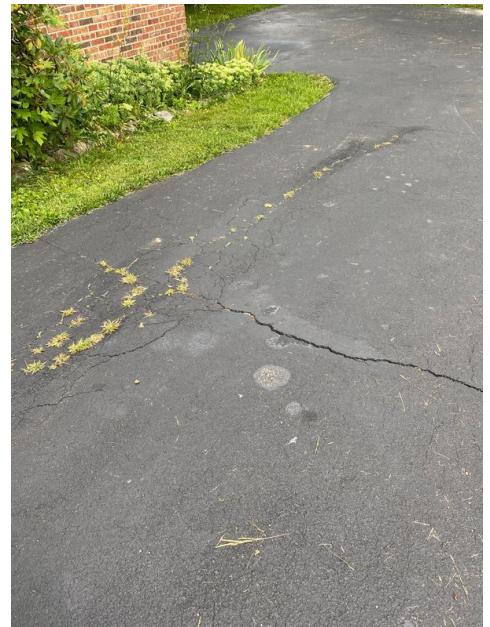
## 3.2.2 Driveway and Walkway Condition

**ASPHALT - CRACKING AND/OR DETERIORATION**

Contact a qualified driveway contractor.

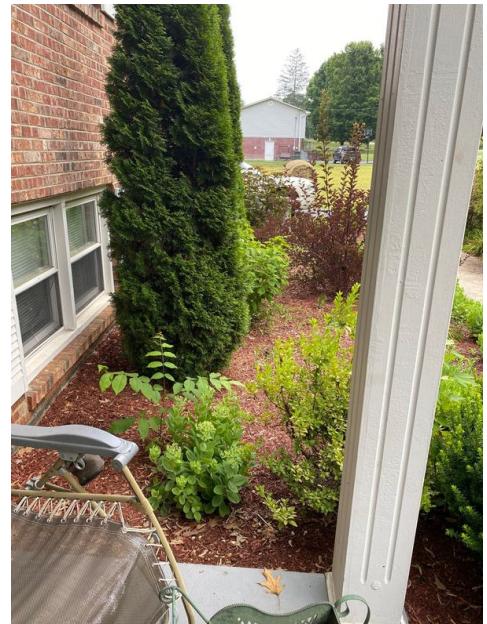
- ⚠ 3.3.1 Grounds - Grading / Lot Drainage: Grading - Not Designed to Manage Rainwater
- ⚠ 3.5.1 Grounds - Decks: Deck(s) - Attached to or Through Veneer

Contact a qualified grading contractor.

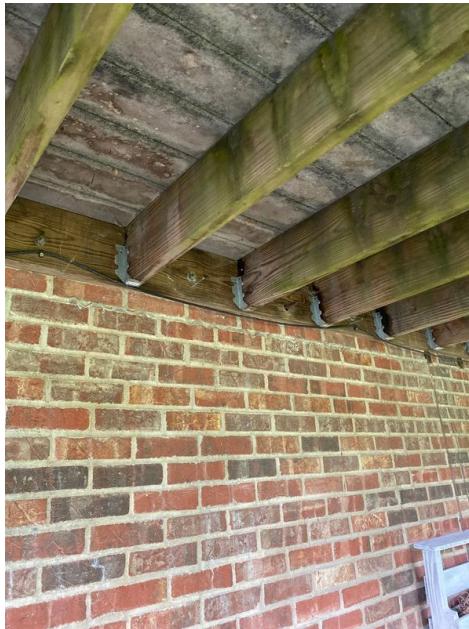
## 3.5.1 Decks

**DECK(S) - ATTACHED TO OR THROUGH VENEER**

Contact a qualified deck contractor.

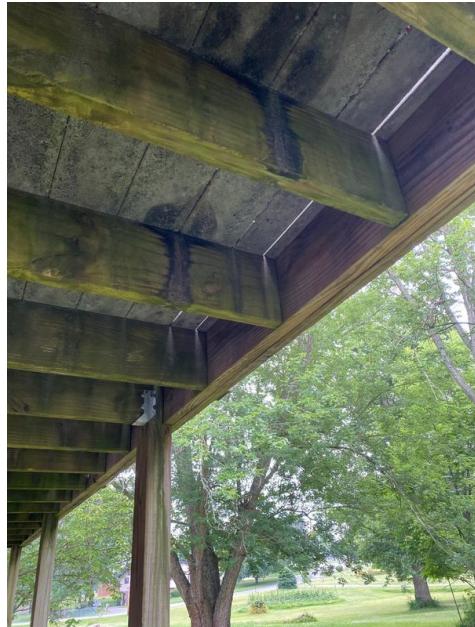
## 3.5.2 Decks

**JOIST HANGERS - MISSING**

Contact a qualified deck contractor.

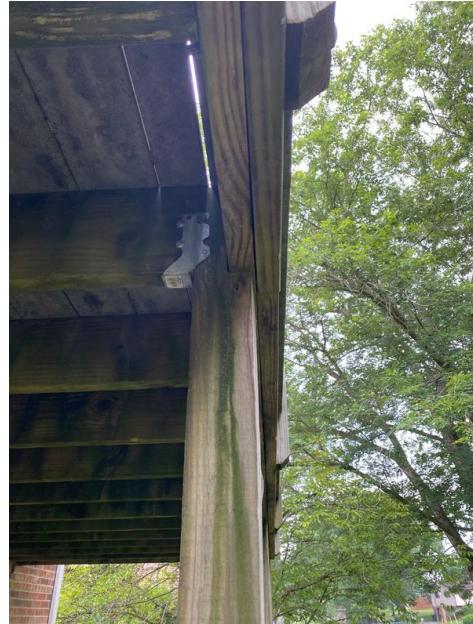
## 3.5.3 Decks

- 3.5.2 Grounds - Decks: Joist Hangers - Missing
- 3.5.3 Grounds - Decks: Beam/Girder - Not Fully Bearing on Support
- 3.7.1 Grounds - Stairs: Stairs - Open Risers

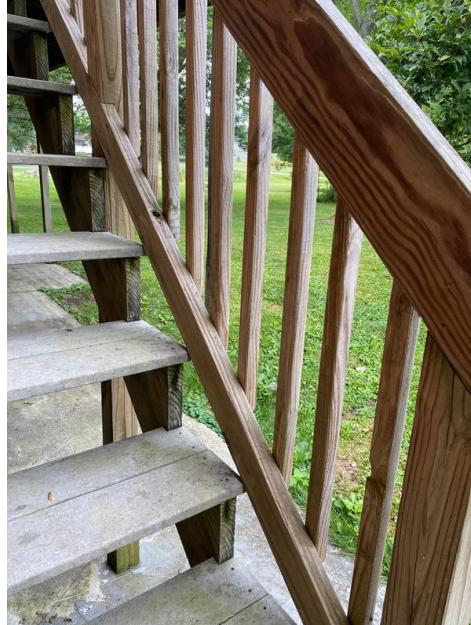
## 3.8.1 Guardrails, Stair Rails, &amp; Handrails

**STAIR RAILING - SPACING EXCEEDED**

Contact a qualified deck contractor.

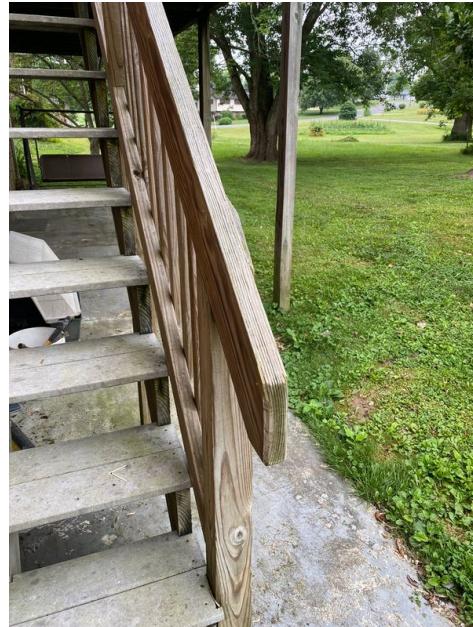
## 3.8.2 Guardrails, Stair Rails, &amp; Handrails

**HANDRAIL - NOT GRASPABLE**

- Marginal Defect

Contact a qualified professional.

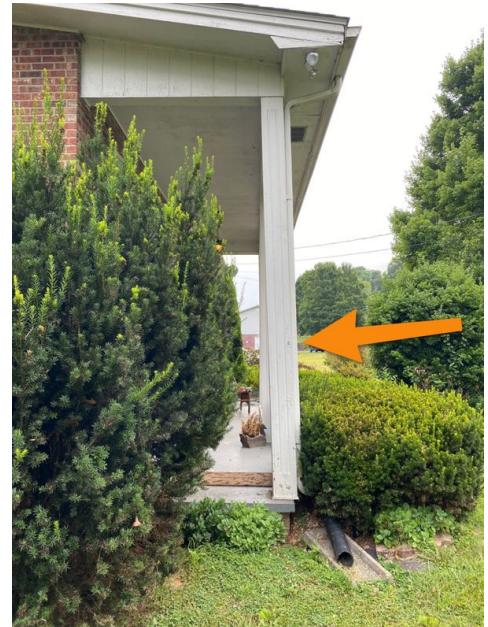
## 3.9.1 Porch / Deck Roof Condition

**SUPPORT POST(S) - OUT OF PLUMB**
- Marginal Defect

Contact a qualified professional.

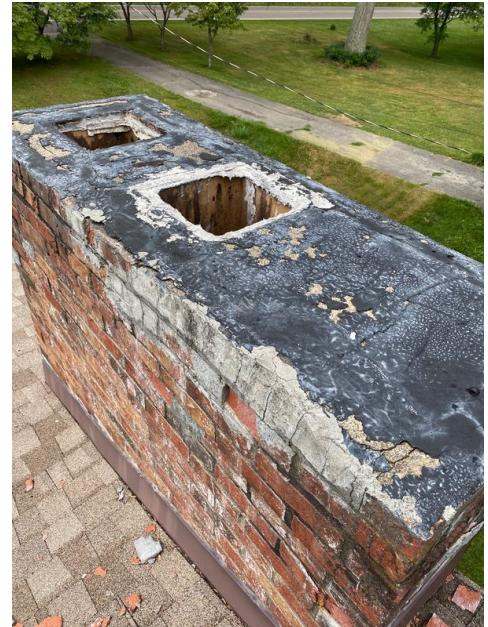
## 4.7.1 Chimney

**CROWN - CRACKING (MOISTURE INFILTRATION)**

Marginal Defect

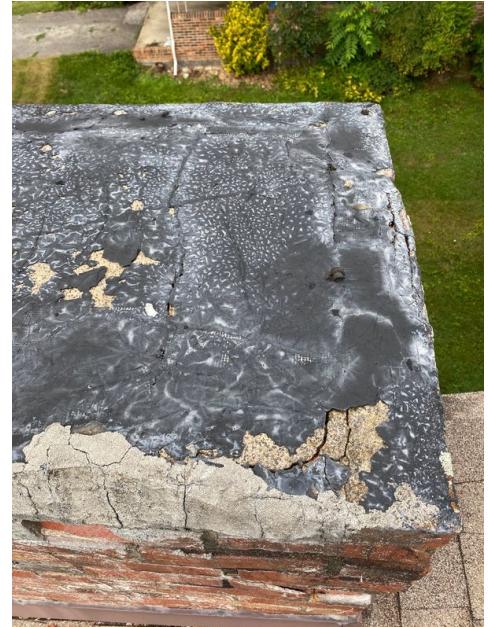
## 4.7.2 Chimney

**CROWN - UNAPPROVED MATERIAL**

Marginal Defect

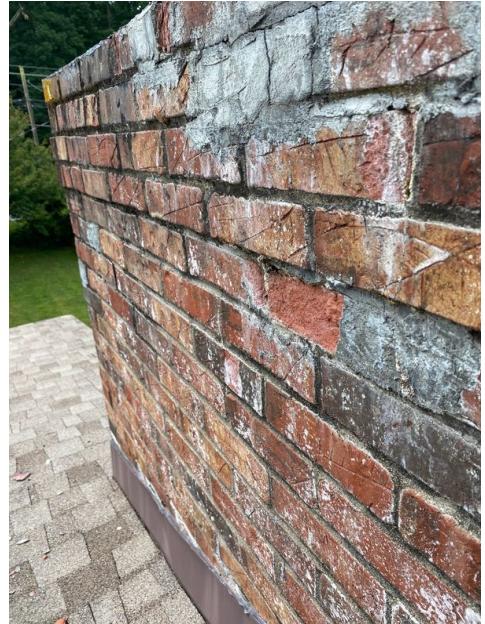
## 4.7.3 Chimney

**BRICK - HEAVY SPALLING**

Contact a qualified masonry professional.

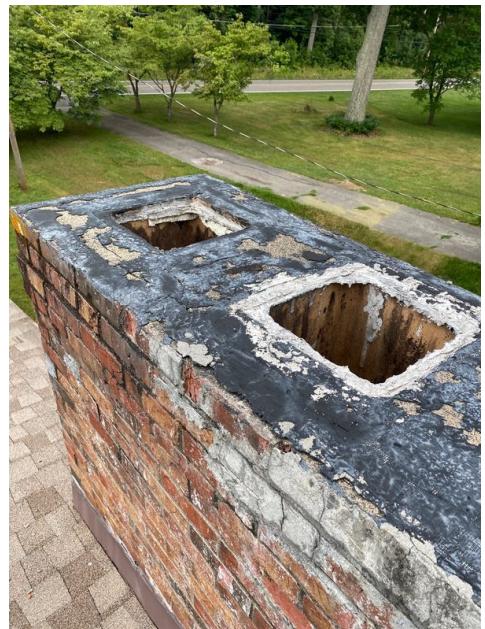
## 4.7.4 Chimney

**FLUE LINER(S) - RAIN CAP MISSING**

Contact a qualified chimney contractor.

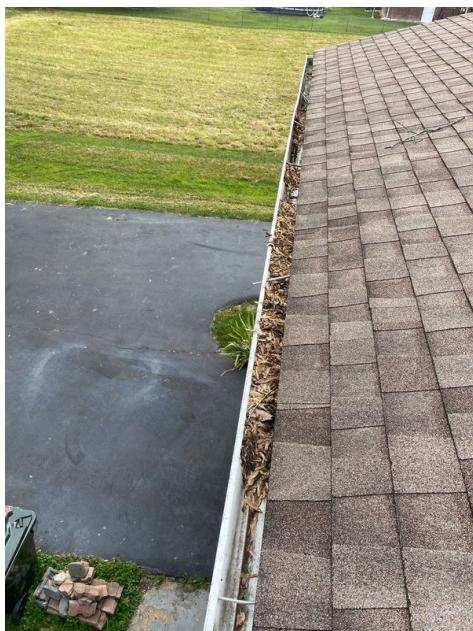
## 4.8.1 Gutters / Downspouts

**GUTTER(S) - END OF LIFE**

Contact a qualified gutter contractor

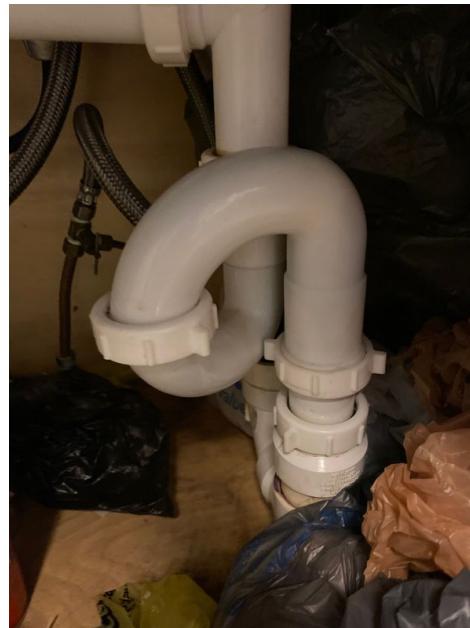
- Marginal Defect
**TRAP - S TRAP PRESENT**

The kitchen drain contained an "S" trap. "S" traps are not allowed by current standards due to the potential of the design to siphon the water "seal" out of the trap, allowing sewer gases to enter the home. Upgrades or repairs as applicable to properly vent the trap(s) is recommended to be performed by a licensed plumbing contractor.

Contact a qualified plumbing contractor.

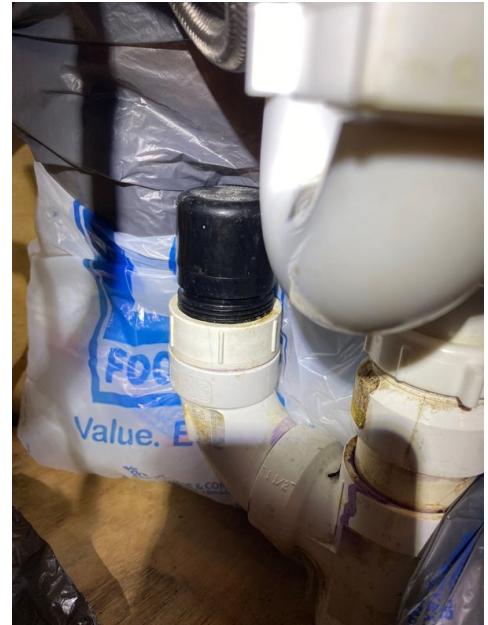
6.5.3 Undersink  
Plumbing - Kitchen

A mechanical vent was used to vent the plumbing drain system at the kitchen sink. Mechanical vents (MAV) are not permitted for use in residential homes (manufactured homes only). Replacement of the MAV is recommended to be conducted with an air admittance valve (AAV) by a licensed plumber or other qualified person.

Contact a qualified plumbing contractor.

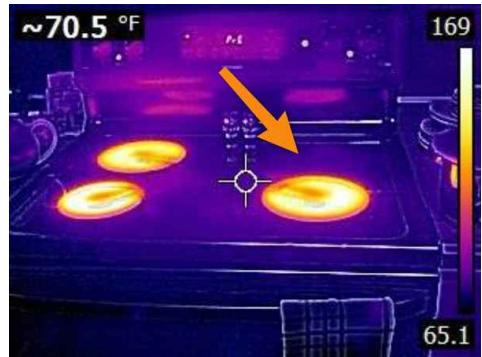
## 6.7.2 Oven/Range

There were element(s) that were not functional at the time of inspection. Repairs or replacement of the element(s) as needed is recommended to be performed by a qualified person for proper operation.

Contact a qualified appliance repair professional.

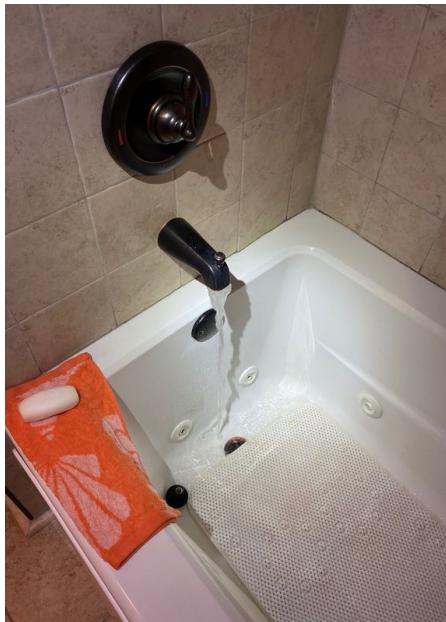
Hallway Bathroom

**LMT** - The motor for the whirlpool tub could not be tested due to a missing stopper. I recommend confirming proper operation prior to closing.

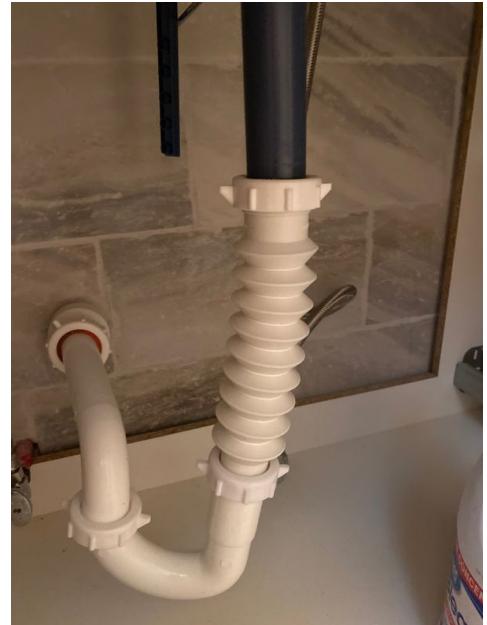
A flex drain pipe was present. Flex drain pipes are not recommended as they may clog more often and affect water drain flow. Current standards call for smooth walled drain pipes only. Replacement of the flex pipe(s) is recommended to be conducted by a licensed plumber.

Contact a qualified plumbing contractor.

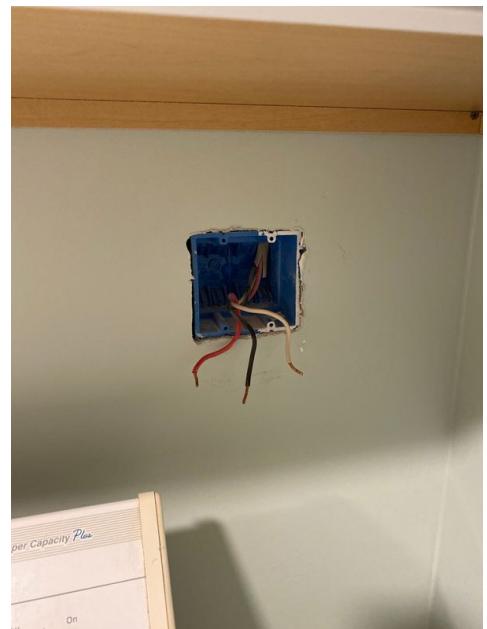
#### LAUNDRY - MISSING DRYER COMPONENTS

Although water valves and a drain were present for a washing machine, a 240V receptacle was not present for a dryer. I recommend getting quotes from applicable contractors to "finish" the area to allow for a dryer prior to the end of your inspection contingency period.

Contact a qualified professional.

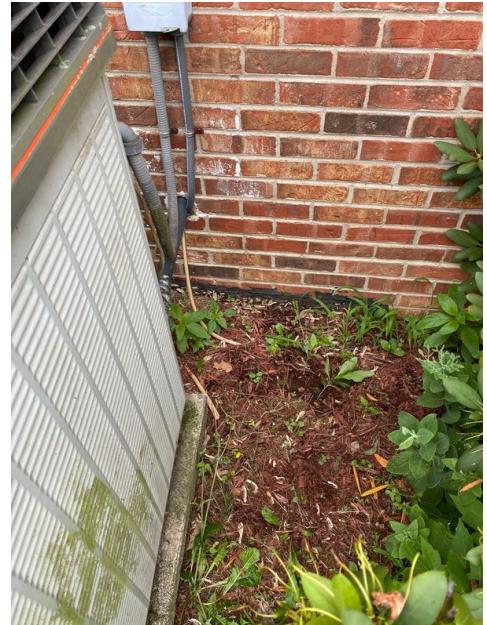
**CONDENSATE DRAIN - TERMINATED NEAR FOUNDATION**

The condensate drain pipe or tubing terminated at or near the foundation of the home. This can allow water to saturate the soil in this area, possibly entering back into or under the structure. Extending the drain, away from the foundation, is recommended to be conducted by a qualified person.

Contact a qualified professional.

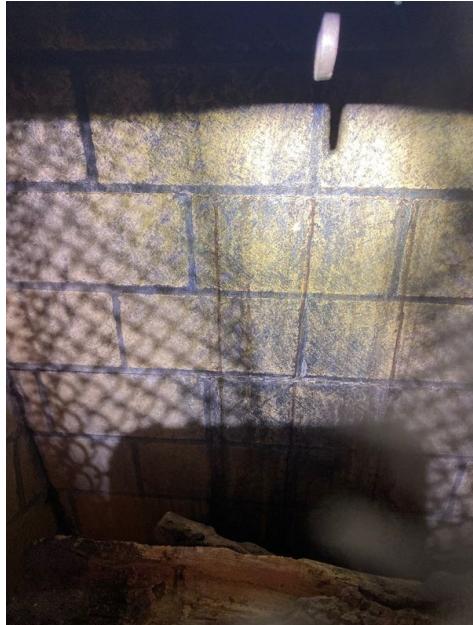
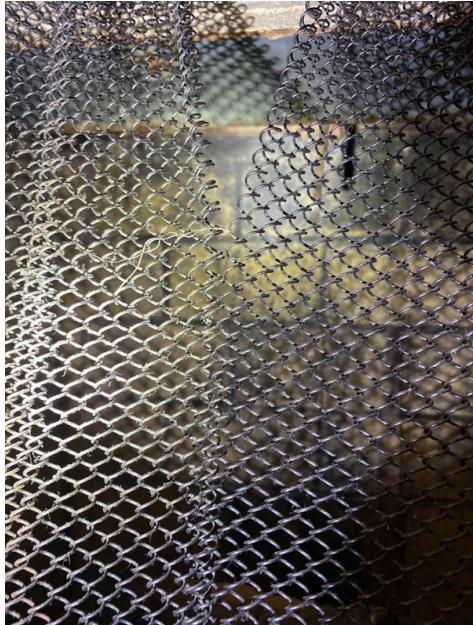
## FIREPLACE - INDICATIONS OF MOISTURE INFILTRATION

Indications of moisture infiltration was present in the fireplace. Evaluation and repairs are recommended as needed by a chimney sweep to prevent any moisture/water infiltration.

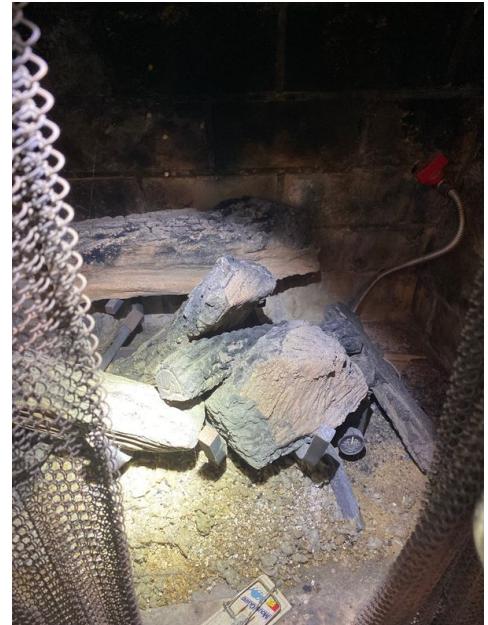
The "logs" have been moved/detached from their original position. Evaluation and repairs or replacement as needed is recommended by a chimney sweep.

Contact a qualified chimney contractor.

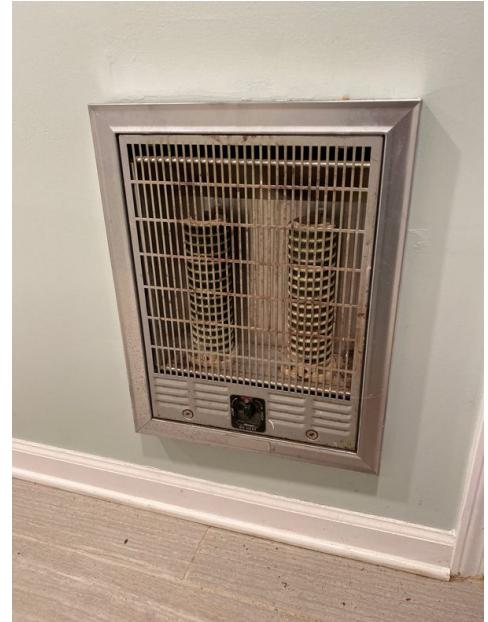
## 10.18.1 Wall Heater(s)

**AGED** - Wall heater(s) were present and the unit(s) were not tested for functionality. Wall heaters of this age are well past their useful life, and may not be safe for use. An evaluation of the unit(s) is recommended to be conducted by a licensed electrician before using these units, or having an electrician to properly disconnect and remove the units.

Contact a qualified electrical contractor.

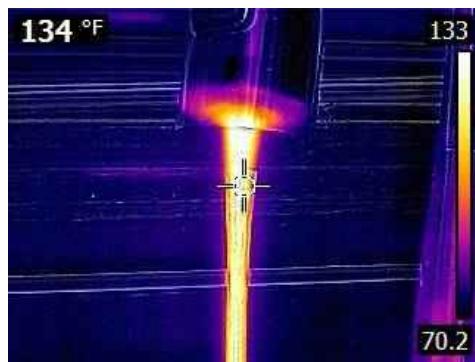
### **WATER TEMP - IN EXCESS OF 120 DEGREES**

The maximum recommended water temperature produced at faucets in the home is 120 degrees due to the possibility of scalding at temperatures above this. But to prevent the formation of Legionellae bacteria in the water heater, tank temperatures are recommended to be kept between 135-140 degrees.

A tempering valve can allow for this combination, keeping water as faucets in the home to safe levels while keeping tank temperatures high enough to kill harmful bacteria. I recommend consulting with a licensed plumber regarding the installation of a tempering valve.

Contact a handyman or DIY project

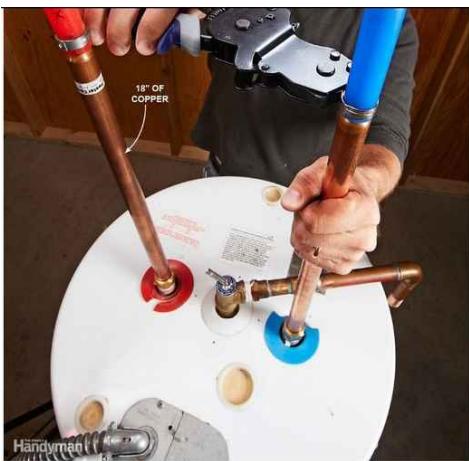
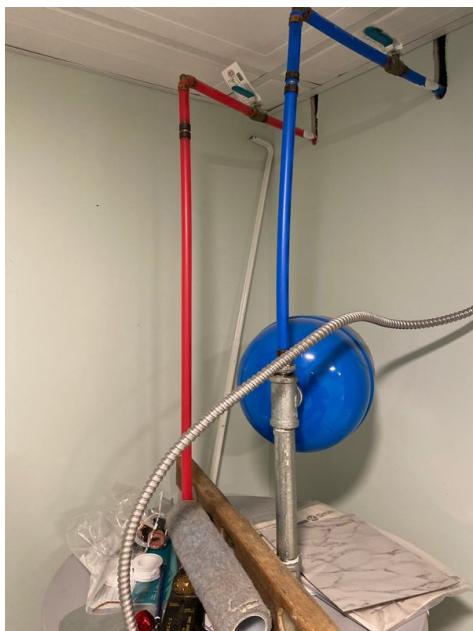
Aquapex water pipes were within the first 18 inches of the water heater unit. Current standards do not allow aquapex pipes to be installed within 18 inches of the water heater. Replacement of the pipes with an approved material is recommended to be conducted by a licensed plumber. This deficiency will be labeled in **Blue** when installed on an electric water heater, and **Orange** when installed on a gas water heater, as I know of no repercussions in conjunction with installing on electric units, but the heat from a flue on a gas water heater could allow for damage to the water pipes.

Contact a qualified plumbing contractor.

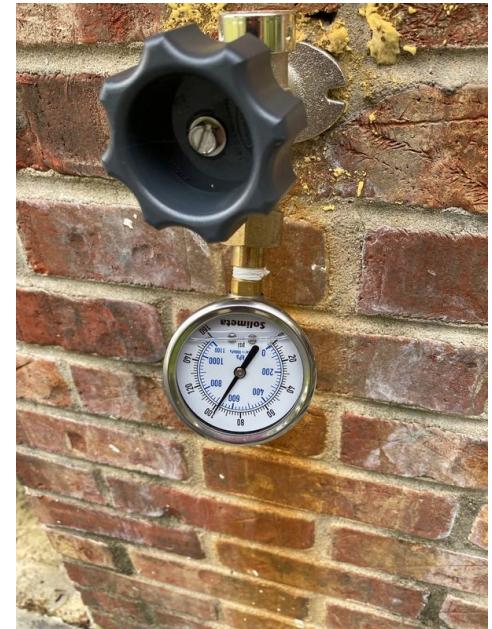
## 12.5.1 Water Pipes

**GALVANIZED - AGED SERVICE PIPE**

Contact a qualified plumbing contractor.

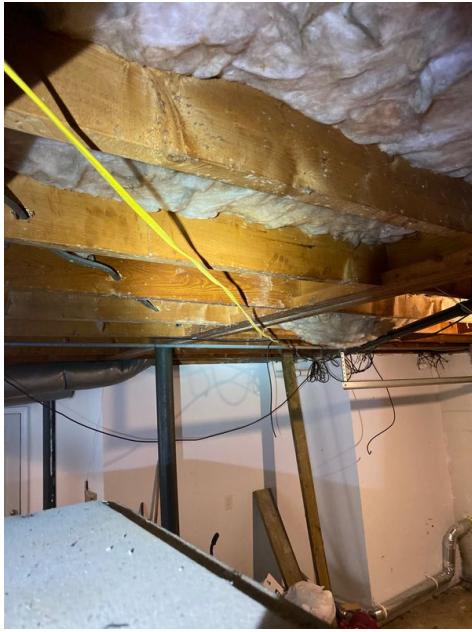
## 13.7.2 Branch Wiring

**WIRING - EXPOSED TERMINATIONS  
PRESENT**

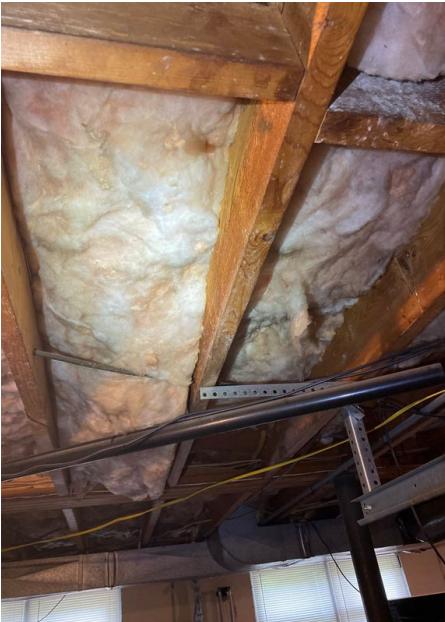
#### General Info: Insulation Between Joists/Trusses

**LMT** - Insulation was present between the floor joists/trusses. This insulation obscured visual accessibility of the subfloor, as well as most portions of the floor structure (joists, etc.). Portions of the plumbing, wiring, and HVAC ductwork, as applicable, are also typically partially covered. This insulation is not moved or manipulated in any way to observe hidden components. The possibility of hidden defects exists in areas that were not visible.

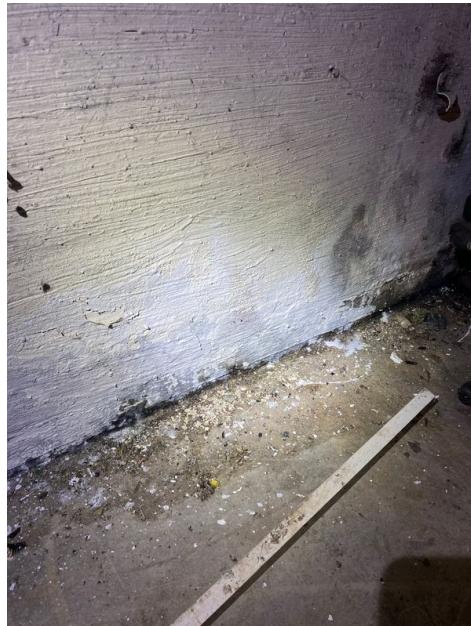
## 15.2.2 Moisture Presence

### MOISTURE - INDICATIONS OF PAST/PRESENT MOISTURE

Contact a foundation contractor.

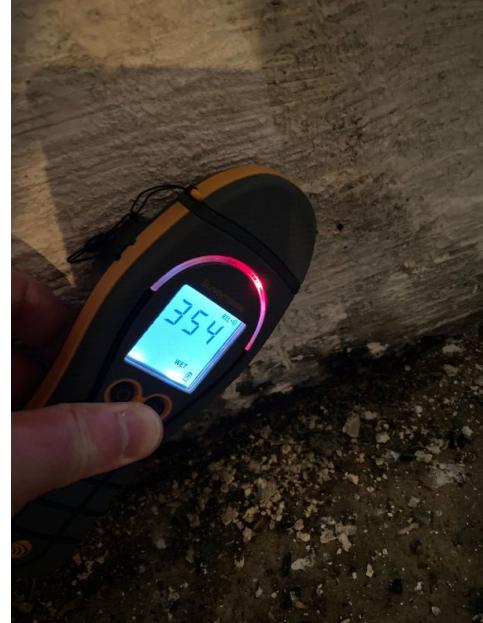
## 15.2.3 Moisture Presence

### ELEVATED MOISTURE CONTENT - FOUNDATION WALLS

Contact a foundation contractor.

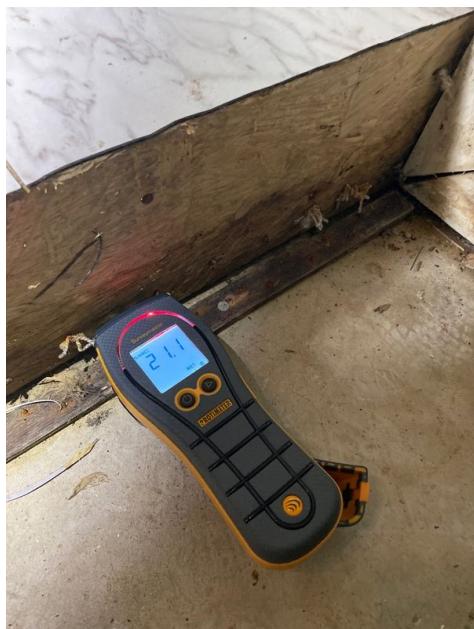
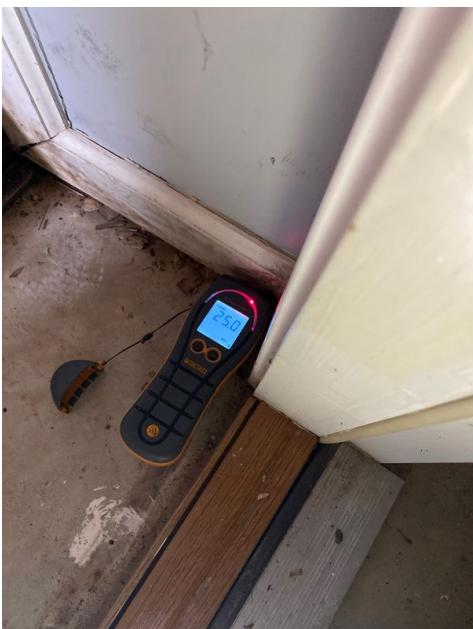
## 15.2.4 Moisture Presence

**FRAMED WALLS - WATER DAMAGE**

Contact a qualified professional.

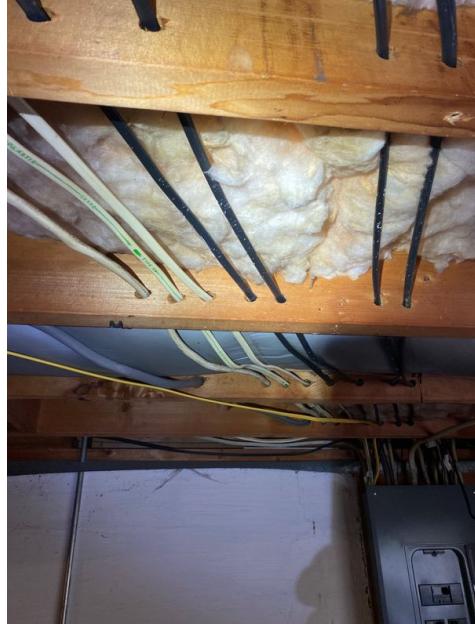
## 15.4.1 Framing / Floor Structure

**JOISTS - IMPROPER BORING OF HOLES**

Cutting, Notching & Drilling of Joists

Contact a qualified general contractor.

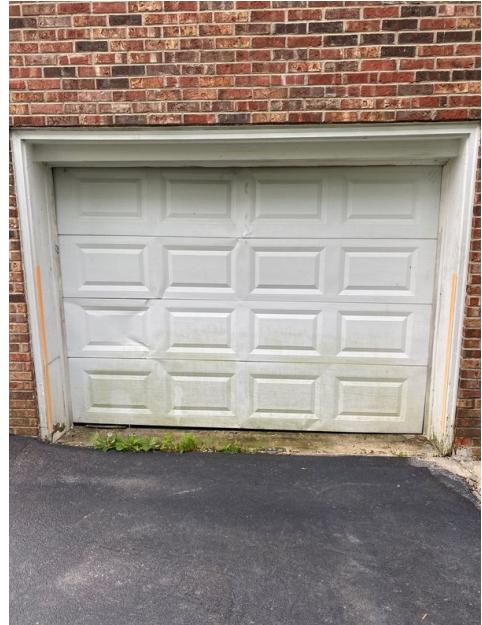
15.10.1 Basement Garage Door(s)

### **DOOR(S) - END OF LIFE**

Contact a qualified garage door contractor.

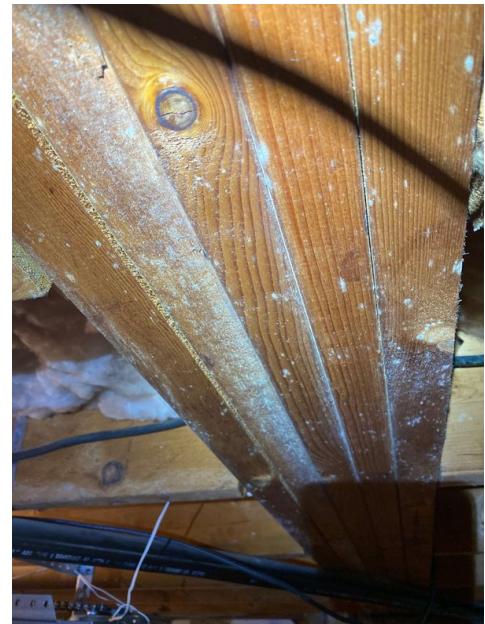
Fungal growth was present on the floor structure in areas. This is typically indicative of high humidity and/or condensation forming on the framing members. This can be caused by moisture intrusion through the foundation walls, leaks in HVAC ductwork, and/or other issues.

1. An evaluation of the floor structure to determine the growth's affect on the wood, along with locating the source of the moisture and fungal growth is recommended to be conducted by a qualified contractor familiar with building sciences and ventilation. Repairs are recommended to be made by this contractor to any damaged wood present along with repairs to eliminate the source of the fungal growth (elevated moisture/humidity).
2. Collecting samples of the growth and sending the samples to an accredited laboratory is recommended to be conducted by a mold inspector.
3. If the testing results of the fungal growth is determined to be mold, evaluation and remediation is recommended to be conducted by an environmental contractor.

Contact a qualified professional.
