Defect Analysis Report — CircuitGuard AI

| Report ID: | RPT-D537834C |

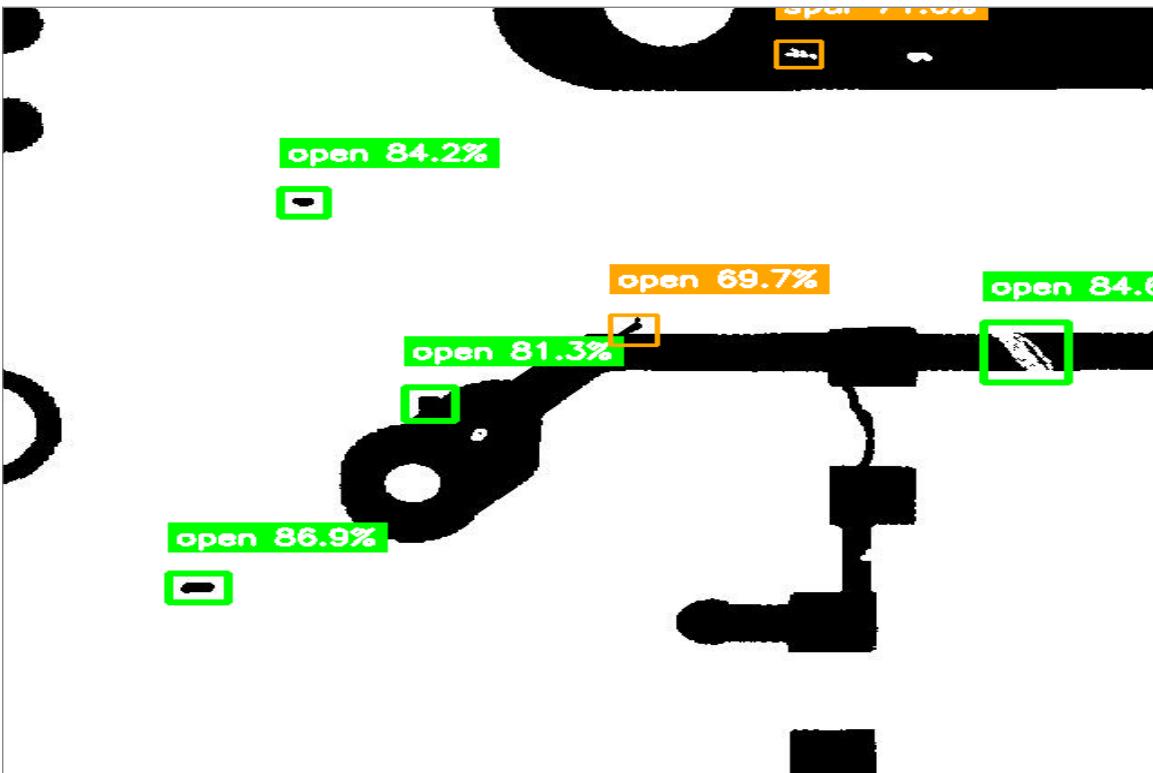
Annotated Results & Defect Details

Detected 6 defect(s). High:4, Medium:2, Low:0. Avg conf: 79.62%.

| ID | Type | Confidence | Position (X,Y) | Size (WxH) | Area (px ²) |
|---|---|---|---|---|---|
| #1 | open | 86.9% | (108,483) | 33x24 | 217 |
| #4 | open | 81.3% | (237,330) | 28x28 | 200 |
| #6 | open | 84.6% | (567,287) | 47x50 | 824 |
| #7 | open | 69.7% | (350,268) | 26x25 | 148 |
| #8 | open | 84.2% | (167,162) | 26x23 | 124 |
| #10 | spur | 71.0% | (441,39) | 25x22 | 106 |
