# Eschede Derailment (June 3rd, 1998, Munich, Germany)

Stanislav Pankevich

This gray paper is a result of a private research done by the author in order to understand the causes of Eschede Catastrophe.

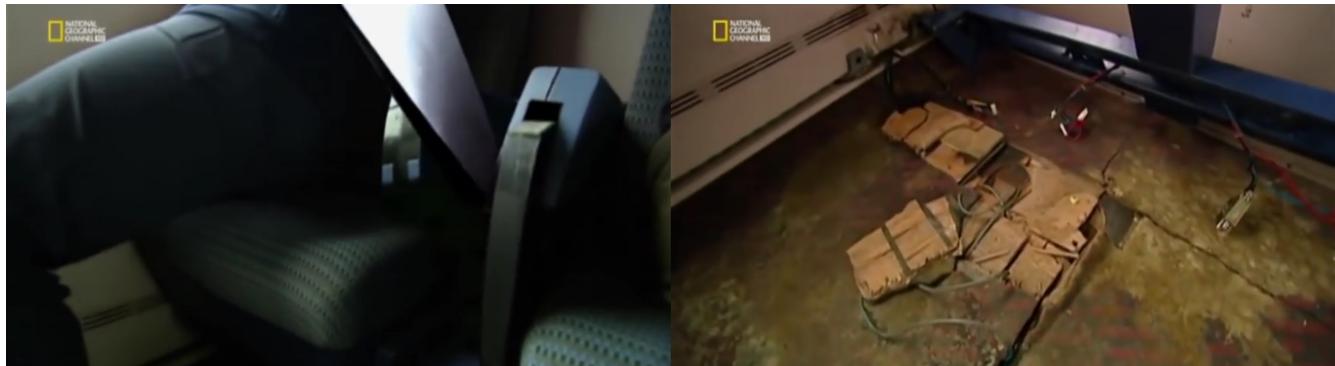
10:56 AM, five hours into the journey, ICE is approaching Eschede Road Bridge at 125mphs. A huge metal shard creates a gaping hole in the carriage floor of the coach 1 (Figure 1).

Investigators explore the wreck train: damage to the compartment, where Jörg Dittmann was travelling, indicates where the wheel rim unraveled, splitting the floor open and piercing the armrest.

**Figure 1:** A huge metal shard creates a gaping hole in the carriage floor of the coach 1 ("Seconds from Disaster"). The image to the left is a simulation.

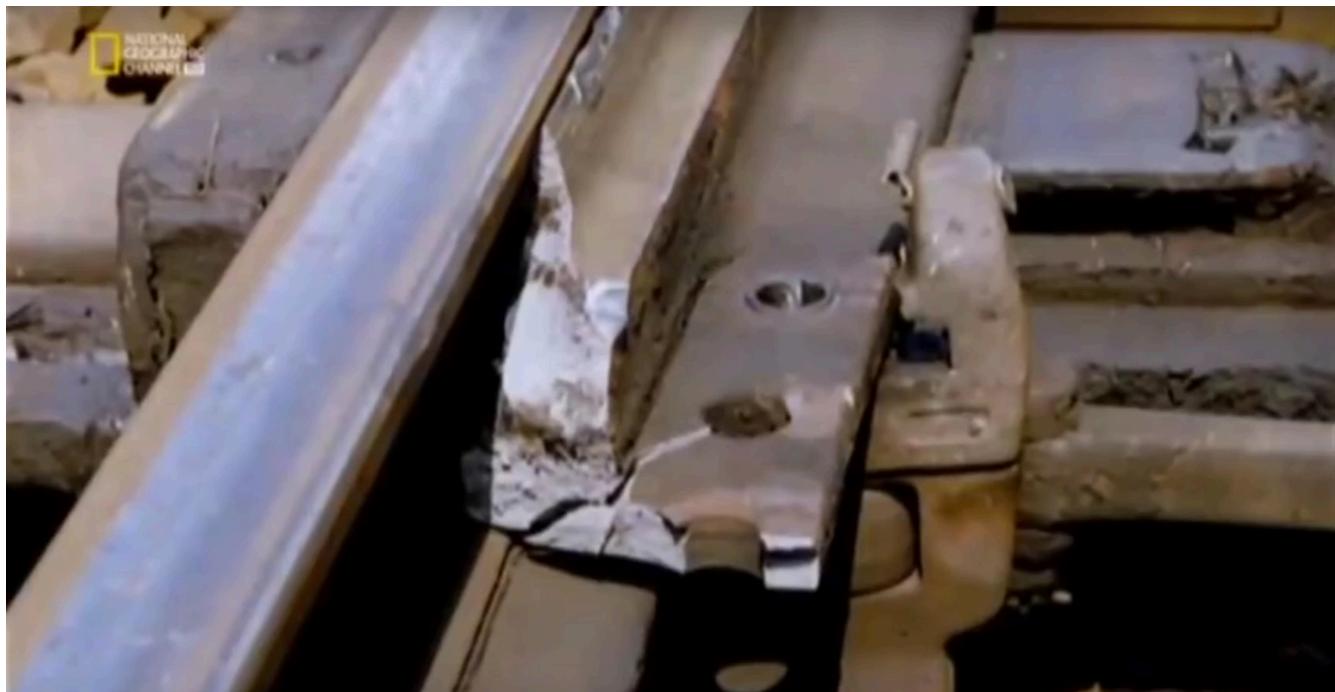
Investigators find that one of the checkrails, a length of steel, is missing. It is been completely torn away from the track. Only a few meters away from the compartment, in the corridor, investigators find the missing checkrail that left gaping wholes in the floor and ceiling.

**Figure 2:** Broken rail

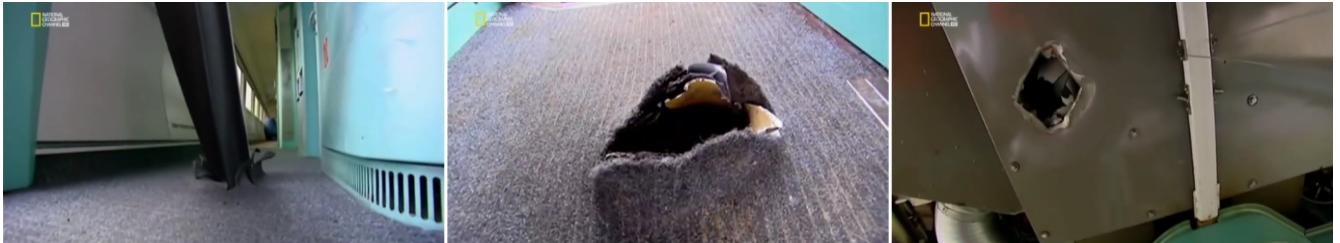
**Figure 3:** Checkrail in wagon (“Seconds from Disaster”). The image to the left is a simulation.

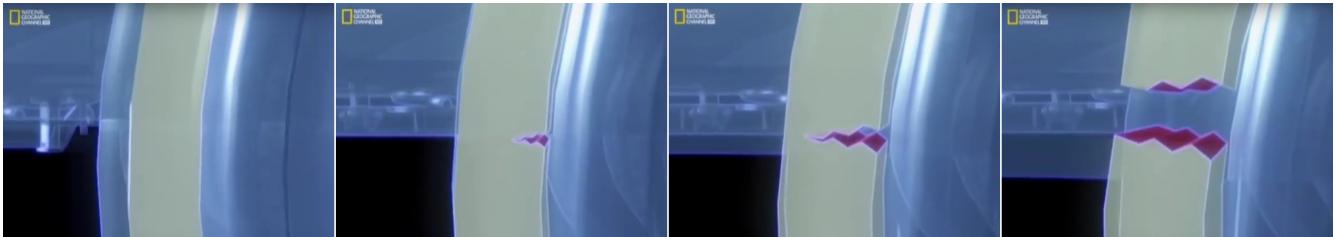
**Figure 4:** Crack development (“Seconds from Disaster”, simulation)

The wheel rim fractured thorough a metal fatigue. Fatigue occurs when a movement is repeated over and over again causing a stress break at a weak point in the metal. A wheel on a train actually flexes slightly as it turns because of the massive load it's under supporting the moving train. These movements are minuscule but the constant flexing of the metal can eventually, given enough usage, cause the wheels destruction through metal fatigue. With a duoblock wheel there is a layer of rubber between the wheel and the rim. The soft rubber allows the outer rim to flex much more than on a monoblock wheel. As the separate rim wears down through use the flexing increases. Without a thorough inspection the wheel rim can become too thin and a small defect can become a crack that eventually fractures causing the outer rim to break away from the inner wheel with devastating results. Metal fatigue fractures in train wheels usually develop over the period of months or years.

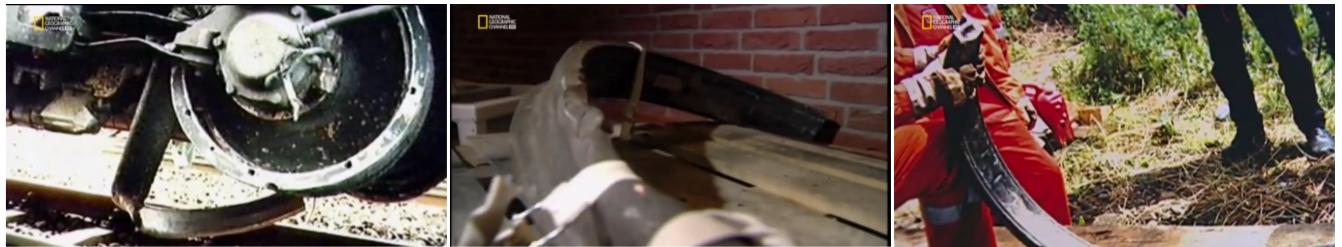
**Figure 6:** Crack of a wheel rim (“Seconds from Disaster”, photos)

A cracking inside the ring of the wheel was responsible. There was no indication of material or production failure. This crack was caused by excessive load and wear. When ICE began operations, there was no certification in place that would document appropriate design and reliability. Moreover no fracture mechanic calculation was done that could prove the strength of the wheel during its lifetime. According to the experts such wheels should not be operated at less than 880 mm diameter (new condition = 920 mm), subject to annual testing for inner and middle zone cracks. (An important NDT fact!) The diameter of the accident wheel was 862 mm. The limit set by Deutsche Bahn is 854 mm.

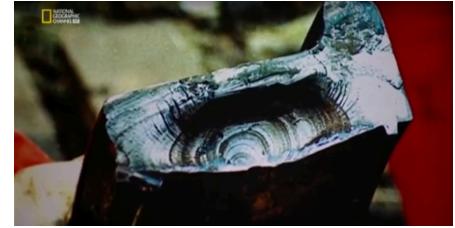
It was soon apparent that dynamic repetitive forces had not been accounted for in the statistical failure modelling done during the design phase, and the resulting design lacked an adequate margin of safety. The following factors, overlooked during design, were noted:

1. The tyres were flattened into an ellipse as the wheel turned through each revolution (approximately 500,000 times during a typical day in service on an ICE train), with corresponding fatigue effects.
2. In contrast to the monobloc wheel design, cracks could also form on the inside of the tyre.
3. As the tyre became thinner due to wear, the dynamic forces were exaggerated, resulting in crack growth.
4. Flat spots and ridges or swells in the tyre dramatically increased the dynamic forces on the assembly and greatly accelerated wear." (Wikipedia 2018a; Documentary film "Seconds From Disaster" 2004)

**Figure 16:** Metal fatigue

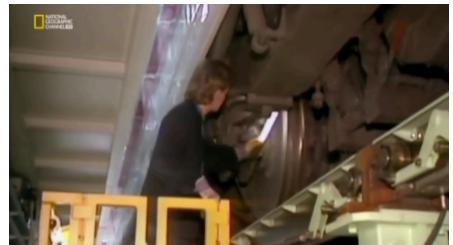
The answer given to the investigation team by Deutsche Bahn: instead of relying on a special metal fatigue detection equipment it turns out that the engineers at Deutsche Bahn's Munich maintenance facility had been carrying out safety checks on ICE's wheels with "nothing more advanced than a flashlight".

"The use of torches will only pick out the largest and most dangerous of cracks. It won't pick out tiny fatigue cracks at an early stage of their life. In terms of detecting potential cracks on the inner side of the rim of a dual block wheel is completely useless technique." Documentary film "Seconds From Disaster" (2004)

**Figure 17:** Manual inspection with flashlights ("Seconds from Disaster")

Today Deutsche Bahn has removed the duoblock wheel type 064 from service and replaced them with traditional monoblock wheels. They maintain that the wheels and the inspections met the standards required at the time and that their engineers could not have predicted a wheel fracture.

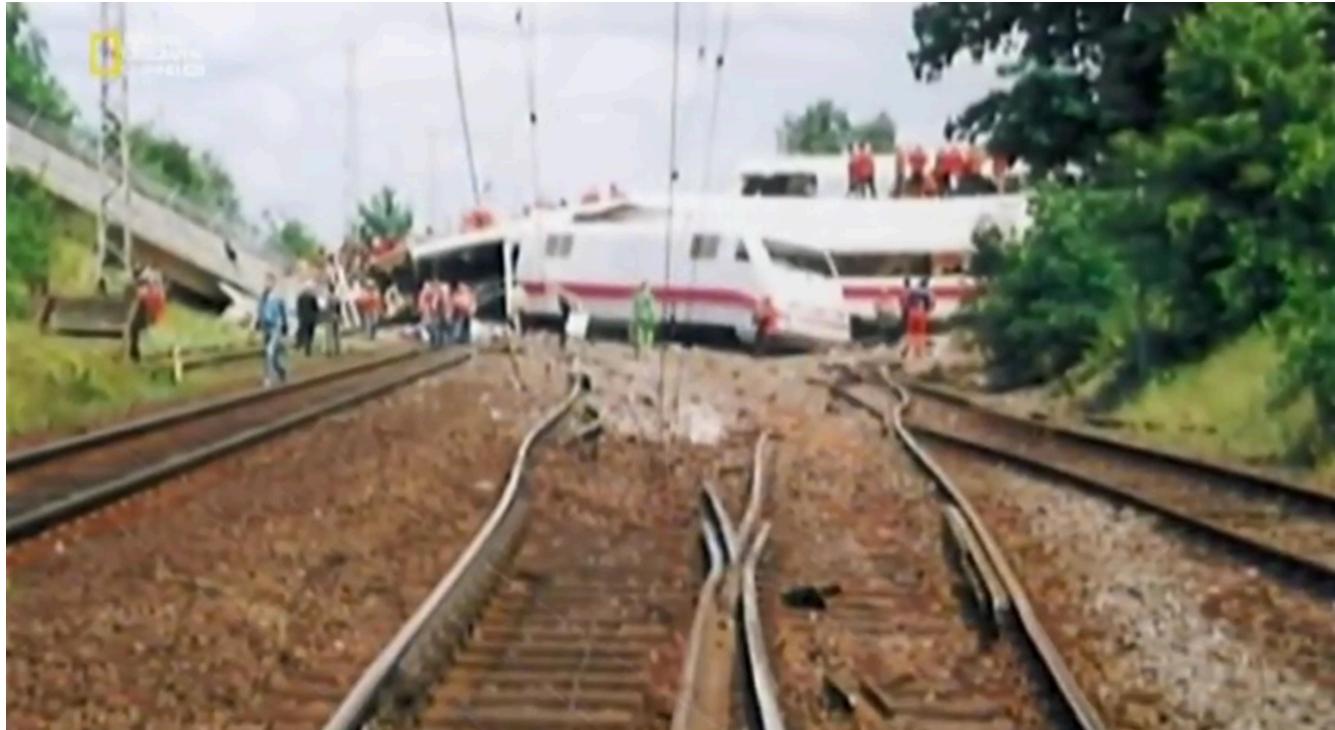
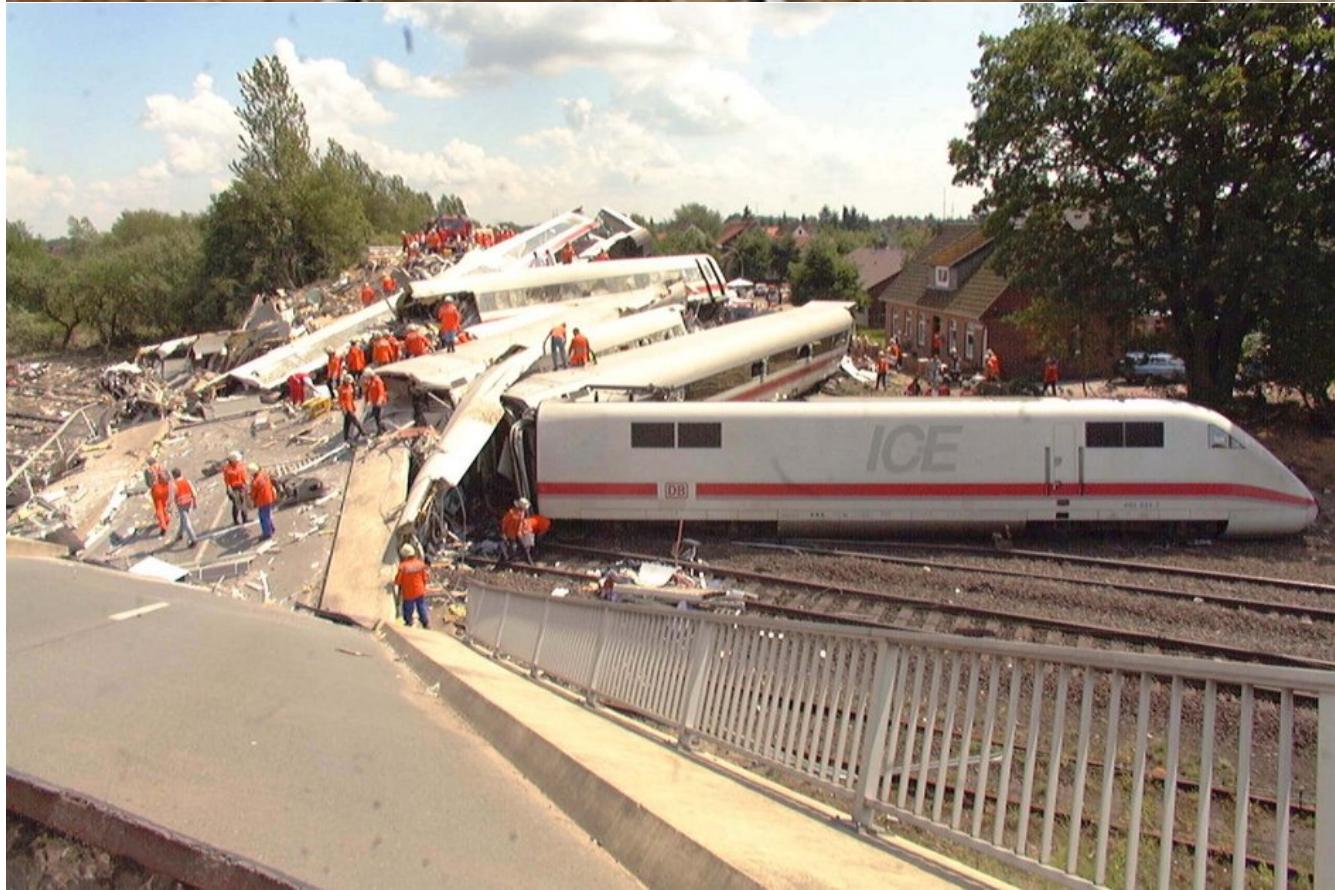
**Figure 18:** “The front power car and coaches one and two cleared the bridge. Coach three hit the bridge, which began to collapse. Coach four cleared the bridge, moved away from the track, and hit a group of trees. The bridge pieces crushed the rear half of coach five. The restaurant coach, six, was crushed to a 15-centimetre (6 in) height. With the track now obstructed completely by the collapsed bridge, the remaining cars jackknifed into the rubble in a zig-zag pattern: cars 7, the service car, the restaurant car, the three first-class cars numbered 10 to 12, and the rear power car all derailed and slammed into the pile. The resulting mess was likened to a partially collapsed folding ruler. An automobile was also found in the wreckage. It belonged to the two railway technicians and was probably parked on the bridge before the accident.”
