PE14-030

FORD

APPENDIX I

Engineering Review

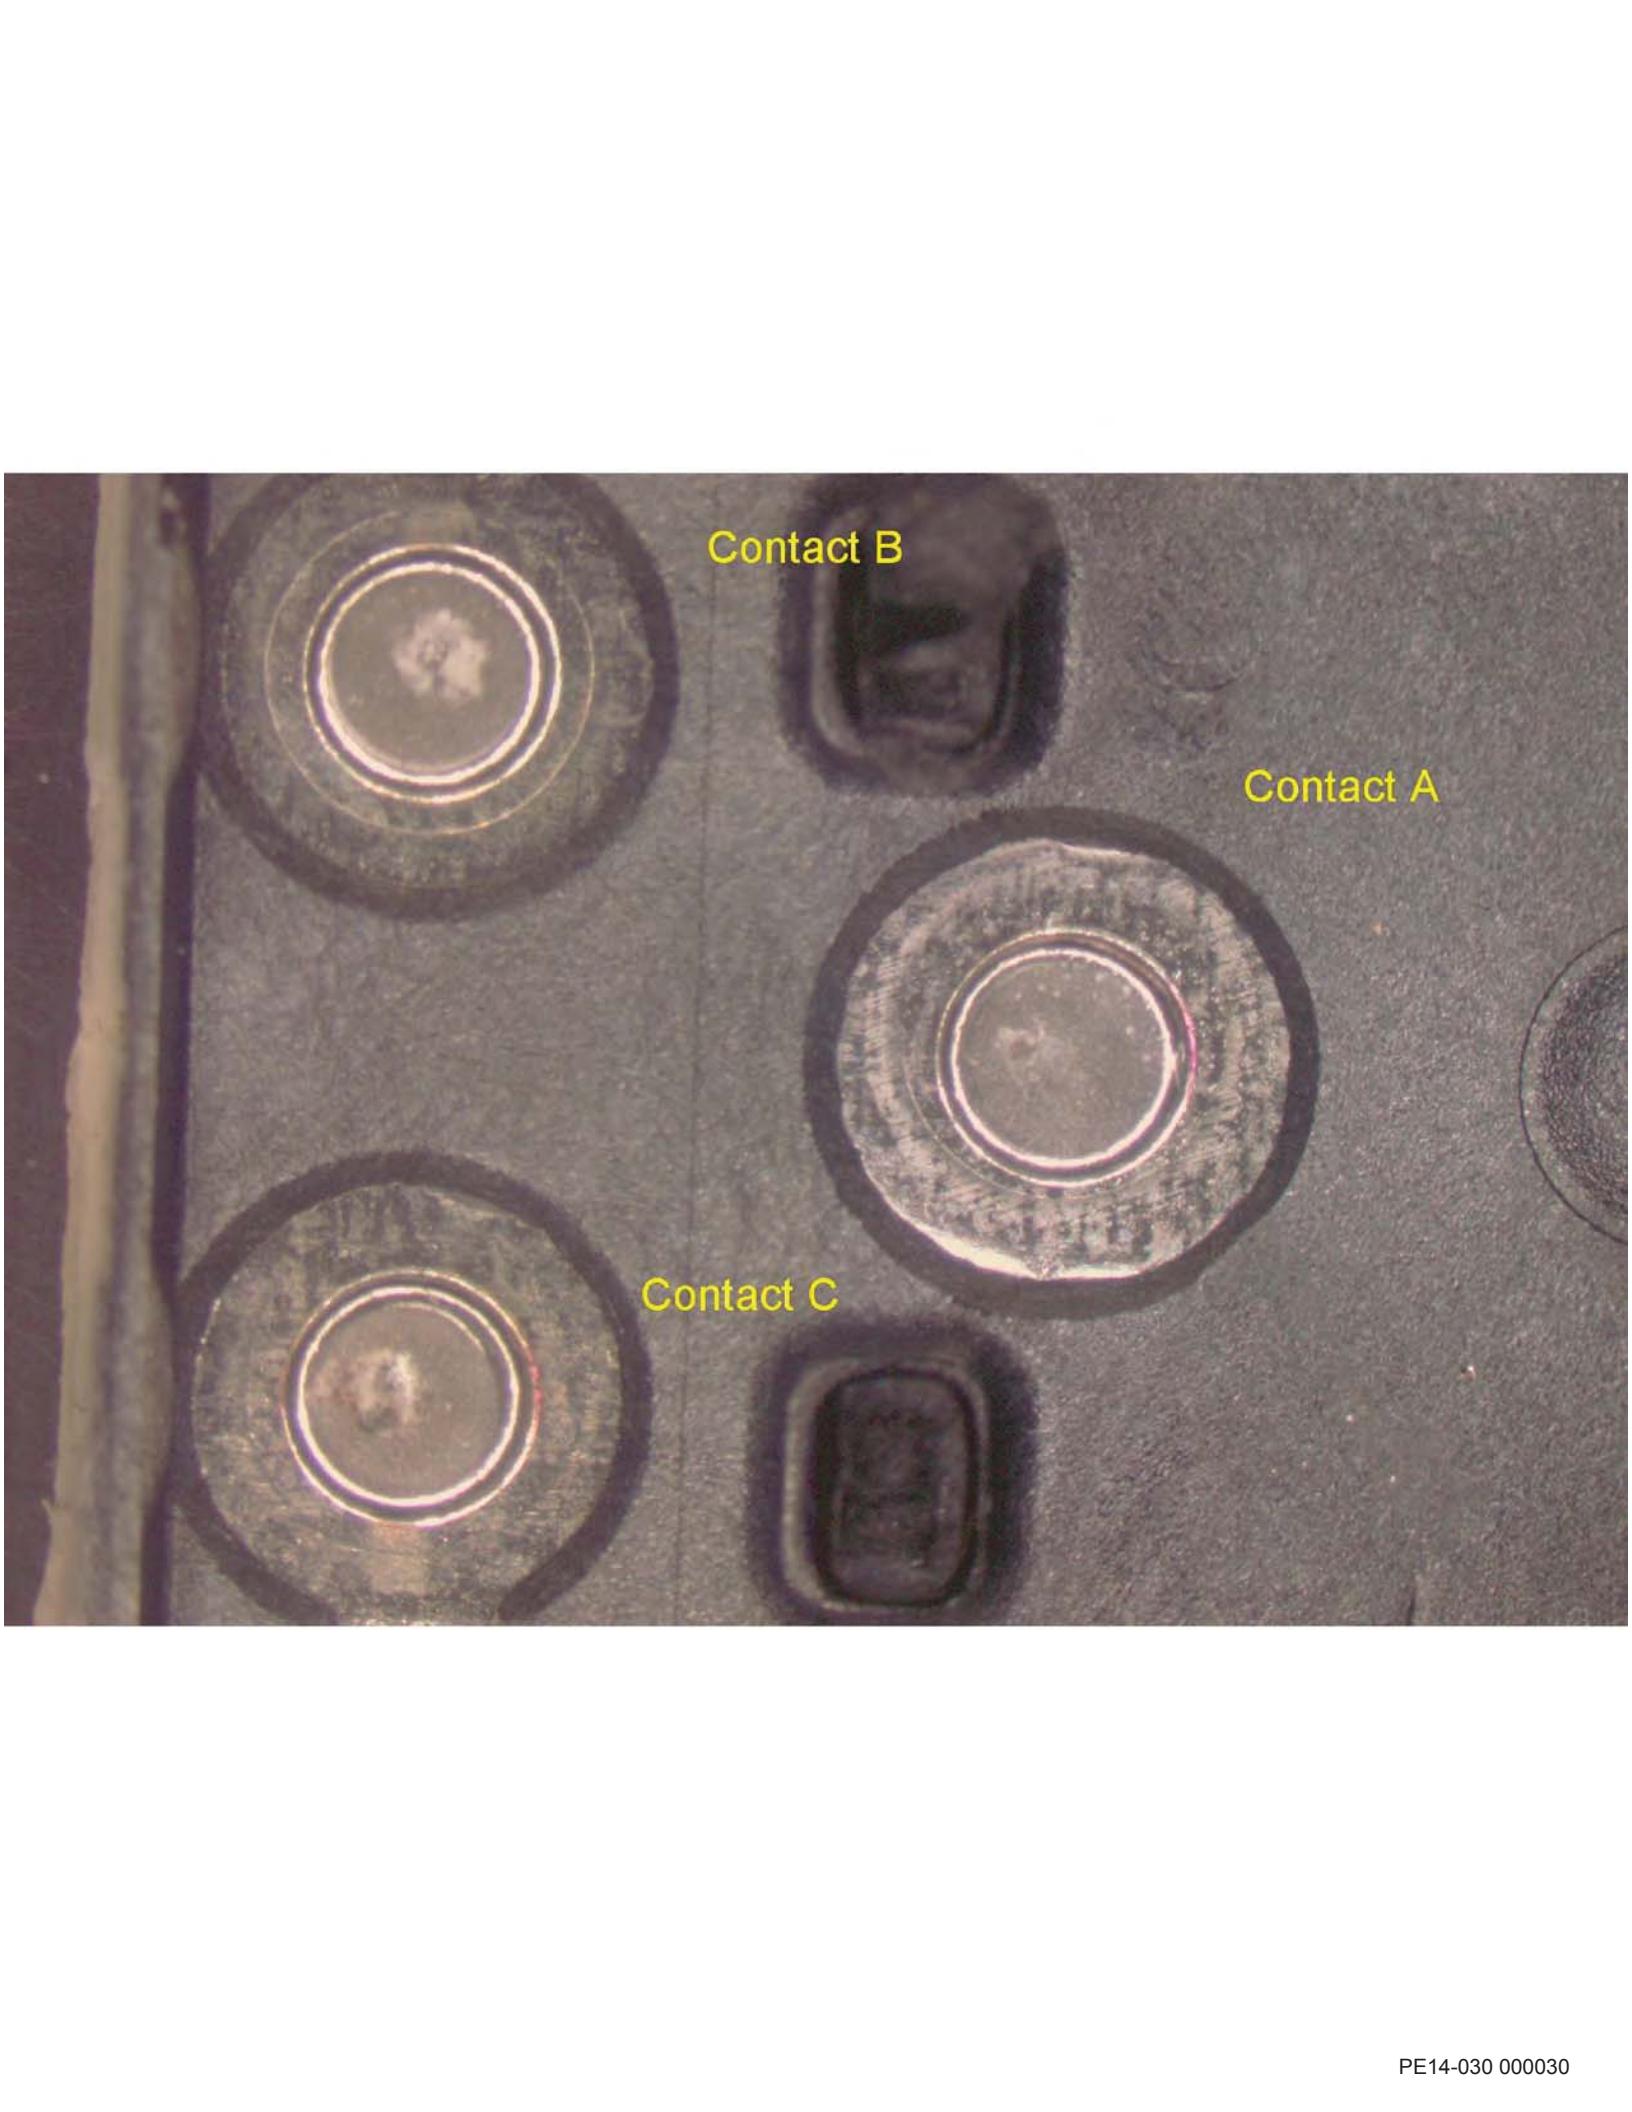
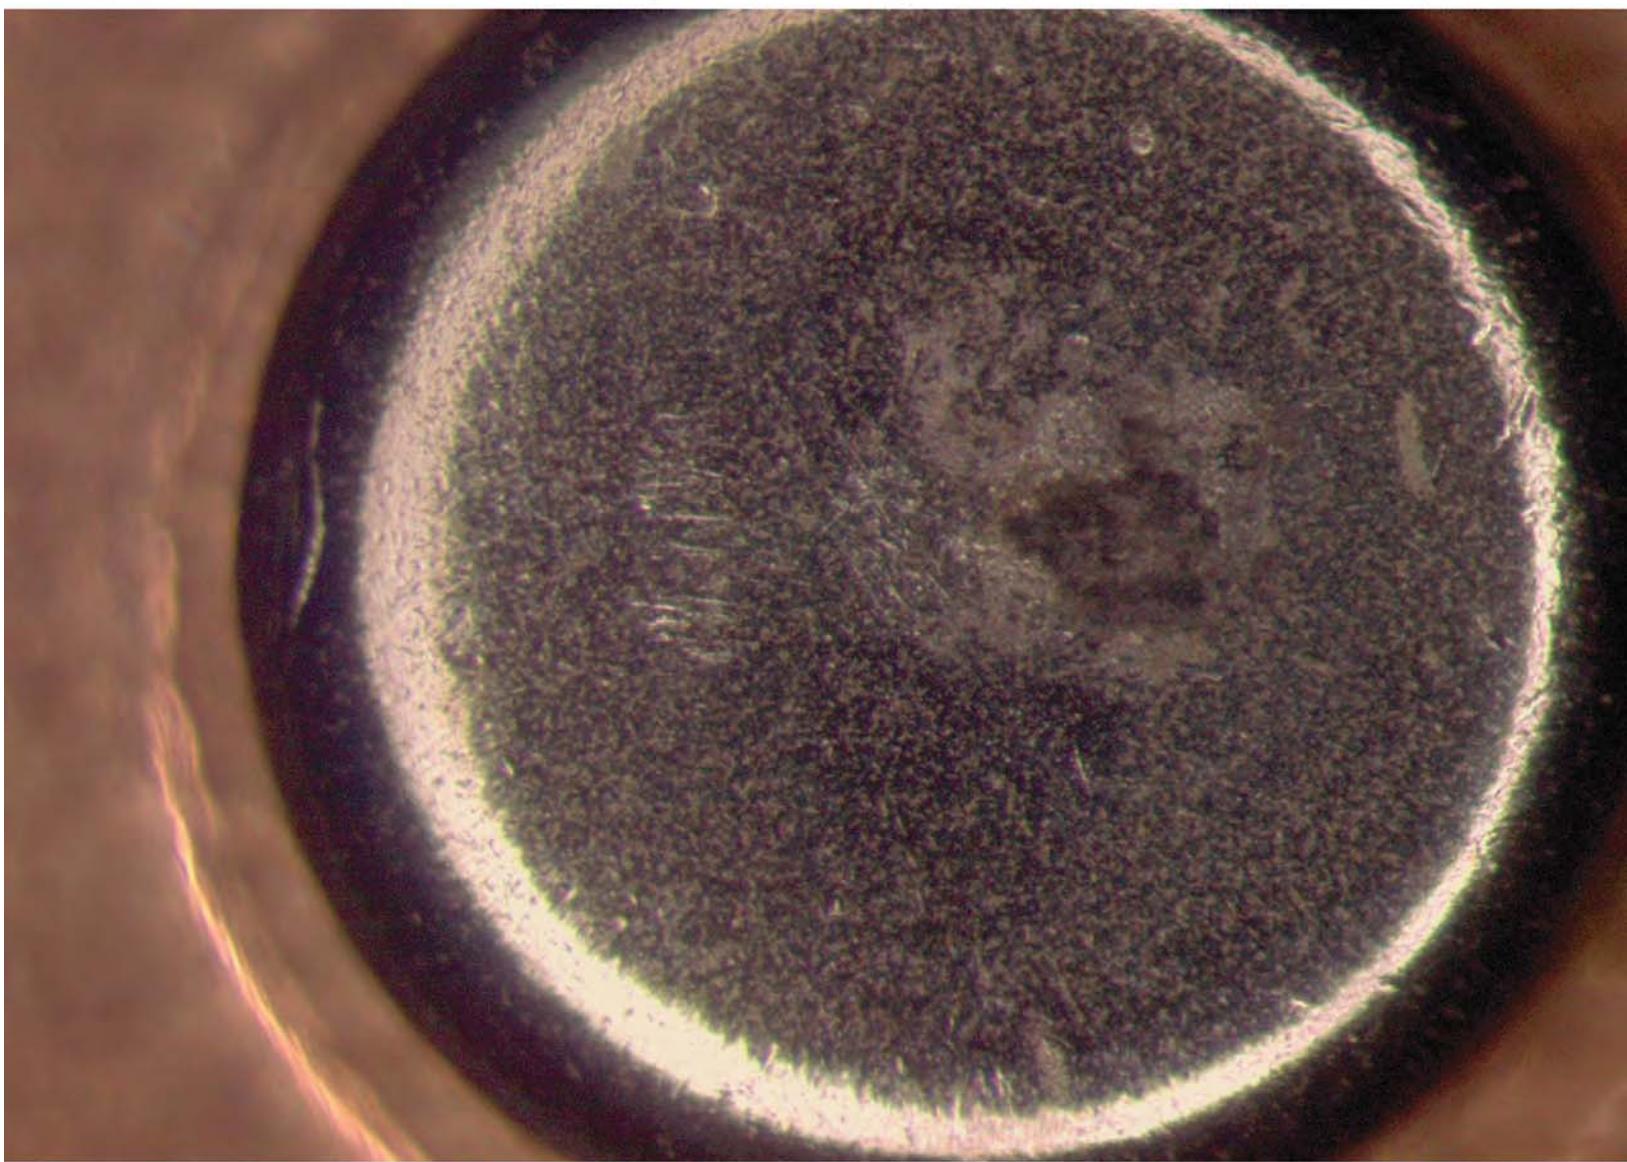
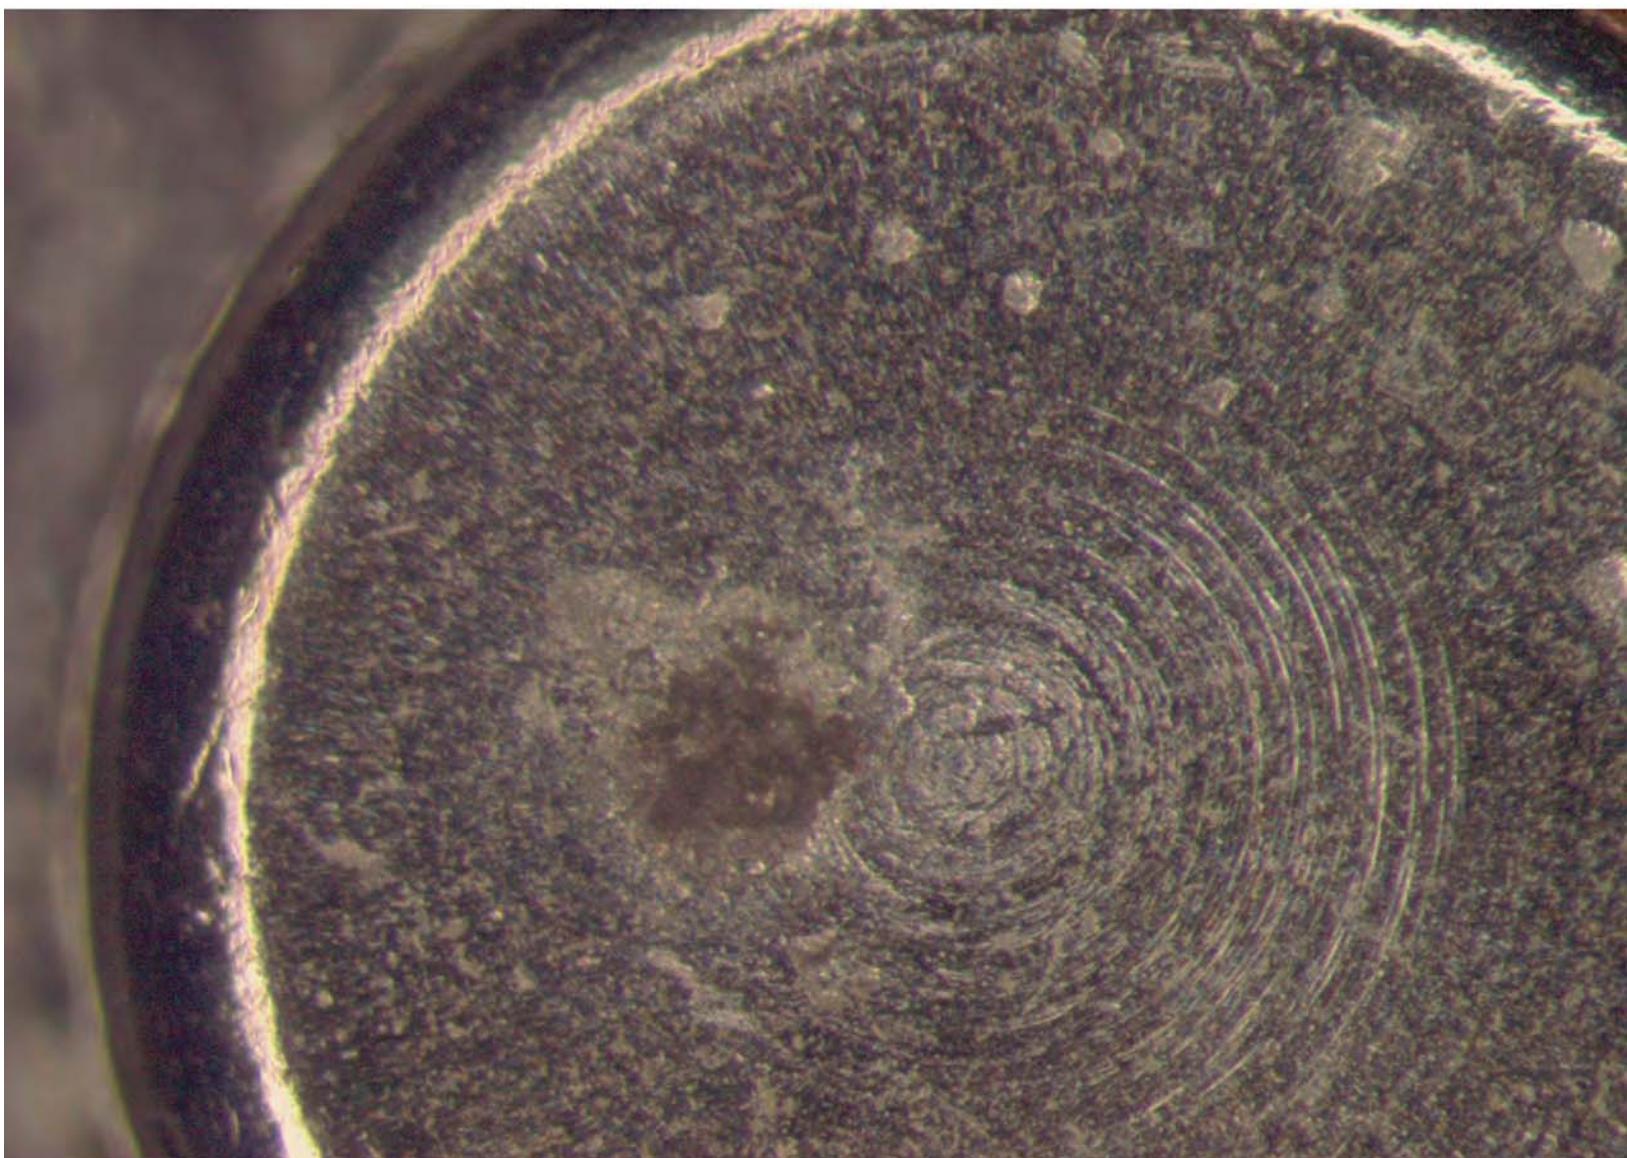
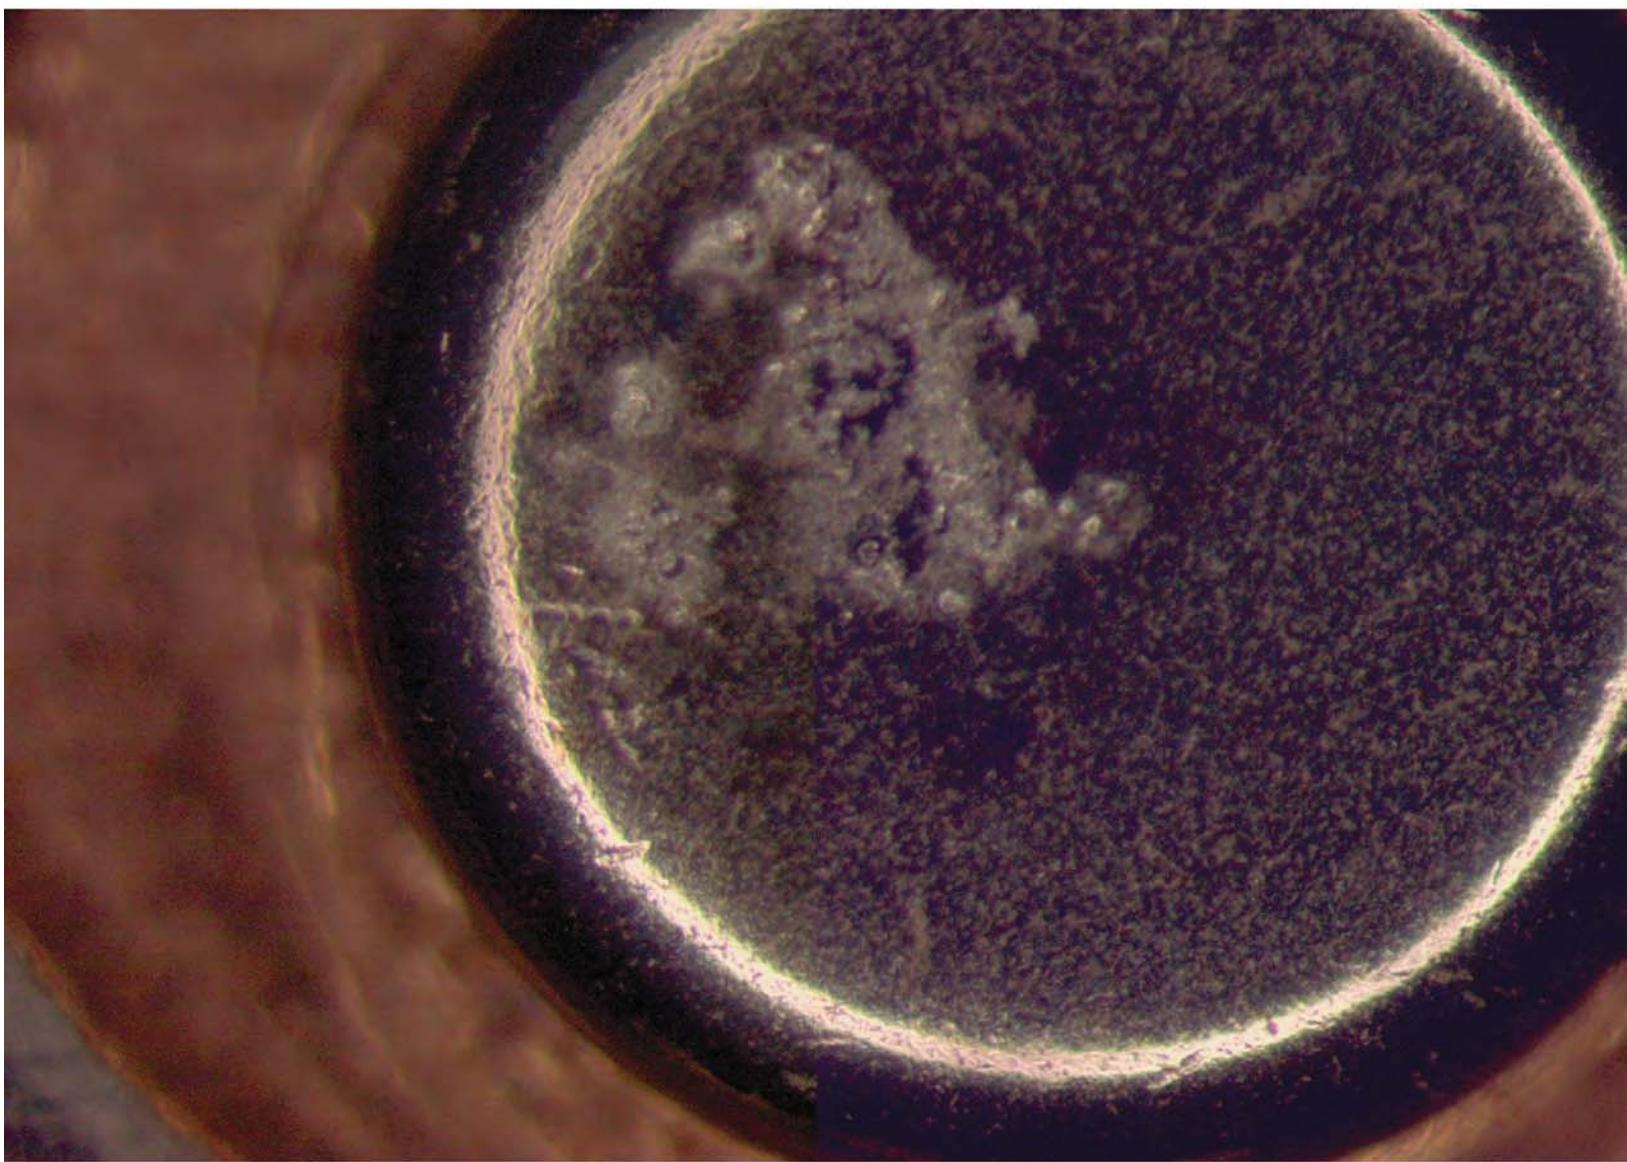
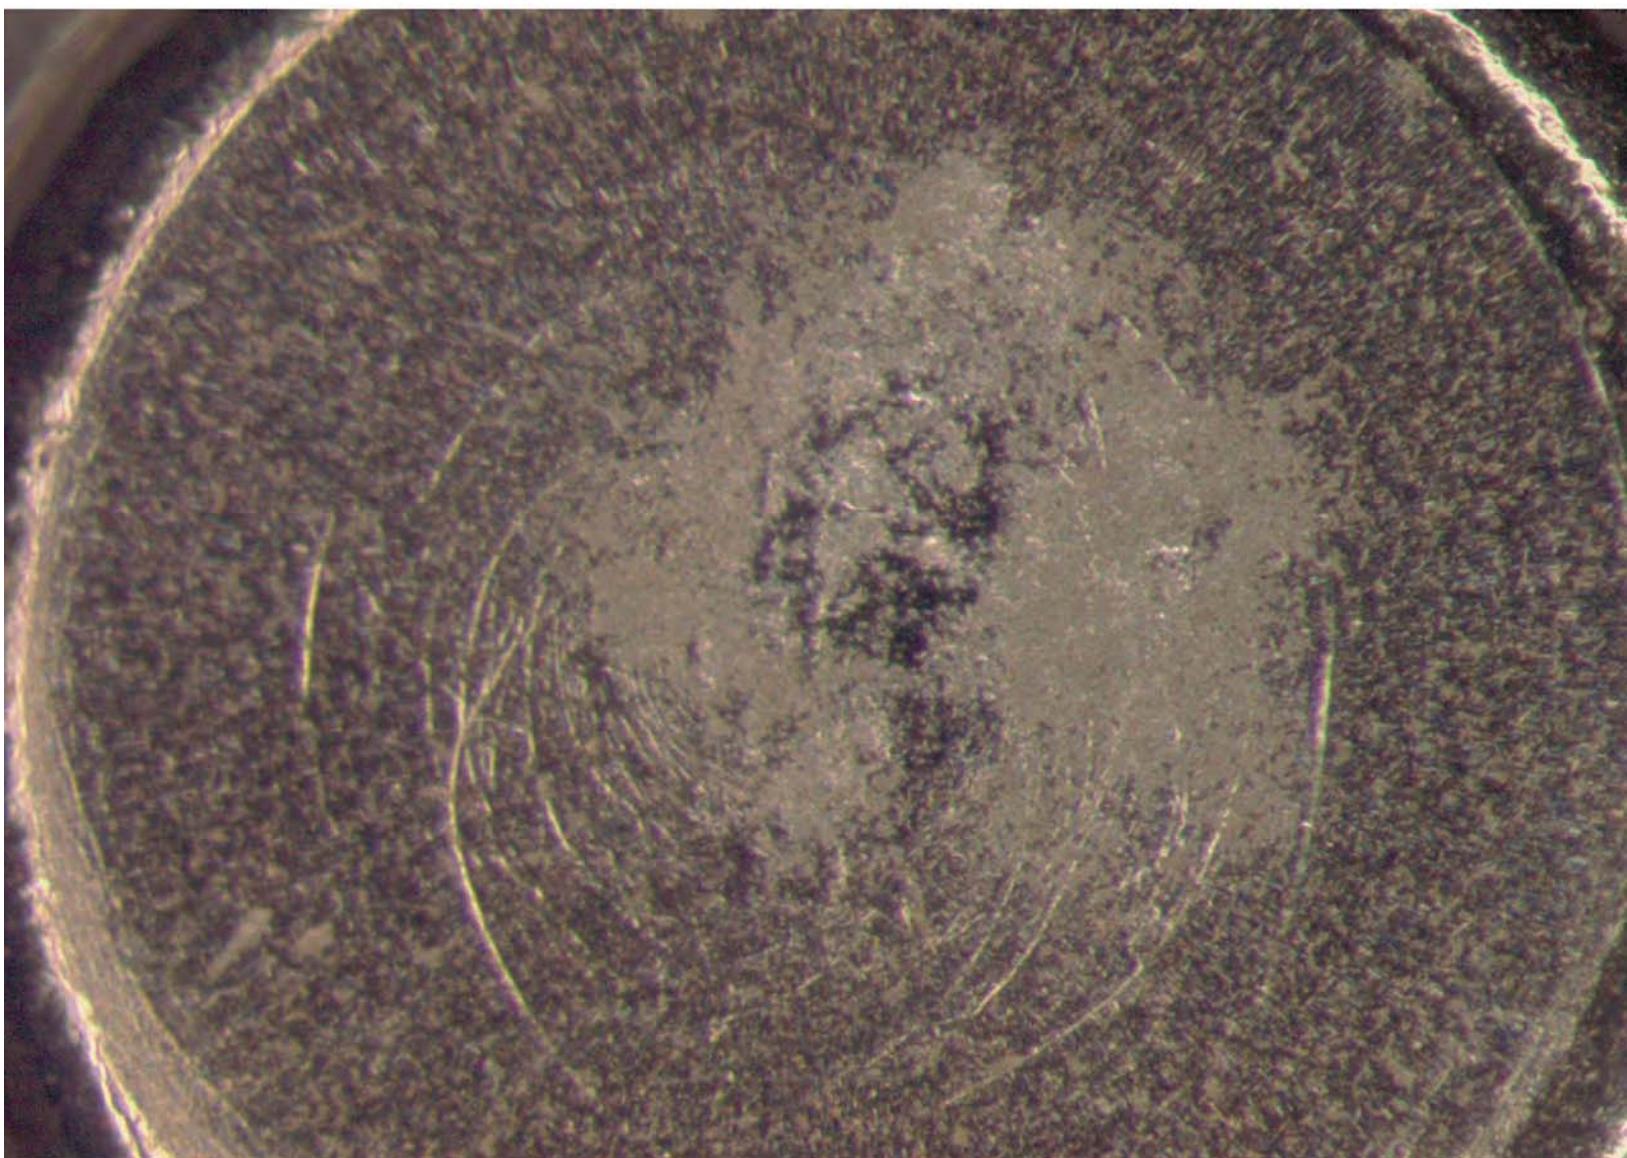
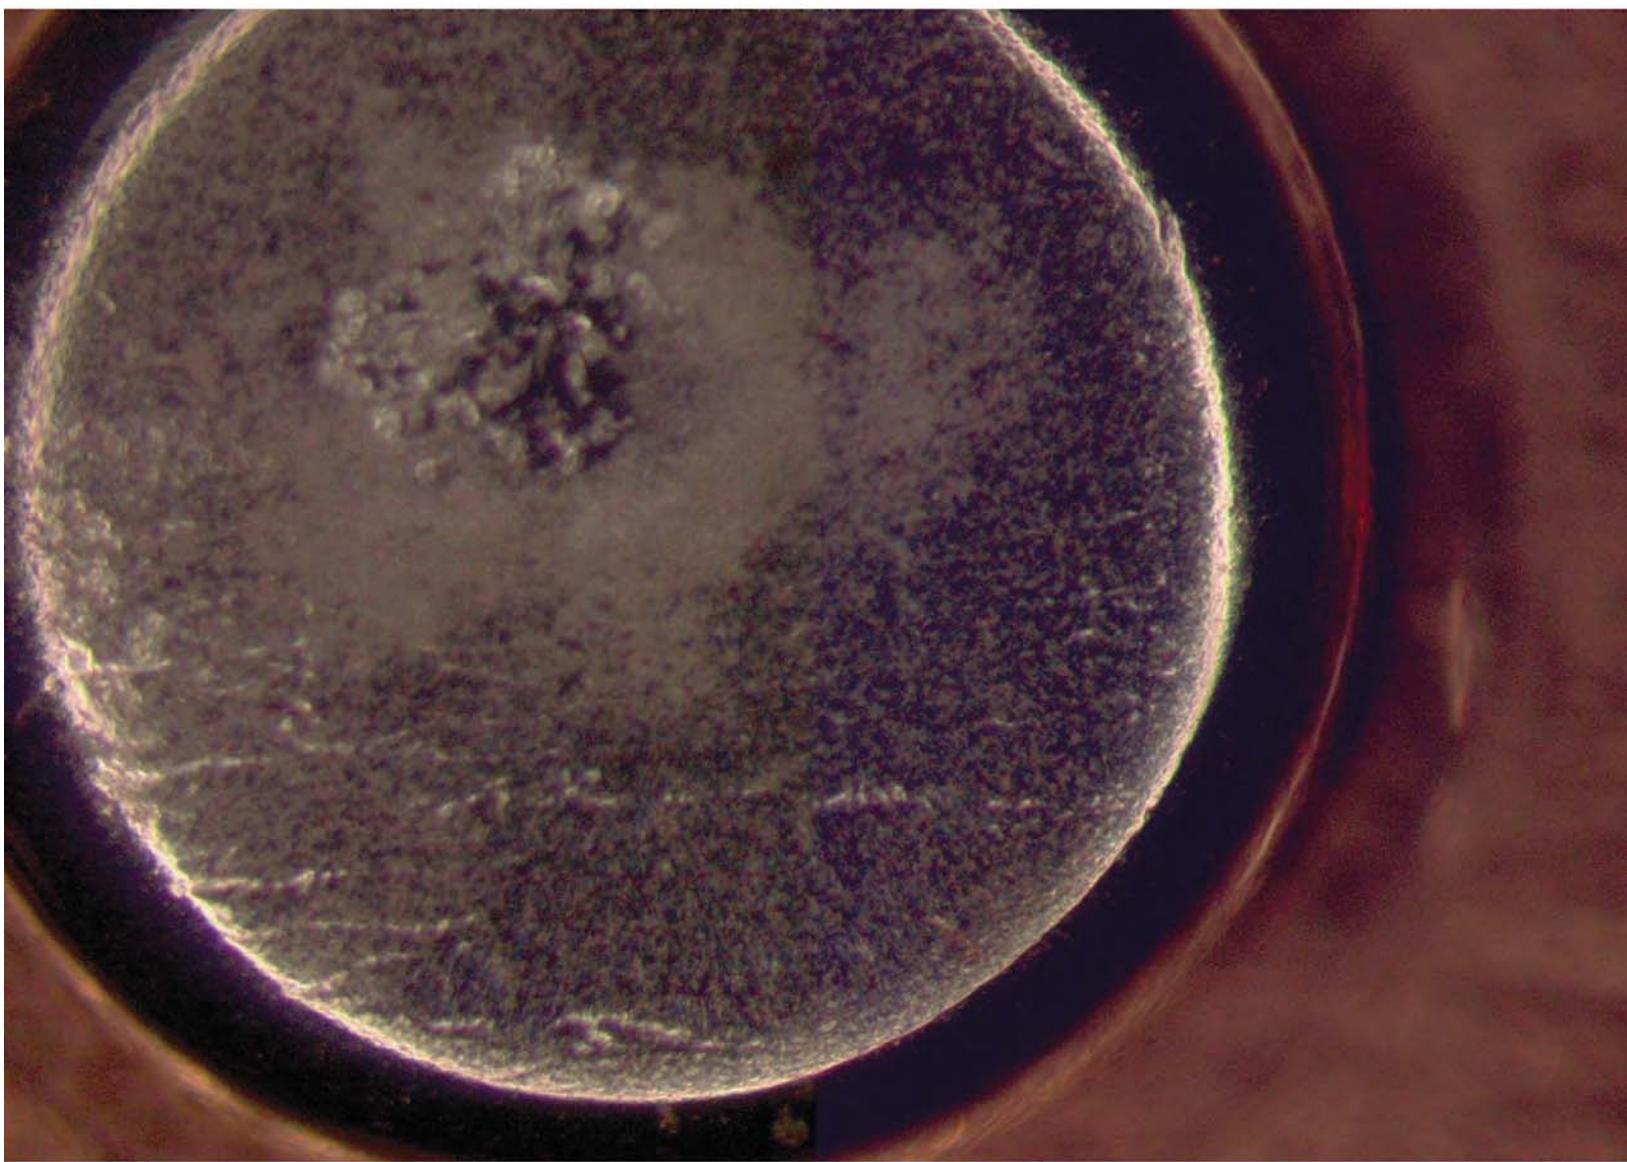
I've attached the optical microscope picture of the contacts from the suspect relay.

Contact B

Contact A

Contact C

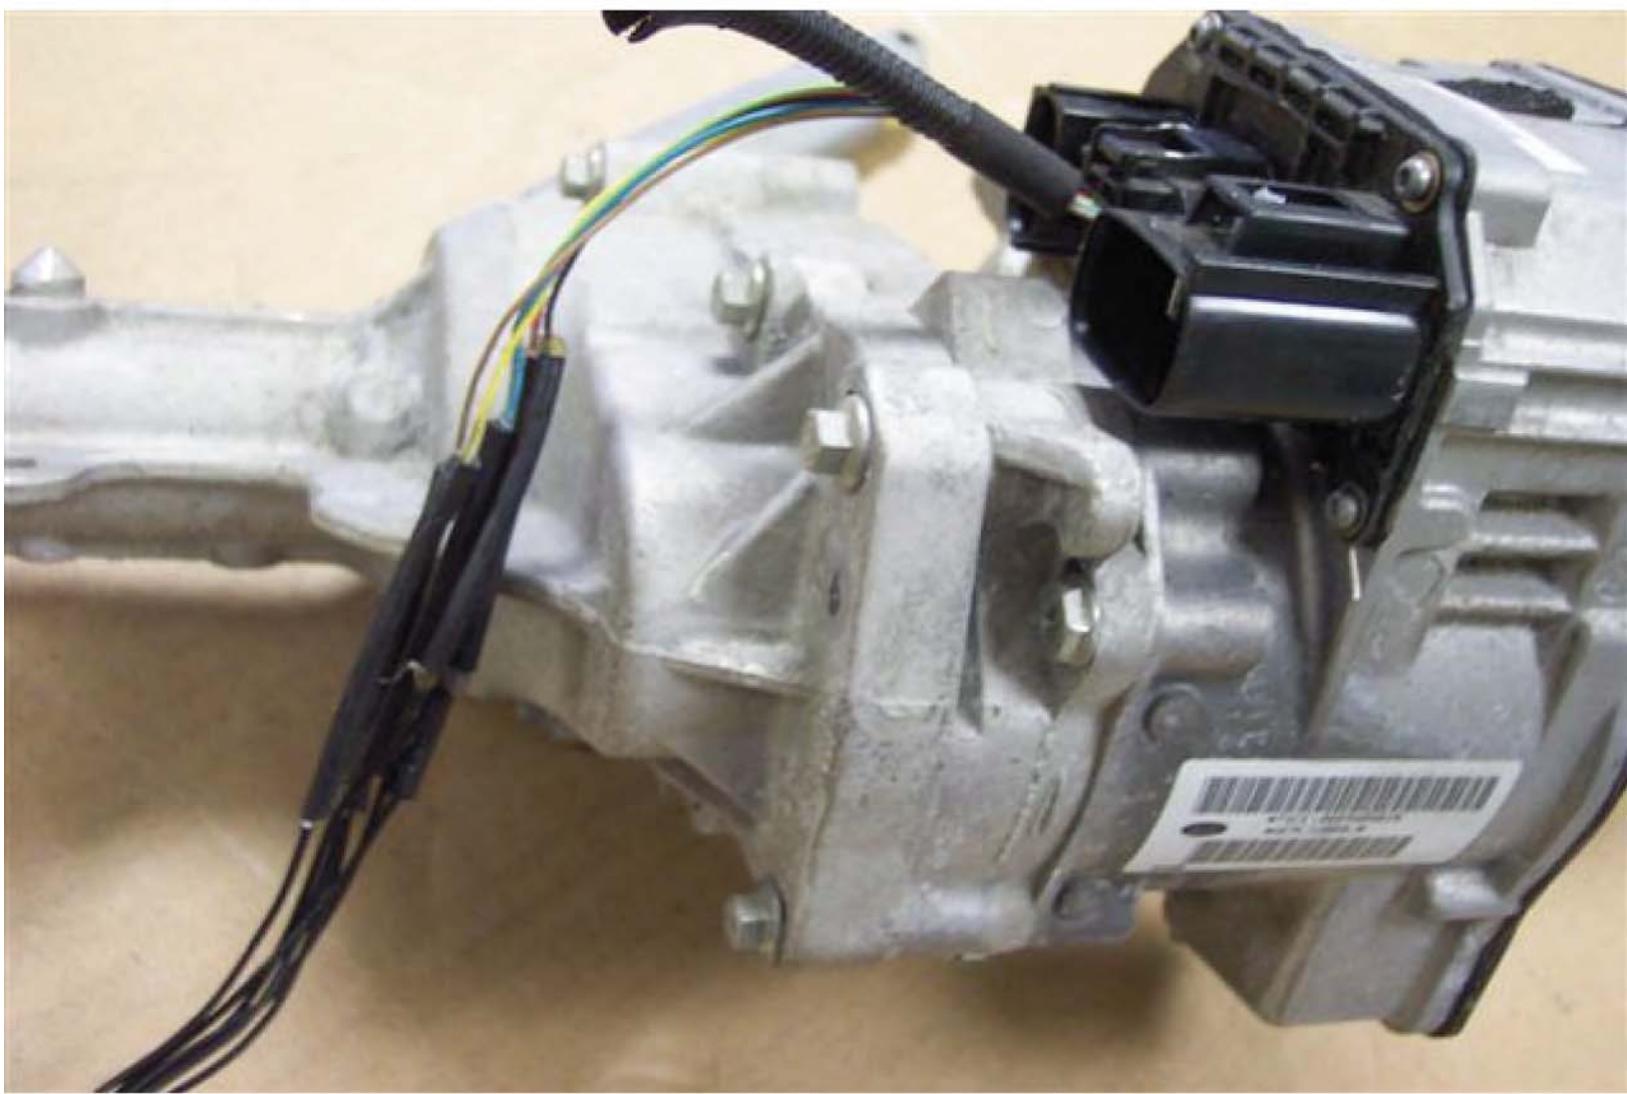
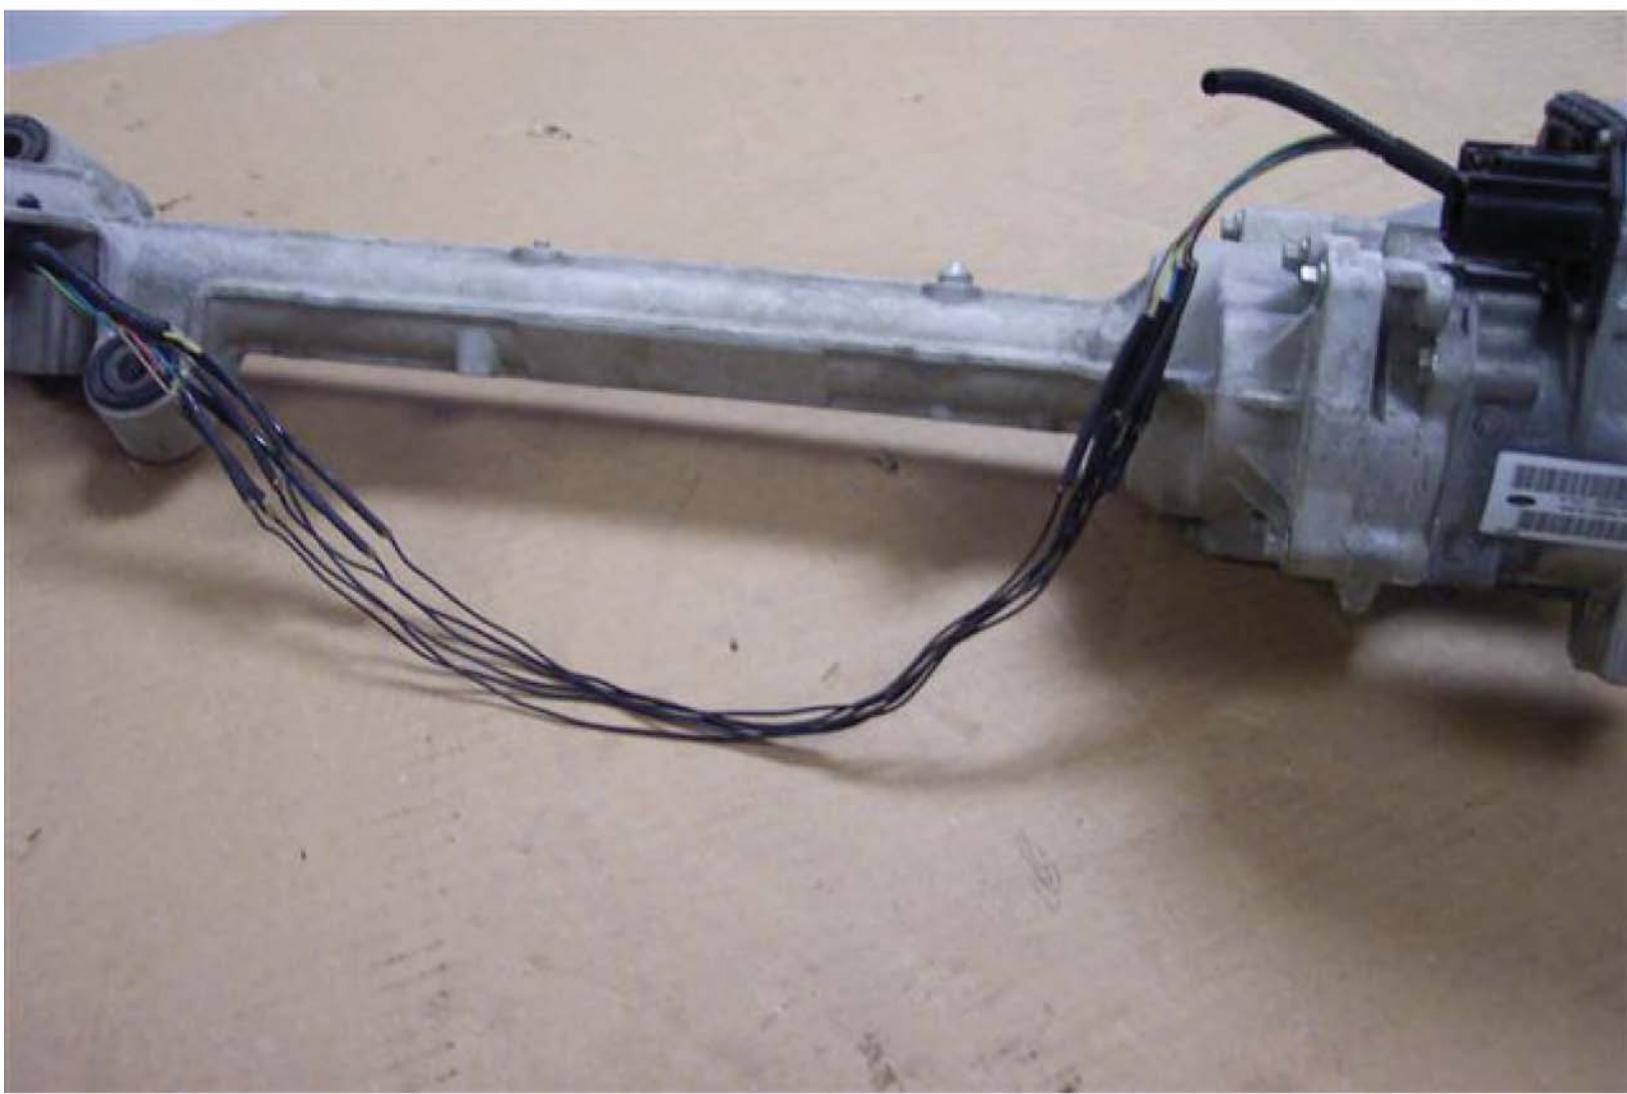
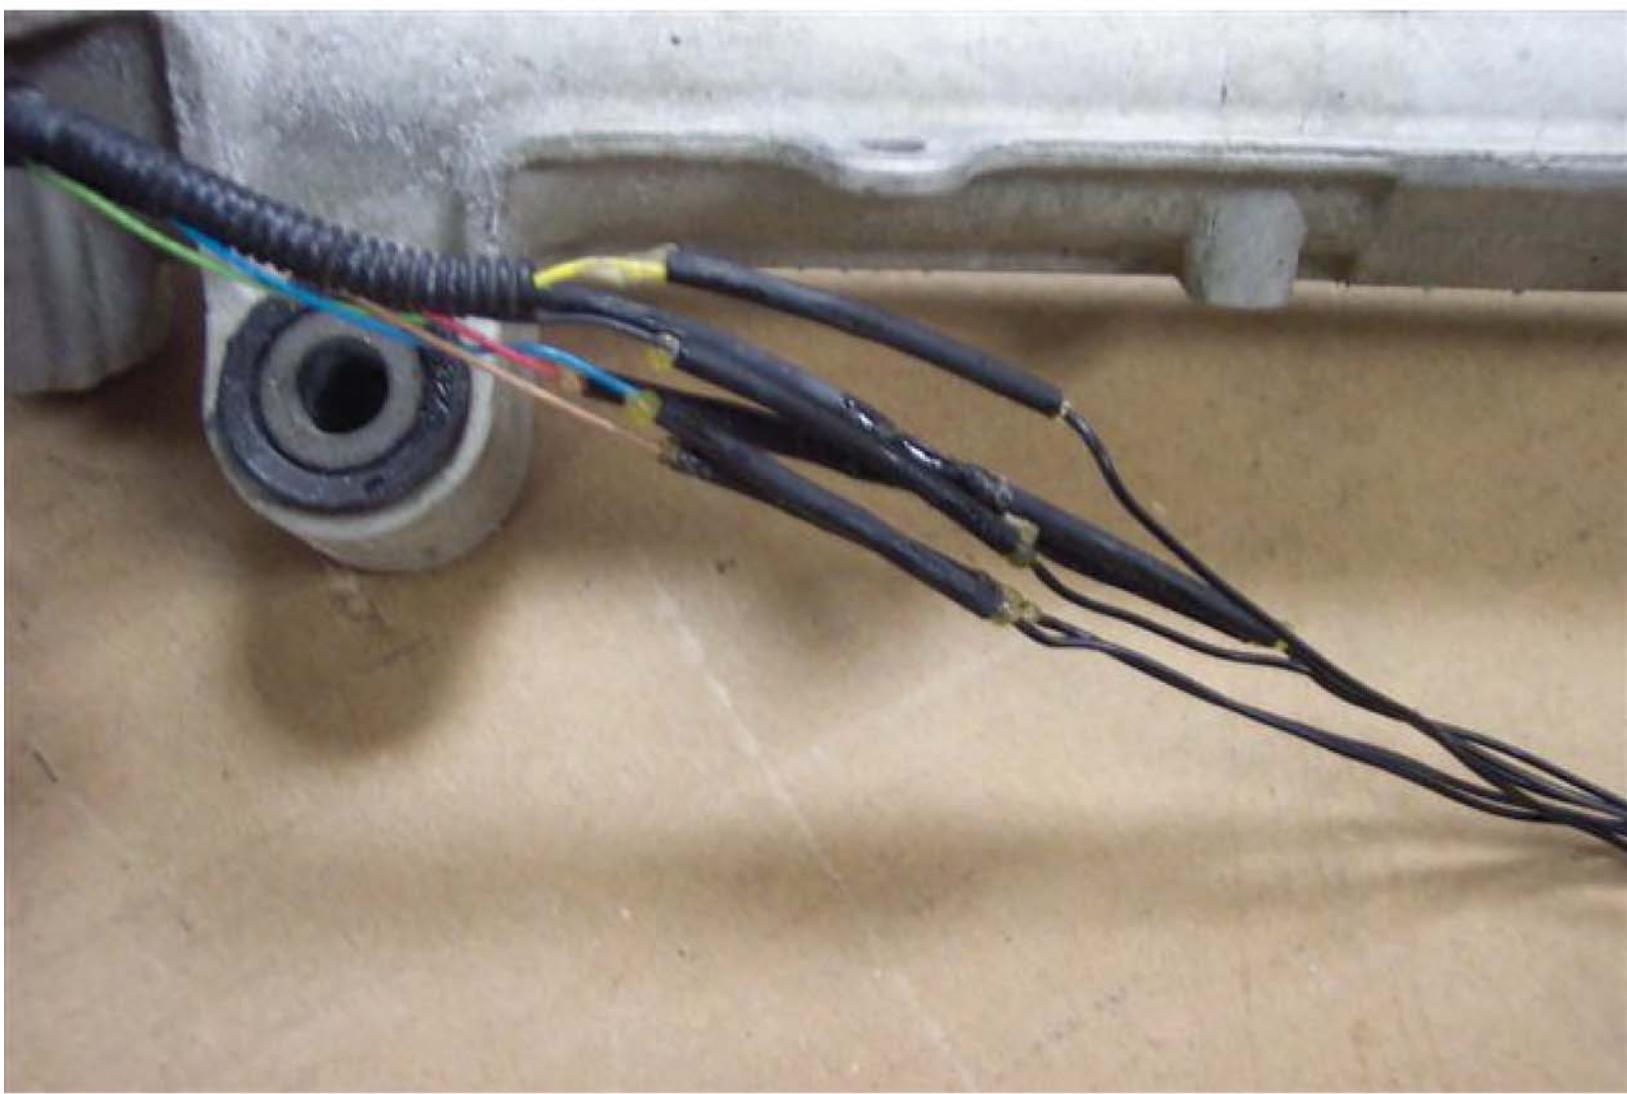
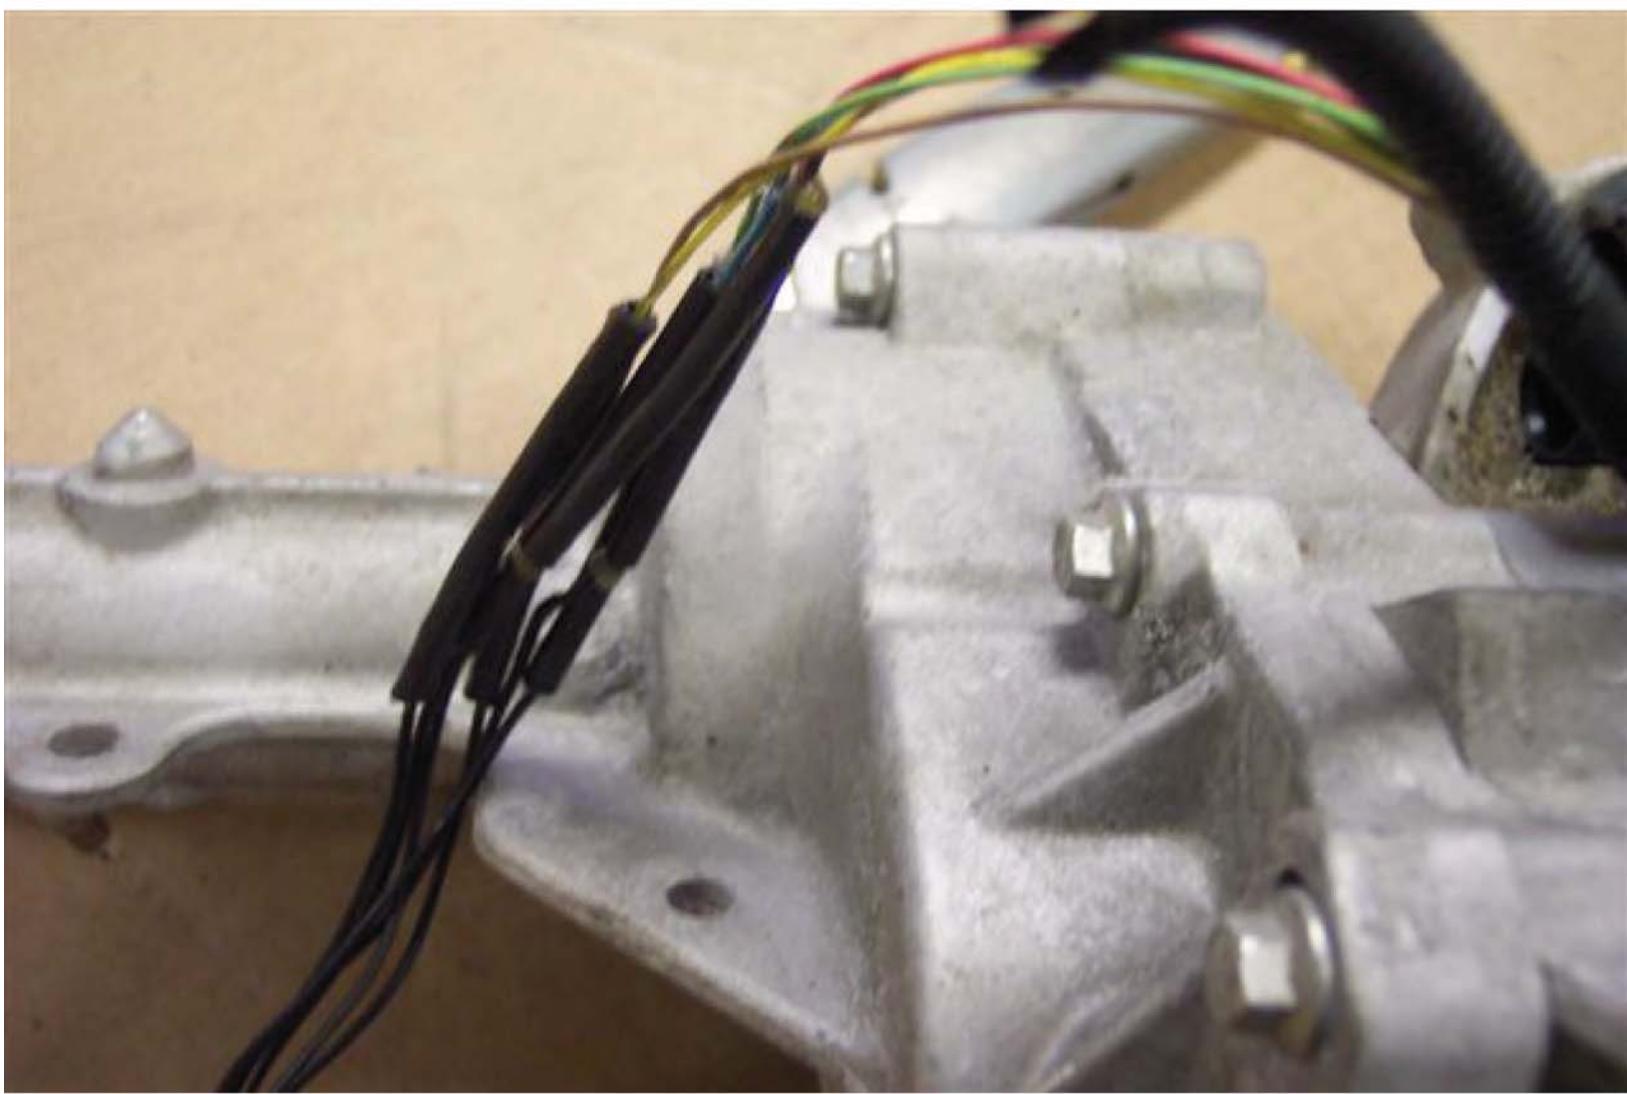
From: Estes, Eric (E.E.)
Sent: Thursday, January 28, 2010 7:45 PM
To: Bahena, Miguel (Mike.); Snider, Tim (T.O.); Diez, Timothy (T.P.); Mrozek, Robert (R.M.)
Subject: FR0123 TS damage
Attachments: FR0123 - Damaged TS harness.pdf; EPAS Gear 001.jpg; EPAS Gear 002.jpg; EPAS Gear 003.jpg; EPAS Gear 004.jpg; EPAS Gear 005.jpg; EPAS Gear 006.jpg
