Examples of how to NOT data center!

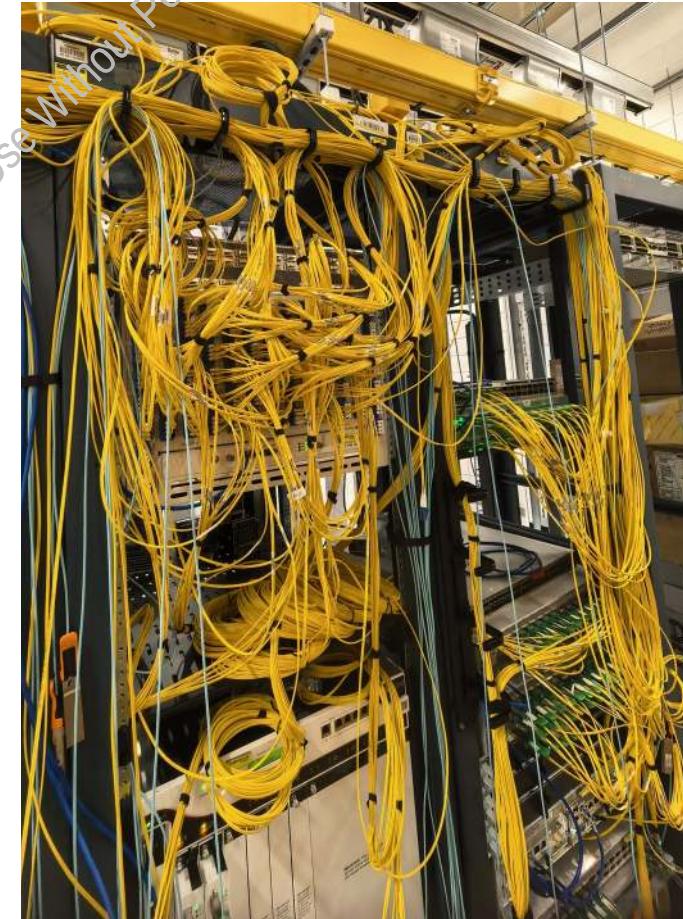
Just bad cabling management

Inappropriate cable length procurement for use

Inappropriate rack/cabinet/equipment combination/configuration, it should be flushed to the front or back or receded to allow for the cabling or utilization of management trays

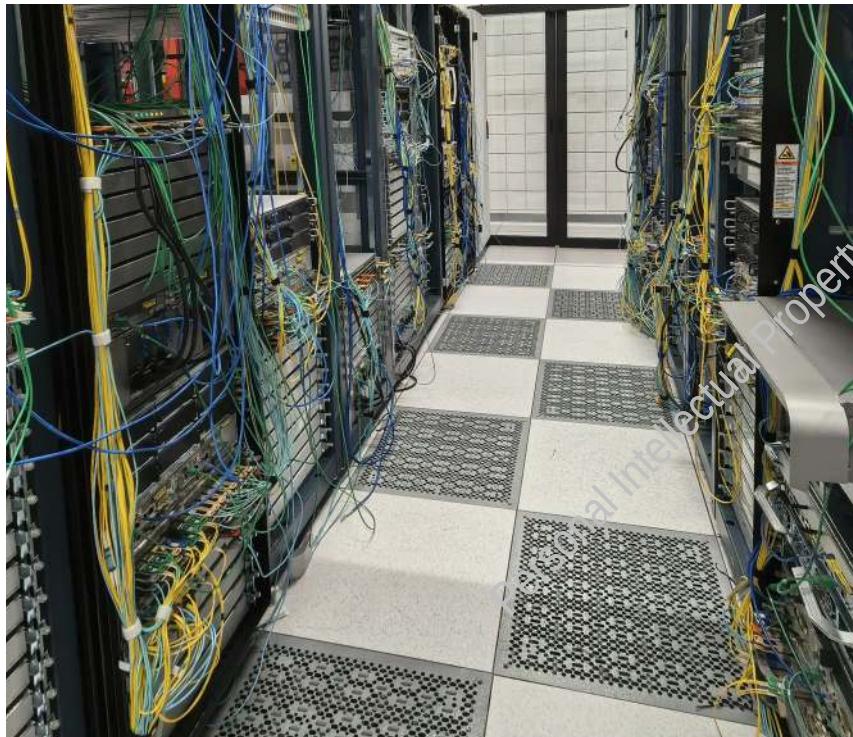
Just bad cabling management
No Use of cable management trays
Inappropriate cable length procurement for use

BAD design practice – only 2 tile space:

barely any room for maneuvering crash carts, equipment pallet jacks, etc...
checkered perforated airflow tiles, budget constraints approach for equipment airflow utilization rather than full solid rows of perforated tiles for adequate airflow/cooling
