Examples of how to NOT data center!

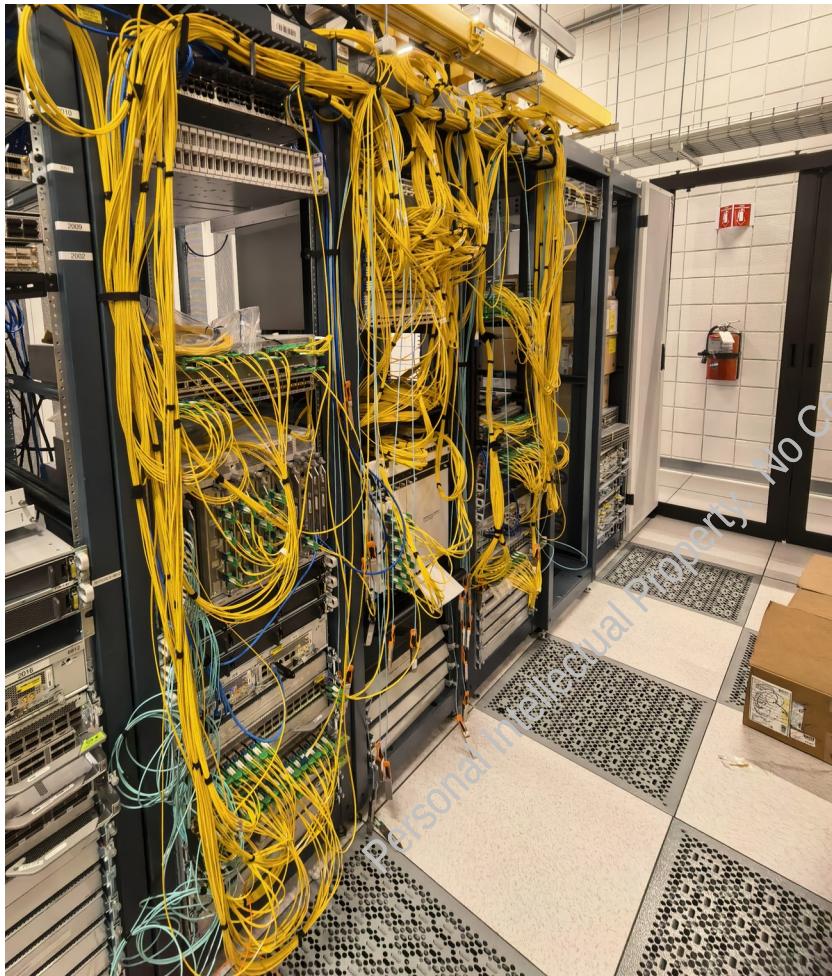
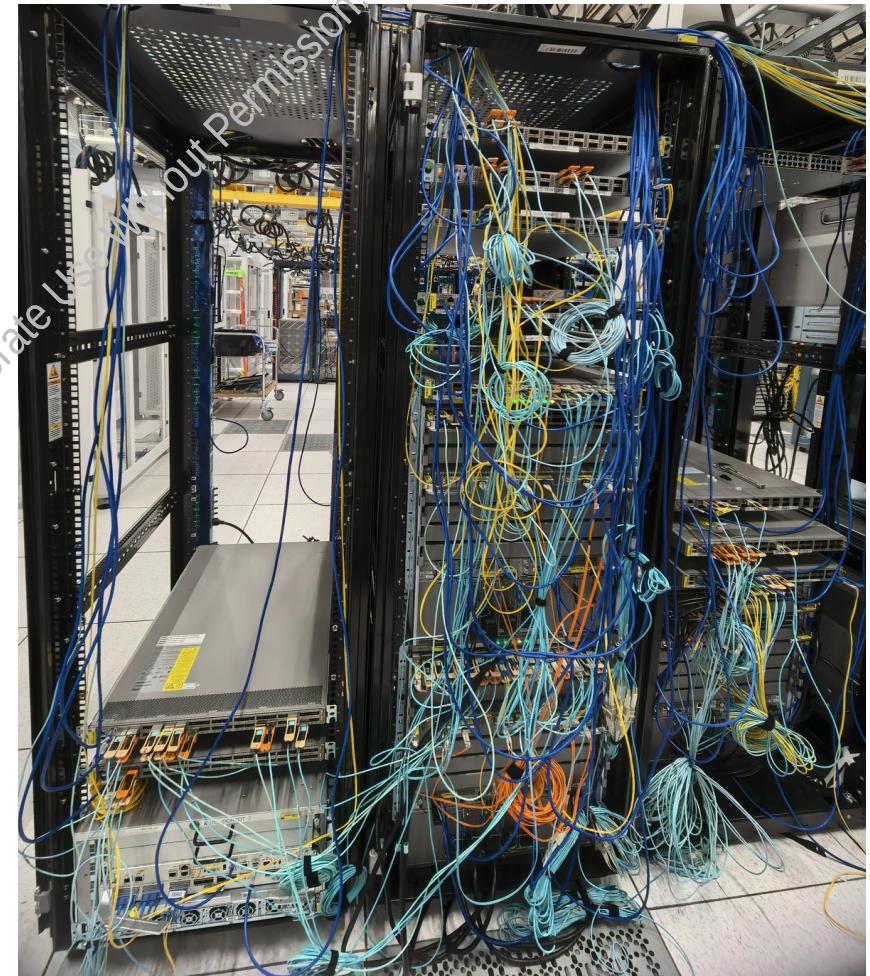
Just bad cabling management
No Use of cable management trays
Inappropriate cable length procurement for use

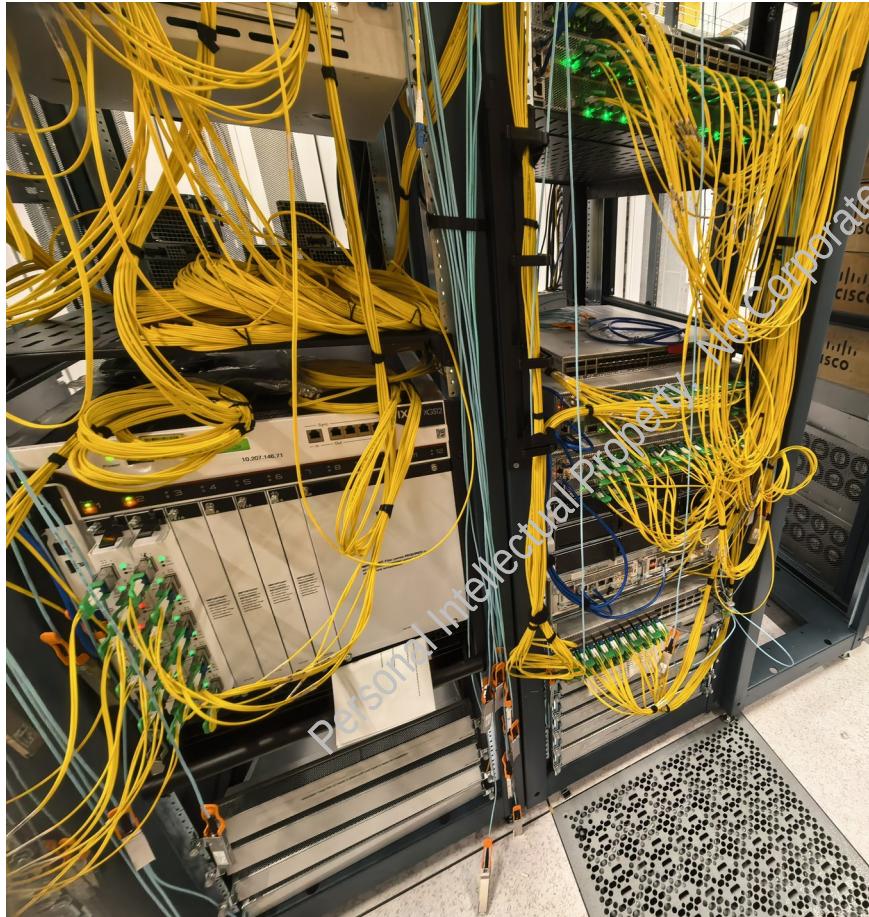
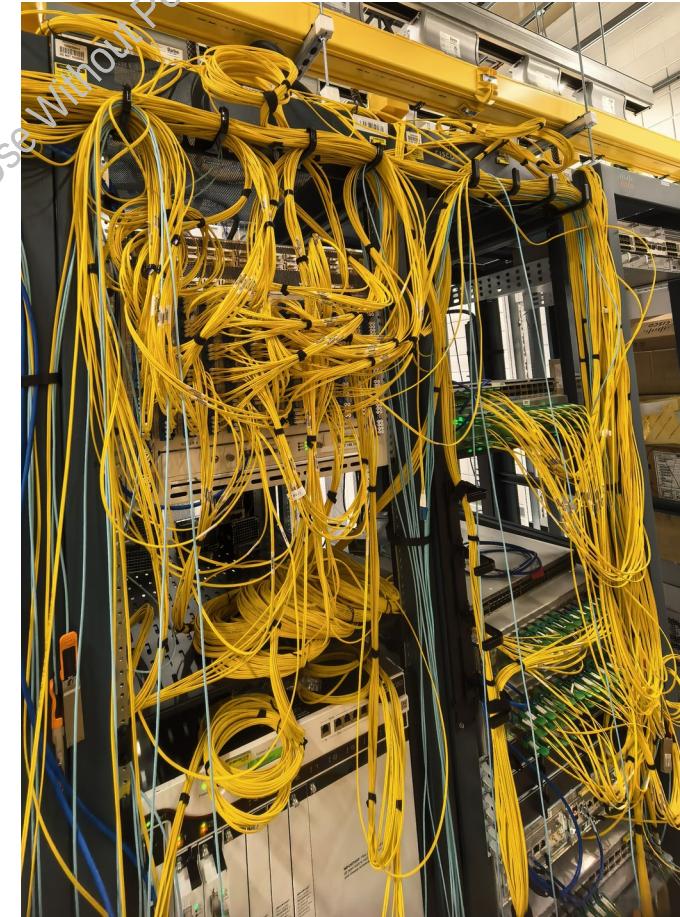
Just bad cabling management

Inappropriate cable length procurement for use

Inappropriate rack/cabinet/equipment combination/configuration, it should be flushed to the front or back or receded to allow for the cabling or utilization of management trays

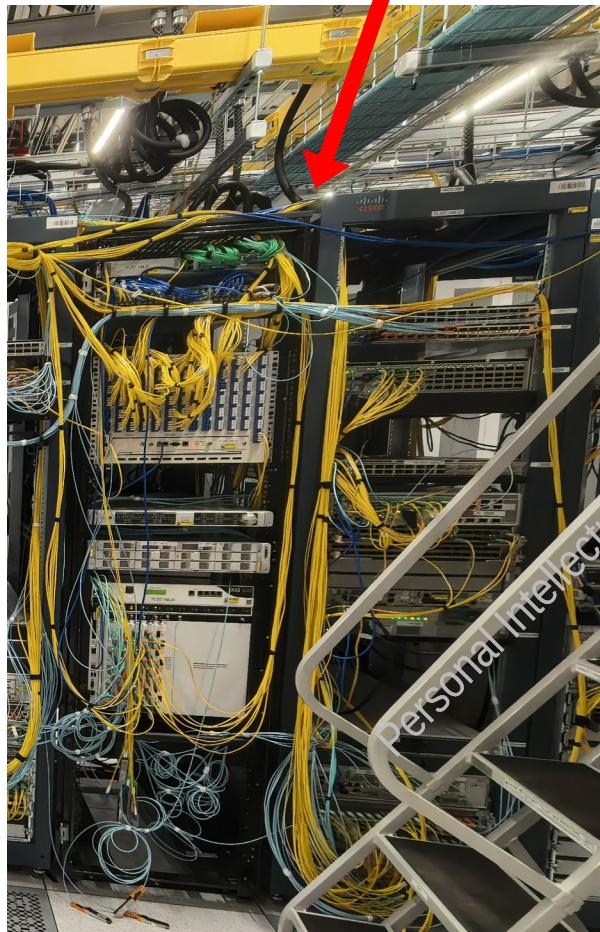
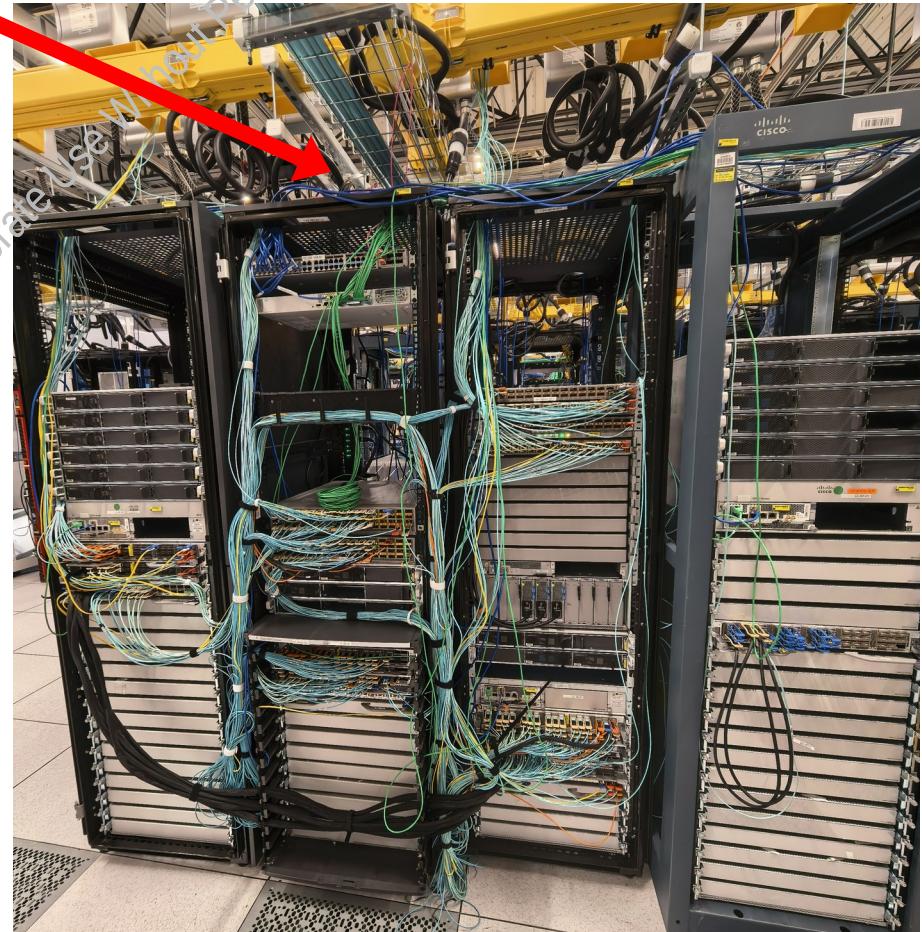
Just bad cabling management
No Use of cable management trays
Inappropriate cable length procurement for use
Obstruction (cabinet) to cable tray access (NIGHTMARE for running cables)

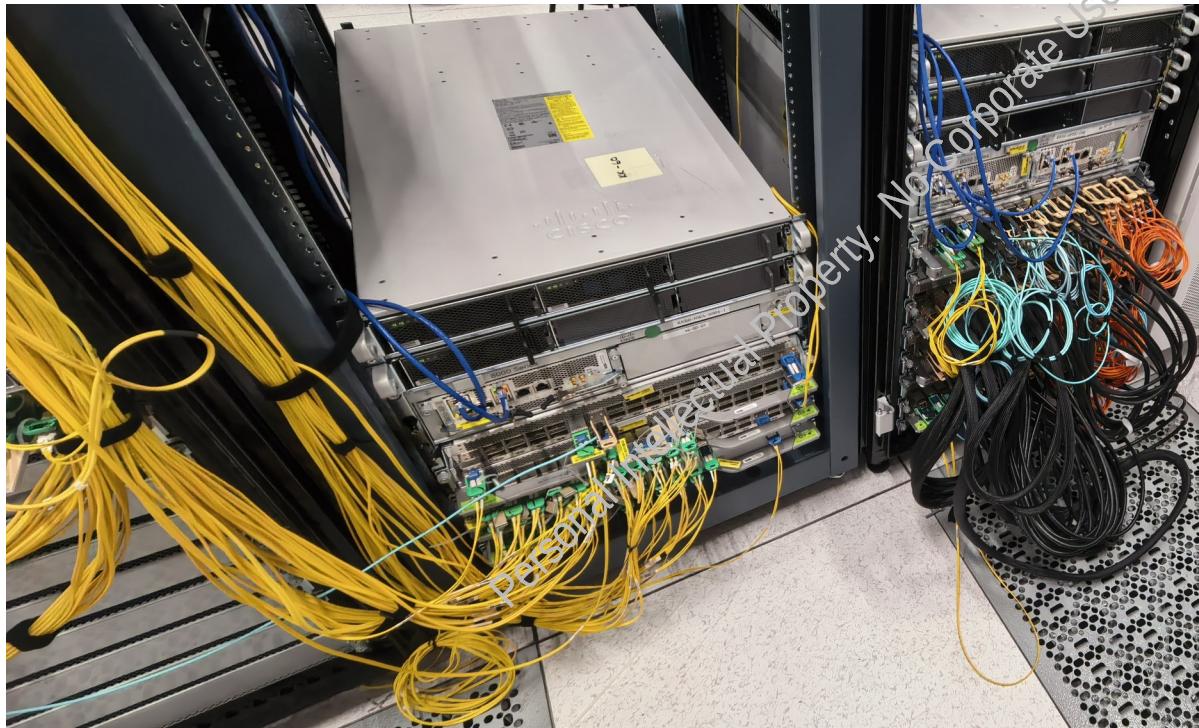
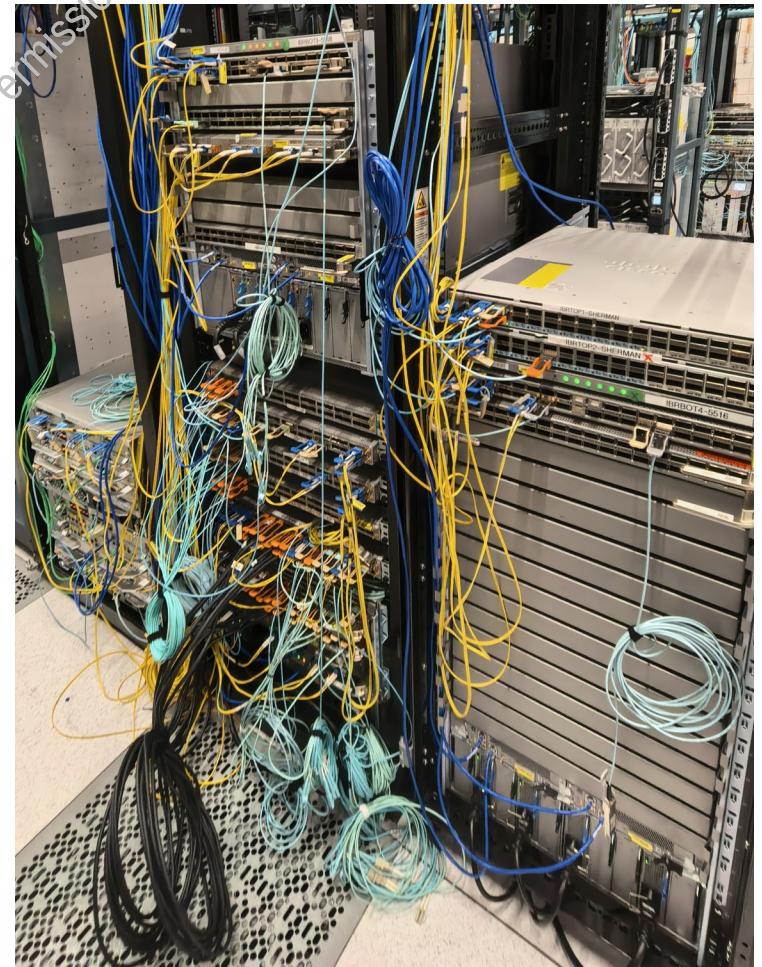
Just bad cabling management
No Use of cable management trays
Inappropriate cable length procurement for use
Obstruction of already limited – only 2 tile space, BAD design practice

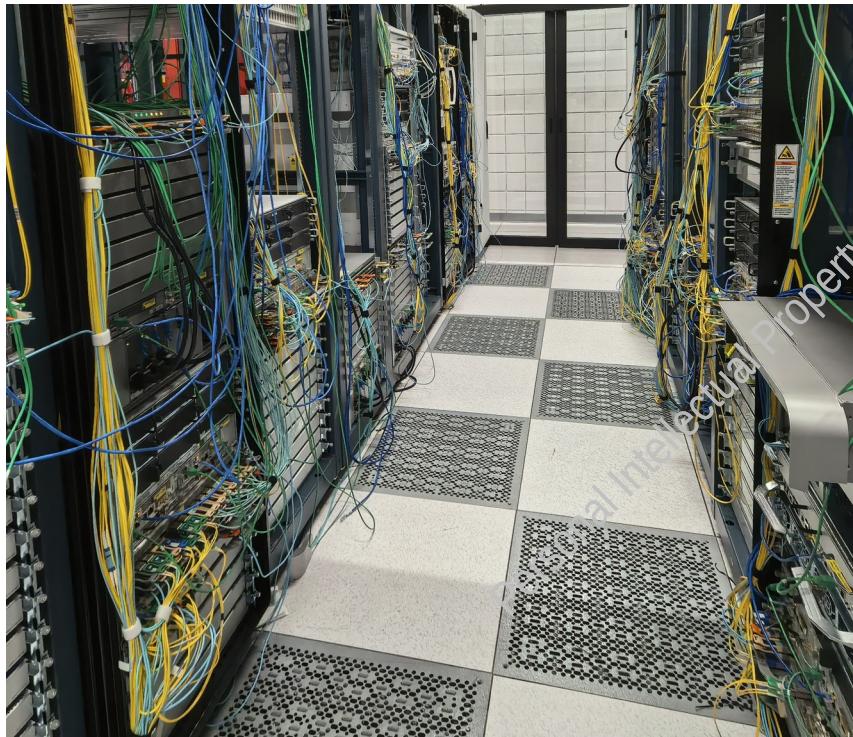
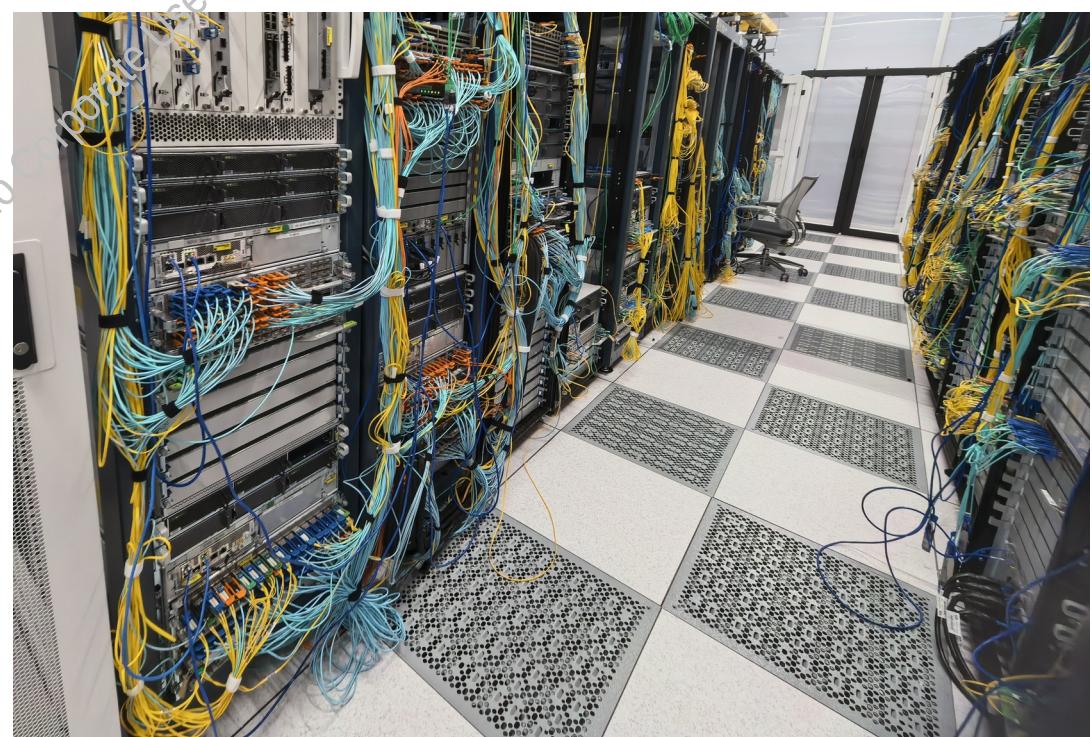
Just bad cabling management
No Use of cable management trays
Inappropriate cable length procurement for use

BAD design practice – only 2 tile space:

barely any room for maneuvering crash carts, equipment pallet jacks, etc...
checkered perforated airflow tiles, budget constraints approach for equipment airflow utilization rather than full solid rows of perforated tiles for adequate airflow/cooling
