## Examples of how to NOT data center!

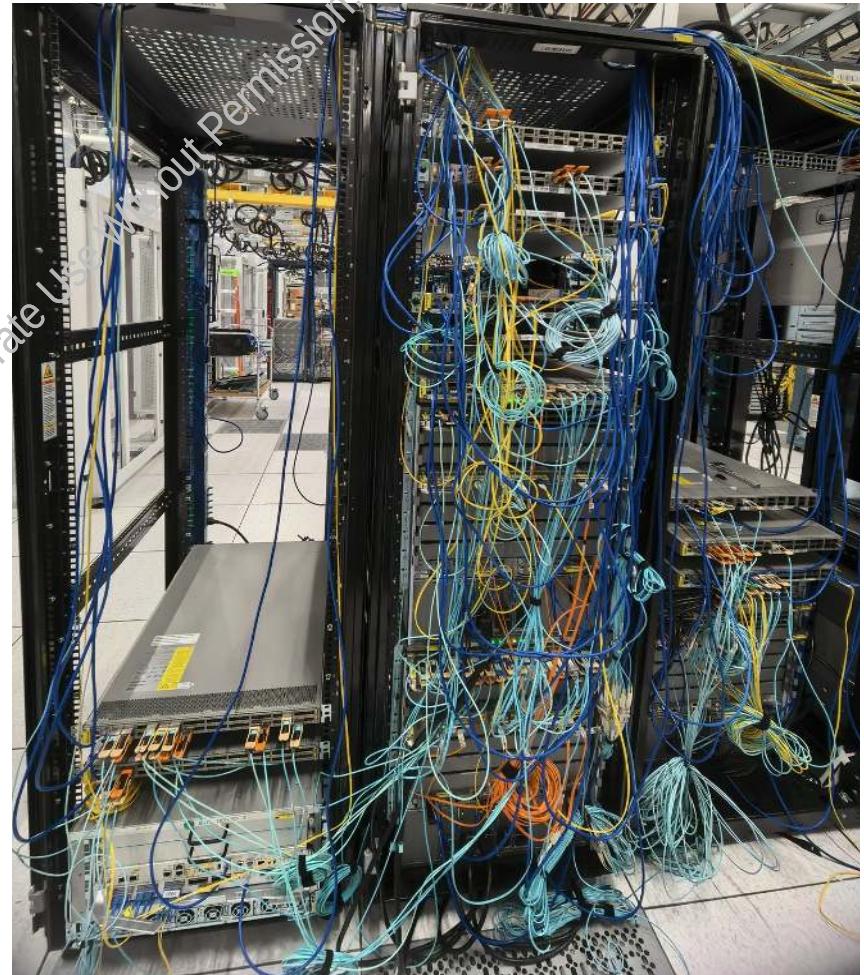
Just bad cabling management  
No Use of cable management trays  
Inappropriate cable length procurement for use

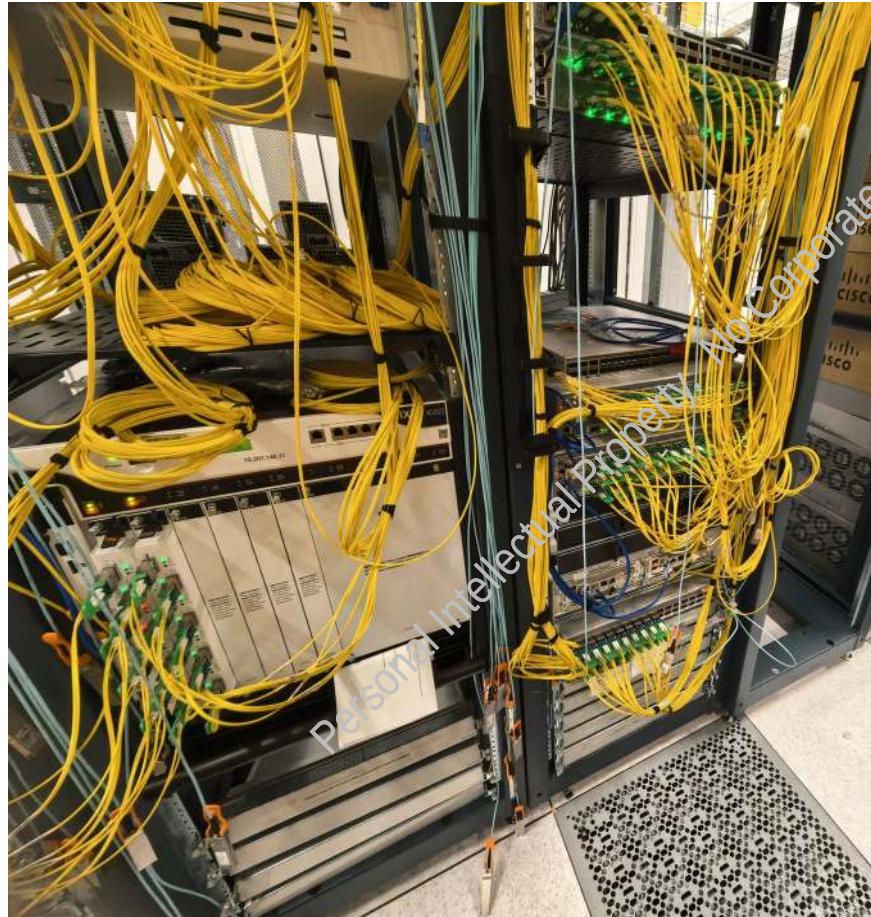
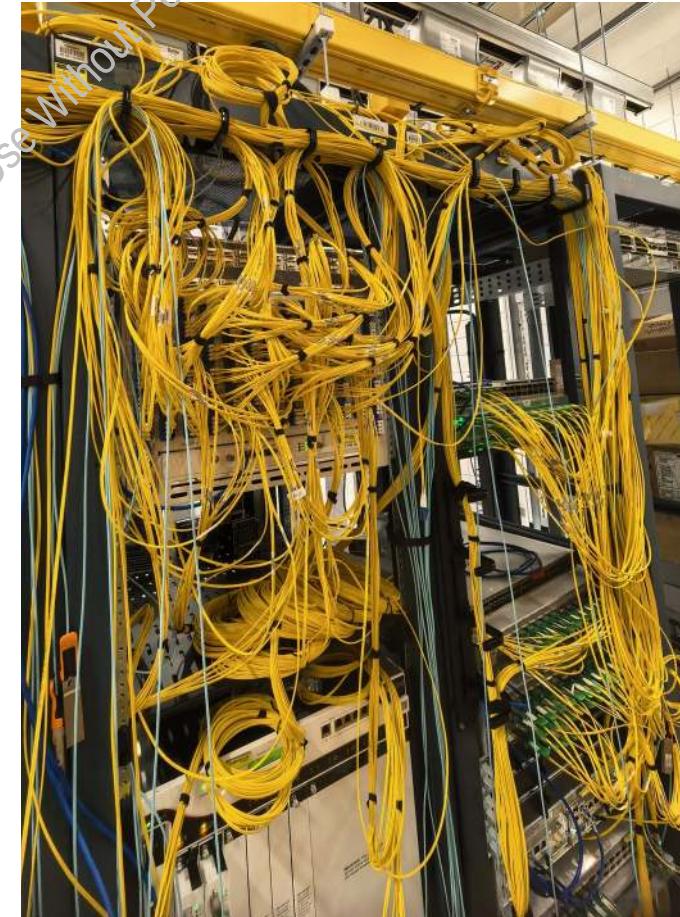
Just bad cabling management

Inappropriate cable length procurement for use

Inappropriate rack/cabinet/equipment combination/configuration, it should be flushed to the front or back or receded to allow for the cabling or utilization of management trays

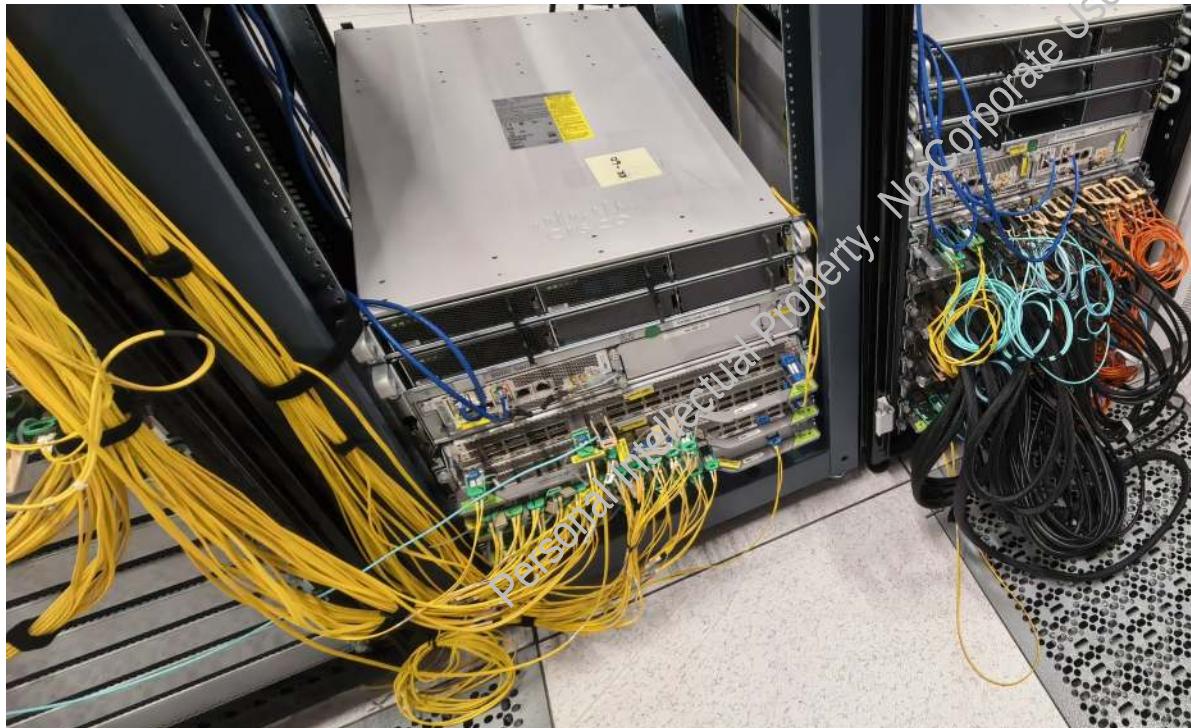
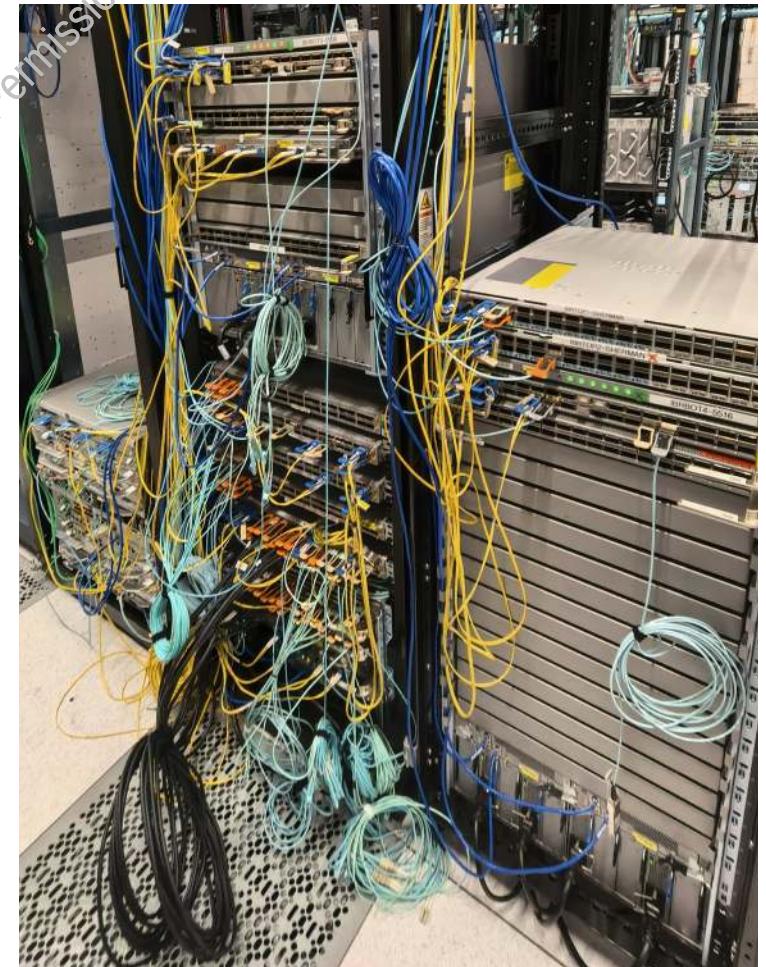
Just bad cabling management  
No Use of cable management trays  
Inappropriate cable length procurement for use  
Obstruction of already limited – only 2 tile space, BAD design practice

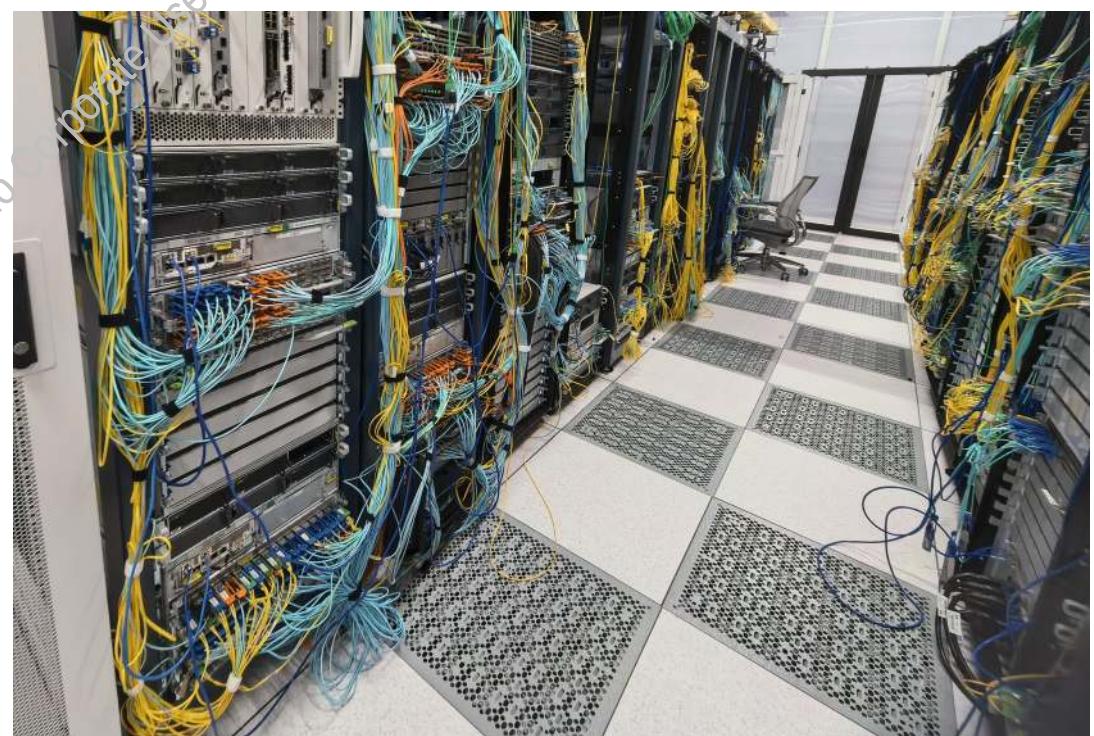
Just bad cabling management  
No Use of cable management trays  
Inappropriate cable length procurement for use

BAD design practice – only 2 tile space:

barely any room for maneuvering crash carts, equipment pallet jacks, etc...  
checkered perforated airflow tiles, budget constraints approach for equipment airflow utilization rather than full solid rows of perforated tiles for adequate airflow/cooling

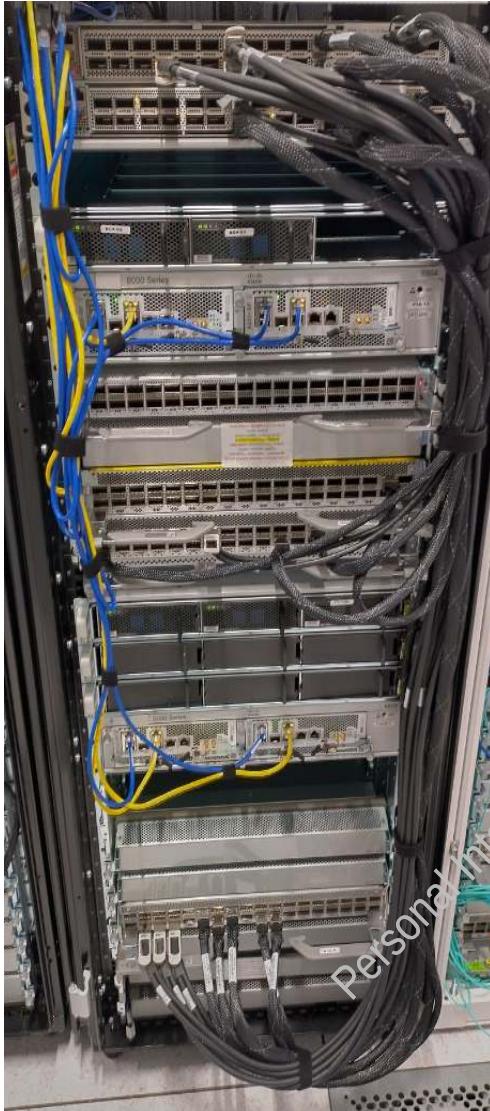
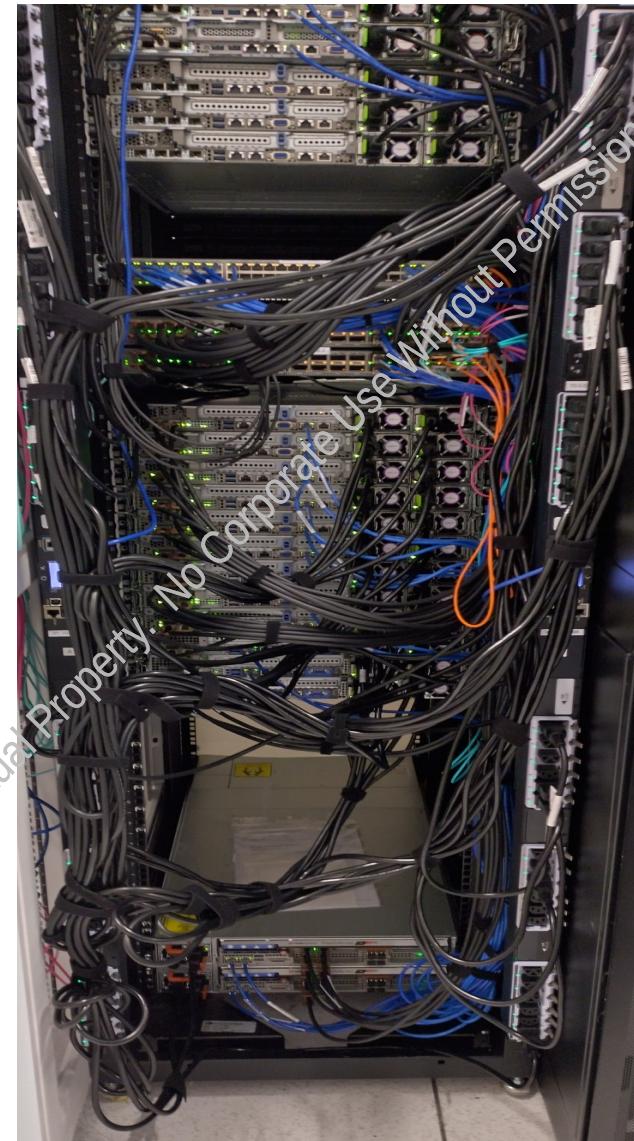
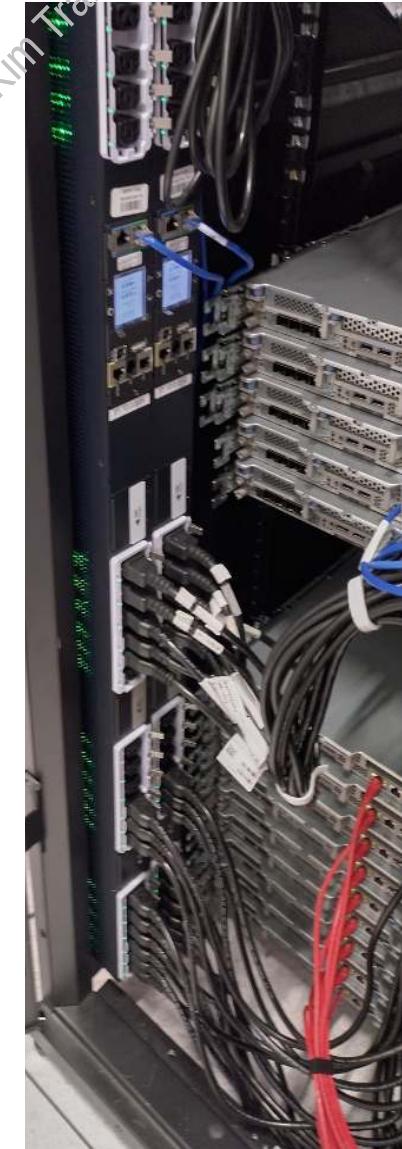
This environment was a nightmare to manage and support.

Amongst this chaos, I do what I can and my work ethics and integrity speaks for itself

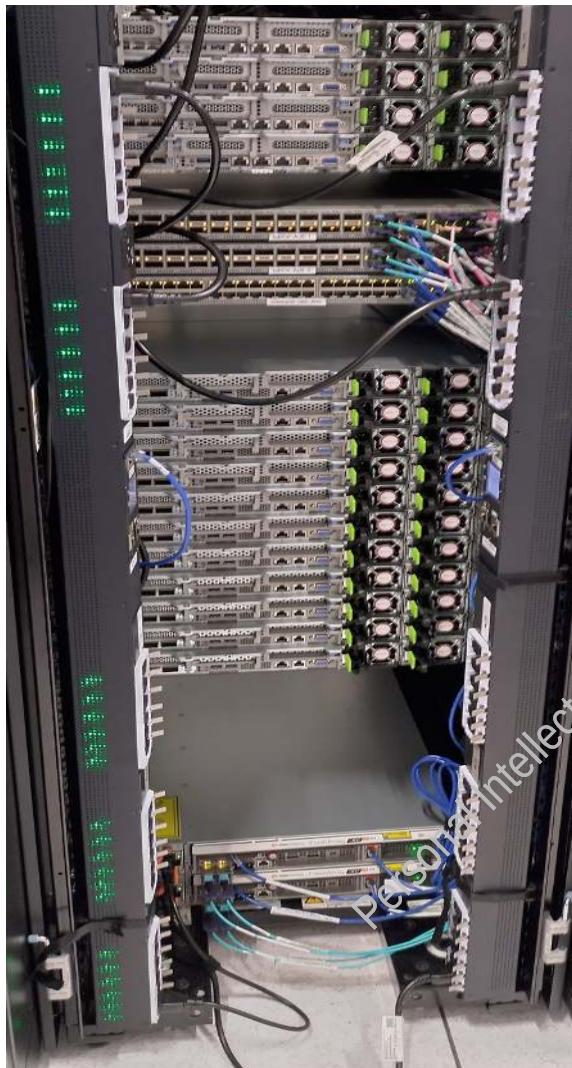
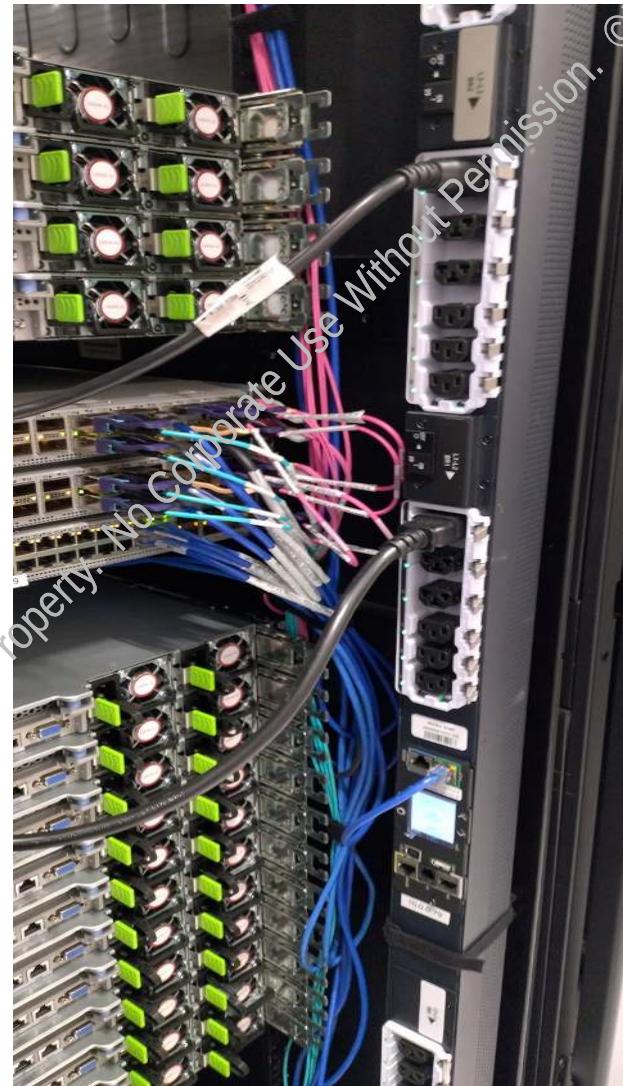
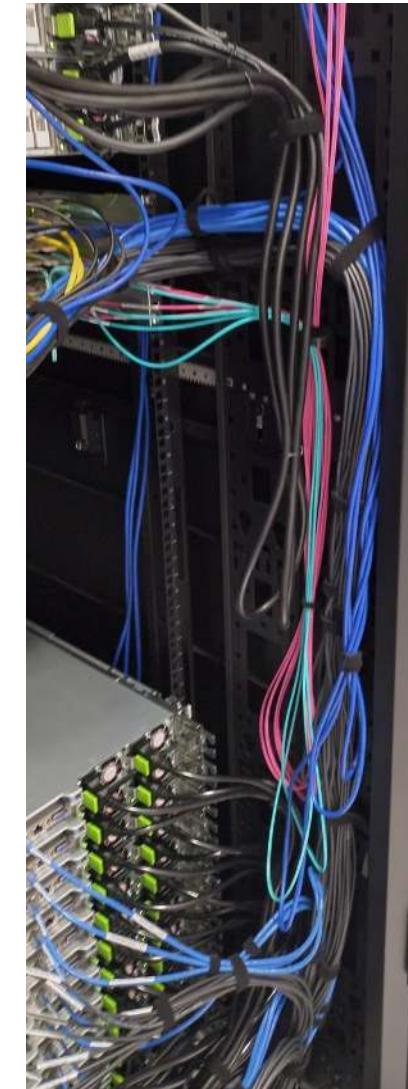
I can only control what's in my power to control...the quality of my work
