NCHRP REPORT 656

**Criteria for Restoration  
of Longitudinal Barriers**

VIRGINIA POLYTECHNIC INSTITUTE AND STATE UNIVERSITY  
Blacksburg, VA

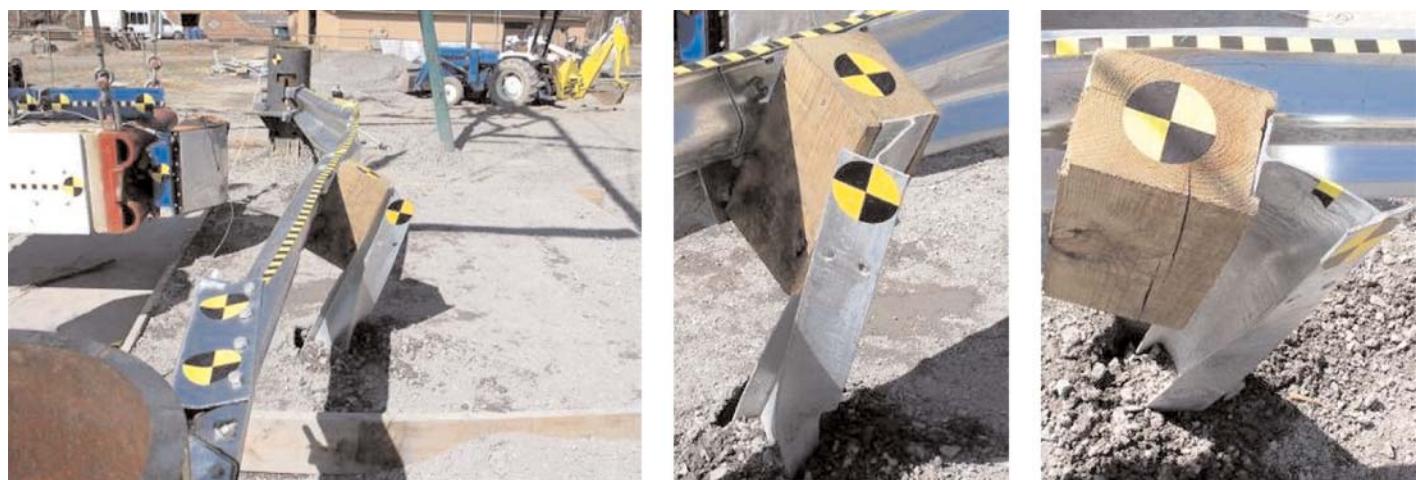
**Figure 15.** Test 03-2: overall damage (right) and post damage at splice (center) and non-splice location (right).

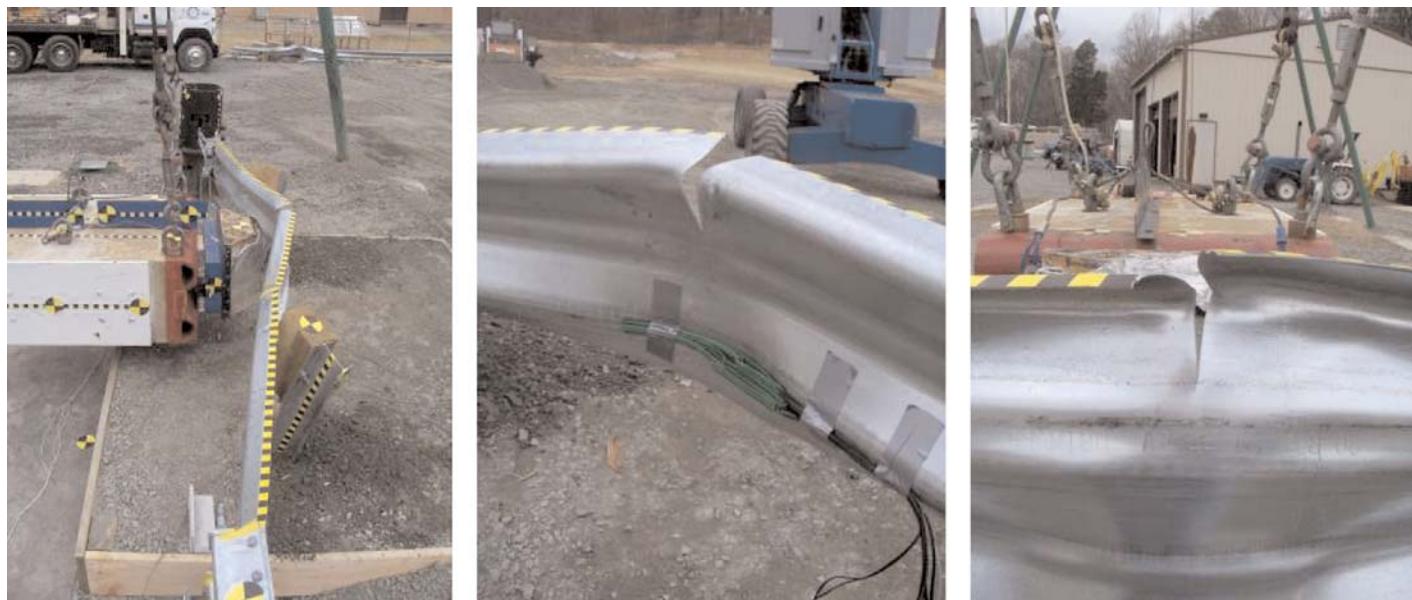
**Figure 18.** Test 08-2: overall damage (left) and detail views of the additional tearing caused by the pendulum impact (center), and post damage at splice location (right).

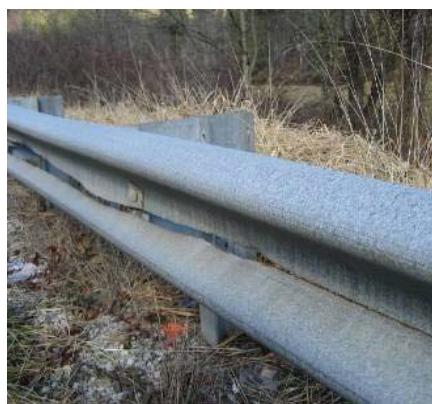
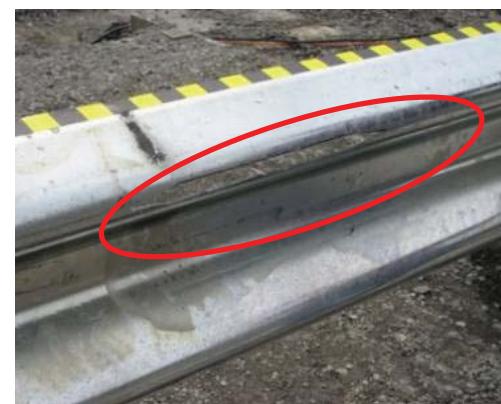
**Figure 19. Horizontal tear evaluated in pendulum tests.**

A horizontal tear was simulated by cutting a longitudinal notch in the center of the upper protrusion of the w-beam using a reciprocating saw. Each end of the notch was cut into a "V" shape to provide a stress concentrator similar to those observed in the field in a crash-induced horizontal tear. The location of the tear corresponded to the pendulum mass impact location, as this was believed to have the largest risk for rail rupture. The horizontal tear was a total of 306 mm (12 inches) long. The middle 204 mm (8 inches) of the tear was 13 mm wide (0.5 inches) with a 51 mm (2 inches) "V" shaped taper on either end.

The horizontal tear damaged barrier in Test 07-3 contained the pendulum mass impacting at 29.3 km/hr (18.2 mph), which was calculated using the data from the high speed video footage. The maximum dynamic deflection of the test section was 579 mm (22.8 inches) at 130 ms after the initial impact, computed from the pendulum acceleration data. The maximum static crush at the center of the w-beam was 406 mm (16.0 inches). The damage at the impact location and individual post damages are shown in Figure 20. Both post-rail connections remained intact and there was 16 mm (0.63 inches) of relative movement between the two w-beams at the splice location. Figure 21 shows time sequential snapshots of Test 07-3 obtained from the high speed camera positioned overhead.

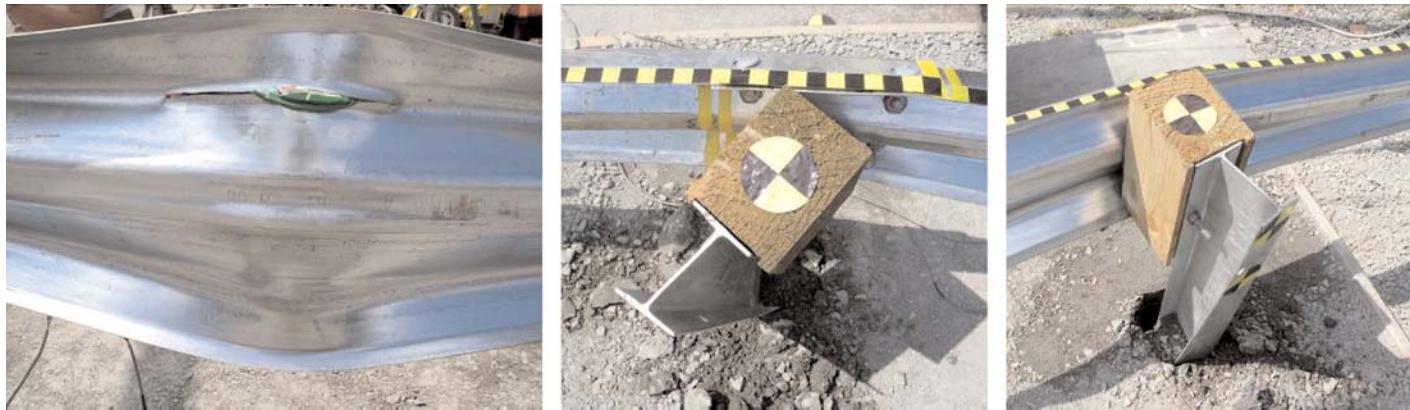
**Figure 20.** Test 07-3: detailed view of impact location (left), post damage at splice (center), and non-splice location (right).

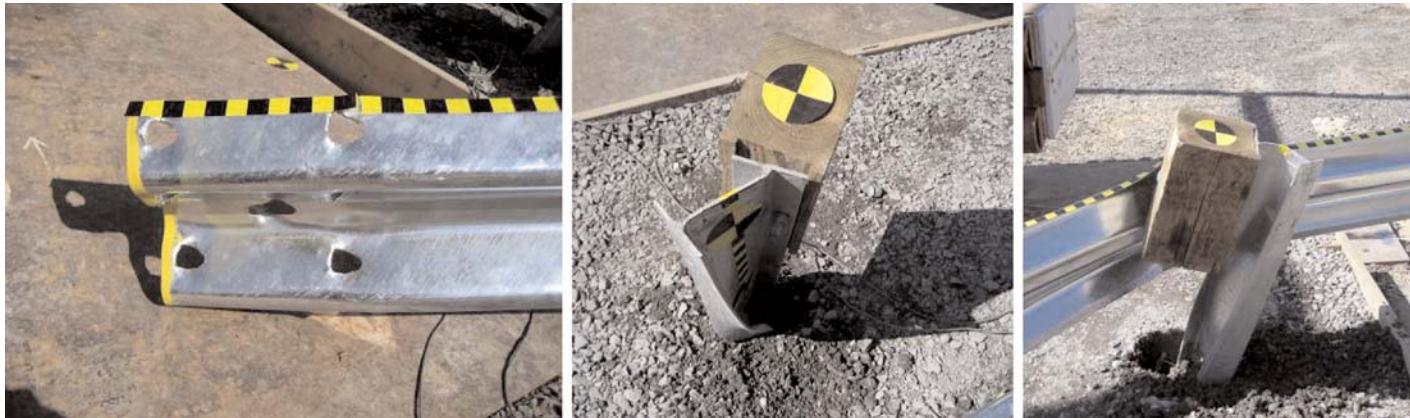
the splice bolts pulling through holes in the rail with none of the individual splice bolts fracturing. At both the splice and non-splice location, the post bolt pulled through the rail element. The splice failure and post damage is shown in Figure 22.

**Figure 22.** Test 02-1: detailed view of splice failure (left), post damage at splice (center), and non-splice location (right).

As a result, the research team has recommended that the repair threshold for horizontal tears be those exceeding a length of 12 inches and a width of 0.5 inches. The rationale for the width specification is that horizontal tears with sufficient width reduce the tensile capacity of the rail through a reduction in available cross-section area in the area of the tear. The research team's recommendation is that larger horizontal tears should be repaired with a medium priority (Exhibit 2.0).

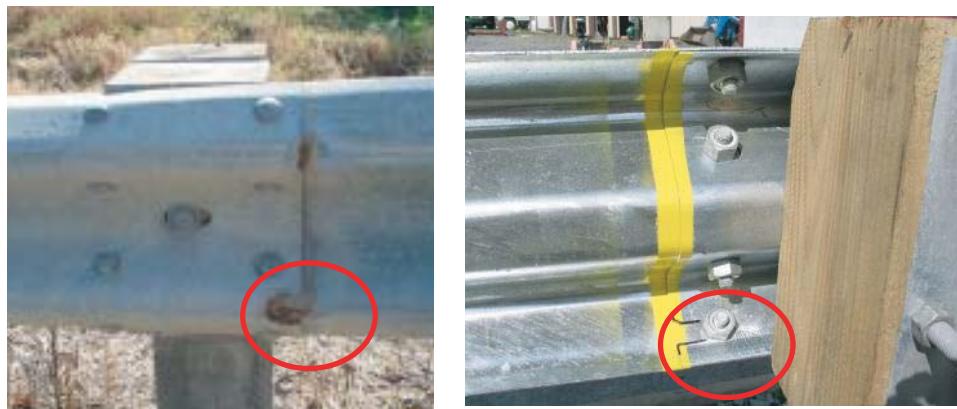
*Figure 23. Splice damage evaluated in pendulum tests.*

The objective of this evaluation was to determine the effect of splice damage on barrier crash performance by pendulum testing (Figure 23). The performance of the barrier section with splice damage was compared to the performance of a similar barrier section with no flaw. The pendulum test setup is described in an earlier chapter on the research approach.

A pendulum test of a strong-post w-beam barrier with splice damage resulted in successful containment of the pendulum mass. The splice damage consisted of extending the hole for a single splice bolt to the end of the rail (e.g., no bearing capacity for that particular bolt). Under a pendulum impact at 29.3 km/hr (18.2 mph), this barrier was able to contain the impacting pendulum mass with performance indistinguishable from the undamaged barrier section. It is known however from full-scale crash testing as well as the splice failures observed in the pendulum tests that the splice is a weak point in the guardrail system. Balancing these two observations, the research team recommends a repair threshold of 2 or more splice bolts with any guardrail material missing around the bolts with high priority. In the case of damage to a single splice bolt, the research team assigned the repair a medium priority (rather than a low priority) based on the fact that the splice is the weak point in the rail element (Exhibit 3.0).

#### Exhibit 3.0. Recommendations for splice damage repair.

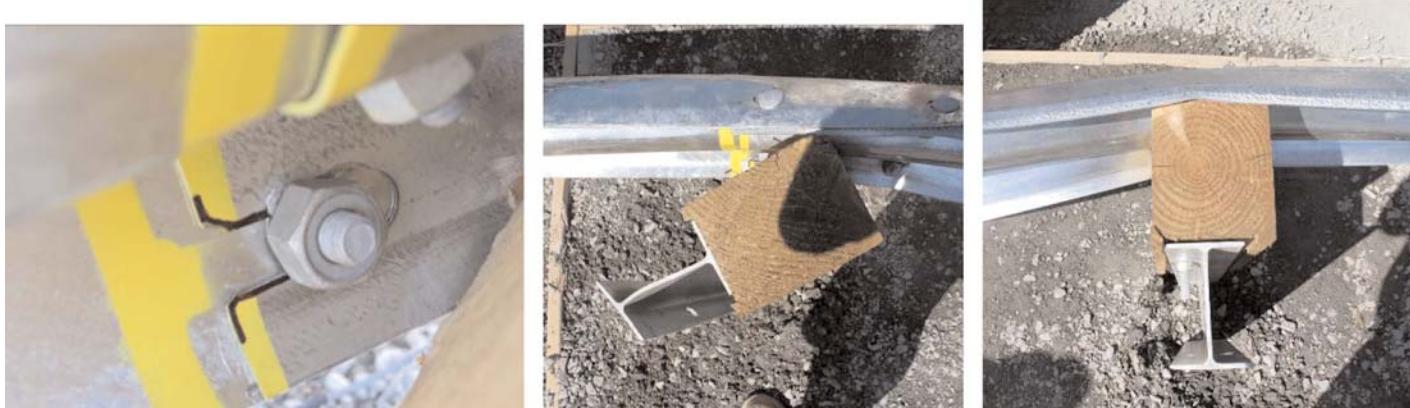
**Figure 24.** Test 07-4: Detail view of splice bolt damage after test (left) and post damage at splice (center) and non-splice location (right).

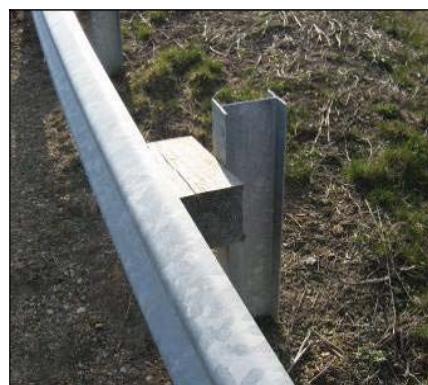
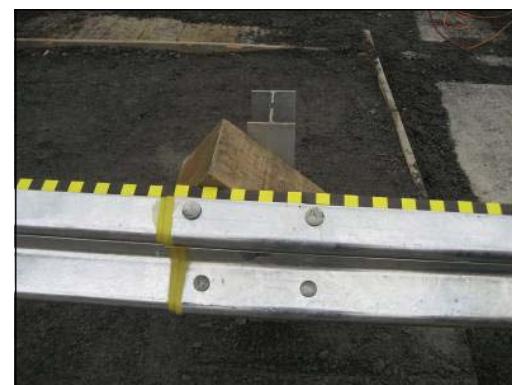
**Figure 26. Twisted blockout evaluated in pendulum tests.**

The objective of this evaluation was to determine the effect of twisted blockouts on barrier crash performance by pendulum testing (Figure 26). The performance of the barrier section with twisted blockouts was compared to the performance of a similar barrier section without this flaw. The pendulum test setup is described in an earlier chapter on the research approach. In this case, the routed wooden blockout at the splice was installed rotated about the post-rail bolt. The blockout was rotated approximately 45 degrees with respect to the vertical in all tests.

The performance of the barrier section with this damage was indistinguishable from that of the undamaged barrier section

in two higher speed tests conducted. This suggests that this damage mode has little effect on the structural adequacy of the barrier. A pendulum test of a strong-post w-beam barrier section with a twisted blockout (~45 degrees relative to the vertical position) at the splice location successfully contained the pendulum mass.

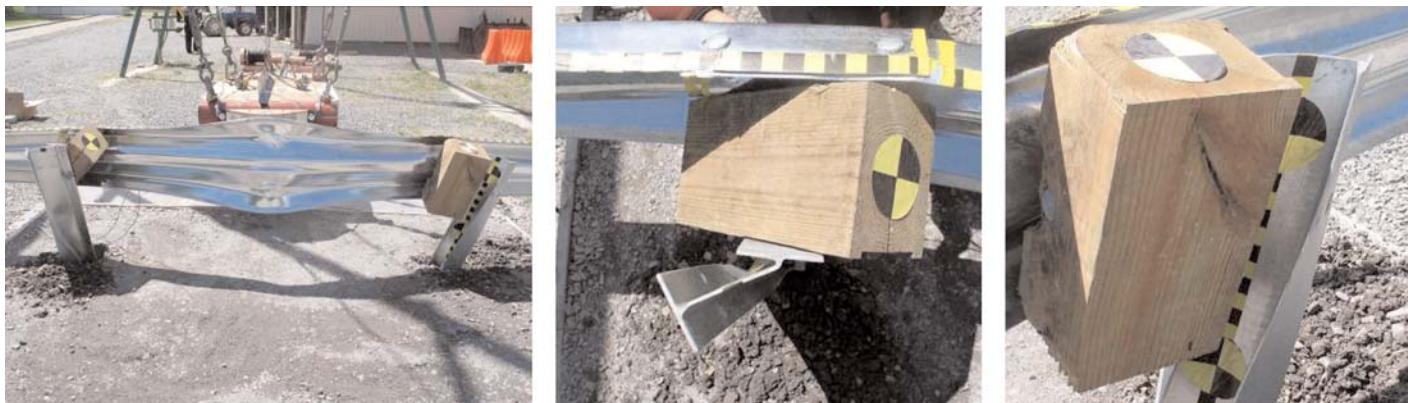
**Figure 27.** Test 03-8: Overall damage (left) and post damage at splice (center) and non-splice location (right).

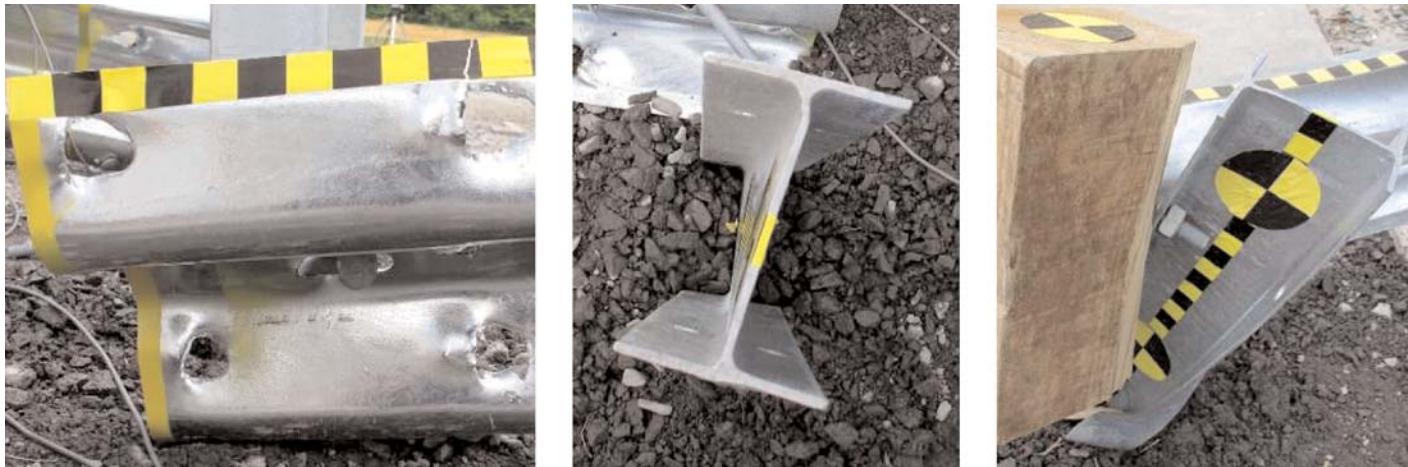
**Figure 30. Test 03-7: splice failure (left) and post damage at splice (center) and non-splice location (right).**

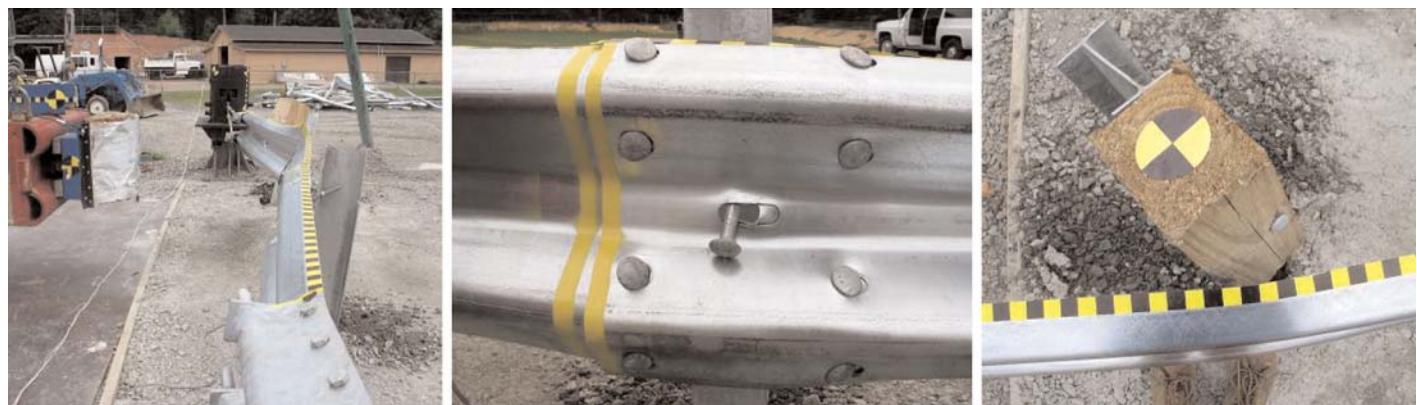
**Figure 32.** Test 07-5: overall damage (left), detail view of damage at splice (center), and post damage at non-splice location (right).

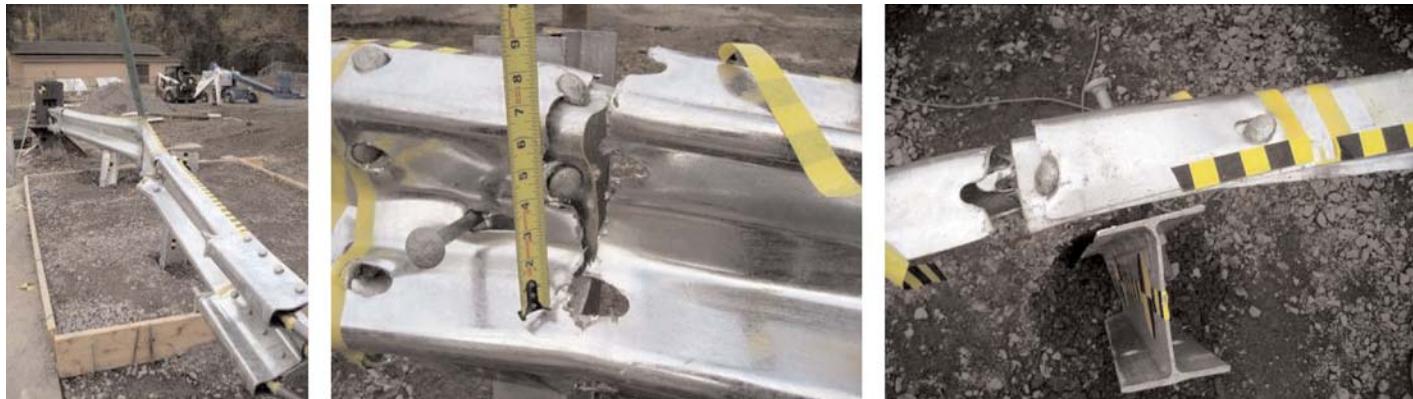
Figure 33. Test 01-4: overall damage (left), rail tear at splice (center), and post damage at splice location (right).

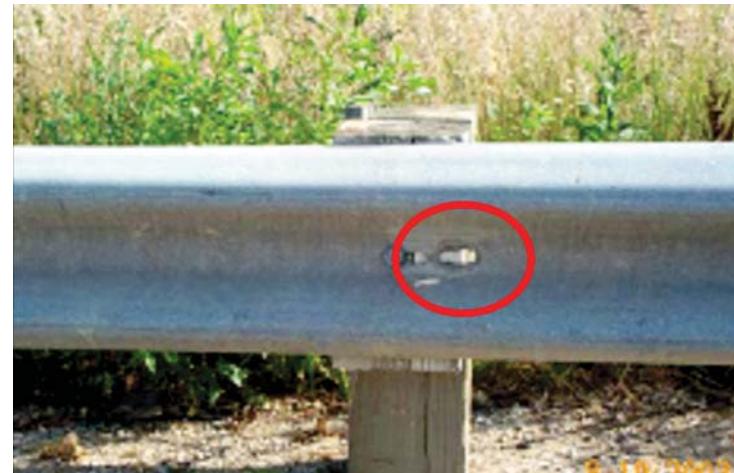
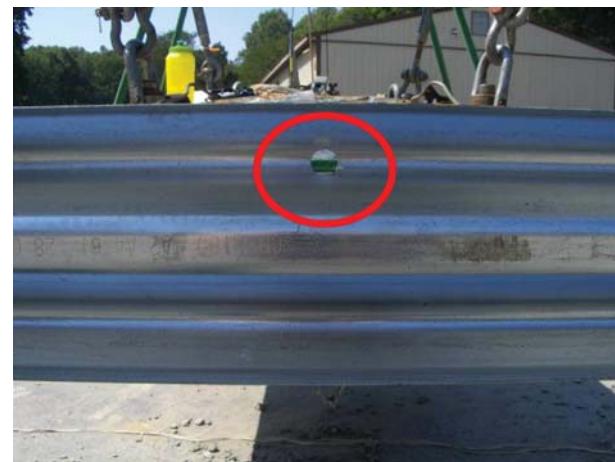
The objective of this evaluation was to determine the effect of a hole in a rail on barrier crash performance through pendulum testing (Figure 34). The performance of the barrier section with an artificially introduced hole was compared to the performance of a similar barrier section with no flaw. The pendulum test setup is described in an earlier chapter on the research approach.

cessful containment of the pendulum mass. To represent worst case conditions, the hole was aligned with the impact location and in the upper fold of the w-beam section. Based on the results of the test, the performance of the hole-damaged rail section was virtually identical to that of the undamaged strong post barrier section tested at the 17.5 mph impact speed. As a result, the research team has recommended that the repair be initiated if the hole exceeds 1 inch in height. Note that the limit on size of a non-manufactured hole has been specified in the vertical, rather than the horizontal, direction because the vertical direction is perpendicular to predominant (tension) loads, and is thus more likely to cause failures. A medium priority was assigned to smaller holes in the rail because of the possibility that holes may serve as the initiation point for horizontal tearing on impact. The only exception would be if this hole was located near the splice as described below.

**Figure 34.** Hole damage evaluated in pendulum tests.

Multiple holes in a rail section or holes with a diameter exceeding a height of 1 inch could lead to rail tearing as seen in the vertical tear pendulum tests. To avoid the possibility of catastrophic rail failure, these modes were assigned a high priority for repair. A special case was a hole of any size which intersects either the top or bottom edge of the rail. Because a hole which disrupts either the upper or lower surface of a rail has the characteristics of a vertical tear, this damage mode has the potential for the same catastrophic failure of the rail that was observed in the pendulum tests of vertical tears. This damage mode was given a high priority for repair (Exhibit 6.0).

#### Exhibit 6.0. Recommendations for hole in rail damage.

Damage Mode	Repair Threshold	Relative Priority
Non-Manufactured holes (such as crash-induced holes, lug-nut damage, or holes rusted-through the rail)	<ul style="list-style-type: none"> <li>More than 2 holes less than 1 in. in height in a 12.5-in. length of rail.</li> <li>Any holes greater than 1 in. in height.</li> <li>Any hole which intersects either the top or bottom edge of the rail.</li> </ul>	High
	1 or 2 holes less than 1 in. in height in a 12.5-in length of rail.	Medium

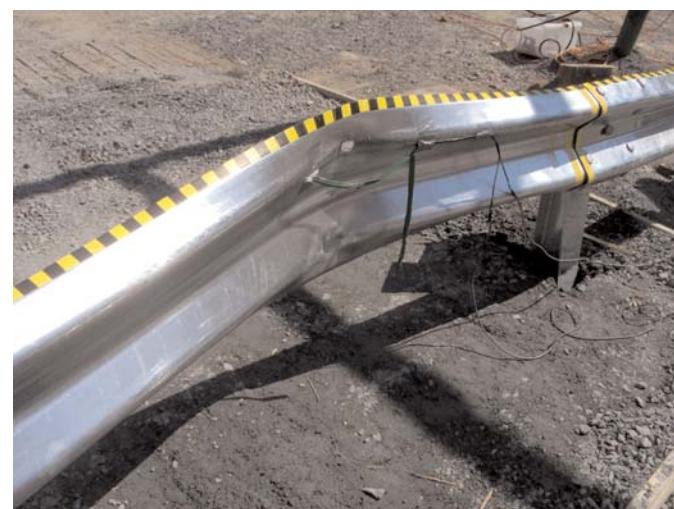
**Figure 35.** Damage near a hole in Test 07-2.

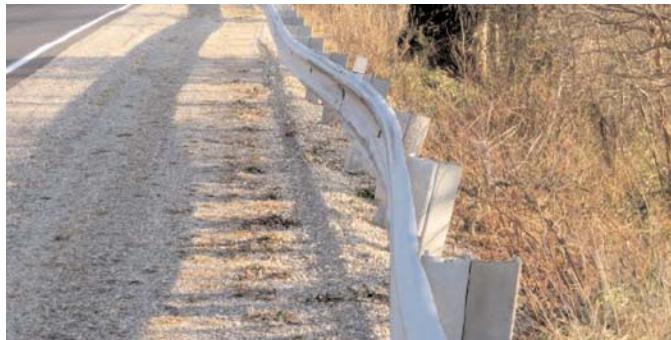
Rail and post deflection is one of the most prevalent types of damage in guardrail, most often caused by a lower severity crash. An example of this damage mode is shown in Figure 37. Impacts where the vehicle speed is lower may result in localized minor damage. Depending on the impact angle, the damage may be incurred only to the rail element, with minimal or no damage to the supporting posts and soil. Impacts with a higher speed but shallower angle can also result in more distributed rail and post deflection.

**Figure 37.** Guardrail with rail and post deflection.

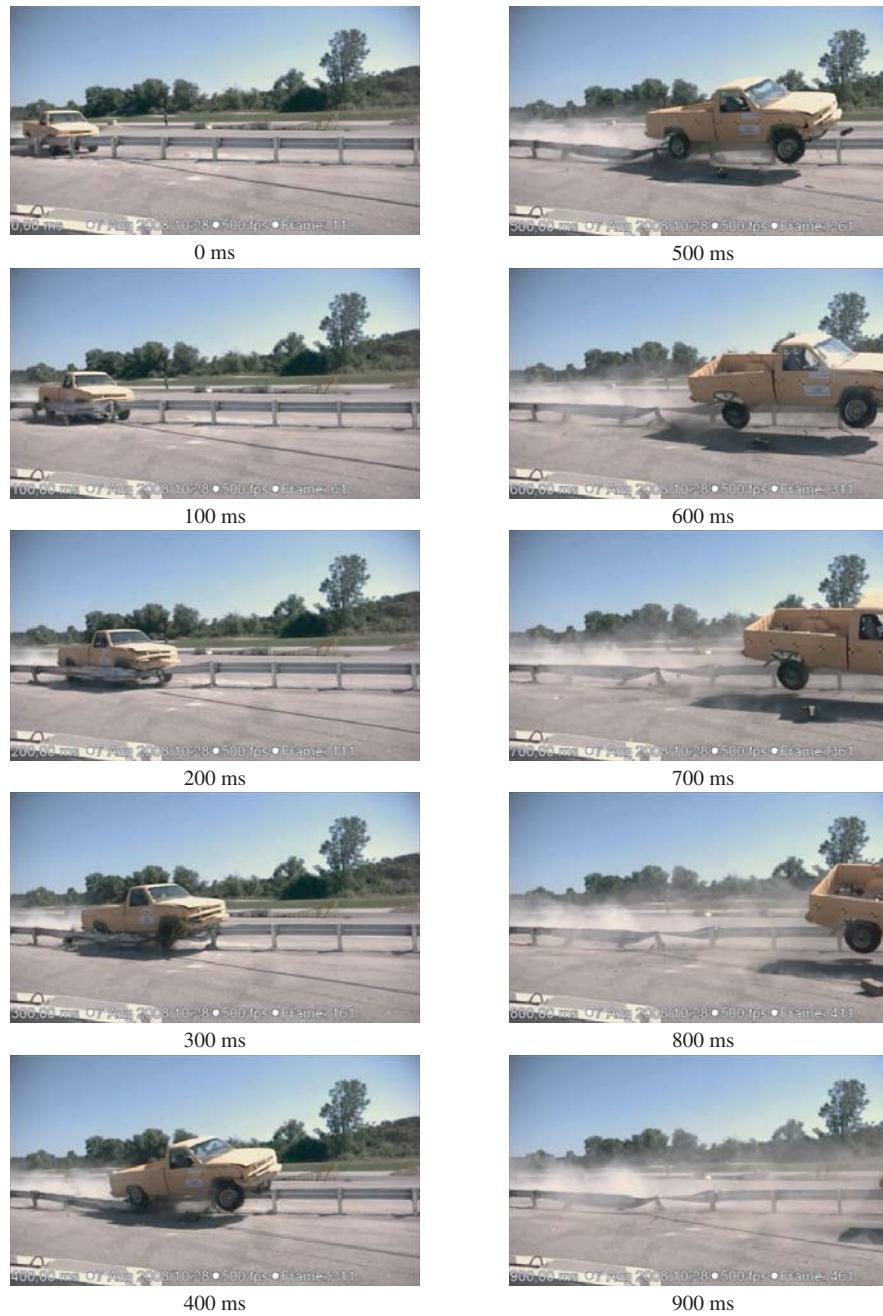
truck impacted the guardrail at the same initial impact point and area damaged by the previous vehicle. The impact conditions were 62.1 mph (99.9 km/hr) at 25.5 degrees (*NCHRP Report 350 Test 3-11* conditions). Due to the damage that had already incurred to the guardrail, the vehicle failed to redirect and overrode the guardrail. The vehicle returned to the ground on the opposite side of the guardrail and continued to travel at 43.2 mph (69.5 km/hr) and at an angle of 18.7 degrees from the guardrail. Post 13 failed to separate from the guardrail despite the significant amount of post and rail deflection during the test. A series of photographs showing the vehicle as it vaulted over the guardrail is shown in Figure 39. As shown in these photographs, the pickup truck vaulted over the barrier and came to rest upright behind the test installation.

**Figure 39. Time series for second, high-speed impact into damaged guardrails.**

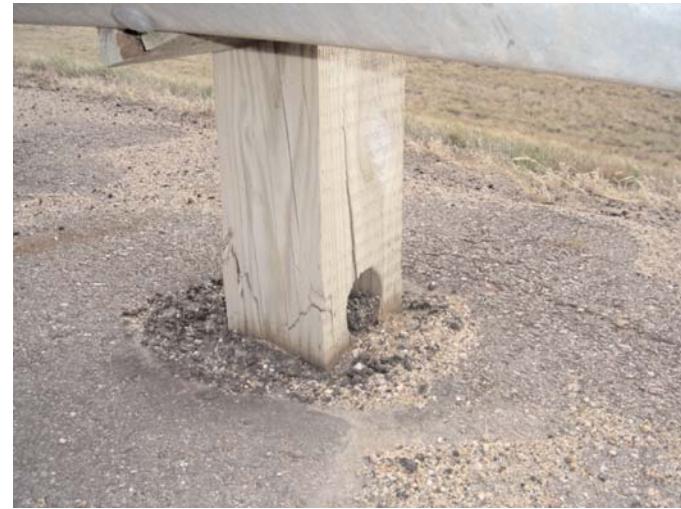
**Figure 64. Wood post with cross-grain cracking (photo: courtesy of South Dakota DOT).**

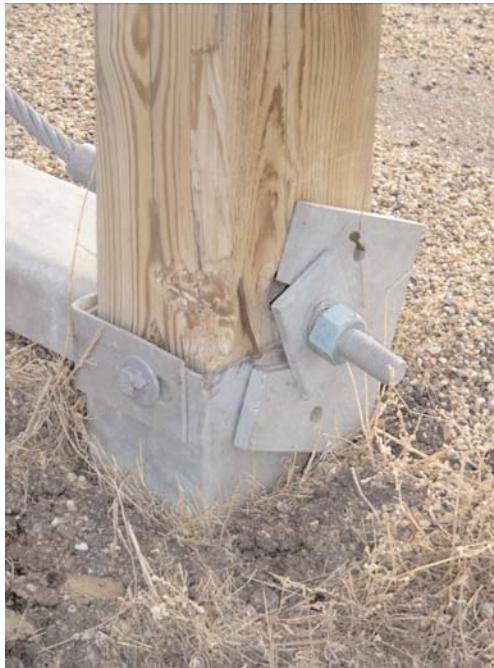
**Figure 65.** Misaligned or missing bearing plates (photo: courtesy of South Dakota DOT).

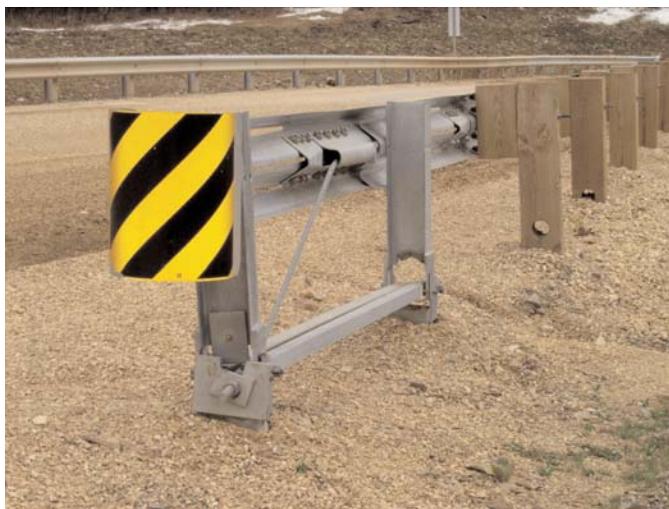
**Figure 66.** Incorrect stub height (photo: courtesy of South Dakota DOT).

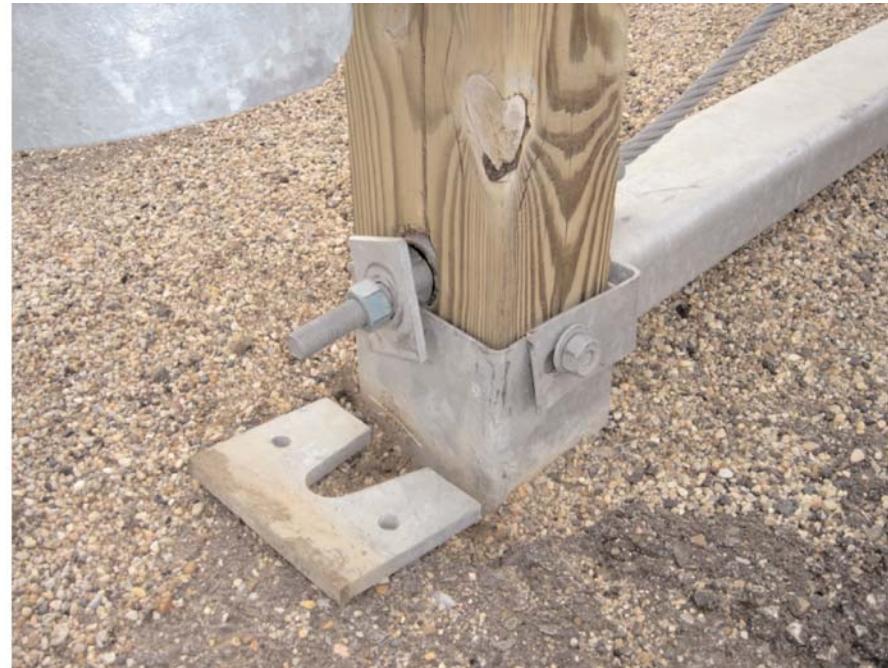
**Figure 67.** Misaligned impact head because of missing lag bolts (photo: courtesy of Ohio DOT).

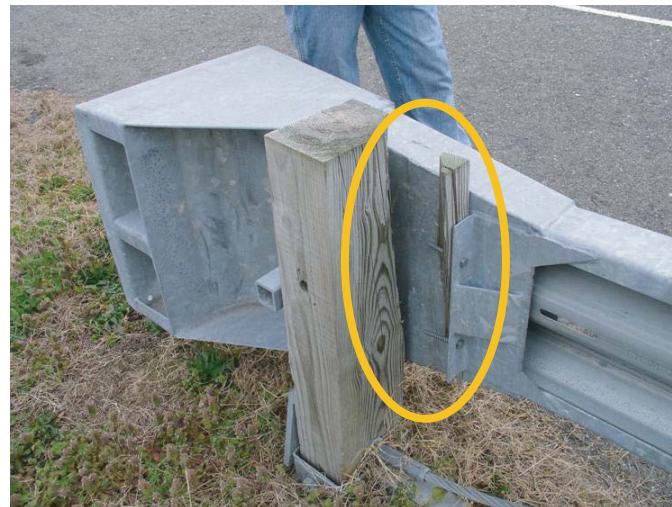
**Figure 68.** Failed attachment of lag bolts to end post.
