## **Quick Troubleshooting Flow – “No Connection to Unit” on Radio**

➔ Example from a site, **5TC3052A** where the AEHC radio was replaced by **TMO FOPS** due to **FID-10** however the actual issue was caused by other module not by the radio.

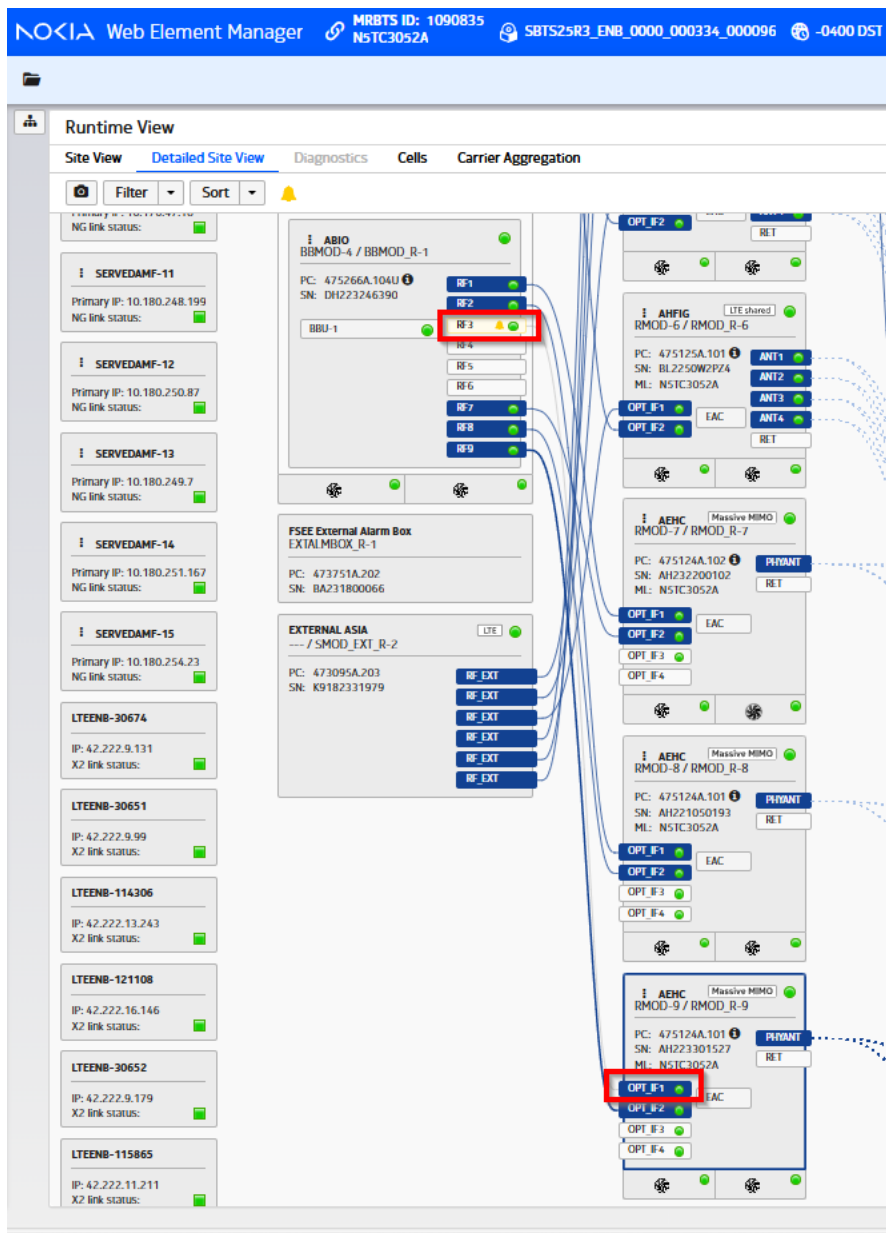
After previous topside investigation and extensive downstairs troubleshooting by FOPs, the issue appears to be in the fiber path from baseband card RF3 to IF1 of gamma AE

## HC. Need more topside investigation.

TC replaced jumper up top and replaced SFP at radio. Also corrected a few other minor issues while onsite.
