**[SPRLL-2227] TC26 | UI changes with no screen touch operations (Ghost touches). Needs to be in Glove and Finger mode.**

[SPRLL-1815] When putting holes in a cover glass, avoid irregular shapes. In any shape, corner radii should be maximized. Irregular shapes and corners add internal stress to the glass resulting in higher variation in glass fragility.

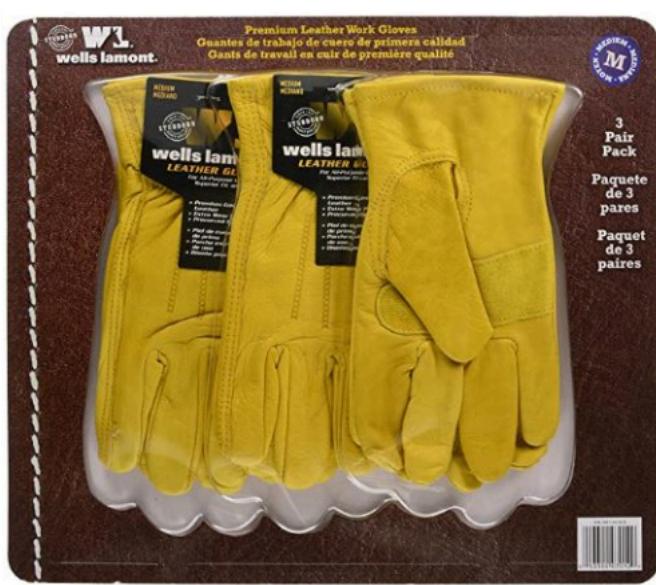
Gloves.PNG (523 kB)

Reproducibility:	Reproducible
Reproduction Steps:	Device Settings > Display > Advanced > Touch panel Mode > Glove and Finger Mode. Try touching the screen with a glove on.
Resolution Date:	2021-05-13 21:42:23.721
Root Cause Details:	Touch Panel
Root Cause Level 2:	Touch Panel
Root Cause Level 3:	Touch Panel
Root Cause Level 4:	Pegatron
SPR Reference #:	SPR-41820
Scrub Result:	Not Set
Source:	ECRT-Electrical
Status Sub-Type:	Please Specify
Synopsis:	L10 tablet running Android Oreo does not work with Glove mode.
Time in Status:	3_*:_1_*:_96944859_* *_5_*:_1_*:_1102300275_* *_6_*:_1_*:_0_* *_10000_*:_1_*:_8307625098
[CHART] Date of First Response:	2021-05-13 21:42:23.721
[CHART] Time in Status:	3_*:_1_*:_96944859_* *_5_*:_1_*:_1102300275_* *_6_*:_1_*:_0_* *_10000_*:_1_*:_8307625098

Choose a more flexible touch controller in terms of tweaking and upgrading firmware for custom gloves
