**Subject:** Approval of LMI on Guidelines for INSPECTION AND  
MAINTENANCE OF STEEL AND CONCRETE STRUCTURES (LMI no.  
LMI/OGN/OPS/CIV/007)

*Inspection and Maintenance of Steel  
and Concrete Structures  
(Non-Corrosive Atmosphere)*

Categories of Type of Defects observed during one of the Preliminary Investigation:

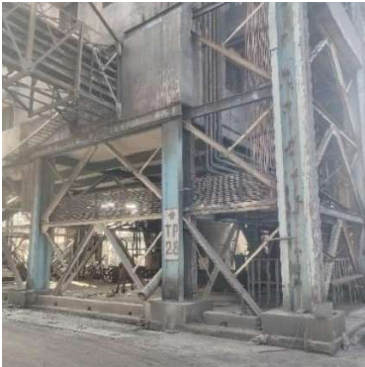
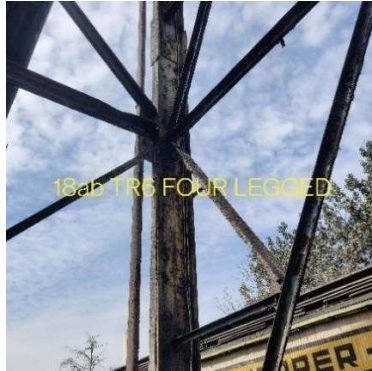
1. Requirement of Painting almost all over CHP steel structures.

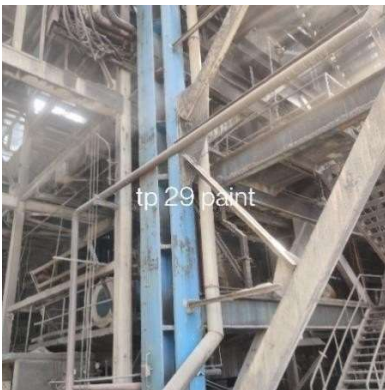
2. TPs near boiler have lot ash deposits on main columns. Like:

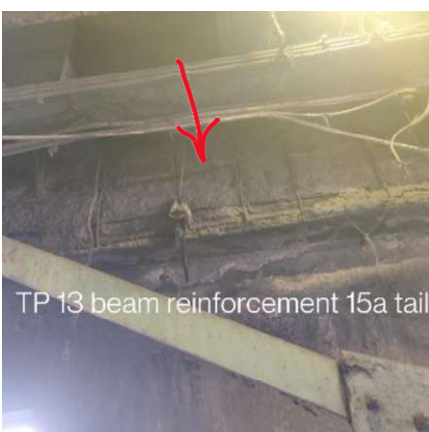
3. Concrete reinforcement visibility at some places in TPs and Crusher houses. Like:

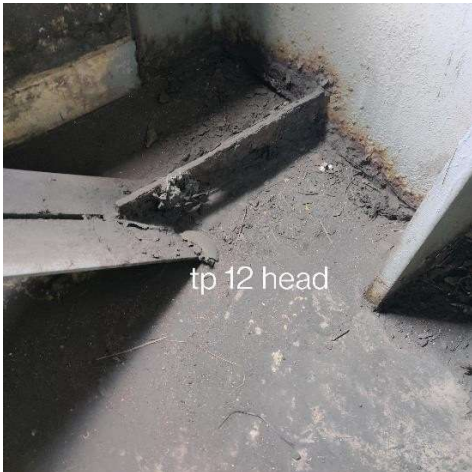
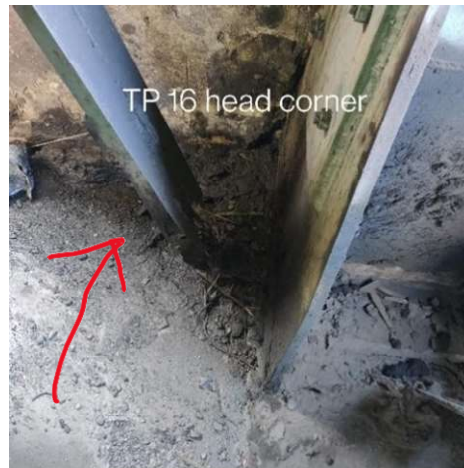
4. TP/Crusher column corners have corroded bracings at floors at many locations **because of which the bracing got discontinued and are not connected with the columns**. These bracings needs to be restored and after restoring **300 mm high encasement with concrete** to be done to avoid any future corrosion. Like:

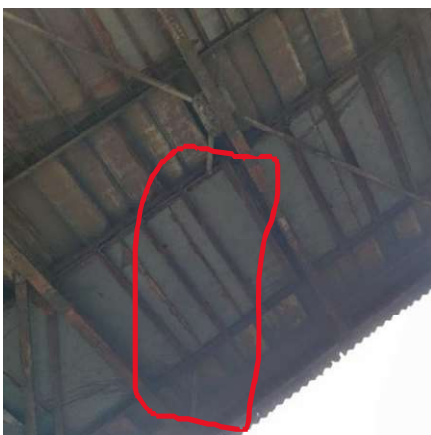
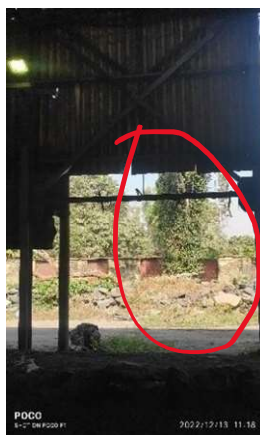
5. **Discontinued/Missing** bracings (1-2 in conv gallery bottom), removed during any material lifting operation:

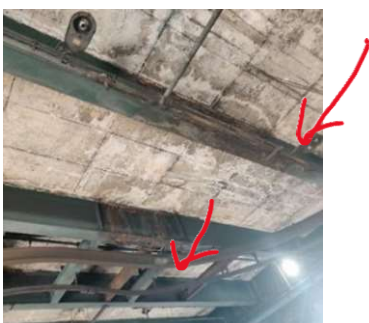
6. Seepages at roofs of TPs leading to corrosion of beams:

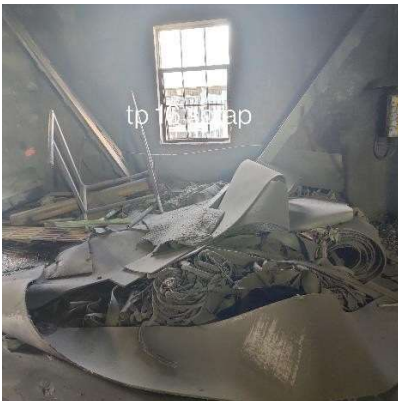
7. Scrap collections at some TPs causing non access and dust accumulations **which will further support the corrosion:**

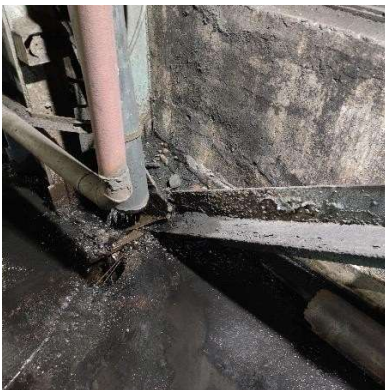
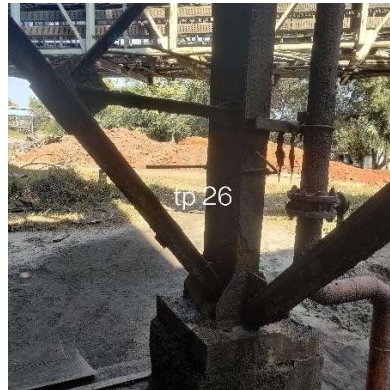
8. Hydrant leakages causing corrosion:

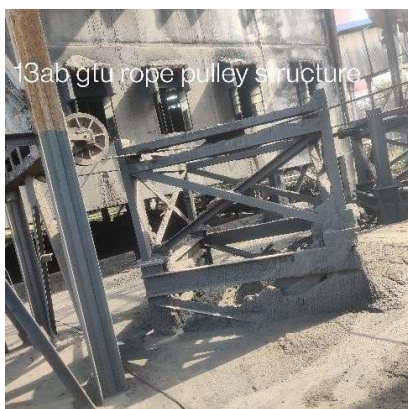
9. GTU structures need cleaning so that foundation bolts do not fail. Like:

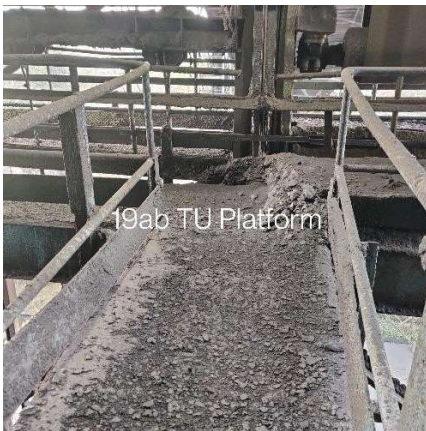
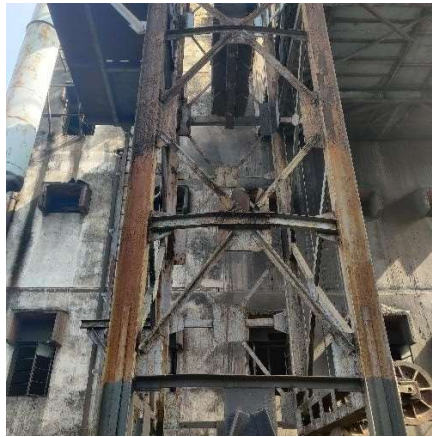
10. GTU platforms and its supports need cleaning regularly and repairs for safety in particular:

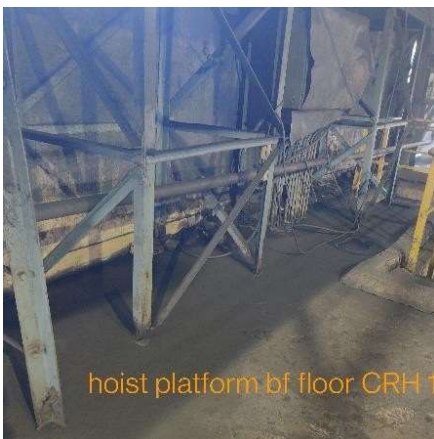
11. Various other platforms like Hoist platform, access platforms erected for miscellaneous works ,need painting and foundation strengthening , for safety in particular.

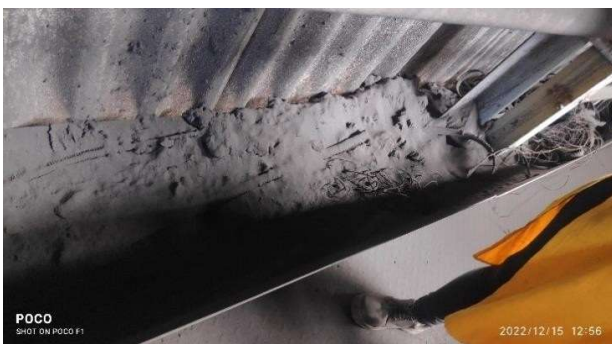
12. Coal dust depositions inside galleries particularly Bottom chord of side trusses at some locations inside galleries/TPs **needs to be cleaned or else corrosion will start or already started.**

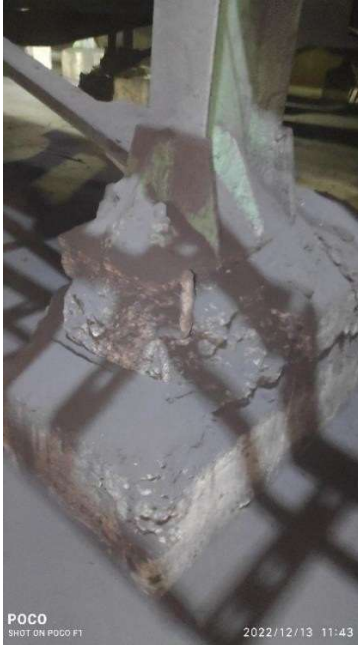
13. Accumulation of coal dust over the pedestals supporting the technological structure needs to be regularly cleaned to avoid corrosion of structure and bolts. At few locations pedestal supporting the structure is damaged which needs to be repaired.

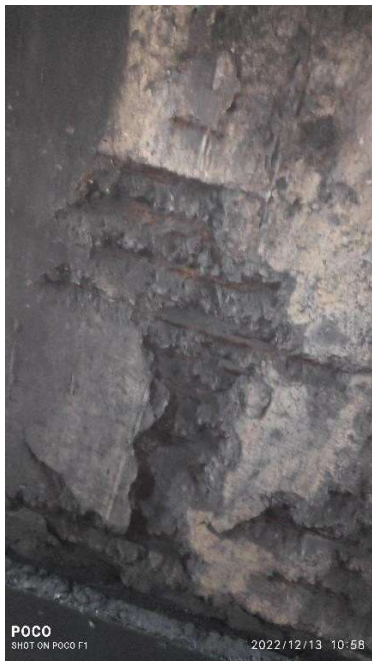
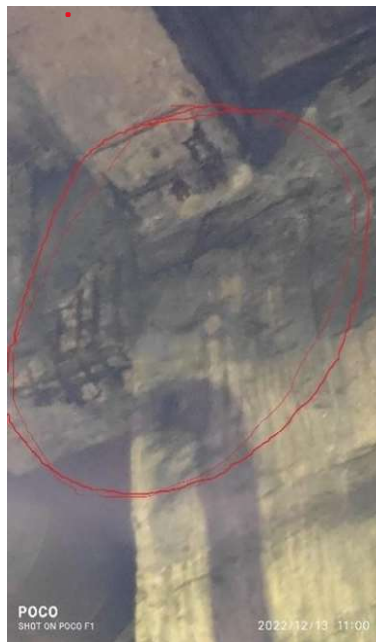
14. Reinforcement of the walls of the underground track hopper is exposed and corroded needs to be repaired or else seepage will start inside the tunnel and corrosion of reinforcement will increase. Exposed reinforcement of beams at column beam junction.

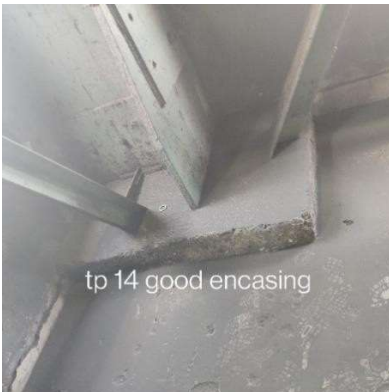
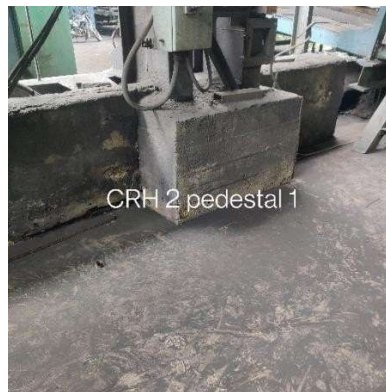
16. Wherever good encasings are done in columns no impact of ageing or water. Like:

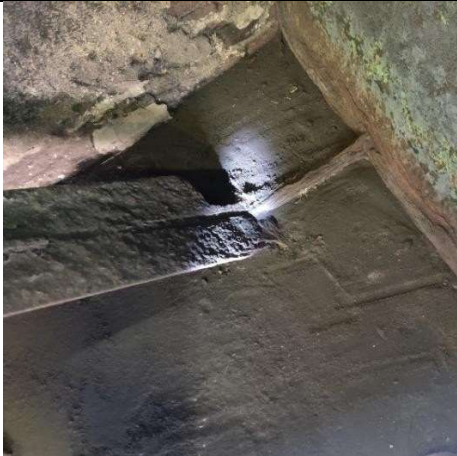
15/12/22: TP11

| TP11 14A/B tail corner bracing and gusset plate corrosion | TP 11 7AB head corner members corrosion |

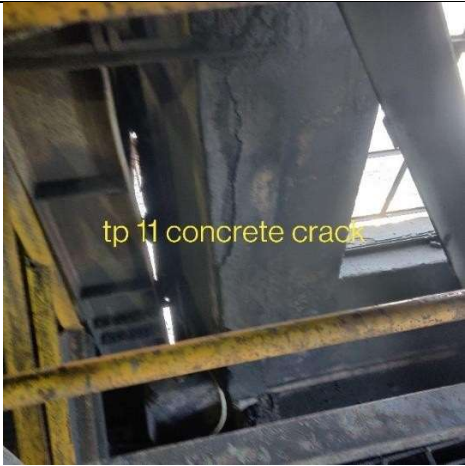
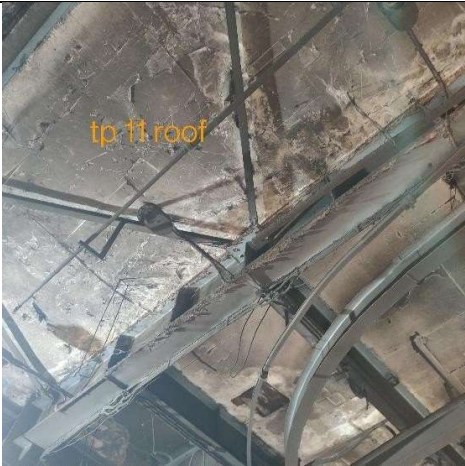
| TP 11 concrete encasing vertical cracks | TP 11 roof seepages and beam rusting |

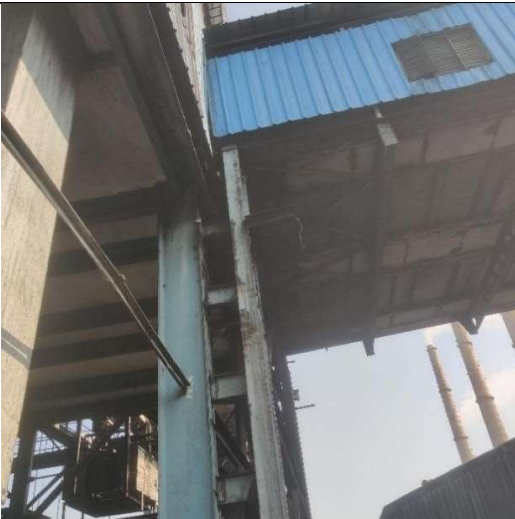
**14/12/22: TP 27 issue of 26AB gallery.** This gallery had come down at junction of TP27 in 2018. Same was held in place by new vertical column and cross beam. The Corbel had got broken owing to which this happened. Additional members (I beam sections) were welded between newly erected columns and original columns . Also Gallery structure also welded additionally to TP columns. But now weld cracks noticed in these joints.

| TP 27 additional corbels /supports develop fresh crack | TP27 additional erected Column with supports |

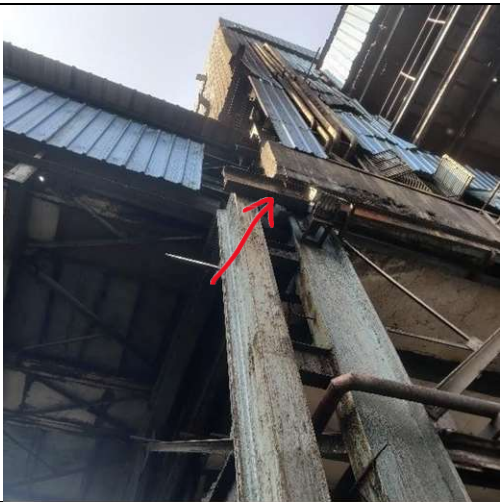
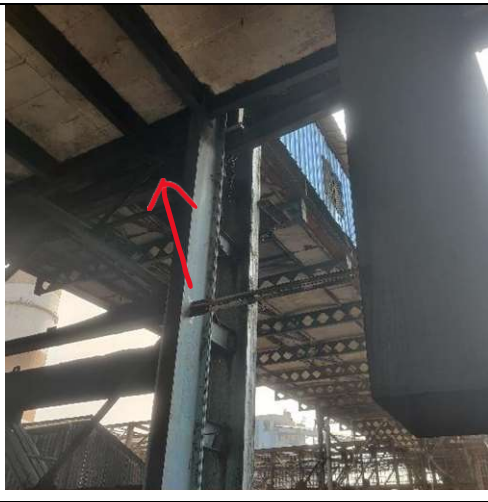
| <p>TP 27 beam supporting Corbel which had got dislodged.</p> | <p>TP27 ,26AB bottom cross beam which had come down</p> |
