**REPORT ON
THE RAINSTORM OF
8 MAY 1992**

GEO REPORT No. 22

**GEOTECHNICAL ENGINEERING OFFICE
CIVIL ENGINEERING DEPARTMENT
HONG KONG**

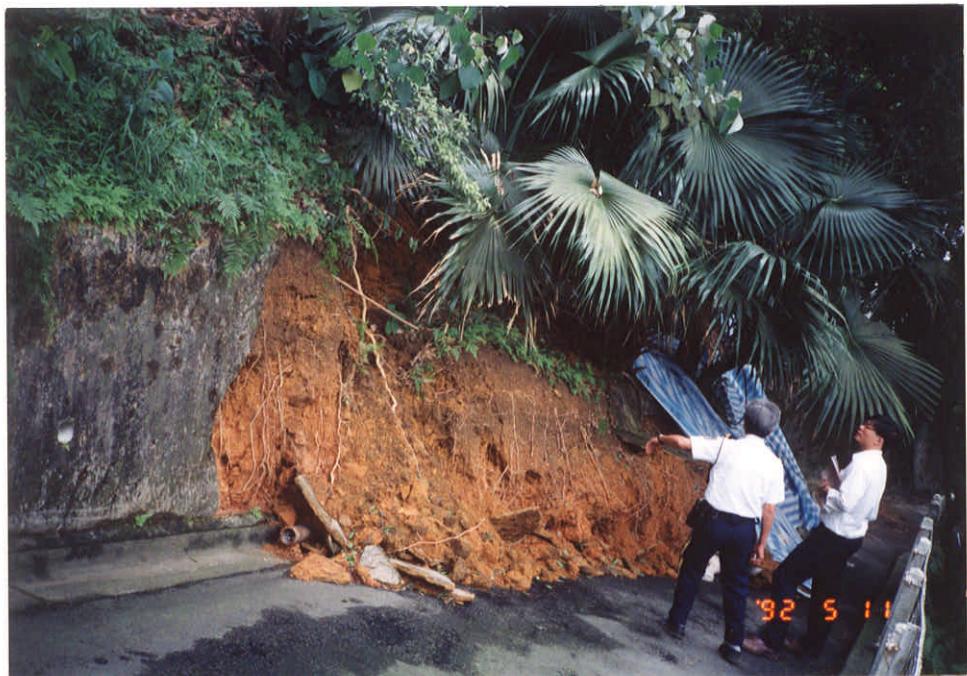
Plate 1 - 12 Severn Road, Mount Gough (Incident HK 5/1)

In total, 151 soil cut slope failures were reported, forming 43% of all incidents. Five of these failures were major. Examples of soil cut slope failures are shown in Plates 1 (Incident HK 5/1), 2 (Incident HK 5/3), 11 (Incident HK 5/26), 12 (Incident HK 5/33), 17 and 18 (Incident HK 5/39), 28 (Incident K 5/8), 32 (Incident MW 5/16), 33 (Incident MW 5/17), 34 (Incident MW 5/45), 35 (Incident MW 5/46), 36 (Incident 5/47), 38 (Incident ME 5/1), 39 (Incident ME 5/16) and 42 (Incident ME 5/32). Two failures (HK 5/104 and HK 5/139) are described in more detail in Sections 4.8 and 4.9 respectively.

Negative No. I9221614 Taken on : 11-5-92
Description : Failure of a soil cut slope affecting a private access.

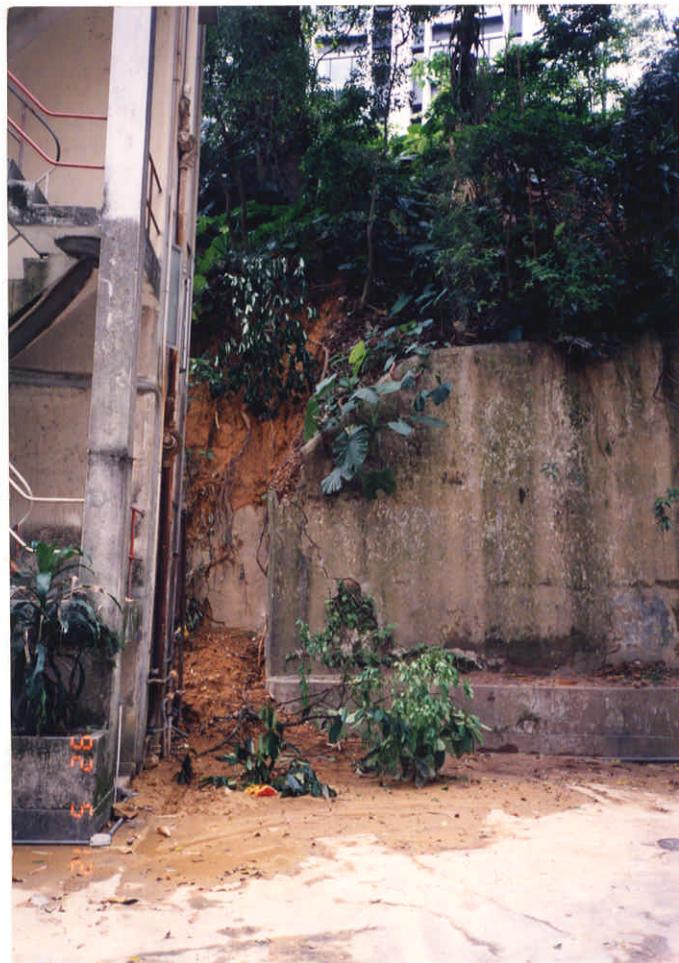
Plate 2 -
78-80 MacDonnell Road, The Peak
(Incident HK 5/3)

Description :
Failure of a soil cut slope affecting a
building lot.

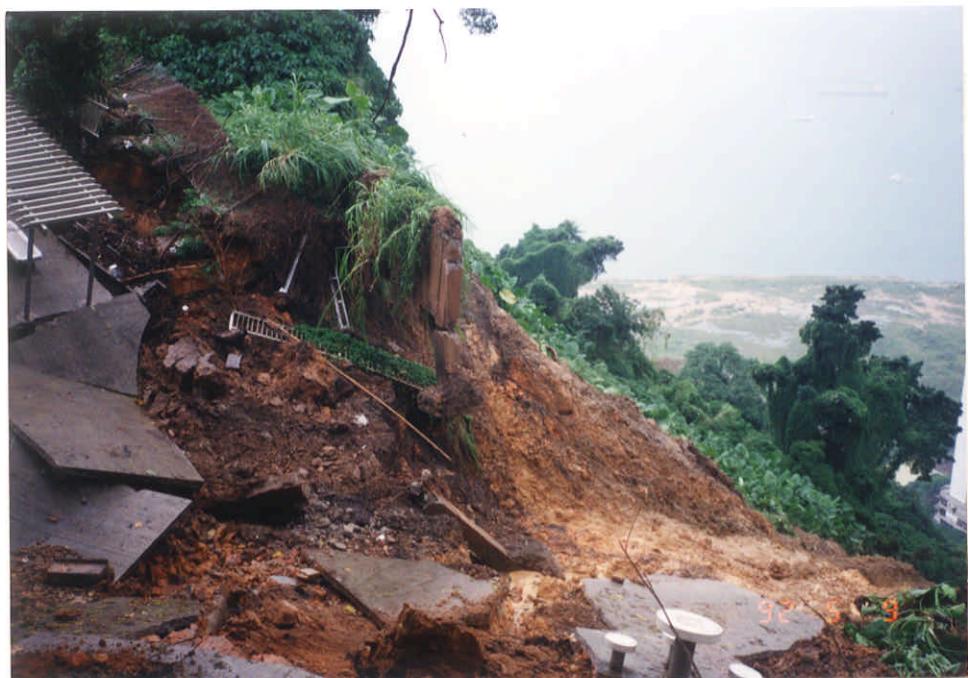
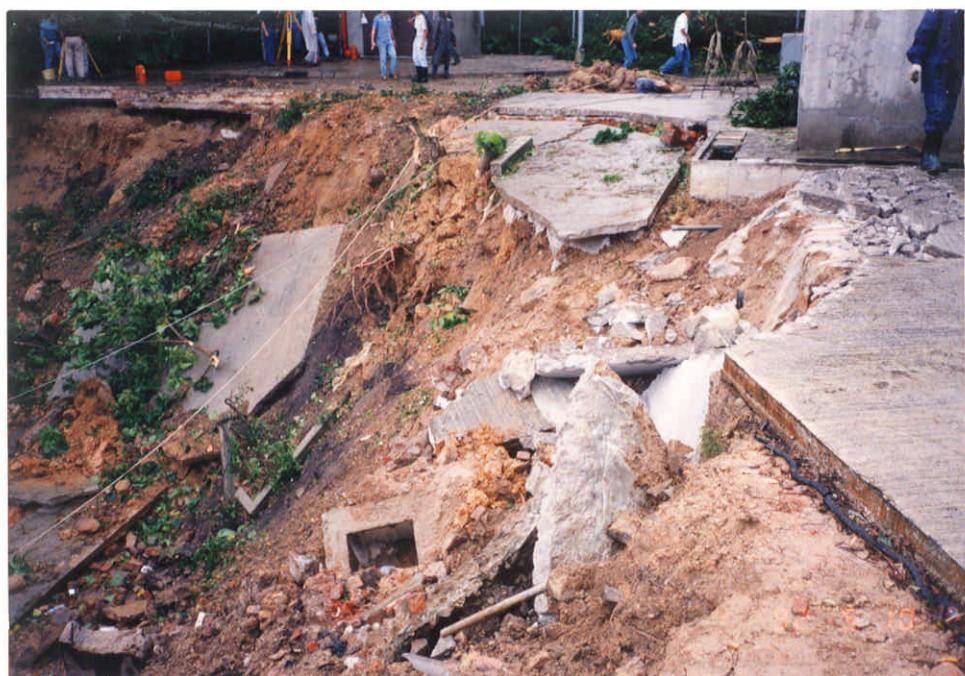
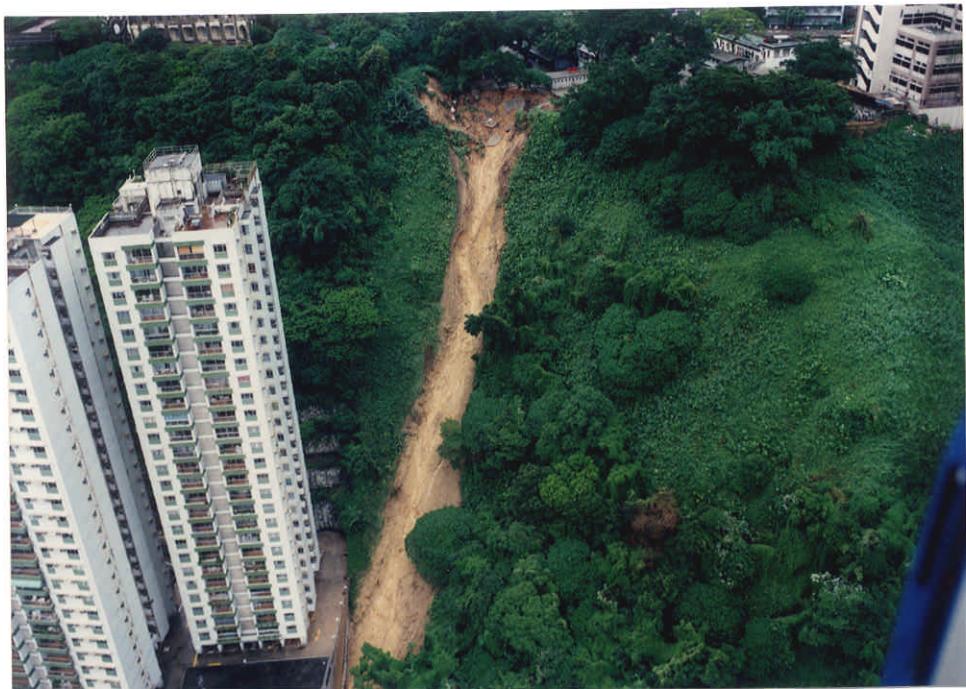
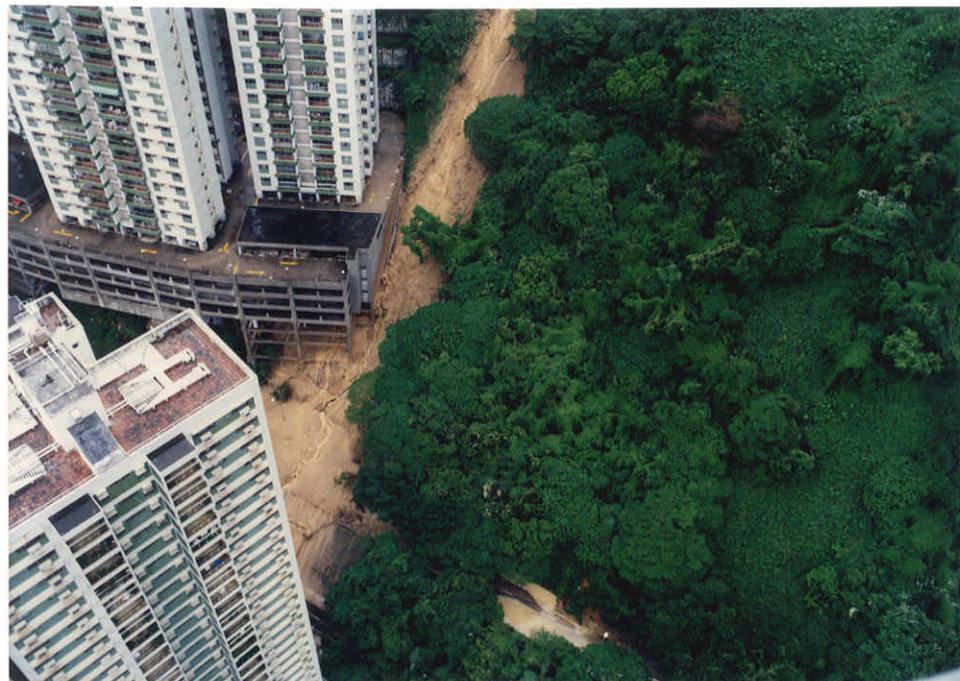
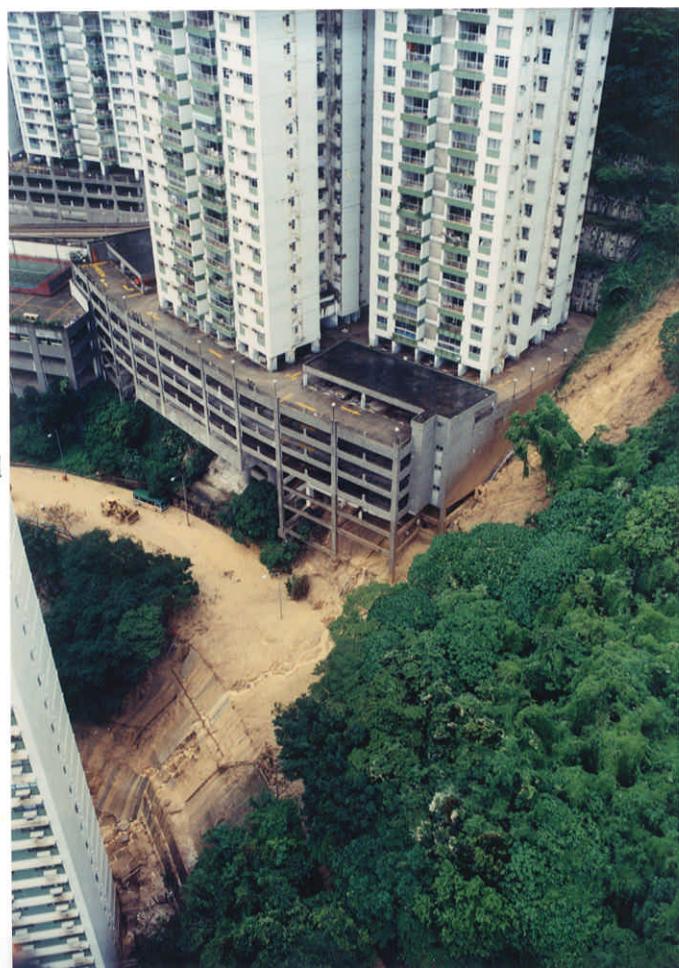
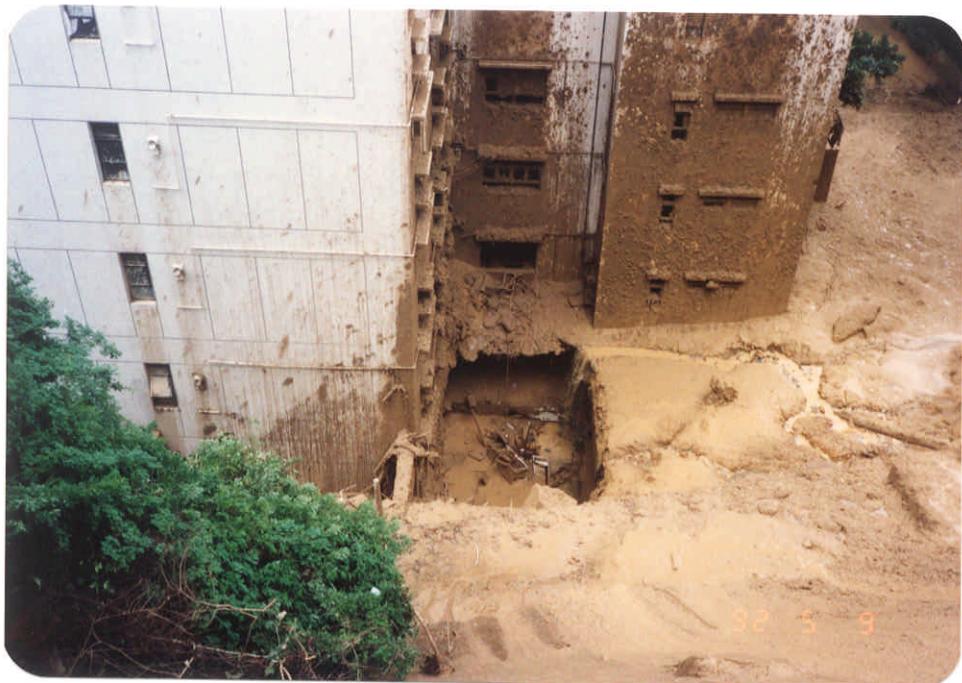
(Major debris flow resulting from the failure of an old retaining wall and the subsequent liquefaction of loose fill. Two deaths. Plates 3 to 8.)

The failure began at about 1400 hrs on 8 May when the central part of the masonry retaining wall collapsed during heavy rain which started at about 1340 hrs. This initial failure released about 700 cu m of fill material into the

The total volume of material involved in these failures was about 3500 cu m. A detailed report on the Baguio landslide may be found in GEO (1992).

Negative No. I9221005 Taken on : 10-5-92
Description : Major failure of a retaining wall and a fill platform (about 3500 cu m).
Two dead, five injured. Edge of fill platform illustrated.

Description : Major failure of a retaining wall and a fill platform (about 3500 cu m).
Two dead, five injured. Blocks 26 and 44 illustrated.

Description :
Major failure of a retaining wall and
a fill platform (about 3500 cu m.)
Two dead, six injured. Block 26
illustrated.

Negative No. I92210I03 Taken on : 9-5-92
Description : Major failure of a retaining wall and a fill platform (about 3500 cu m).
Two dead, five injured. Block 44 illustrated.

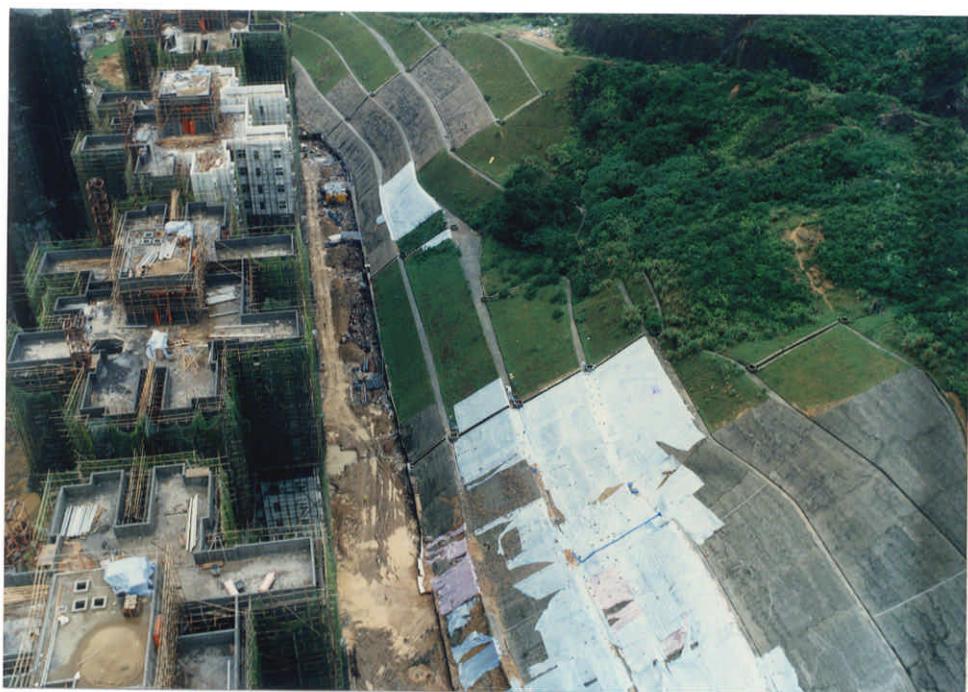
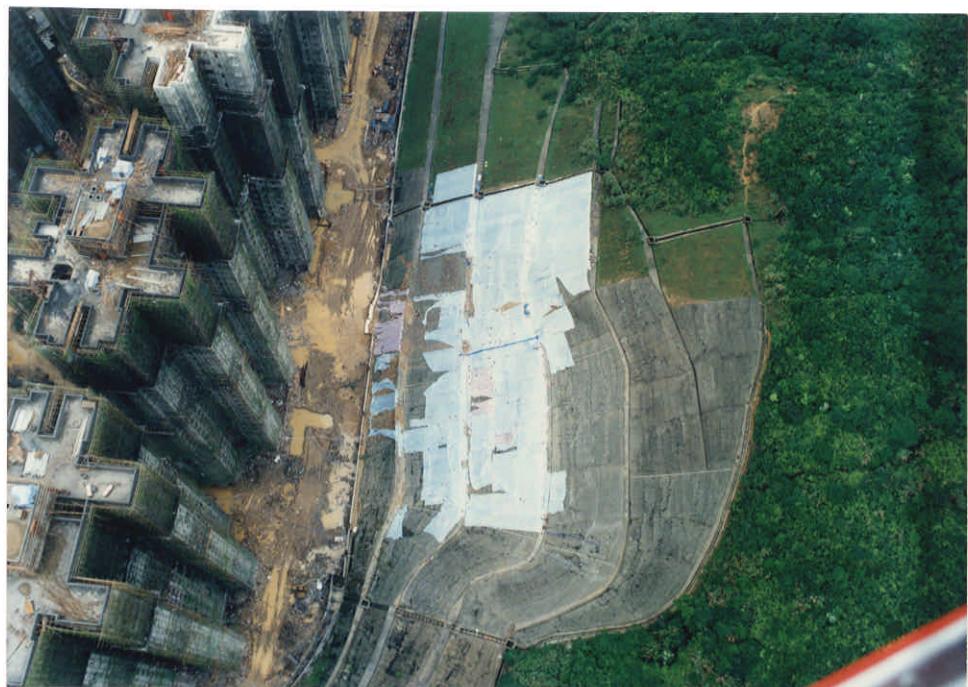
Plates 9 & 10 - Siu Sai Wan PSPS Site, Chai Wan (Incident HK 5/18)

4.3 Incident HK 5/18, Siu Sai Wan Private Sector Participation Scheme Site
(Continuing major failure of a soil cut slope, affecting a construction site. Plates 9 and 10.)

This site, which has a history of instability and at which a previous major failure occurred in April 1992, was being investigated by the GEO when the rainstorm of 8 May triggered further movement. The failures at this site are relatively deep-seated and slow moving, with the failed mass remaining on the slope. The GEO investigation suggests that the failures may be associated with deep weathering of hydrothermally altered volcanic rock (tuff), coupled with a complex groundwater regime. The failure of 8 May caused damage to chunam, concrete berm slabs and U-channels.

Negative No. 14594 Taken on : 9-5-92
Description : Major failure of a soil/rock cut slope (about 100 cu m).

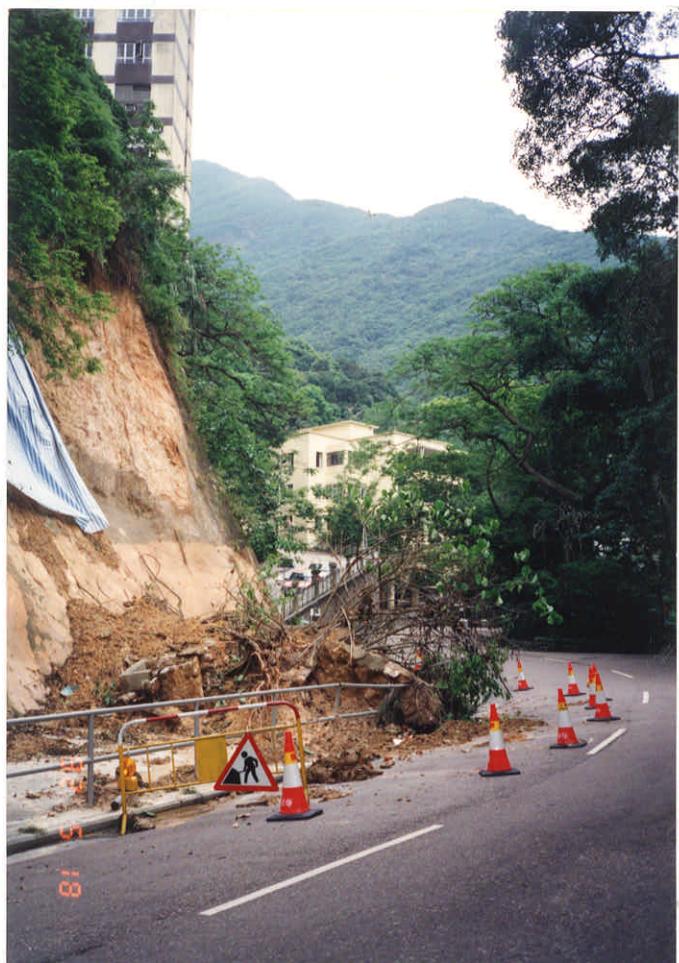
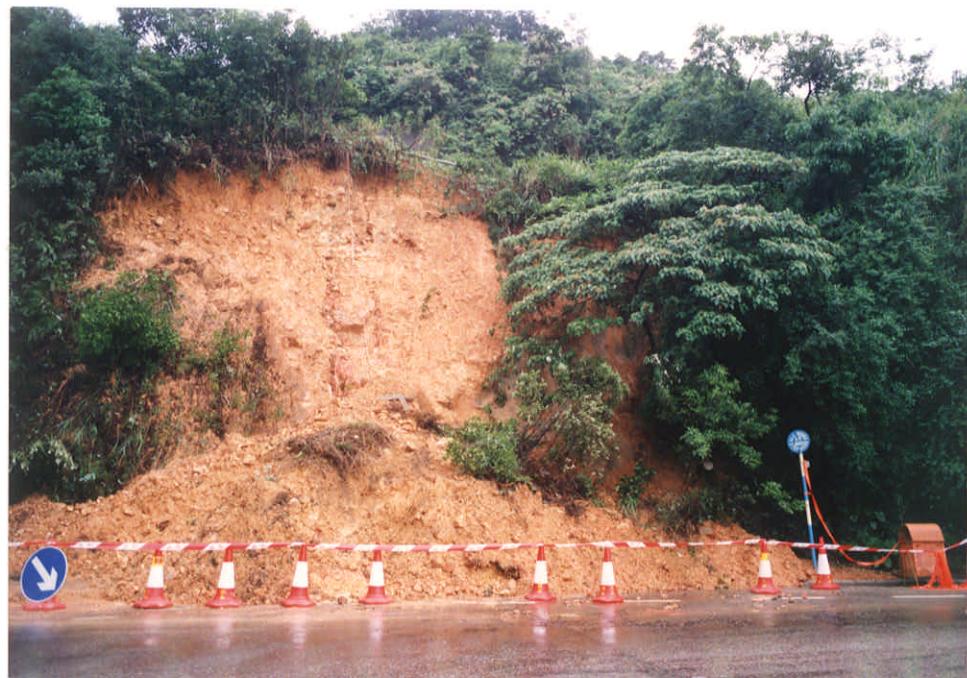
Plate 12 - Junction of Stubbs Road and Peak Road, The Peak (Incident HK 5/33)

Negative No. I9220816 Taken on : 8-5-92
Description : Failure of a soil cut slope resulting in the blockage of one road lane.

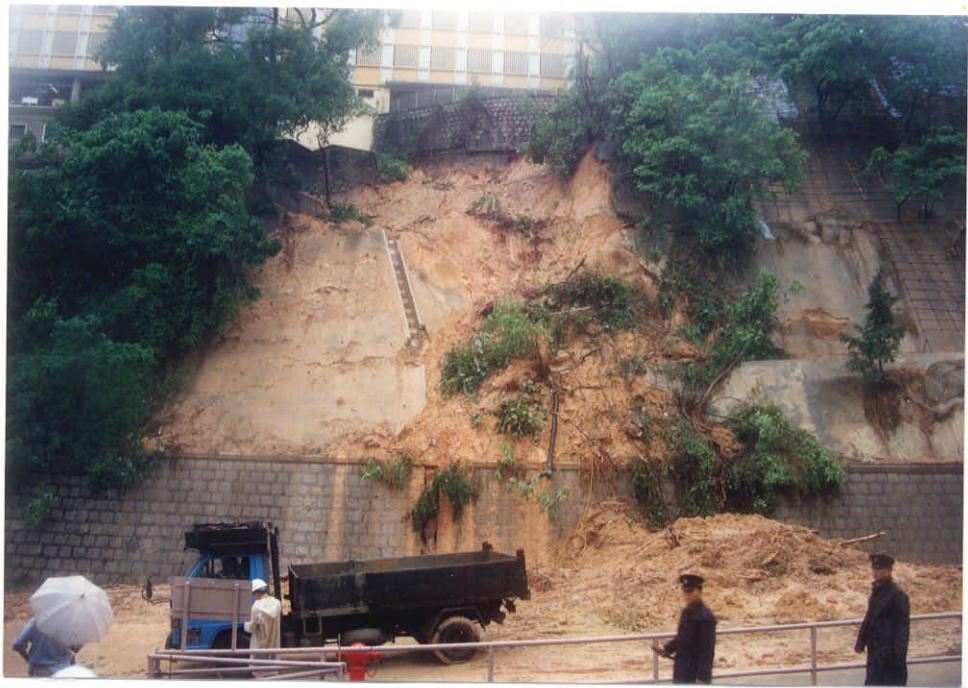
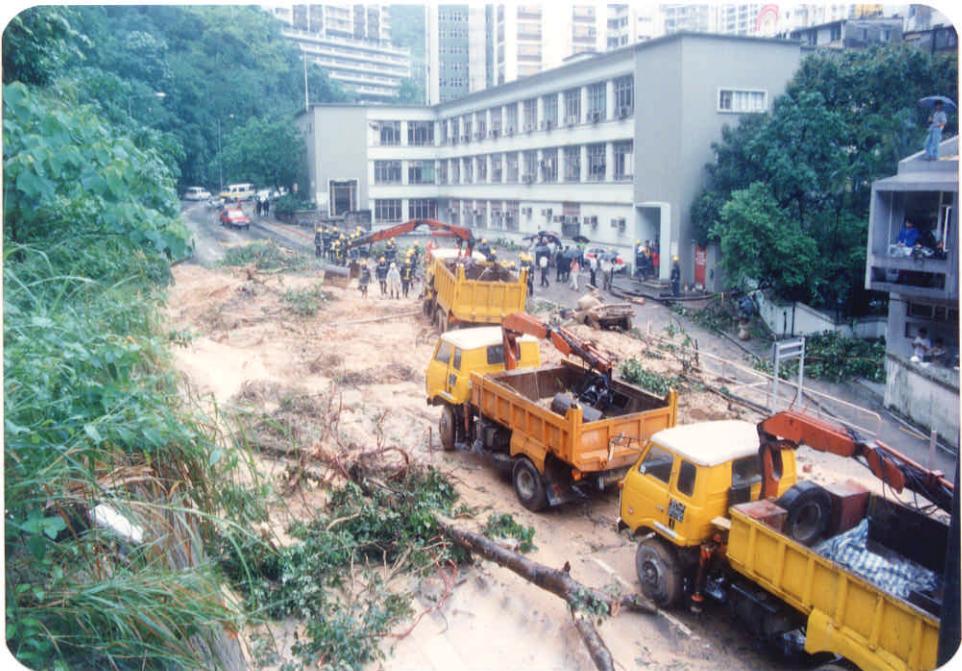
Plates 13 & 14 - Kennedy Road, below Wah Yan College, Happy Valley
(Incident HK 5/38)

4.4 Incident HK 5/38, Kennedy Road, below Wah Yan College, Happy Valley
(Major failure of a fill slope. One death. Plates 13 to 16.)

At about 0810 on 8 May, fill at the crest of a 24 m high soil cut slope failed during heavy rain. The debris, about 500 cu m, struck a passing car and killed the motorist inside. Three lanes of Kennedy Road were blocked while Wan Chai Clinic and parts of Wah Yan College were closed.

Description : Major failure of a fill slope (about 500 cu m). One dead, three lanes of Kennedy Road blocked.

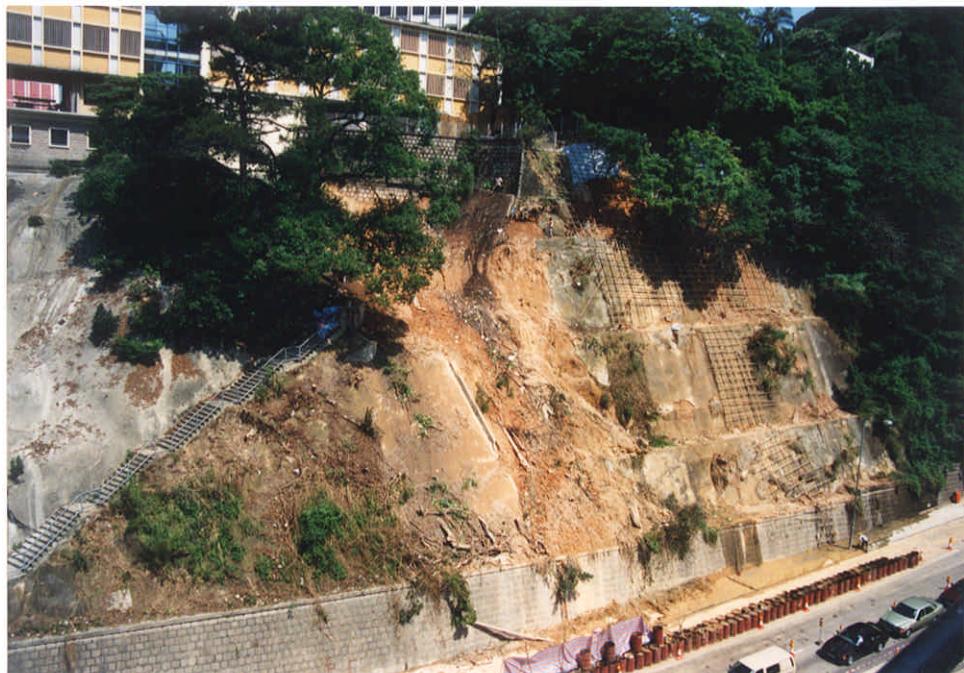
Plates 15 & 16 - Kennedy Road, below Wah Yan College, Happy Valley
(Incident HK 5/38)

Negative No. SP9207517 Taken on : 14-5-92
Description : Major failure of a fill slope (about 500 cu m). One dead, three lanes of Kennedy Road blocked.

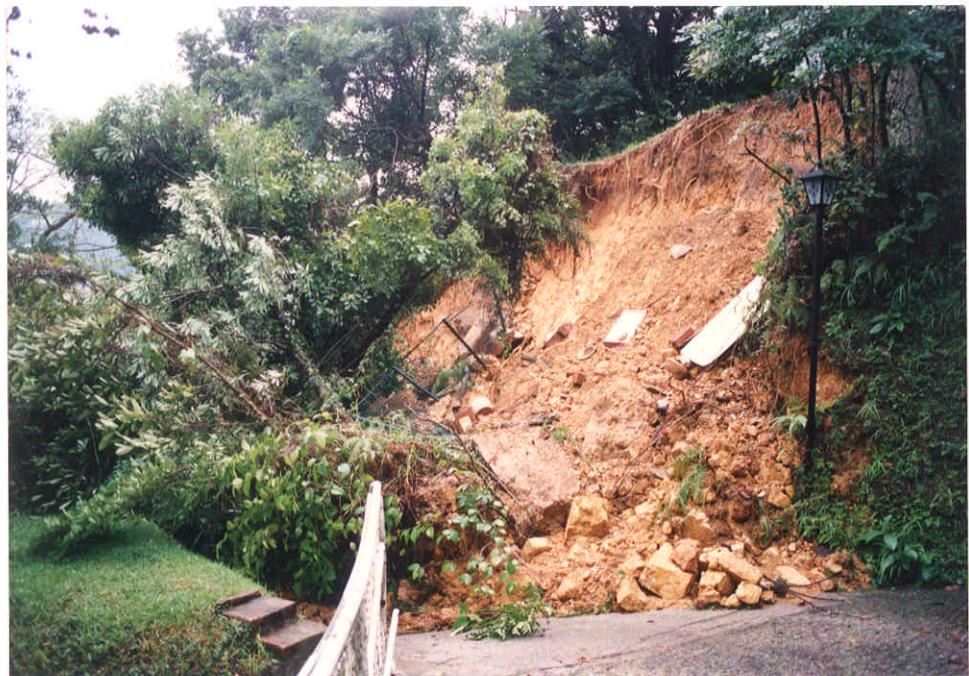
Plate 17 - 9 Middle Gap Road, Wan Chai Gap (Incident HK 5/39)

Description : Failure of a soil cut slope resulting in the blockage of a private access.

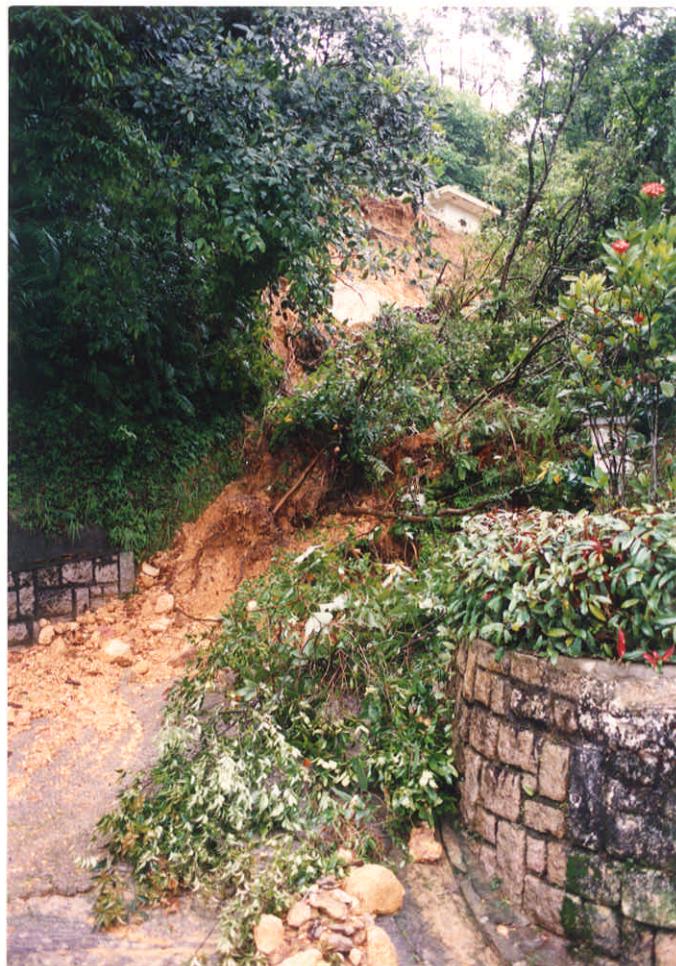
A total of 45 incidents affected these areas, two of which were major. Examples are shown in Plates 1 (Incident HK 5/1), 17 and 18 (Incident HK 5/39), 32 (Incident MW 5/16), 39 (Incident ME 5/67) and 42 (Incident ME 5/32).

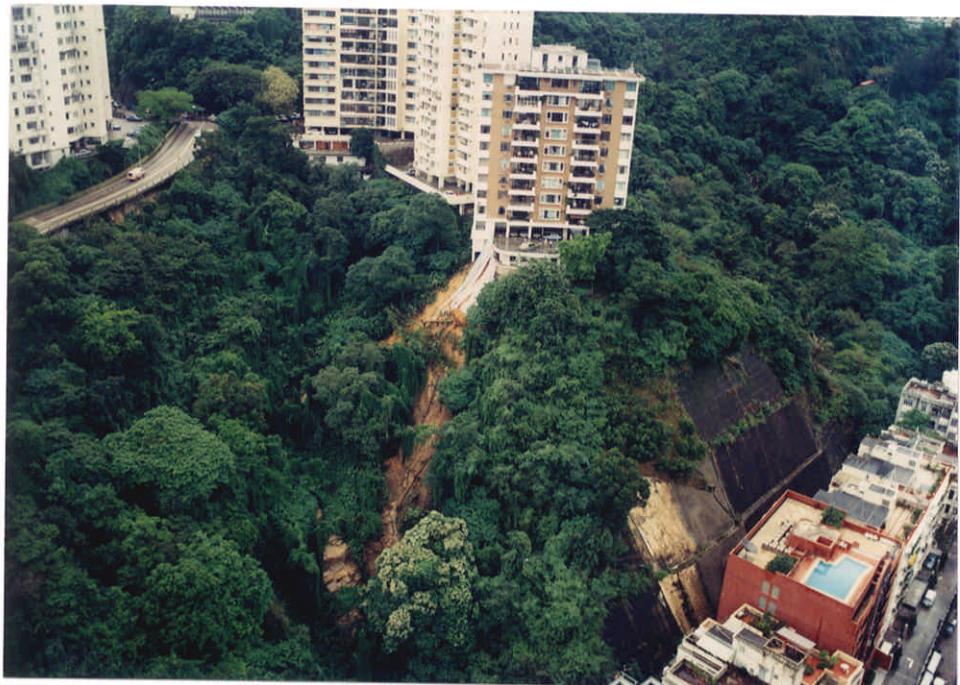
Plate 20 - Below 156 Tai Hang Road, So Kon Po (Incident HK 5/50)

Negative No. 14602 Taken on : 9-5-92
Description : Major failure of a fill slope (about 100 cu m).

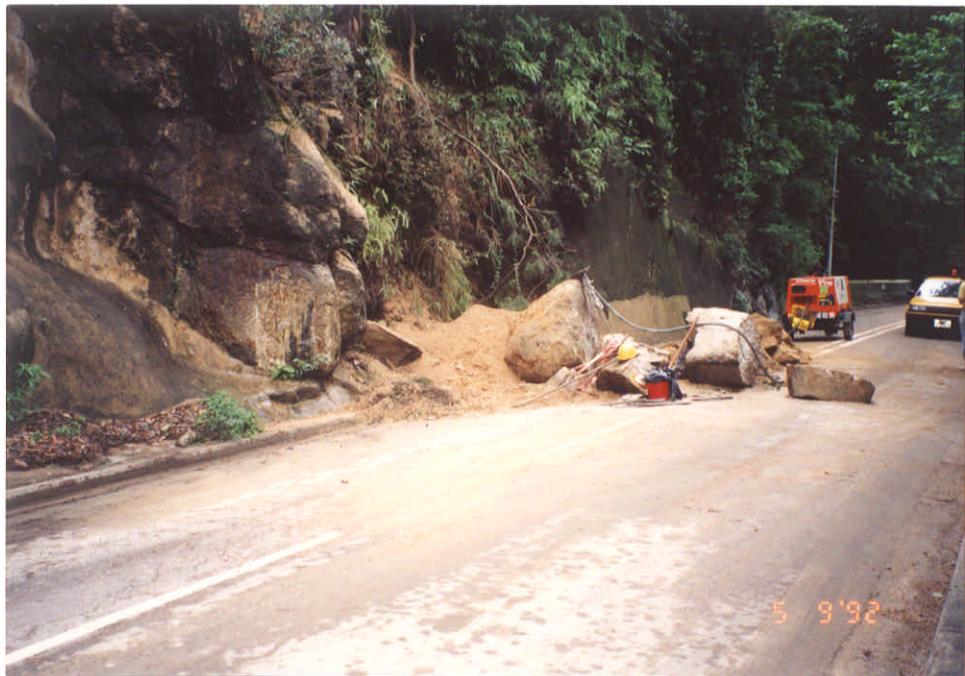
Plate 21 - Tai Hang Road, Jardine's Lookout (Incident HK 5/55)

Negative No. I9224802 Taken on : 9-5-92
Description : Failure of a soil/rock cut slope resulting in the blockage of two road lanes.

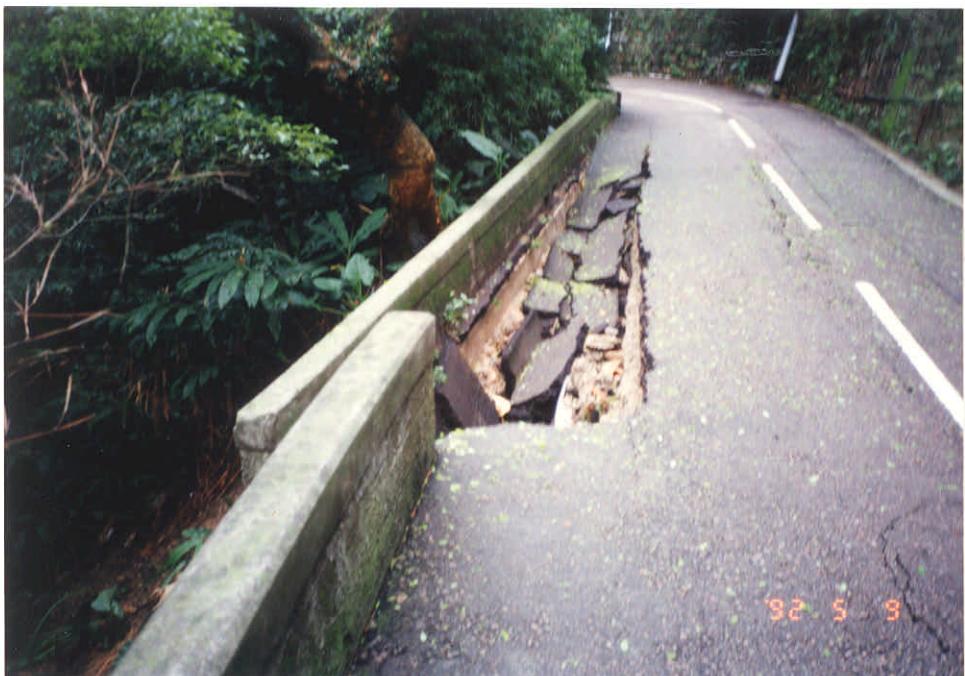
Plate 22 - Below 5 Coombe Road, Magazine Gap (Incident HK 5/70)

- 4.7 Incident HK 5/70, below 5 Coombe Road, Magazine Gap
(Major failure of a retaining wall resulting in subsidence and the closure of two lanes of the road. Plate 22.)

On 8 May, a 20 m length of retaining wall on the downslope side of Coombe Road failed and moved about 1 m downslope. Both lanes of the road were closed. Localised surface failures were noted on the slope below the retaining wall, together with a broken water pipe which may have contributed to the failure.

Negative No. A9206704 Taken on : 9-5-92
Description : Major failure of a retaining wall resulting in ground subsidence and the closure of two road lanes.

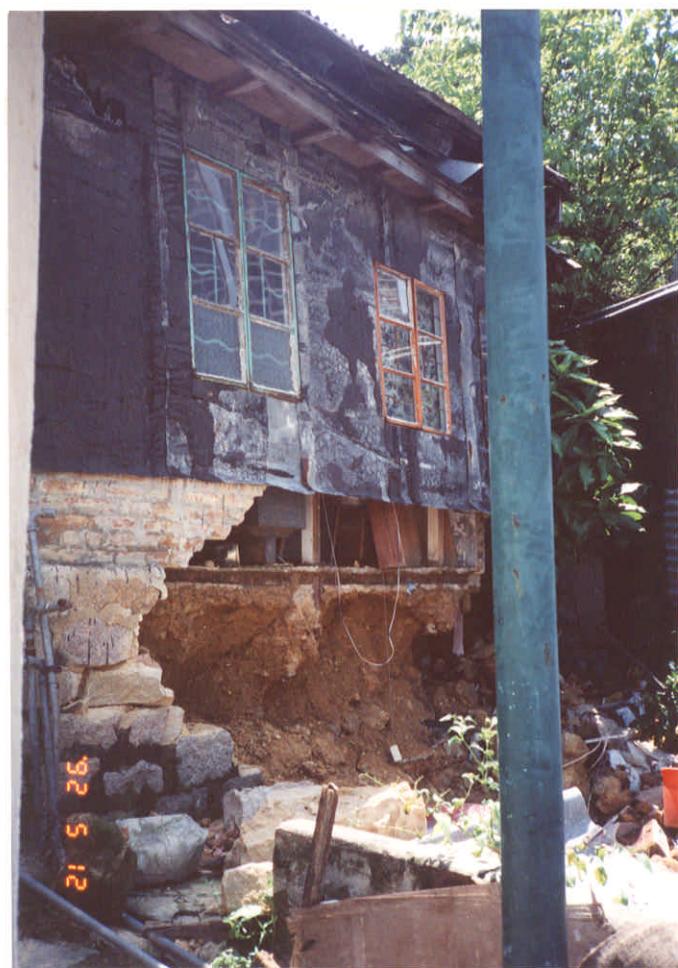
Plate 23 - Behind Mobil Marine Petrol Station, Ap Lei Chau (Incident HK 5/80)

A total of 45 incidents affected squatter areas. Of these, 25 occurred on Hong Kong Island, four in Kowloon and sixteen in the New Territories. No failures affecting squatter areas were major. Failures led to the permanent evacuation of 92 huts and the temporary evacuation of seventeen huts. Examples are shown in Plates 23 (Incident HK 5/80) and 24 (Incident HK 5/98).

Description : Failure of a soil/rock cut slope resulting in the permanent evacuation of two huts.

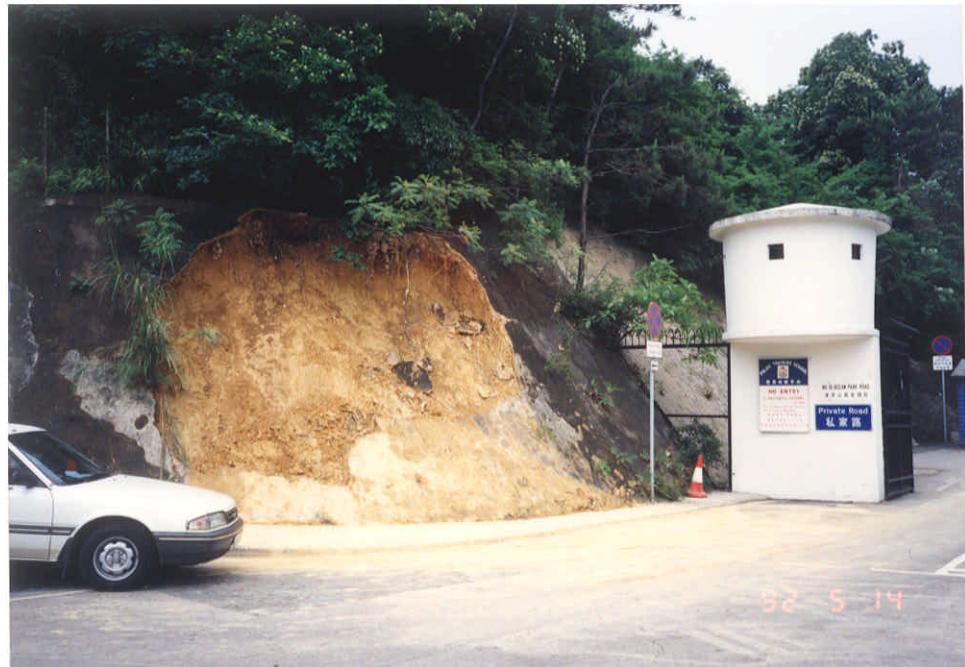
Plate 25 - Ocean Park Road, Wong Chuk Hang (Incident HK 5/152)

Negative No. I9224212A Taken on : 14-5-92
Description : Failure of a soil/rock cut slope affecting a pedestrian pavement.

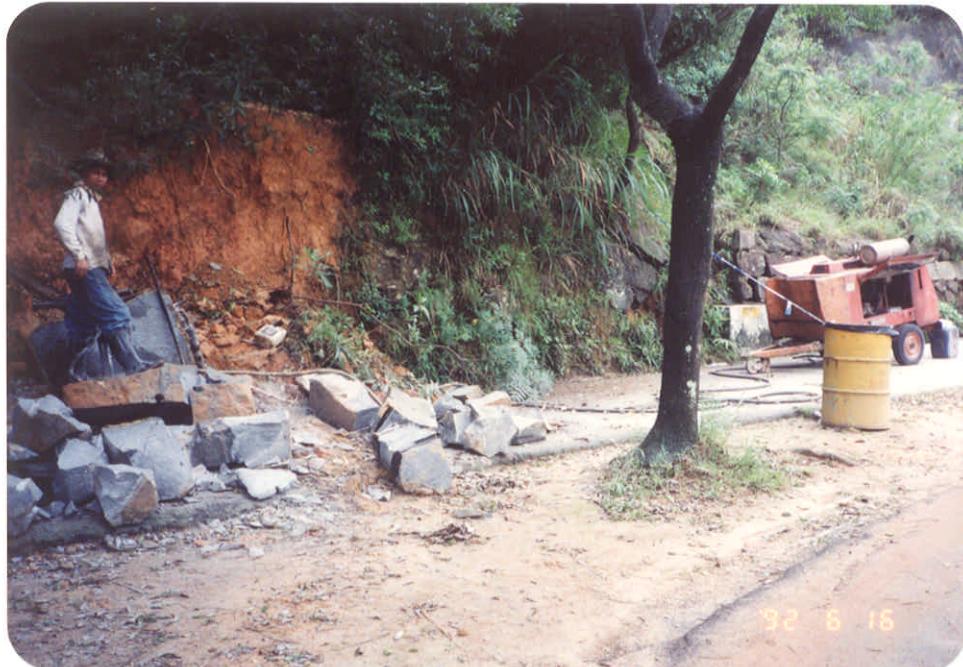
Plate 26 - Aberdeen SW Service Reservoir (Incident HK 6/2)

Negative No. I9235707 Taken on :16-6-92
Description : Rock/boulder fall affecting a footpath.

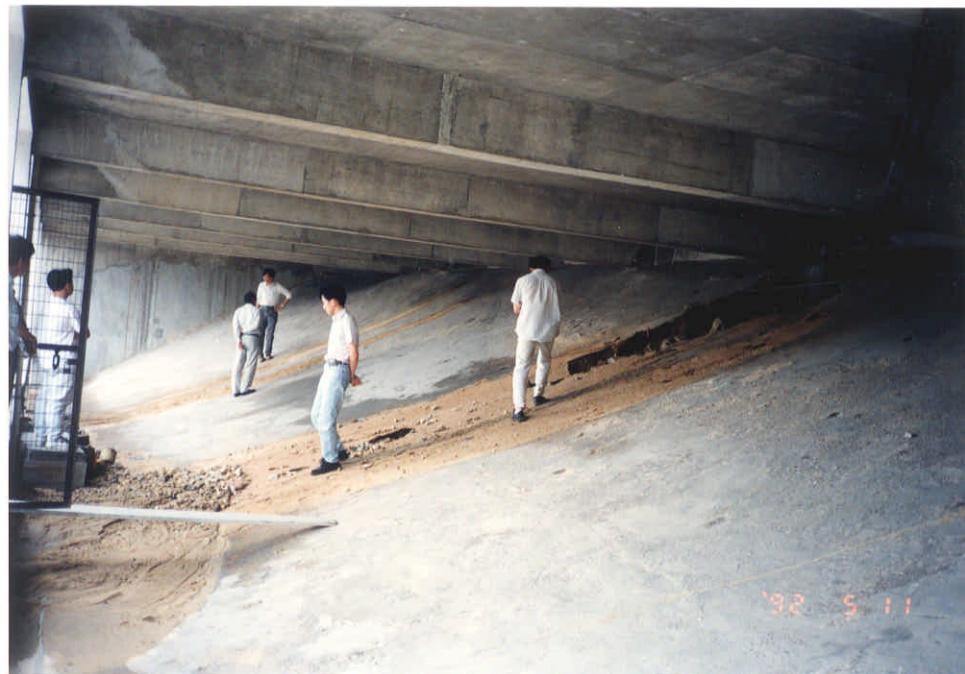
Plate 28 - Buddhist College, 3 Ko Chiu Road (Incident K 5/8)

Negative No. ME9217909 Taken on : 11-5-92
Description : Failure of a soil cut slope.

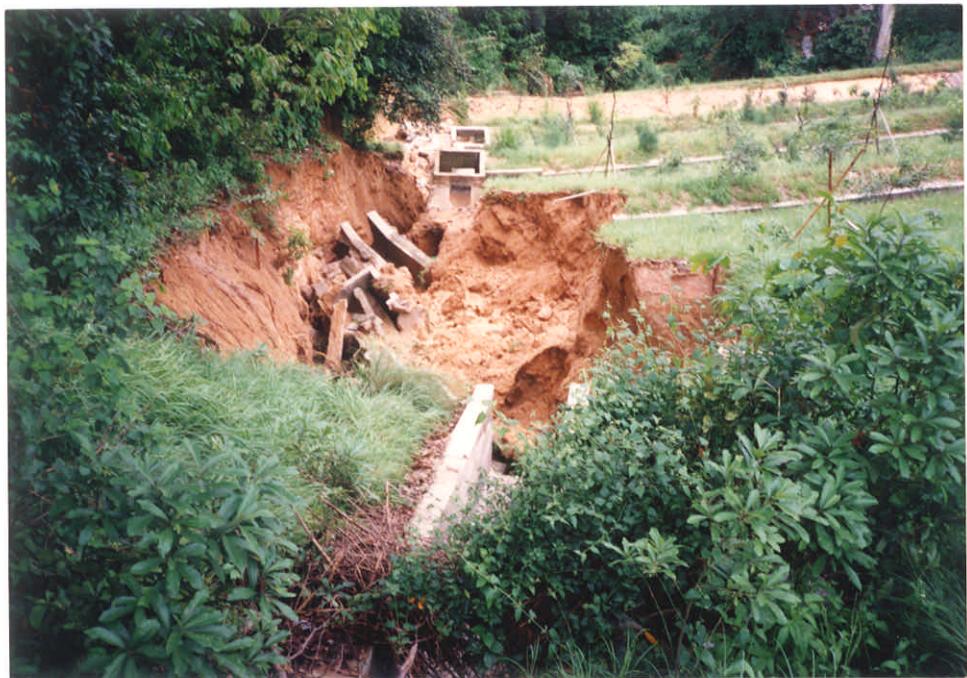
Plate 29 - Tai Po Road Near Carlton Hotel, Kowloon (Incident MW 5/3)

4.12 Incident MW 5/3, Tai Po Road, Kowloon
(Major failure of a fill slope resulting in the closure of one road lane.
Plate 29.)

Negative No. MW9210505 Taken on : 9-5-92
Description : Major failure of a fill slope (over 50 cu m) resulting in the closure of one road lane.

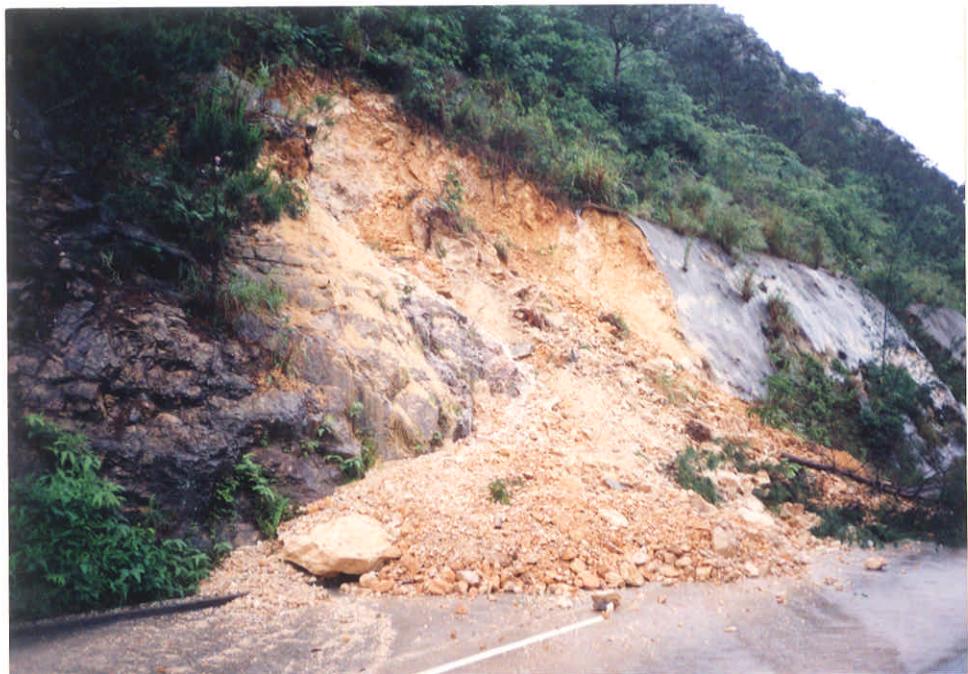
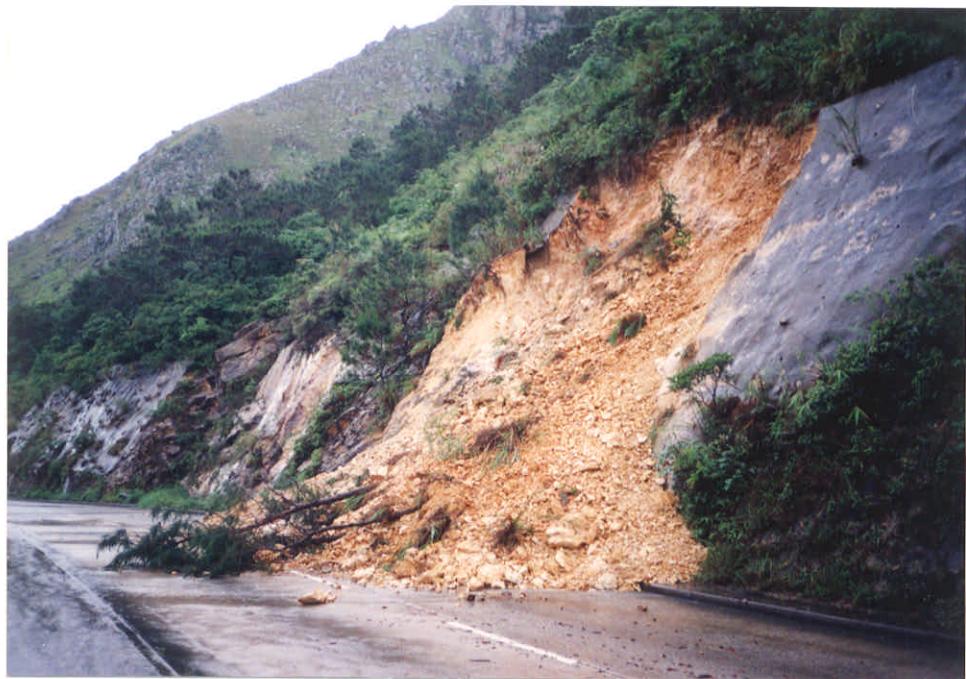
Plates 30 & 31 - Tai O Road, near MS 12 $\frac{3}{4}$, Lantau Island (Incident MW 5/12)

Description : Failure of a soil/rock cut slope resulting in the blockage of a pedestrian pavement and one road lane.

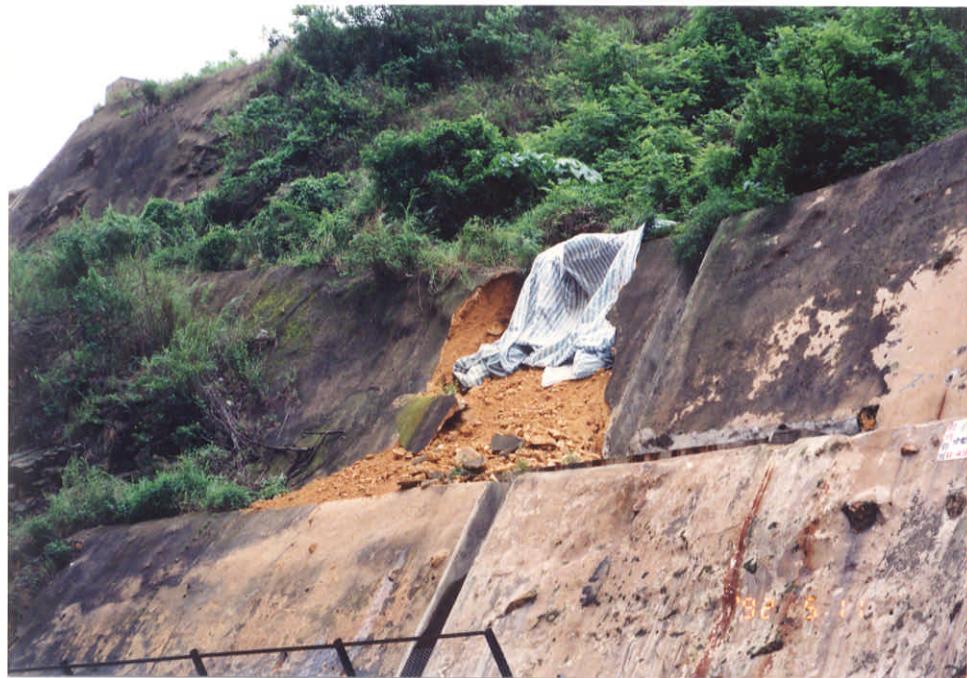
Plate 32 - Kwai Fuk Road, Kwai Chung (Incident MW 5/16)

Negative No. MW9210806 Taken on : 11-5-92
Description : Failure of a soil cut slope affecting a pedestrian pavement.

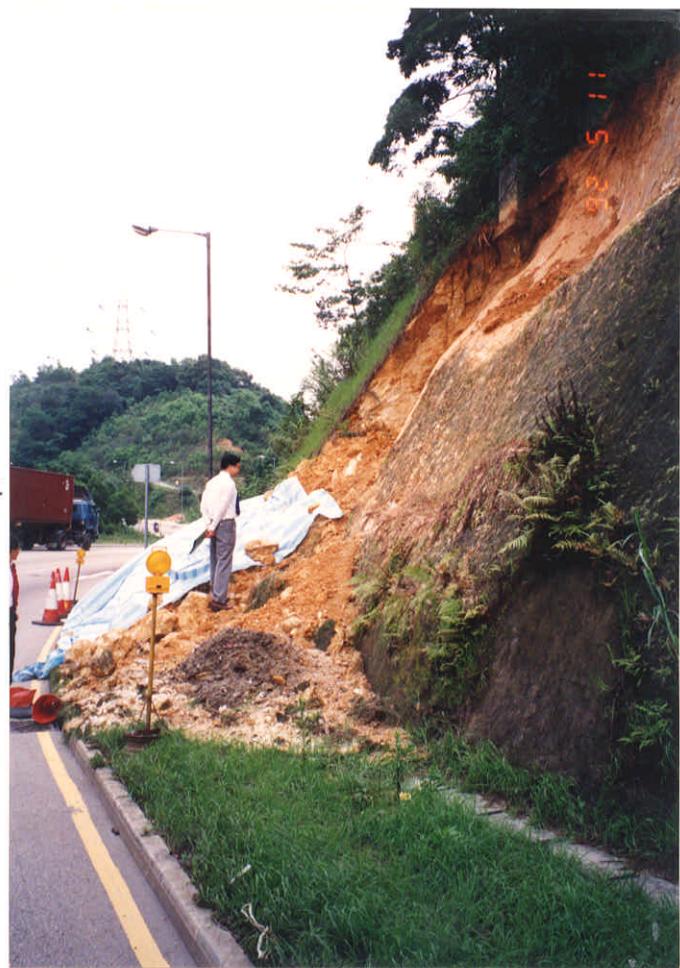
Plate 33 -
Piper's Hill, Shatin
(Incident MW 5/17)

Description :
Failure of a soil cut slope affecting a road.

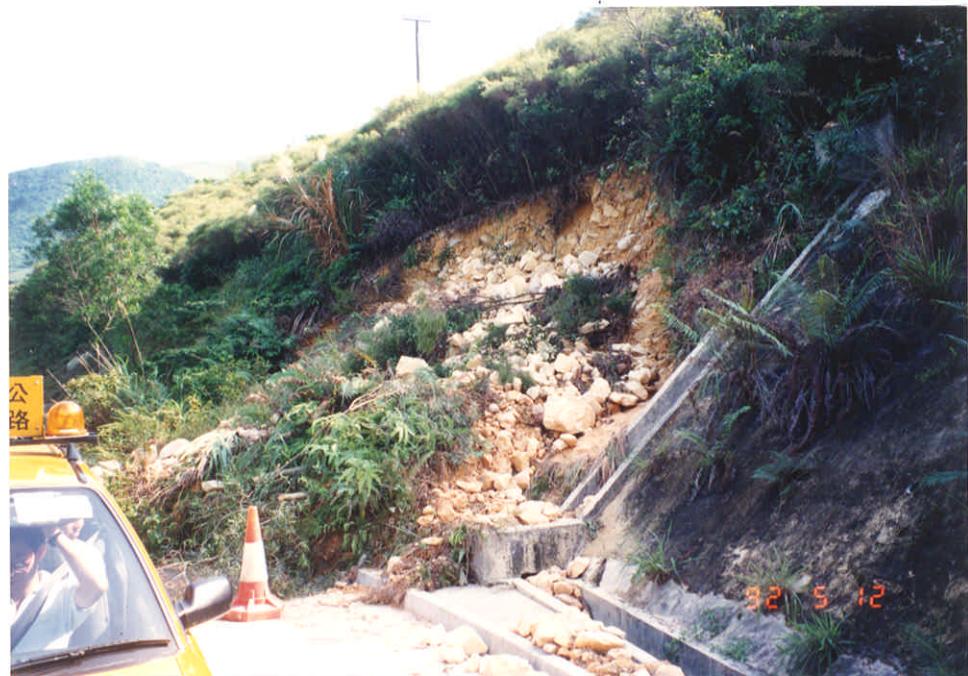
Plate 34 - Sham Wat Road, Lantau Island (Incident MW 5/45)

Negative No. MW9211524 Taken on : 12-5-92
Description : Failure of a soil cut slope resulting in the partial blockage of a road.

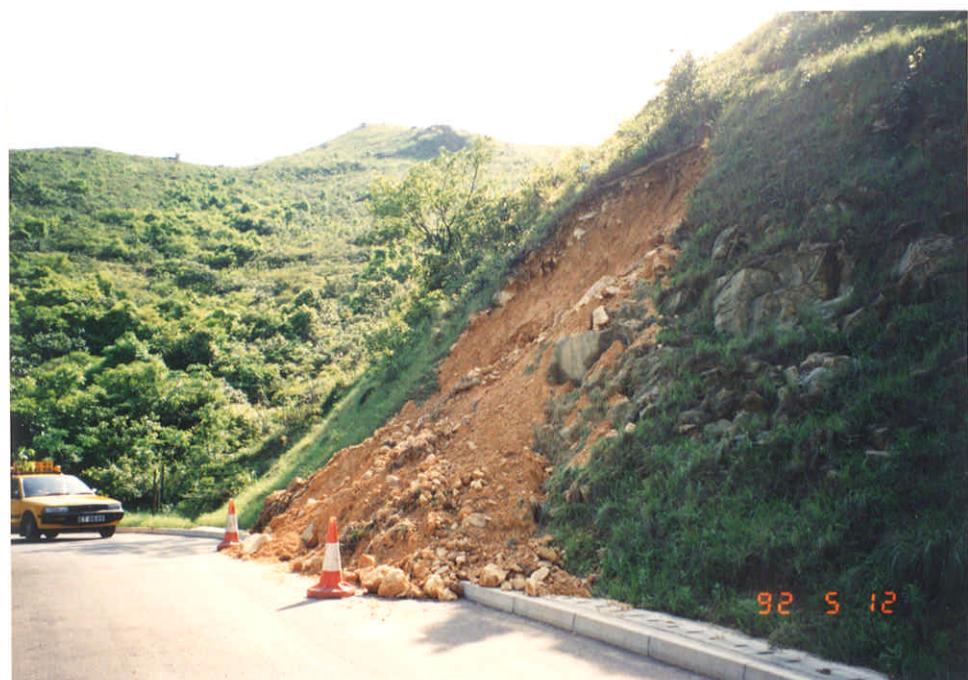
Plate 35 - Sham Wat Road, Lantau Island (Incident MW 5/46)

Negative No. MW9211519 Taken on : 12-5-92
Description : Failure of a soil cut slope resulting in the partial blockage of a road.

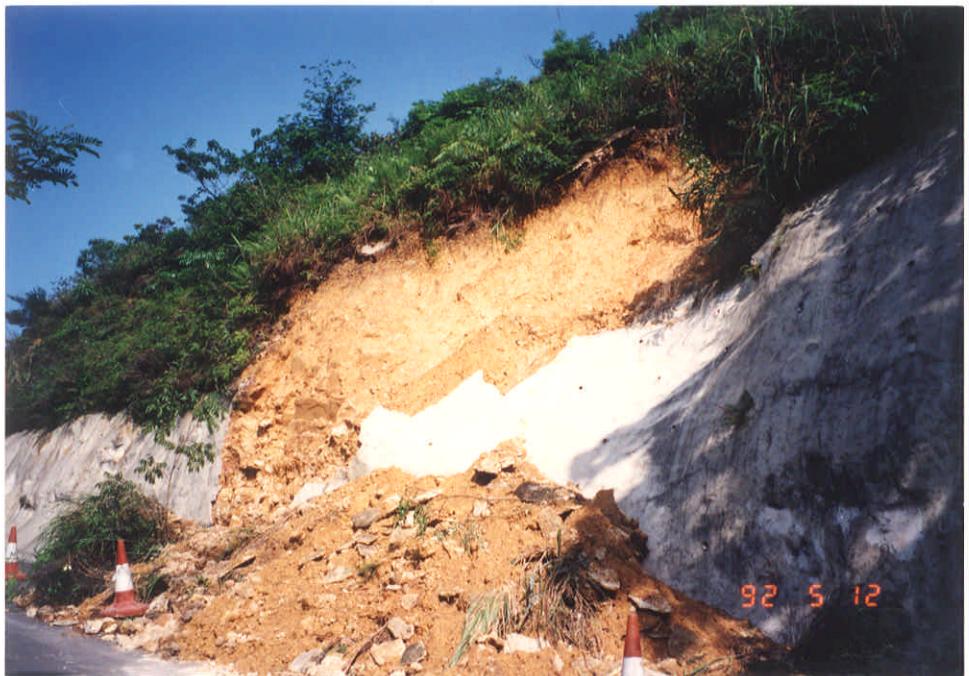
Plate 36 - Sham Wat Road, Lantau Island (Incident MW 5/47)

Negative No. MW9211521 Taken on : 12-5-92
Description : Failure of a soil cut slope resulting in the partial blockage of a road.
