**REPORT ON
THE RAINSTORM OF
8 MAY 1992**

GEO REPORT No. 22

**GEOTECHNICAL ENGINEERING OFFICE
CIVIL ENGINEERING DEPARTMENT
HONG KONG**

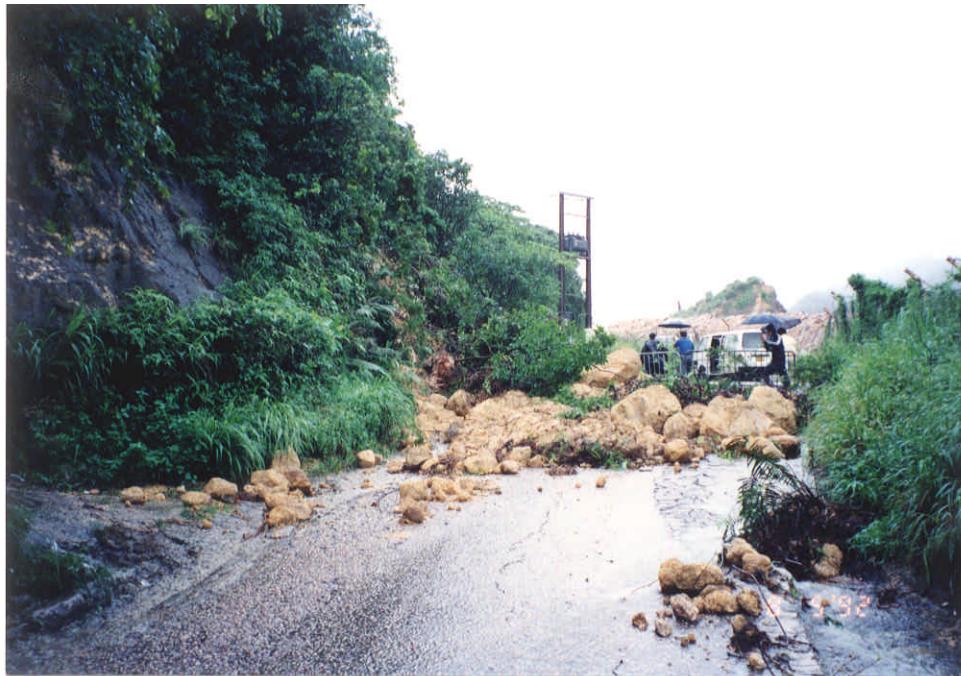
Plate 38 - Anderson Road, Sau Mau Ping (Incident ME 5/1)

Negative No. ME9218819 Taken on : 8-5-92
Description : Failure of a soil cut slope resulting in the blockage of one road lane.

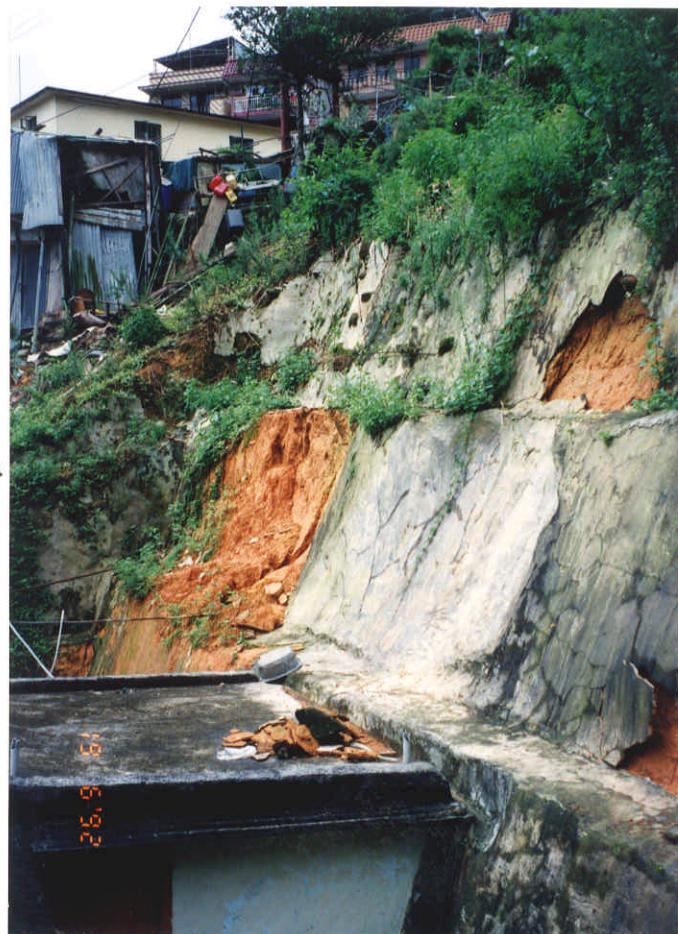
Plate 39 -
42 Tui Hoi Village, Sai Kung
(Incident ME 5/16)

Description :
Failure of a soil cut slope affecting a
building lot.

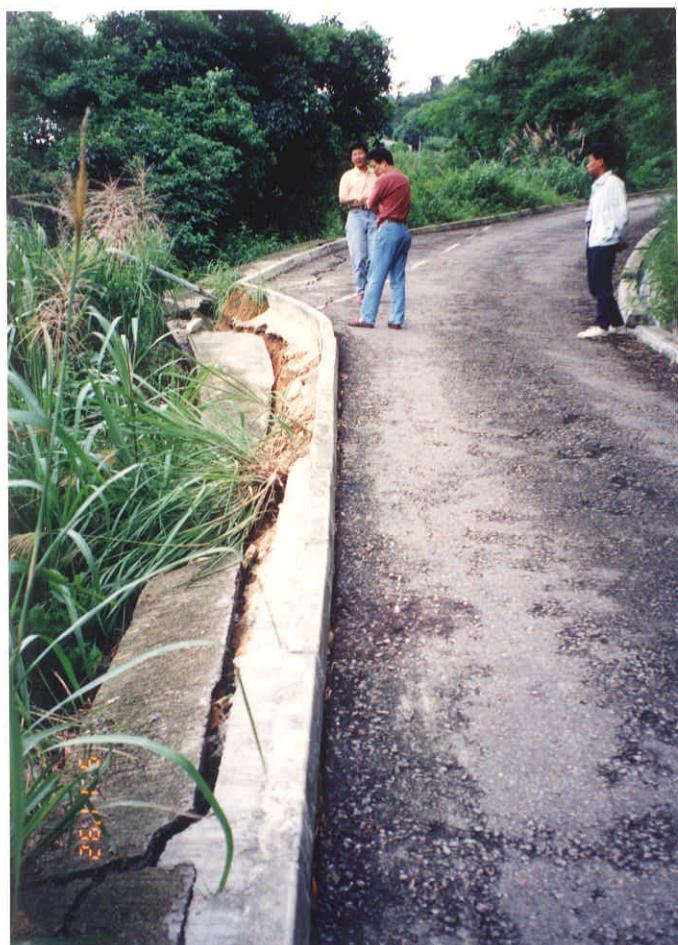
Plate 40 - Wong Chuk Yeung, Fo Tan, Shatin (Incident ME 5/22)

Negative No. ME9218018 Taken on : 11-5-92
Description : Subsidence failure affecting a pedestrian pavement.

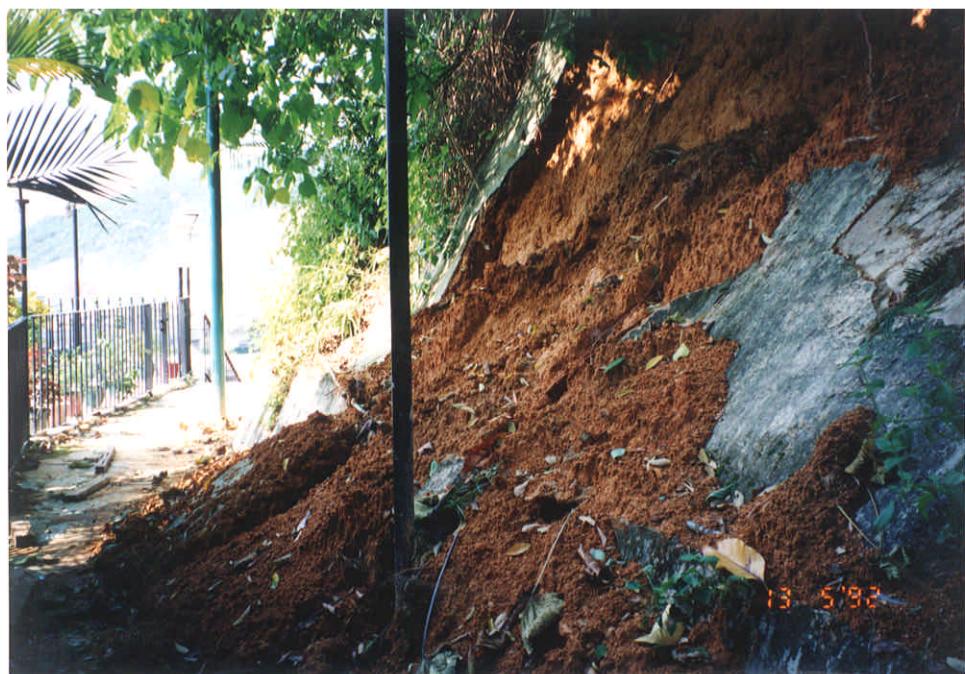
Plate 42 - 20 Ngau Pai Sha Village, Shatin (Incident ME 5/32)

Negative No. ME9219421 Taken on : 13-5-92
Description : Failure of a soil cut slope affecting a private access.
