# ROAD INFRASTRUCTURE EVIDENCE REPORT

Visual Documentation of Systematic Neglect in Bedian Road & Ali View Garden Area

Lahore, Punjab, Pakistan

**Reference:** ROAD-20250817-EVIDENCE

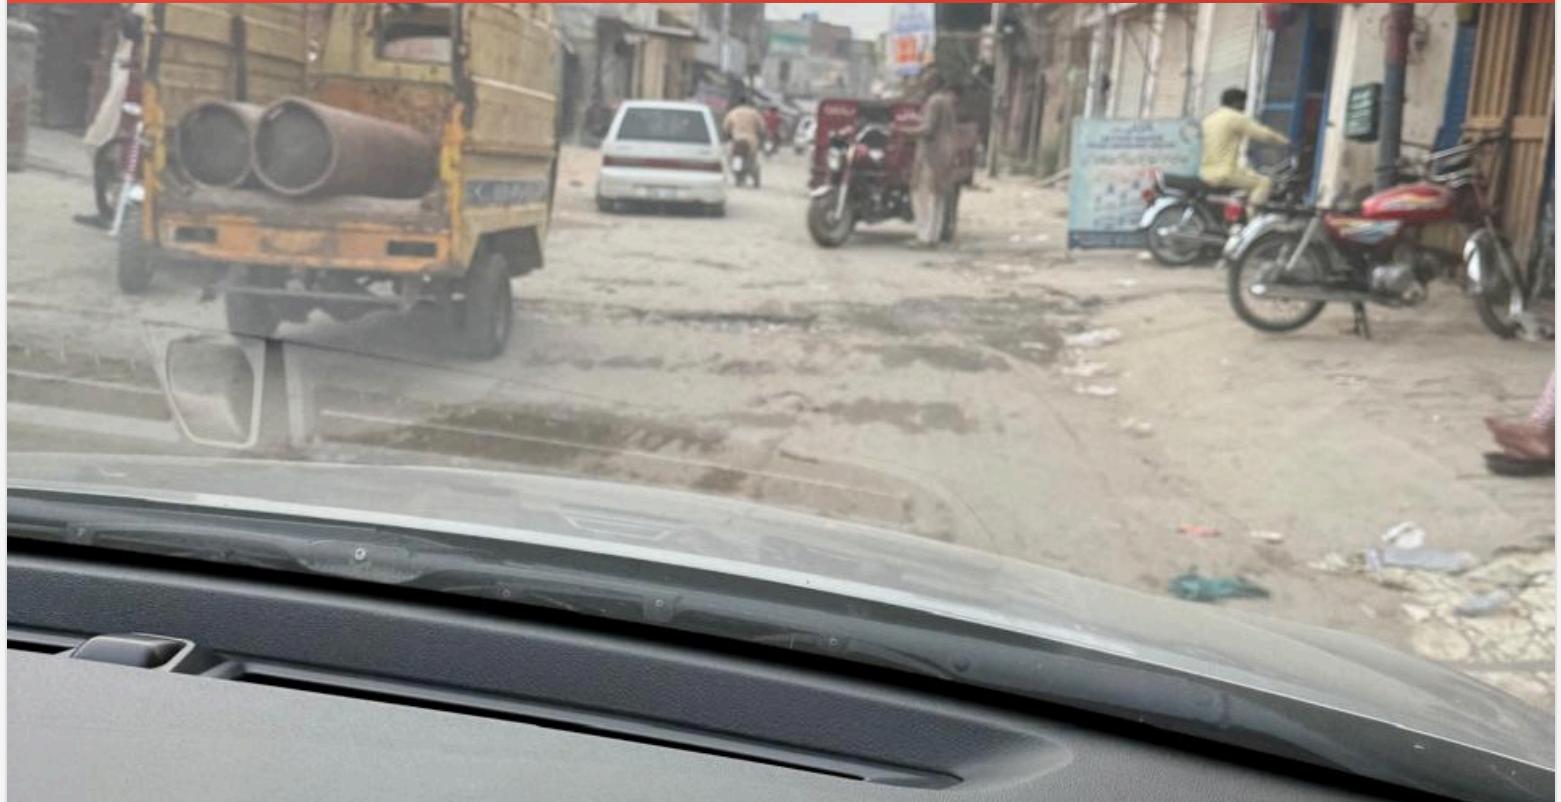
# Dusty Unpaved Roads - Bedian Road Commercial Area - 31.5189°N, 74.3601°E

**Description:** Commercial section of Bedian Road showing completely unpaved conditions with heavy dust accumulation. Construction trucks and motorcycles forced to navigate through deteriorated surface. Shops and businesses operating despite inadequate road infrastructure. Visible comparison to well-maintained roads in nearby cantonment areas.

**CRITICAL - UNPAVED COMMERCIAL ROAD**

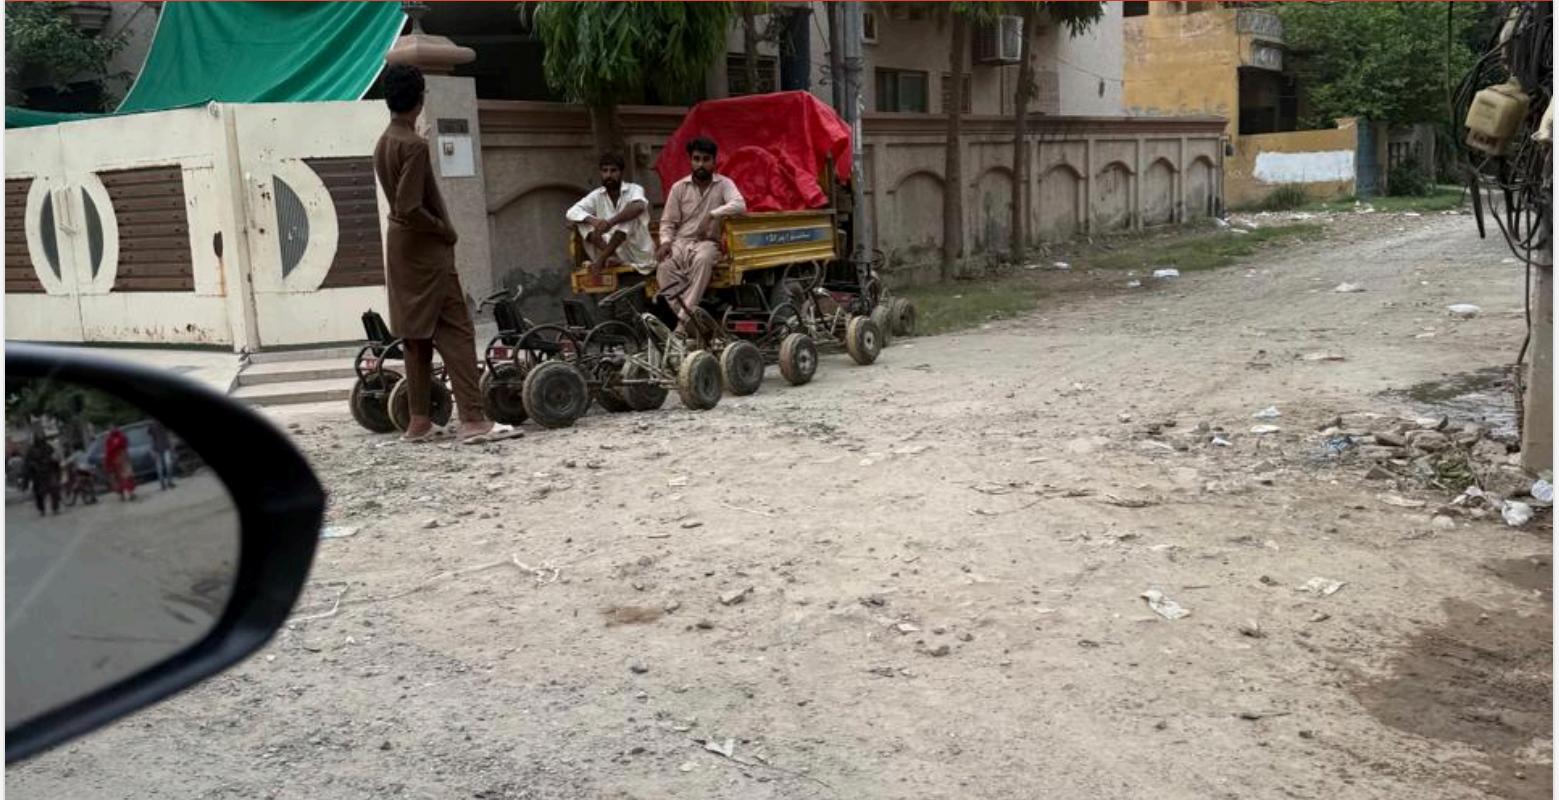
# Deteriorated Surface Conditions - Ali View Garden Approach - 31.5195°N, 74.3598°E

**Description:** Approach road to Ali View Garden residential society showing severe deterioration. Residents forced to use carts and motorcycles on broken, uneven surfaces. Despite housing thousands of families, this area receives no proper road maintenance. Clear evidence of discriminatory resource allocation.

**HIGH - RESIDENTIAL ACCESS COMPROMISED**

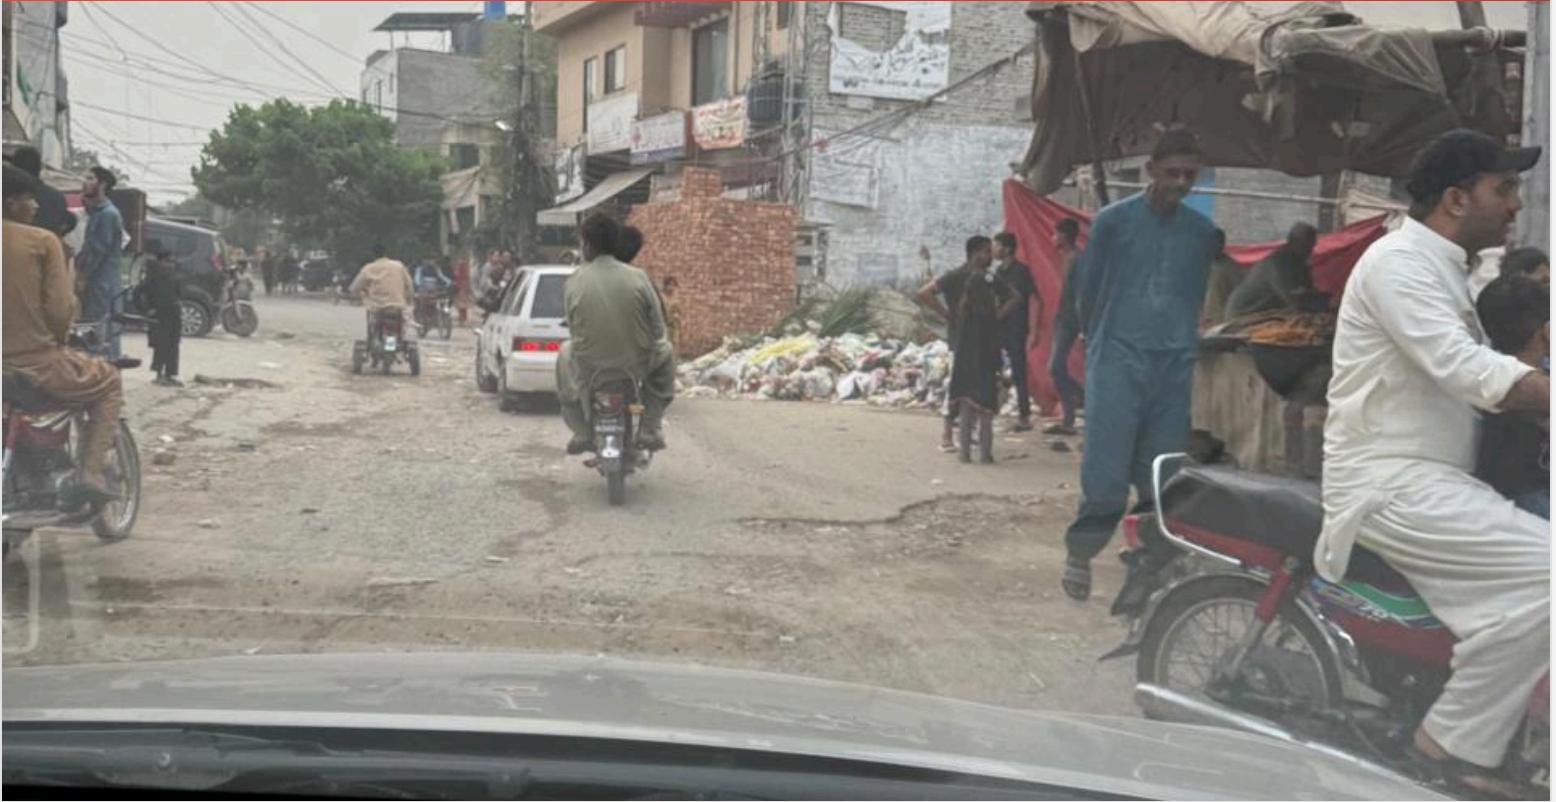
# Construction Debris Hazards - Main Bedian Road - 31.5202°N, 74.3595°E

**Description:** Main Bedian Road showing unregulated construction material storage directly on road surface. Brick piles and debris creating dangerous traffic conditions. Motorcycles and vehicles forced to navigate around obstacles. Complete absence of traffic management and road usage enforcement.

**CRITICAL - TRAFFIC SAFETY HAZARD**

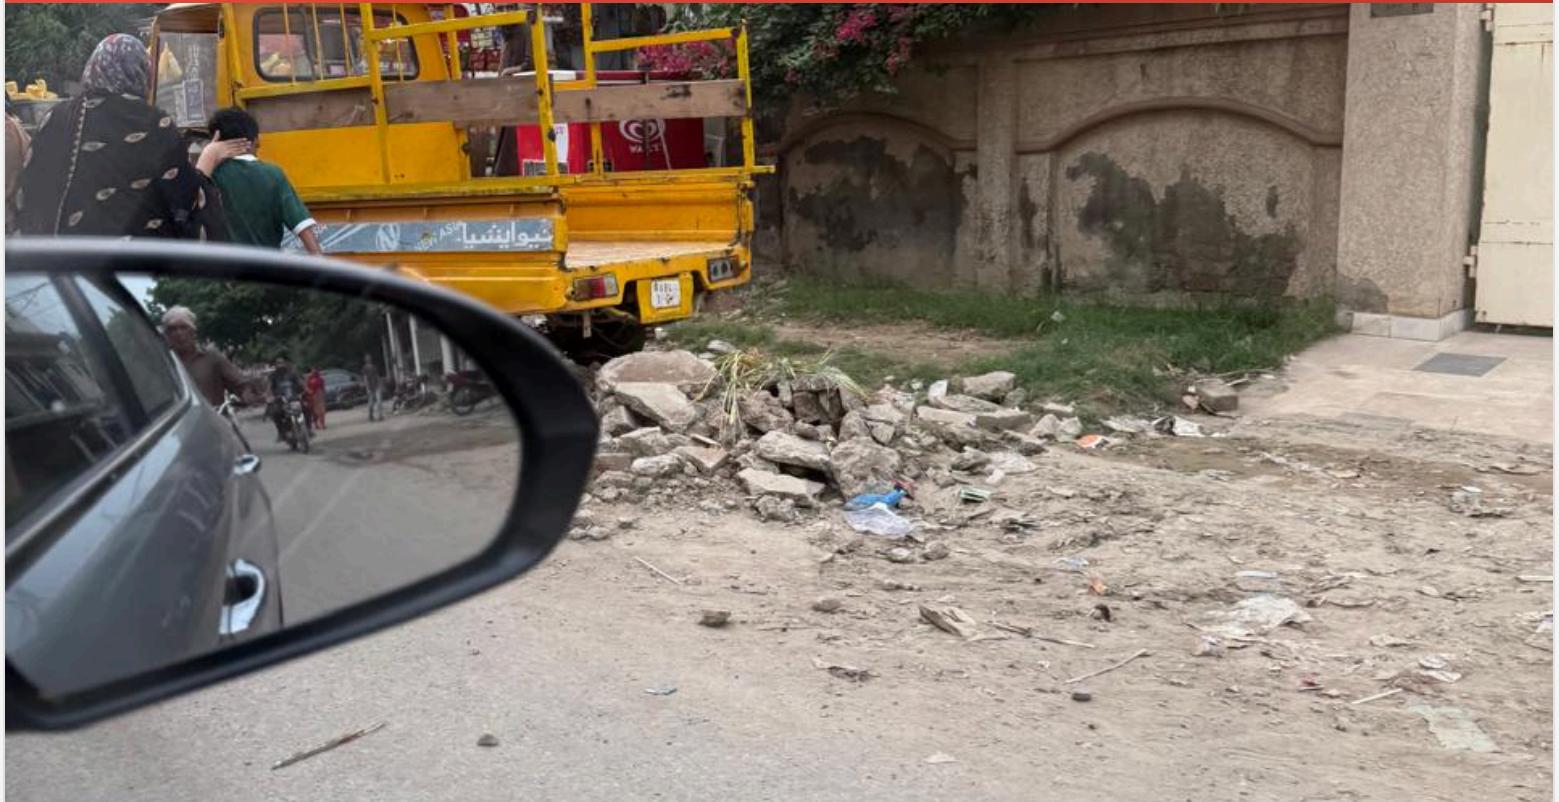
# Road Rubble and Debris - Bedian Road Maintenance Zone - 31.5208°N, 74.3592°E

**Description:** Evidence of substandard road repair attempts using loose rubble and broken concrete. School bus visible in background highlighting safety concerns for children. Contrast visible between maintained private compound area and neglected public road infrastructure.

**HIGH - SUBSTANDARD REPAIR MATERIALS**

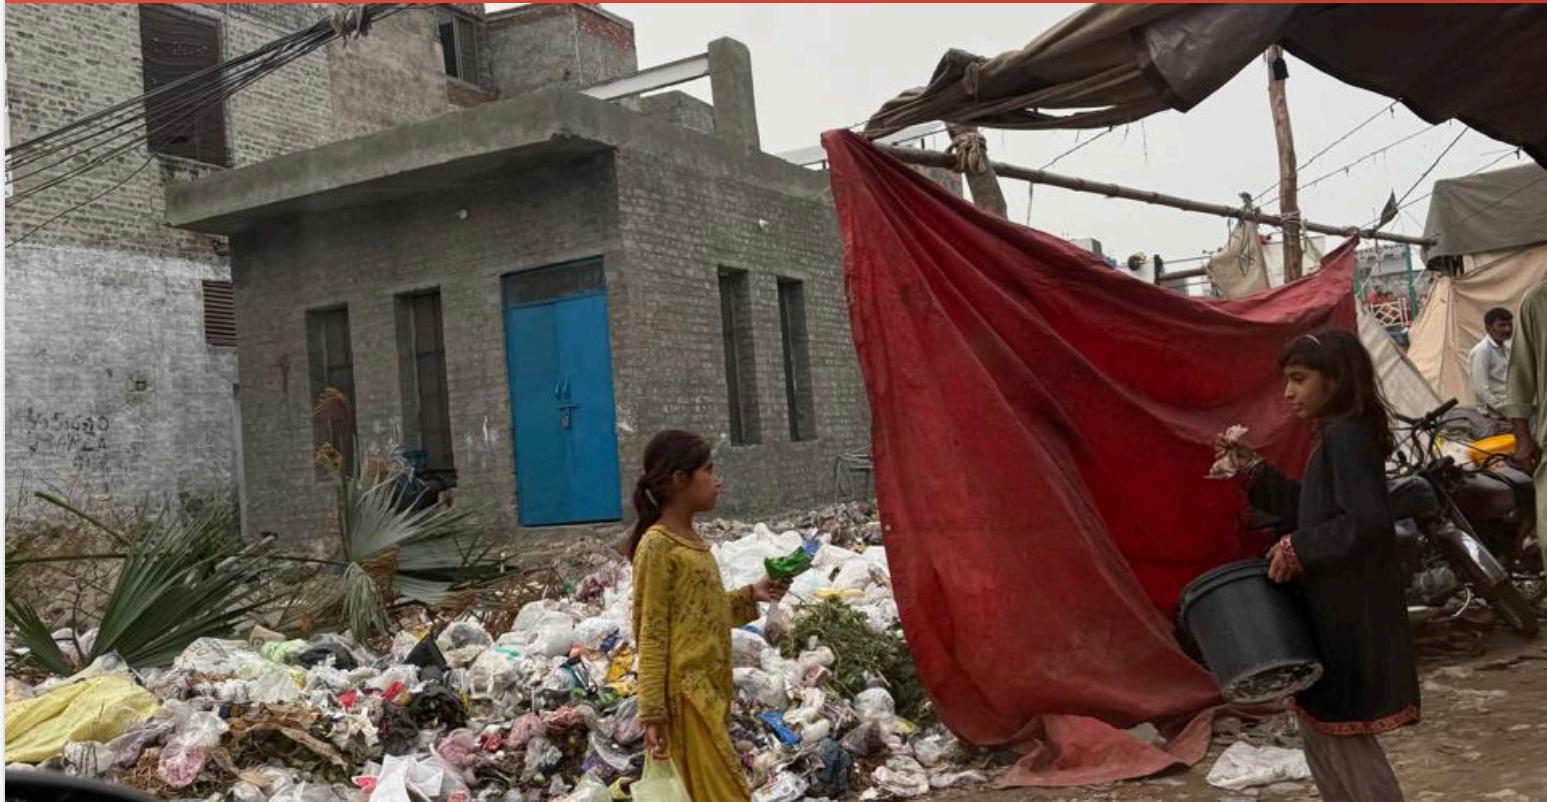
# Waste Management Failure - Bedian Road Residential - 31.5212°N, 74.3588°E

**Description:** Massive accumulation of garbage and waste directly on road surface. Children and residents forced to navigate around unsanitary conditions. Complete breakdown of waste management services. Public health hazard affecting thousands of residents daily.

CRITICAL - PUBLIC HEALTH EMERGENCY

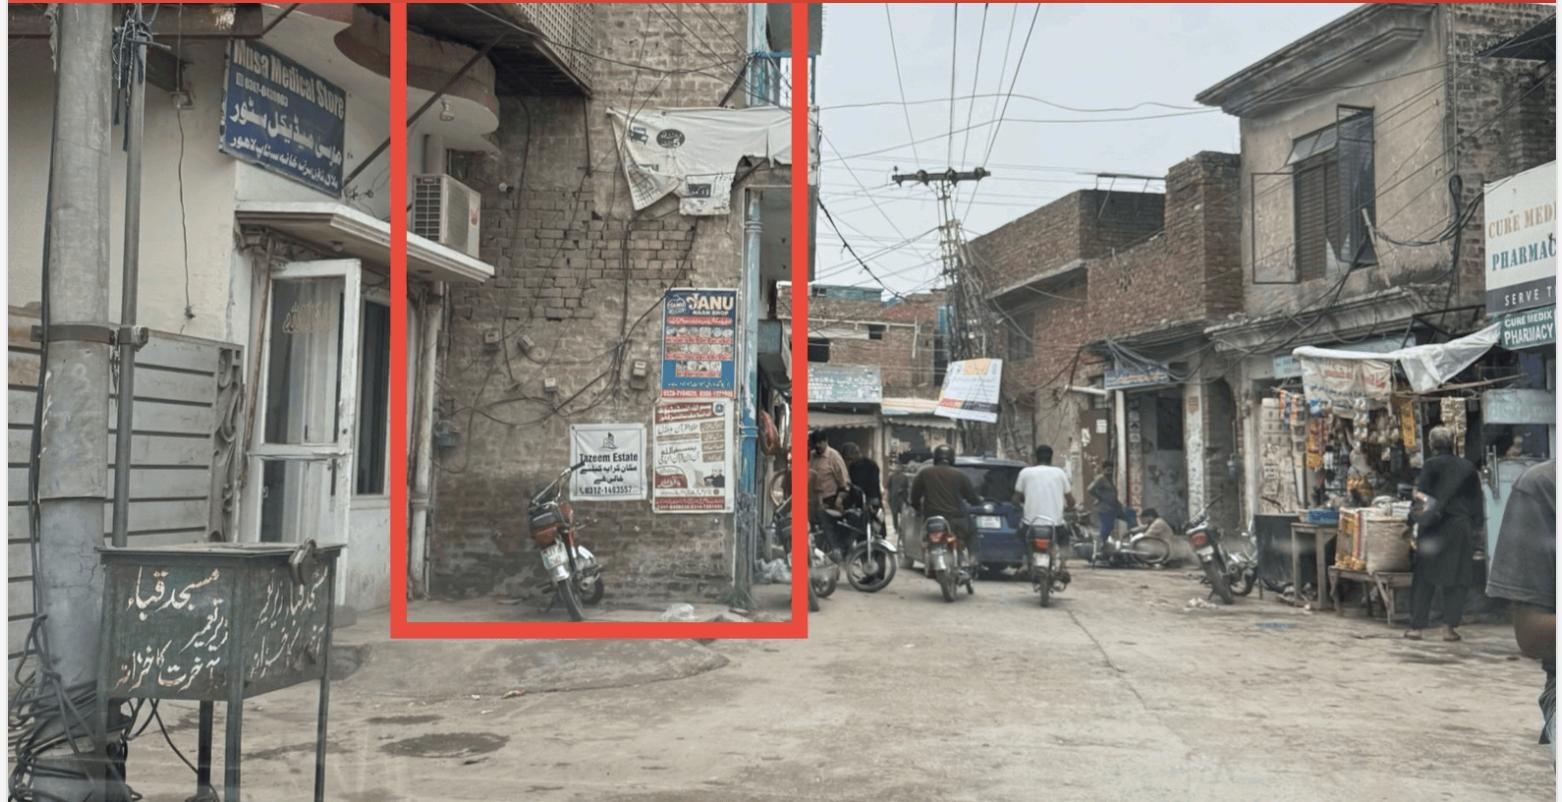
# Illegal Construction Encroachment - Bedian Road Central - 31.5218°N, 74.3585°E

**Description:** Illegal construction extending into road space (highlighted building). Structure reduces effective road width creating dangerous bottlenecks for traffic. Evidence of complete lack of building code enforcement and regulatory oversight. This encroachment forces vehicles into opposing traffic lanes.

**CRITICAL - ILLEGAL ENCROACHMENT**

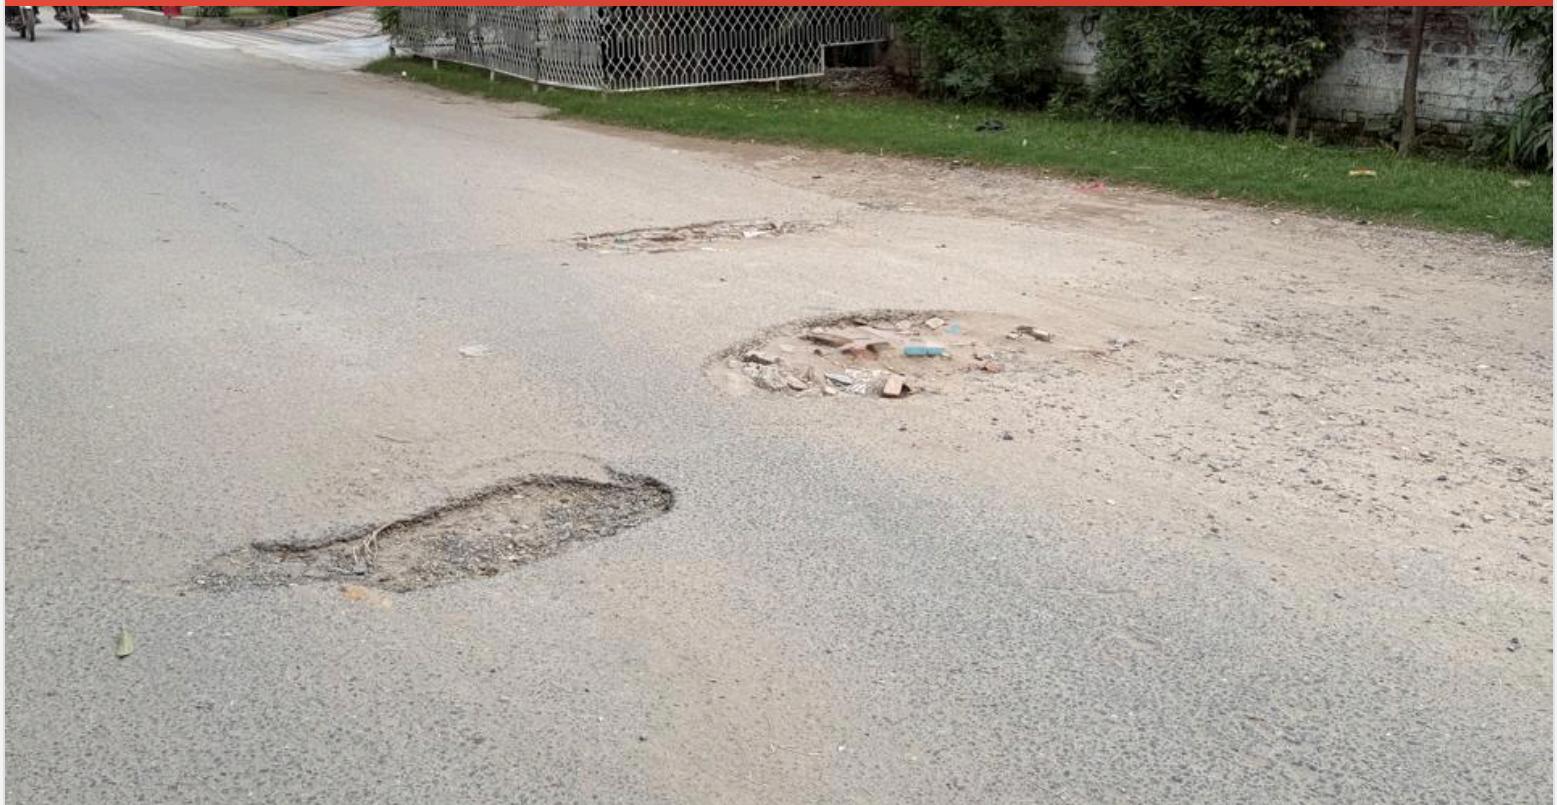
# Pothole Formation Near Maintained Areas - Boundary Zone - 31.5225°N, 74.3582°E

**Description:** Clear contrast between well-maintained landscaped areas and deteriorated road surface with visible potholes. This location demonstrates discriminatory resource allocation where cantonment-controlled areas receive proper maintenance while civilian areas are neglected.

HIGH - DISCRIMINATORY MAINTENANCE

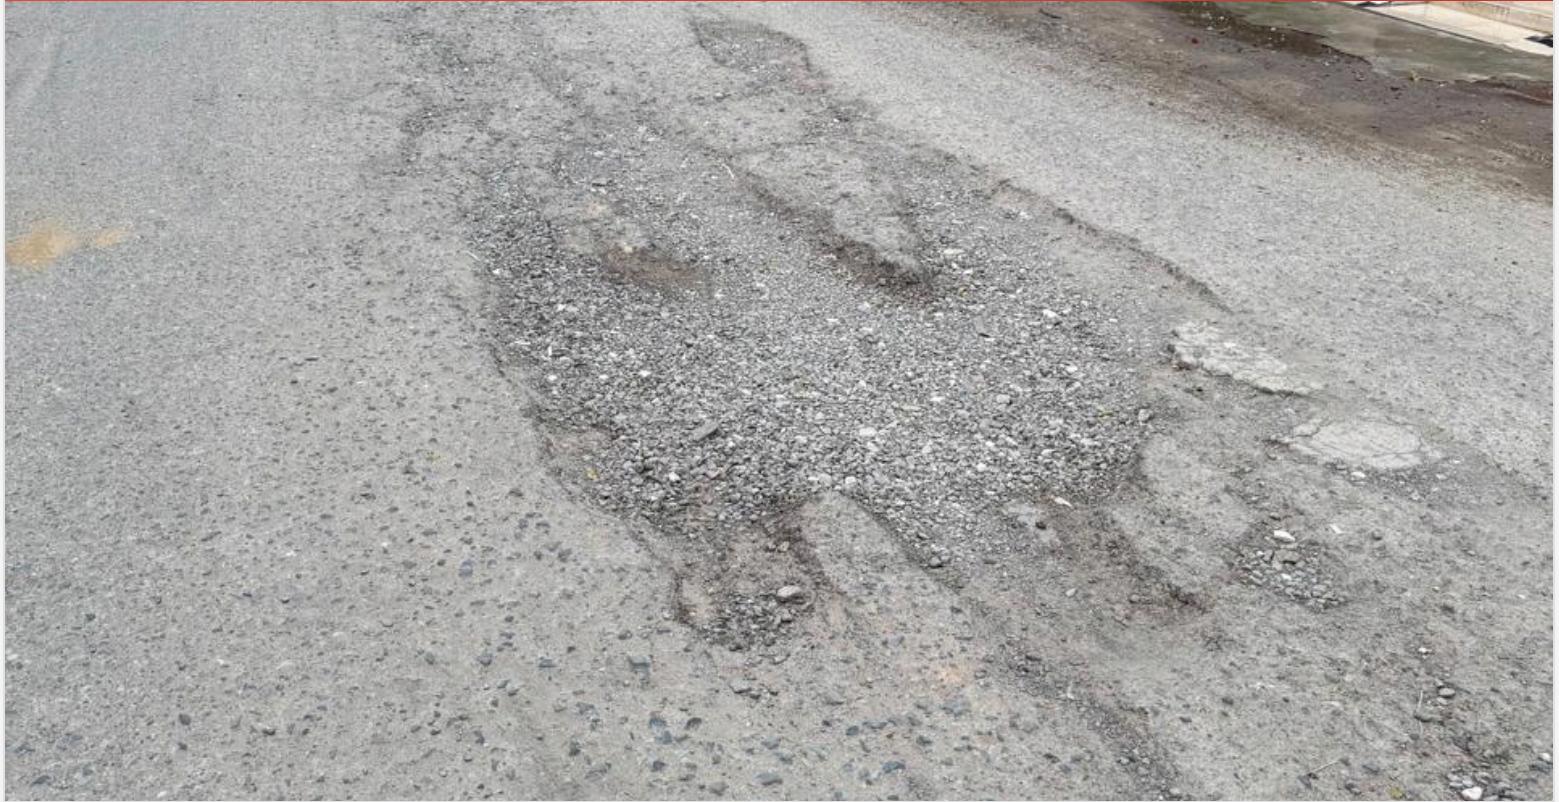
# Multiple Pothole Cluster - Ali View Garden Access - 31.5232°N, 74.3578°E

**Description:** Multiple large potholes filled with loose gravel and rubble instead of proper road material. Vehicles and motorcycles forced to swerve dangerously to avoid damage. Evidence of repeated failed repair attempts using substandard materials that wash away during rains.

**CRITICAL - MULTIPLE ROAD HAZARDS**

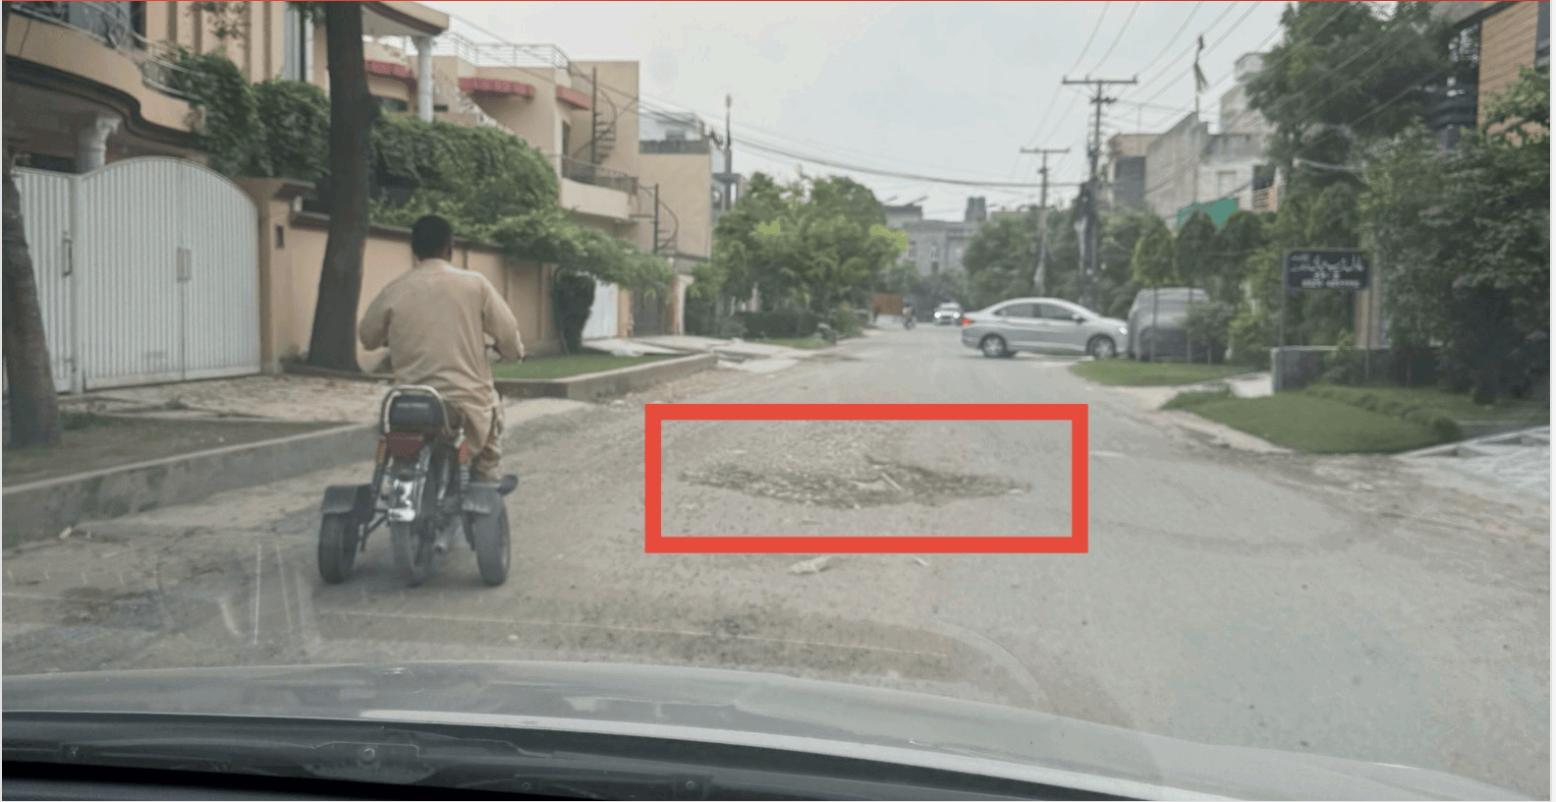
# Major Road Crater - Central Traffic Lane - 31.5238°N, 74.3575°E

**Description:** Massive road crater (highlighted in red) occupying central traffic lane. This hazard forces all traffic into single lane operation creating dangerous head-on collision risks. Represents complete infrastructure failure requiring immediate emergency repair.

CRITICAL - EMERGENCY ROAD HAZARD

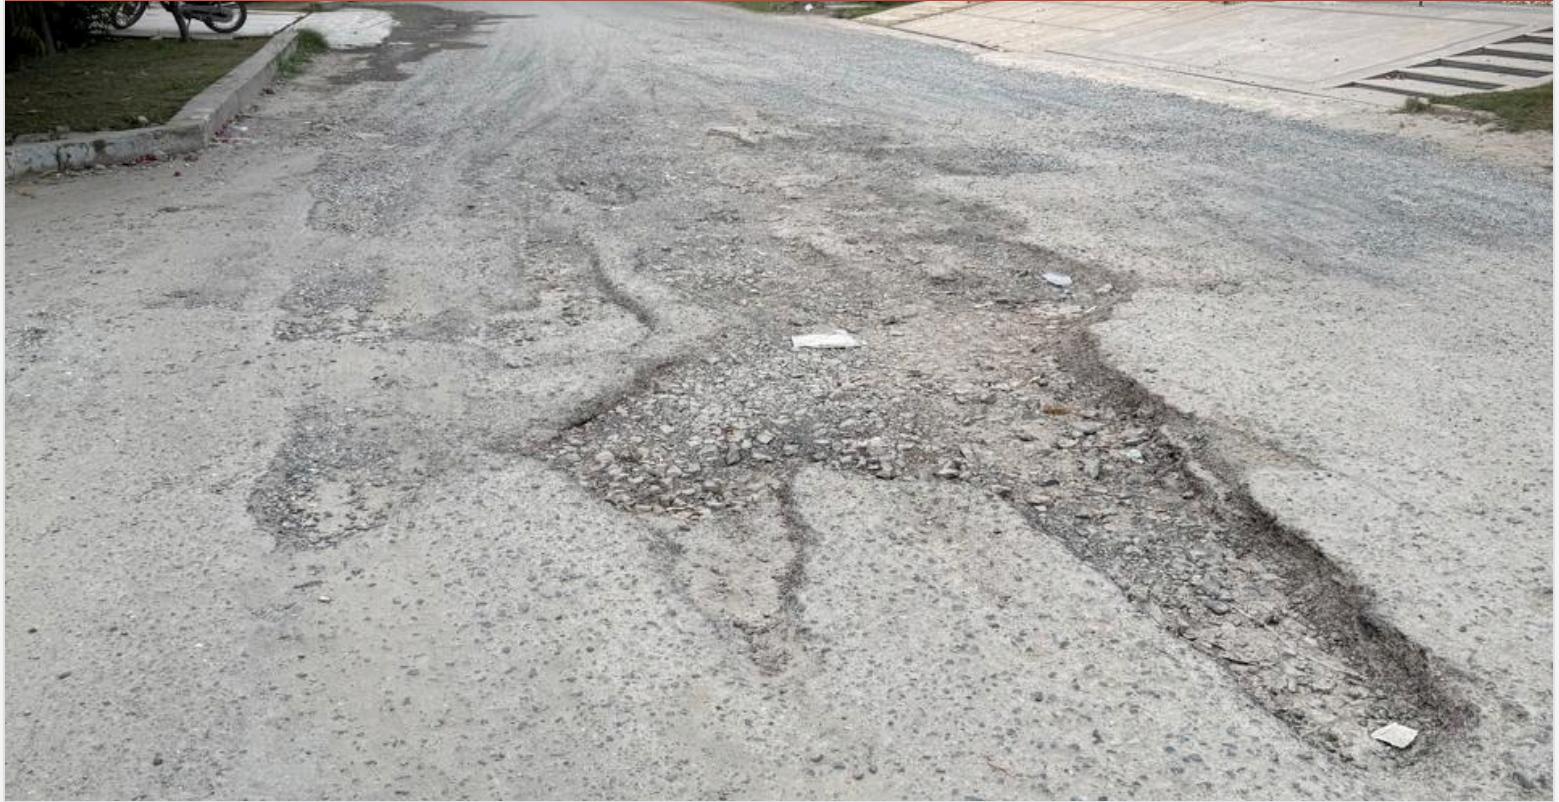
# Severe Road Deterioration - Residential Access - 31.5245°N, 74.3572°E

**Description:** Extensive road surface deterioration with overlapping potholes and structural cracks. Despite serving high-end residential properties visible in background, this access road receives no maintenance. Demonstrates that neglect affects all economic segments in the area.

**CRITICAL - STRUCTURAL ROAD FAILURE**

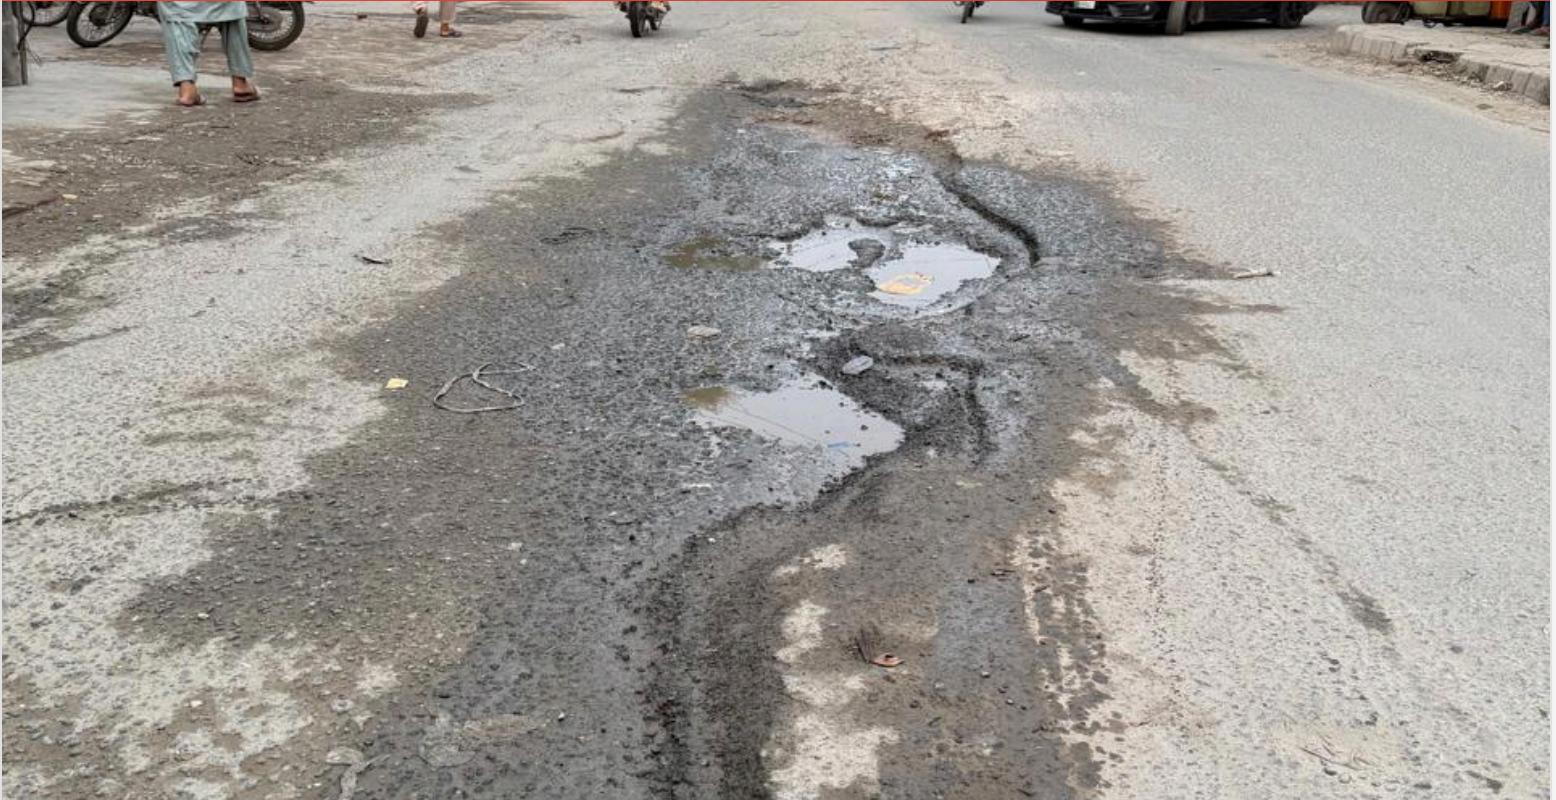
# Water-Logged Potholes - Active Traffic Zone - 31.5252°N, 74.3568°E

**Description:** Water-logged potholes in center of active traffic lane. Motorcycles, cars, and rickshaws forced to navigate around standing water hazards. Complete drainage system failure evident. During monsoon season, these become major flooding points affecting entire area accessibility.

**CRITICAL - DRAINAGE & TRAFFIC HAZARD**
