# AccessScan Compliance Audit Report

Audit Identifier Reference: 9382370c  
Overall Compliance Valuation Score: 90% (Excellent Accessibility Profile)

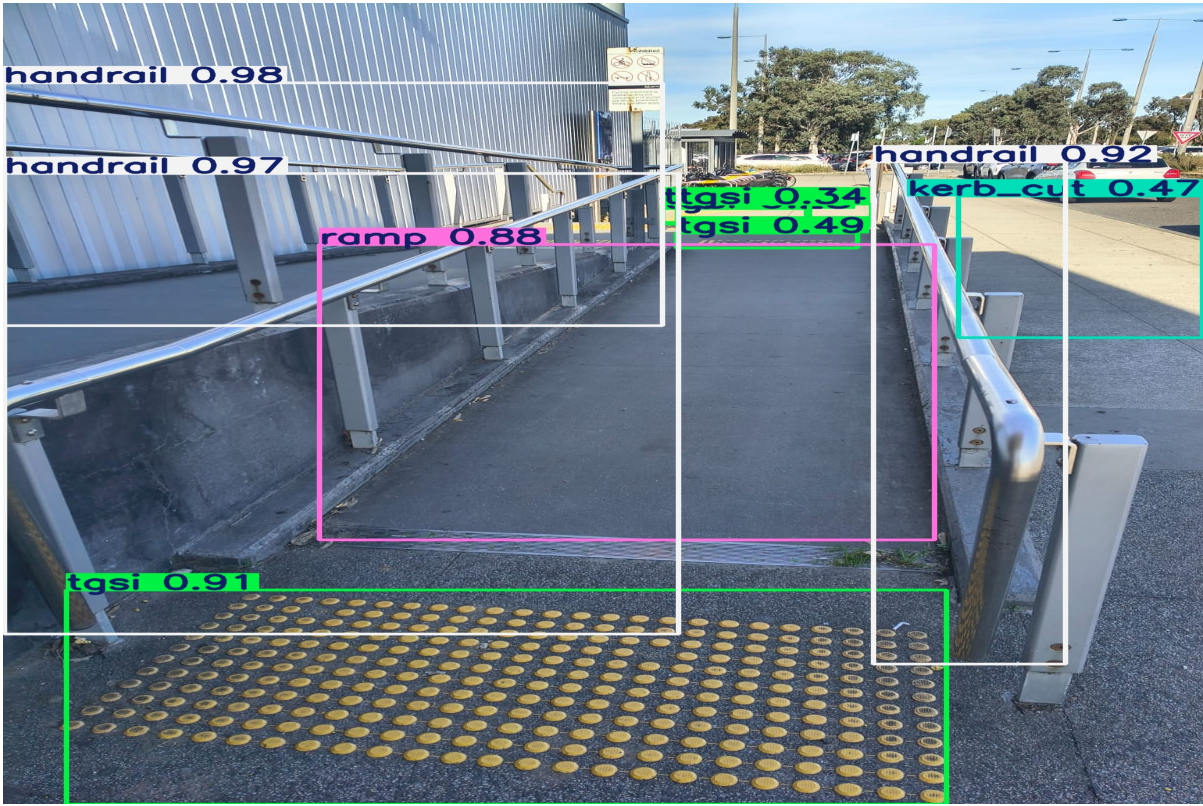
## Captured Audit Visual Instance Frame:

| <b>RAMP</b> | DSAPT Part 5.2 | <b>NON-COMPLIANT</b> | Evaluated gradient is 12.0° — Violates the 1:14 threshold requirement limit[cite: 242]. |
