# AccessScan Compliance Audit Report

Audit Identifier Reference: c40c4721  
Overall Compliance Valuation Score: 90% (Excellent Accessibility Profile)

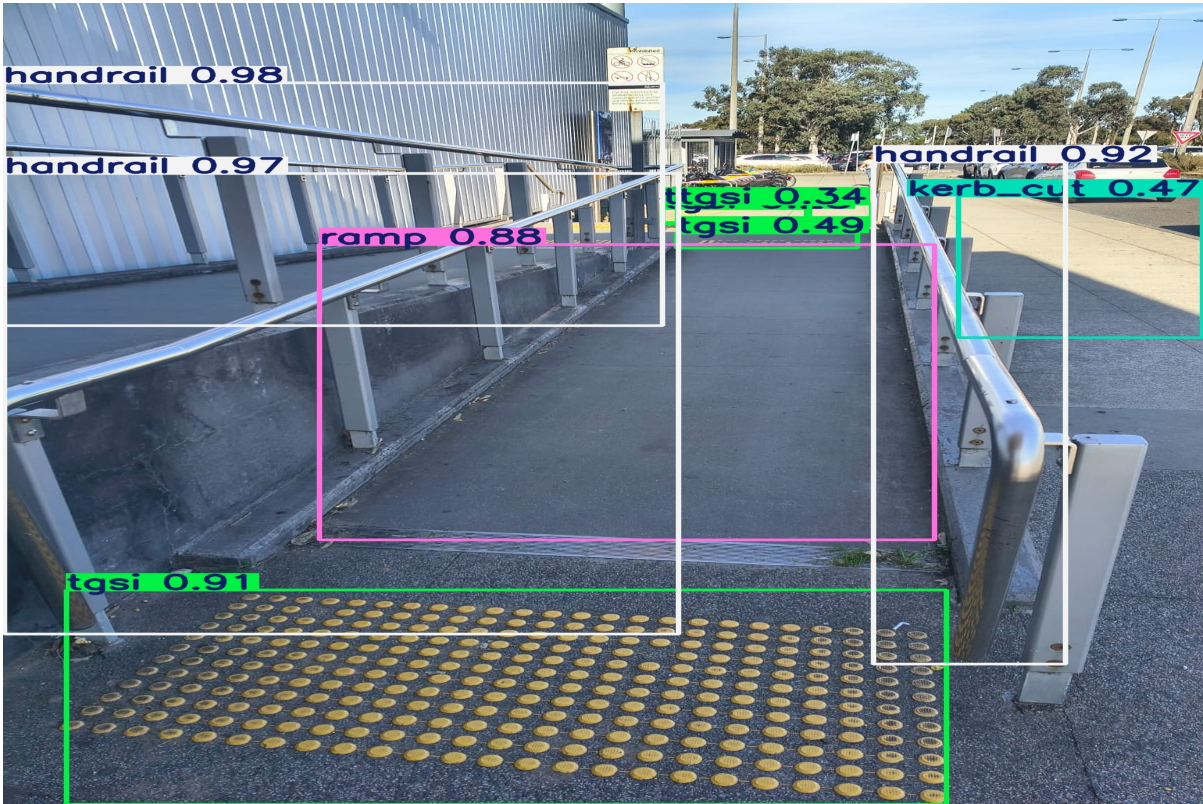
| <b>RAMP</b> | DSAPT Part 5.2 | <b>NON-COMPLIANT</b> | Evaluated gradient is 12.0° — Violates the 1:14 threshold requirement limit[cite: 242]. |
