# FA report of TP NG issue (NDF)

JUNGLIM G140HAB01.2

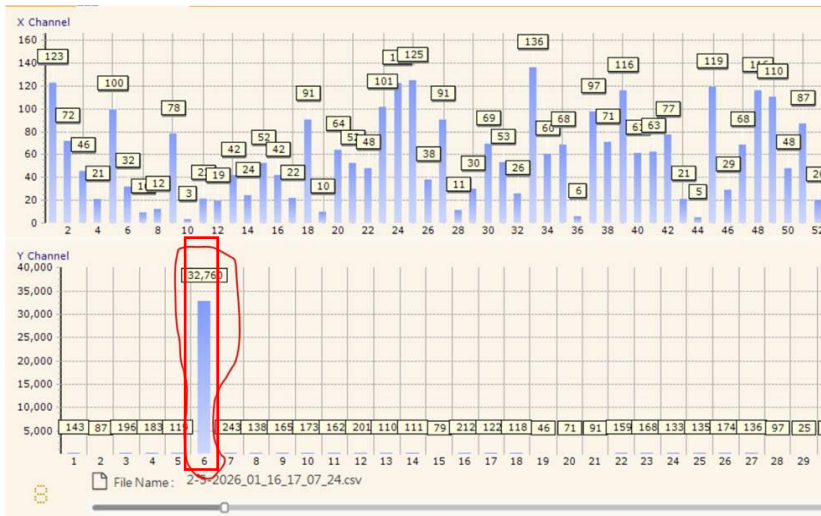
- 1) JUNGLIM found one piece of G140HAB01.2 panel with TP NG (Intermittent Touch Malfunction)
- 2) After checking the phenomenon, the symptom is not visible in AUO.

Customer reported  
abnormal TX6 value

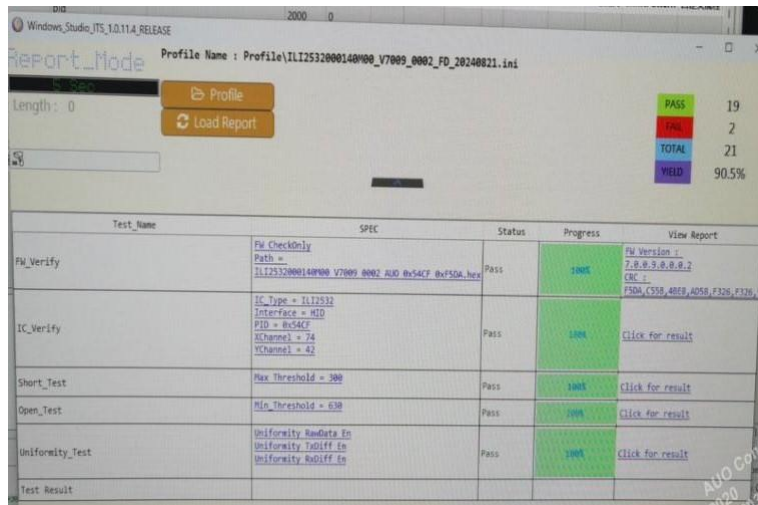
- Step1: During the full panel functional test, all test cycles (20 cycles) passed without any abnormal findings. The Uniformity test also showed no NG result, and no issue related to TX6 was observed during the evaluation.

No TP NG  
detect

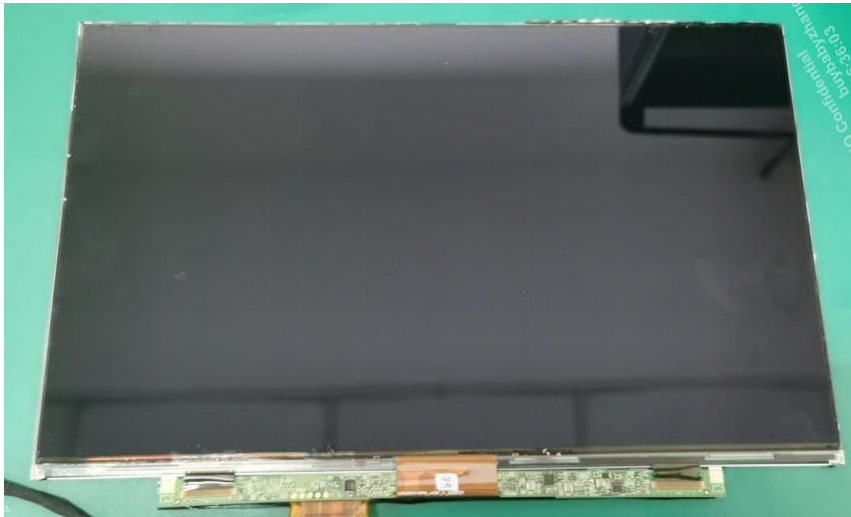
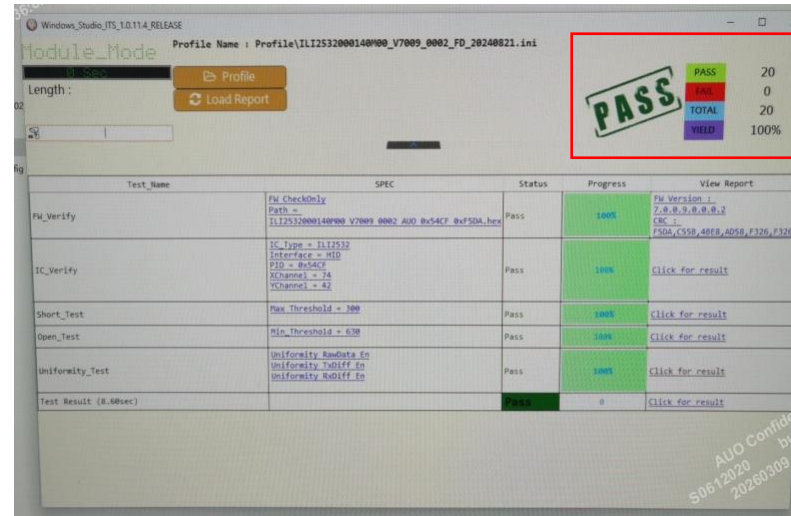
- Step2: After removing the lens, the standalone panel was retested for 20 cycles, and no TP NG was observed.

no TP NG was  
observed

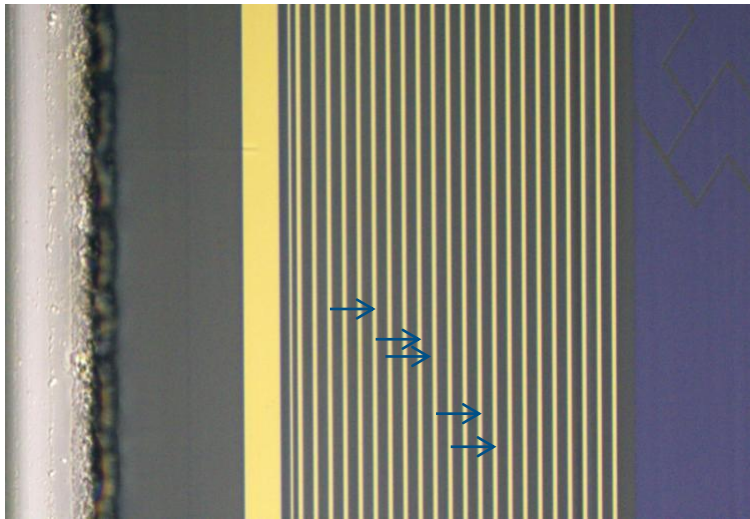
- Step3: Under OM inspection, the short-edge TX fan-out traces were checked.  
No short or damage was observed on any of the related TX fan-out lines.

TX6/9/10/13/14  
fanout OK

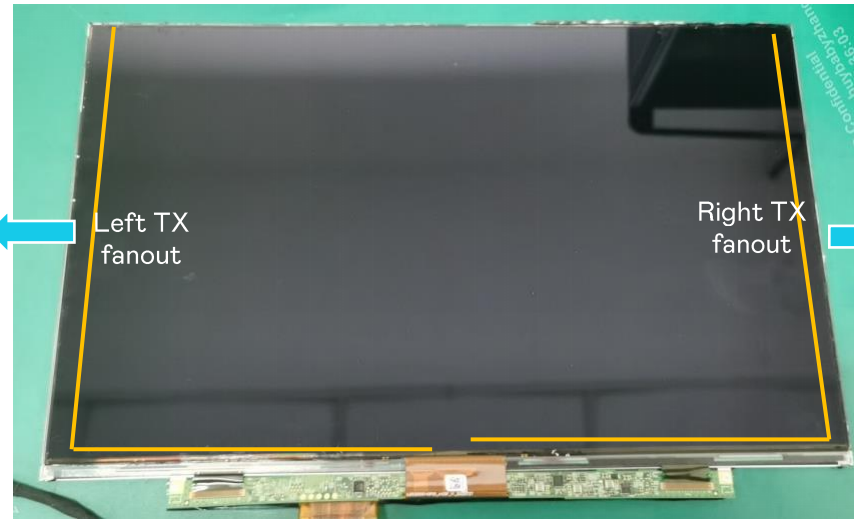
TX fan-out  
distribution

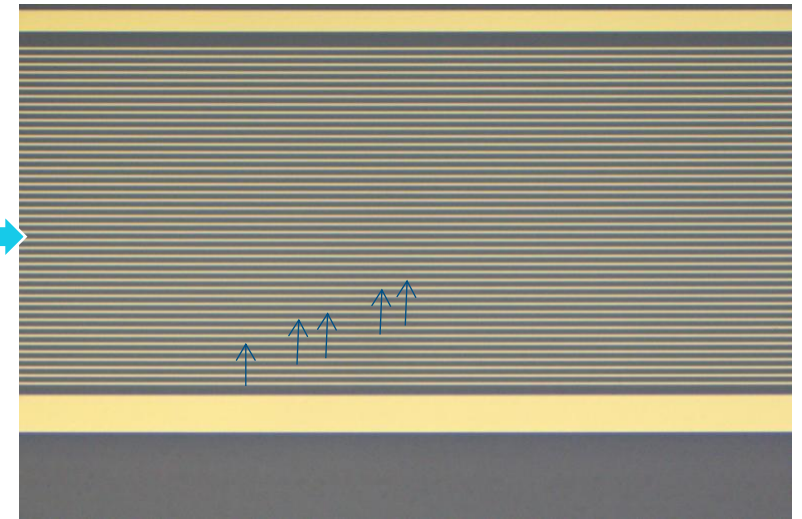
TX6/9/10/13/14  
fanout OK

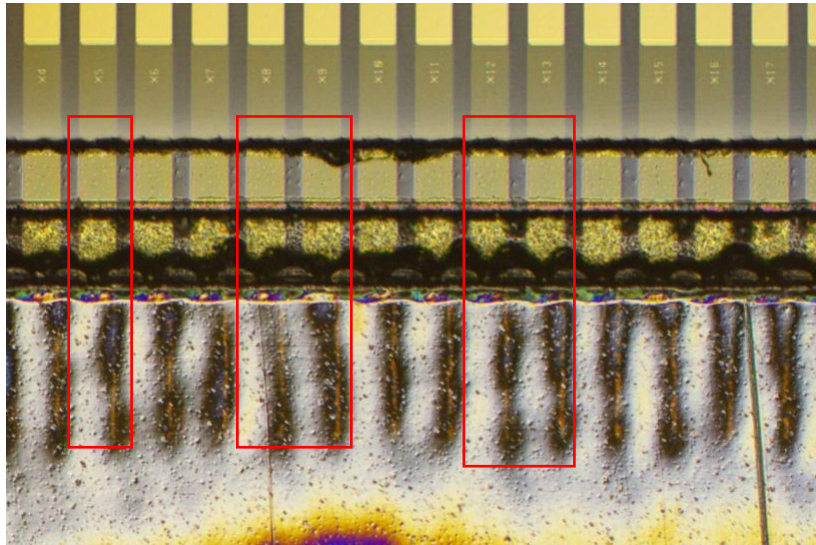
- Step4: Under OM inspection, the TP FPC bonding at the corresponding TX6 / TX9 / TX10 / TX13 / TX14 locations was examined. Clear bonding marks were observed, indicating that the bonding condition is normal with no signs of open or damage.

Left side TX6 / 9 / 10  
/ 13 / 14 bonding OK
