# FA report of Ghost Touch (NDF)

JUNGLIM G156HAB03.2

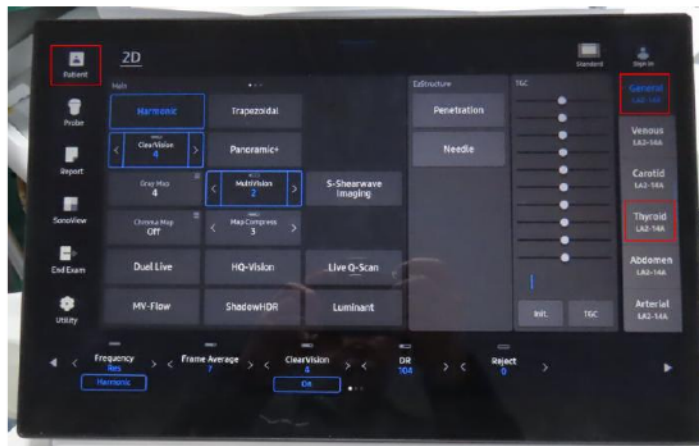
Customer Reported Symptom

1. The customer reported that a Ghost Touch phenomenon occurred during field use.
2. Intermittent touch input is detected in the area marked in red even when no physical touch is applied.
3. JUNGLIM also conducted reproduction verification; however, the reported symptom could not be reproduced.

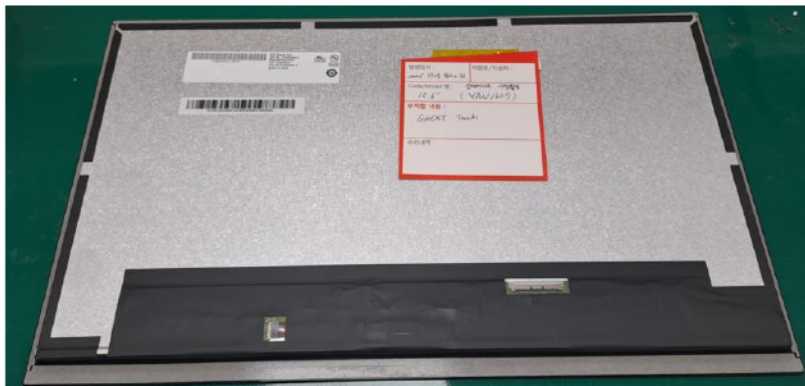
No abnormality was found on the panel appearance. No cosmetic defect, damage, or contamination was observed on either front or rear side.

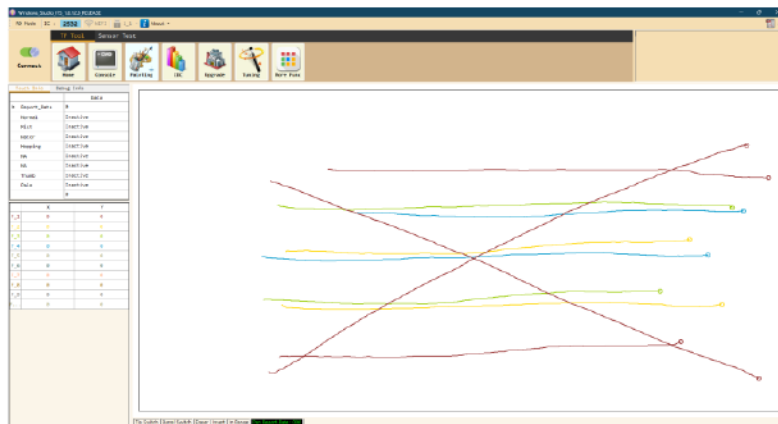
Drawing and Multi-Touch Test

During drawing and multi-touch operation, normal touch functionality was confirmed with no interruption or malfunction observed.

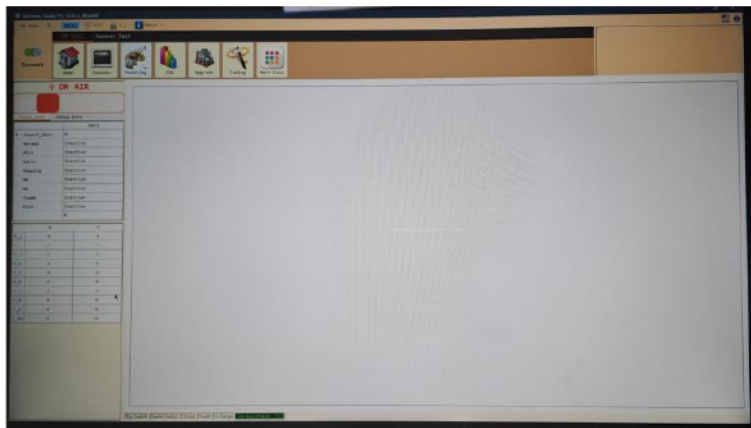
A painting program was used to verify whether any Ghost Touch phenomenon occurred, and no abnormality was observed.

A 96-hour recording test was conducted under both room temperature and 40°C conditions for 48 hours each.

If any touch event had occurred, the corresponding data was expected to be recorded; however, no related data was found in the recorded log.

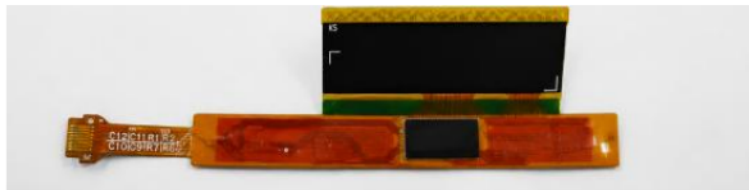
Surface condition and solder points were inspected using CCD equipment, and no abnormality was observed.

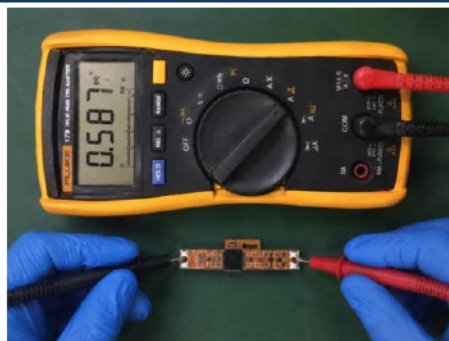
The returned sample showed a voltage drop of approximately **0.587 V**, which was consistent with the normal reference condition.

Additionally, a 48-hour aging test at 80°C was conducted on the TP and Touch Controller Board assembly. No Ghost Touch phenomenon was observed during the test, and the reported symptom could not be reproduced.

Good IC voltage drop measurement = 0.587DCV
