# FA report of Abnormal Display issue

JUNGLIM A070VW08 V2

AUO

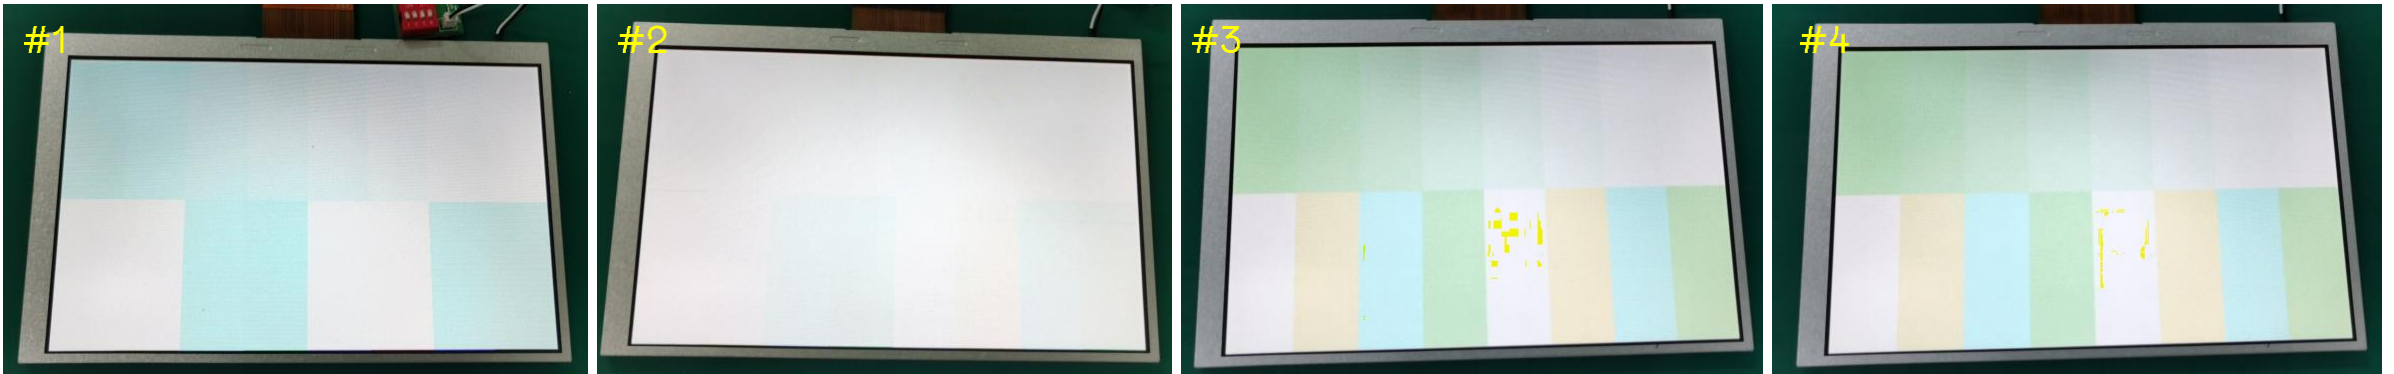
- 1) JUNGLIM returned 4pcs A070VW08 V2 panel with Abnormal Display .
- 2) After checking the phenomenon, the symptom can be seen in AUO.

The 4 panels image are same pale

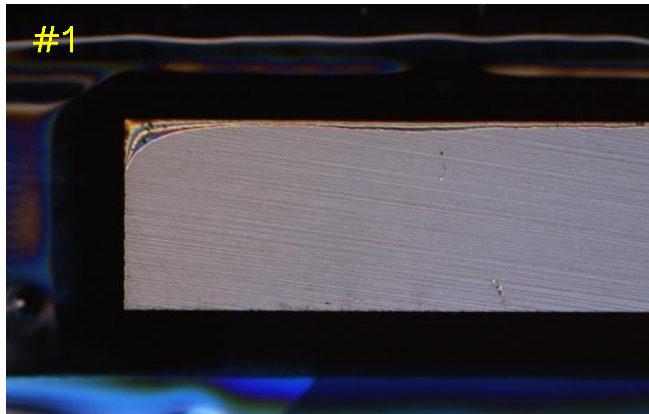
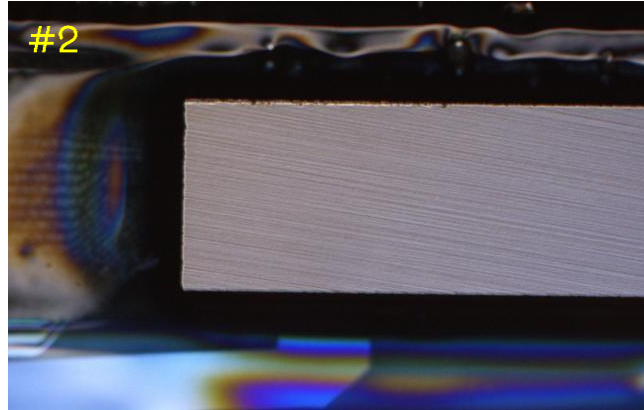
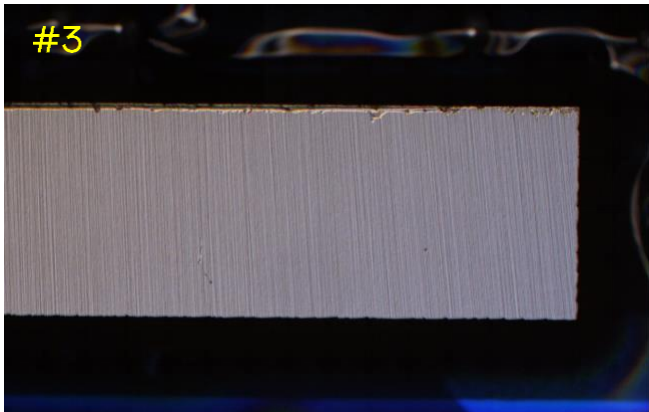
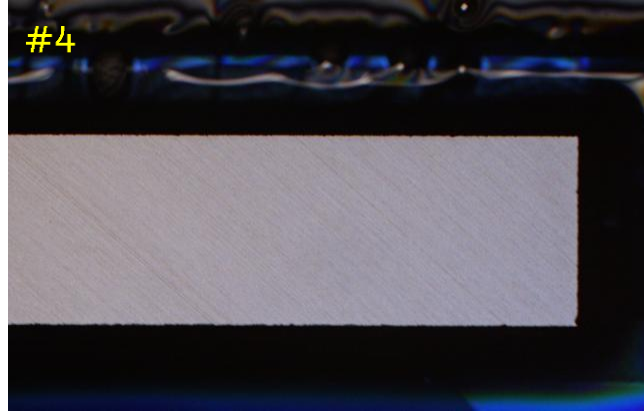
- Step2: There is no abnormality in the appearance of S-IC when observing the 4 panels, and the tuffy glue is also normal.

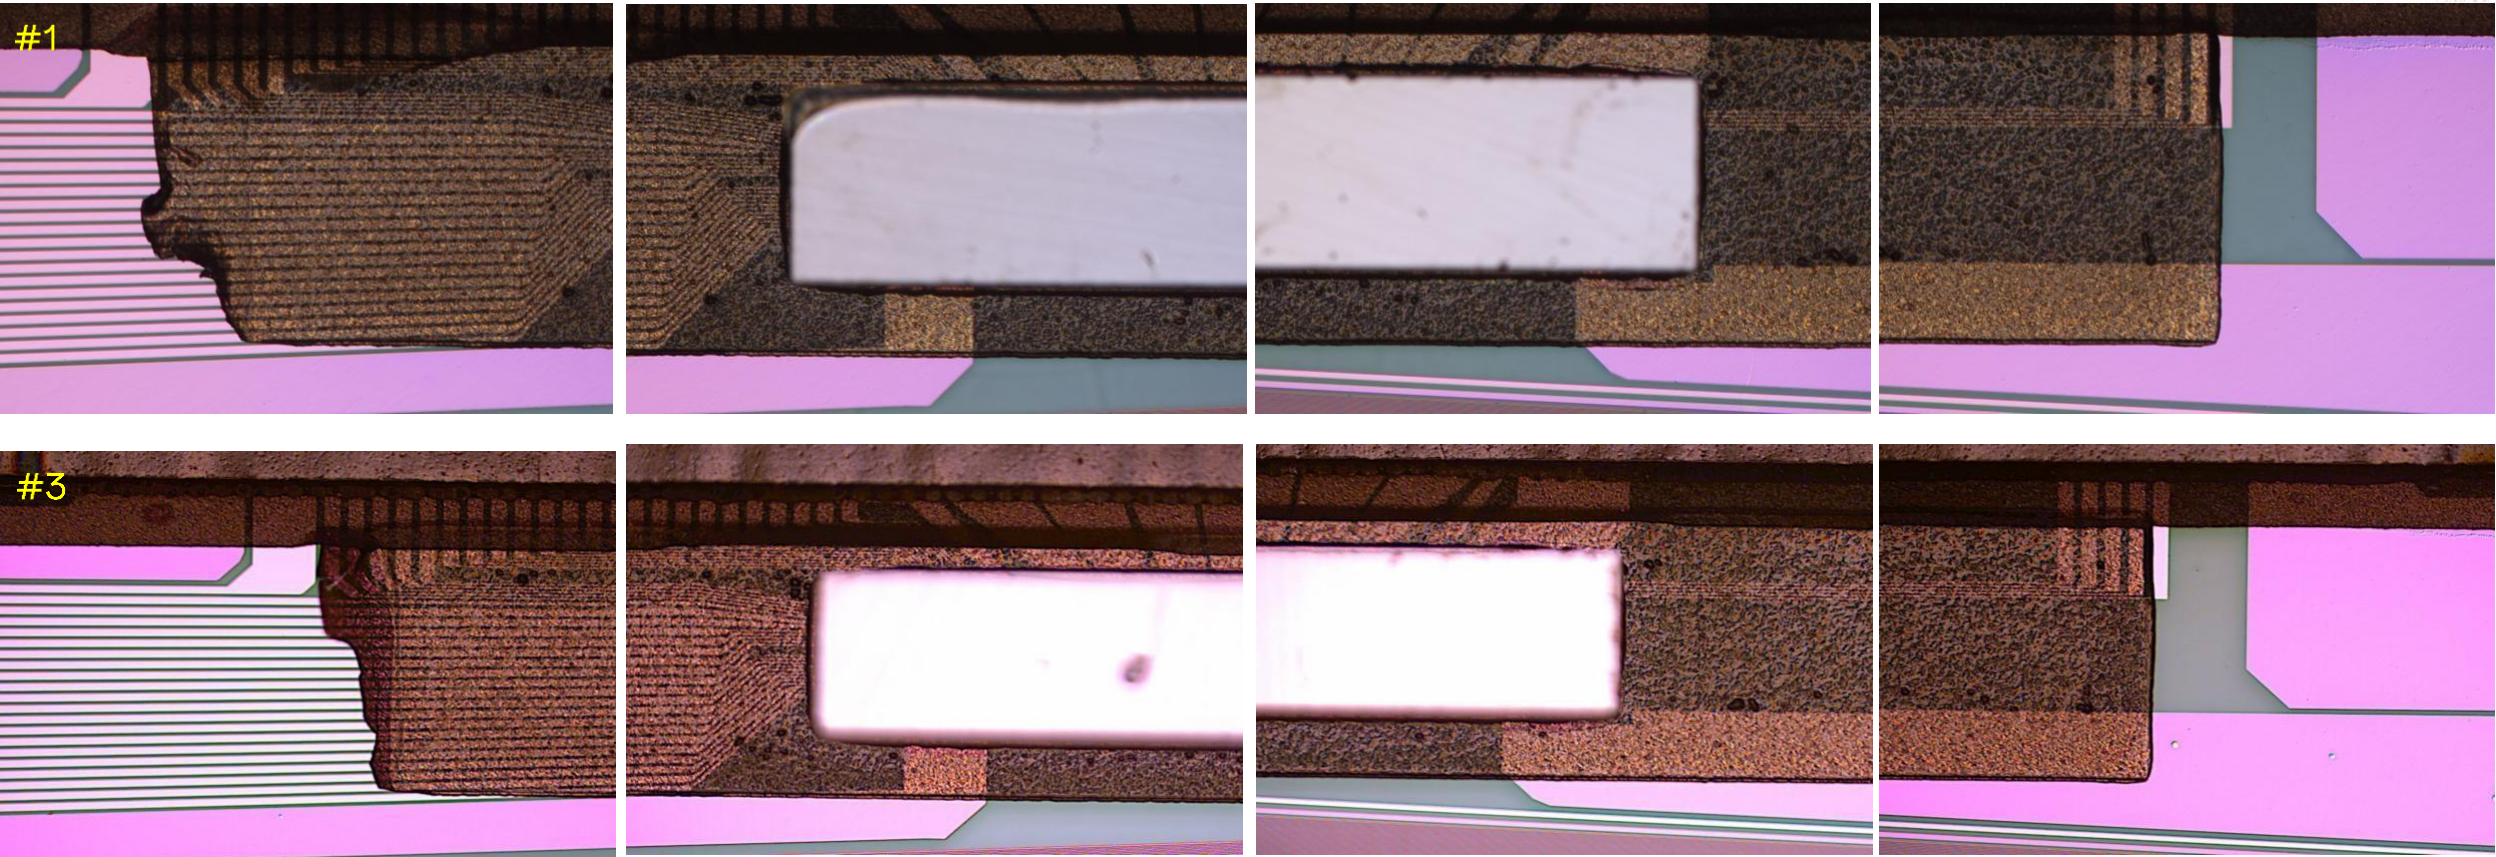
- Step5:random picked 2pcs and clean the tuffy, use OM check the SIC and ACF status are normal.

IC、ACF外围无异常

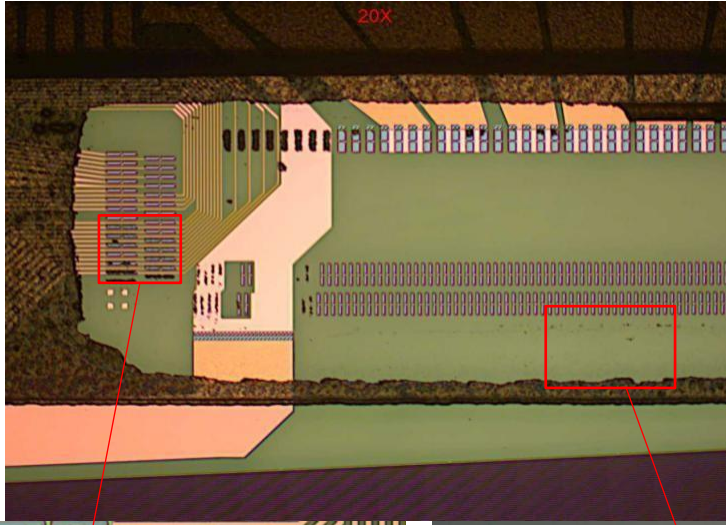
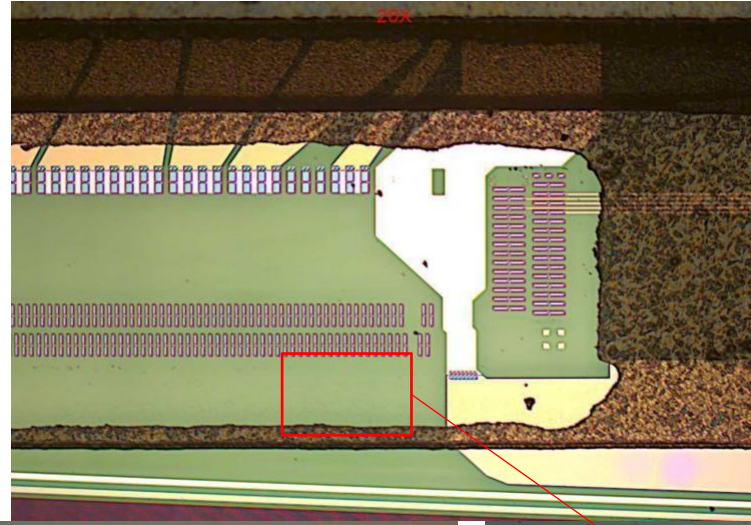
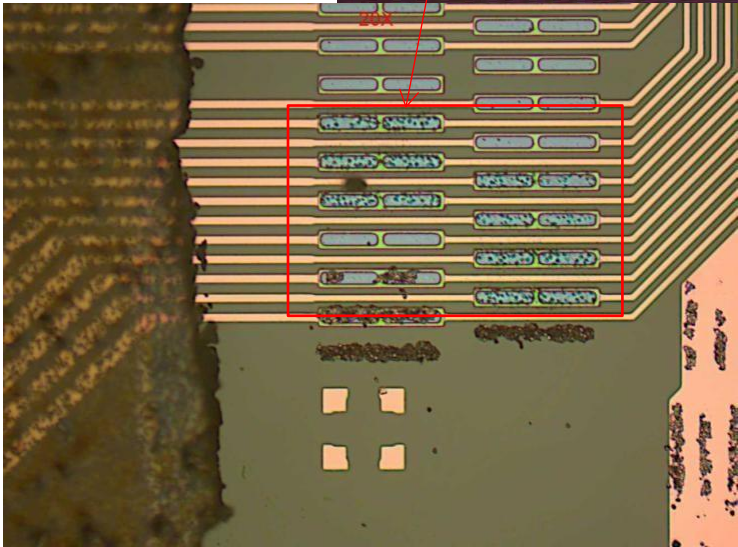
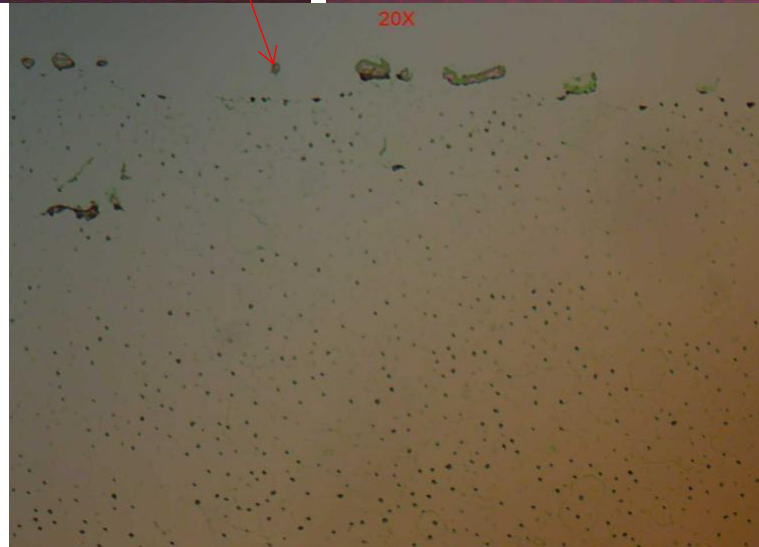
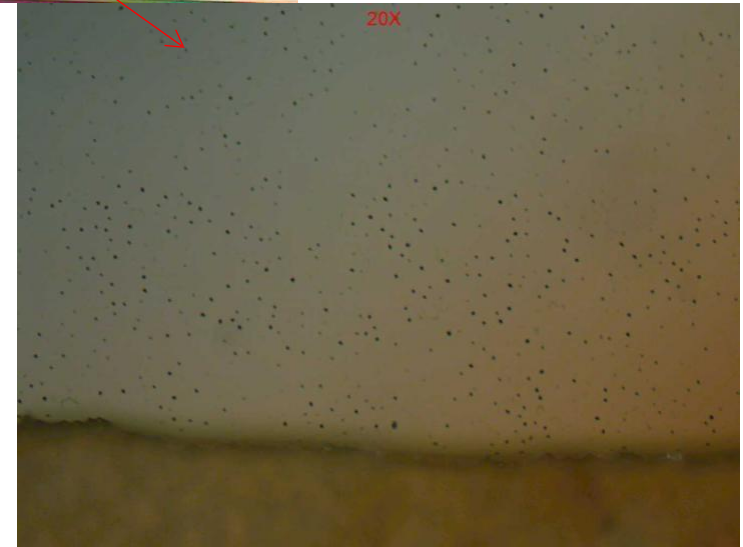
- Step6: Remove the #1 S/IC, use OM we see some smudge on the glass on the circuit

- Modify the process of product -2024/8
- The LCC machine had been inhibited
- Add EC clean and Plasma to ensure the cleanness of the circuit area.

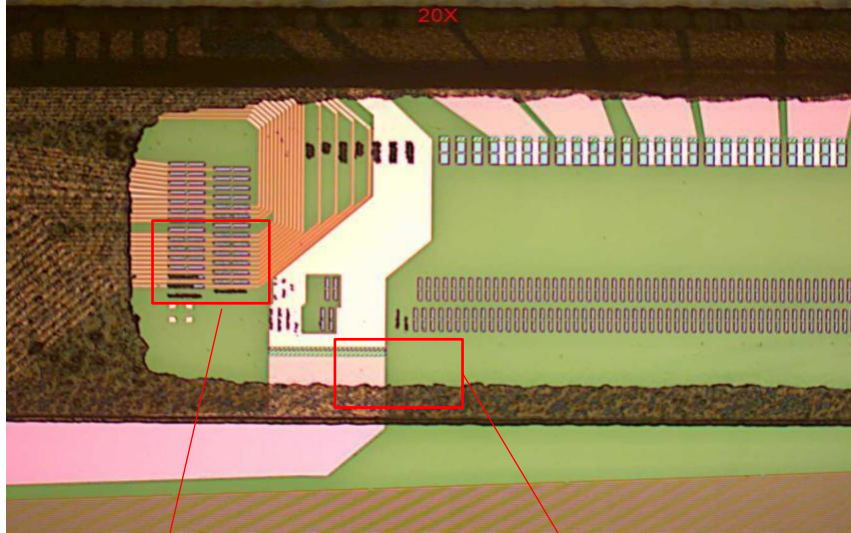
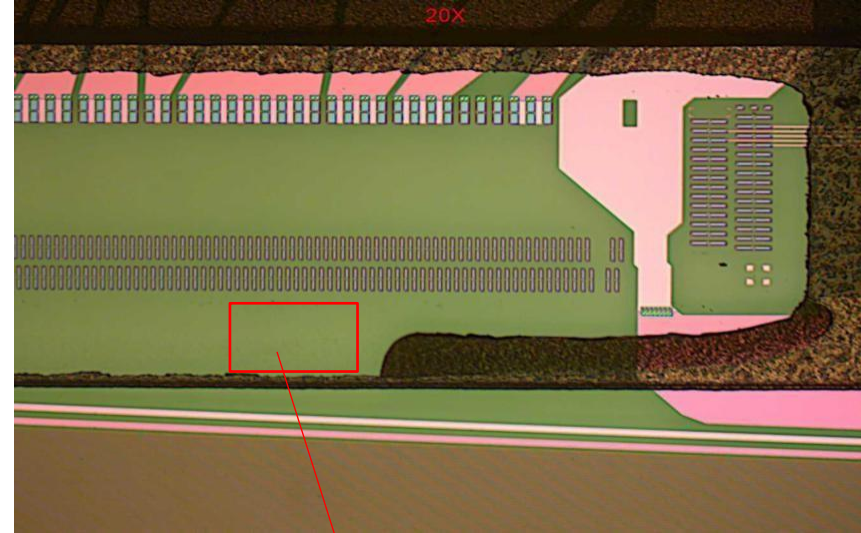
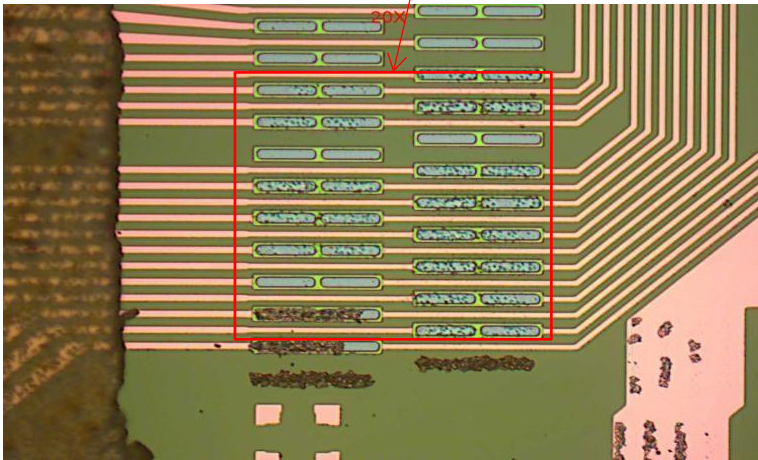
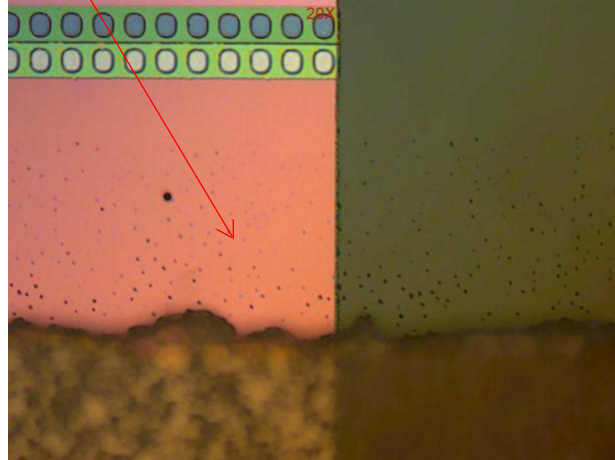
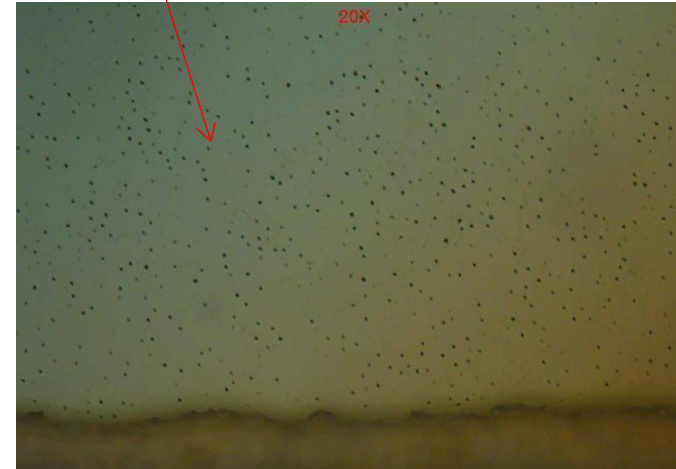
- Step7: Remove the #3 S/IC, use OM we also see some smudge on the glass on the circuit.

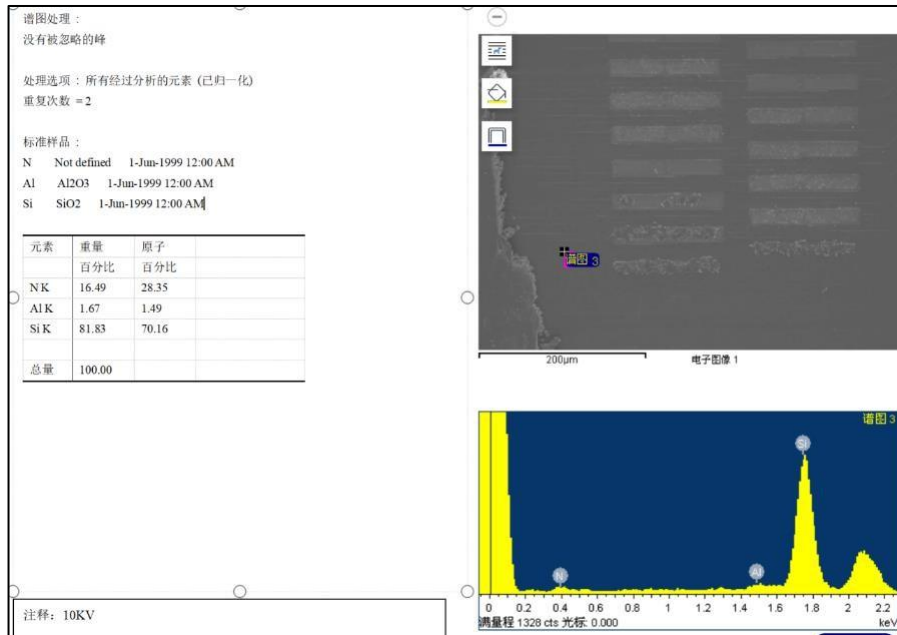
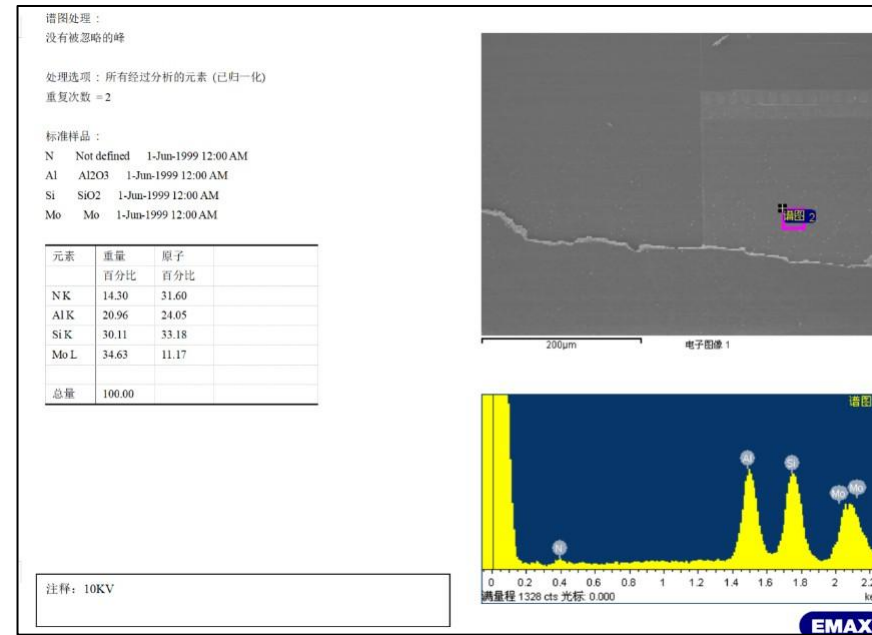
EDS result

- Step8: The EDS show no abnormal element on the smudge, so the smudge should be composed of ACF&particle.

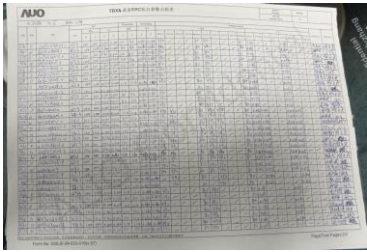
Parameter  
check list

3/5 no tooling and mfg status abnormality found in checklist

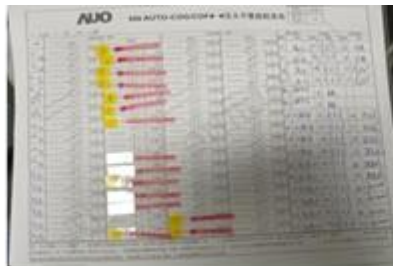
Pressure head  
Flatness check list

5/13 no tooling and mfg status abnormality found in checklist

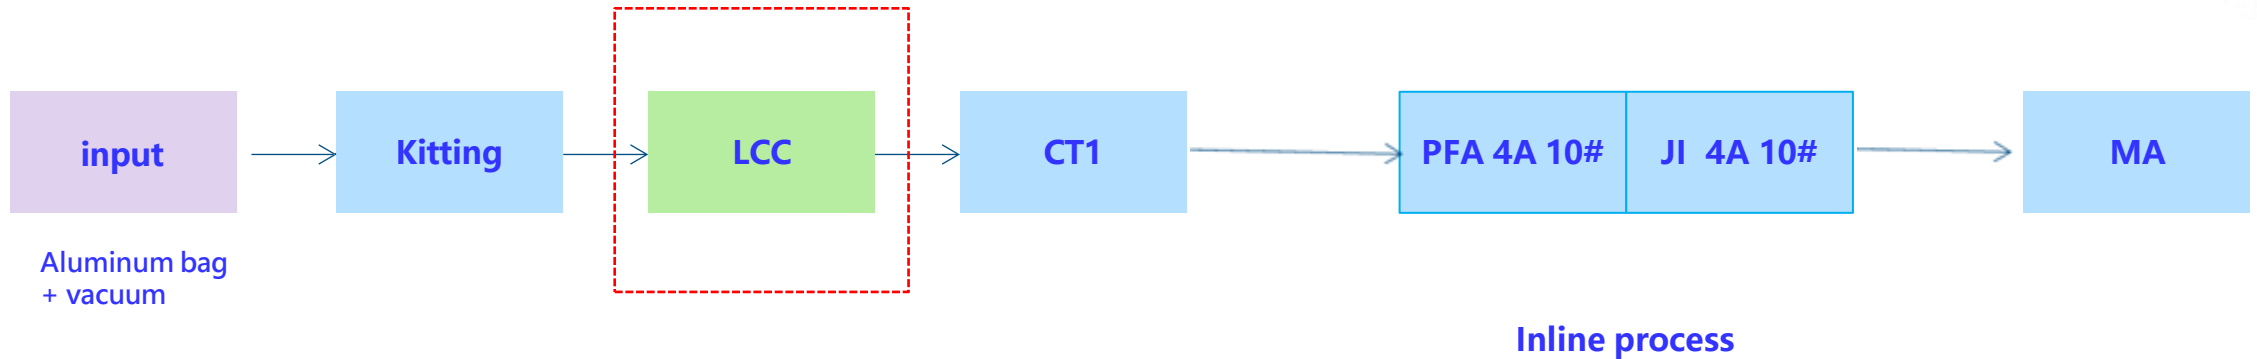
- Step12: The process that could cause smudges on the glass surface is the LCC cleaning process.
